# IndianOil

## JOURNEY RISK MANAGEMENT (JRM) STUDY

### Salem Terminal to SASTHA FUELS

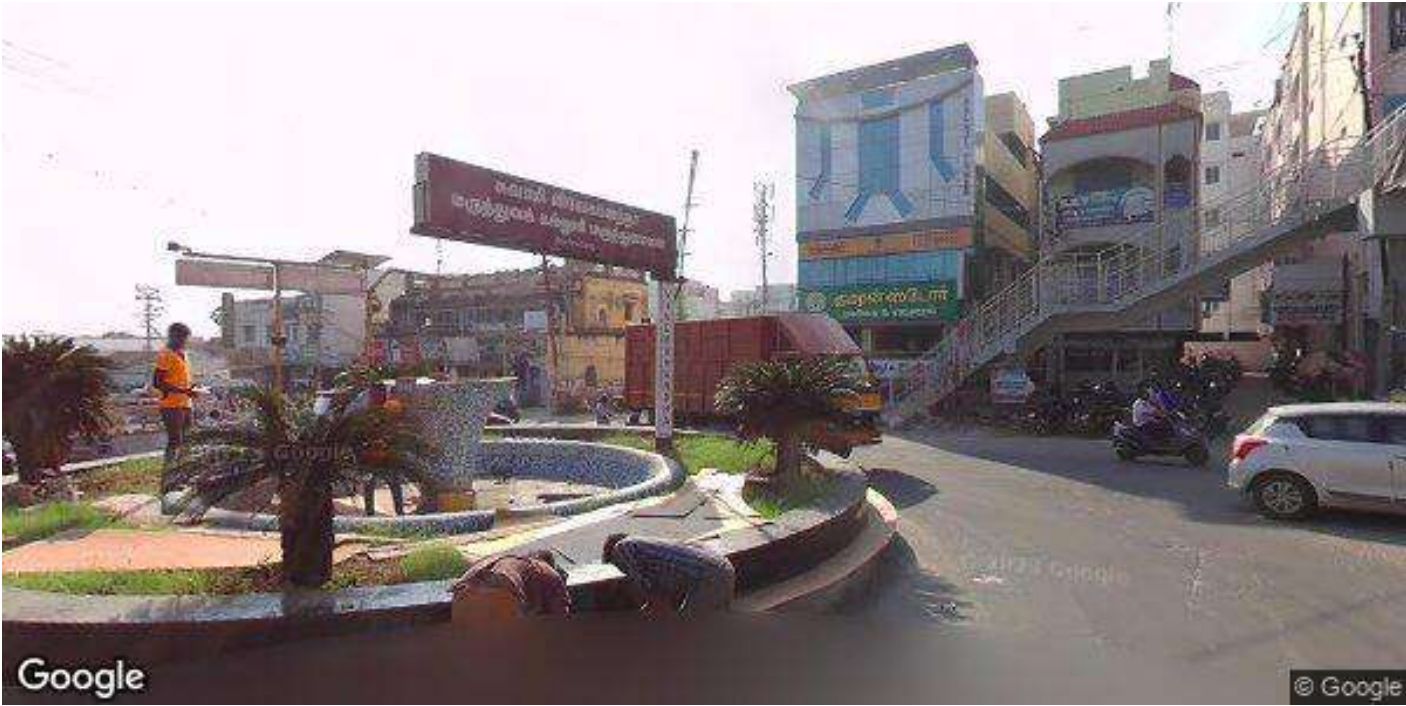
Coordinates: 11.38395, 77.89480

Risk Type: Roundabout

Risk Level: High

Speed Limit: 15 KM/Hr

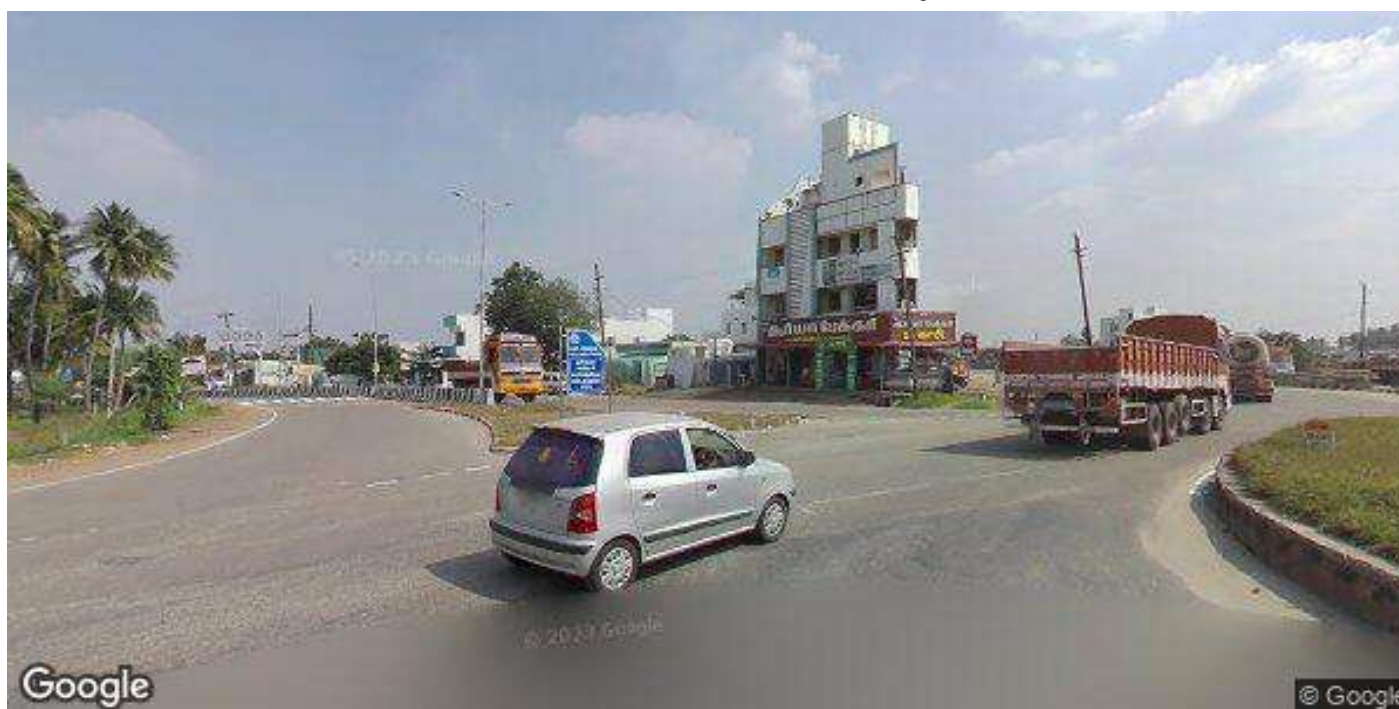
**Coordinates:** 10.92958, 78.05452

**Risk Type:** Roundabout

**Risk Level:** High

**Speed Limit:** 15 KM/Hr

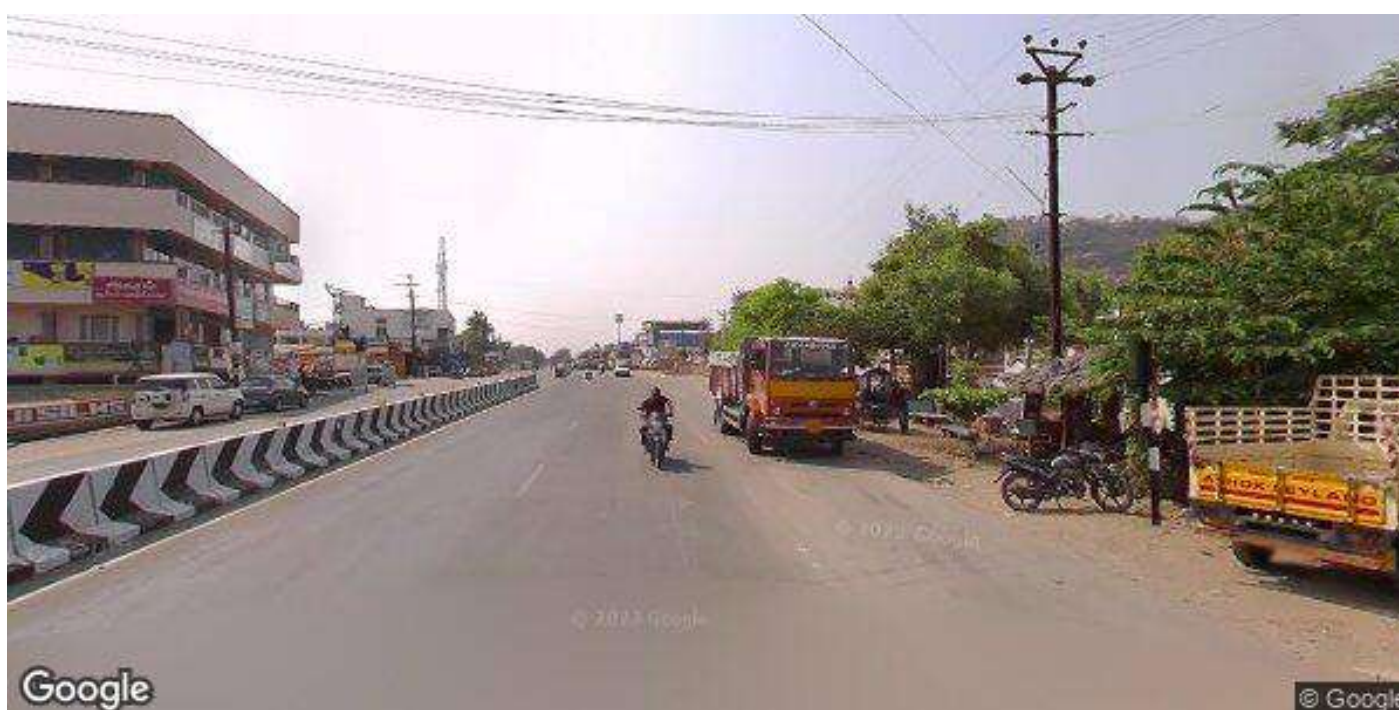
**Coordinates:** 11.39685, 77.88861

**Risk Type:** Turn

**Risk Level:** Medium

**Speed Limit:** 30 KM/Hr

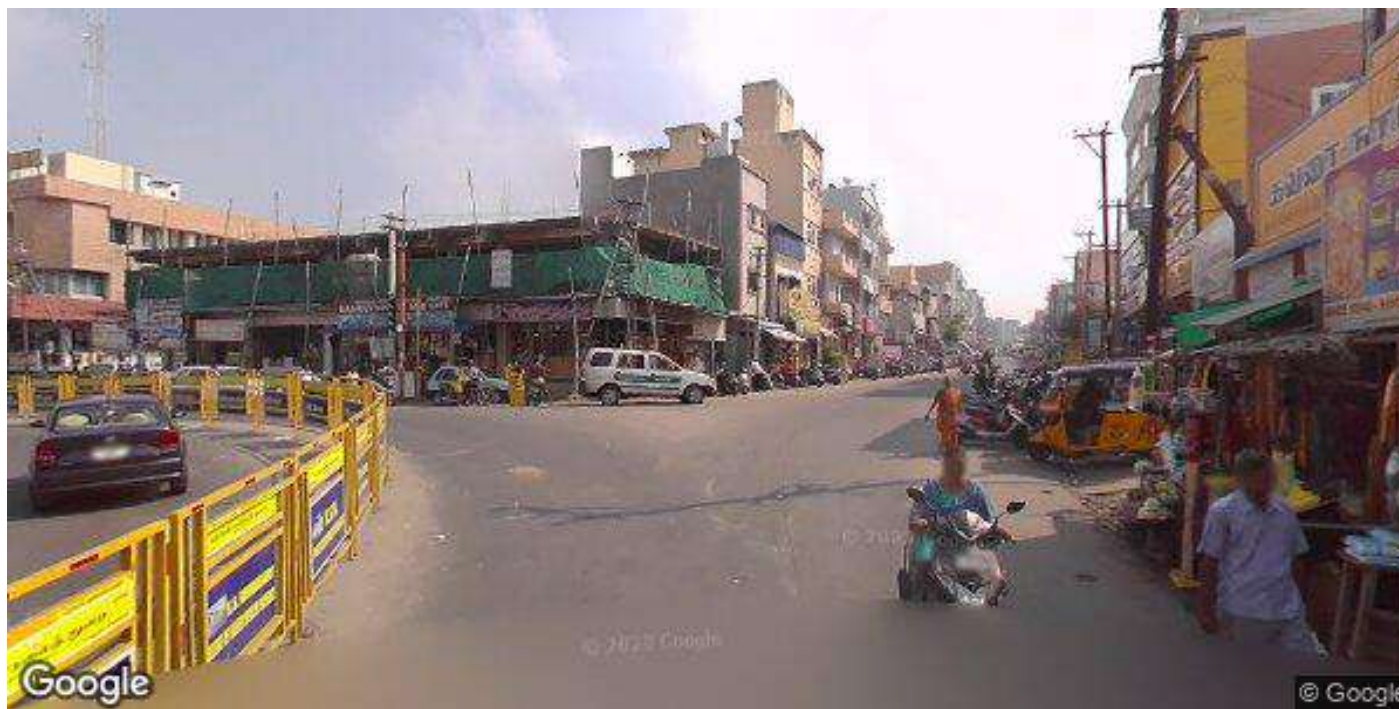
**Risk Type:** Turn  
**Risk Level:** High  
**Speed Limit:** 15 KM/Hr  
**Coordinates:** 11.37862, 77.89488

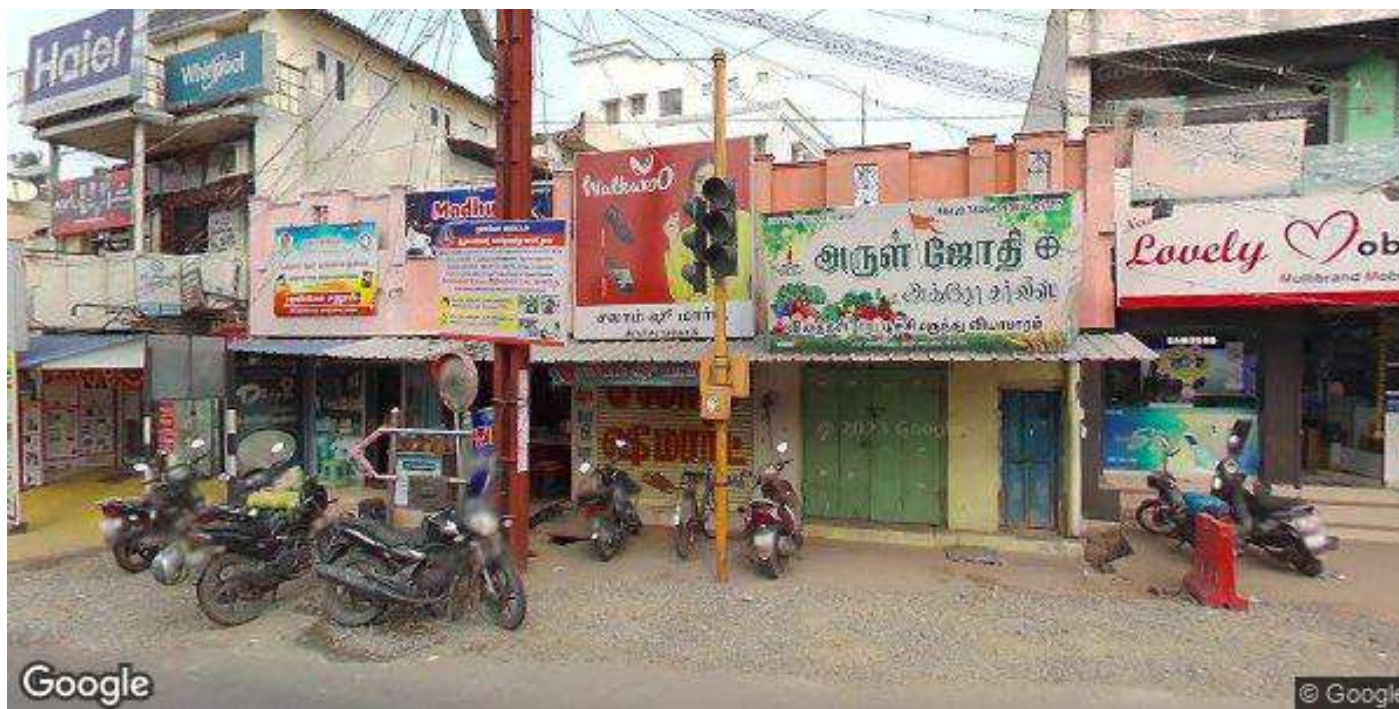
**Risk Type:** Turn  
**Risk Level:** High  
**Speed Limit:** 15 KM/Hr  
**Coordinates:** 11.37850, 77.89453

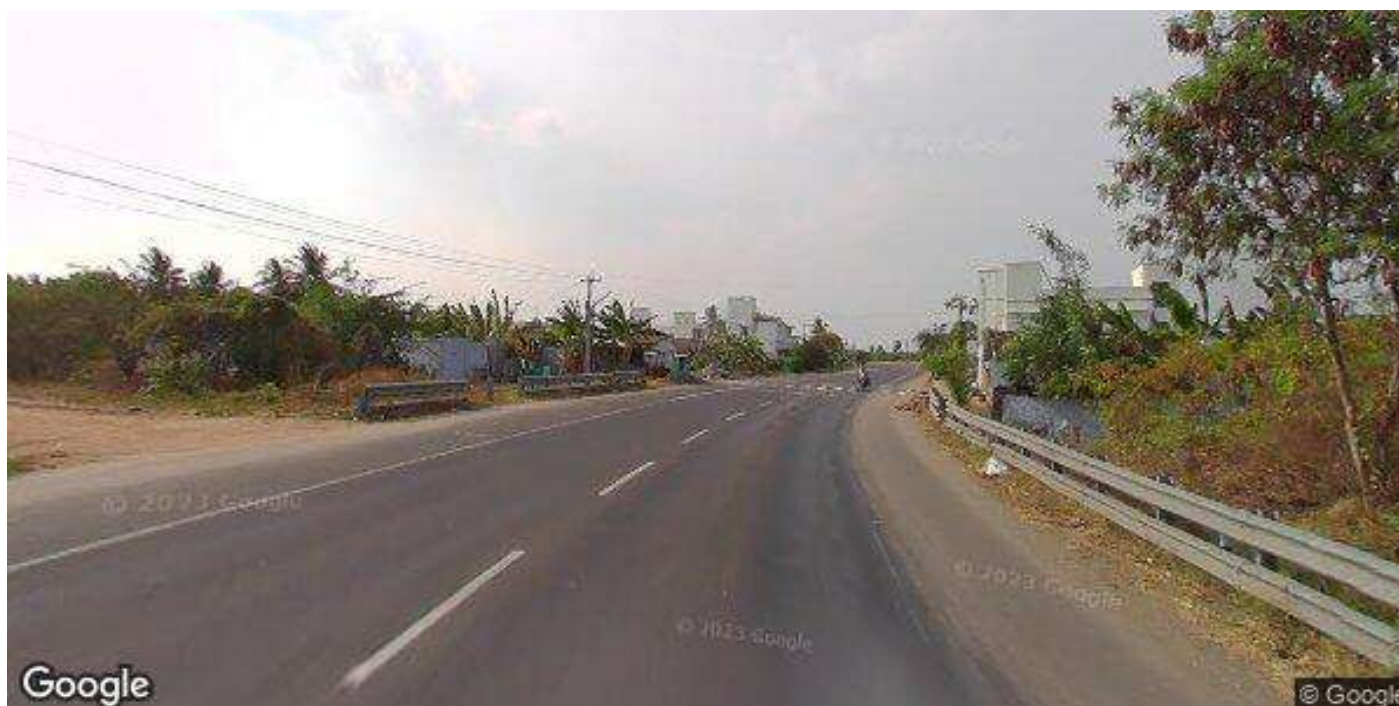
**Risk Type:** Turn  
**Risk Level:** Medium  
**Speed Limit:** 30 KM/Hr  
**Coordinates:** 11.16764, 78.01565

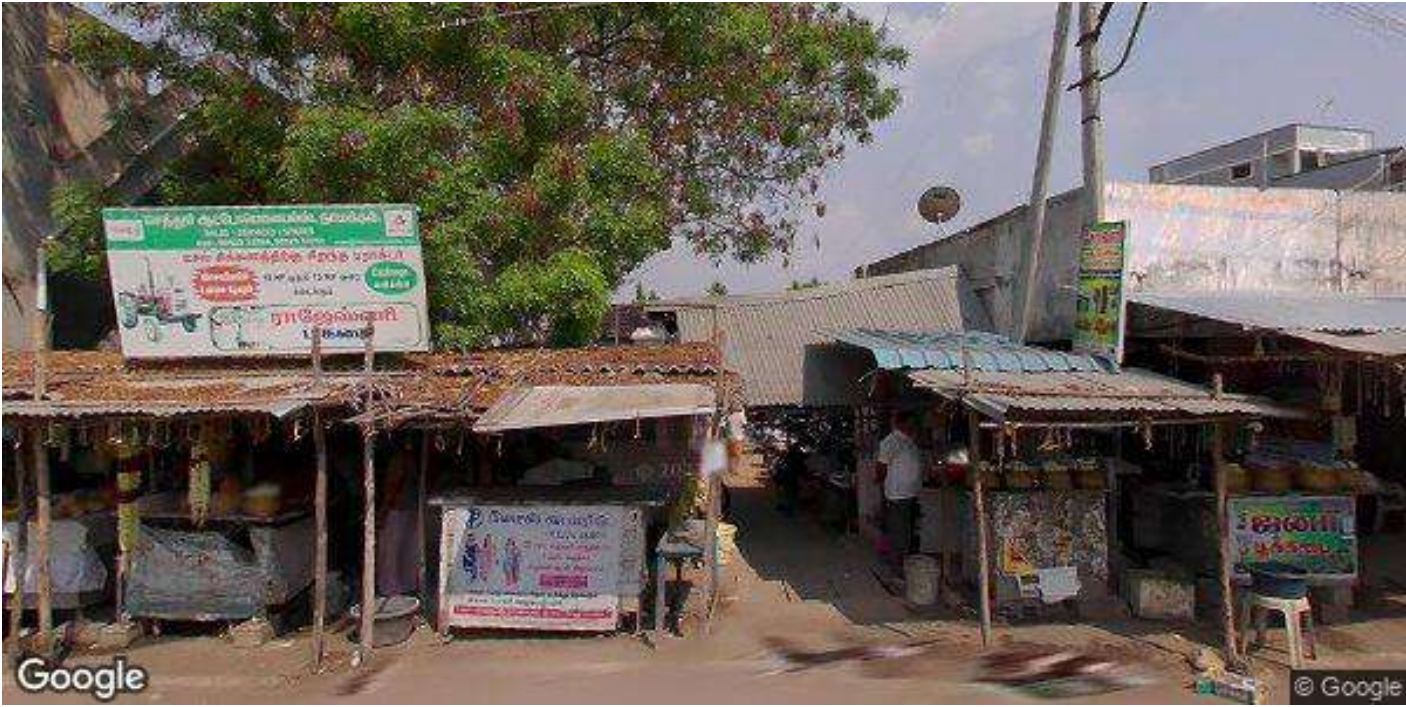
**Risk Type:** Turn  
**Risk Level:** High  
**Speed Limit:** 15 KM/Hr  
**Coordinates:** 11.15573, 78.02176

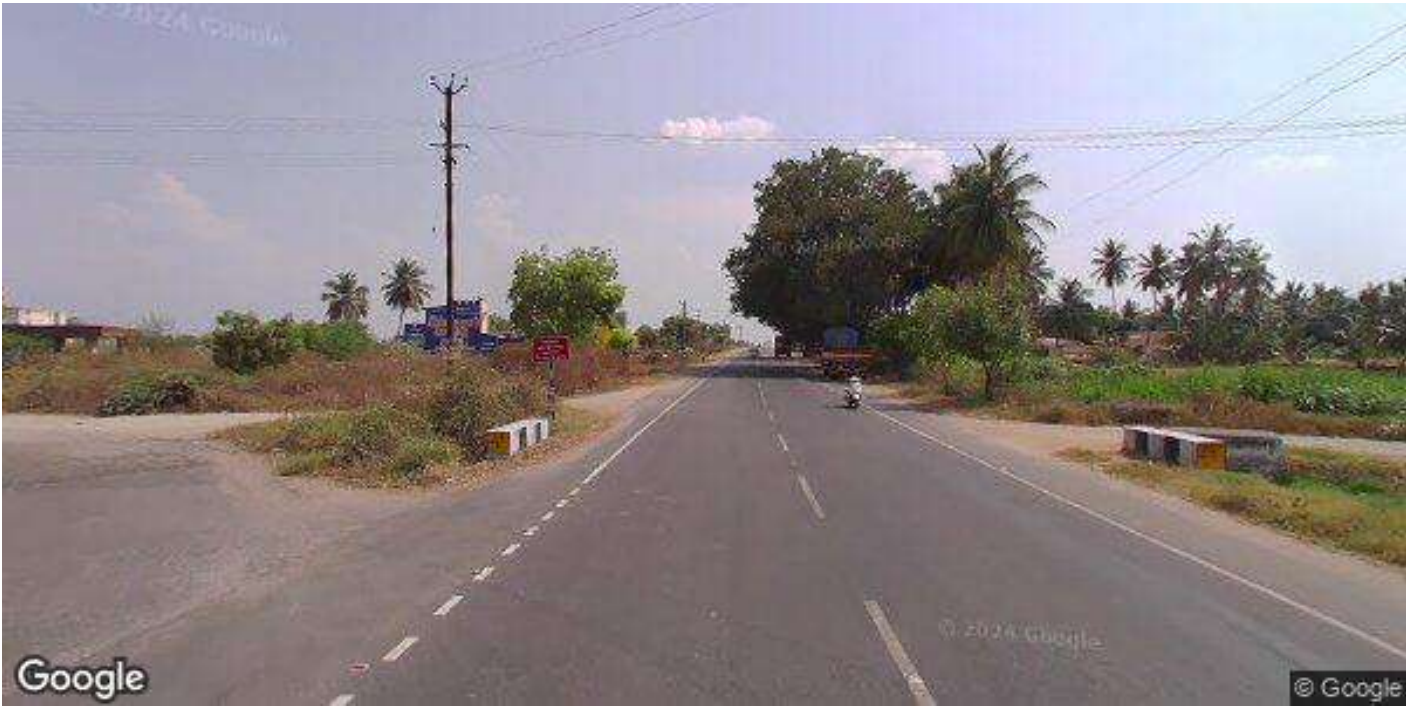
**Risk Type:** Turn  
**Risk Level:** High  
**Speed Limit:** 15 KM/Hr  
**Coordinates:** 11.14545, 78.02208

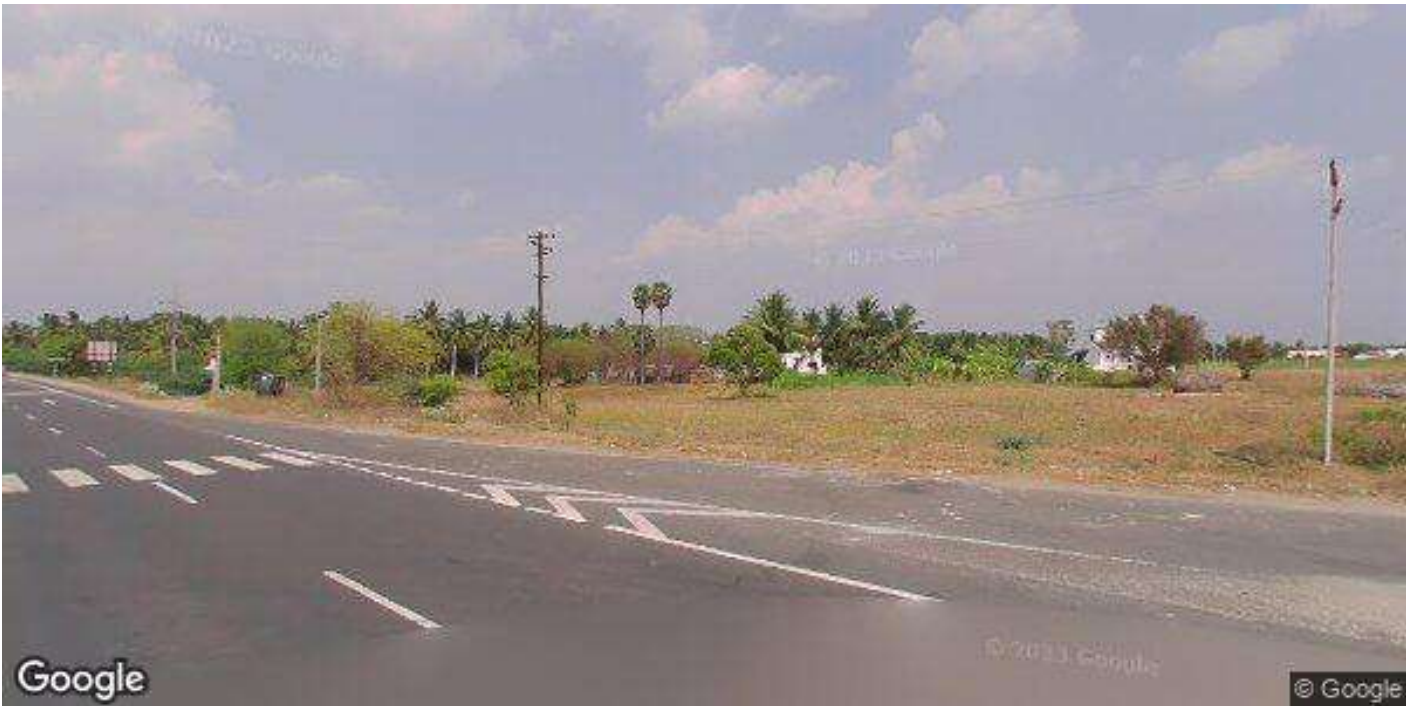
**Risk Type:** Turn  
**Risk Level:** High  
**Speed Limit:** 15 KM/Hr  
**Coordinates:** 11.14480, 78.02291

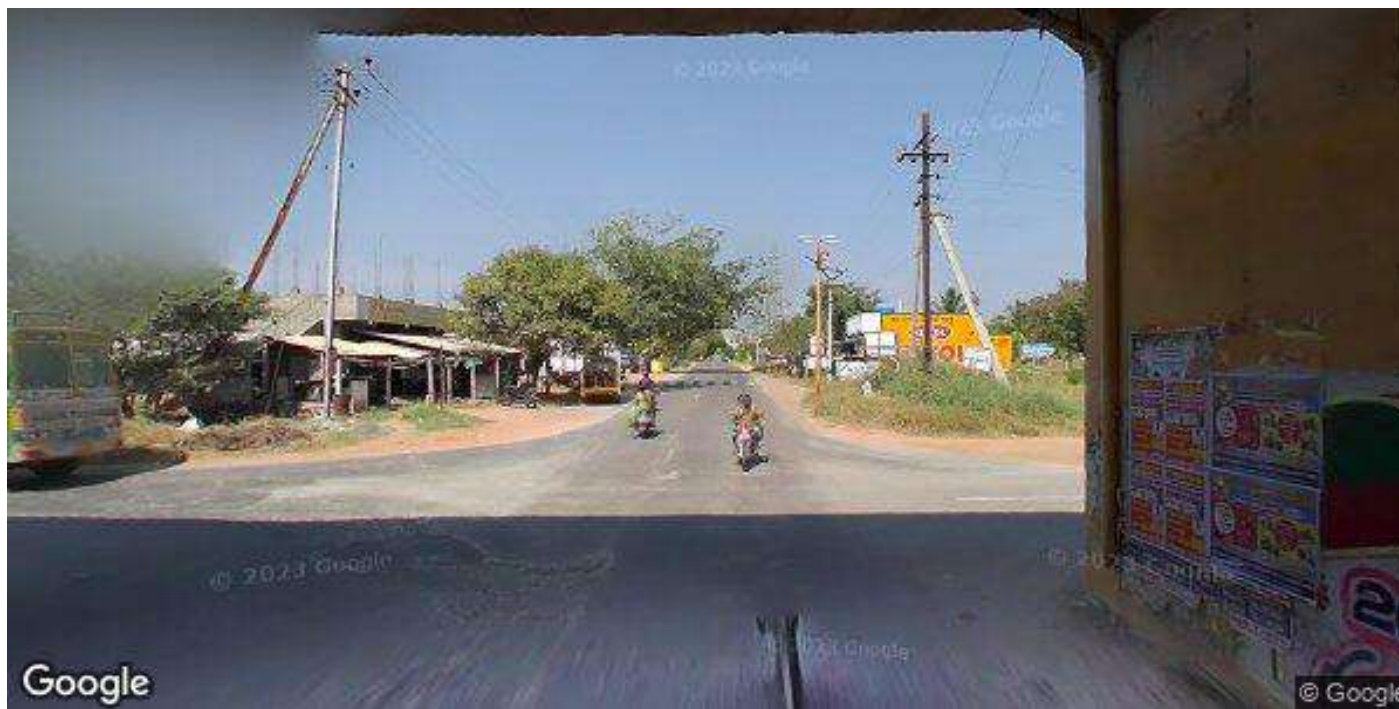
**Risk Type:** Turn  
**Risk Level:** High  
**Speed Limit:** 15 KM/Hr  
**Coordinates:** 10.92509, 78.15310

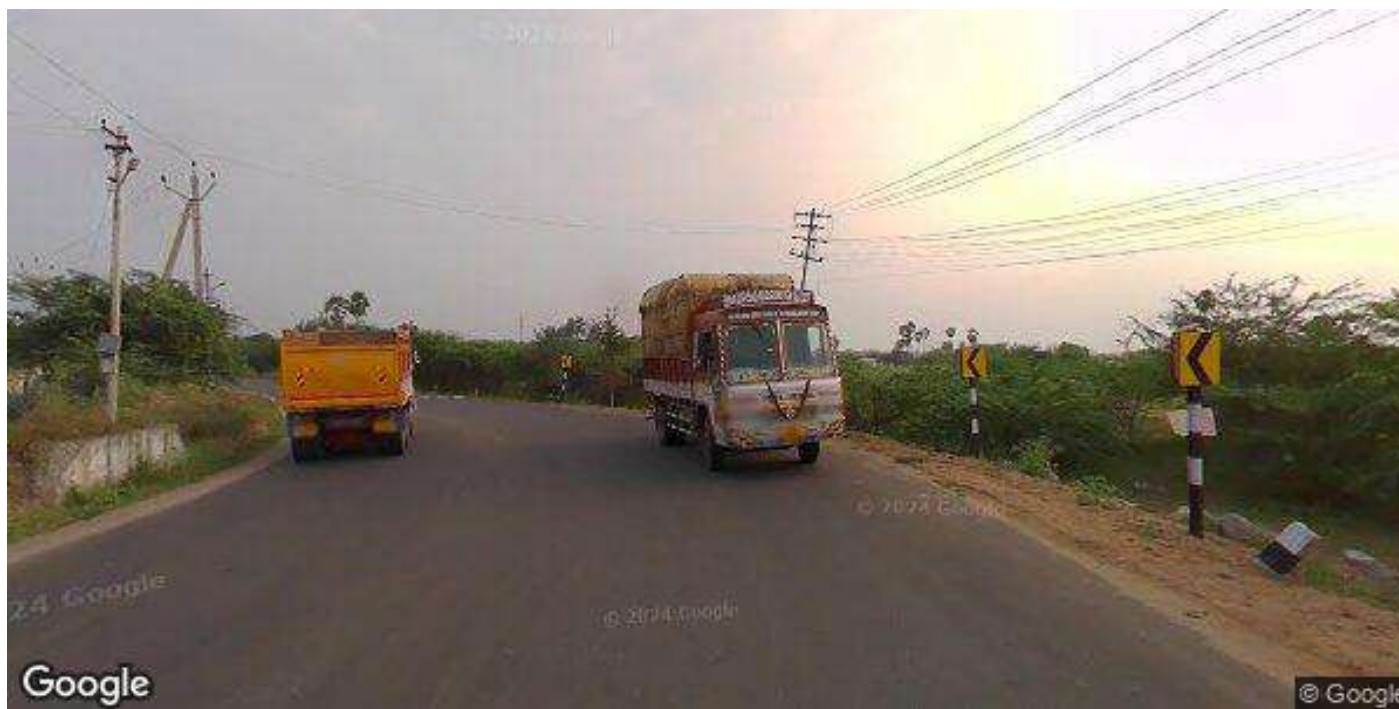
**Risk Type:** Turn  
**Risk Level:** Medium  
**Speed Limit:** 30 KM/Hr  
**Coordinates:** 10.90842, 78.15408

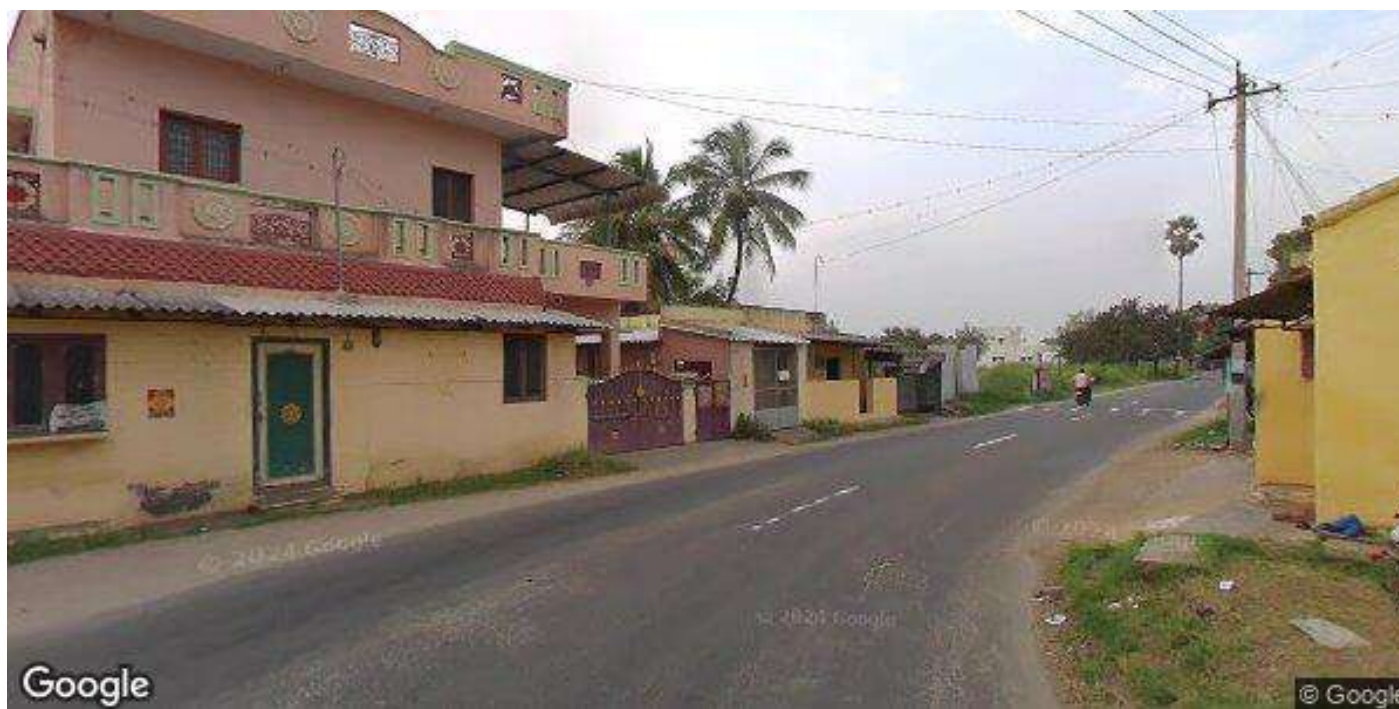
**Risk Type:** Turn  
**Risk Level:** High  
**Speed Limit:** 15 KM/Hr  
**Coordinates:** 10.90229, 78.15716

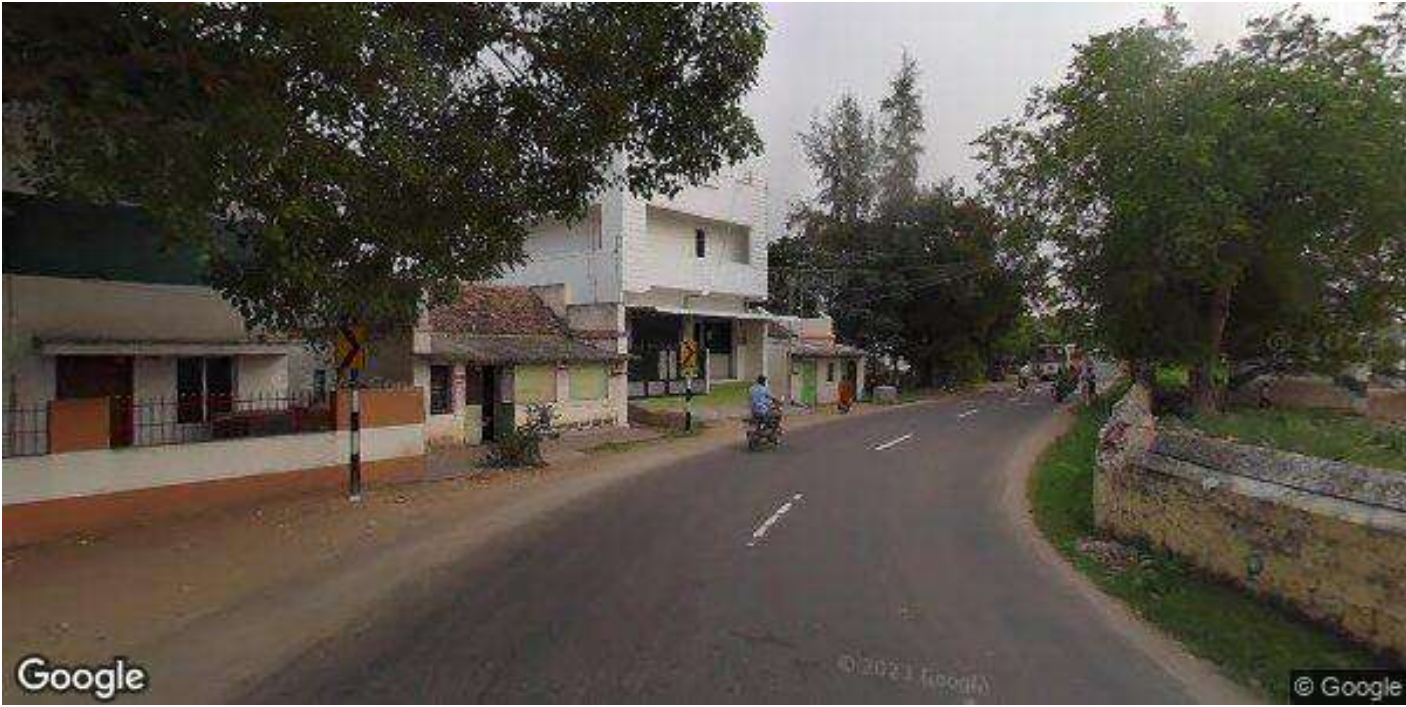
**Risk Type:** Turn  
**Risk Level:** High  
**Speed Limit:** 15 KM/Hr  
**Coordinates:** 10.90225, 78.15799

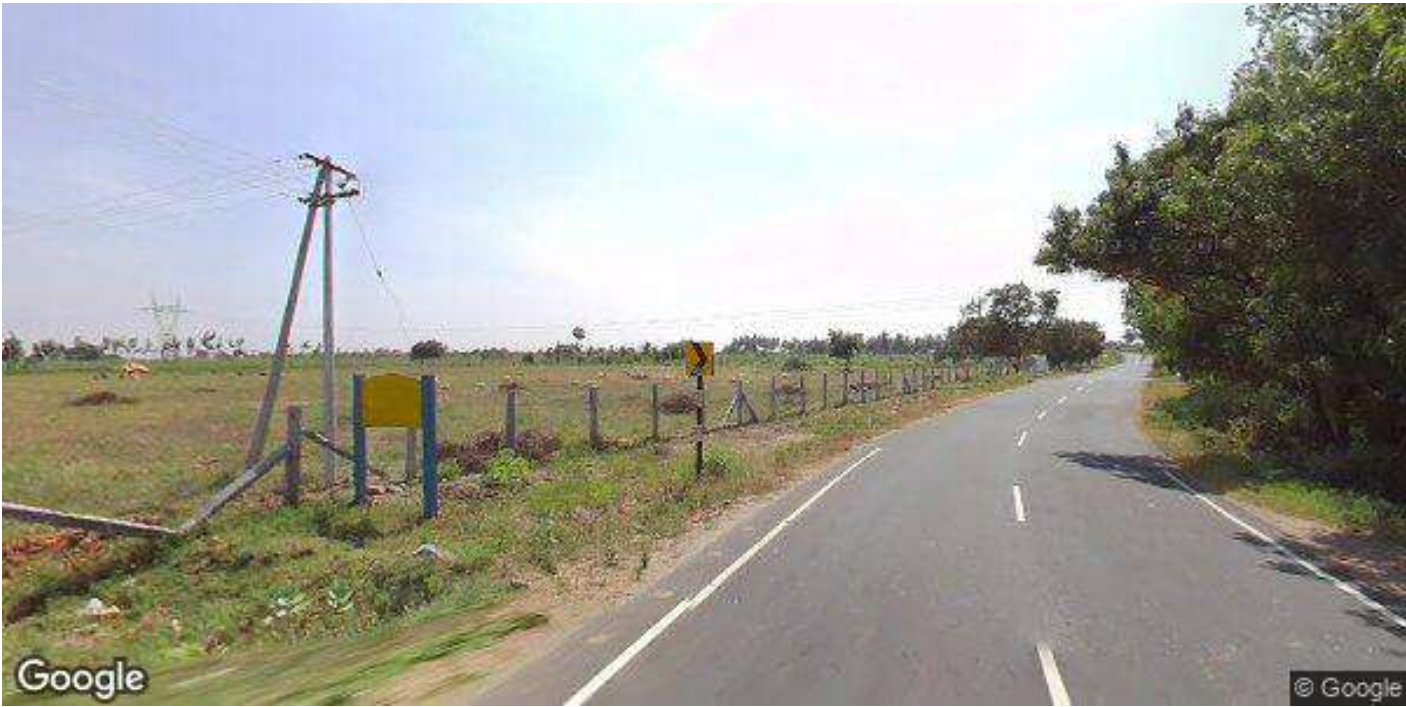
**Risk Type:** Turn  
**Risk Level:** Medium  
**Speed Limit:** 30 KM/Hr  
**Coordinates:** 10.88119, 78.16362

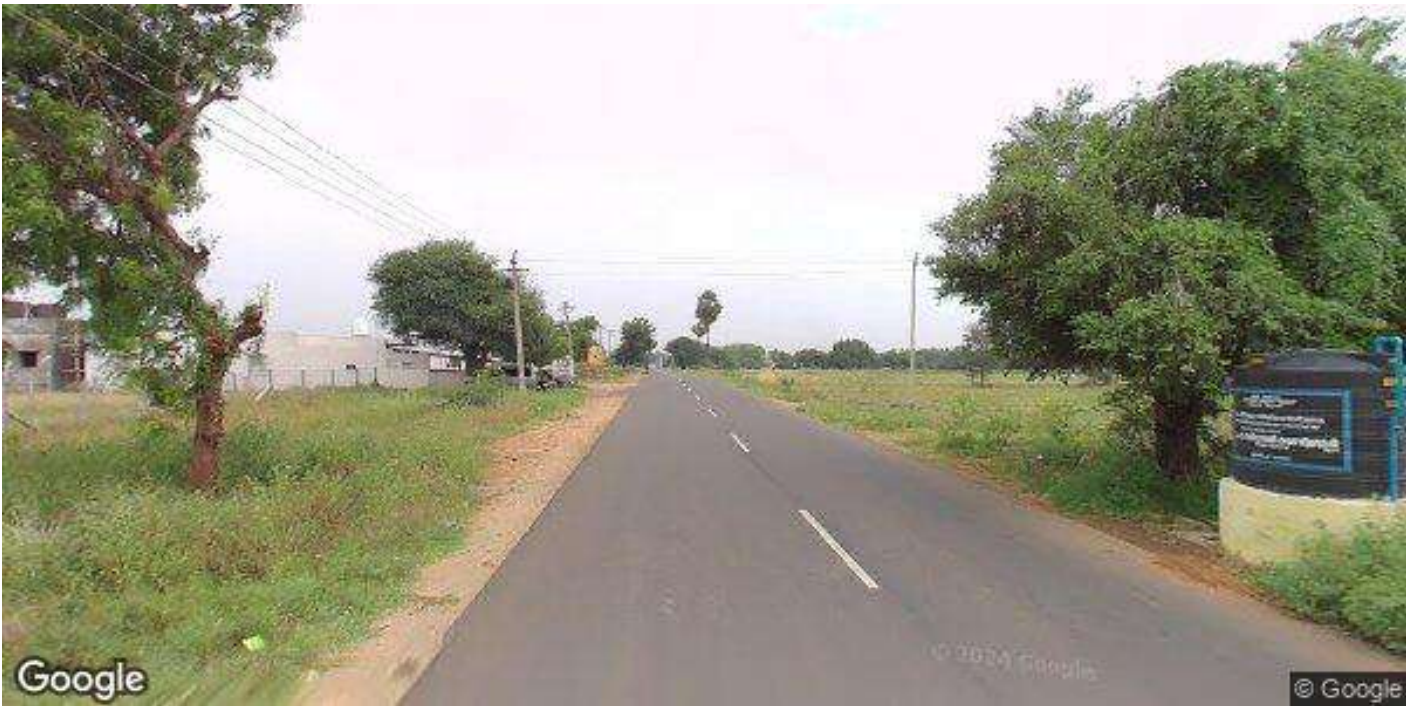
**Risk Type:** Blind Spot  
**Risk Level:** Blind Spot  
**Speed Limit:** 10 KM/Hr  
**Coordinates:** 10.85366, 78.16142
