# IndianOil

## JOURNEY RISK MANAGEMENT (JRM) STUDY

### Salem Terminal to SRI ANDAVAR FUELS

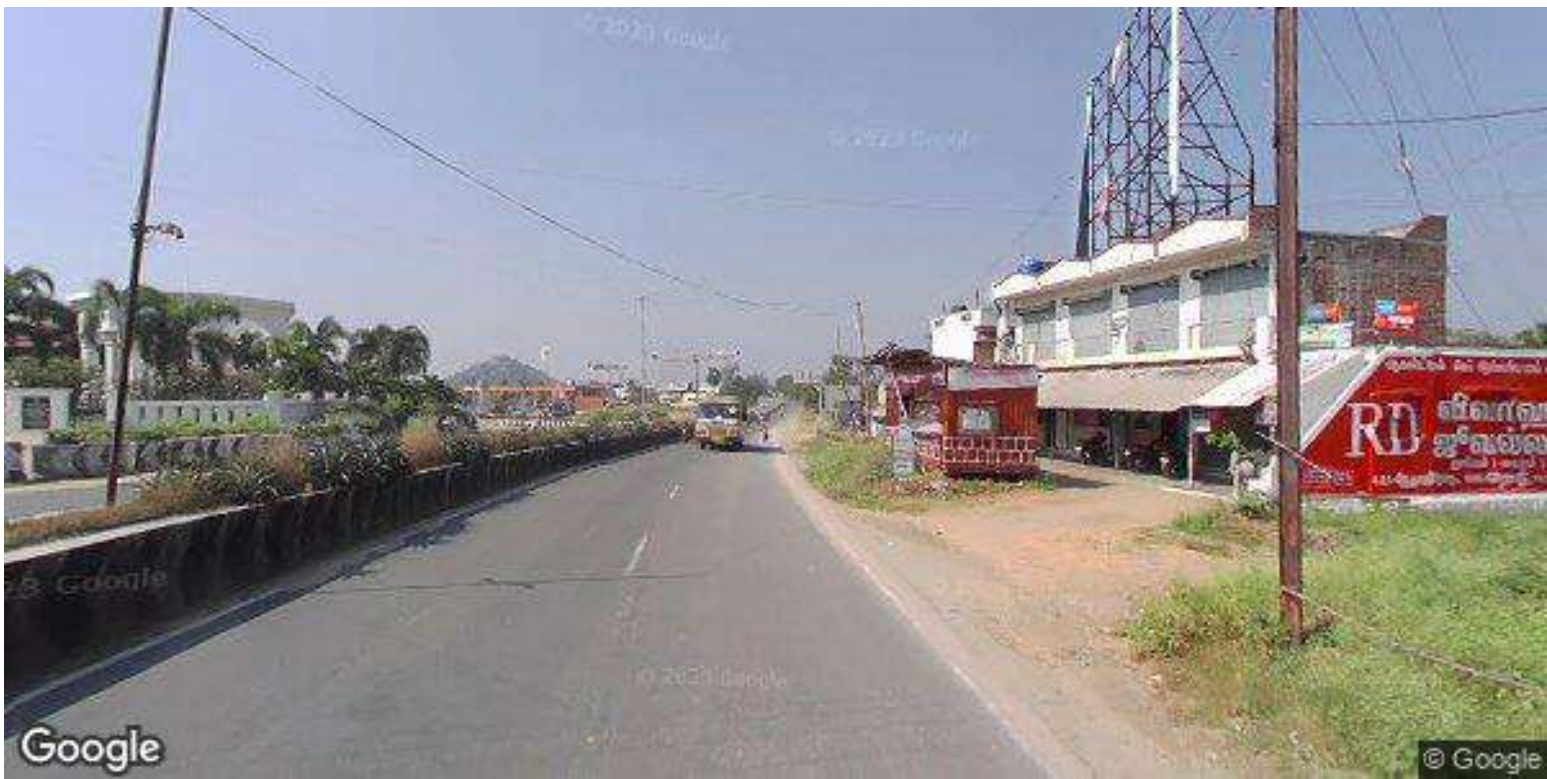
**Risk Type:** Blind Spot  
**Risk Level:** Blind Spot  
**Speed Limit:** 10 KM/Hr  
**Coordinates:** 11.46330, 77.84929

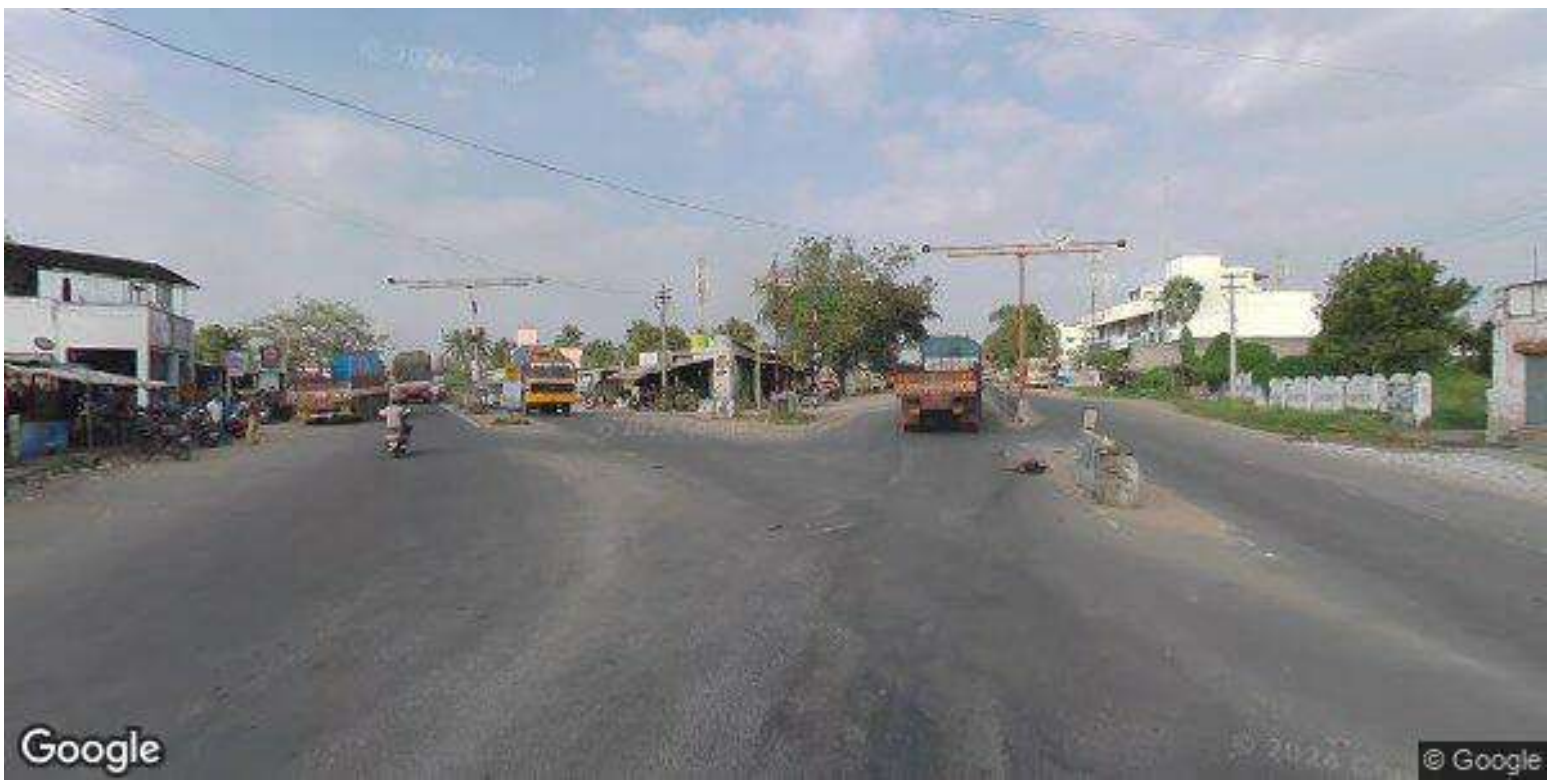
**Risk Type:** Turn  
**Risk Level:** Medium  
**Speed Limit:** 30 KM/Hr  
**Coordinates:** 11.48366, 77.88781

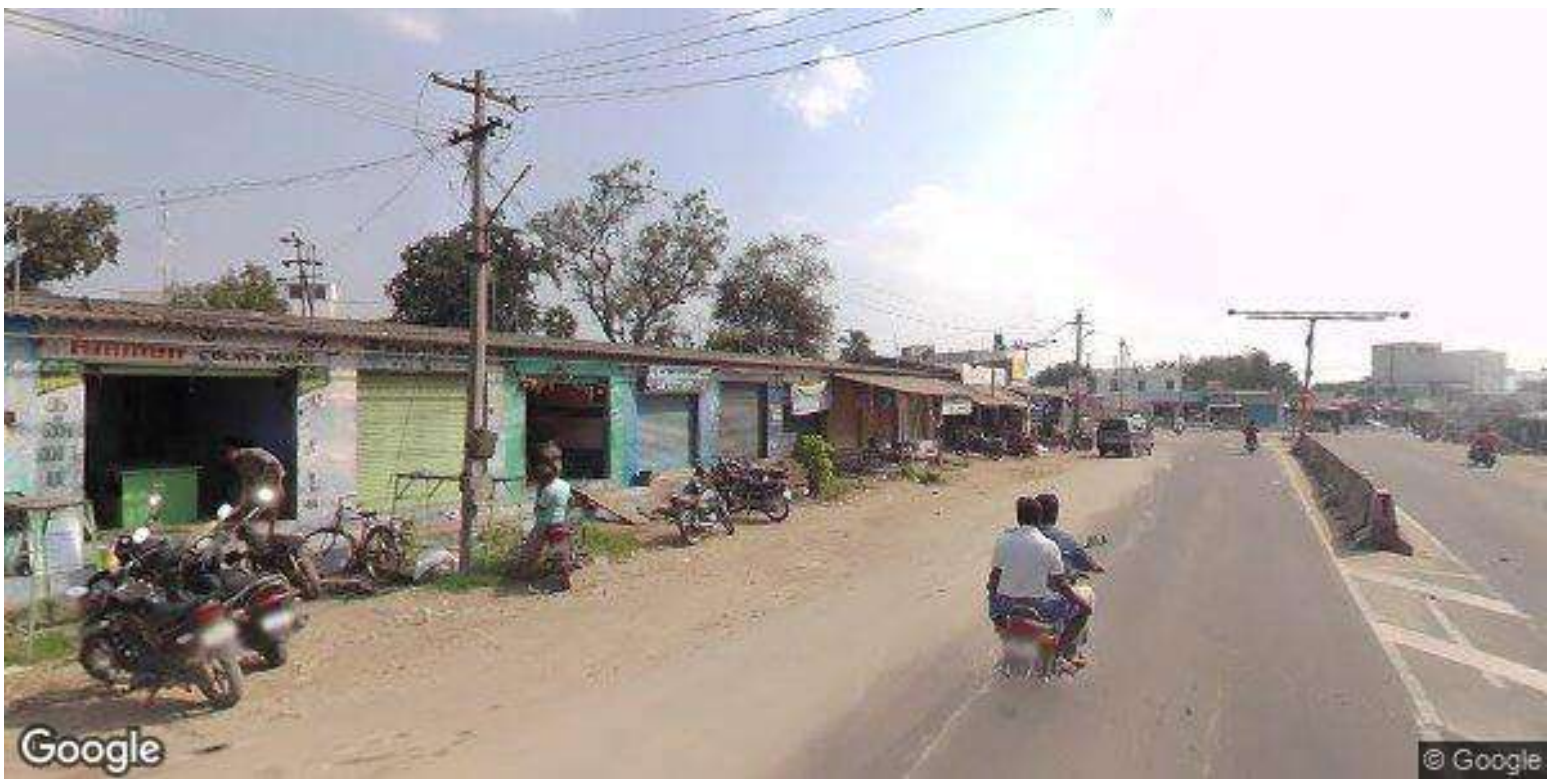
**Coordinates:** 11.48446, 77.88787

**Risk Type:** Turn

**Risk Level:** Medium

**Speed Limit:** 30 KM/Hr
