## **JOURNEY RISK MANAGEMENT (JRM) STUDY**

### **Salem Terminal To SRE KRISHNA ENTERPRISES**

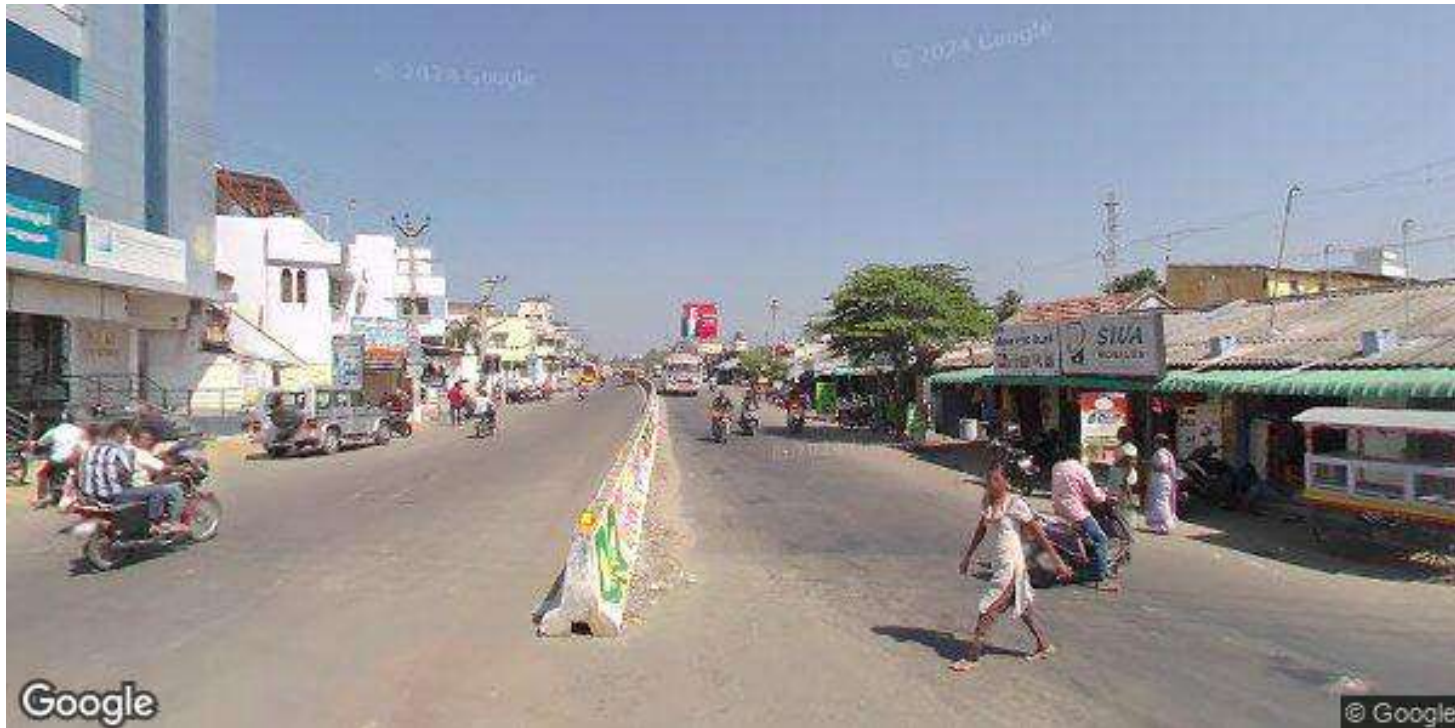
**Coordinates:** 11.37086, 77.74828

**Risk Type:** Roundabout

**Risk Level:** High

**Speed Limit:** 15 KM/Hr

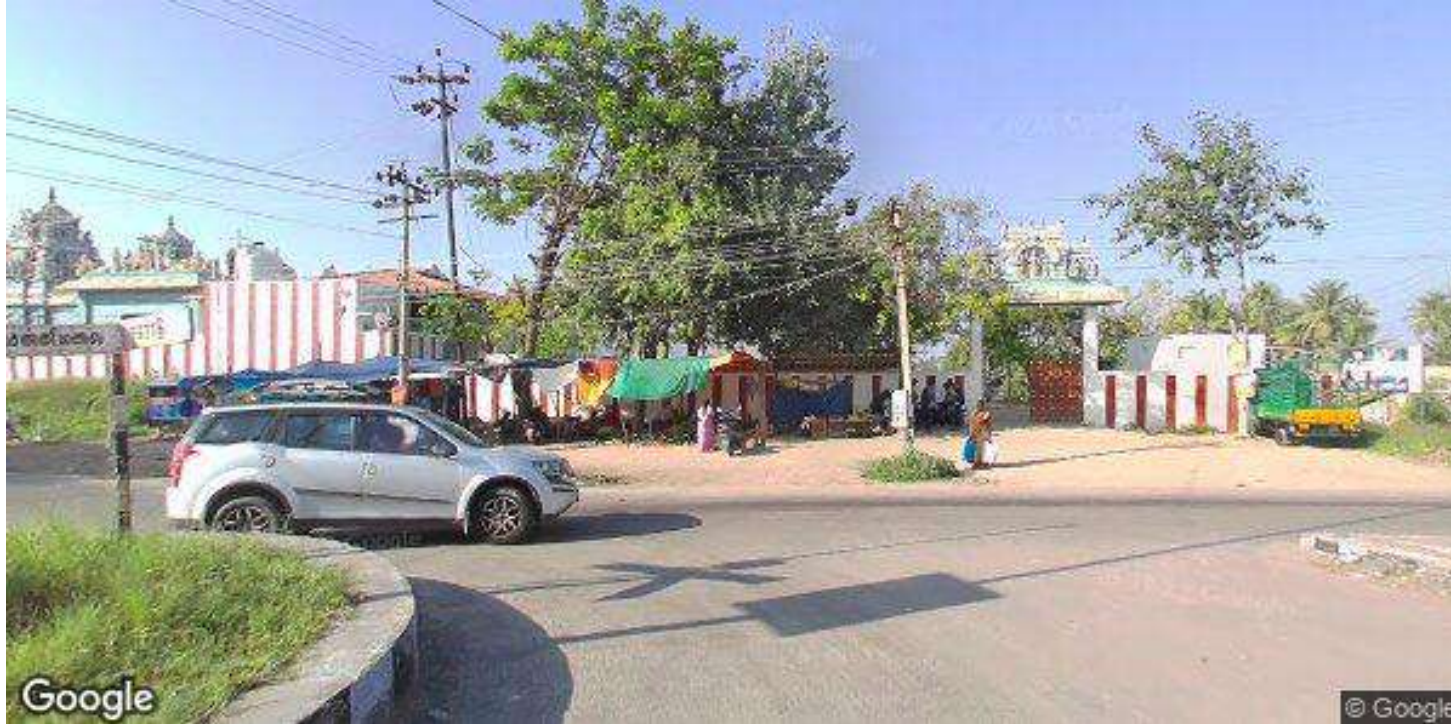
**Risk Type:** Roundabout  
**Risk Level:** High  
**Speed Limit:** 15 KM/Hr  
**Coordinates:** 11.23678, 77.65868

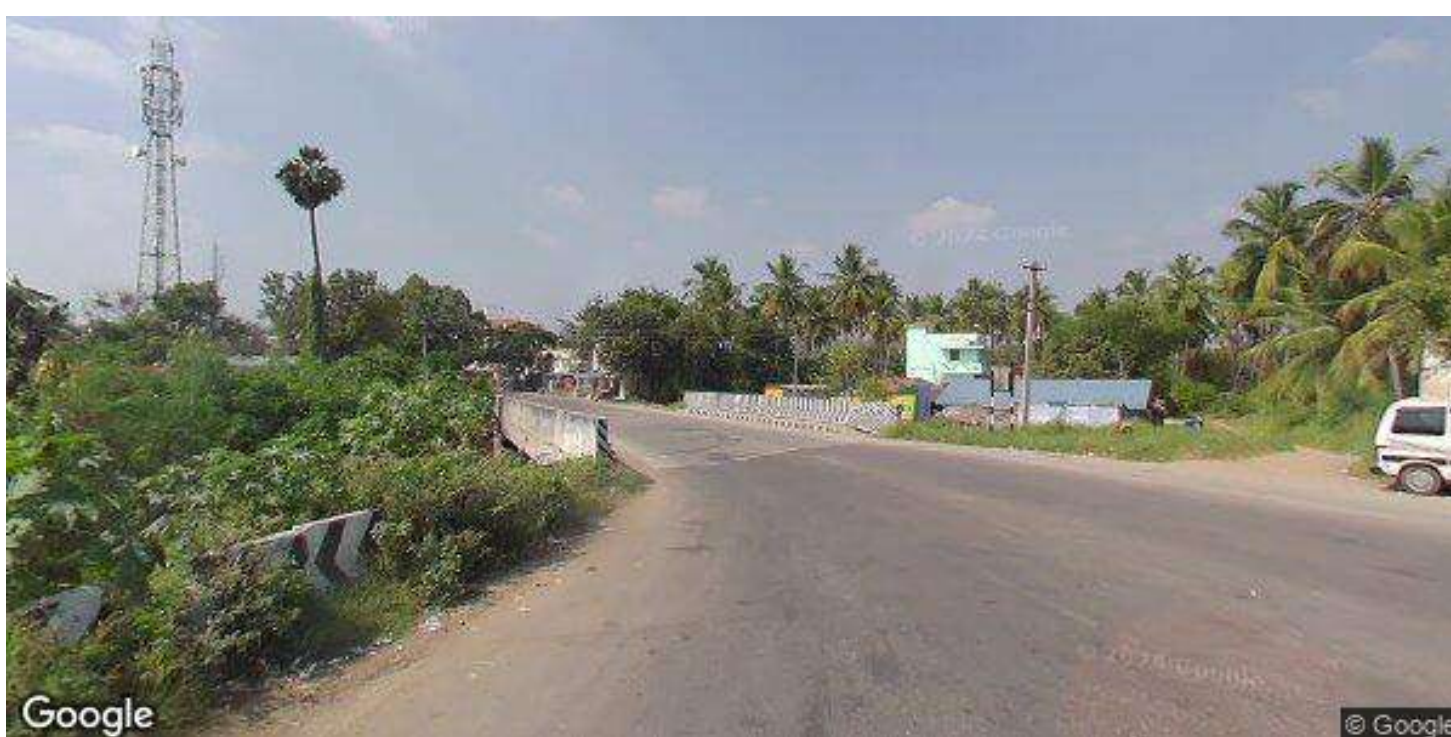
**Coordinates: 11.44893, 77.87413**

**Risk Type:** Turn  
**Risk Level:** Medium

**Speed Limit: 30 KM/Hr**

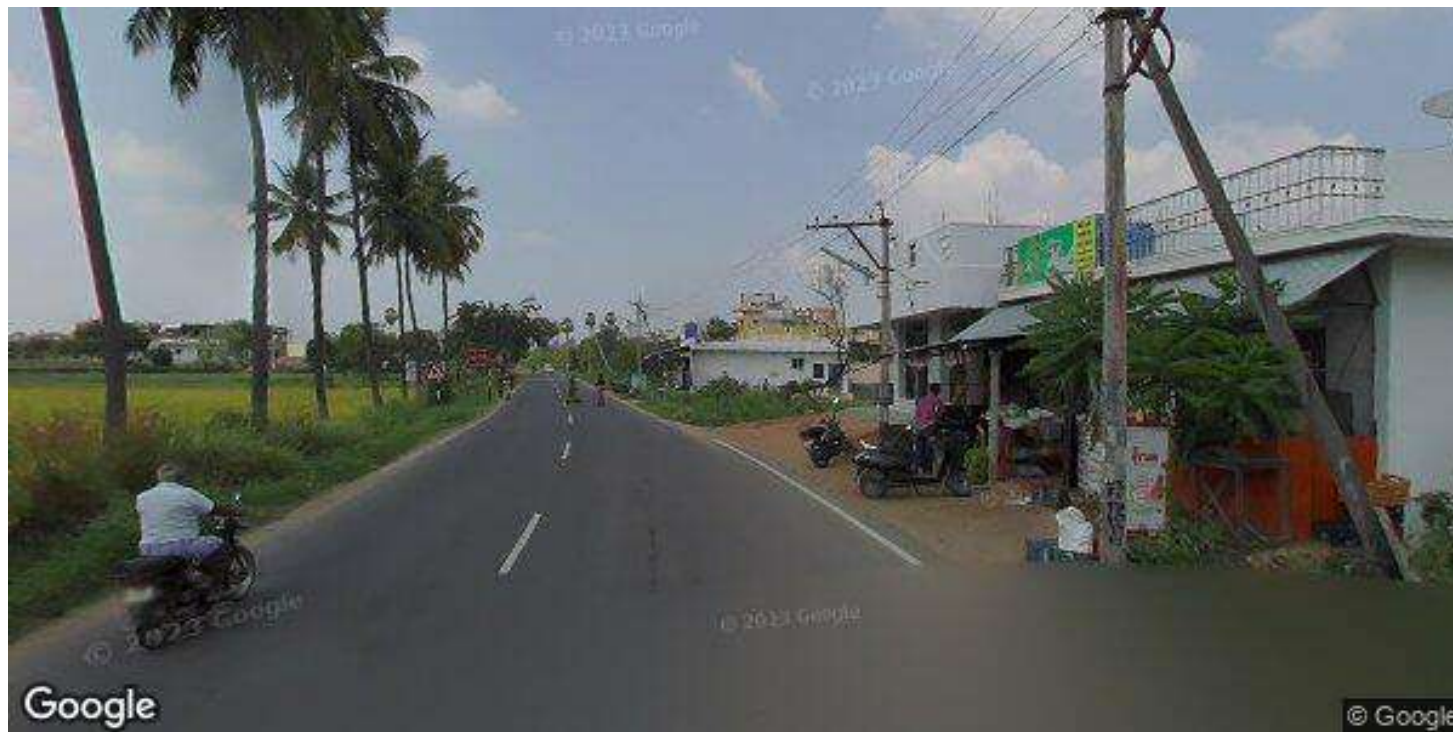
**Coordinates: 11.45127, 77.86734**

**Risk Type: Turn**

**Risk Level: Medium**

**Speed Limit: 30 KM/Hr**

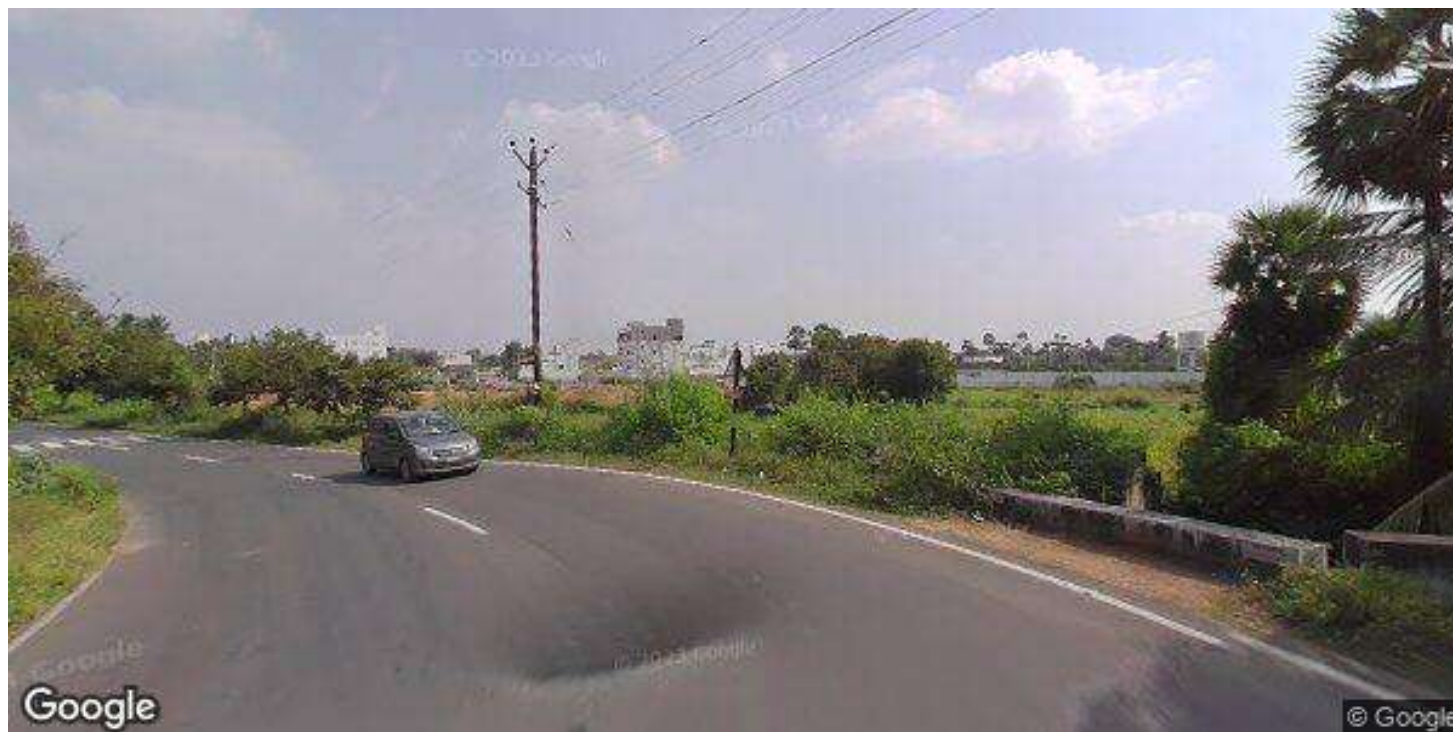
**Coordinates: 11.45350, 77.85700**

**Risk Type: Turn**

**Risk Level: High**

**Speed Limit: 15 KM/Hr**

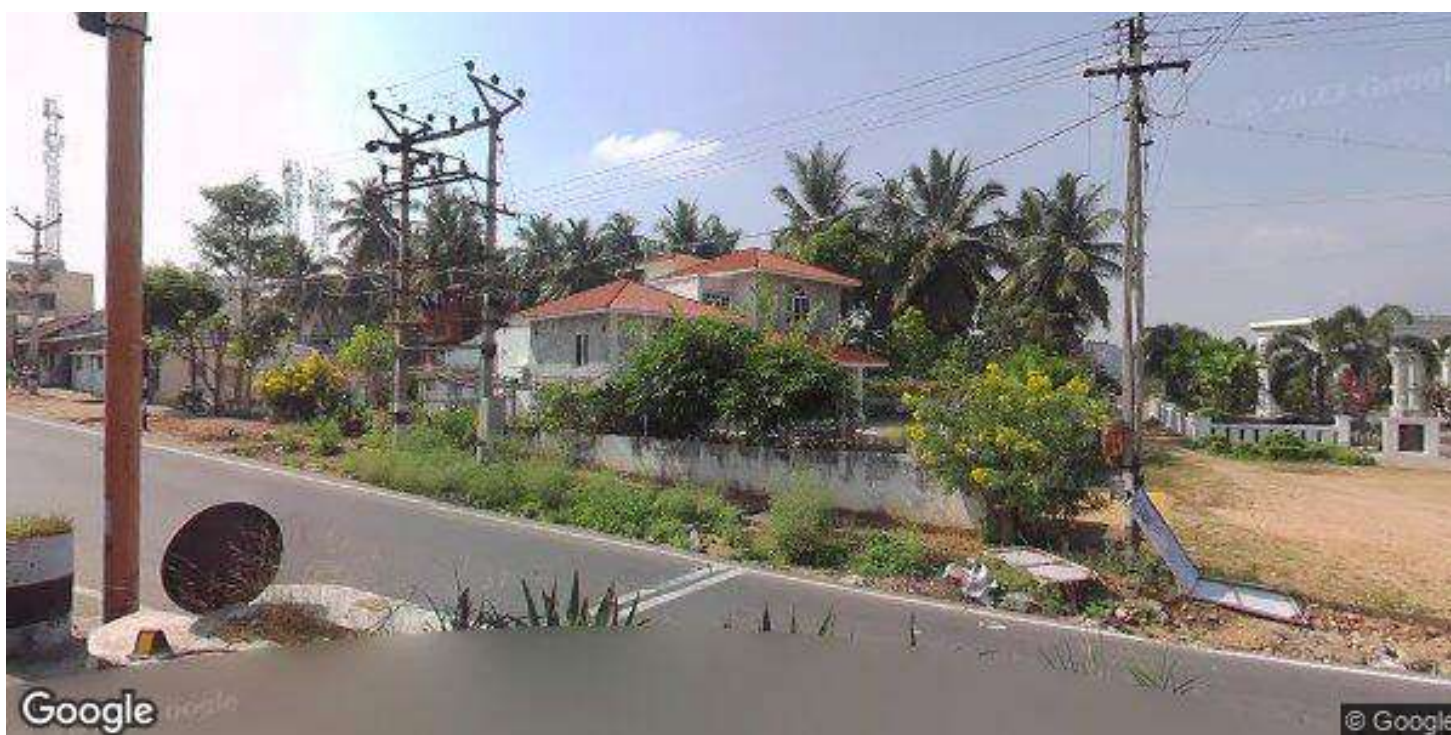
**Risk Type:** Turn  
**Risk Level:** Medium  
**Speed Limit:** 30 KM/Hr  
**Coordinates:** 11.46303, 77.84945

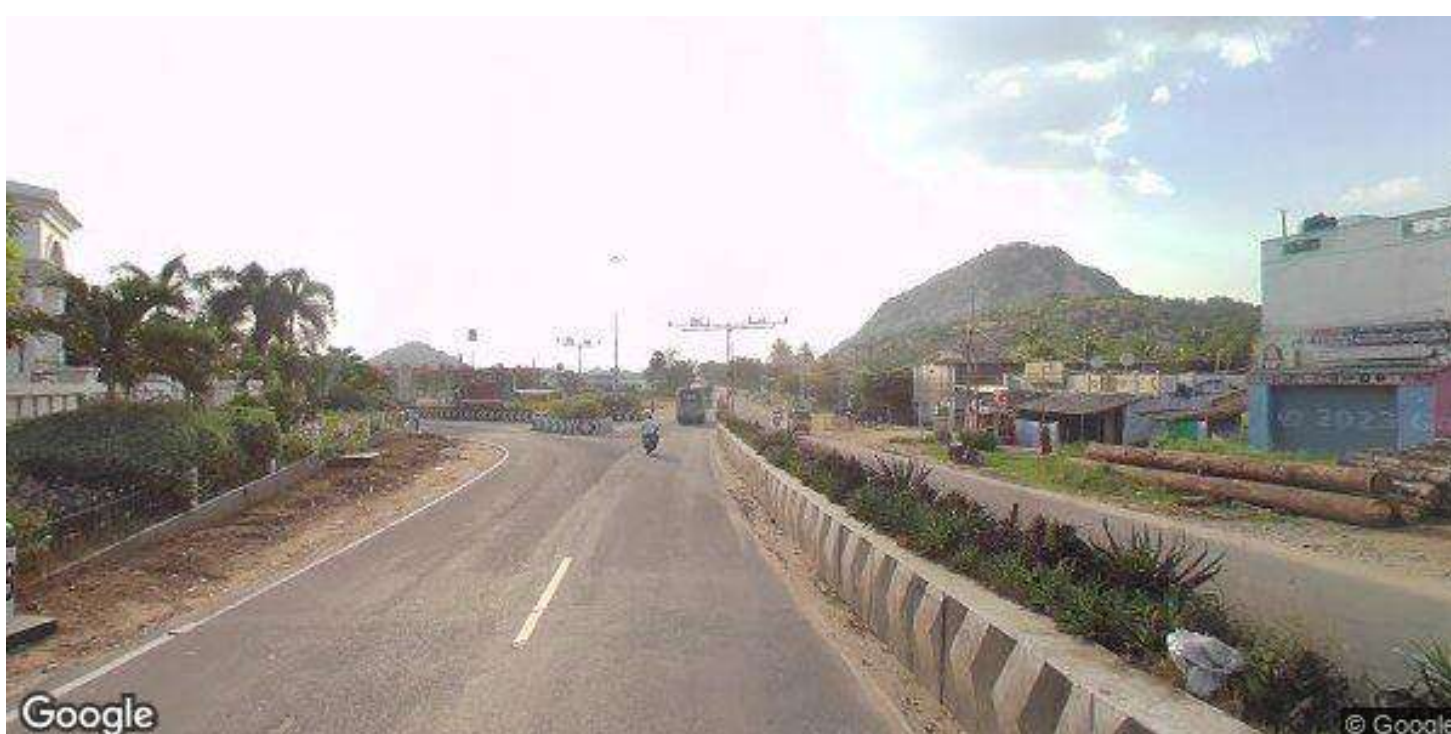
Coordinates: 11.46317, 77.84906

**Risk Type:** Turn  
**Risk Level:** Medium

Speed Limit: 30 KM/Hr

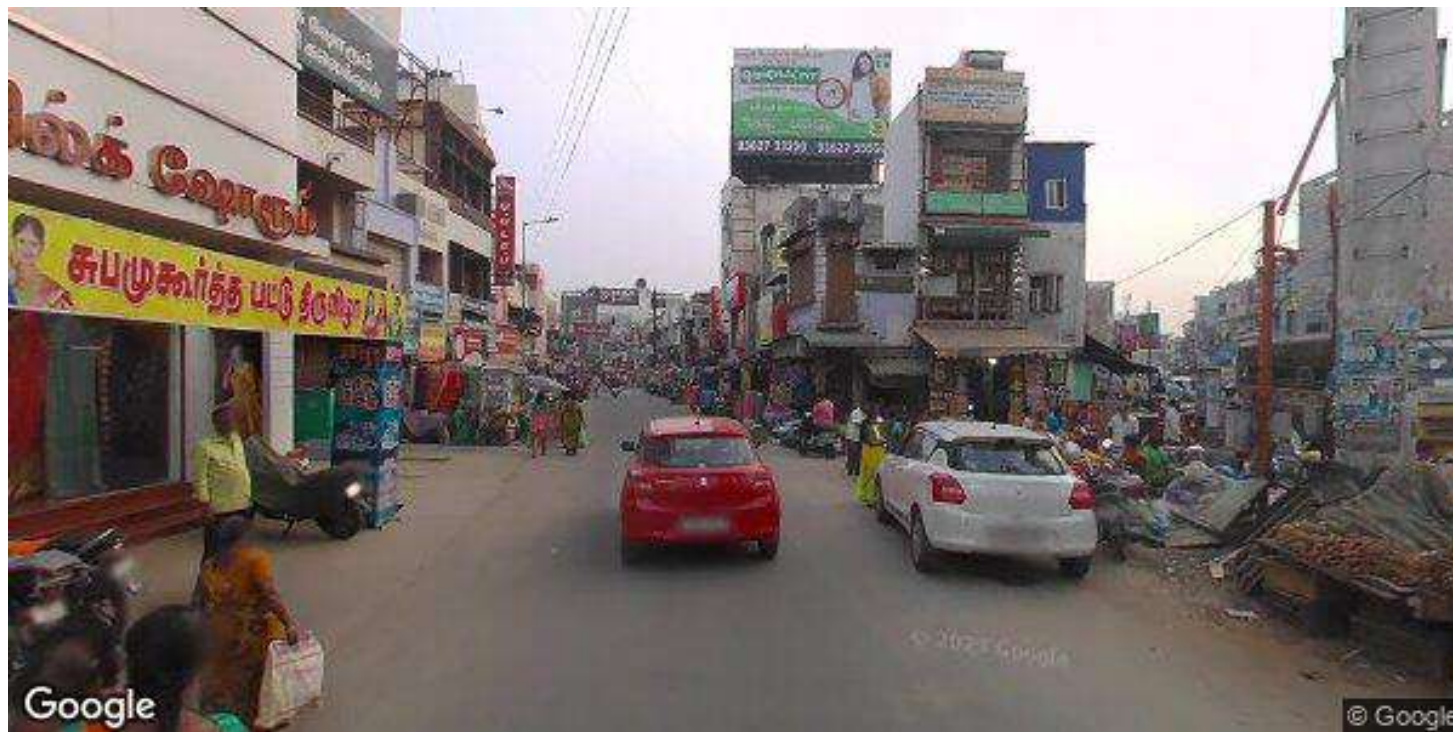
Coordinates: 11.34172, 77.72823

Risk Type: Turn

Risk Level: Medium

Speed Limit: 30 KM/Hr

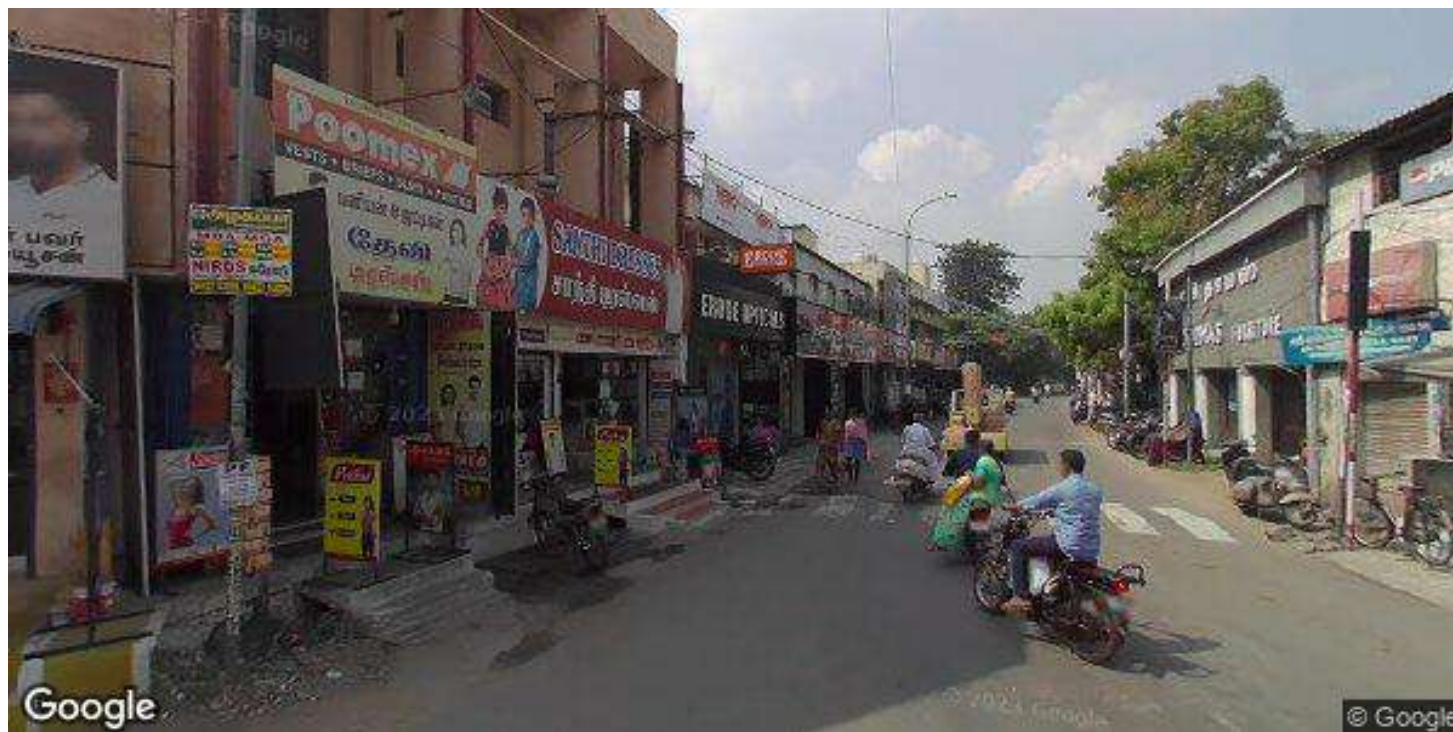
Coordinates: 11.33920, 77.72902

Risk Type: Blind Spot

Risk Level: Blind Spot

Speed Limit: 10 KM/Hr

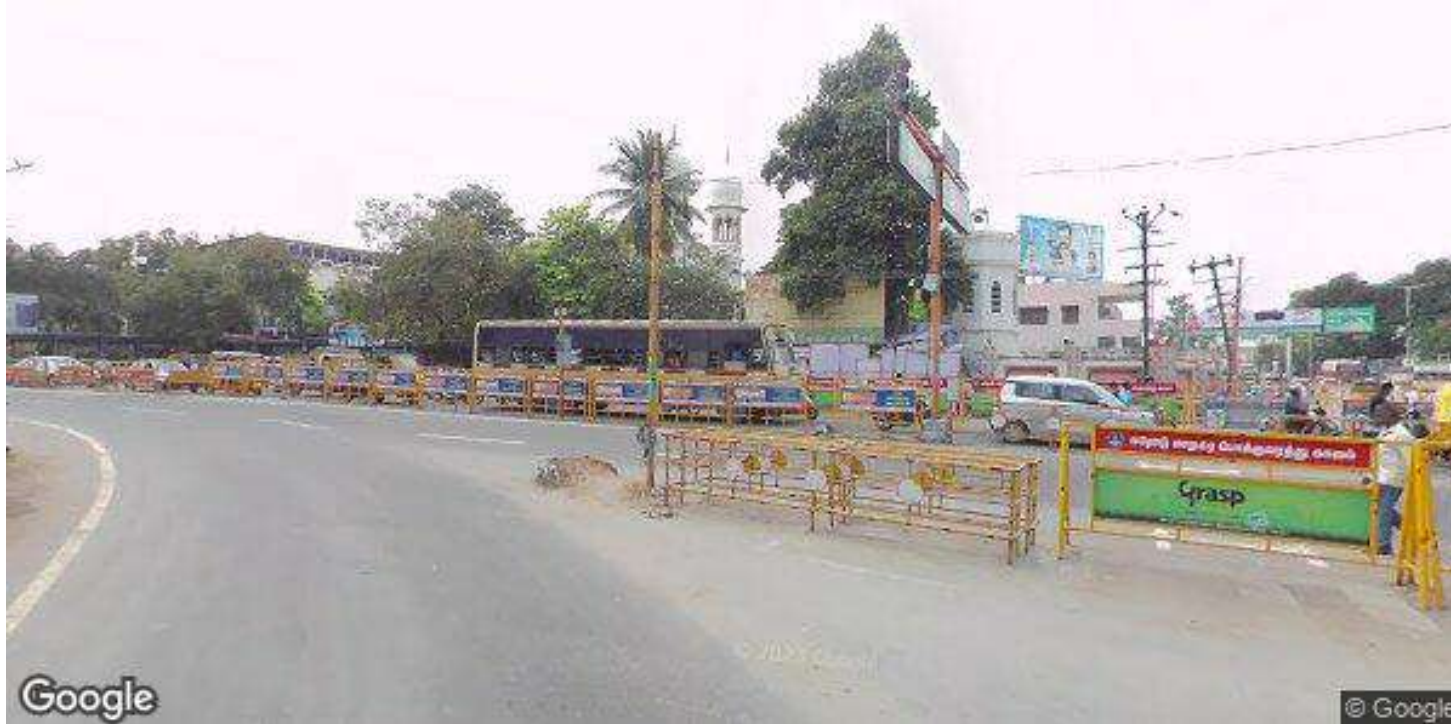
**Coordinates:** 11.33909, 77.72653

**Risk Type:** Turn

**Risk Level:** Medium

**Speed Limit:** 30 KM/Hr

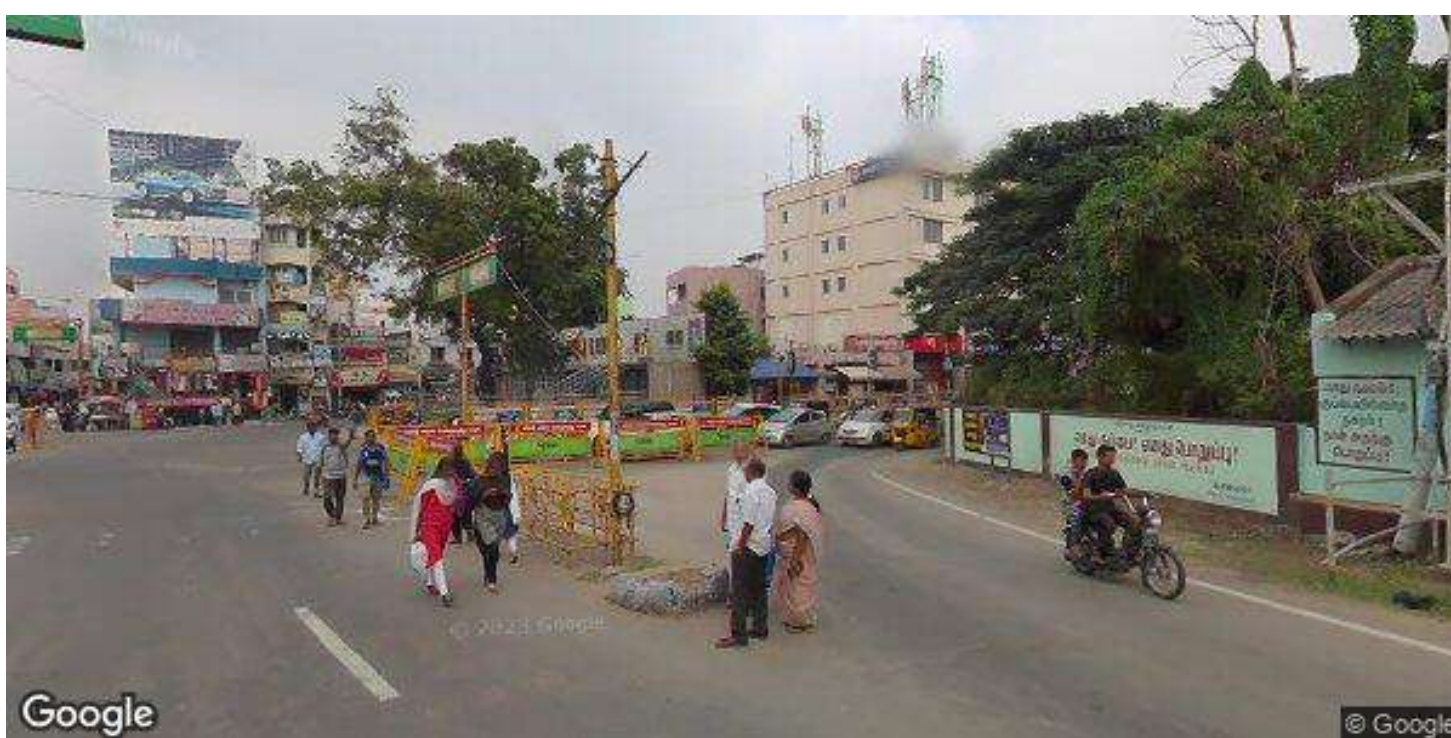
**Coordinates:** 11.33896, 77.72642

**Risk Type:** Turn

**Risk Level:** Medium

**Speed Limit:** 30 KM/Hr

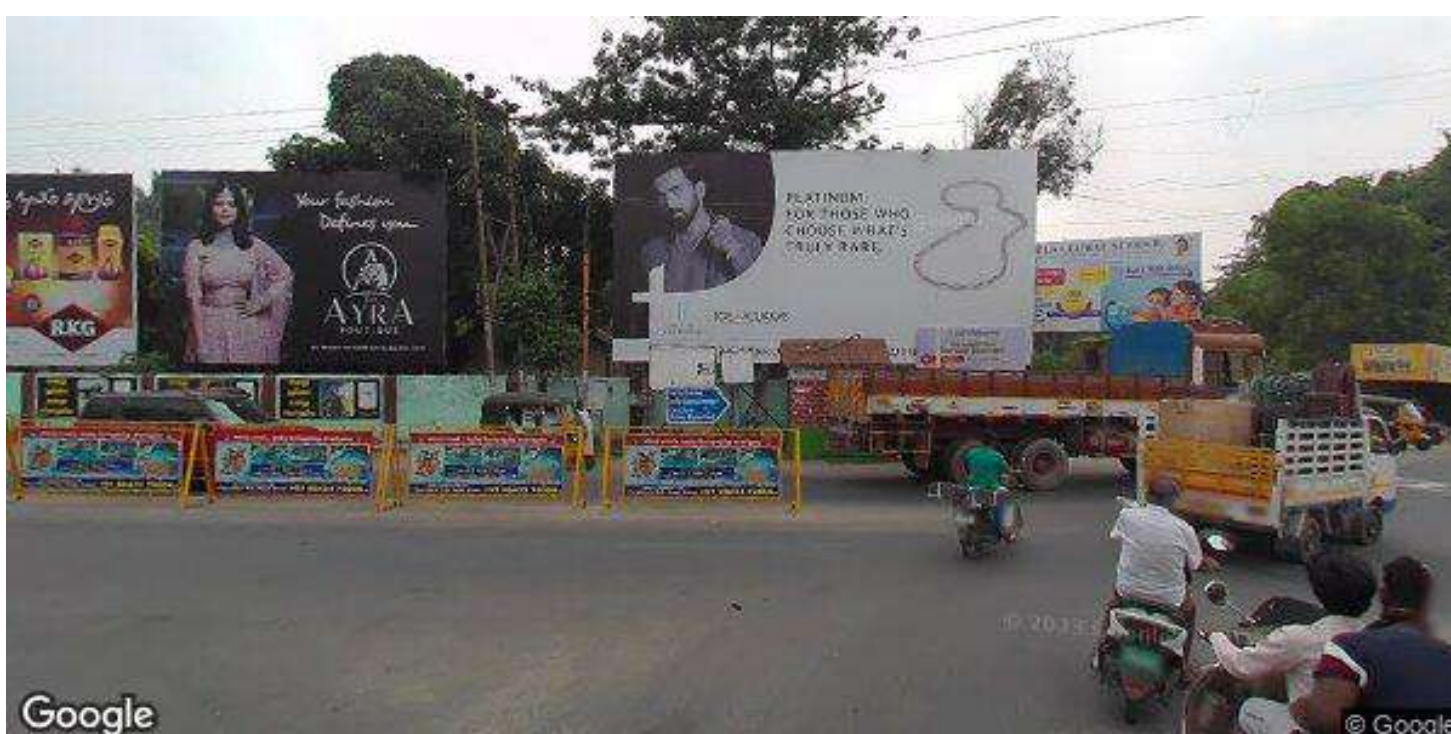
Coordinates: 11.33092, 77.72748

**Risk Type:** Turn

**Risk Level:** Medium

Speed Limit: 30 KM/Hr

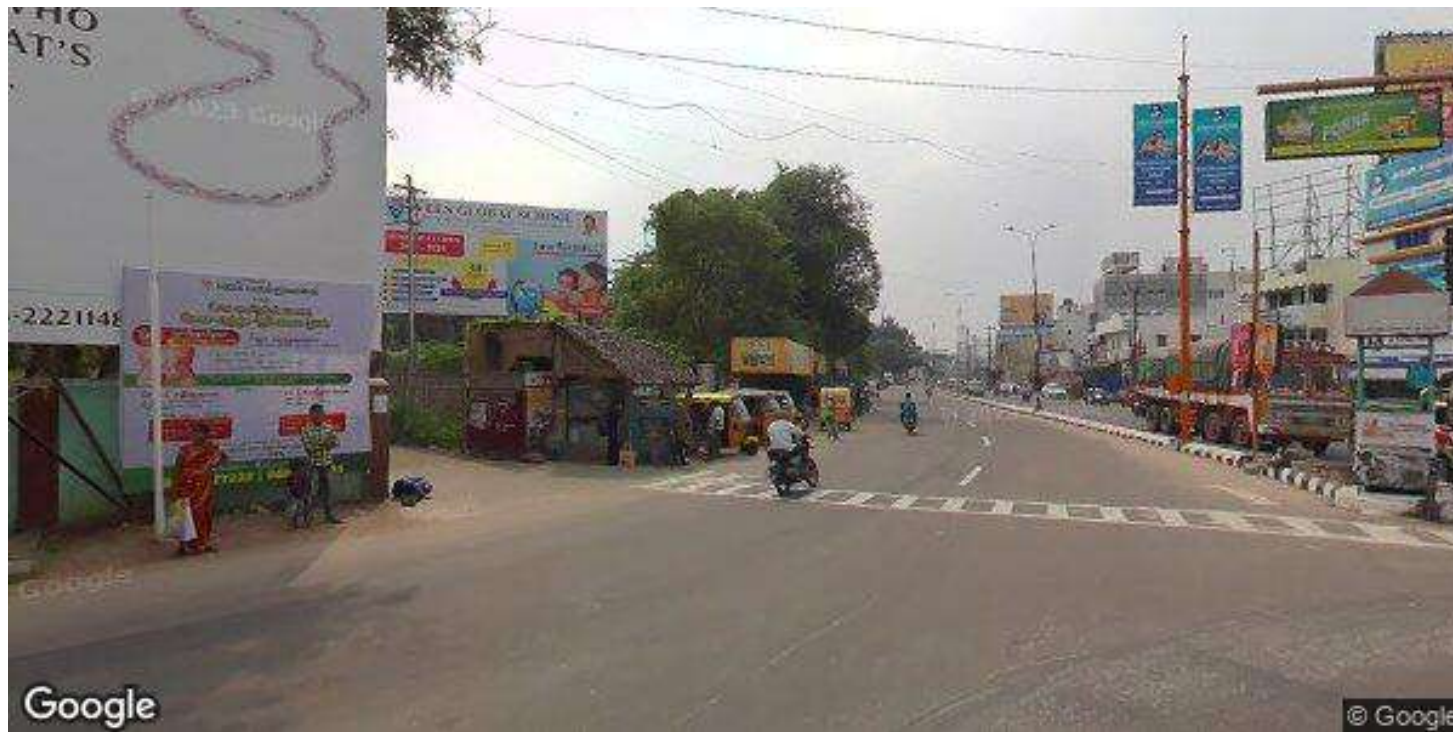
Coordinates: 11.33085, 77.72744

Risk Type: Turn

Risk Level: Medium

Speed Limit: 30 KM/Hr

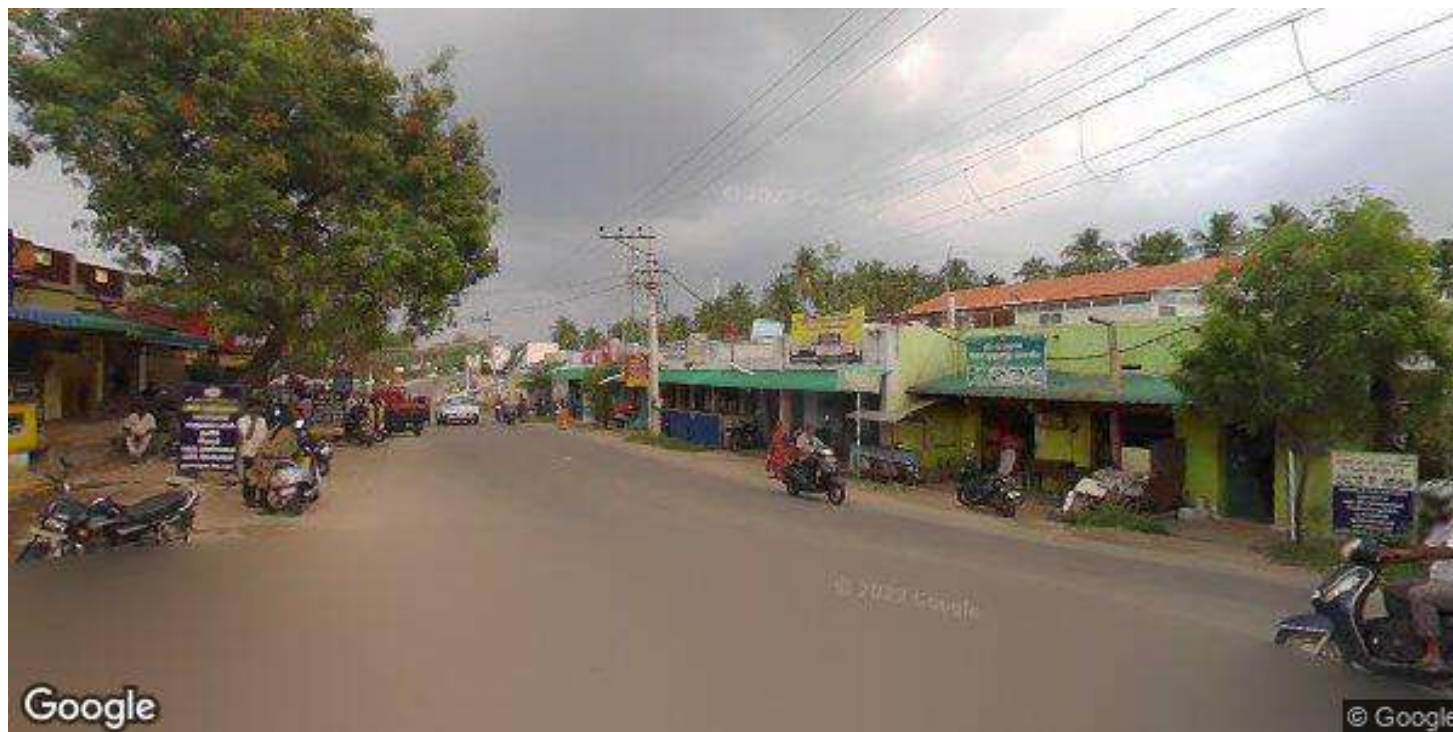
Coordinates: 11.31172, 77.70715

Risk Type: Turn

Risk Level: High

Speed Limit: 15 KM/Hr

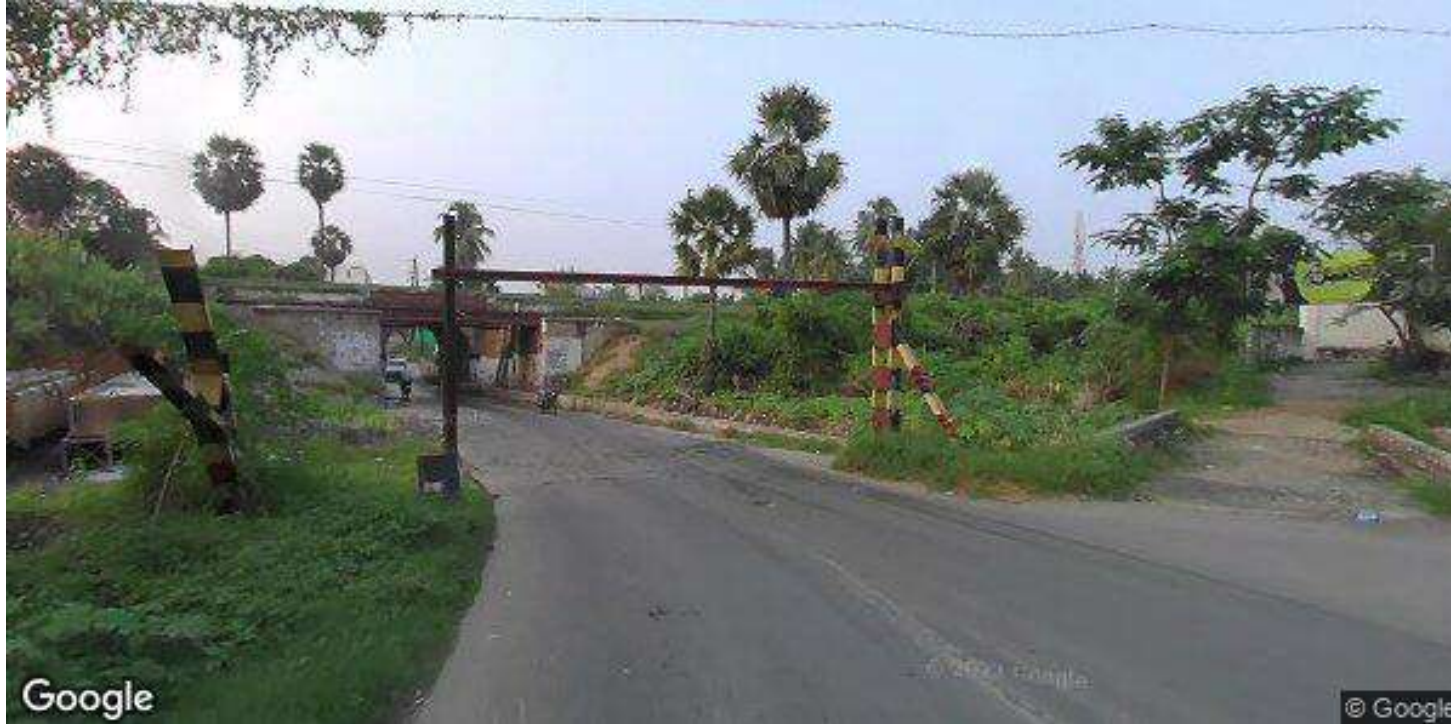
**Coordinates:** 11.31043, 77.70784

**Risk Type:** Turn

**Risk Level:** Medium

**Speed Limit:** 30 KM/Hr

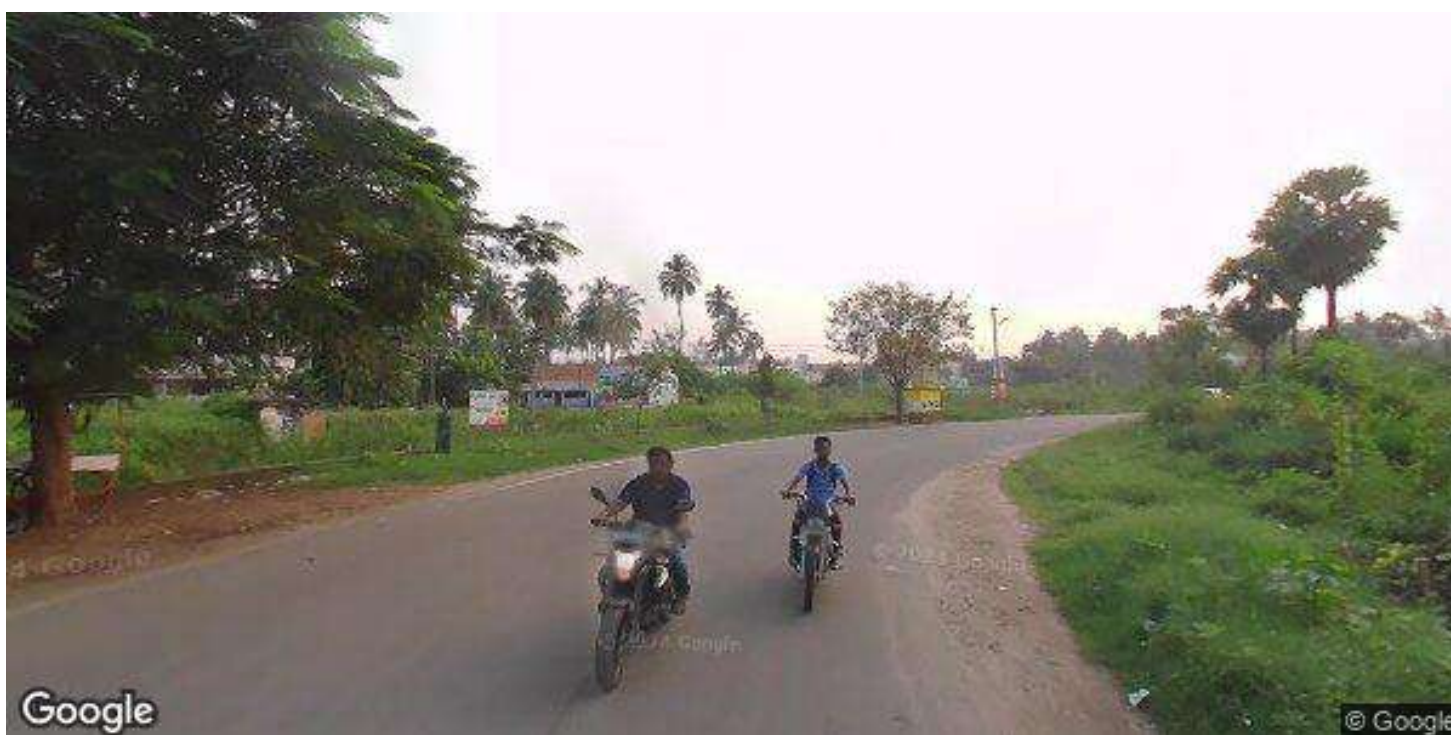
**Coordinates:** 11.31028, 77.70782

**Risk Type:** Turn

**Risk Level:** Medium

**Speed Limit:** 30 KM/Hr

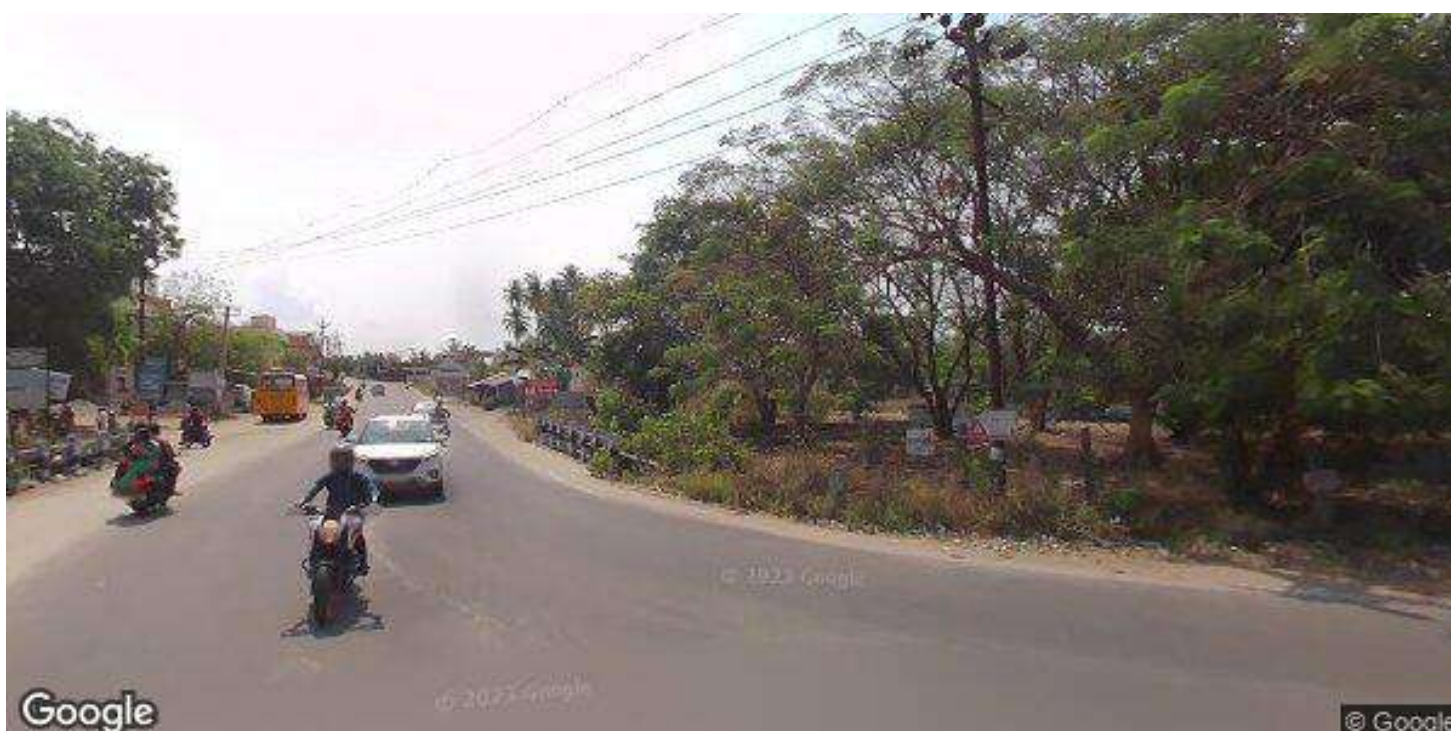
**Coordinates: 11.23904, 77.66459**

**Risk Type:** Blind Spot

**Risk Level:** Blind Spot

**Speed Limit: 10 KM/Hr**

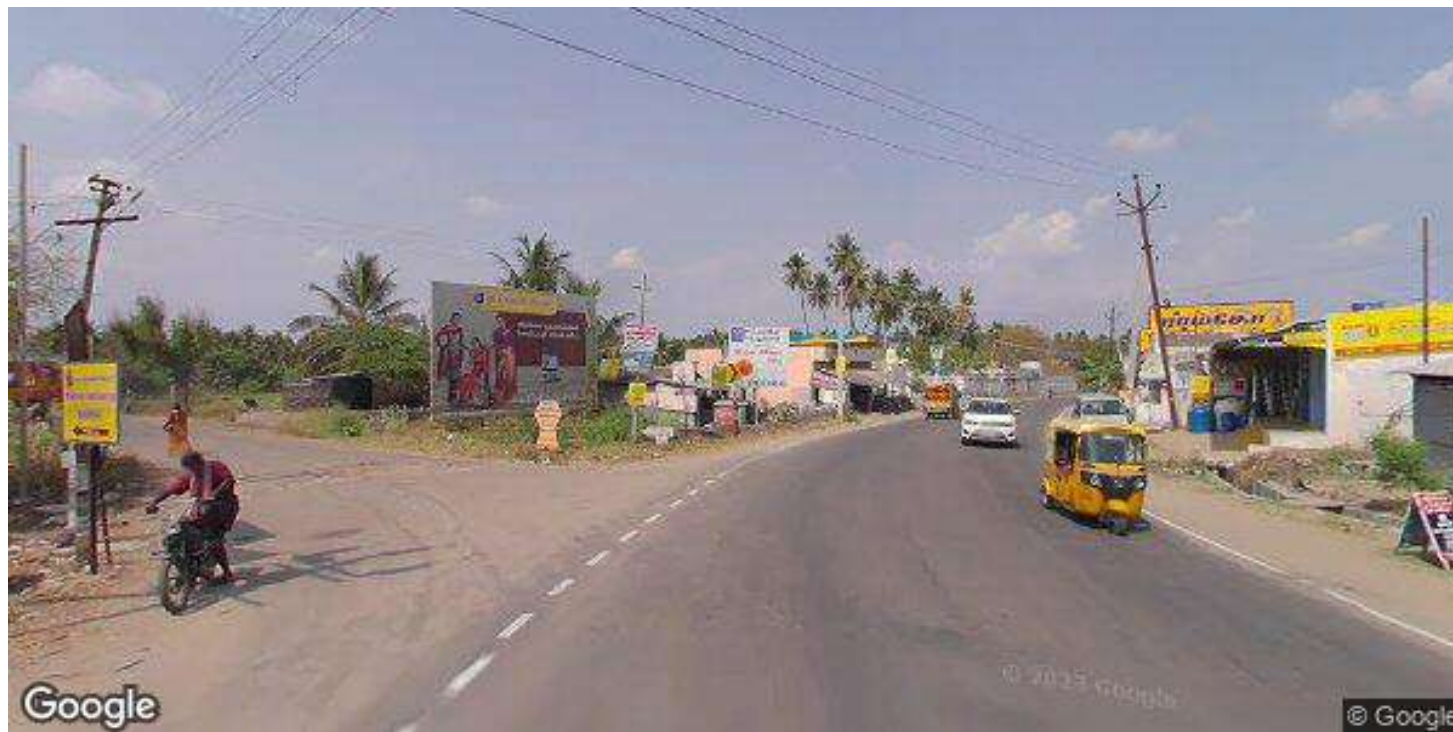
**Coordinates: 11.23843, 77.66240**

**Risk Type: Turn**

**Risk Level: Medium**

**Speed Limit: 30 KM/Hr**

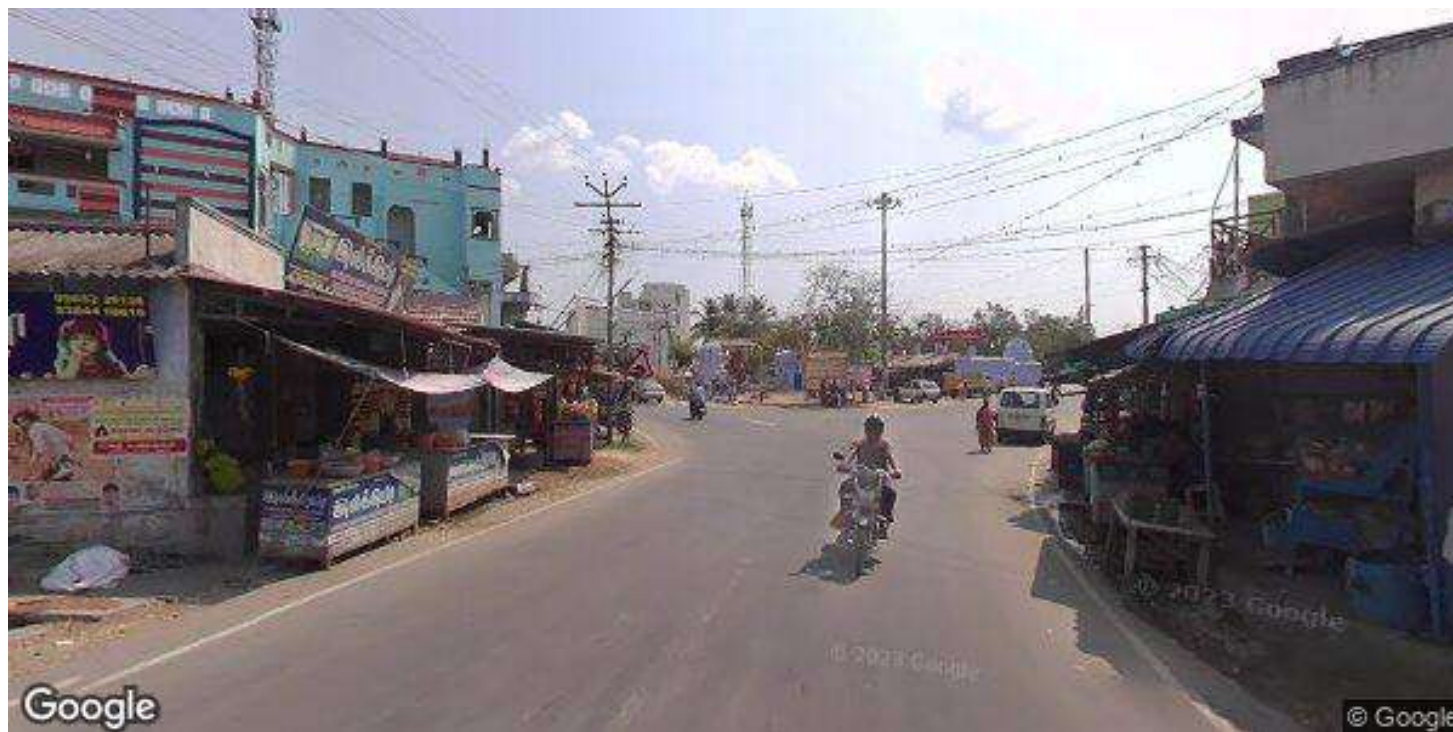
**Coordinates: 11.23750, 77.66185**

**Risk Type: Turn**

**Risk Level: Medium**

**Speed Limit: 30 KM/Hr**

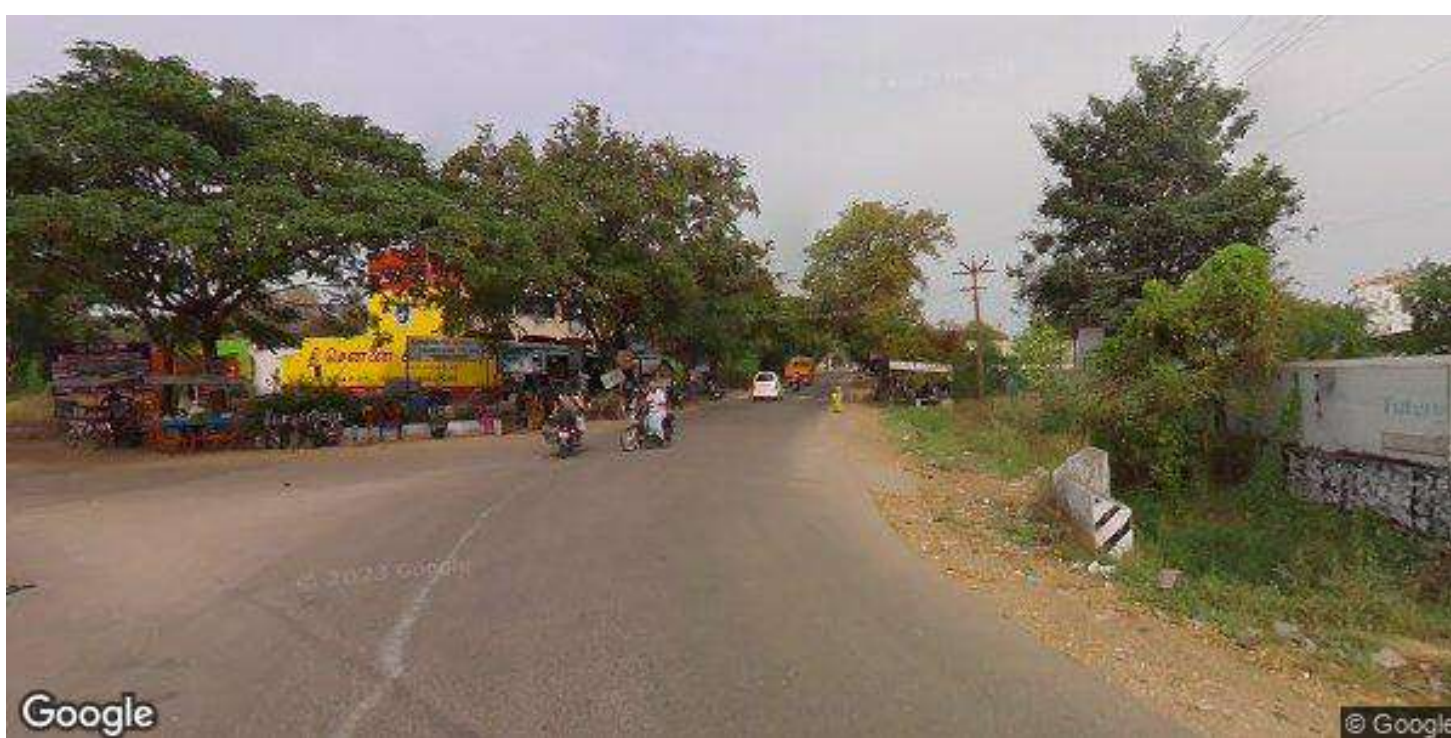
**Coordinates:** 11.18700, 77.60980

**Risk Type:** Turn

**Risk Level:** High

**Speed Limit:** 15 KM/Hr
