## JOURNEY RISK MANAGEMENT (JRM) STUDY

### Salem Terminal to T.K.S. FUELS STATION

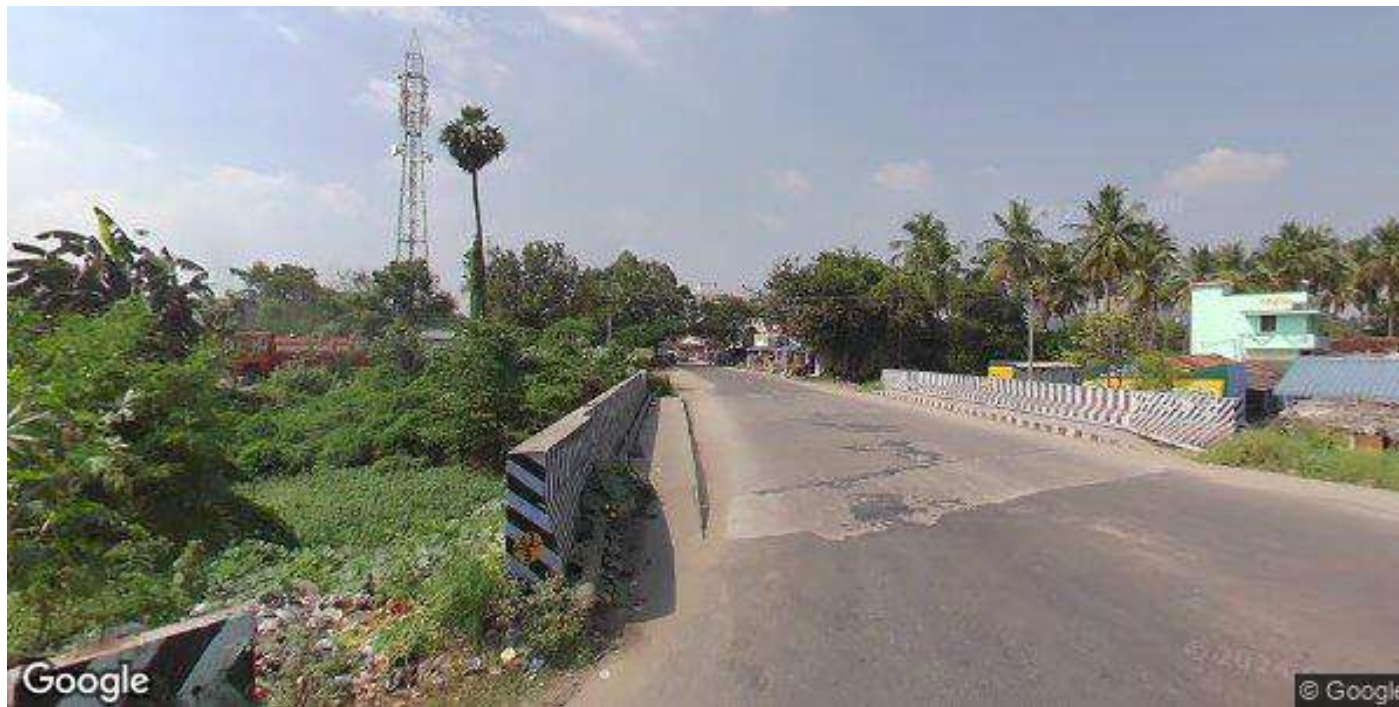
**Risk Type:** Turn  
**Risk Level:** High  
**Speed Limit:** 15 KM/Hr  
**Coordinates:** 11.44900, 77.87406

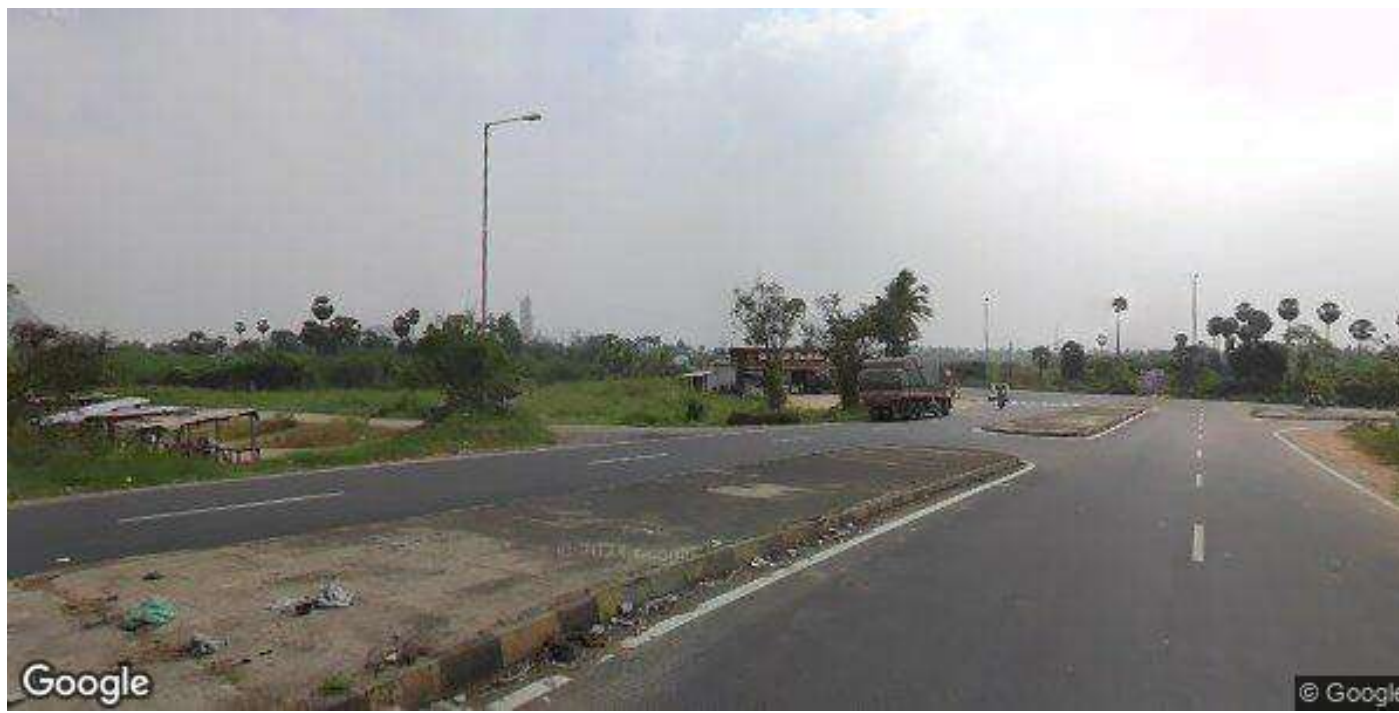
**Risk Type:** Turn  
**Risk Level:** High  
**Speed Limit:** 15 KM/Hr  
**Coordinates:** 11.45605, 77.81683

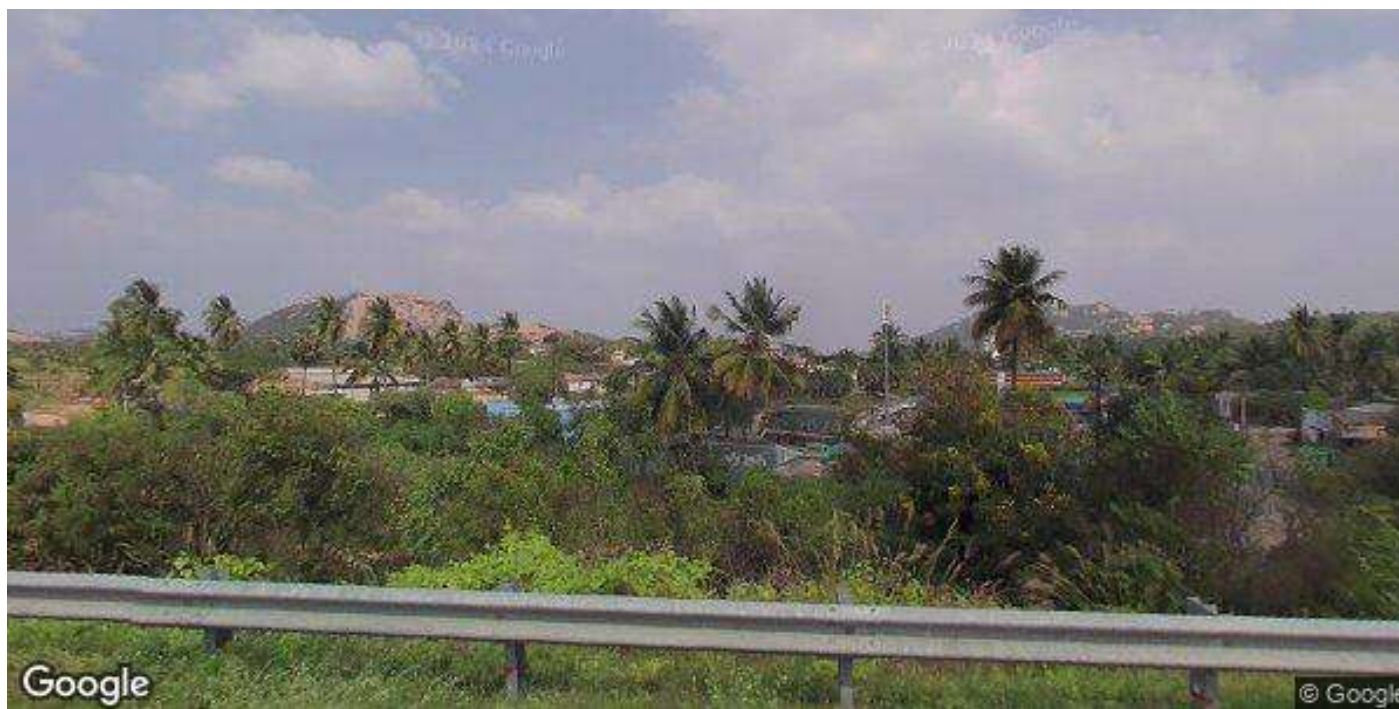
**Risk Type:** Turn  
**Risk Level:** Medium  
**Speed Limit:** 30 KM/Hr  
**Coordinates:** 11.49383, 77.88501

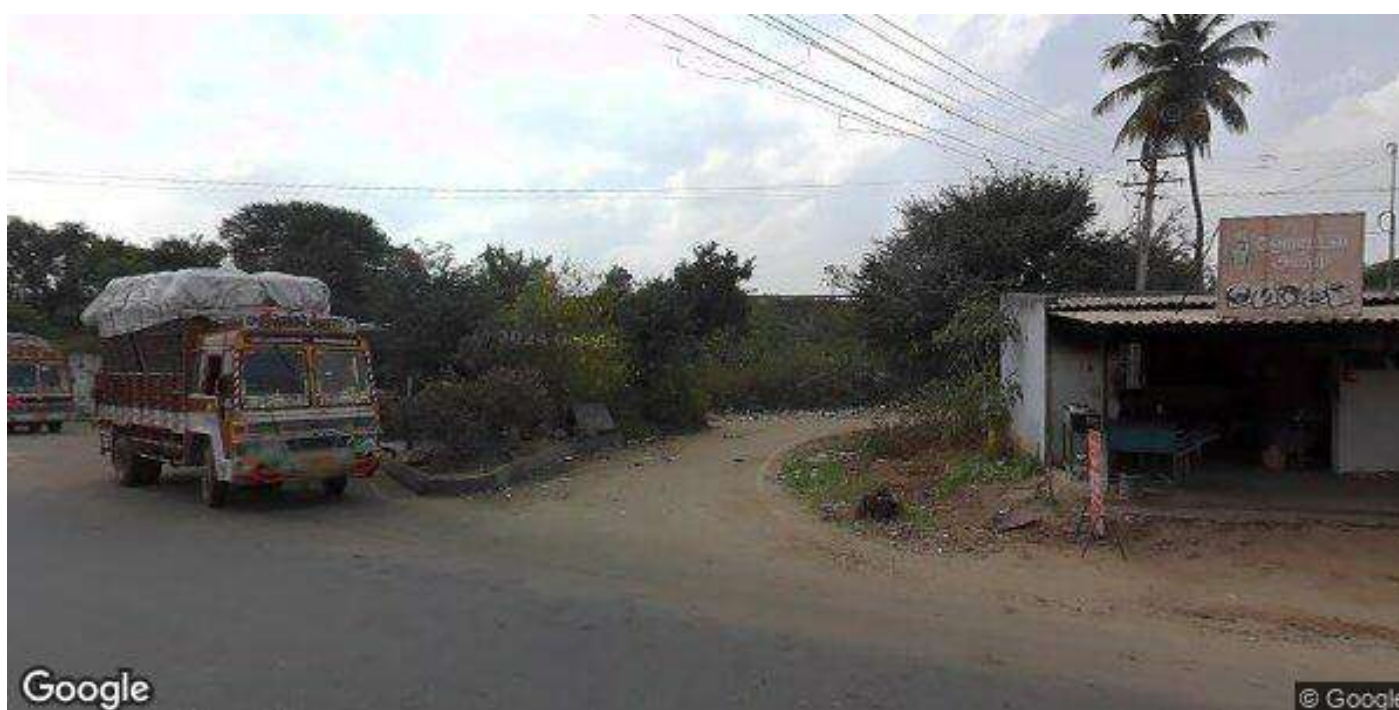
**Risk Type:** Blind Spot  
**Risk Level:** Blind Spot  
**Speed Limit:** 10 KM/Hr  
**Coordinates:** 11.49400, 77.88538

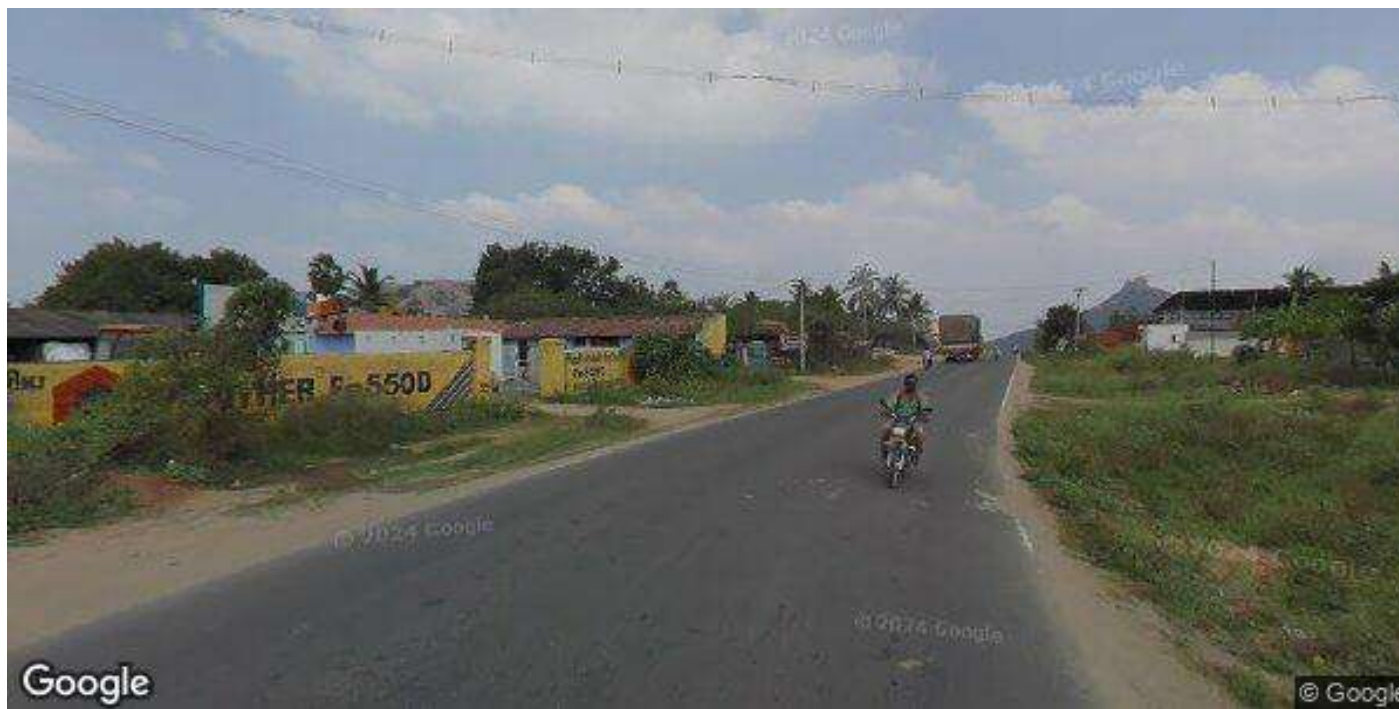
**Risk Type:** Turn  
**Risk Level:** High  
**Speed Limit:** 15 KM/Hr  
**Coordinates:** 11.49469, 77.88488

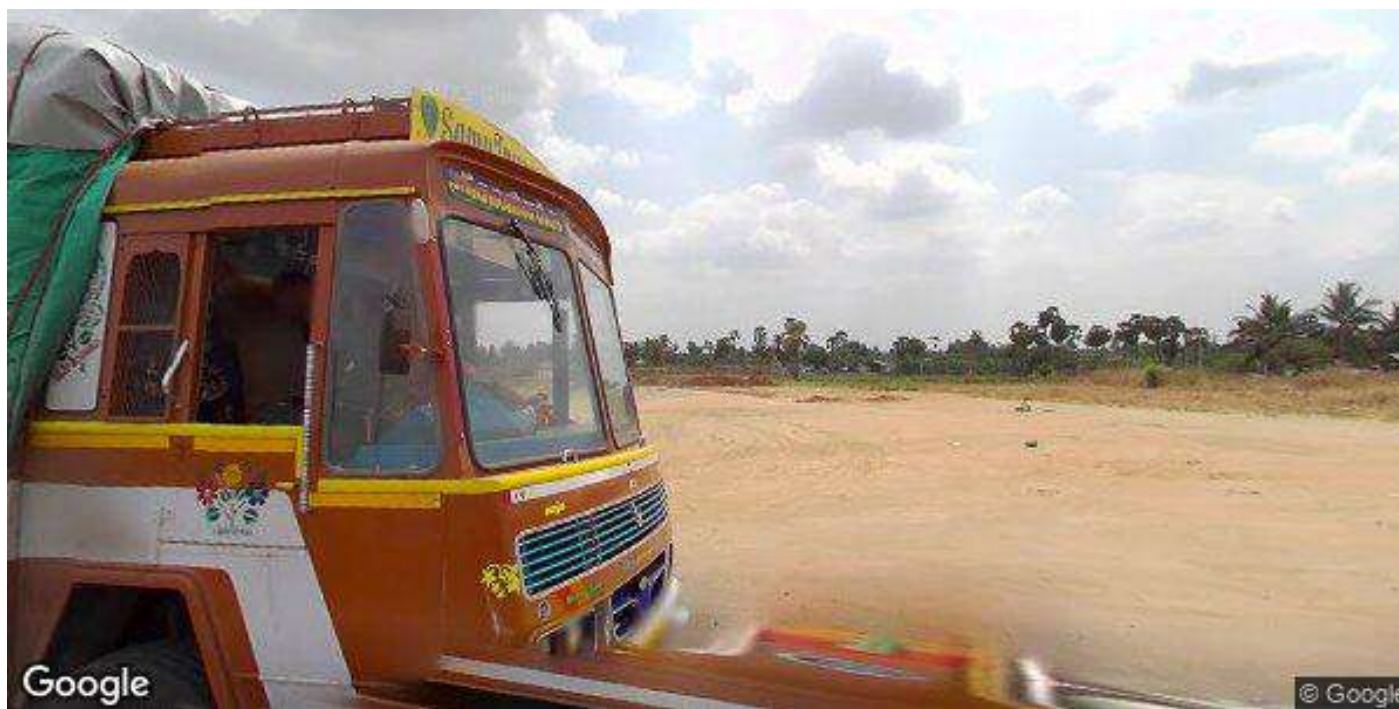
**Risk Type:** Turn  
**Risk Level:** High  
**Speed Limit:** 15 KM/Hr  
**Coordinates:** 11.55618, 77.89789

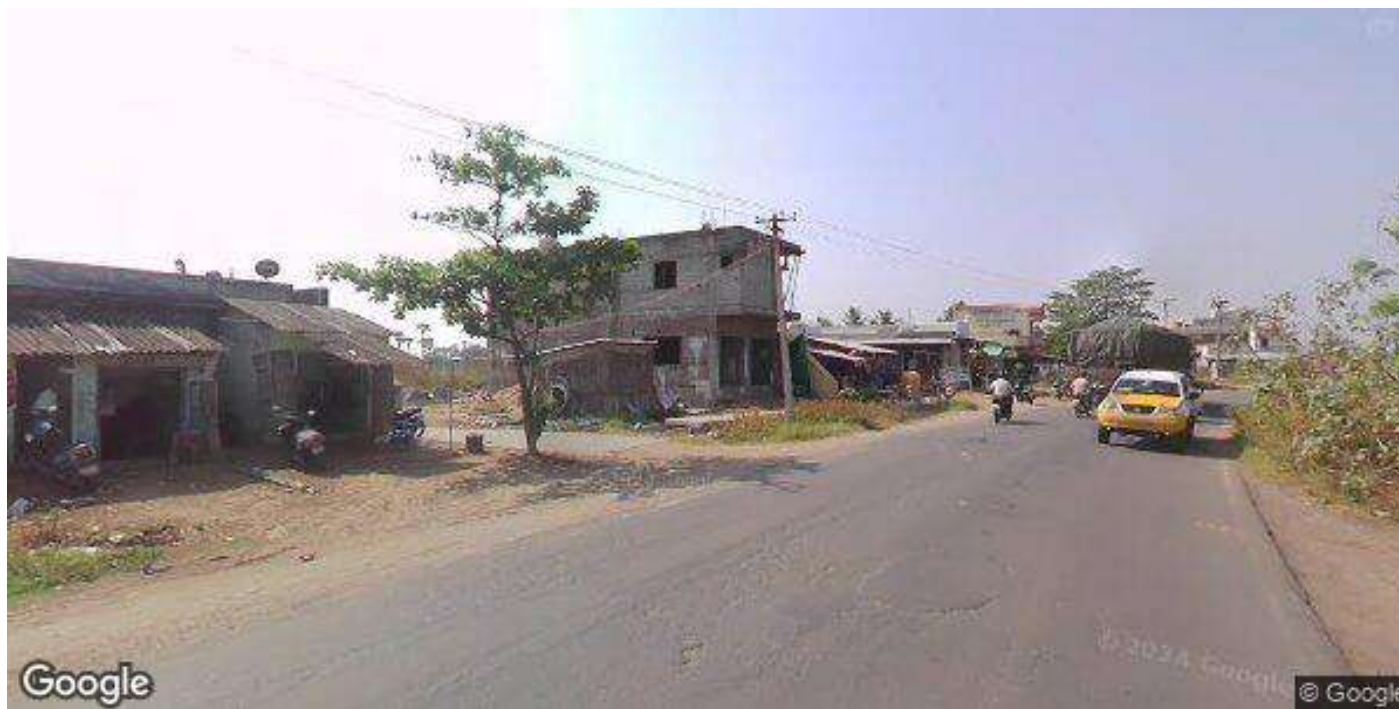
**Risk Type:** Turn  
**Risk Level:** Medium  
**Speed Limit:** 30 KM/Hr  
**Coordinates:** 11.59201, 77.90649

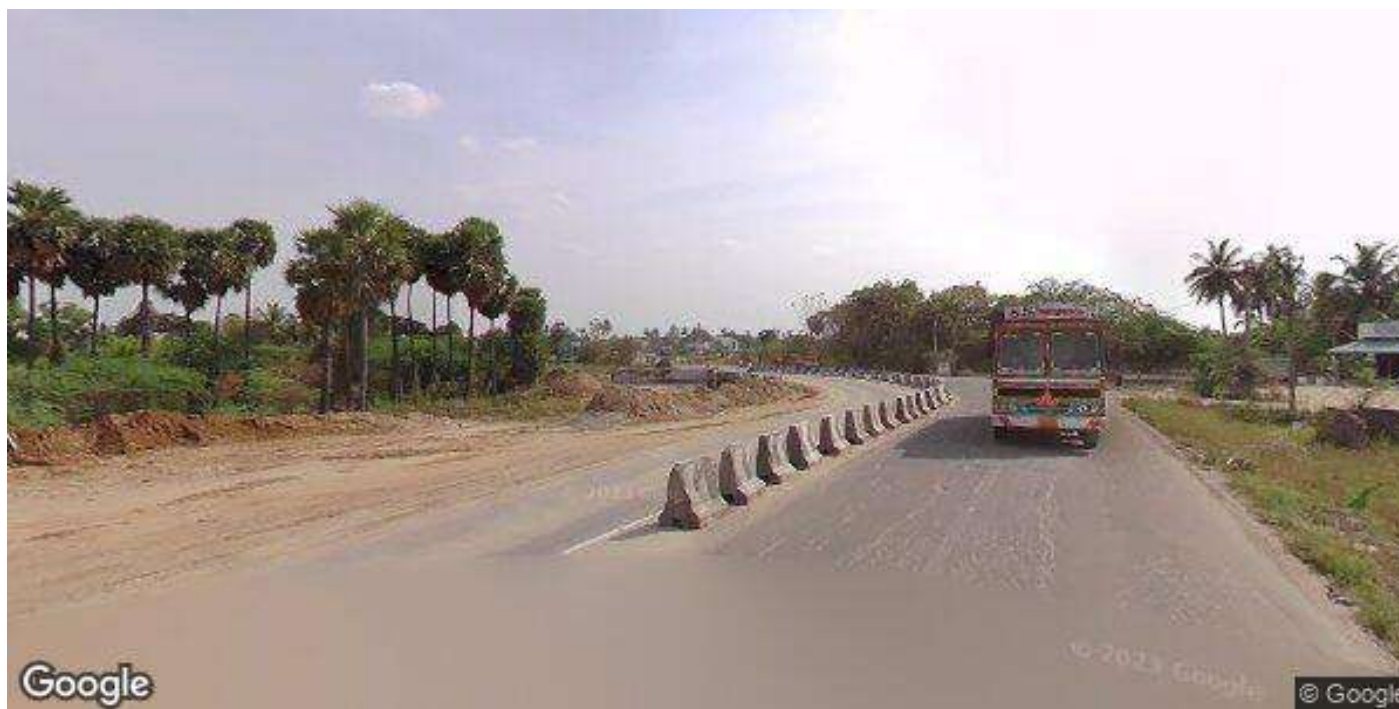
**Risk Type:** Turn  
**Risk Level:** Medium  
**Speed Limit:** 30 KM/Hr  
**Coordinates:** 11.63882, 77.94859

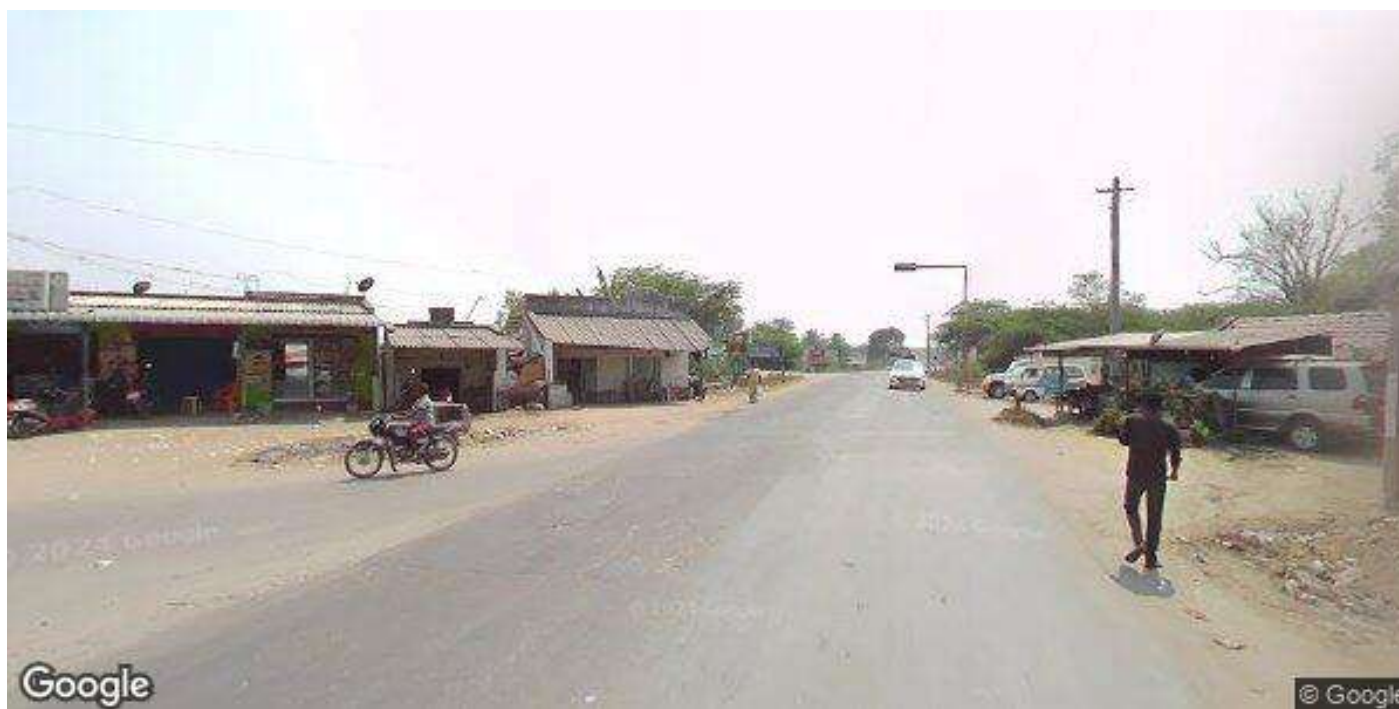
**Risk Type:** Turn  
**Risk Level:** Medium  
**Speed Limit:** 30 KM/Hr  
**Coordinates:** 11.64161, 77.95177

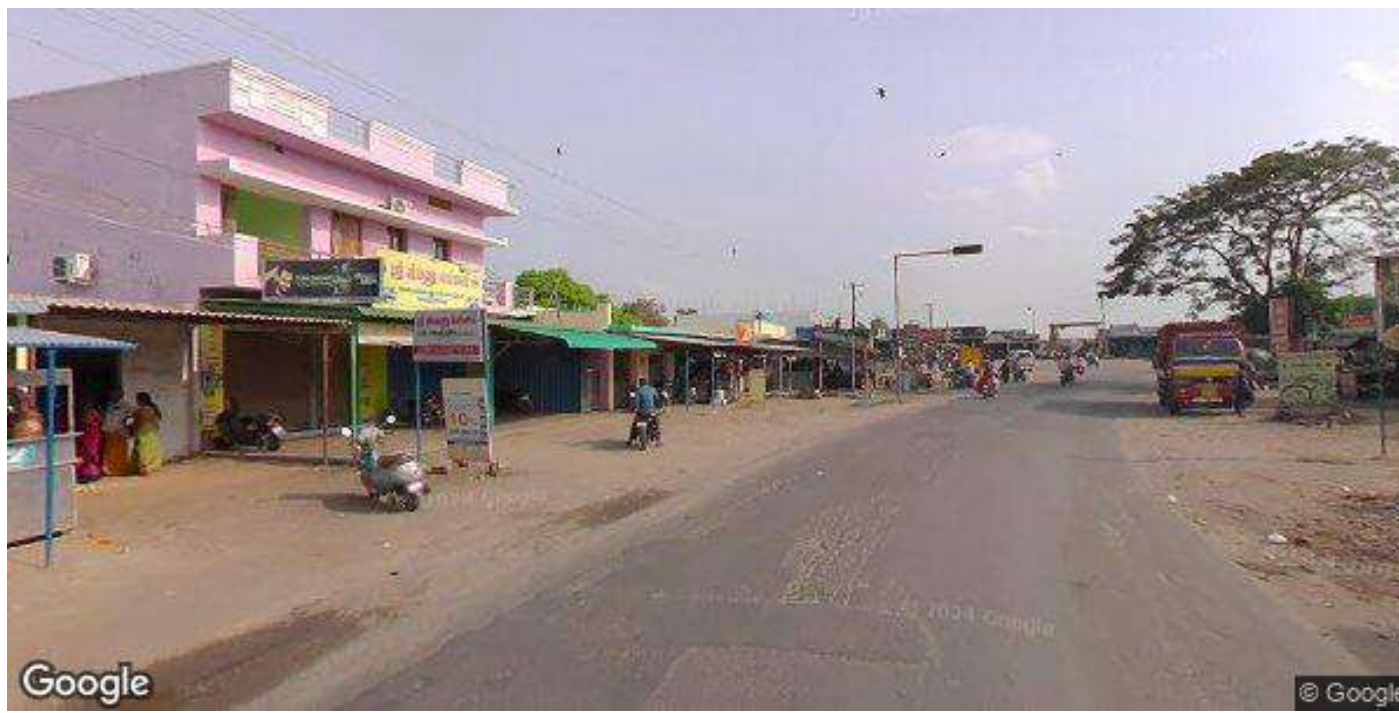
**Risk Type:** Turn  
**Risk Level:** Medium  
**Speed Limit:** 30 KM/Hr  
**Coordinates:** 11.64226, 77.95200

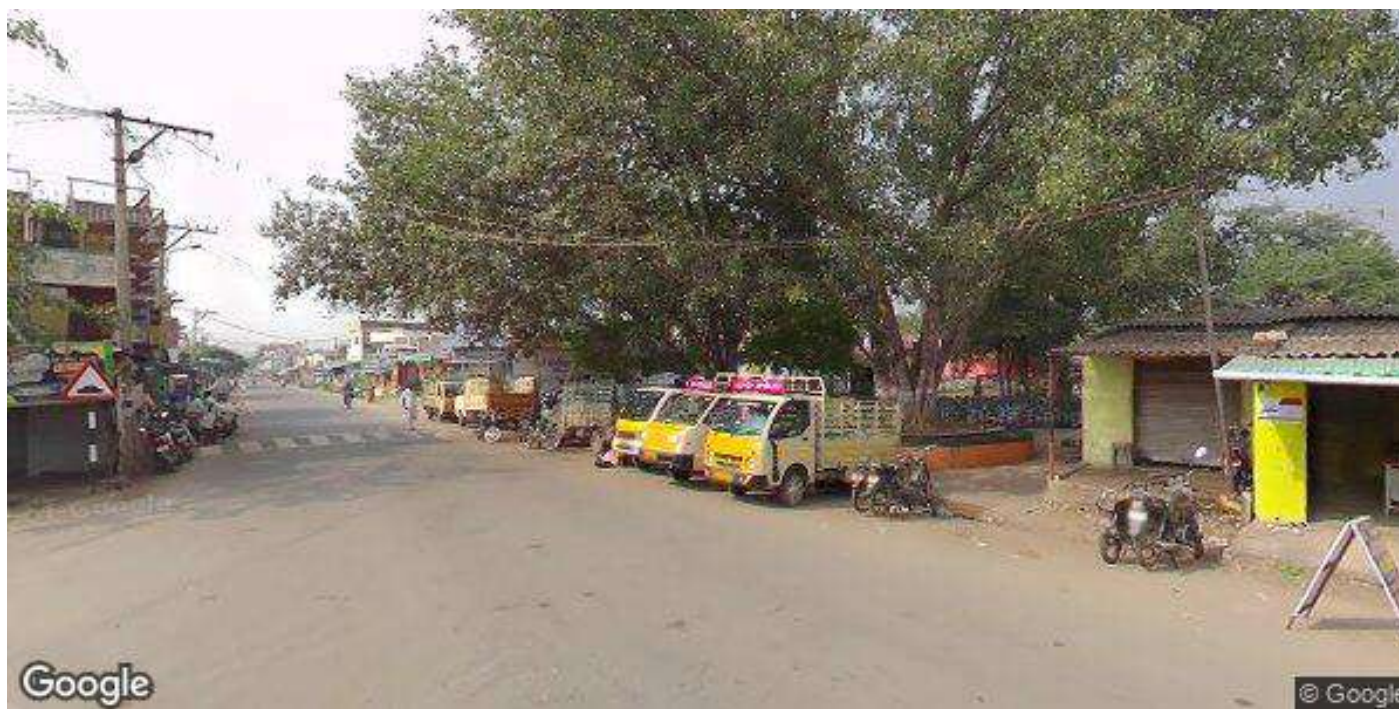
**Risk Type:** Turn  
**Risk Level:** Medium  
**Speed Limit:** 30 KM/Hr  
**Coordinates:** 11.64716, 77.95118

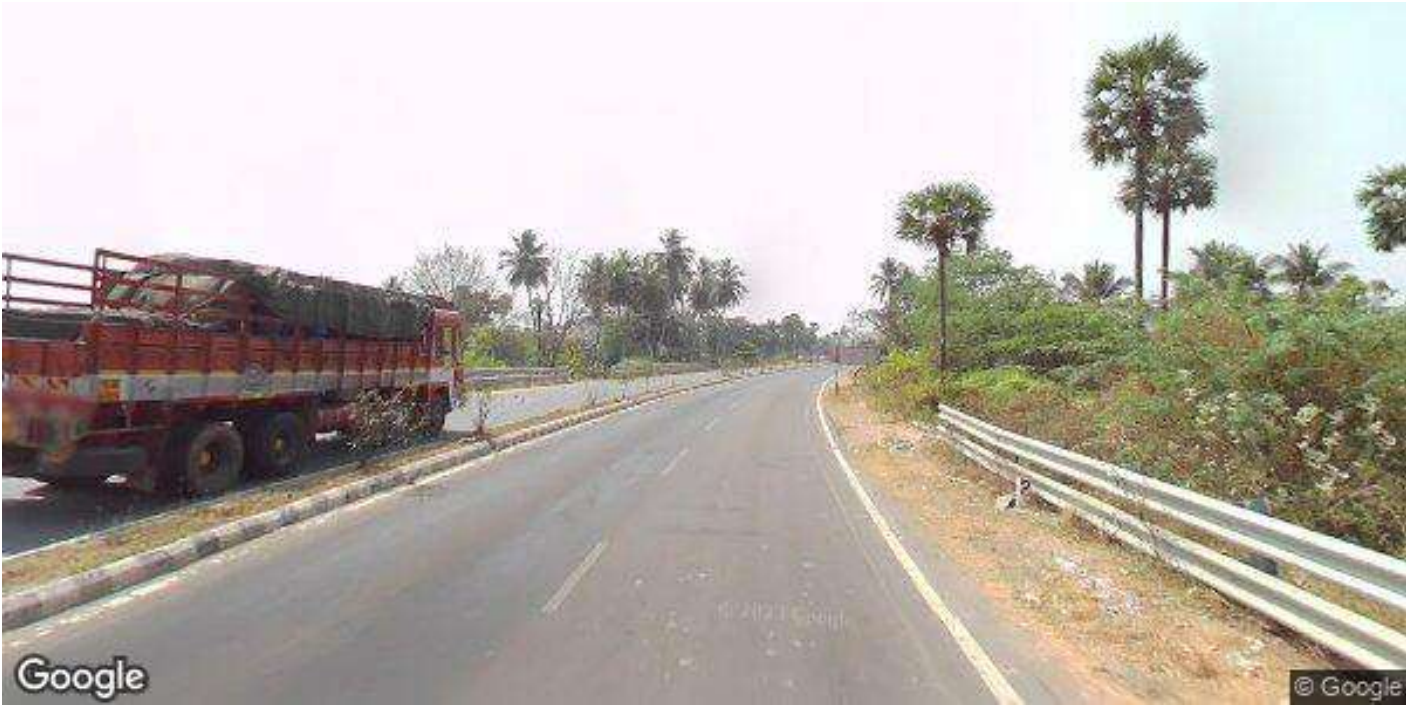
**Risk Type:** Turn  
**Risk Level:** Medium  
**Speed Limit:** 30 KM/Hr  
**Coordinates:** 11.70077, 77.97957

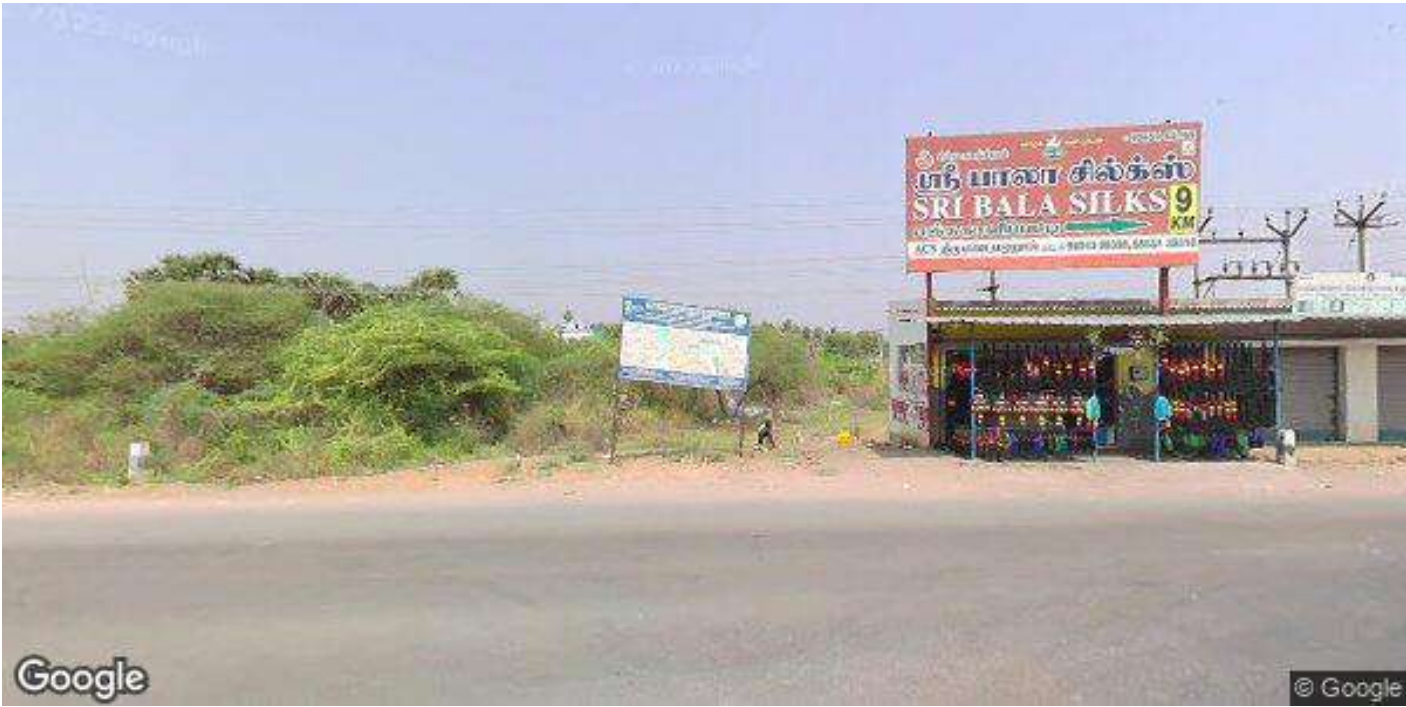
**Risk Type:** Turn  
**Risk Level:** High  
**Speed Limit:** 15 KM/Hr  
**Coordinates:** 11.70223, 77.97860

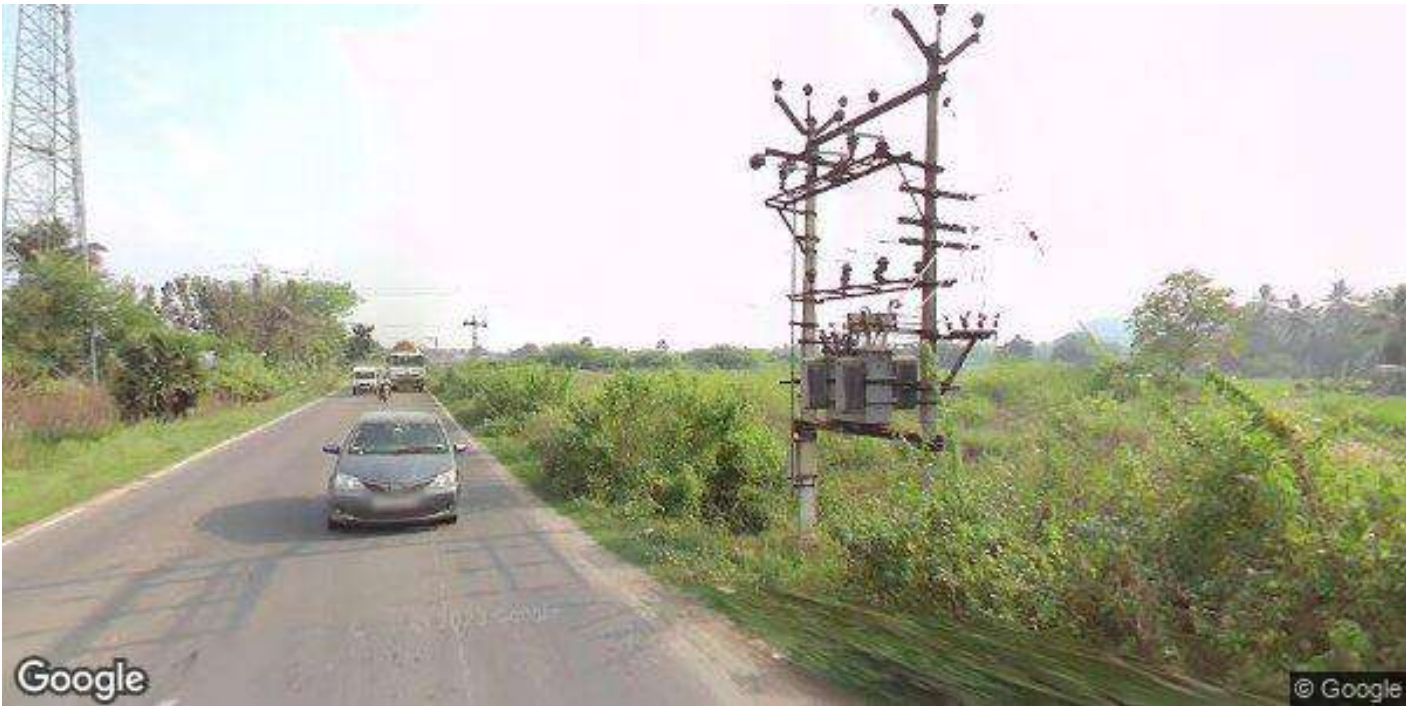
**Risk Type:** Turn  
**Risk Level:** Medium  
**Speed Limit:** 30 KM/Hr  
**Coordinates:** 11.71402, 77.99586

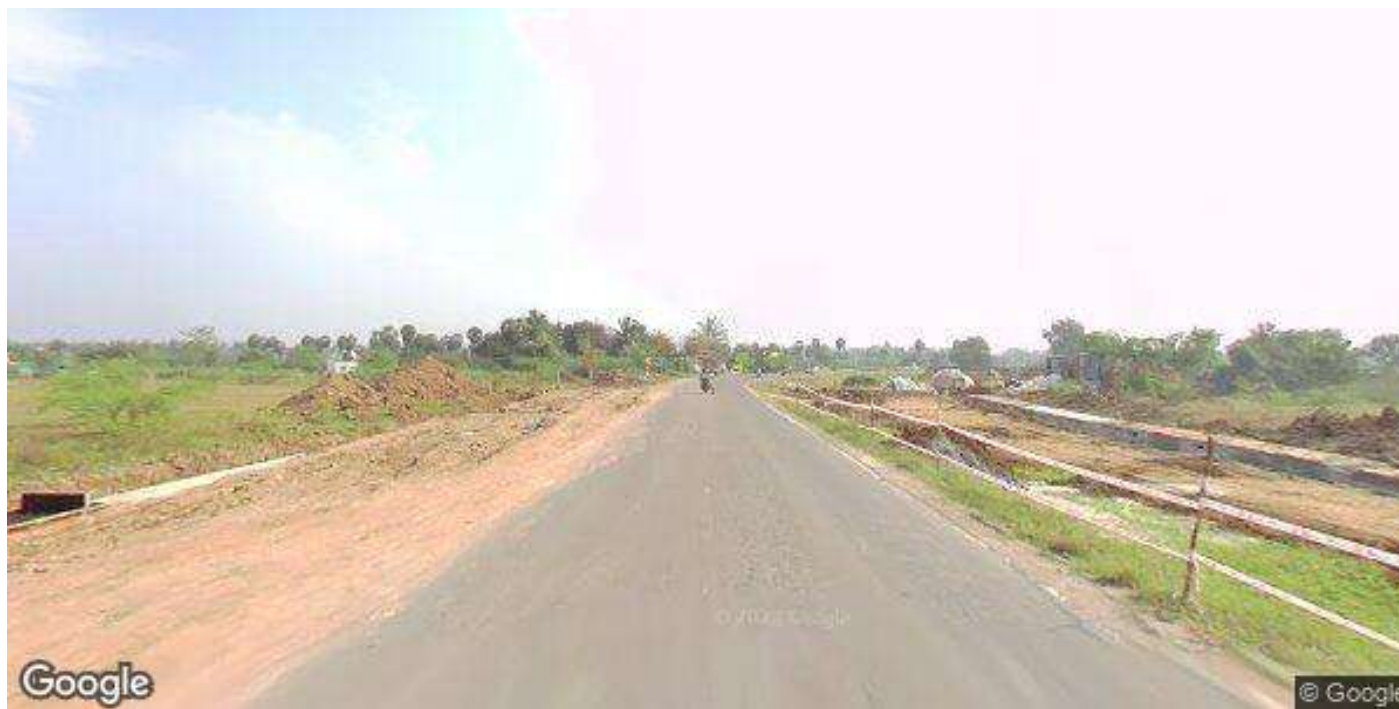
**Risk Type:** Turn  
**Risk Level:** Medium  
**Speed Limit:** 30 KM/Hr  
**Coordinates:** 11.71704, 77.99948

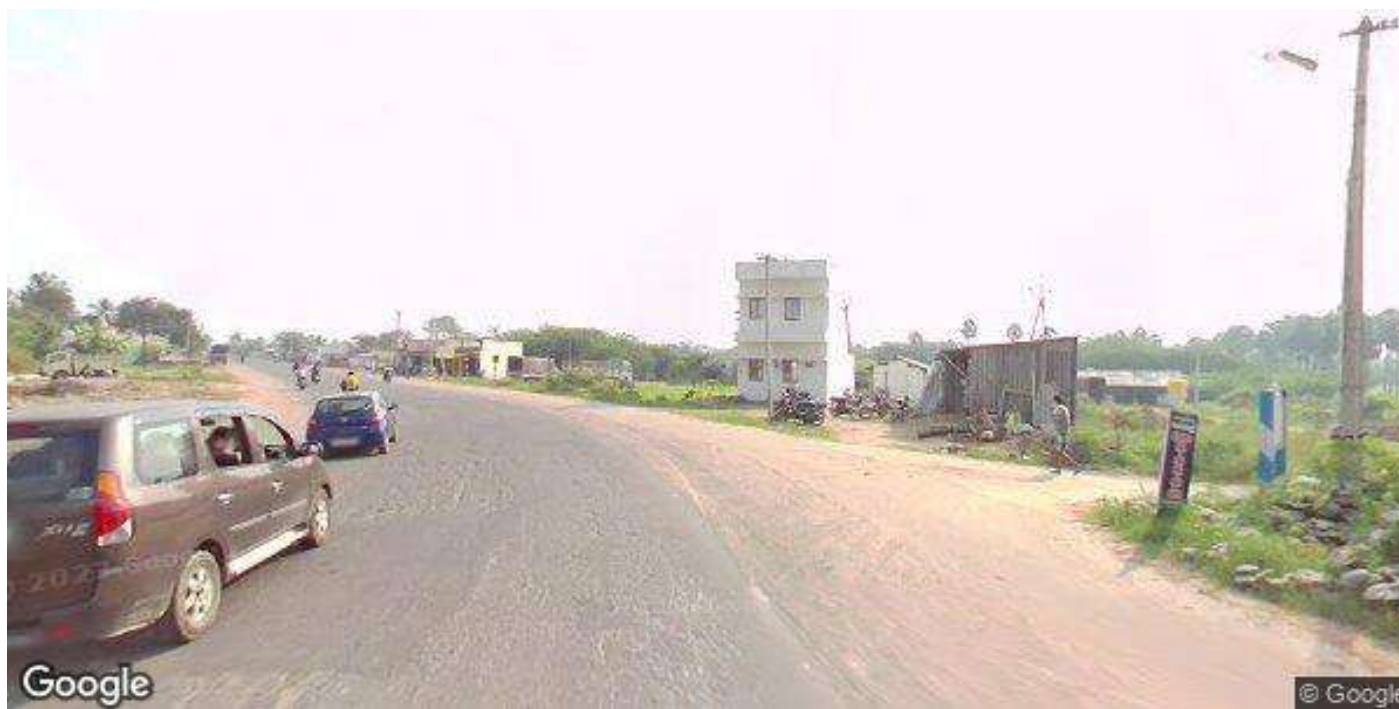
**Risk Type:** Turn  
**Risk Level:** Medium  
**Speed Limit:** 30 KM/Hr  
**Coordinates:** 11.71918, 78.01127

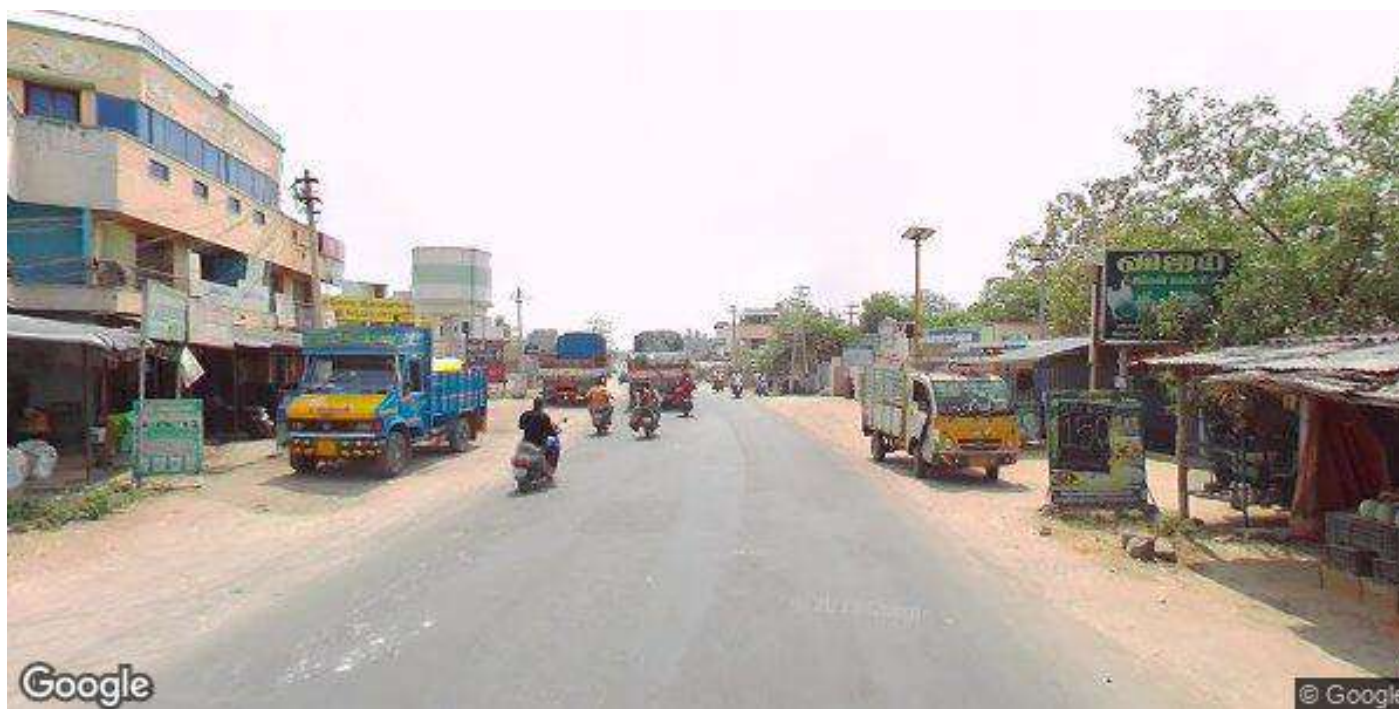
**Risk Type:** Turn  
**Risk Level:** Medium  
**Speed Limit:** 30 KM/Hr  
**Coordinates:** 11.73769, 78.03451

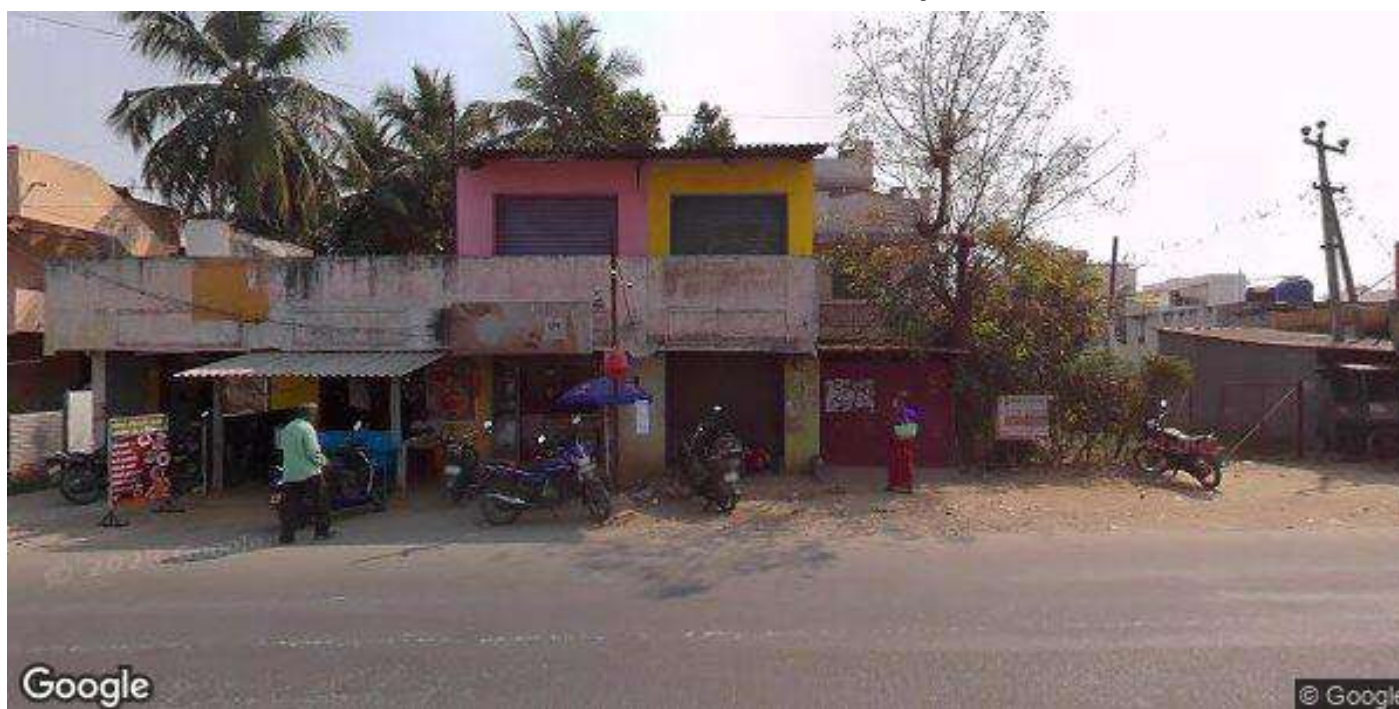
**Risk Type:** Turn  
**Risk Level:** Medium  
**Speed Limit:** 30 KM/Hr  
**Coordinates:** 11.73785, 78.03551

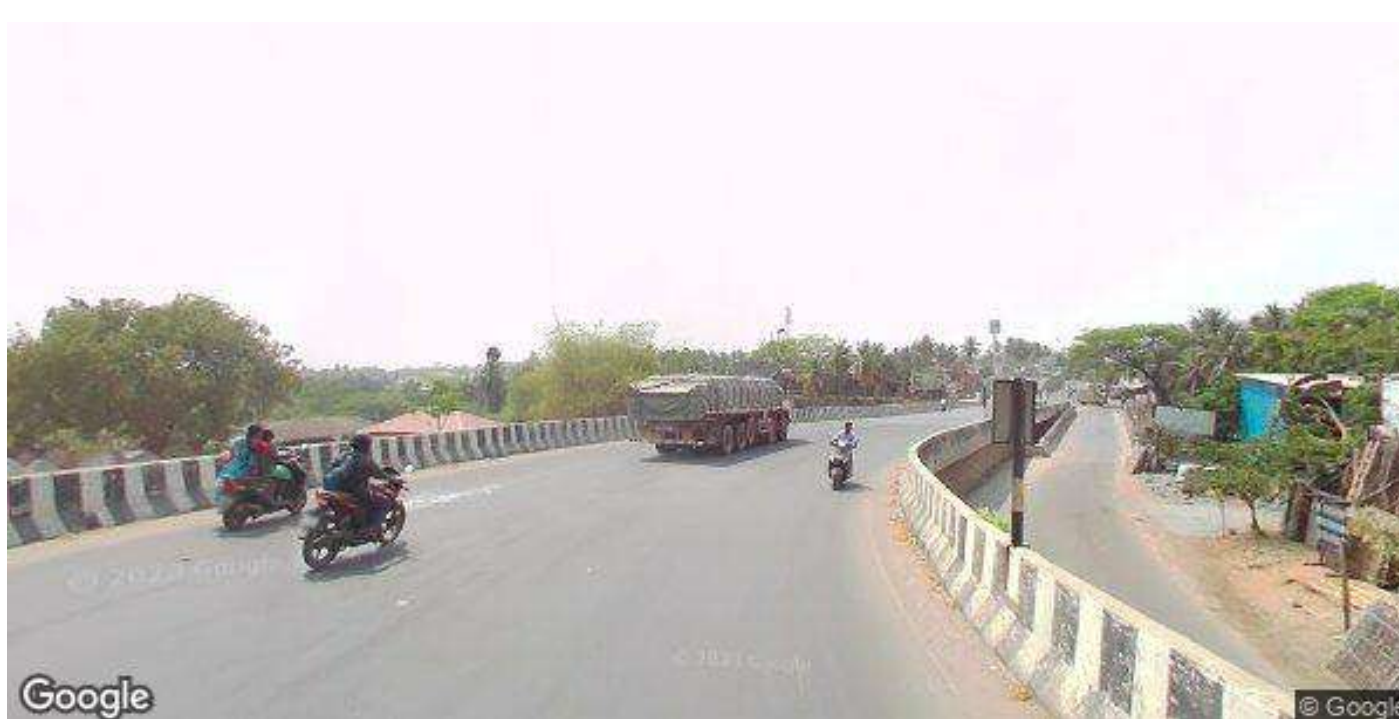
**Risk Type:** Turn  
**Risk Level:** High  
**Speed Limit:** 15 KM/Hr  
**Coordinates:** 11.73651, 78.03871

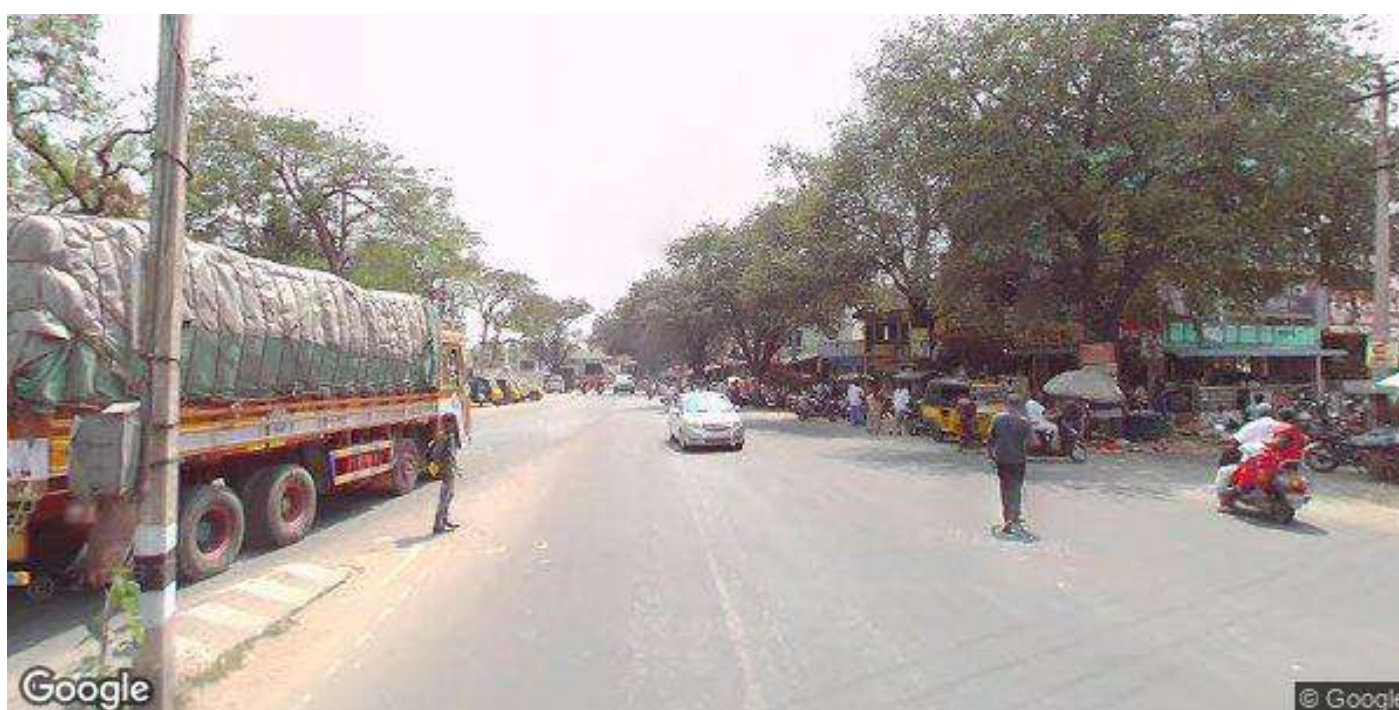
**Risk Type:** Turn  
**Risk Level:** Medium  
**Speed Limit:** 30 KM/Hr  
**Coordinates:** 11.74271, 78.04717

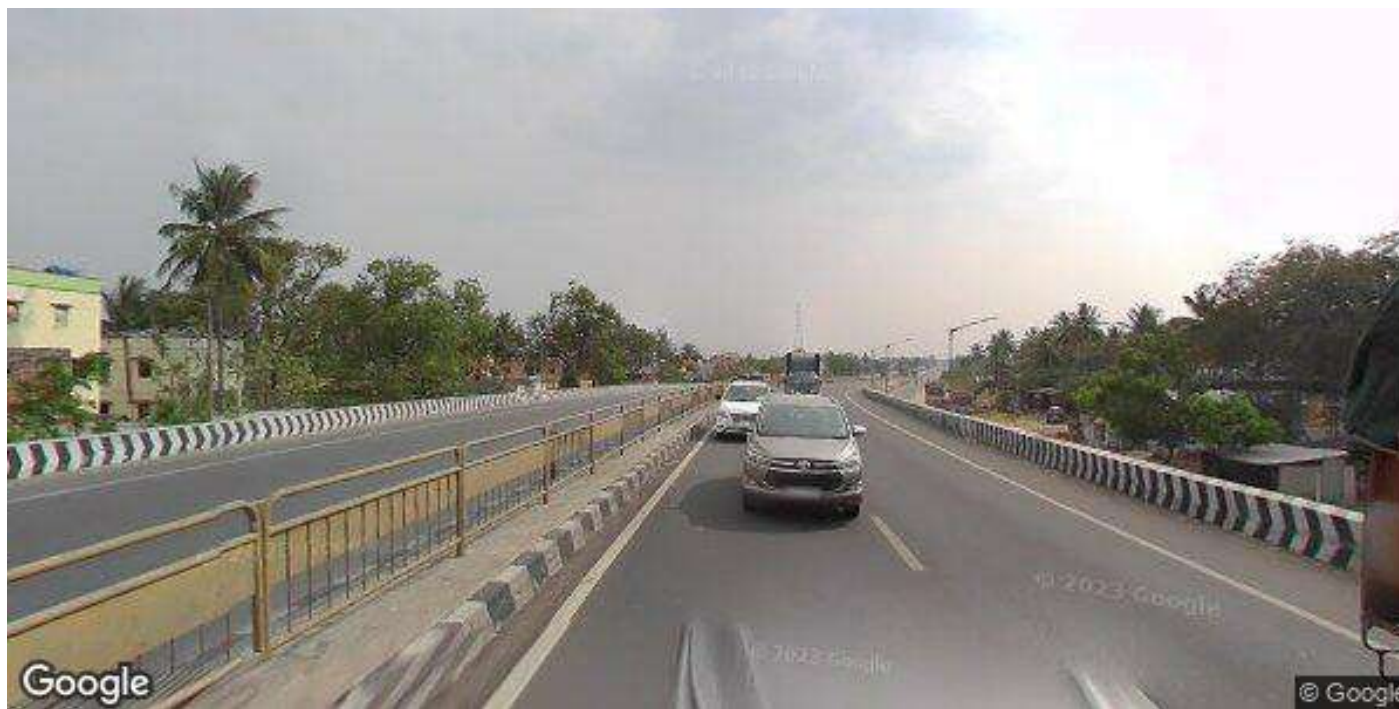
**Risk Type:** Turn  
**Risk Level:** Medium  
**Speed Limit:** 30 KM/Hr  
**Coordinates:** 11.86763, 78.08336

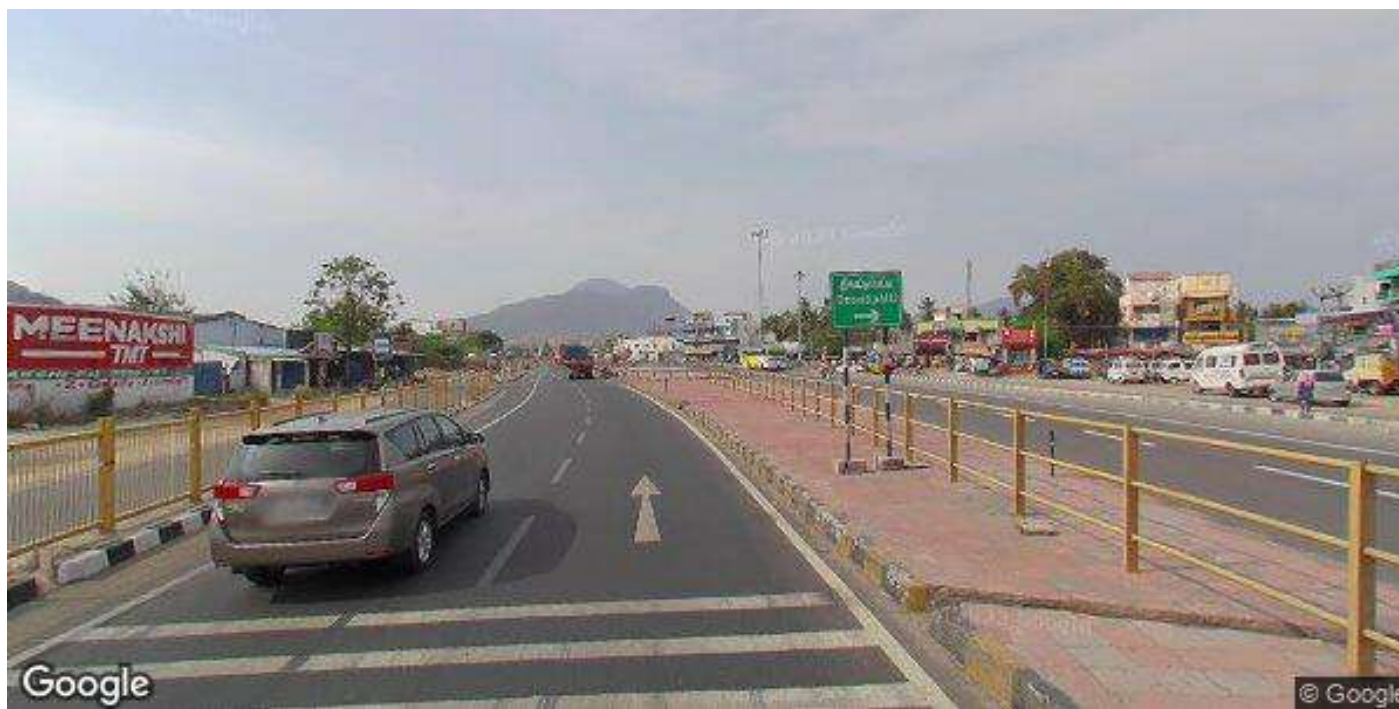
**Risk Type:** Turn  
**Risk Level:** Medium  
**Speed Limit:** 30 KM/Hr  
**Coordinates:** 11.87000, 78.08385
