## JOURNEY RISK MANAGEMENT (JRM) STUDY

### Salem Terminal to T.K.S. FUELS STATION

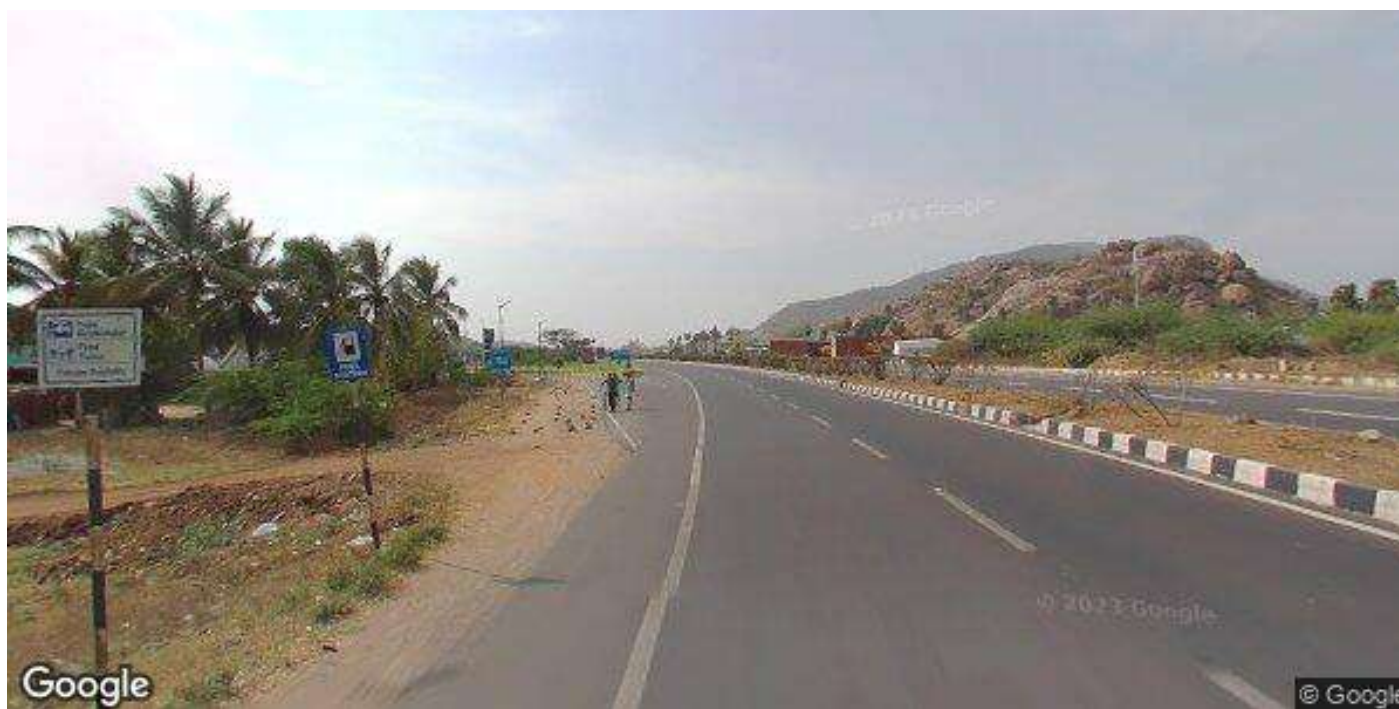
**Risk Type:** Turn  
**Risk Level:** Medium  
**Speed Limit:** 30 KM/Hr  
**Coordinates:** 11.88060, 78.08128

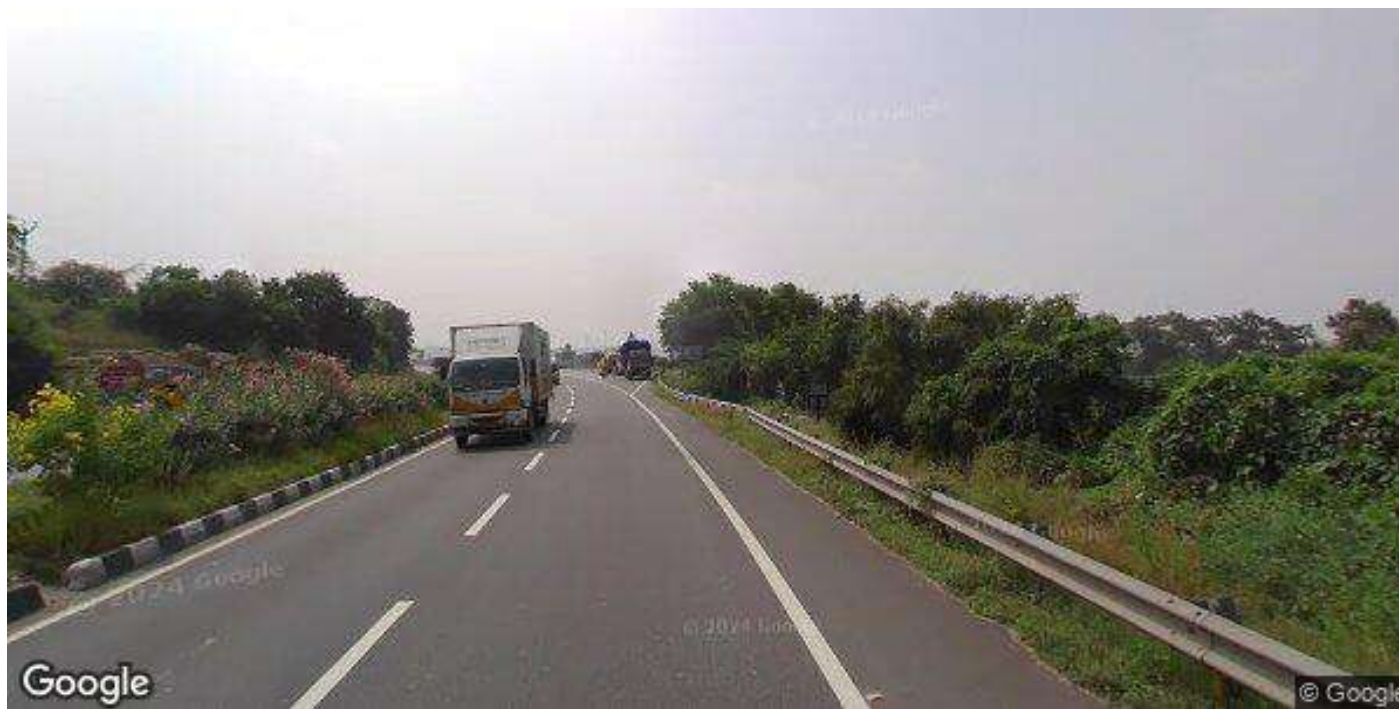
**Risk Type:** Turn  
**Risk Level:** Medium  
**Speed Limit:** 30 KM/Hr  
**Coordinates:** 11.91329, 78.05861

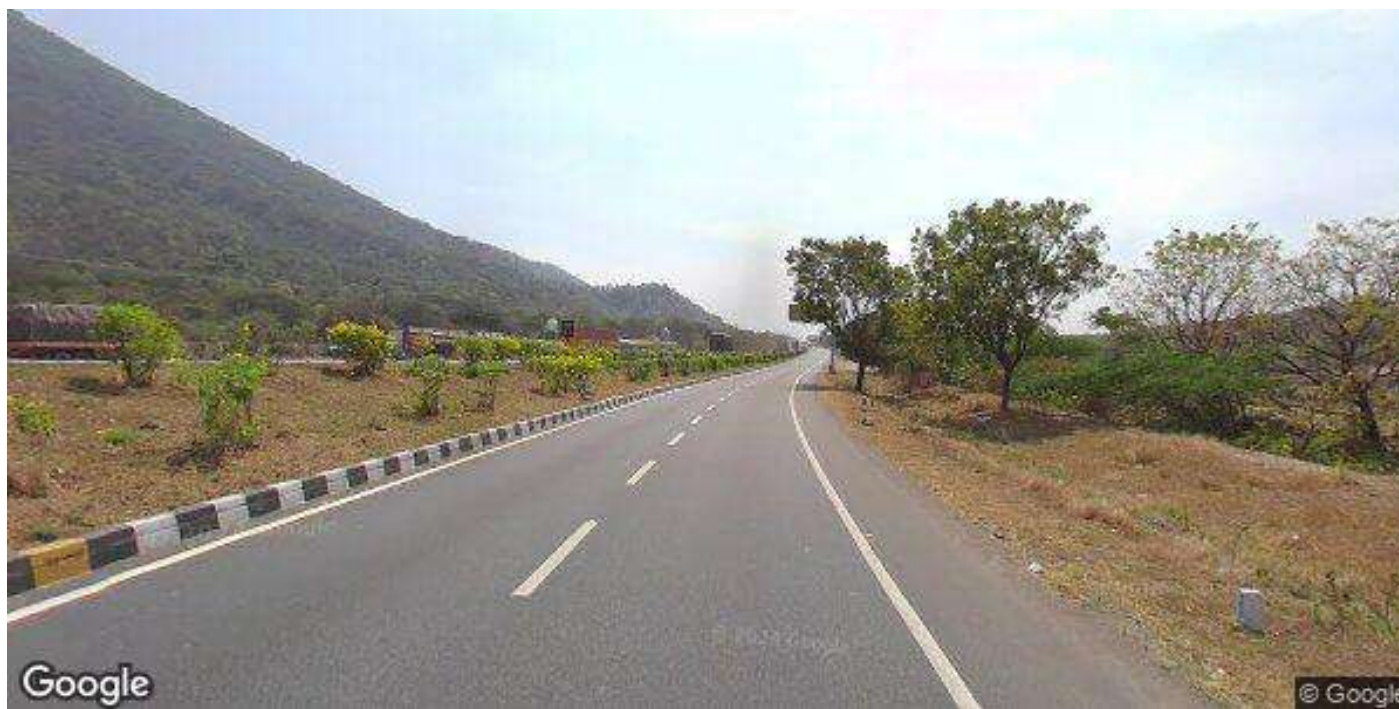
**Risk Type:** Turn  
**Risk Level:** Medium  
**Speed Limit:** 30 KM/Hr  
**Coordinates:** 11.92540, 78.06494

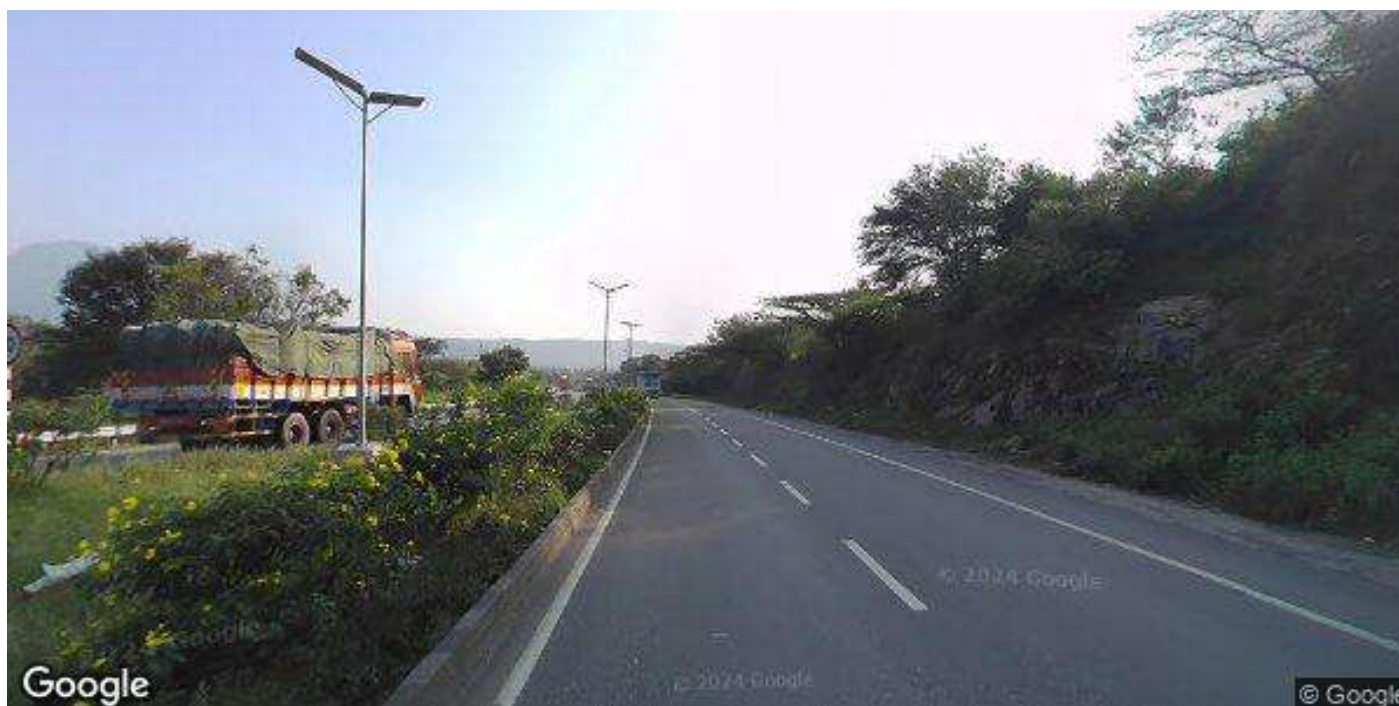
**Risk Type:** Turn  
**Risk Level:** Medium  
**Speed Limit:** 30 KM/Hr  
**Coordinates:** 11.95482, 78.04687

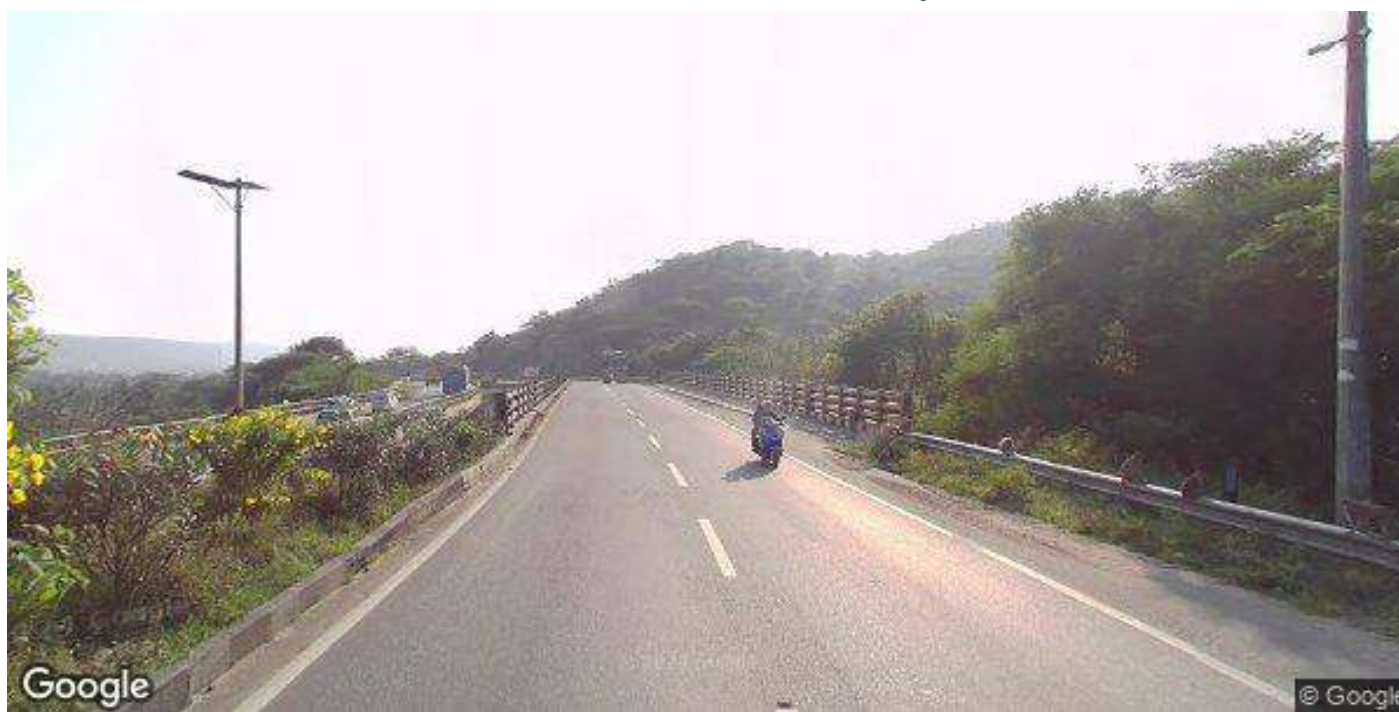
**Risk Type:** Turn  
**Risk Level:** Medium  
**Speed Limit:** 30 KM/Hr  
**Coordinates:** 11.95633, 78.04755

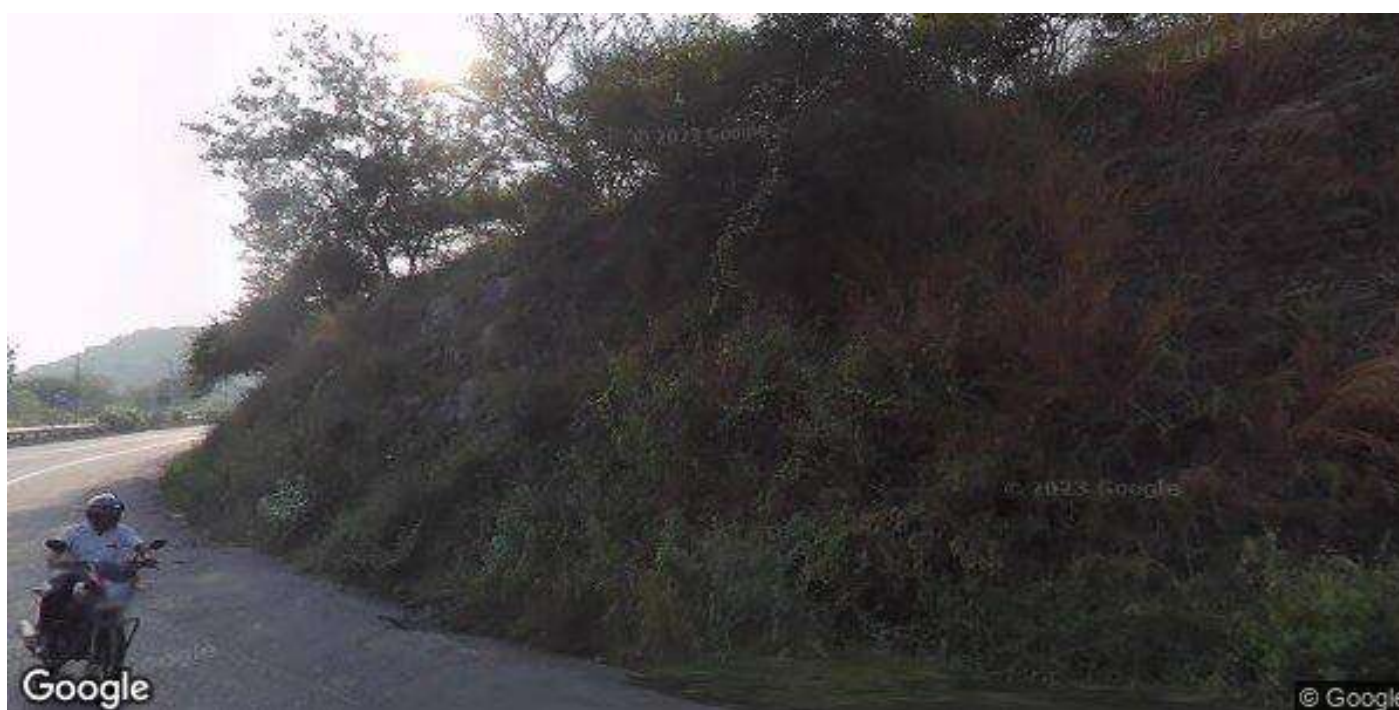
**Risk Type:** Turn  
**Risk Level:** High  
**Speed Limit:** 15 KM/Hr  
**Coordinates:** 11.95837, 78.04986

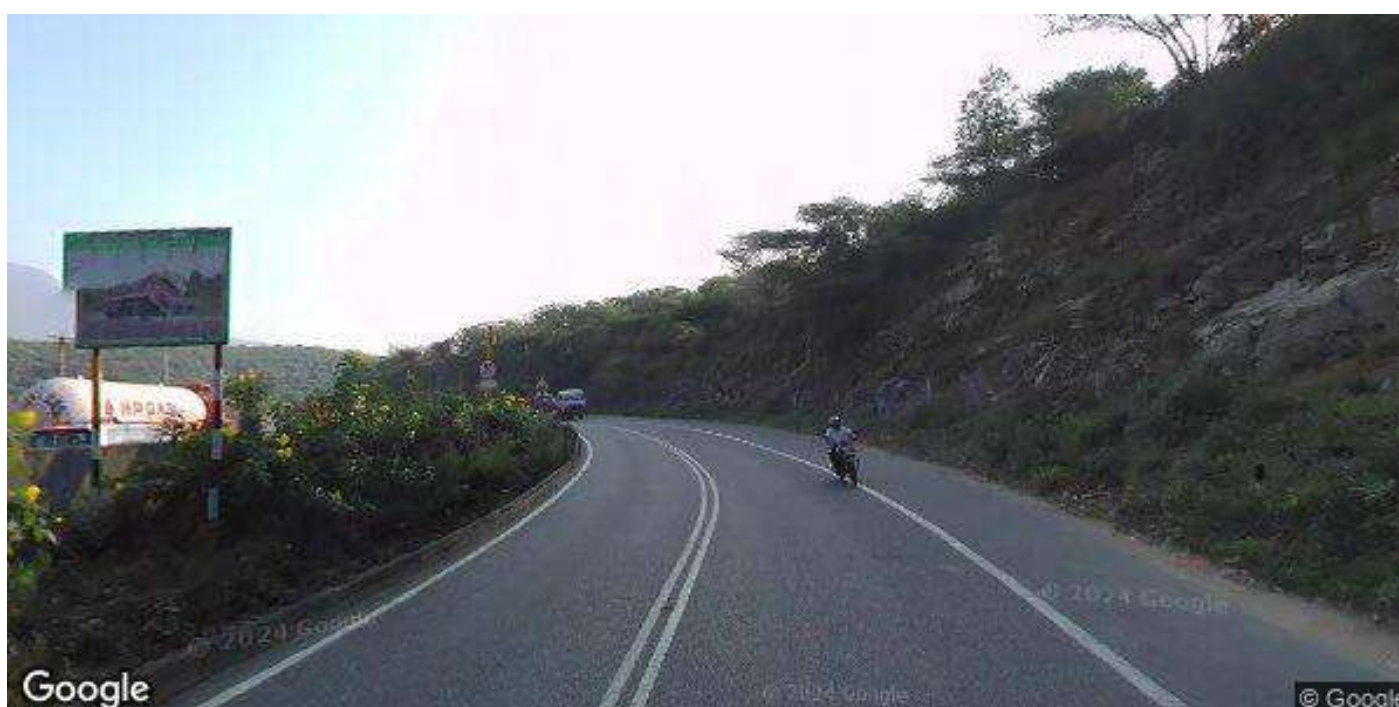
**Risk Type:** Turn  
**Risk Level:** Medium  
**Speed Limit:** 30 KM/Hr  
**Coordinates:** 11.96054, 78.04953

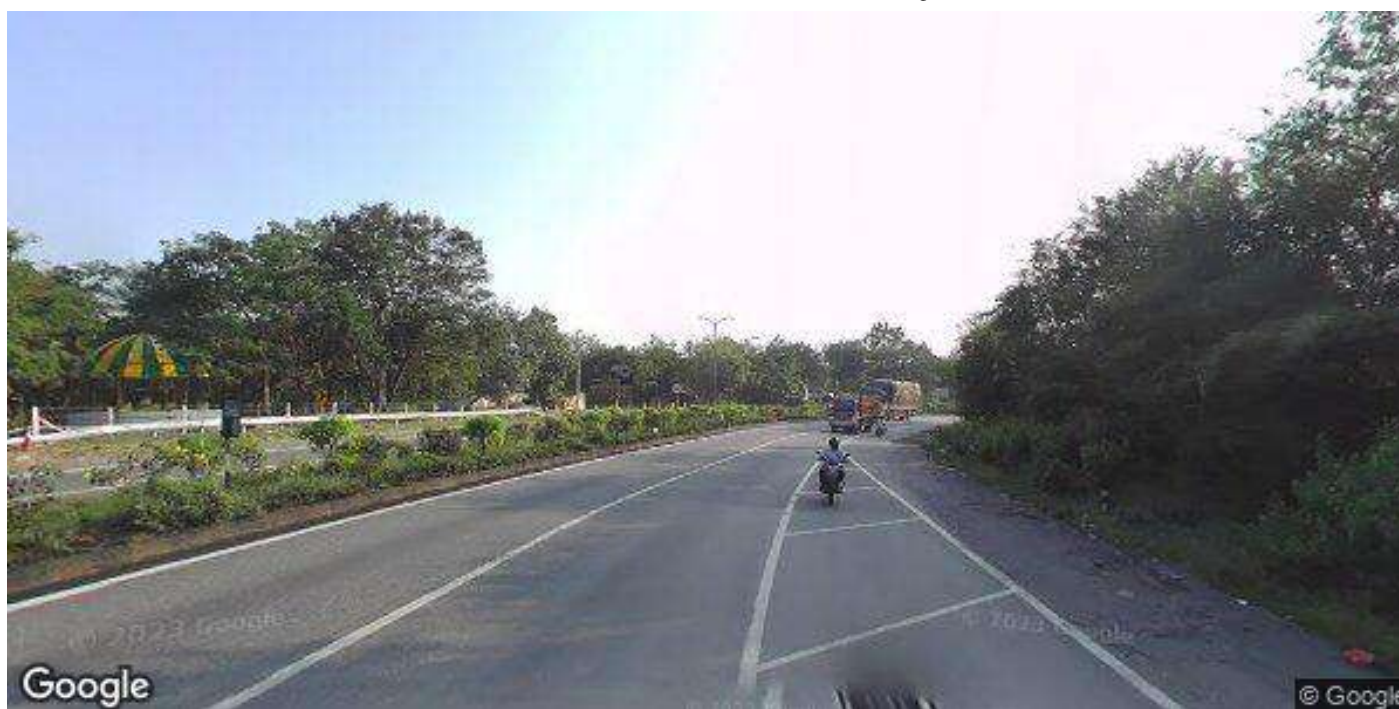
**Risk Type:** Turn  
**Risk Level:** High  
**Speed Limit:** 15 KM/Hr  
**Coordinates:** 11.96347, 78.05142

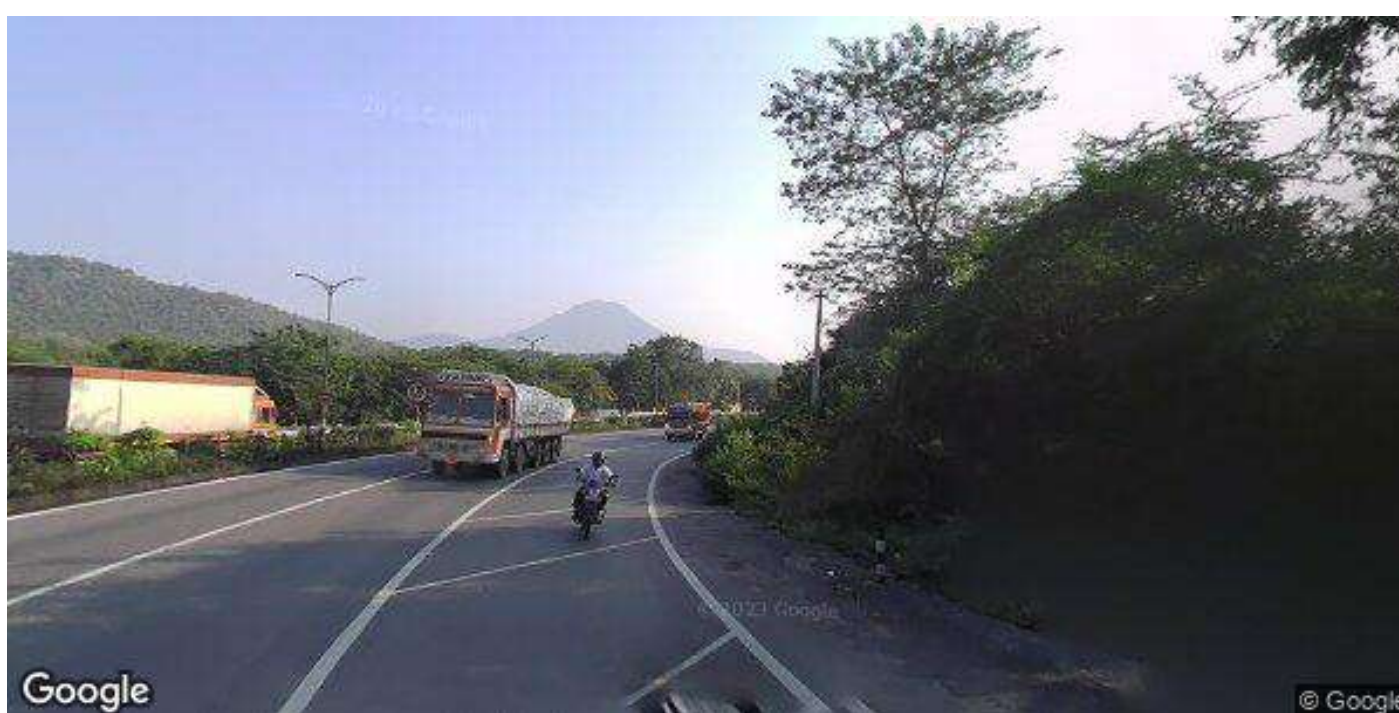
**Risk Type:** Turn  
**Risk Level:** Medium  
**Speed Limit:** 30 KM/Hr  
**Coordinates:** 11.96415, 78.05126

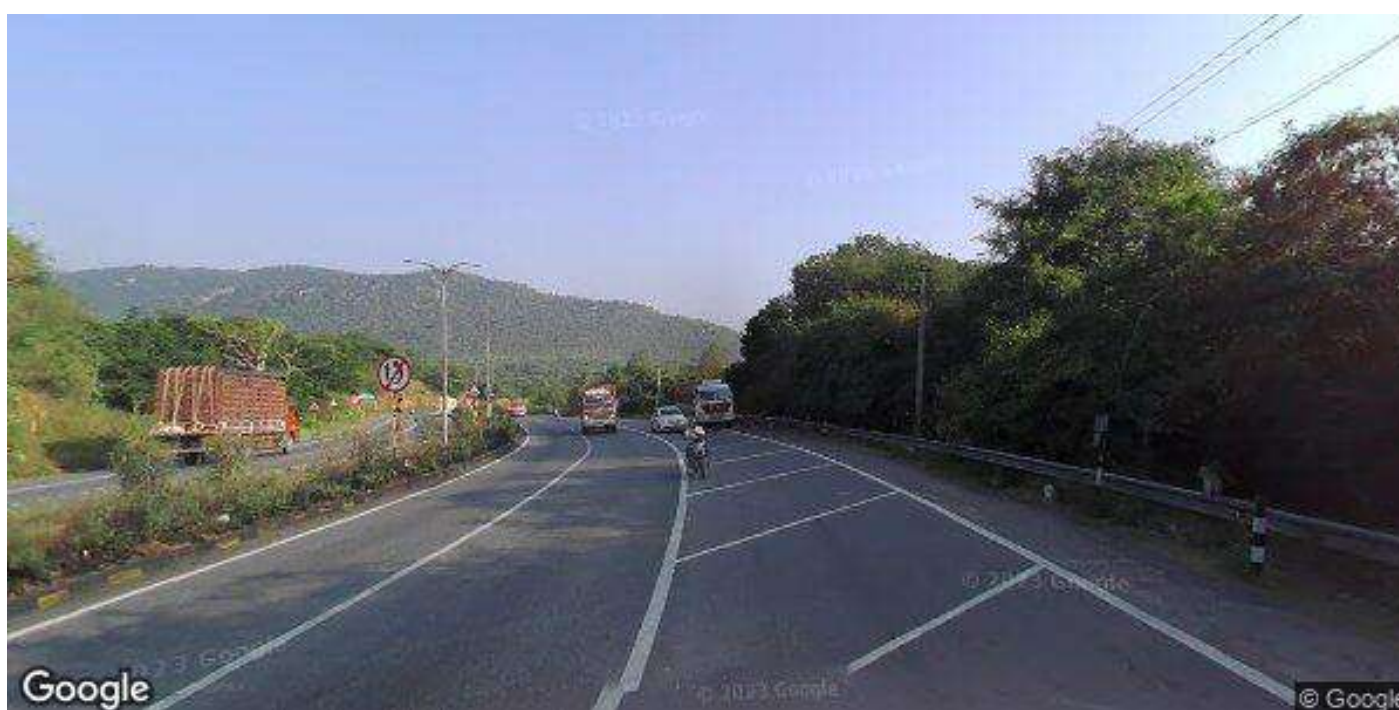
**Risk Type:** Turn  
**Risk Level:** Medium  
**Speed Limit:** 30 KM/Hr  
**Coordinates:** 11.96519, 78.04958

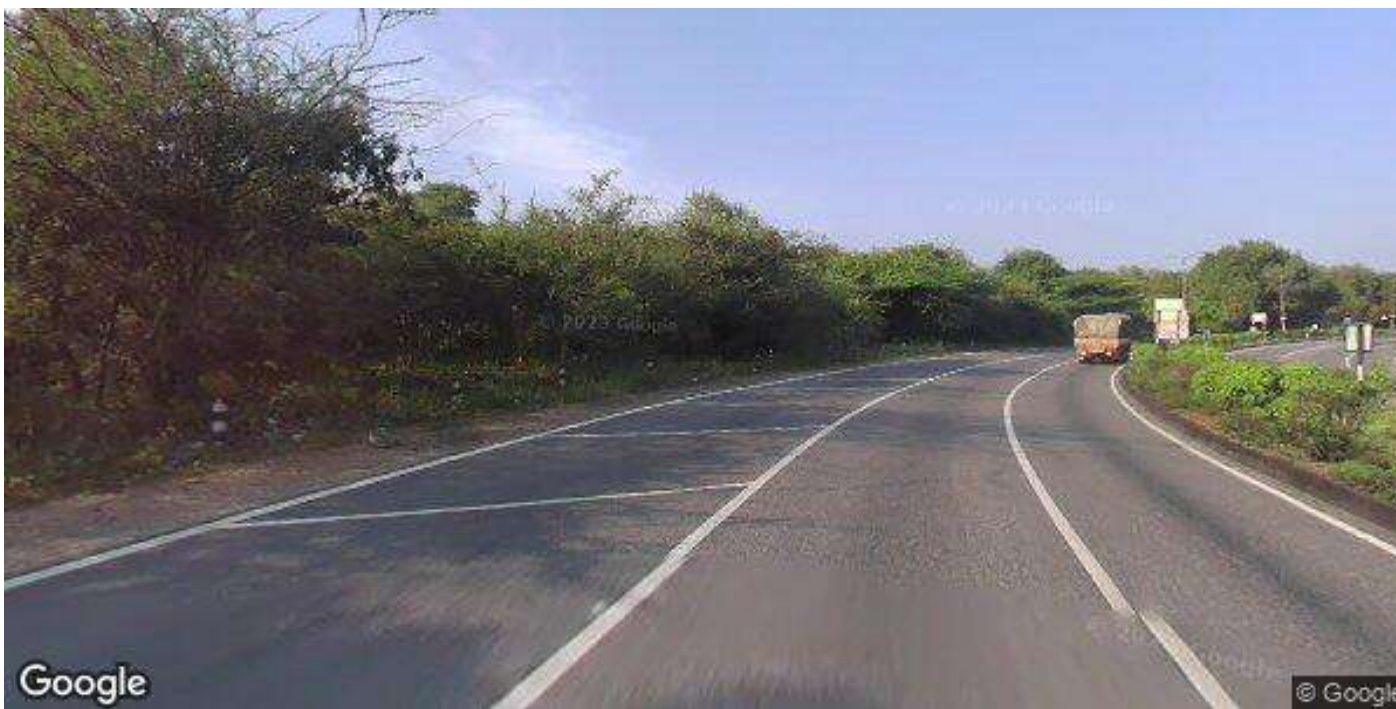
**Risk Type:** Turn  
**Risk Level:** High  
**Speed Limit:** 15 KM/Hr  
**Coordinates:** 11.96620, 78.04920

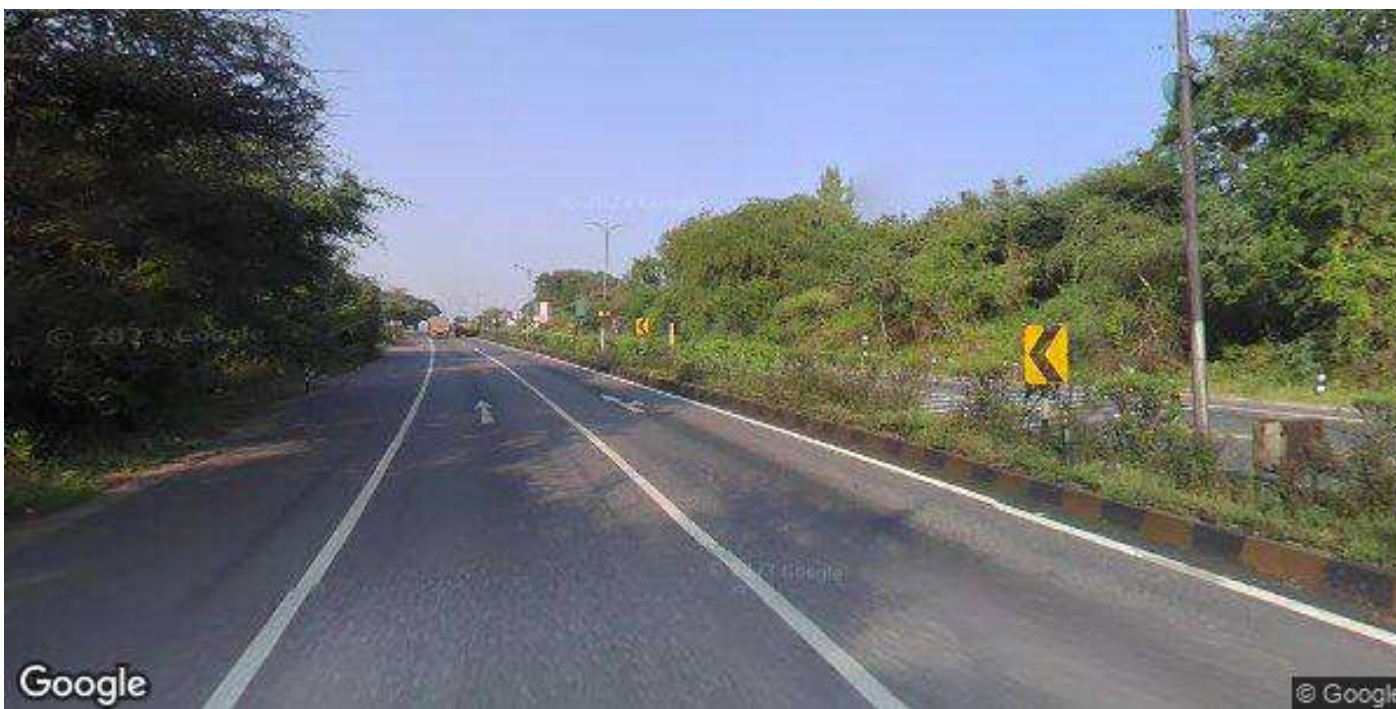
**Risk Type:** Turn  
**Risk Level:** Medium  
**Speed Limit:** 30 KM/Hr  
**Coordinates:** 11.96842, 78.05097

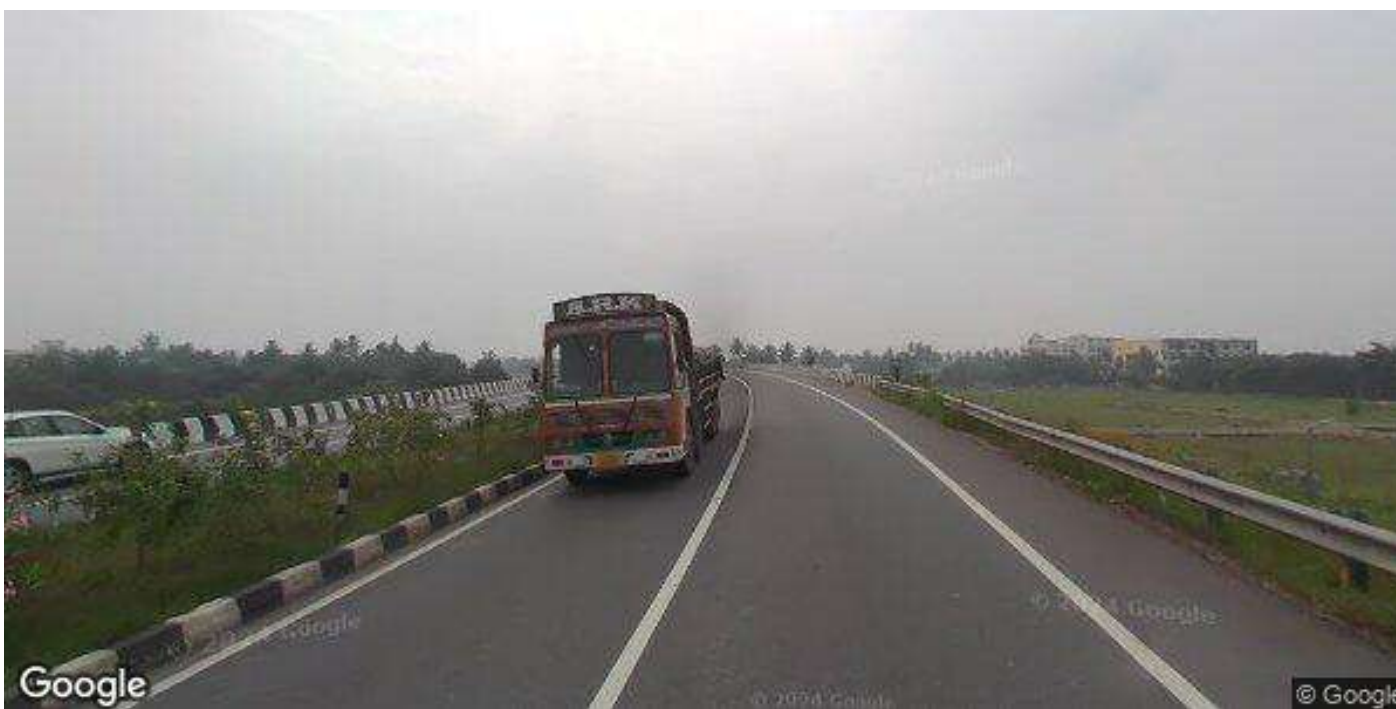
**Risk Type:** Turn  
**Risk Level:** Medium  
**Speed Limit:** 30 KM/Hr  
**Coordinates:** 12.24648, 78.19537

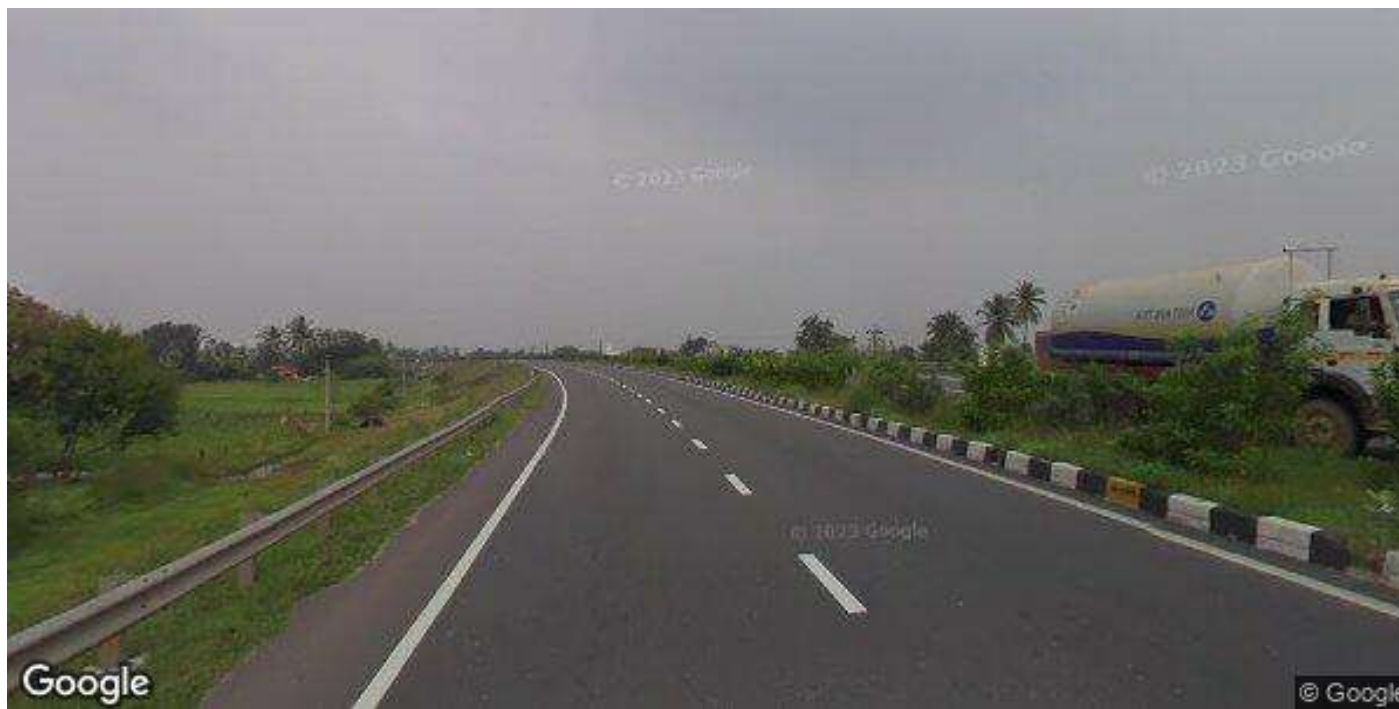
**Risk Type:** Turn  
**Risk Level:** Medium  
**Speed Limit:** 30 KM/Hr  
**Coordinates:** 12.25238, 78.20039

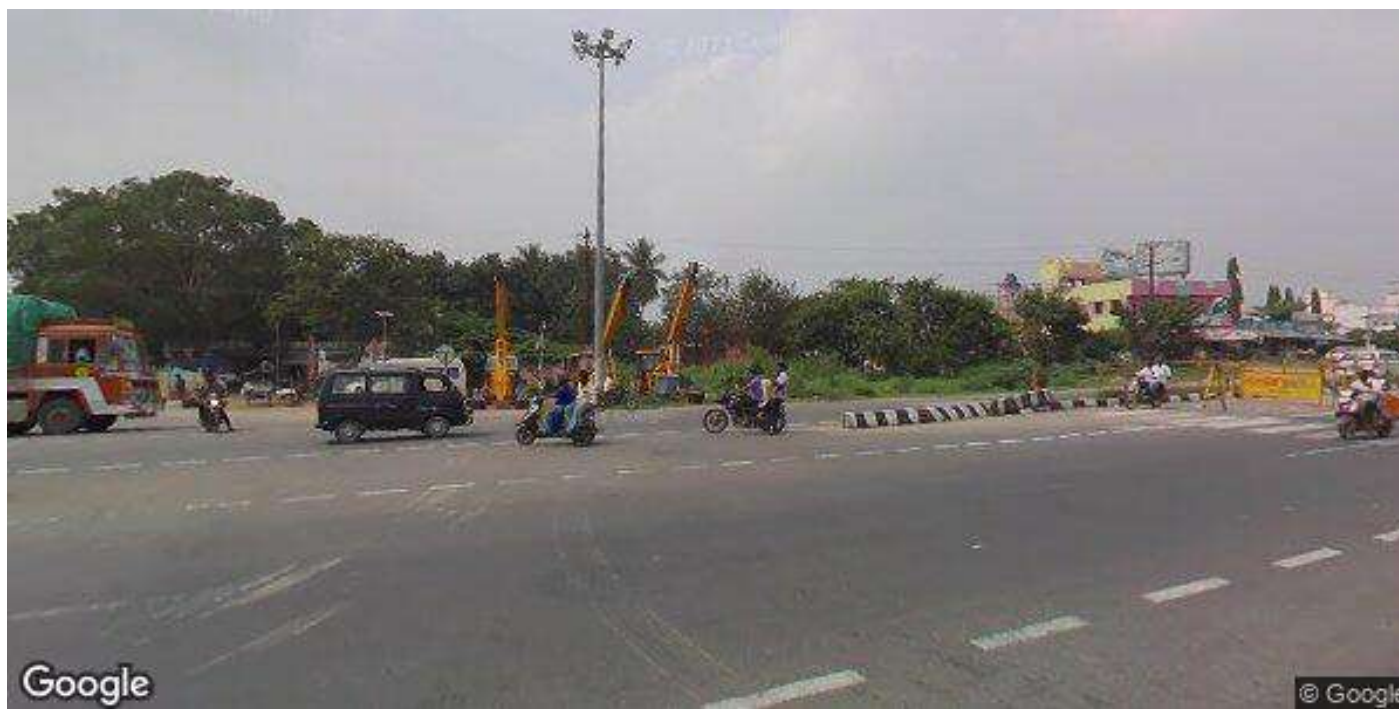
**Risk Type:** Turn  
**Risk Level:** High  
**Speed Limit:** 15 KM/Hr  
**Coordinates:** 12.31467, 78.20768

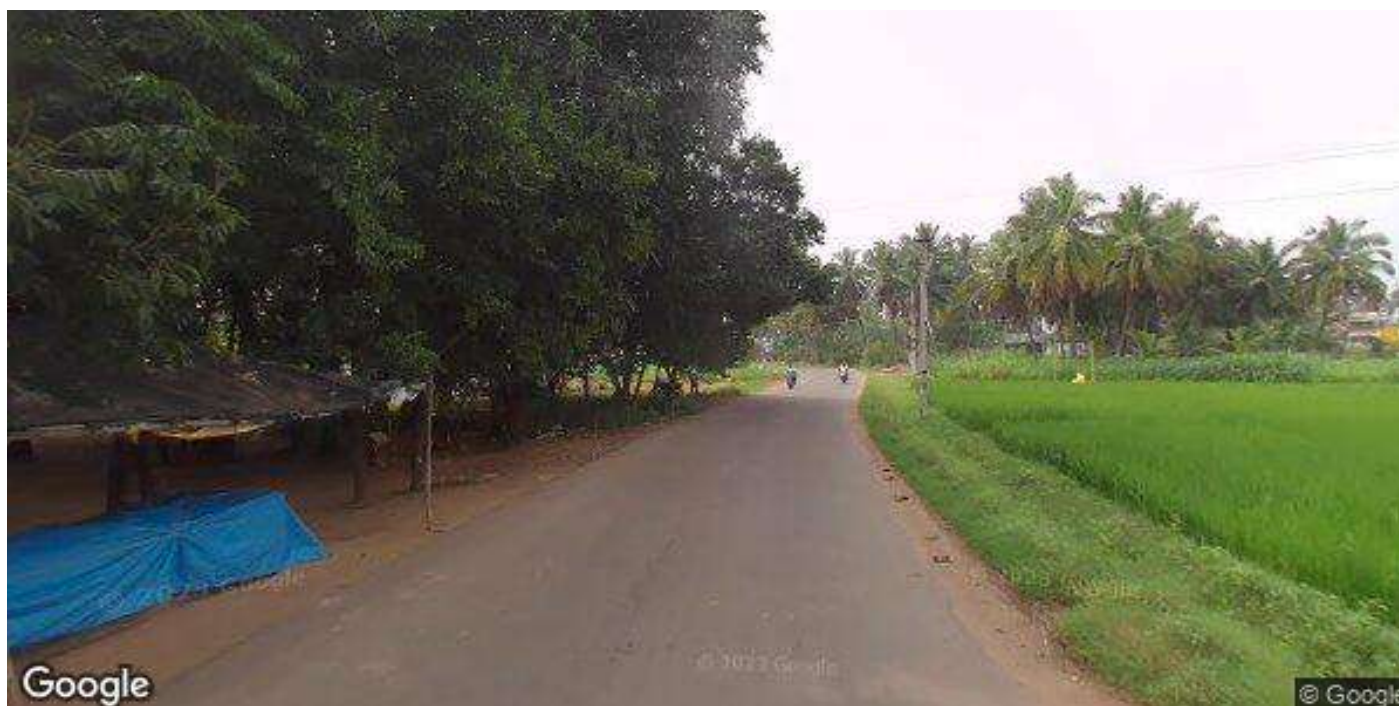
**Risk Type:** Turn  
**Risk Level:** Medium  
**Speed Limit:** 30 KM/Hr  
**Coordinates:** 12.31791, 78.21461

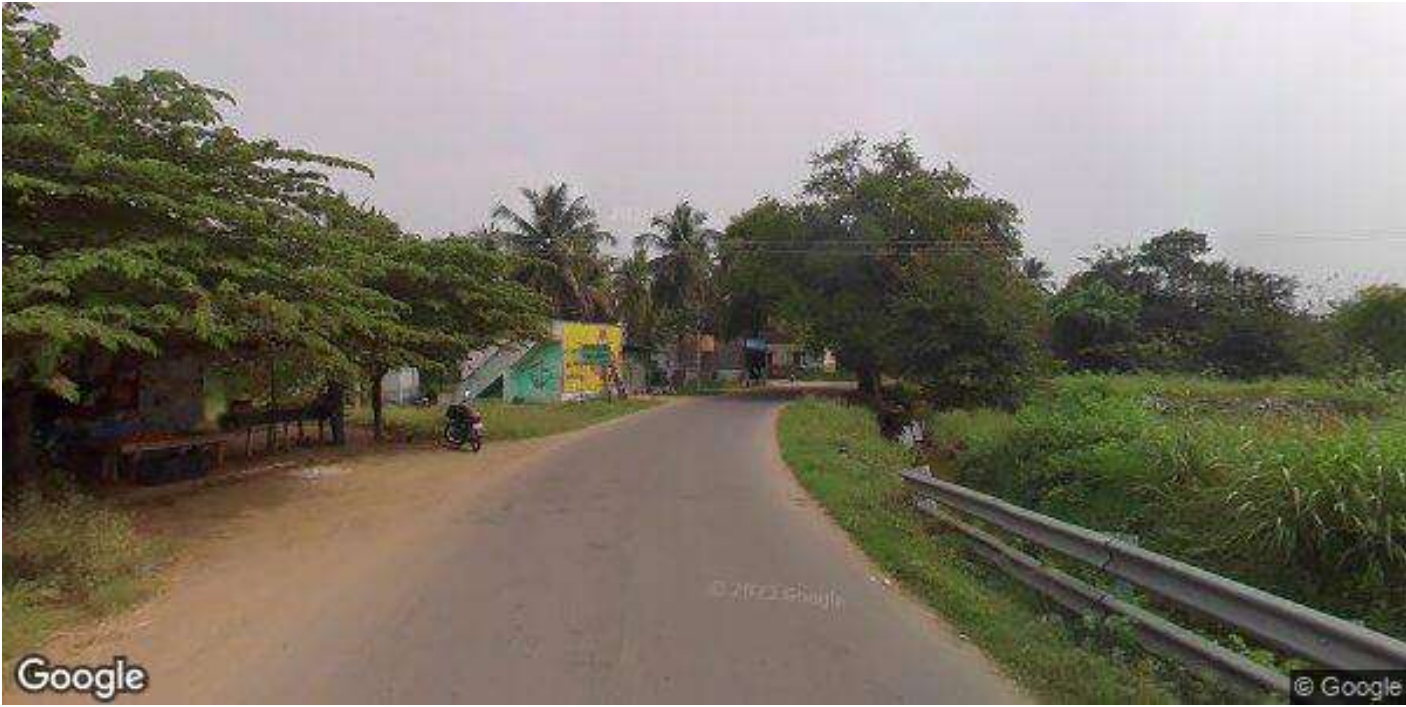
**Risk Type:** Turn  
**Risk Level:** High  
**Speed Limit:** 15 KM/Hr  
**Coordinates:** 12.31908, 78.21586

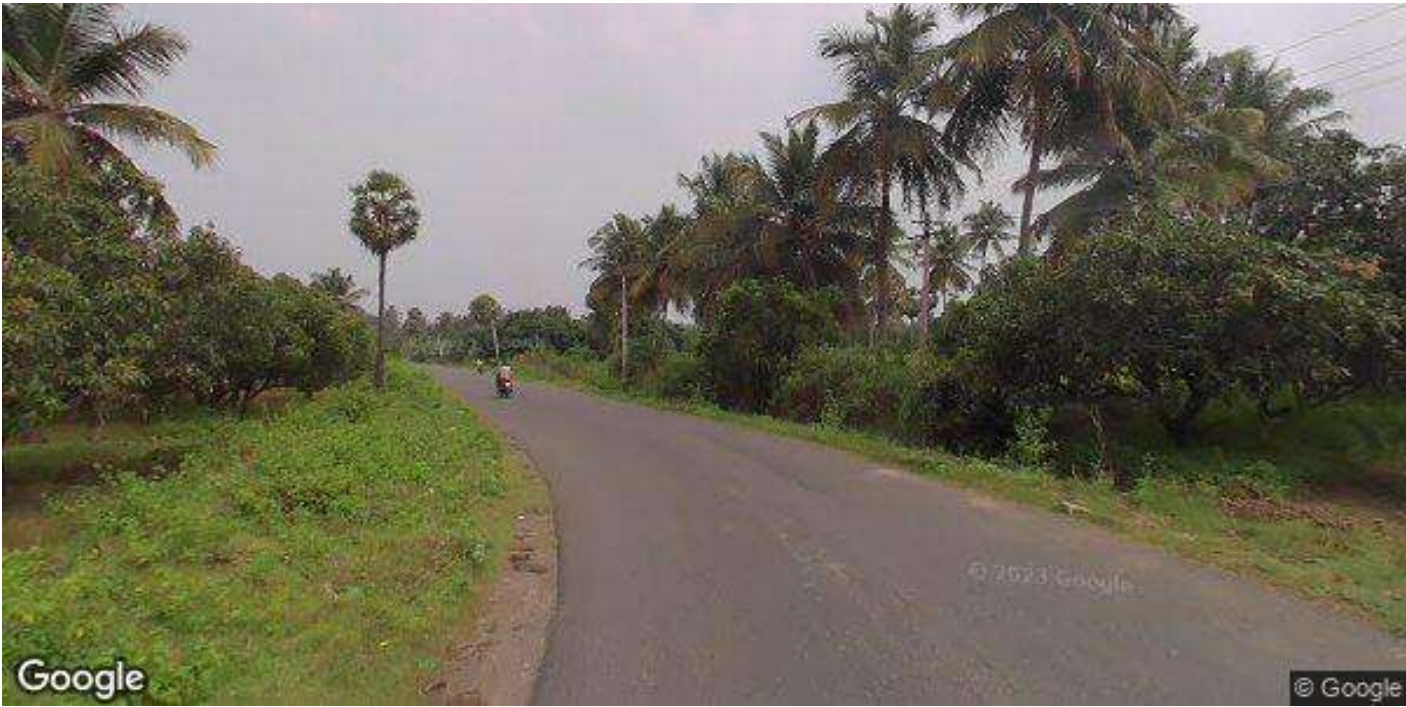
**Risk Type:** Turn  
**Risk Level:** High  
**Speed Limit:** 15 KM/Hr  
**Coordinates:** 12.32377, 78.24215
