# IndianOil

## JOURNEY RISK MANAGEMENT (JRM) STUDY

### Salem Terminal to CHENNAMMAL AGENCIES

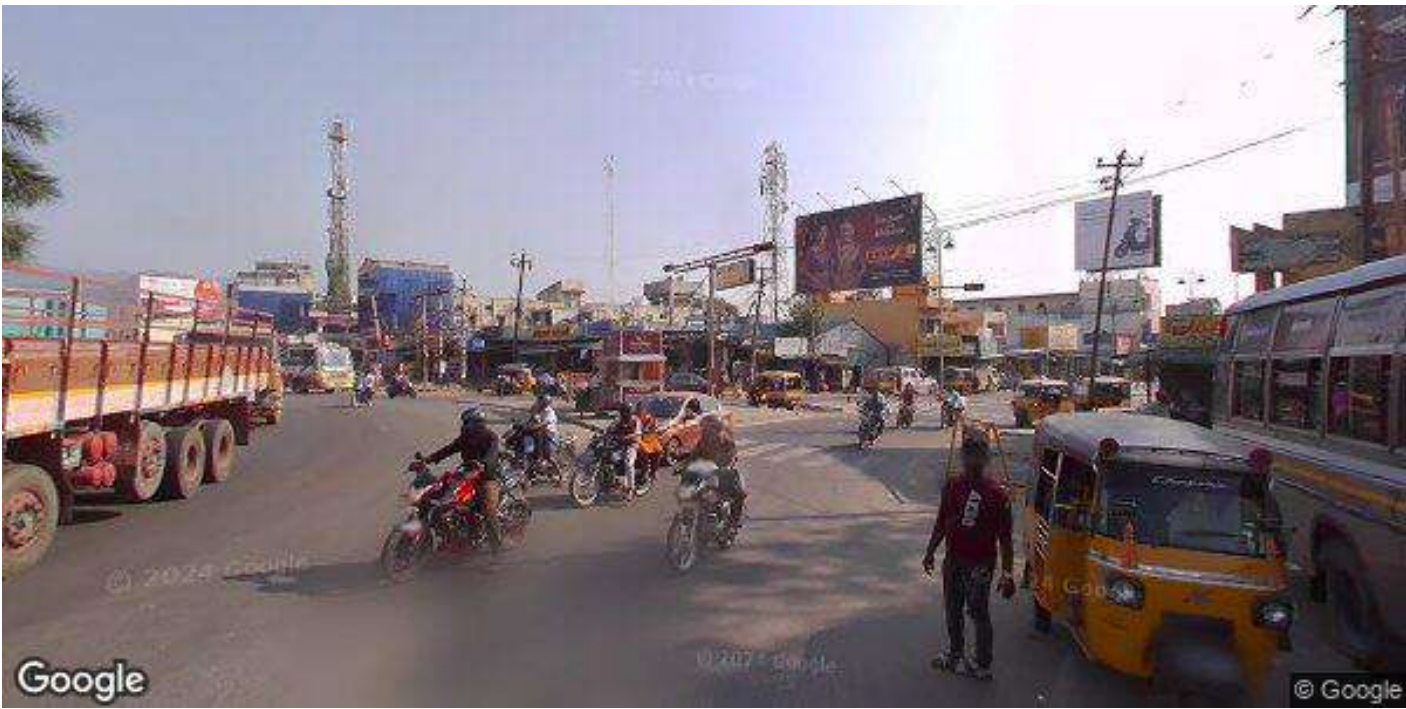
| | Risk Type | Risk Level | Coordinates | Speed Limit |
|---|---|---|---|---|
| 0 | Roundabout | High | 11.63266, 78.12699 | 15 KM/Hr |

Risk Type: Roundabout  
Risk Level: High

**Speed Limit: 15 KM/Hr**  
**Coordinates: 11.63266, 78.12699**

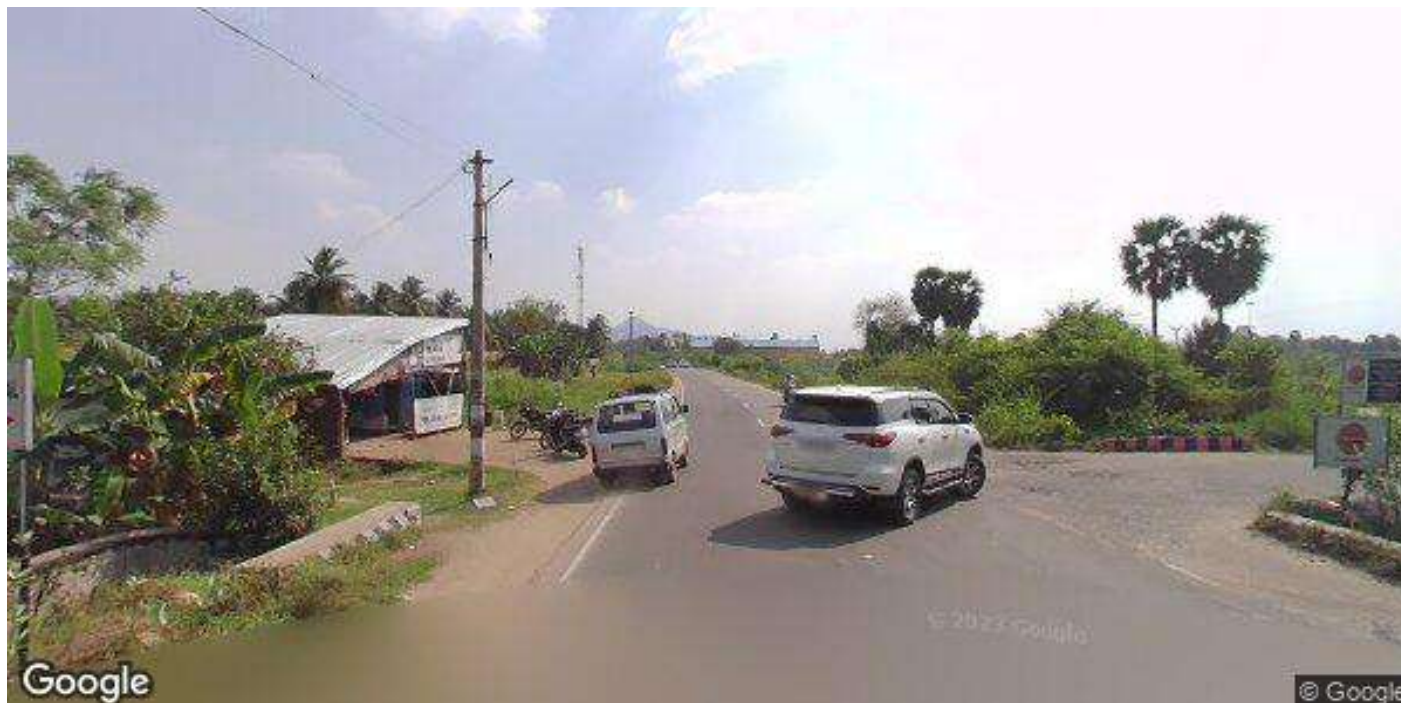
| | Risk Type | Risk Level | Coordinates | Speed Limit |
|---|---|---|---|---|
| 2 | Turn | High | 11.44029, 77.87544 | 15 KM/Hr |

**Risk Type: Turn**  
**Risk Level: High**  
**Speed Limit: 15 KM/Hr**  
**Coordinates: 11.44029, 77.87544**

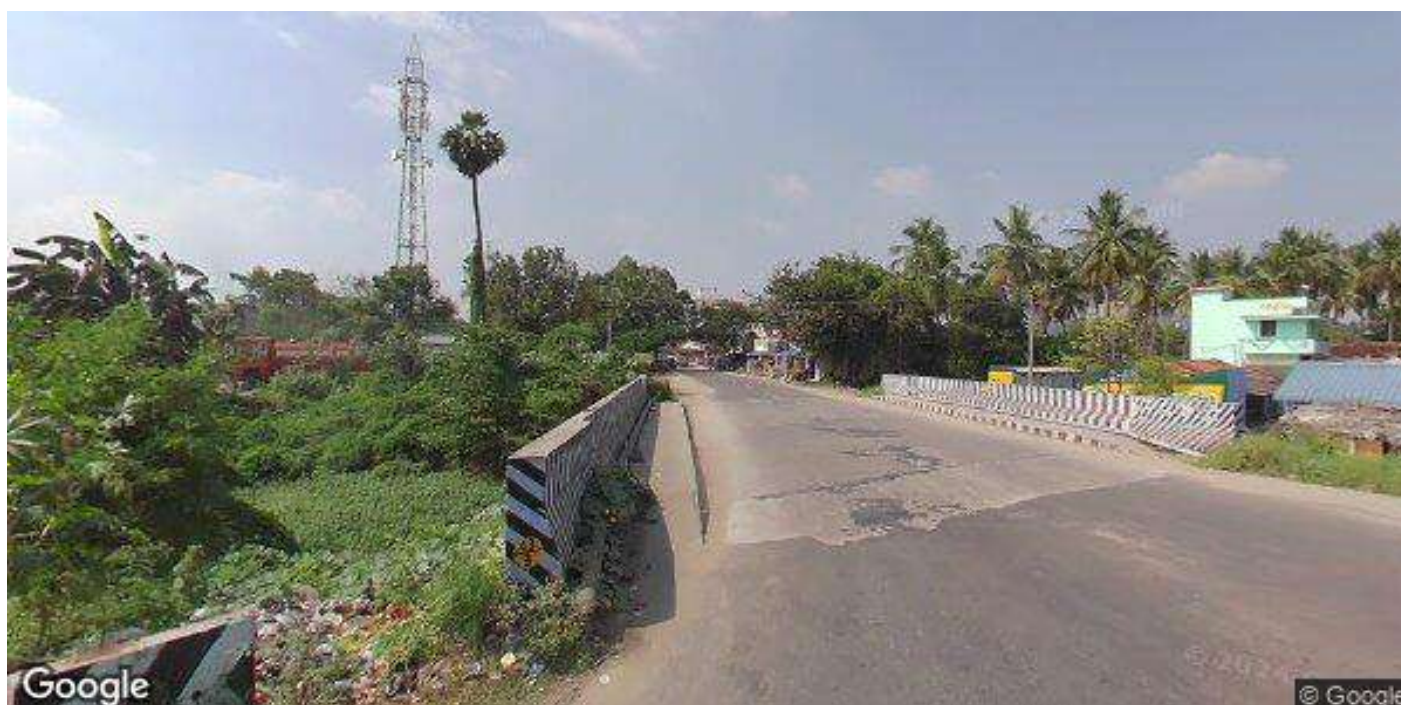
| | Risk Type | Risk Level | Coordinates | Speed Limit |
|---|---|---|---|---|
| 3 | Turn | High | 11.44900, 77.87406 | 15 KM/Hr |

**Risk Type: Turn**  
**Risk Level: High**  
**Speed Limit: 15 KM/Hr**  
**Coordinates: 11.44900, 77.87406**

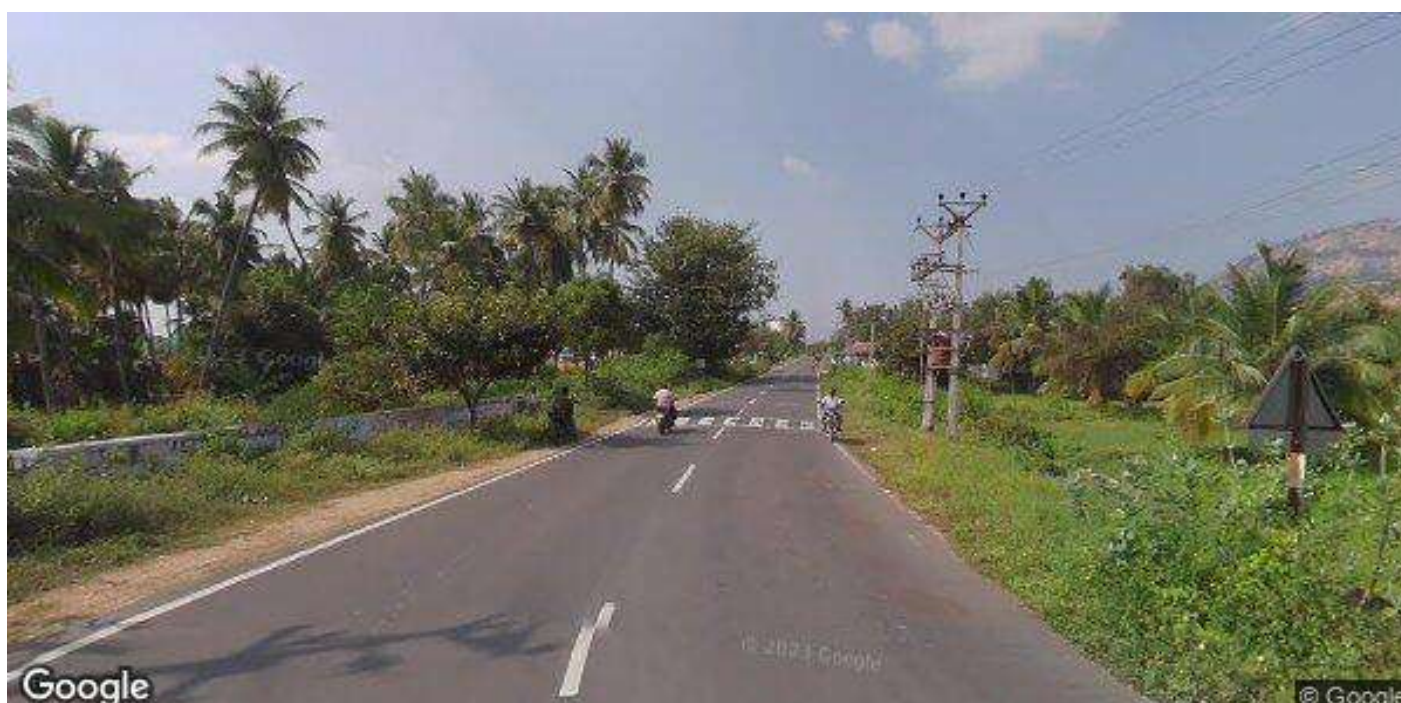
| | Risk Type | Risk Level | Coordinates | Speed Limit |
|---|---|---|---|---|
| 4 | Turn | High | 11.45353, 77.85697 | 15 KM/Hr |

**Risk Type:** Turn  
**Risk Level:** High  
**Speed Limit:** 15 KM/Hr  
**Coordinates:** 11.45353, 77.85697

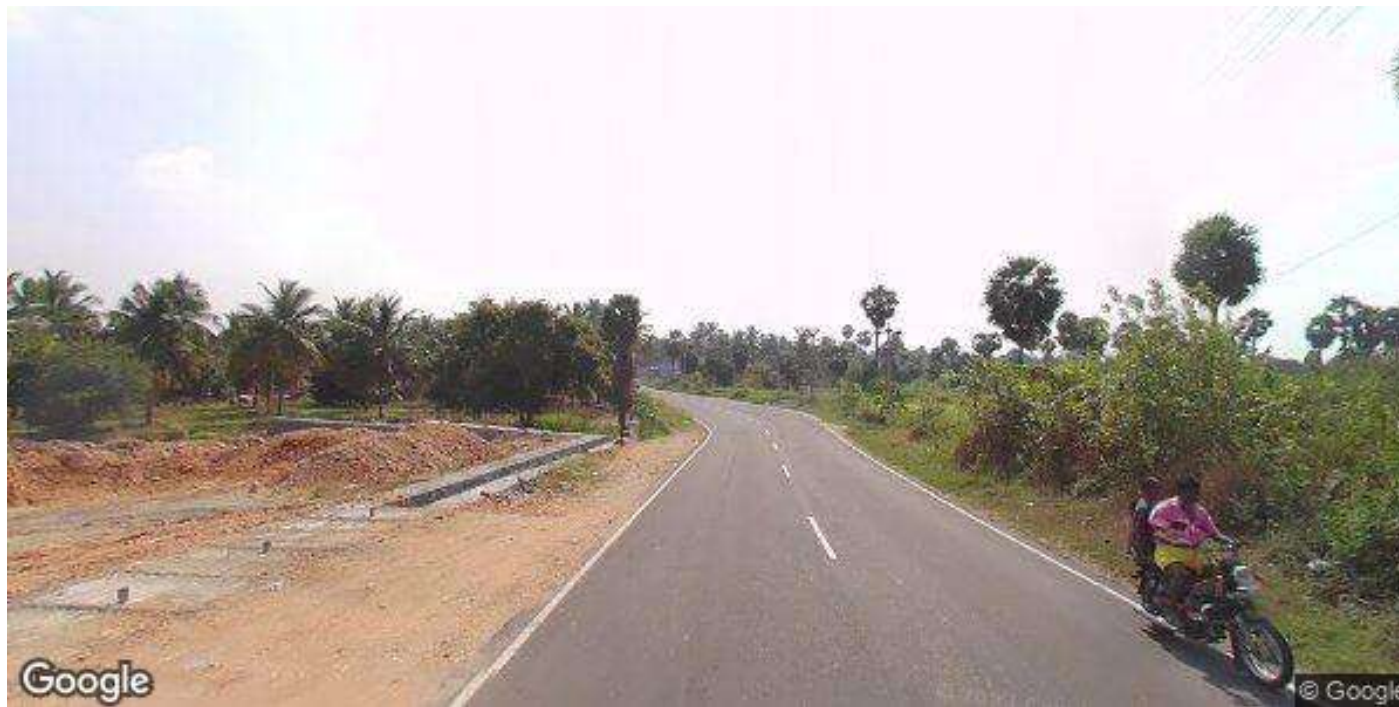
| | Risk Type | Risk Level | Coordinates | Speed Limit |
|---|---|---|---|---|
| 5 | Turn | Medium | 11.45781, 77.85203 | 30 KM/Hr |

**Risk Type:** Turn  
**Risk Level:** Medium  
**Speed Limit:** 30 KM/Hr  
**Coordinates:** 11.45781, 77.85203

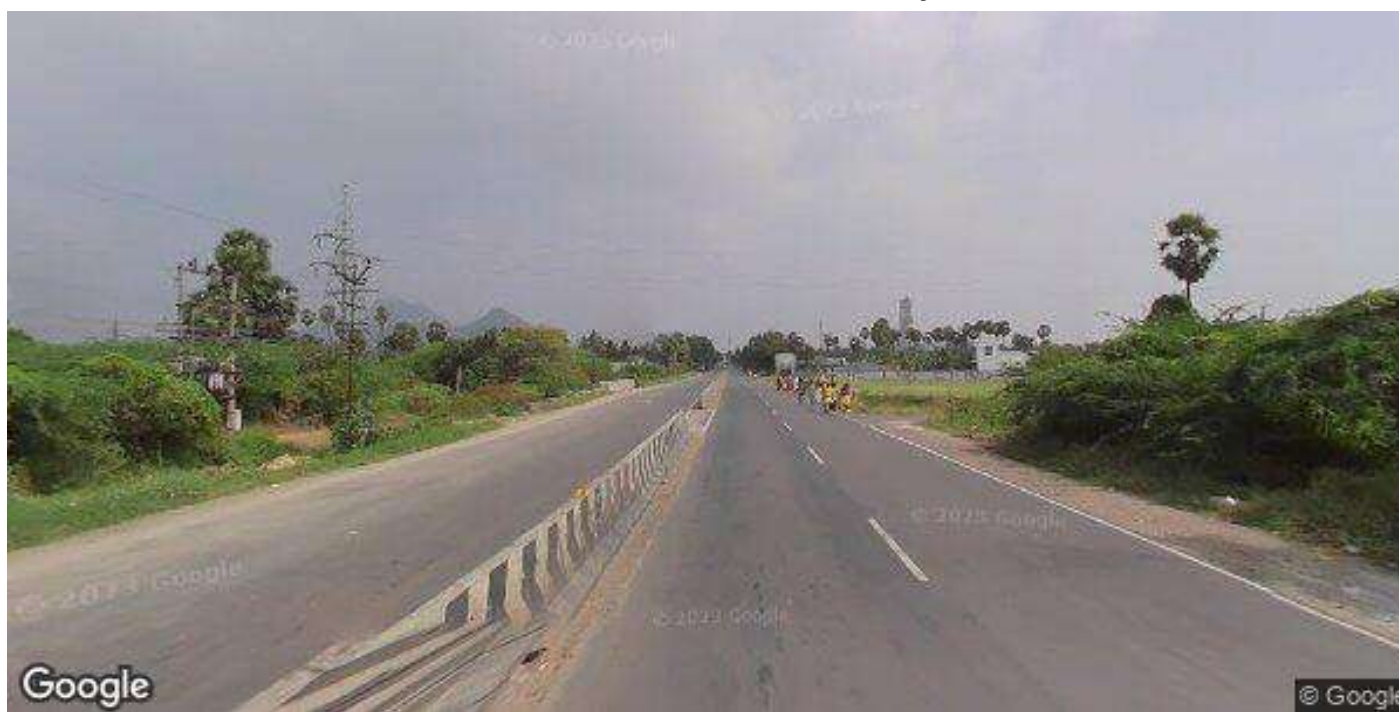
| | Risk Type | Risk Level | Coordinates | Speed Limit |
|---|---|---|---|---|
| 7 | Turn | Medium | 11.45546, 77.81800 | 30 KM/Hr |

**Risk Type:** Turn  
**Risk Level:** Medium  
**Speed Limit:** 30 KM/Hr  
**Coordinates:** 11.45546, 77.81800

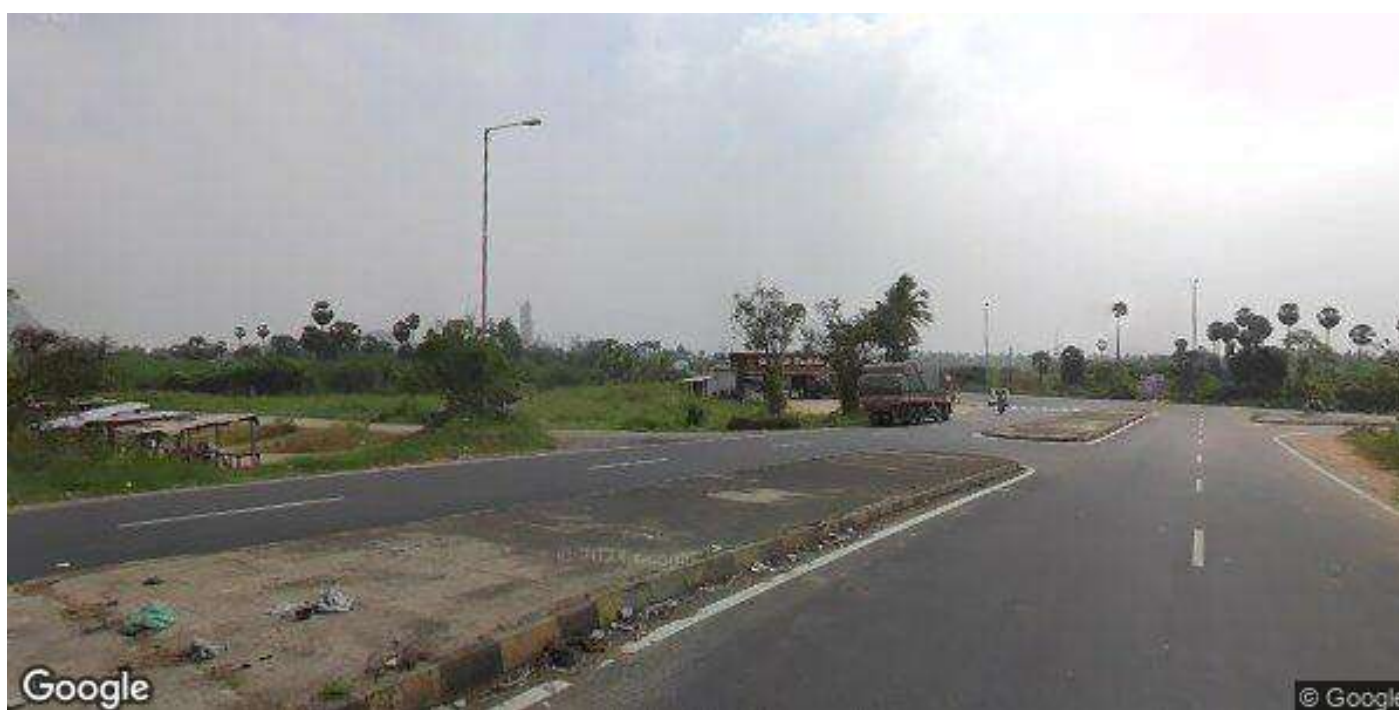
| | Risk Type | Risk Level | Coordinates | Speed Limit |
|---|---|---|---|---|
| 8 | Blind Spot | Blind Spot | 11.45605, 77.81683 | 10 KM/Hr |

**Risk Type:** Blind Spot  
**Risk Level:** Blind Spot  
**Speed Limit:** 10 KM/Hr  
**Coordinates:** 11.45605, 77.81683

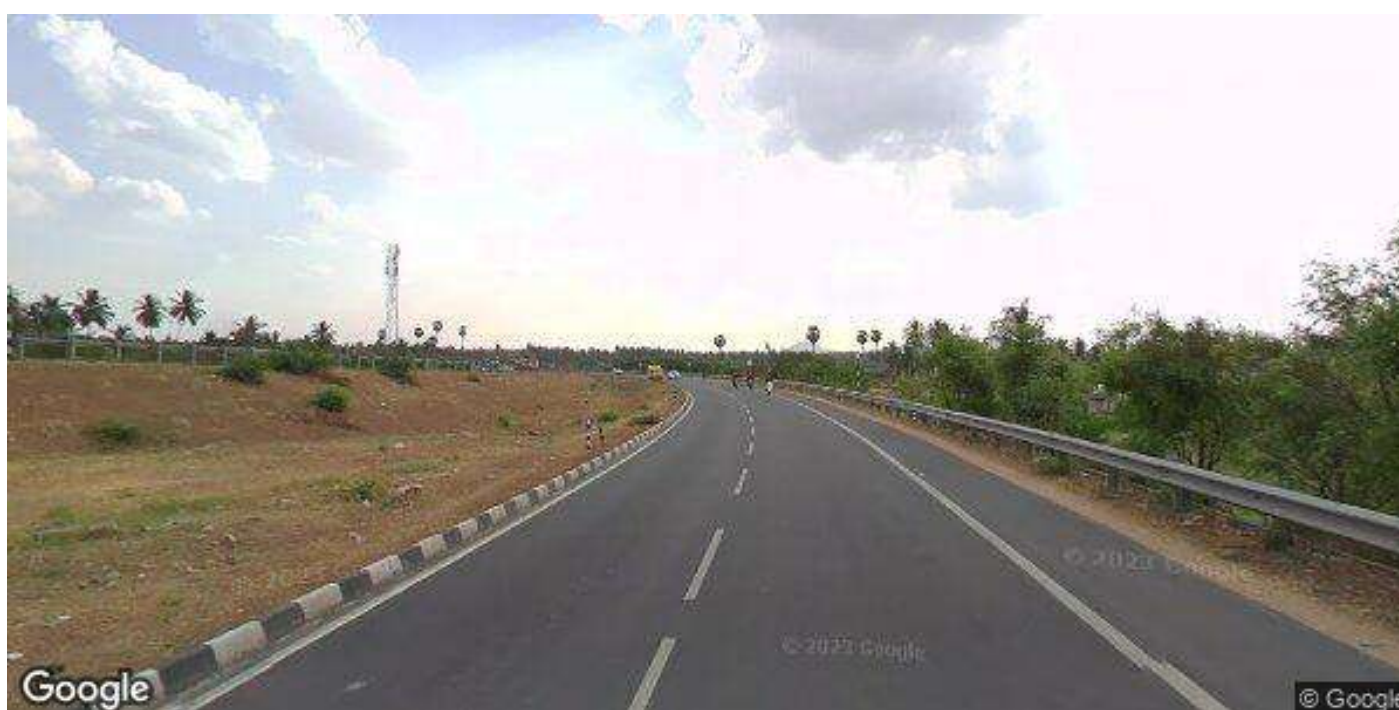
| | Risk Type | Risk Level | Coordinates | Speed Limit |
|---|---|---|---|---|
| 9 | Turn | High | 11.53573, 77.95794 | 15 KM/Hr |

**Risk Type:** Turn  
**Risk Level:** High  
**Speed Limit:** 15 KM/Hr  
**Coordinates:** 11.53573, 77.95794

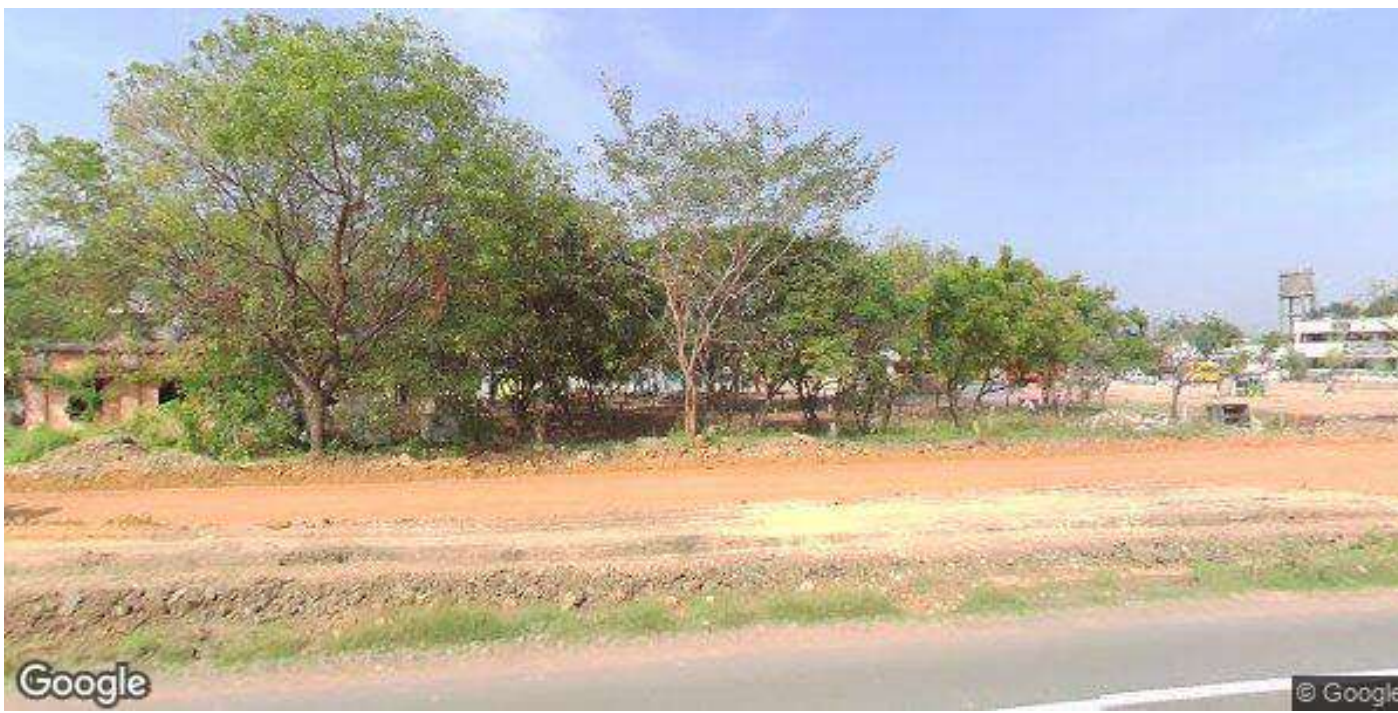
| | Risk Type | Risk Level | Coordinates | Speed Limit |
|---|---|---|---|---|
| 10 | Turn | Medium | 11.62100, 78.10723 | 30 KM/Hr |

**Risk Type:** Turn  
**Risk Level:** Medium  
**Speed Limit:** 30 KM/Hr  
**Coordinates:** 11.62100, 78.10723

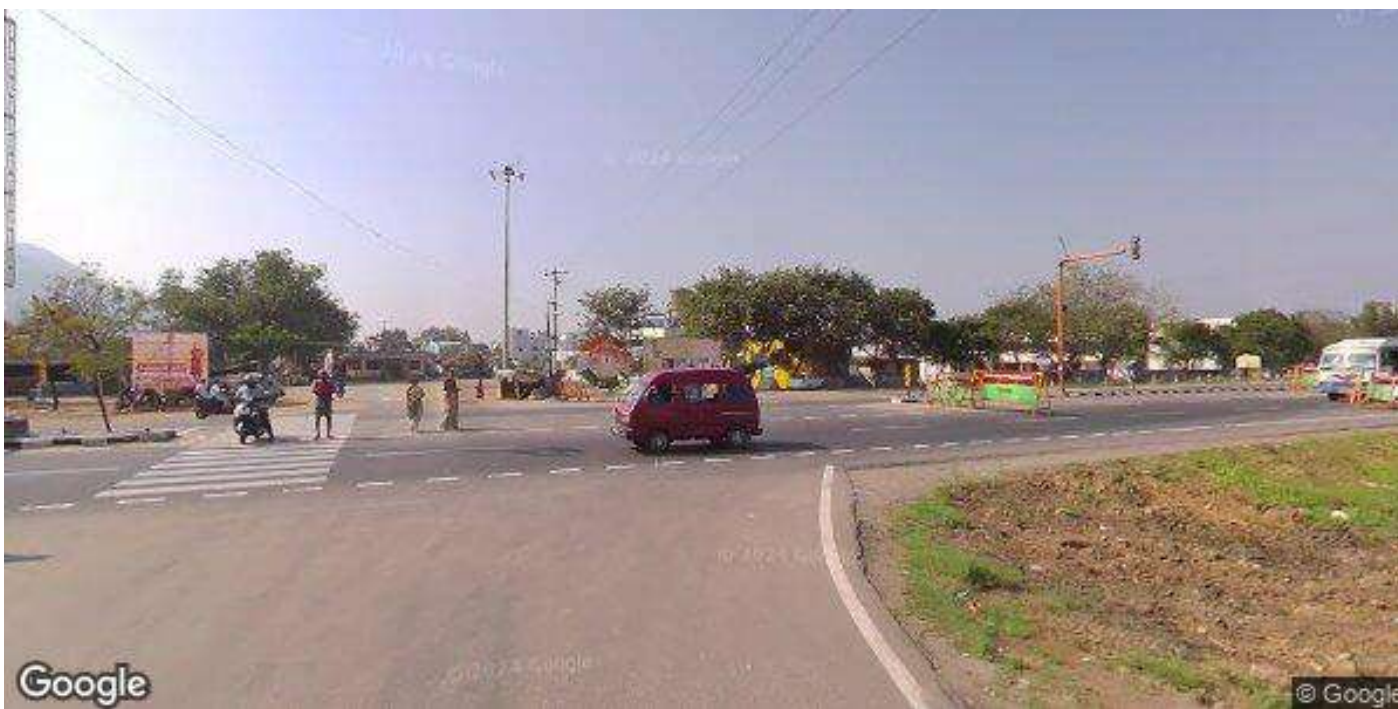
| | Risk Type | Risk Level | Coordinates | Speed Limit |
|---|---|---|---|---|
| 11 | Blind Spot | Blind Spot | 11.62130, 78.10776 | 10 KM/Hr |

**Risk Type:** Blind Spot  
**Risk Level:** Blind Spot  
**Speed Limit:** 10 KM/Hr  
**Coordinates:** 11.62130, 78.10776

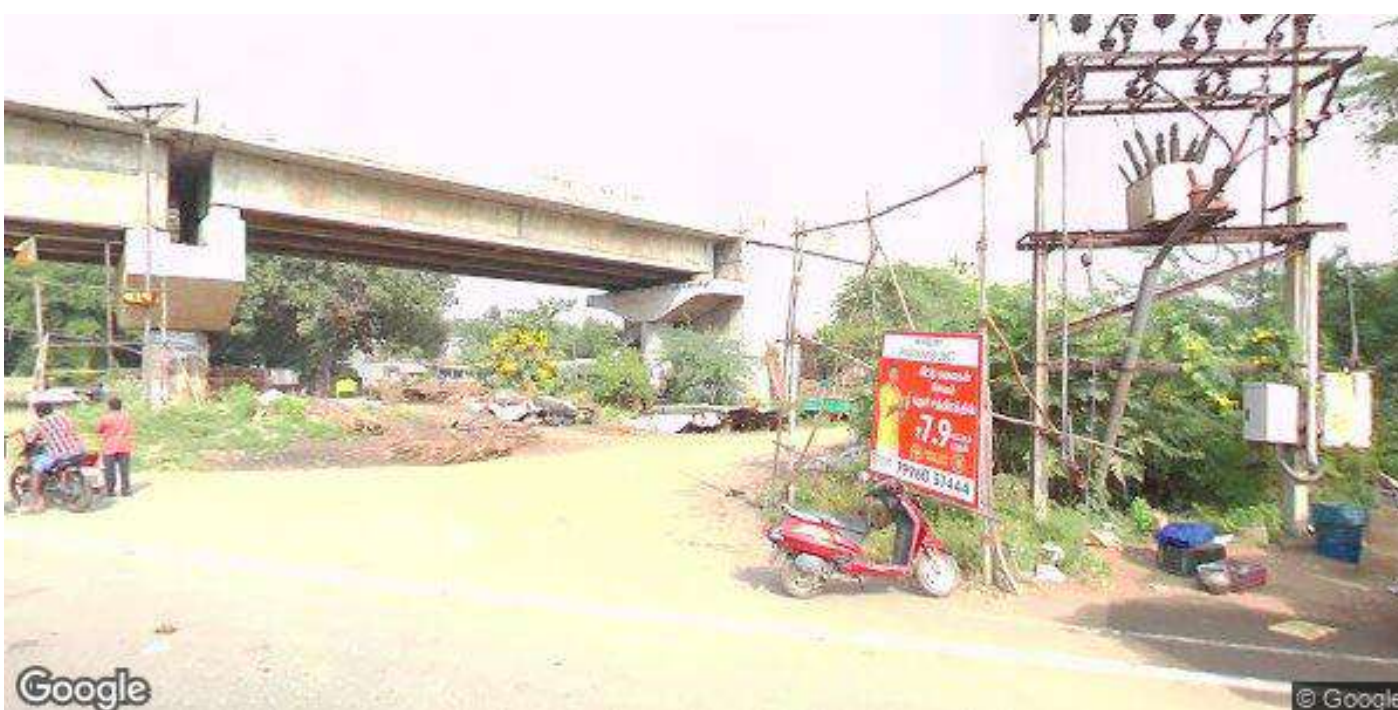
| | Risk Type | Risk Level | Coordinates | Speed Limit |
|---|---|---|---|---|
| 12 | Blind Spot | Blind Spot | 11.61235, 78.10438 | 10 KM/Hr |

**Risk Type:** Blind Spot  
**Risk Level:** Blind Spot  
**Speed Limit:** 10 KM/Hr  
**Coordinates:** 11.61235, 78.10438

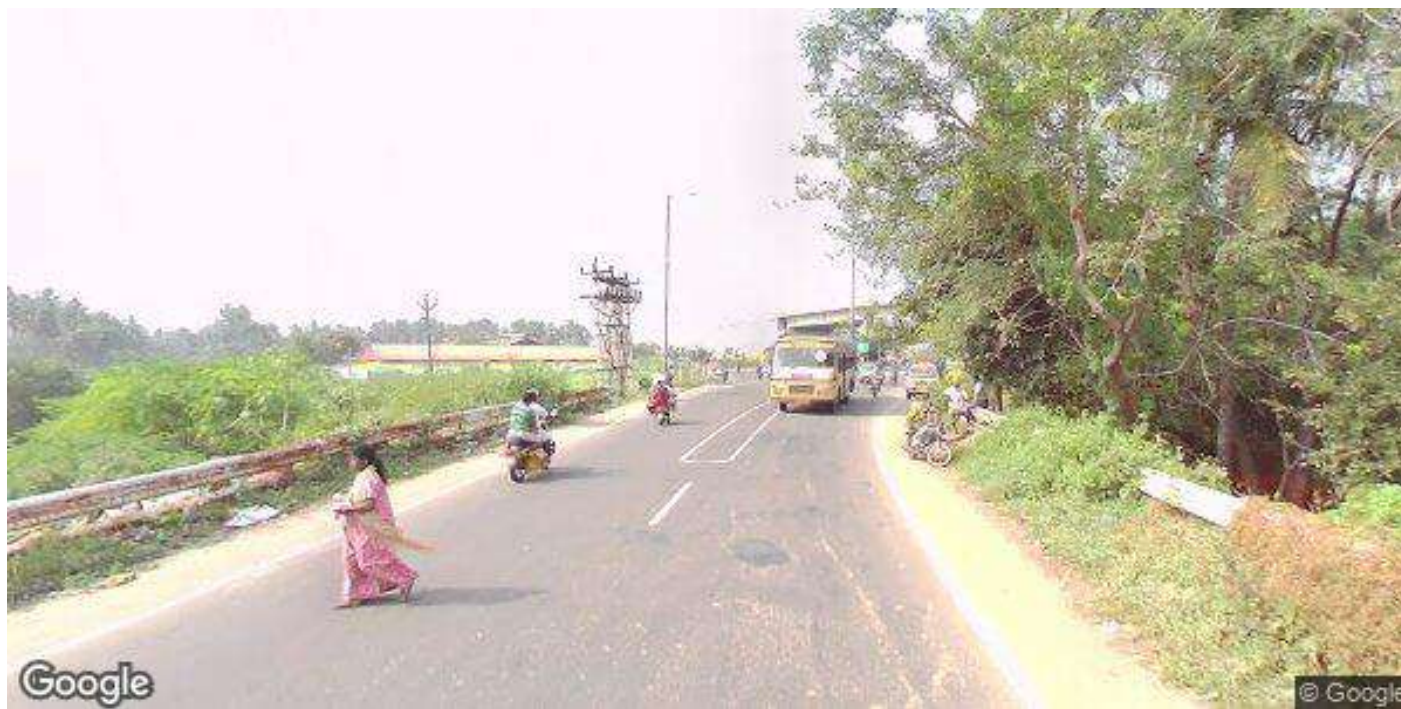
| | Risk Type | Risk Level | Coordinates | Speed Limit |
|---|---|---|---|---|
| 13 | Turn | Medium | 11.61235, 78.10495 | 30 KM/Hr |

**Risk Type:** Turn  
**Risk Level:** Medium  
**Speed Limit:** 30 KM/Hr  
**Coordinates:** 11.61235, 78.10495

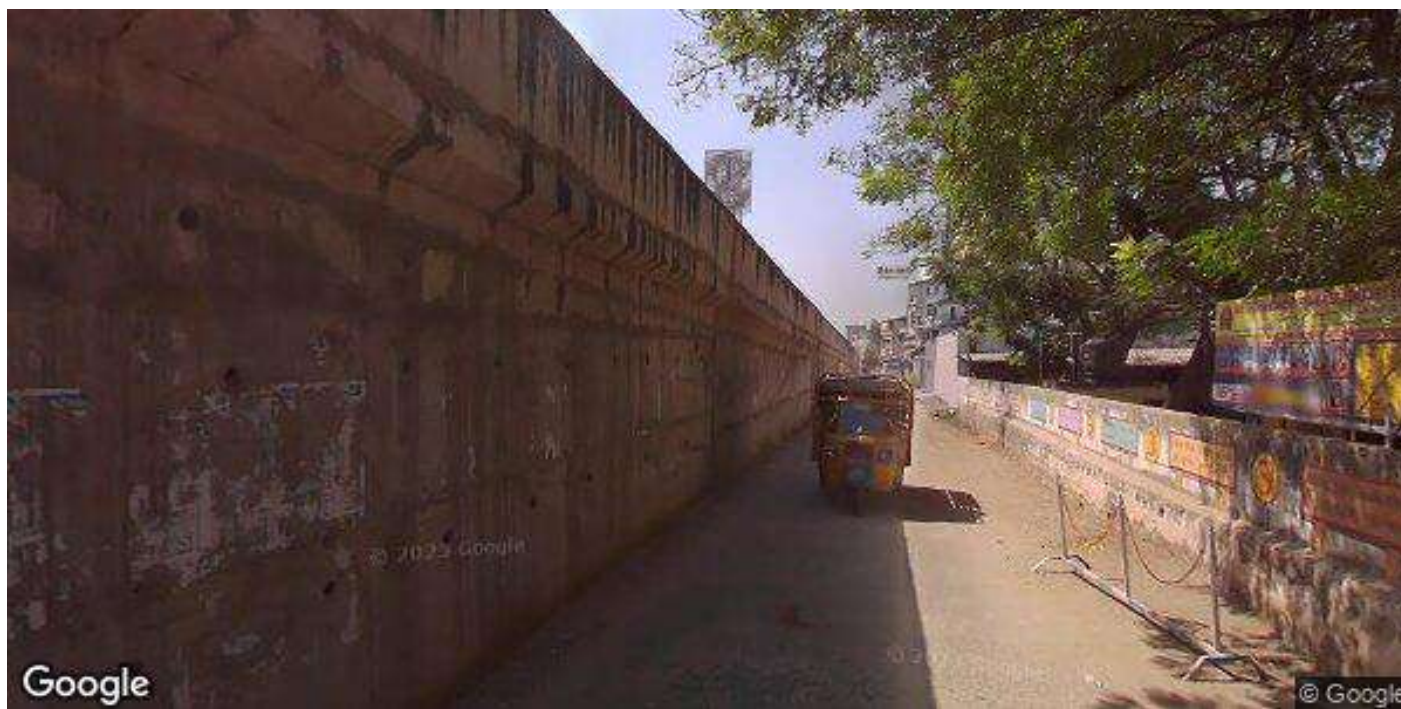
| | Risk Type | Risk Level | Coordinates | Speed Limit |
|---|---|---|---|---|
| 14 | Blind Spot | Blind Spot | 11.62871, 78.12299 | 10 KM/Hr |

**Risk Type:** Blind Spot  
**Risk Level:** Blind Spot  
**Speed Limit:** 10 KM/Hr  
**Coordinates:** 11.62871, 78.12299

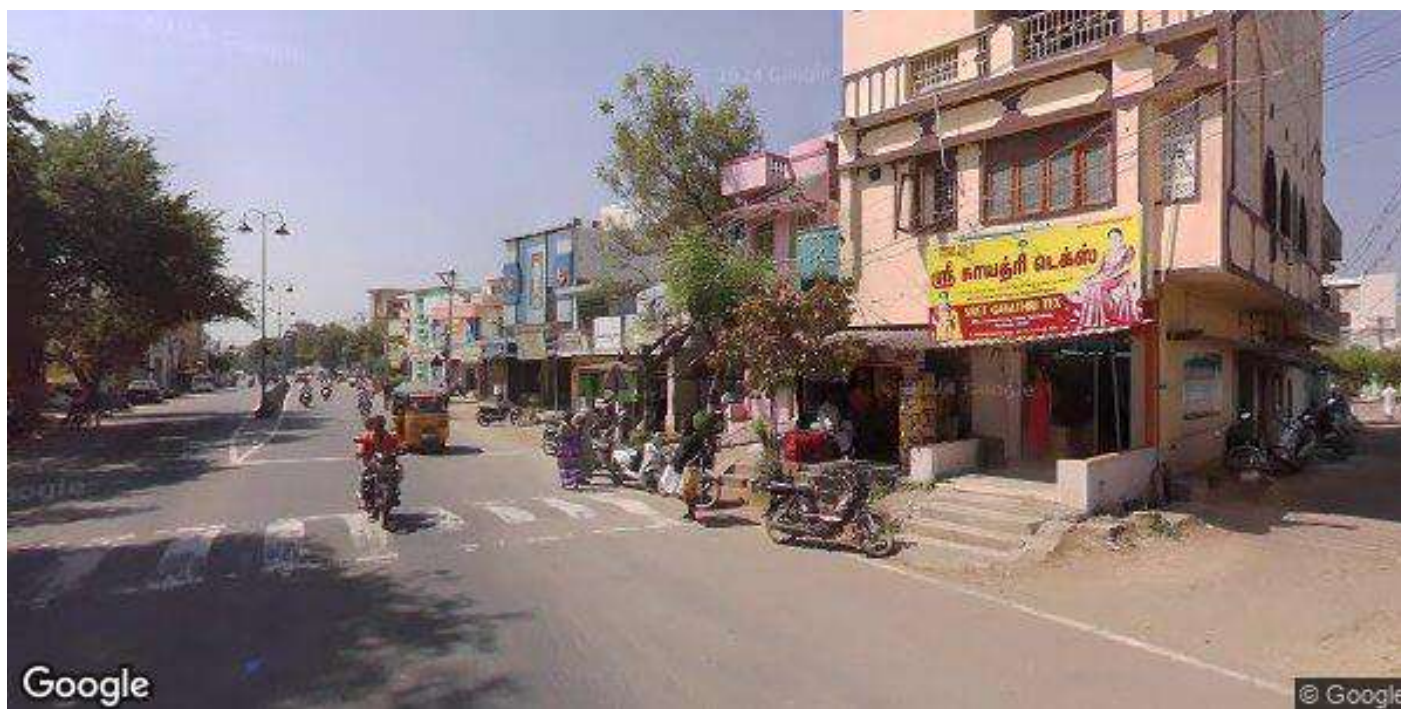
| | Risk Type | Risk Level | Coordinates | Speed Limit |
|---|---|---|---|---|
| 15 | Blind Spot | Blind Spot | 11.62788, 78.12219 | 10 KM/Hr |

**Risk Type:** Blind Spot  
**Risk Level:** Blind Spot  
**Speed Limit:** 10 KM/Hr  
**Coordinates:** 11.62788, 78.12219

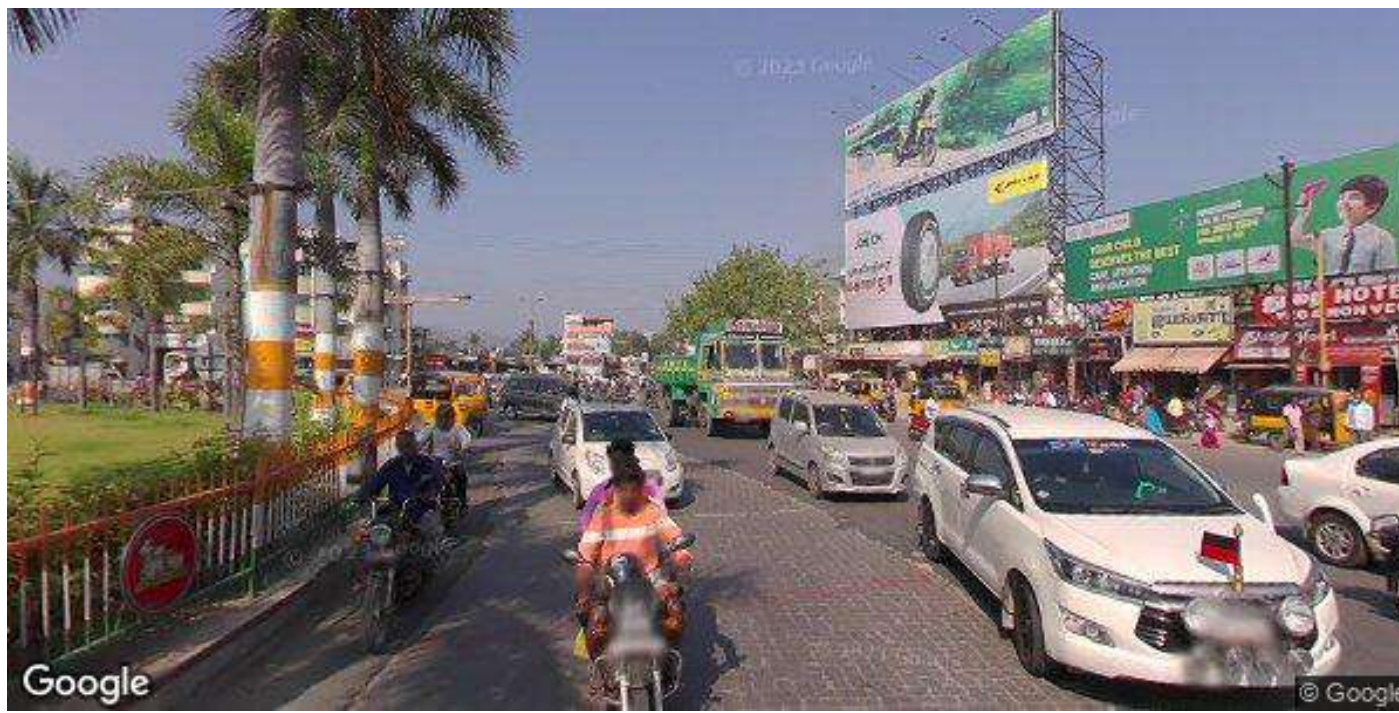
| | Risk Type | Risk Level | Coordinates | Speed Limit |
|---|---|---|---|---|
| 16 | Turn | High | 11.63302, 78.12742 | 15 KM/Hr |

**Risk Type:** Turn  
**Risk Level:** High  
**Speed Limit:** 15 KM/Hr  
**Coordinates:** 11.63302, 78.12742

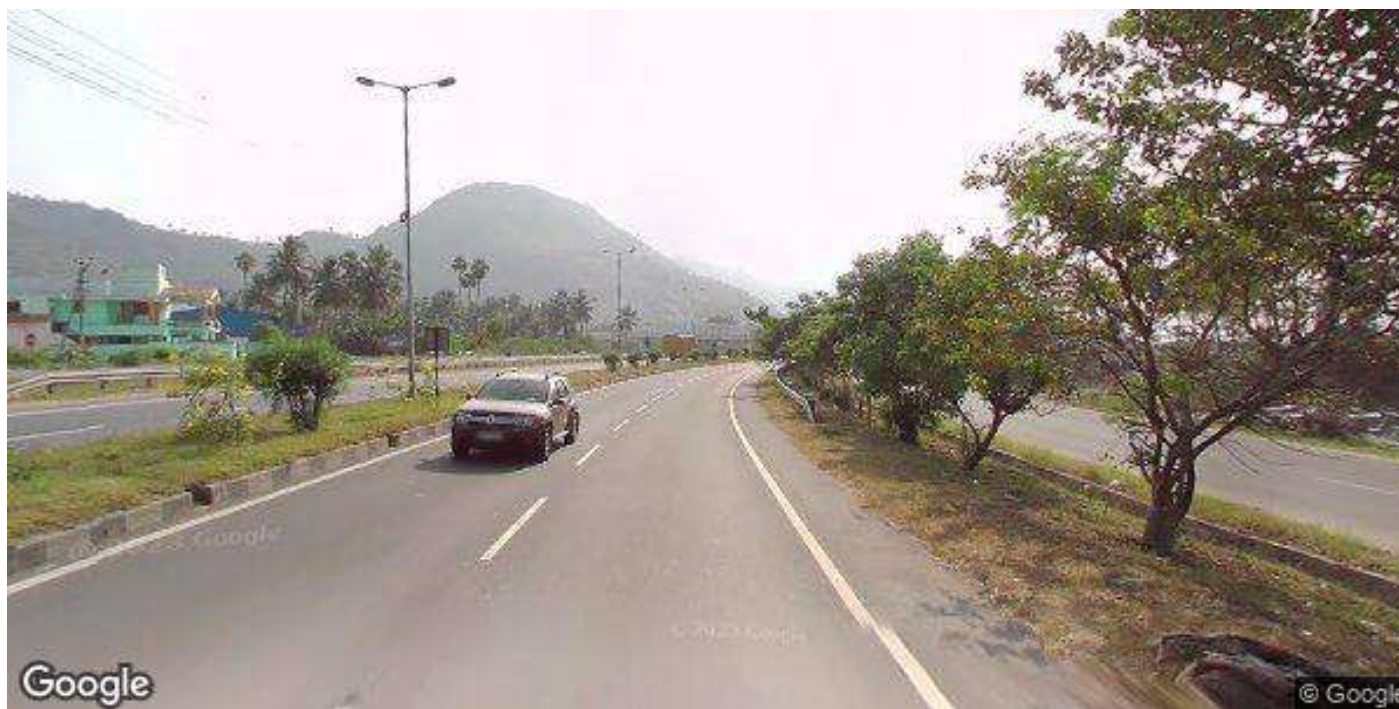
| | Risk Type | Risk Level | Coordinates | Speed Limit |
|---|---|---|---|---|
| 17 | Turn | Medium | 11.62938, 78.16601 | 30 KM/Hr |

**Risk Type:** Turn  
**Risk Level:** Medium  
**Speed Limit:** 30 KM/Hr  
**Coordinates:** 11.62938, 78.16601

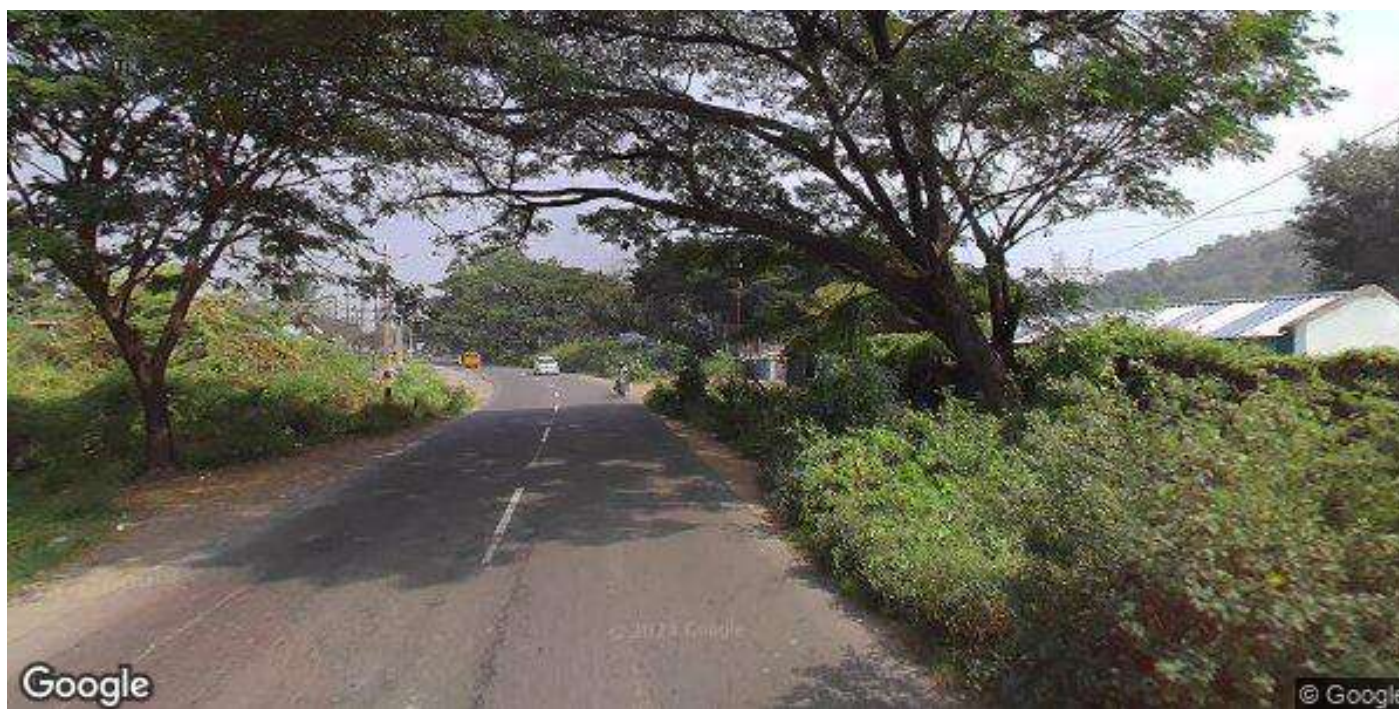
| | Risk Type | Risk Level | Coordinates | Speed Limit |
|---|---|---|---|---|
| 18 | Turn | Medium | 11.65825, 78.20469 | 30 KM/Hr |

**Risk Type:** Turn  
**Risk Level:** Medium  
**Speed Limit:** 30 KM/Hr  
**Coordinates:** 11.65825, 78.20469

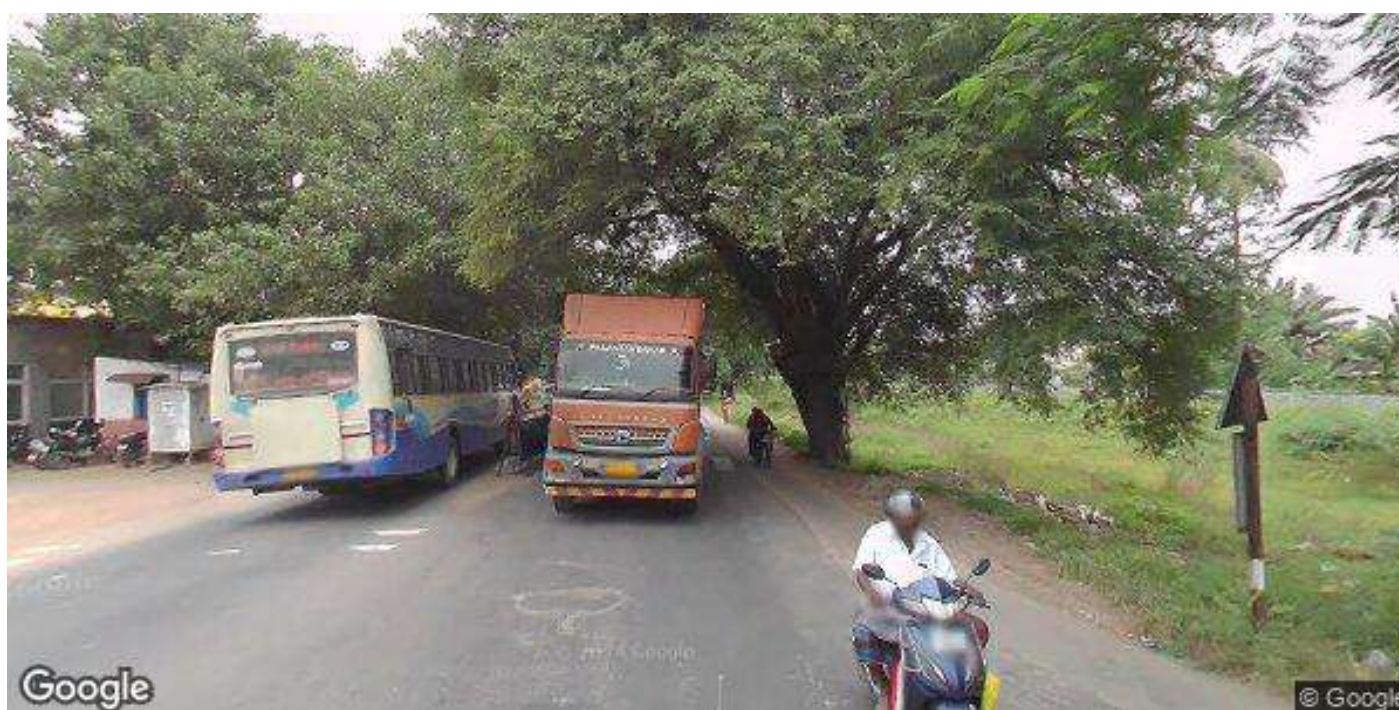
| | Risk Type | Risk Level | Coordinates | Speed Limit |
|---|---|---|---|---|
| 20 | Turn | High | 11.67116, 78.23102 | 15 KM/Hr |

**Risk Type:** Turn  
**Risk Level:** High  
**Speed Limit:** 15 KM/Hr  
**Coordinates:** 11.67116, 78.23102

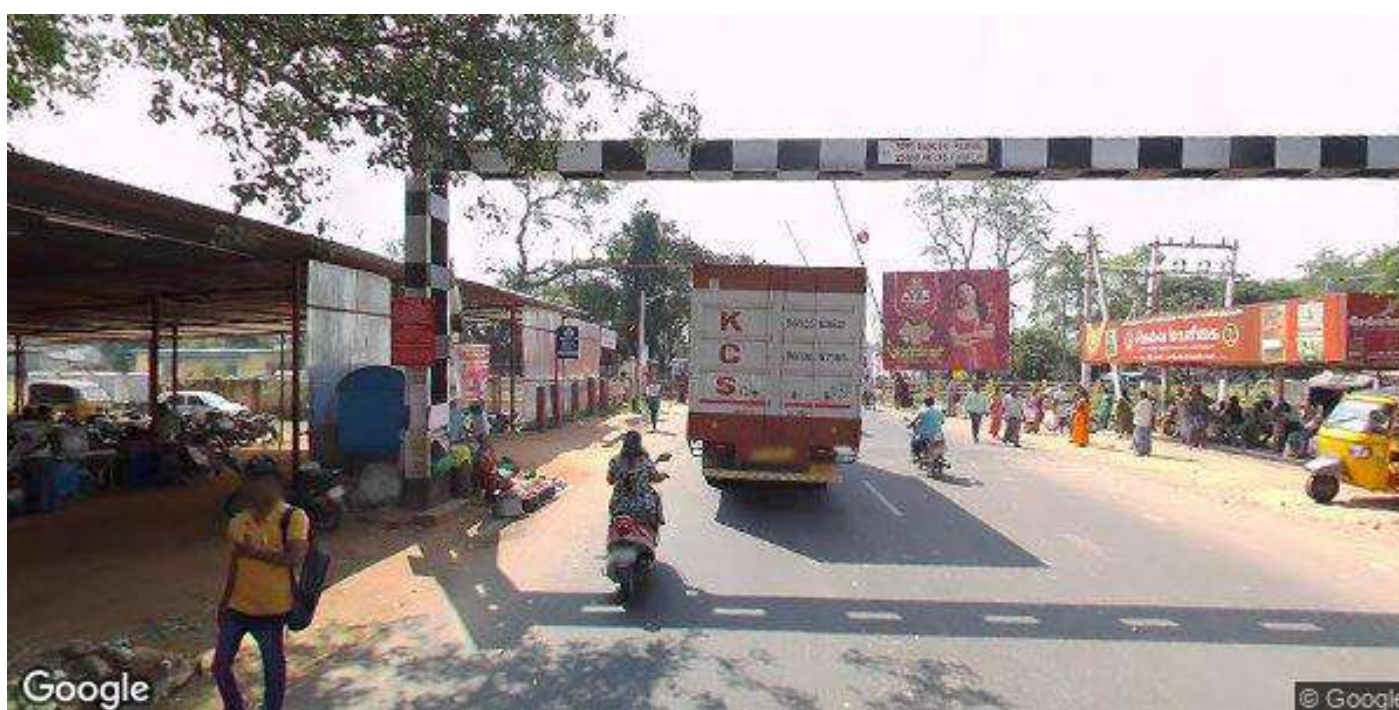
| | Risk Type | Risk Level | Coordinates | Speed Limit |
|---|---|---|---|---|
| 21 | Turn | Medium | 11.67182, 78.23141 | 30 KM/Hr |

**Risk Type:** Turn  
**Risk Level:** Medium  
**Speed Limit:** 30 KM/Hr  
**Coordinates:** 11.67182, 78.23141

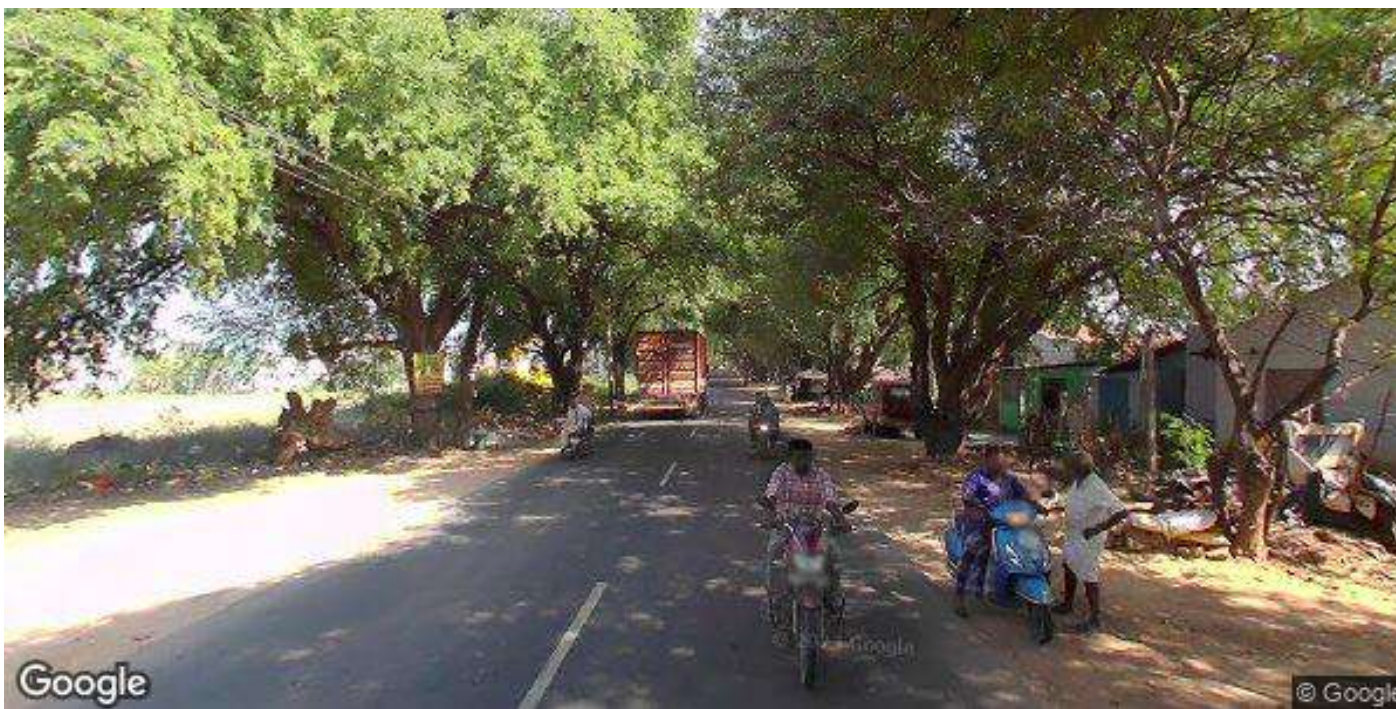
| | Risk Type | Risk Level | Coordinates | Speed Limit |
|---|---|---|---|---|
| 22 | Turn | Medium | 11.67500, 78.23962 | 30 KM/Hr |

**Risk Type:** Turn  
**Risk Level:** Medium  
**Speed Limit:** 30 KM/Hr  
**Coordinates:** 11.67500, 78.23962

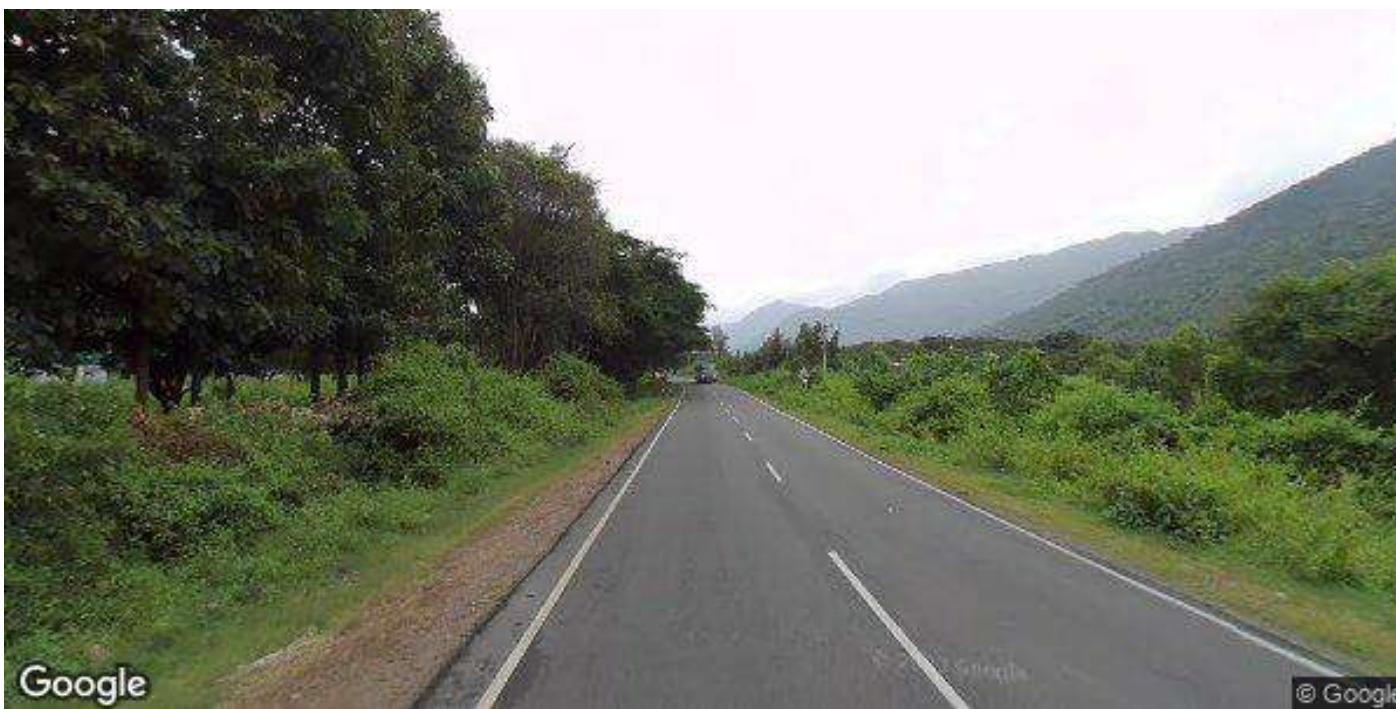
| | Risk Type | Risk Level | Coordinates | Speed Limit |
|---|---|---|---|---|
| 23 | Turn | Medium | 11.80474, 78.33353 | 30 KM/Hr |

**Risk Type:** Turn  
**Risk Level:** Medium  
**Speed Limit:** 30 KM/Hr  
**Coordinates:** 11.80474, 78.33353
