# IndianOil

## JOURNEY RISK MANAGEMENT (JRM) STUDY

### Salem Terminal to CHENNAMMAL AGENCIES

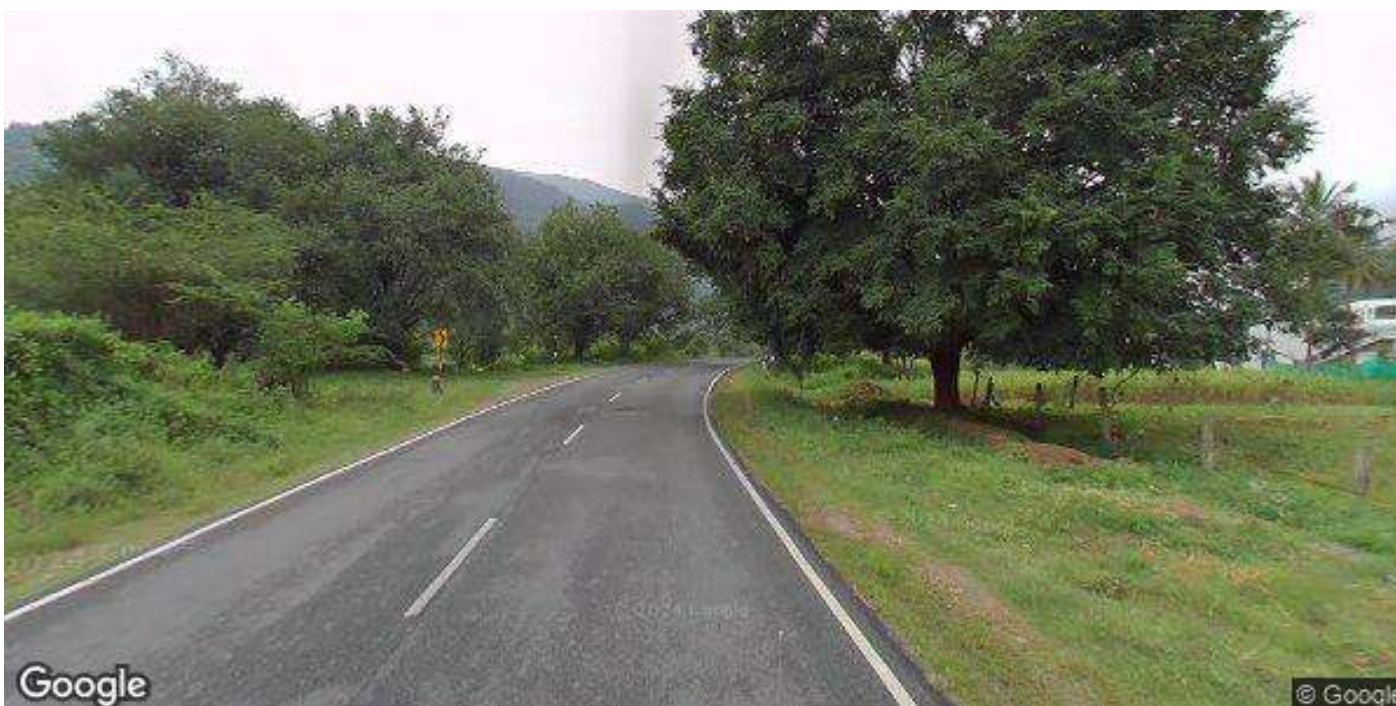
| | Risk Type | Risk Level | Coordinates | Speed Limit |
|---|---|---|---|---|
| 24 | Turn | Medium | 11.81272, 78.34092 | 30 KM/Hr |

**Risk Type:** Turn  
**Risk Level:** Medium  
**Speed Limit:** 30 KM/Hr  
**Coordinates:** 11.81272, 78.34092

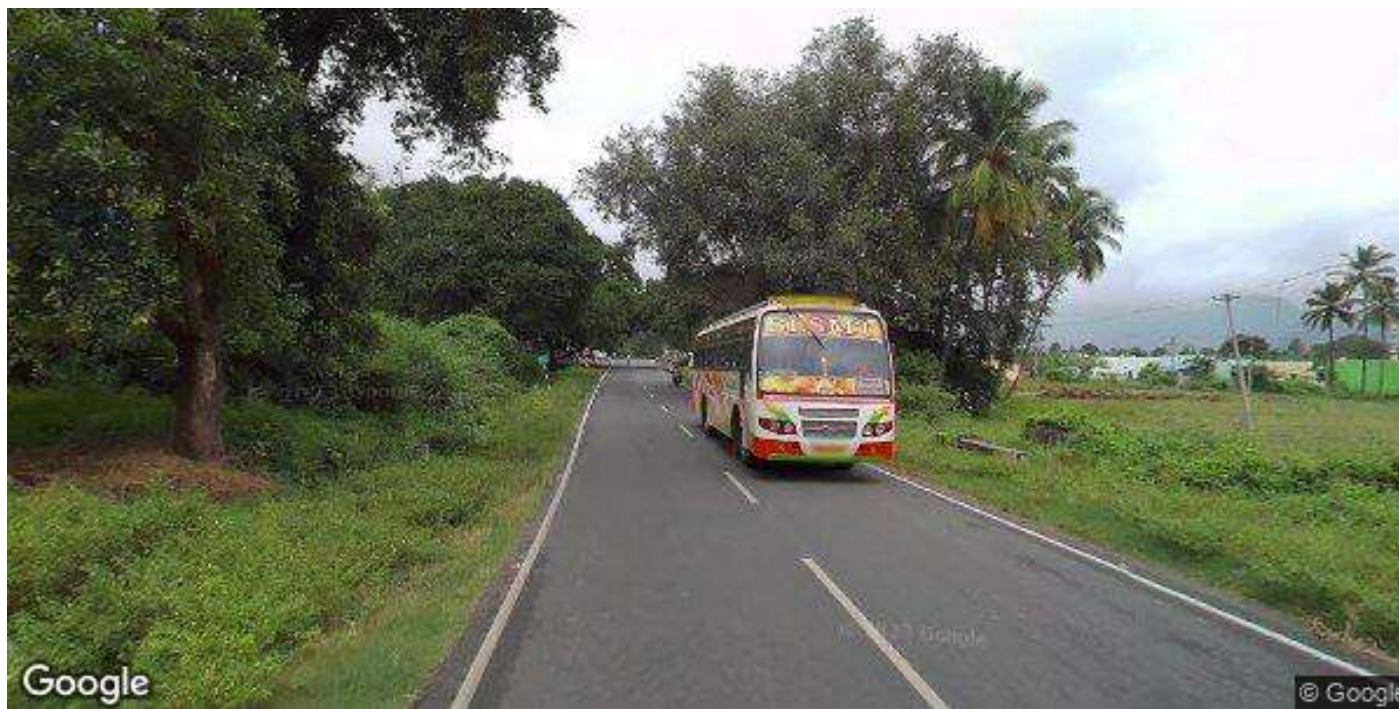
| | Risk Type | Risk Level | Coordinates | Speed Limit |
|---|---|---|---|---|
| 25 | Turn | Medium | 11.83514, 78.35305 | 30 KM/Hr |

**Risk Type:** Turn  
**Risk Level:** Medium  
**Speed Limit:** 30 KM/Hr  
**Coordinates:** 11.83514, 78.35305

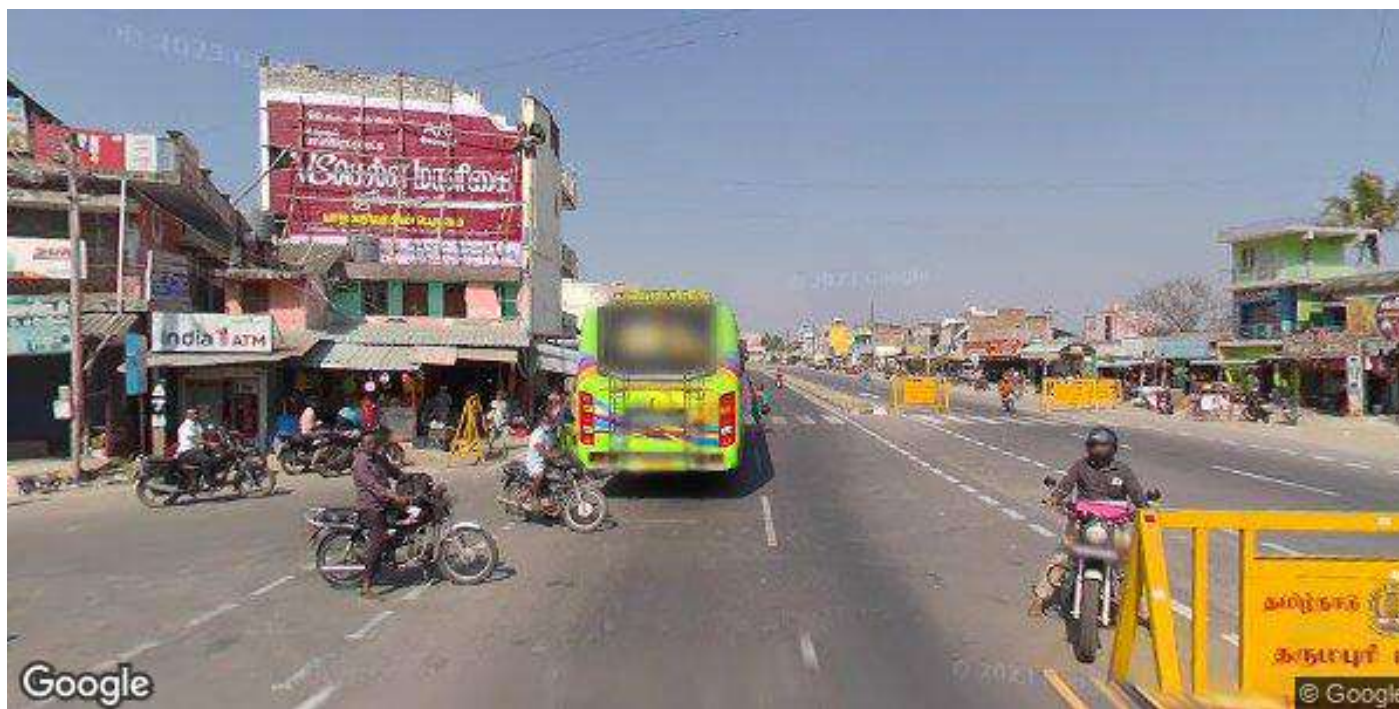
| | Risk Type | Risk Level | Coordinates | Speed Limit |
|---|---|---|---|---|
| 26 | Turn | Medium | 11.99608, 78.44589 | 30 KM/Hr |

**Risk Type:** Turn  
**Risk Level:** Medium  
**Speed Limit:** 30 KM/Hr  
**Coordinates:** 11.99608, 78.44589

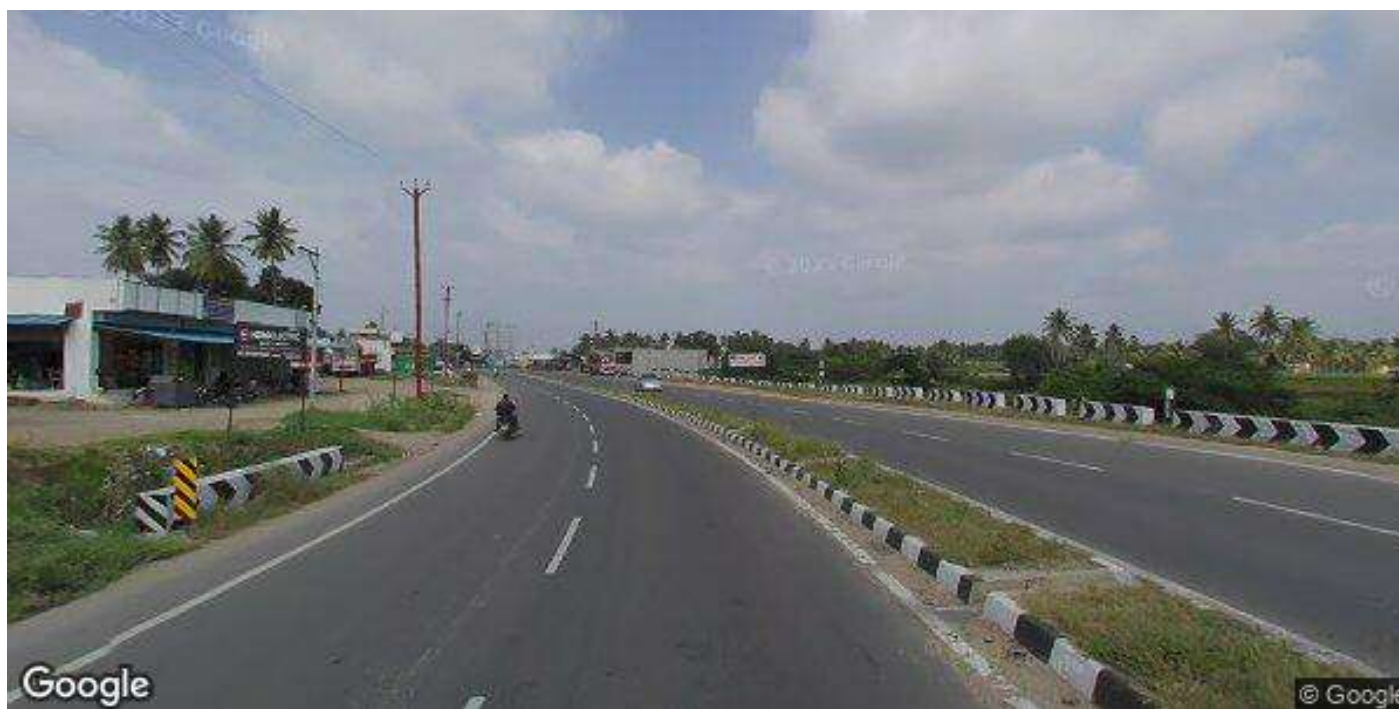
| | Risk Type | Risk Level | Coordinates | Speed Limit |
|---|---|---|---|---|
| 27 | Turn | Medium | 12.04286, 78.48352 | 30 KM/Hr |

**Risk Type:** Turn  
**Risk Level:** Medium  
**Speed Limit:** 30 KM/Hr  
**Coordinates:** 12.04286, 78.48352

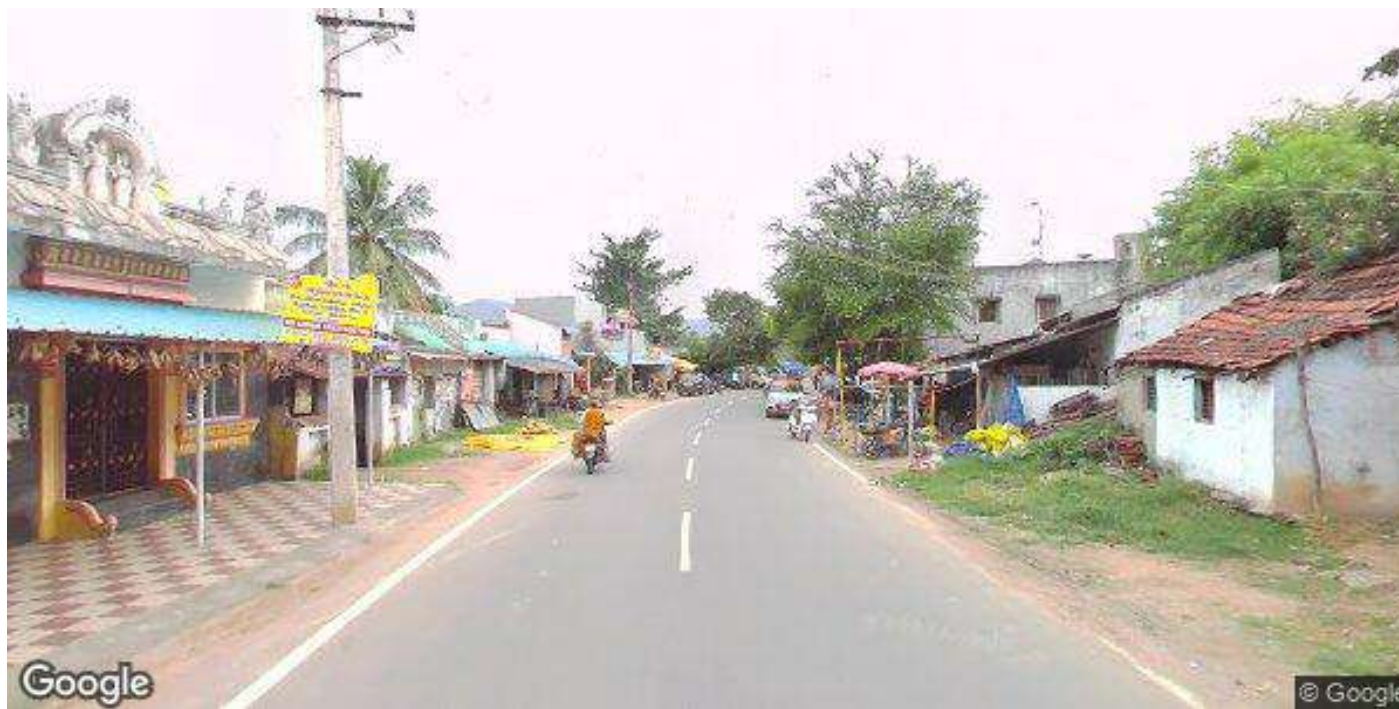
| | Risk Type | Risk Level | Coordinates | Speed Limit |
|---|---|---|---|---|
| 28 | Turn | Medium | 12.04845, 78.48385 | 30 KM/Hr |

**Risk Type:** Turn  
**Risk Level:** Medium  
**Speed Limit:** 30 KM/Hr  
**Coordinates:** 12.04845, 78.48385

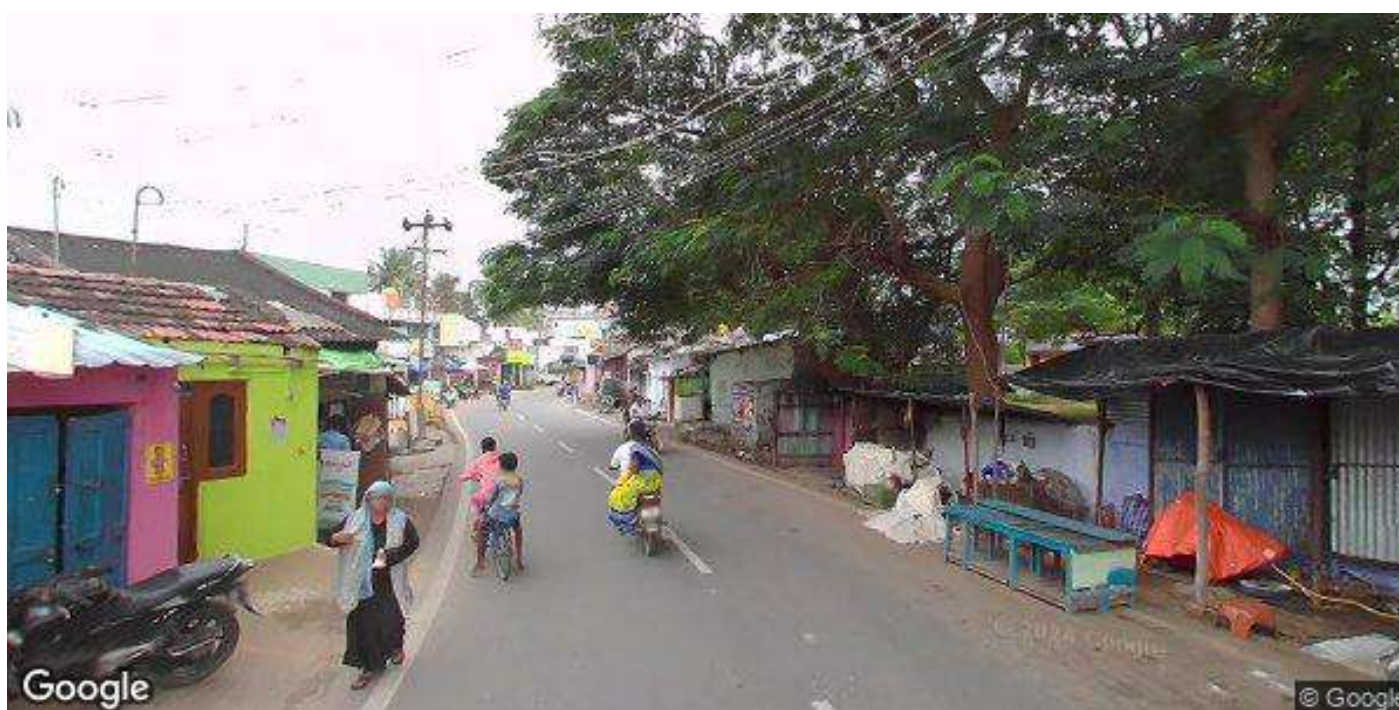
| | Risk Type | Risk Level | Coordinates | Speed Limit |
|---|---|---|---|---|
| 29 | Turn | Medium | 12.04958, 78.48314 | 30 KM/Hr |

**Risk Type:** Turn  
**Risk Level:** Medium  
**Speed Limit:** 30 KM/Hr  
**Coordinates:** 12.04958, 78.48314

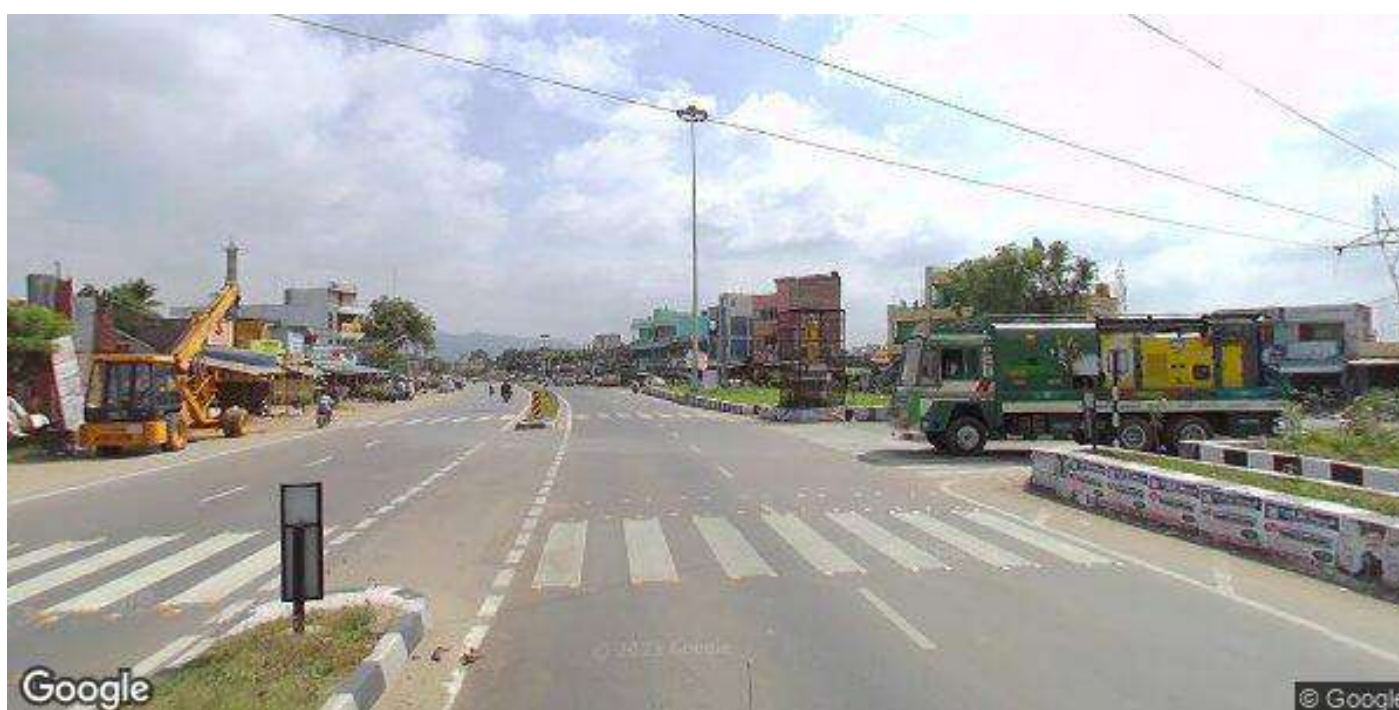
| | Risk Type | Risk Level | Coordinates | Speed Limit |
|---|---|---|---|---|
| 30 | Turn | Medium | 12.06149, 78.47722 | 30 KM/Hr |

**Risk Type:** Turn  
**Risk Level:** Medium  
**Speed Limit:** 30 KM/Hr  
**Coordinates:** 12.06149, 78.47722

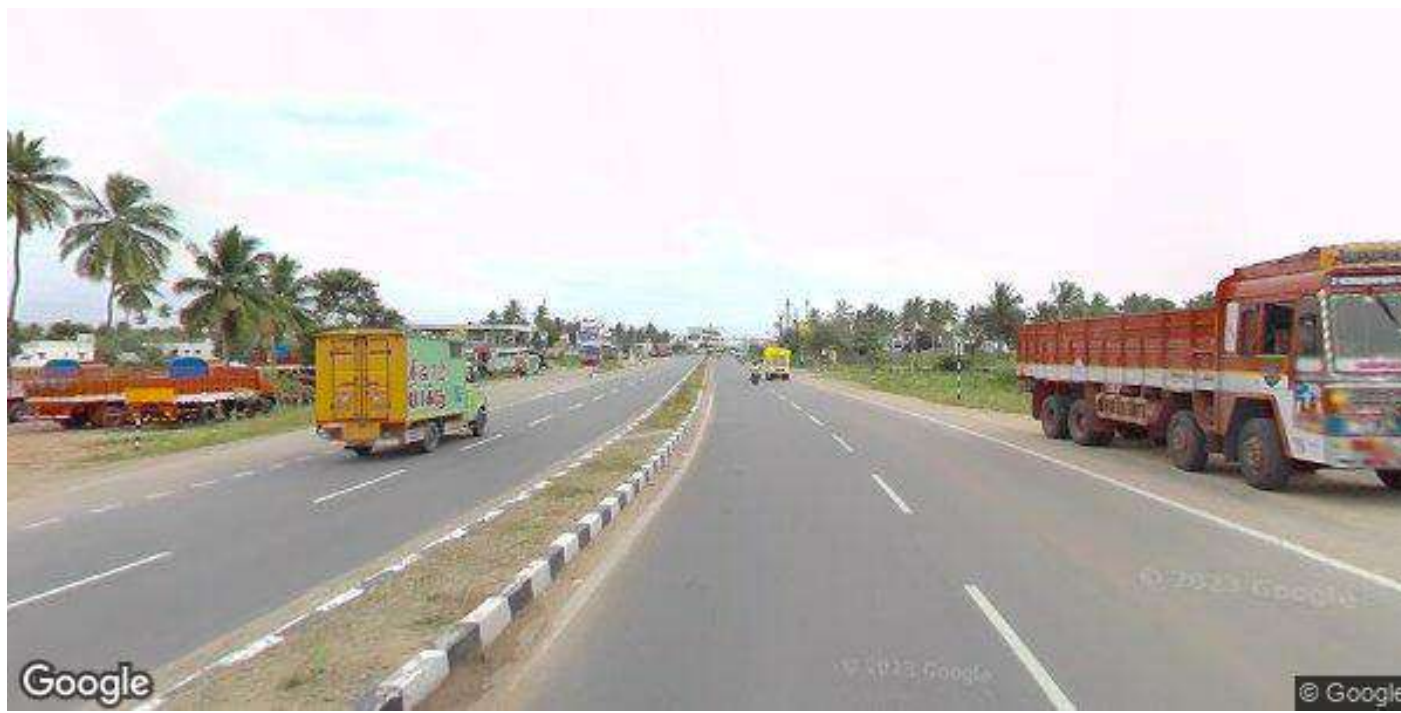
| | Risk Type | Risk Level | Coordinates | Speed Limit |
|---|---|---|---|---|
| 31 | Turn | Medium | 12.06932, 78.47655 | 30 KM/Hr |

**Risk Type:** Turn  
**Risk Level:** Medium  
**Speed Limit:** 30 KM/Hr  
**Coordinates:** 12.06932, 78.47655

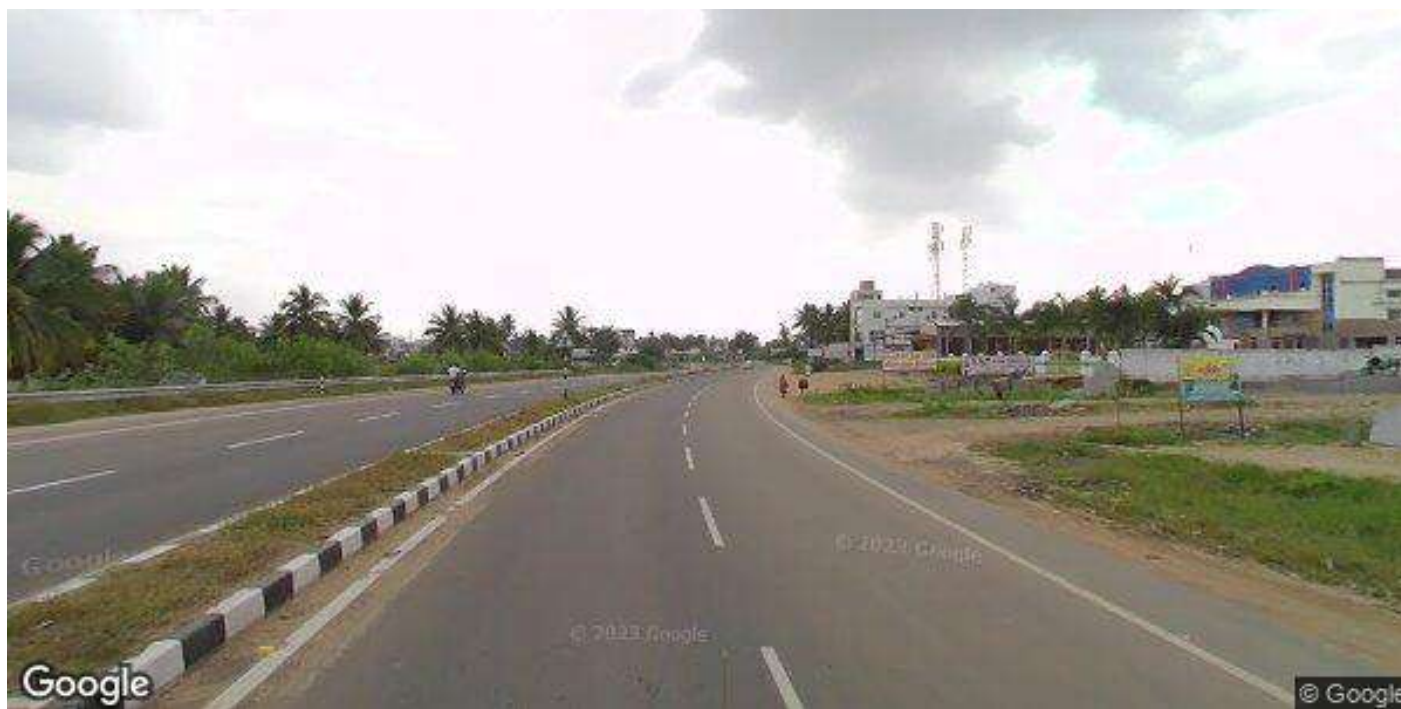
| | Risk Type | Risk Level | Coordinates | Speed Limit |
|---|---|---|---|---|
| 32 | Turn | Medium | 12.07112, 78.47724 | 30 KM/Hr |

**Risk Type:** Turn  
**Risk Level:** Medium  
**Speed Limit:** 30 KM/Hr  
**Coordinates:** 12.07112, 78.47724

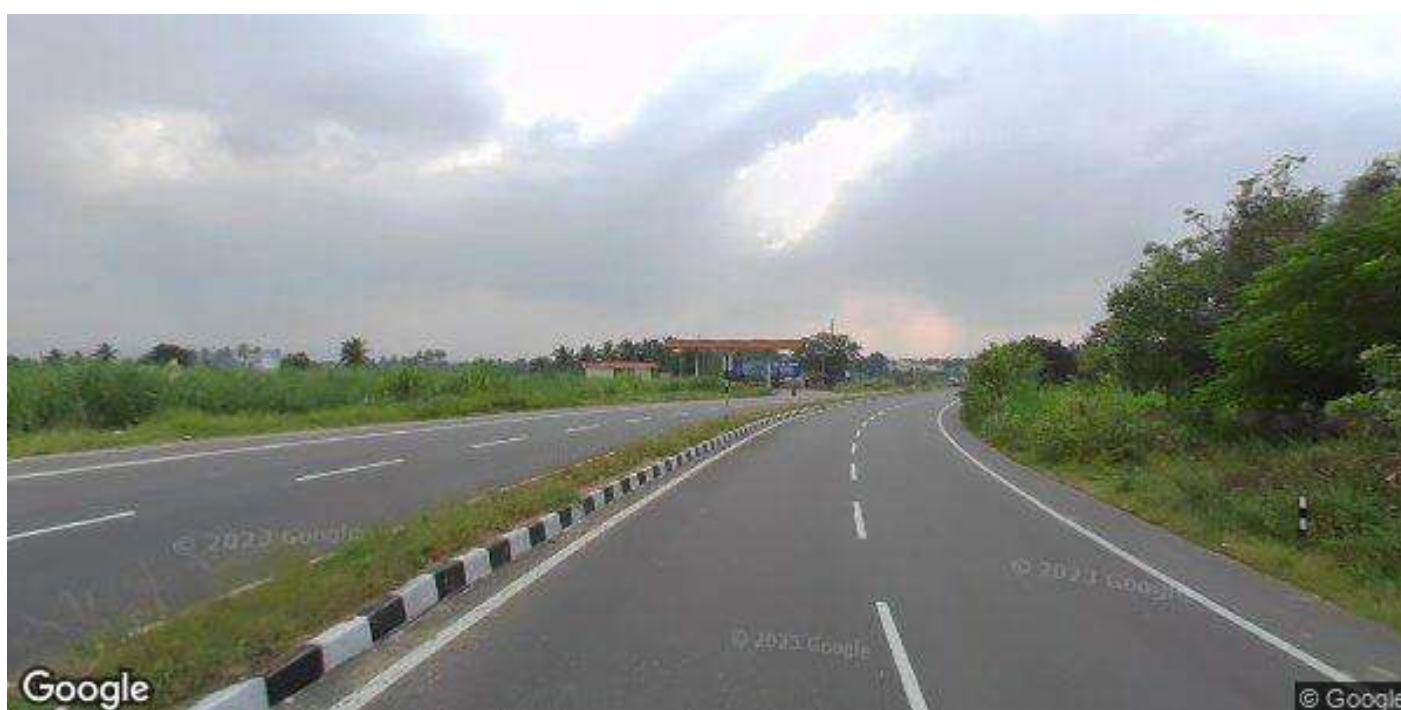
| | Risk Type | Risk Level | Coordinates | Speed Limit |
|---|---|---|---|---|
| 33 | Turn | Medium | 12.11669, 78.49766 | 30 KM/Hr |

**Risk Type:** Turn  
**Risk Level:** Medium  
**Speed Limit:** 30 KM/Hr  
**Coordinates:** 12.11669, 78.49766

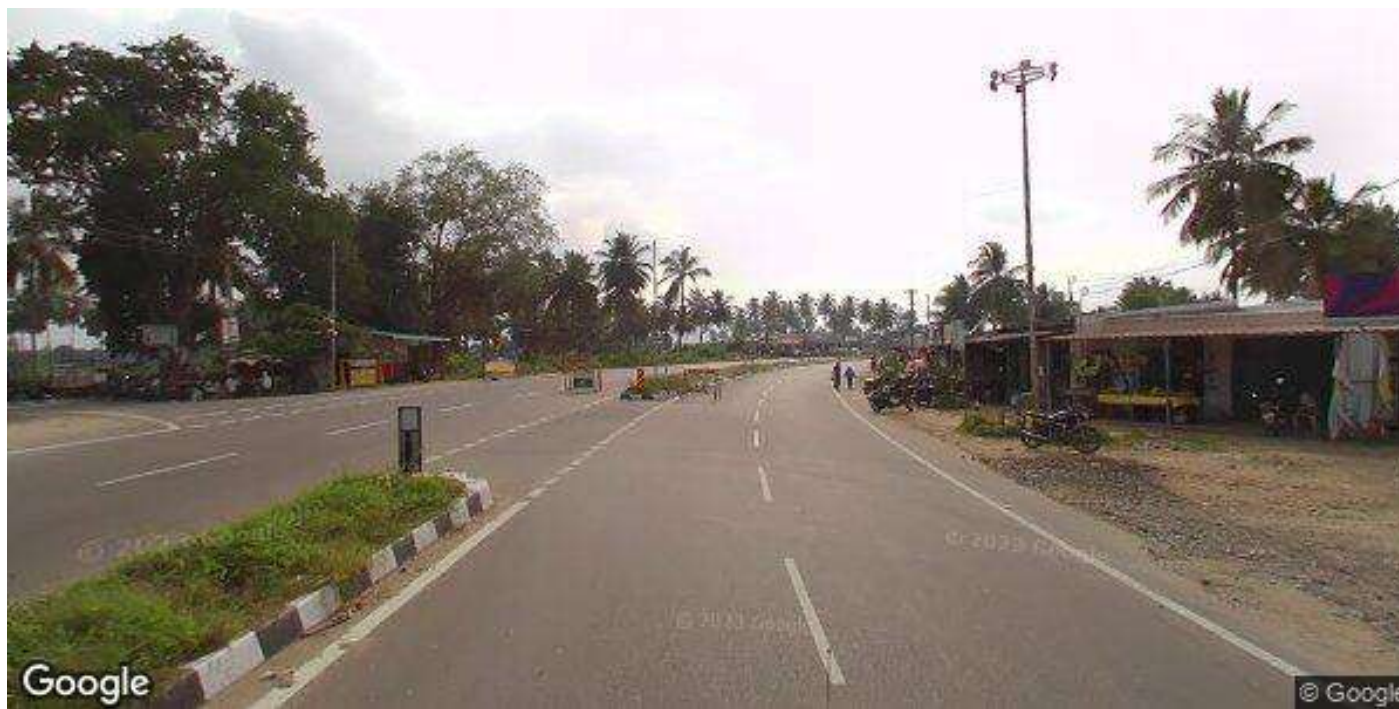
| | Risk Type | Risk Level | Coordinates | Speed Limit |
|---|---|---|---|---|
| 34 | Turn | Medium | 12.17764, 78.54800 | 30 KM/Hr |

**Risk Type:** Turn  
**Risk Level:** Medium  
**Speed Limit:** 30 KM/Hr  
**Coordinates:** 12.17764, 78.54800

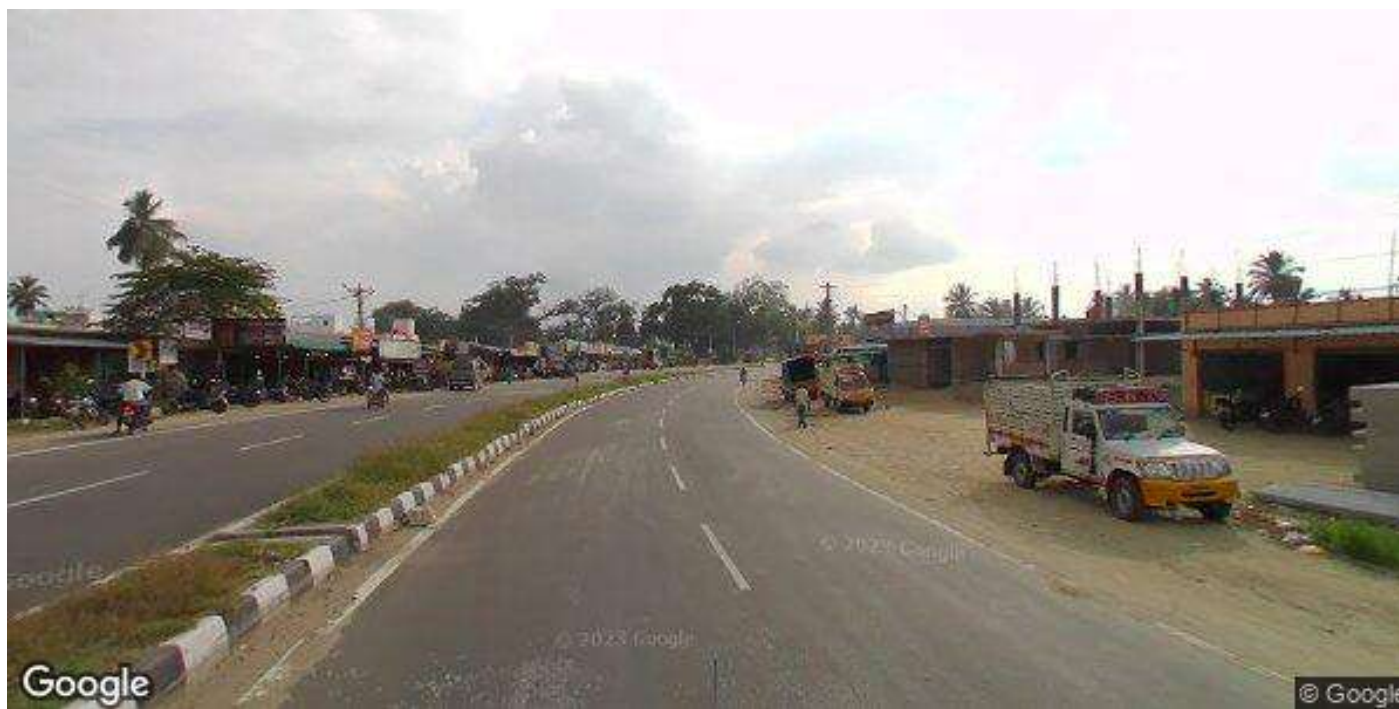
| | Risk Type | Risk Level | Coordinates | Speed Limit |
|---|---|---|---|---|
| 35 | Turn | Medium | 12.17847, 78.54856 | 30 KM/Hr |

**Risk Type:** Turn  
**Risk Level:** Medium  
**Speed Limit:** 30 KM/Hr  
**Coordinates:** 12.17847, 78.54856

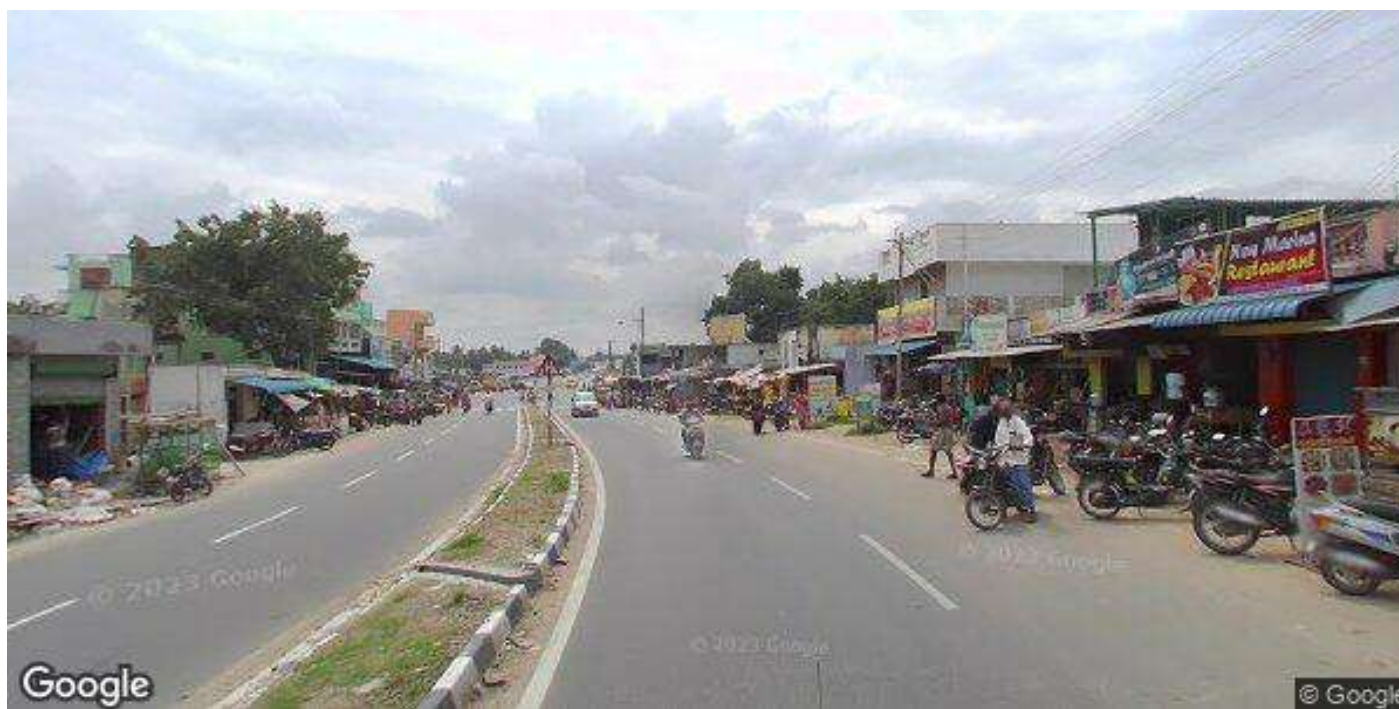
| | Risk Type | Risk Level | Coordinates | Speed Limit |
|---|---|---|---|---|
| 36 | Turn | Medium | 12.18223, 78.54843 | 30 KM/Hr |

**Risk Type:** Turn  
**Risk Level:** Medium  
**Speed Limit:** 30 KM/Hr  
**Coordinates:** 12.18223, 78.54843

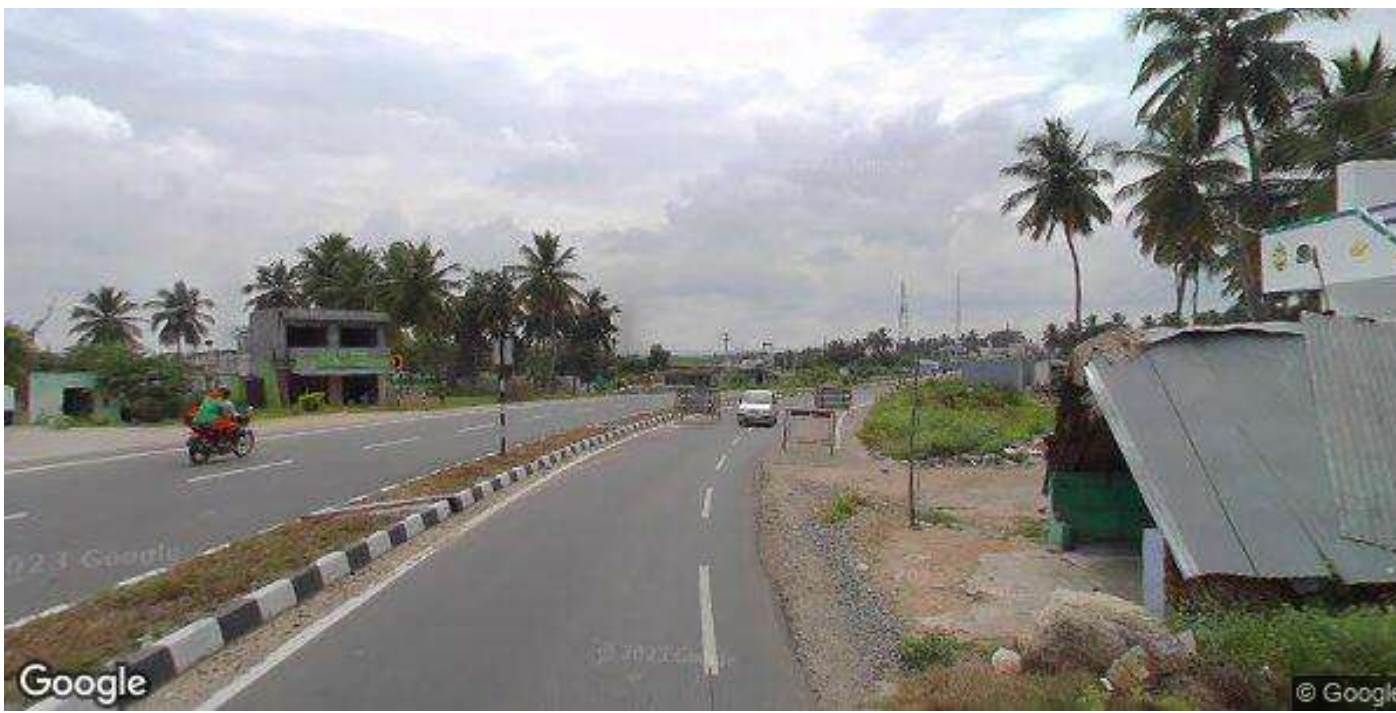
| | Risk Type | Risk Level | Coordinates | Speed Limit |
|---|---|---|---|---|
| 37 | Turn | High | 12.18614, 78.54962 | 15 KM/Hr |

**Risk Type:** Turn  
**Risk Level:** High  
**Speed Limit:** 15 KM/Hr  
**Coordinates:** 12.18614, 78.54962

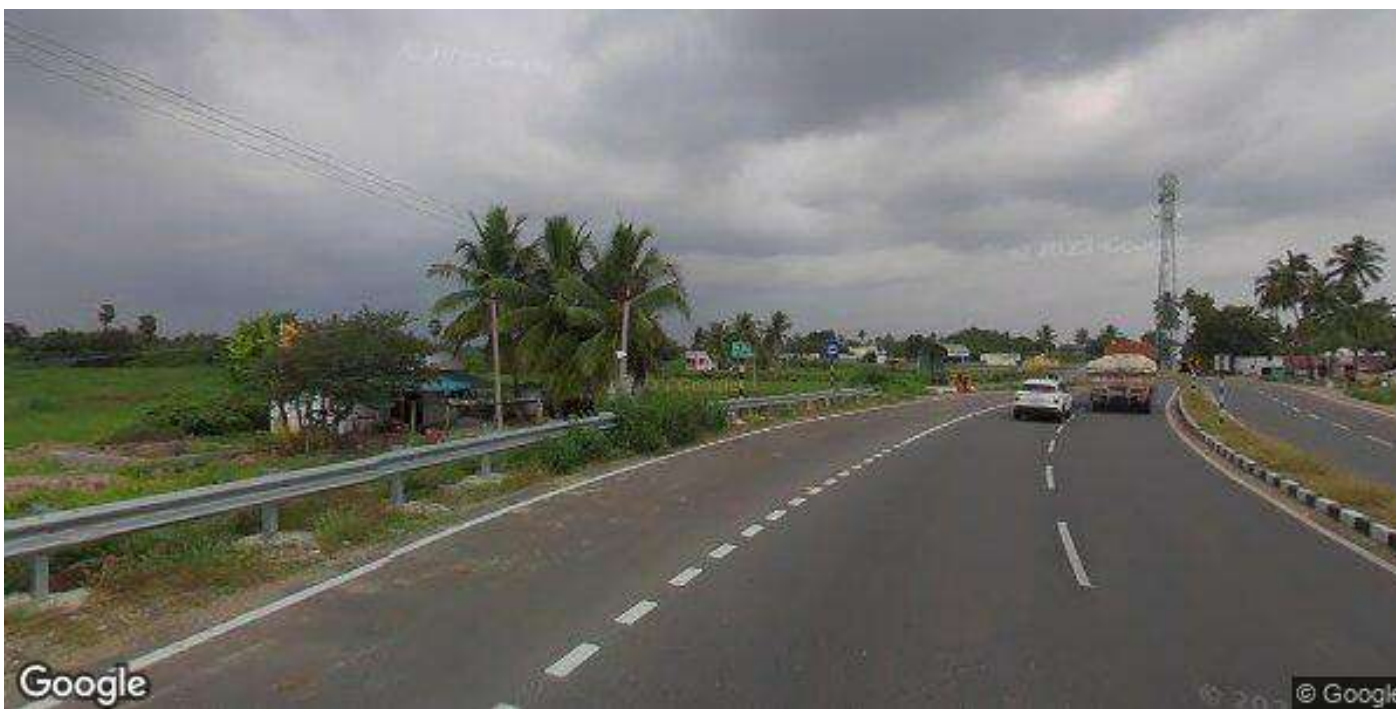
| | Risk Type | Risk Level | Coordinates | Speed Limit |
|---|---|---|---|---|
| 38 | Turn | Medium | 12.20953, 78.54358 | 30 KM/Hr |

**Risk Type:** Turn  
**Risk Level:** Medium  
**Speed Limit:** 30 KM/Hr  
**Coordinates:** 12.20953, 78.54358

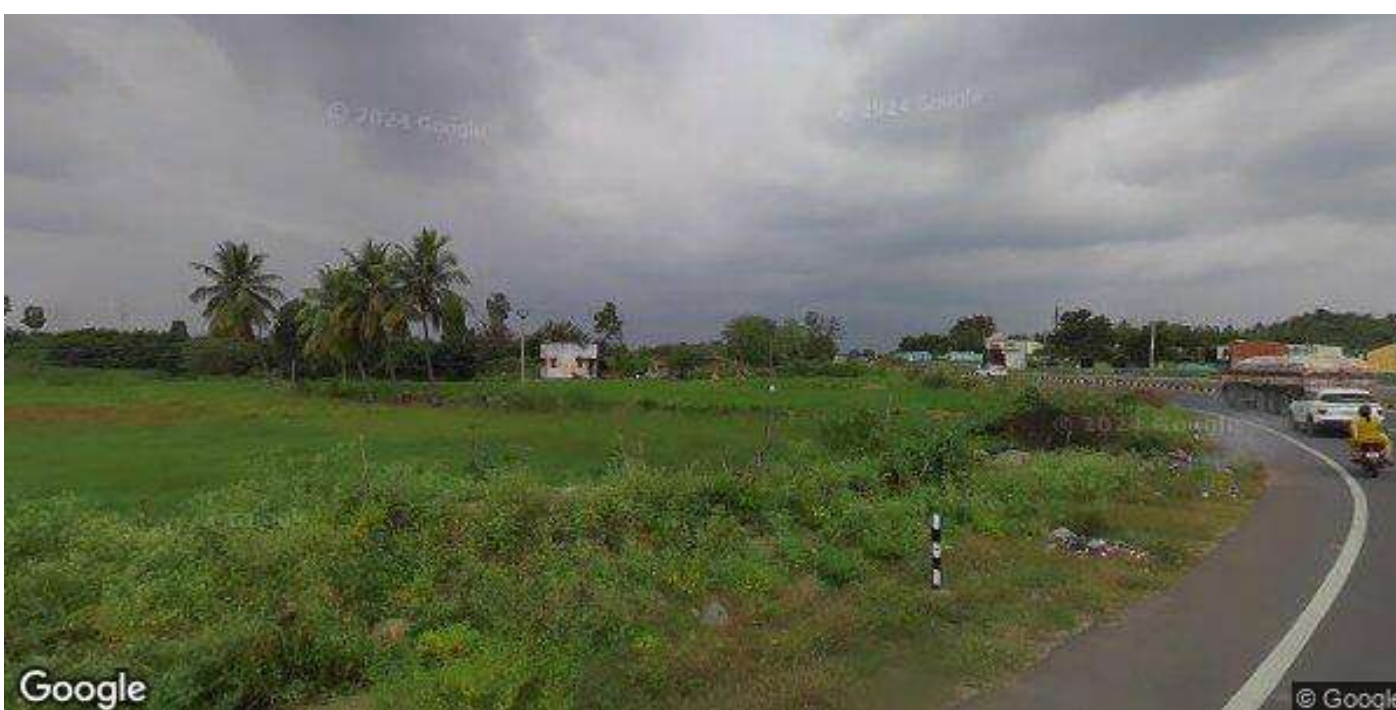
| | Risk Type | Risk Level | Coordinates | Speed Limit |
|---|---|---|---|---|
| 39 | Turn | High | 12.21030, 78.54402 | 15 KM/Hr |

**Risk Type:** Turn  
**Risk Level:** High  
**Speed Limit:** 15 KM/Hr  
**Coordinates:** 12.21030, 78.54402

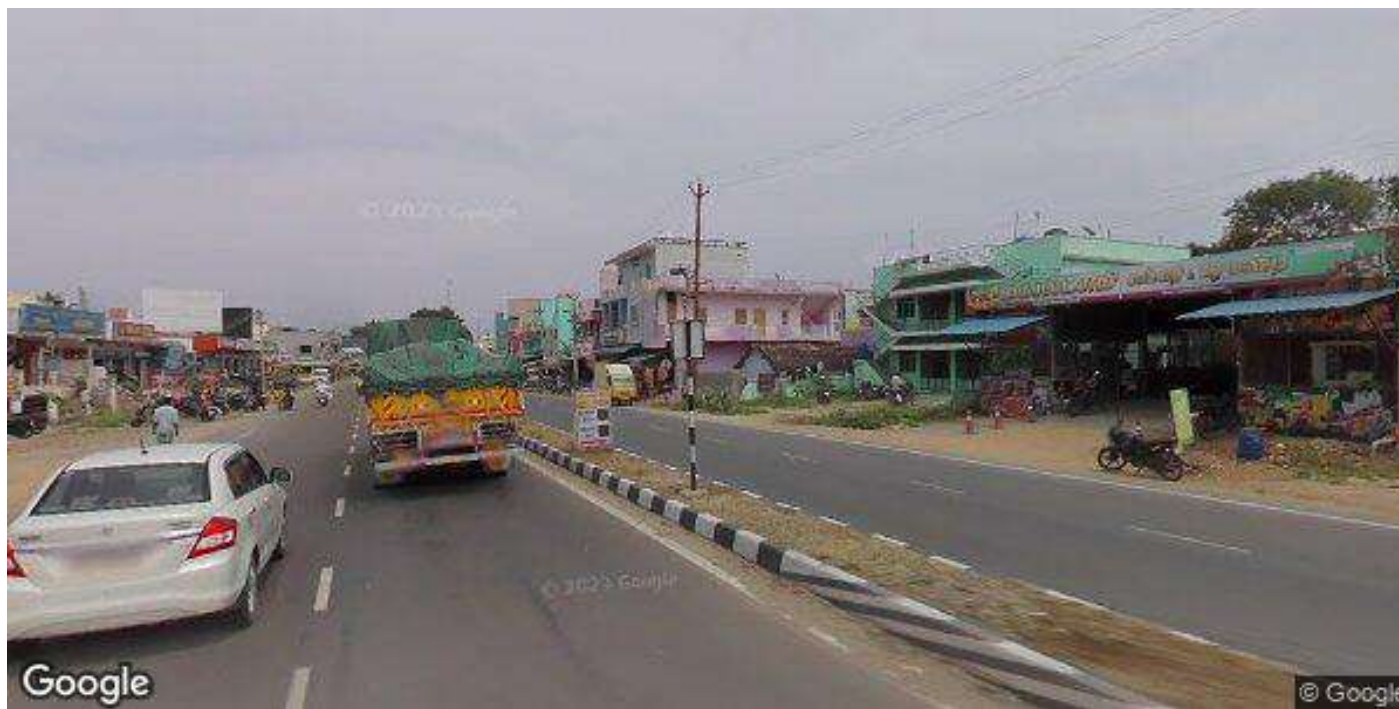
| | Risk Type | Risk Level | Coordinates | Speed Limit |
|---|---|---|---|---|
| 40 | Turn | Medium | 12.25956, 78.53301 | 30 KM/Hr |

**Risk Type:** Turn  
**Risk Level:** Medium  
**Speed Limit:** 30 KM/Hr  
**Coordinates:** 12.25956, 78.53301

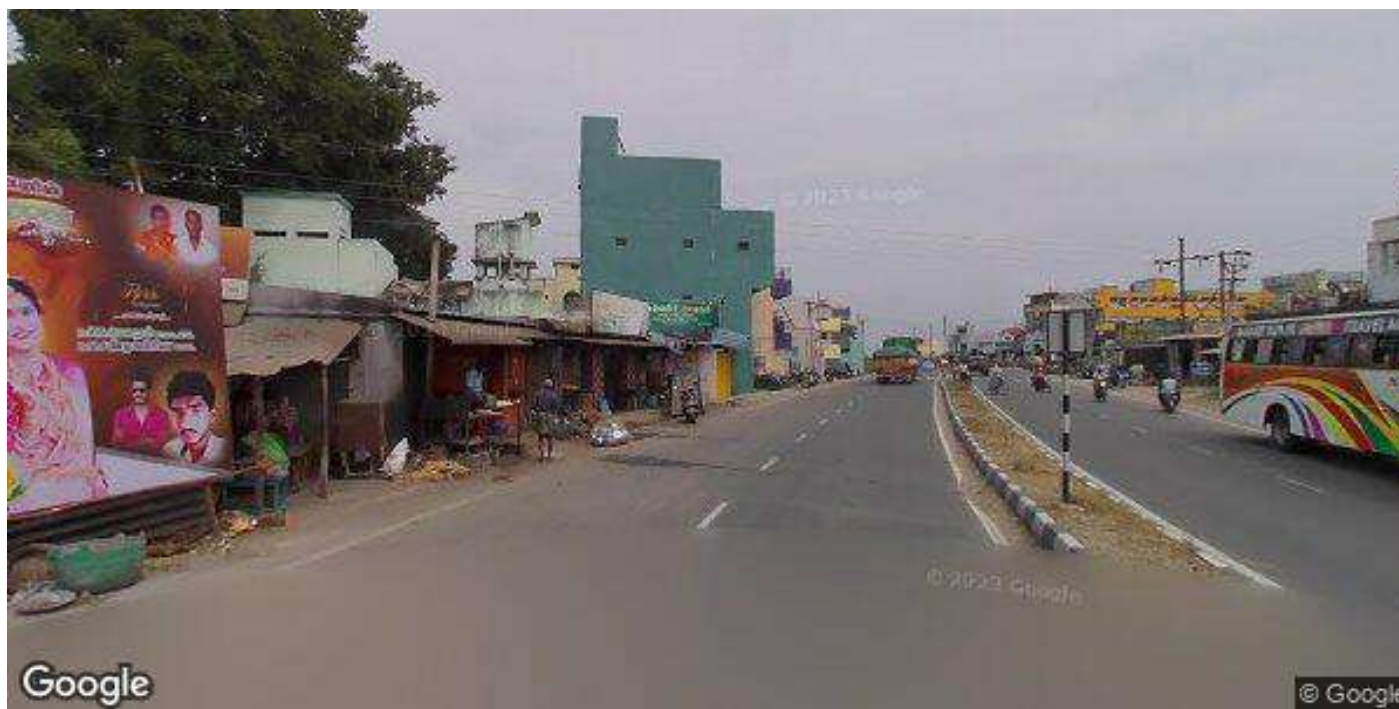
| | Risk Type | Risk Level | Coordinates | Speed Limit |
|---|---|---|---|---|
| 41 | Turn | Medium | 12.26092, 78.53324 | 30 KM/Hr |

**Risk Type:** Turn  
**Risk Level:** Medium  
**Speed Limit:** 30 KM/Hr  
**Coordinates:** 12.26092, 78.53324

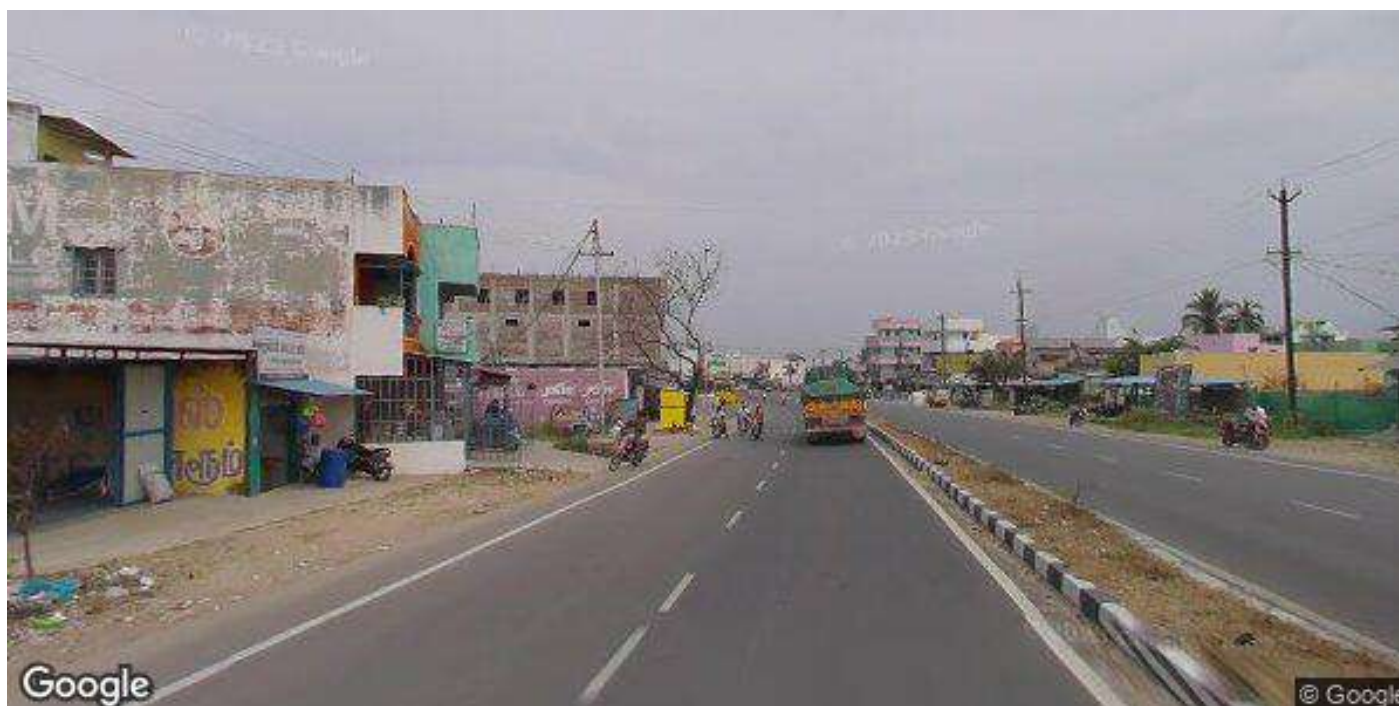
| | Risk Type | Risk Level | Coordinates | Speed Limit |
|---|---|---|---|---|
| 42 | Turn | Medium | 12.26207, 78.53436 | 30 KM/Hr |

**Risk Type:** Turn  
**Risk Level:** Medium  
**Speed Limit:** 30 KM/Hr  
**Coordinates:** 12.26207, 78.53436

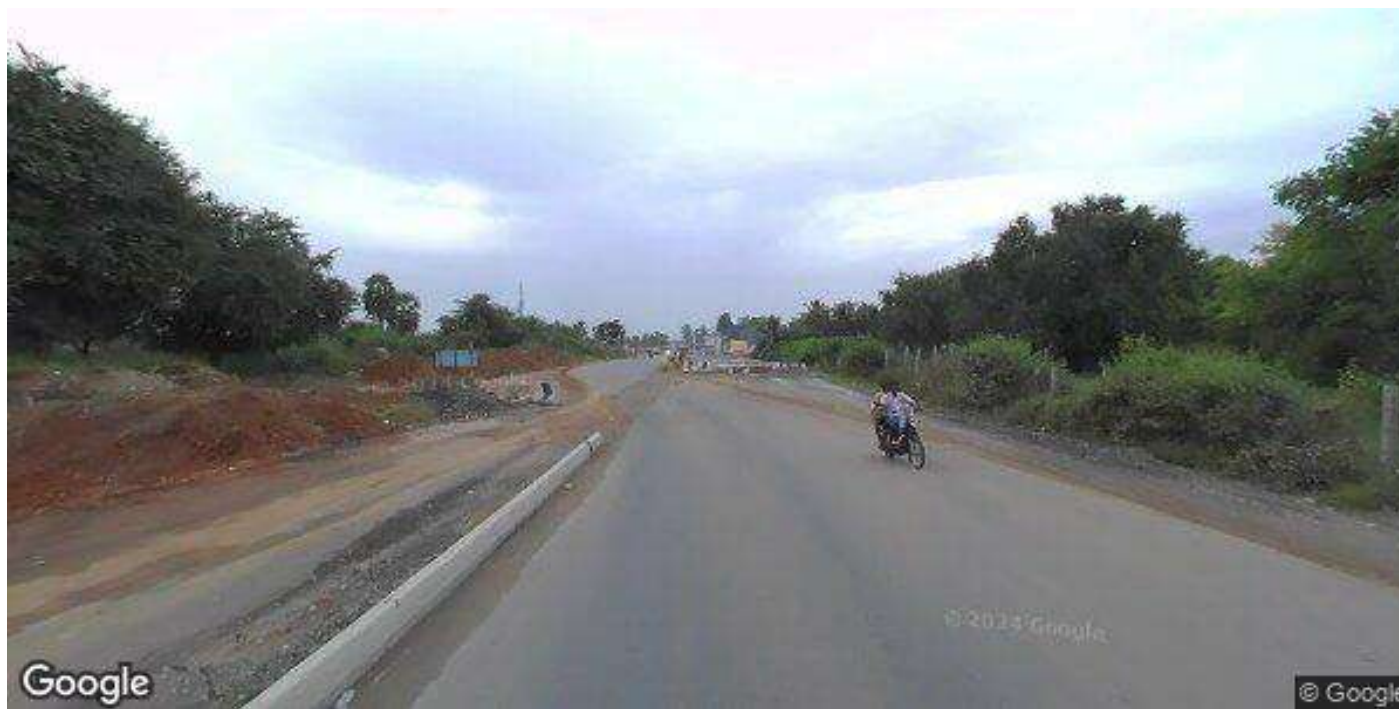
| | Risk Type | Risk Level | Coordinates | Speed Limit |
|---|---|---|---|---|
| 43 | Turn | Medium | 12.31095, 78.53818 | 30 KM/Hr |

**Risk Type:** Turn  
**Risk Level:** Medium  
**Speed Limit:** 30 KM/Hr  
**Coordinates:** 12.31095, 78.53818

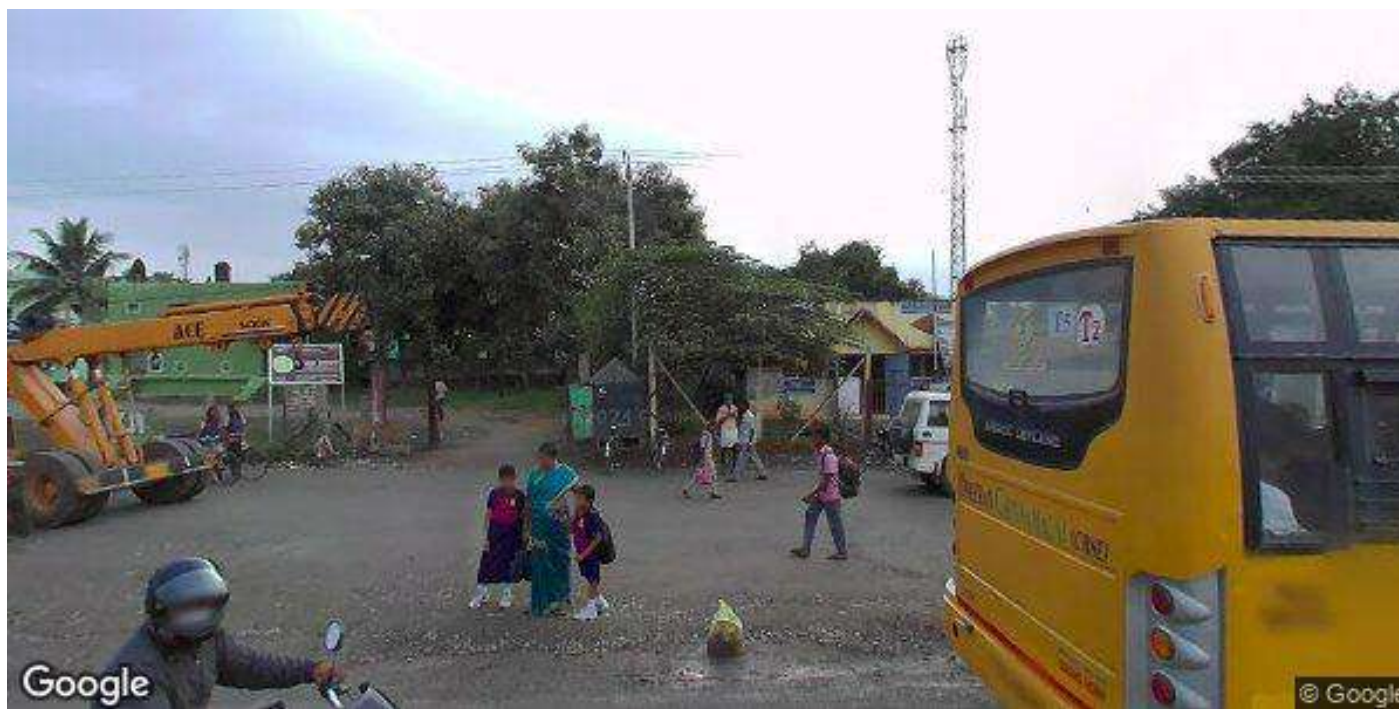
| | Risk Type | Risk Level | Coordinates | Speed Limit |
|---|---|---|---|---|
| 44 | Turn | High | 12.36356, 78.54371 | 15 KM/Hr |

**Risk Type:** Turn  
**Risk Level:** High  
**Speed Limit:** 15 KM/Hr  
**Coordinates:** 12.36356, 78.54371
