# IndianOil

## JOURNEY RISK MANAGEMENT (JRM) STUDY

### Salem Terminal to CHENNAMMAL AGENCIES

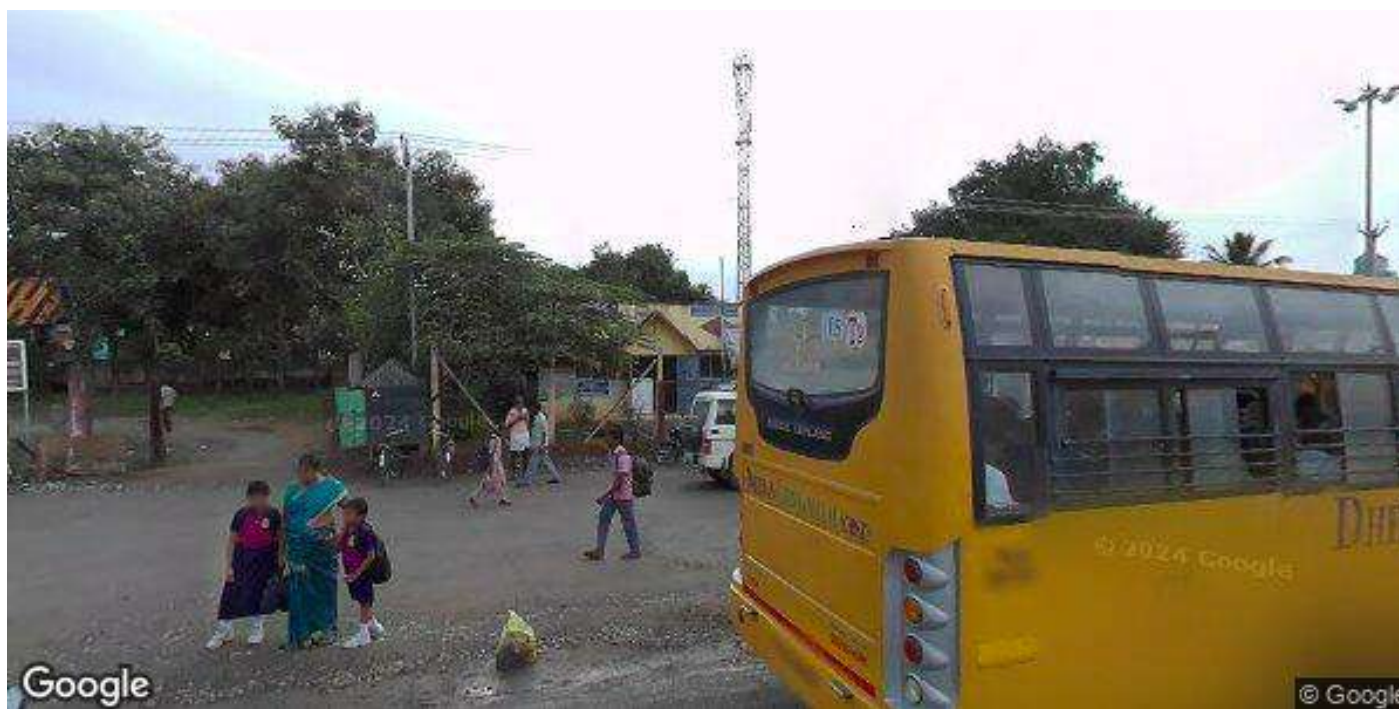
| | Risk Type | Risk Level | Coordinates | Speed Limit |
|---|---|---|---|---|
| 45 | Turn | High | 12.36375, 78.54324 | 15 KM/Hr |

**Risk Type:** Turn  
**Risk Level:** High  
**Speed Limit:** 15 KM/Hr  
**Coordinates:** 12.36375, 78.54324
