# IndianOil

## JOURNEY RISK MANAGEMENT (JRM) STUDY

### Salem Terminal TO SRI DHANALAKSHMI AGENCIES

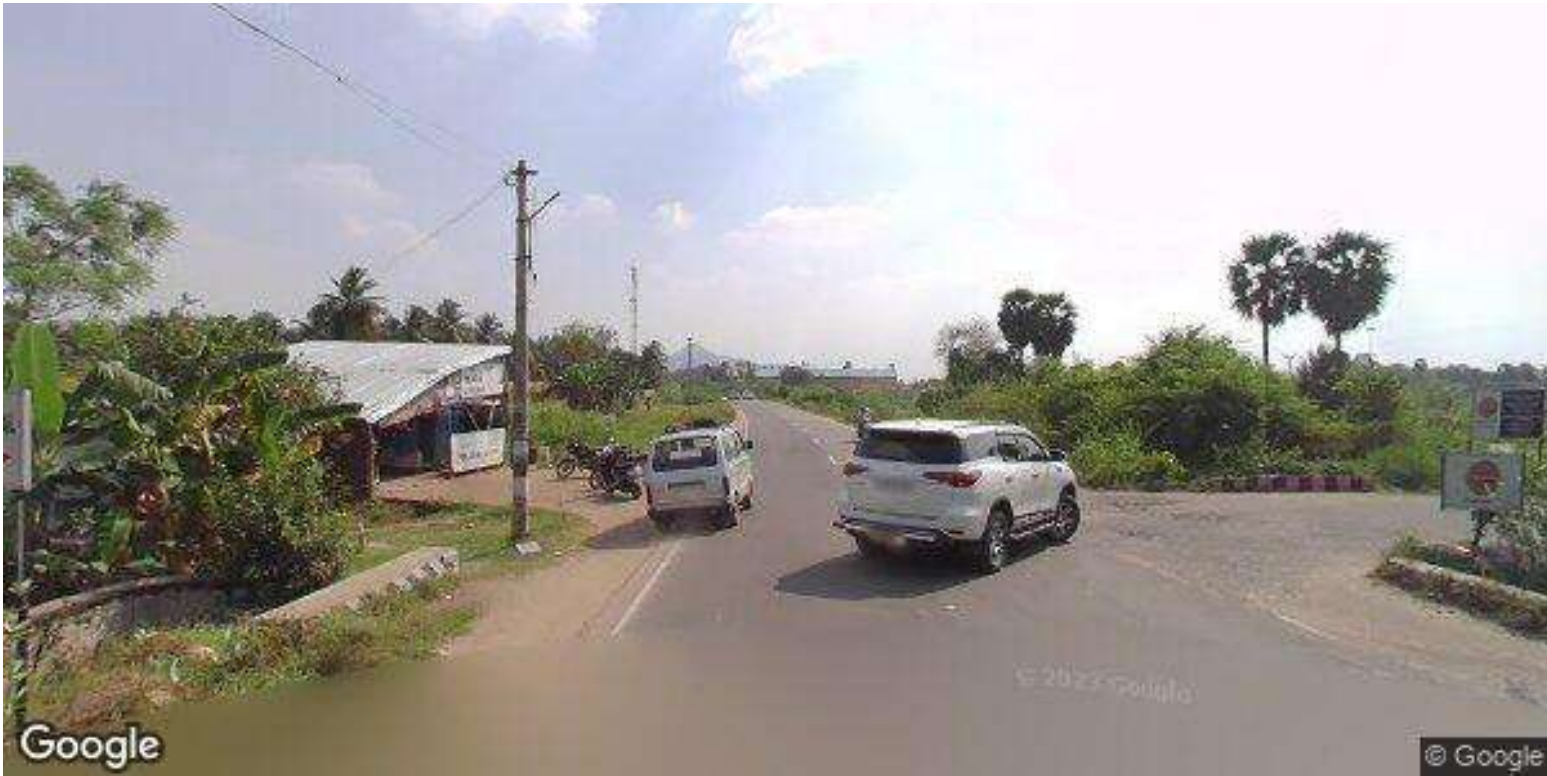
Coordinates: 11.44029, 77.87544

Risk Type: Turn

Risk Level: High

Speed Limit: 15 KM/Hr

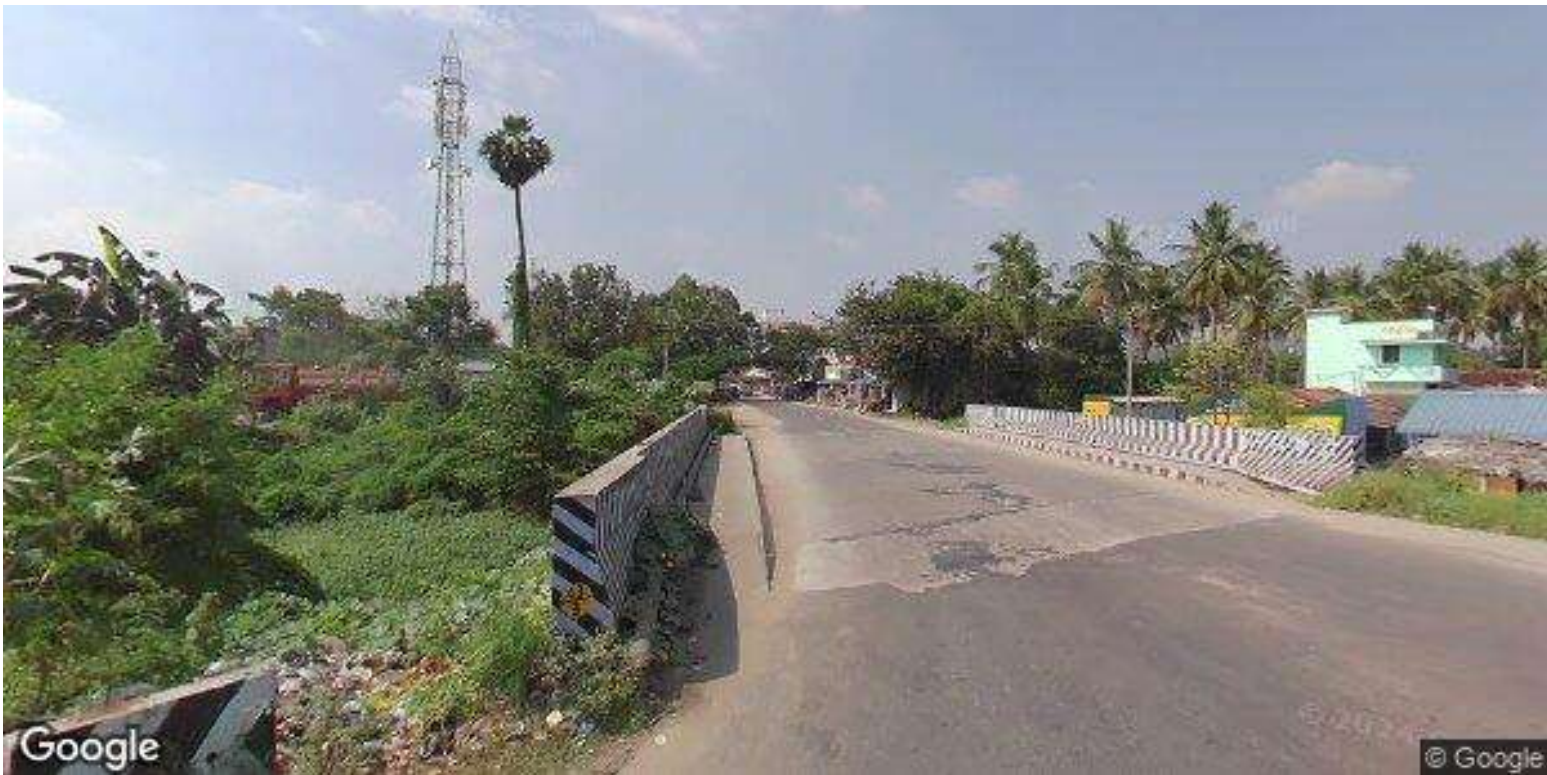
Coordinates: 11.44900, 77.87406

Risk Type: Turn

Risk Level: Medium

Speed Limit: 30 KM/Hr

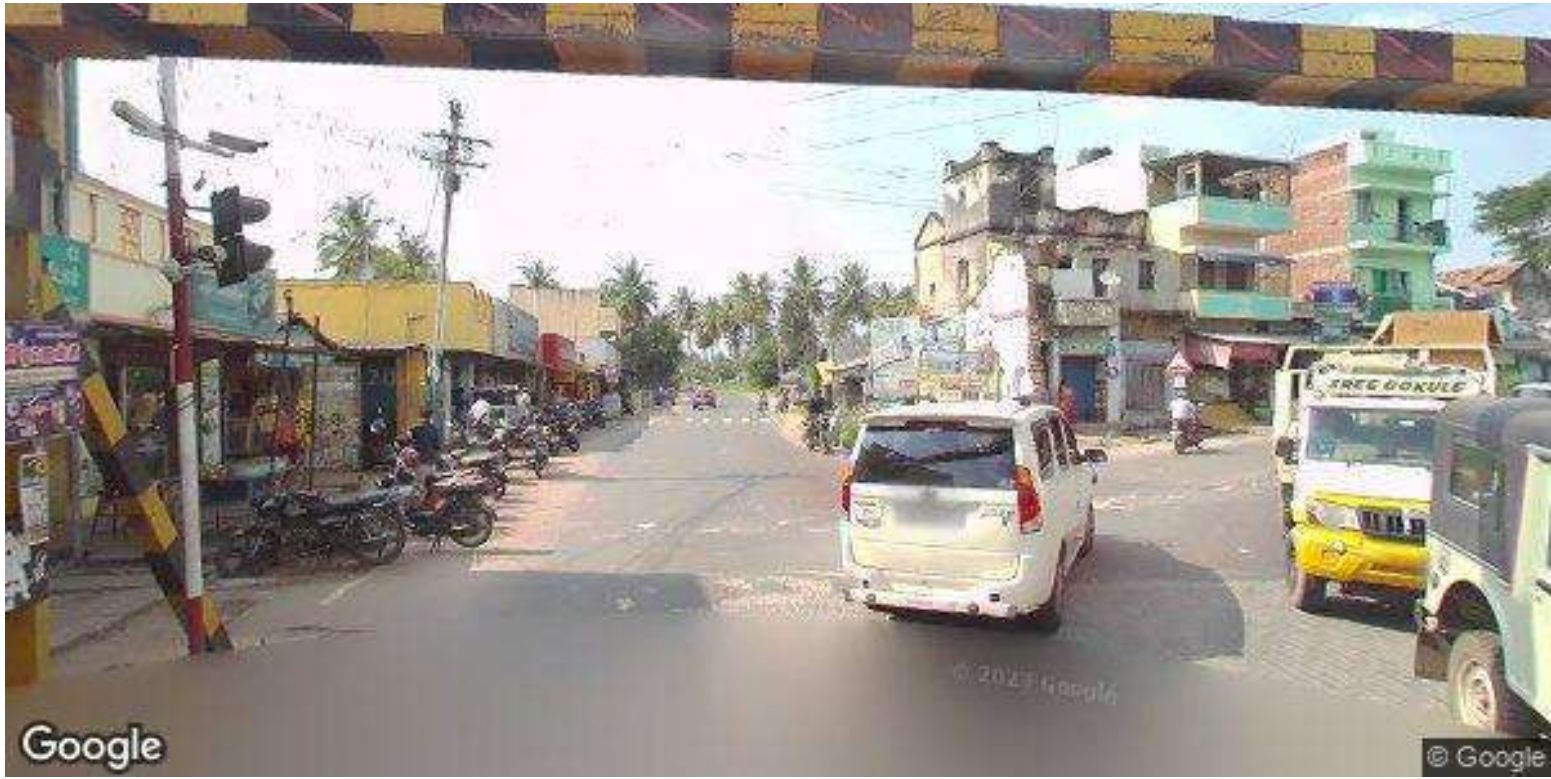
Risk Type: Turn  
Risk Level: High  
Speed Limit: 15 KM/Hr  
Coordinates: 11.45004, 77.87206

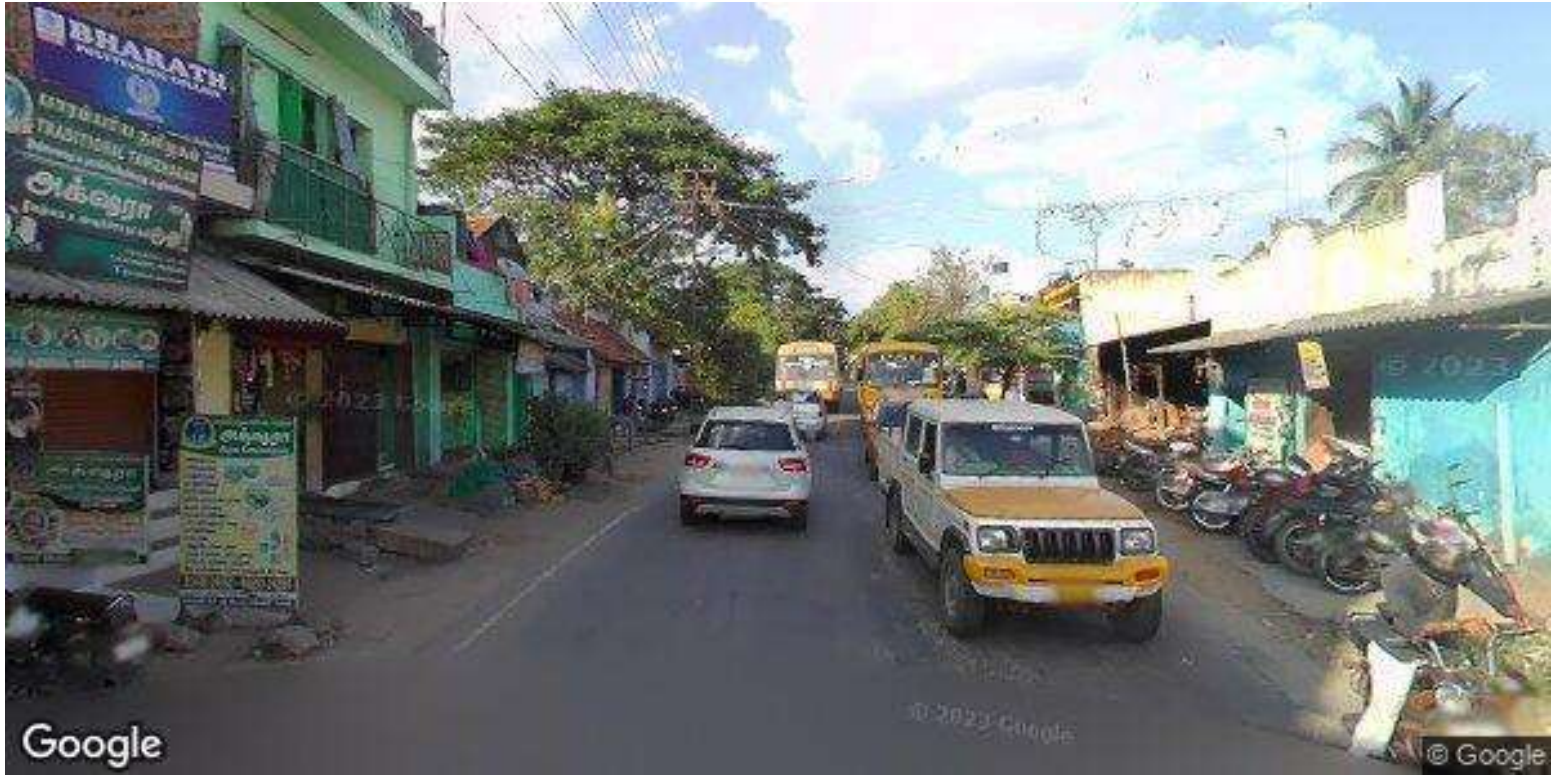
Risk Type: Turn  
Risk Level: Medium  
Speed Limit: 30 KM/Hr  
Coordinates: 11.45028, 77.87202

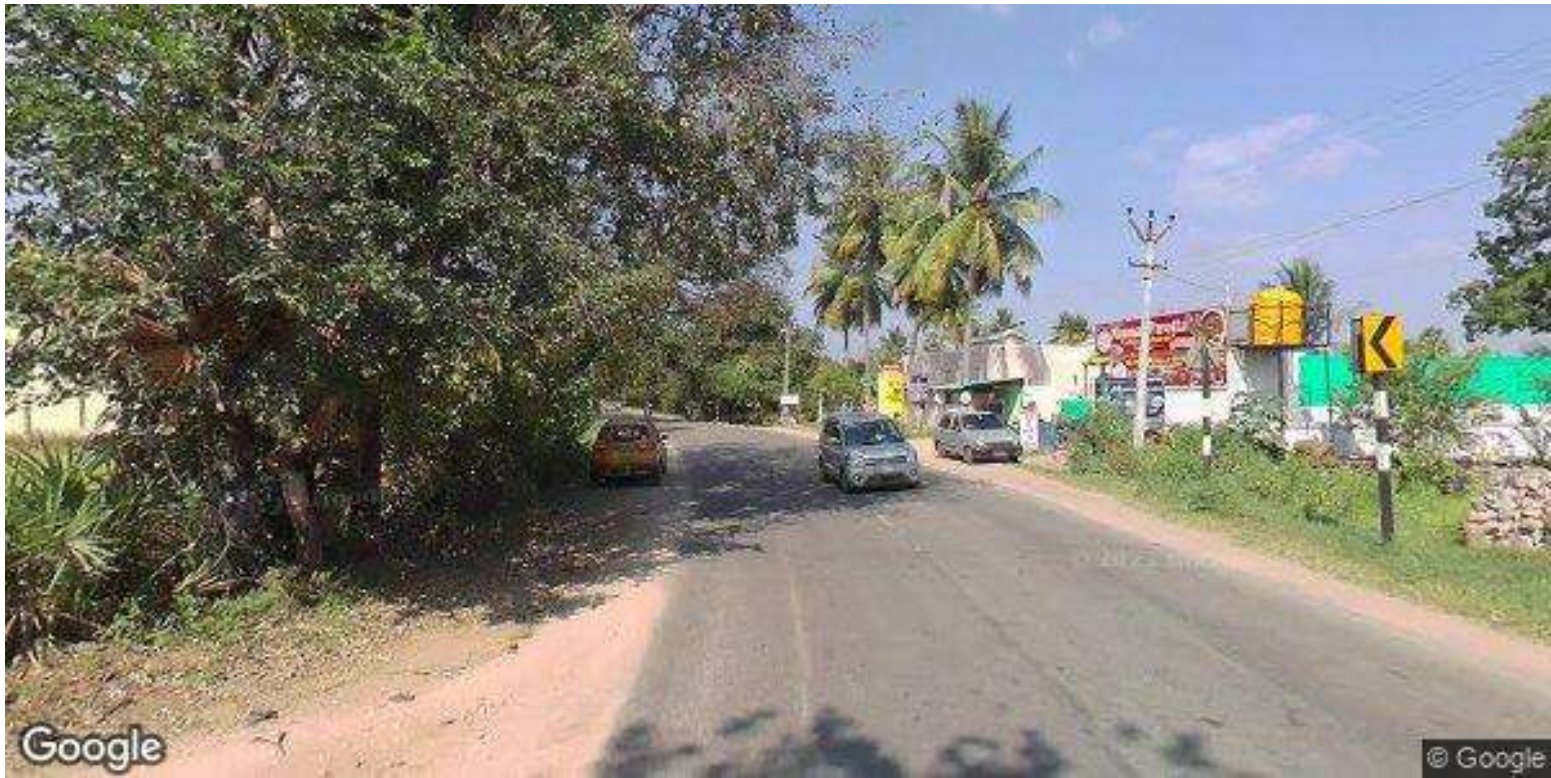
**Risk Type:** Turn  
**Risk Level:** Medium  
**Speed Limit:** 30 KM/Hr  
**Coordinates:** 11.45309, 77.87325

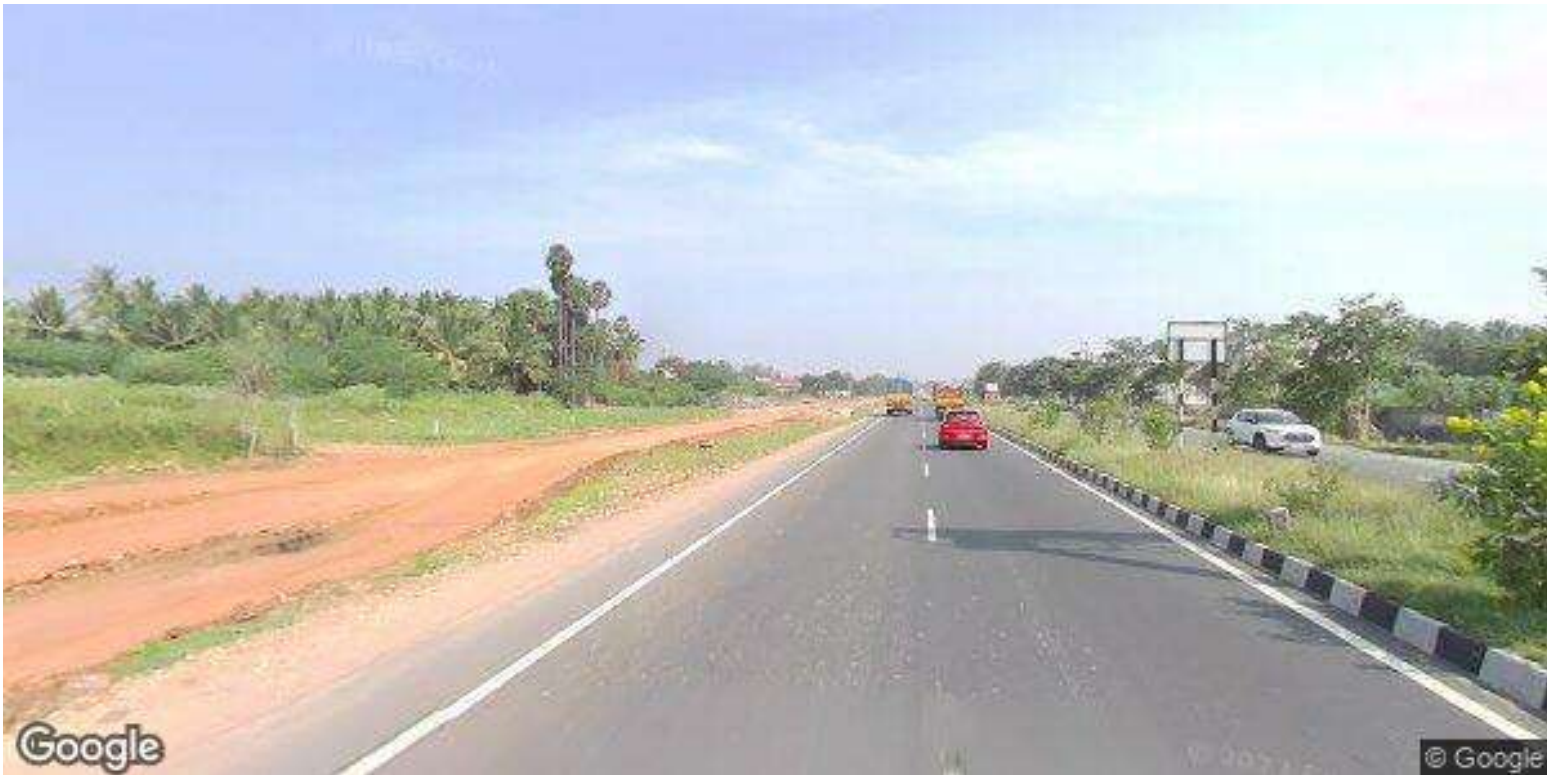
**Coordinates: 11.61753, 78.10608**

**Risk Type: Turn**

**Risk Level: Medium**

**Speed Limit: 30 KM/Hr**

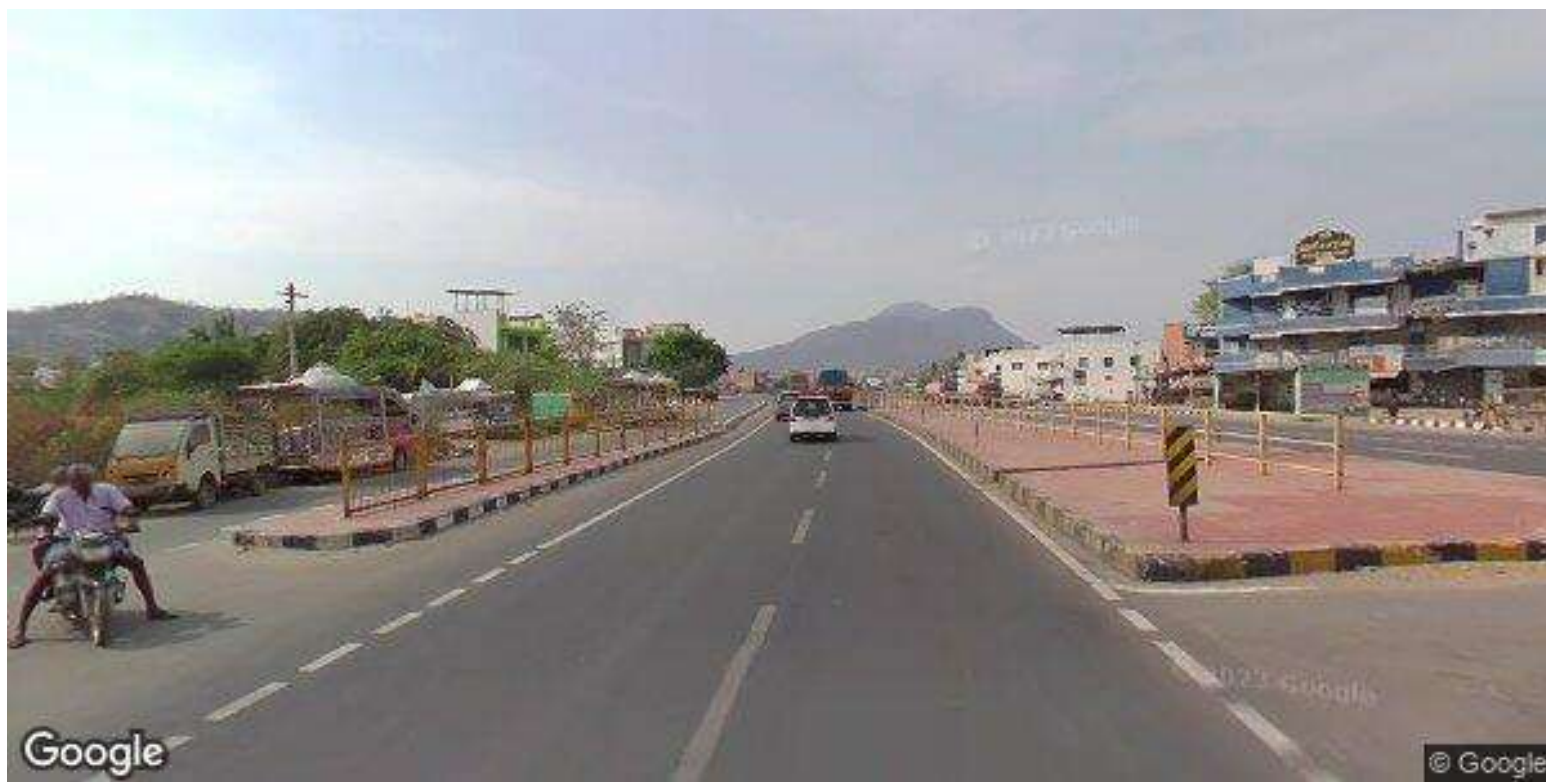
**Coordinates:** 11.87104, 78.08356

**Risk Type:** Blind Spot

**Risk Level:** Blind Spot

**Speed Limit:** 10 KM/Hr

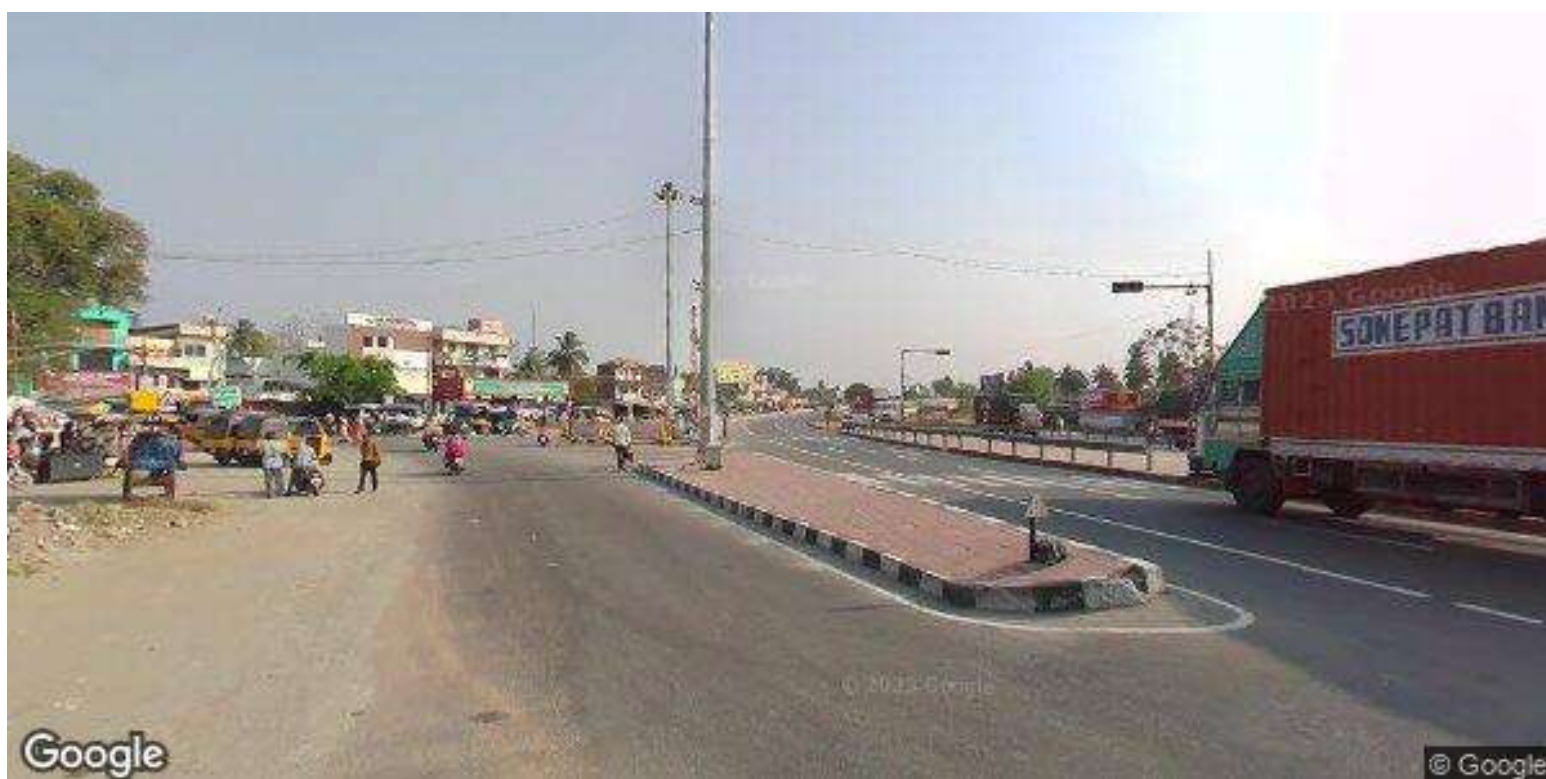
**Coordinates:** 11.87111, 78.08382

**Risk Type:** Turn

**Risk Level:** High

**Speed Limit:** 15 KM/Hr

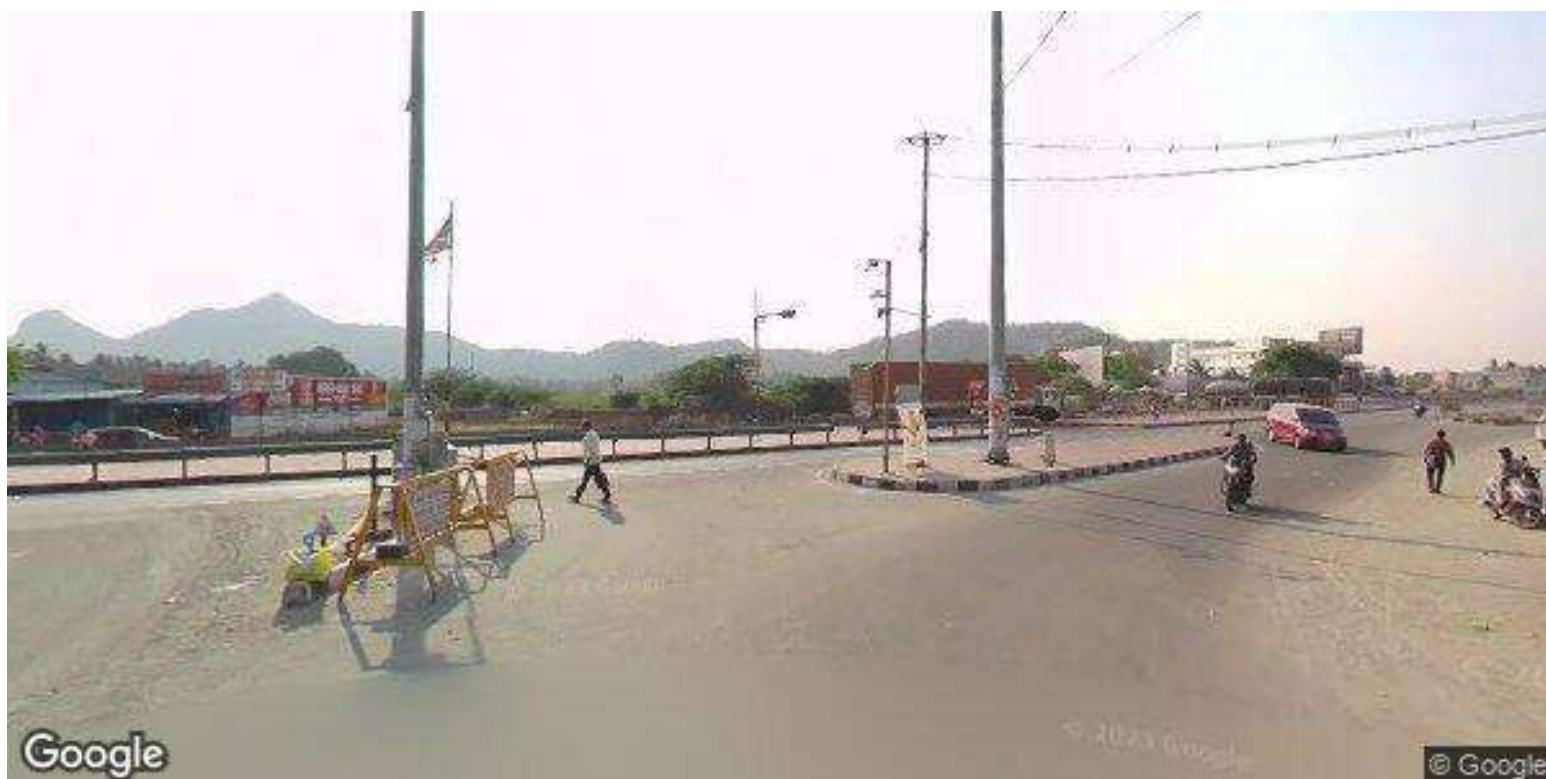
**Coordinates:** 11.87077, 78.08404

**Risk Type:** Turn

**Risk Level:** High

**Speed Limit:** 15 KM/Hr

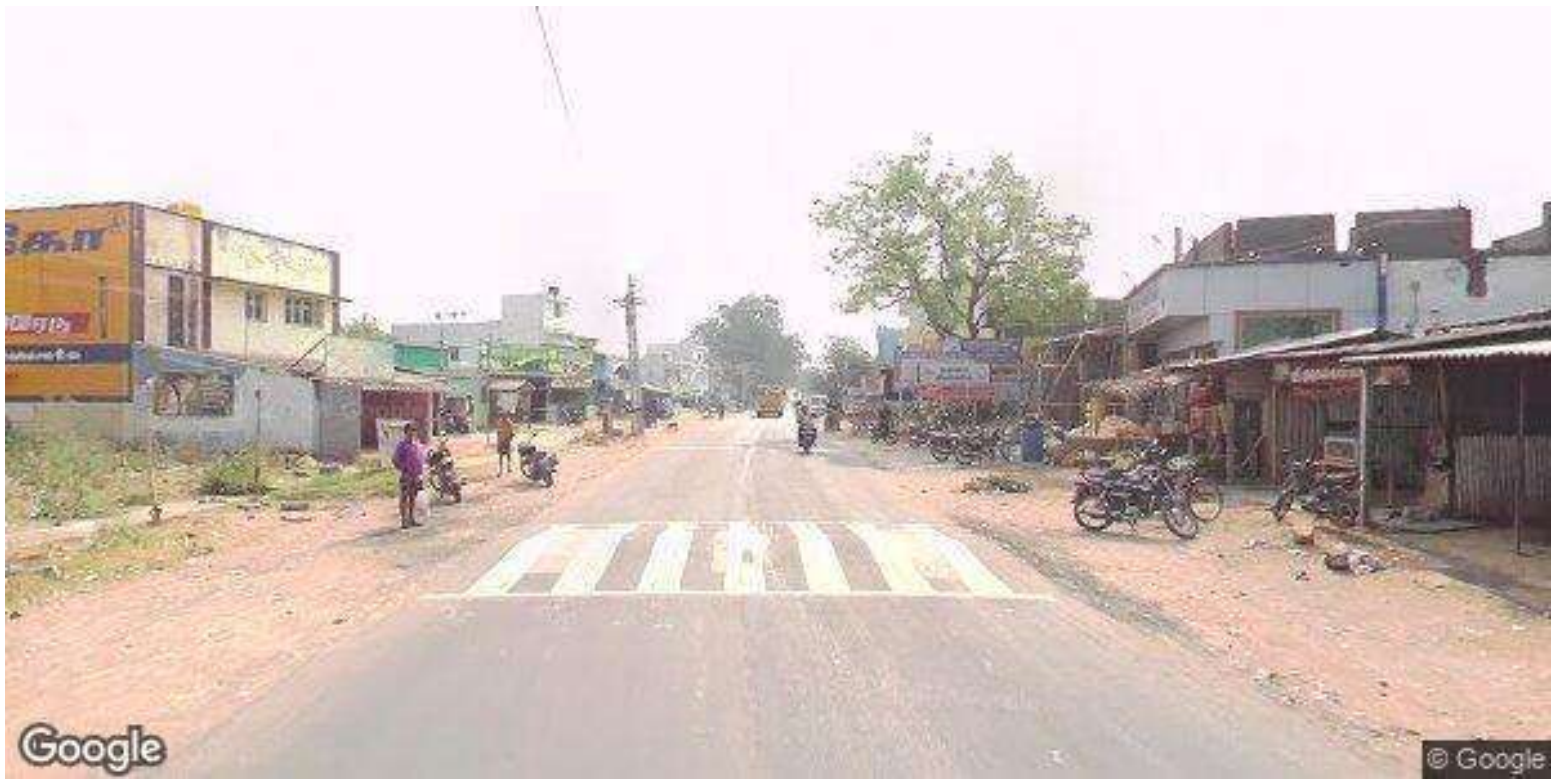
**Coordinates:** 11.87255, 78.08723

**Risk Type:** Turn

**Risk Level:** Medium

**Speed Limit:** 30 KM/Hr
