# IndianOil

## JOURNEY RISK MANAGEMENT (JRM) STUDY

### Salem Terminal TO SATHYA AGENCIES

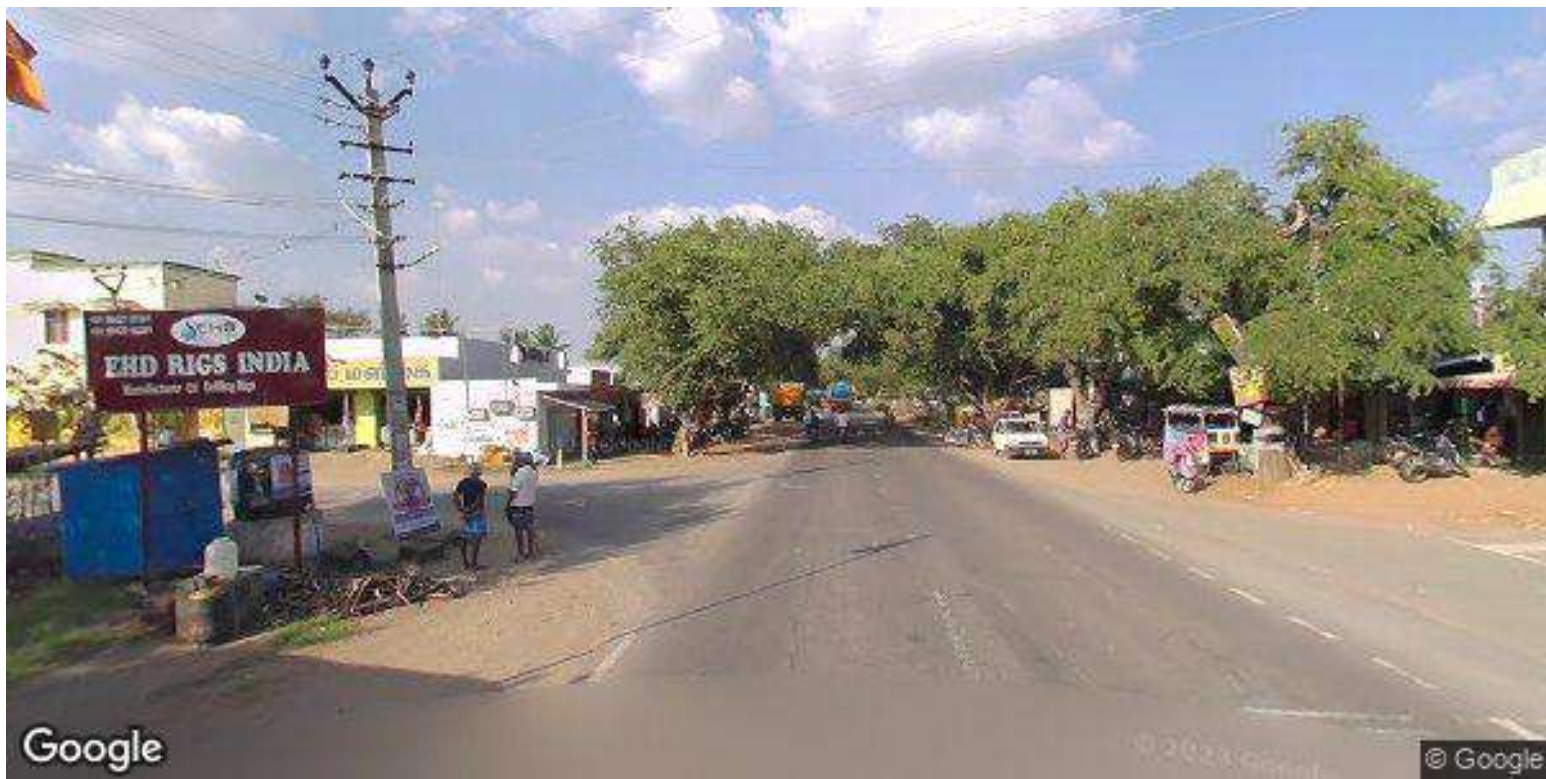
**Coordinates:** 11.41975, 77.88075

**Risk Type:** Turn

**Risk Level:** High

**Speed Limit:** 15 KM/Hr

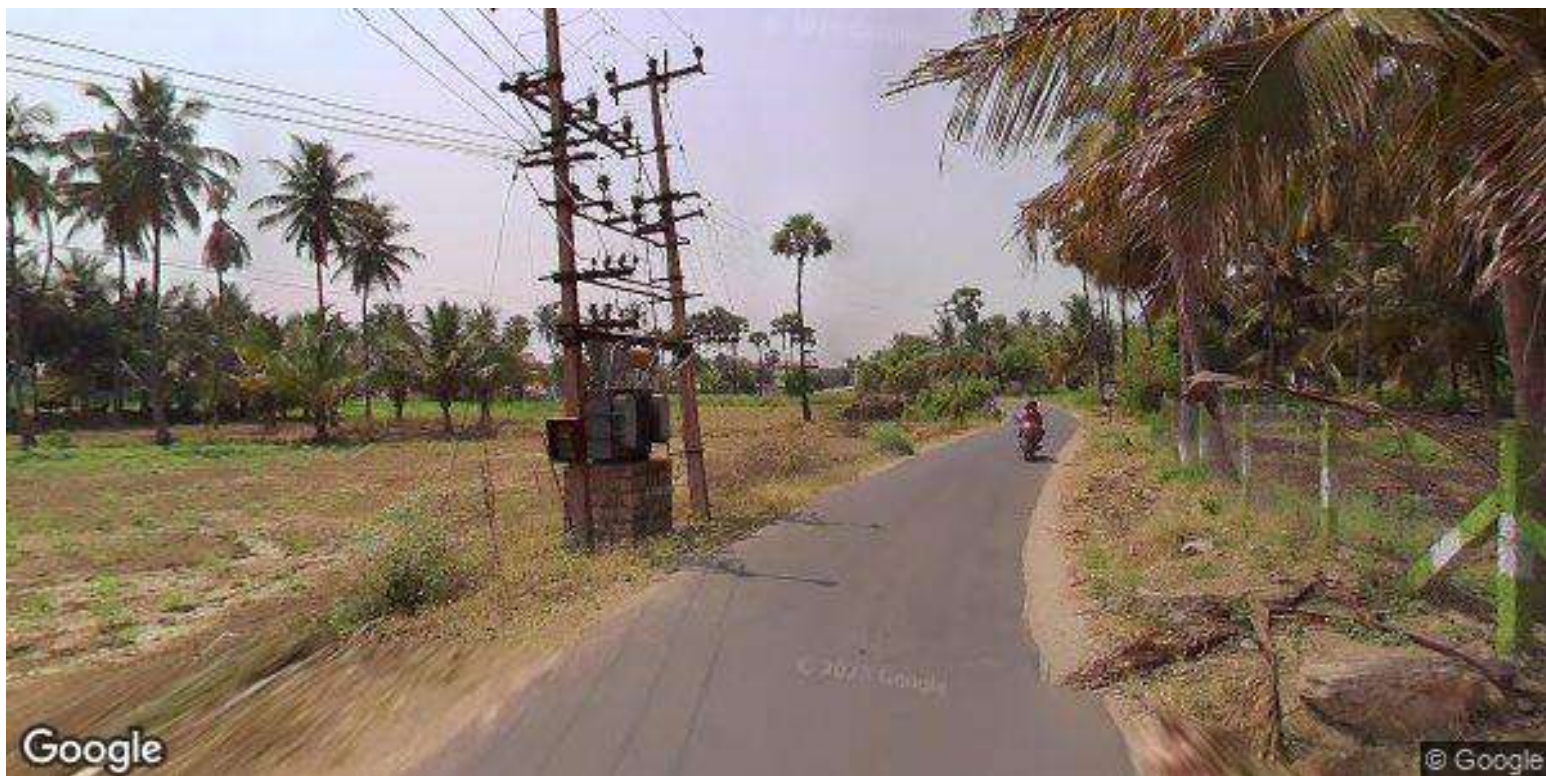
**Coordinates:** 11.41840, 77.88528

**Risk Type:** Turn

**Risk Level:** Medium

**Speed Limit:** 30 KM/Hr

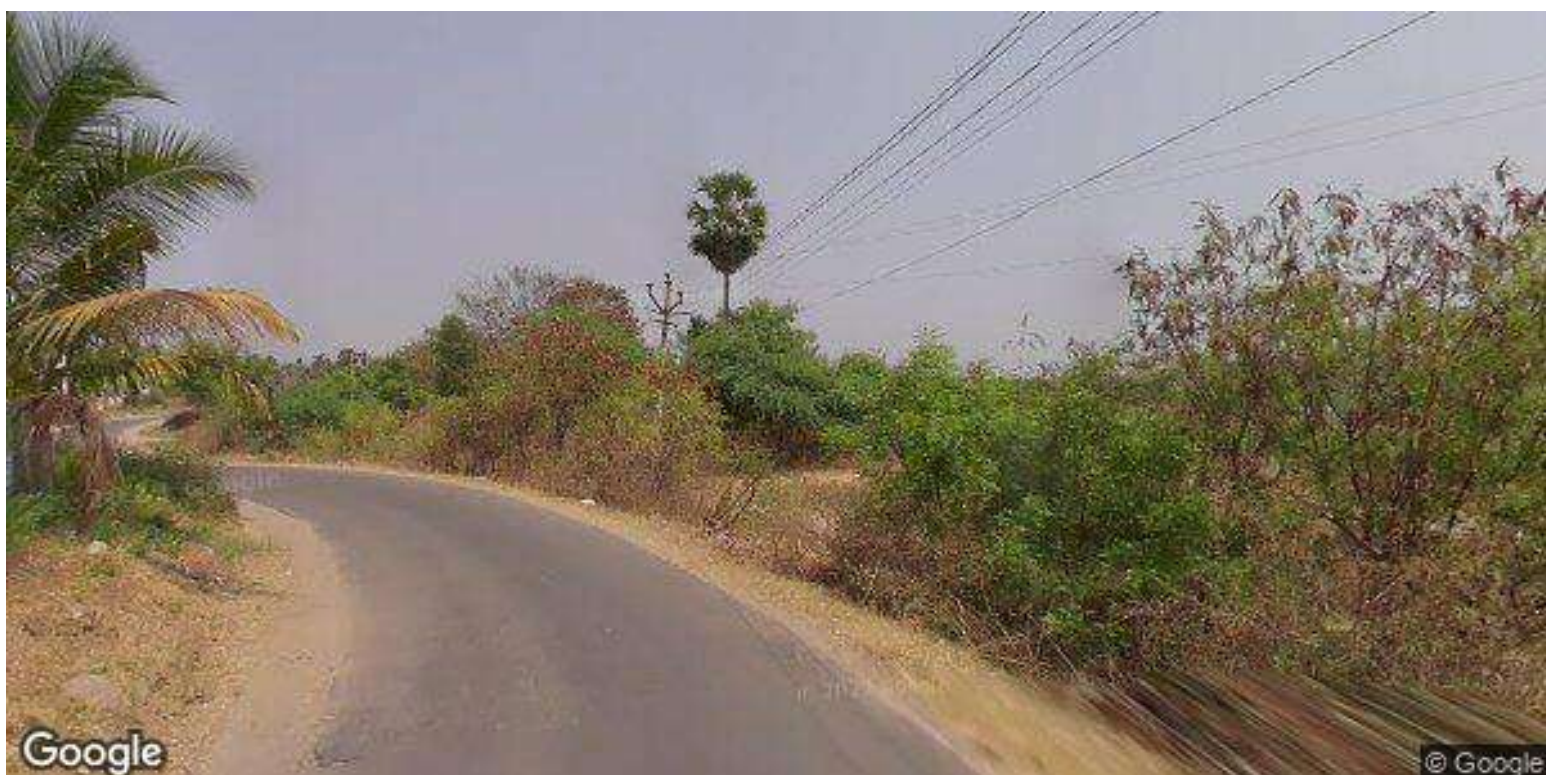
**Risk Type:** Turn  
**Risk Level:** Medium  
**Speed Limit:** 30 KM/Hr  
**Coordinates:** 11.41829, 77.88568

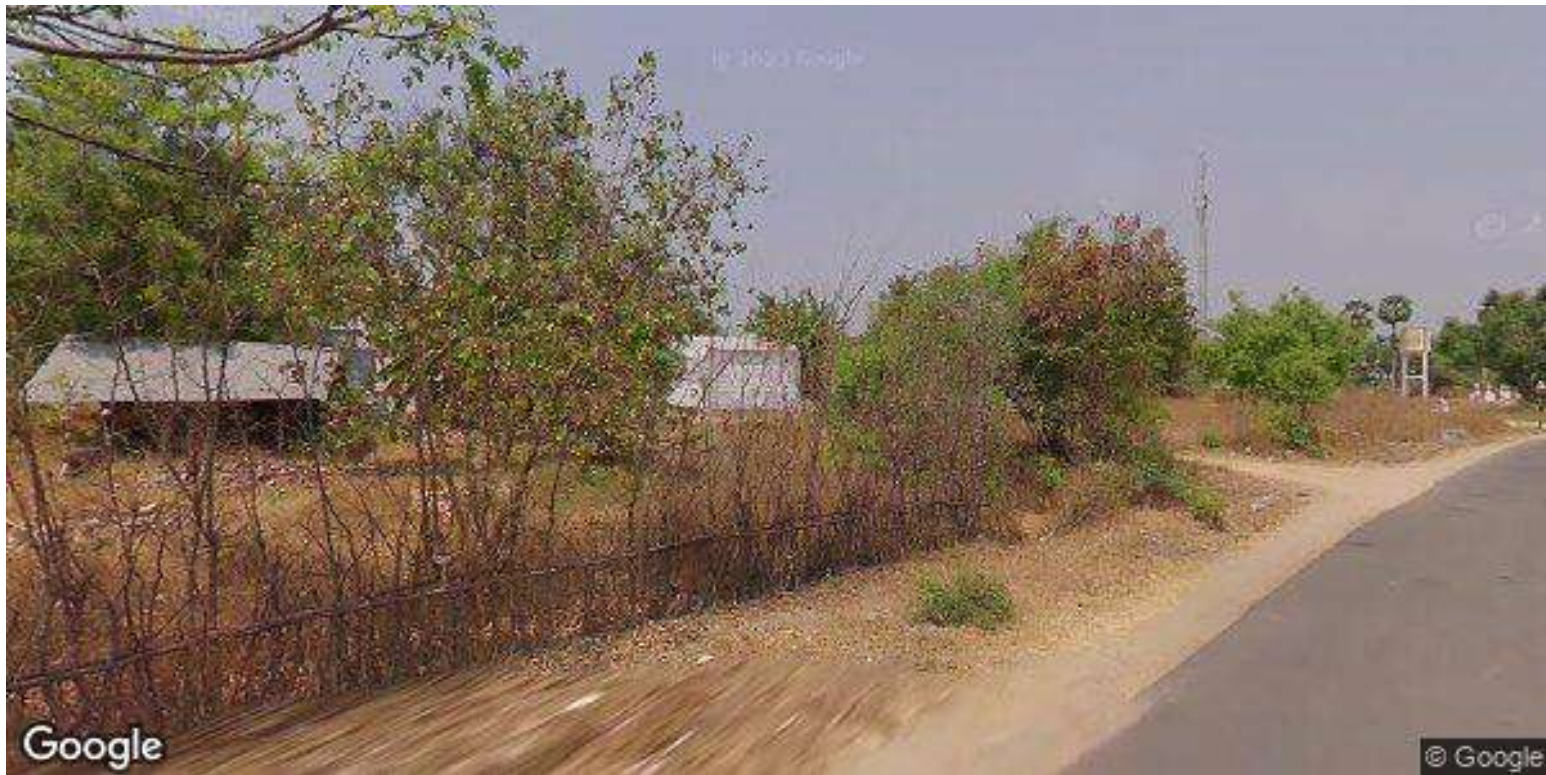
**Risk Type:** Turn  
**Risk Level:** Medium  
**Speed Limit:** 30 KM/Hr  
**Coordinates:** 11.41849, 77.88613

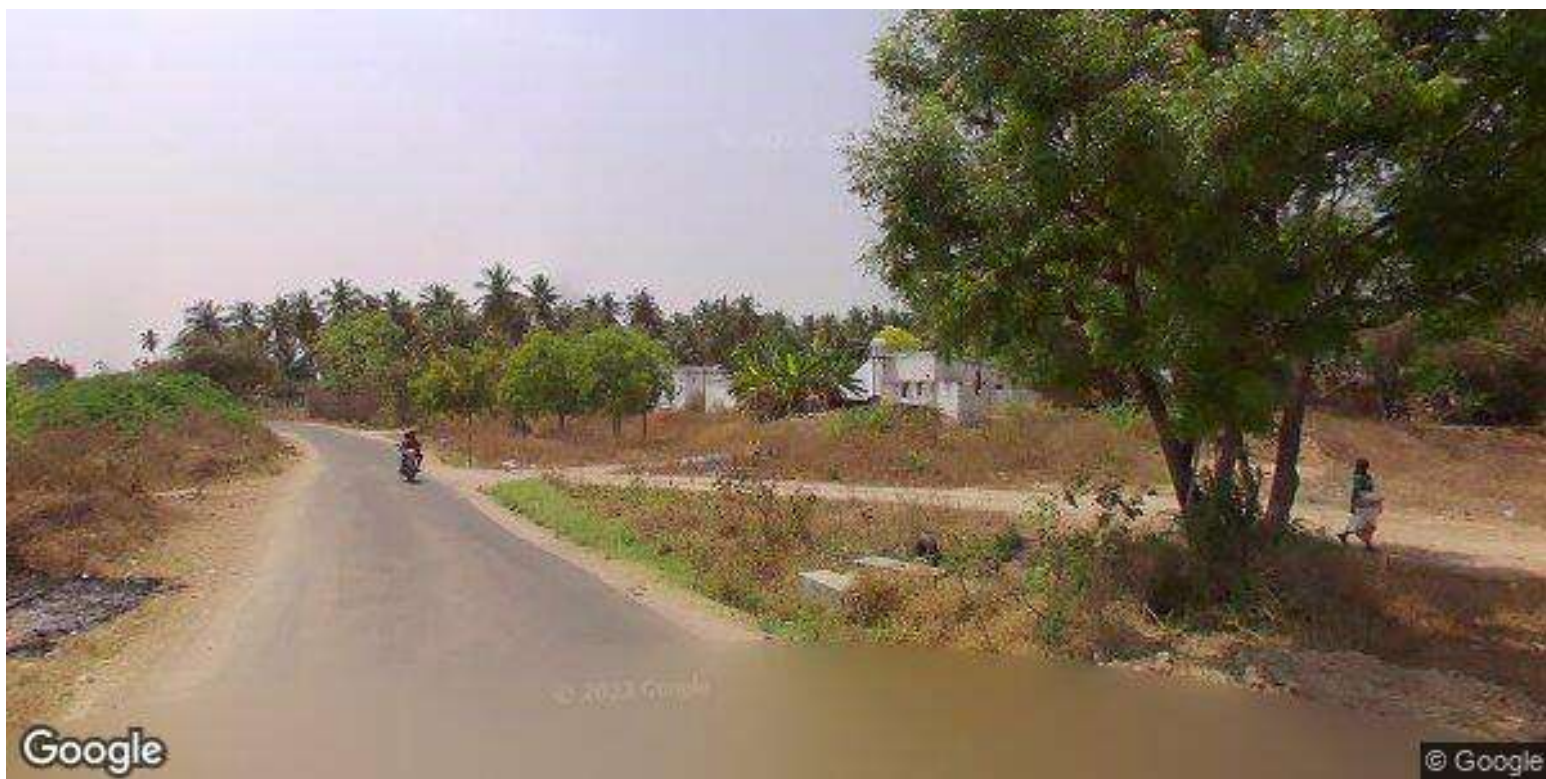
**Risk Type:** Turn  
**Risk Level:** Medium  
**Speed Limit:** 30 KM/Hr  
**Coordinates:** 11.41861, 77.88687

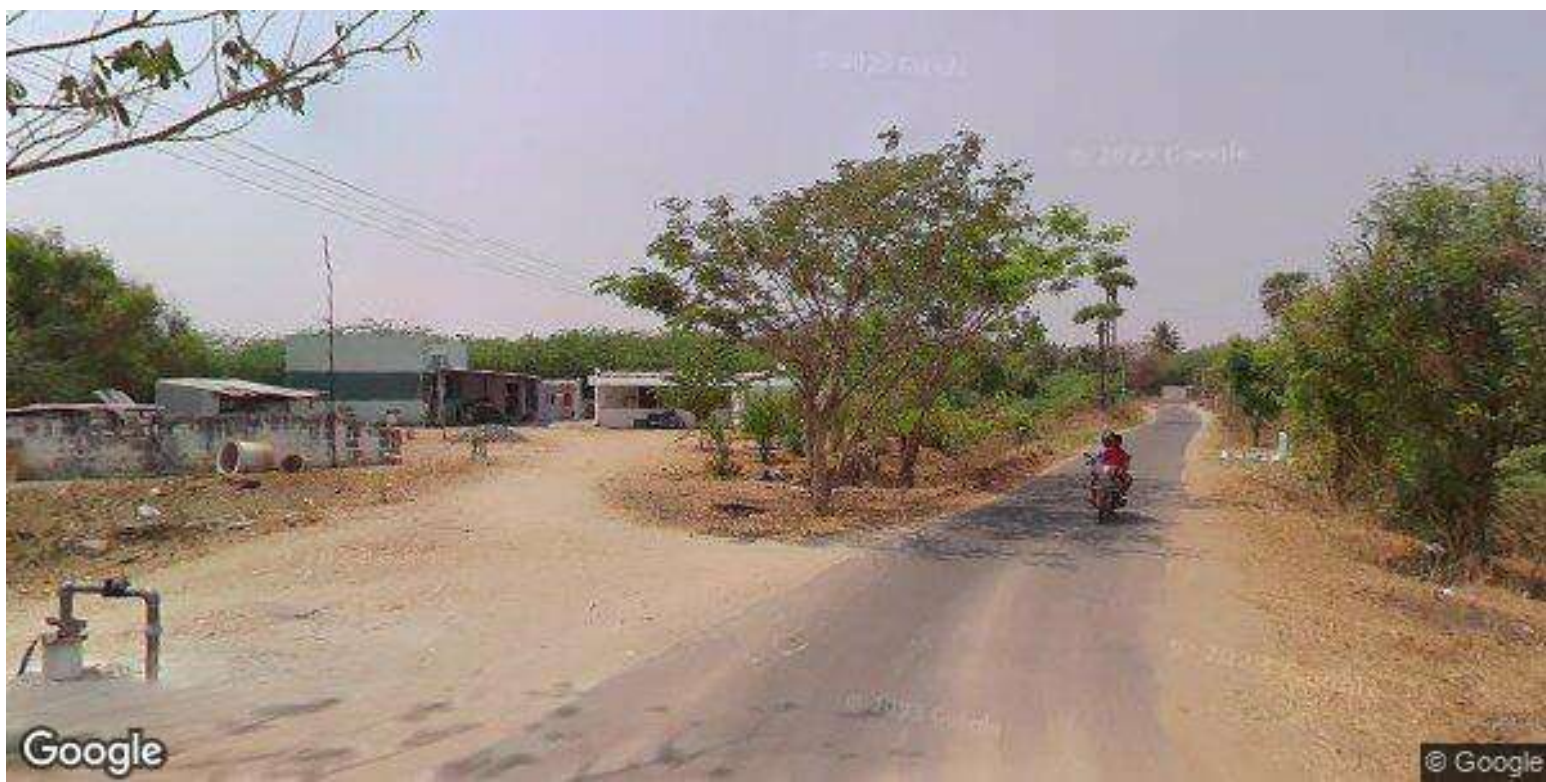
**Coordinates:** 11.41768, 77.88731

**Risk Type:** Turn

**Risk Level:** Medium

**Speed Limit:** 30 KM/Hr

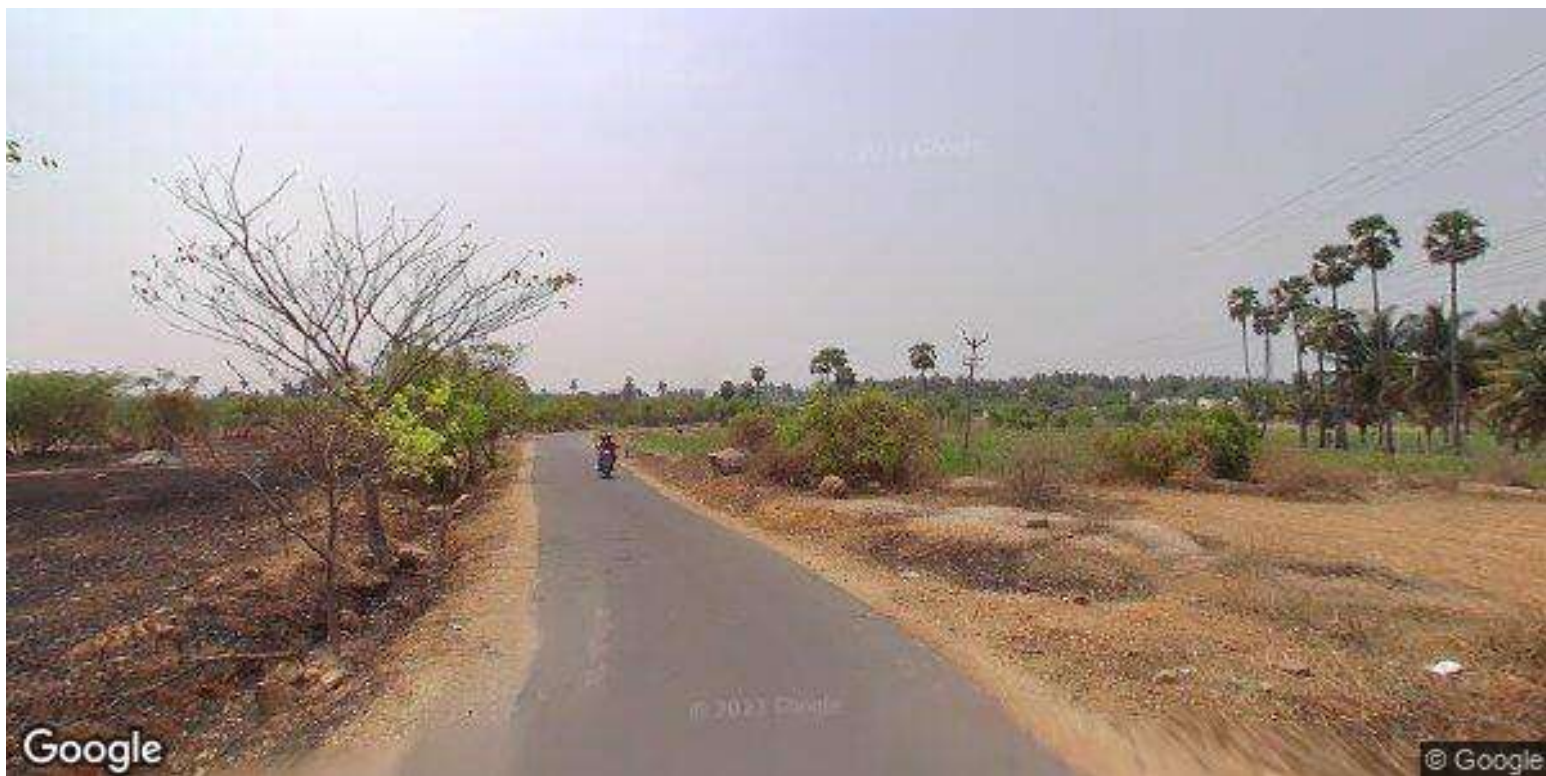
**Coordinates:** 11.41721, 77.88924

**Risk Type:** Turn

**Risk Level:** Medium

**Speed Limit:** 30 KM/Hr

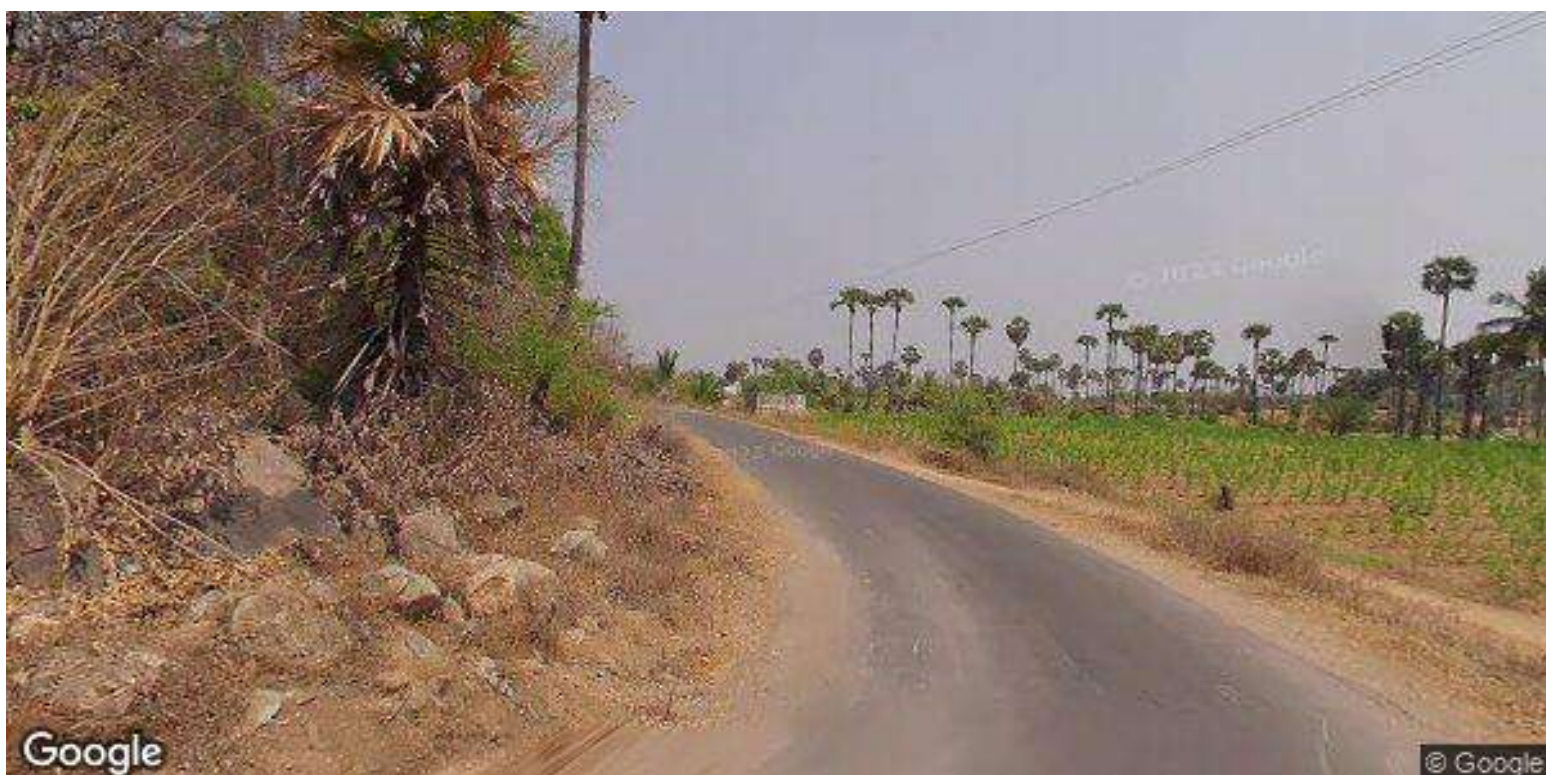
**Risk Type:** Turn  
**Risk Level:** Medium  
**Speed Limit:** 30 KM/Hr  
**Coordinates:** 11.41378, 77.90072

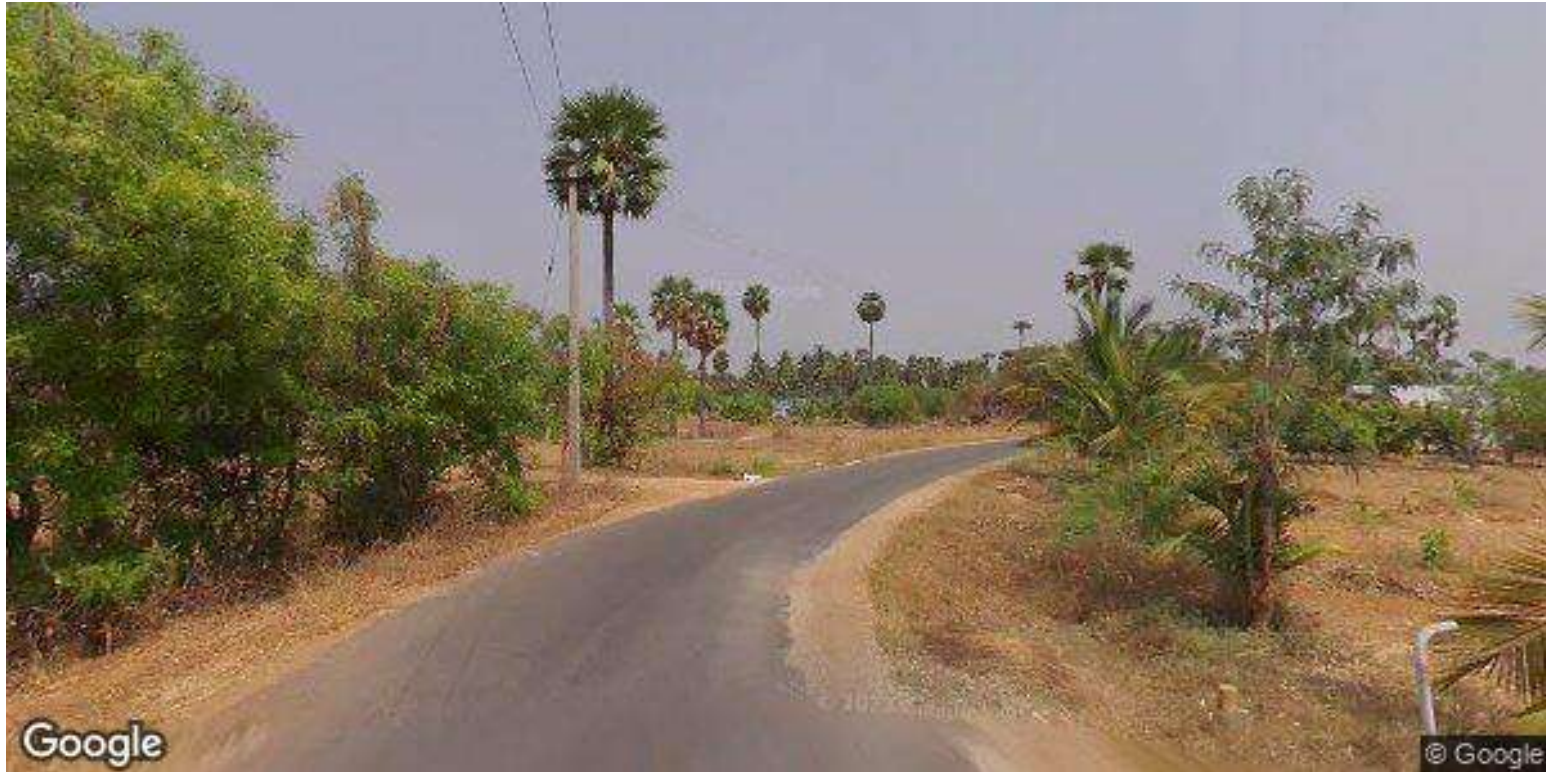
**Risk Type:** Turn  
**Risk Level:** Medium  
**Speed Limit:** 30 KM/Hr  
**Coordinates:** 11.41389, 77.90165

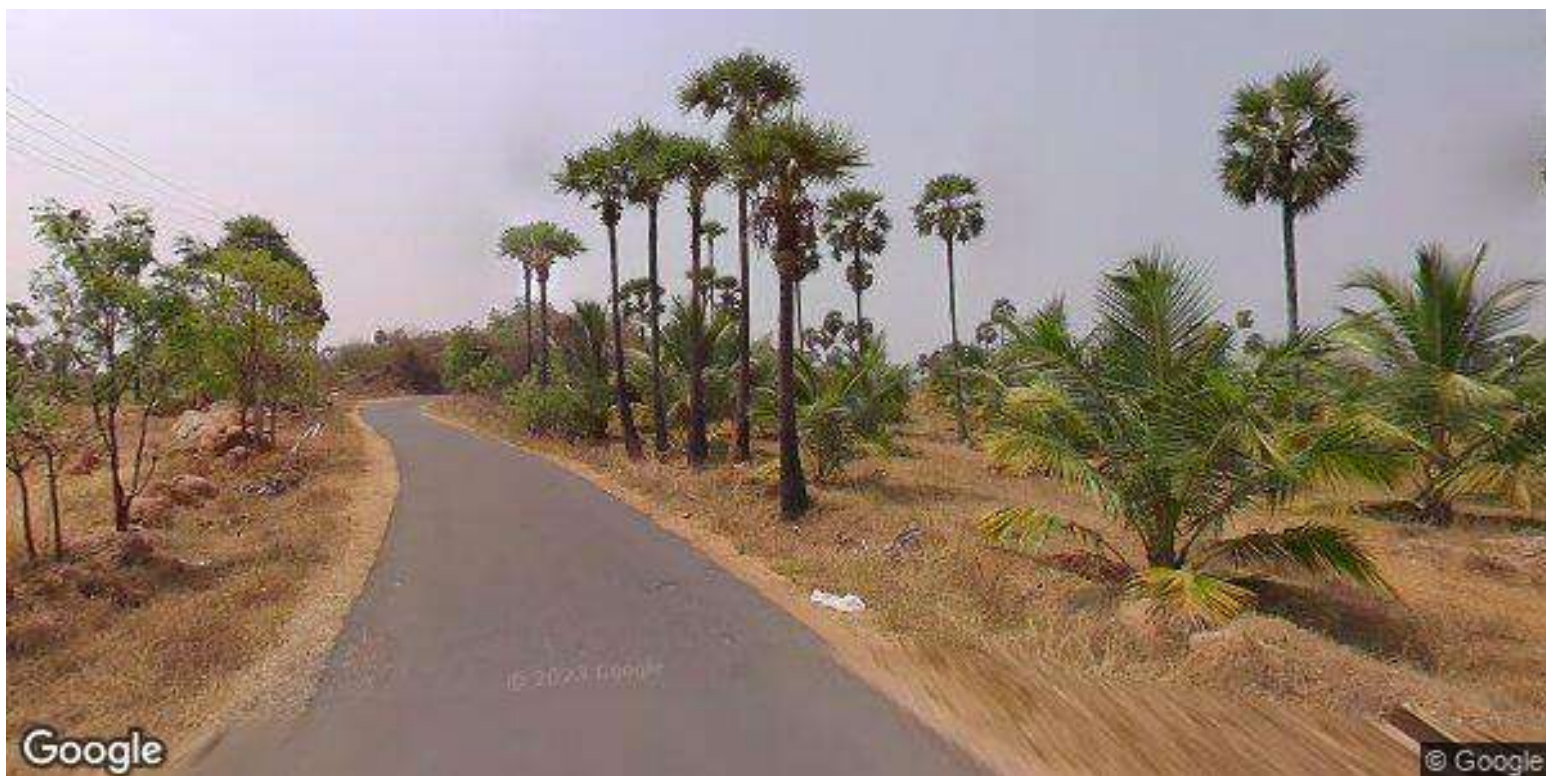
**Risk Type:** Turn  
**Risk Level:** Medium  
**Speed Limit:** 30 KM/Hr  
**Coordinates:** 11.41330, 77.90306

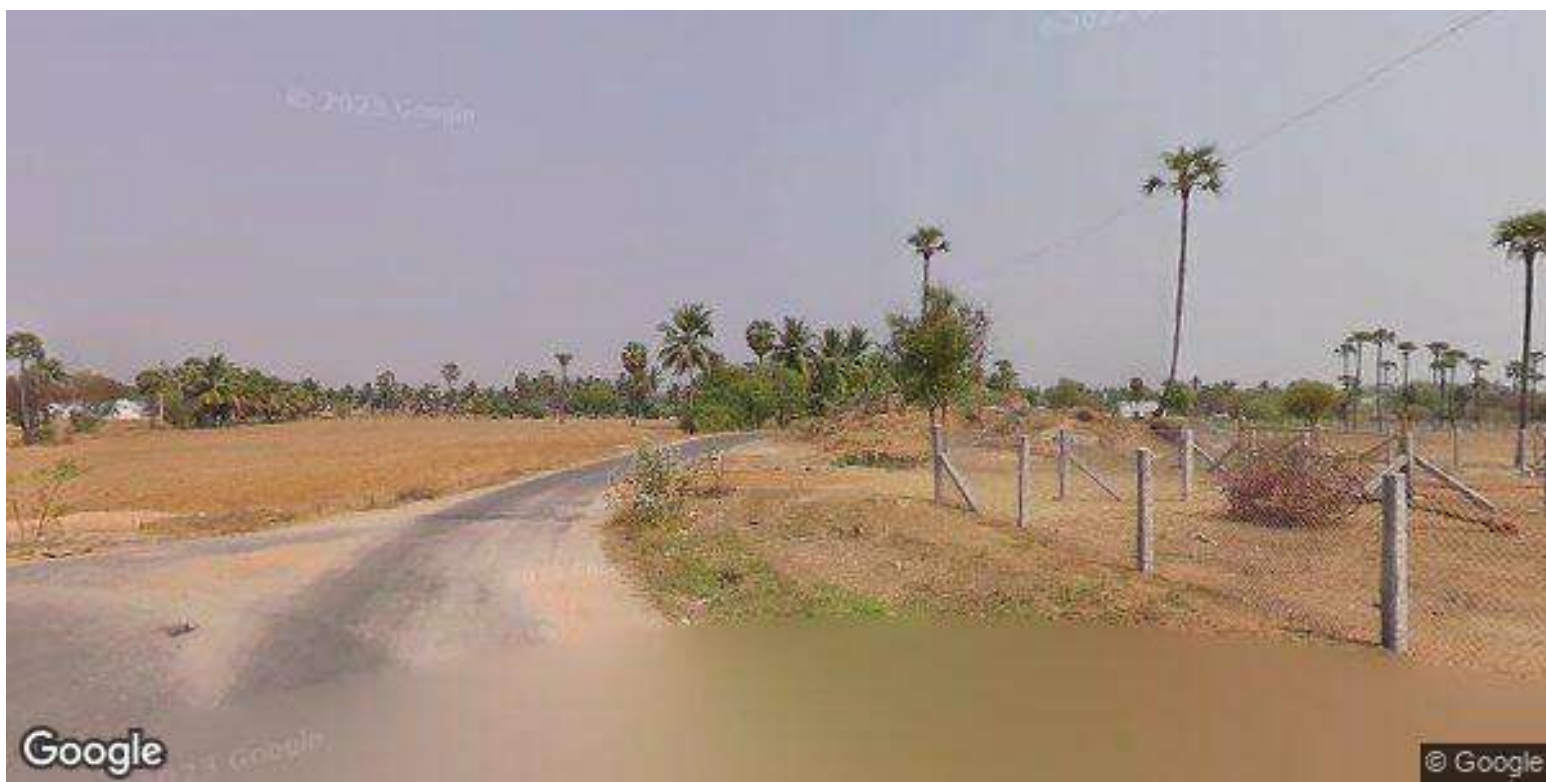
**Coordinates:** 11.41231, 77.90487

**Risk Type:** Turn

**Risk Level:** Medium

**Speed Limit:** 30 KM/Hr

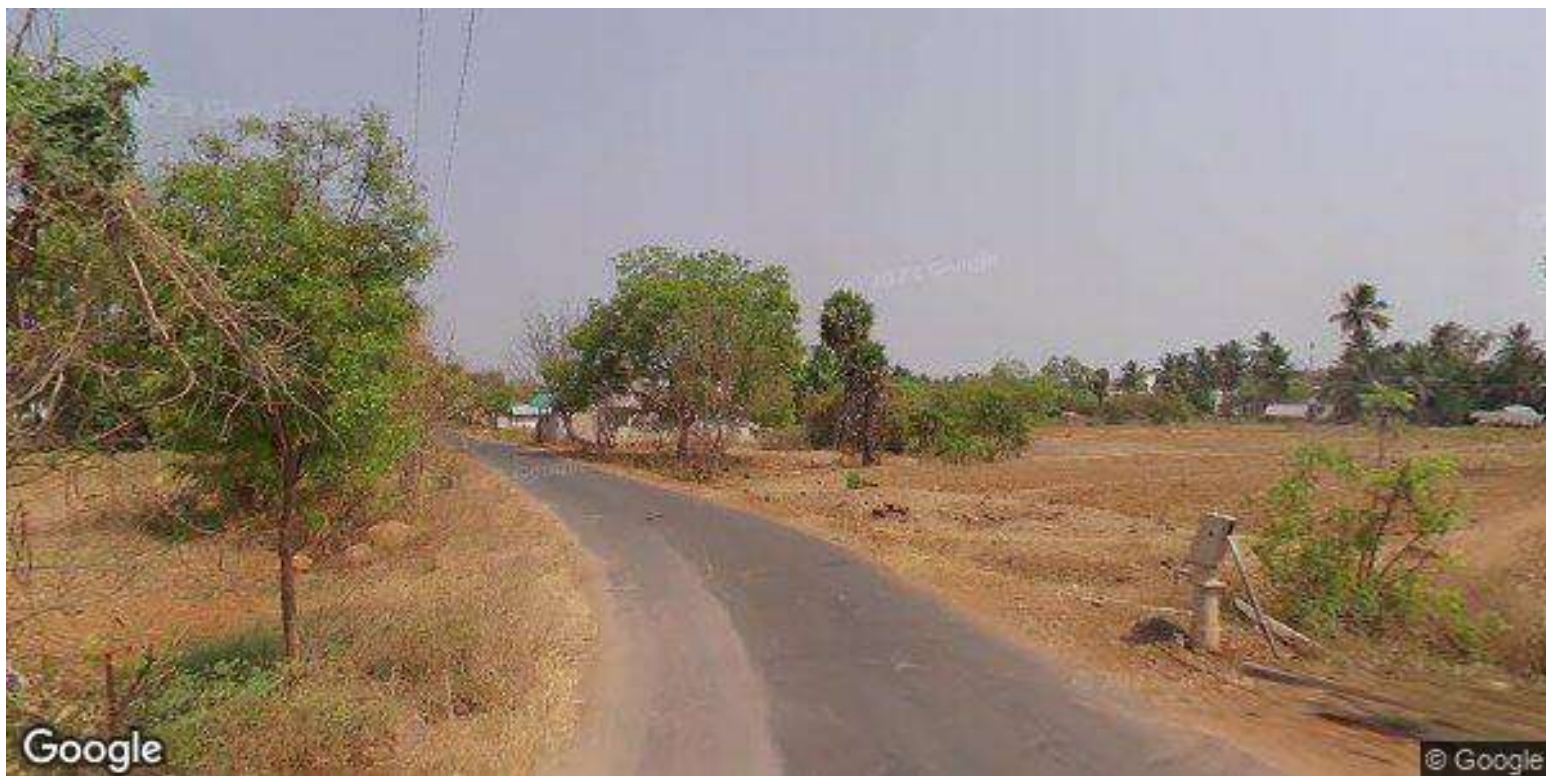
**Coordinates:** 11.41110, 77.90632

**Risk Type:** Turn

**Risk Level:** Medium

**Speed Limit:** 30 KM/Hr

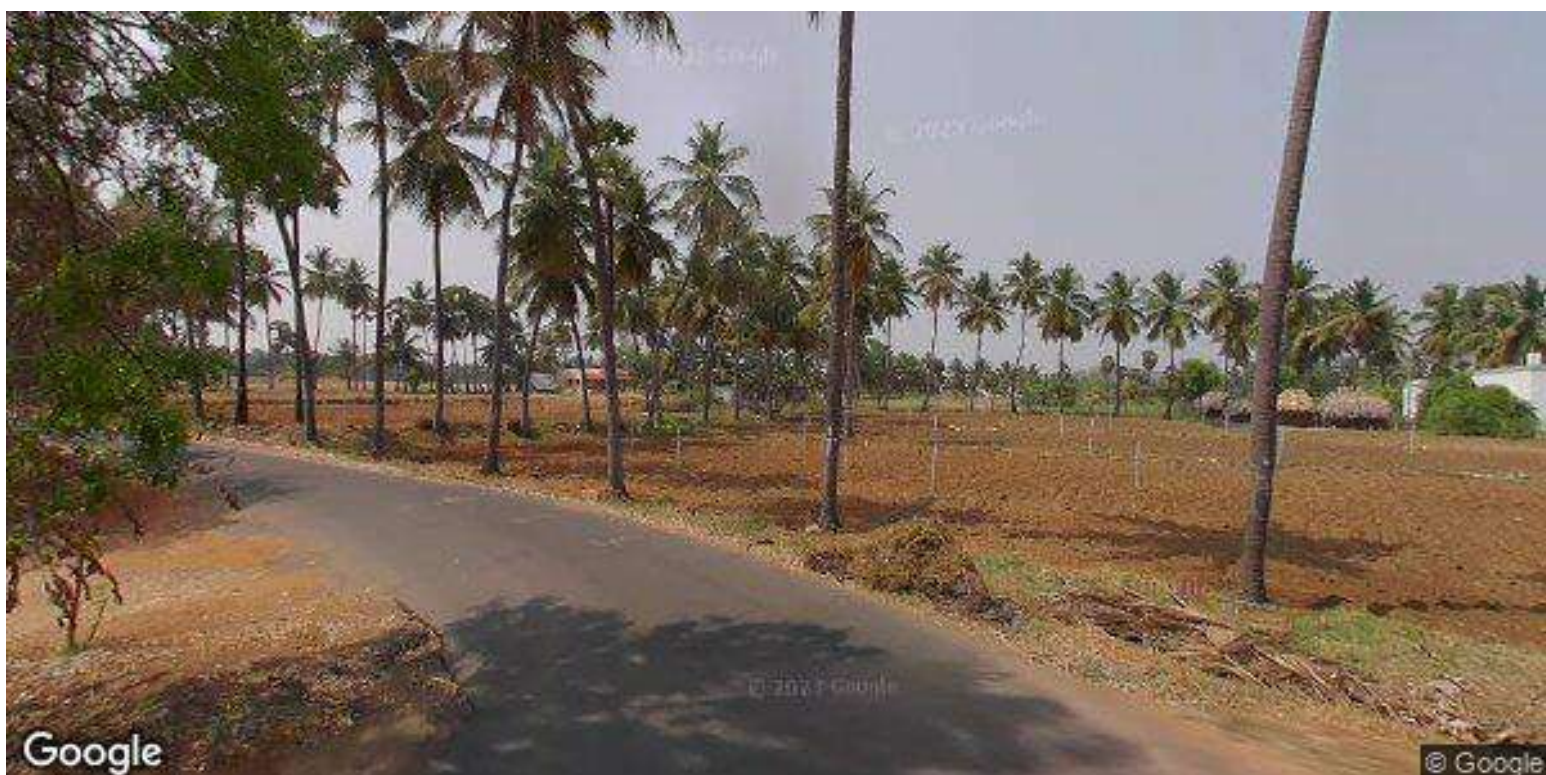
**Risk Type:** Turn  
**Risk Level:** High  
**Speed Limit:** 15 KM/Hr  
**Coordinates:** 11.41087, 77.90784

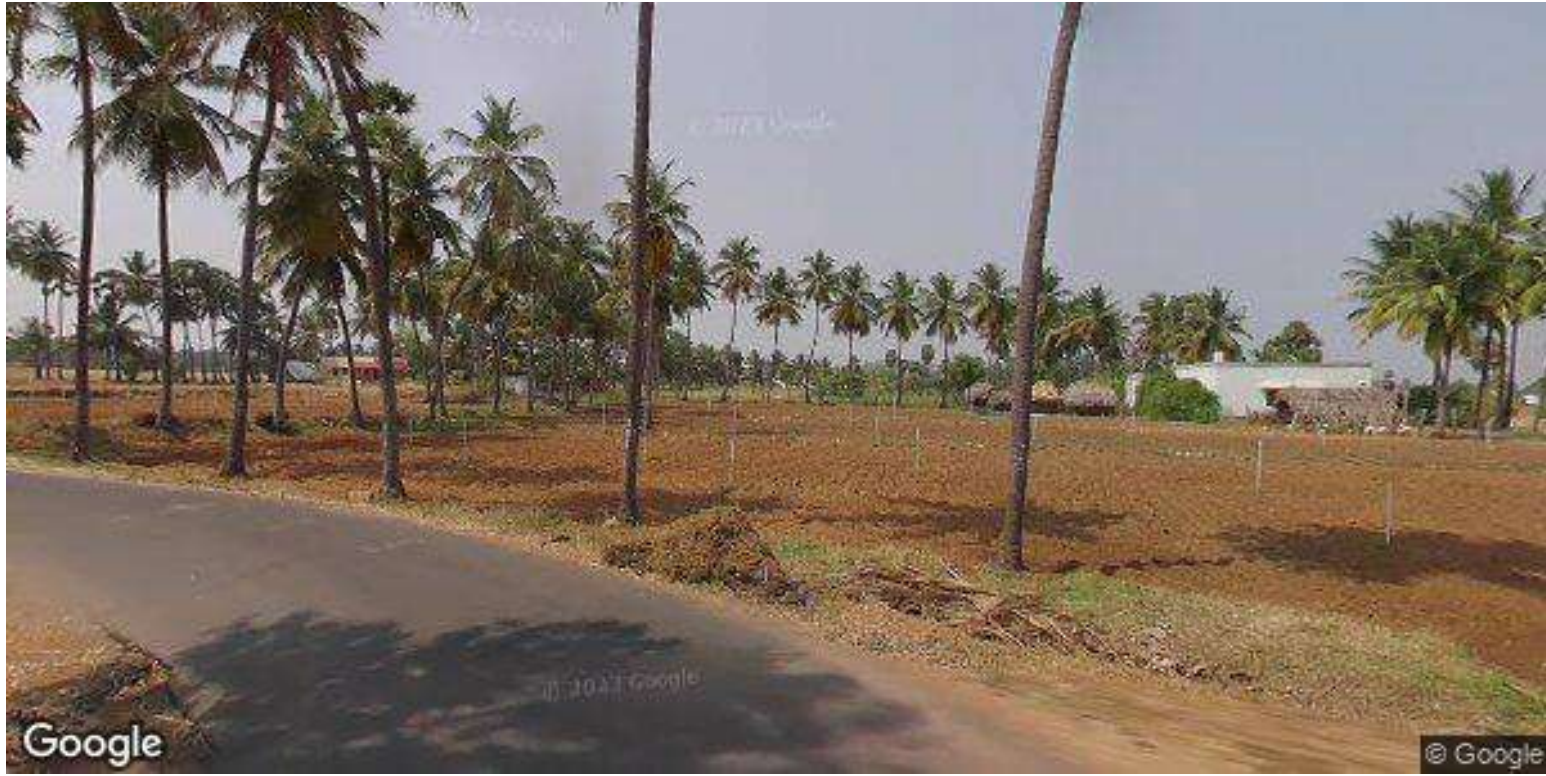
**Risk Type:** Turn  
**Risk Level:** Medium  
**Speed Limit:** 30 KM/Hr  
**Coordinates:** 11.41083, 77.90786

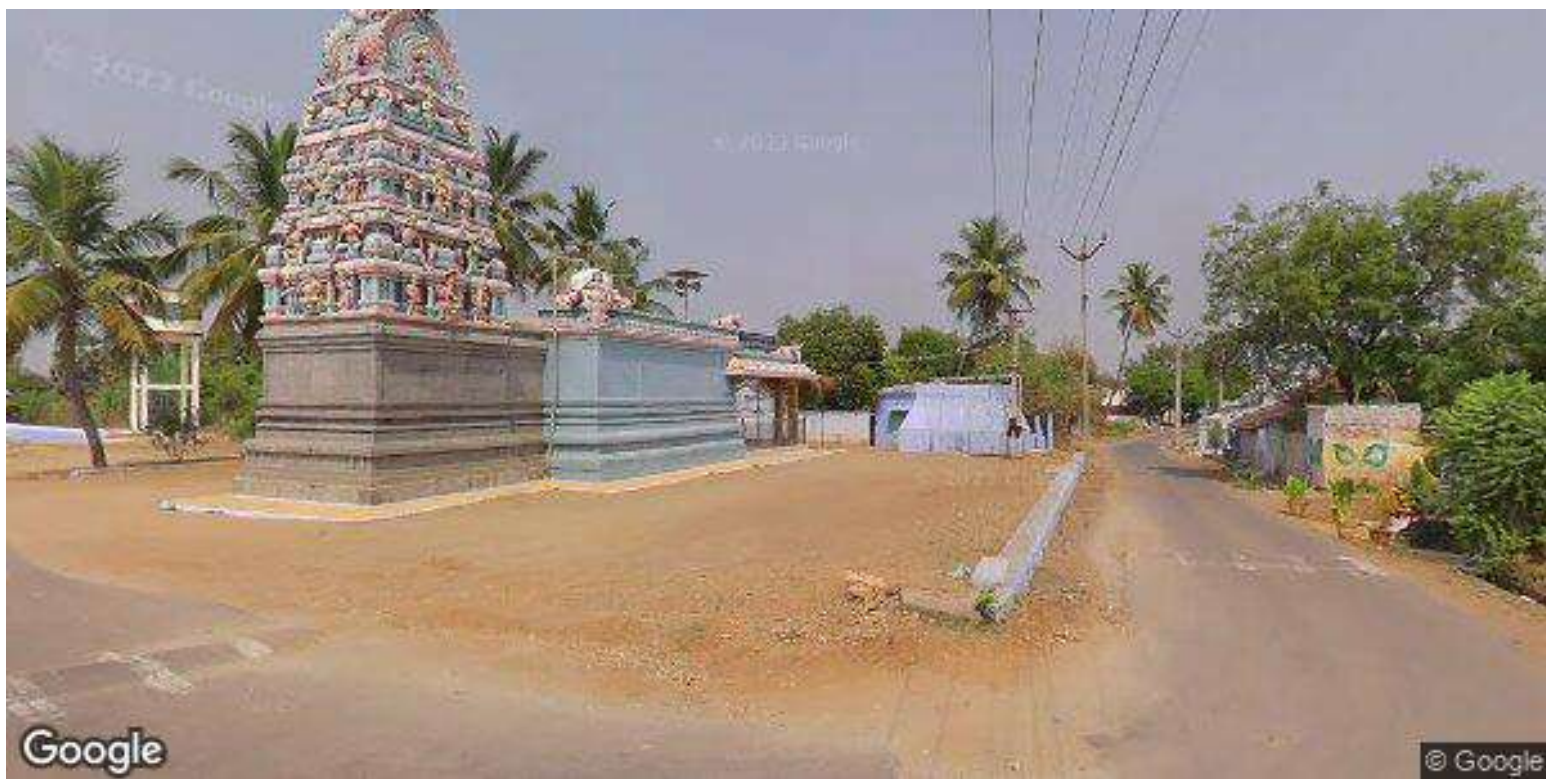
**Risk Type:** Blind Spot  
**Risk Level:** Blind Spot  
**Speed Limit:** 10 KM/Hr  
**Coordinates:** 11.40927, 77.90787

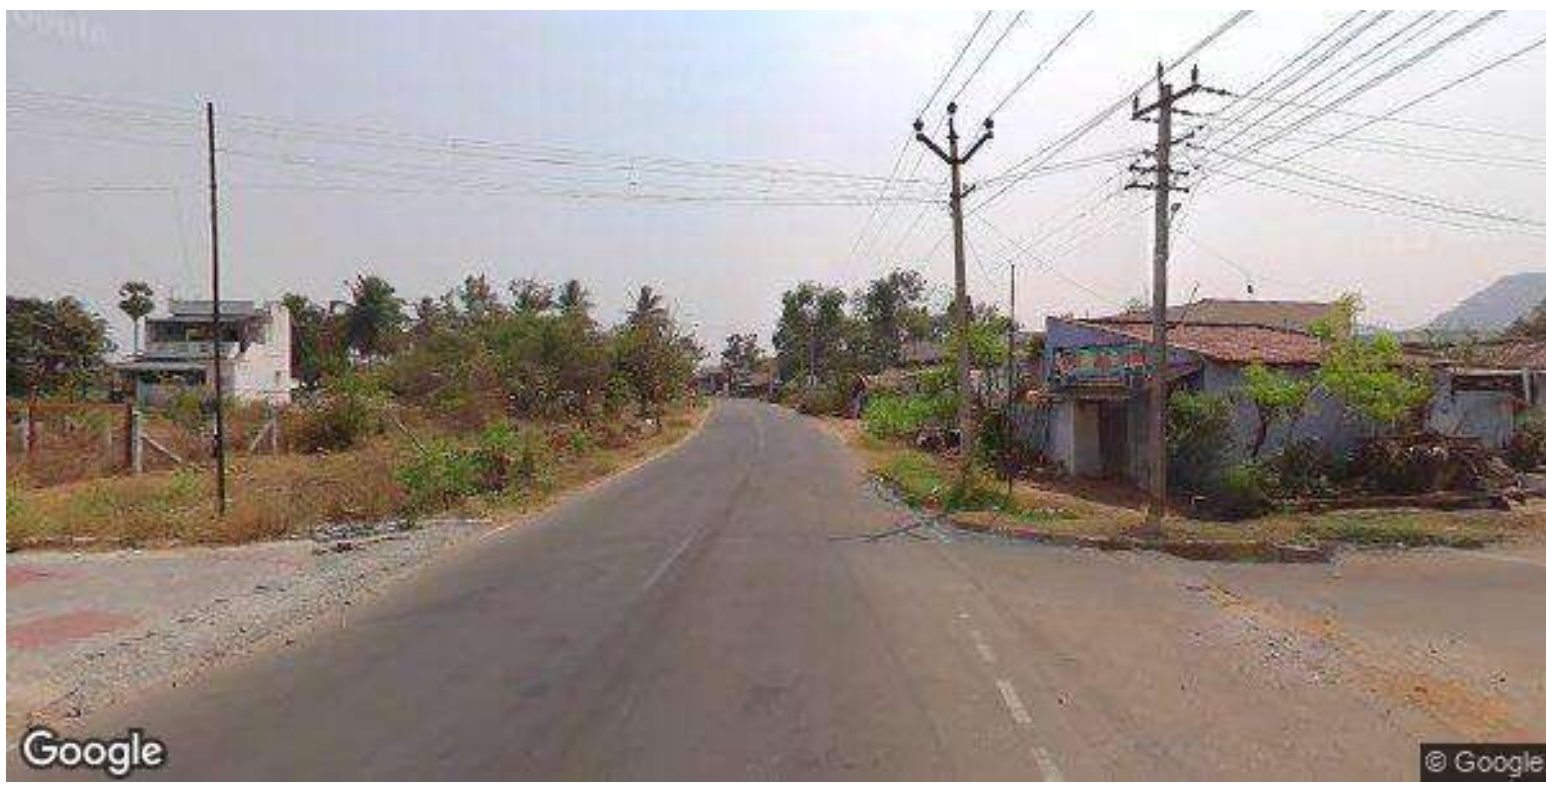
**Coordinates:** 11.40911, 77.90939

**Risk Type:** Blind Spot

**Risk Level:** Blind Spot

**Speed Limit:** 10 KM/Hr

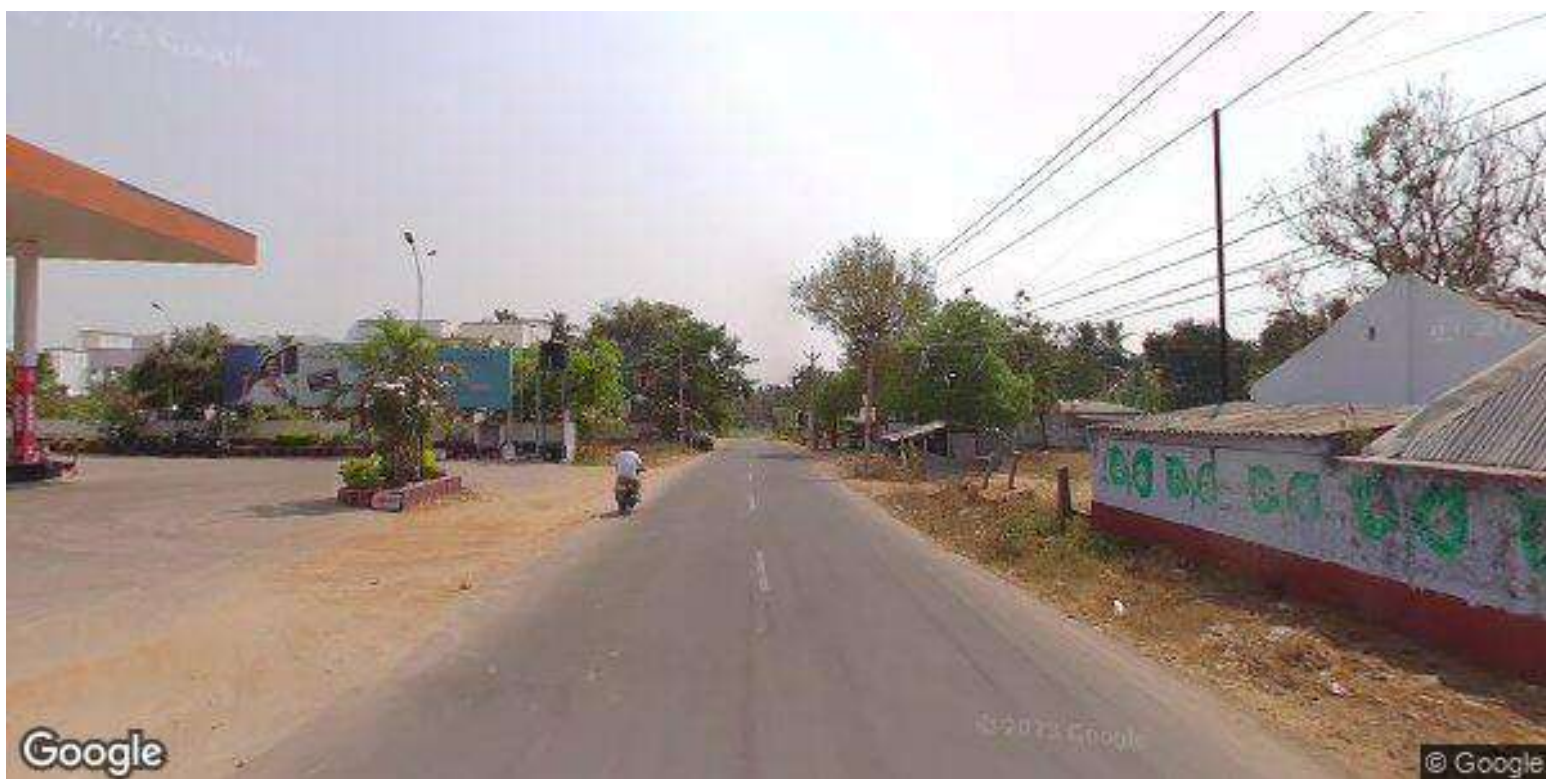
**Coordinates:** 11.40243, 77.90667

**Risk Type:** Blind Spot

**Risk Level:** Blind Spot

**Speed Limit:** 10 KM/Hr
