## JOURNEY RISK MANAGEMENT (JRM) STUDY

### Salem Terminal TO ERODE PRECISION FARM PRODUCER

Route Analysis Report from CVQF+23W, Sangagiri to 4RG3+9C6, SH 84C, Tamil Nadu

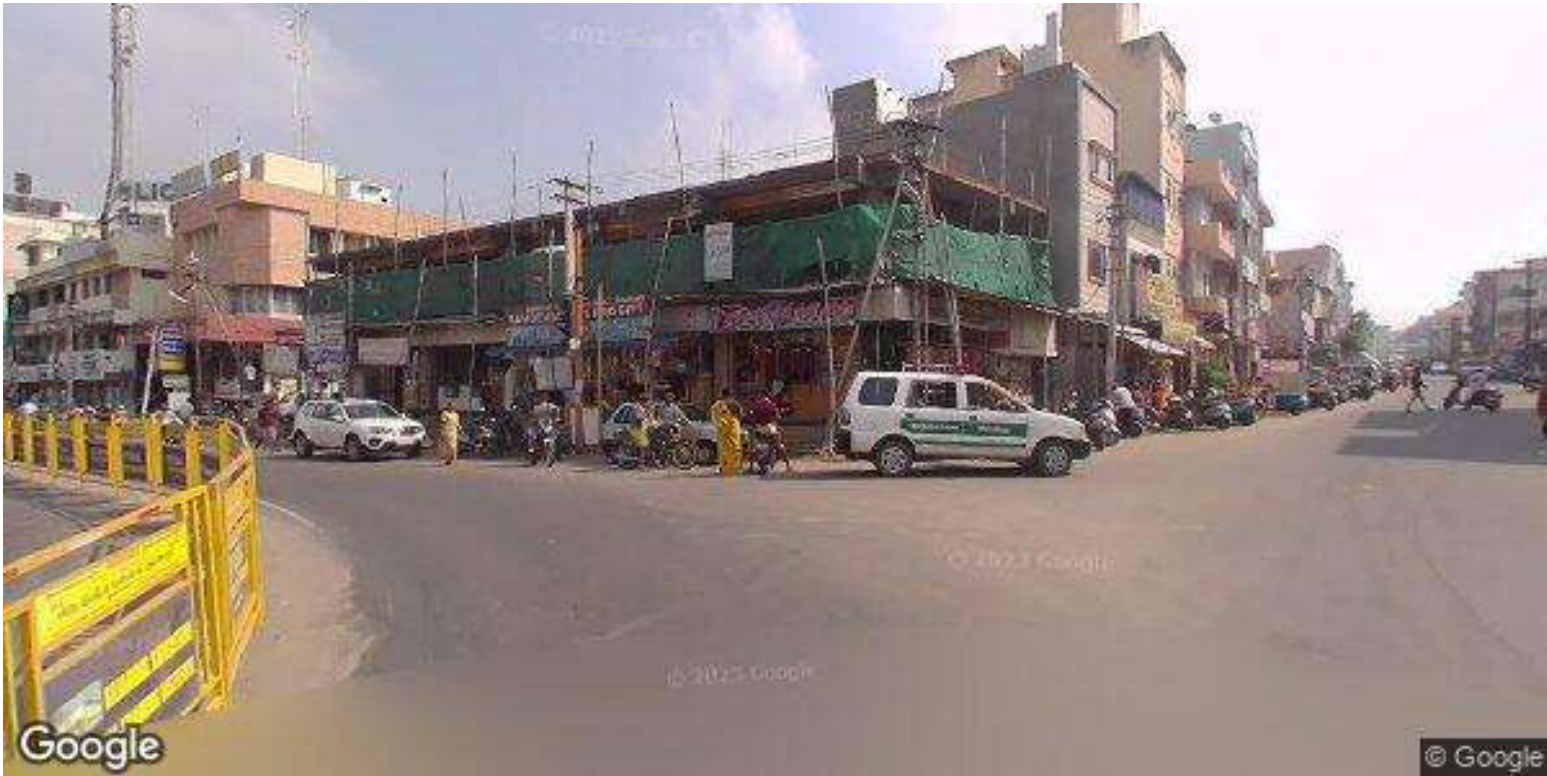
**Risk Type:** Turn  
**Risk Level:** High  
**Speed Limit:** 15 KM/Hr  
**Coordinates:** 11.37868, 77.89498

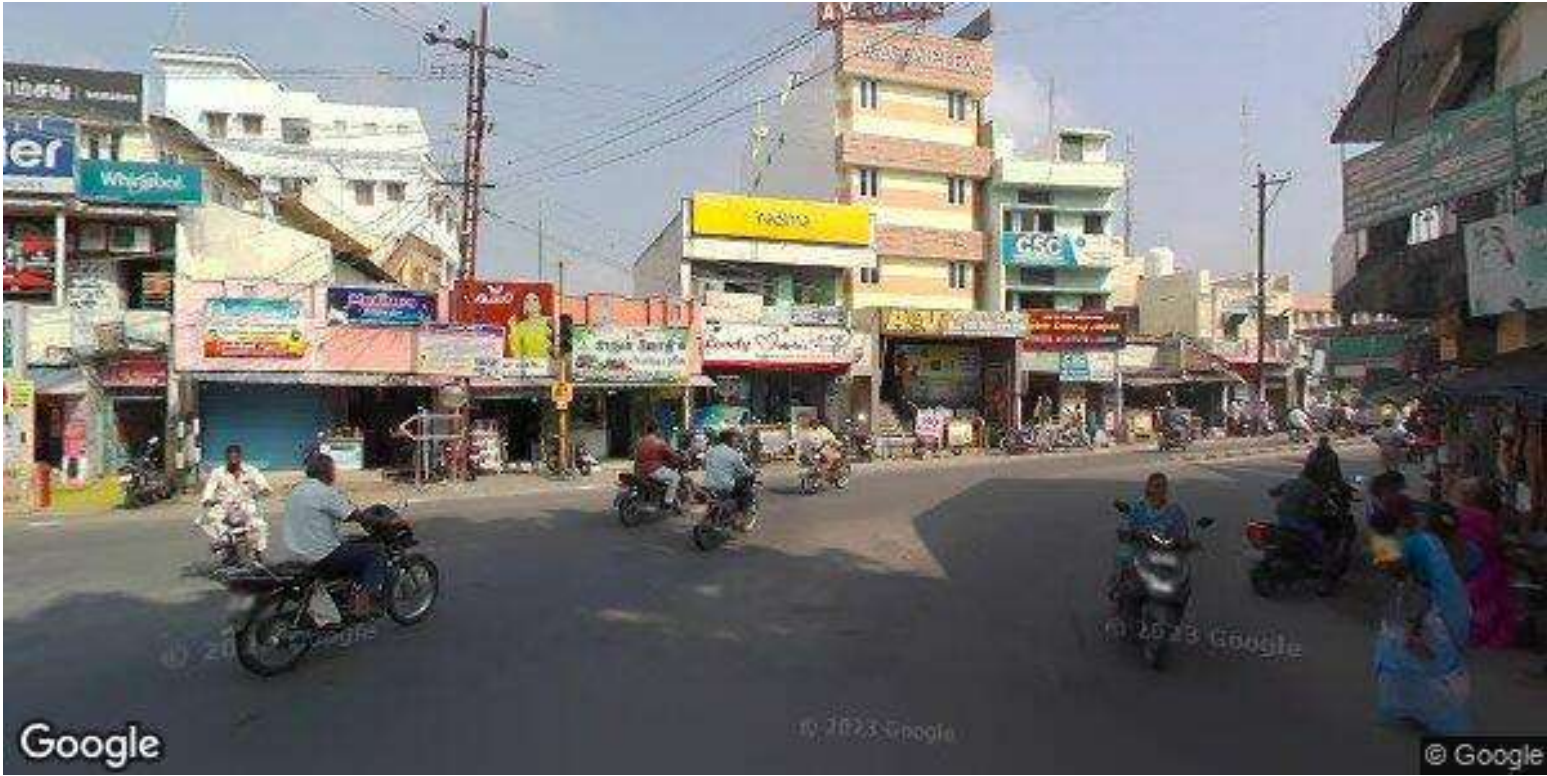
**Risk Type:** Turn  
**Risk Level:** Medium  
**Speed Limit:** 30 KM/Hr  
**Coordinates:** 11.37842, 77.89452

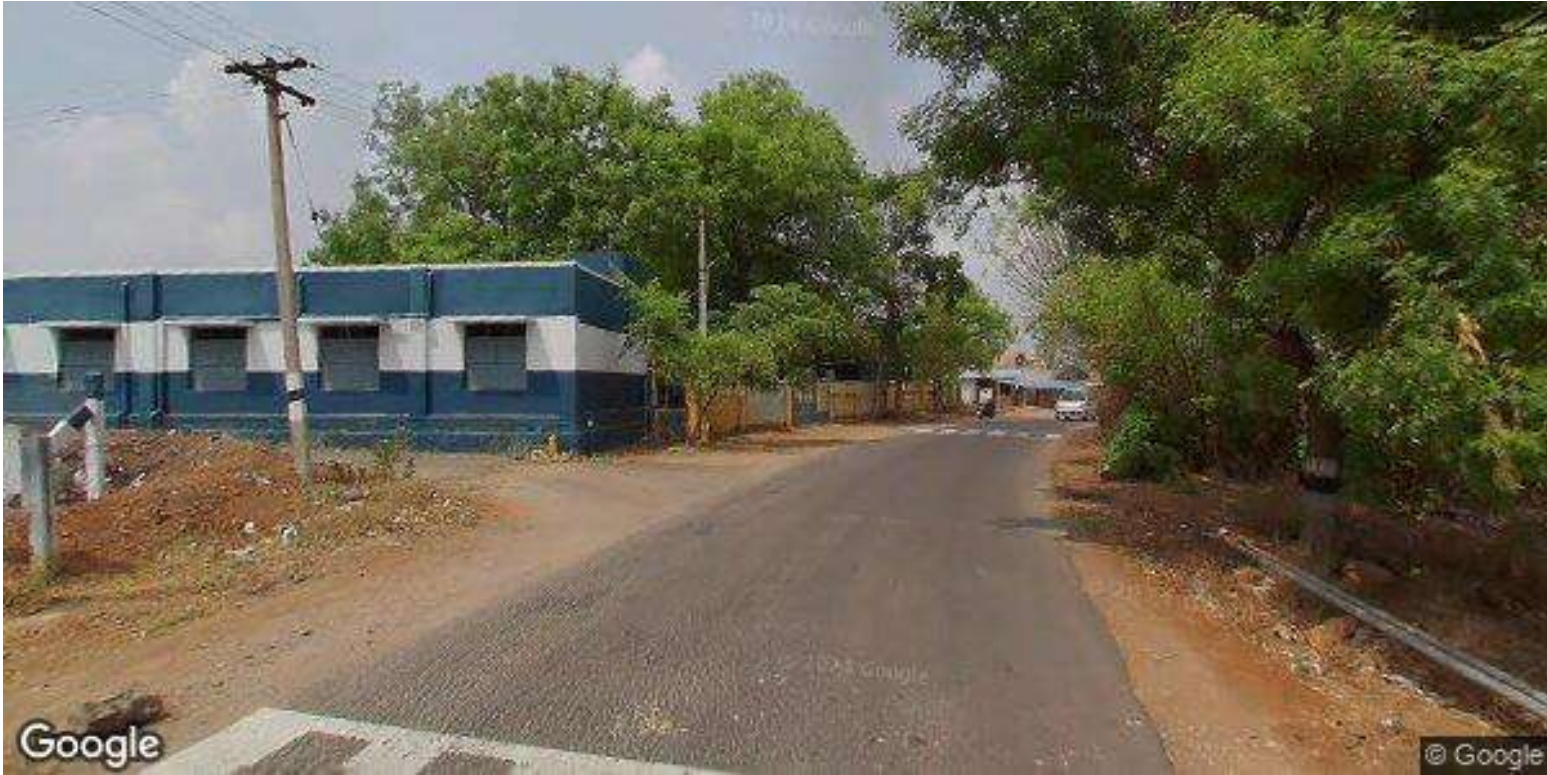
**Risk Type:** Turn  
**Risk Level:** High  
**Speed Limit:** 15 KM/Hr  
**Coordinates:** 11.33268, 77.88827

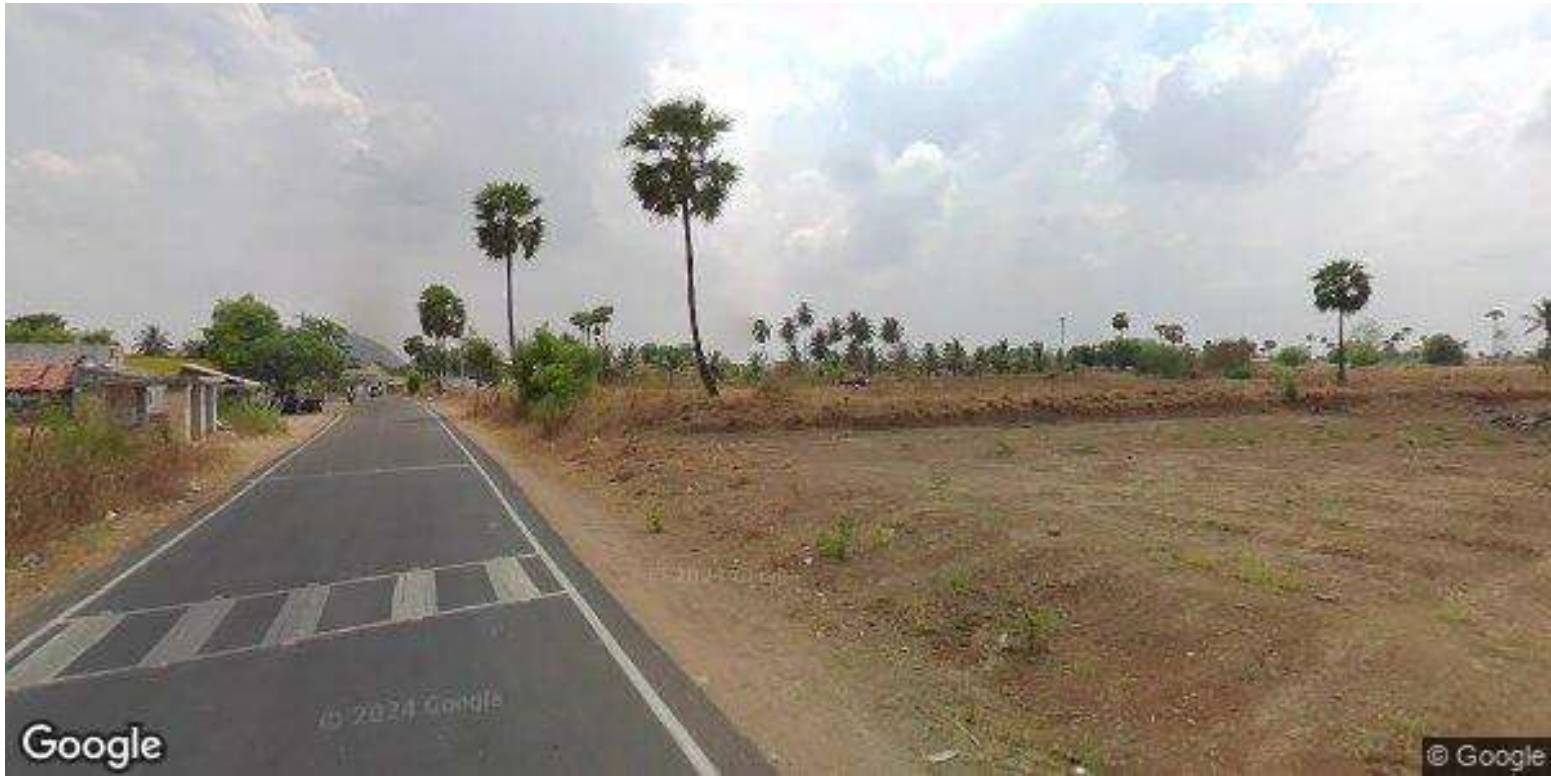
**Risk Type:** Turn  
**Risk Level:** Medium  
**Speed Limit:** 30 KM/Hr  
**Coordinates:** 11.33071, 77.88660

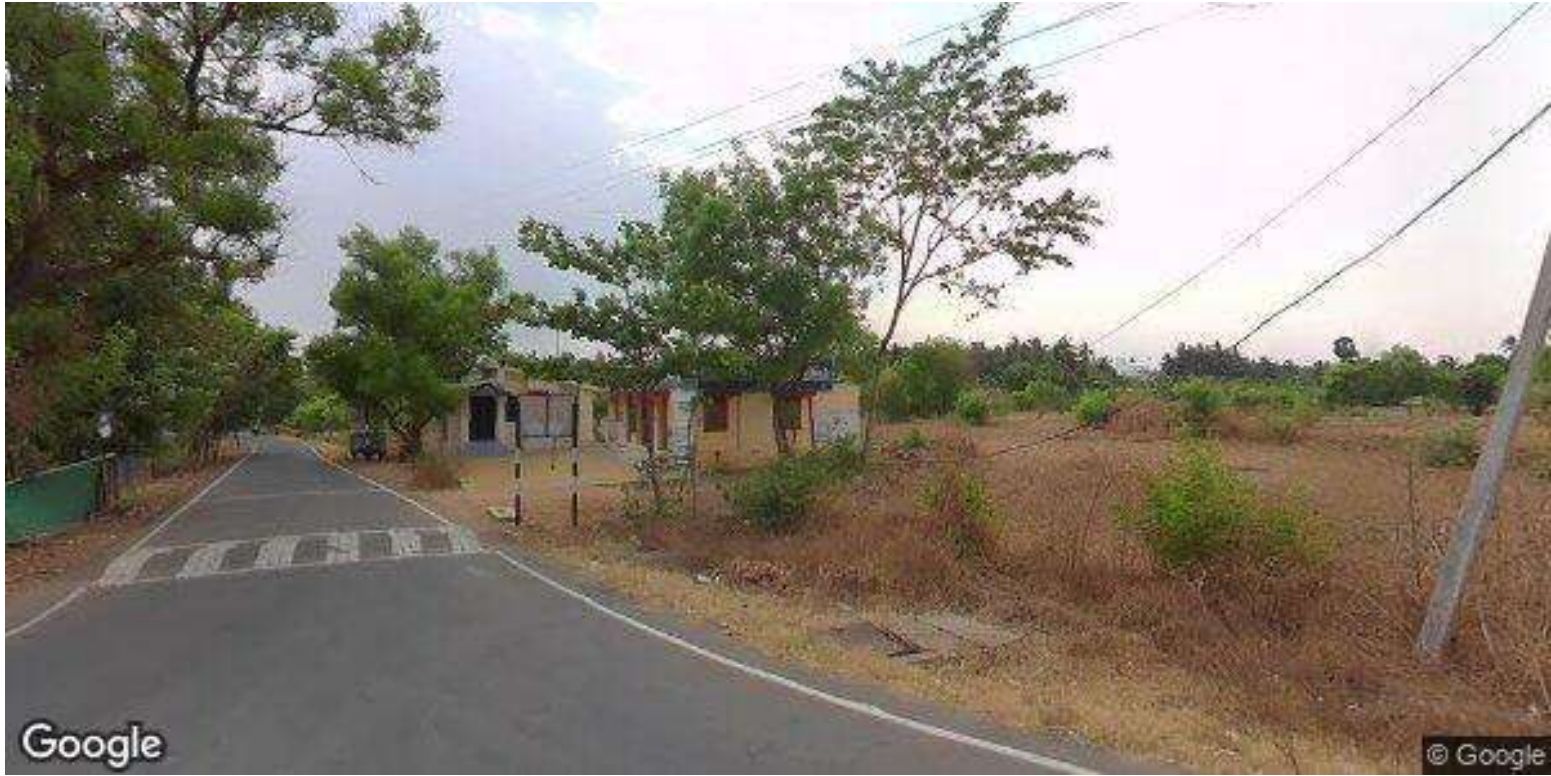
**Risk Type:** Turn  
**Risk Level:** High  
**Speed Limit:** 15 KM/Hr  
**Coordinates:** 11.33065, 77.88650

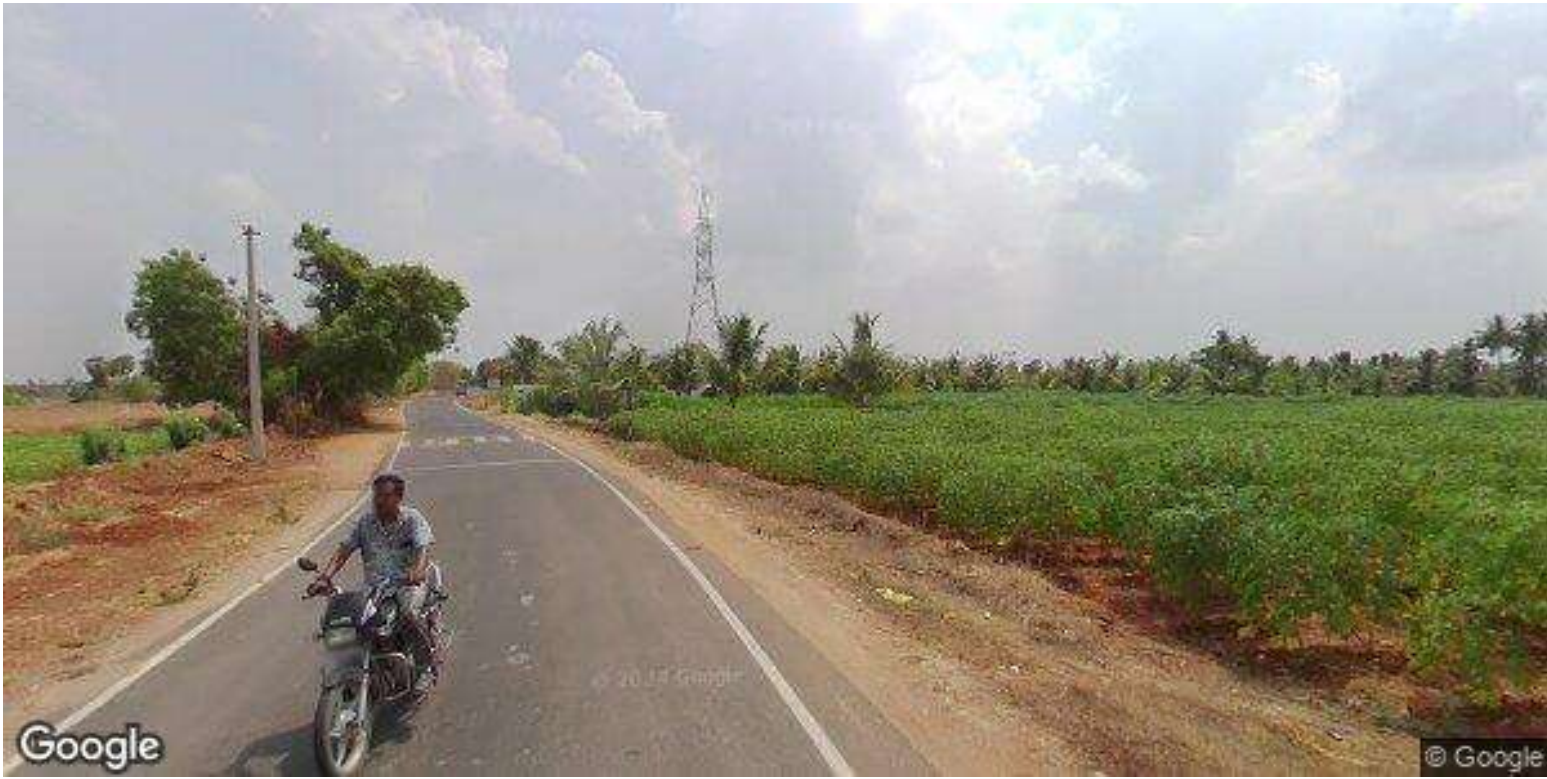
**Risk Type:** Turn  
**Risk Level:** Medium  
**Speed Limit:** 30 KM/Hr  
**Coordinates:** 11.32155, 77.88499

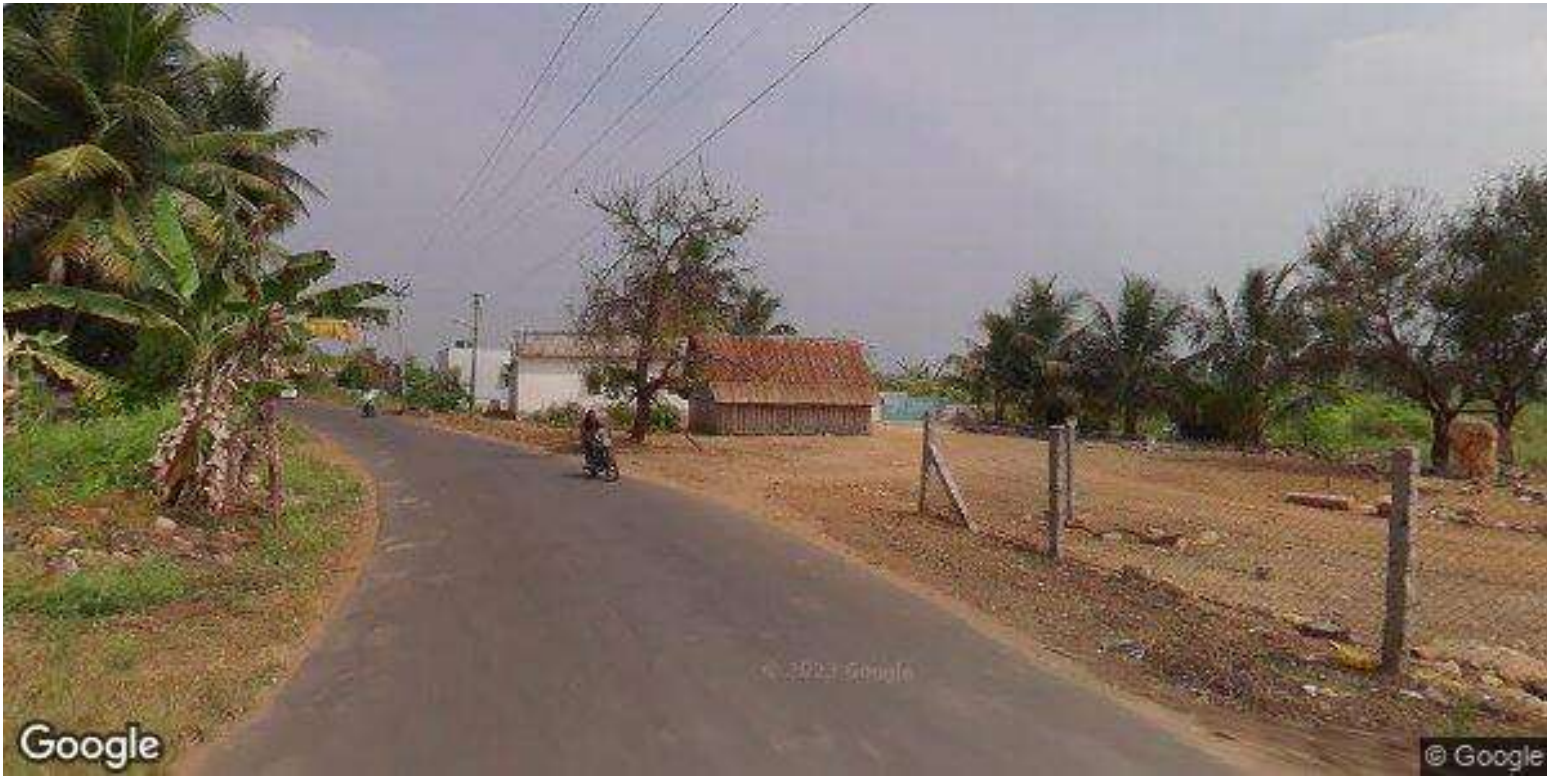
**Risk Type:** Turn  
**Risk Level:** Medium  
**Speed Limit:** 30 KM/Hr  
**Coordinates:** 11.31205, 77.88131

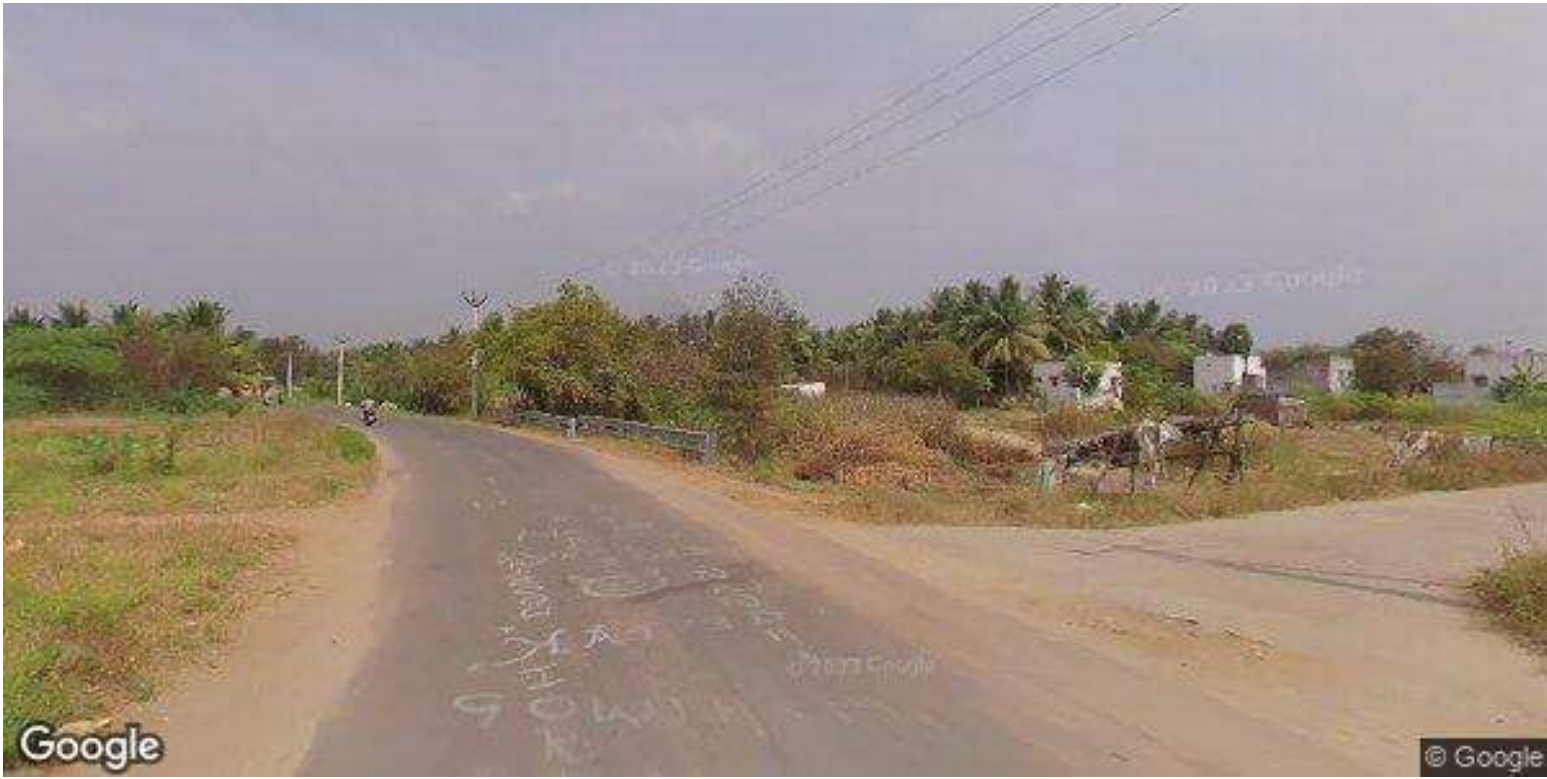
**Risk Type:** Turn  
**Risk Level:** Medium  
**Speed Limit:** 30 KM/Hr  
**Coordinates:** 11.30805, 77.87934

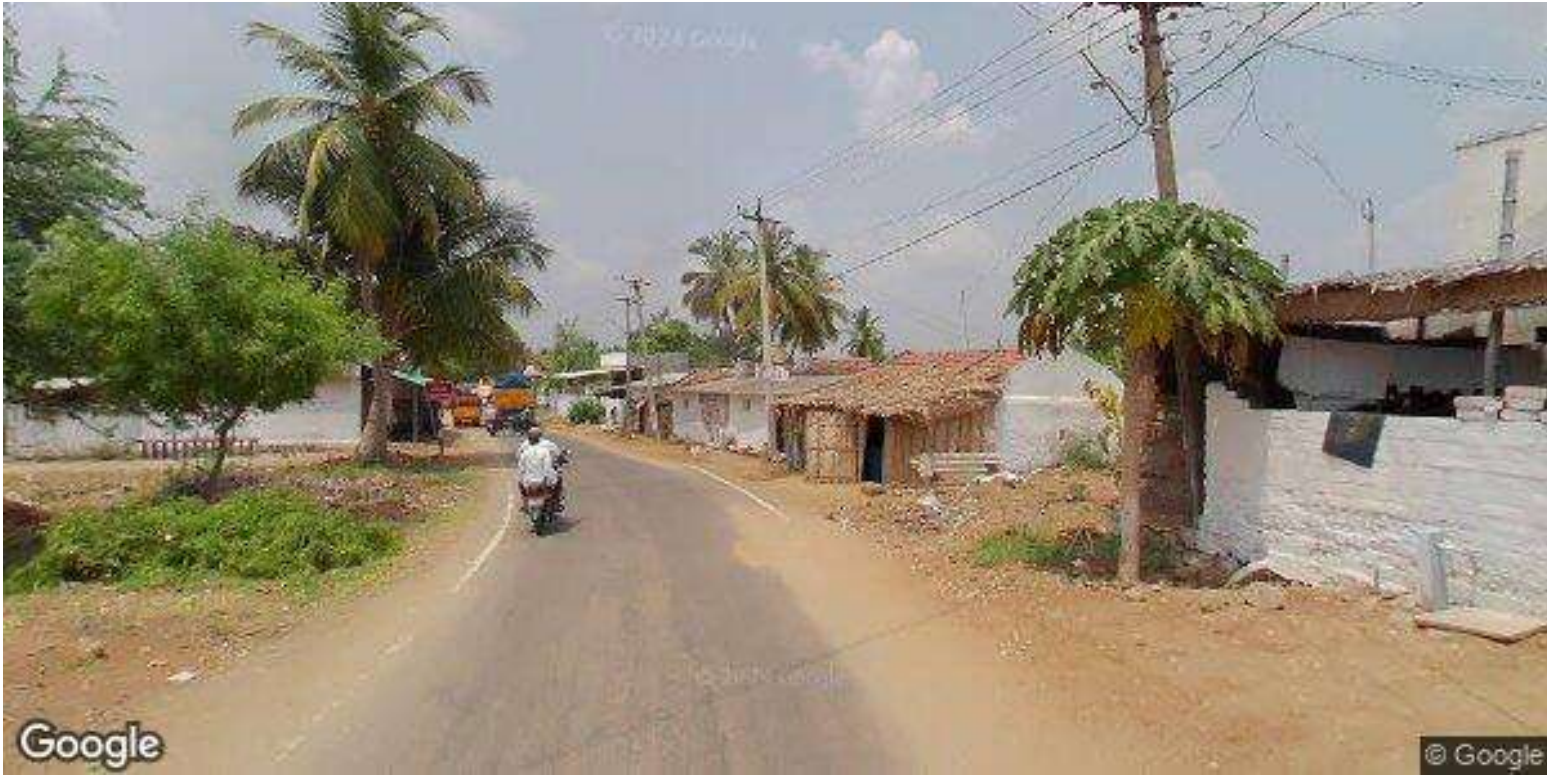
**Risk Type:** Turn  
**Risk Level:** Medium  
**Speed Limit:** 30 KM/Hr  
**Coordinates:** 11.30625, 77.87776

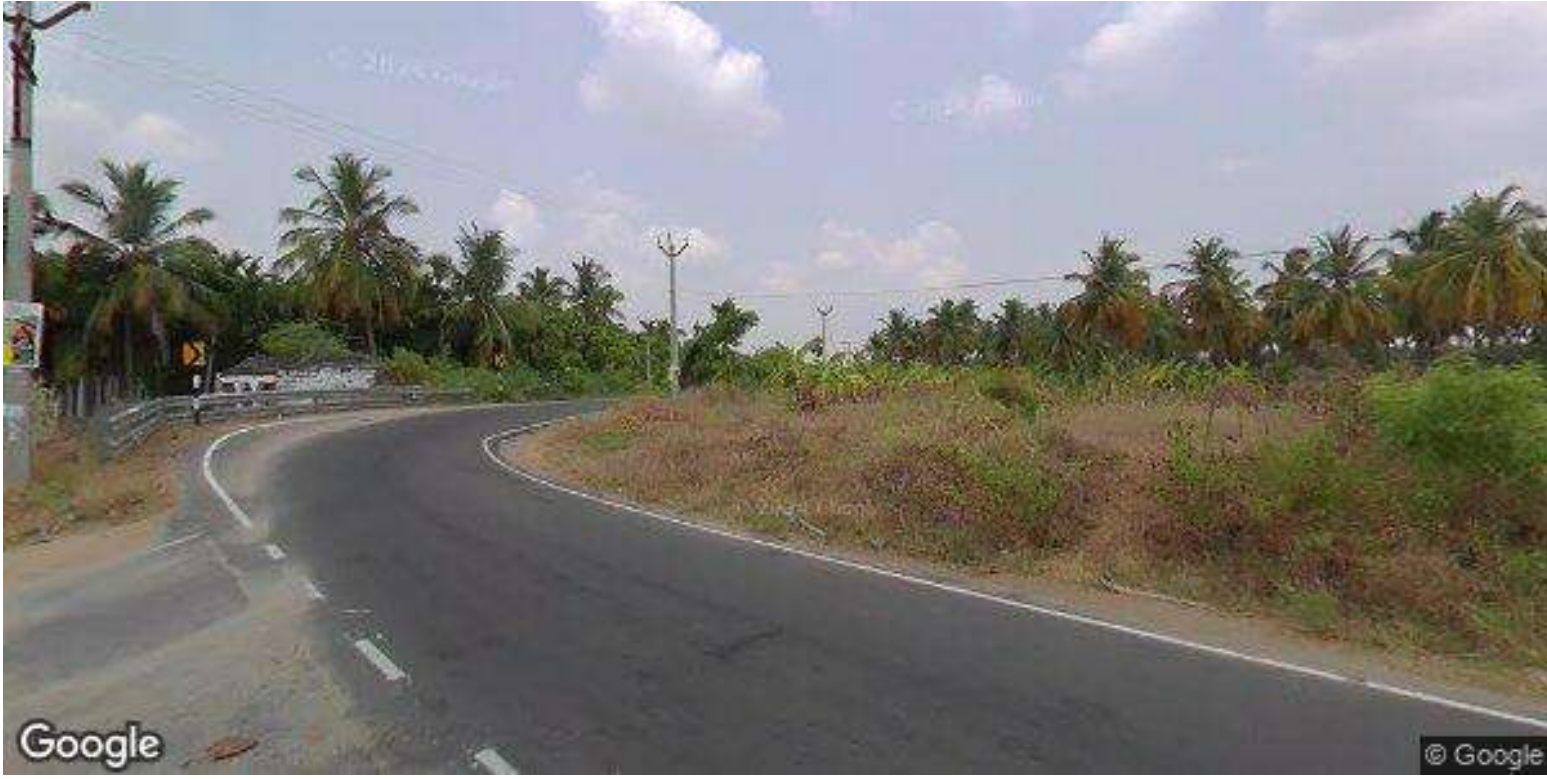
**Risk Type:** Turn  
**Risk Level:** High  
**Speed Limit:** 15 KM/Hr  
**Coordinates:** 11.29763, 77.87710

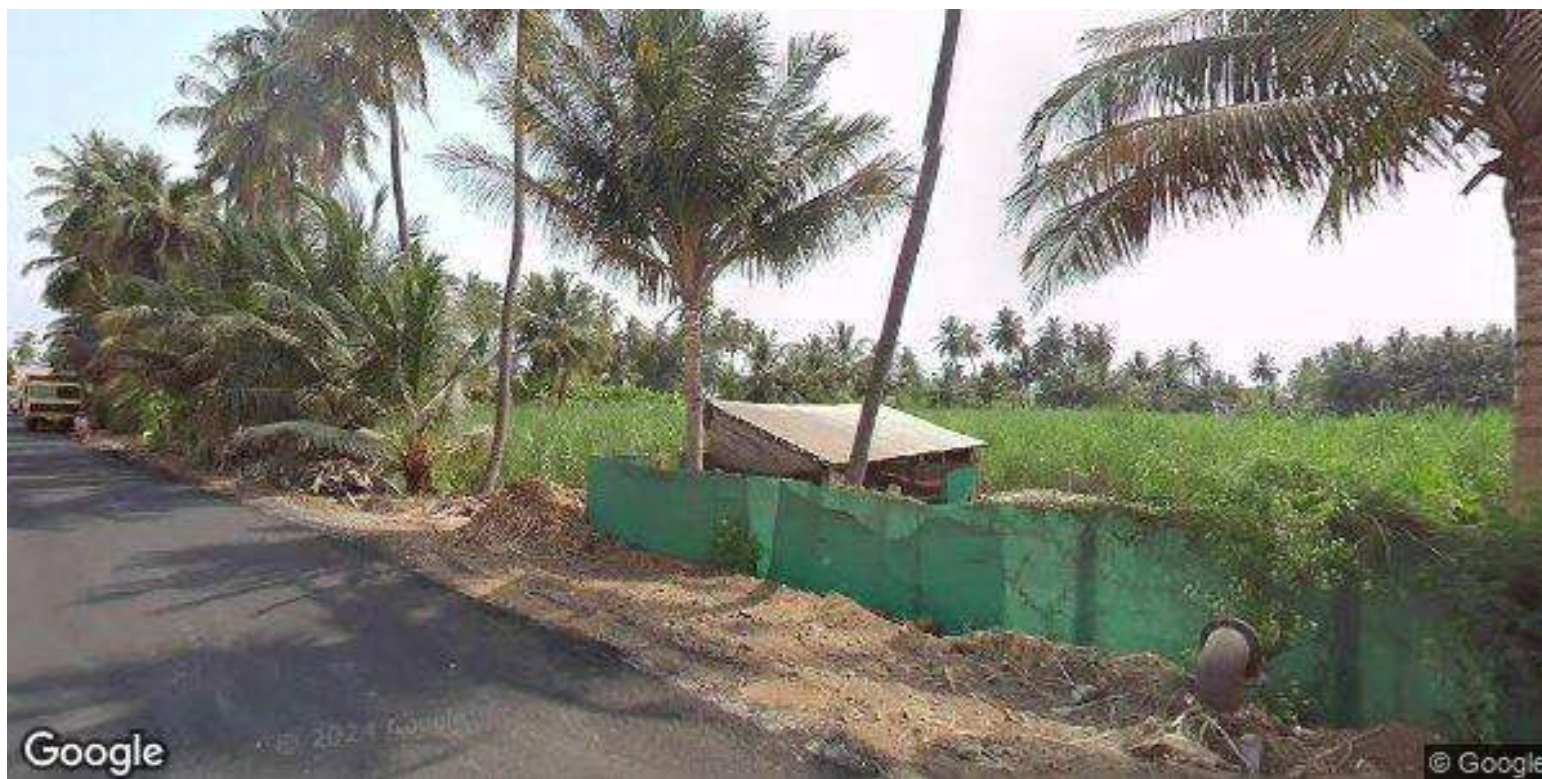
**Risk Type:** Turn

**Risk Level:** High

**Speed Limit:** 15 KM/Hr

**Coordinates:** 11.26017, 77.85606

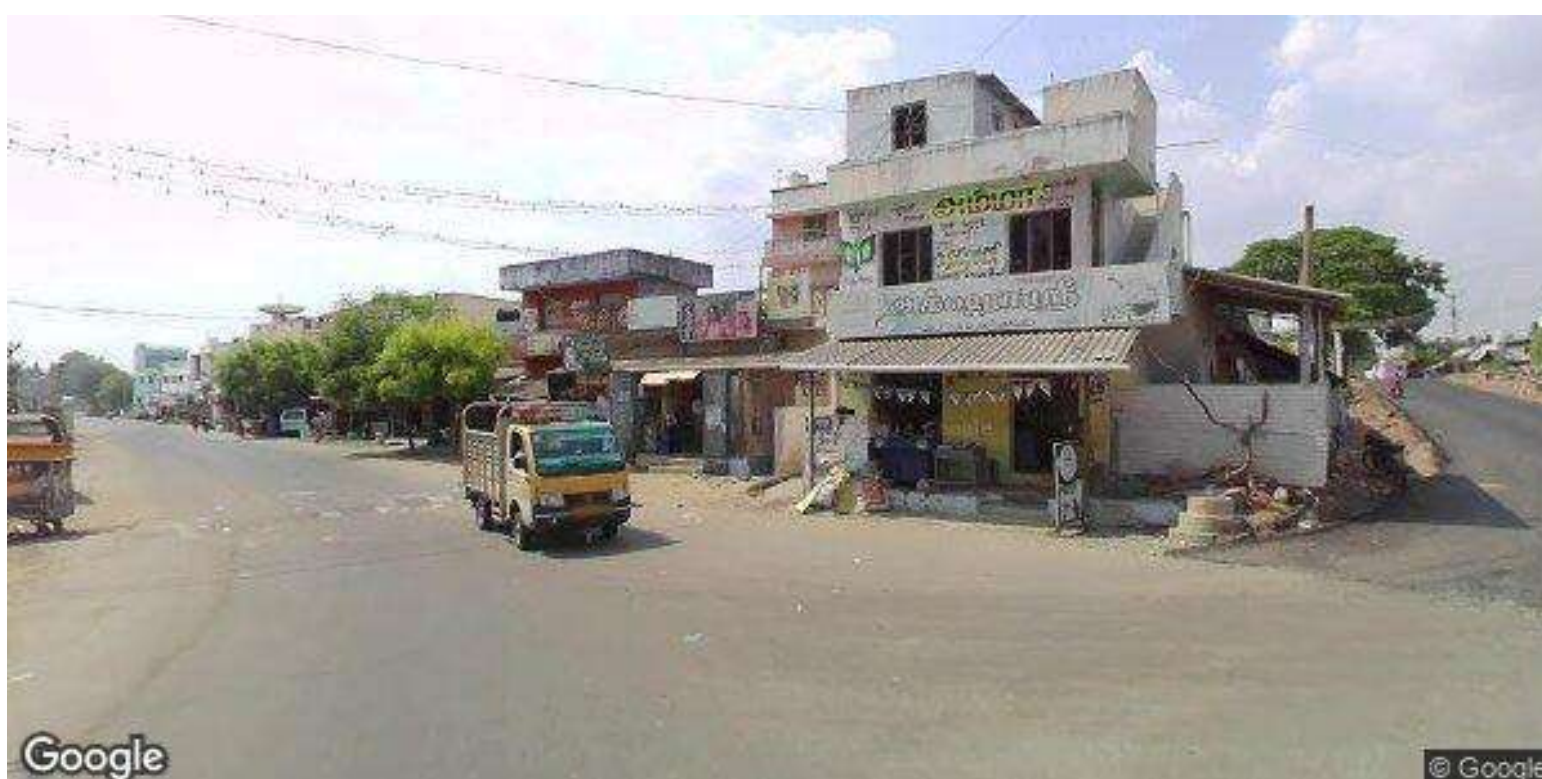
**Risk Type:** Turn

**Risk Level:** High

**Speed Limit:** 15 KM/Hr

**Coordinates:** 11.25802, 77.85511

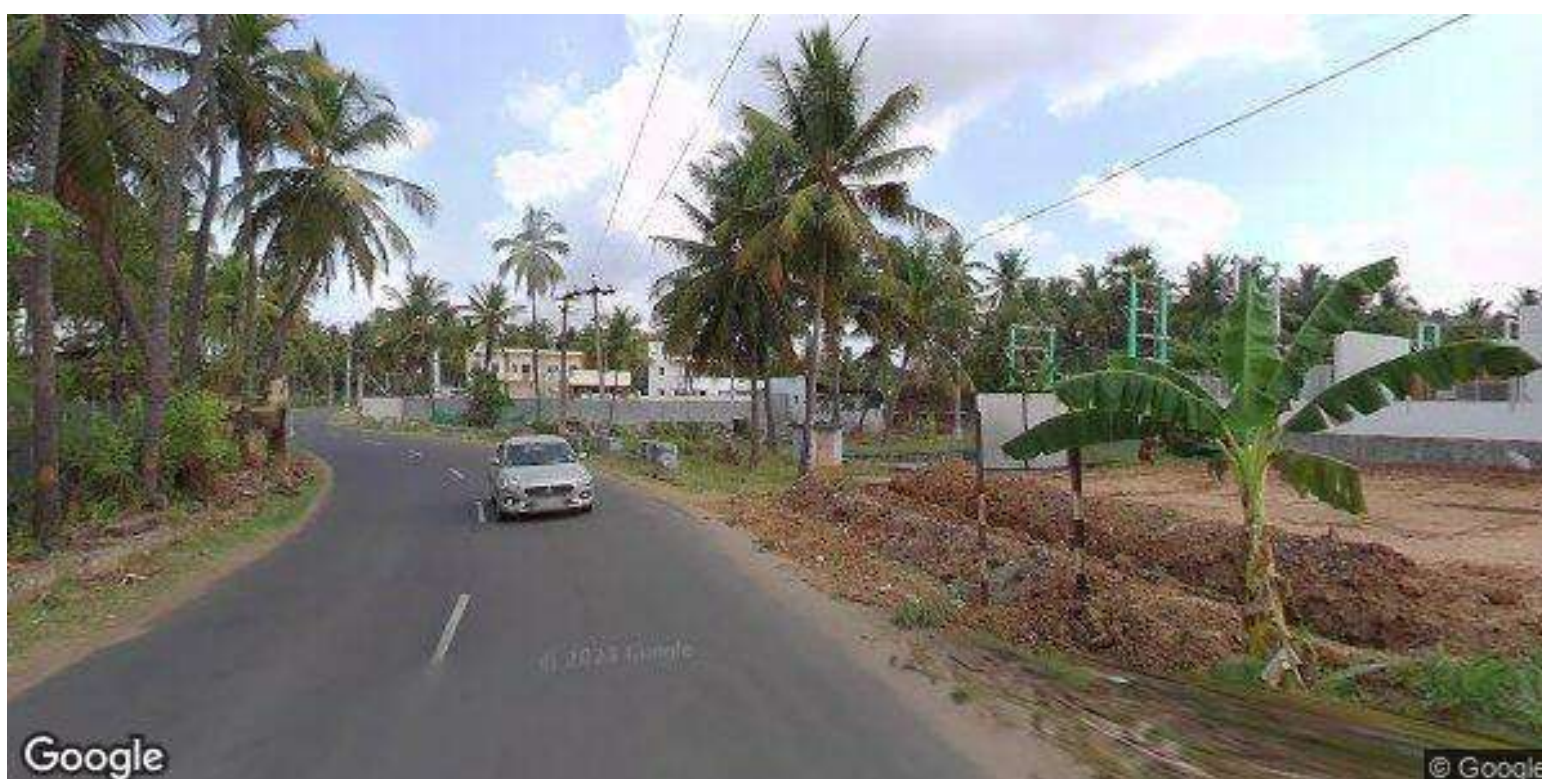
**Risk Type:** Turn  
**Risk Level:** Medium  
**Speed Limit:** 30 KM/Hr  
**Coordinates:** 11.25287, 77.86220

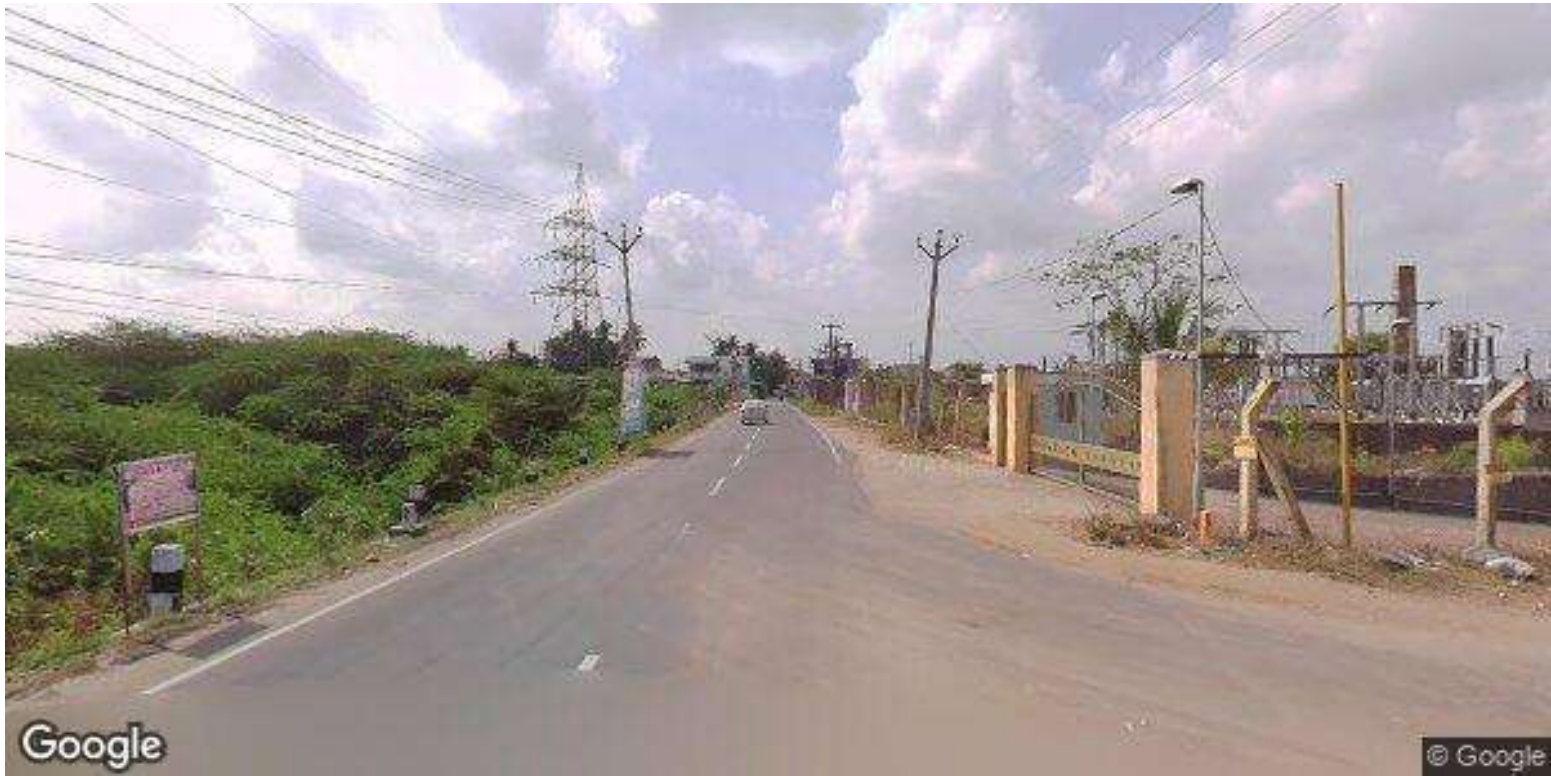
**Risk Type:** Turn  
**Risk Level:** High  
**Speed Limit:** 15 KM/Hr  
**Coordinates:** 11.24384, 77.86689

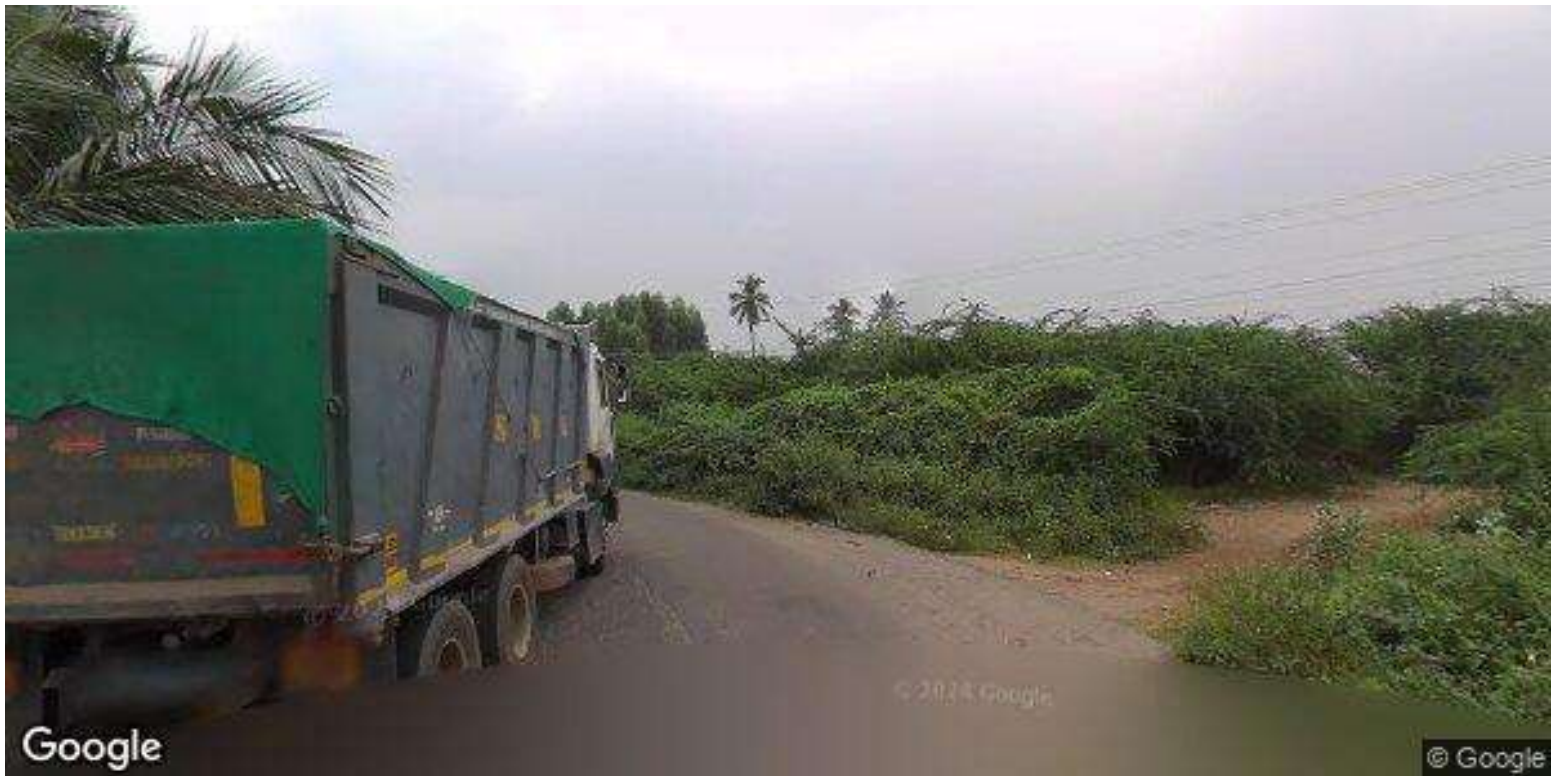
**Risk Type:** Turn  
**Risk Level:** High  
**Speed Limit:** 15 KM/Hr  
**Coordinates:** 11.24100, 77.86030

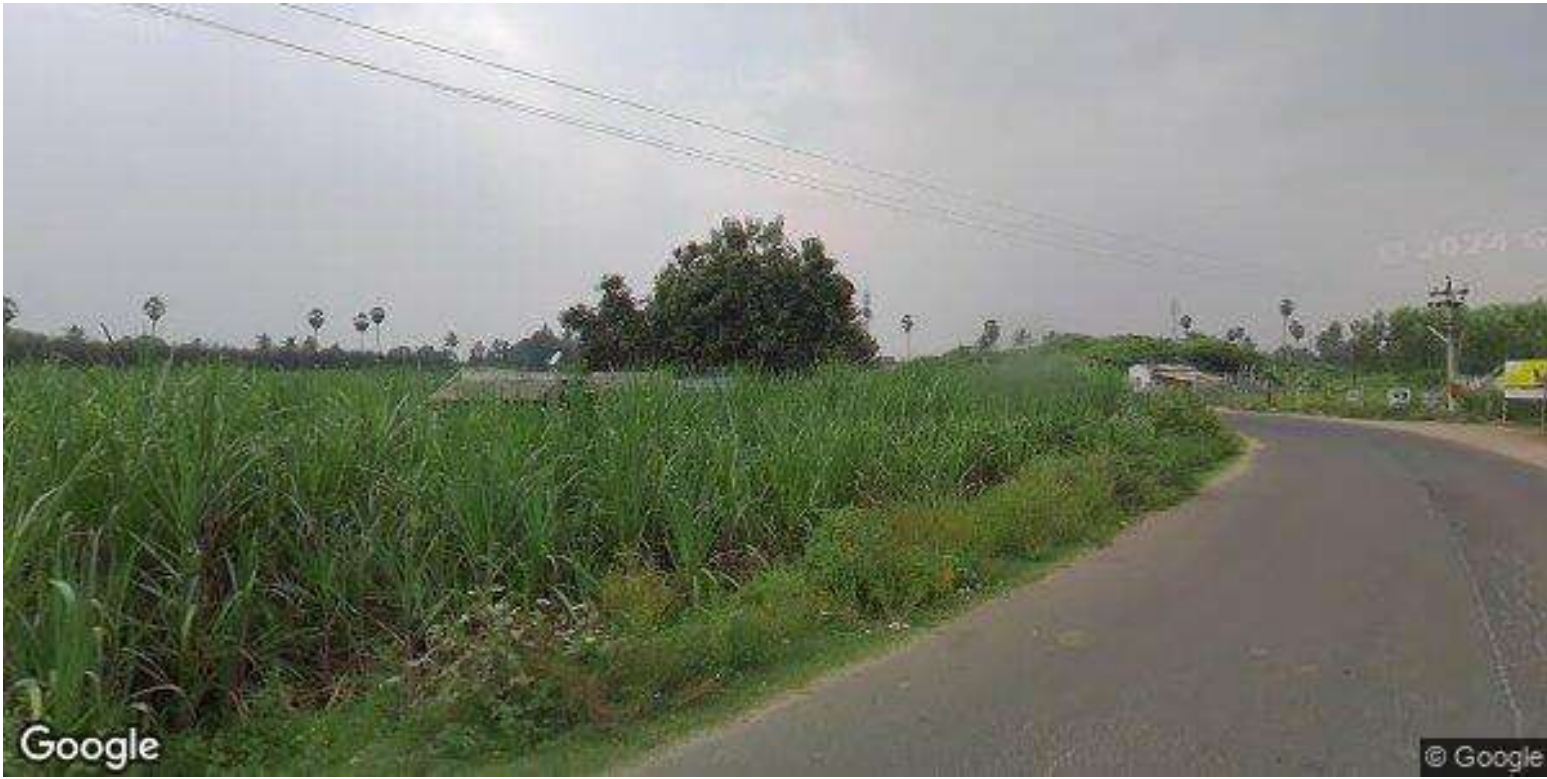
**Risk Type:** Turn  
**Risk Level:** Medium  
**Speed Limit:** 30 KM/Hr  
**Coordinates:** 11.24196, 77.85902

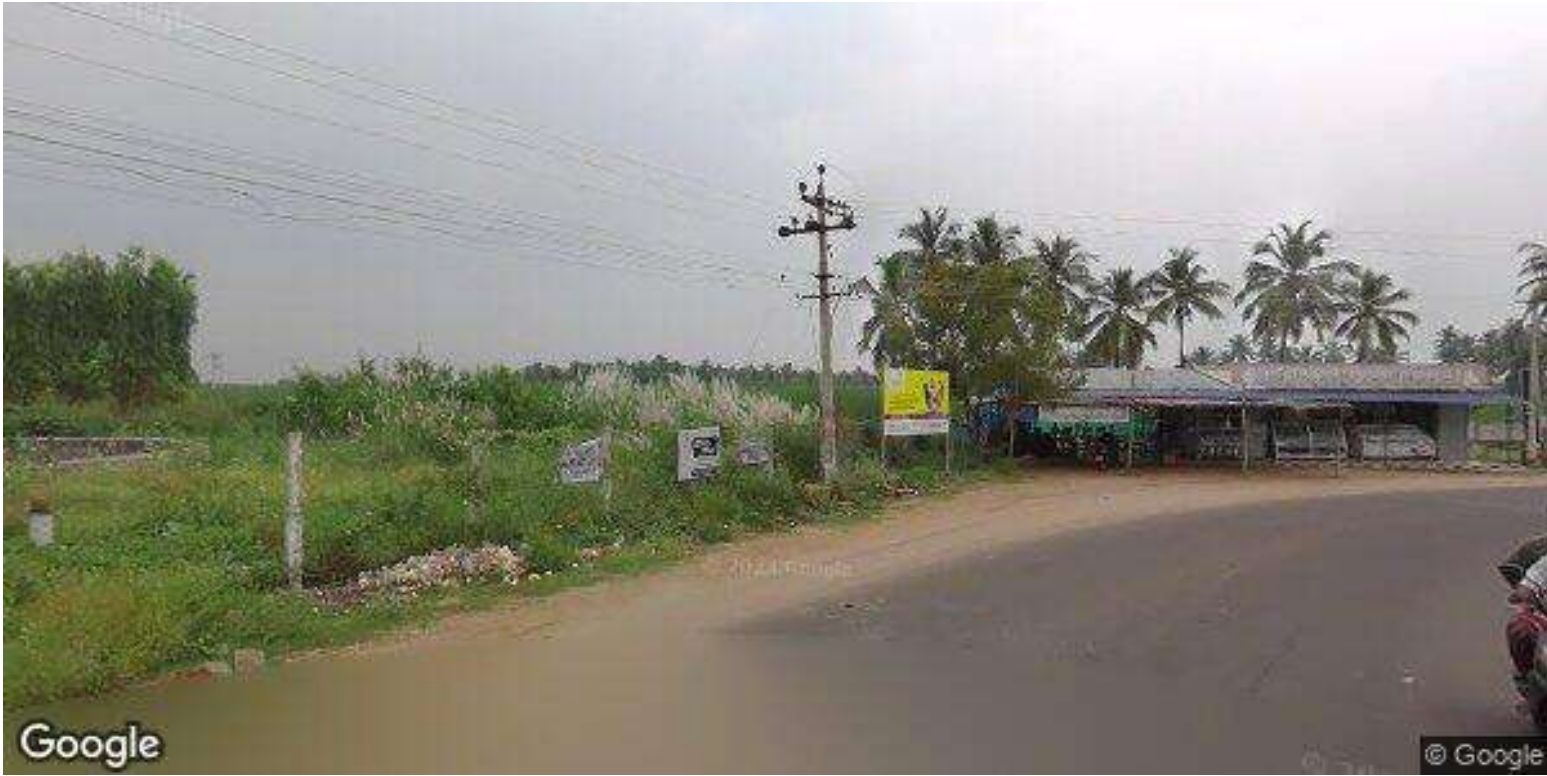
**Risk Type:** Turn  
**Risk Level:** Medium  
**Speed Limit:** 30 KM/Hr  
**Coordinates:** 11.24193, 77.85850

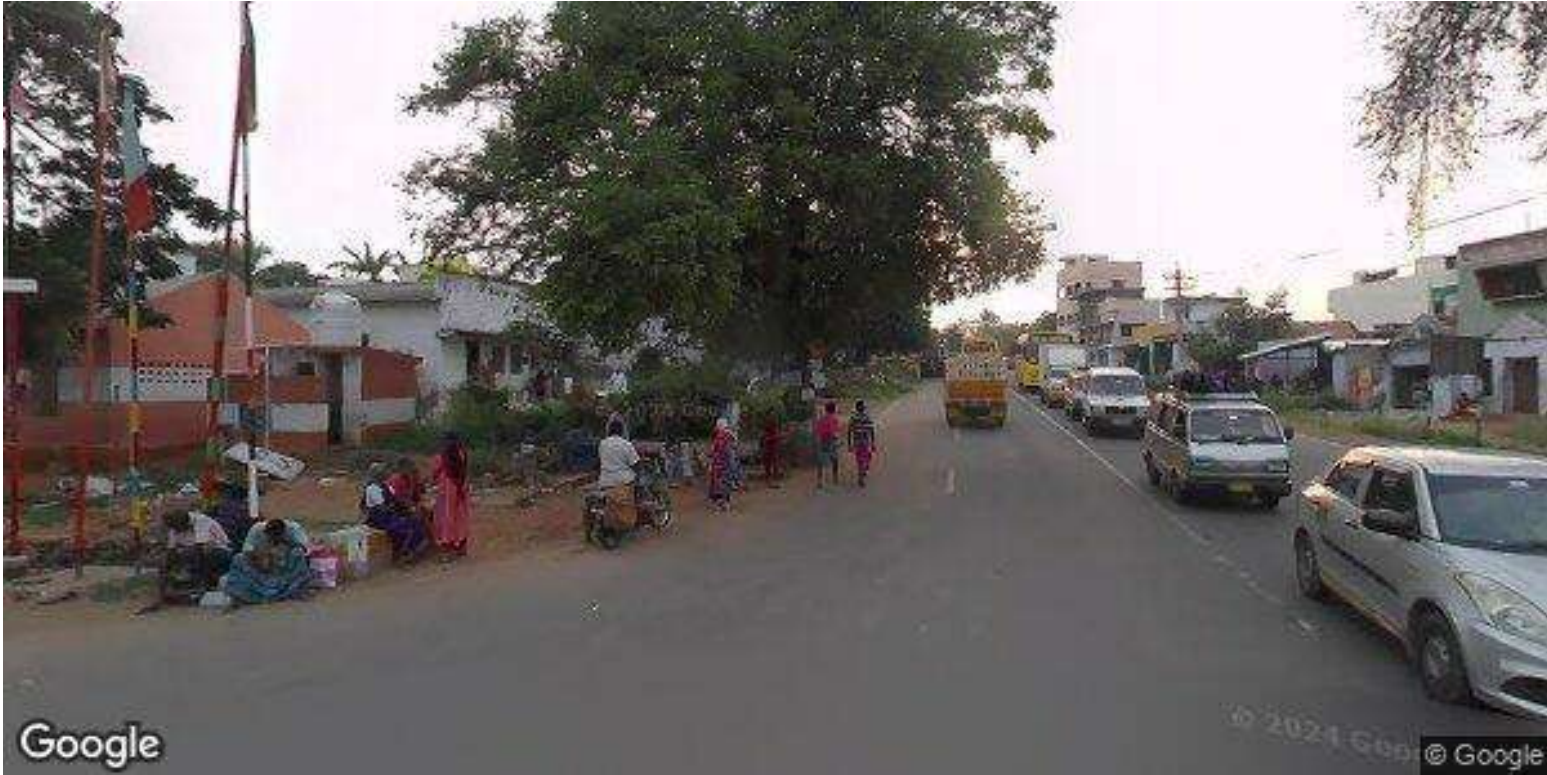
**Risk Type:** Turn  
**Risk Level:** Medium  
**Speed Limit:** 30 KM/Hr  
**Coordinates:** 11.23960, 77.85563
