## JOURNEY RISK MANAGEMENT (JRM) STUDY

### Salem Terminal TO ERODE PRECISION FARM PRODUCER

Route Analysis Report from CVQF+23W, Sangagiri to 4RG3+9C6, SH 84C, Tamil Nadu

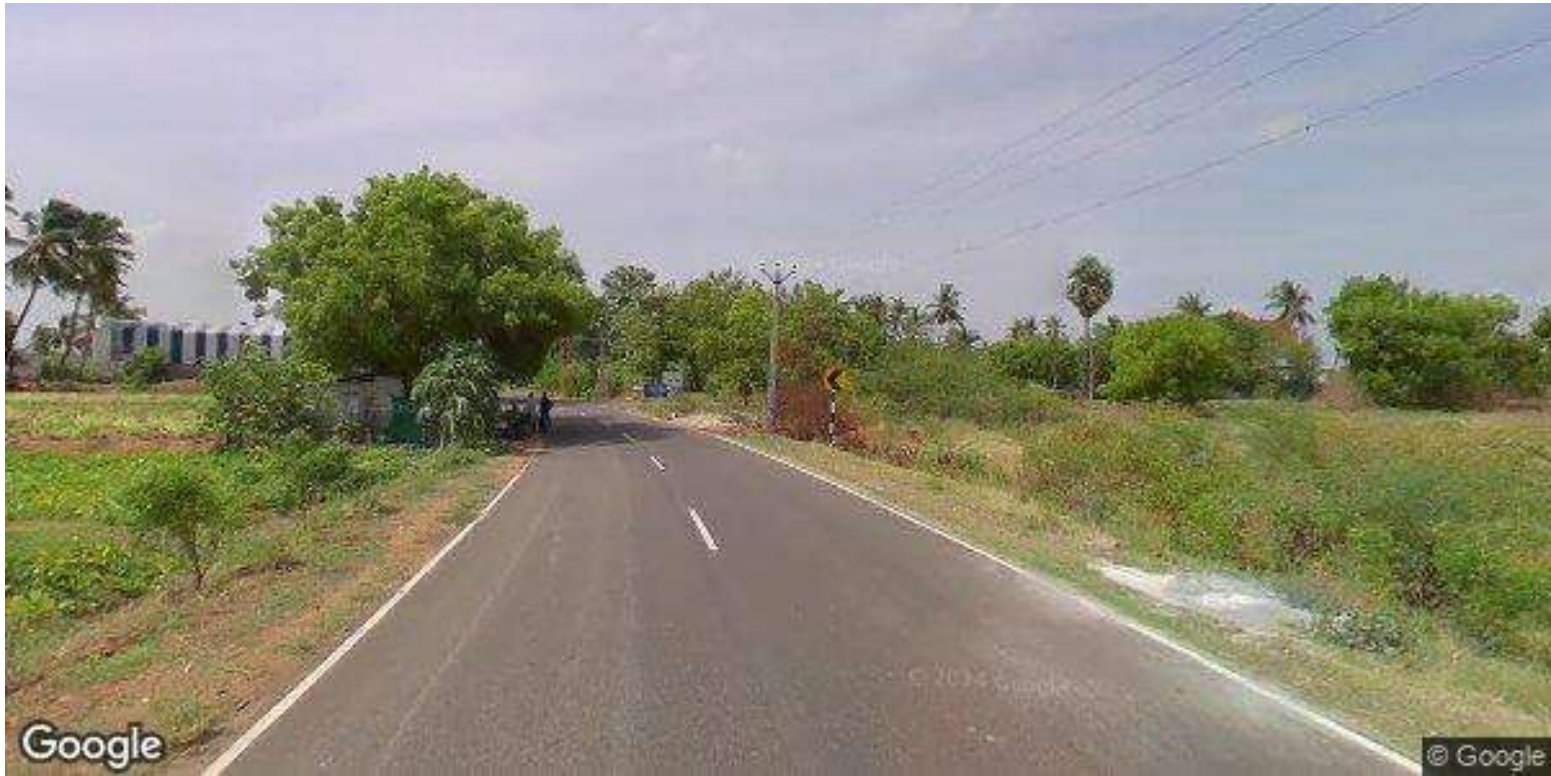
**Risk Type:** Turn  
**Risk Level:** Medium  
**Speed Limit:** 30 KM/Hr  
**Coordinates:** 11.20949, 77.81173

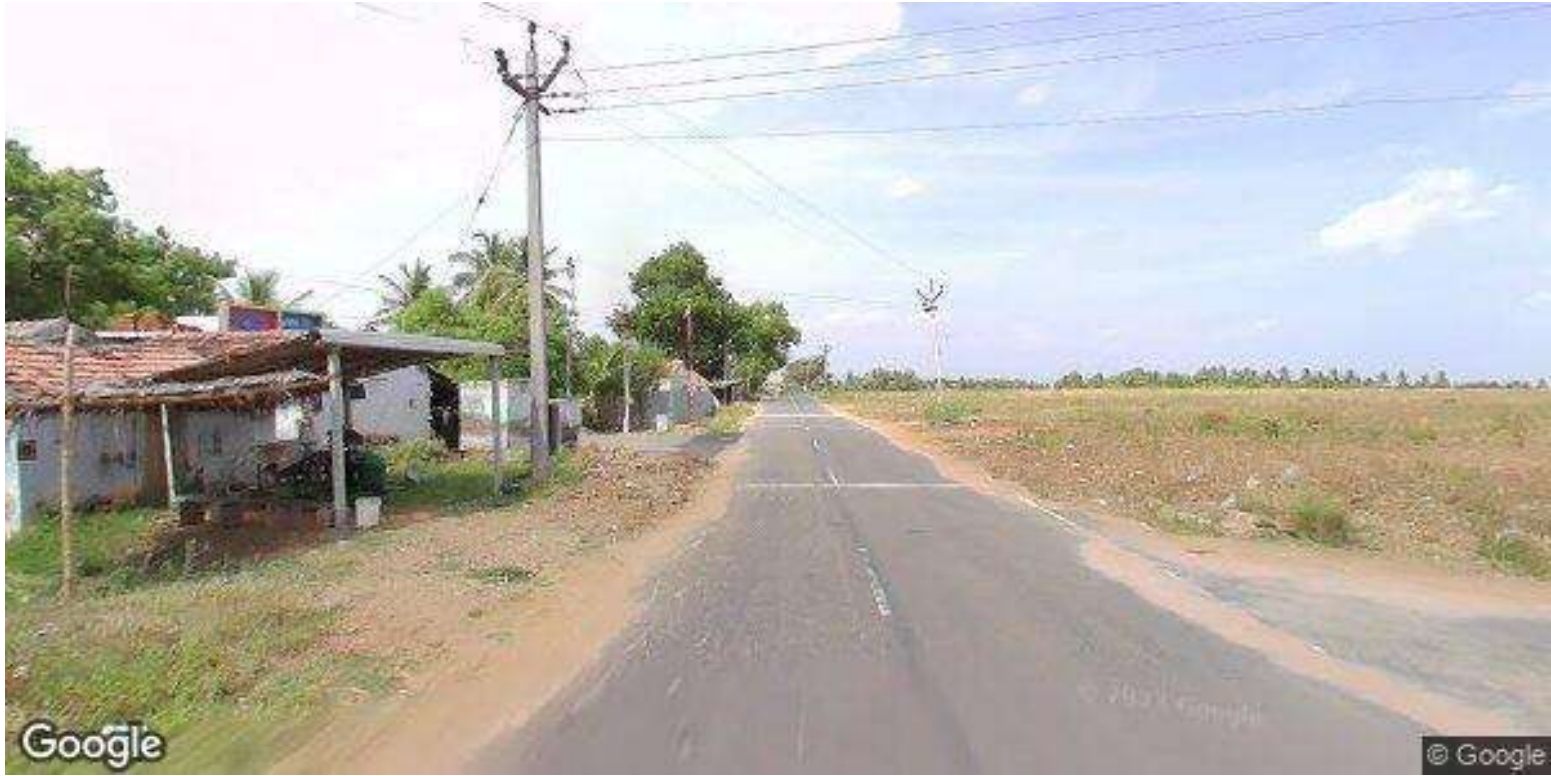
**Risk Type:** Turn  
**Risk Level:** High  
**Speed Limit:** 15 KM/Hr  
**Coordinates:** 11.20231, 77.79886

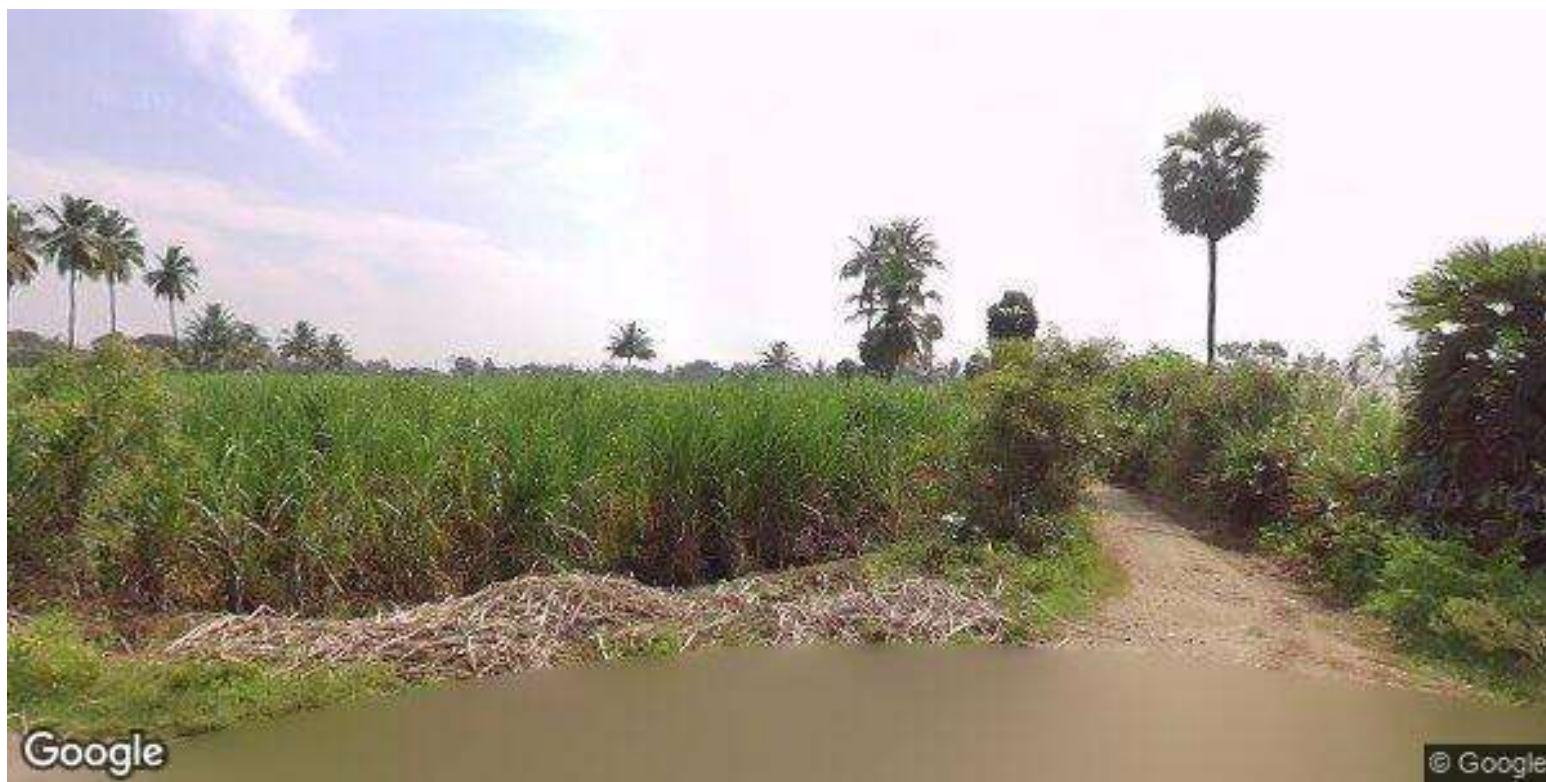
**Risk Type: Turn**

**Risk Level: High**

**Speed Limit: 15 KM/Hr**

**Coordinates: 11.18798, 77.80052**

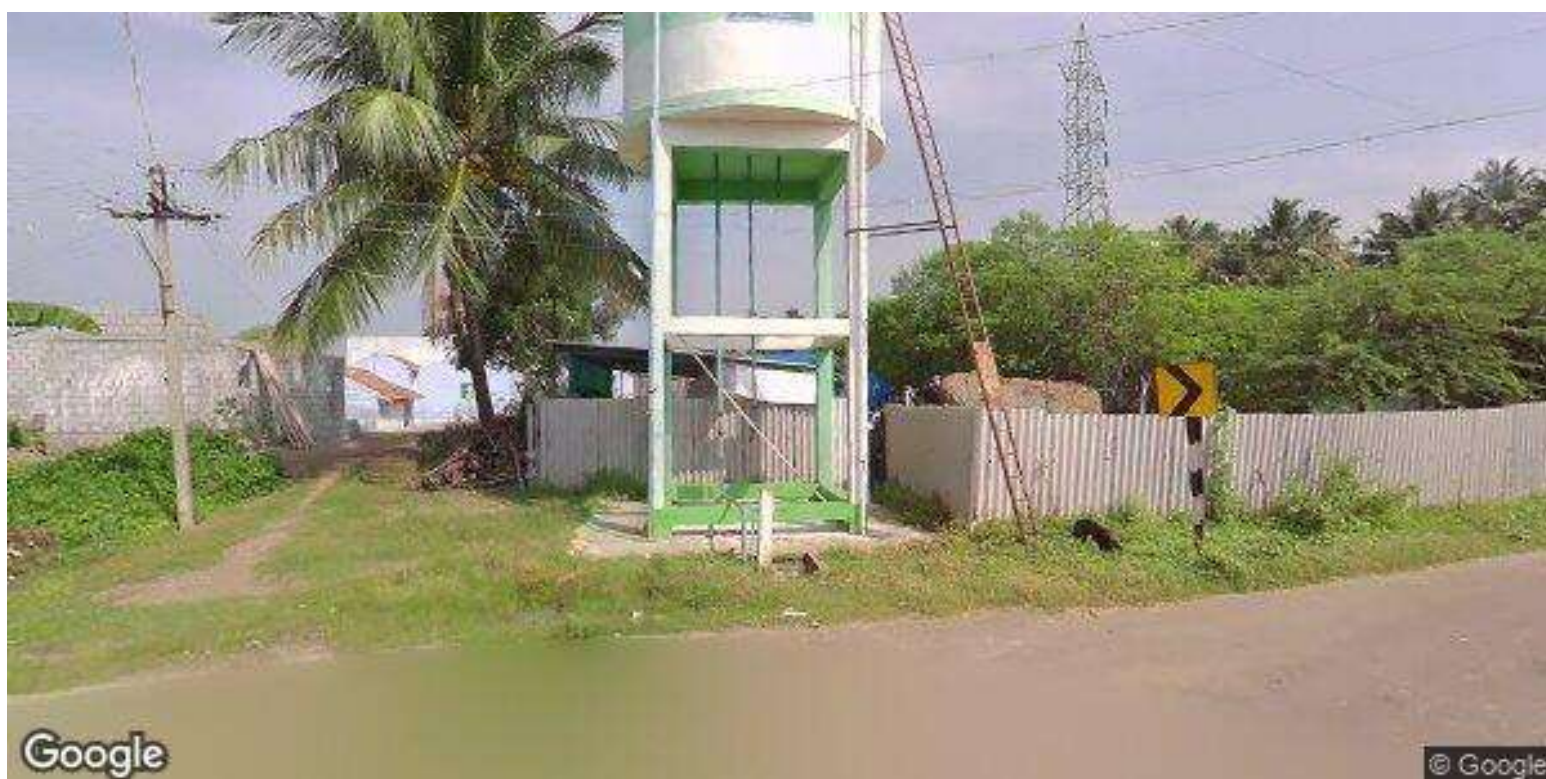
**Risk Type: Turn**

**Risk Level: High**

**Speed Limit: 15 KM/Hr**

**Coordinates: 11.18779, 77.79733**

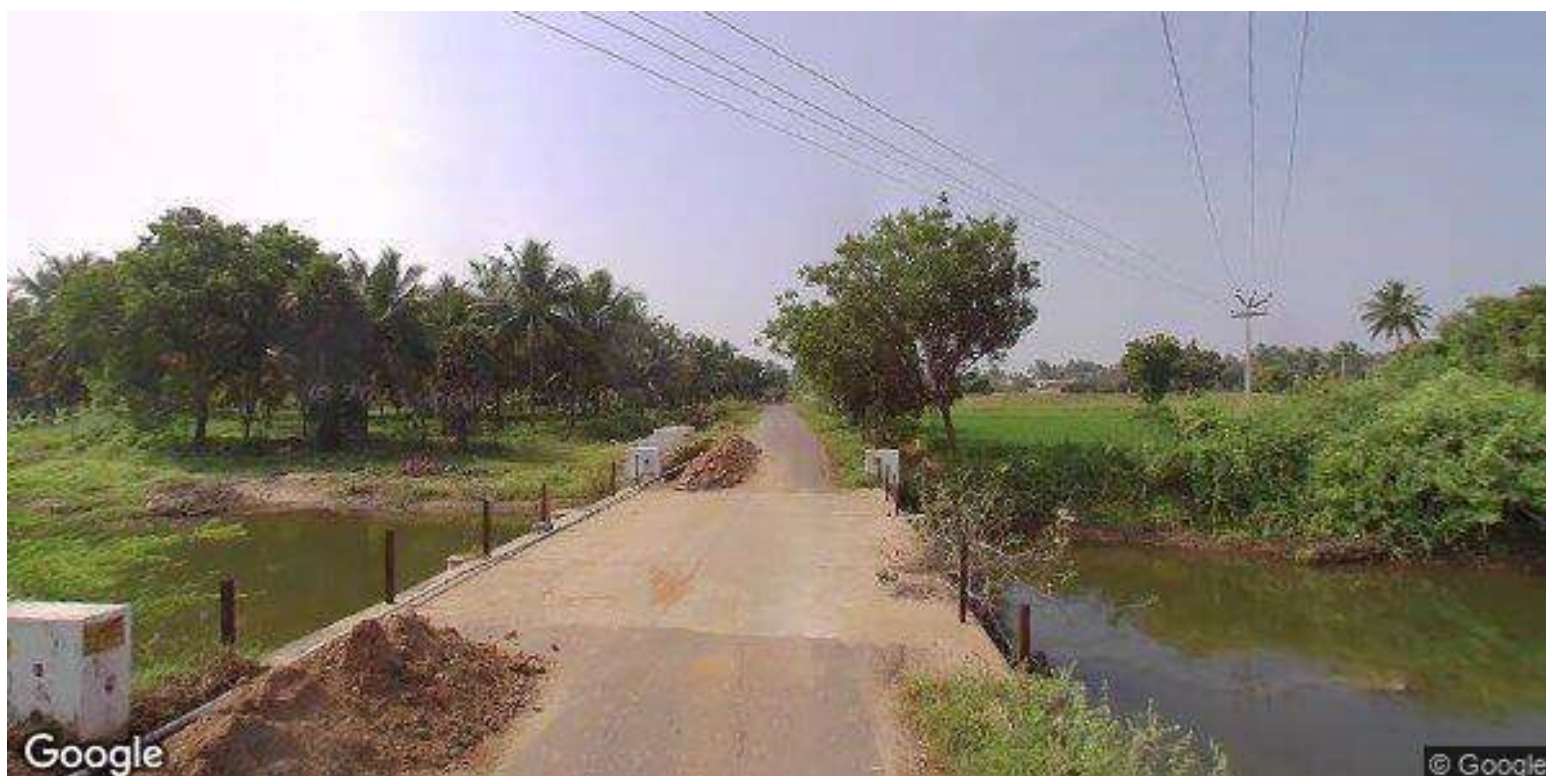
**Risk Type:** Turn  
**Risk Level:** Medium  
**Speed Limit:** 30 KM/Hr  
**Coordinates:** 11.18542, 77.79672

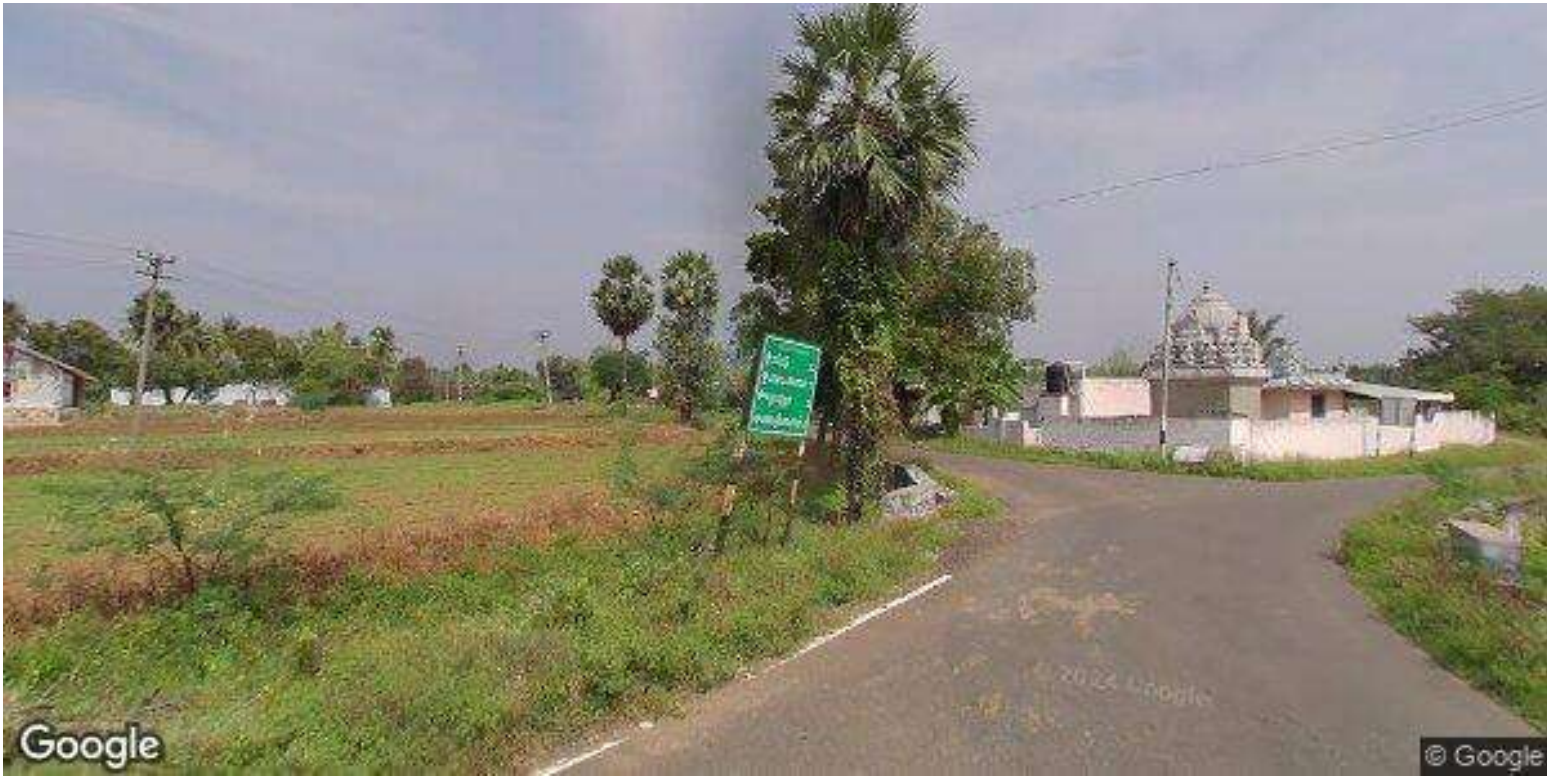
**Risk Type:** Turn  
**Risk Level:** High  
**Speed Limit:** 15 KM/Hr  
**Coordinates:** 11.18312, 77.79425

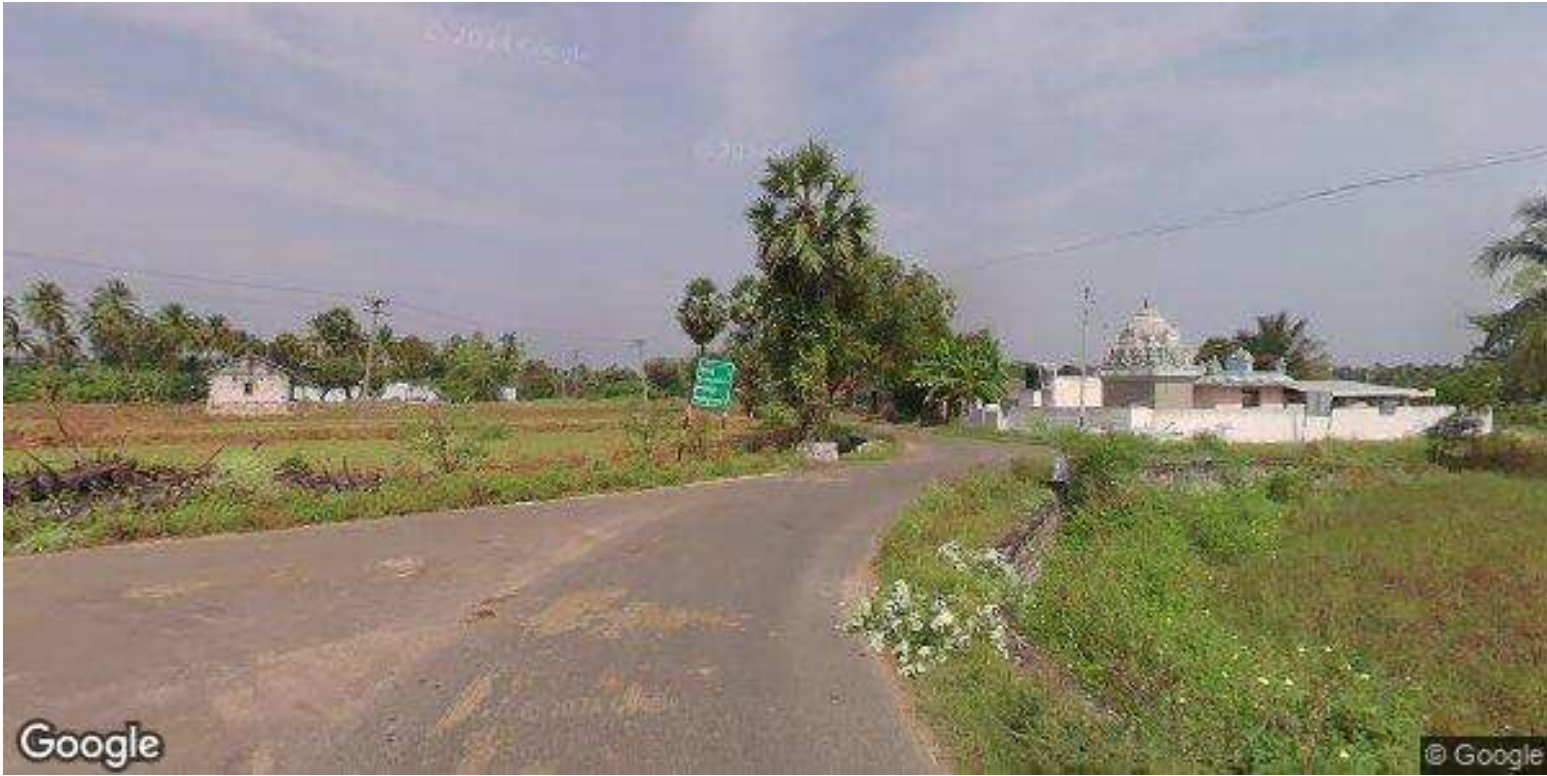
**Risk Type:** Turn  
**Risk Level:** Medium  
**Speed Limit:** 30 KM/Hr  
**Coordinates:** 11.18298, 77.79420

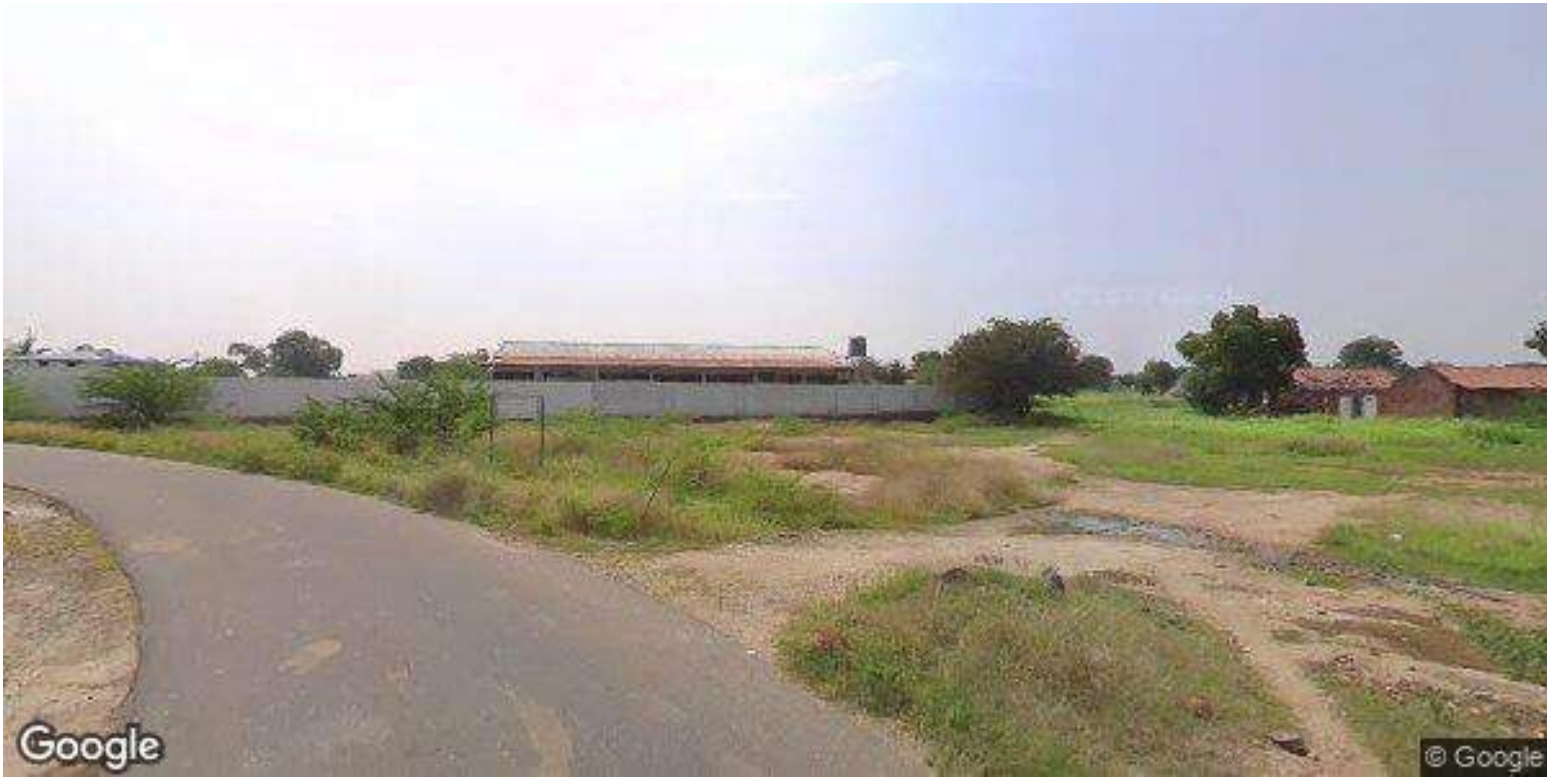
**Risk Type:** Turn  
**Risk Level:** Medium  
**Speed Limit:** 30 KM/Hr  
**Coordinates:** 11.17594, 77.79491

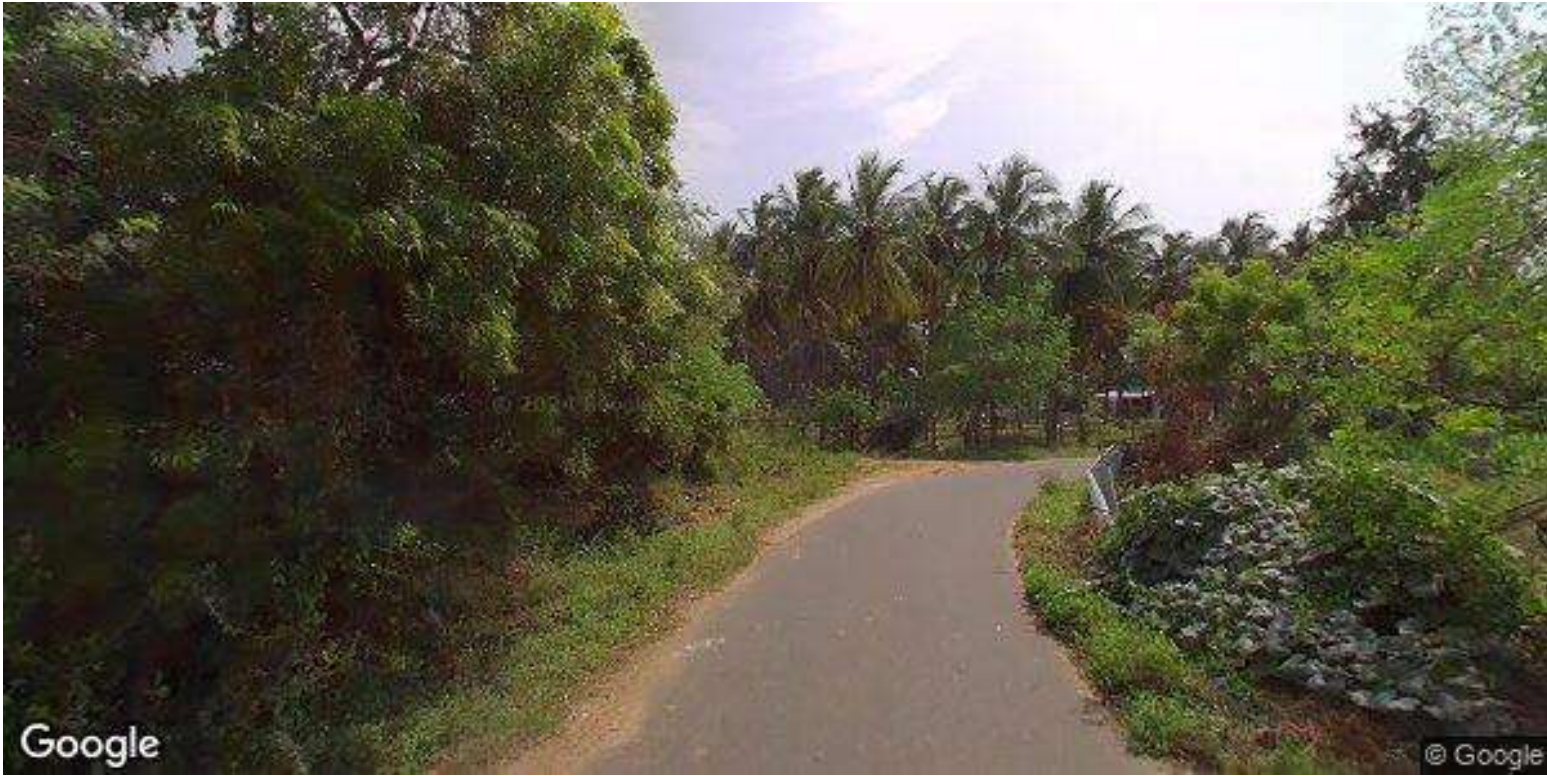
**Risk Type:** Turn  
**Risk Level:** Medium  
**Speed Limit:** 30 KM/Hr  
**Coordinates:** 11.17301, 77.79650

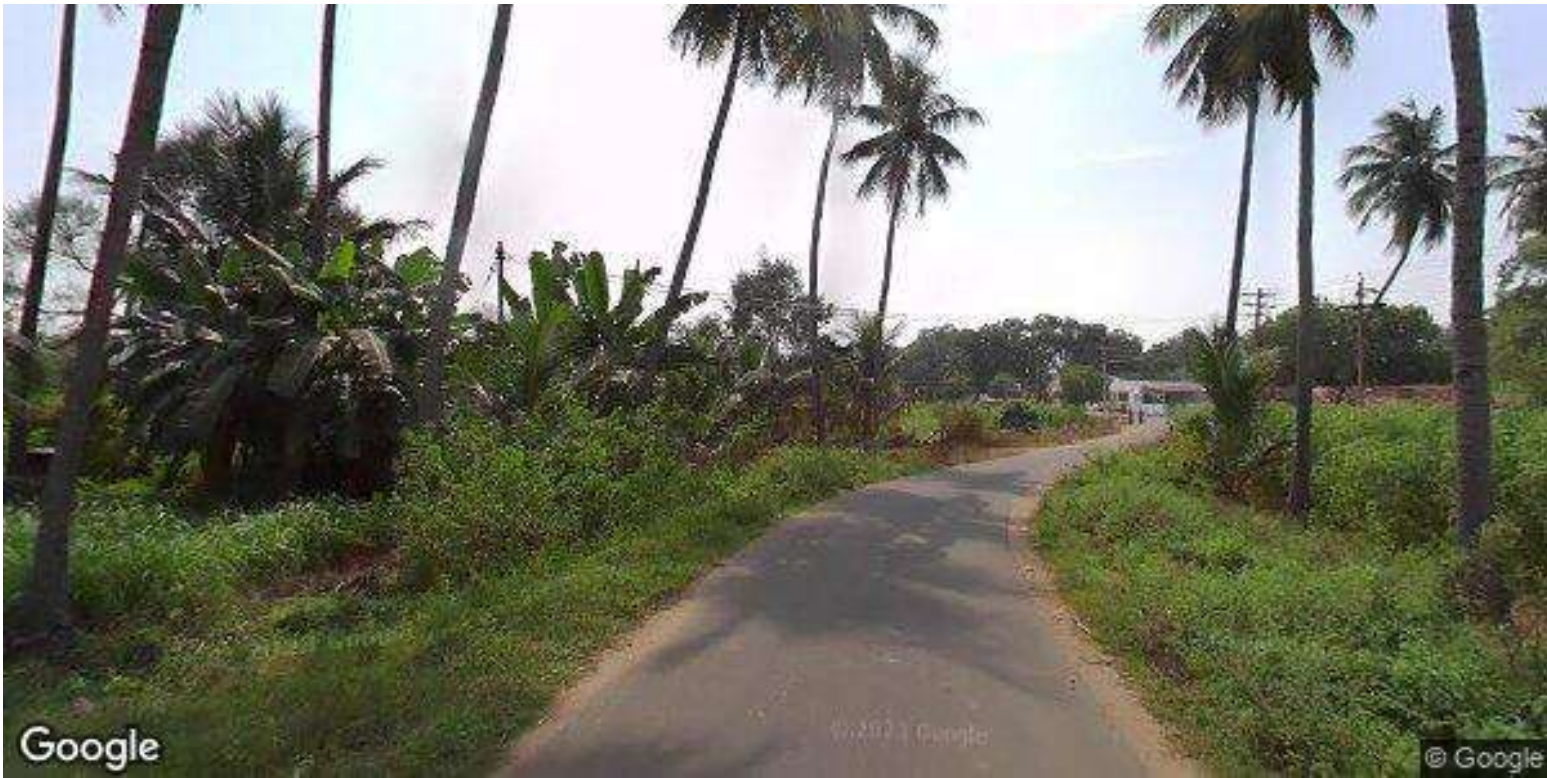
**Risk Type:** Turn  
**Risk Level:** Medium  
**Speed Limit:** 30 KM/Hr  
**Coordinates:** 11.16706, 77.79514

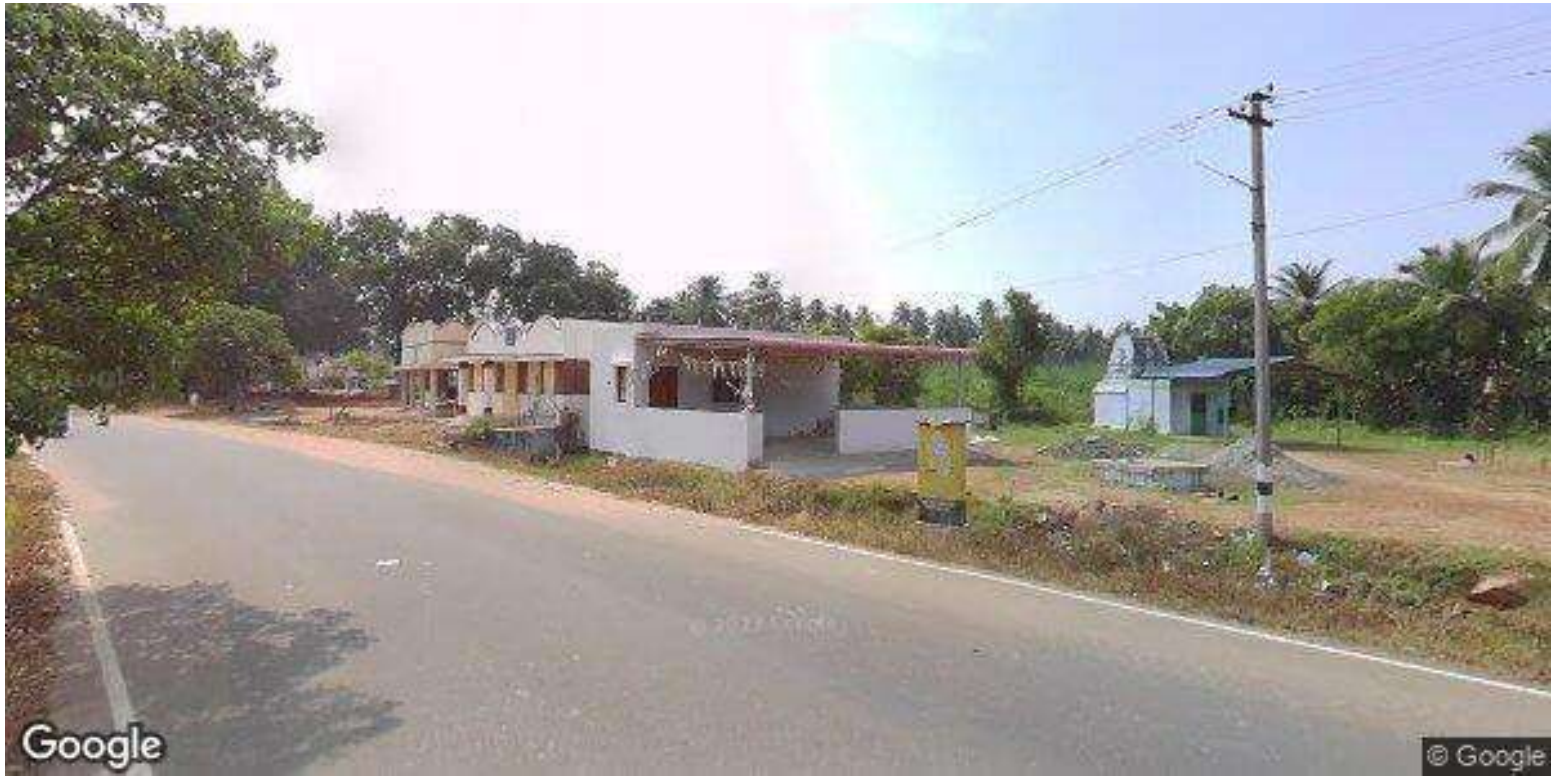
**Risk Type:** Turn  
**Risk Level:** Medium  
**Speed Limit:** 30 KM/Hr  
**Coordinates:** 11.16632, 77.79476

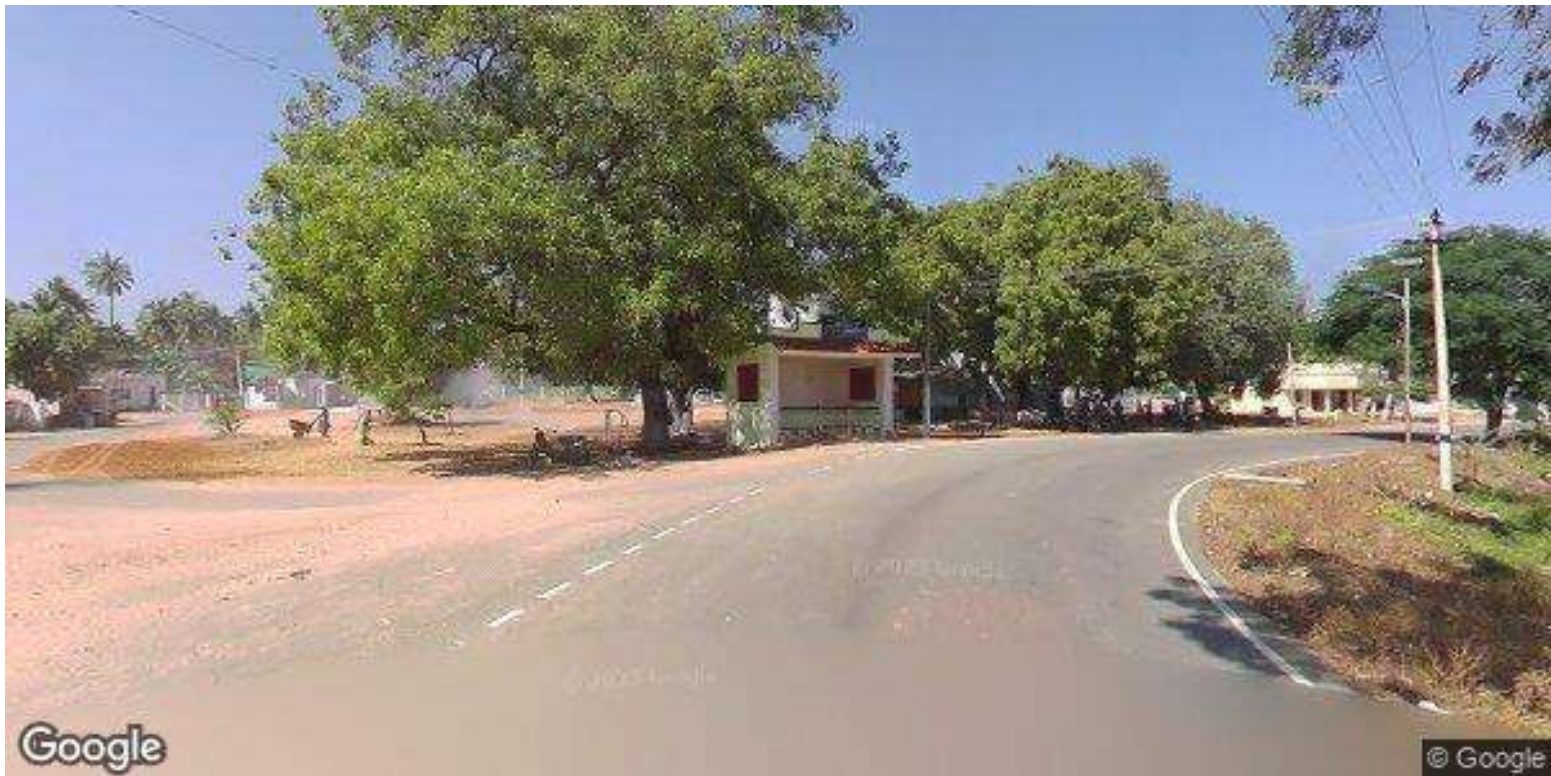
**Risk Type:** Blind Spot  
**Risk Level:** Blind Spot  
**Speed Limit:** 10 KM/Hr  
**Coordinates:** 11.16520, 77.79528

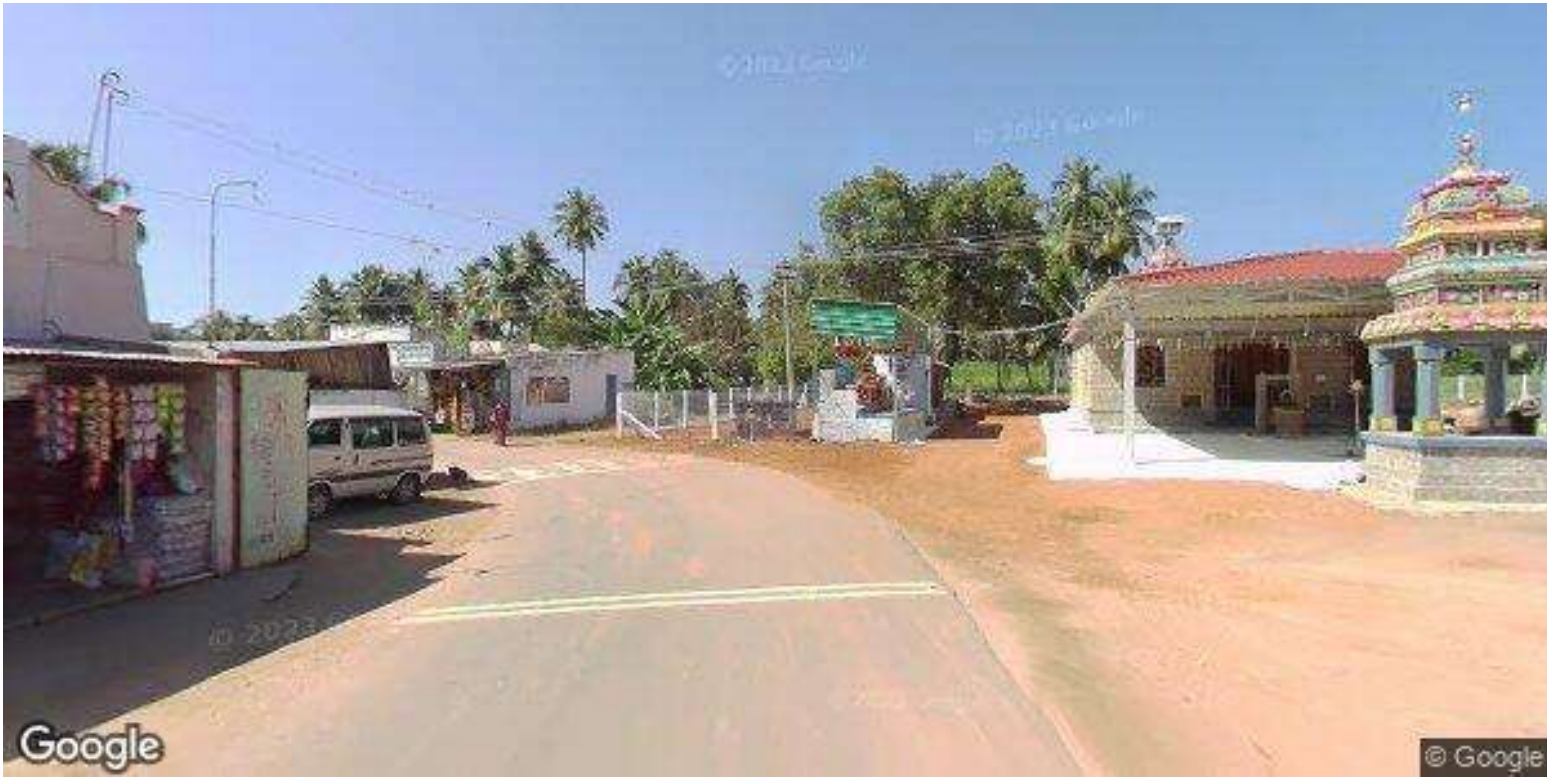
**Risk Type:** Turn  
**Risk Level:** Medium  
**Speed Limit:** 30 KM/Hr  
**Coordinates:** 11.16499, 77.79473

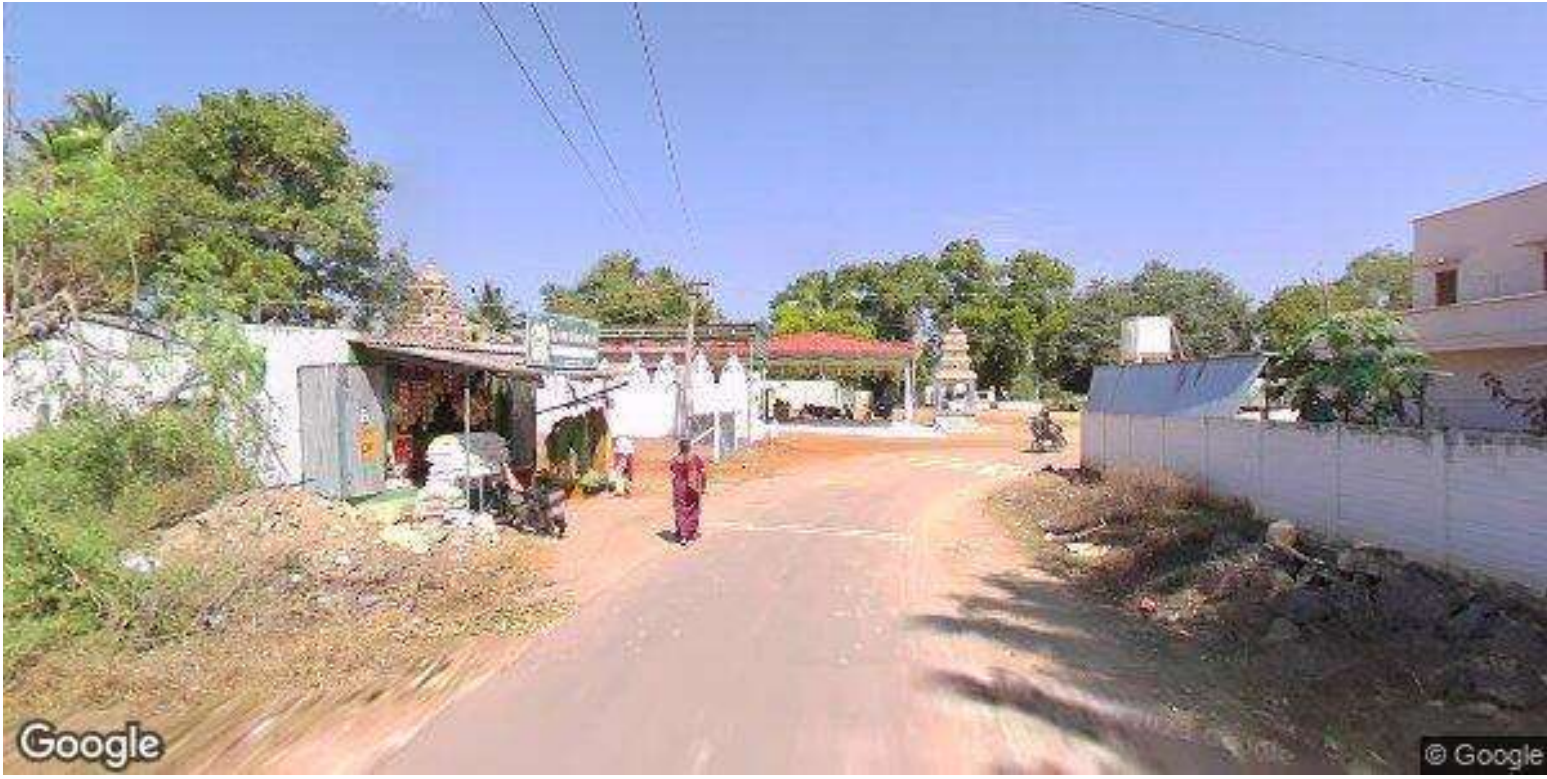
**Risk Type:** Turn  
**Risk Level:** High  
**Speed Limit:** 15 KM/Hr  
**Coordinates:** 11.16470, 77.79449

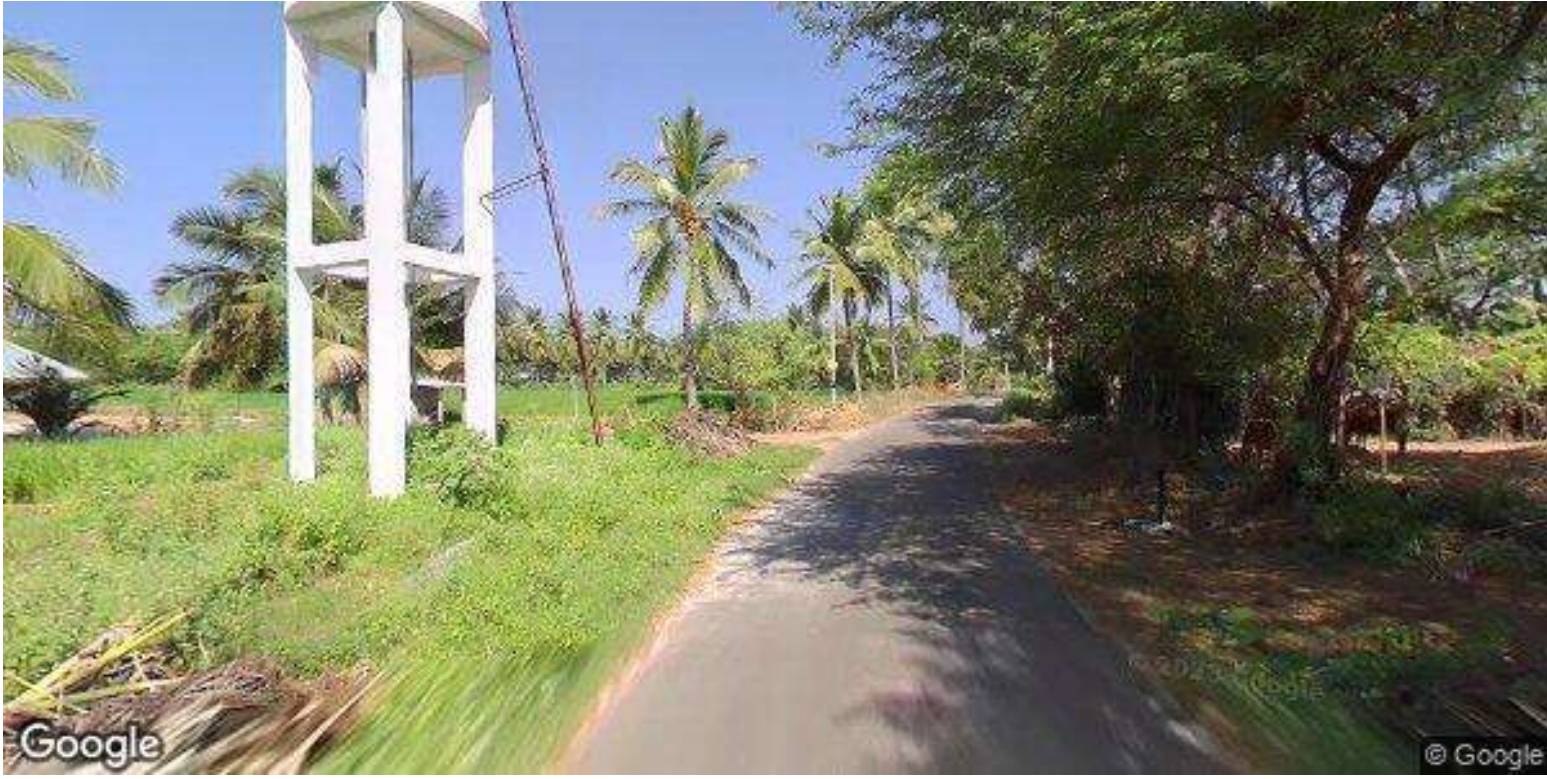
**Risk Type:** Turn  
**Risk Level:** Medium  
**Speed Limit:** 30 KM/Hr  
**Coordinates:** 11.16107, 77.79366

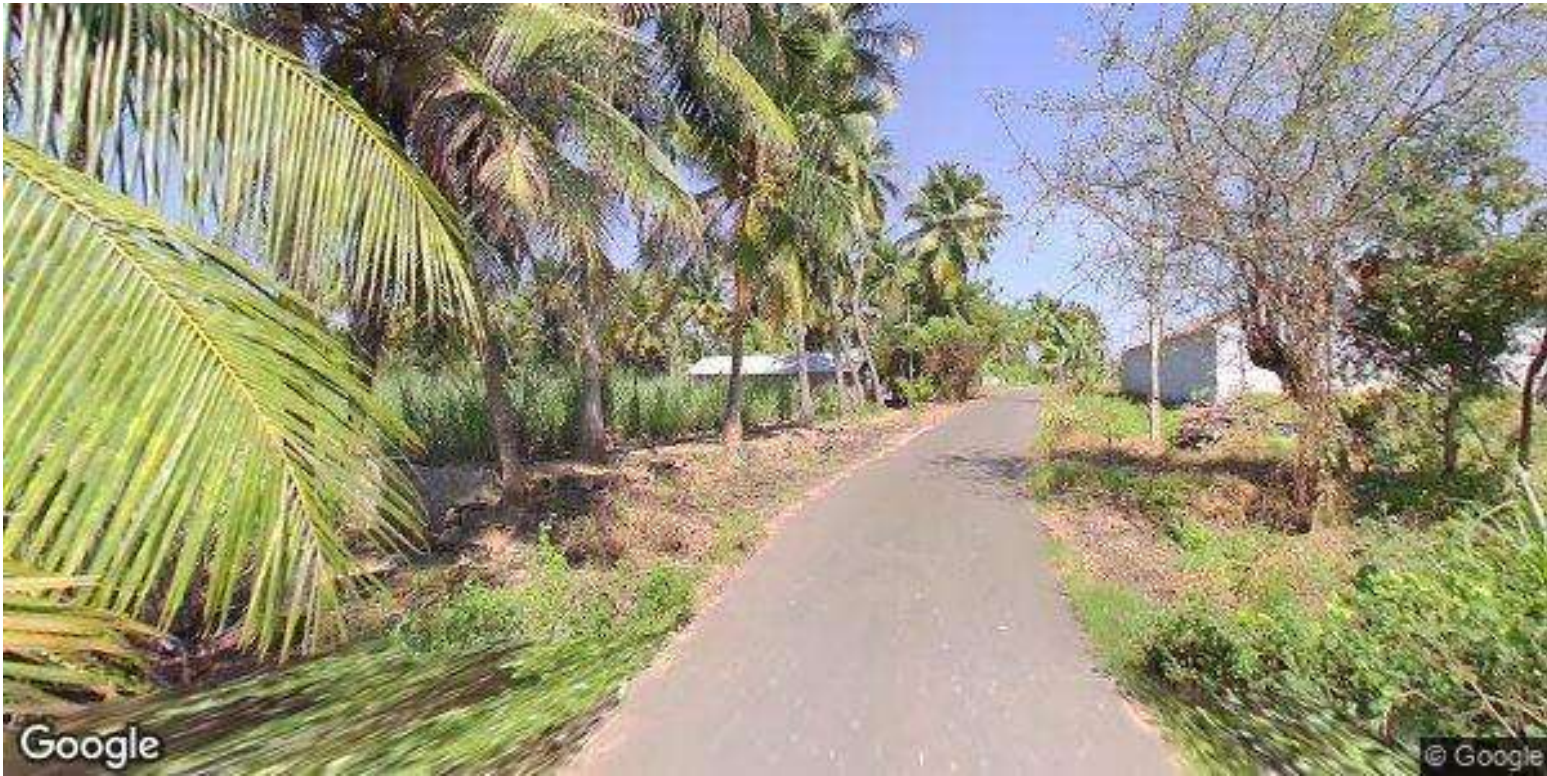
**Risk Type:** Turn  
**Risk Level:** Medium  
**Speed Limit:** 30 KM/Hr  
**Coordinates:** 11.15590, 77.79390

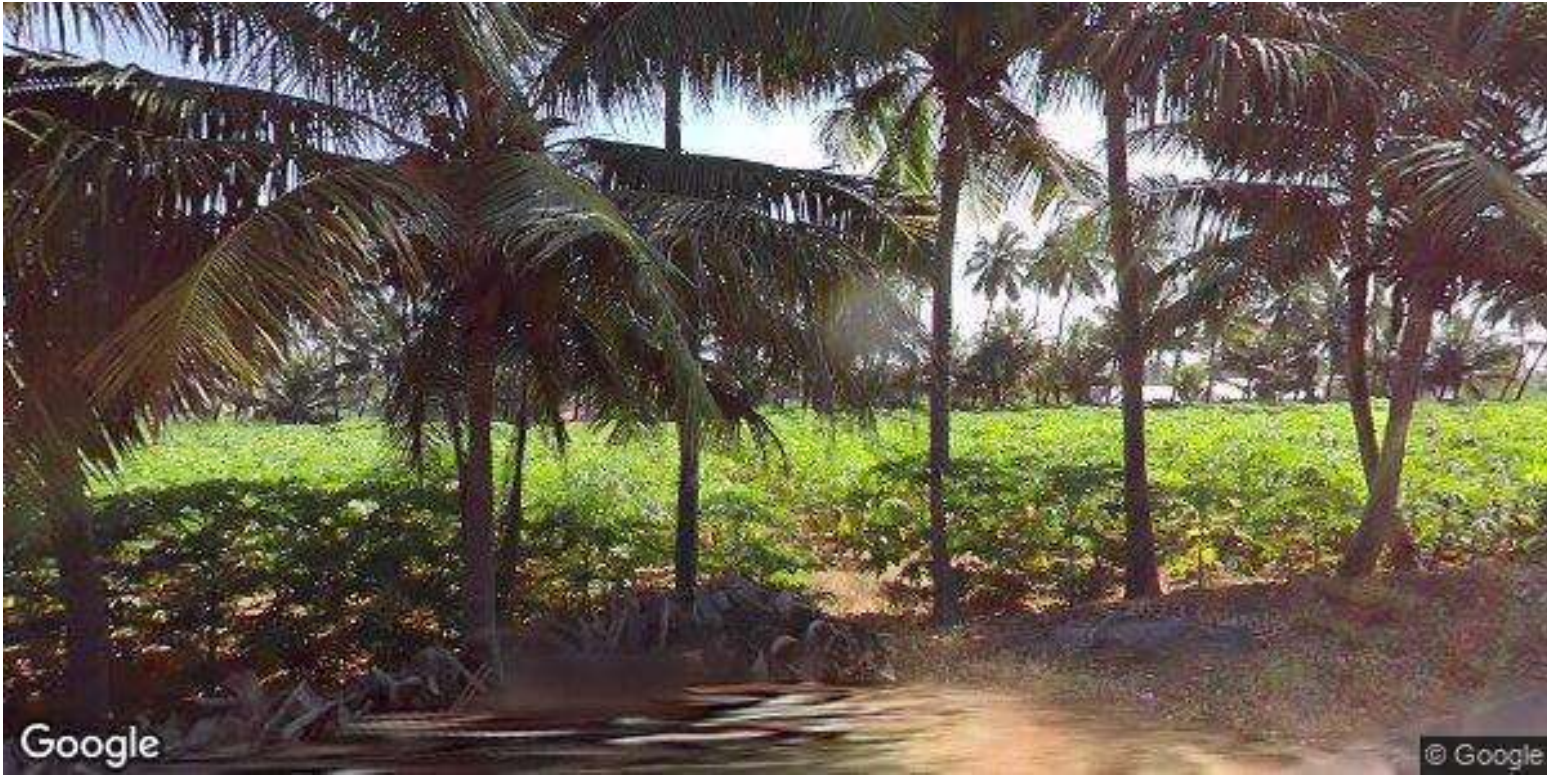
**Risk Type:** Turn  
**Risk Level:** Medium  
**Speed Limit:** 30 KM/Hr  
**Coordinates:** 11.15044, 77.79729

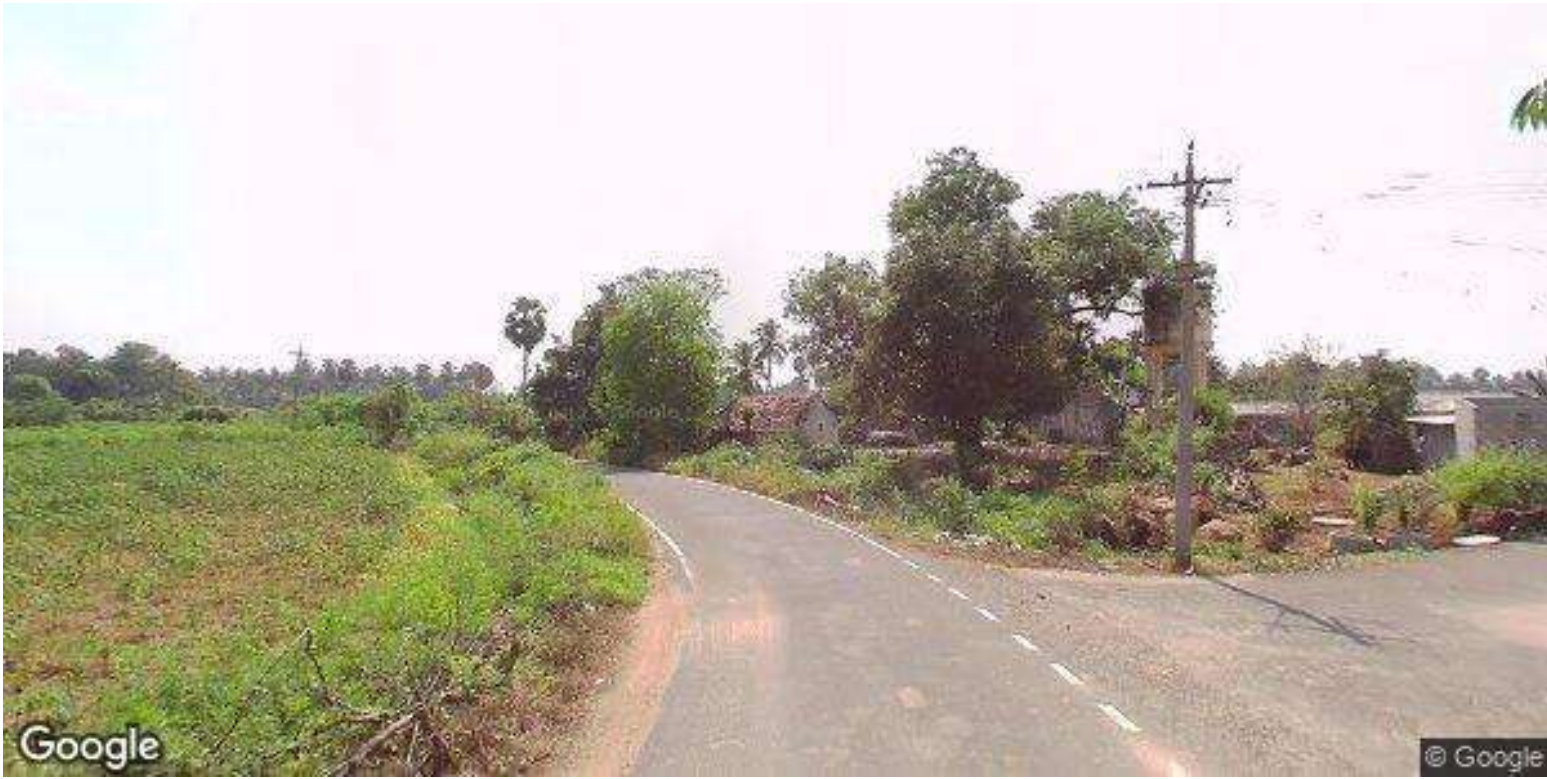
**Risk Type:** Turn  
**Risk Level:** Medium  
**Speed Limit:** 30 KM/Hr  
**Coordinates:** 11.13966, 77.79872
