## JOURNEY RISK MANAGEMENT (JRM) STUDY

### Salem Terminal TO ERODE PRECISION FARM PRODUCER

Route Analysis Report from CVQF+23W, Sangagiri to 4RG3+9C6, SH 84C, Tamil Nadu

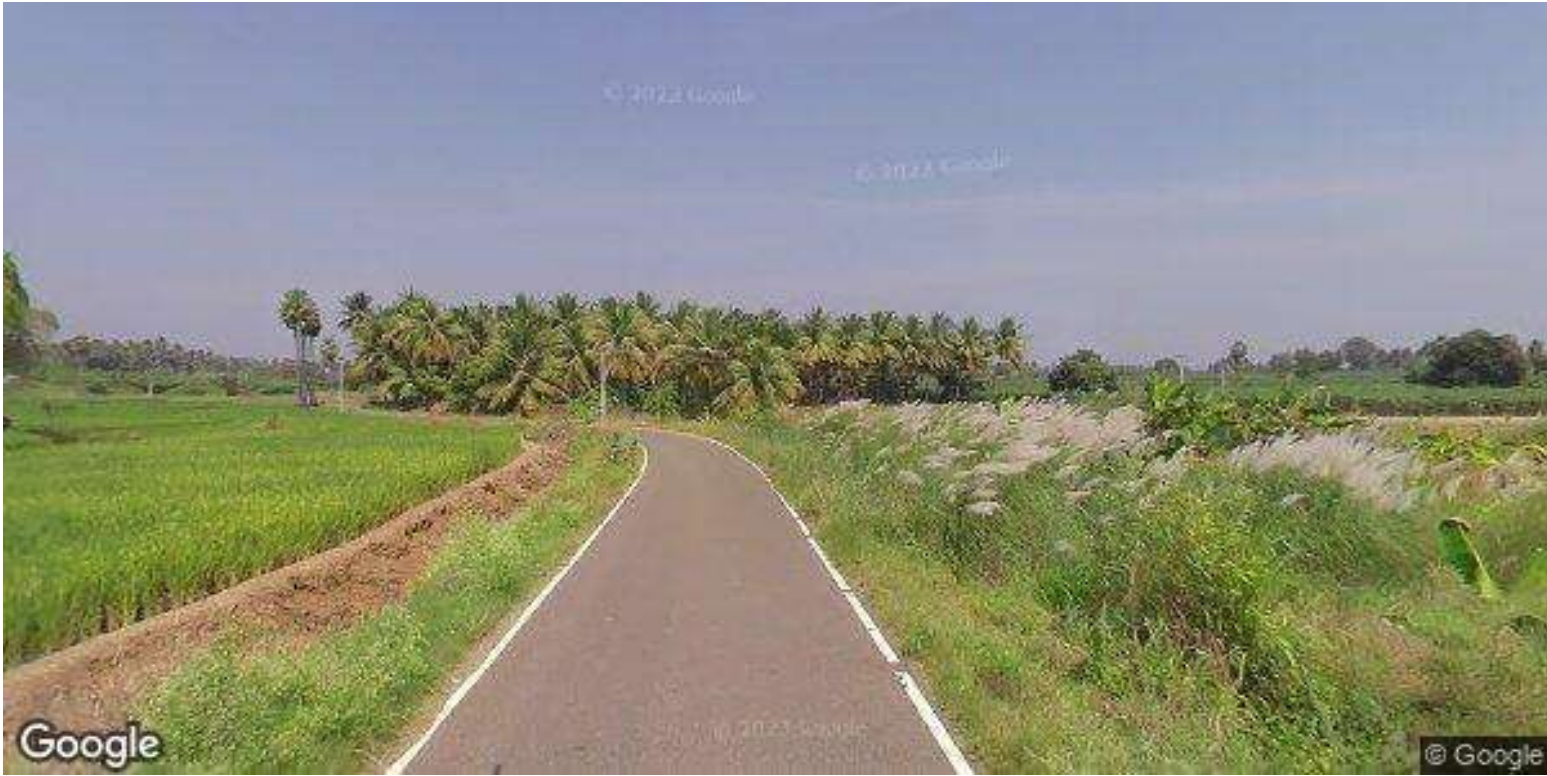
**Risk Type:** Turn  
**Risk Level:** Medium  
**Speed Limit:** 30 KM/Hr  
**Coordinates:** 11.13645, 77.80023

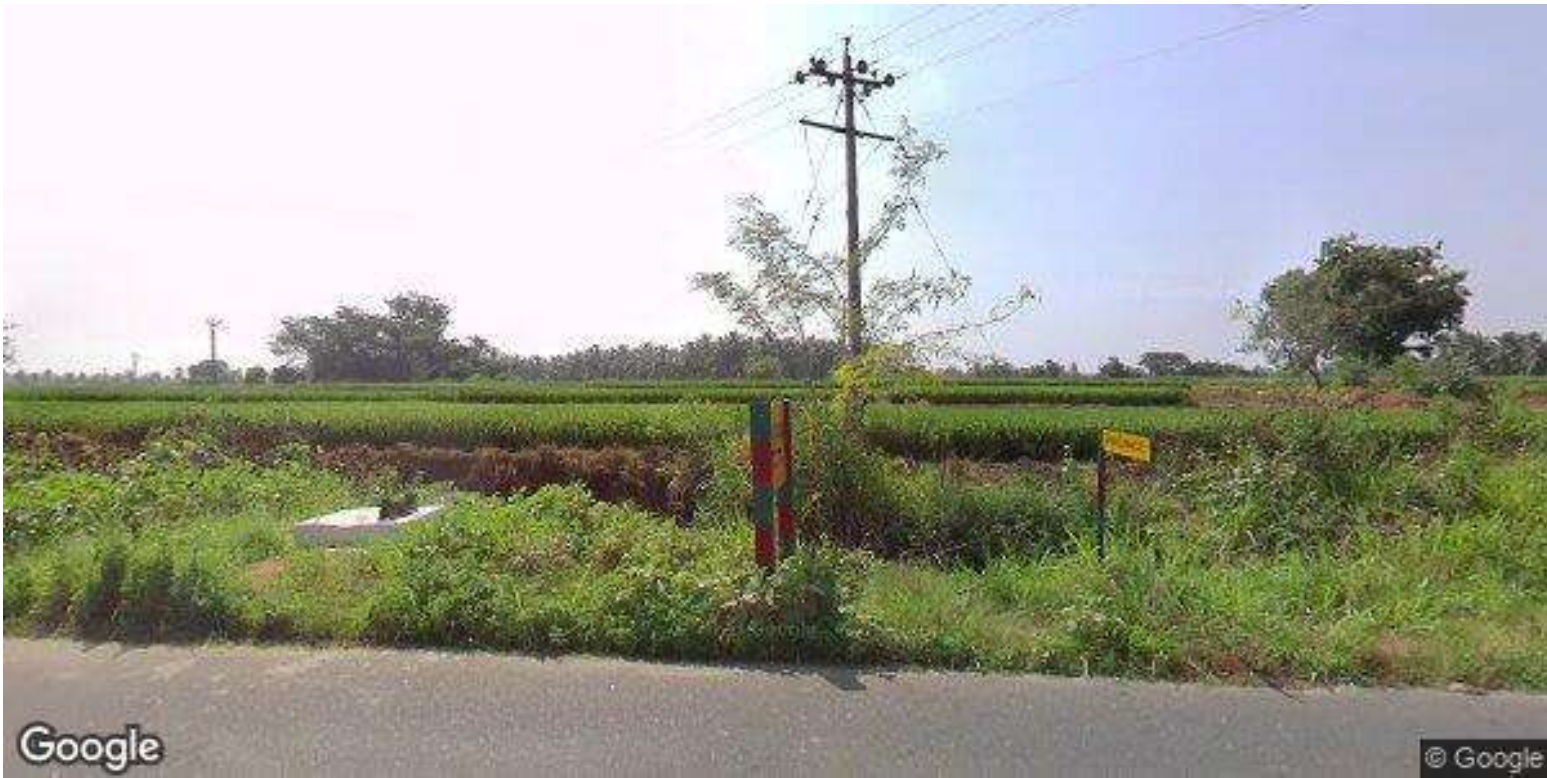
**Risk Type:** Turn  
**Risk Level:** High  
**Speed Limit:** 15 KM/Hr  
**Coordinates:** 11.13519, 77.79955

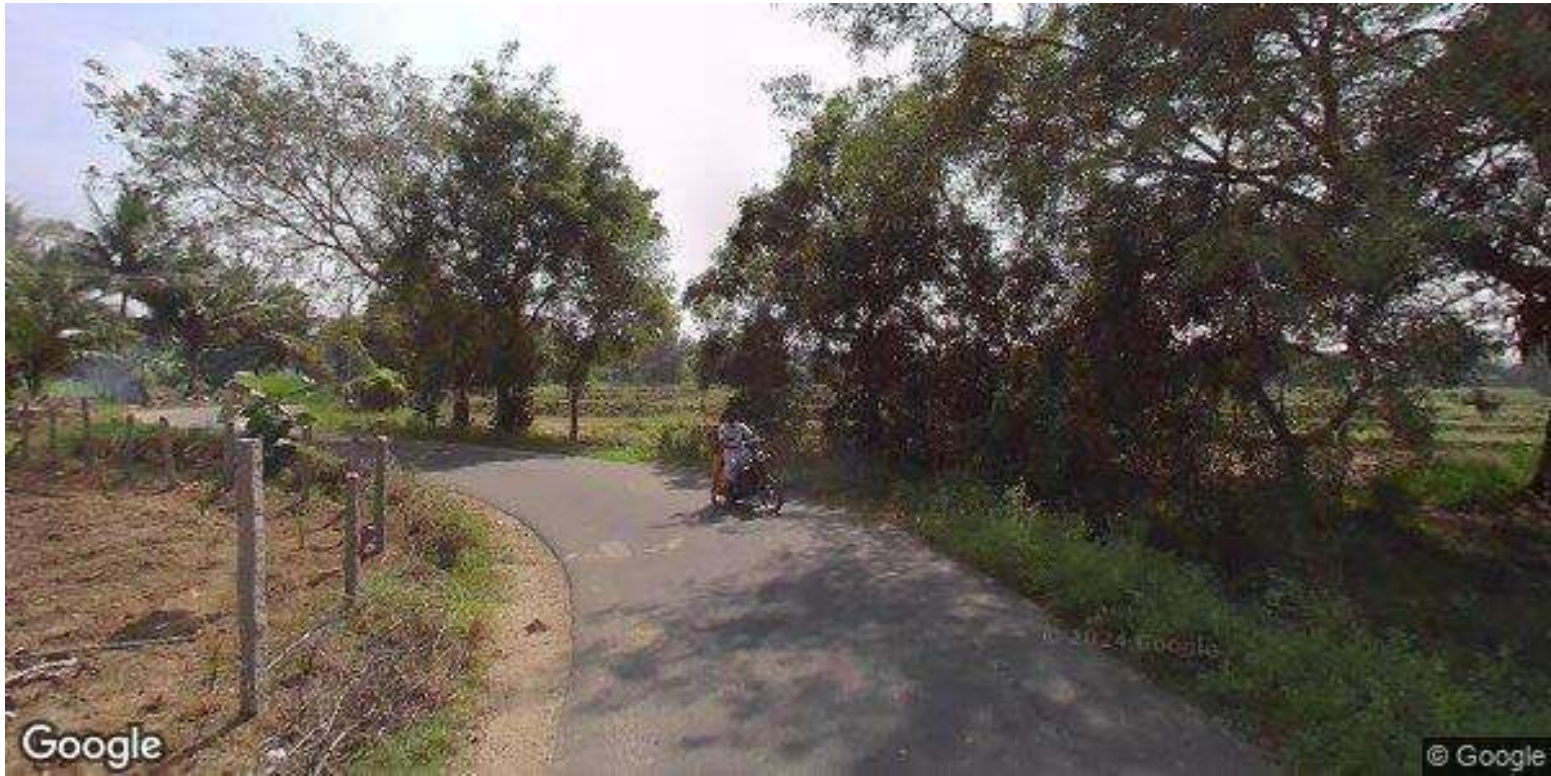
**Risk Type:** Turn  
**Risk Level:** High  
**Speed Limit:** 15 KM/Hr  
**Coordinates:** 11.13046, 77.80159

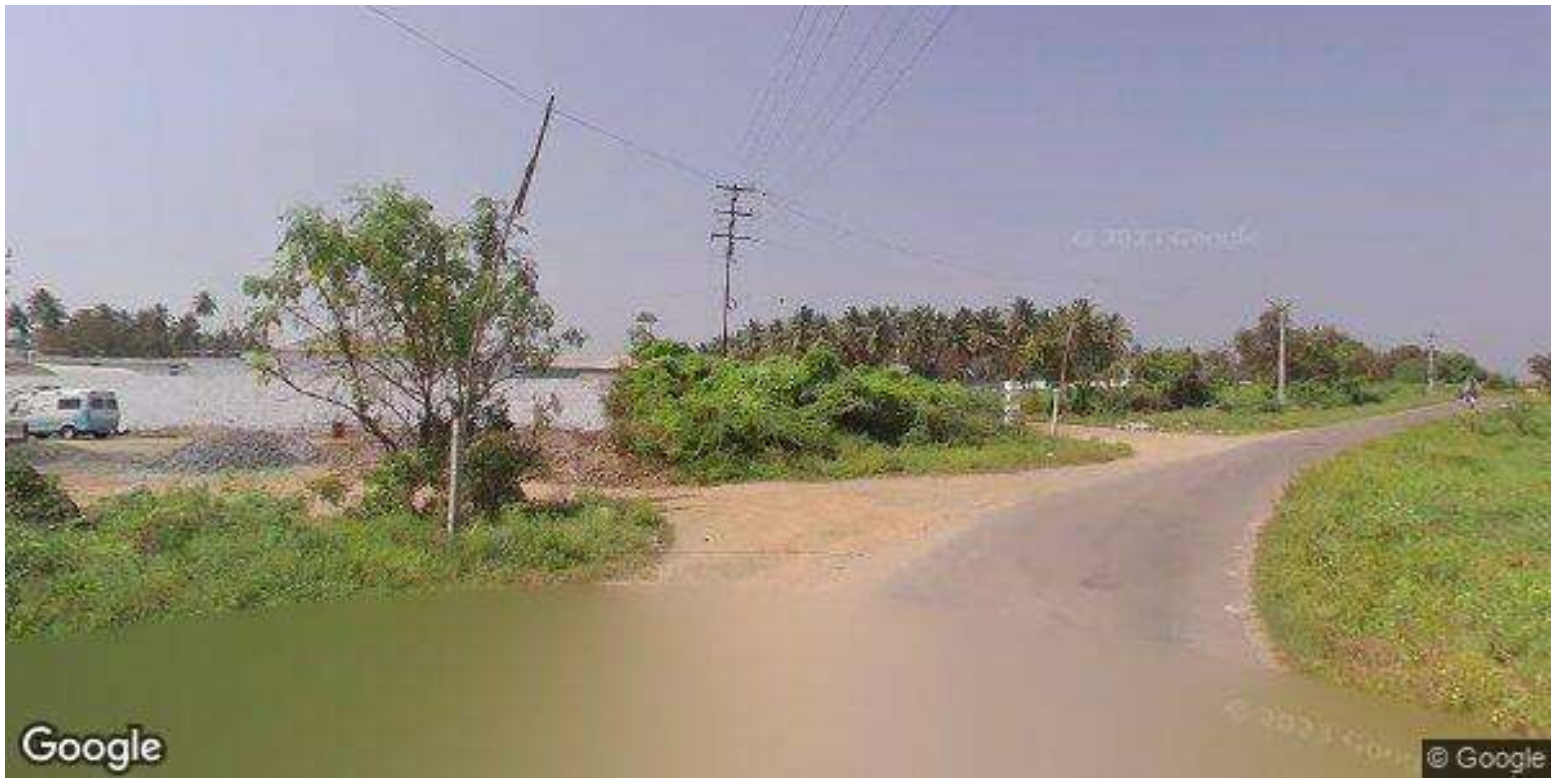
**Risk Type:** Turn  
**Risk Level:** Medium  
**Speed Limit:** 30 KM/Hr  
**Coordinates:** 11.12680, 77.80416

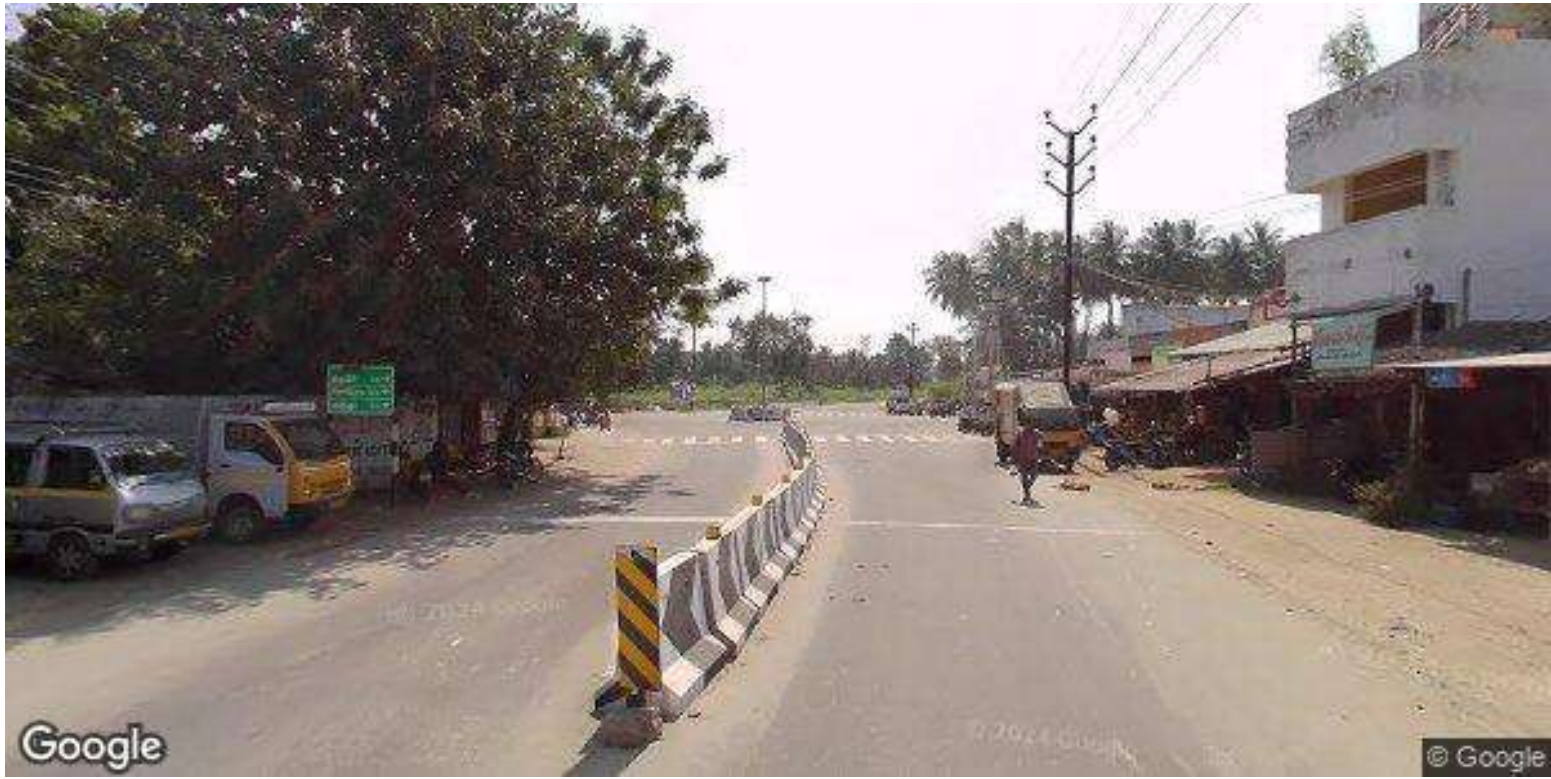
**Risk Type:** Turn  
**Risk Level:** High  
**Speed Limit:** 15 KM/Hr  
**Coordinates:** 11.12661, 77.80462

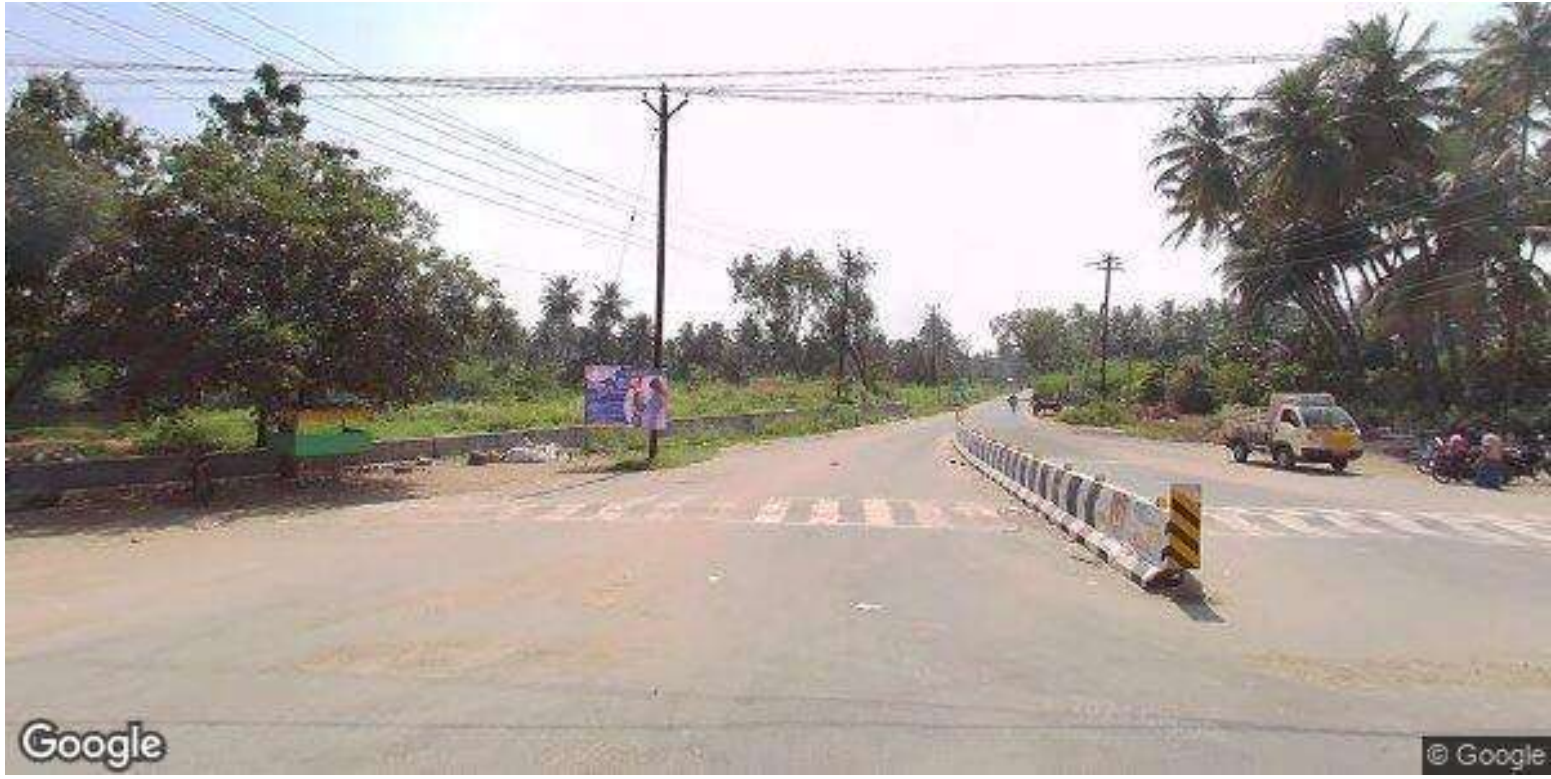
**Risk Type:** Turn  
**Risk Level:** High  
**Speed Limit:** 15 KM/Hr  
**Coordinates:** 11.12613, 77.80463
