# IndianOil

## JOURNEY RISK MANAGEMENT (JRM) STUDY

### Salem Terminal to AADHINI AGENCY

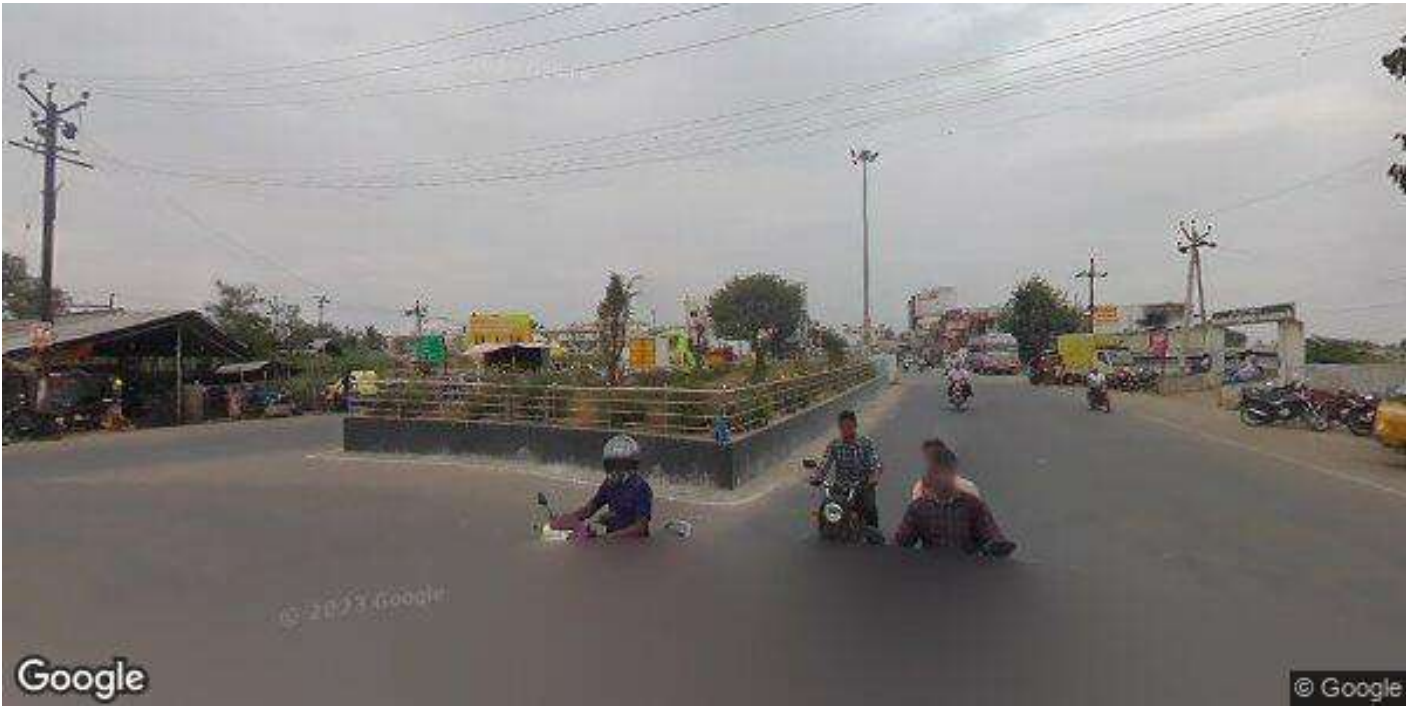
Risk Type: Roundabout  
Risk Level: High  
Speed Limit: 15 KM/Hr  
Coordinates: 11.58435, 77.83651

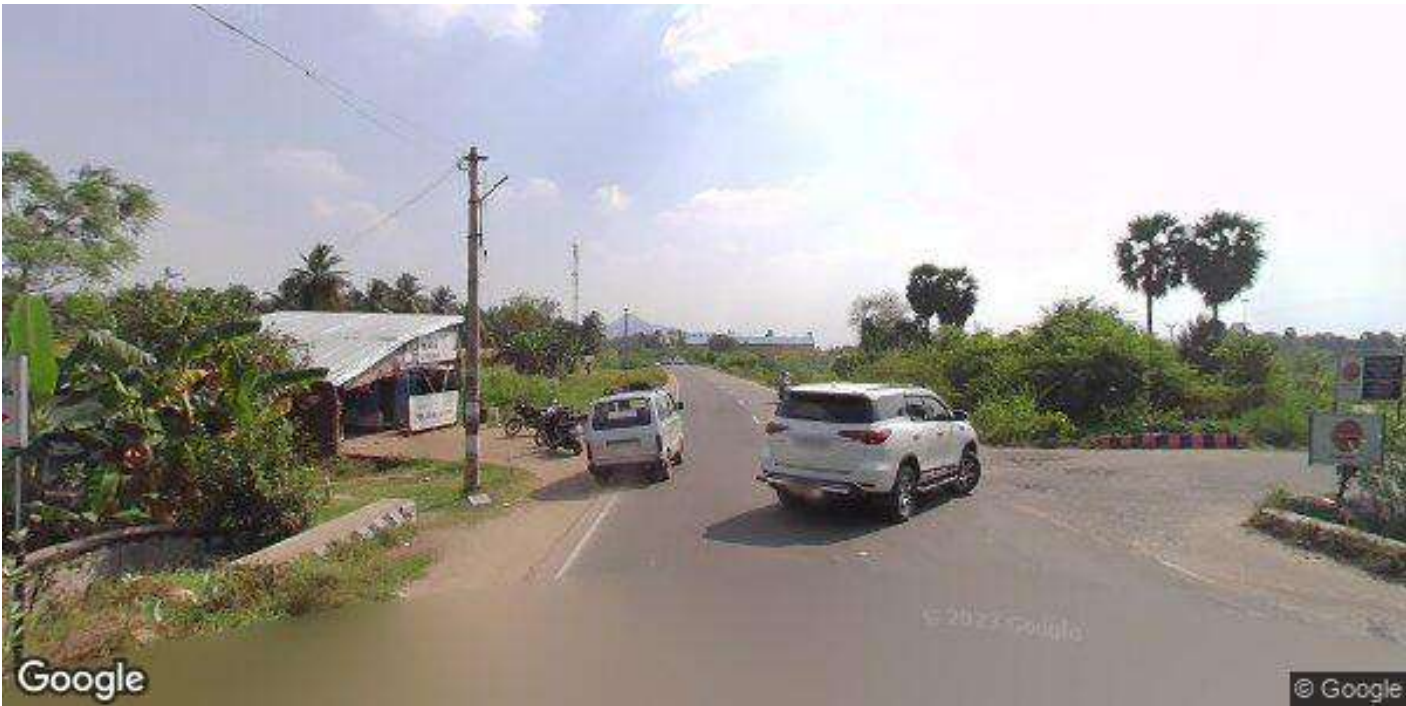
Risk Type: Turn  
Risk Level: High  
Speed Limit: 15 KM/Hr  
Coordinates: 11.44029, 77.87544

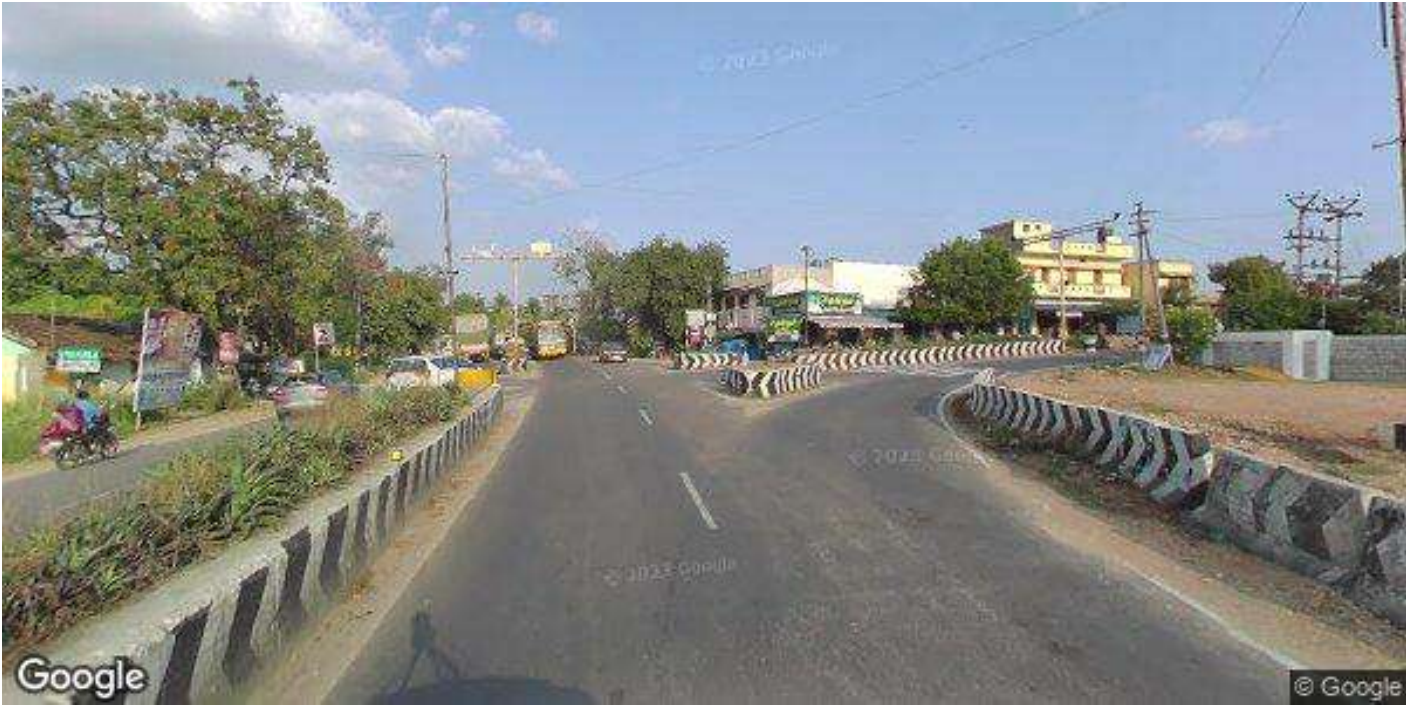
**Risk Type:** Turn  
**Risk Level:** Medium  
**Speed Limit:** 30 KM/Hr  
**Coordinates:** 11.46318, 77.84913

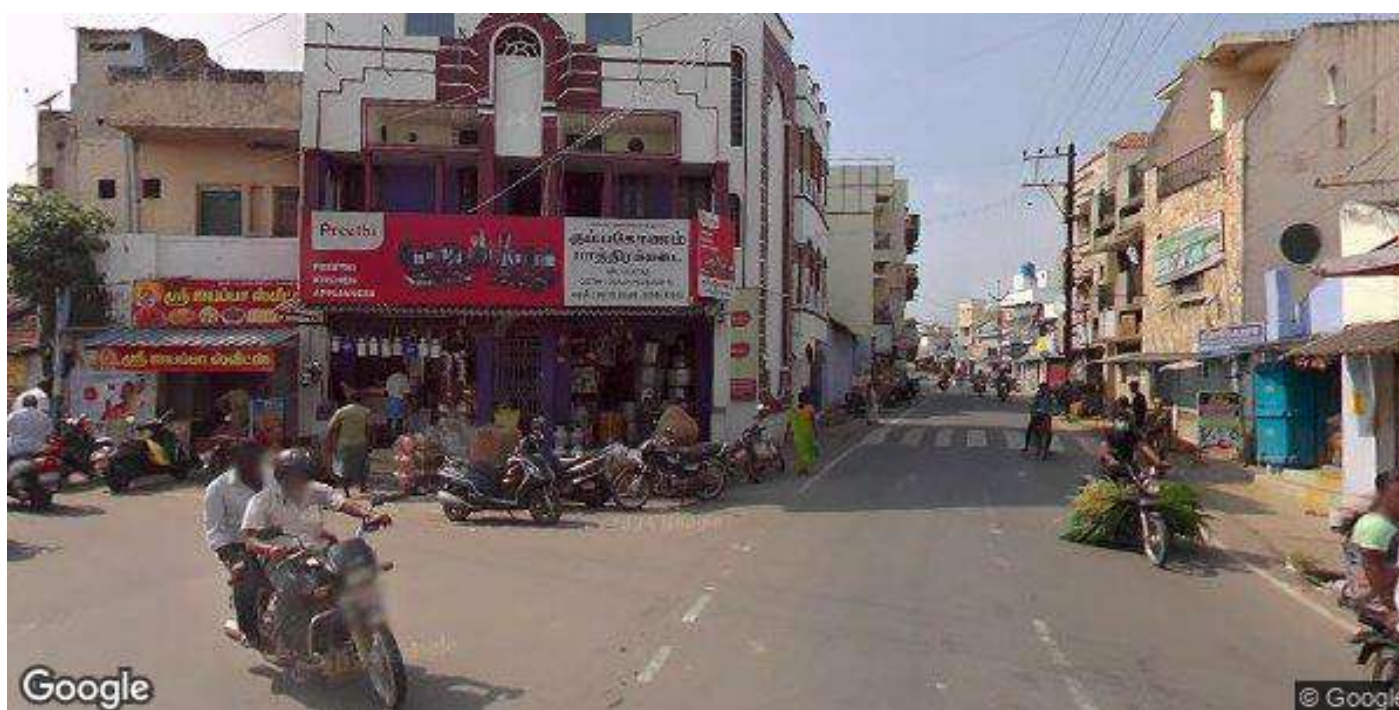
**Risk Type:** Turn  
**Risk Level:** High  
**Speed Limit:** 15 KM/Hr  
**Coordinates:** 11.58533, 77.83450

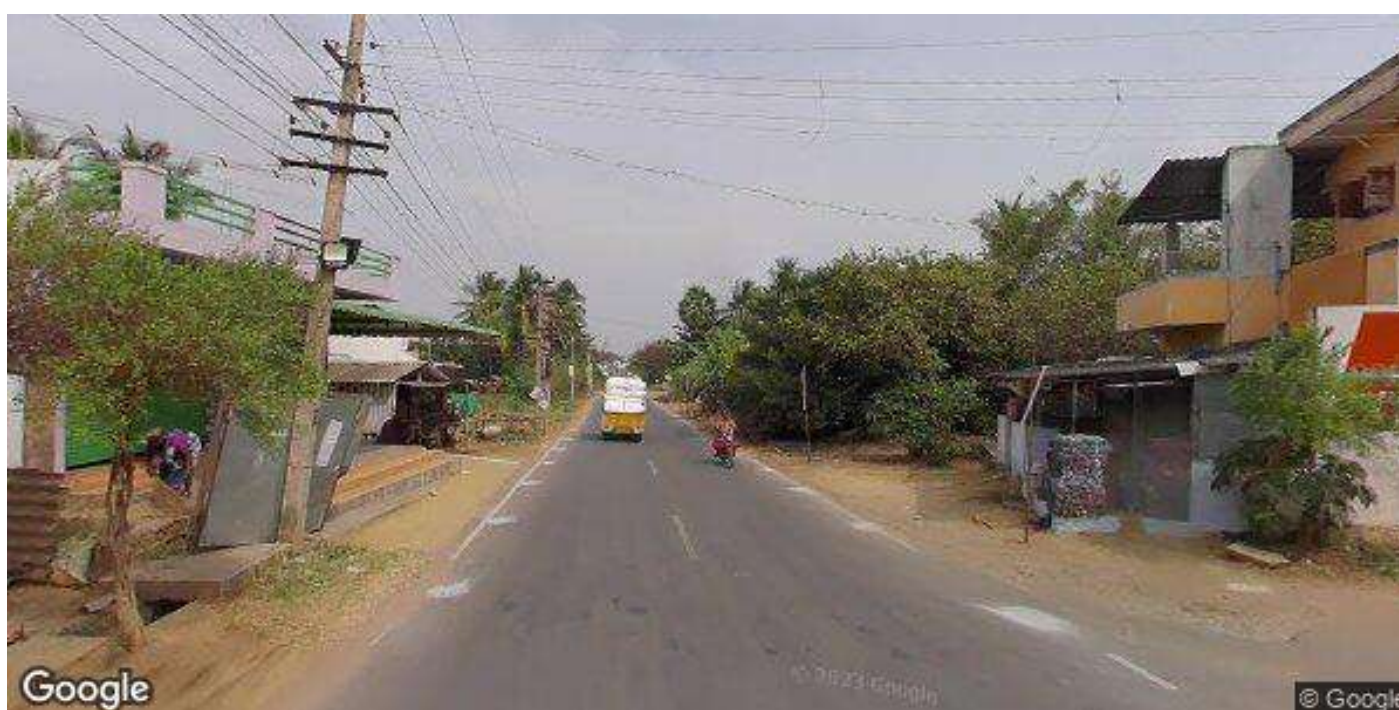
**Risk Type:** Turn  
**Risk Level:** High  
**Speed Limit:** 15 KM/Hr  
**Coordinates:** 11.58052, 77.82229

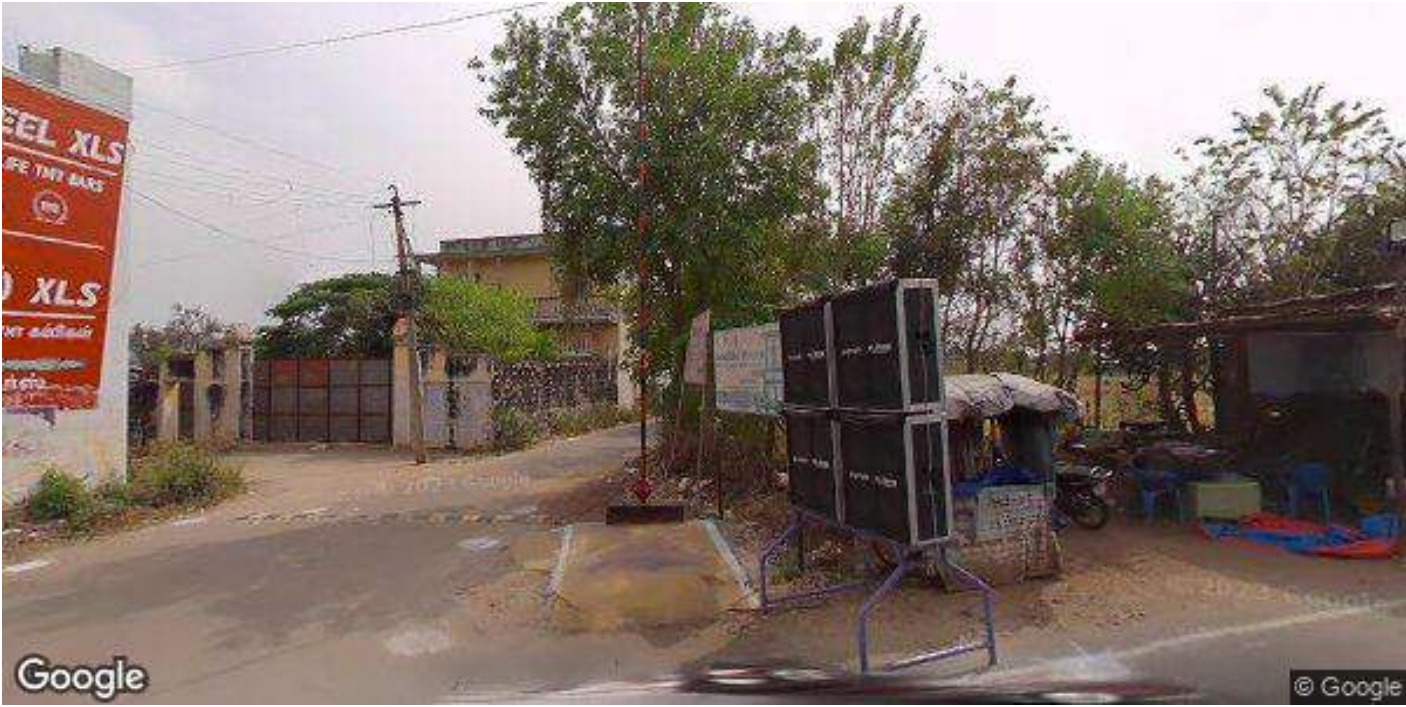
**Risk Type:** Blind Spot  
**Risk Level:** Blind Spot  
**Speed Limit:** 10 KM/Hr  
**Coordinates:** 11.58039, 77.82224
