# IndianOil

## JOURNEY RISK MANAGEMENT (JRM) STUDY

### Salem Terminal to SANTHOSH AGENCIES

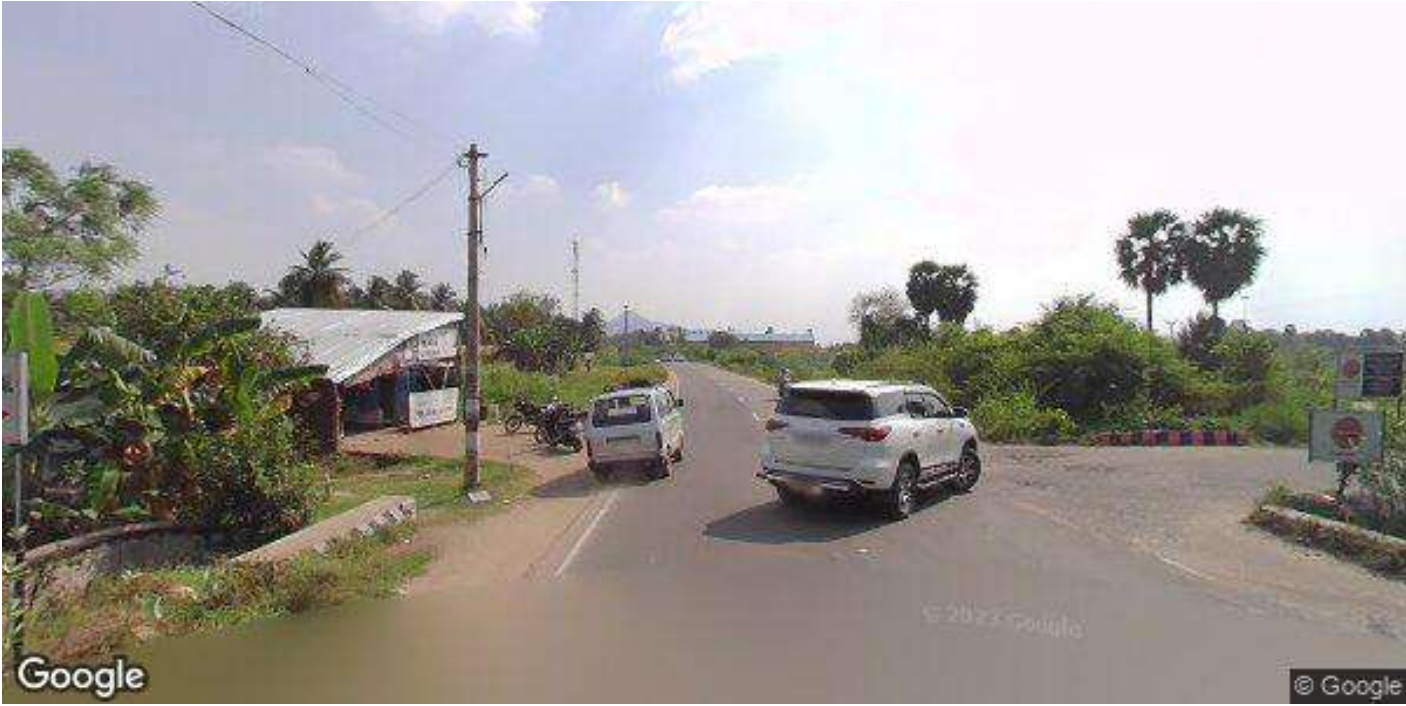
Risk Type: Blind Spot  
Risk Level: Blind Spot  
Speed Limit: 10 KM/Hr  
Coordinates: 11.44029, 77.87544

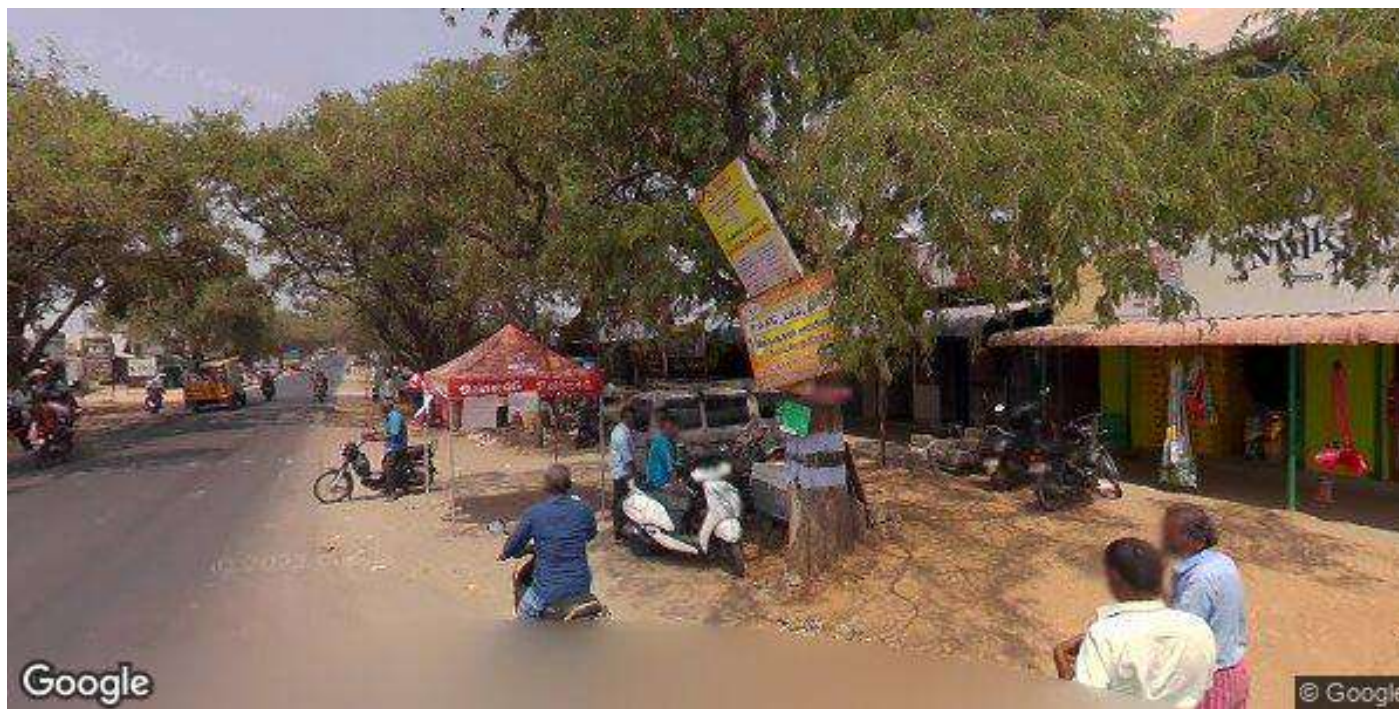
**Risk Type:** Blind Spot  
**Risk Level:** Blind Spot  
**Speed Limit:** 10 KM/Hr  
**Coordinates:** 11.41981, 77.88078

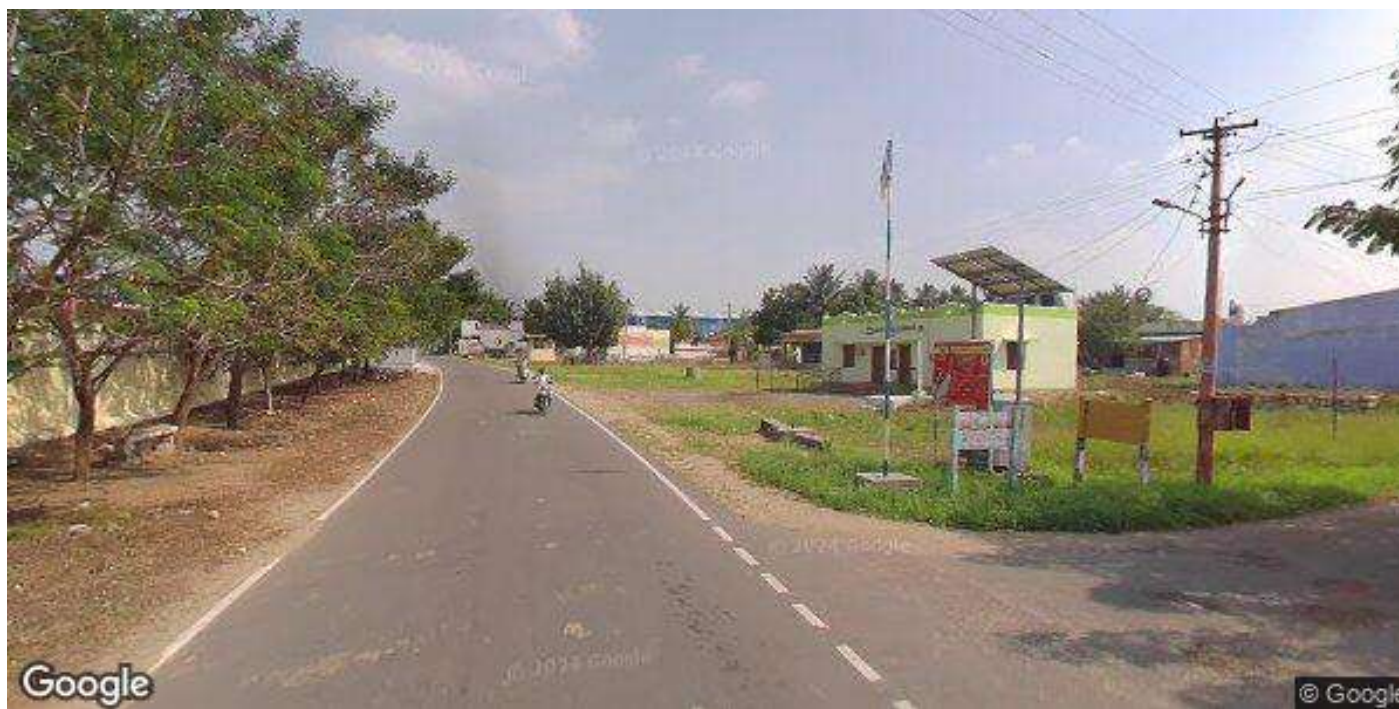
**Risk Type:** Blind Spot  
**Risk Level:** Blind Spot  
**Speed Limit:** 10 KM/Hr  
**Coordinates:** 11.42333, 77.87394

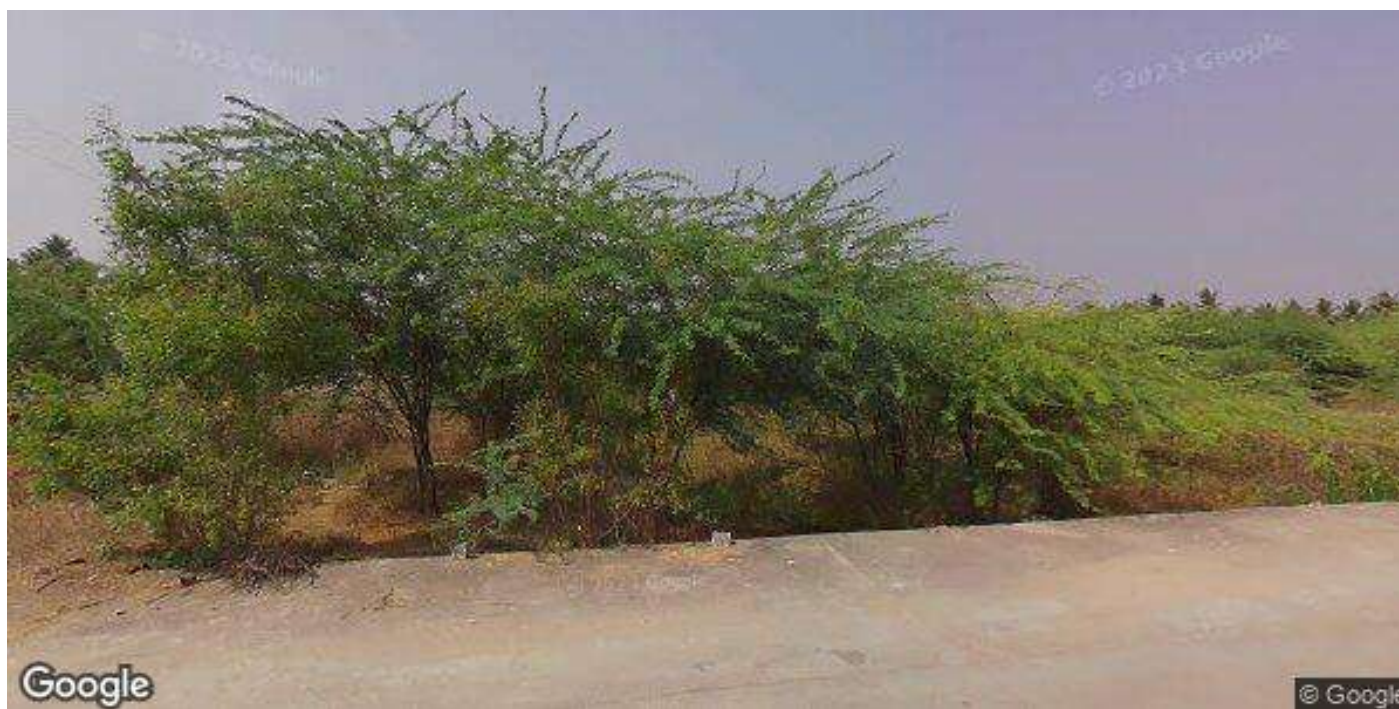
**Risk Type:** Turn  
**Risk Level:** High  
**Speed Limit:** 15 KM/Hr  
**Coordinates:** 11.41917, 77.87022

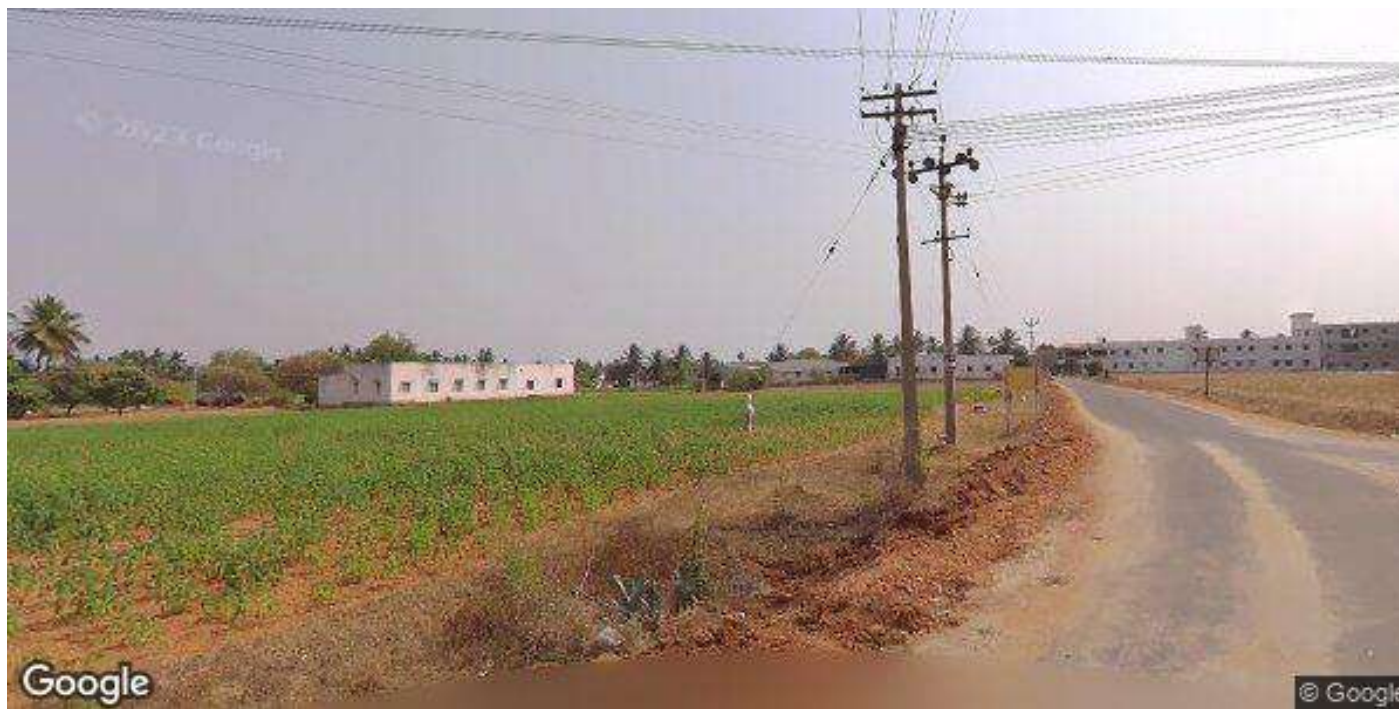
**Risk Type:** Turn  
**Risk Level:** High  
**Speed Limit:** 15 KM/Hr  
**Coordinates:** 11.40478, 77.86020

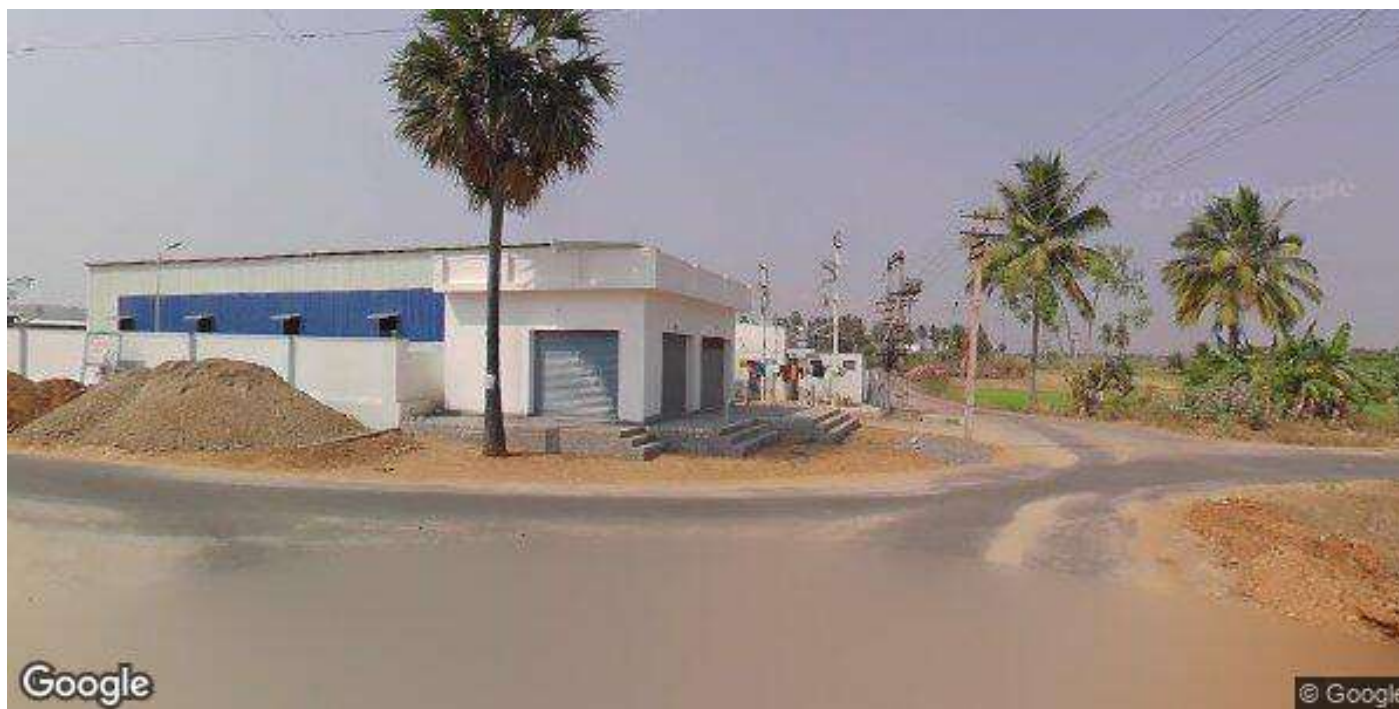
**Risk Type:** Turn  
**Risk Level:** High  
**Speed Limit:** 15 KM/Hr  
**Coordinates:** 11.40471, 77.86004

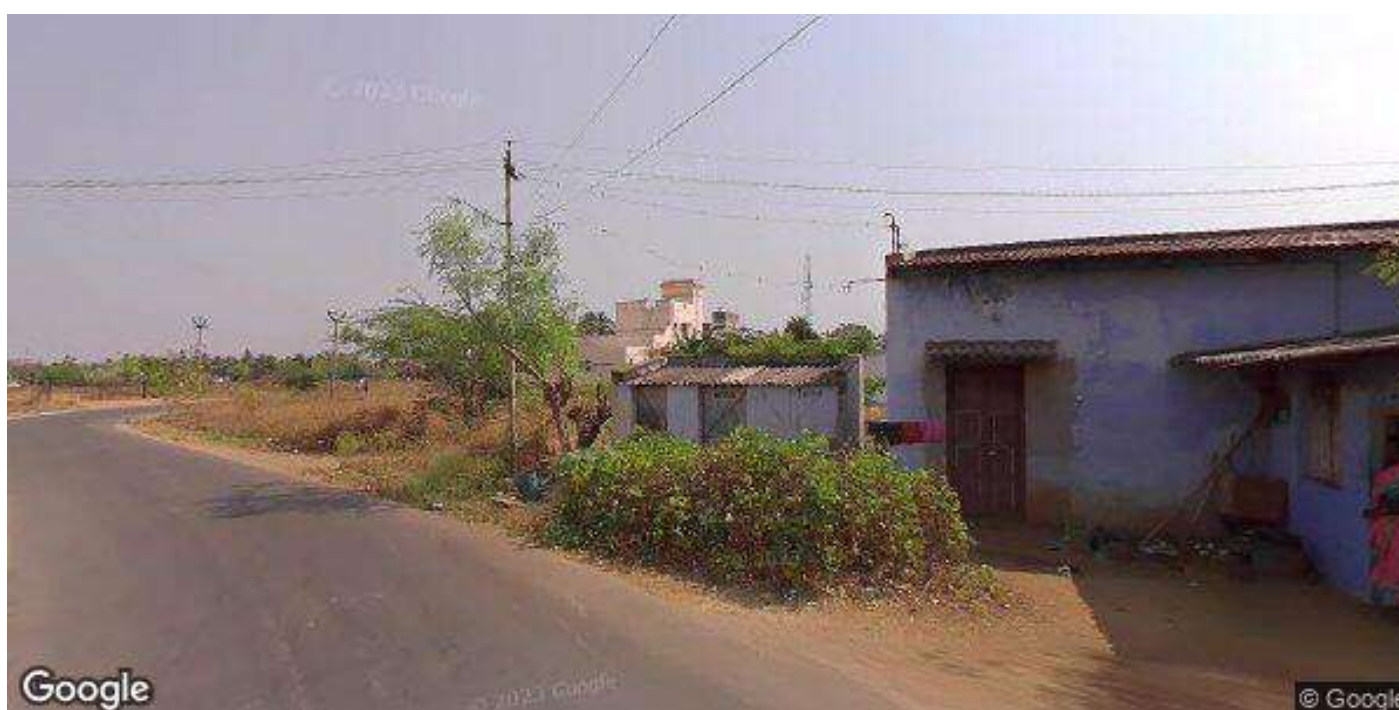
**Risk Type:** Turn  
**Risk Level:** Medium  
**Speed Limit:** 30 KM/Hr  
**Coordinates:** 11.39361, 77.85502

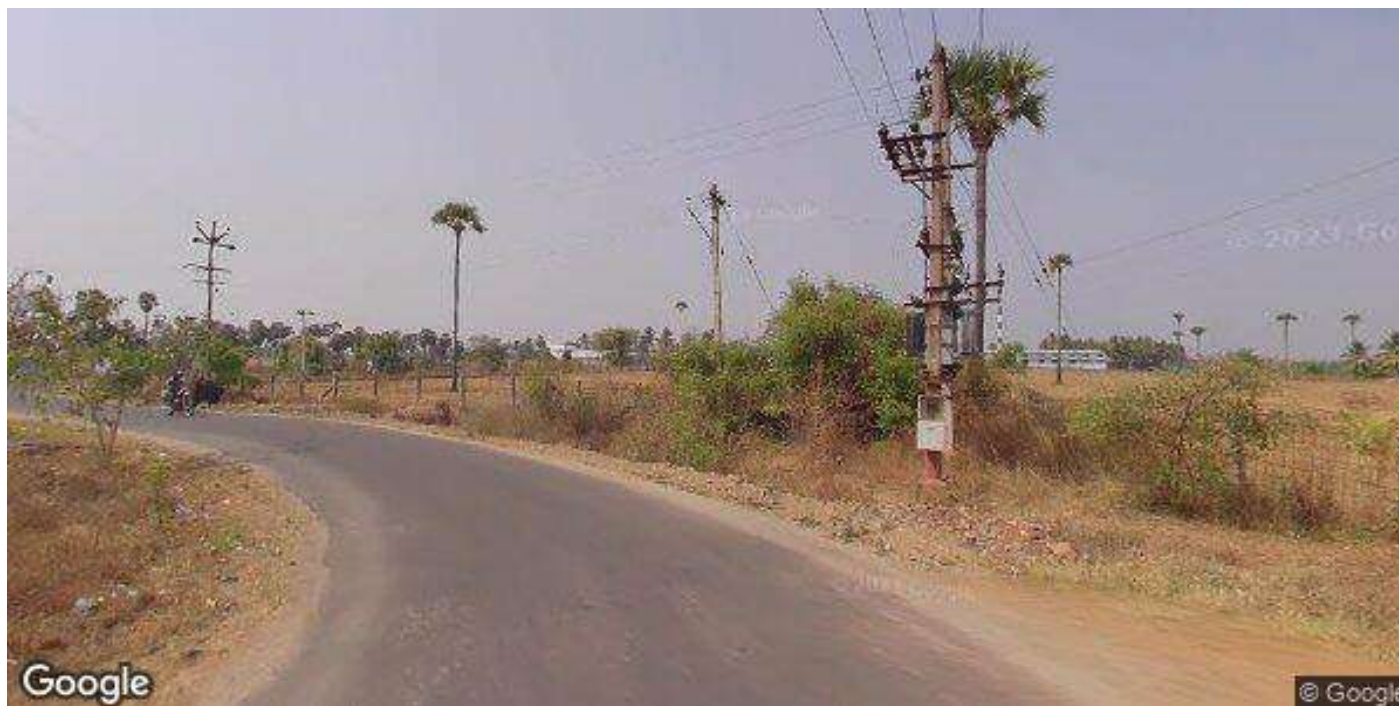
**Risk Type:** Turn  
**Risk Level:** Medium  
**Speed Limit:** 30 KM/Hr  
**Coordinates:** 11.39323, 77.85539

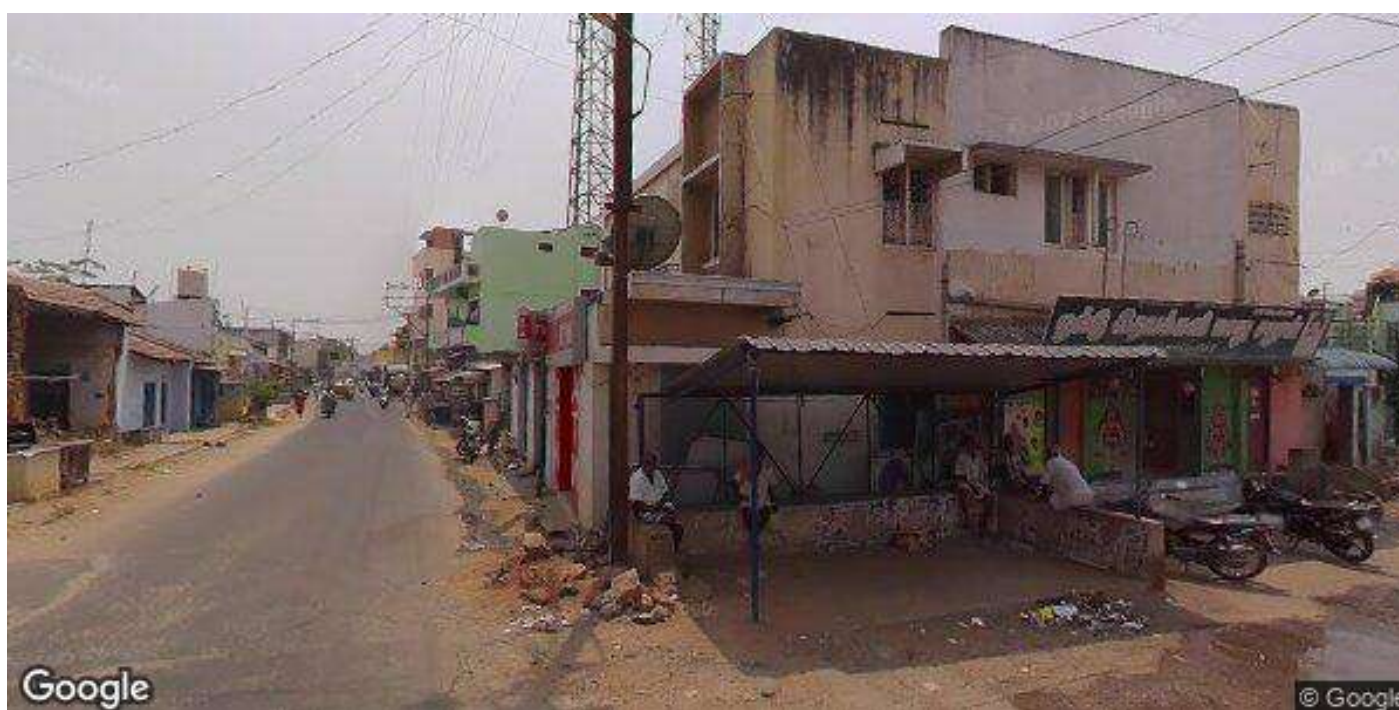
**Risk Type:** Blind Spot  
**Risk Level:** Blind Spot  
**Speed Limit:** 10 KM/Hr  
**Coordinates:** 11.39047, 77.85509

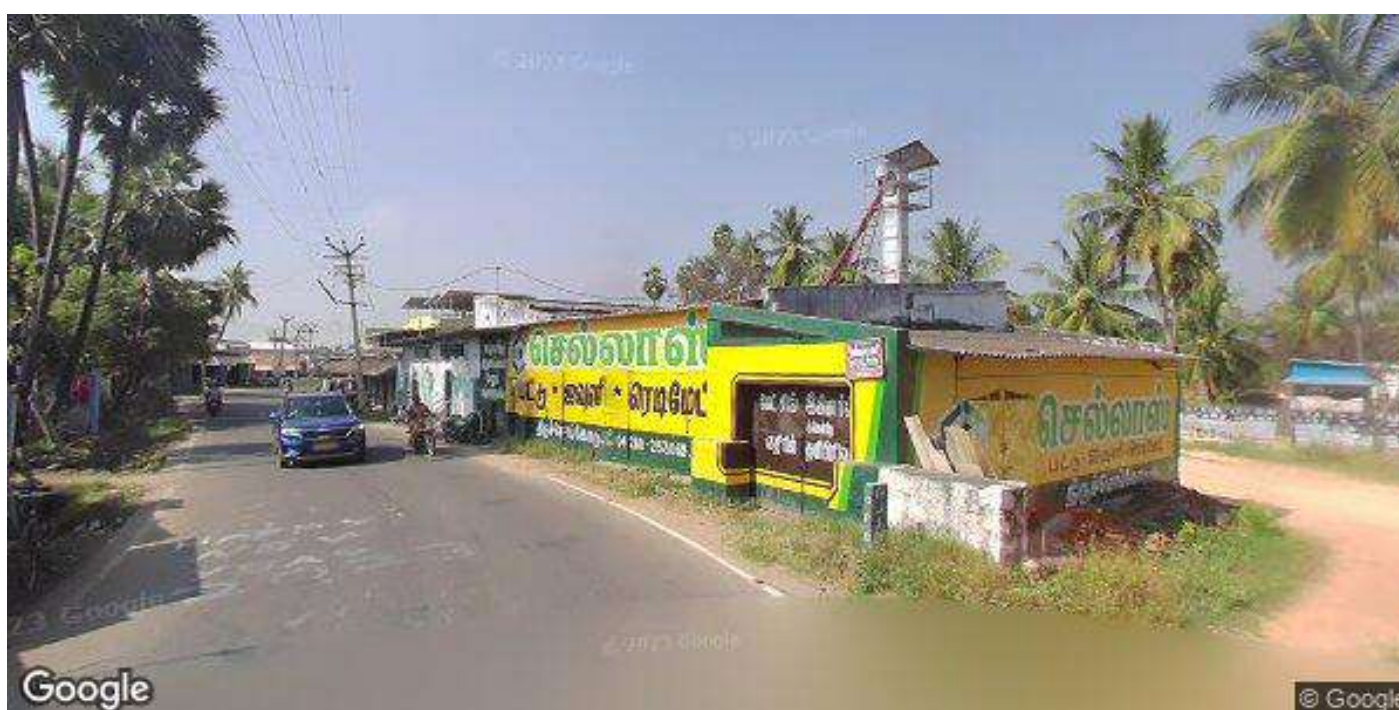
**Risk Type:** Turn  
**Risk Level:** Medium  
**Speed Limit:** 30 KM/Hr  
**Coordinates:** 11.39431, 77.83265

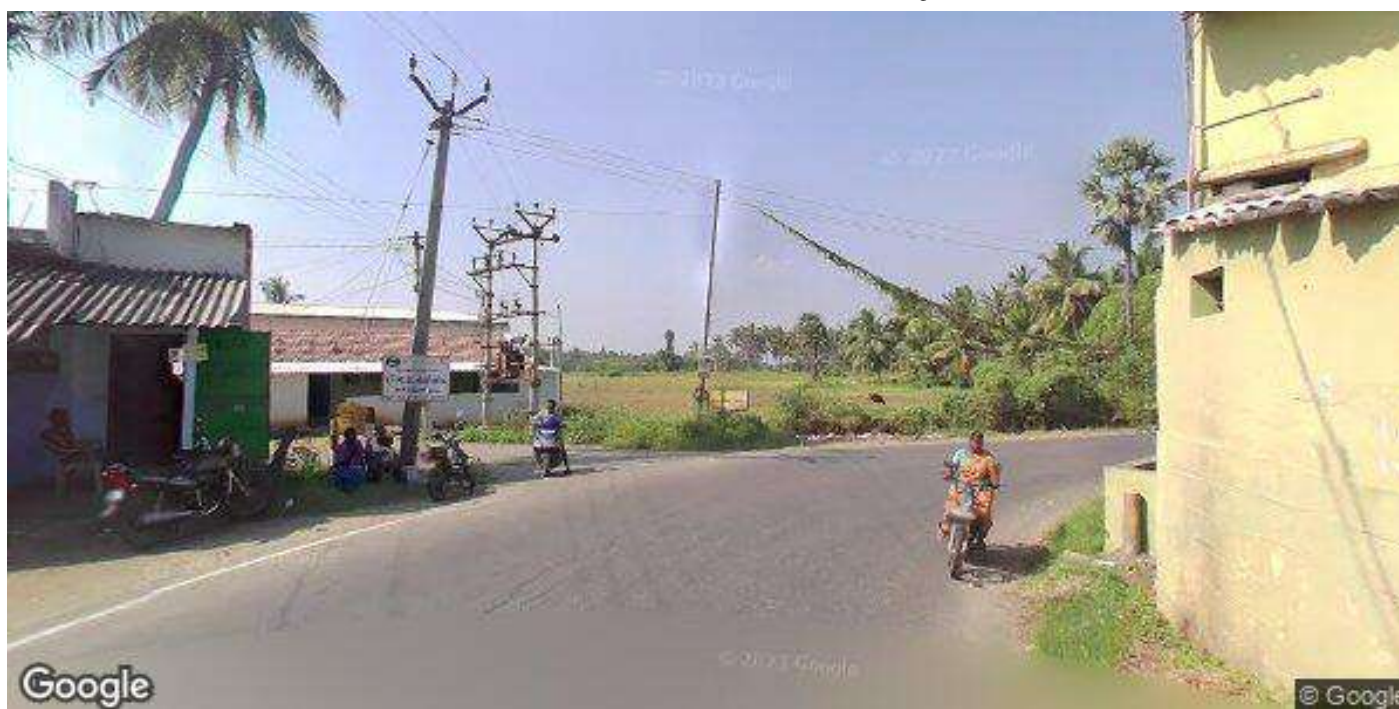
**Risk Type:** Turn  
**Risk Level:** Medium  
**Speed Limit:** 30 KM/Hr  
**Coordinates:** 11.39383, 77.83222

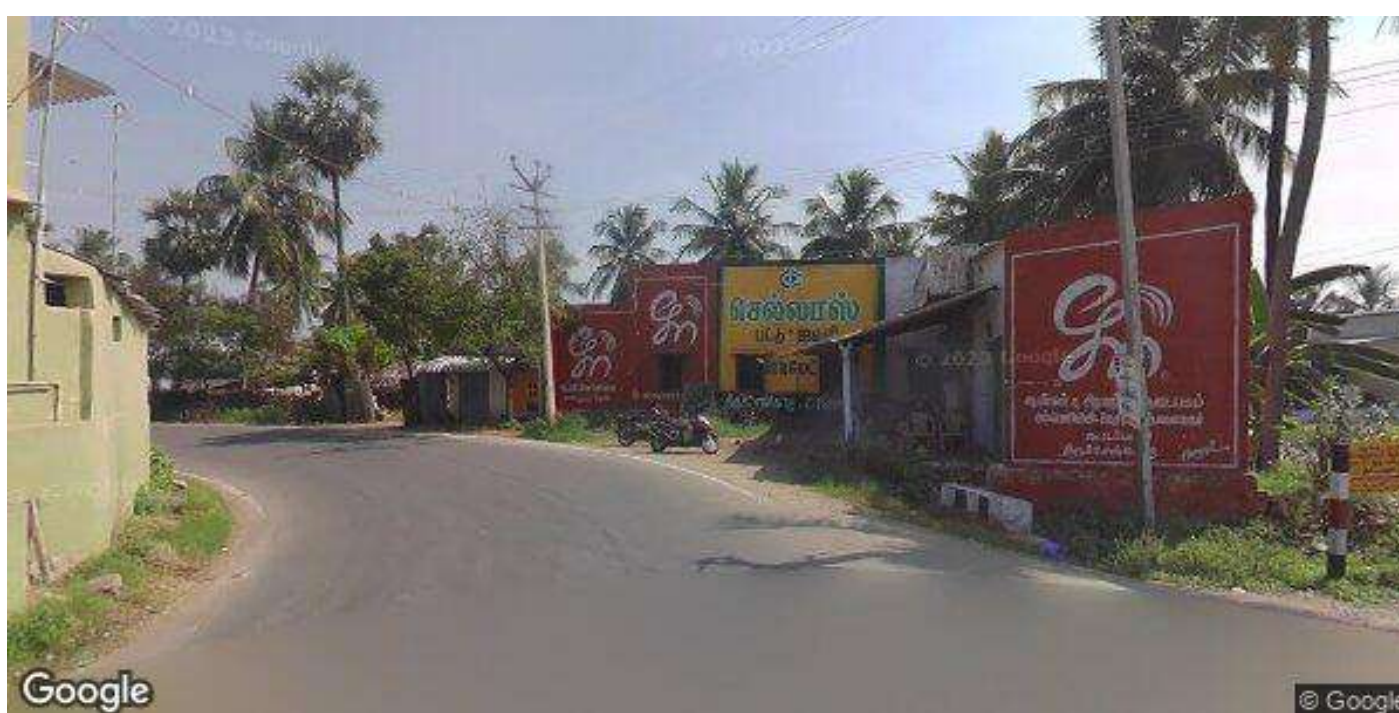
**Risk Type:** Turn  
**Risk Level:** Medium  
**Speed Limit:** 30 KM/Hr  
**Coordinates:** 11.39381, 77.83208

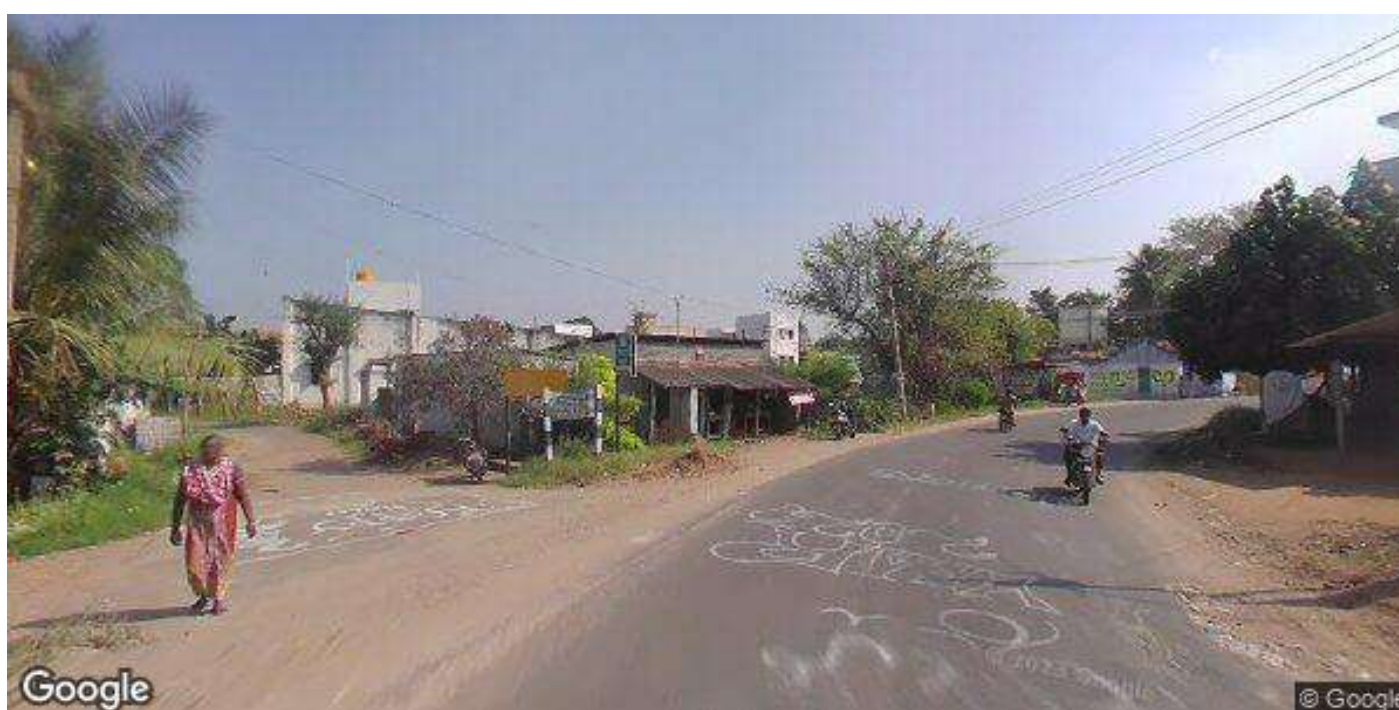
**Risk Type:** Turn  
**Risk Level:** Medium  
**Speed Limit:** 30 KM/Hr  
**Coordinates:** 11.39468, 77.82800

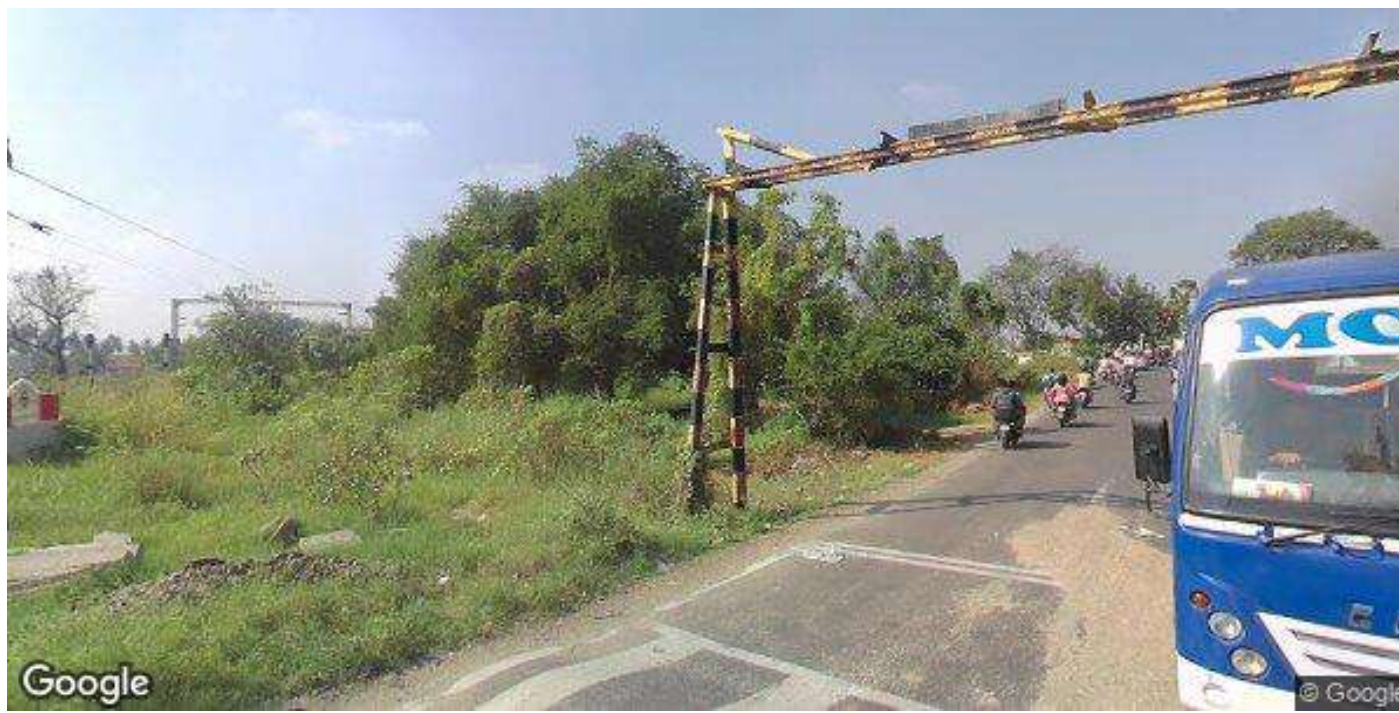
**Risk Type:** Turn  
**Risk Level:** Medium  
**Speed Limit:** 30 KM/Hr  
**Coordinates:** 11.39692, 77.81974

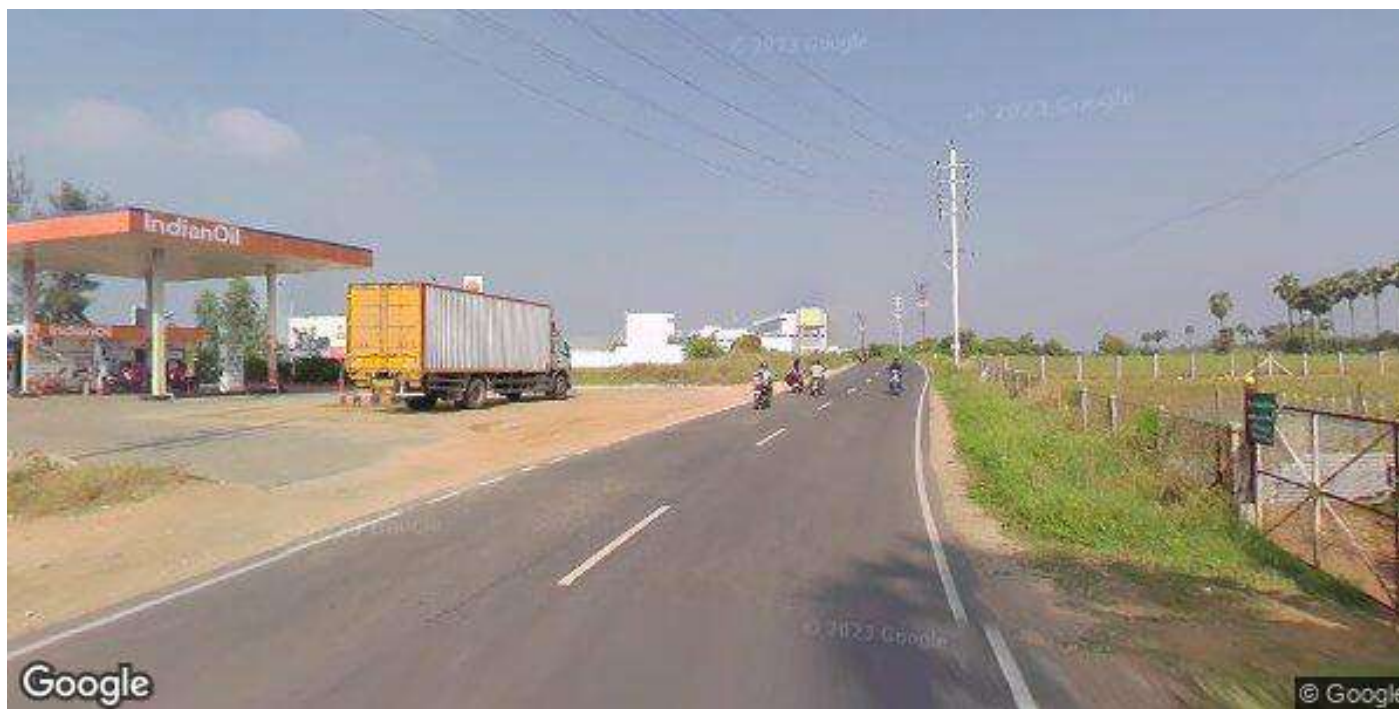
**Risk Type:** Turn  
**Risk Level:** High  
**Speed Limit:** 15 KM/Hr  
**Coordinates:** 11.39915, 77.81187
