## JOURNEY RISK MANAGEMENT (JRM) STUDY

### Salem Terminal to SRI LINGESH AGENCY

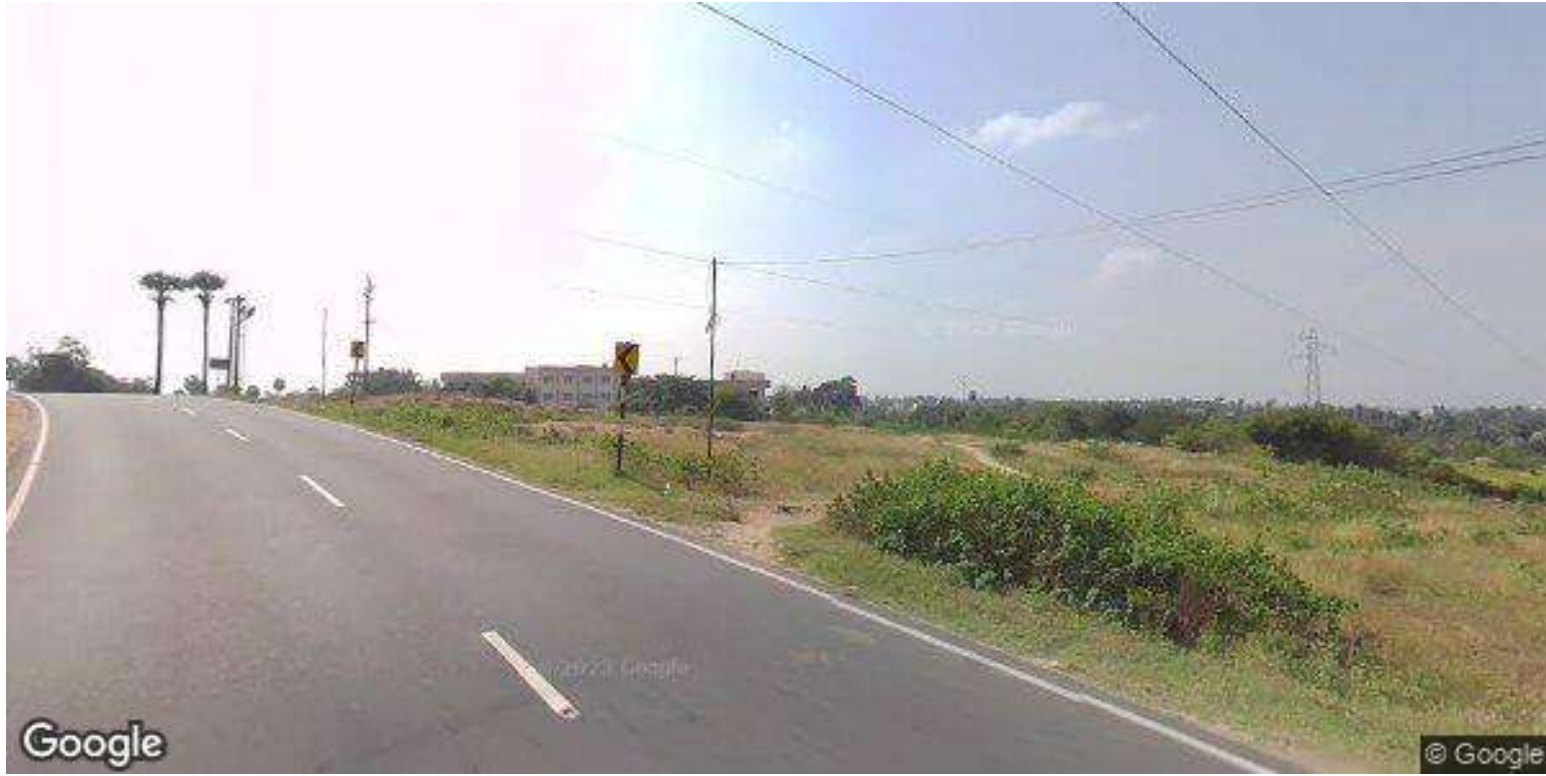
**Risk Type:** Turn  
**Risk Level:** Medium  
**Speed Limit:** 30 KM/Hr  
**Coordinates:** 11.46048, 77.85036

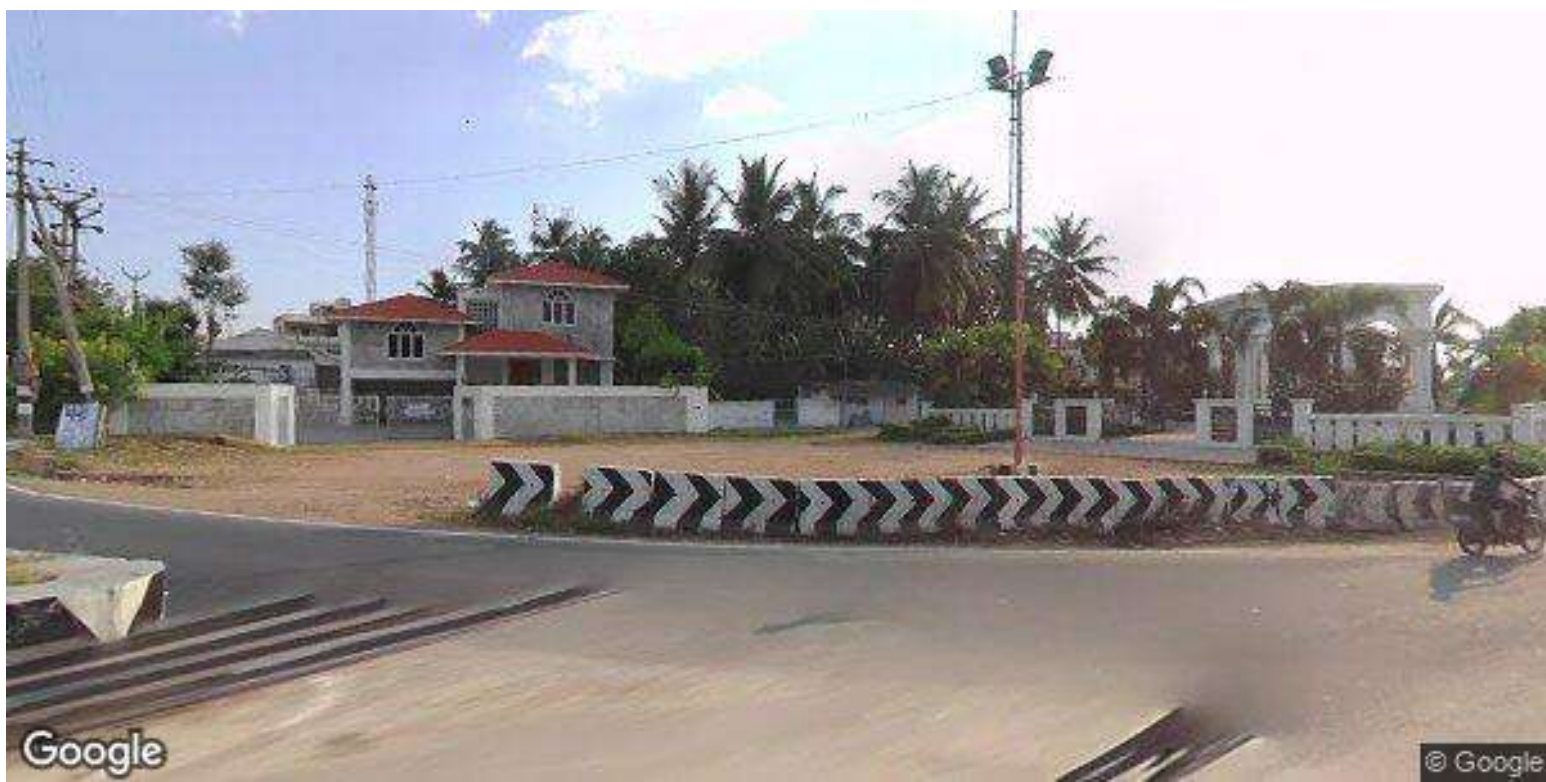
**Coordinates:** 11.46314, 77.84928

**Risk Type:** Turn

**Risk Level:** Medium

**Speed Limit:** 30 KM/Hr

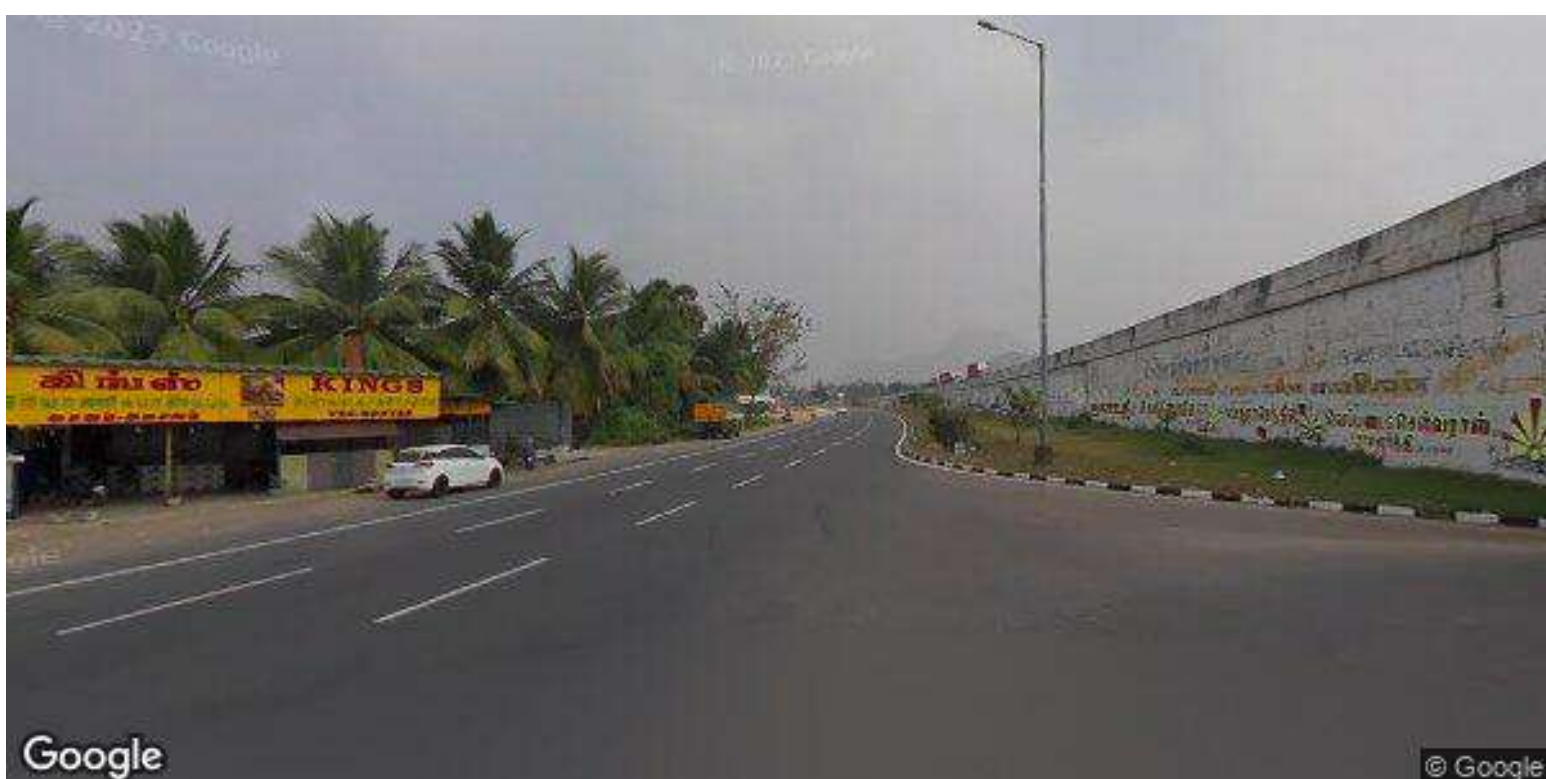
**Risk Type:** Turn  
**Risk Level:** High  
**Speed Limit:** 15 KM/Hr  
**Coordinates:** 11.45634, 77.81673

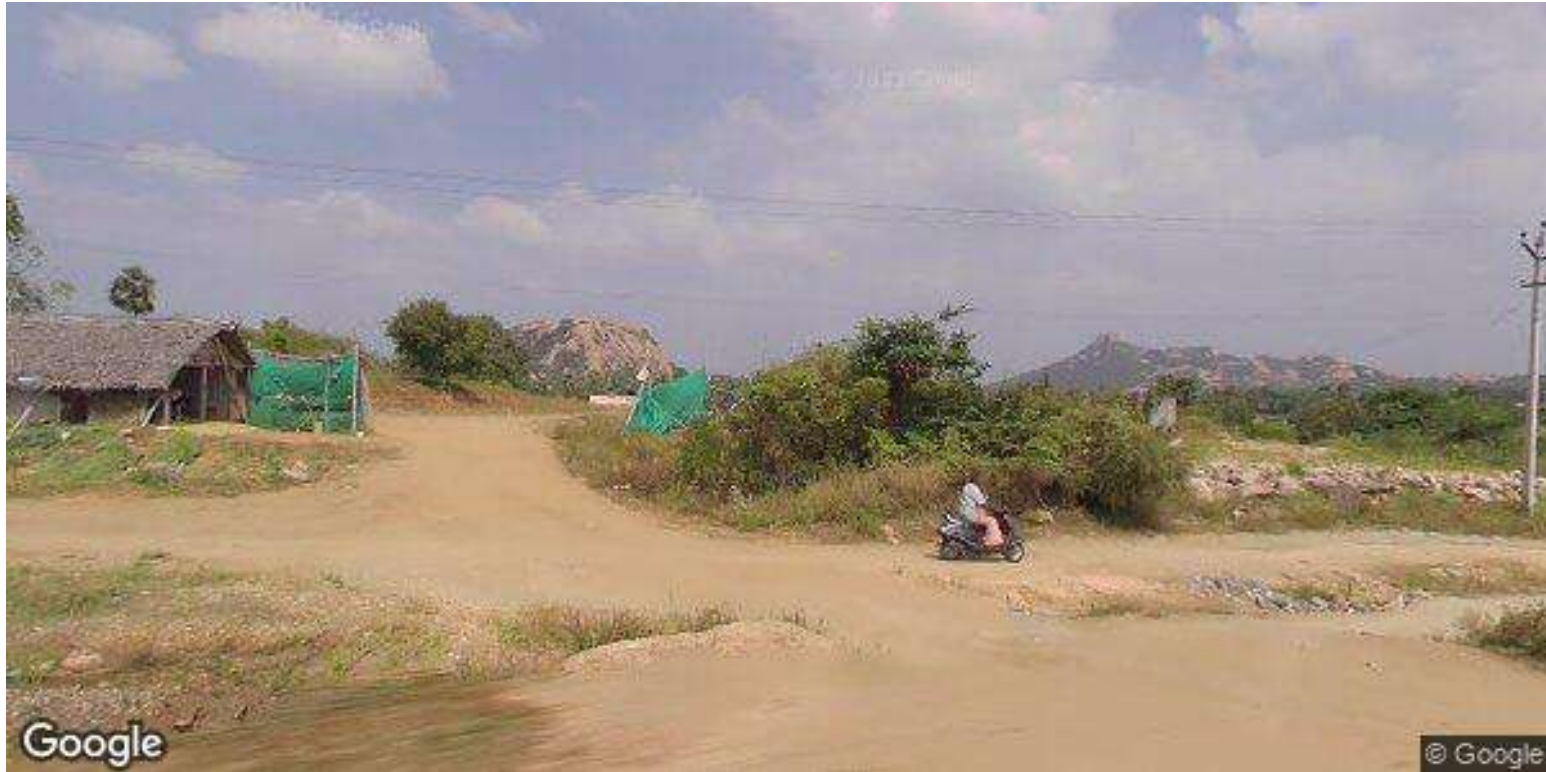
**Risk Type:** Turn  
**Risk Level:** Medium  
**Speed Limit:** 30 KM/Hr  
**Coordinates:** 11.49421, 77.88021

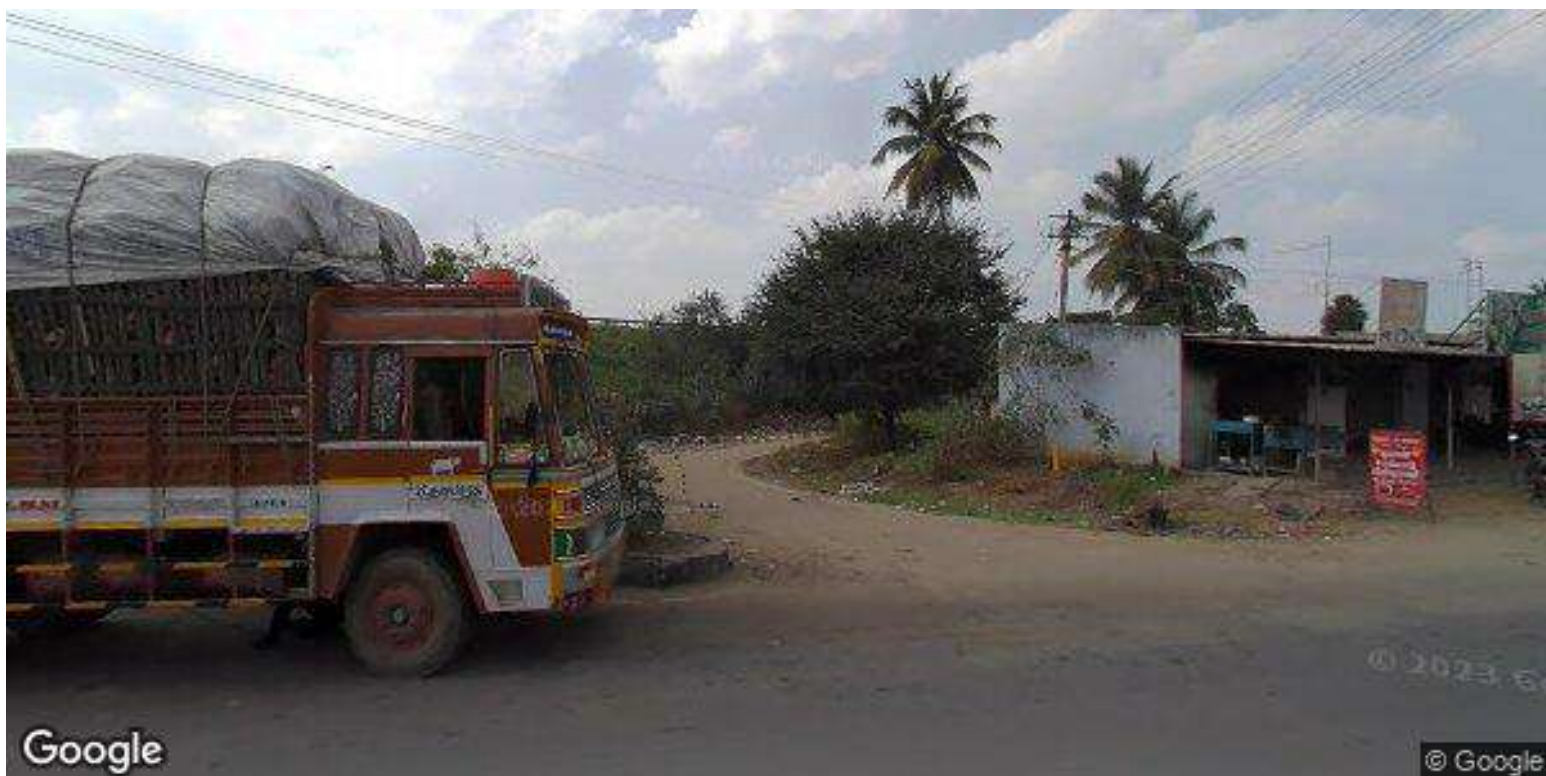
**Risk Type:** Turn  
**Risk Level:** High  
**Speed Limit:** 15 KM/Hr  
**Coordinates:** 11.49383, 77.88526

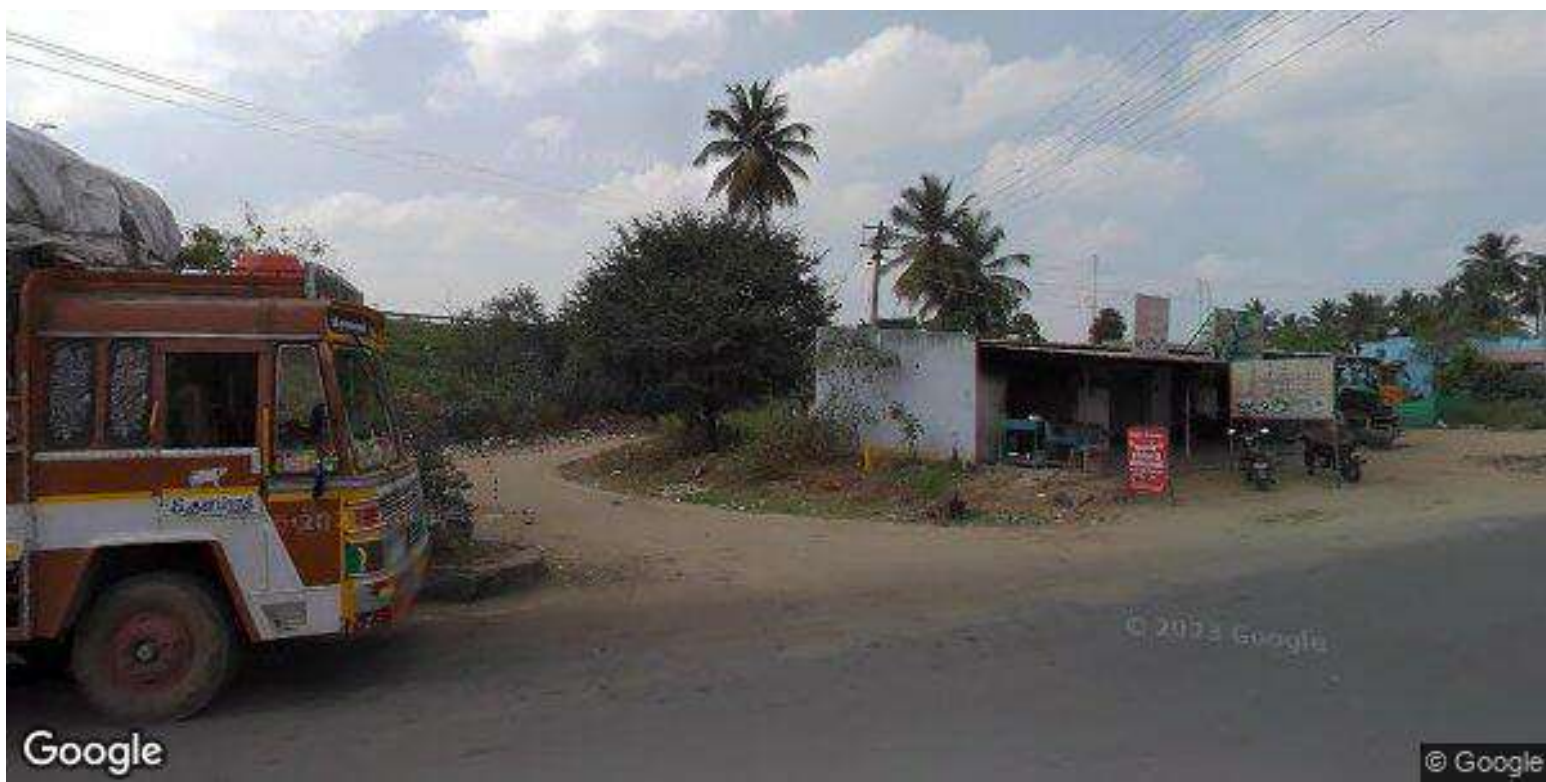
**Coordinates:** 11.49395, 77.88537

**Risk Type:** Turn

**Risk Level:** High

**Speed Limit:** 15 KM/Hr

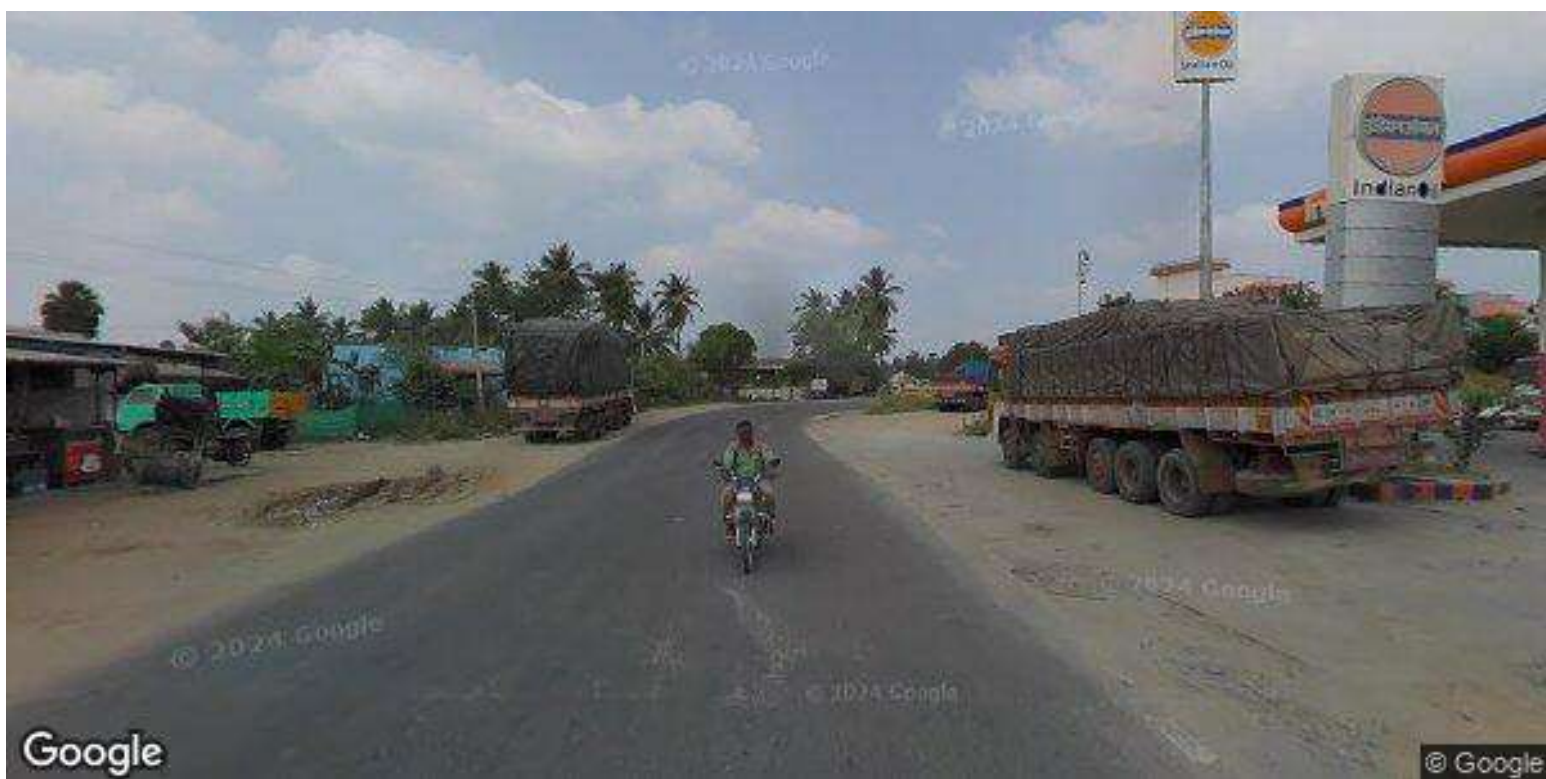
**Coordinates:** 11.49409, 77.88536

**Risk Type:** Turn

**Risk Level:** High

**Speed Limit:** 15 KM/Hr

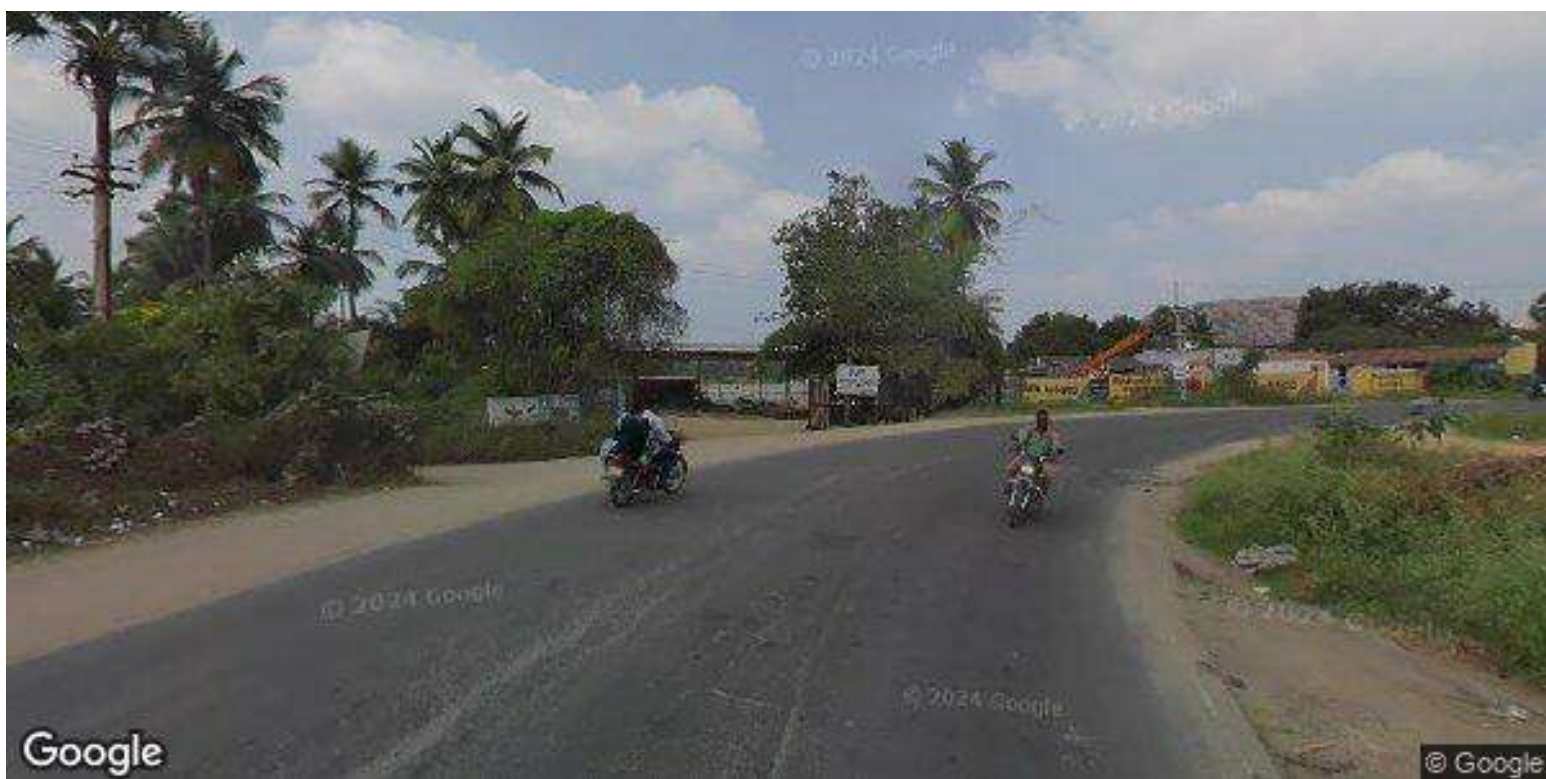
**Risk Type:** Turn  
**Risk Level:** Medium  
**Speed Limit:** 30 KM/Hr  
**Coordinates:** 11.49435, 77.88499

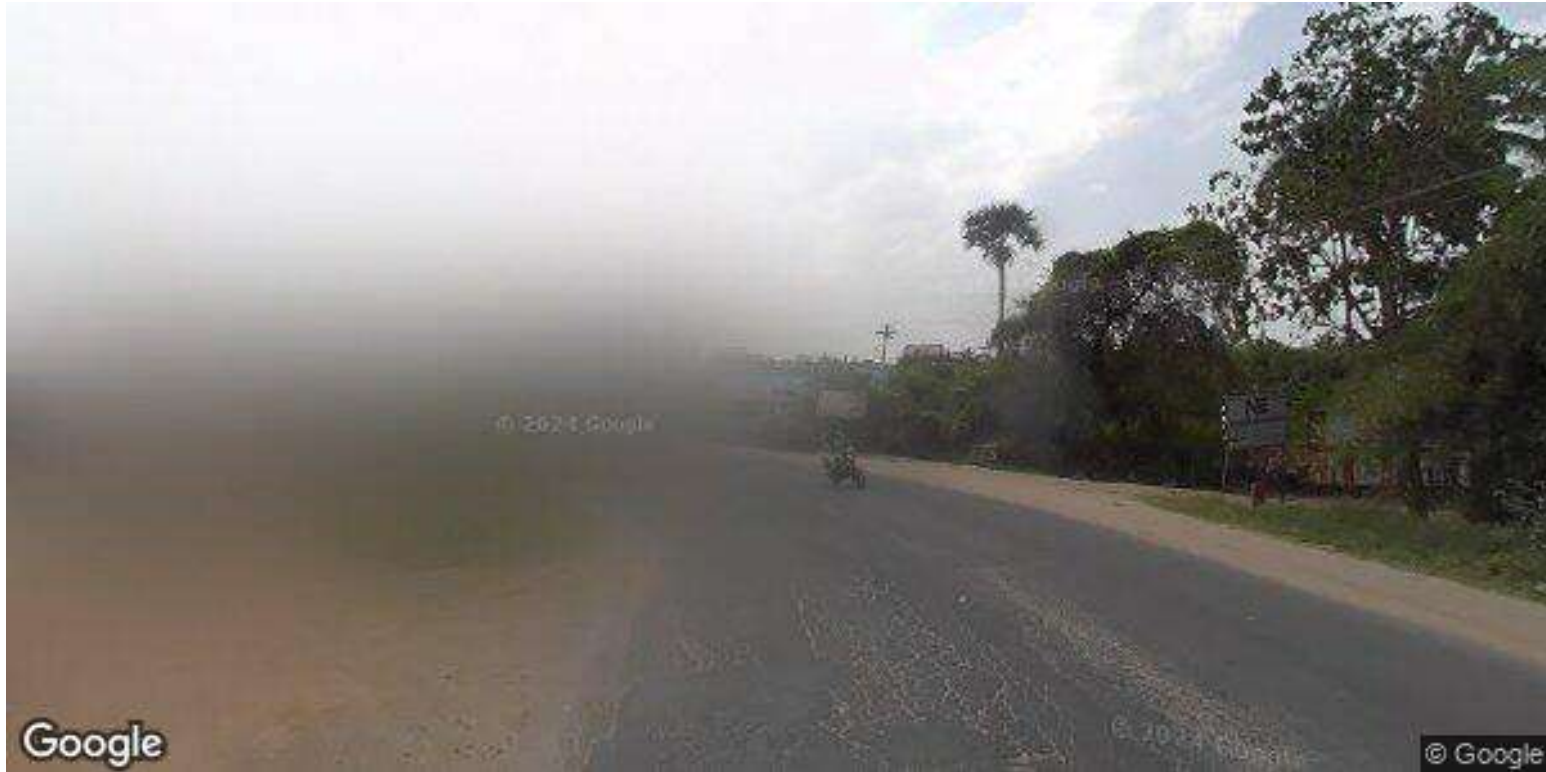
**Risk Type:** Turn  
**Risk Level:** Medium  
**Speed Limit:** 30 KM/Hr  
**Coordinates:** 11.49465, 77.88488

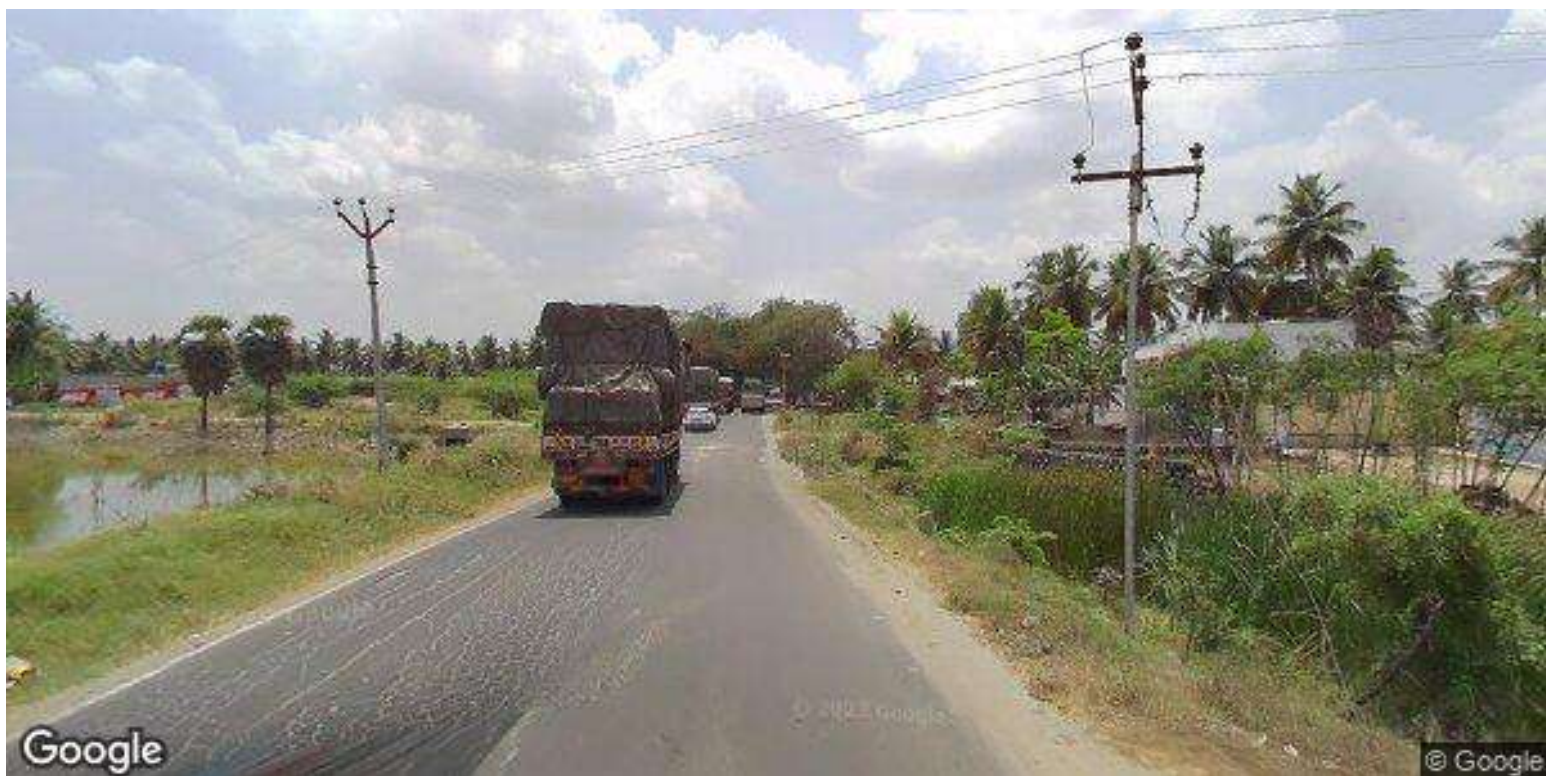
**Risk Type:** Turn  
**Risk Level:** Medium  
**Speed Limit:** 30 KM/Hr  
**Coordinates:** 11.56072, 77.89919

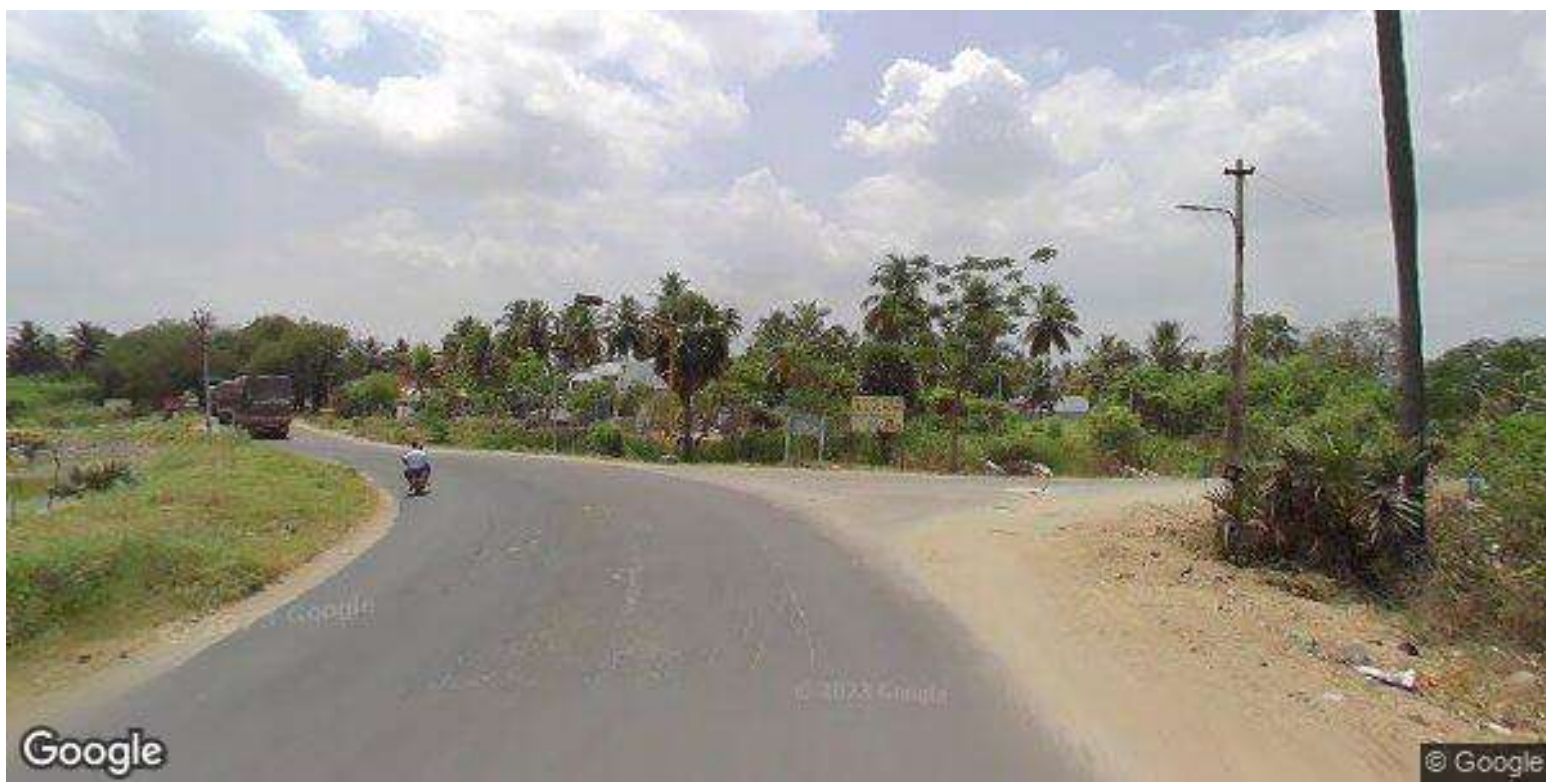
**Coordinates:** 11.56096, 77.89931

**Risk Type:** Turn

**Risk Level:** Medium

**Speed Limit:** 30 KM/Hr

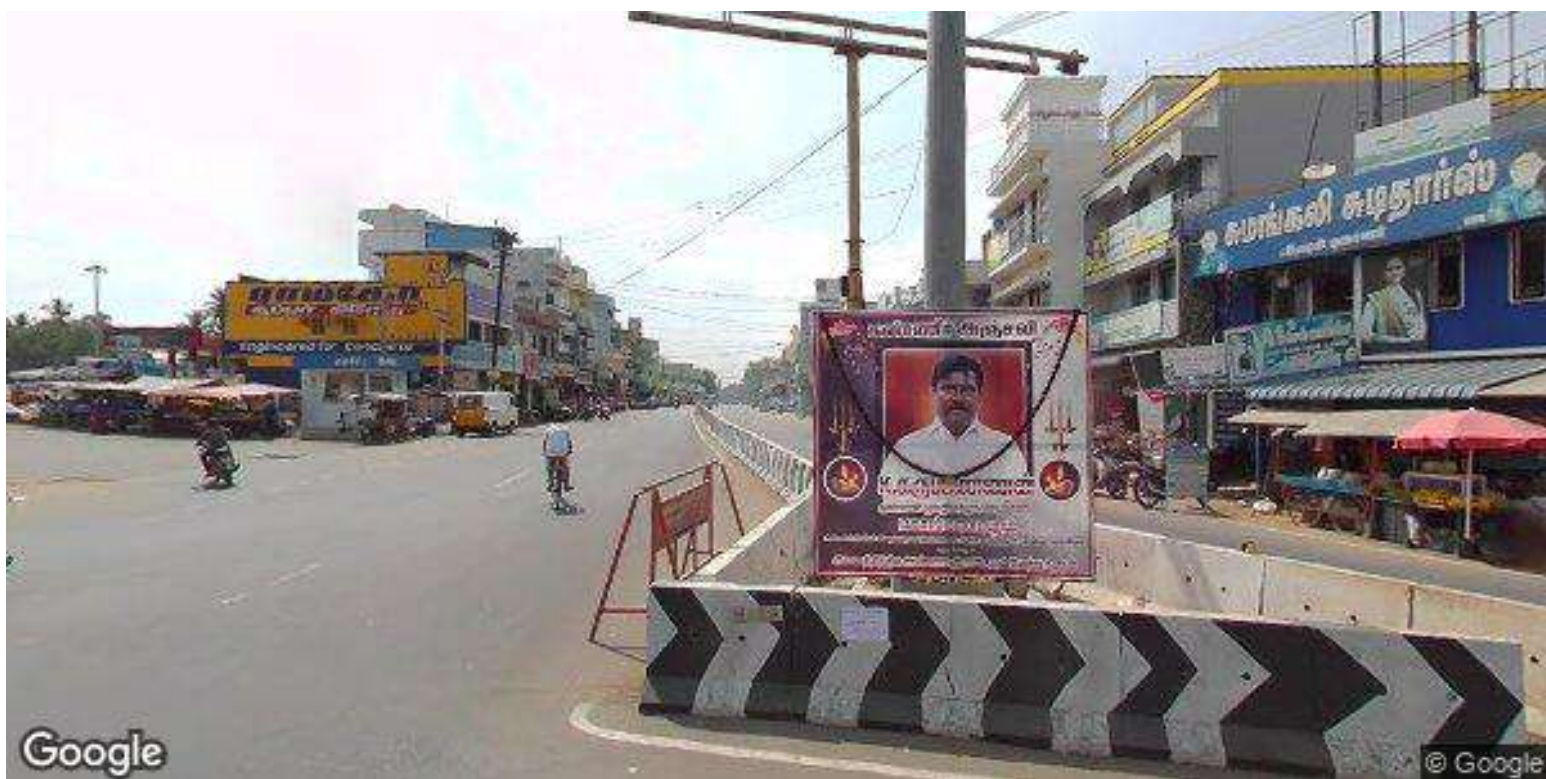
**Coordinates:** 11.57035, 77.90223

**Risk Type:** Turn

**Risk Level:** High

**Speed Limit:** 15 KM/Hr

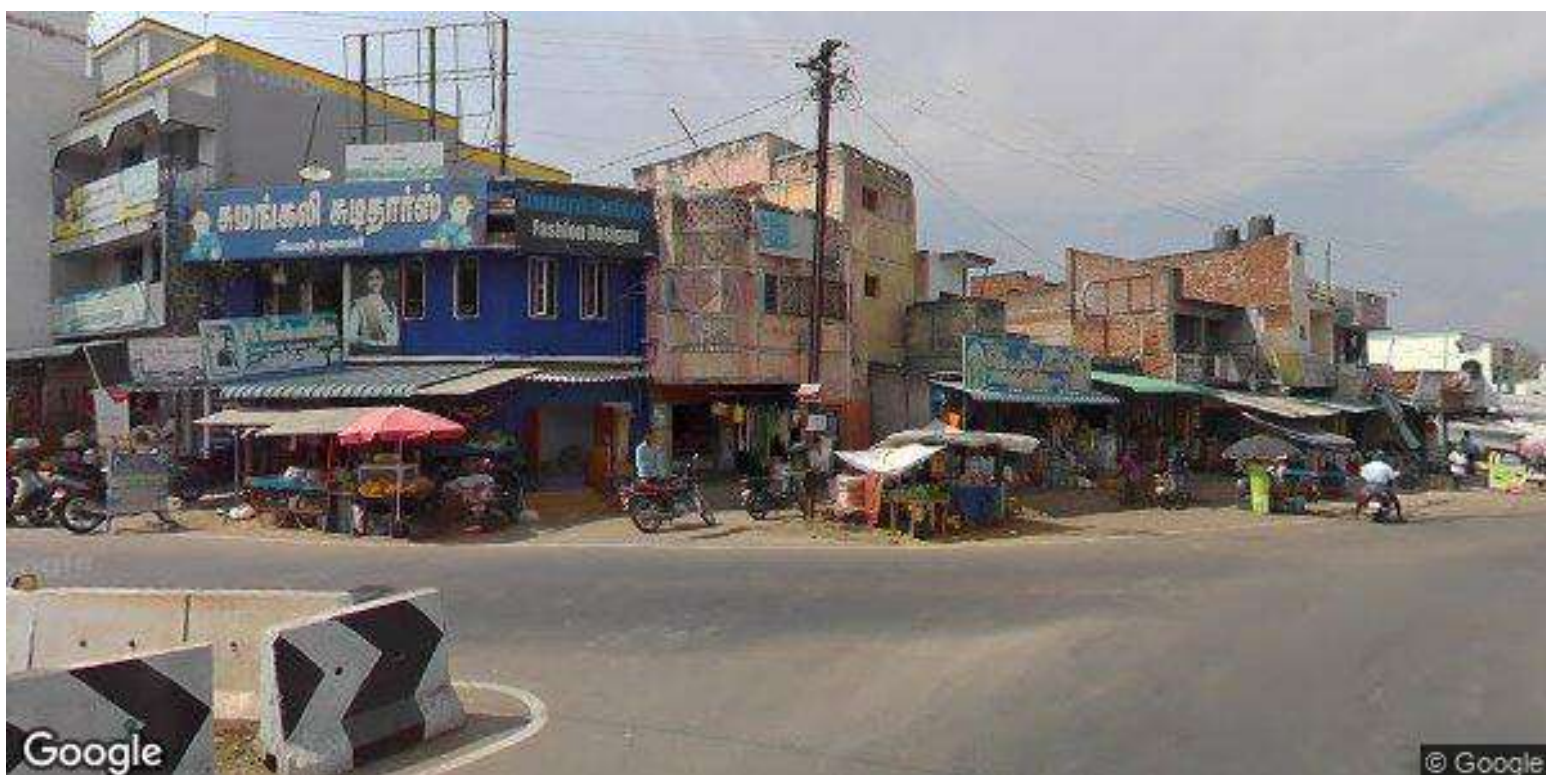
**Risk Type:** Turn  
**Risk Level:** Medium  
**Speed Limit:** 30 KM/Hr  
**Coordinates:** 11.57041, 77.90221

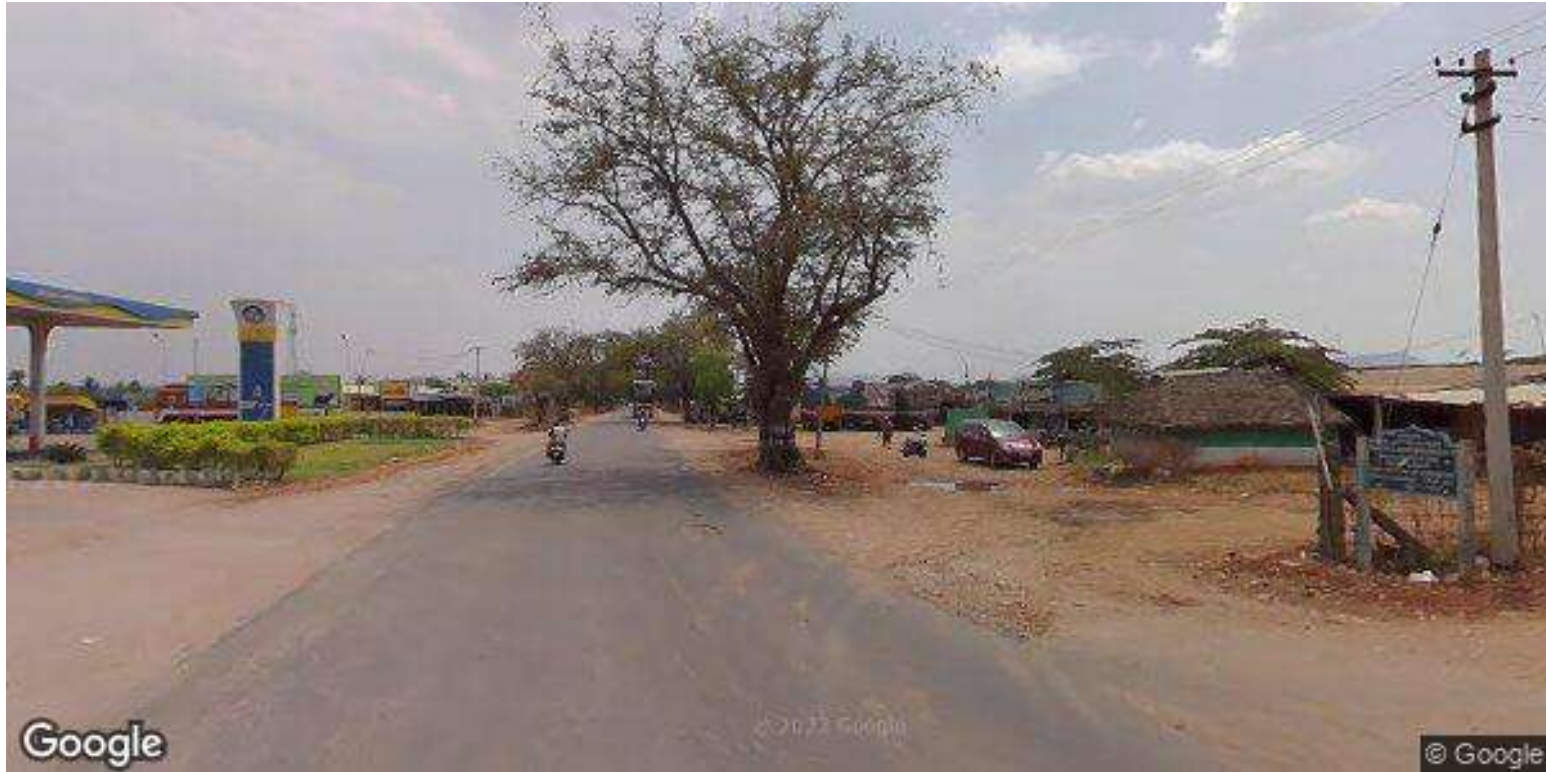
**Risk Type:** Turn  
**Risk Level:** Medium  
**Speed Limit:** 30 KM/Hr  
**Coordinates:** 11.58279, 77.90658

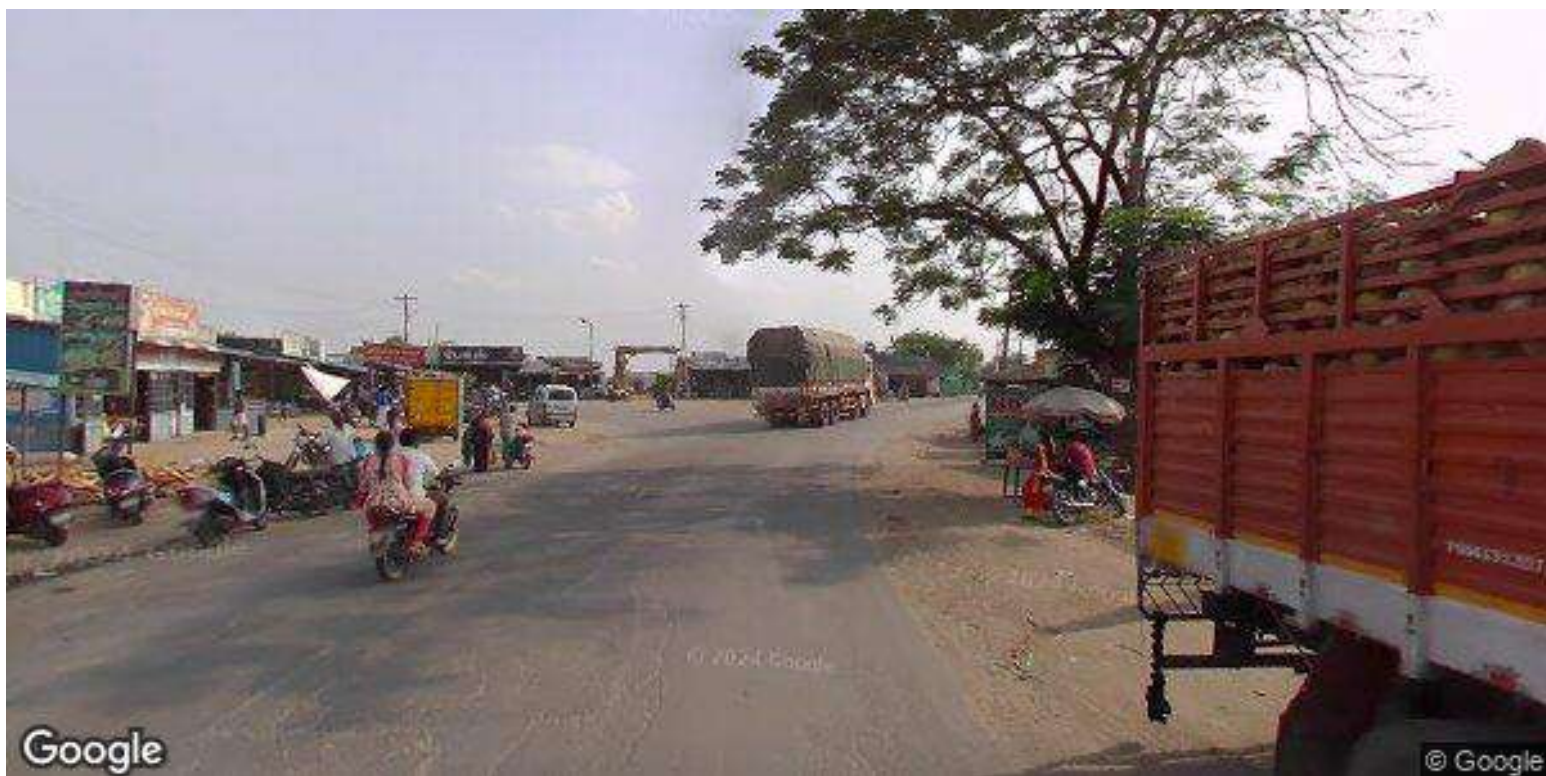
**Risk Type:** Turn  
**Risk Level:** Medium  
**Speed Limit:** 30 KM/Hr  
**Coordinates:** 11.64197, 77.95197

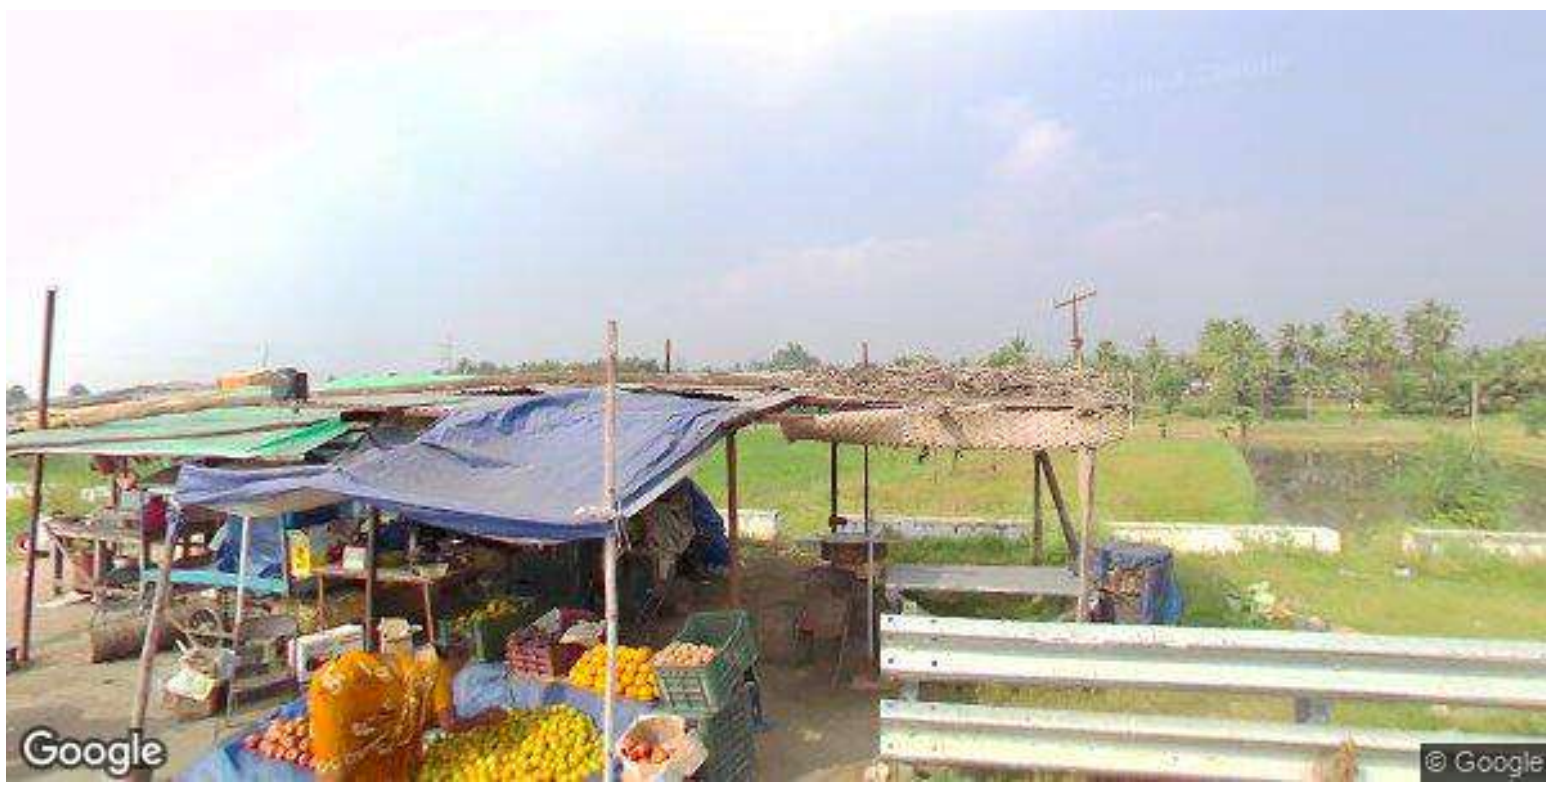
**Coordinates:** 11.67858, 77.96834

**Risk Type:** Turn

**Risk Level:** Medium

**Speed Limit:** 30 KM/Hr

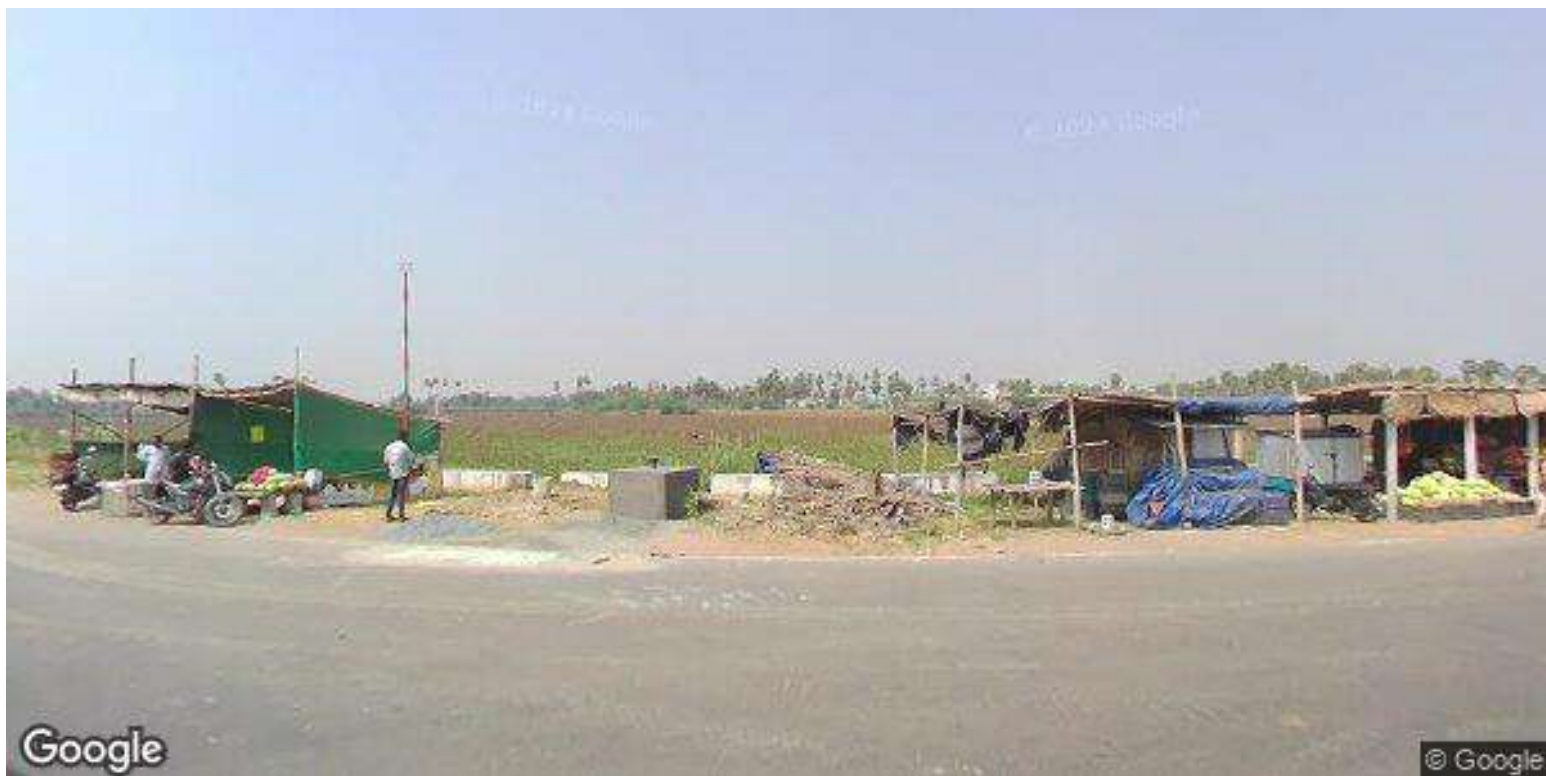
**Coordinates:** 11.68915, 77.97734

**Risk Type:** Turn

**Risk Level:** High

**Speed Limit:** 15 KM/Hr

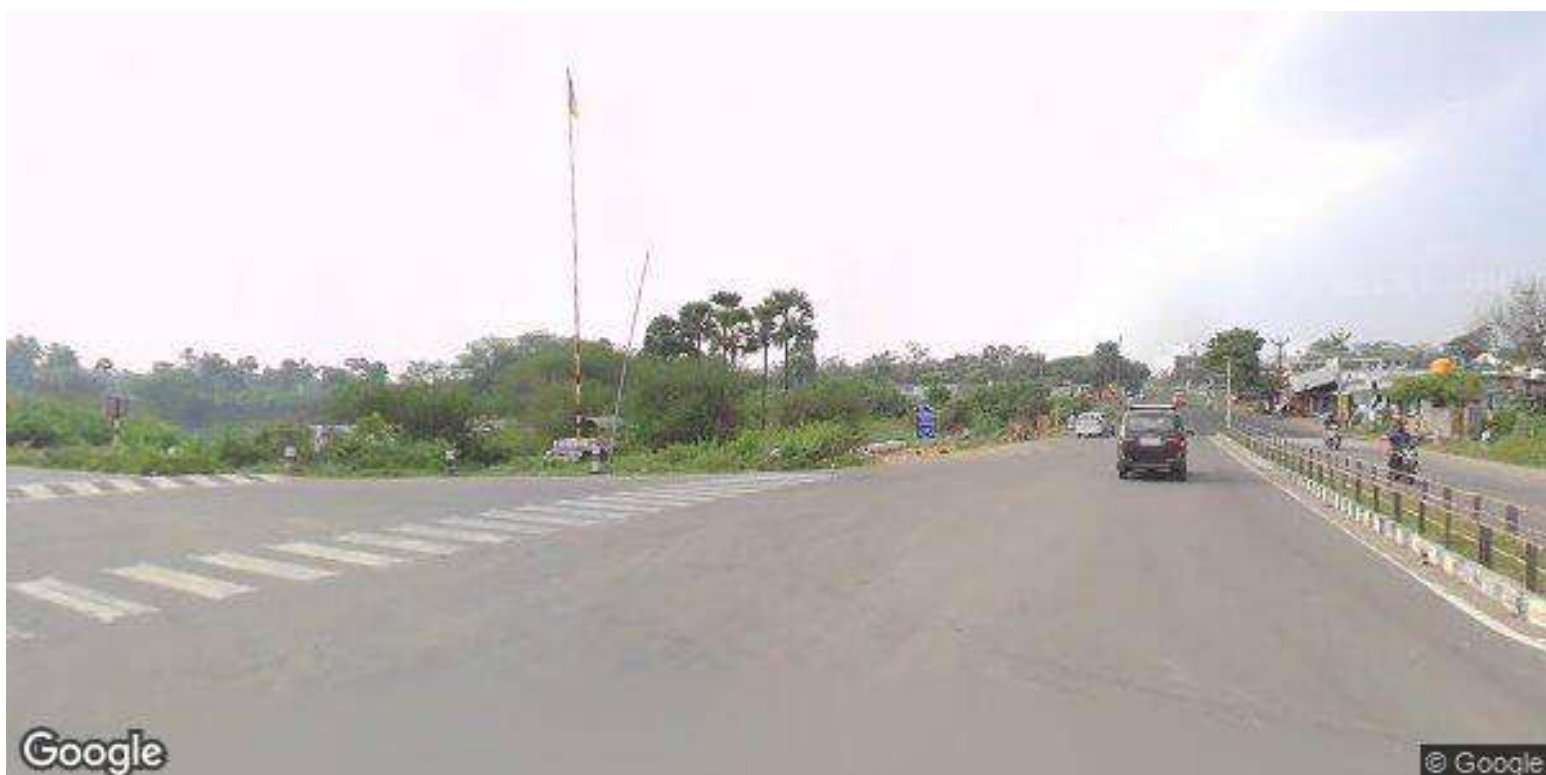
**Risk Type:** Turn  
**Risk Level:** Medium  
**Speed Limit:** 30 KM/Hr  
**Coordinates:** 11.70218, 77.97866
