## JOURNEY RISK MANAGEMENT (JRM) STUDY

### Salem Terminal to SRI LINGESH AGENCY

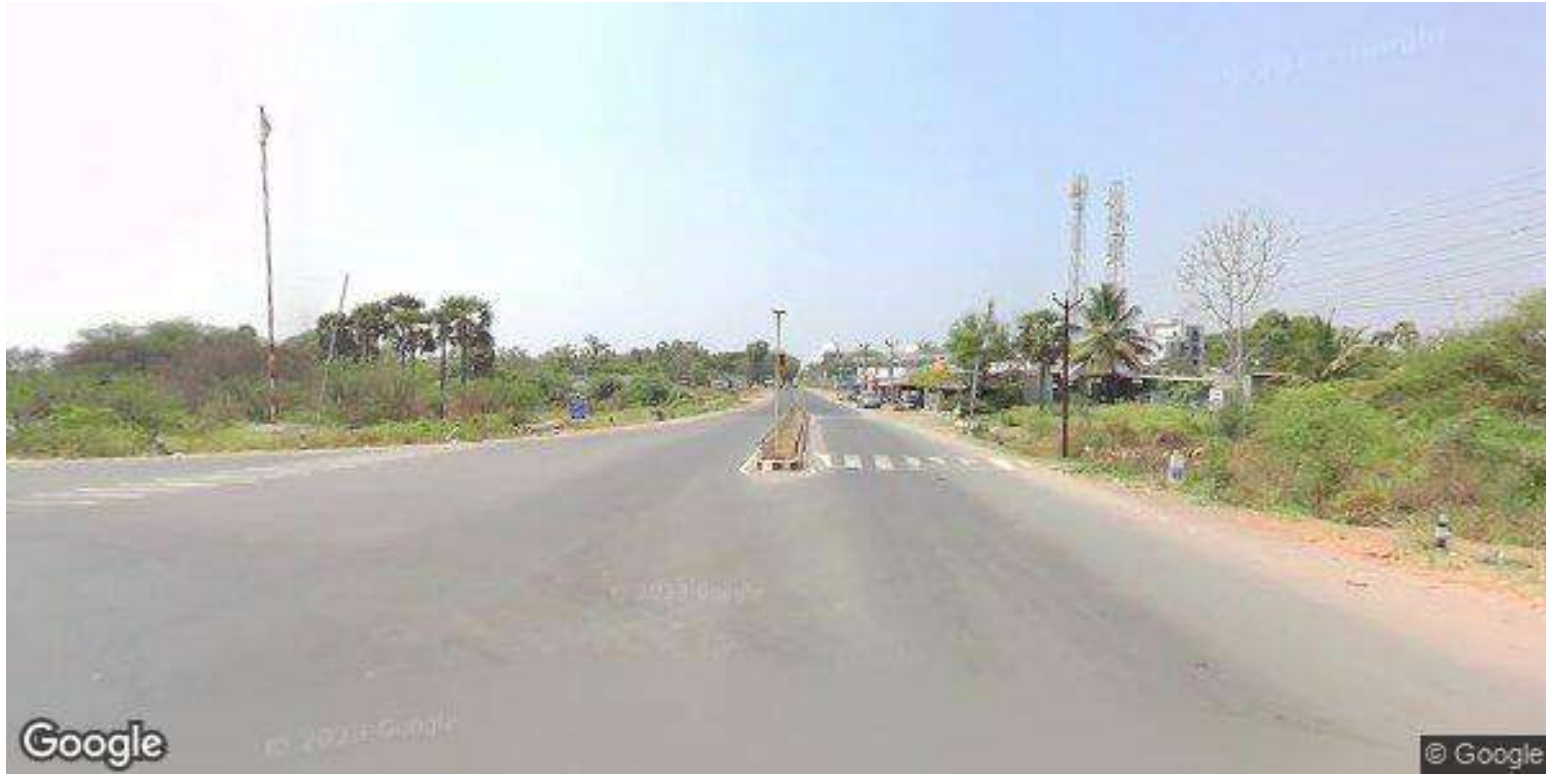
**Risk Type:** Turn  
**Risk Level:** High  
**Speed Limit:** 15 KM/Hr  
**Coordinates:** 11.70227, 77.97864

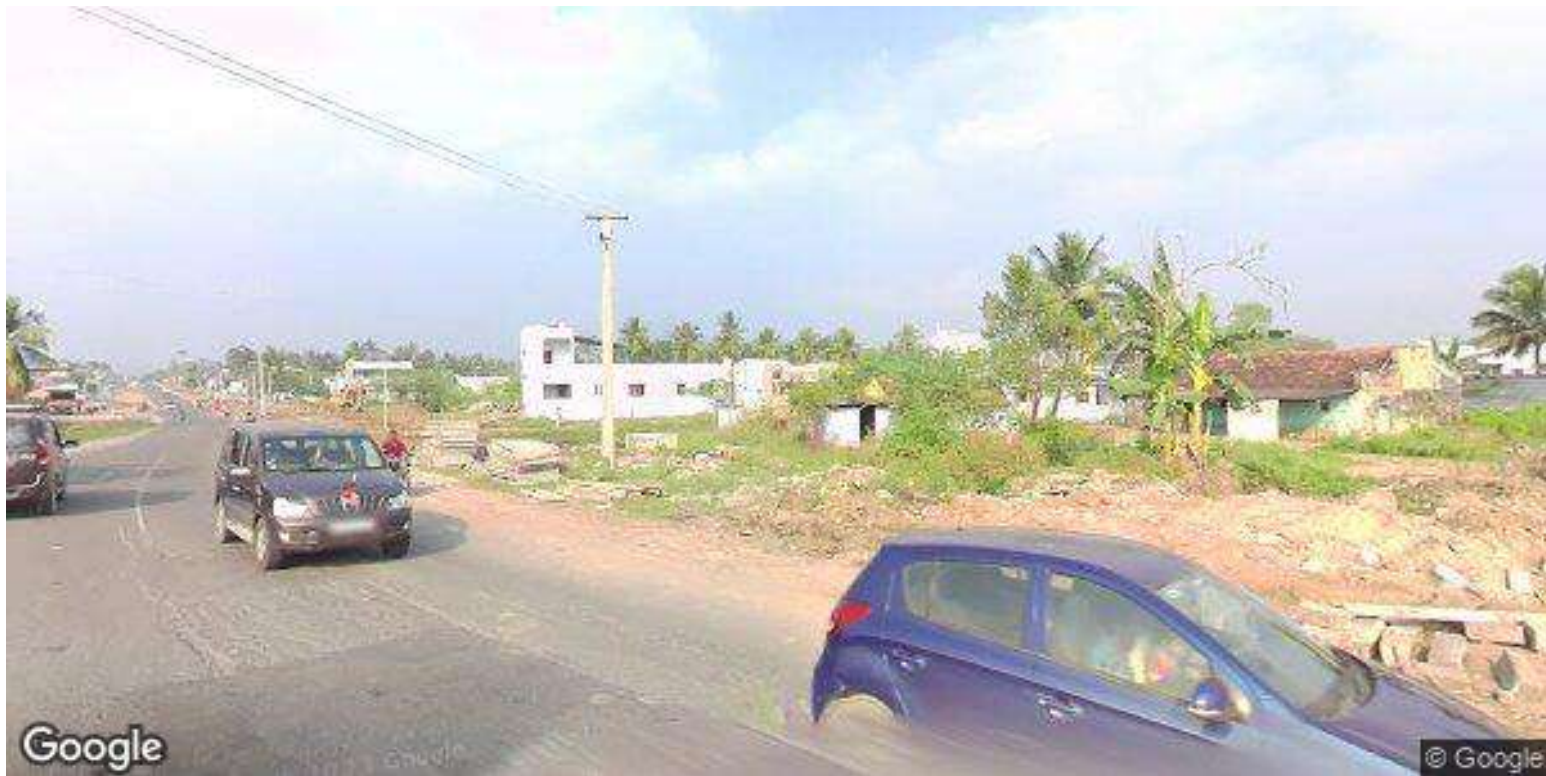
**Risk Type:** Turn  
**Risk Level:** Medium  
**Speed Limit:** 30 KM/Hr  
**Coordinates:** 11.71921, 78.01133

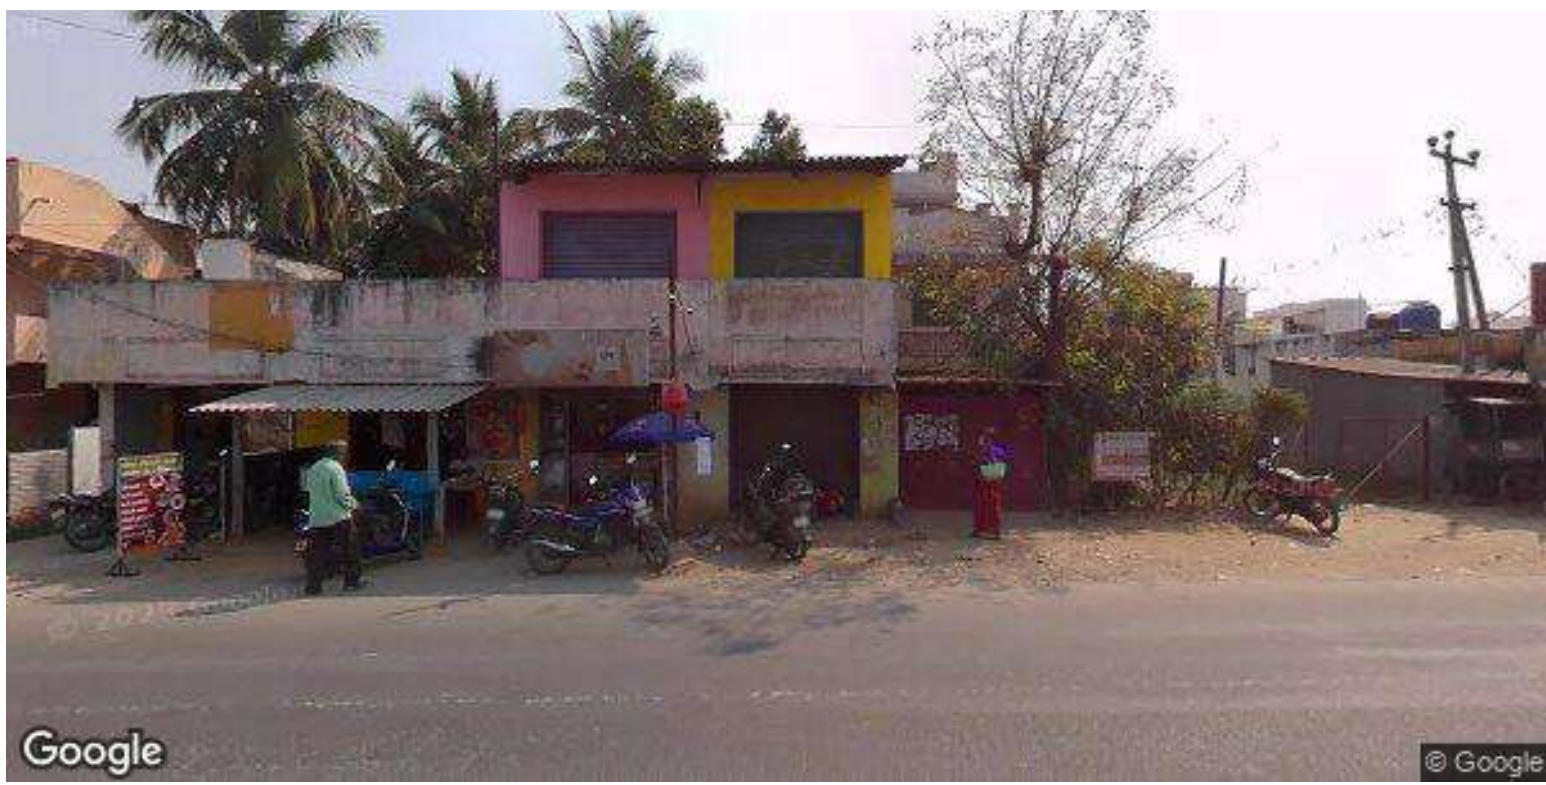
**Coordinates:** 11.73785, 78.03551

**Risk Type:** Blind Spot

**Risk Level:** Blind Spot

**Speed Limit:** 10 KM/Hr
