# IndianOil

## JOURNEY RISK MANAGEMENT (JRM) STUDY

### Salem Terminal to PPS FUELS

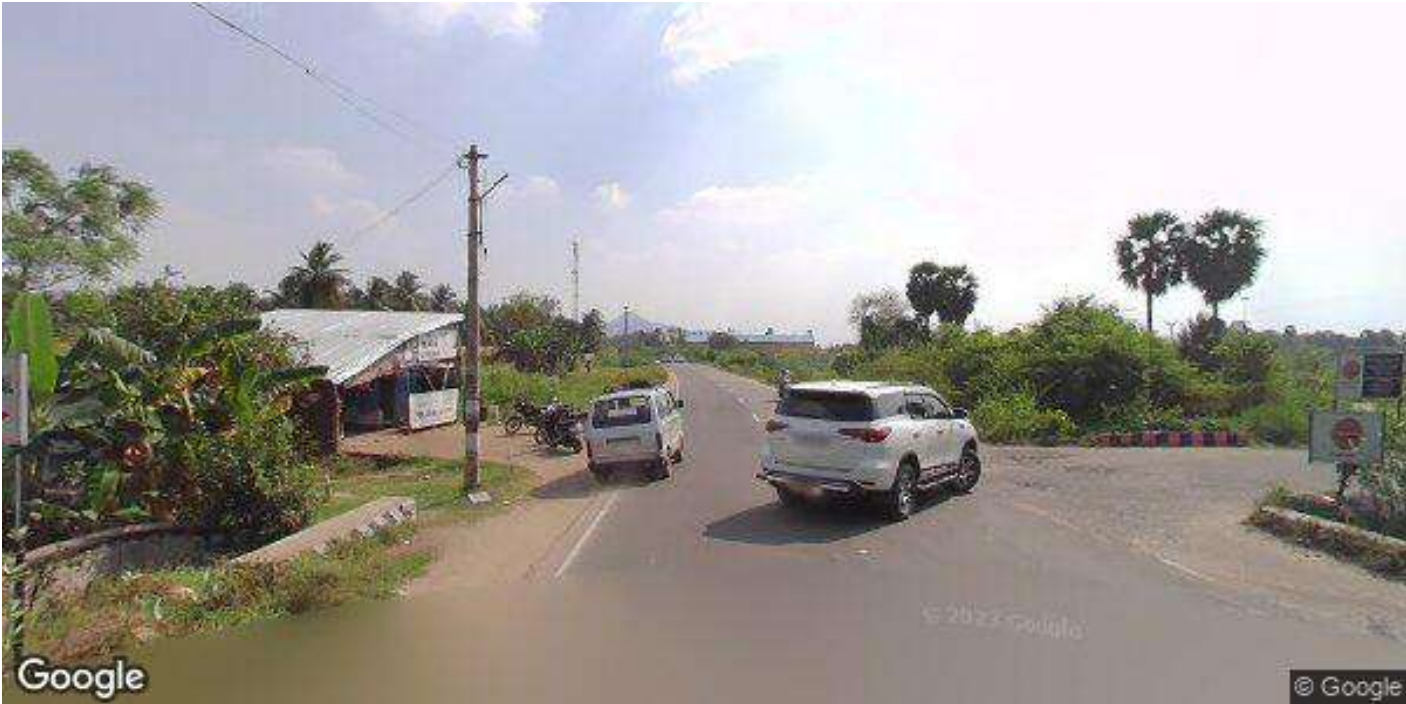
Risk Type: Turn  
Risk Level: High  
Speed Limit: 15 KM/Hr  
Coordinates: 11.44029, 77.87544

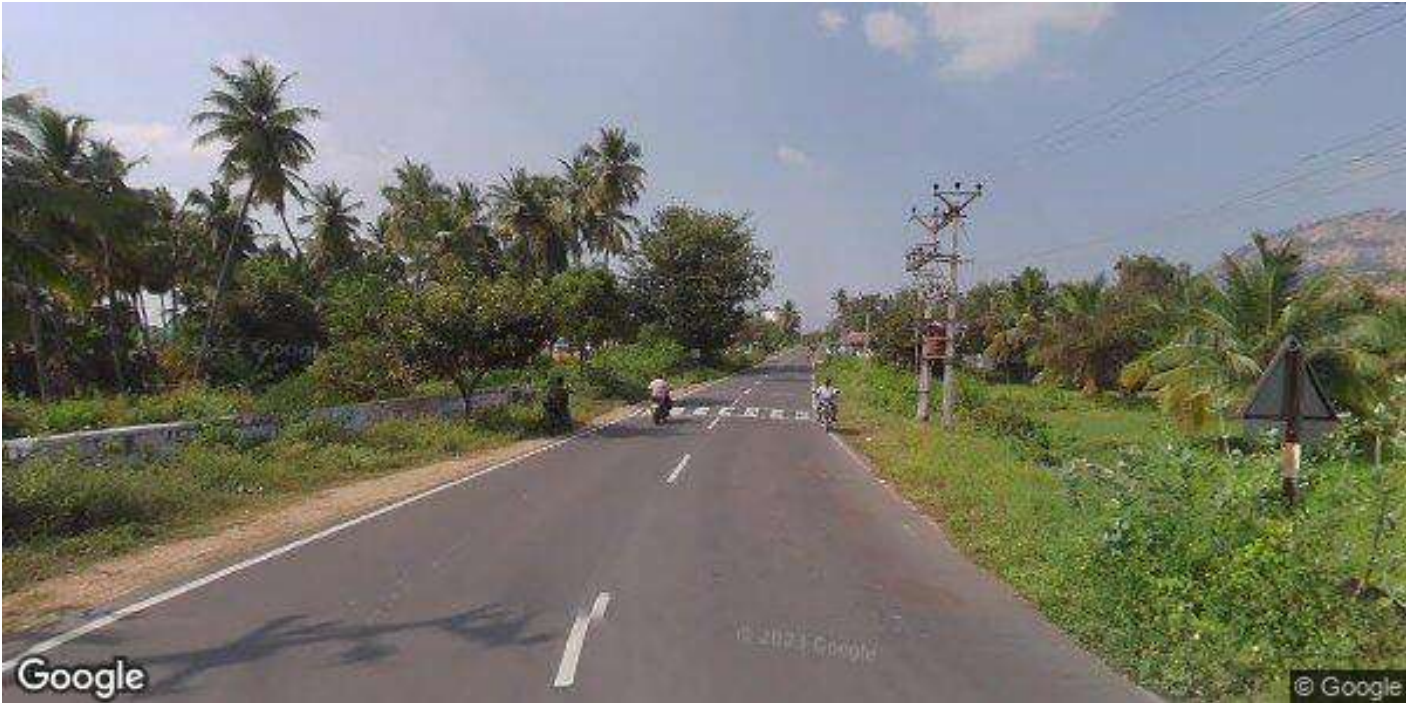
Risk Type: Turn  
Risk Level: Medium

**Speed Limit: 30 KM/Hr**  
**Coordinates: 11.45353, 77.85697**

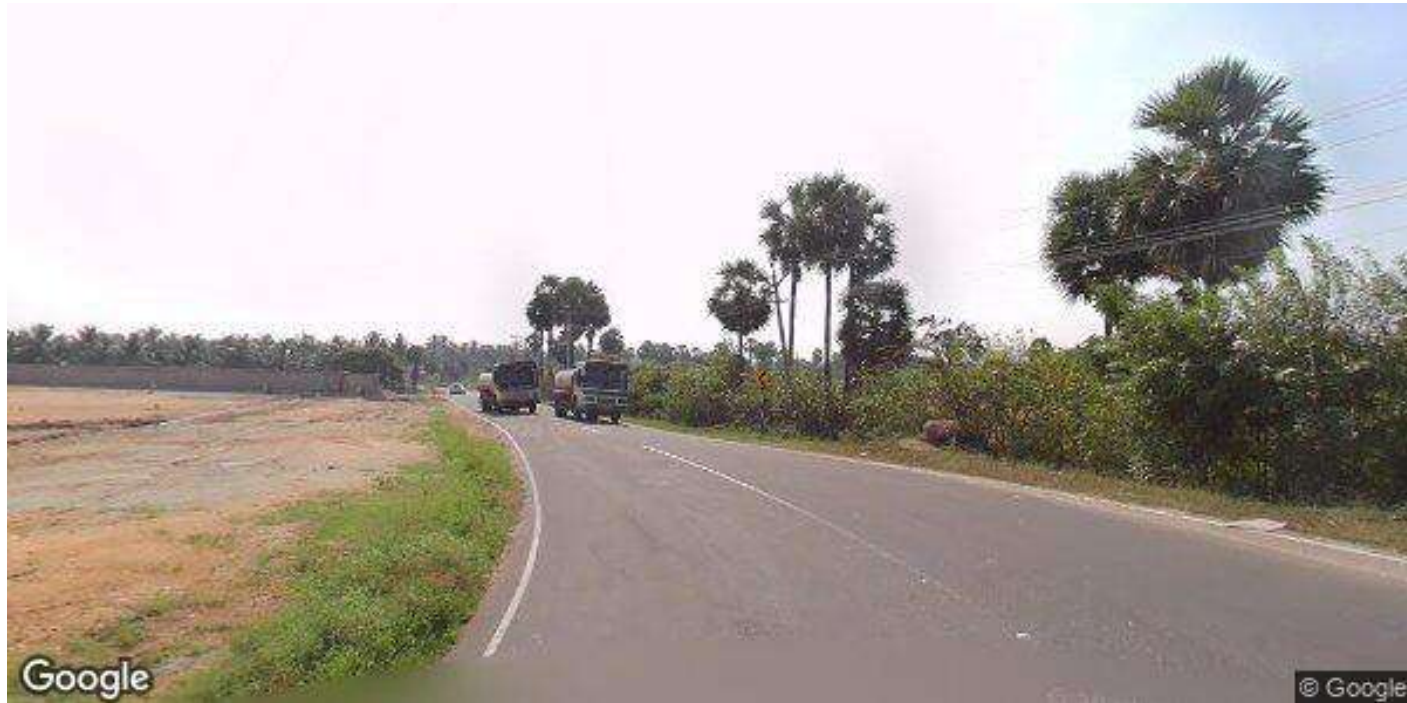
**Risk Type: Turn**  
**Risk Level: Medium**  
**Speed Limit: 30 KM/Hr**  
**Coordinates: 11.45839, 77.85143**

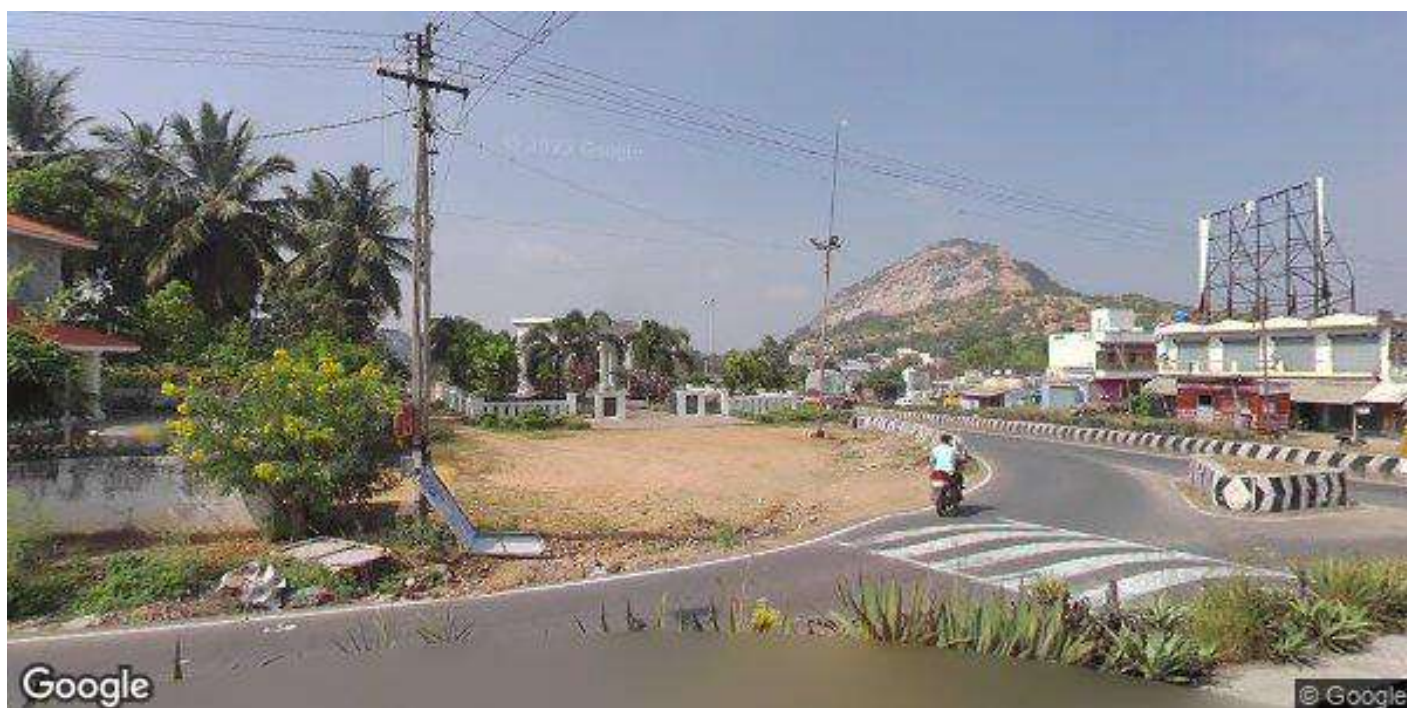
**Risk Type: Turn**  
**Risk Level: Medium**  
**Speed Limit: 30 KM/Hr**  
**Coordinates: 11.46307, 77.84941**

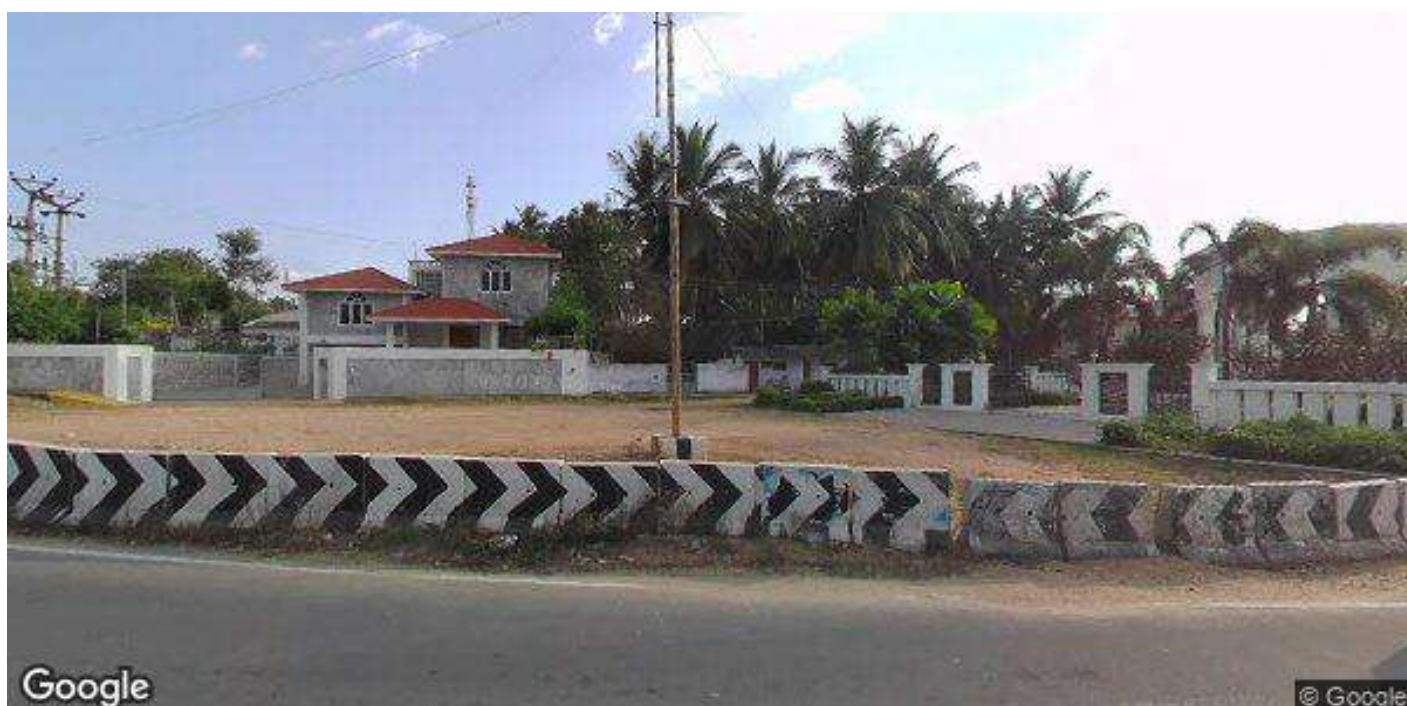
**Risk Type:** Turn  
**Risk Level:** Medium  
**Speed Limit:** 30 KM/Hr  
**Coordinates:** 11.46316, 77.84921

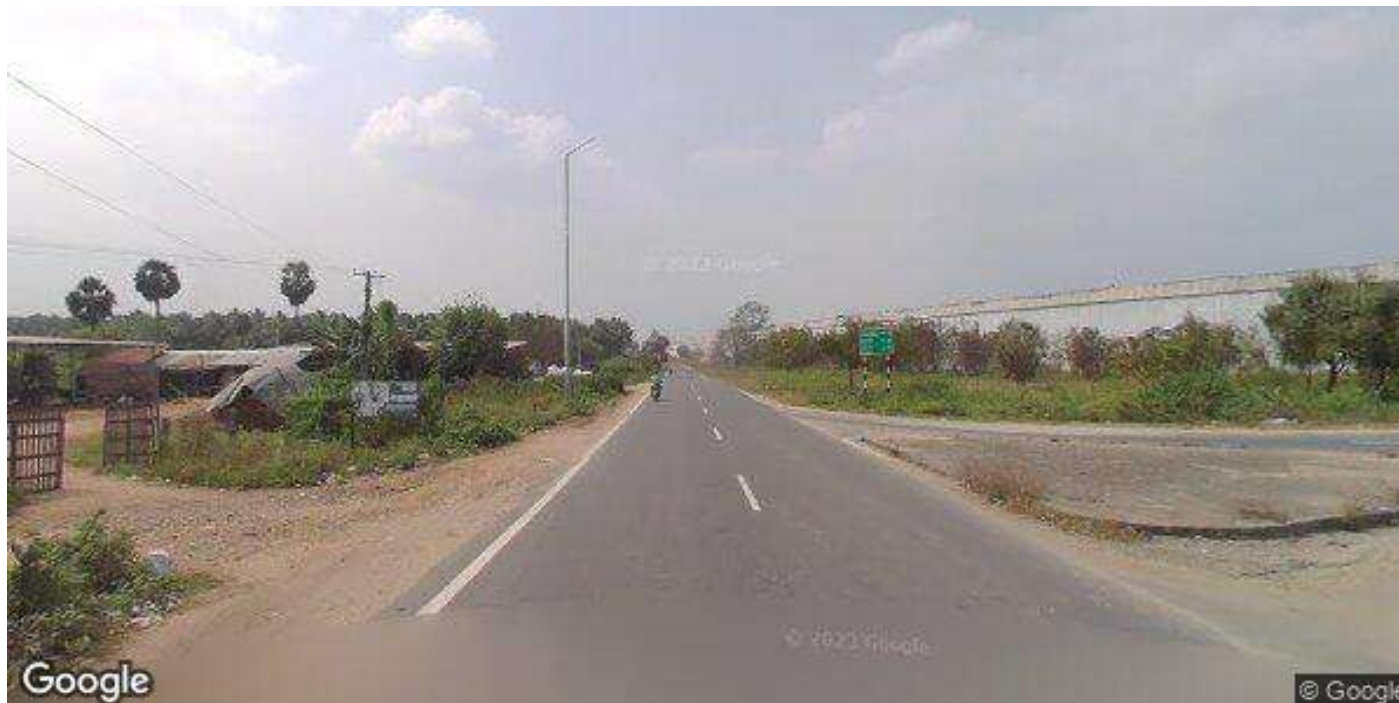
**Risk Type:** Turn  
**Risk Level:** High  
**Speed Limit:** 15 KM/Hr  
**Coordinates:** 11.45542, 77.81725

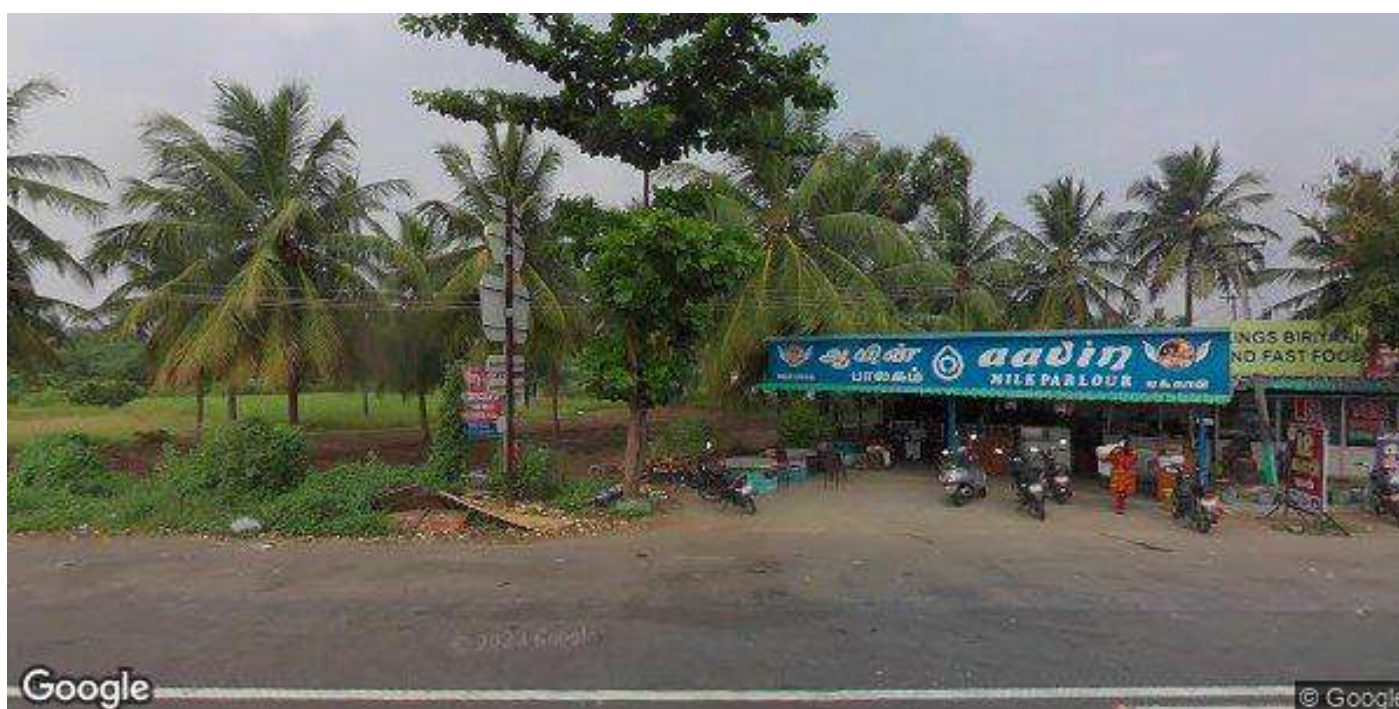
**Risk Type:** Blind Spot  
**Risk Level:** Blind Spot  
**Speed Limit:** 10 KM/Hr  
**Coordinates:** 11.45631, 77.81668

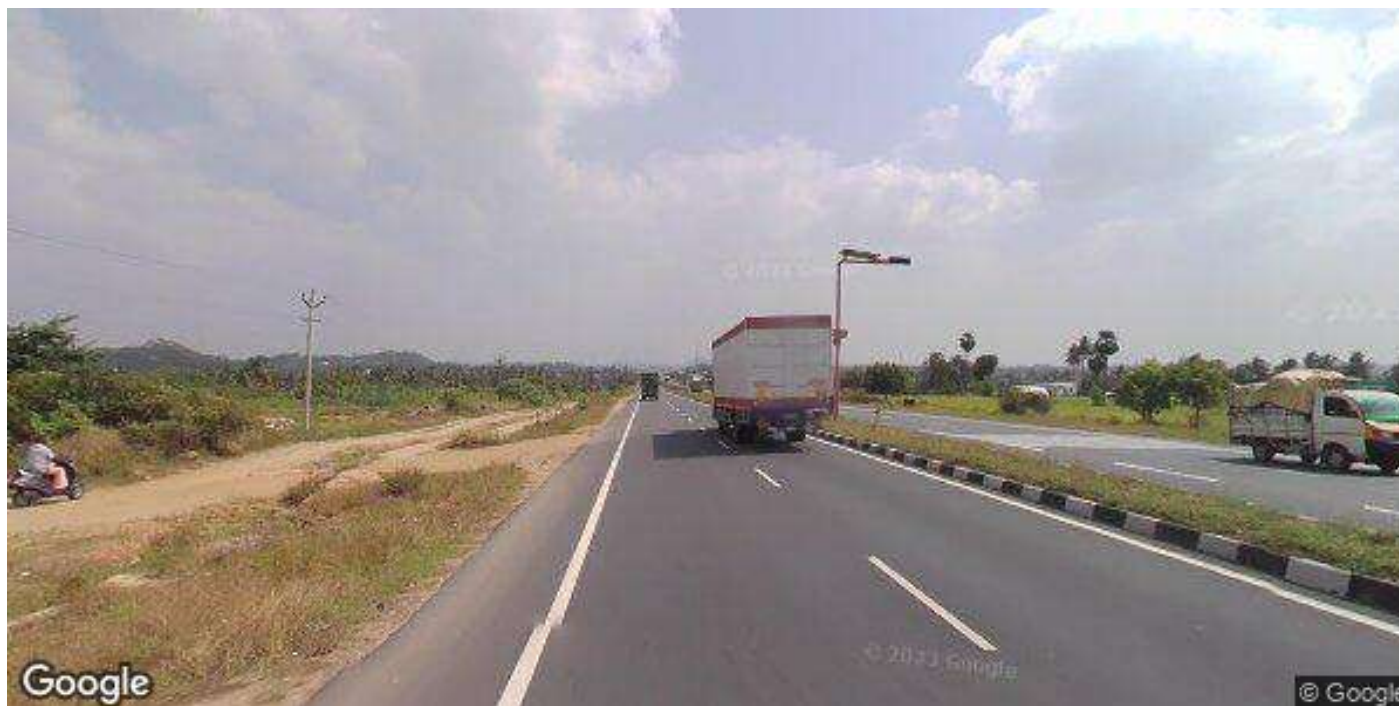
**Risk Type:** Turn  
**Risk Level:** High  
**Speed Limit:** 15 KM/Hr  
**Coordinates:** 11.49409, 77.88004

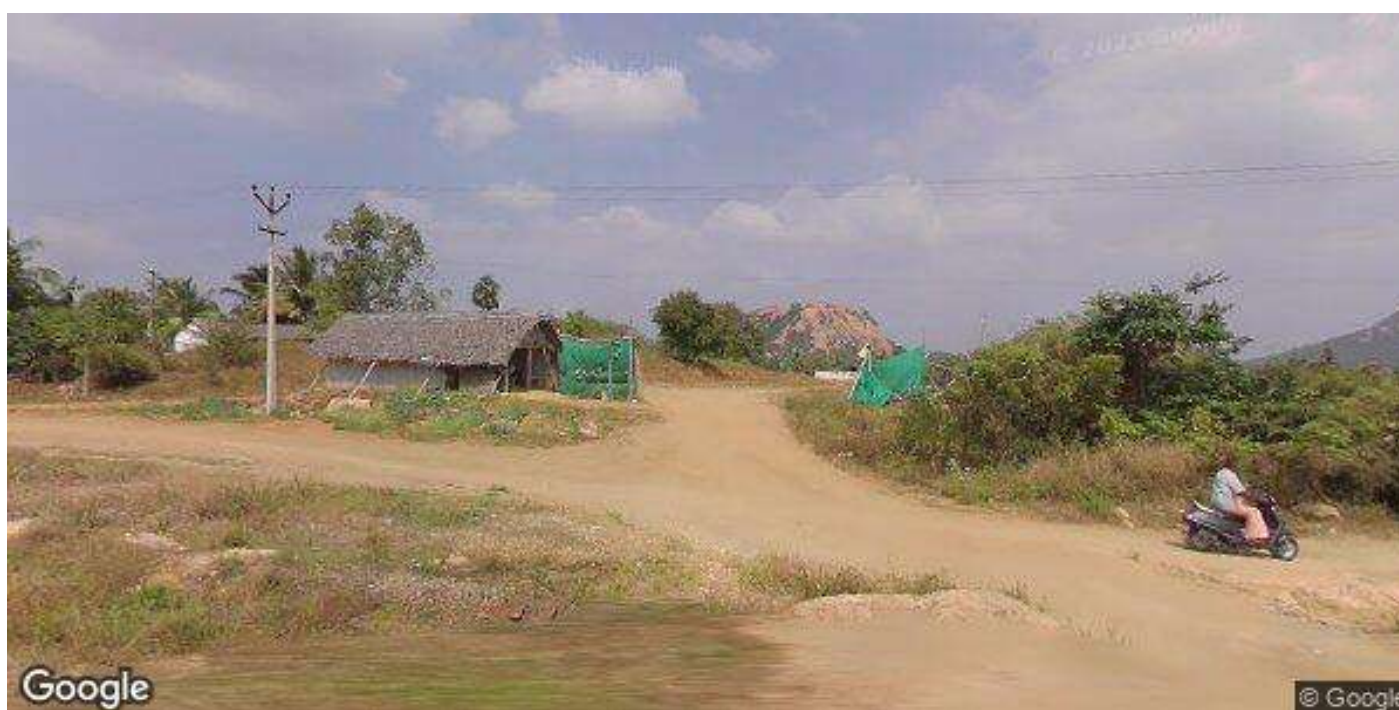
**Risk Type:** Turn  
**Risk Level:** Medium  
**Speed Limit:** 30 KM/Hr  
**Coordinates:** 11.49420, 77.88016

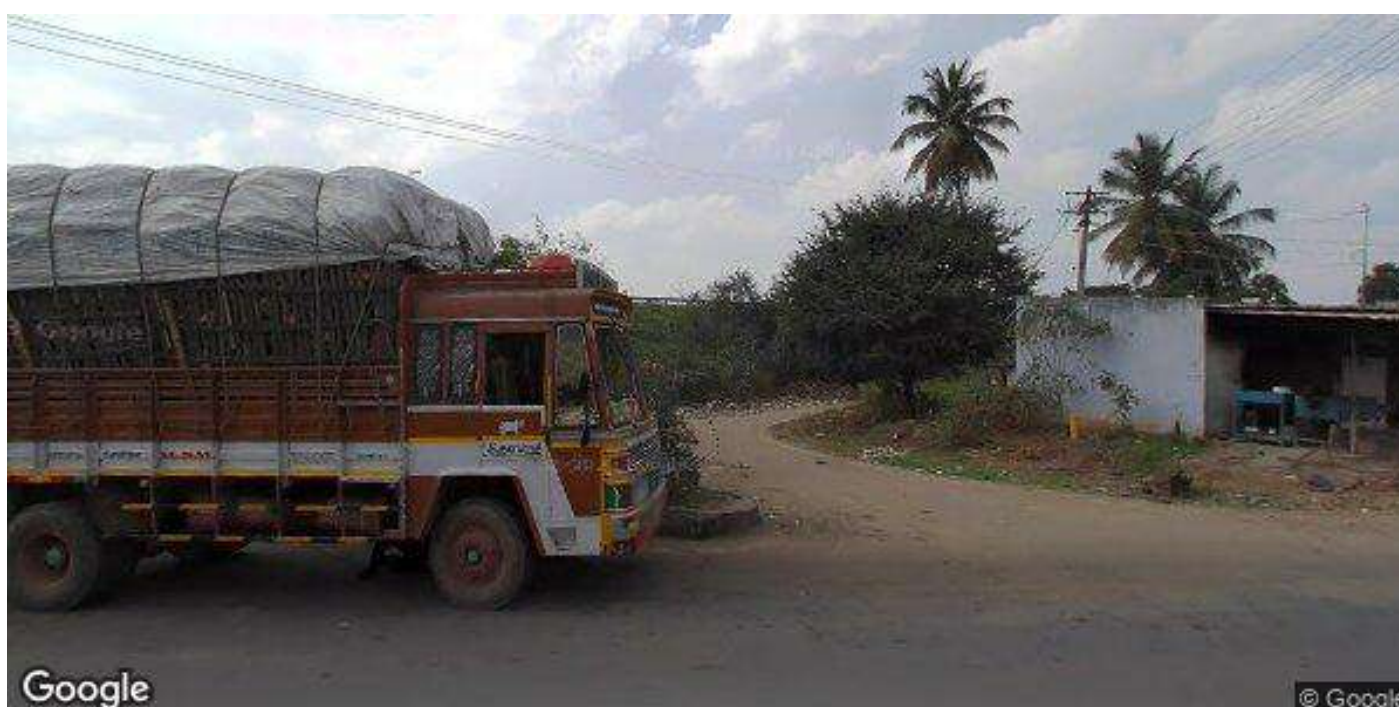
**Risk Type:** Turn  
**Risk Level:** High  
**Speed Limit:** 15 KM/Hr  
**Coordinates:** 11.49382, 77.88530

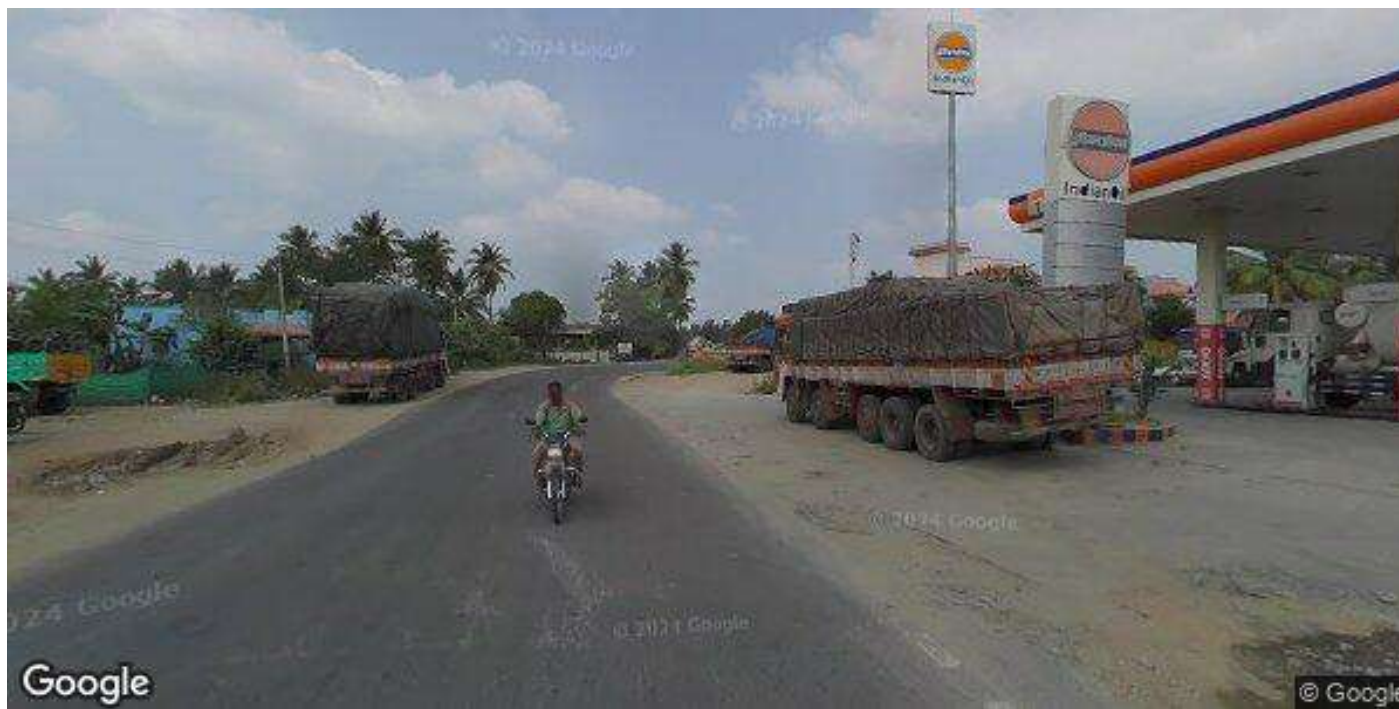
**Risk Type:** Turn  
**Risk Level:** High  
**Speed Limit:** 15 KM/Hr  
**Coordinates:** 11.49408, 77.88538

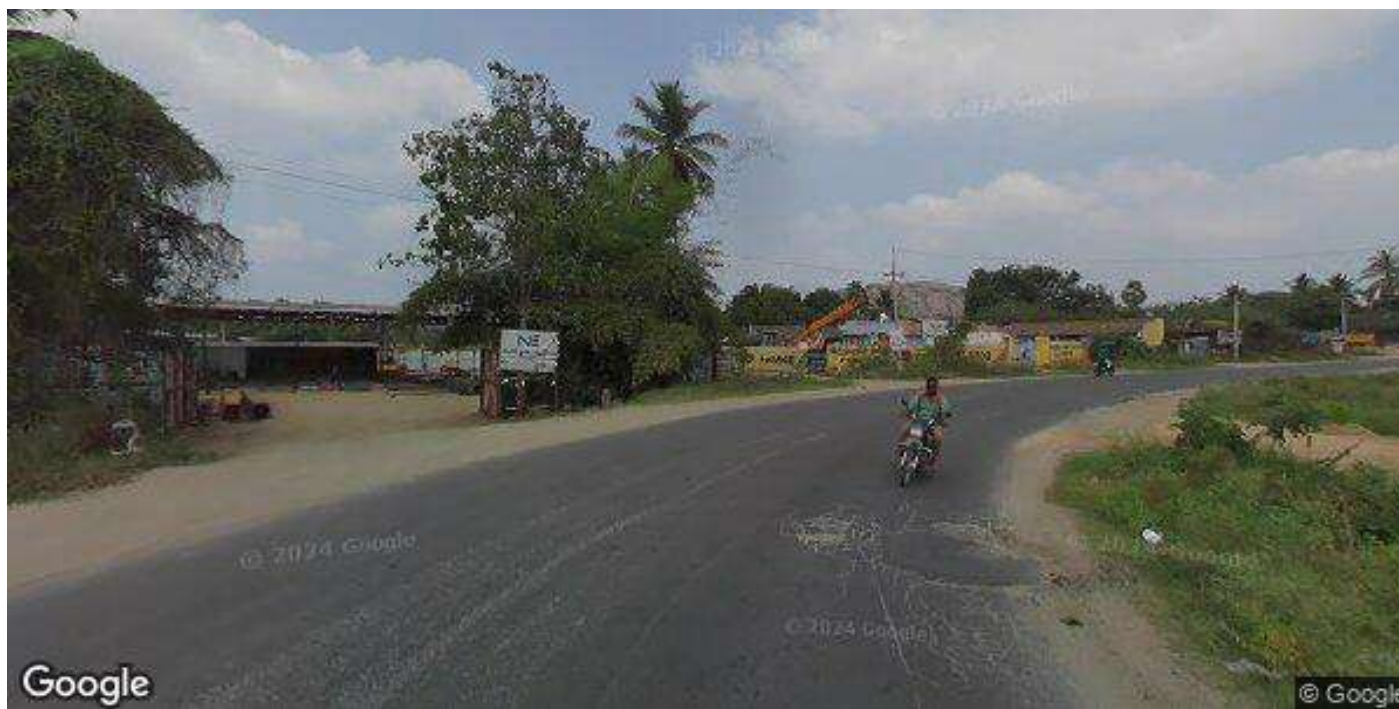
**Risk Type:** Turn  
**Risk Level:** Medium  
**Speed Limit:** 30 KM/Hr  
**Coordinates:** 11.49444, 77.88492

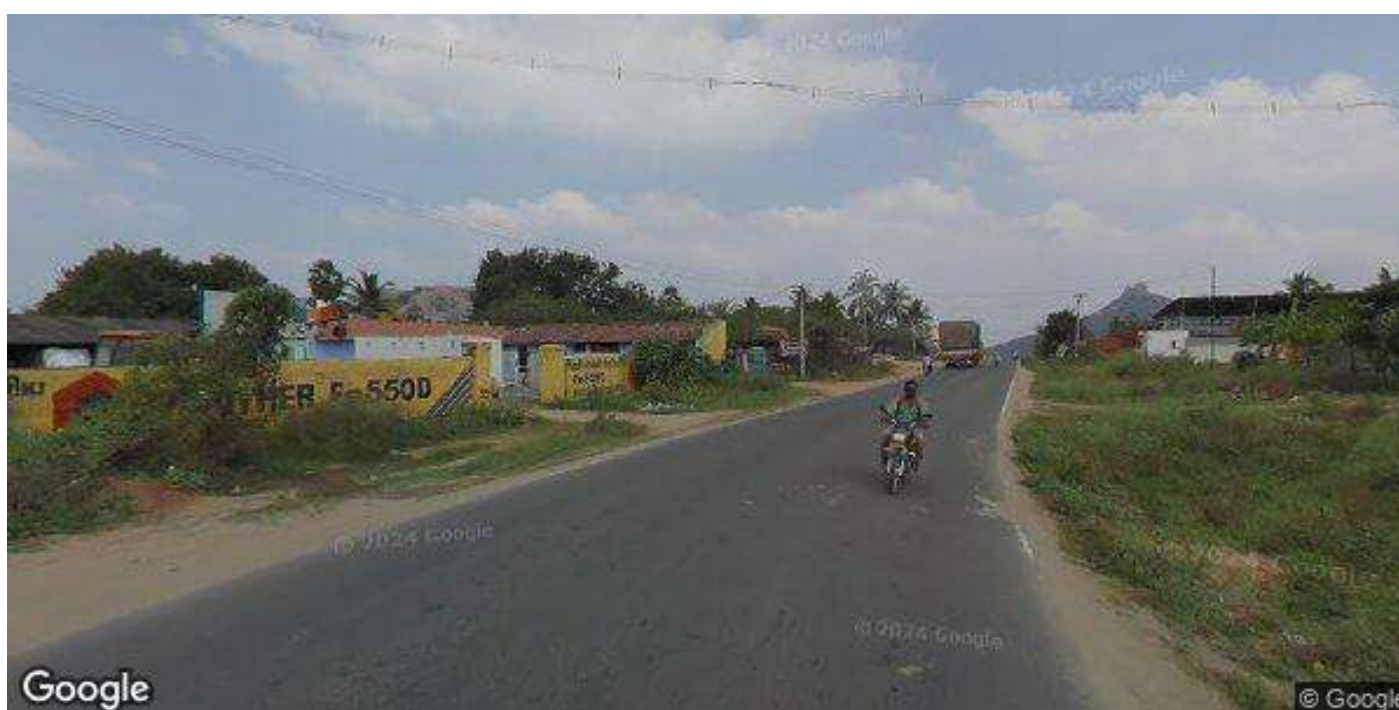
**Risk Type:** Turn  
**Risk Level:** Medium  
**Speed Limit:** 30 KM/Hr  
**Coordinates:** 11.49469, 77.88488

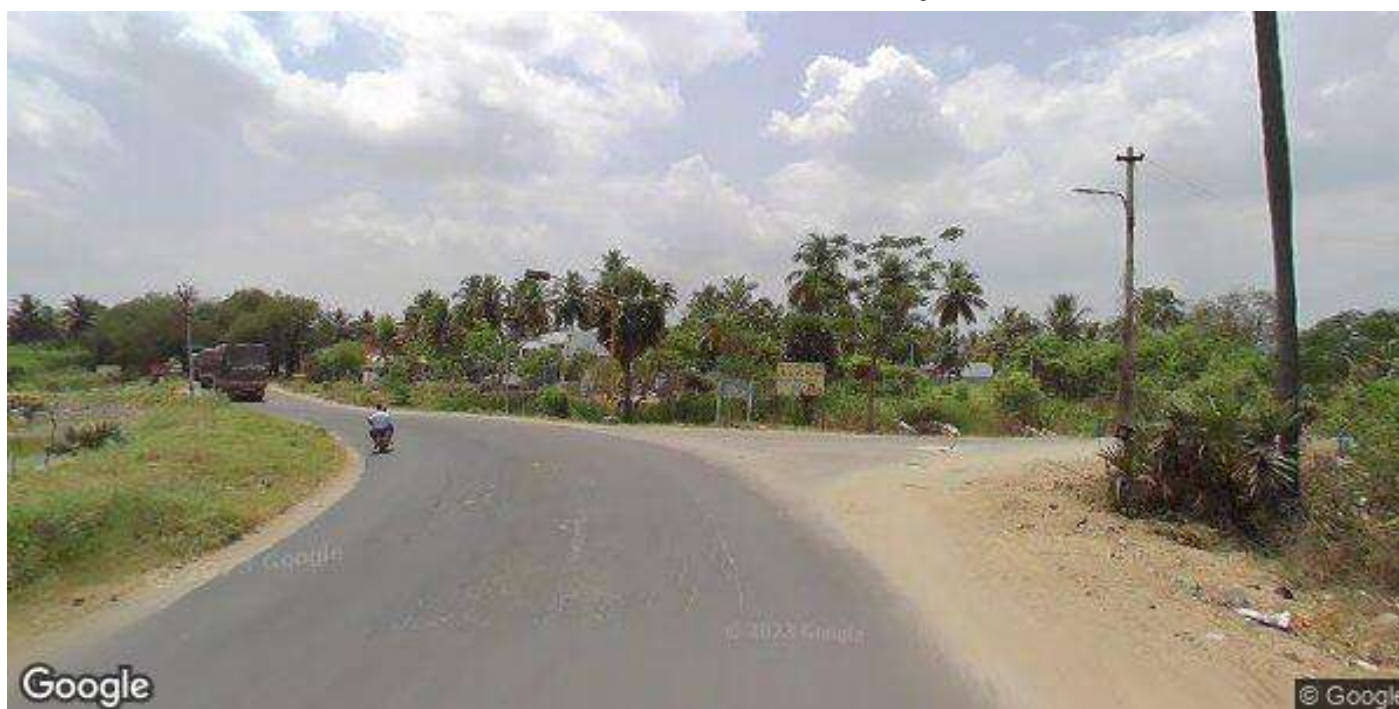
**Risk Type:** Turn  
**Risk Level:** Medium  
**Speed Limit:** 30 KM/Hr  
**Coordinates:** 11.56096, 77.89931

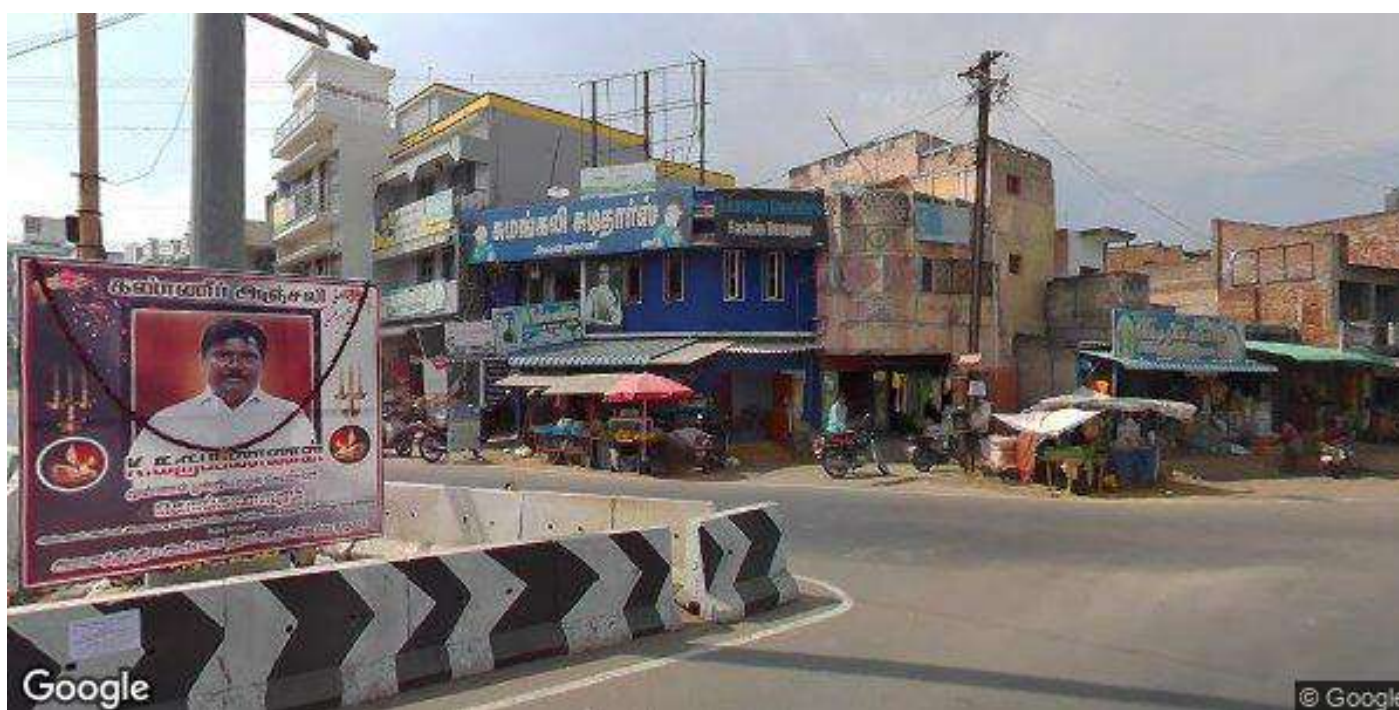
**Risk Type:** Turn  
**Risk Level:** Medium  
**Speed Limit:** 30 KM/Hr  
**Coordinates:** 11.57036, 77.90223

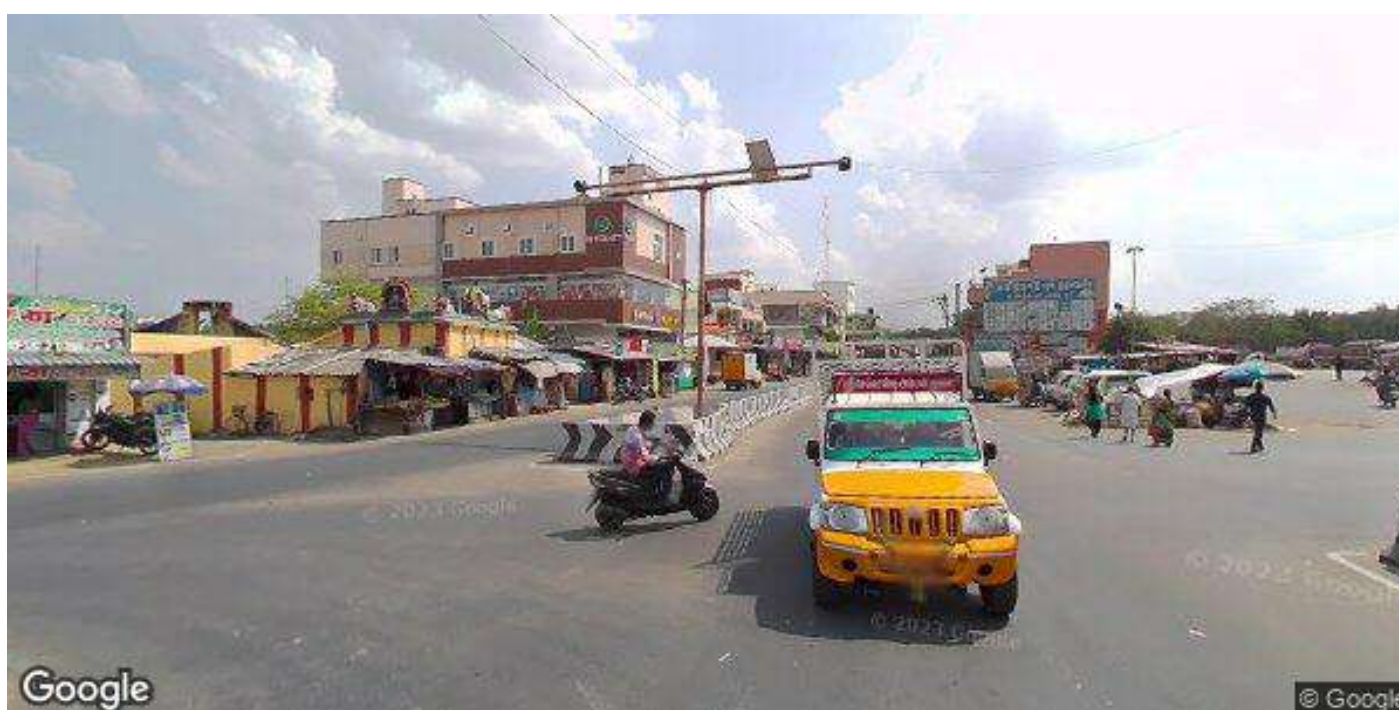
**Risk Type:** Turn  
**Risk Level:** Medium  
**Speed Limit:** 30 KM/Hr  
**Coordinates:** 11.57042, 77.90222

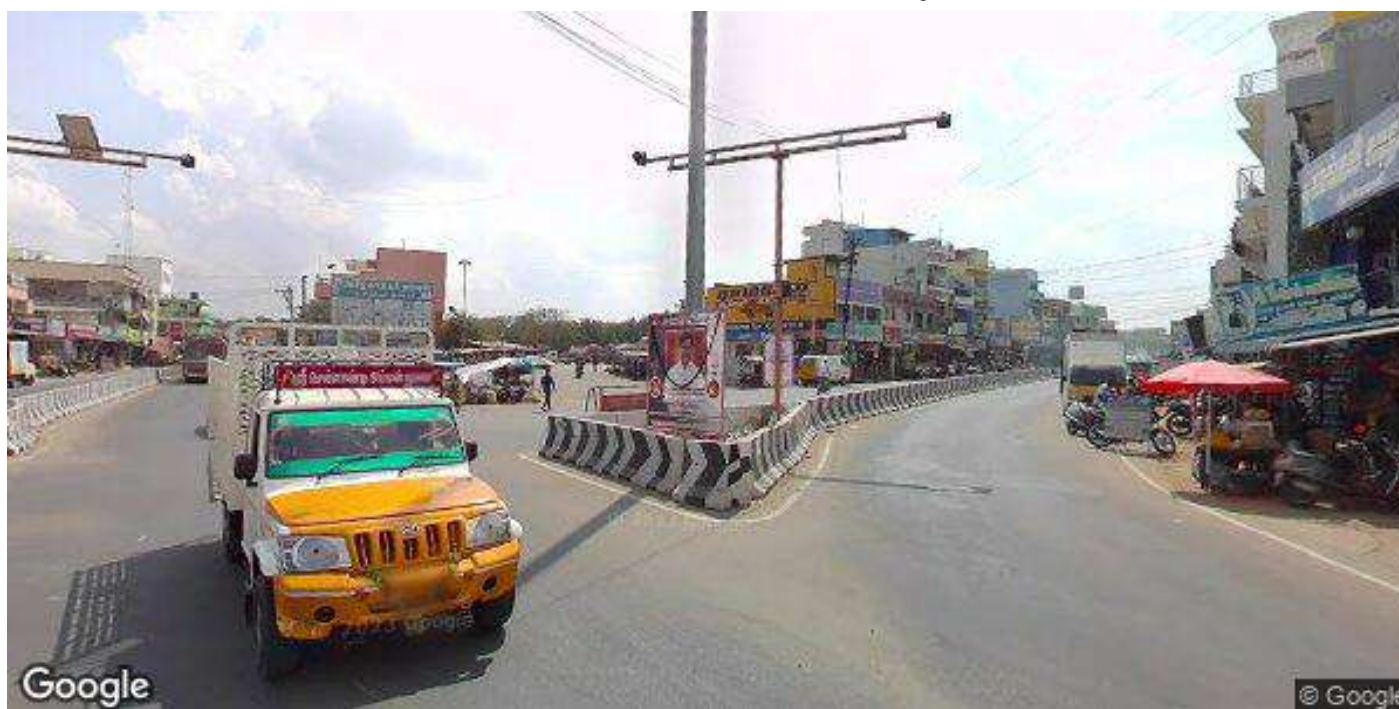
**Risk Type:** Turn  
**Risk Level:** Medium  
**Speed Limit:** 30 KM/Hr  
**Coordinates:** 11.57053, 77.90227

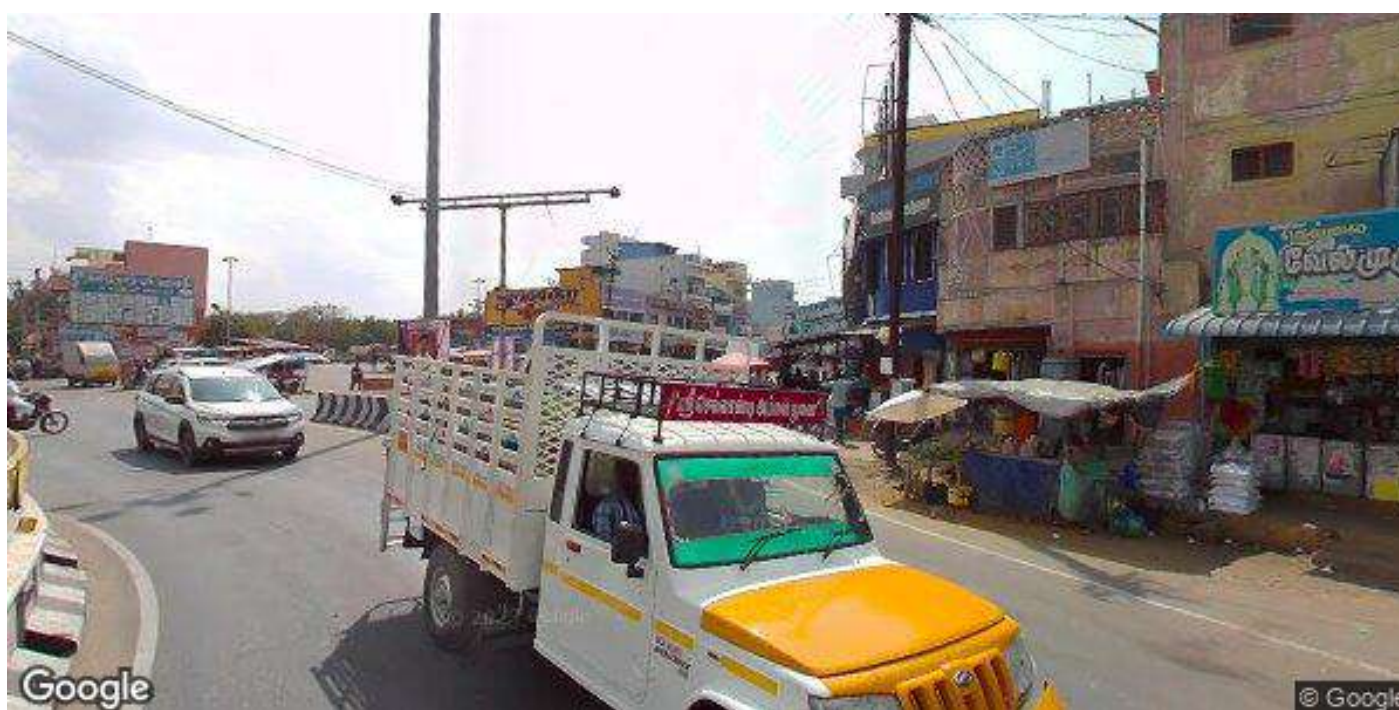
**Risk Type:** Turn  
**Risk Level:** Medium  
**Speed Limit:** 30 KM/Hr  
**Coordinates:** 11.57056, 77.90234

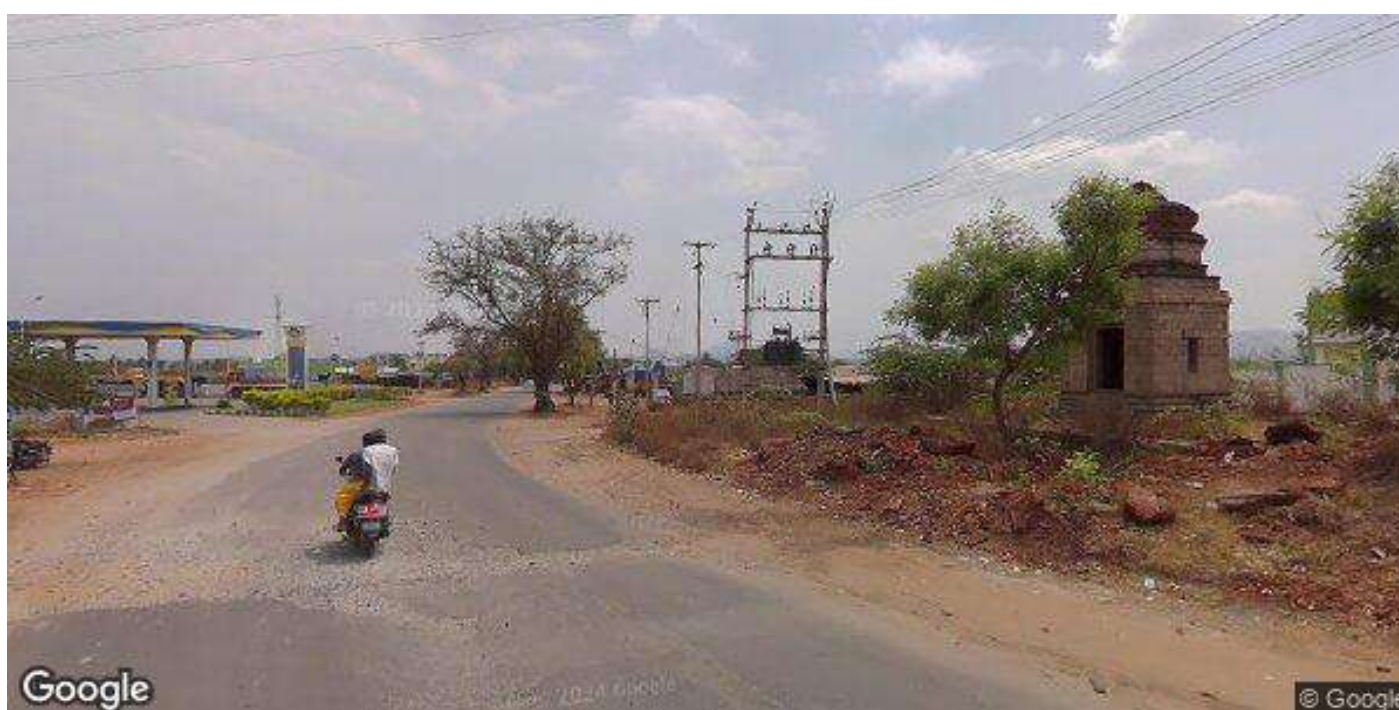
**Risk Type:** Turn  
**Risk Level:** Medium  
**Speed Limit:** 30 KM/Hr  
**Coordinates:** 11.58304, 77.90656

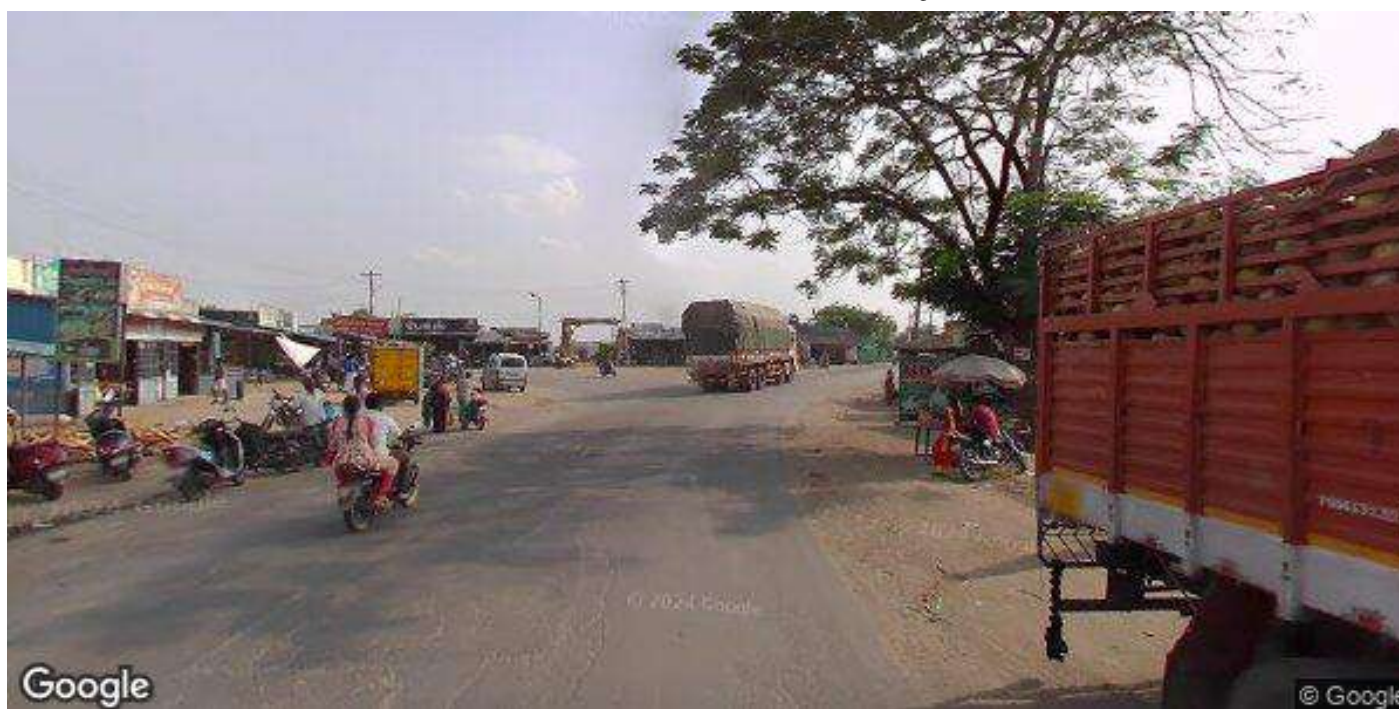
**Risk Type:** Turn  
**Risk Level:** Medium  
**Speed Limit:** 30 KM/Hr  
**Coordinates:** 11.64197, 77.95197

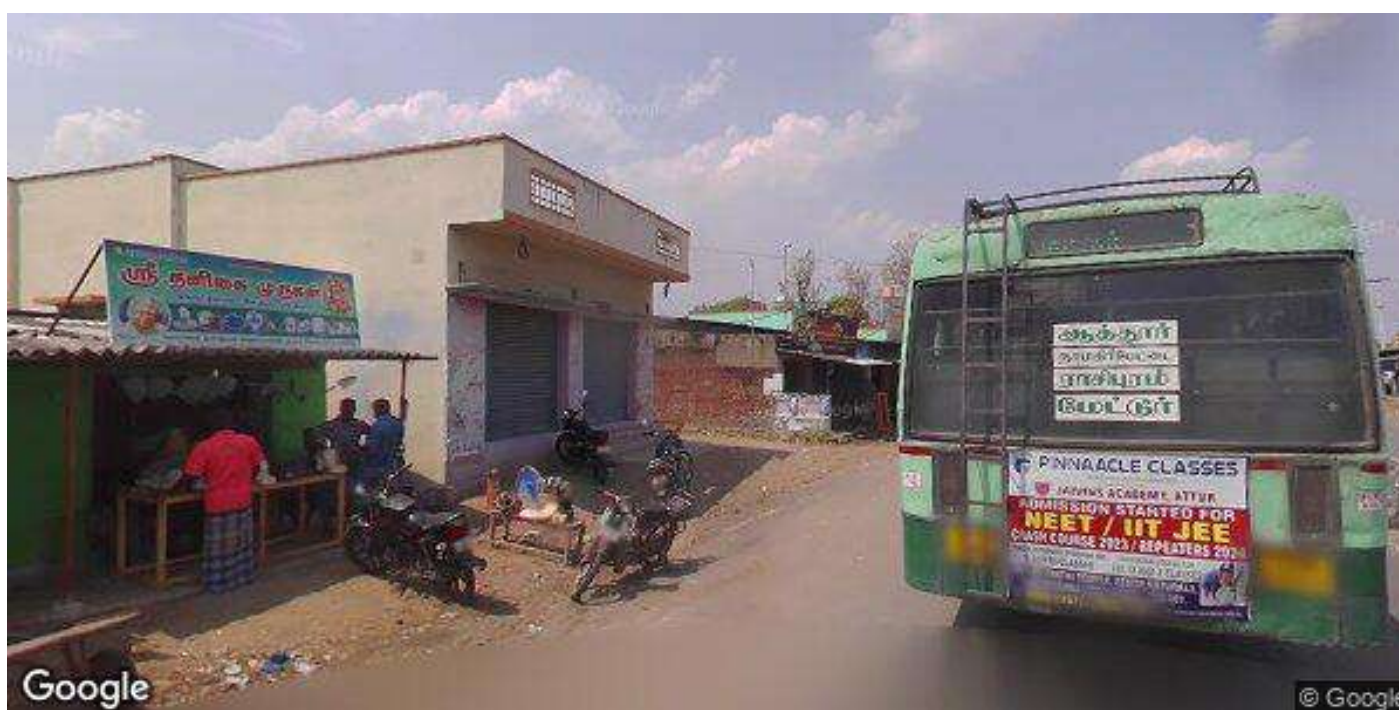
**Risk Type:** Turn  
**Risk Level:** Medium  
**Speed Limit:** 30 KM/Hr  
**Coordinates:** 11.64721, 77.95118
