# IndianOil

## JOURNEY RISK MANAGEMENT (JRM) STUDY

### Salem Terminal TO AVC ASSOCIATES

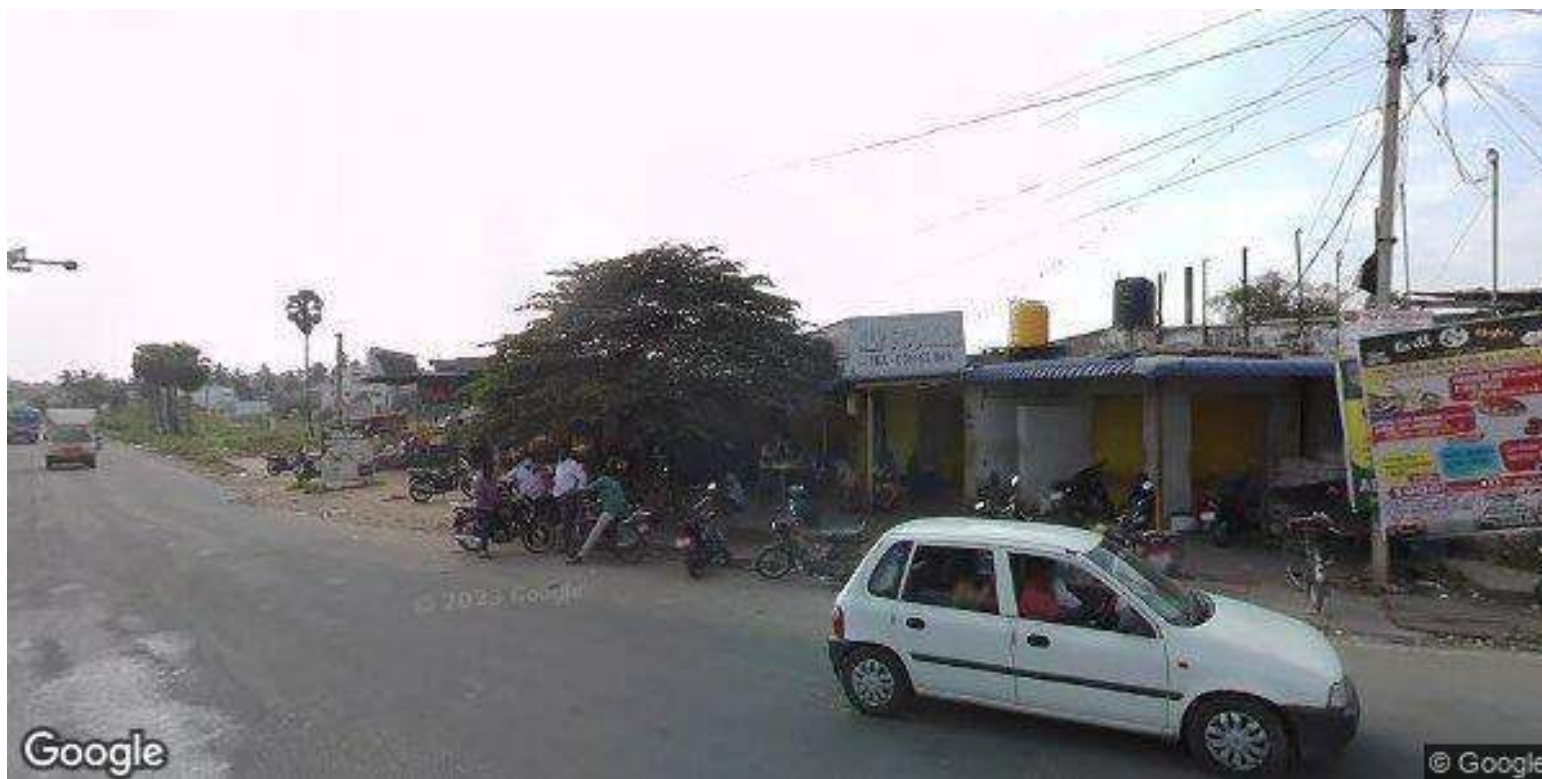
**Coordinates: 11.48369, 77.88781**

**Risk Type: Turn**

**Risk Level: High**

**Speed Limit: 15 KM/Hr**

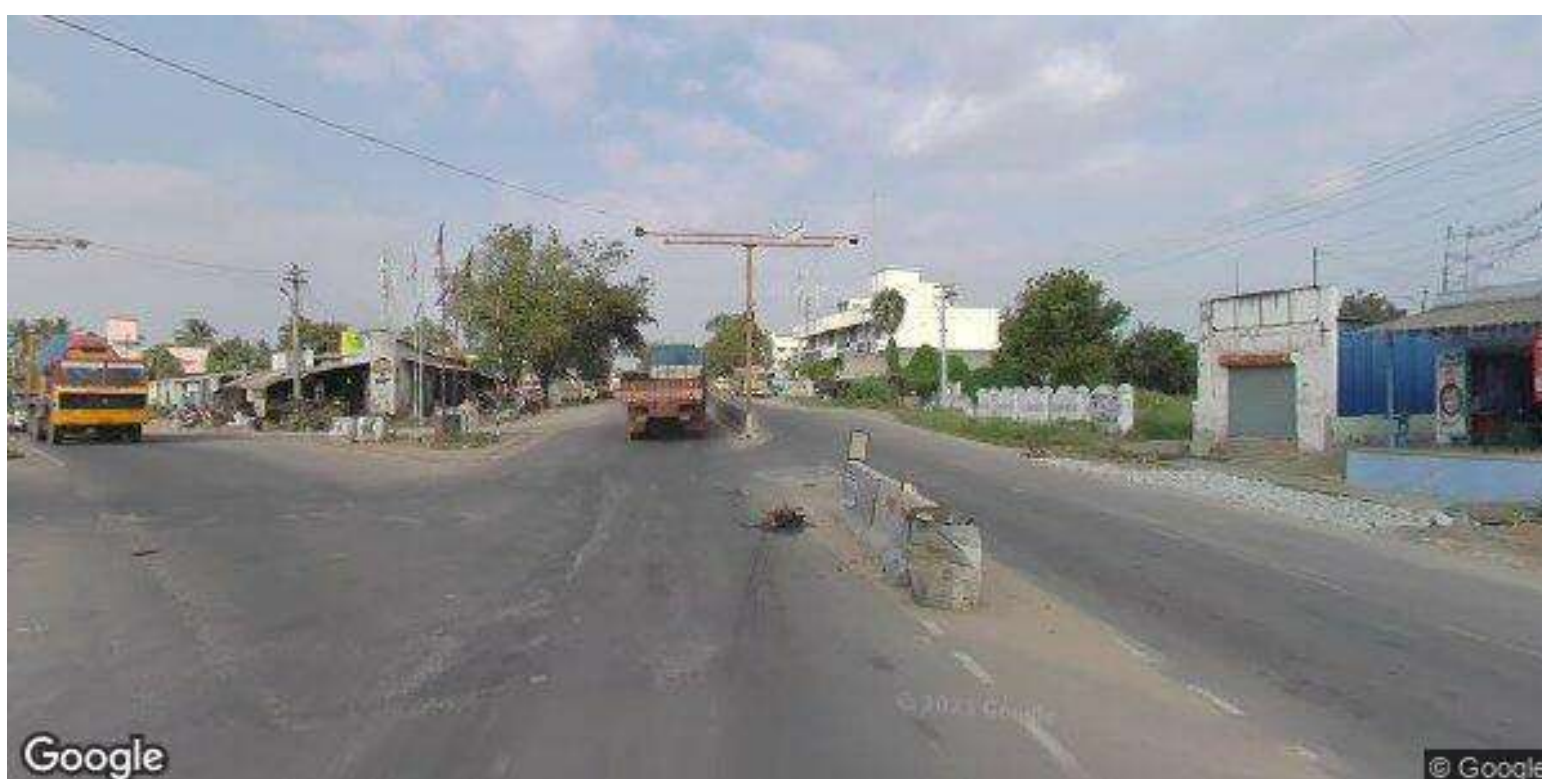
**Coordinates: 11.48370, 77.88787**

**Risk Type: Turn**

**Risk Level: Medium**

**Speed Limit: 30 KM/Hr**

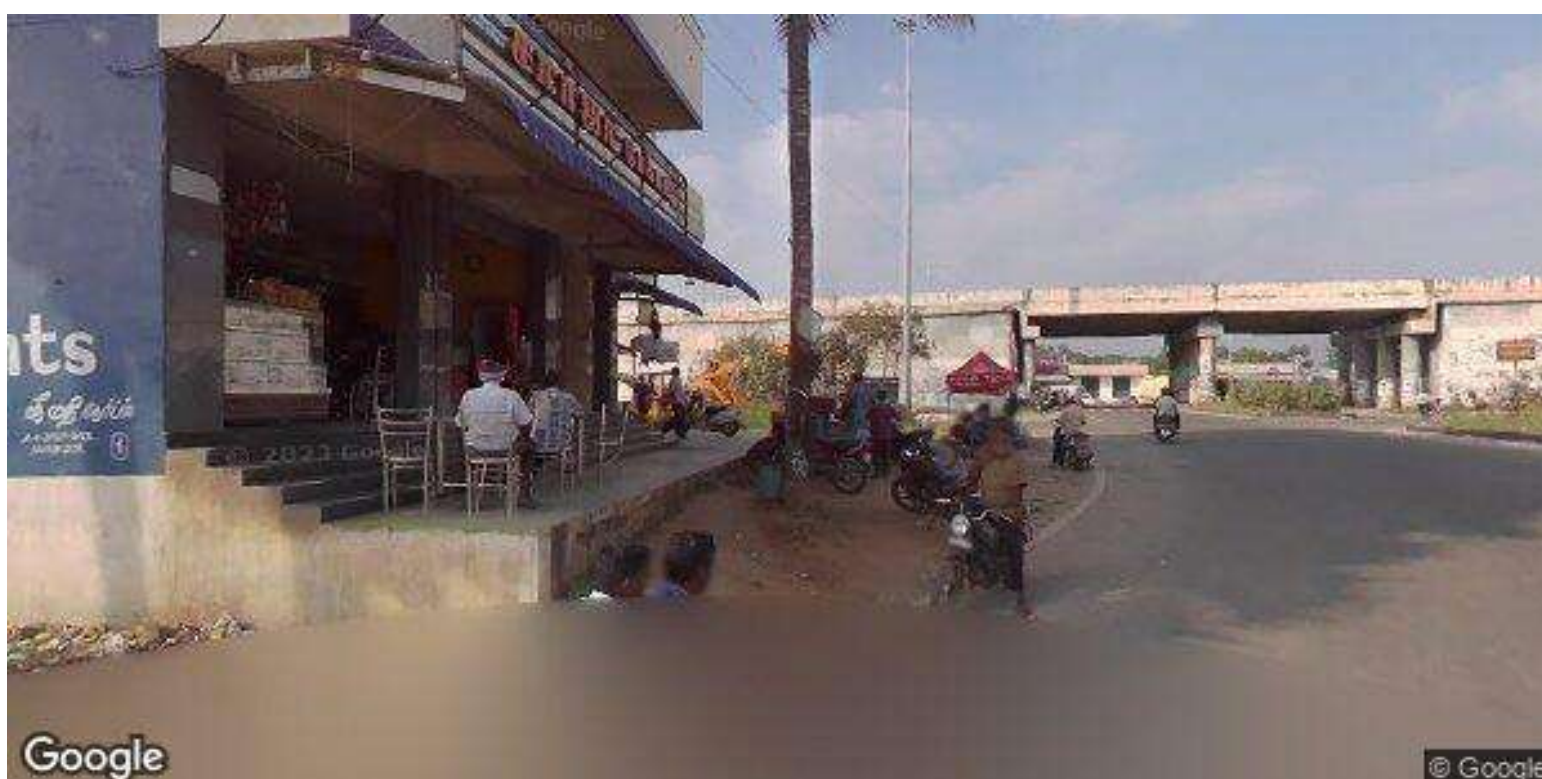
**Risk Type:** Turn  
**Risk Level:** Medium  
**Speed Limit:** 30 KM/Hr  
**Coordinates:** 11.49149, 77.89601

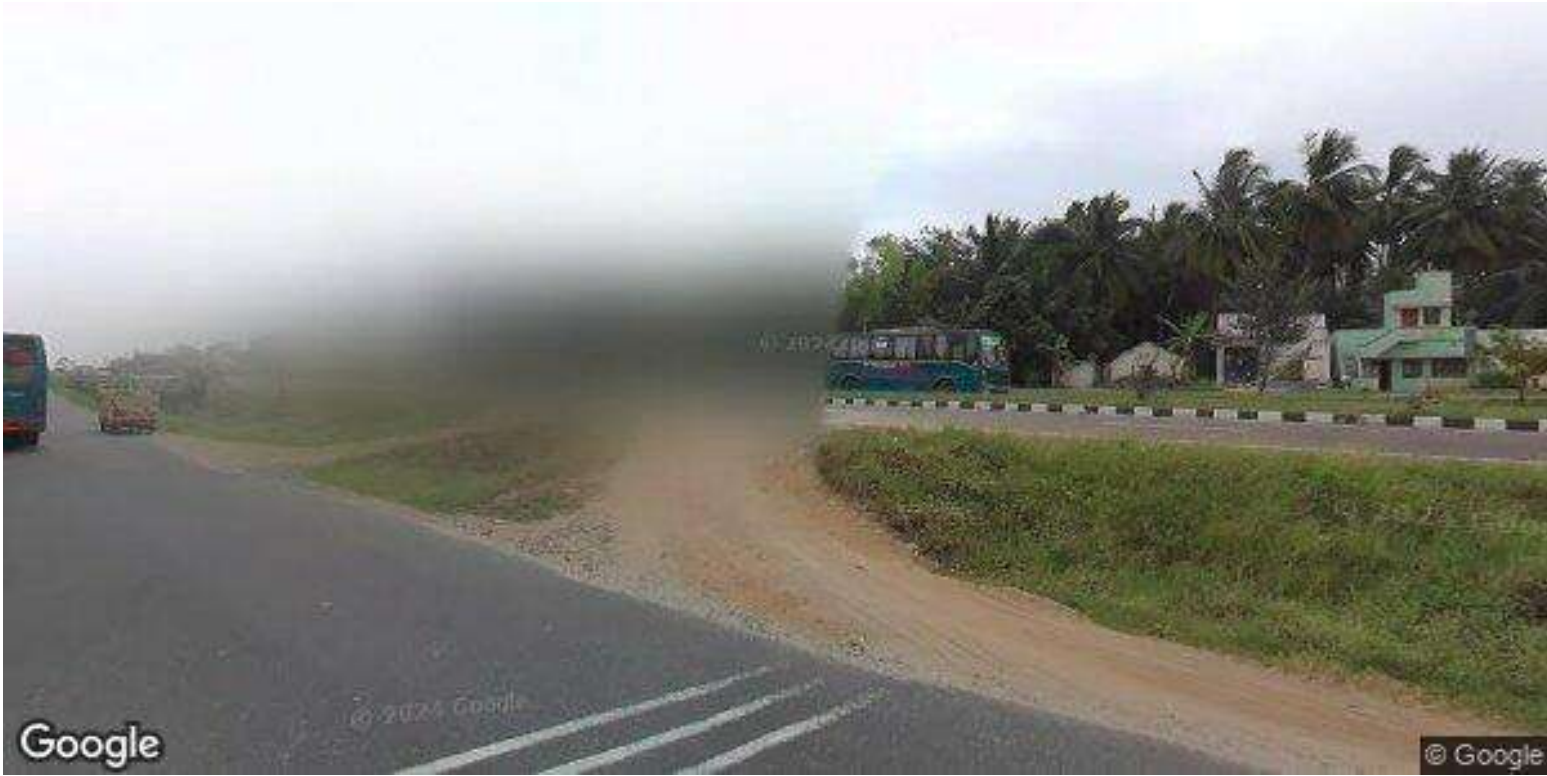
**Risk Type:** Turn  
**Risk Level:** Medium  
**Speed Limit:** 30 KM/Hr  
**Coordinates:** 11.55622, 78.00774

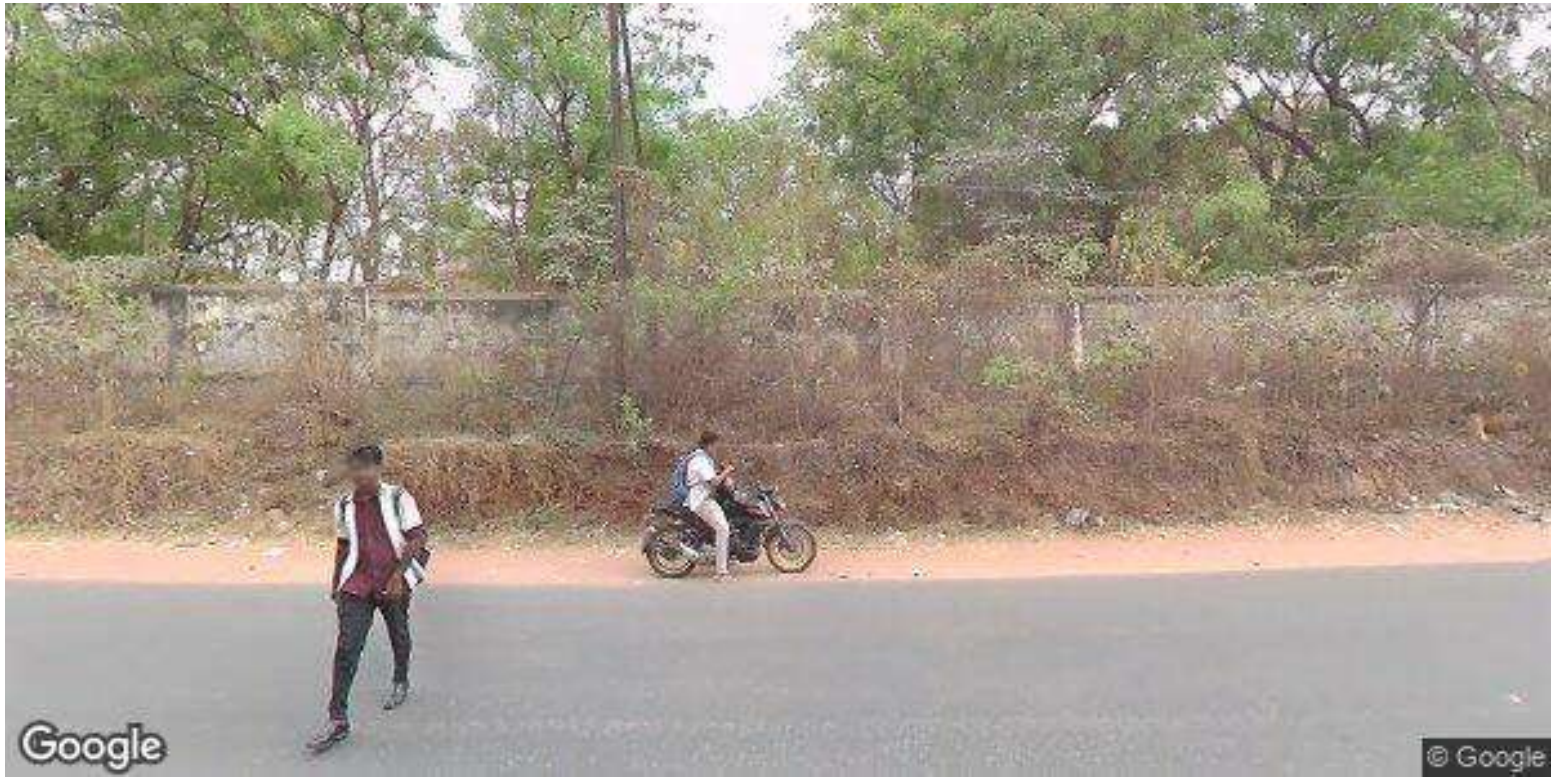
**Risk Type:** Turn  
**Risk Level:** High  
**Speed Limit:** 15 KM/Hr  
**Coordinates:** 11.55800, 78.01305

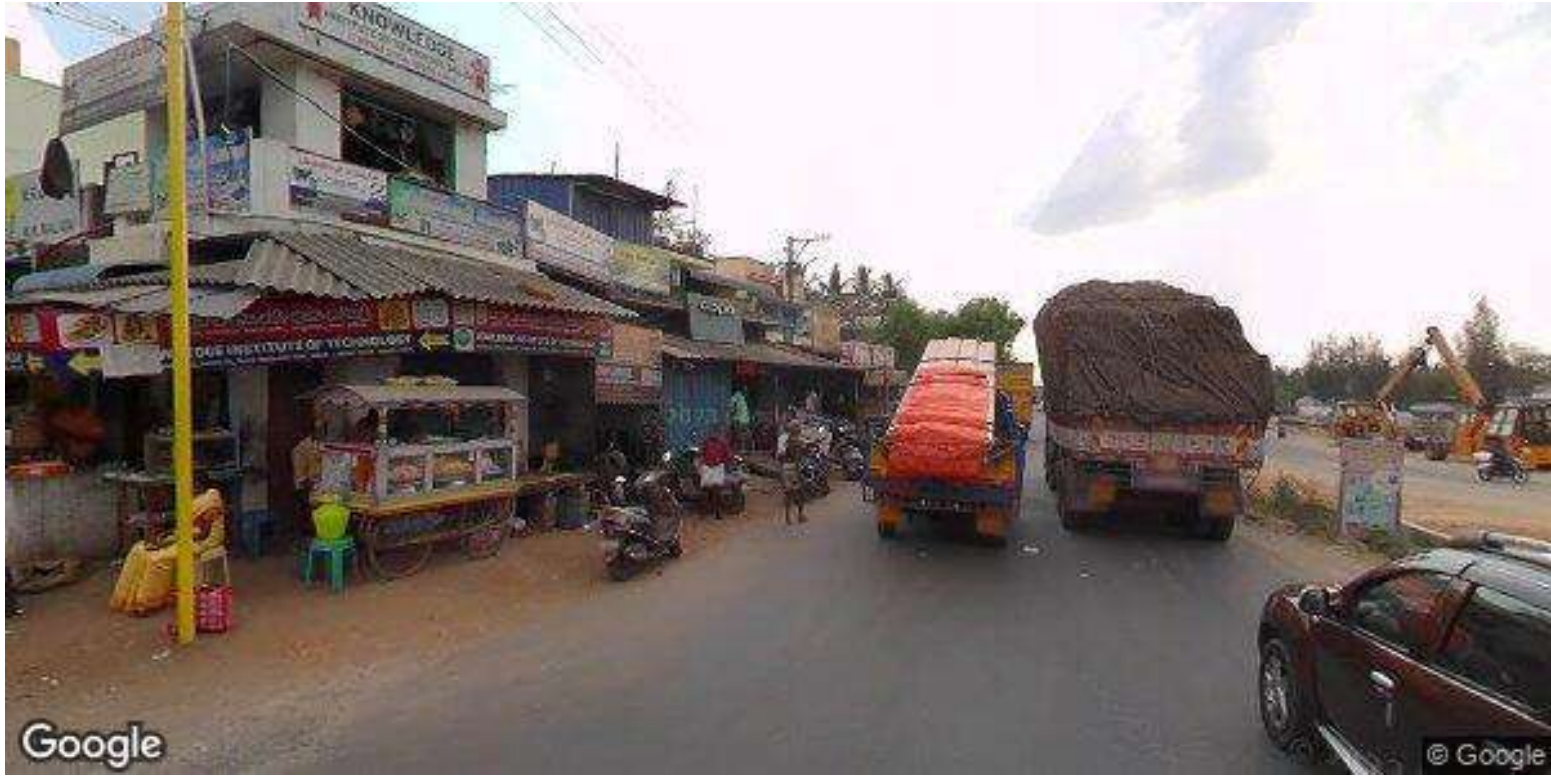
**Risk Type:** Blind Spot  
**Risk Level:** Blind Spot  
**Speed Limit:** 10 KM/Hr  
**Coordinates:** 11.55707, 78.01094

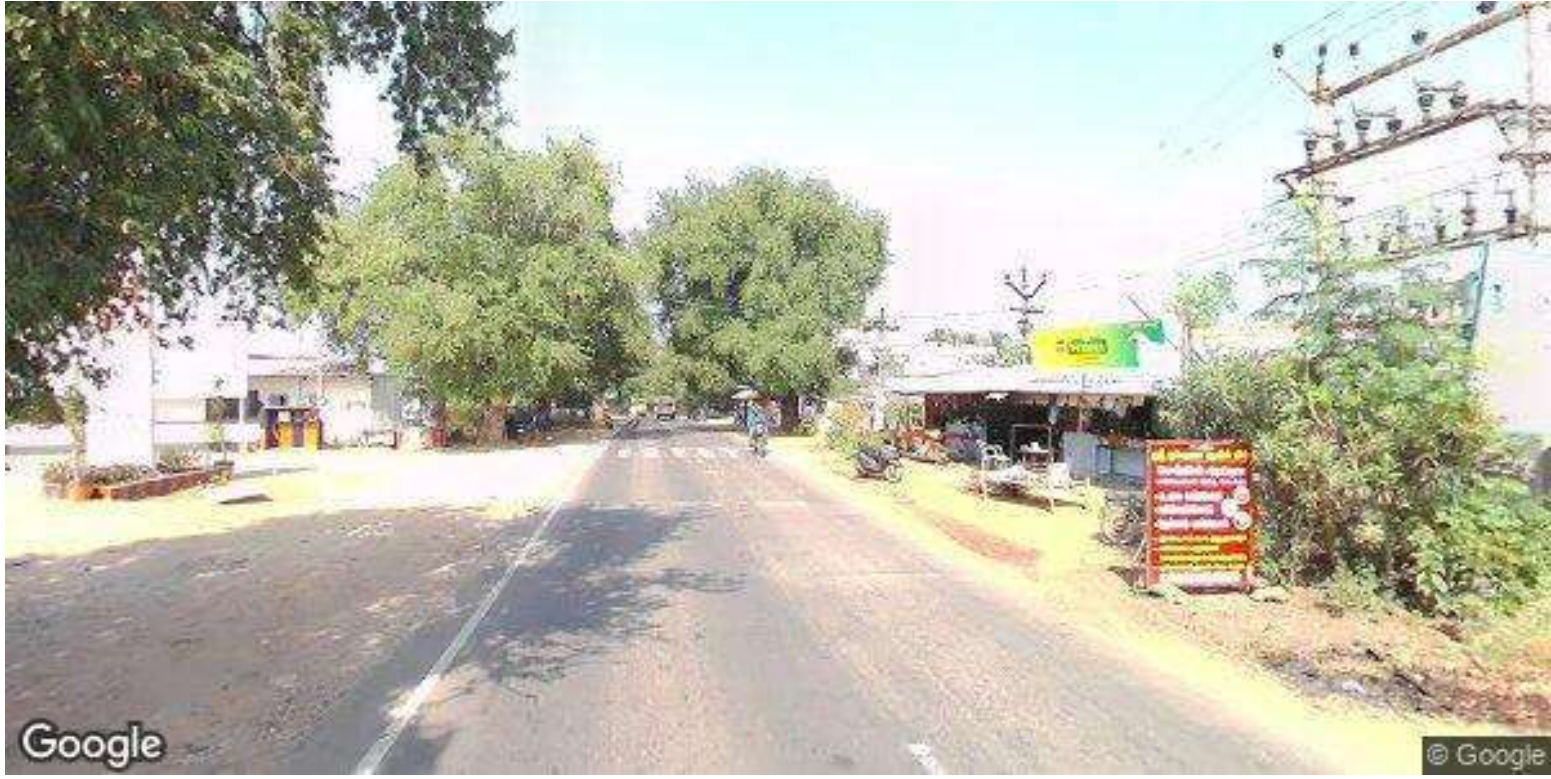
**Coordinates:** 11.55027, 78.01896

**Risk Type:** Turn

**Risk Level:** High

**Speed Limit:** 15 KM/Hr
