# IndianOil

## JOURNEY RISK MANAGEMENT (JRM) STUDY

### Salem Terminal to SHREE VARI CORPORATION

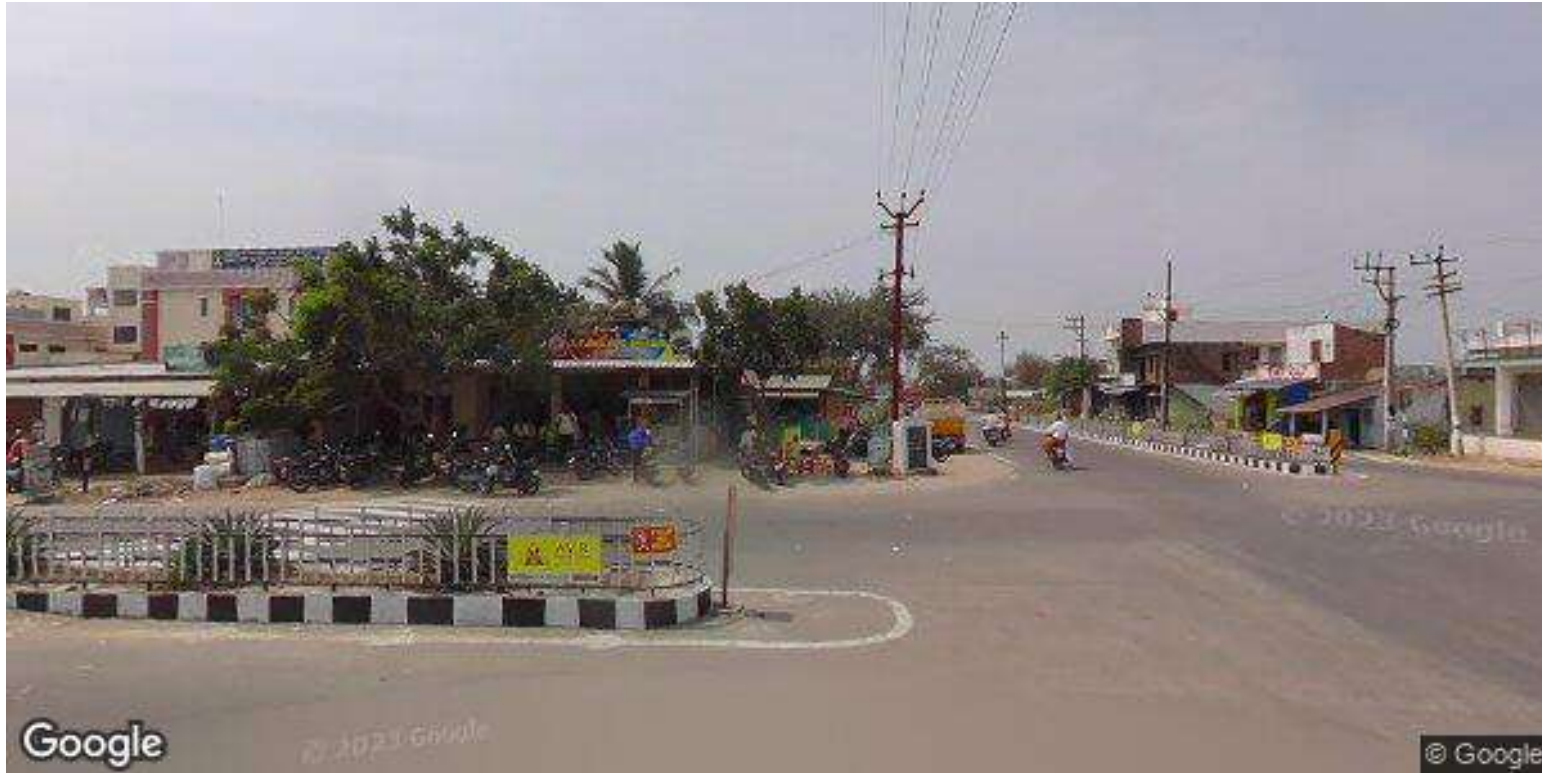
**Coordinates:** 11.58300, 77.85813

**Risk Type:** Roundabout

**Risk Level:** High

**Speed Limit:** 15 KM/Hr

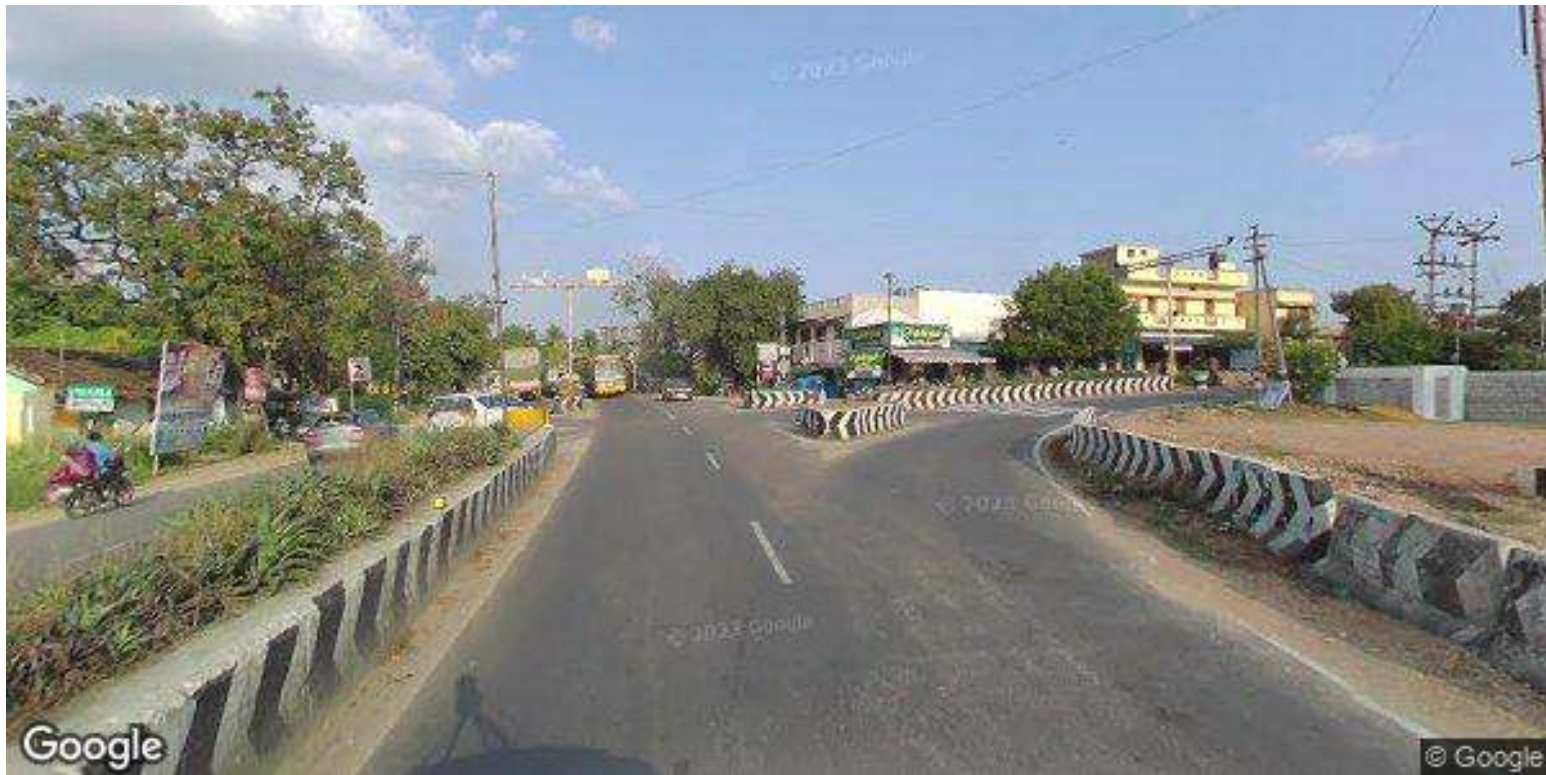
**Coordinates: 11.46318, 77.84913**

**Risk Type: Turn**

**Risk Level: Medium**

**Speed Limit: 30 KM/Hr**

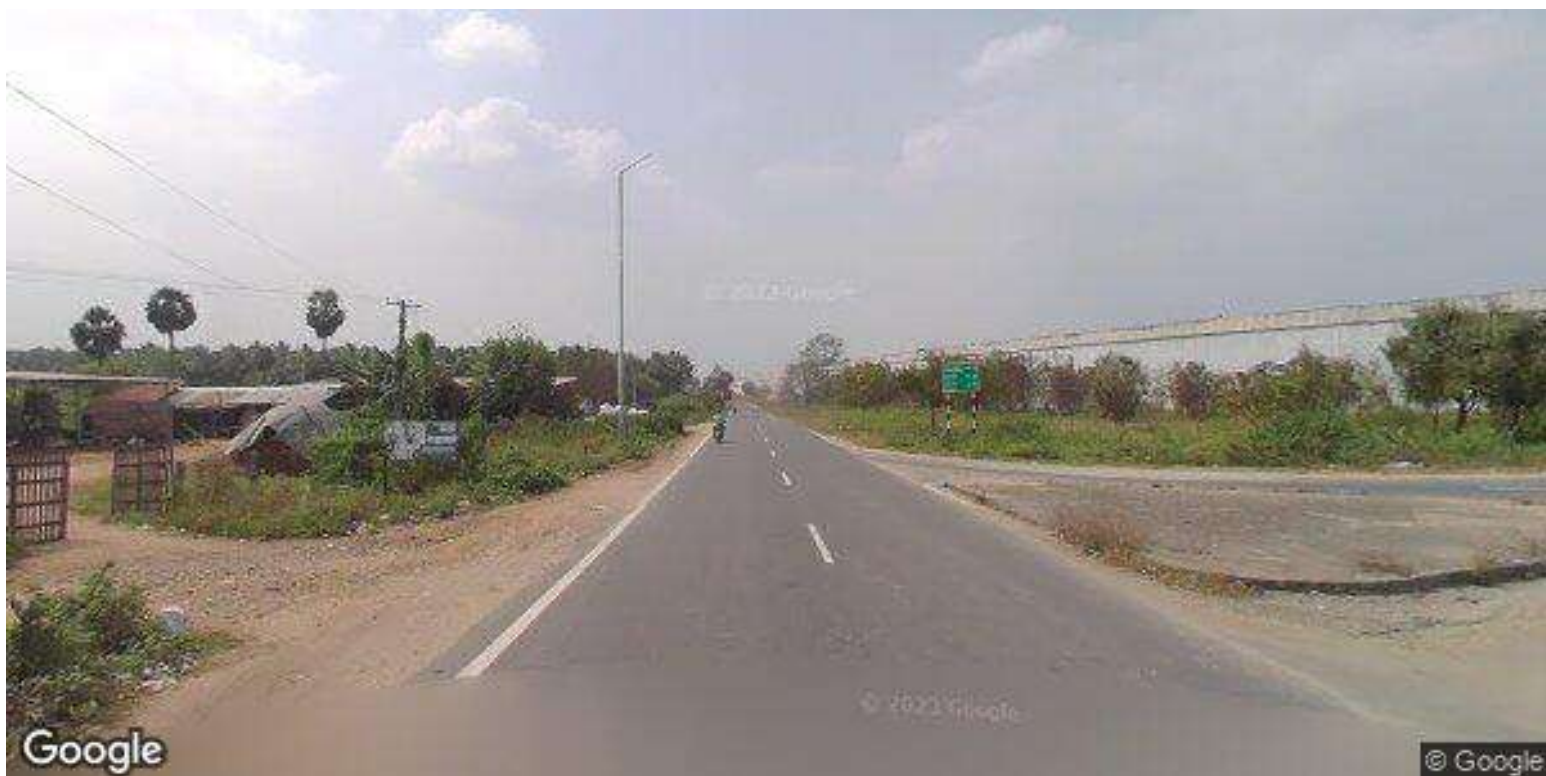
**Coordinates: 11.45542, 77.81725**

**Risk Type: Turn**

**Risk Level: High**

**Speed Limit: 15 KM/Hr**

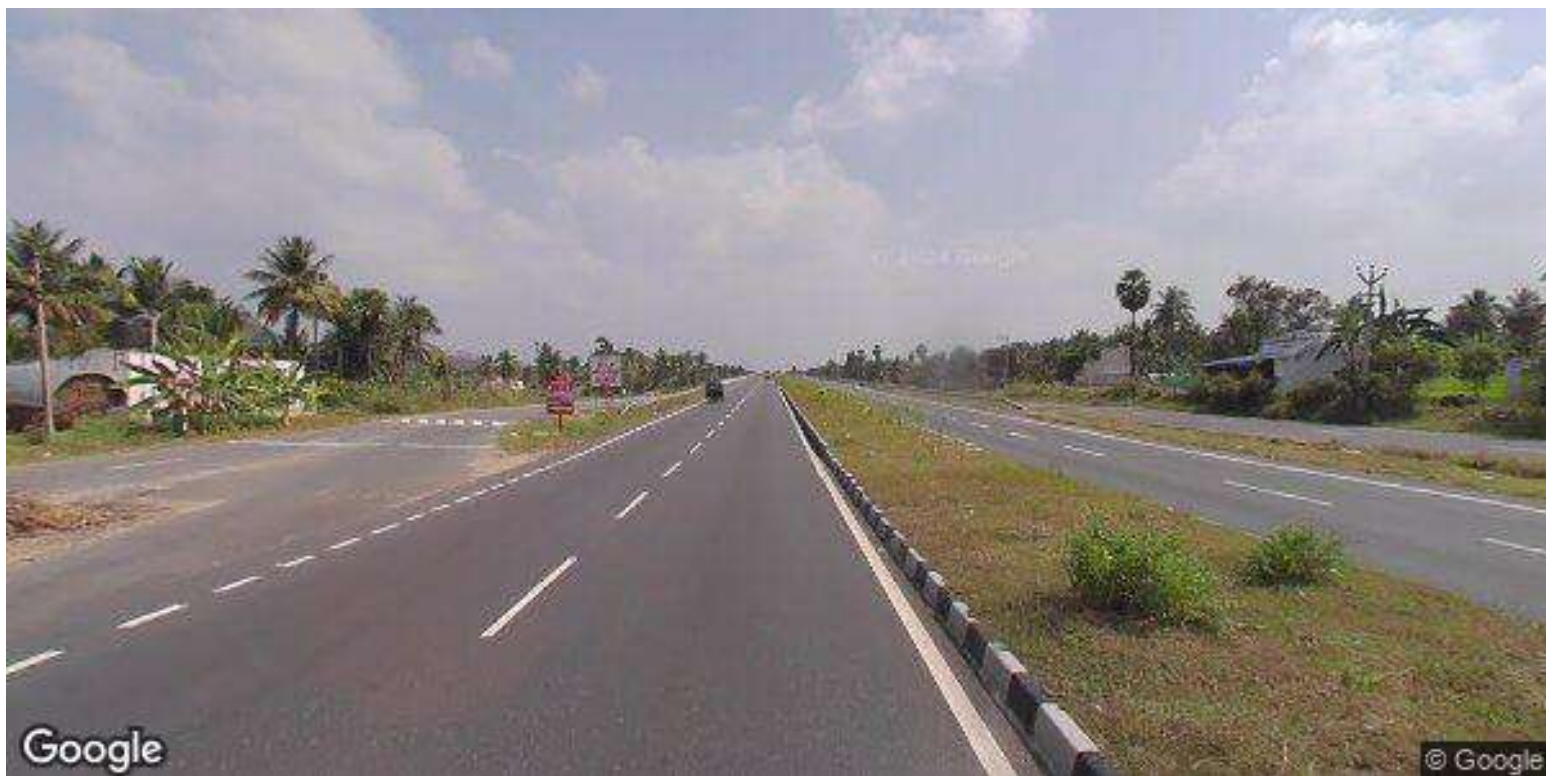
**Coordinates:** 11.49249, 77.85820

**Risk Type:** Turn

**Risk Level:** Medium

**Speed Limit:** 30 KM/Hr

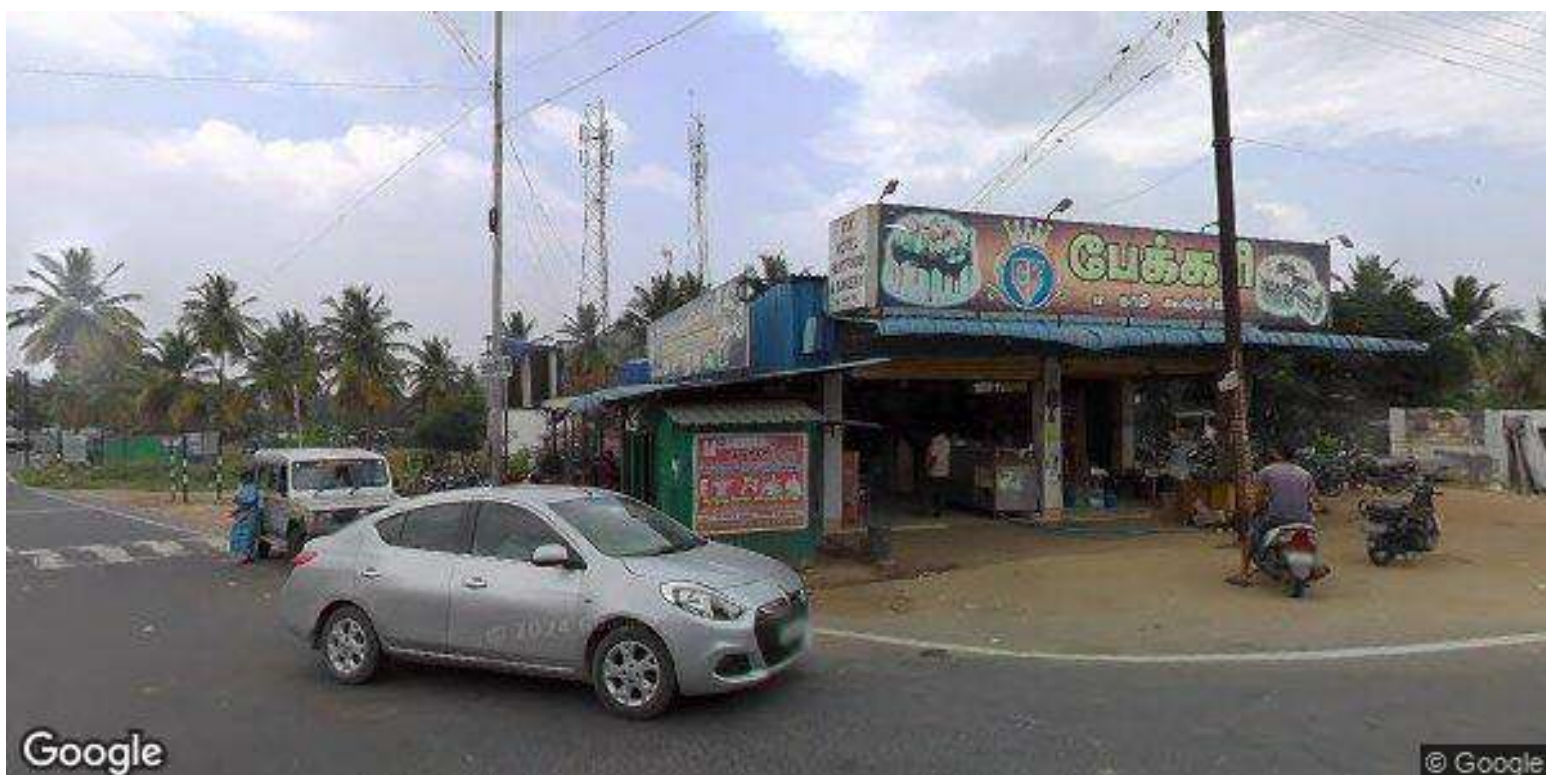
**Risk Type:** Blind Spot  
**Risk Level:** Blind Spot  
**Speed Limit:** 10 KM/Hr  
**Coordinates:** 11.49390, 77.86748

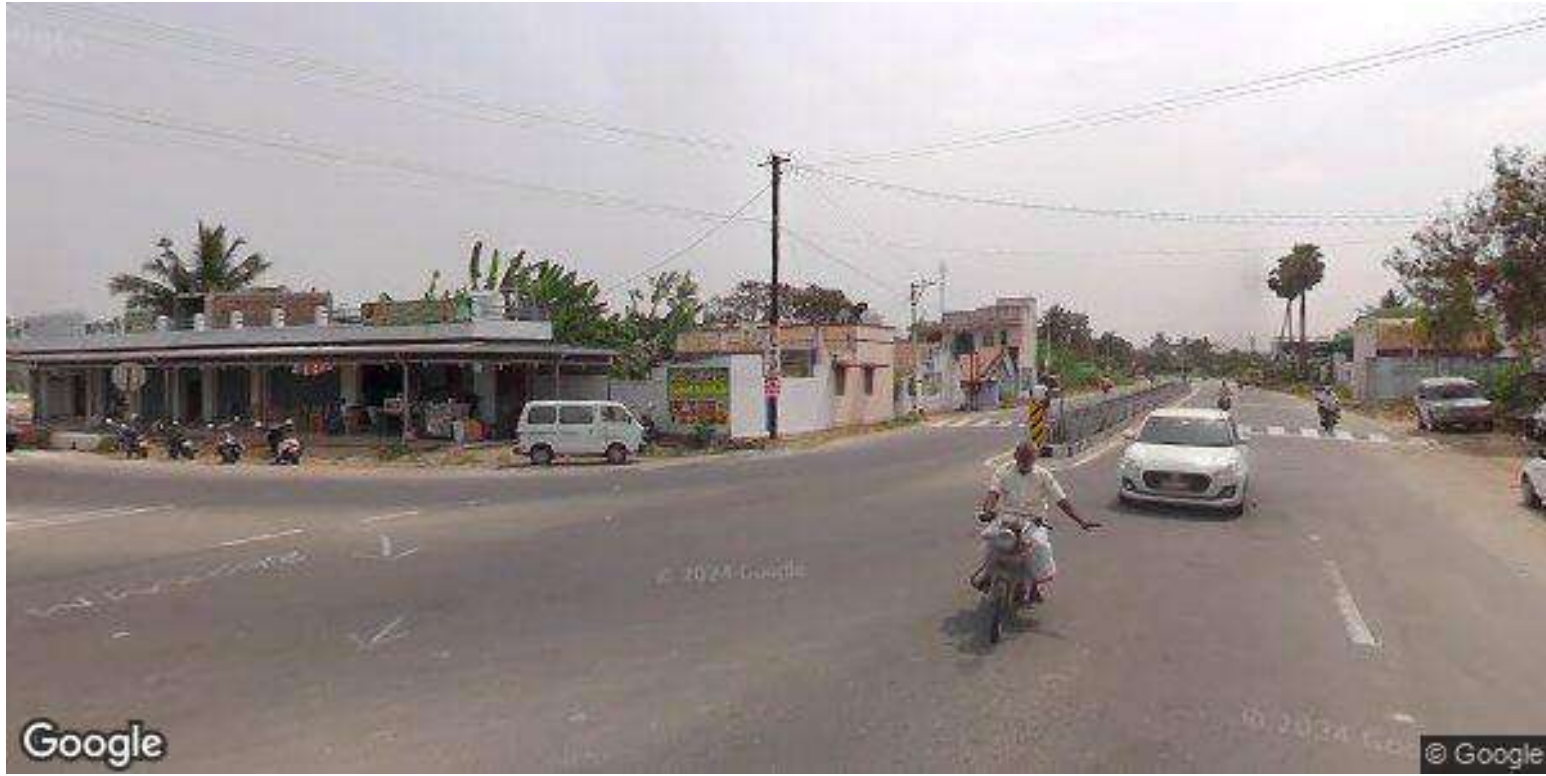
**Risk Type:** Turn  
**Risk Level:** High  
**Speed Limit:** 15 KM/Hr  
**Coordinates:** 11.57903, 77.85432
