## **JOURNEY RISK MANAGEMENT (JRM) STUDY**

### **Salem Terminal To SPK PETROLEUM**

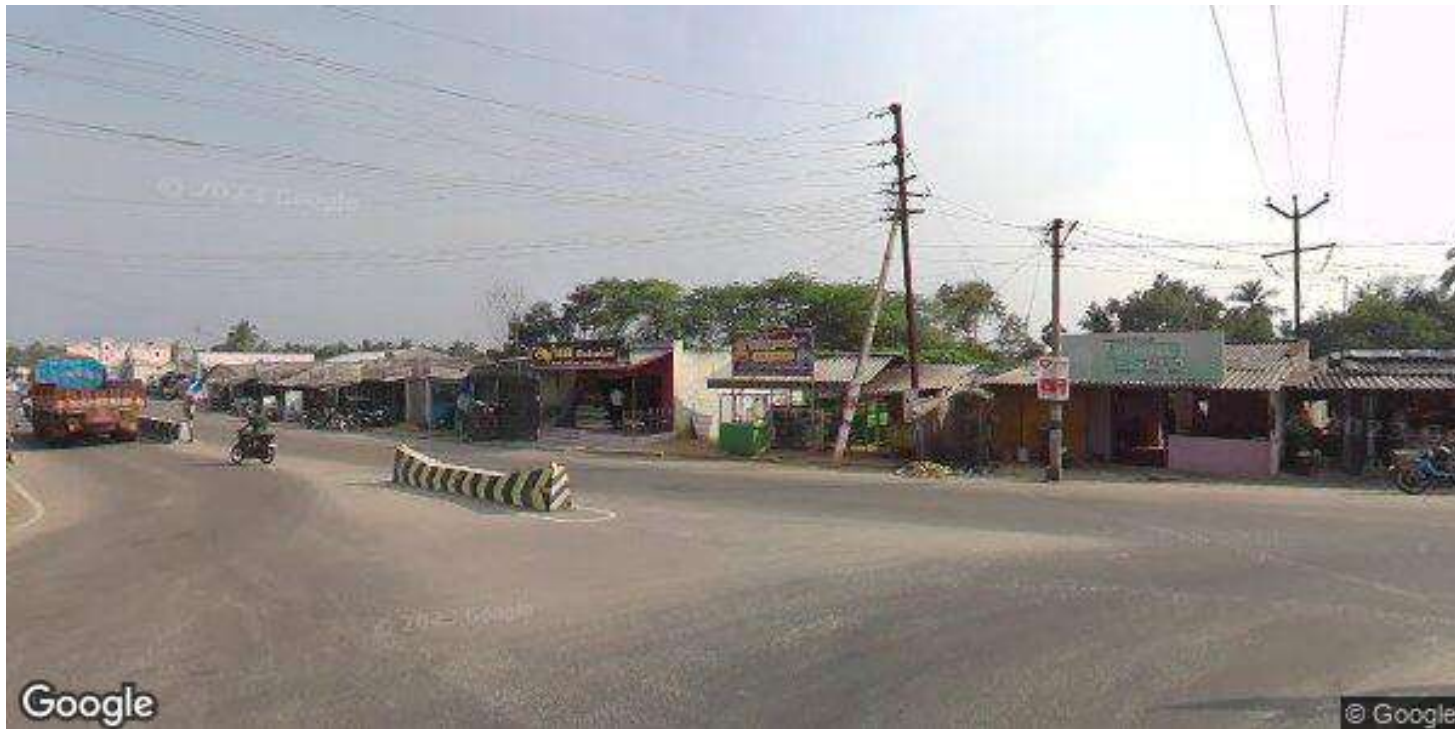
**Risk Type:** Roundabout  
**Risk Level:** High  
**Speed Limit:** 15 KM/Hr  
**Coordinates:** 11.04637, 77.73761

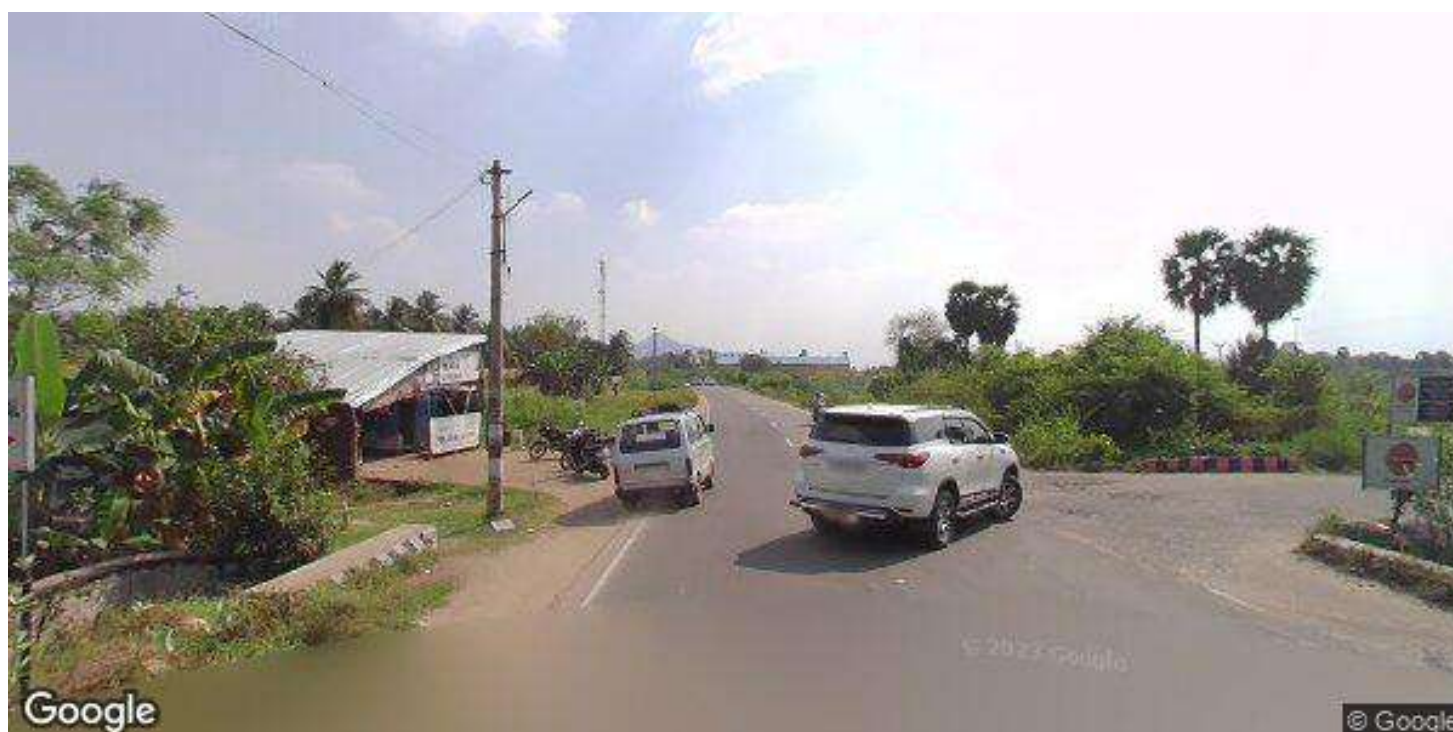
**Risk Type:** Turn  
**Risk Level:** High  
**Speed Limit:** 15 KM/Hr  
**Coordinates:** 11.44029, 77.87544

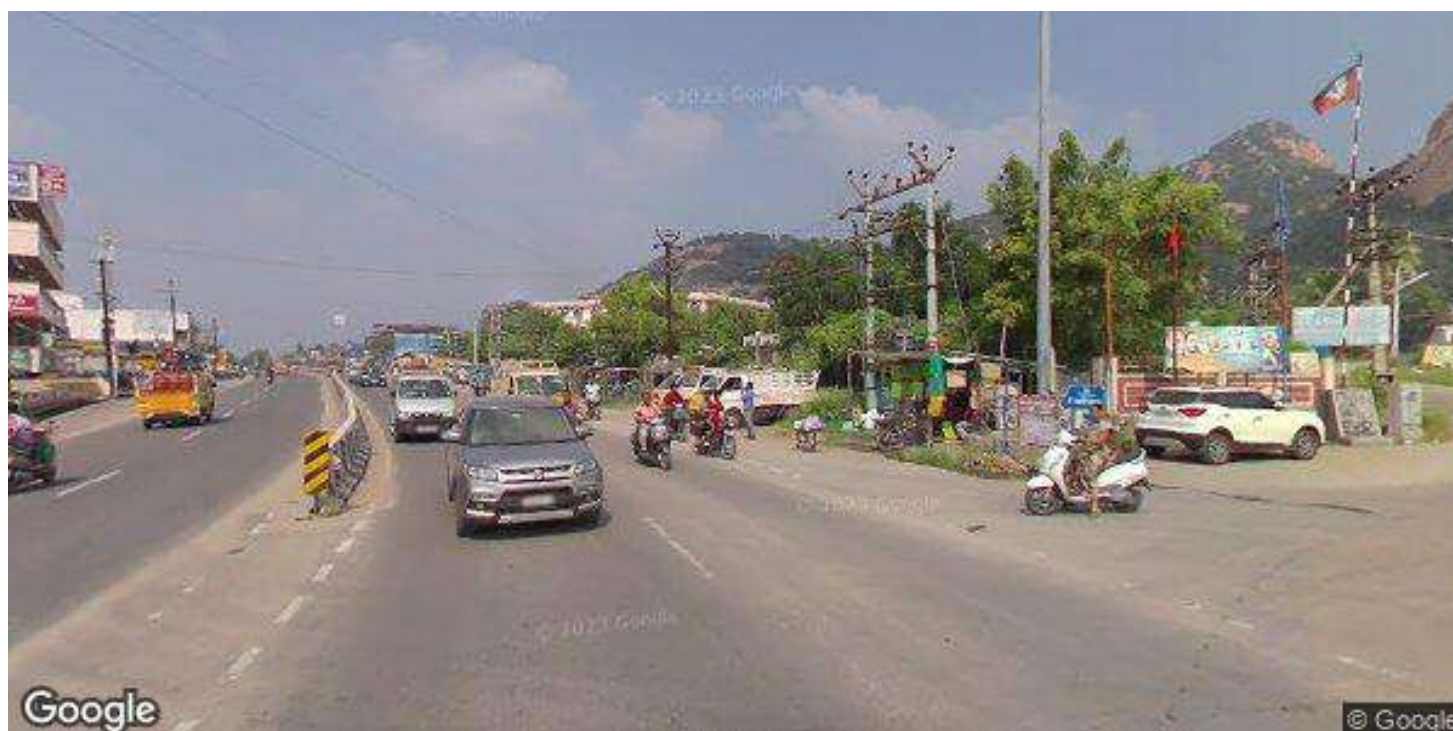
**Risk Type:** Turn  
**Risk Level:** Medium  
**Speed Limit:** 30 KM/Hr  
**Coordinates:** 11.39671, 77.88878

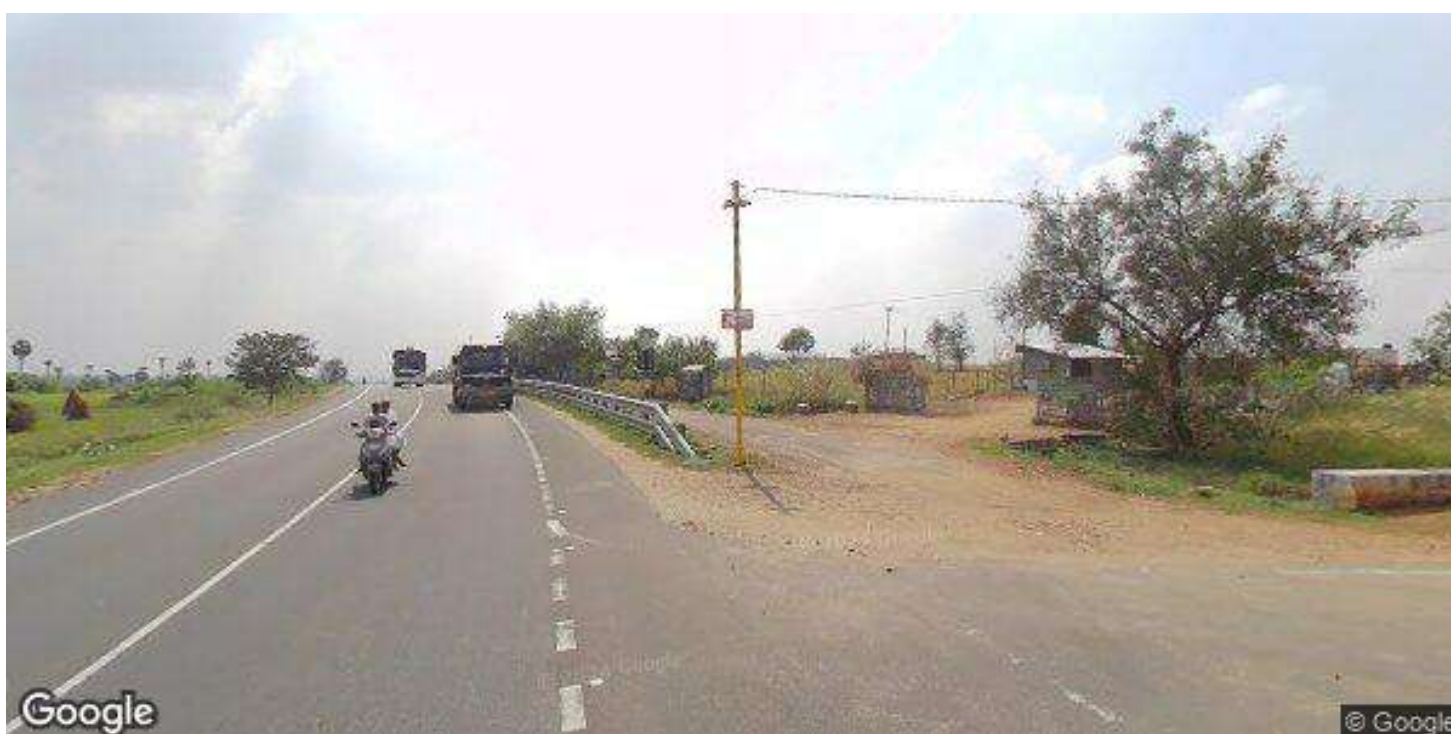
**Coordinates: 11.34151, 77.90137**

**Risk Type:** Turn

**Risk Level:** Medium

**Speed Limit: 30 KM/Hr**

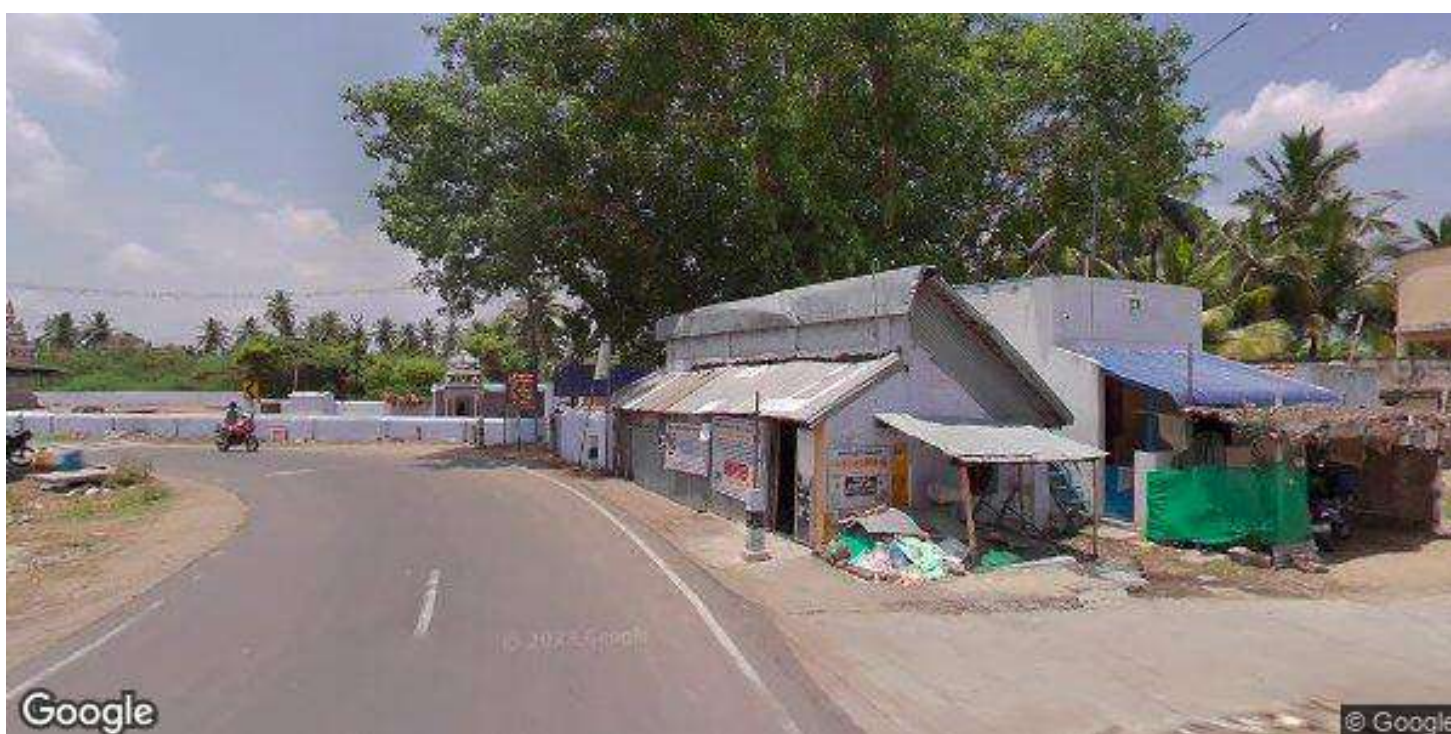
**Coordinates: 11.24061, 77.86899**

**Risk Type:** Turn

**Risk Level:** High

**Speed Limit: 15 KM/Hr**

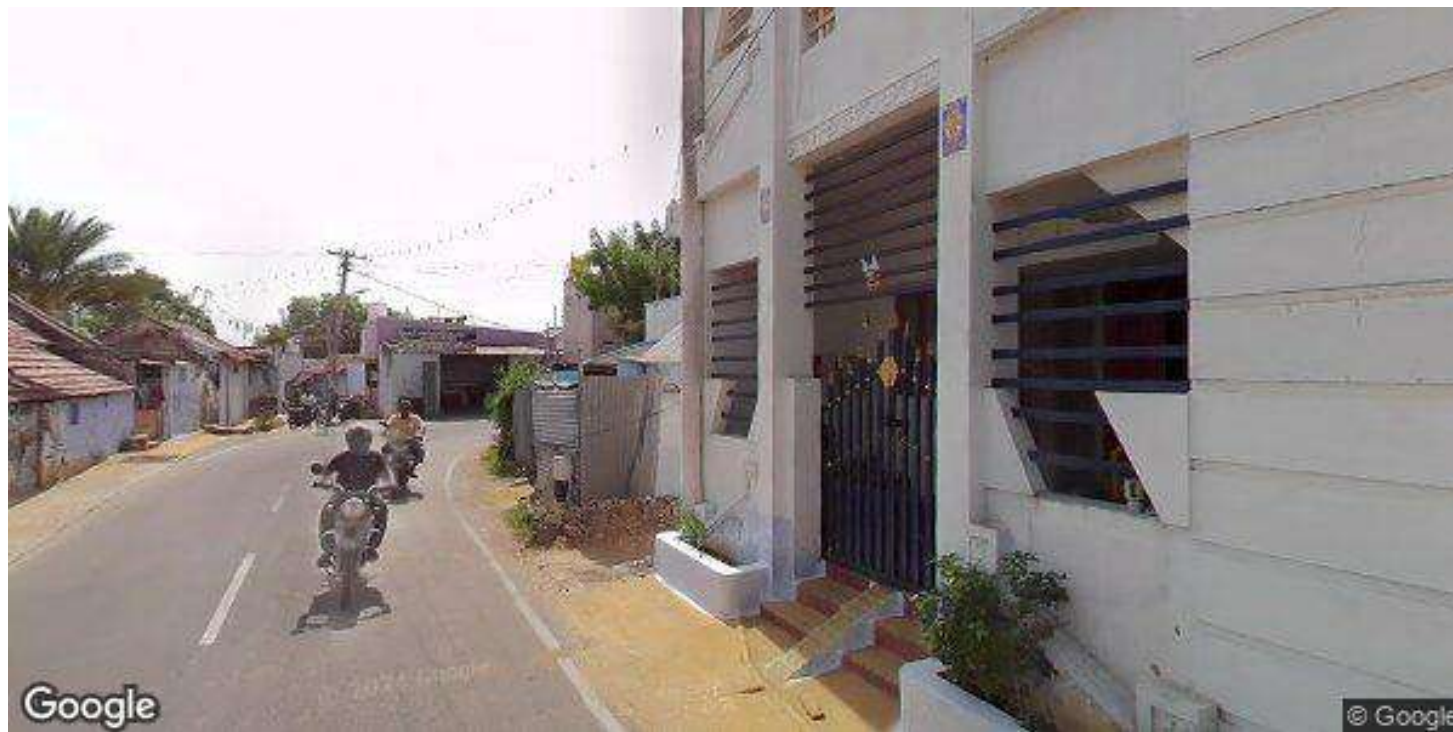
**Coordinates: 11.24157, 77.86876**

**Risk Type: Turn**

**Risk Level: High**

**Speed Limit: 15 KM/Hr**

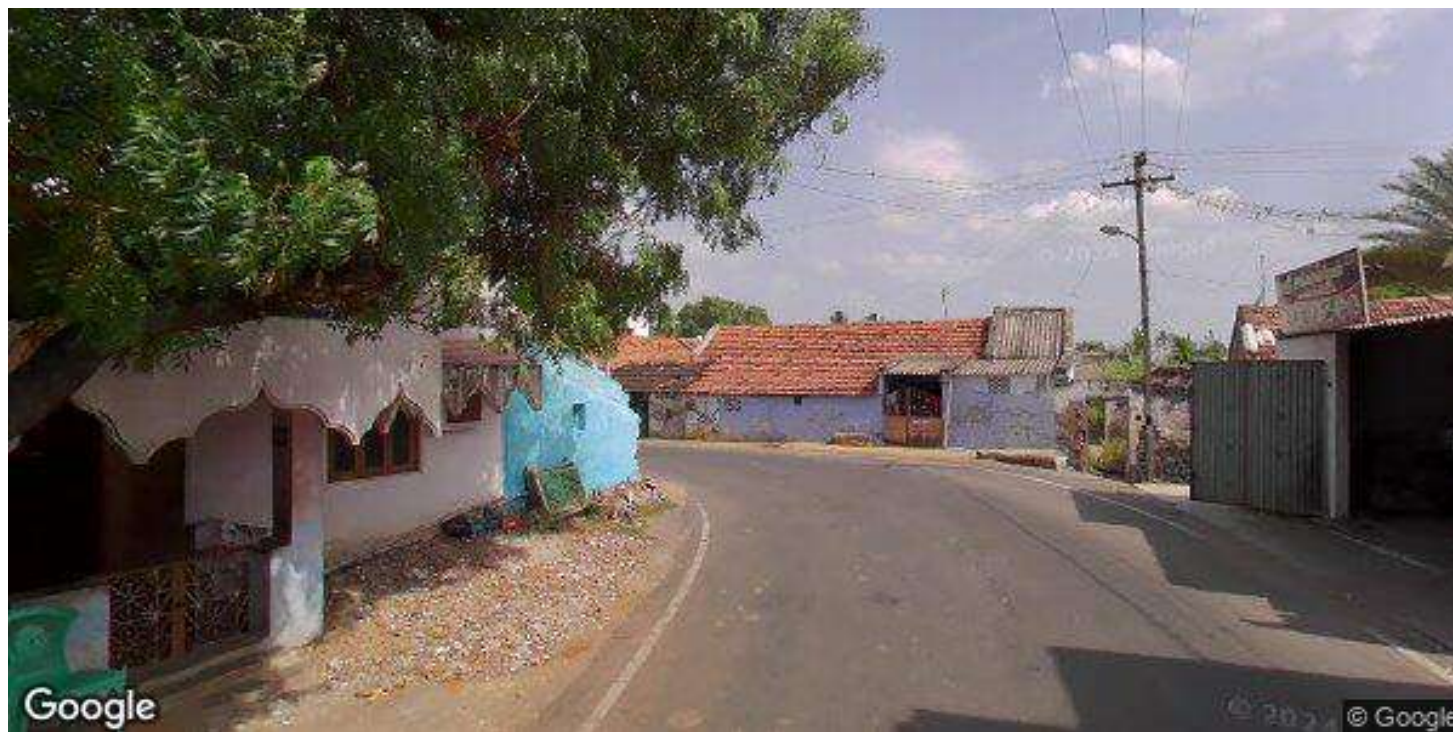
**Coordinates: 11.24167, 77.86843**

**Risk Type: Turn**

**Risk Level: High**

**Speed Limit: 15 KM/Hr**

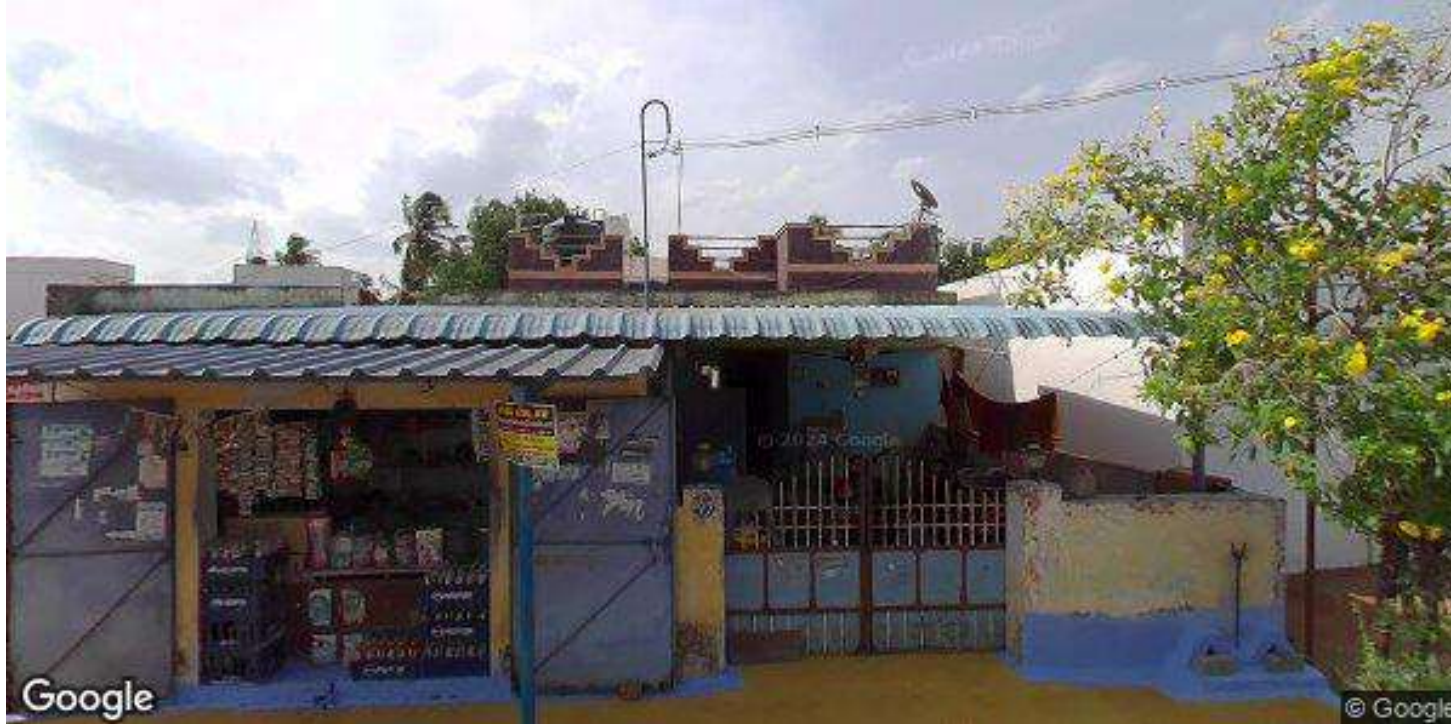
**Coordinates:** 11.24242, 77.86833

**Risk Type:** Turn

**Risk Level:** High

**Speed Limit:** 15 KM/Hr

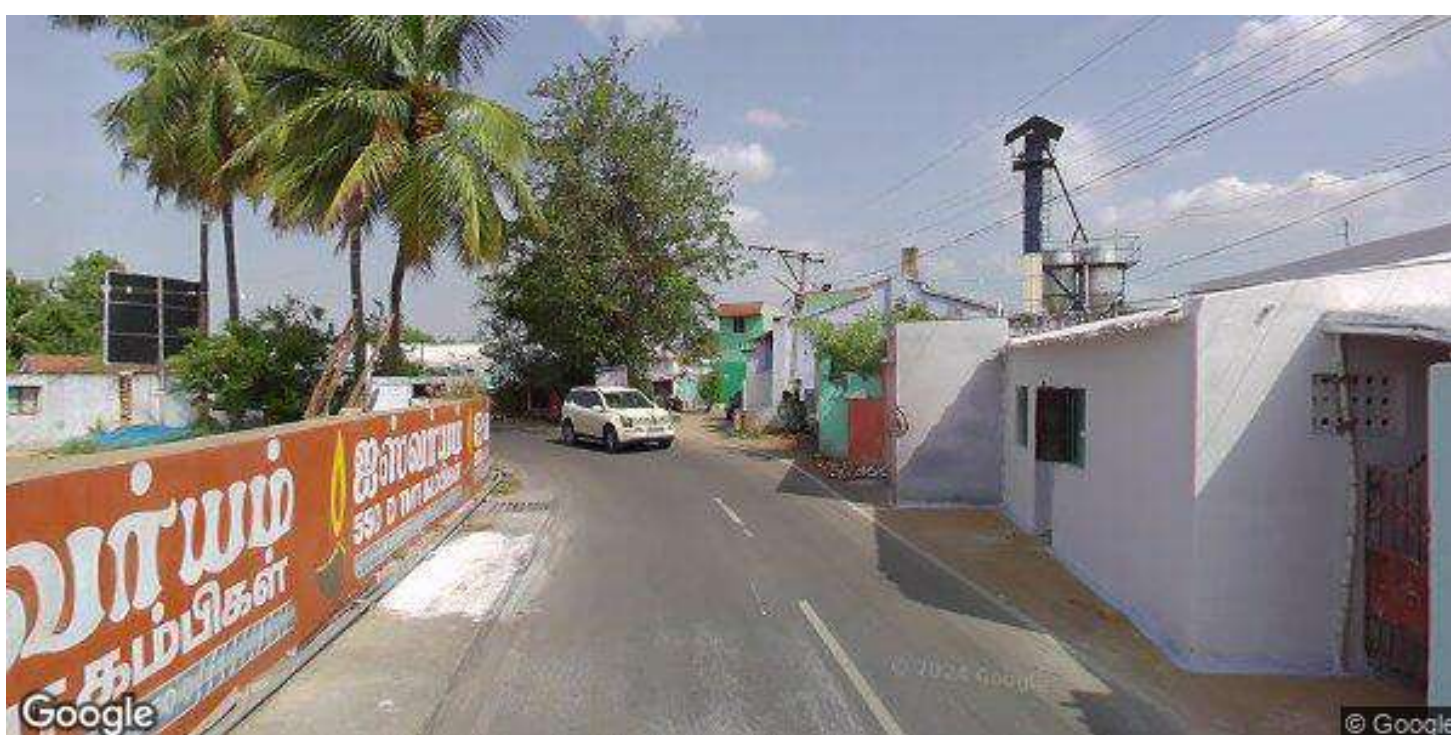
**Coordinates:** 11.24252, 77.86780

**Risk Type:** Turn

**Risk Level:** Medium

**Speed Limit:** 30 KM/Hr

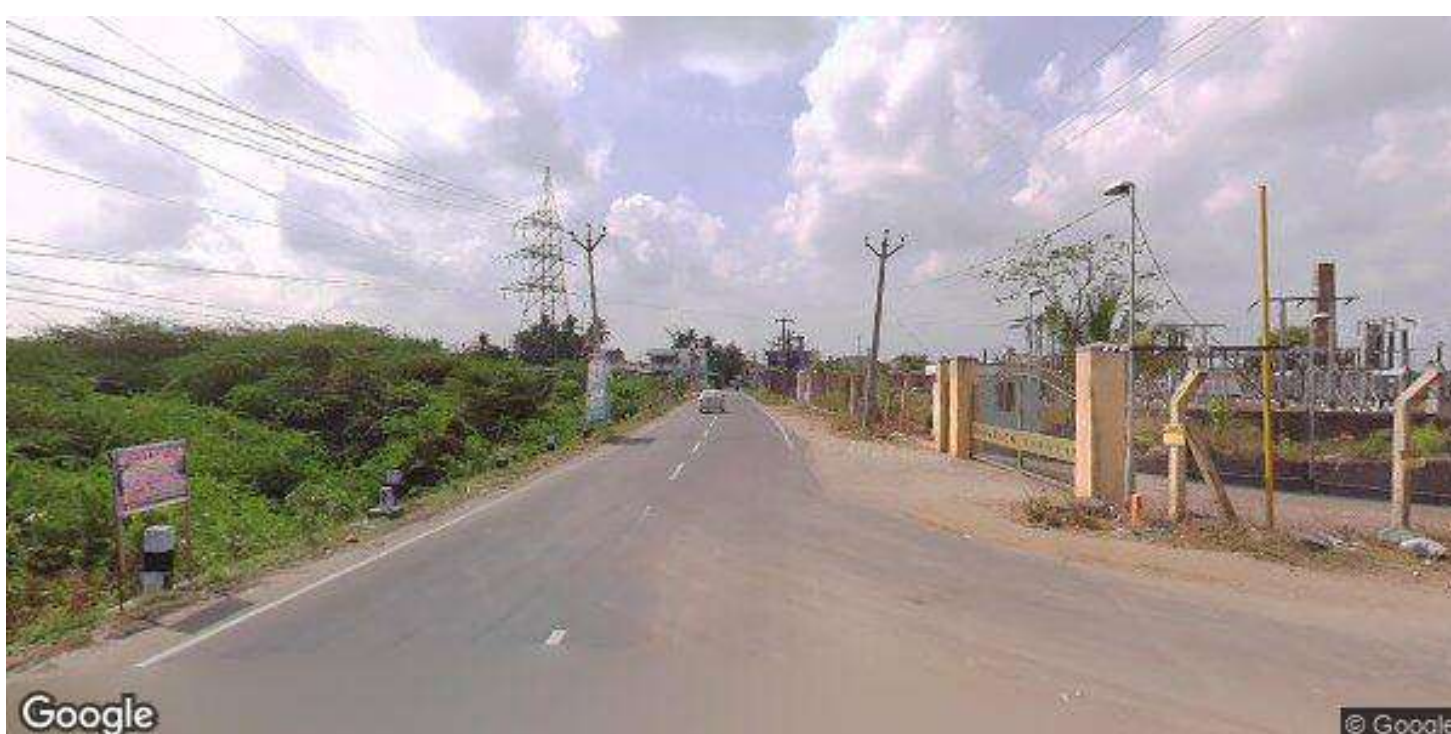
**Coordinates: 11.24384, 77.86689**

**Risk Type:** Blind Spot

**Risk Level:** Blind Spot

**Speed Limit: 10 KM/Hr**

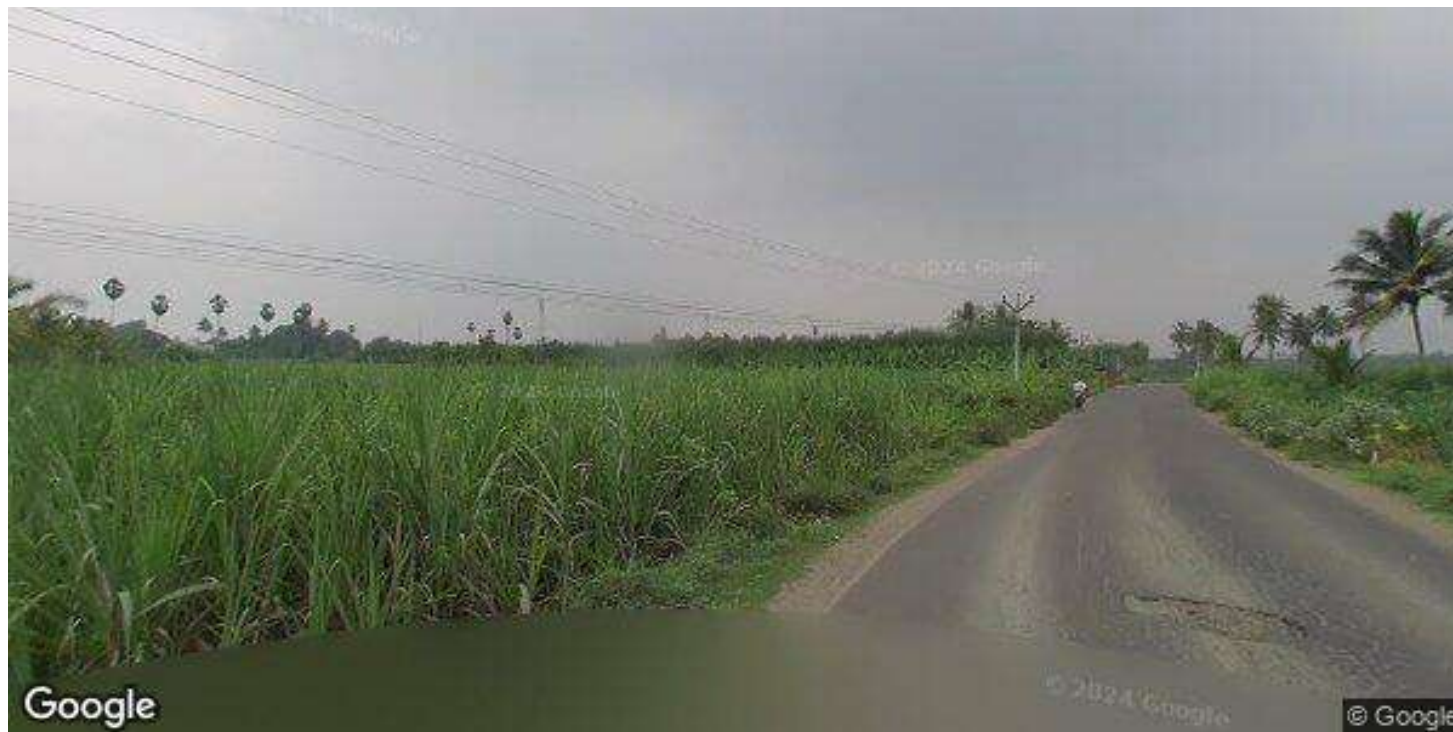
**Coordinates: 11.24101, 77.86023**

**Risk Type: Turn**

**Risk Level: High**

**Speed Limit: 15 KM/Hr**

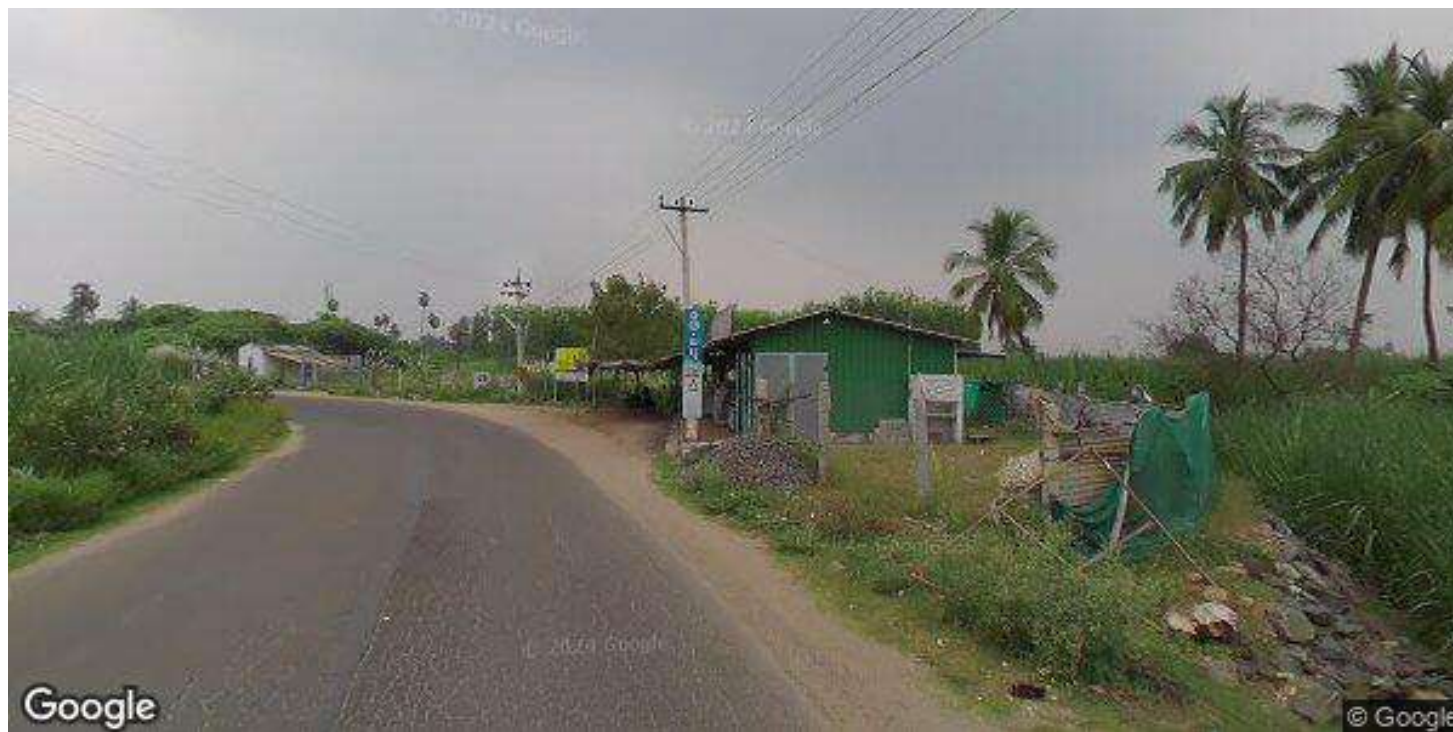
**Coordinates: 11.24198, 77.85893**

**Risk Type: Turn**

**Risk Level: Medium**

**Speed Limit: 30 KM/Hr**

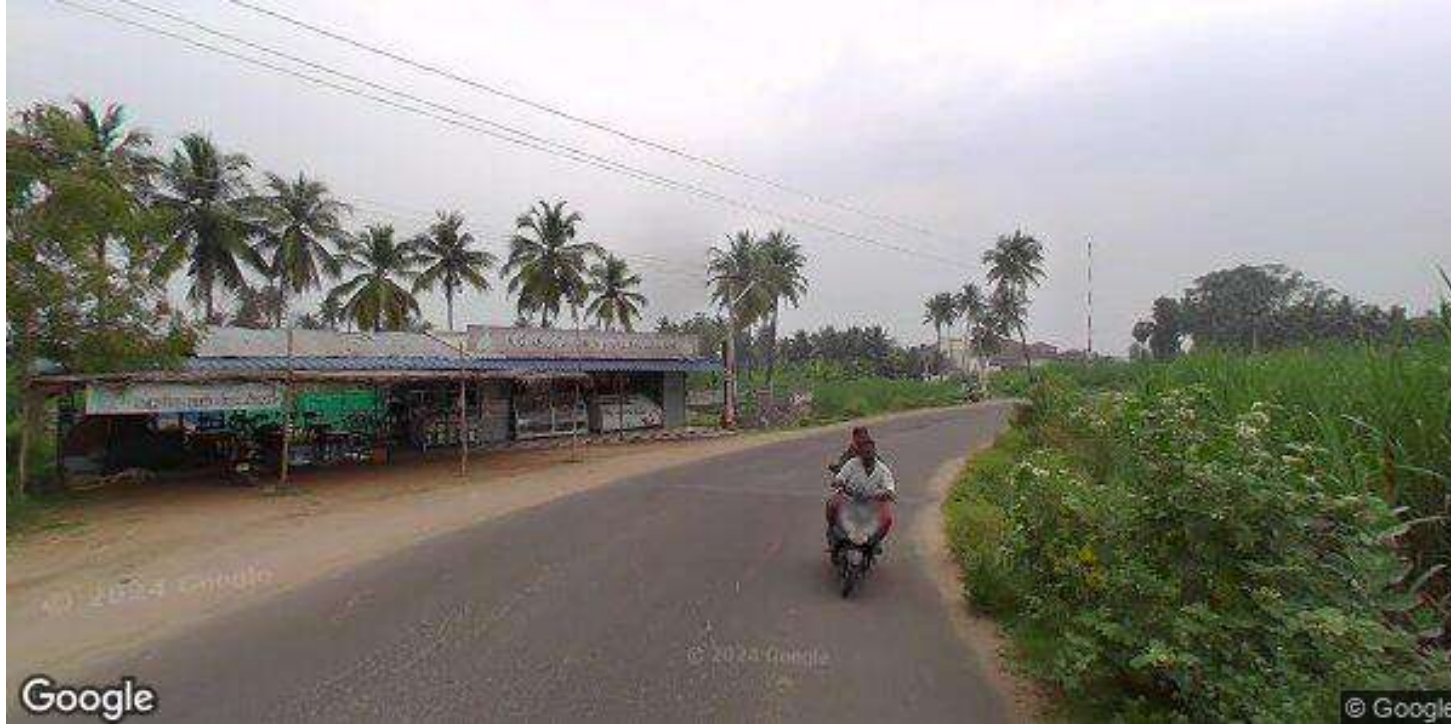
**Coordinates:** 11.24198, 77.85860

**Risk Type:** Turn

**Risk Level:** Medium

**Speed Limit:** 30 KM/Hr

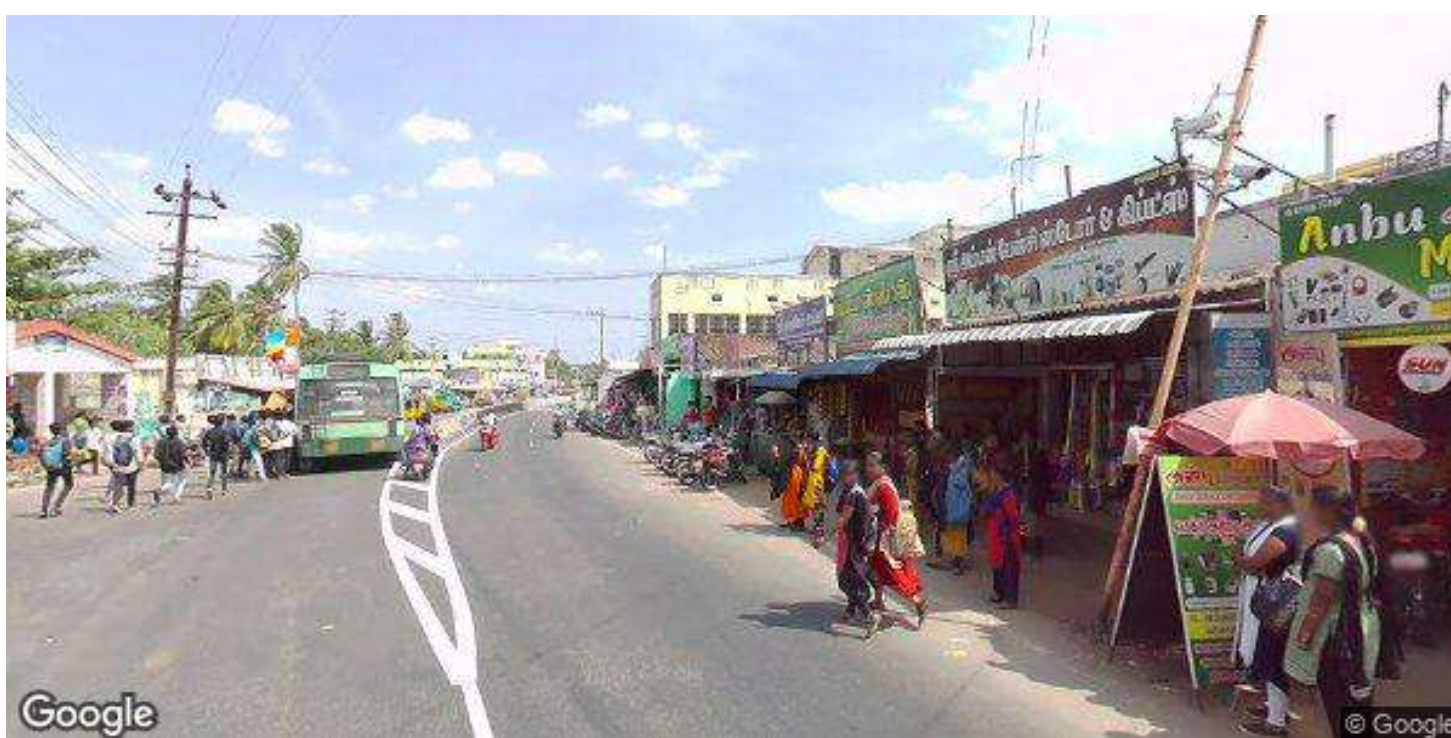
**Coordinates:** 11.18861, 77.77108

**Risk Type:** Blind Spot

**Risk Level:** Blind Spot

**Speed Limit:** 10 KM/Hr

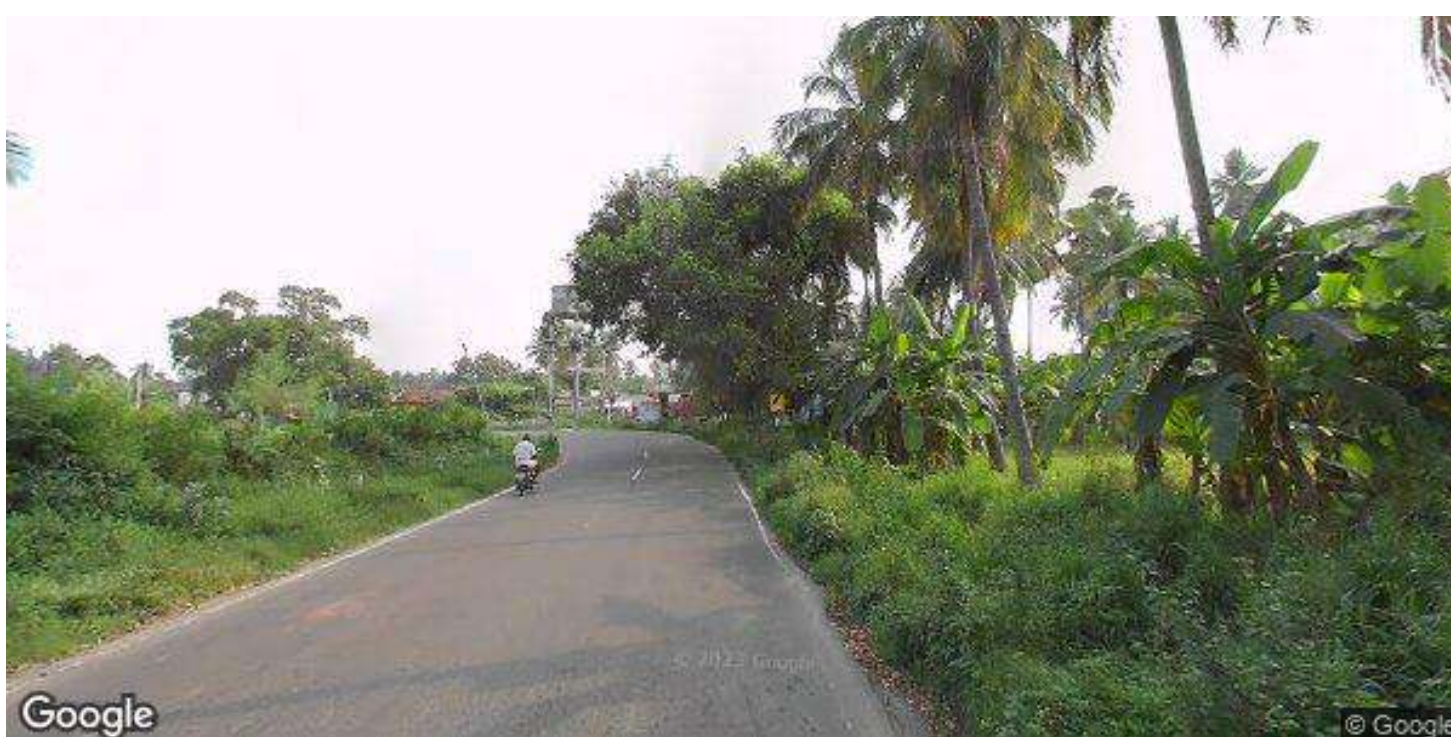
**Coordinates: 11.16450, 77.77357**

**Risk Type:** Turn

**Risk Level:** Medium

**Speed Limit: 30 KM/Hr**

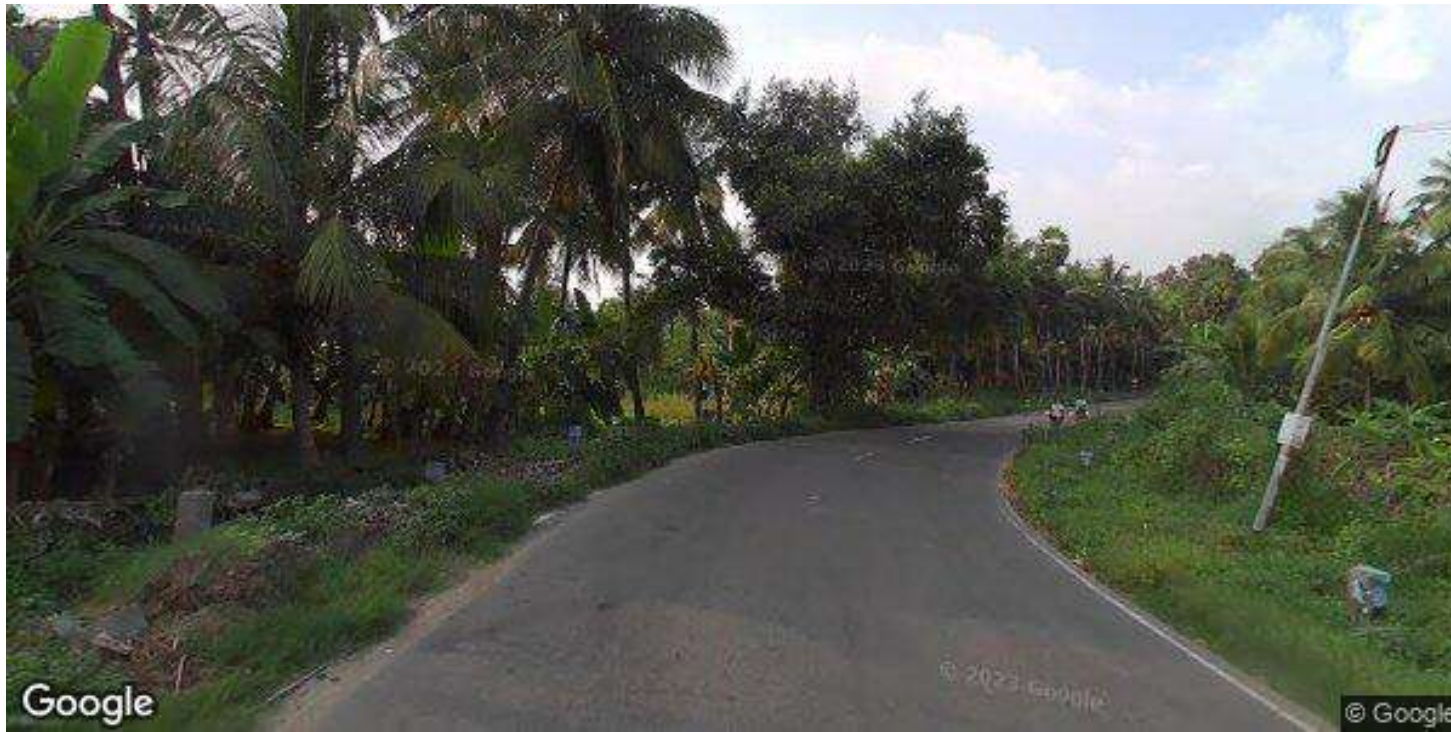
**Coordinates: 11.16407, 77.77376**

**Risk Type: Turn**

**Risk Level: Medium**

**Speed Limit: 30 KM/Hr**

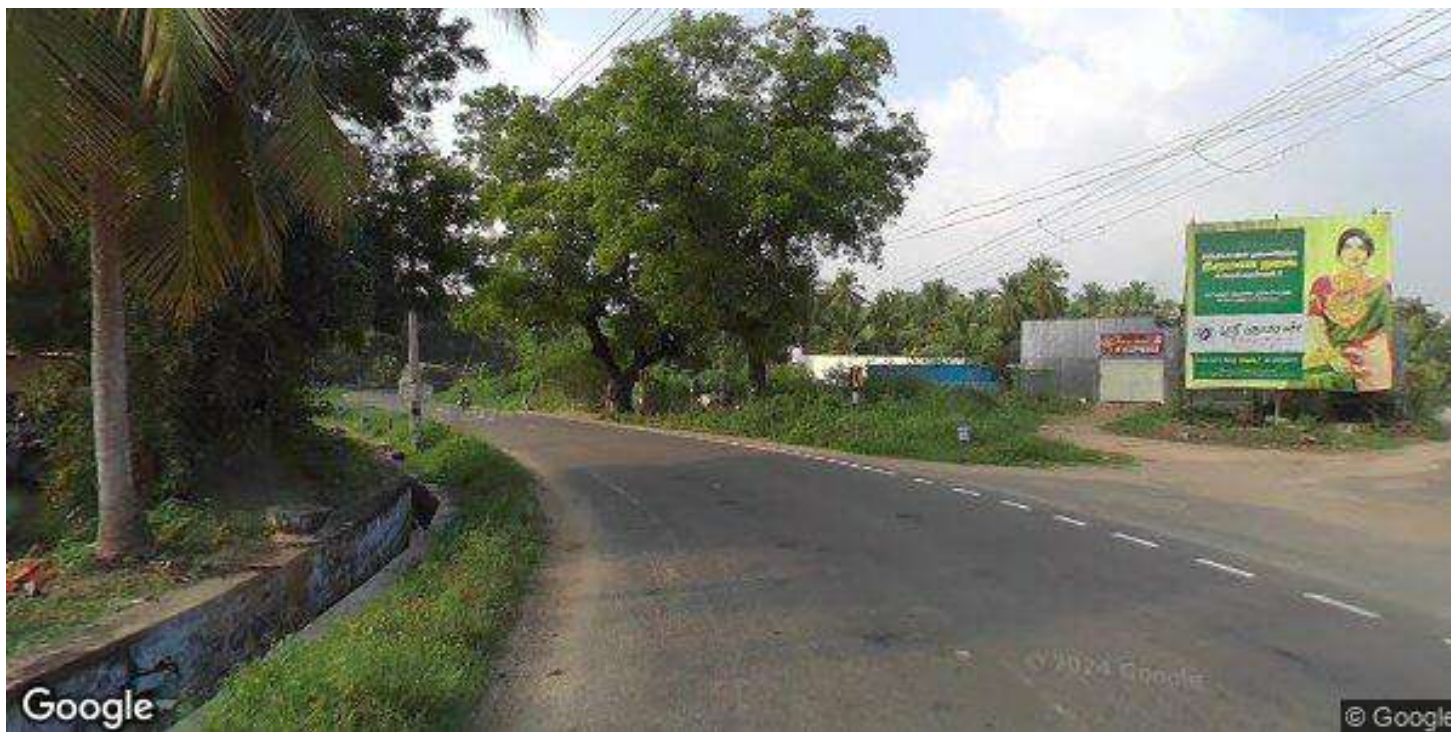
**Coordinates: 11.16357, 77.77434**

**Risk Type: Turn**

**Risk Level: Medium**

**Speed Limit: 30 KM/Hr**

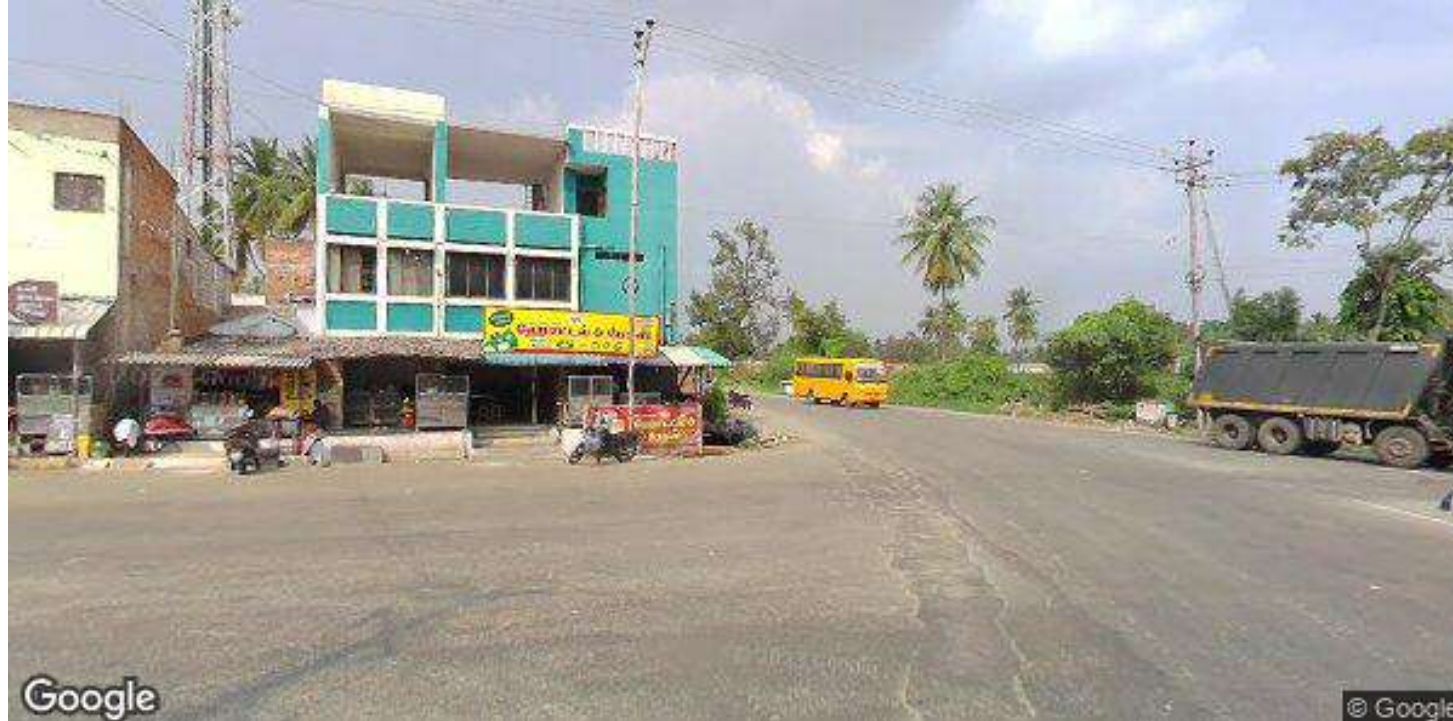
**Risk Type:** Turn  
**Risk Level:** High  
**Speed Limit:** 15 KM/Hr  
**Coordinates:** 11.13667, 77.76526

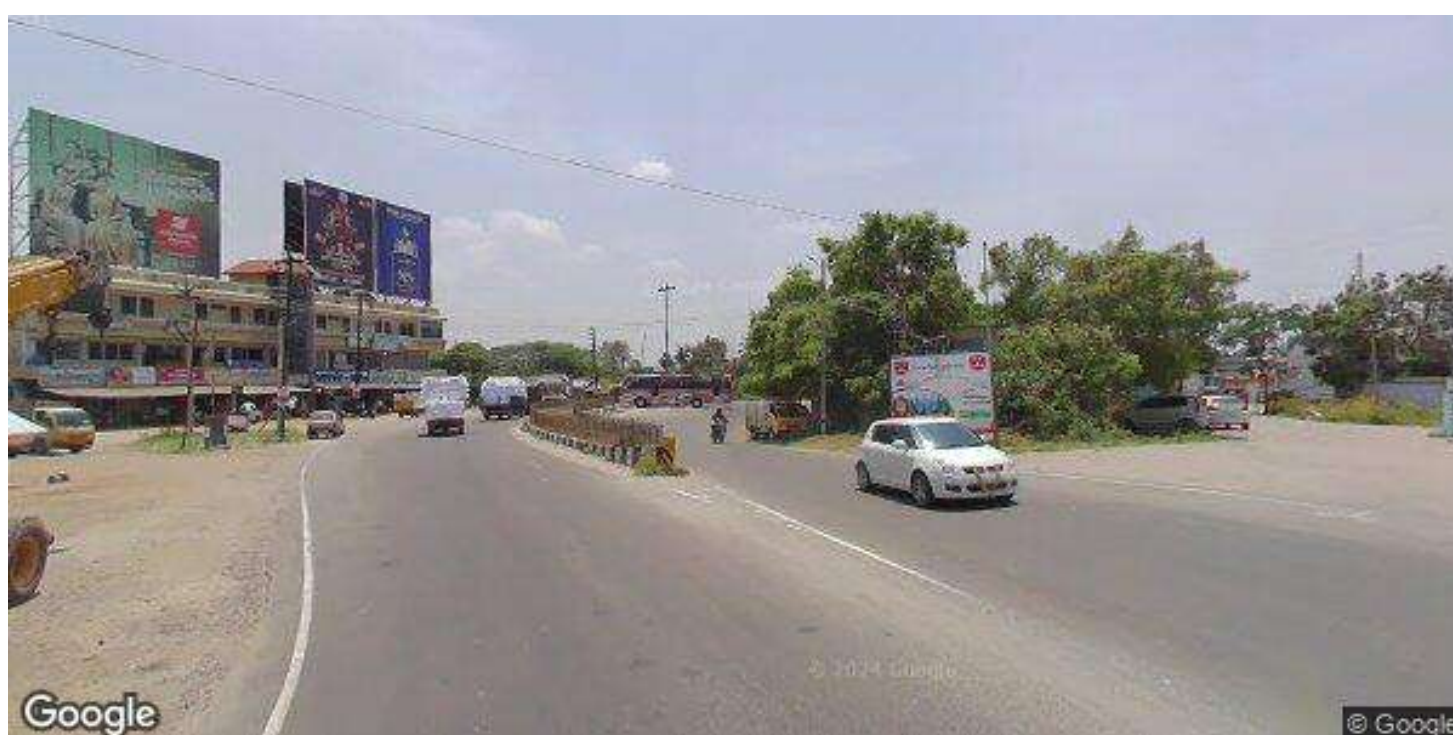
**Risk Type:** Turn  
**Risk Level:** Medium  
**Speed Limit:** 30 KM/Hr  
**Coordinates:** 11.04703, 77.73745

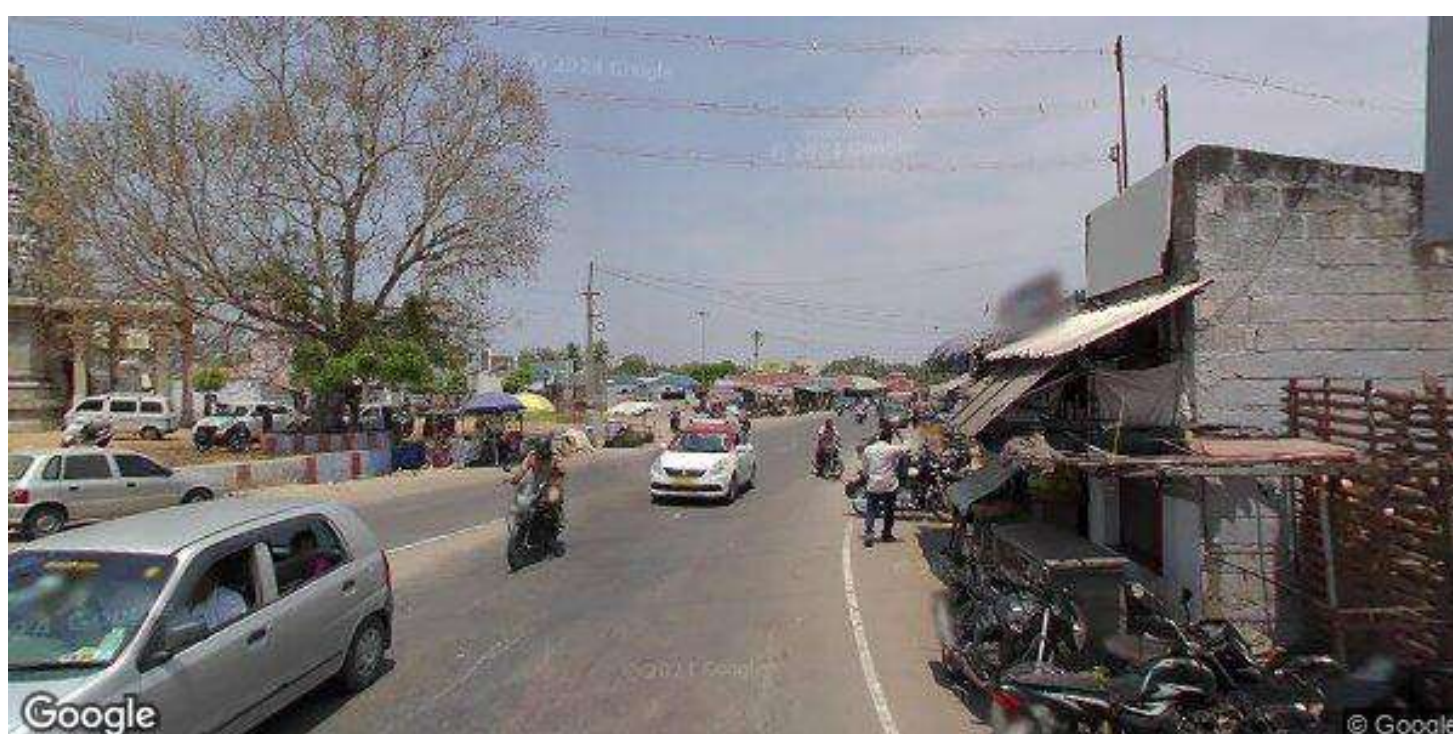
**Coordinates: 11.04528, 77.73627**

**Risk Type:** Turn  
**Risk Level:** Medium

**Speed Limit: 30 KM/Hr**

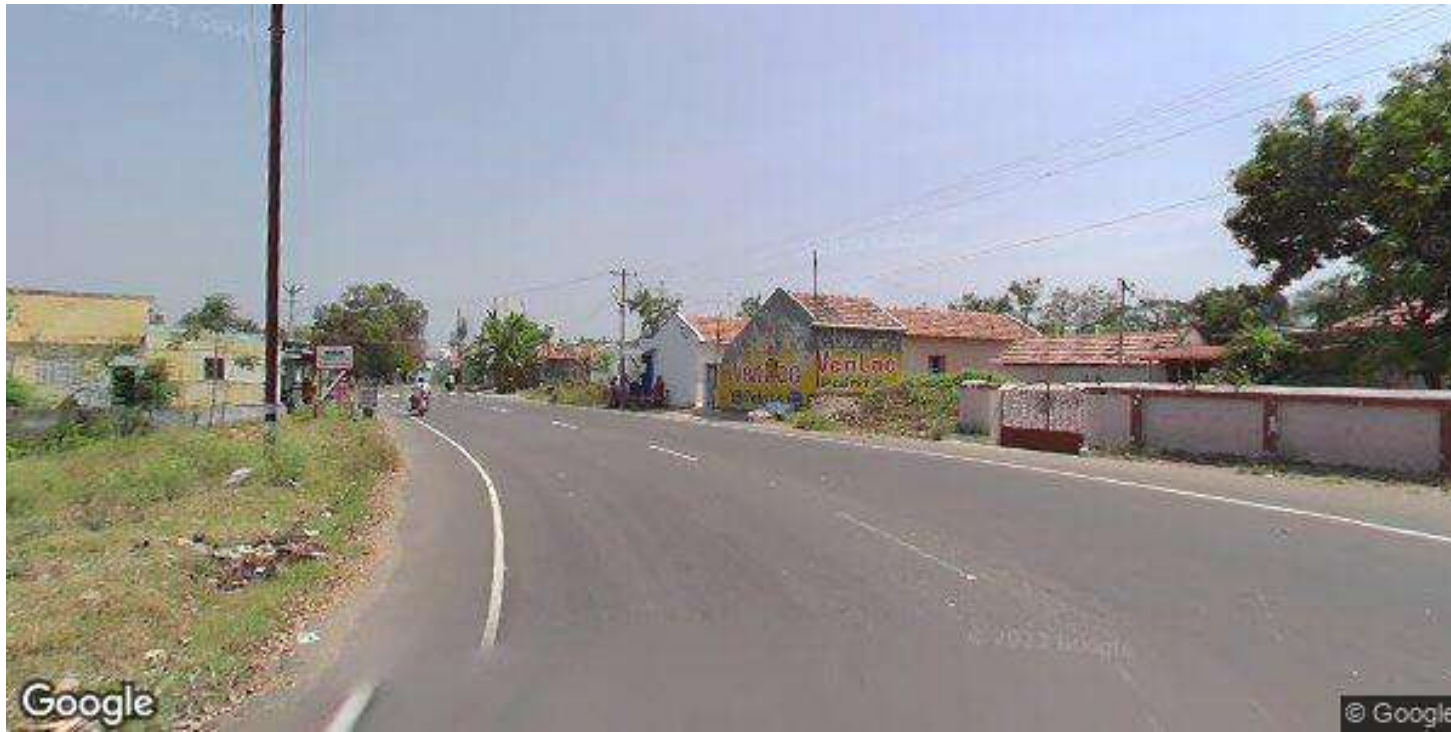
**Coordinates: 10.99029, 77.72513**

**Risk Type: Turn**

**Risk Level: High**

**Speed Limit: 15 KM/Hr**
