## **JOURNEY RISK MANAGEMENT (JRM) STUDY**

### **Salem Terminal To SPK PETROLEUM**

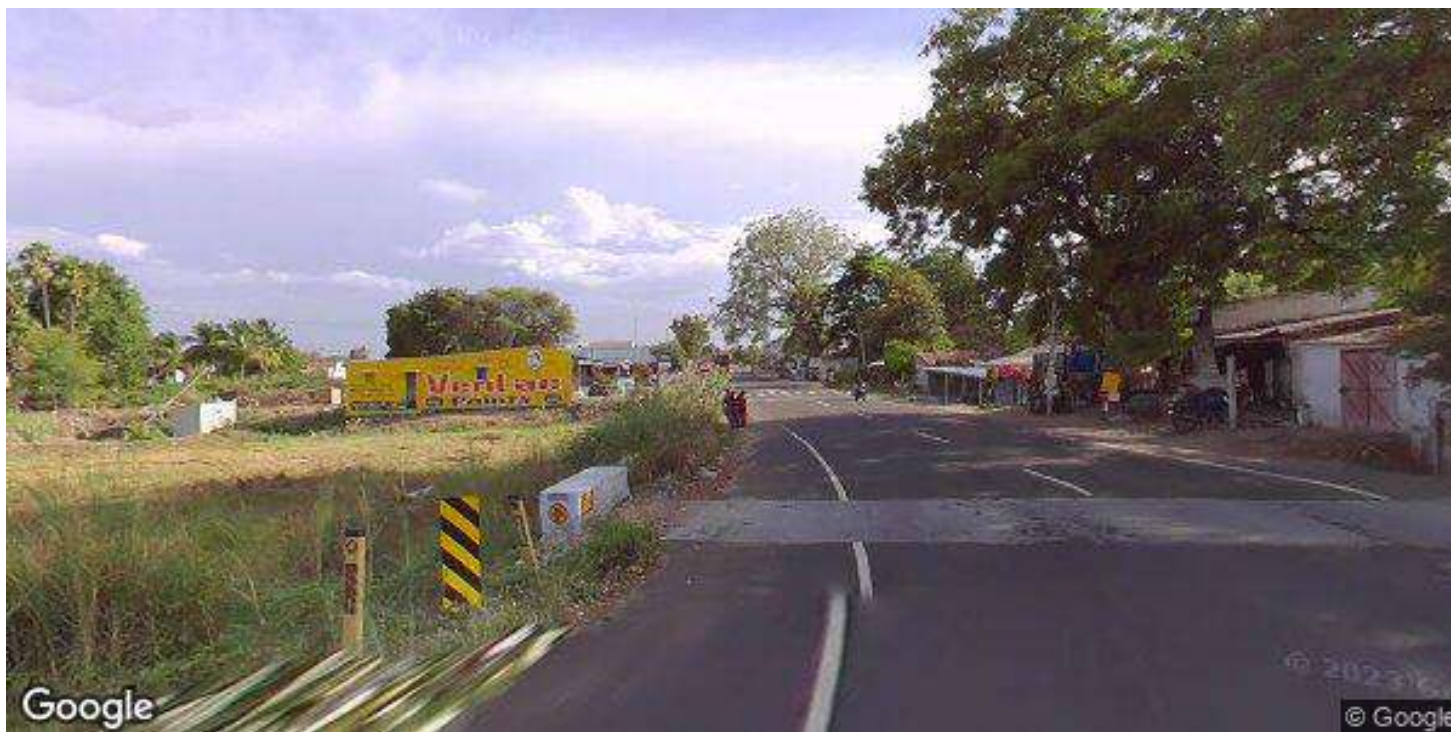
**Coordinates: 10.98961, 77.72379**

**Risk Type: Turn**

**Risk Level: Medium**

**Speed Limit: 30 KM/Hr**

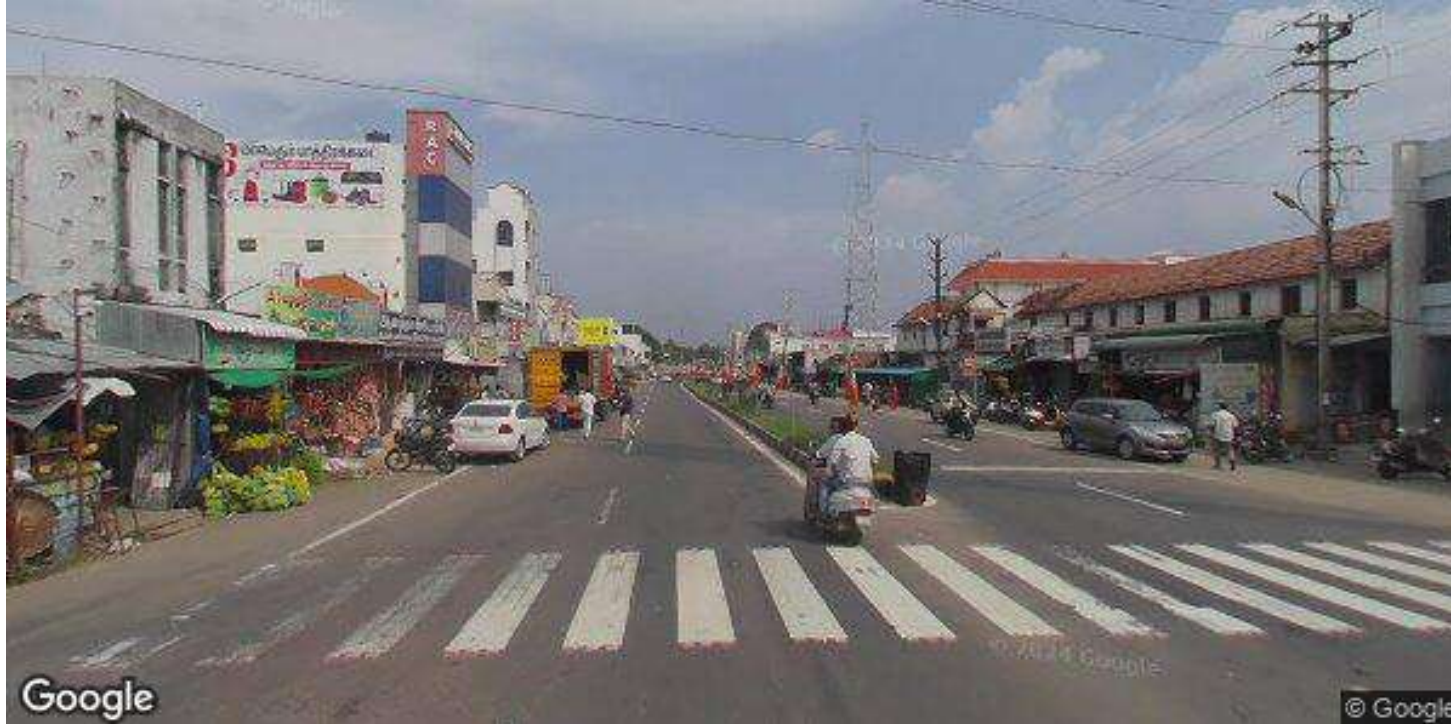
**Coordinates:** 10.94597, 77.71319

**Risk Type:** Turn

**Risk Level:** High

**Speed Limit:** 15 KM/Hr

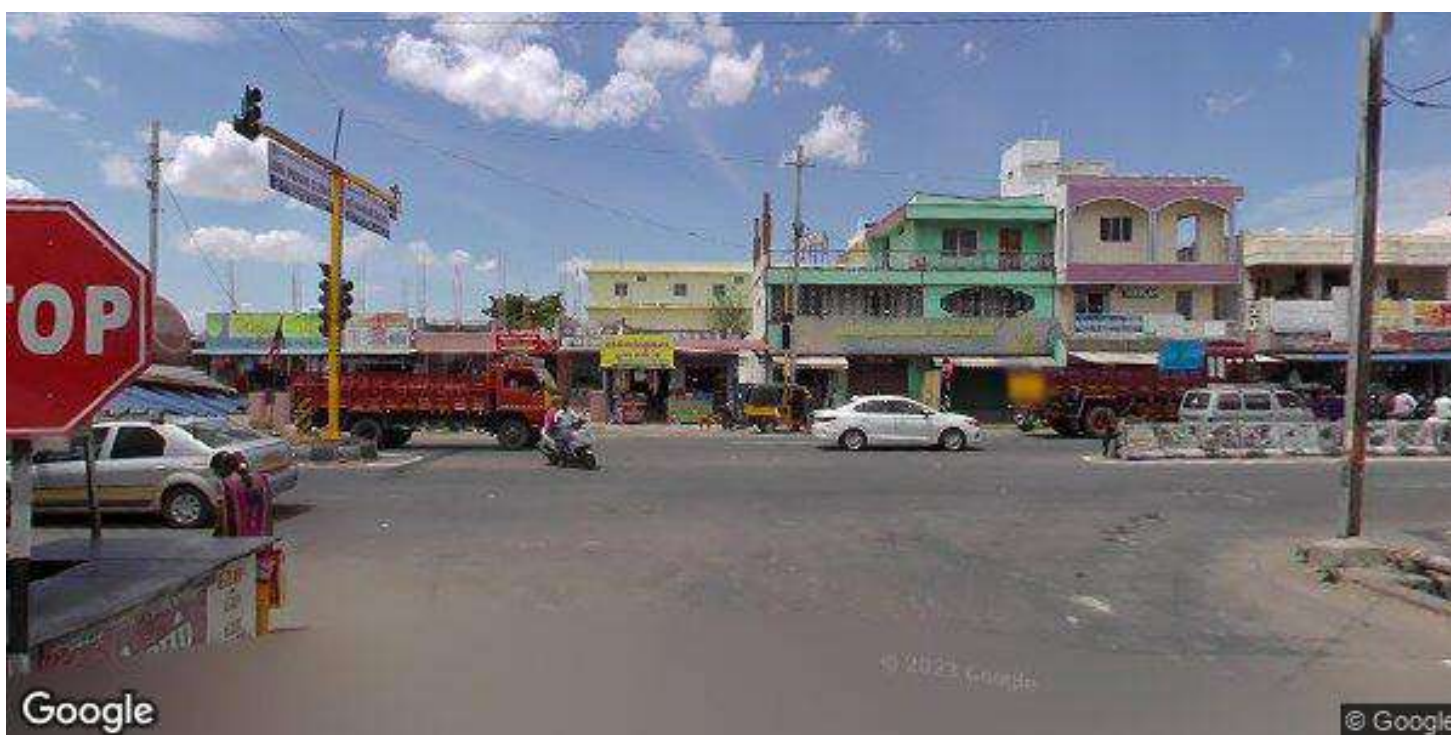
**Coordinates:** 10.94582, 77.71257

**Risk Type:** Turn

**Risk Level:** High

**Speed Limit:** 15 KM/Hr

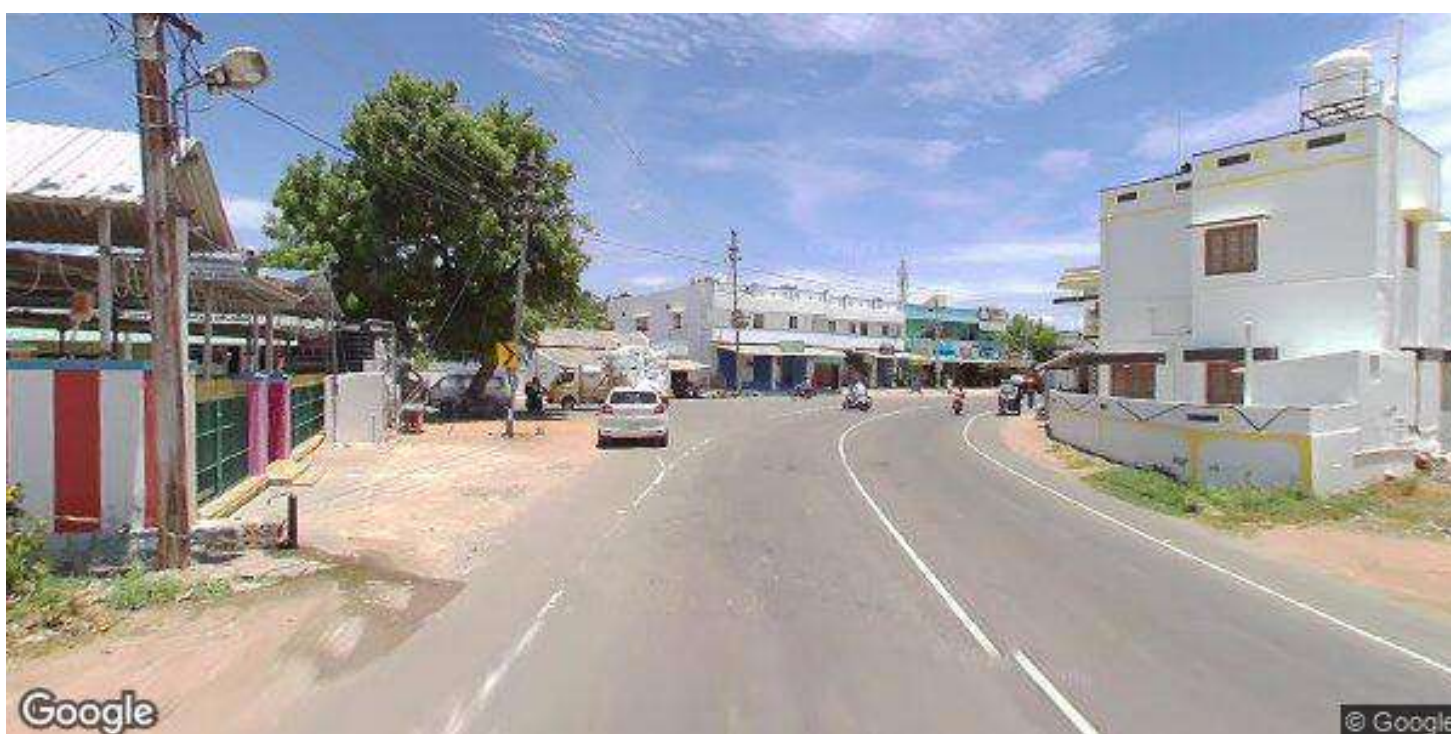
**Risk Type:** Turn

**Risk Level:** Medium

**Speed Limit:** 30 KM/Hr  
**Coordinates:** 10.93825, 77.70342
