# IndianOil

## JOURNEY RISK MANAGEMENT (JRM) STUDY

### Salem Terminal to ANDAVAR AGENCIES

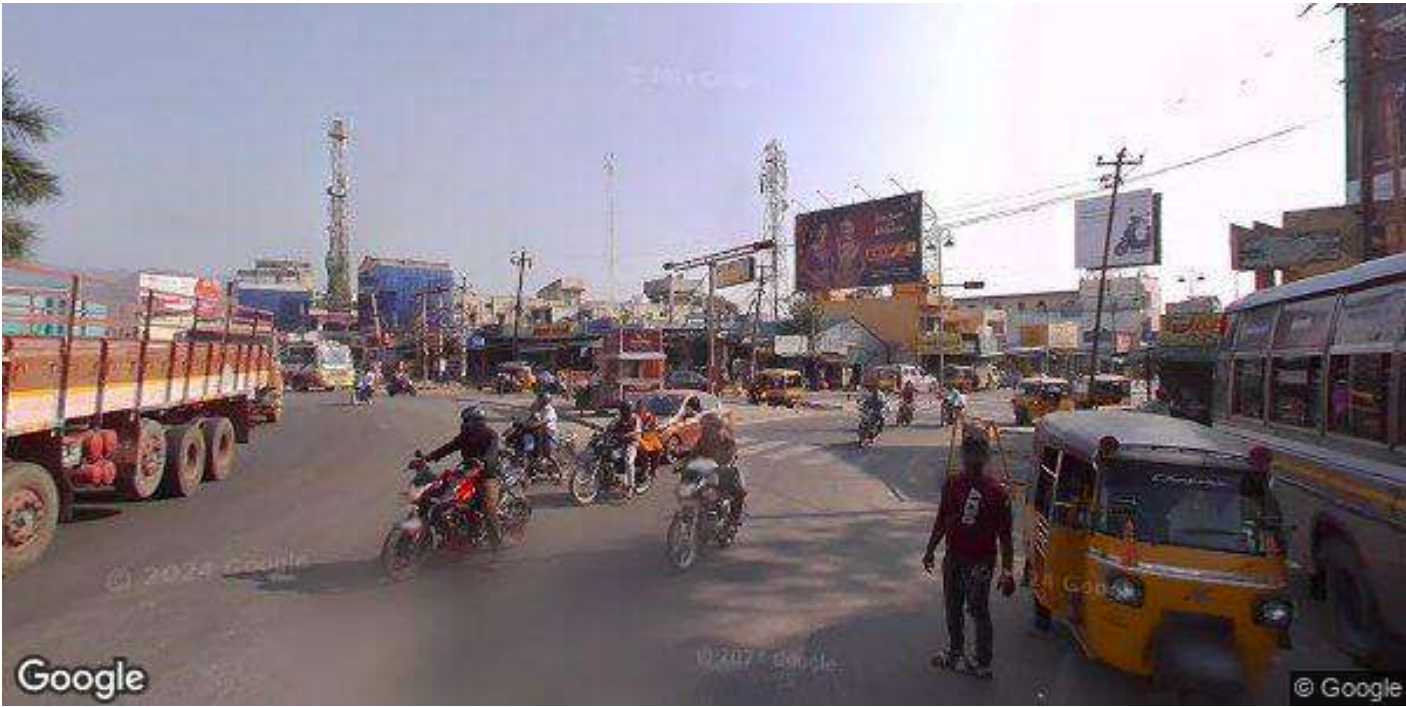
Risk Type: Roundabout

Risk Level: High

Coordinates: 11.63266, 78.12699

Speed Limit: 15 KM/Hr

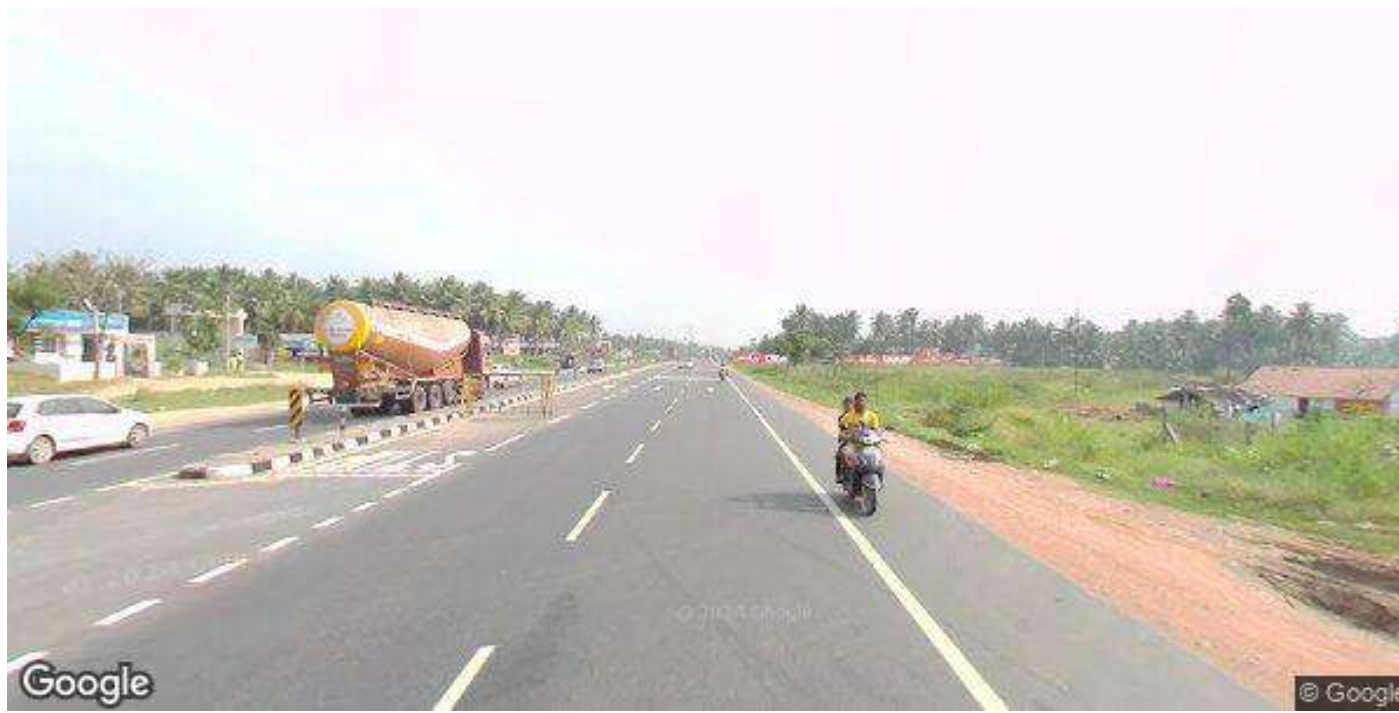
**Risk Type:** U-Turn  
**Risk Level:** High  
**Speed Limit:** 10 KM/Hr  
**Coordinates:** 11.5991031, 78.0887685

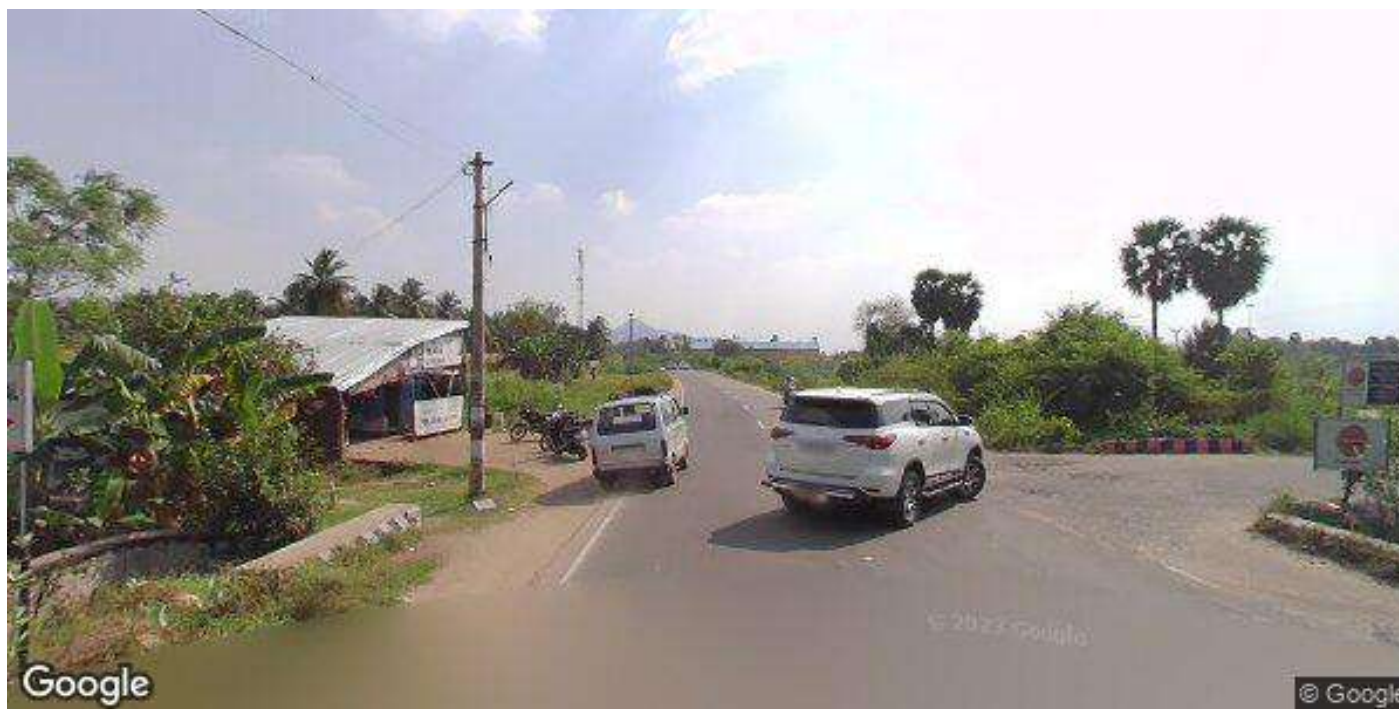
**Risk Type:** Turn  
**Risk Level:** High  
**Speed Limit:** 15 KM/Hr  
**Coordinates:** 11.44029, 77.87544

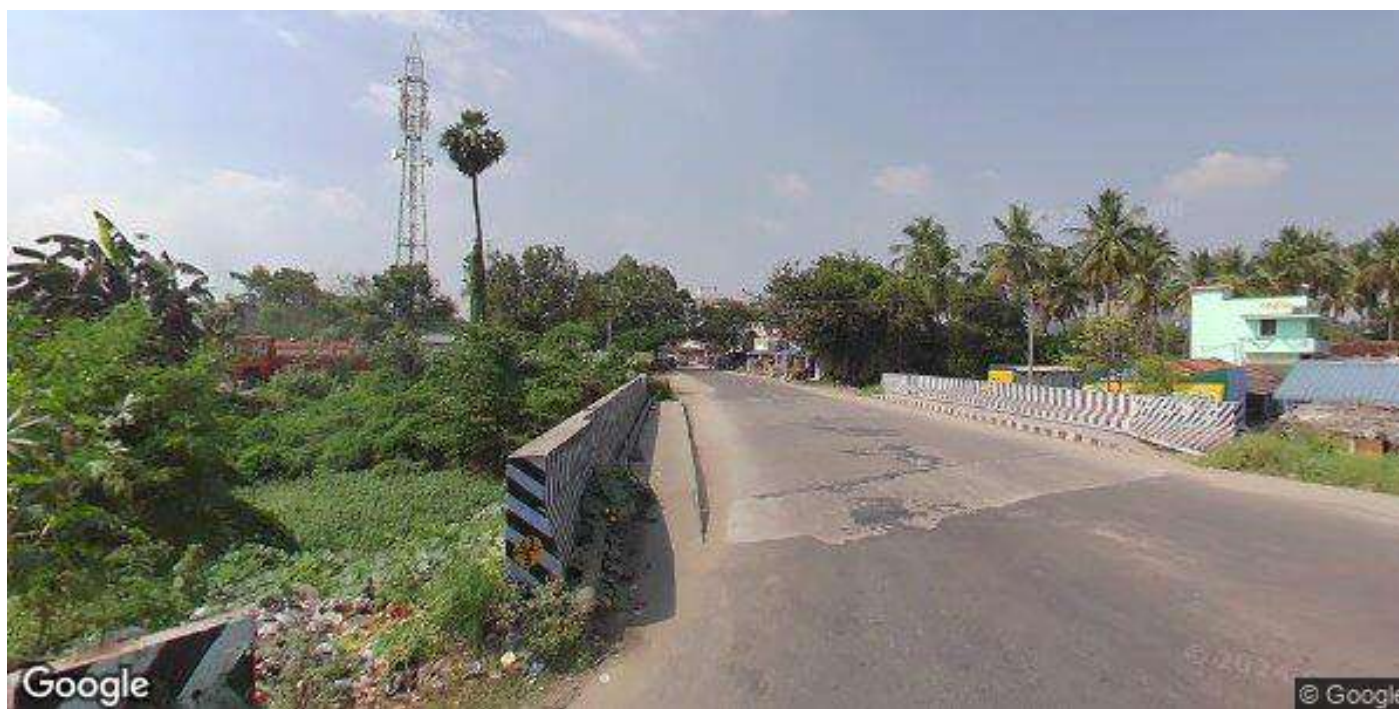
**Risk Type:** Turn  
**Risk Level:** Medium  
**Speed Limit:** 30 KM/Hr  
**Coordinates:** 11.44900, 77.87406

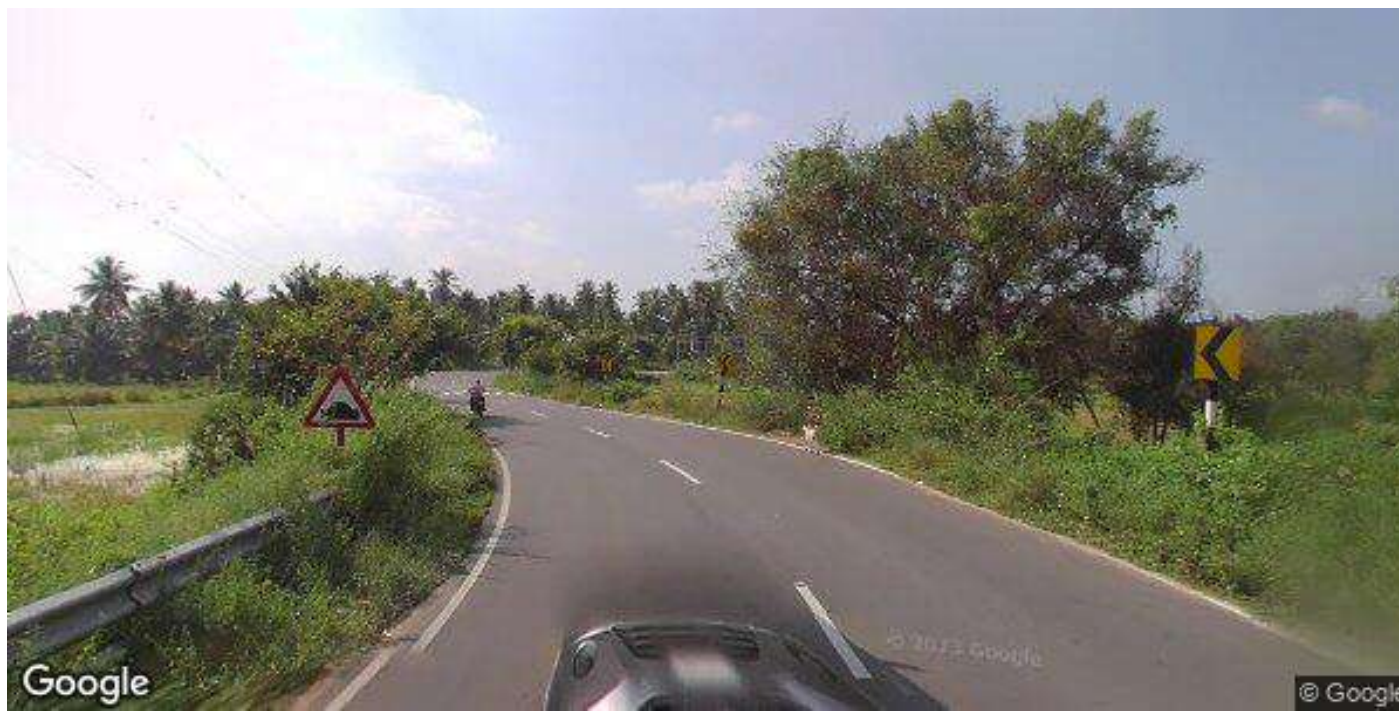
**Risk Type:** Turn  
**Risk Level:** Medium  
**Speed Limit:** 30 KM/Hr  
**Coordinates:** 11.45358, 77.85781

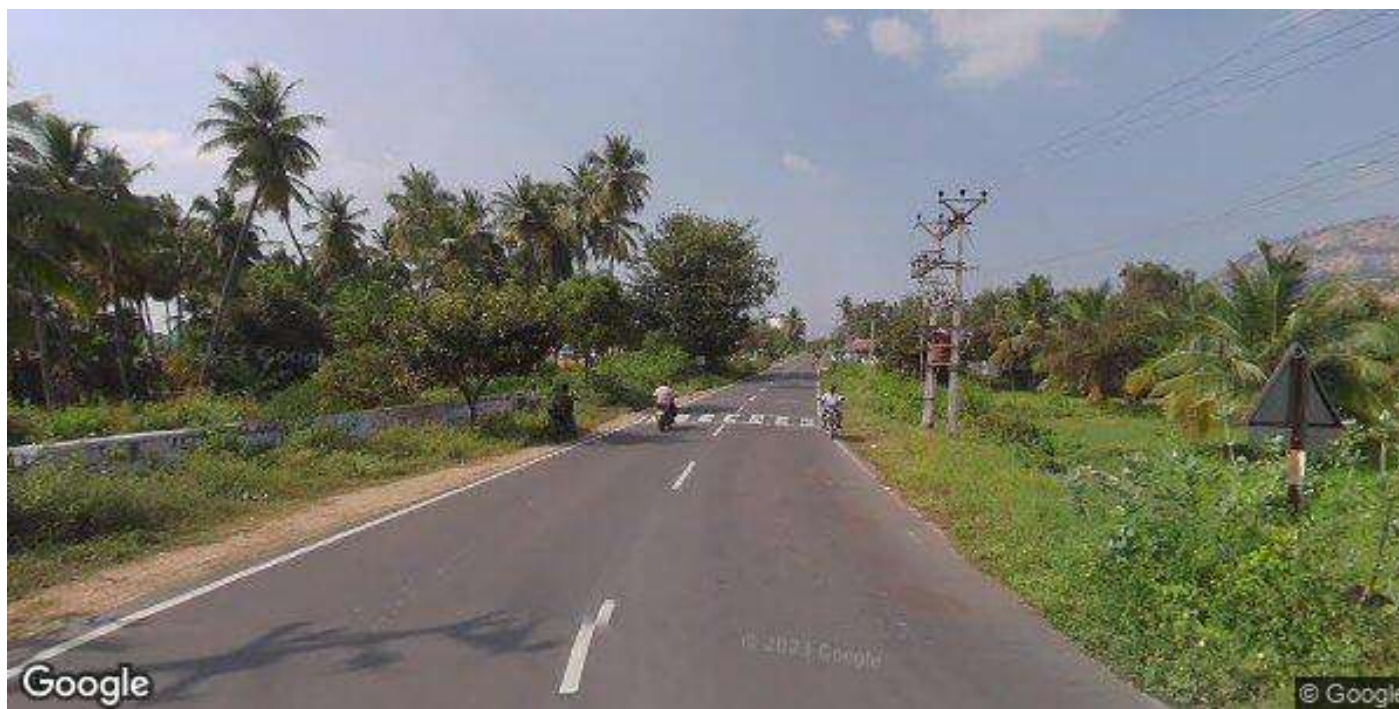
**Risk Type:** Turn  
**Risk Level:** High  
**Speed Limit:** 15 KM/Hr  
**Coordinates:** 11.45353, 77.85697

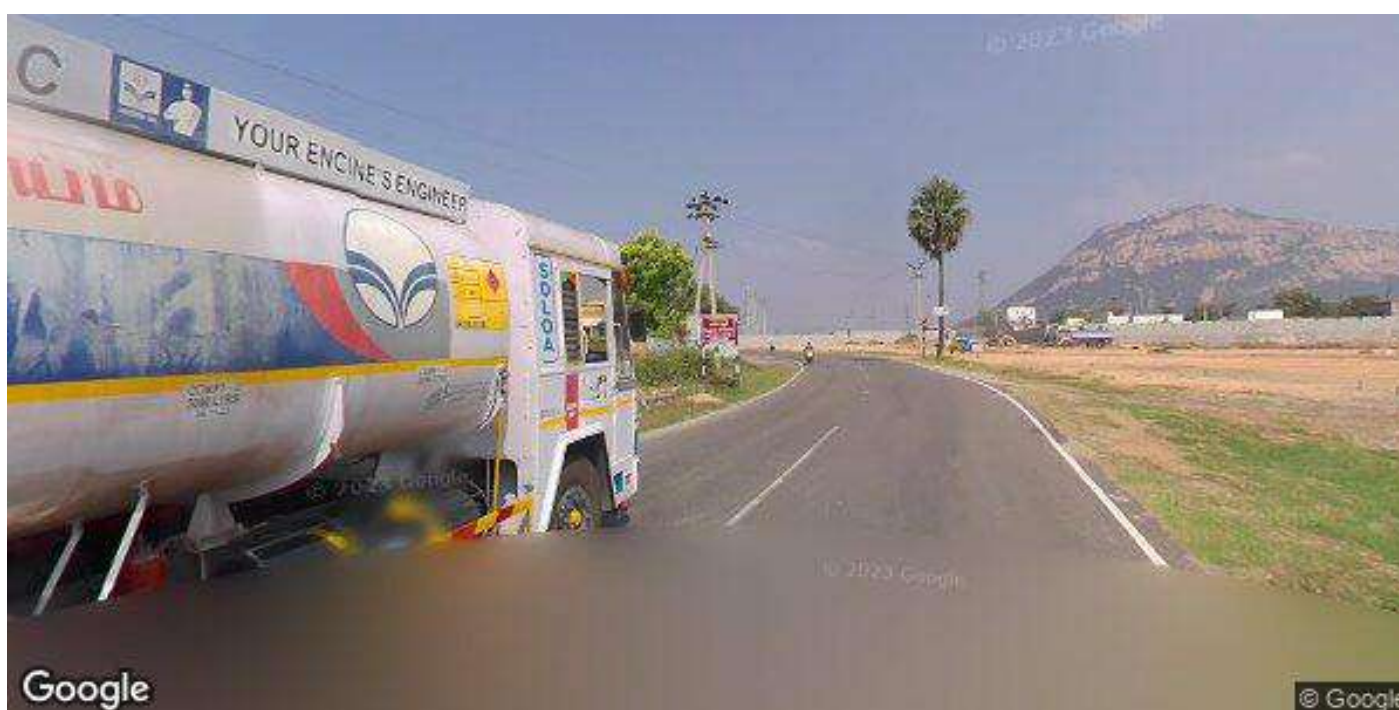
**Risk Type:** Turn  
**Risk Level:** Medium  
**Speed Limit:** 30 KM/Hr  
**Coordinates:** 11.45853, 77.85139

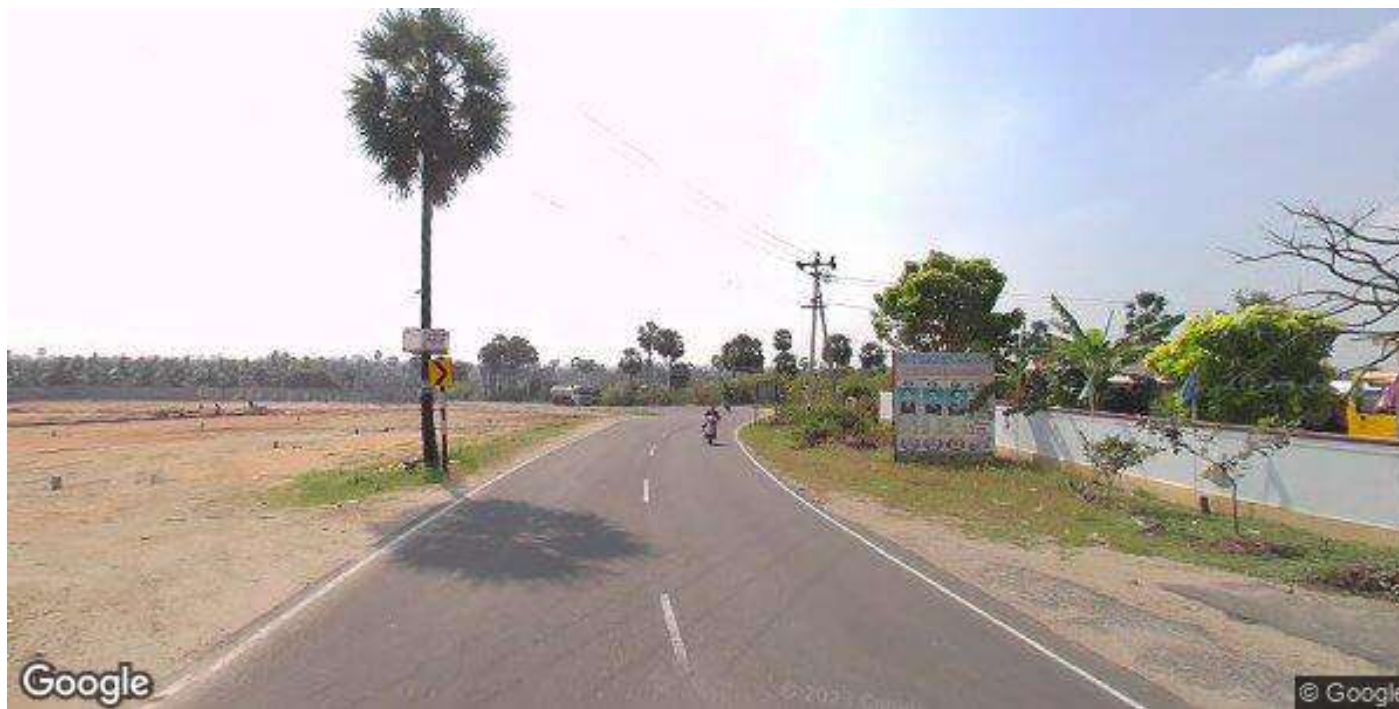
**Risk Type:** Turn  
**Risk Level:** Medium  
**Speed Limit:** 30 KM/Hr  
**Coordinates:** 11.45906, 77.85132

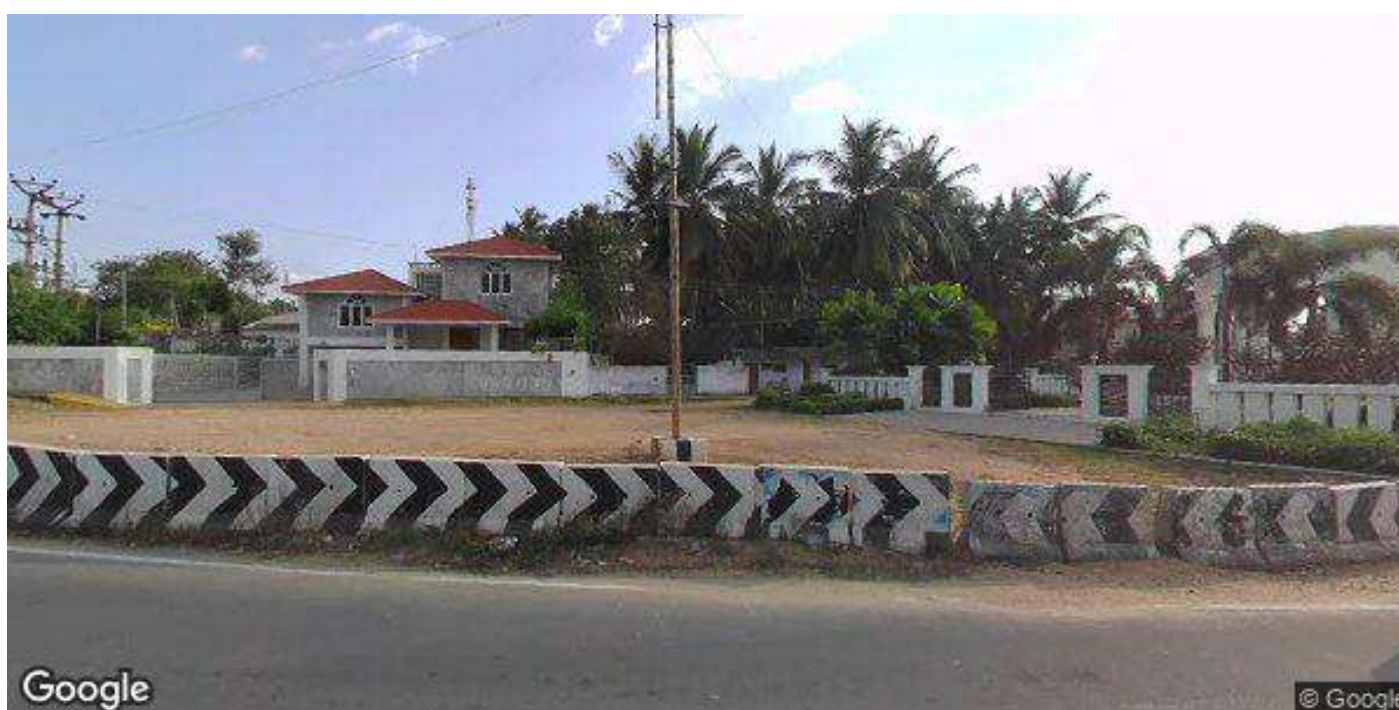
**Risk Type:** Turn  
**Risk Level:** Medium  
**Speed Limit:** 30 KM/Hr  
**Coordinates:** 11.46316, 77.84921

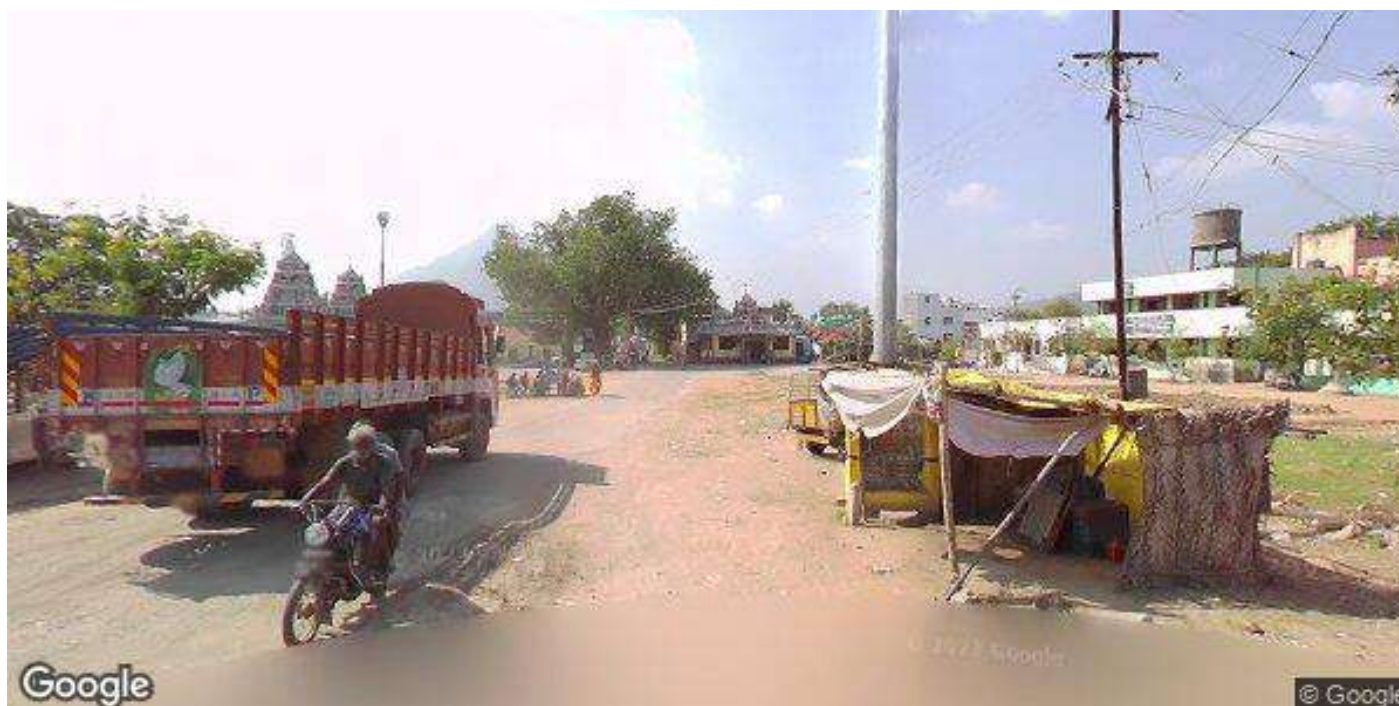
**Risk Type:** Blind Spot  
**Risk Level:** Blind Spot  
**Speed Limit:** 10 KM/Hr  
**Coordinates:** 11.62145, 78.10740

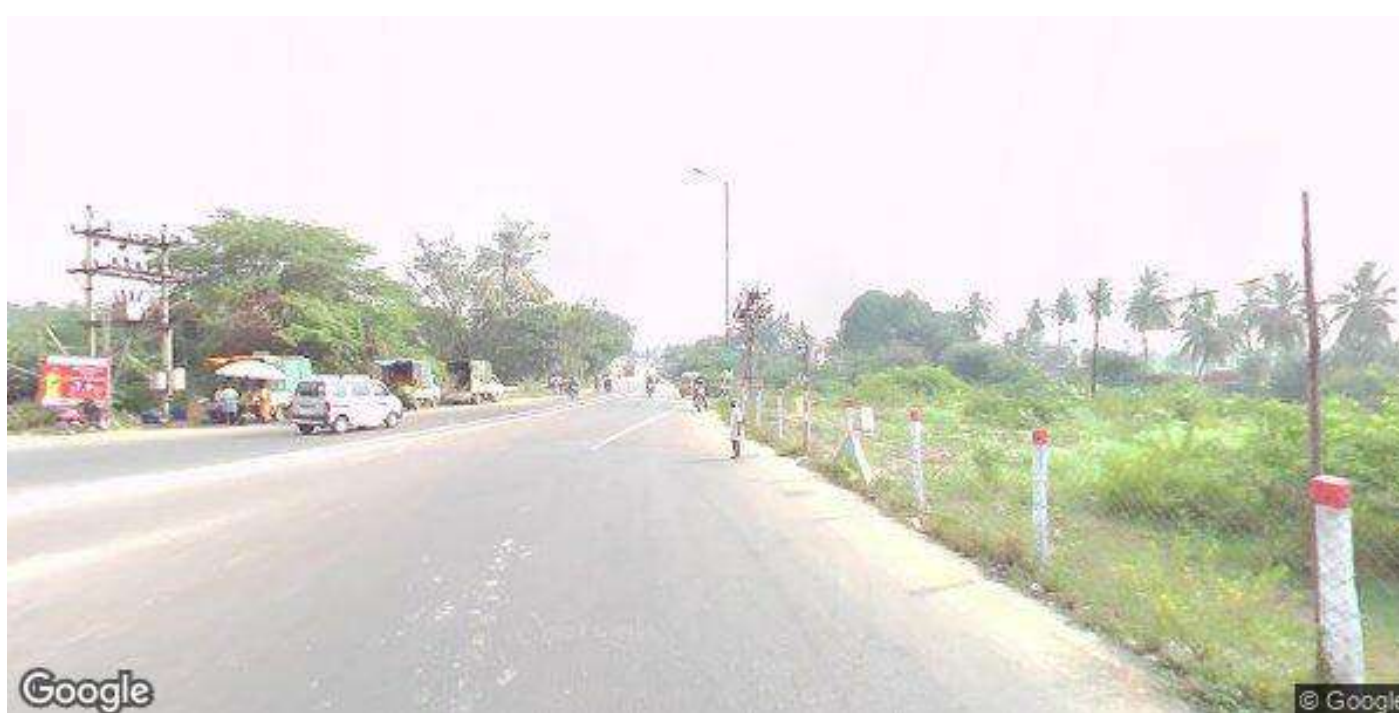
**Risk Type:** Turn  
**Risk Level:** Medium  
**Speed Limit:** 30 KM/Hr  
**Coordinates:** 11.61205, 78.10427

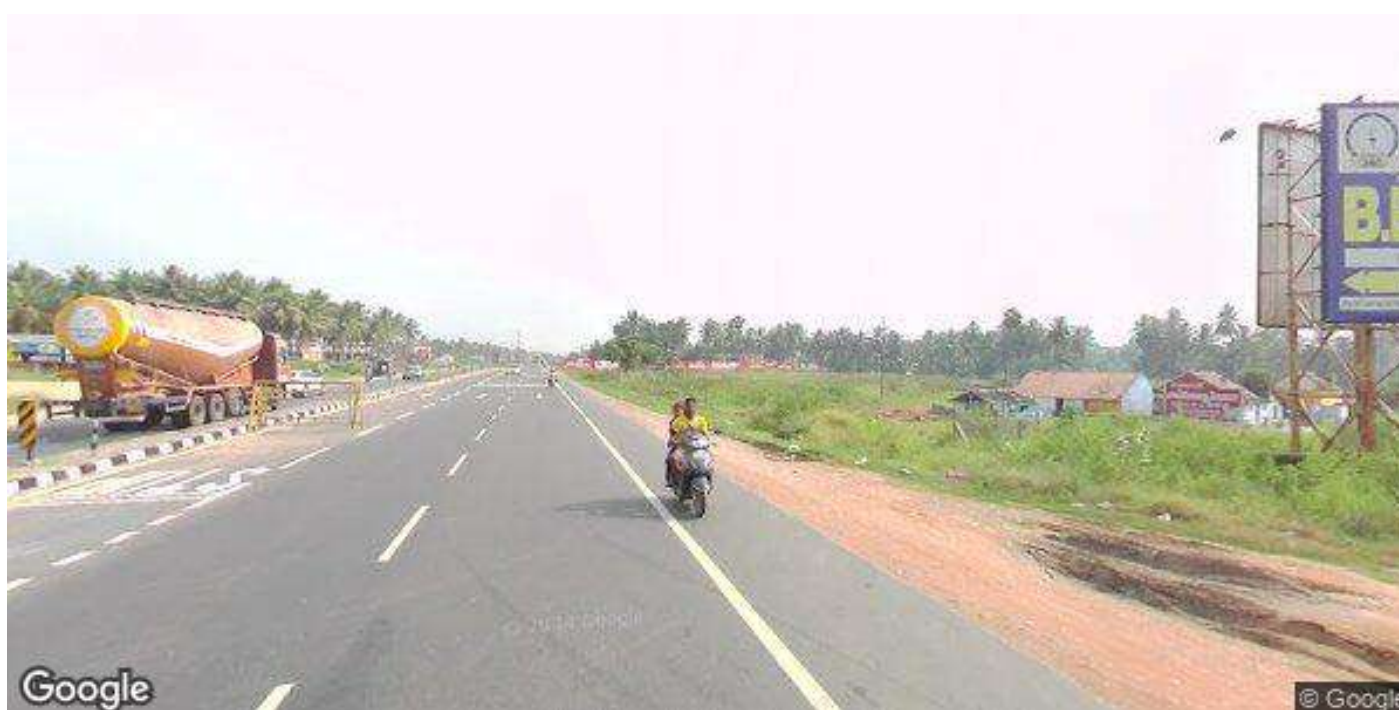
**Risk Type:** Turn  
**Risk Level:** High  
**Speed Limit:** 15 KM/Hr  
**Coordinates:** 11.59910, 78.08877

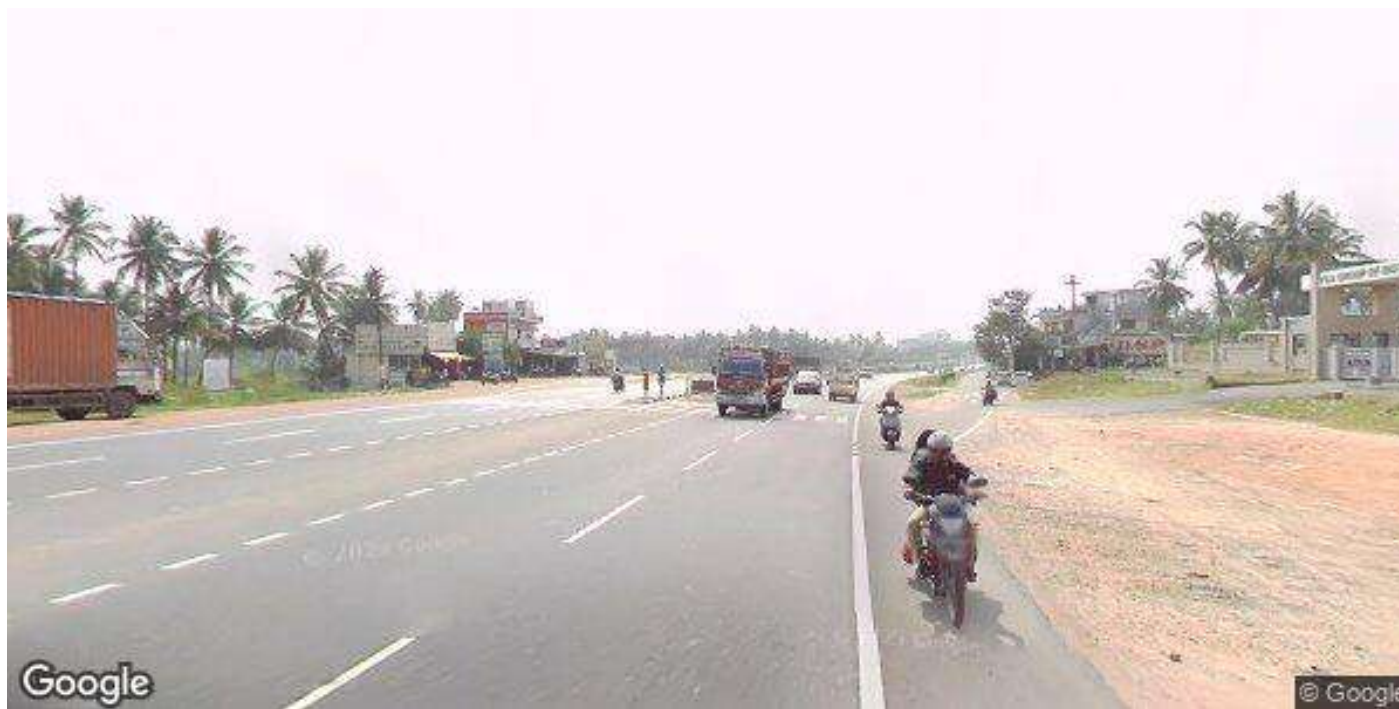
**Risk Type:** Blind Spot  
**Risk Level:** Blind Spot  
**Speed Limit:** 10 KM/Hr  
**Coordinates:** 11.59918, 78.08868

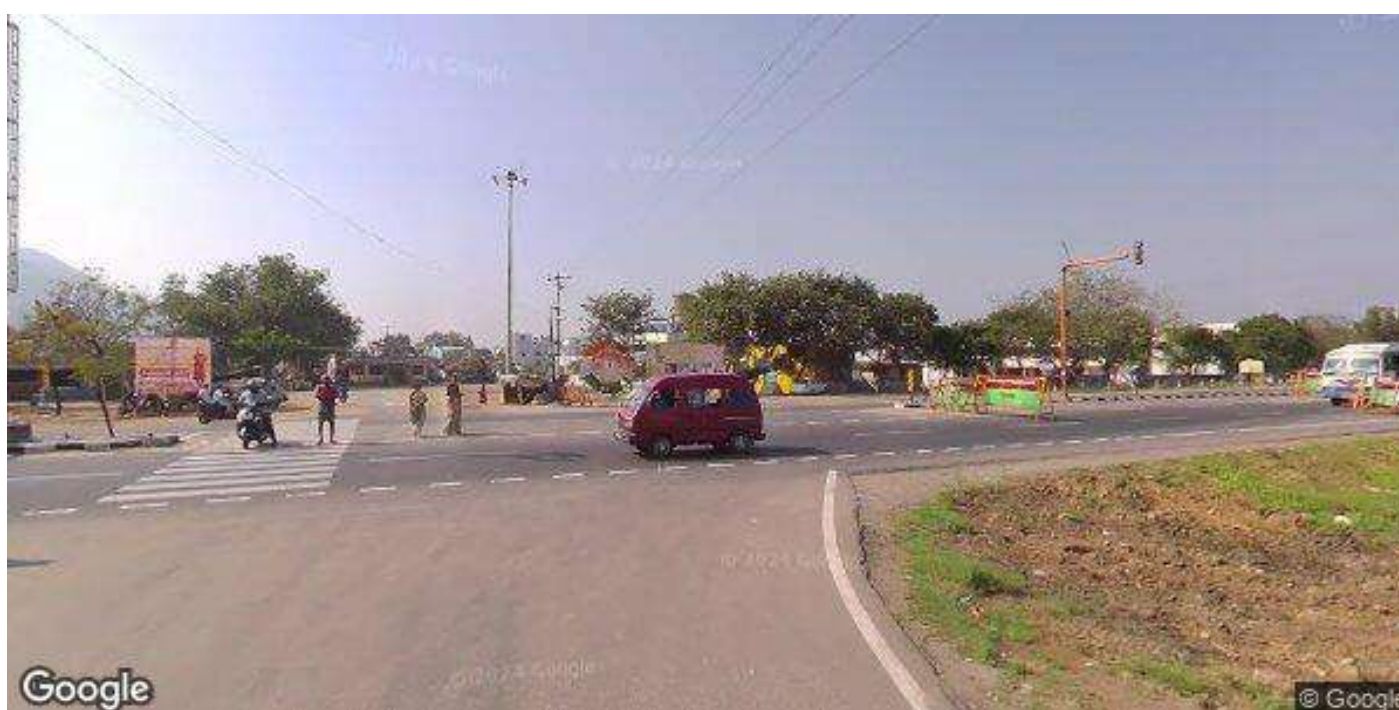
**Risk Type:** Turn  
**Risk Level:** High  
**Speed Limit:** 15 KM/Hr  
**Coordinates:** 11.62130, 78.10776

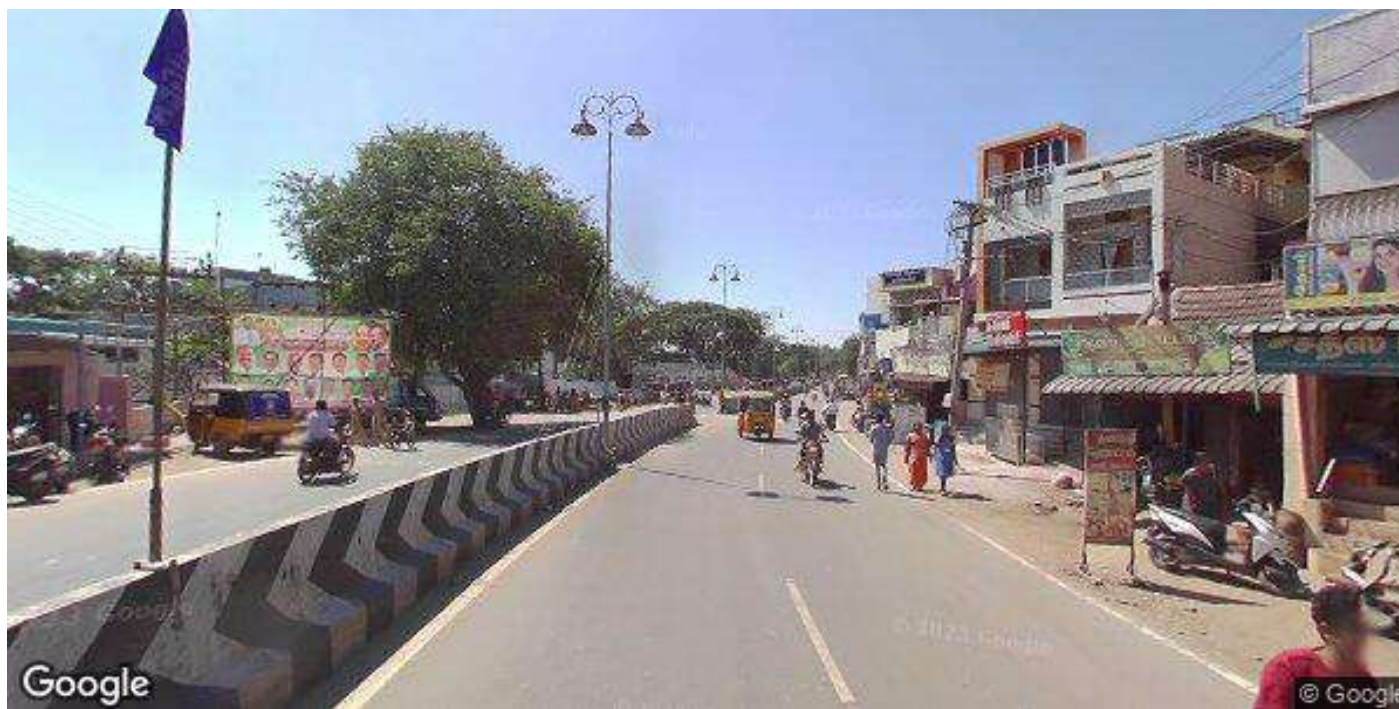
**Risk Type:** Turn  
**Risk Level:** Medium  
**Speed Limit:** 30 KM/Hr  
**Coordinates:** 11.62498, 78.12011

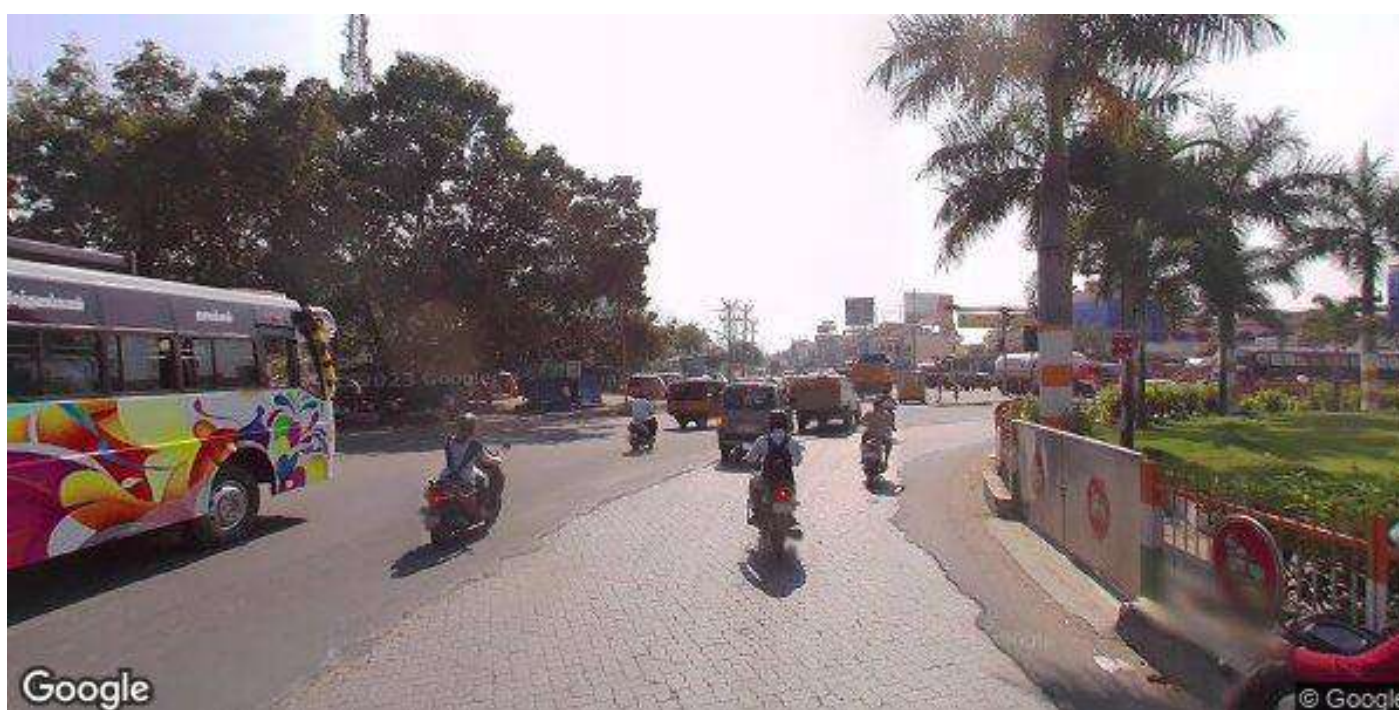
**Risk Type:** Turn  
**Risk Level:** High  
**Speed Limit:** 15 KM/Hr  
**Coordinates:** 11.63297, 78.12749

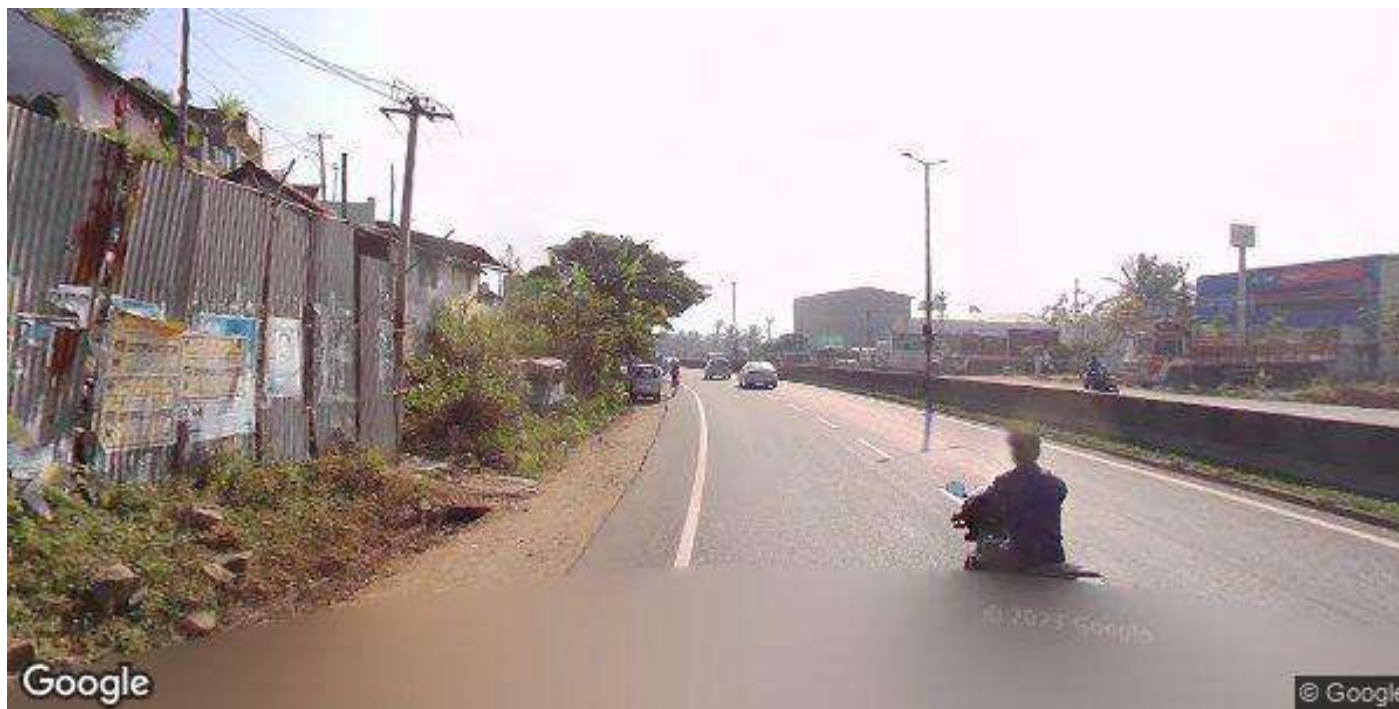
**Risk Type:** Turn  
**Risk Level:** Medium  
**Speed Limit:** 30 KM/Hr  
**Coordinates:** 11.62826, 78.13337

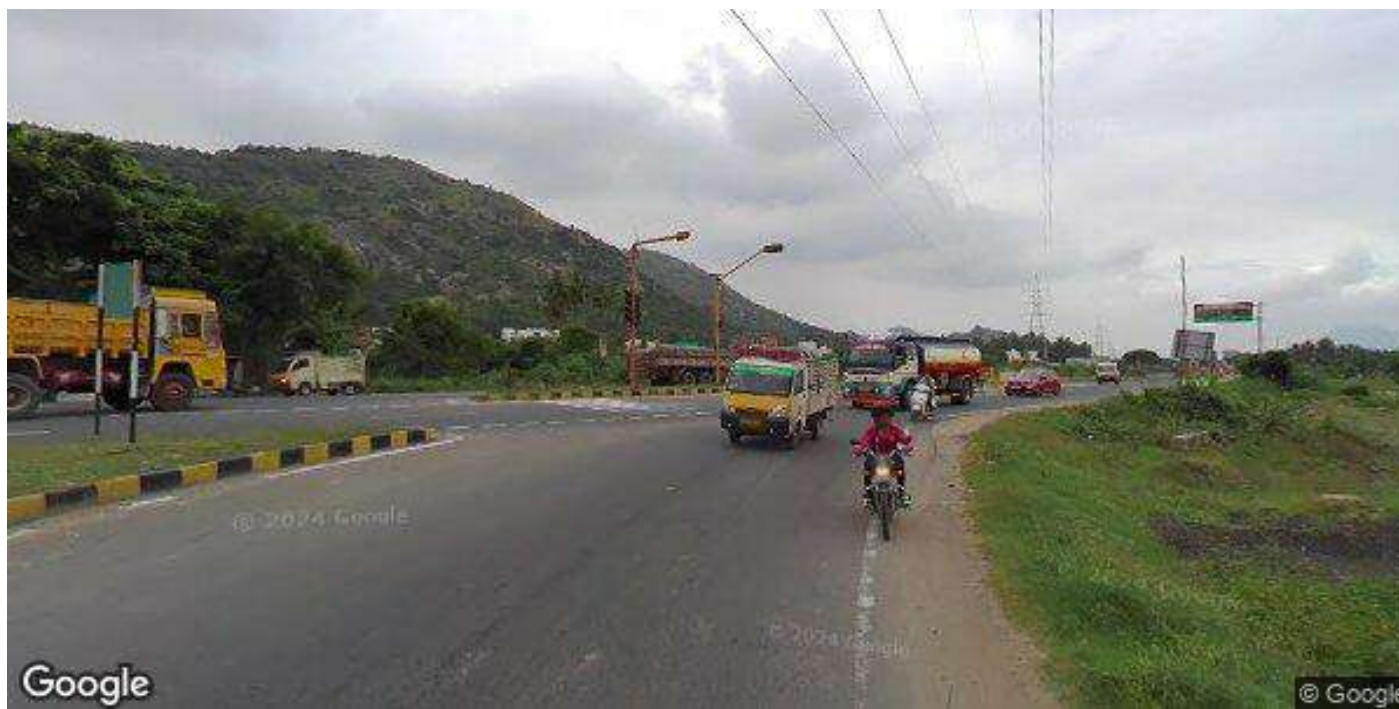
**Risk Type:** Turn  
**Risk Level:** Medium  
**Speed Limit:** 30 KM/Hr  
**Coordinates:** 11.65632, 78.20220

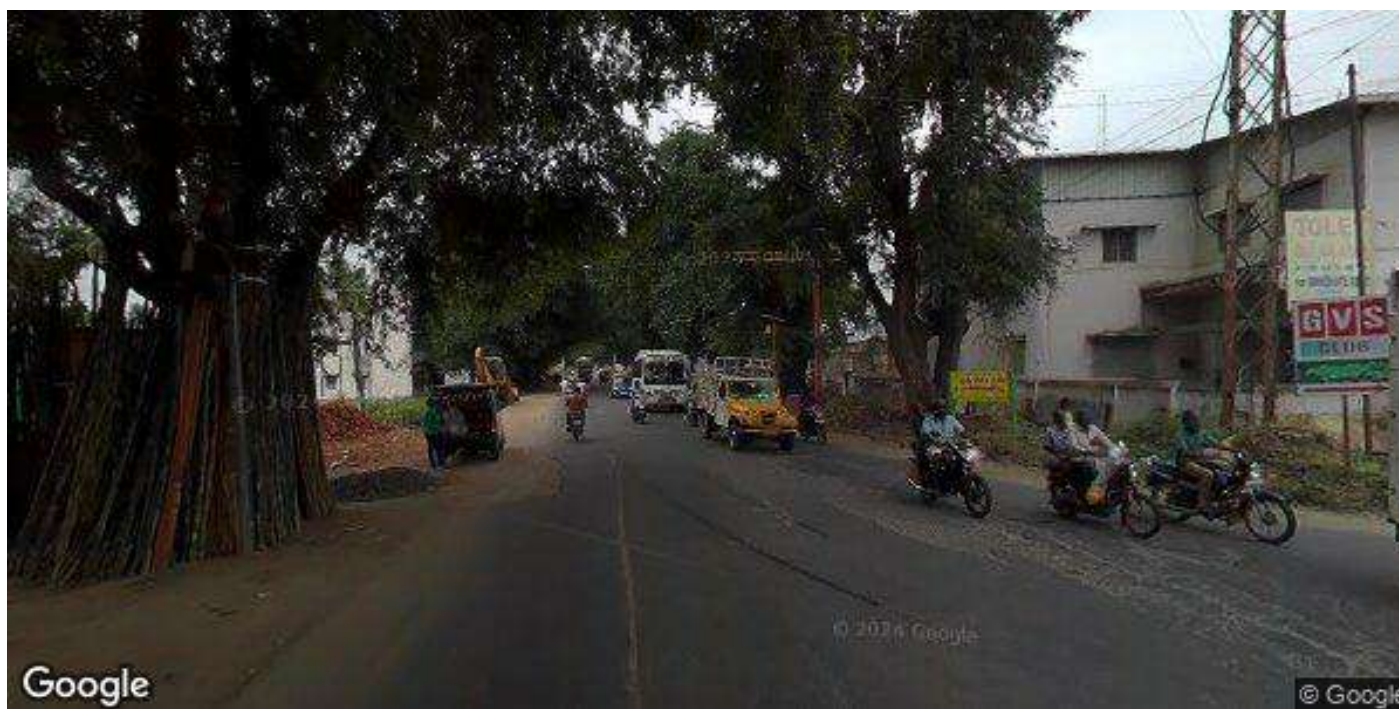
**Risk Type:** Turn  
**Risk Level:** High  
**Speed Limit:** 15 KM/Hr  
**Coordinates:** 11.66380, 78.20648

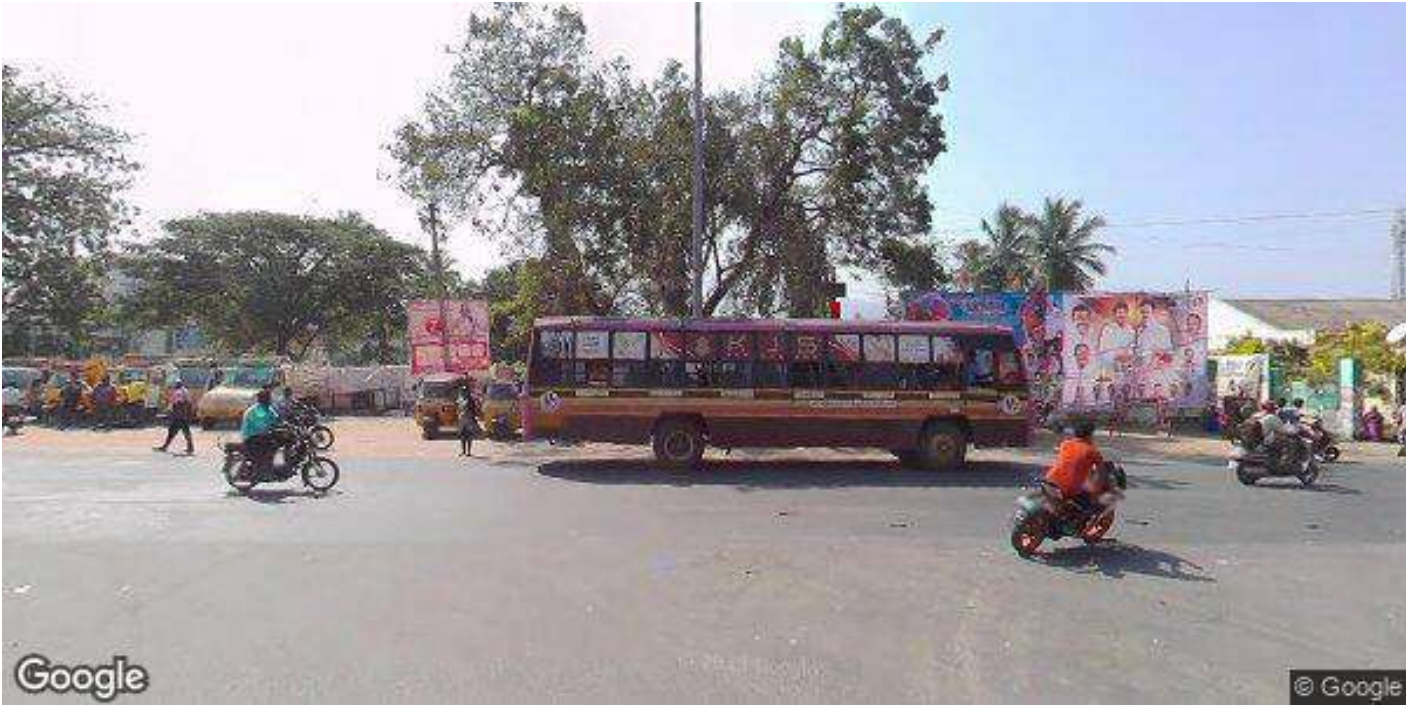
**Risk Type:** Turn  
**Risk Level:** High  
**Speed Limit:** 15 KM/Hr  
**Coordinates:** 11.67120, 78.23136

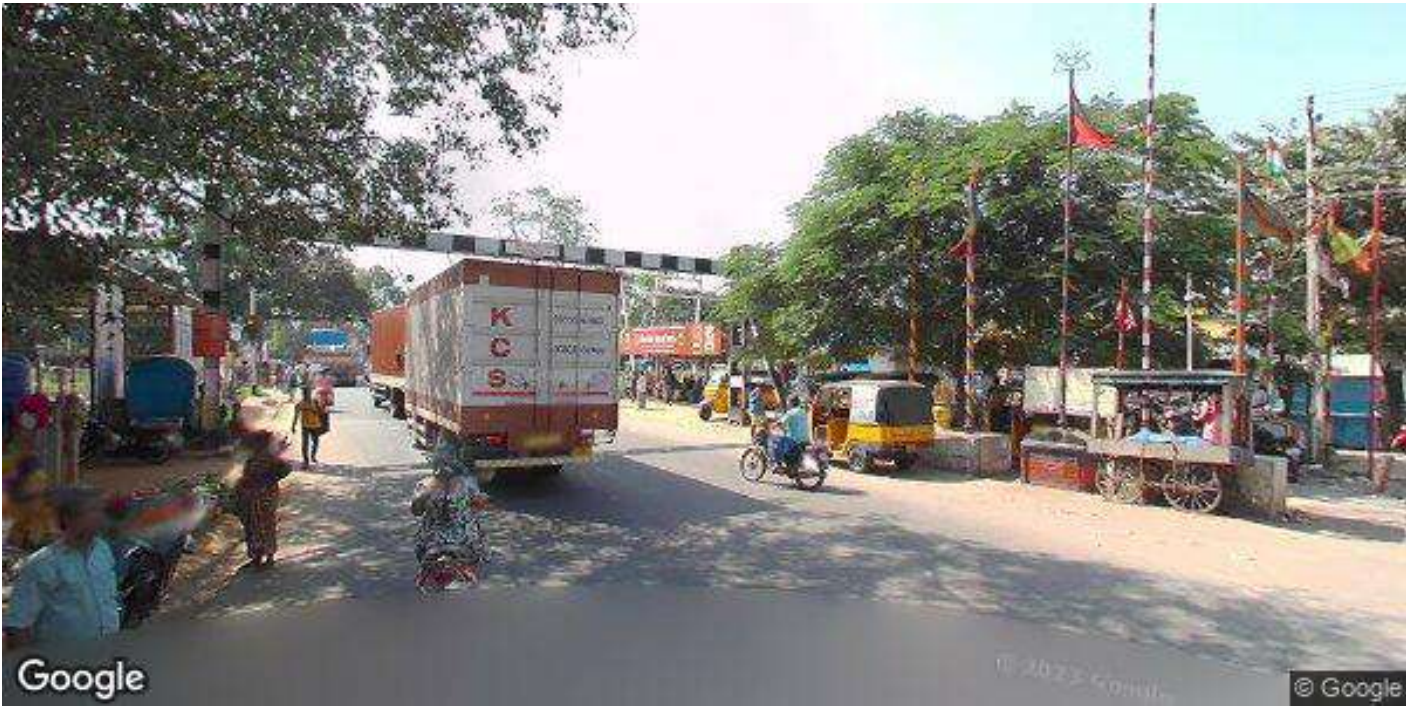
**Risk Type:** Turn  
**Risk Level:** Medium  
**Speed Limit:** 30 KM/Hr  
**Coordinates:** 11.67190, 78.23144

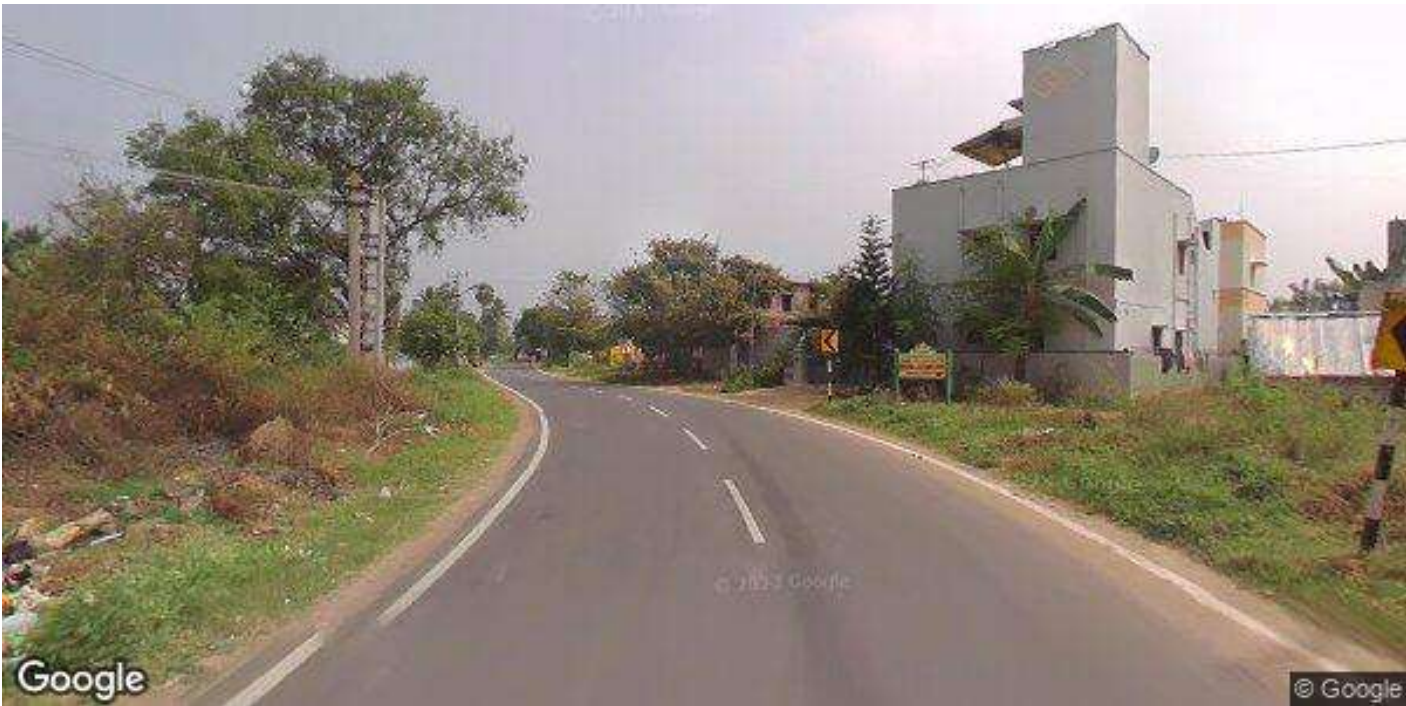
**Risk Type:** Turn  
**Risk Level:** Medium  
**Speed Limit:** 30 KM/Hr  
**Coordinates:** 11.67672, 78.24922
