# IndianOil

## JOURNEY RISK MANAGEMENT (JRM) STUDY

### Salem Terminal to ANDAVAR AGENCIES

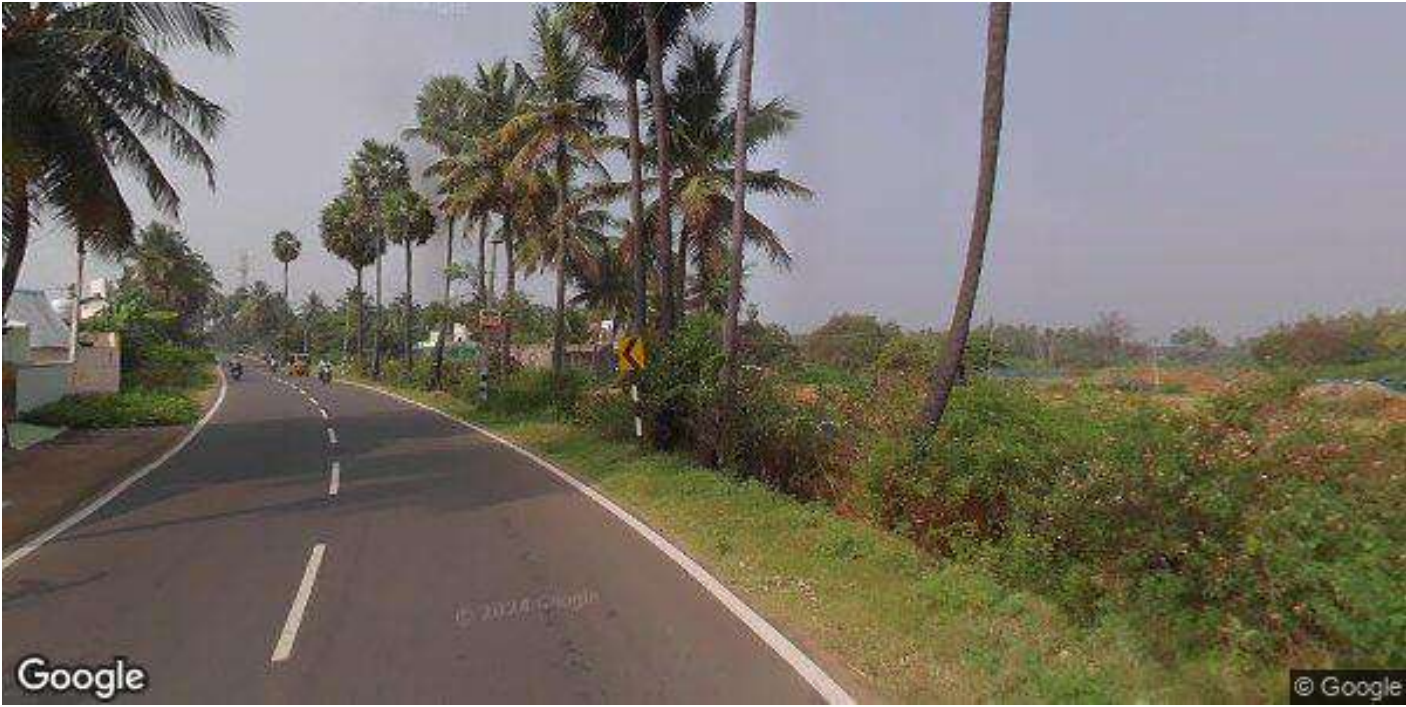
**Risk Type:** Turn  
**Risk Level:** Medium  
**Speed Limit:** 30 KM/Hr  
**Coordinates:** 11.67944, 78.25198

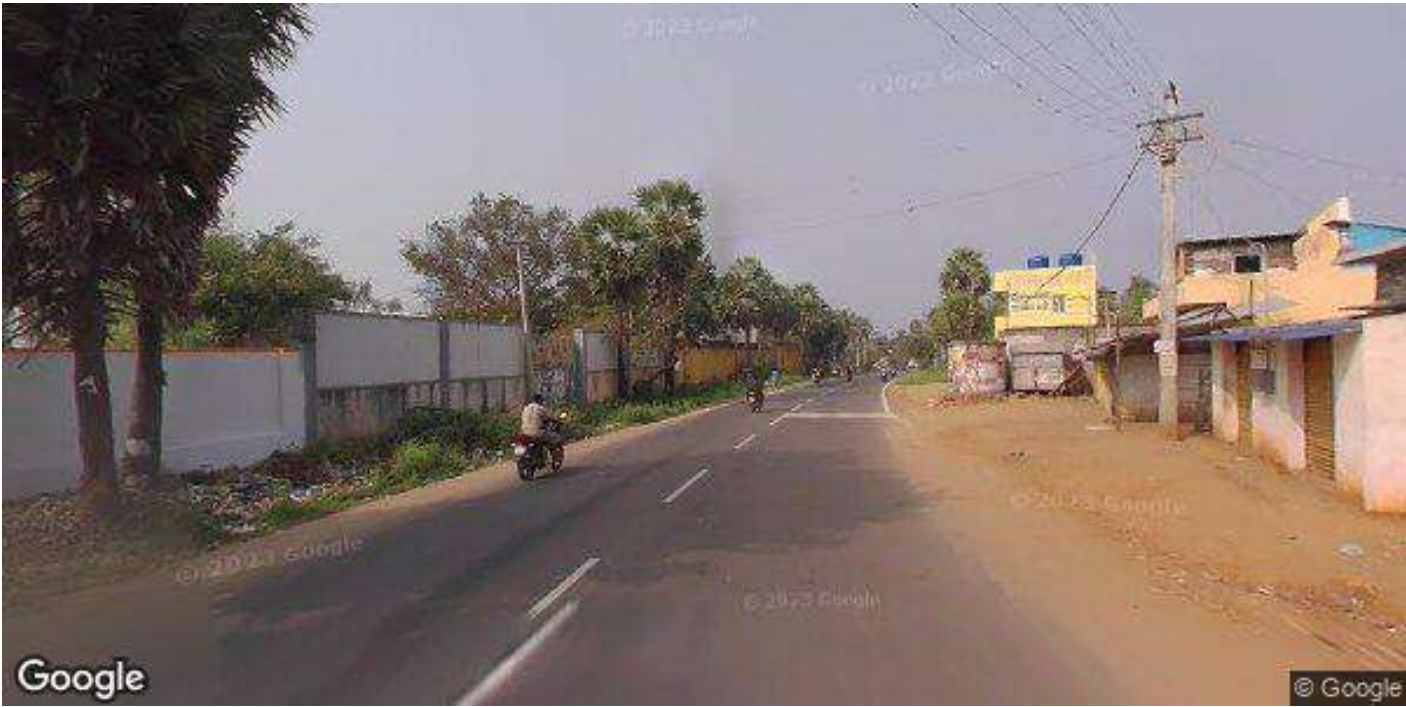
**Risk Type:** Turn  
**Risk Level:** Medium  
**Speed Limit:** 30 KM/Hr  
**Coordinates:** 11.68547, 78.26757
