# IndianOil

## JOURNEY RISK MANAGEMENT (JRM) STUDY

### Salem Terminal to A.K.S. AGENCIES

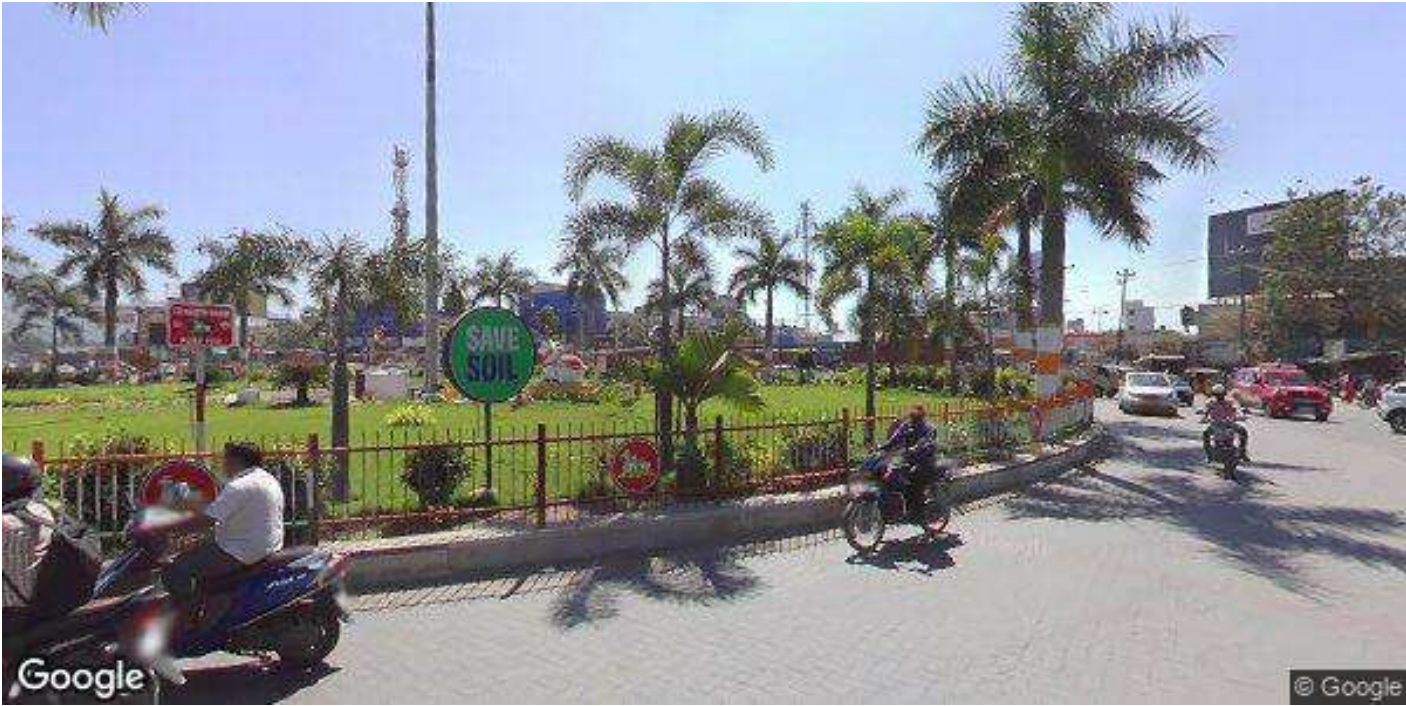
Coordinates: 11.63303, 78.12713

Risk Type: Roundabout

Risk Level: High

Speed Limit: 15 KM/Hr

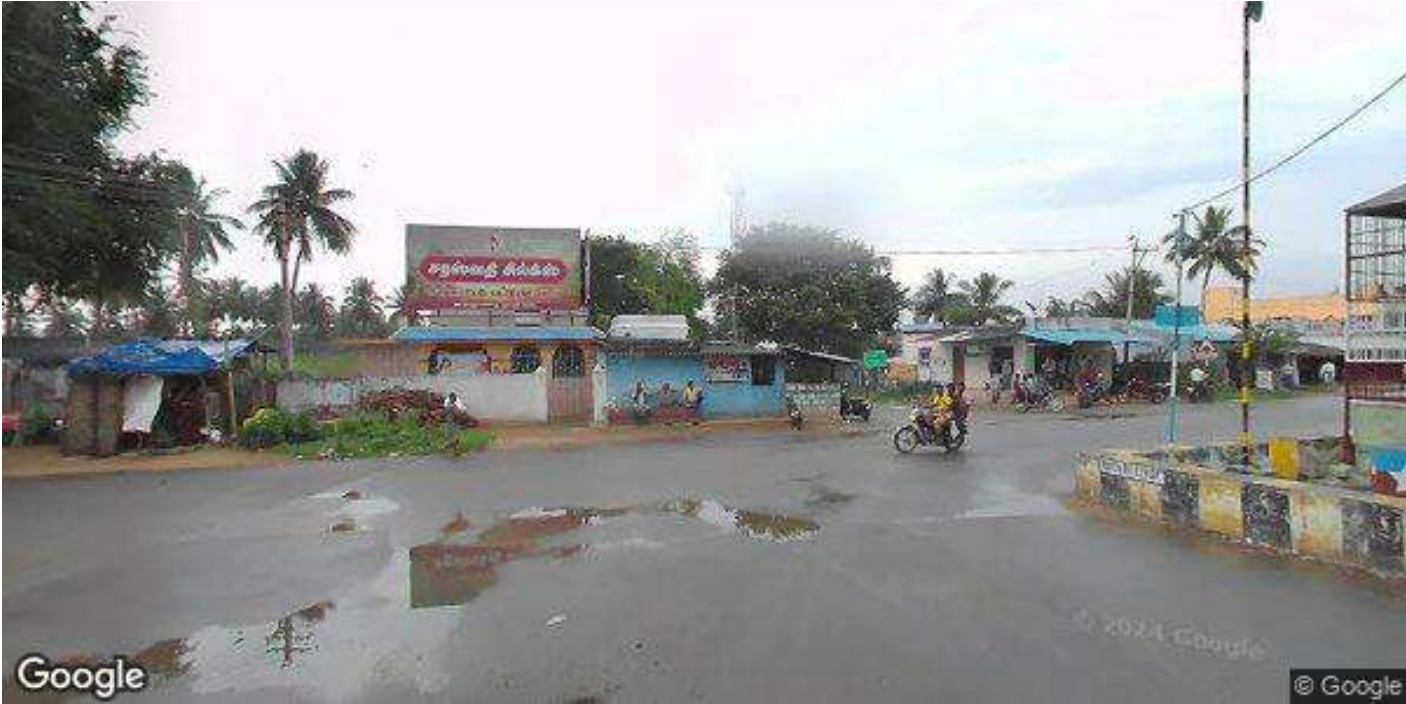
**Coordinates: 12.11402, 78.56990**

**Risk Type: Roundabout**

**Risk Level: High**

**Speed Limit: 15 KM/Hr**

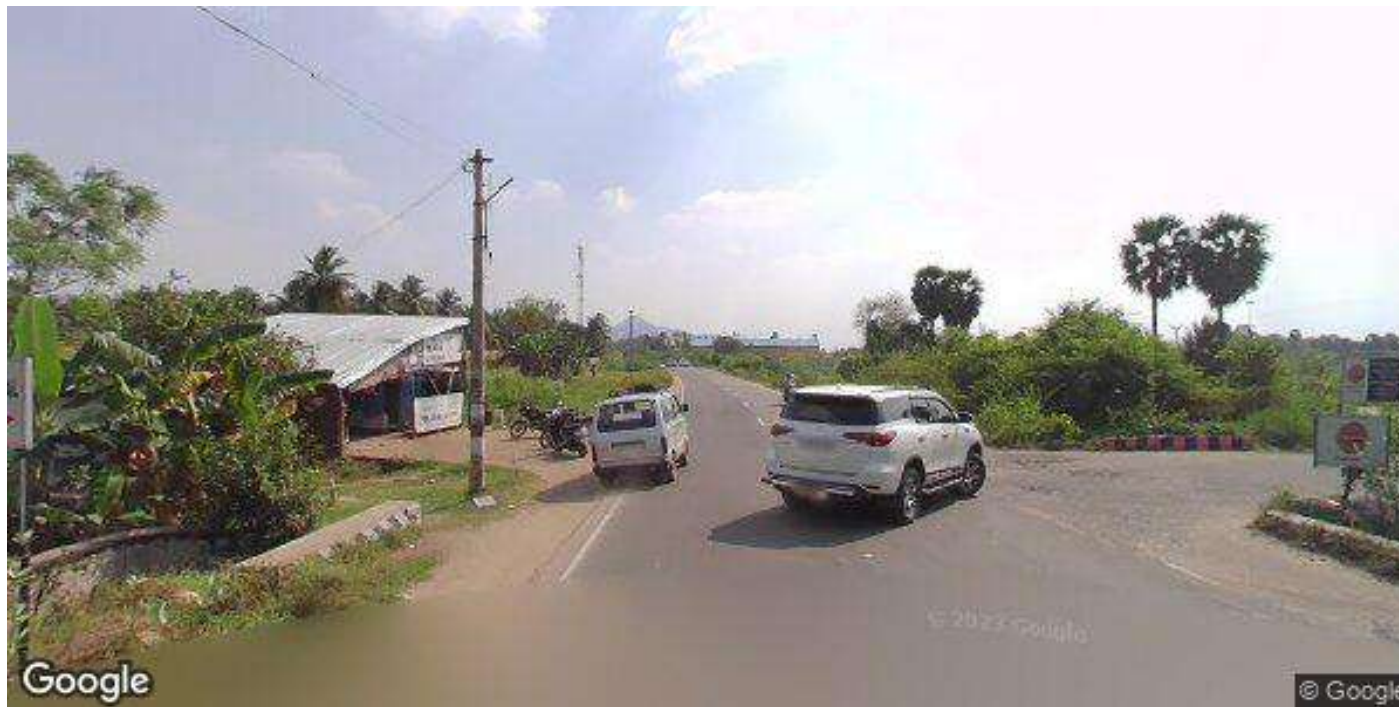
**Coordinates: 11.44029, 77.87544**

**Risk Type: Turn**

**Risk Level: High**

**Speed Limit: 15 KM/Hr**

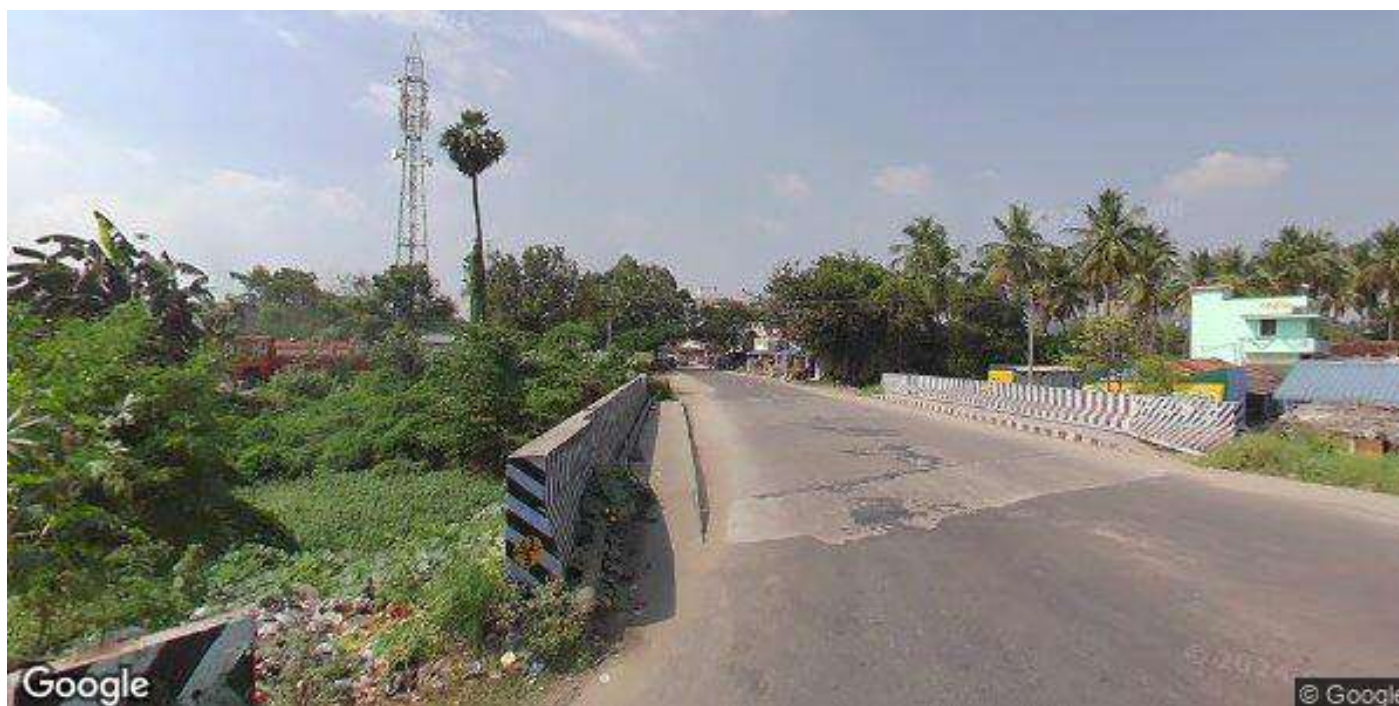
**Coordinates: 11.44900, 77.87406**

**Risk Type: Turn**

**Risk Level: High**

**Speed Limit: 15 KM/Hr**

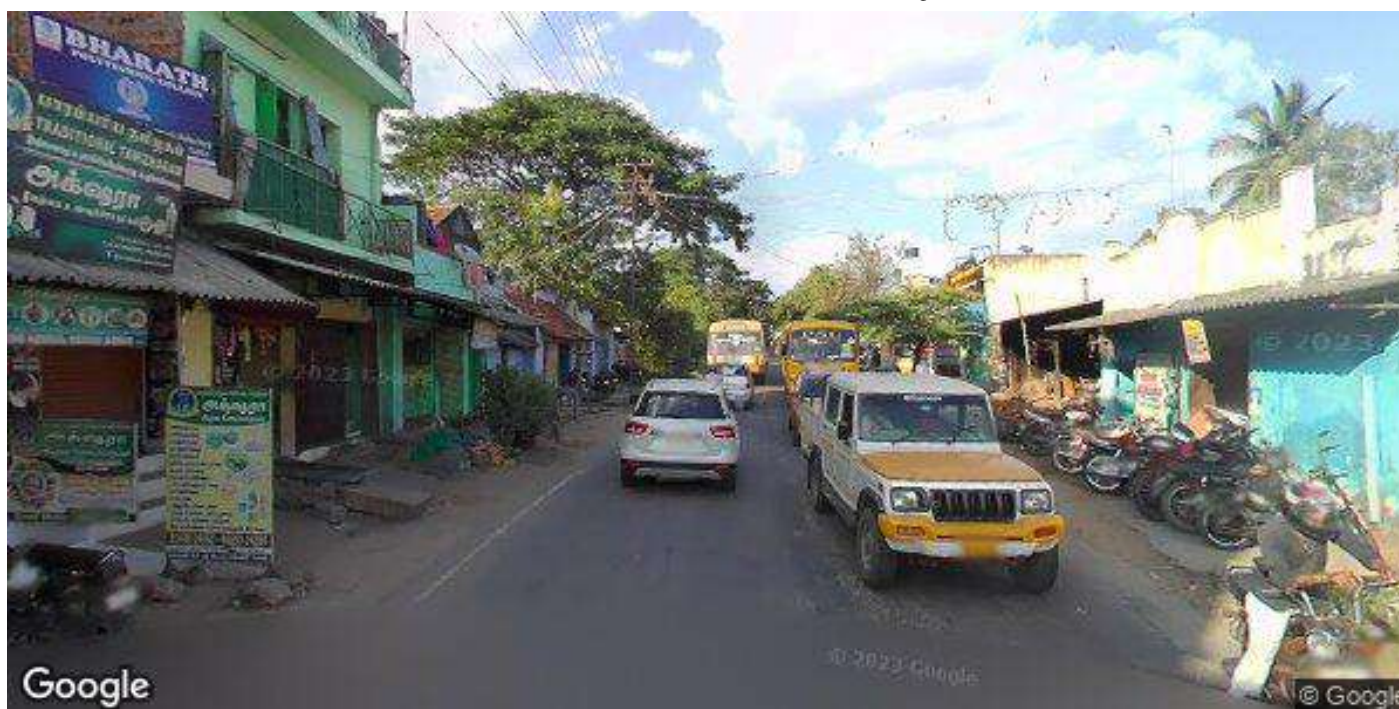
**Risk Type:** Turn  
**Risk Level:** High  
**Speed Limit:** 15 KM/Hr  
**Coordinates:** 11.45028, 77.87202

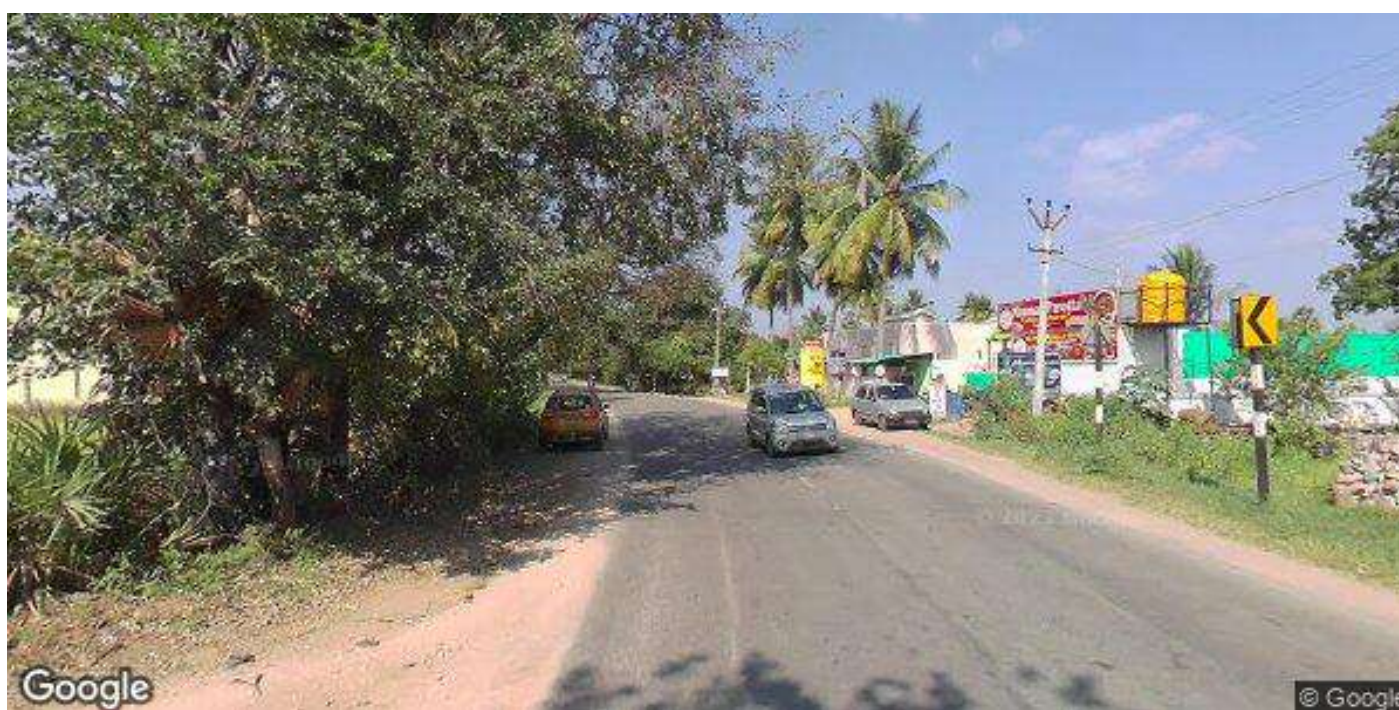
**Risk Type:** Turn  
**Risk Level:** Medium  
**Speed Limit:** 30 KM/Hr  
**Coordinates:** 11.45309, 77.87325

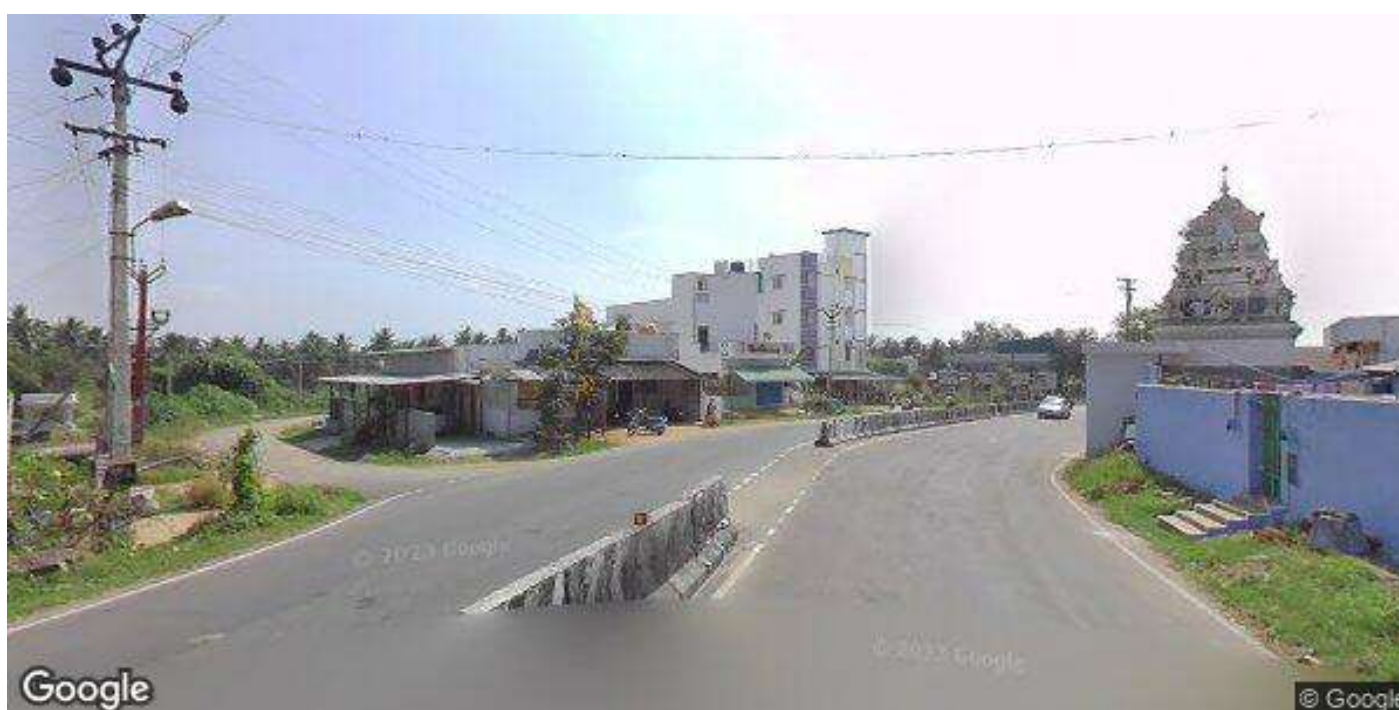
**Risk Type:** Turn  
**Risk Level:** Medium  
**Speed Limit:** 30 KM/Hr  
**Coordinates:** 11.46400, 77.87323

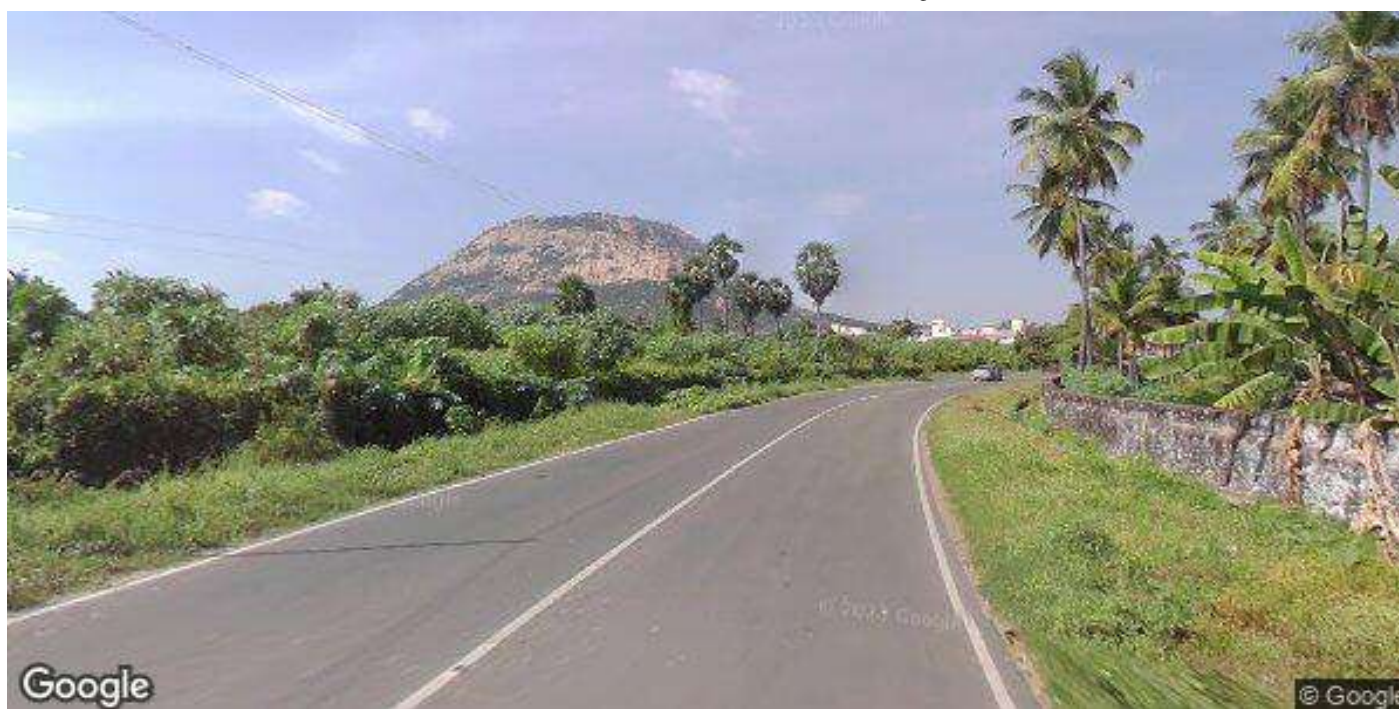
**Risk Type:** Turn  
**Risk Level:** Medium  
**Speed Limit:** 30 KM/Hr  
**Coordinates:** 11.46765, 77.87037

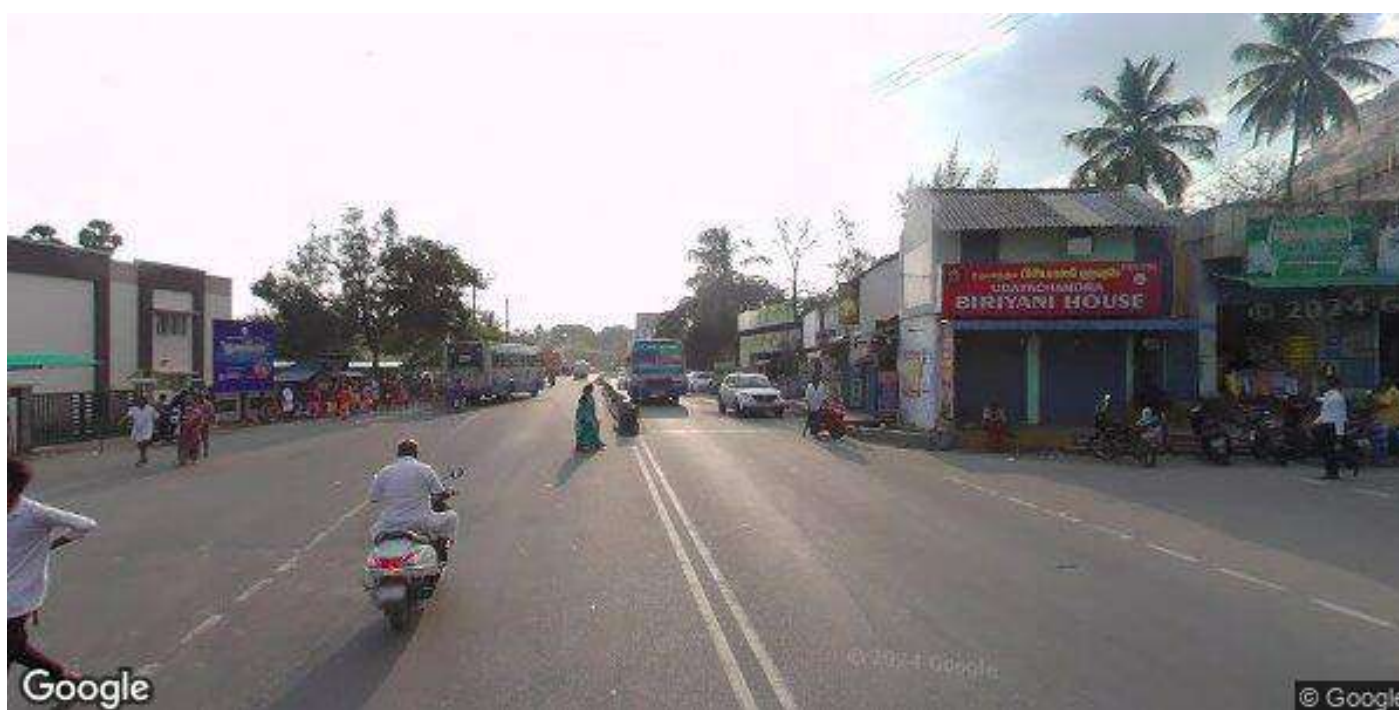
**Risk Type:** Turn  
**Risk Level:** High  
**Speed Limit:** 15 KM/Hr  
**Coordinates:** 11.47403, 77.86841

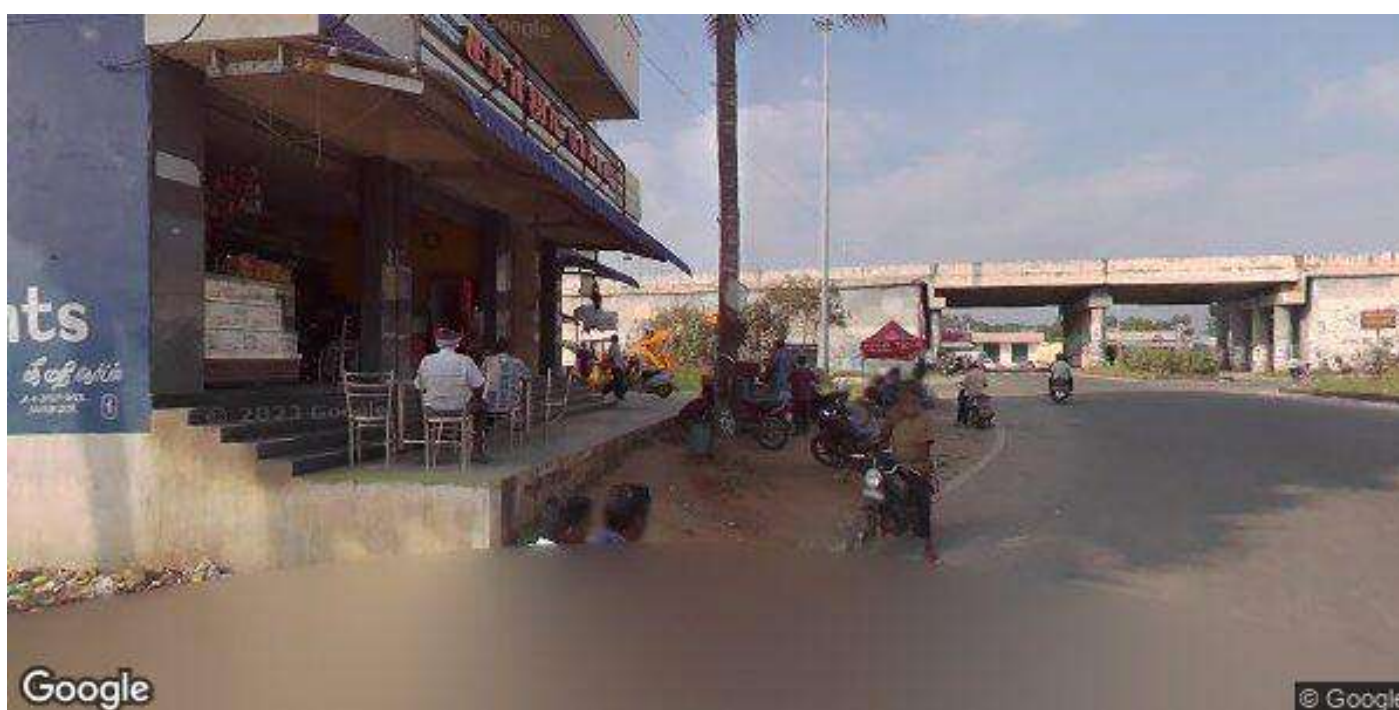
**Risk Type:** Turn  
**Risk Level:** High  
**Speed Limit:** 15 KM/Hr  
**Coordinates:** 11.49149, 77.89601

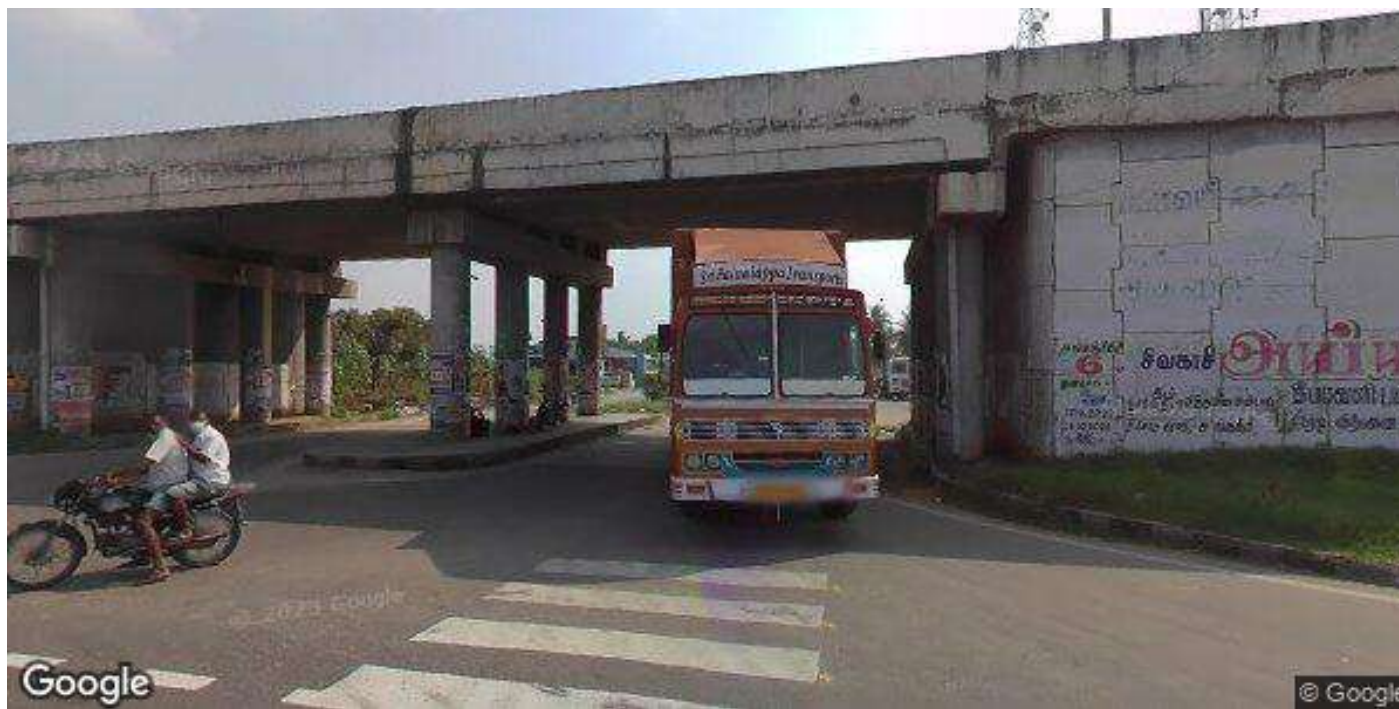
**Risk Type:** Turn  
**Risk Level:** High  
**Speed Limit:** 15 KM/Hr  
**Coordinates:** 11.49224, 77.89601

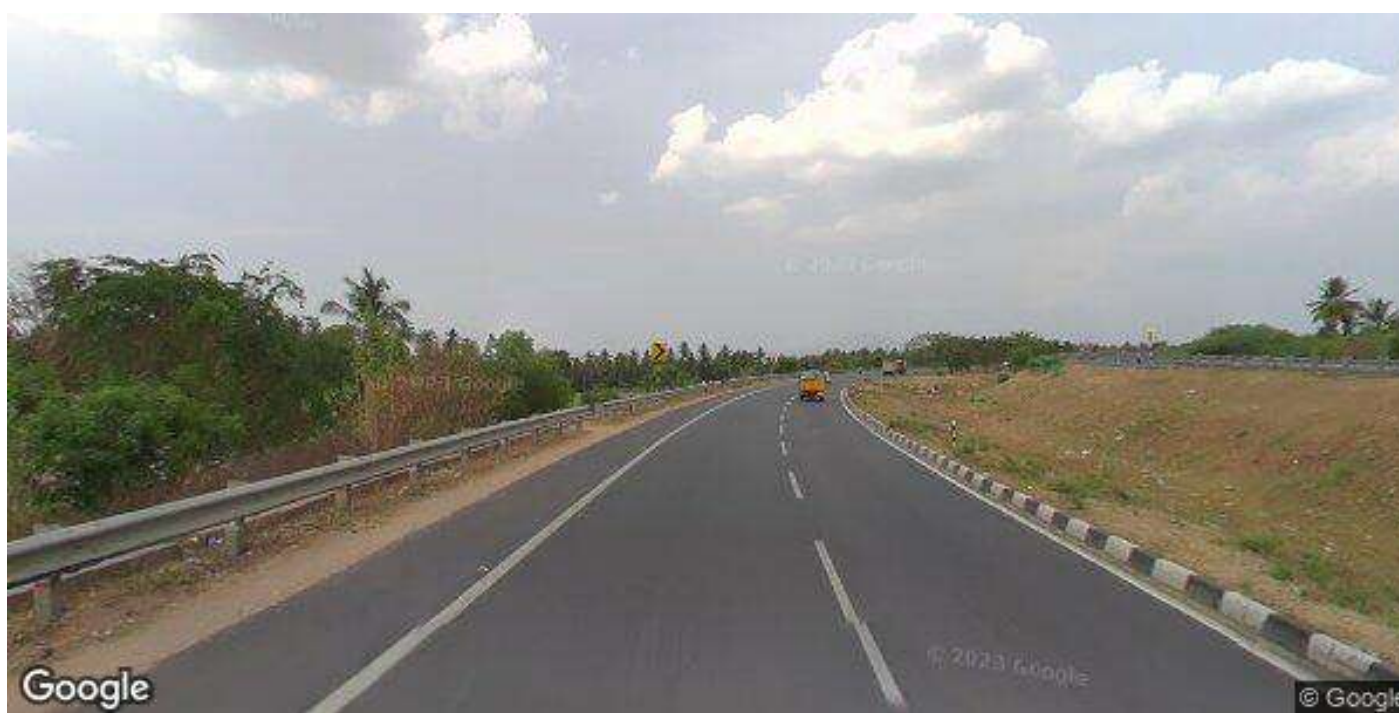
**Risk Type:** Turn  
**Risk Level:** Medium  
**Speed Limit:** 30 KM/Hr  
**Coordinates:** 11.53501, 77.95707

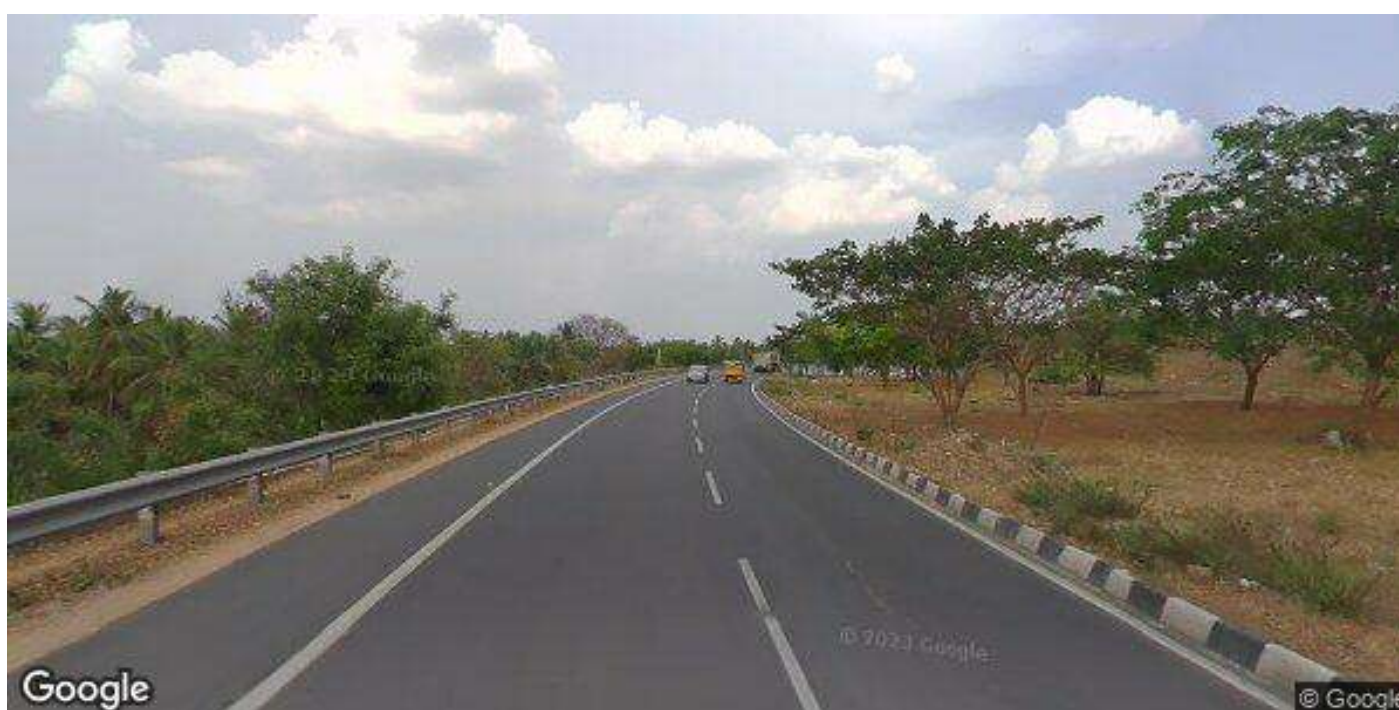
**Risk Type:** Turn  
**Risk Level:** Medium  
**Speed Limit:** 30 KM/Hr  
**Coordinates:** 11.53601, 77.95856

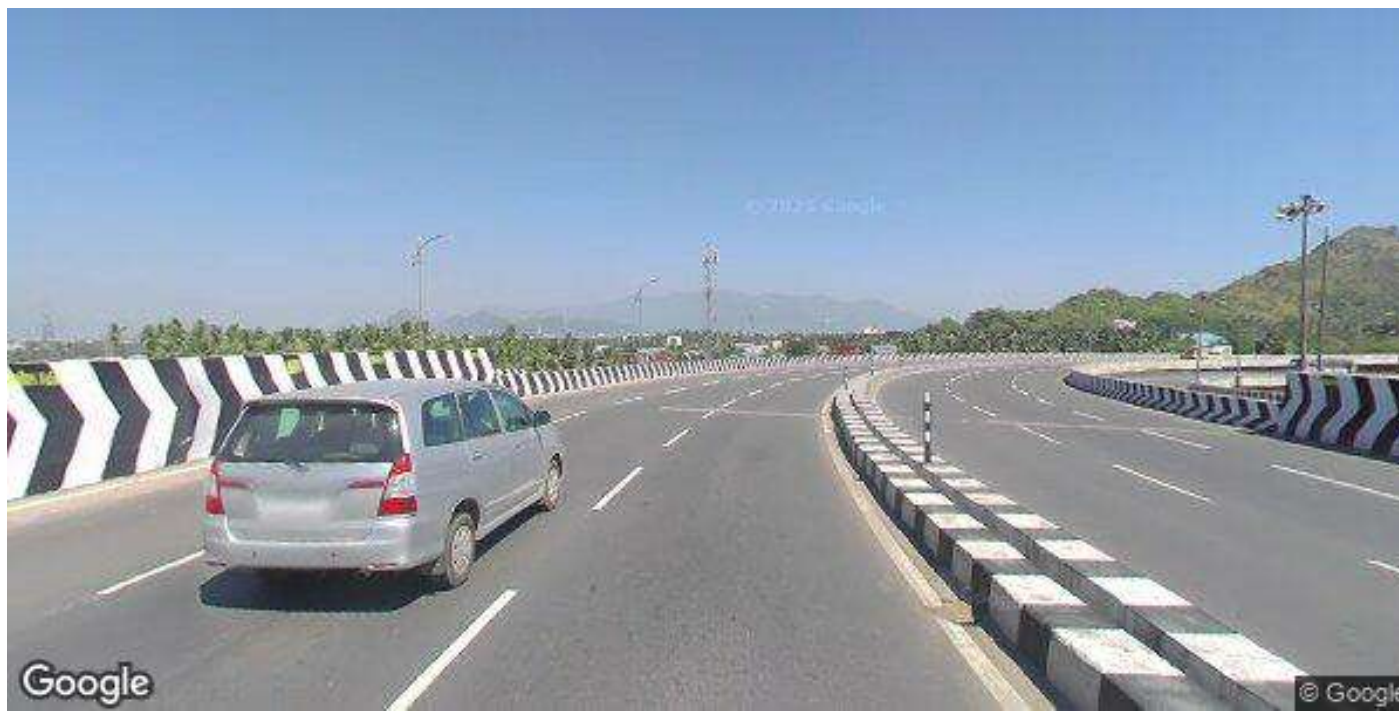
**Risk Type:** Turn  
**Risk Level:** High  
**Speed Limit:** 15 KM/Hr  
**Coordinates:** 11.64172, 78.11817

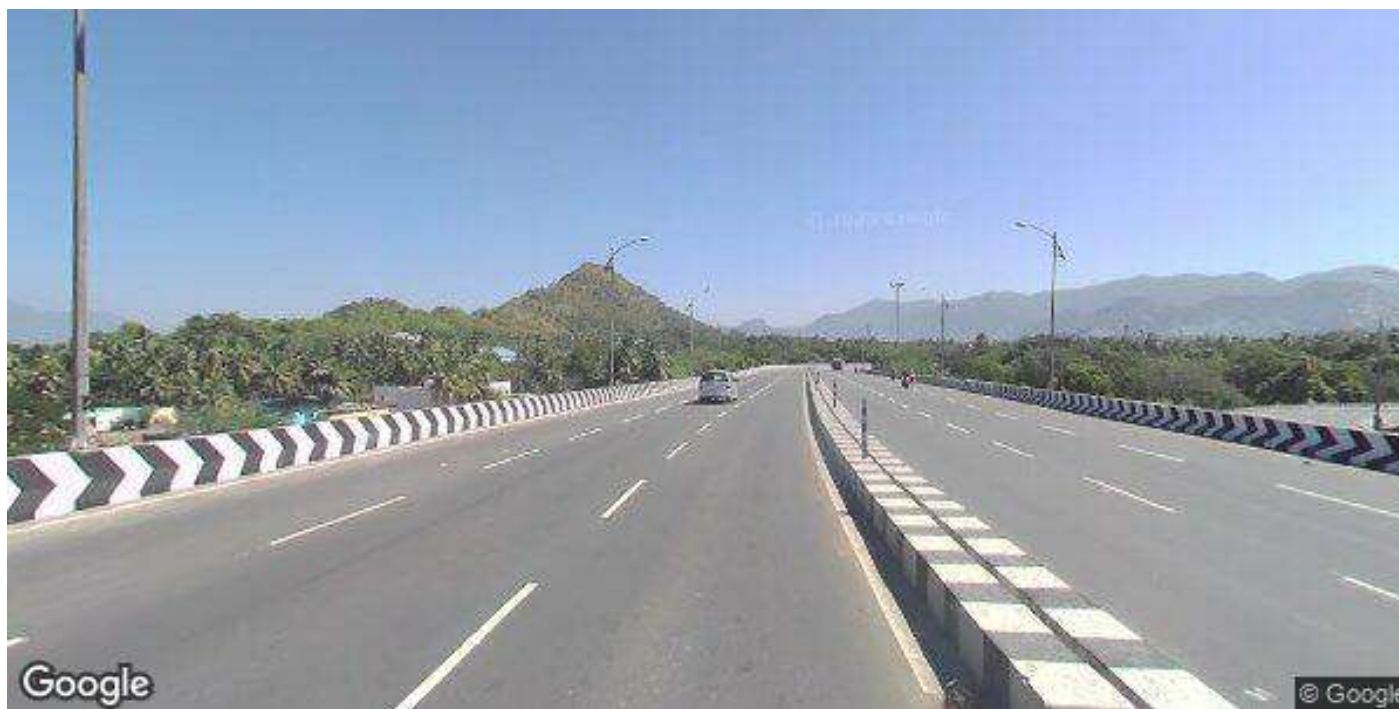
**Risk Type:** Turn  
**Risk Level:** Medium  
**Speed Limit:** 30 KM/Hr  
**Coordinates:** 11.64224, 78.11928

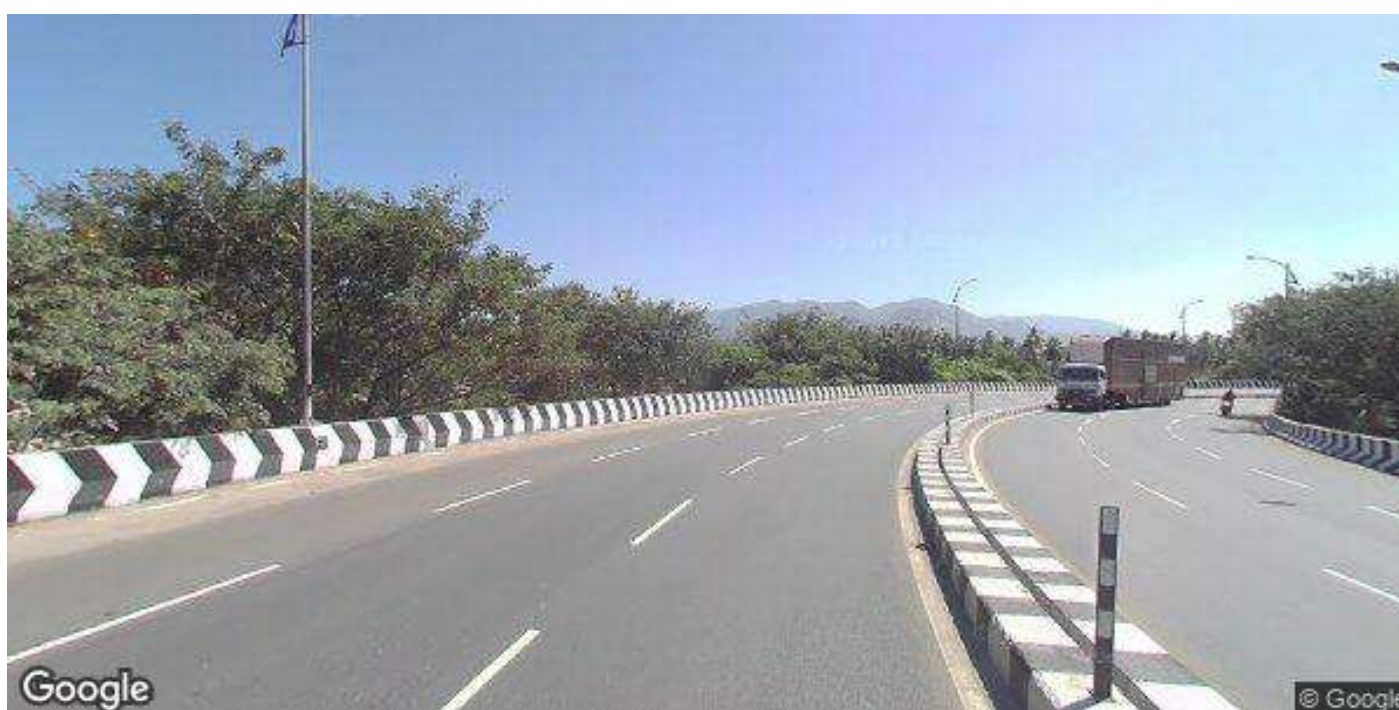
**Risk Type:** Turn  
**Risk Level:** High  
**Speed Limit:** 15 KM/Hr  
**Coordinates:** 11.64195, 78.12129

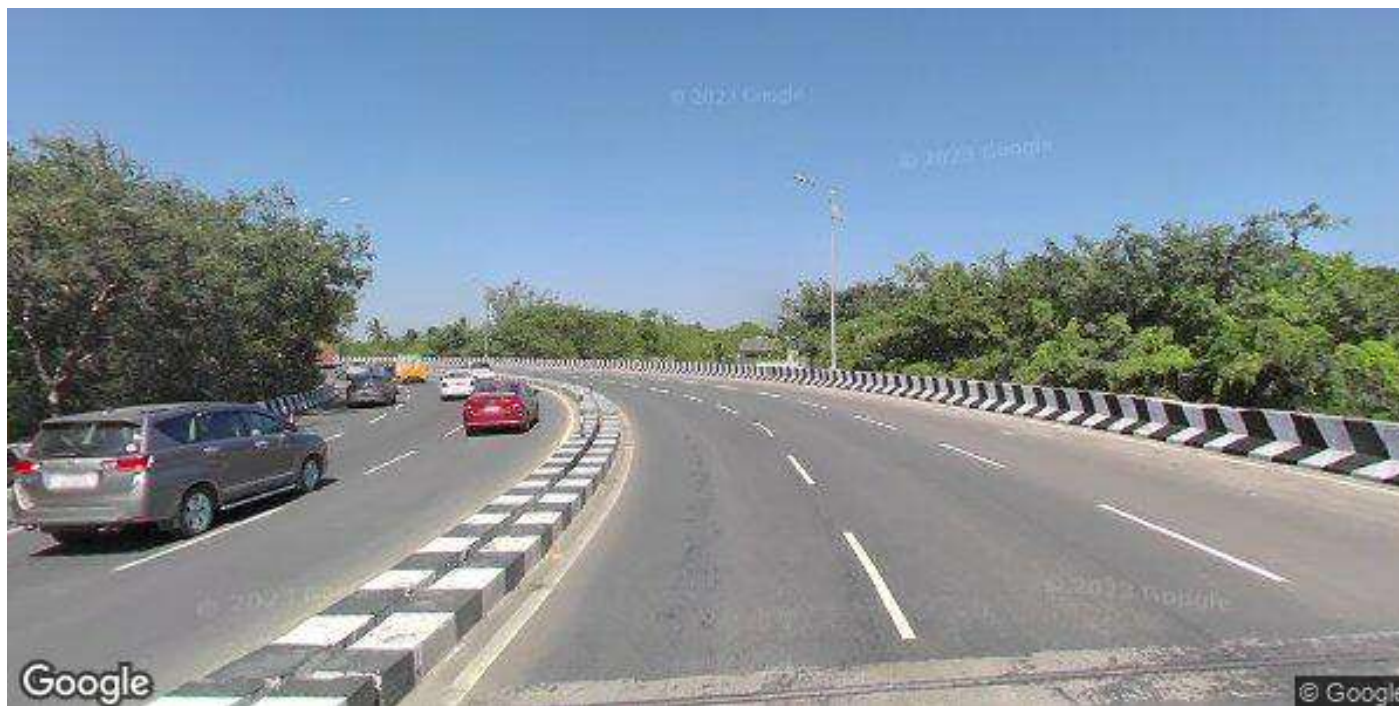
**Risk Type:** Turn  
**Risk Level:** High  
**Speed Limit:** 15 KM/Hr  
**Coordinates:** 11.64120, 78.12168

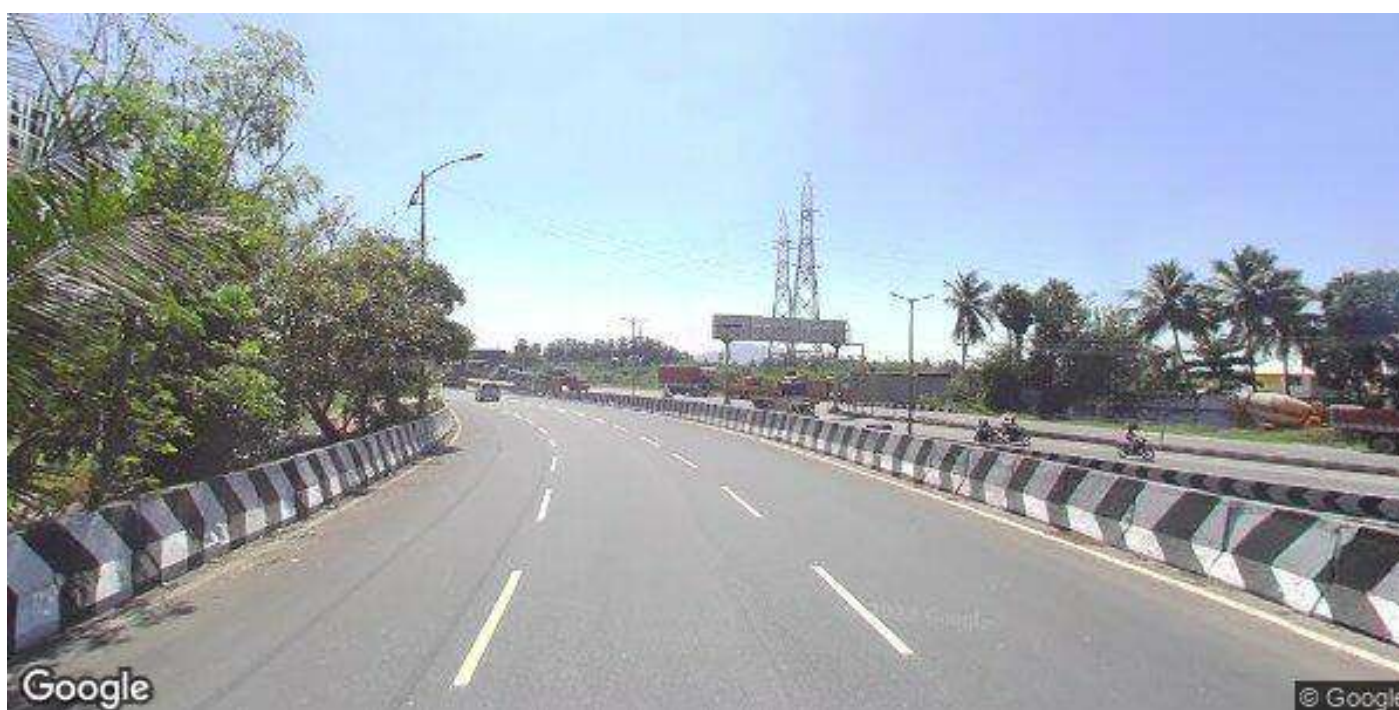
**Risk Type:** Turn  
**Risk Level:** Medium  
**Speed Limit:** 30 KM/Hr  
**Coordinates:** 11.63948, 78.12081

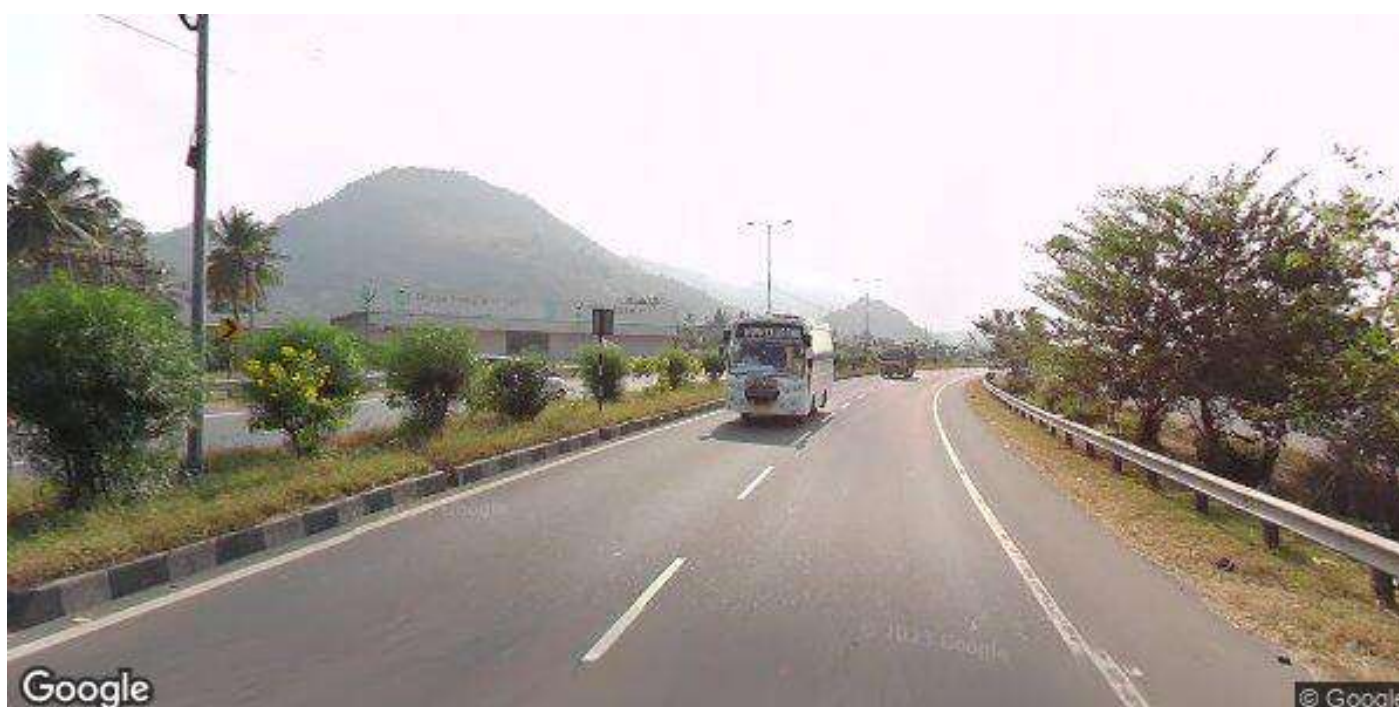
**Risk Type:** Turn  
**Risk Level:** Medium  
**Speed Limit:** 30 KM/Hr  
**Coordinates:** 11.62861, 78.16526

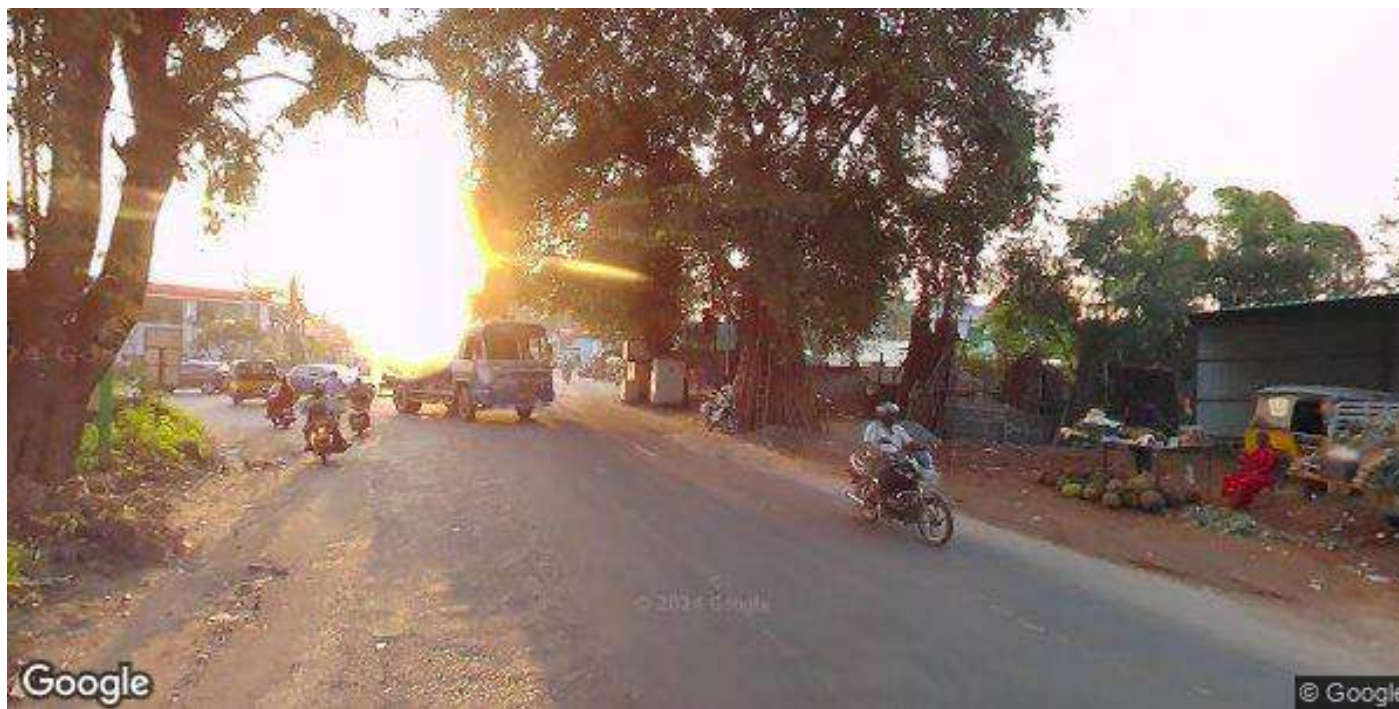
**Risk Type:** Turn  
**Risk Level:** Medium  
**Speed Limit:** 30 KM/Hr  
**Coordinates:** 11.66388, 78.20672

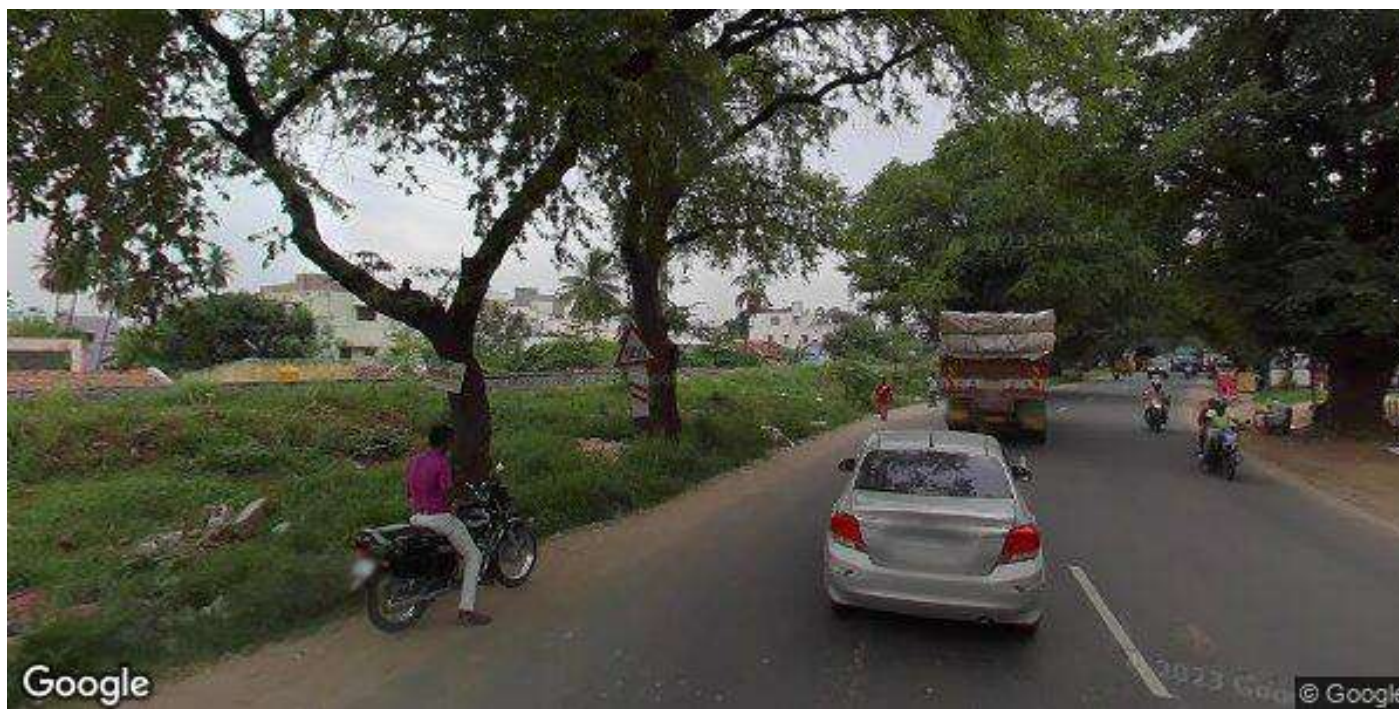
**Risk Type:** Turn  
**Risk Level:** Medium  
**Speed Limit:** 30 KM/Hr  
**Coordinates:** 11.67129, 78.22978

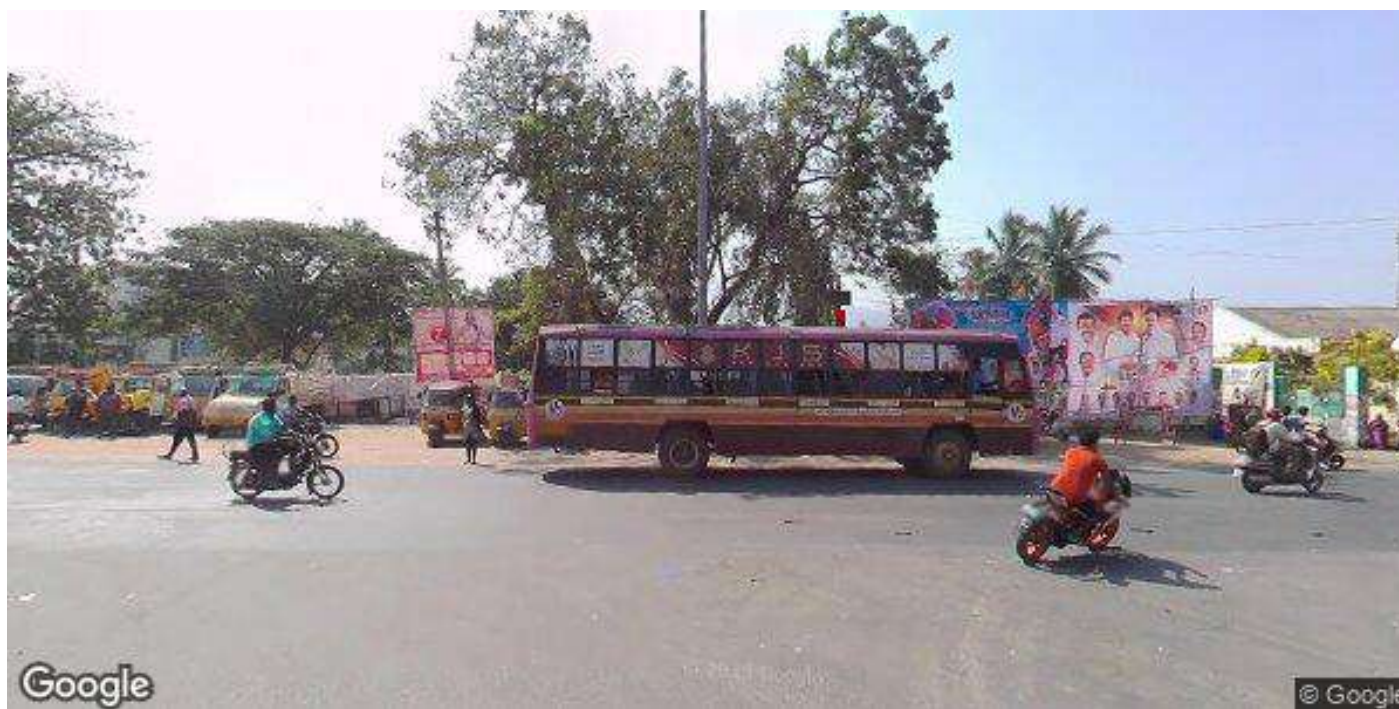
**Risk Type:** Turn  
**Risk Level:** High  
**Speed Limit:** 15 KM/Hr  
**Coordinates:** 11.67120, 78.23136
