# IndianOil

## JOURNEY RISK MANAGEMENT (JRM) STUDY

### Salem Terminal to A.K.S. AGENCIES

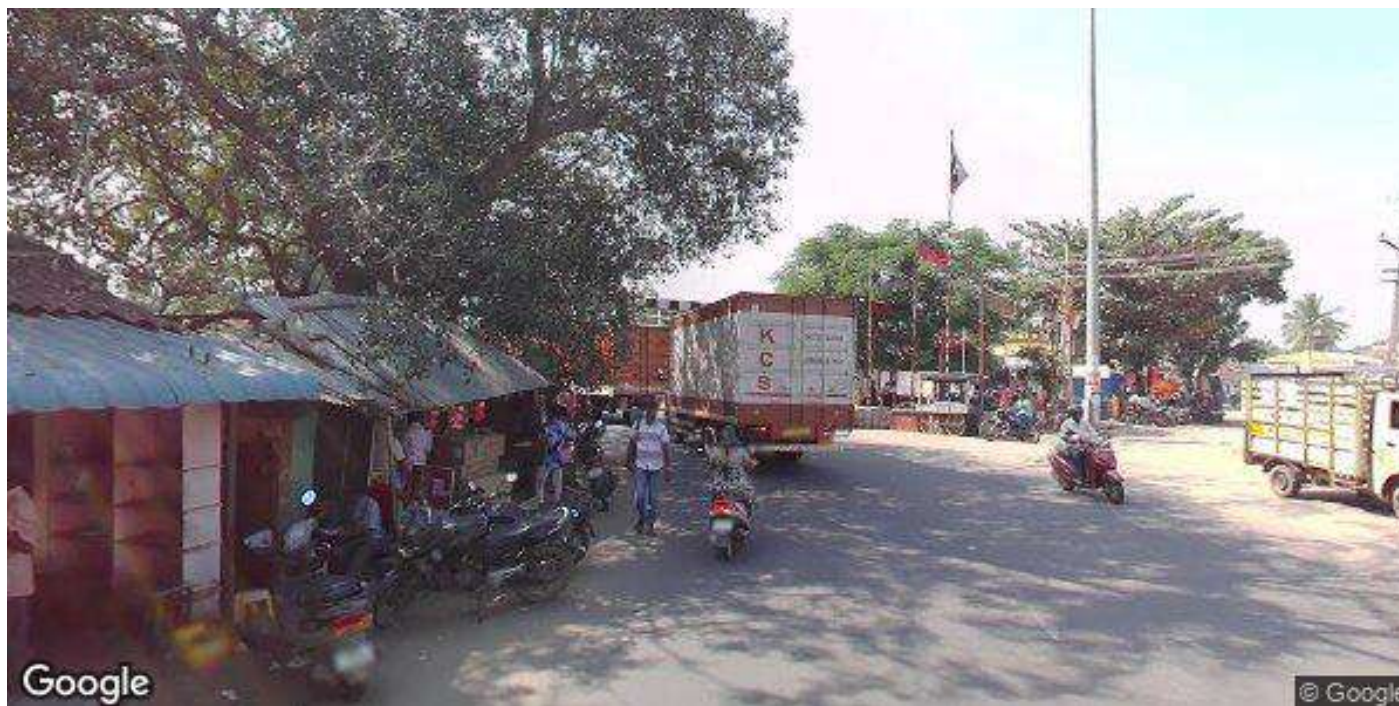
**Risk Type:** Turn  
**Risk Level:** Medium  
**Speed Limit:** 30 KM/Hr  
**Coordinates:** 11.67198, 78.23148

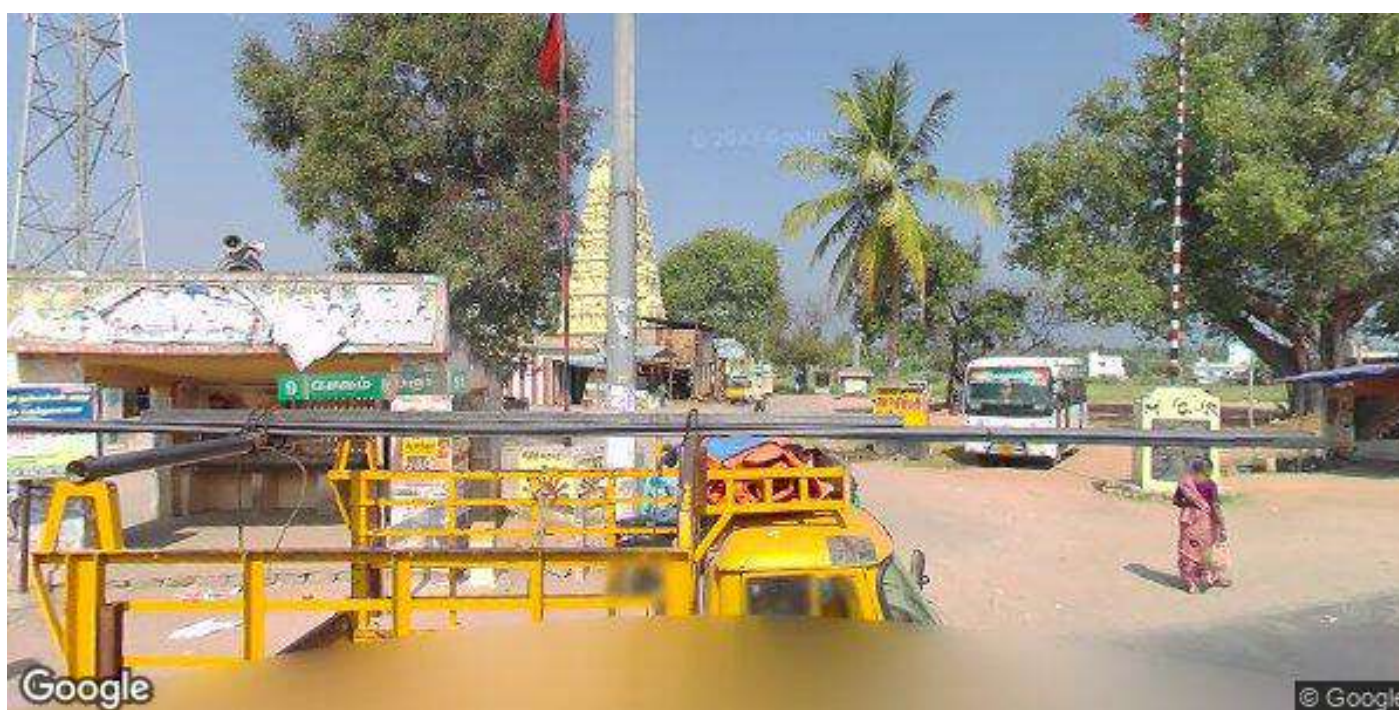
**Risk Type:** Turn  
**Risk Level:** Medium  
**Speed Limit:** 30 KM/Hr  
**Coordinates:** 11.67440, 78.23914

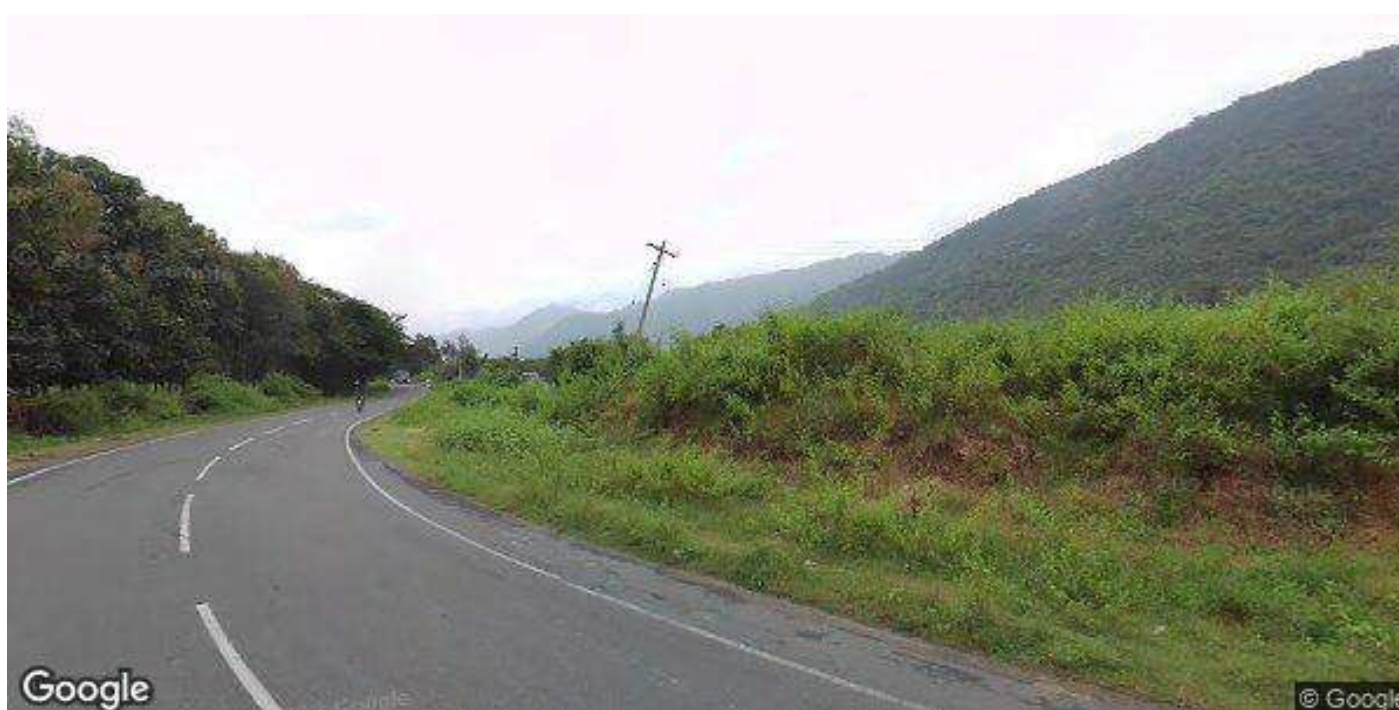
**Risk Type:** Turn  
**Risk Level:** Medium  
**Speed Limit:** 30 KM/Hr  
**Coordinates:** 11.80440, 78.33325

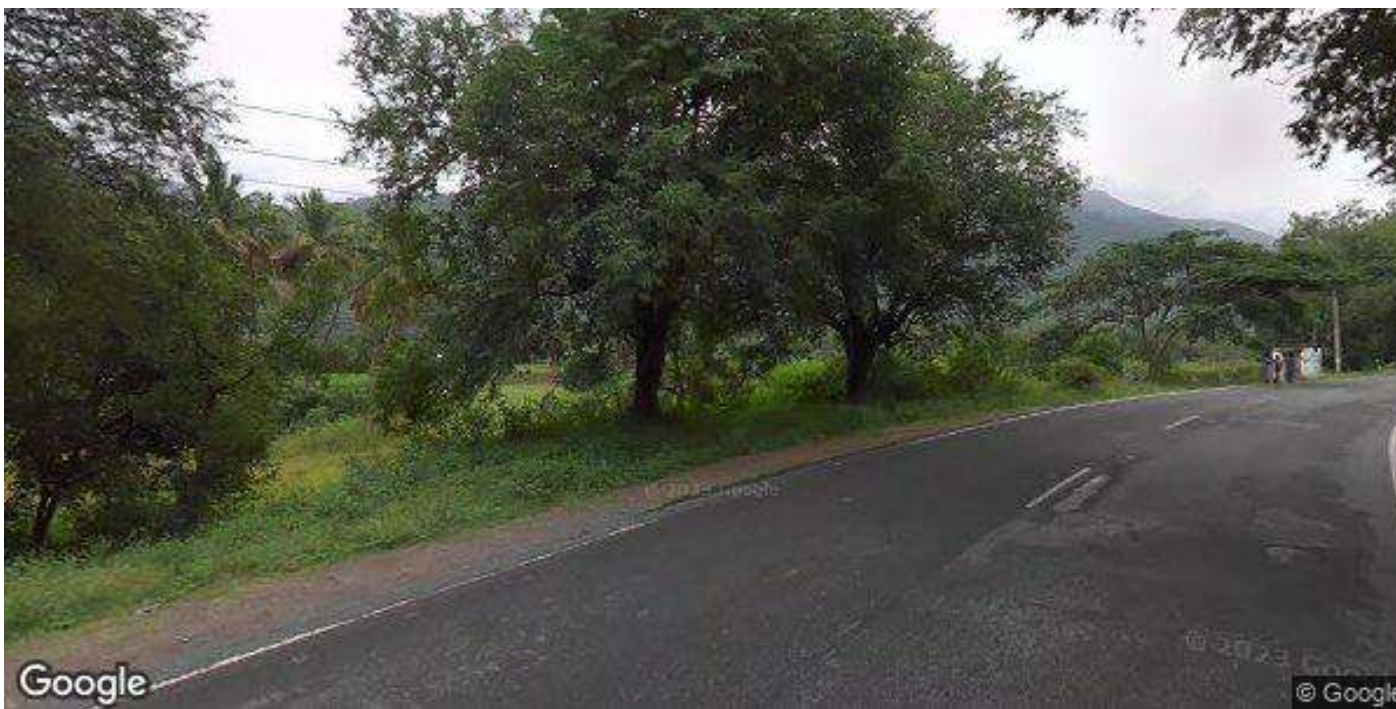
**Risk Type:** Turn  
**Risk Level:** Medium  
**Speed Limit:** 30 KM/Hr  
**Coordinates:** 11.81235, 78.34084

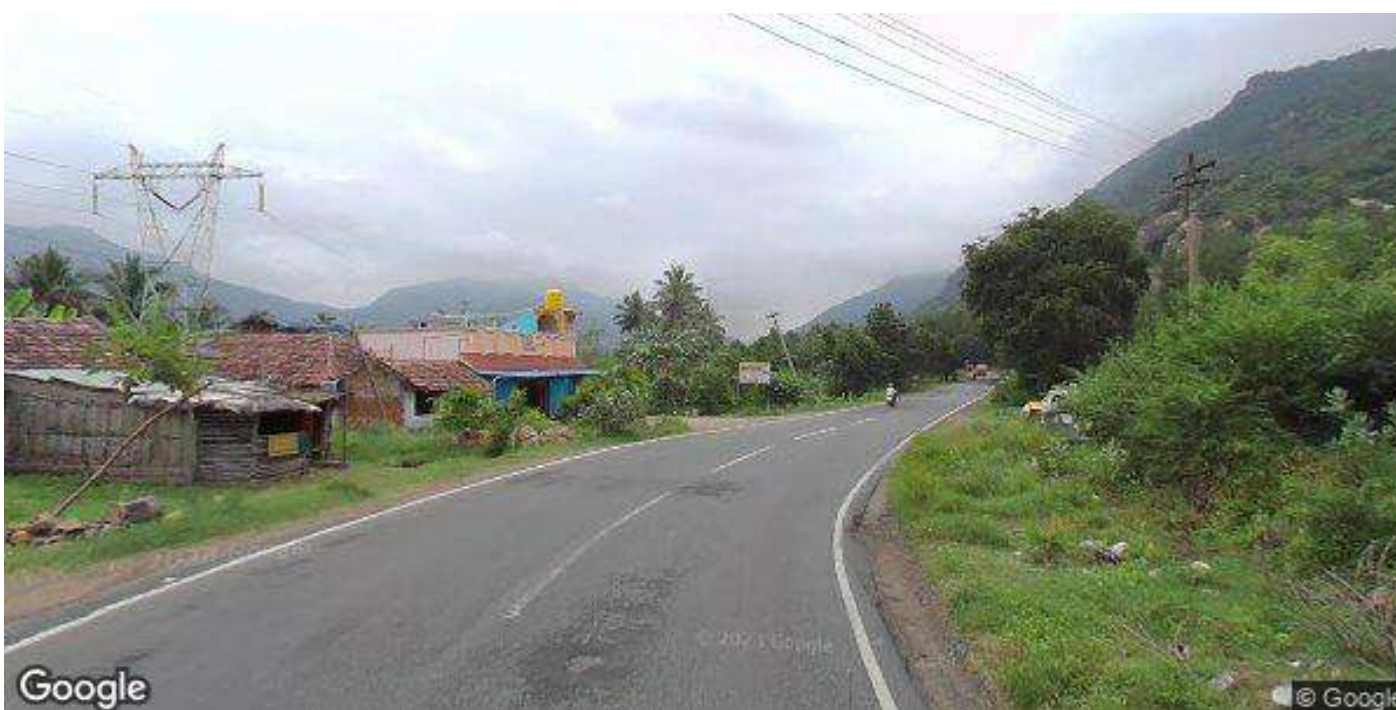
**Risk Type:** Turn  
**Risk Level:** Medium  
**Speed Limit:** 30 KM/Hr  
**Coordinates:** 11.83482, 78.35294

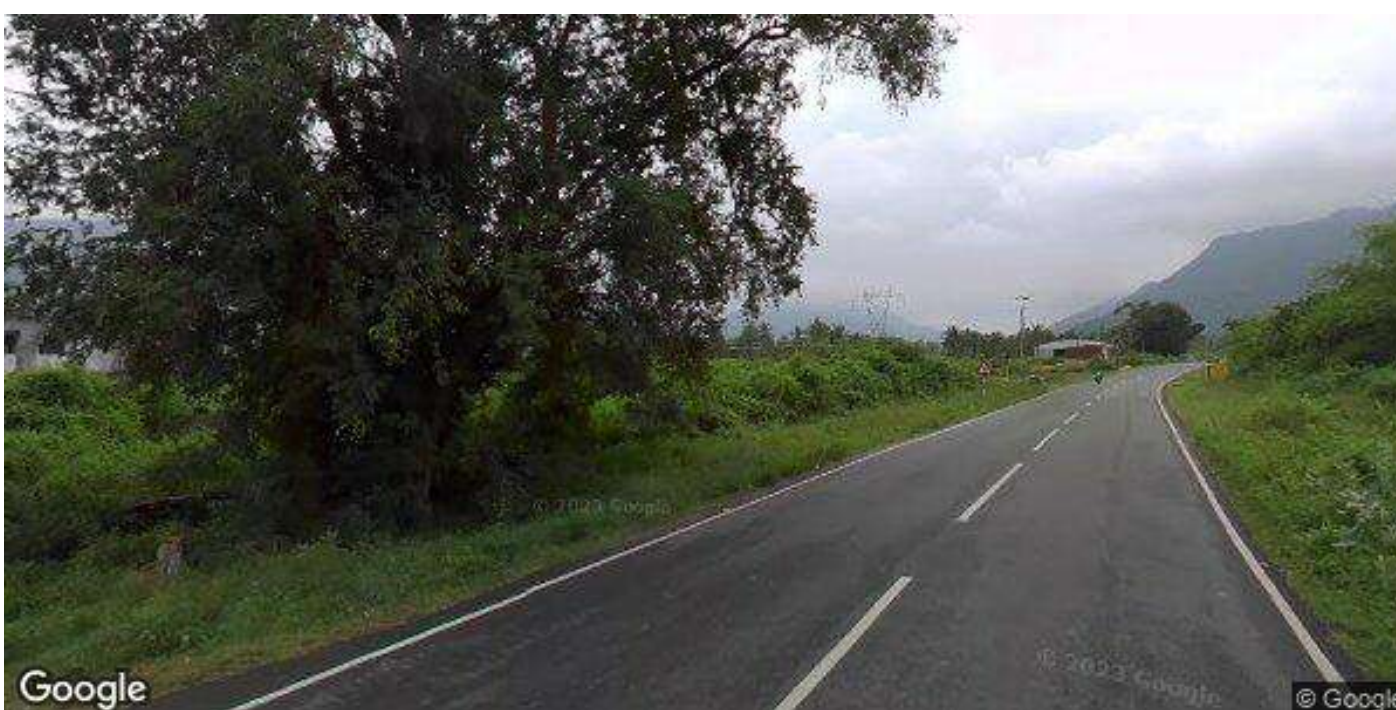
**Risk Type:** Turn  
**Risk Level:** Medium  
**Speed Limit:** 30 KM/Hr  
**Coordinates:** 11.84738, 78.36062

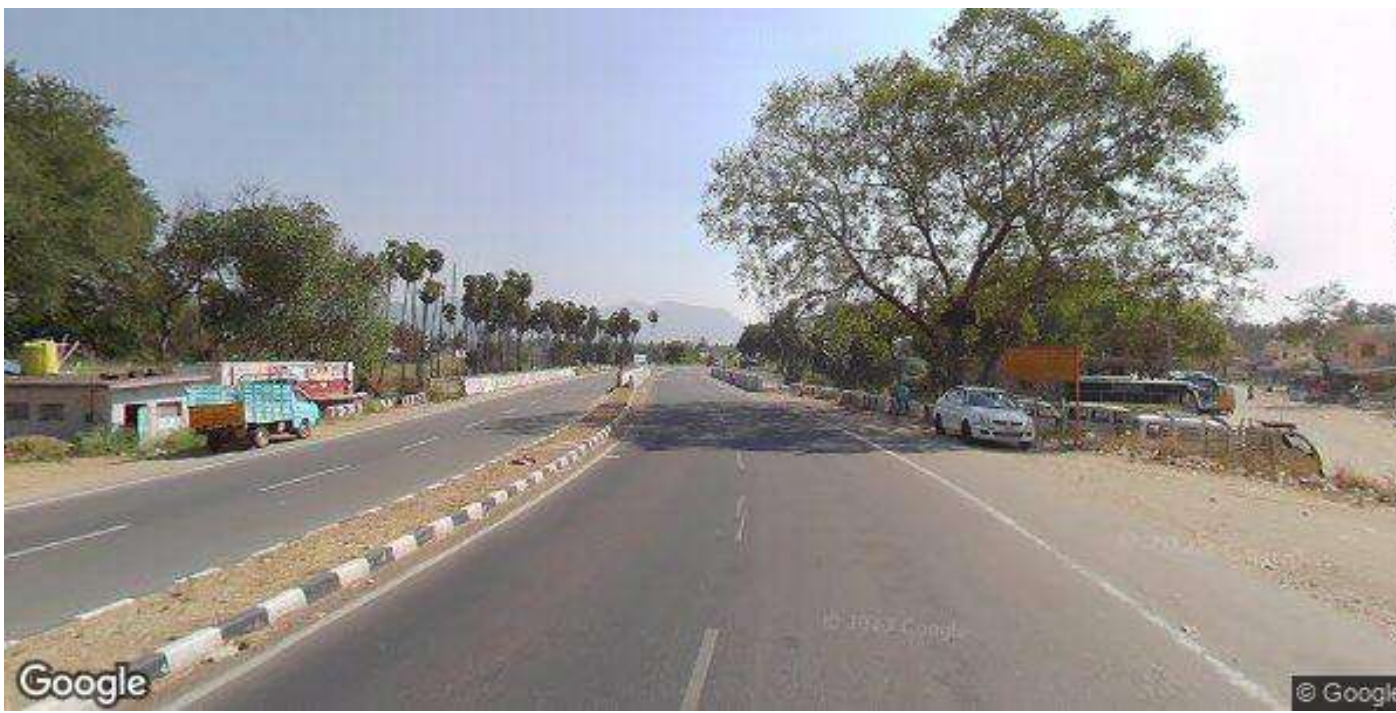
**Risk Type:** Turn  
**Risk Level:** Medium  
**Speed Limit:** 30 KM/Hr  
**Coordinates:** 11.99554, 78.44553

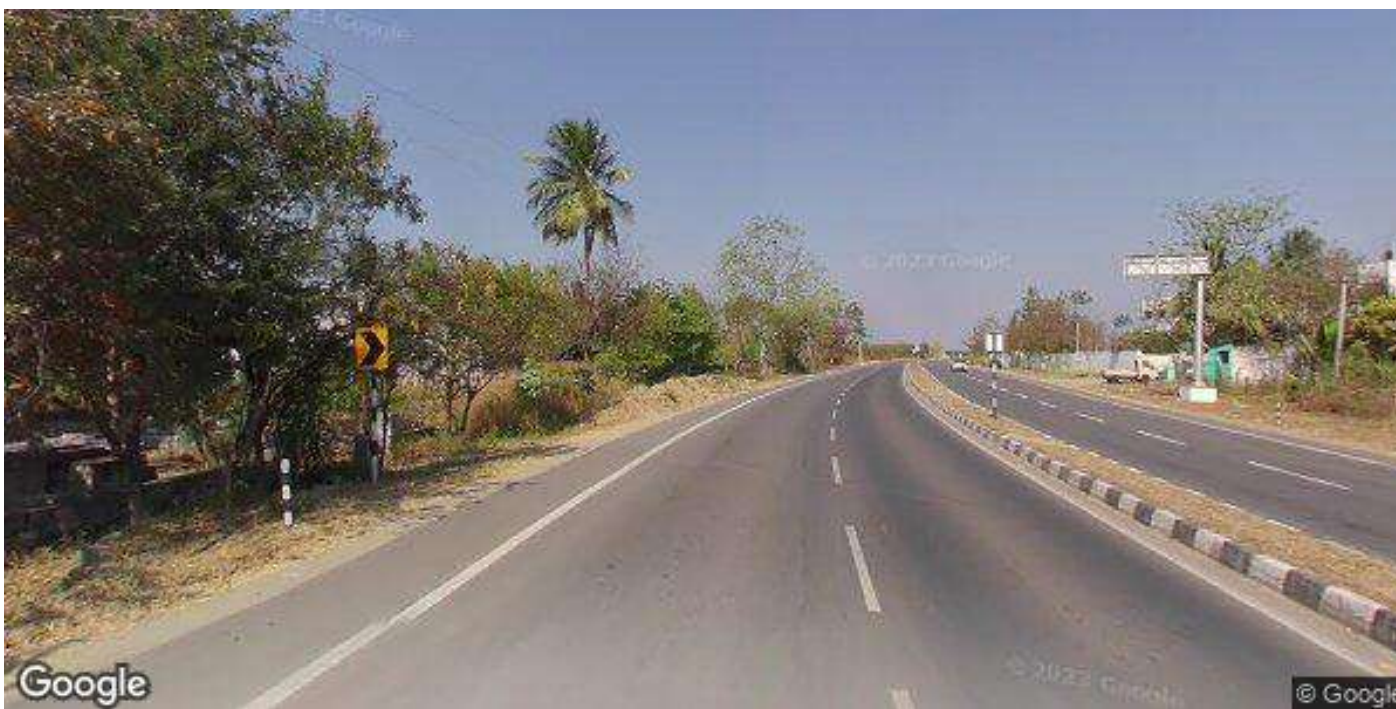
**Risk Type:** Turn  
**Risk Level:** Medium  
**Speed Limit:** 30 KM/Hr  
**Coordinates:** 12.01577, 78.45673

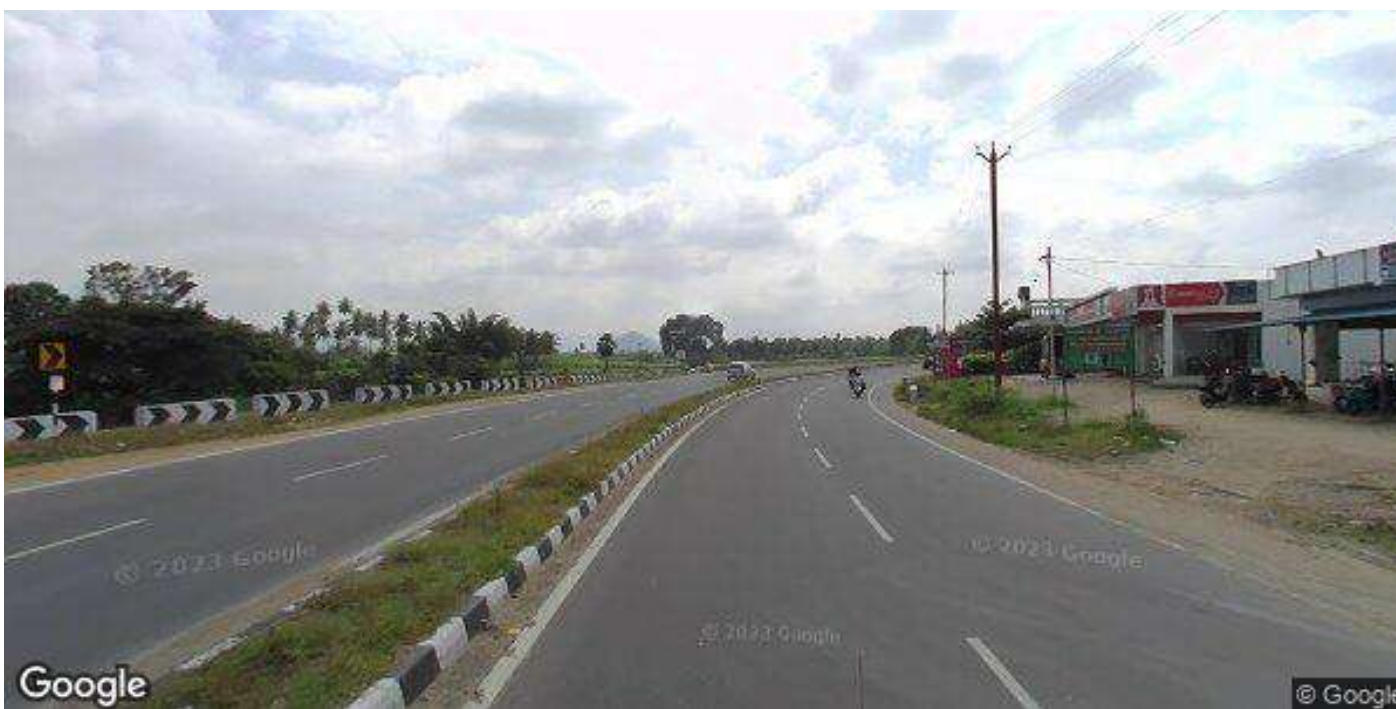
**Risk Type:** Turn  
**Risk Level:** Medium  
**Speed Limit:** 30 KM/Hr  
**Coordinates:** 12.04335, 78.48368

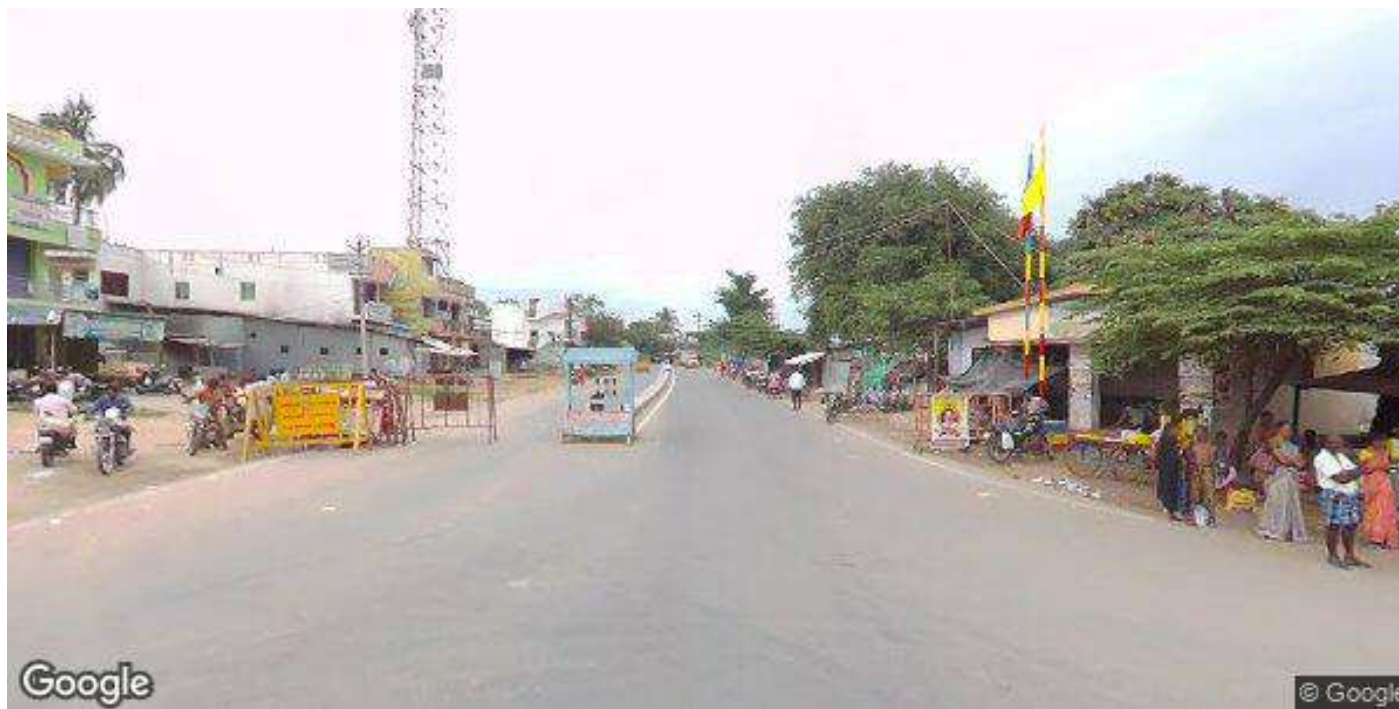
**Risk Type:** Blind Spot  
**Risk Level:** Blind Spot  
**Speed Limit:** 10 KM/Hr  
**Coordinates:** 12.04669, 78.48390

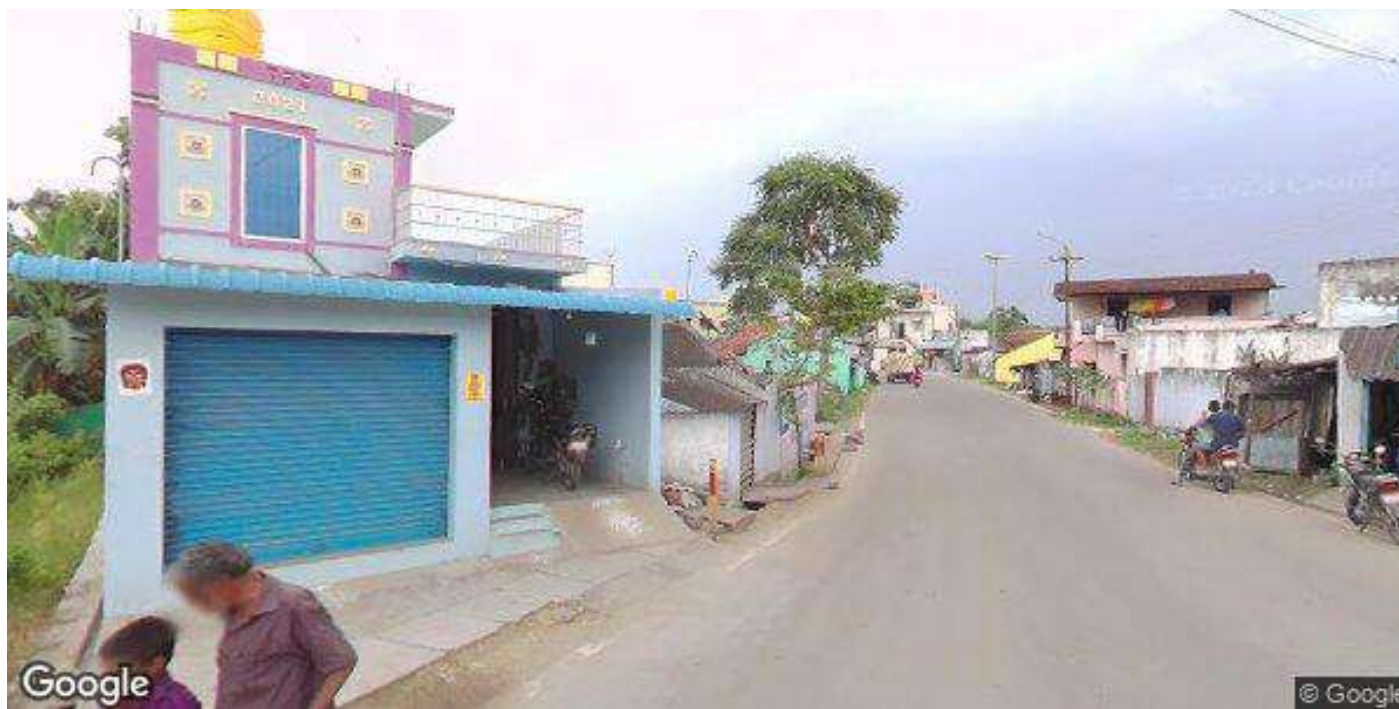
**Risk Type:** Turn  
**Risk Level:** Medium  
**Speed Limit:** 30 KM/Hr  
**Coordinates:** 12.04654, 78.48540

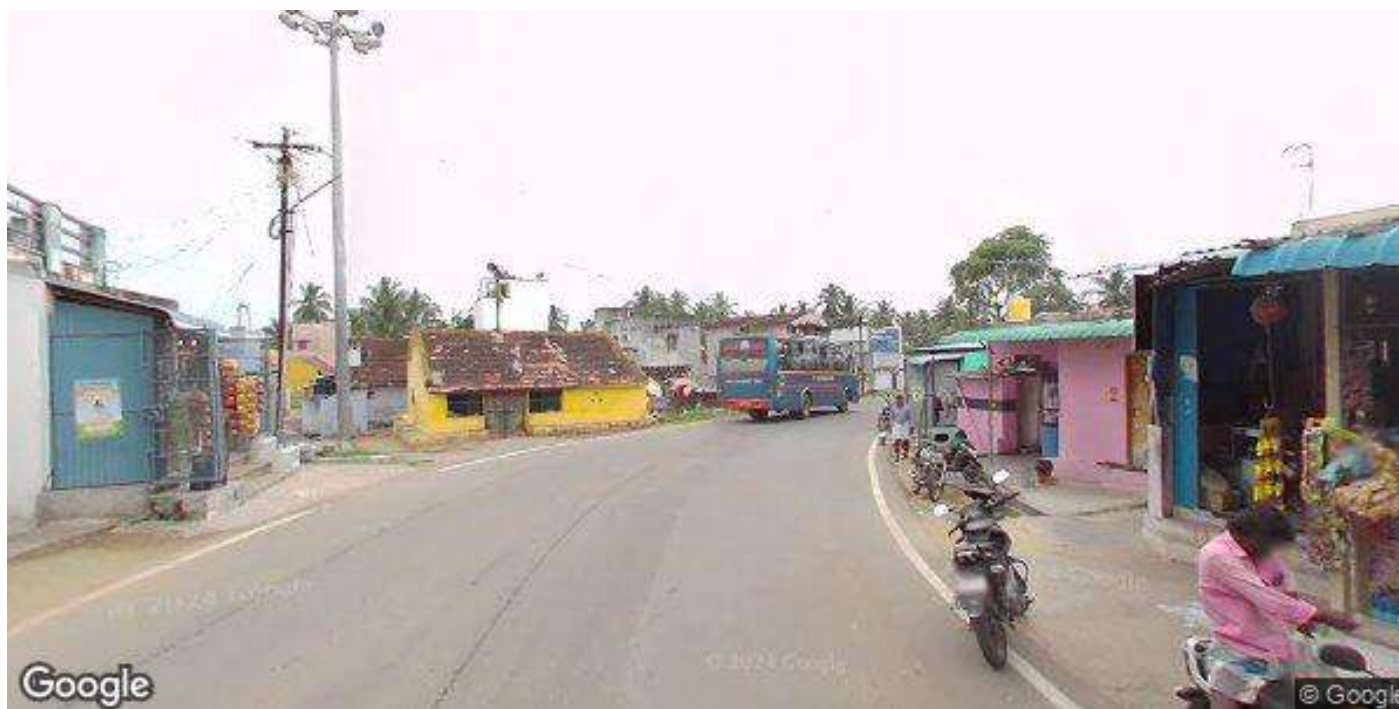
**Risk Type:** Turn  
**Risk Level:** Medium  
**Speed Limit:** 30 KM/Hr  
**Coordinates:** 12.04700, 78.48599

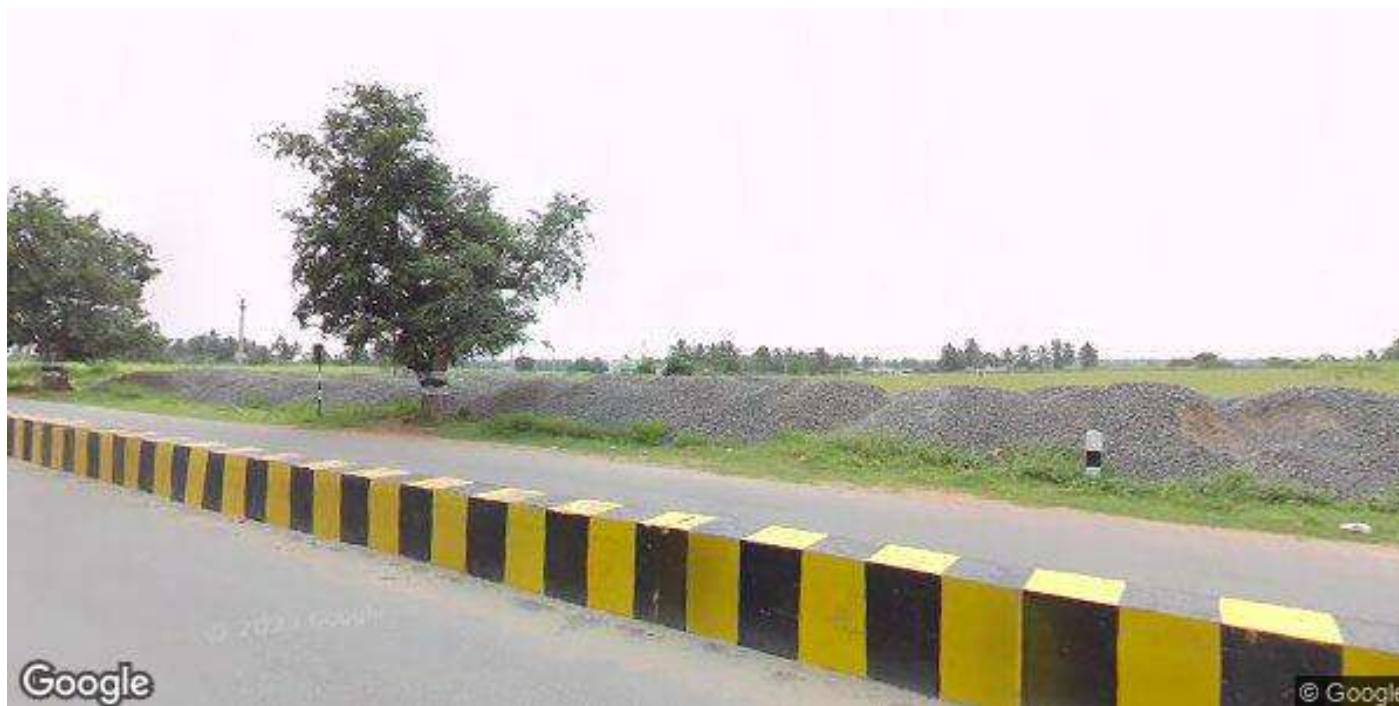
**Risk Type:** Turn  
**Risk Level:** Medium  
**Speed Limit:** 30 KM/Hr  
**Coordinates:** 12.07921, 78.50963

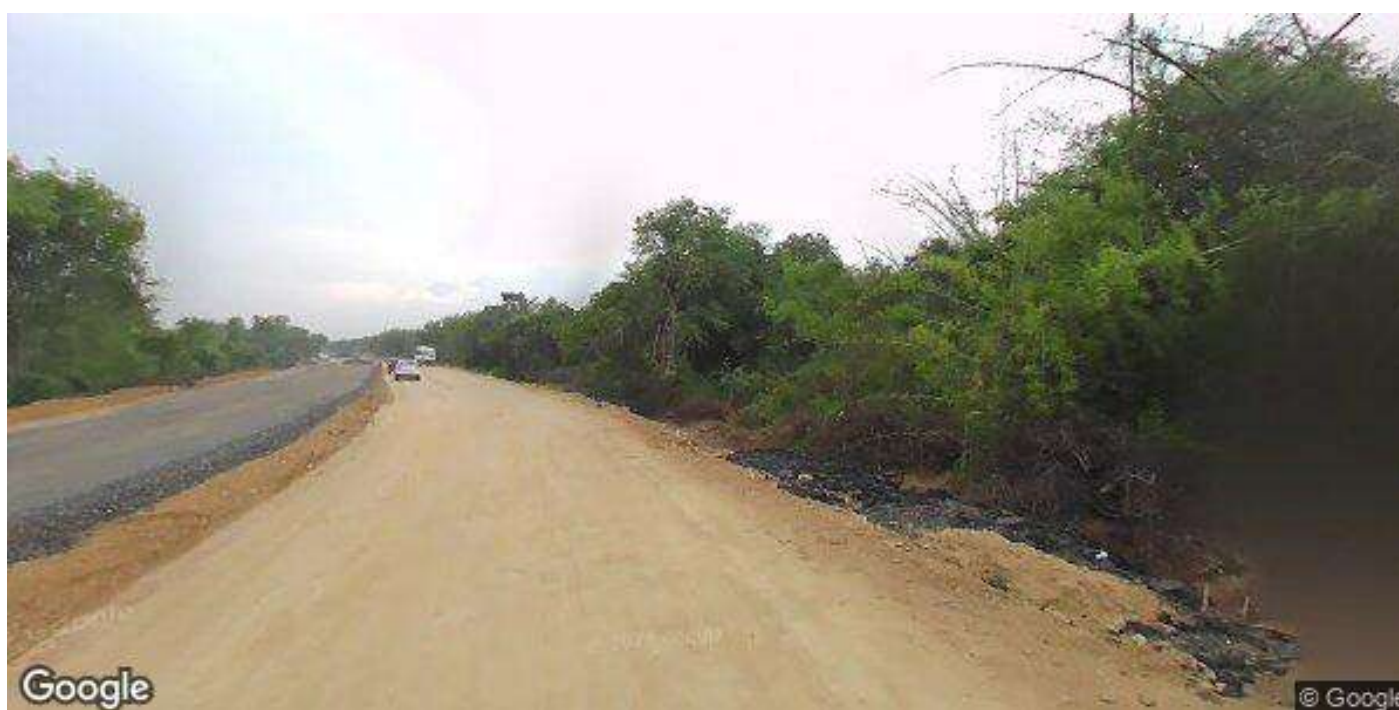
**Risk Type:** Turn  
**Risk Level:** Medium  
**Speed Limit:** 30 KM/Hr  
**Coordinates:** 12.10411, 78.55184

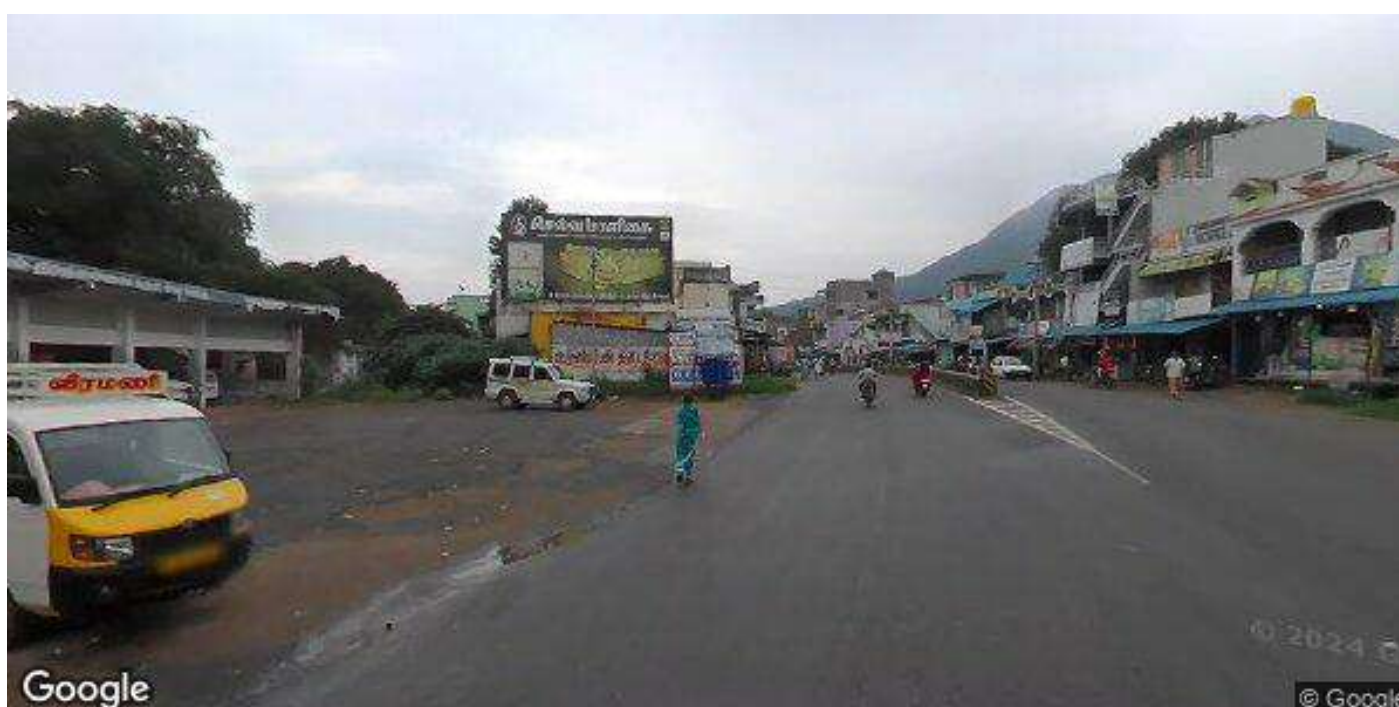
**Risk Type:** Turn  
**Risk Level:** High  
**Speed Limit:** 15 KM/Hr  
**Coordinates:** 12.10251, 78.58906
