# IndianOil

## JOURNEY RISK MANAGEMENT (JRM) STUDY

### Salem Terminal TO EDCCWS ERODE RING ROAD

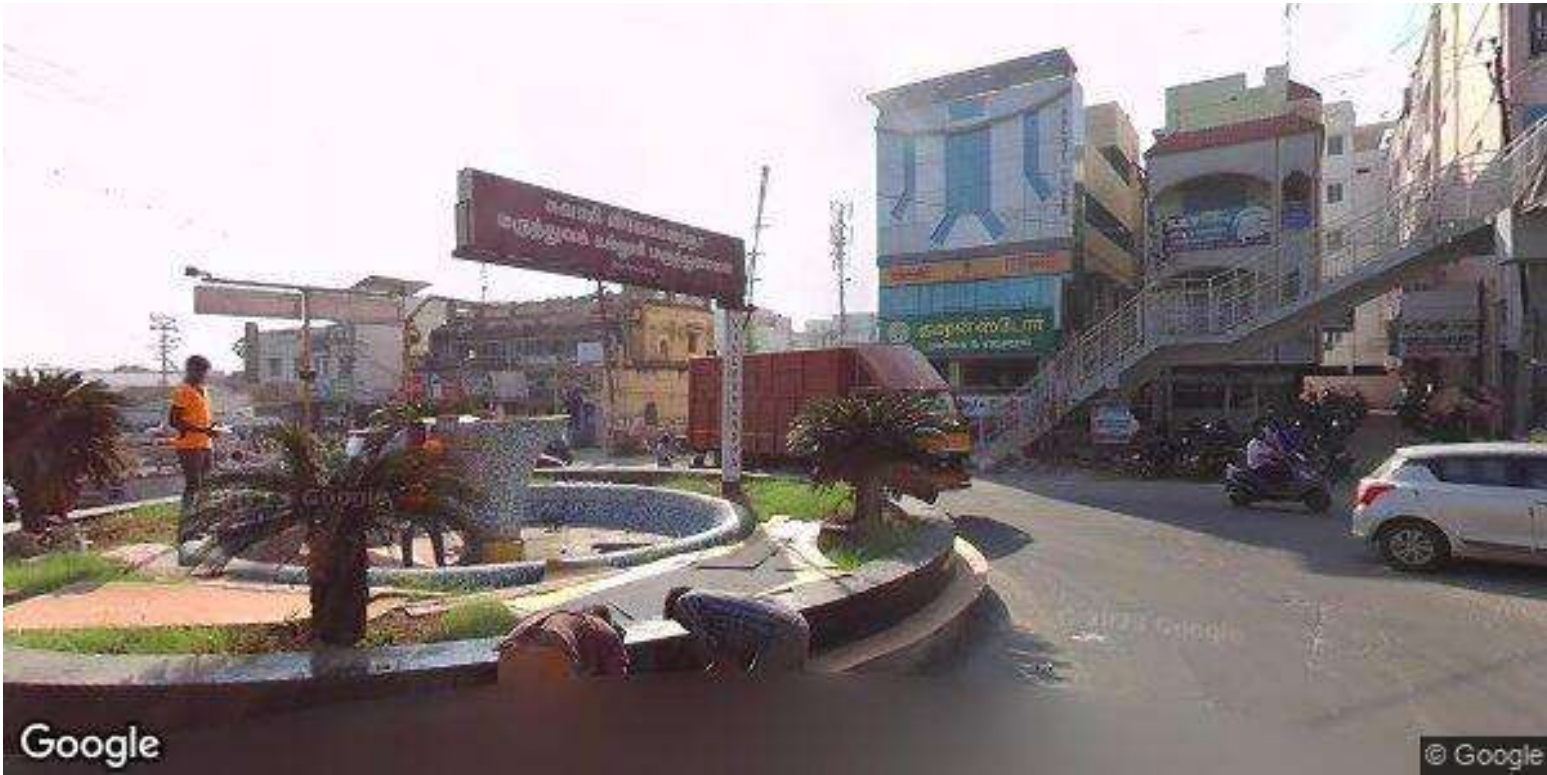
Coordinates: 11.38395, 77.89480

Risk Type: Roundabout

Risk Level: High

Speed Limit: 15 KM/Hr

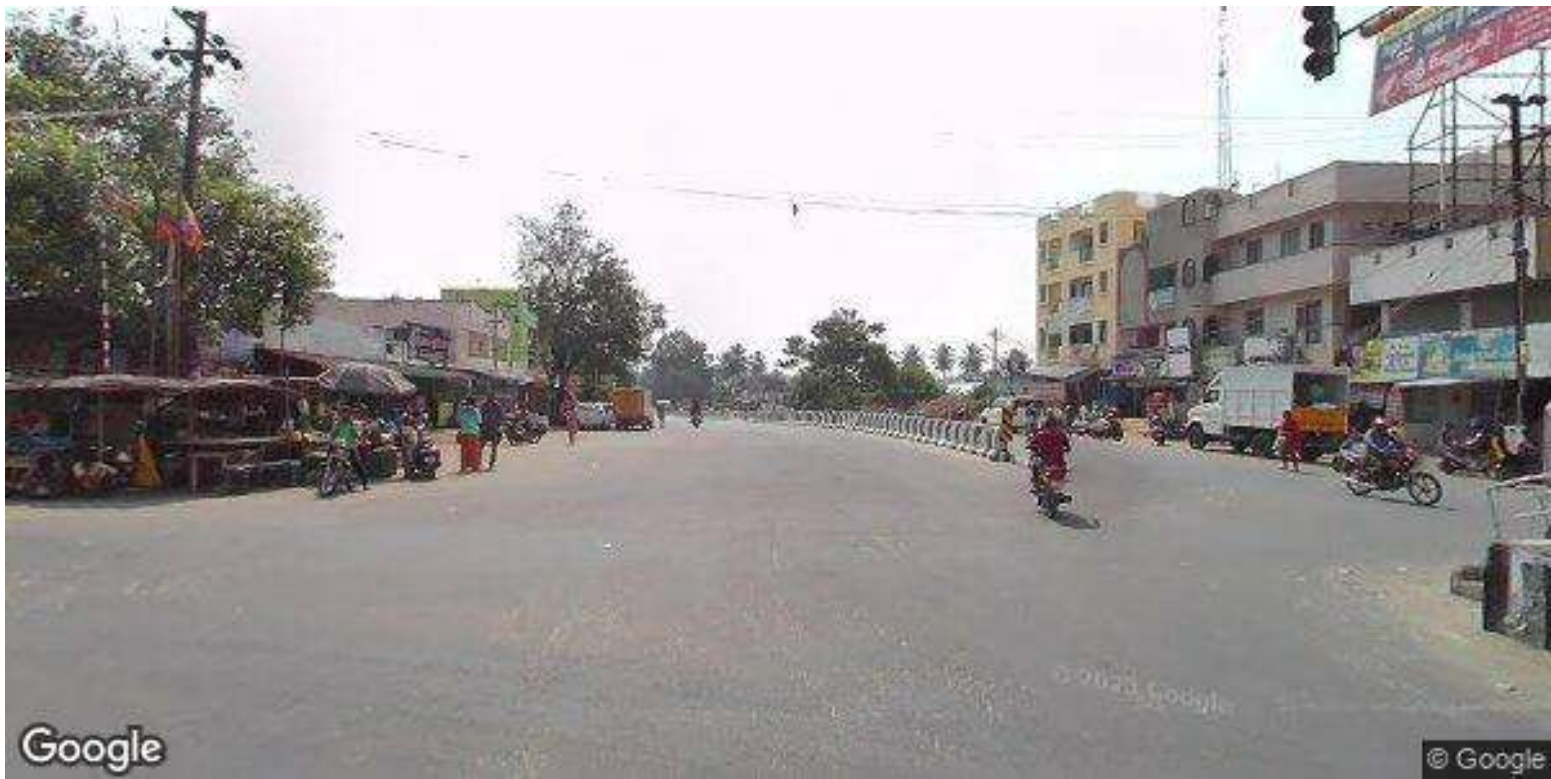
**Risk Type:** Turn  
**Risk Level:** High  
**Speed Limit:** 15 KM/Hr  
**Coordinates:** 11.36604, 77.88887

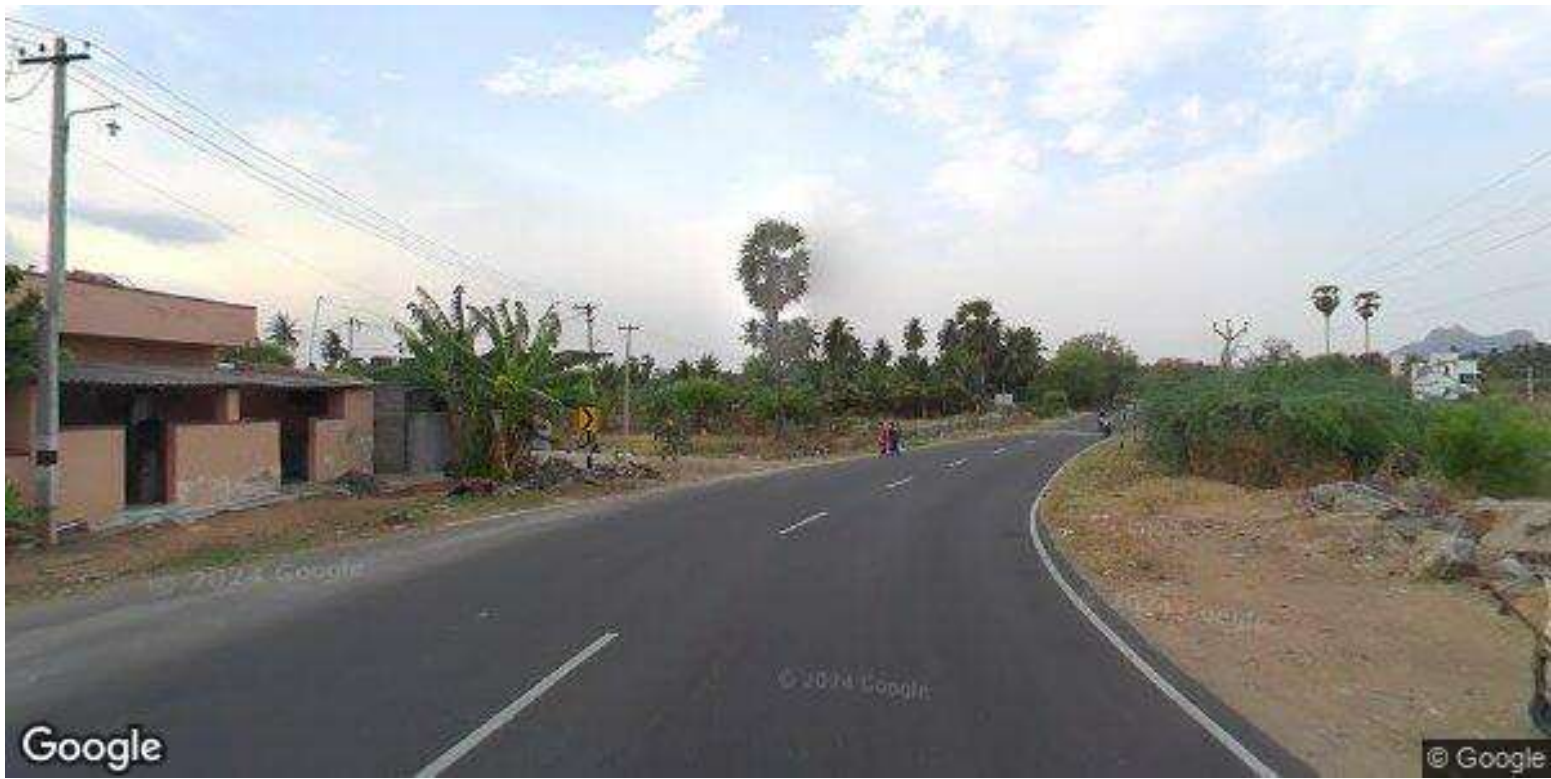
**Risk Type:** Turn  
**Risk Level:** Medium  
**Speed Limit:** 30 KM/Hr  
**Coordinates:** 11.33882, 77.86218
