# IndianOil

## JOURNEY RISK MANAGEMENT (JRM) STUDY

### Salem Terminal to AEGAN PETRO FILLS

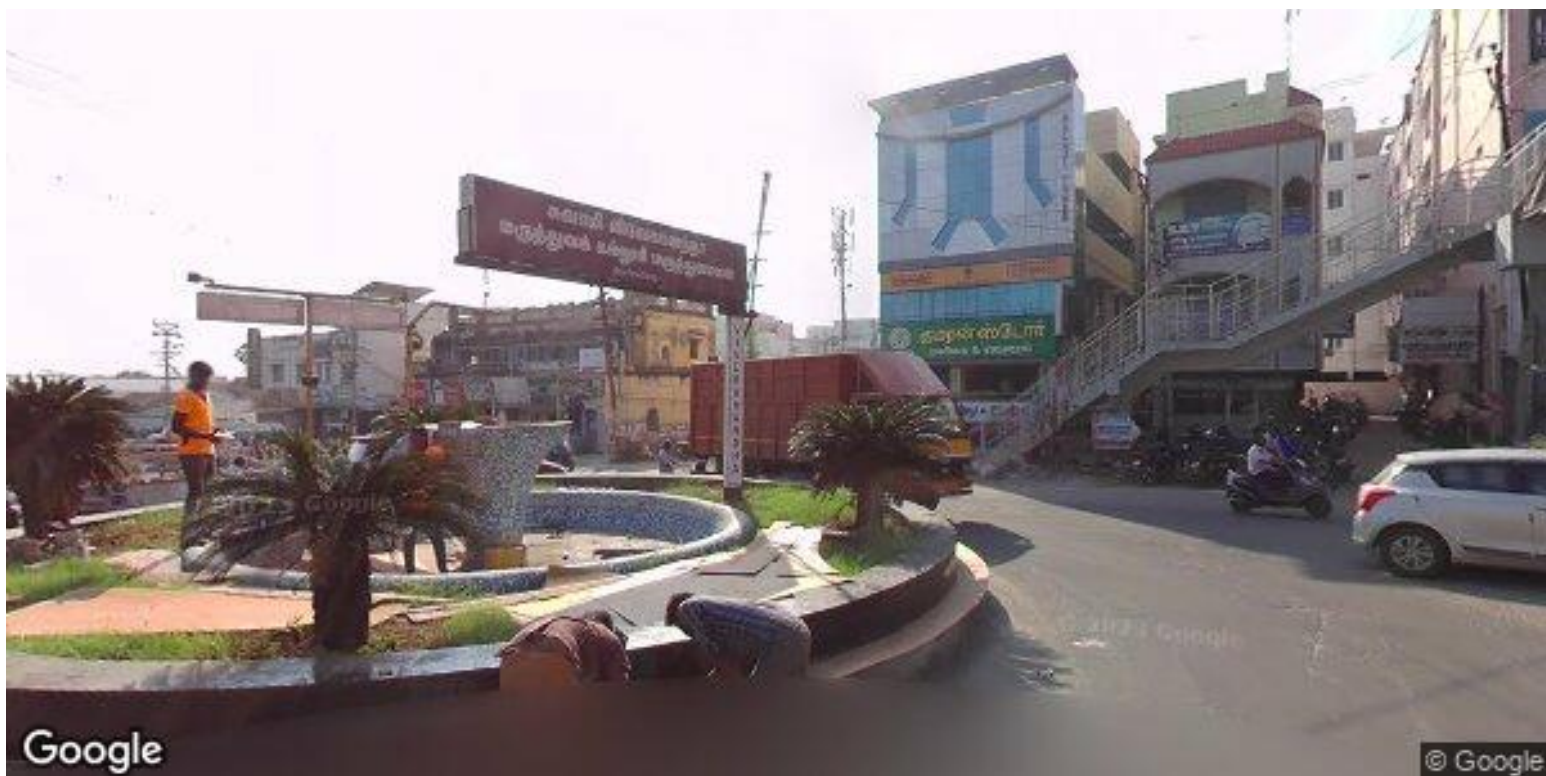
**Risk Type:** Roundabout

**Risk Level:** High

**Speed Limit: 15 KM/Hr**  
**Coordinates: 11.38395, 77.89480**

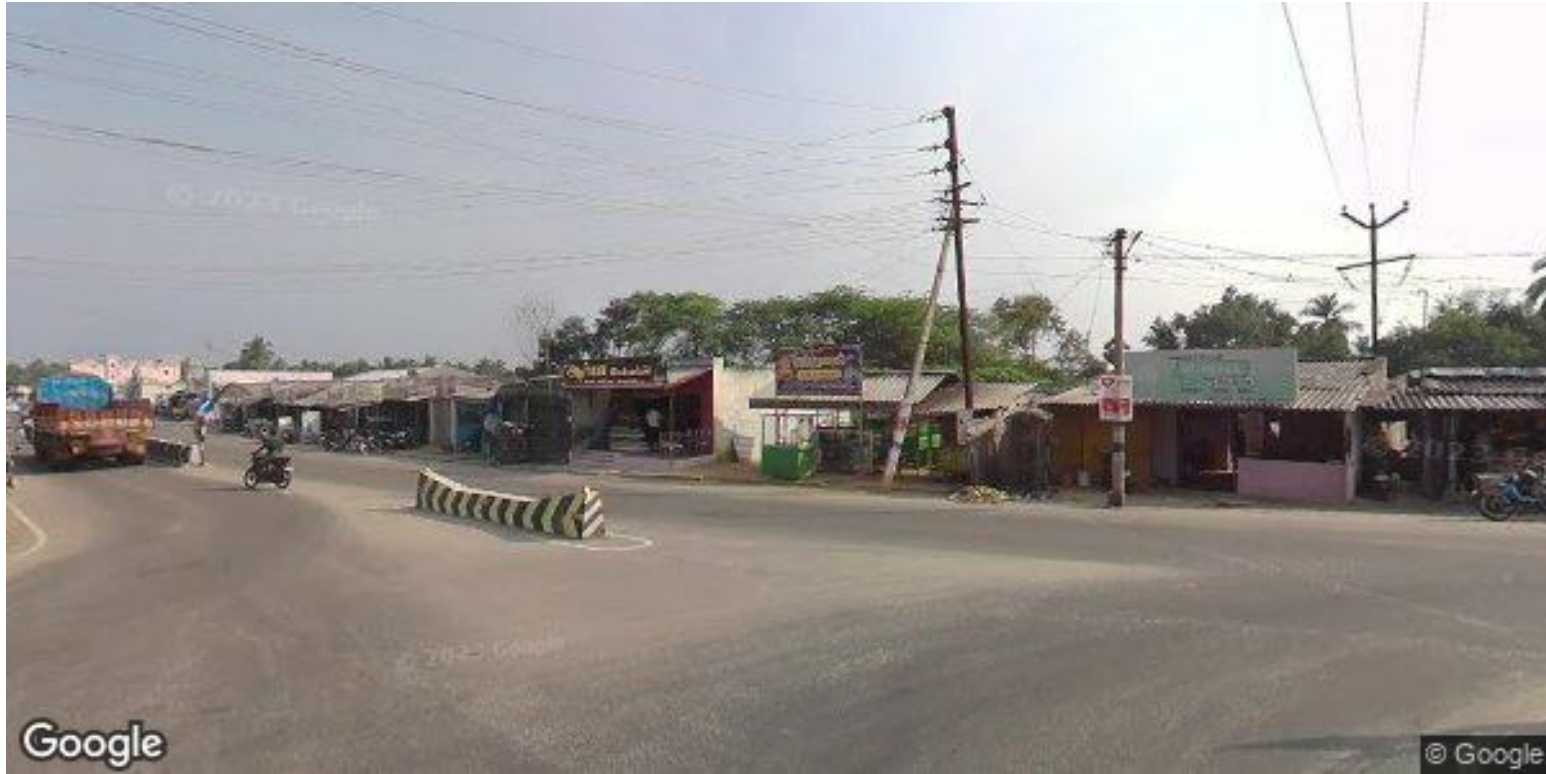
**Risk Type: Roundabout**  
**Risk Level: High**  
**Speed Limit: 15 KM/Hr**  
**Coordinates: 11.04637, 77.73761**

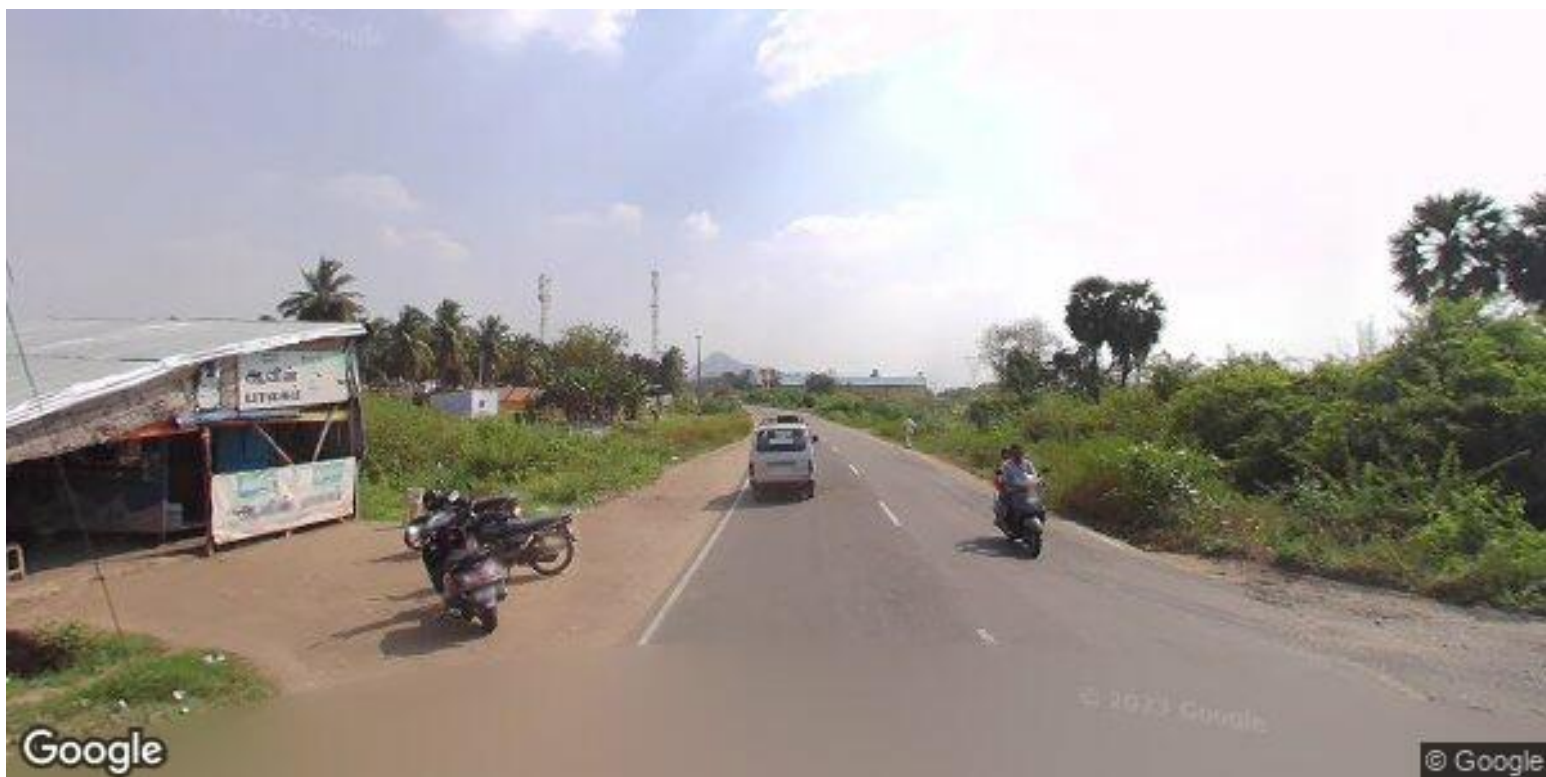
**Risk Type: Turn**  
**Risk Level: High**  
**Speed Limit: 15 KM/Hr**  
**Coordinates: 11.44022, 77.87546**

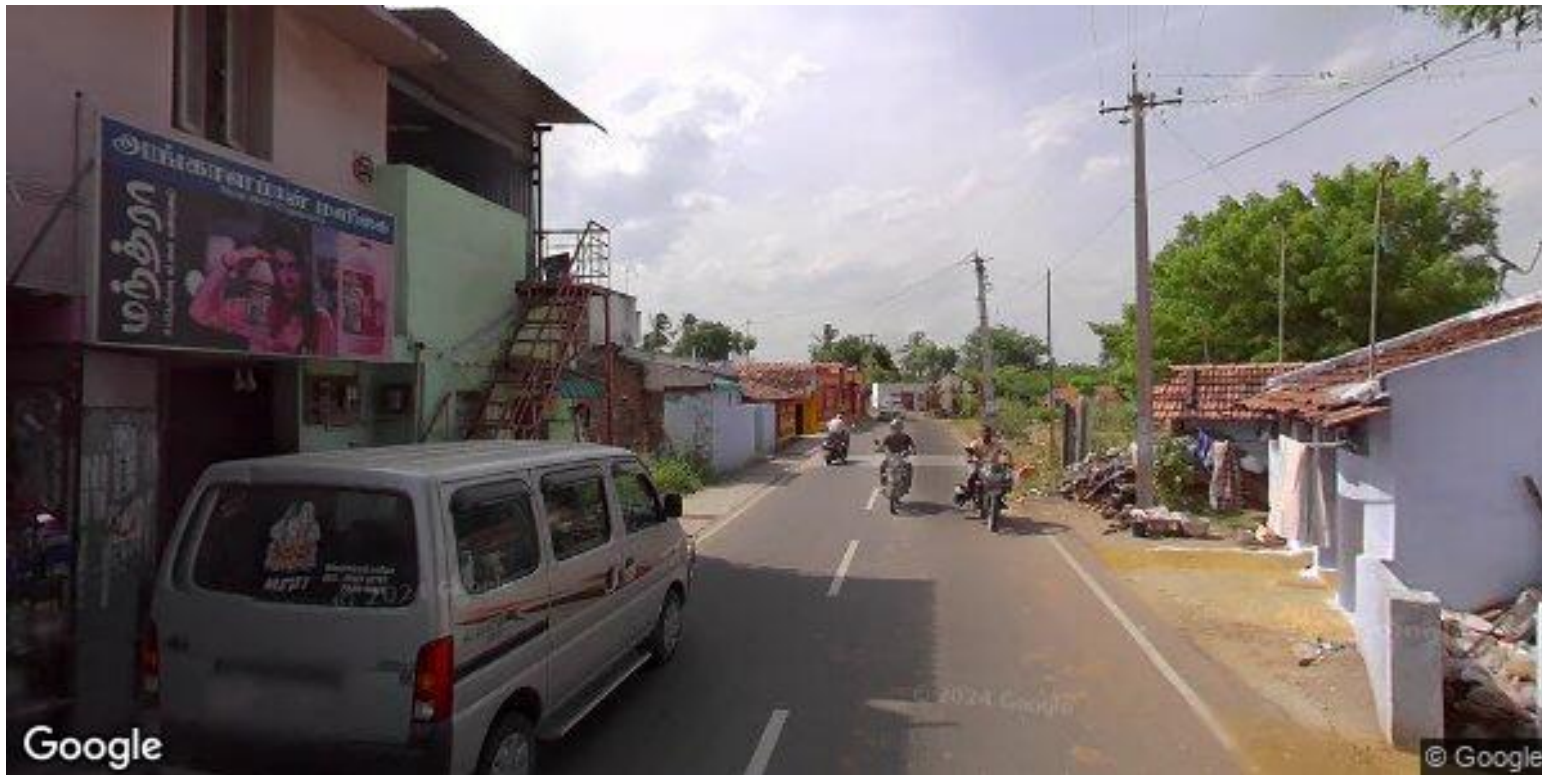
**Risk Type:** Turn

**Risk Level:** High

**Speed Limit:** 15 KM/Hr

**Coordinates:** 11.24170, 77.86842

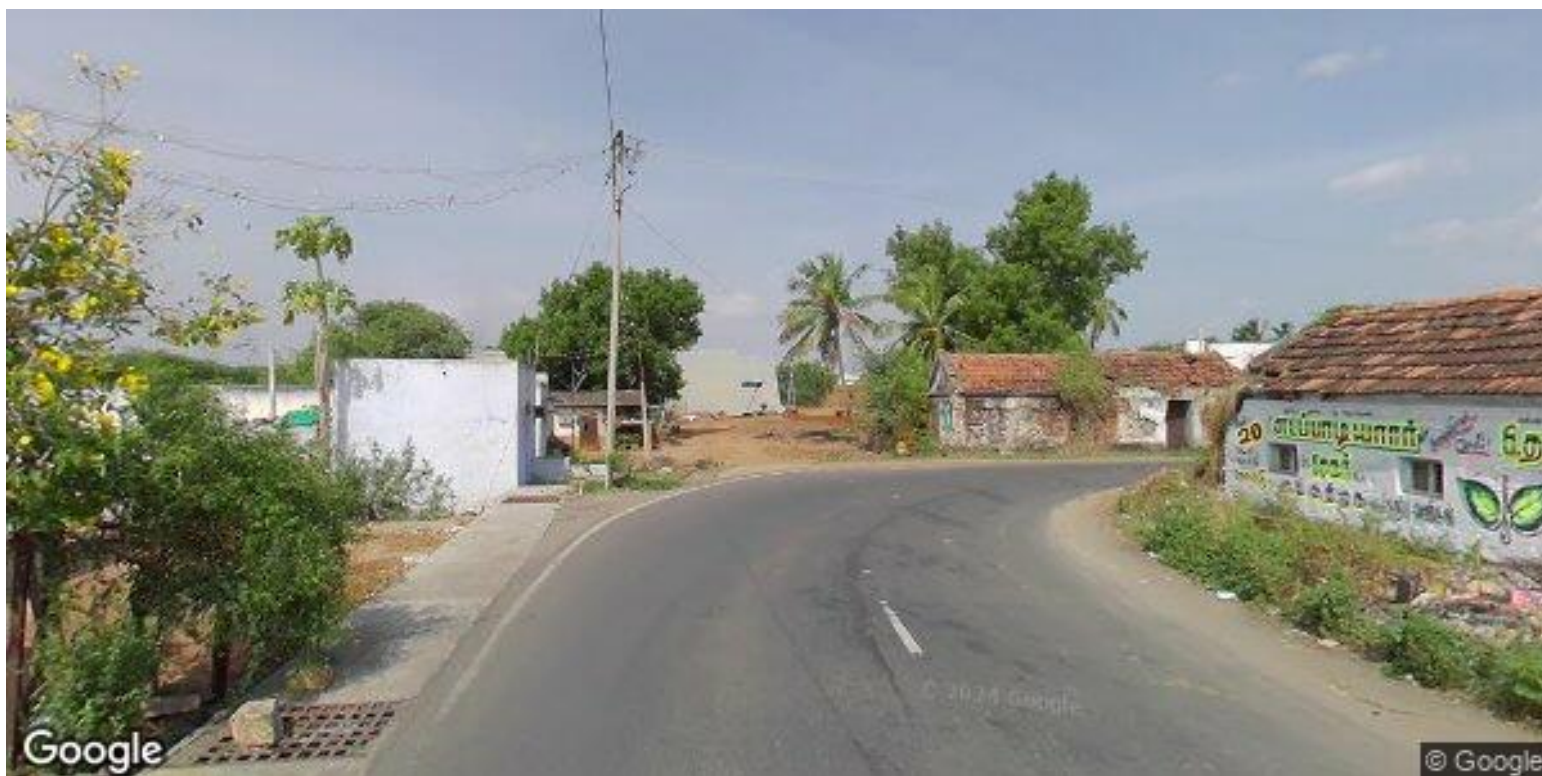
**Risk Type:** Turn

**Risk Level:** High

**Speed Limit:** 15 KM/Hr

**Coordinates:** 11.24248, 77.86829

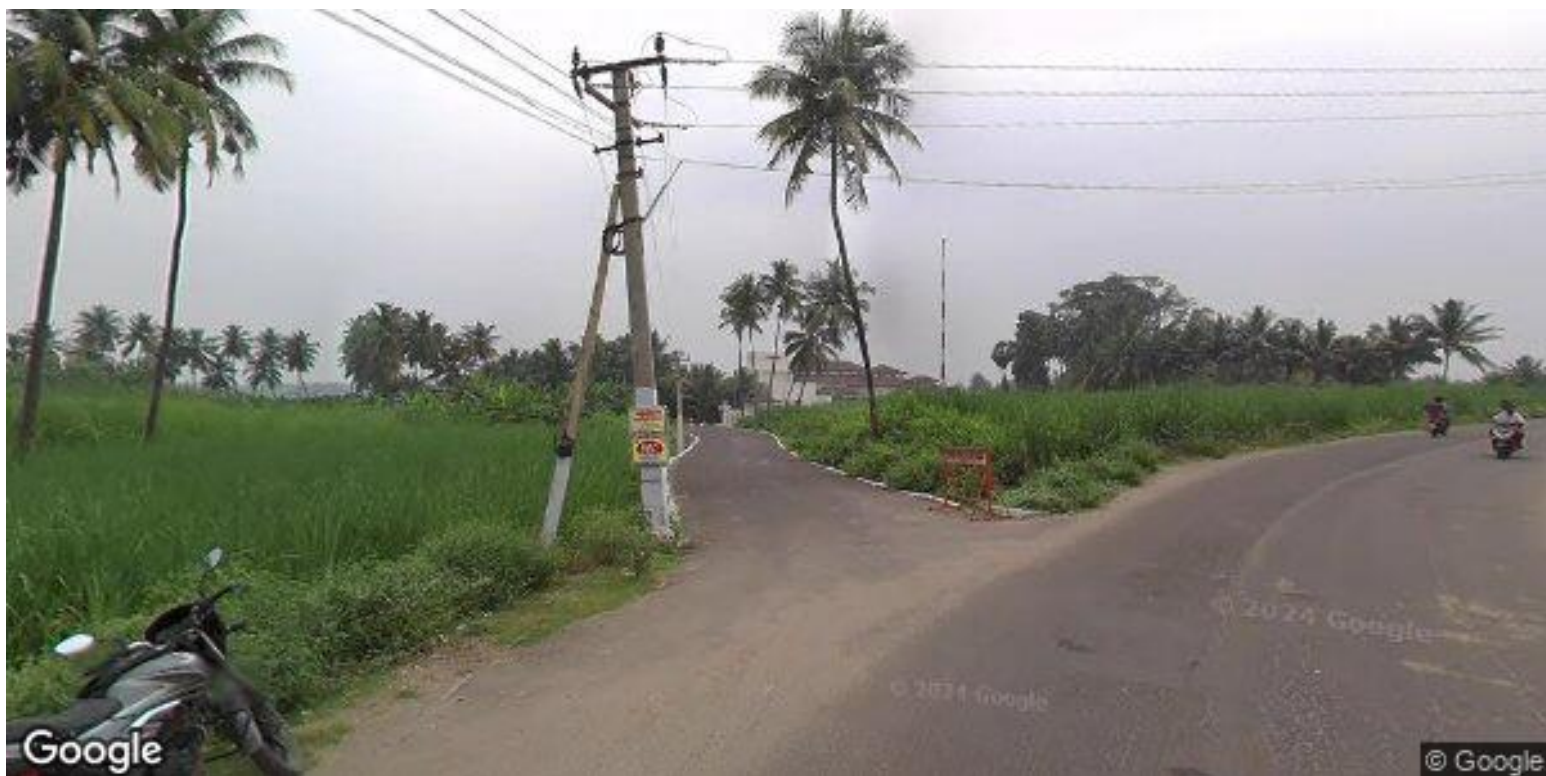
**Risk Type:** Turn  
**Risk Level:** Medium  
**Speed Limit:** 30 KM/Hr  
**Coordinates:** 11.24197, 77.85905

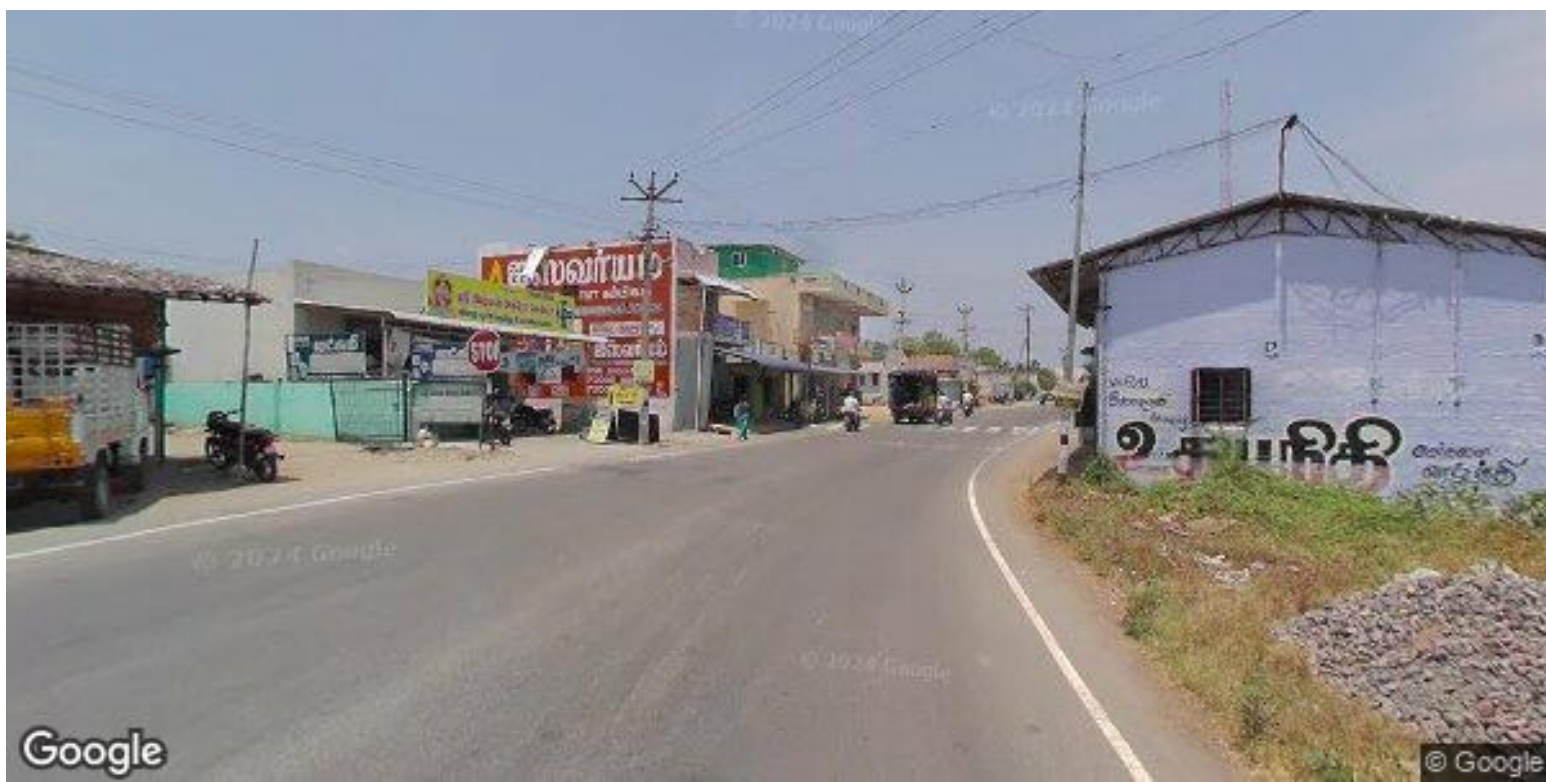
**Risk Type:** Turn

**Risk Level:** Medium

**Speed Limit:** 30 KM/Hr

**Coordinates:** 11.04718, 77.73742

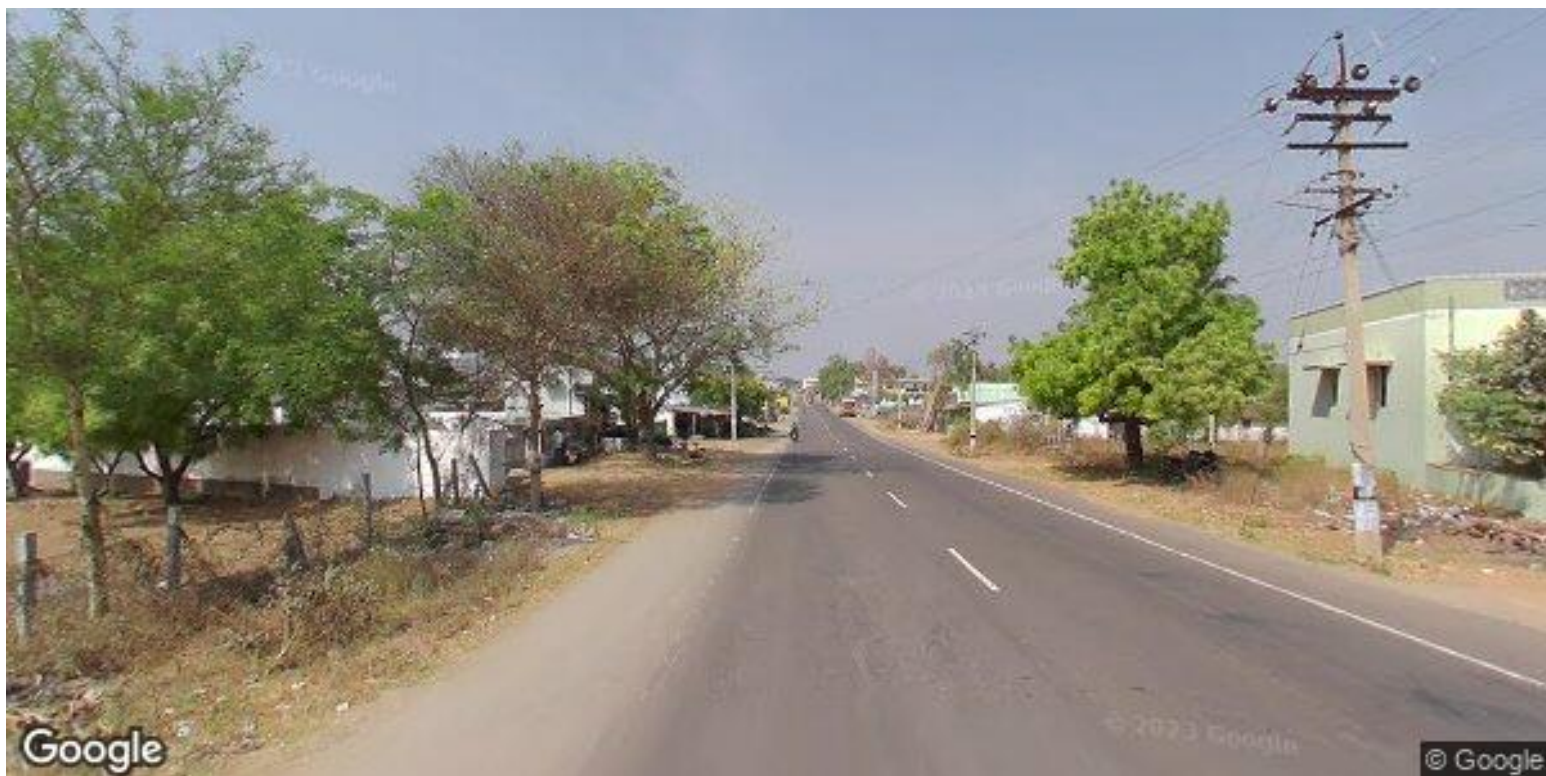
**Risk Type:** Turn

**Risk Level:** High

**Speed Limit:** 15 KM/Hr

**Coordinates:** 11.04826, 77.74469

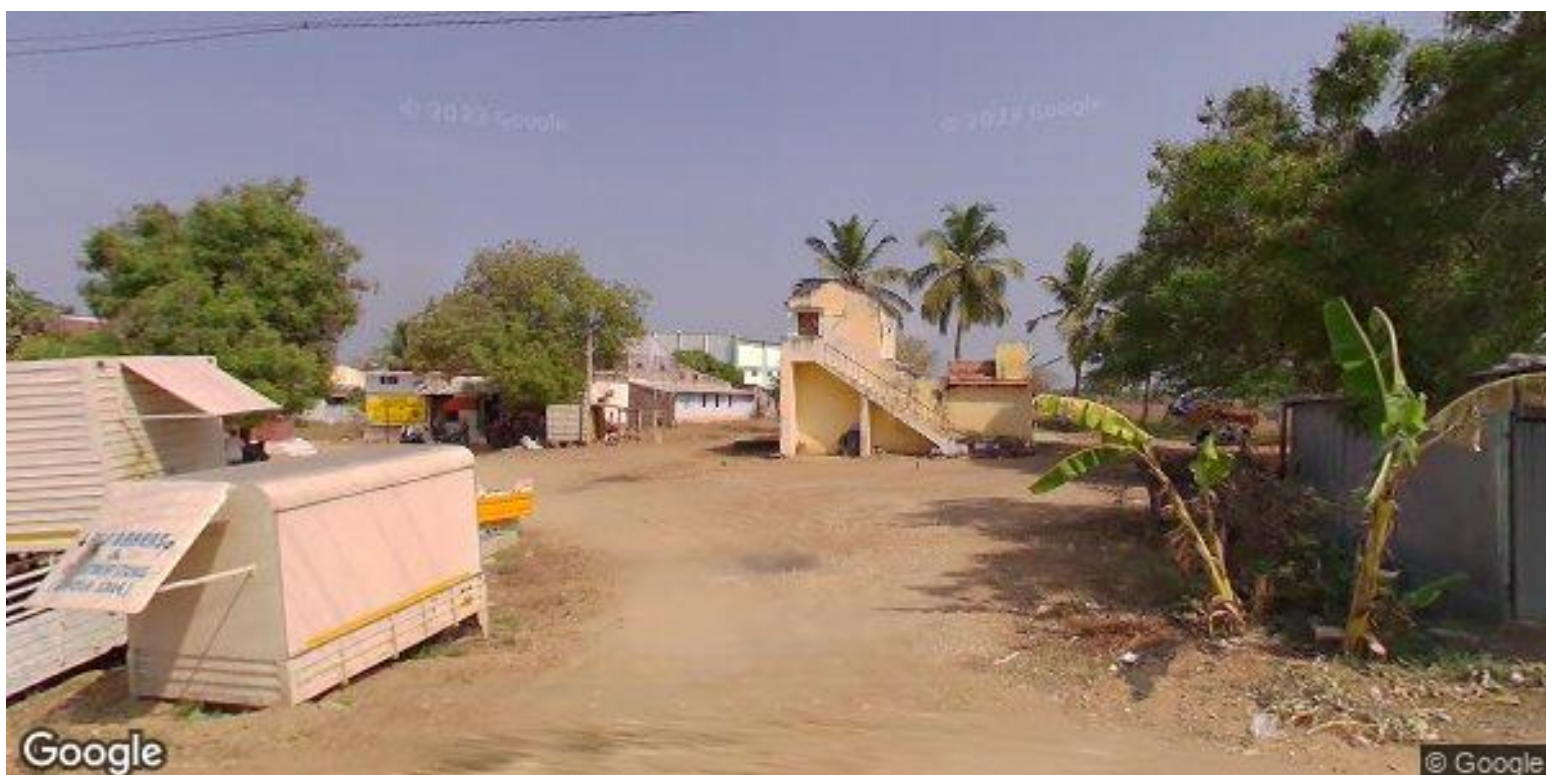
**Risk Type:** Blind Spot  
**Risk Level:** Blind Spot  
**Speed Limit:** 10 KM/Hr  
**Coordinates:** 11.04848, 77.74469

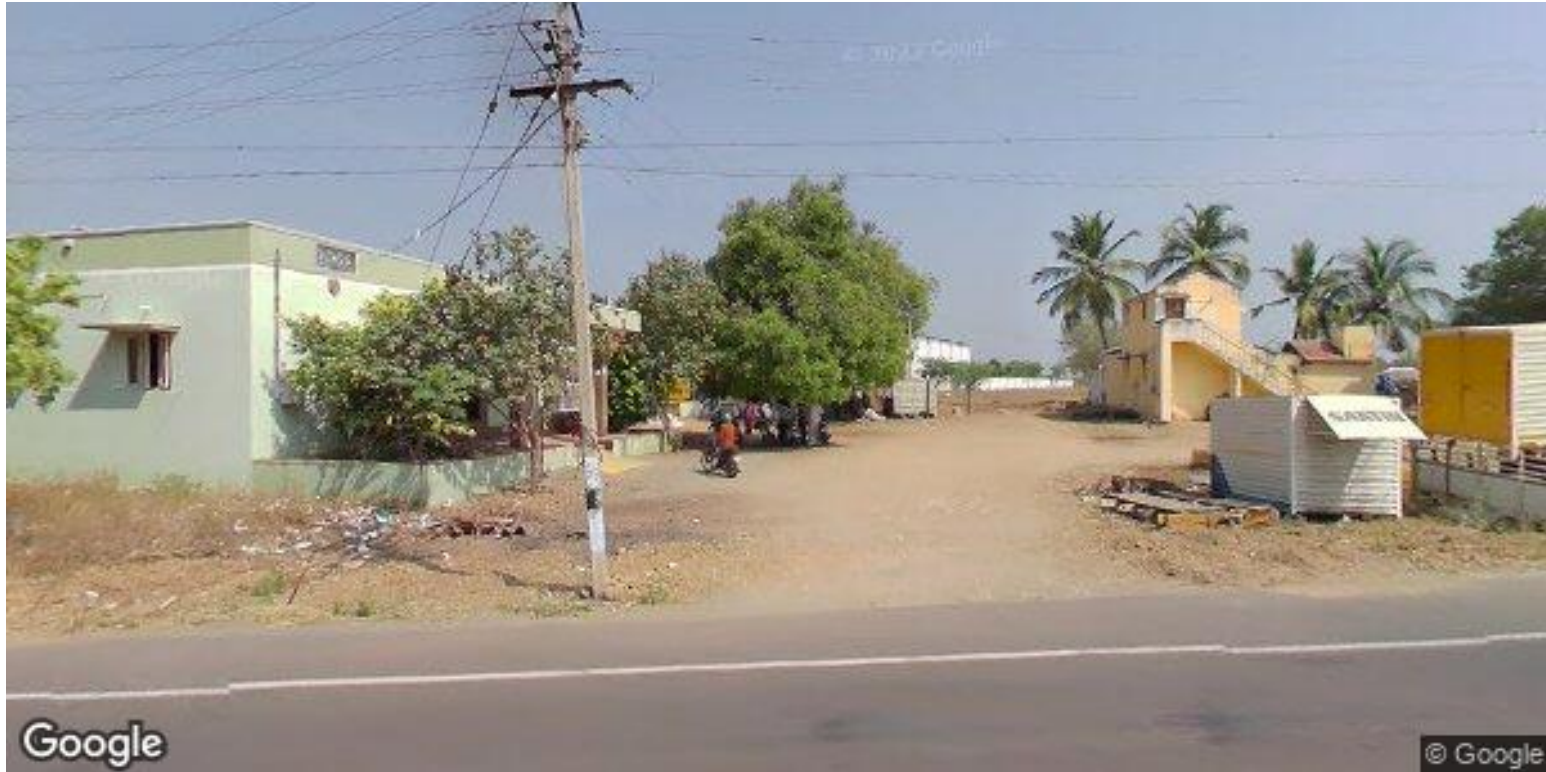
**Risk Type:** Turn  
**Risk Level:** High  
**Speed Limit:** 15 KM/Hr  
**Coordinates:** 11.04838, 77.74455

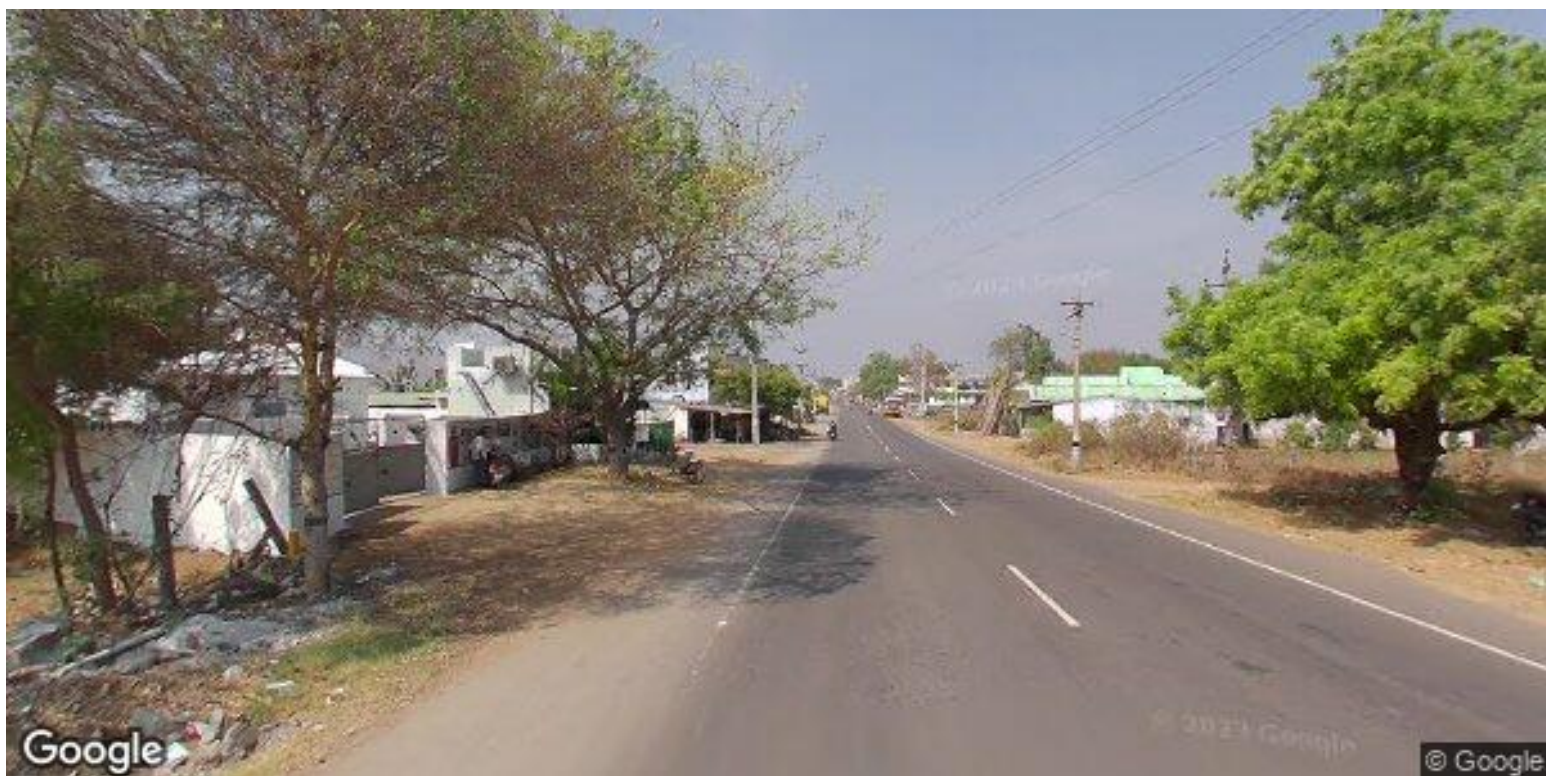
**Risk Type:** Turn  
**Risk Level:** High  
**Speed Limit:** 15 KM/Hr  
**Coordinates:** 11.04821, 77.74461
