# IndianOil

## JOURNEY RISK MANAGEMENT (JRM) STUDY

### Salem Terminal TO SINTHIYA NATESAN FUELS

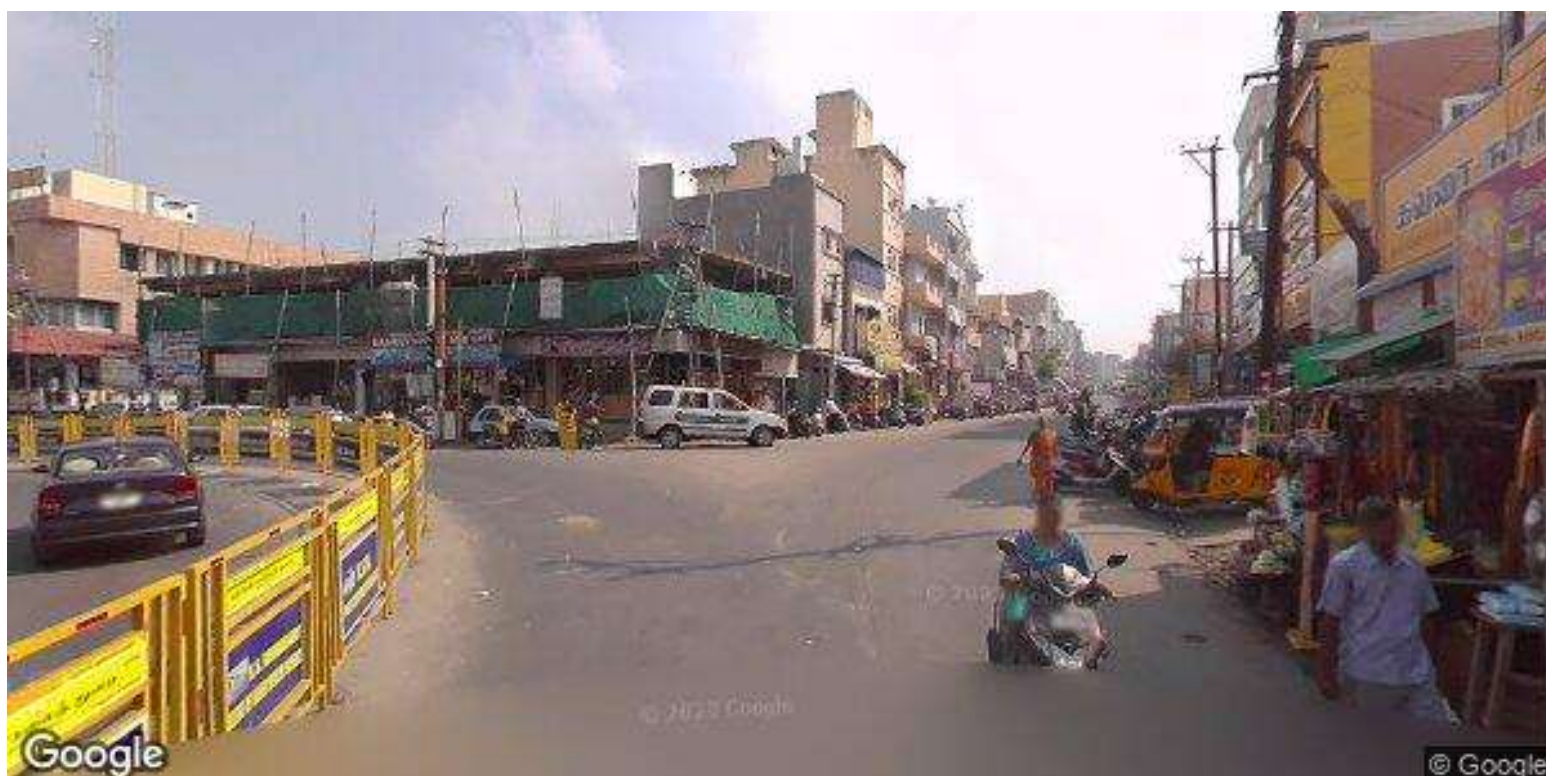
Coordinates: 11.37862, 77.89488

Risk Type: Turn

Risk Level: High

Speed Limit: 15 KM/Hr

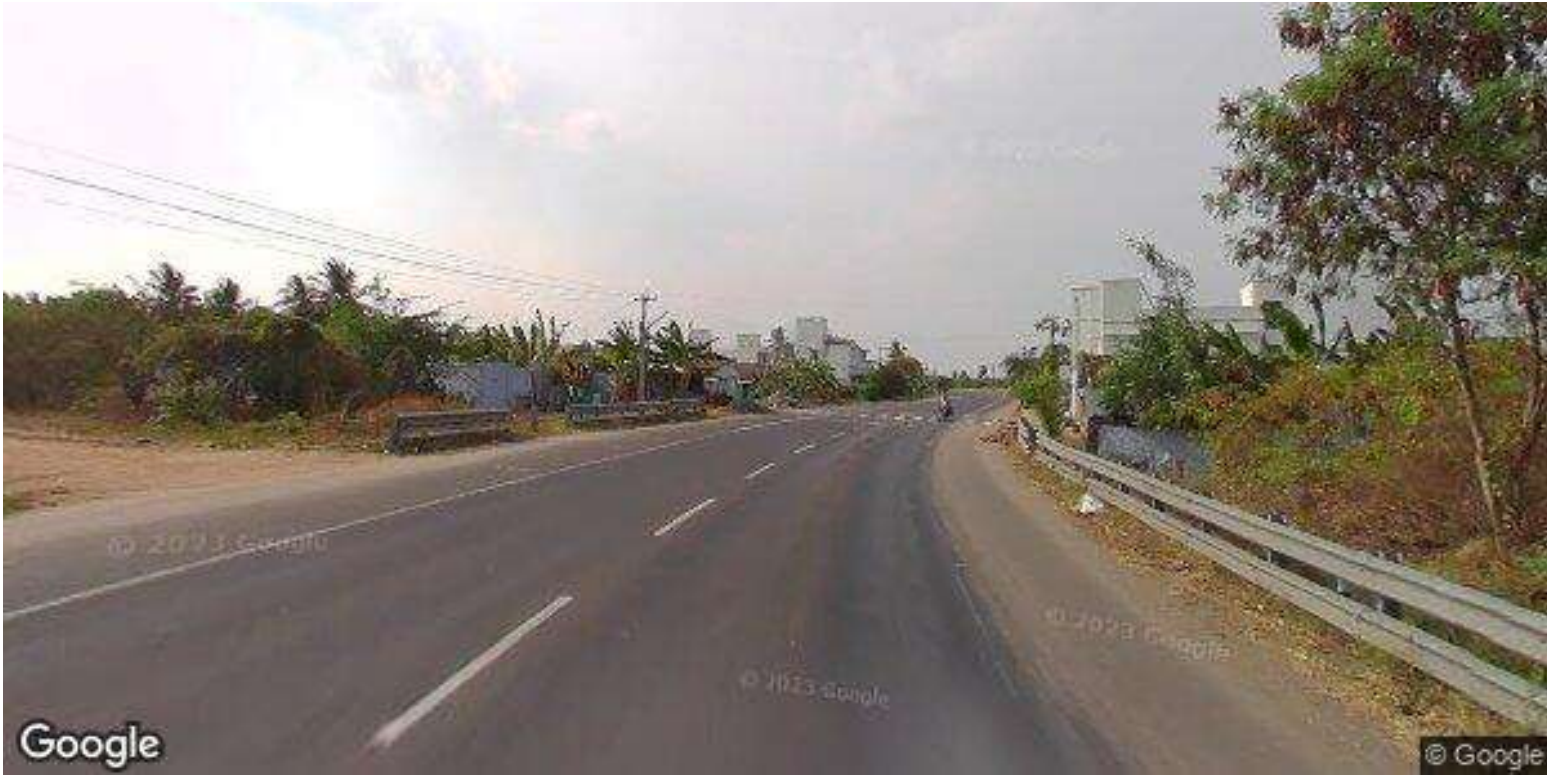
Coordinates: 11.16764, 78.01565

Risk Type: Turn

Risk Level: Medium

Speed Limit: 30 KM/Hr

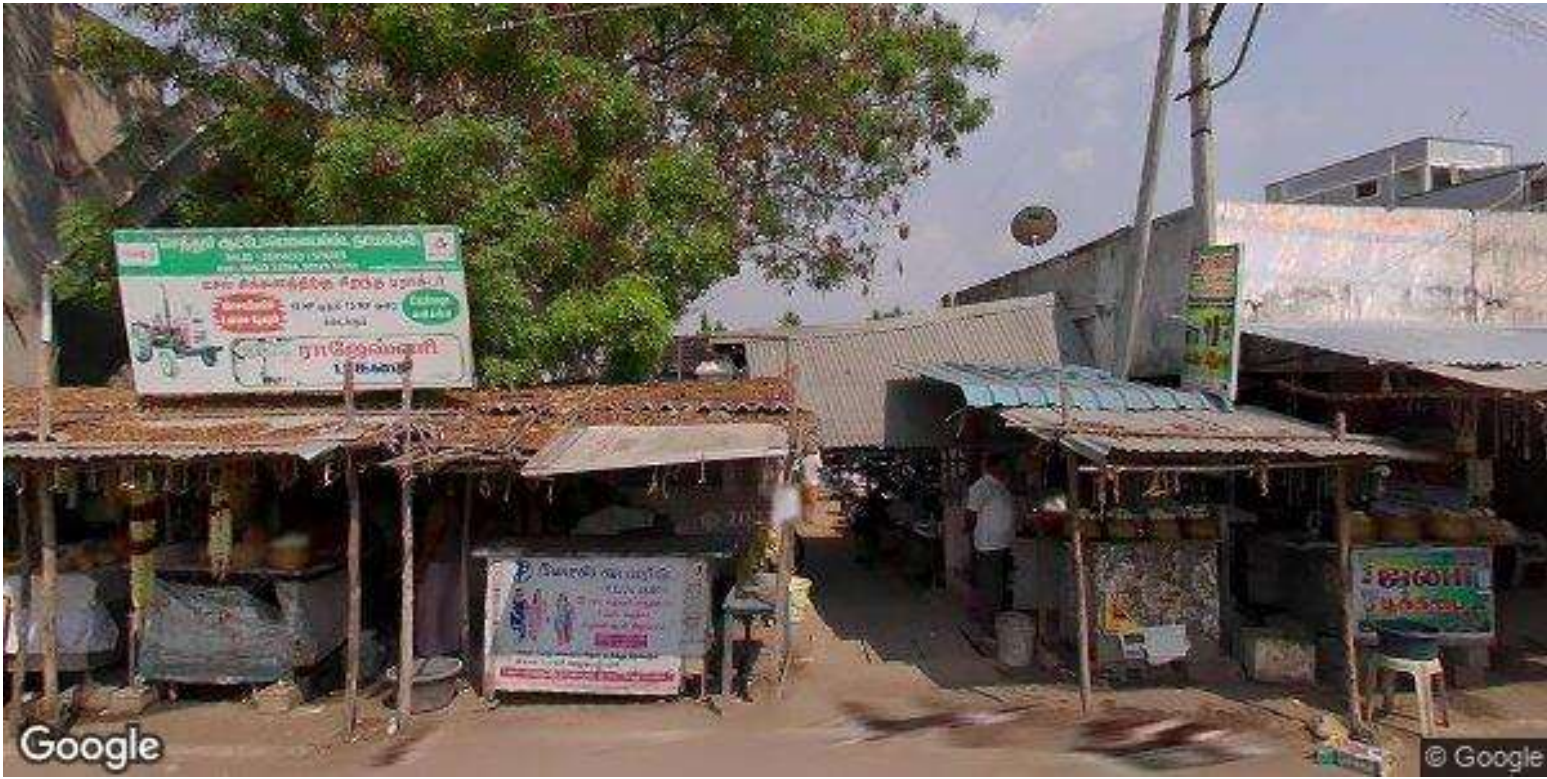
Risk Type: Turn  
Risk Level: High  
Speed Limit: 15 KM/Hr  
Coordinates: 11.15573, 78.02176

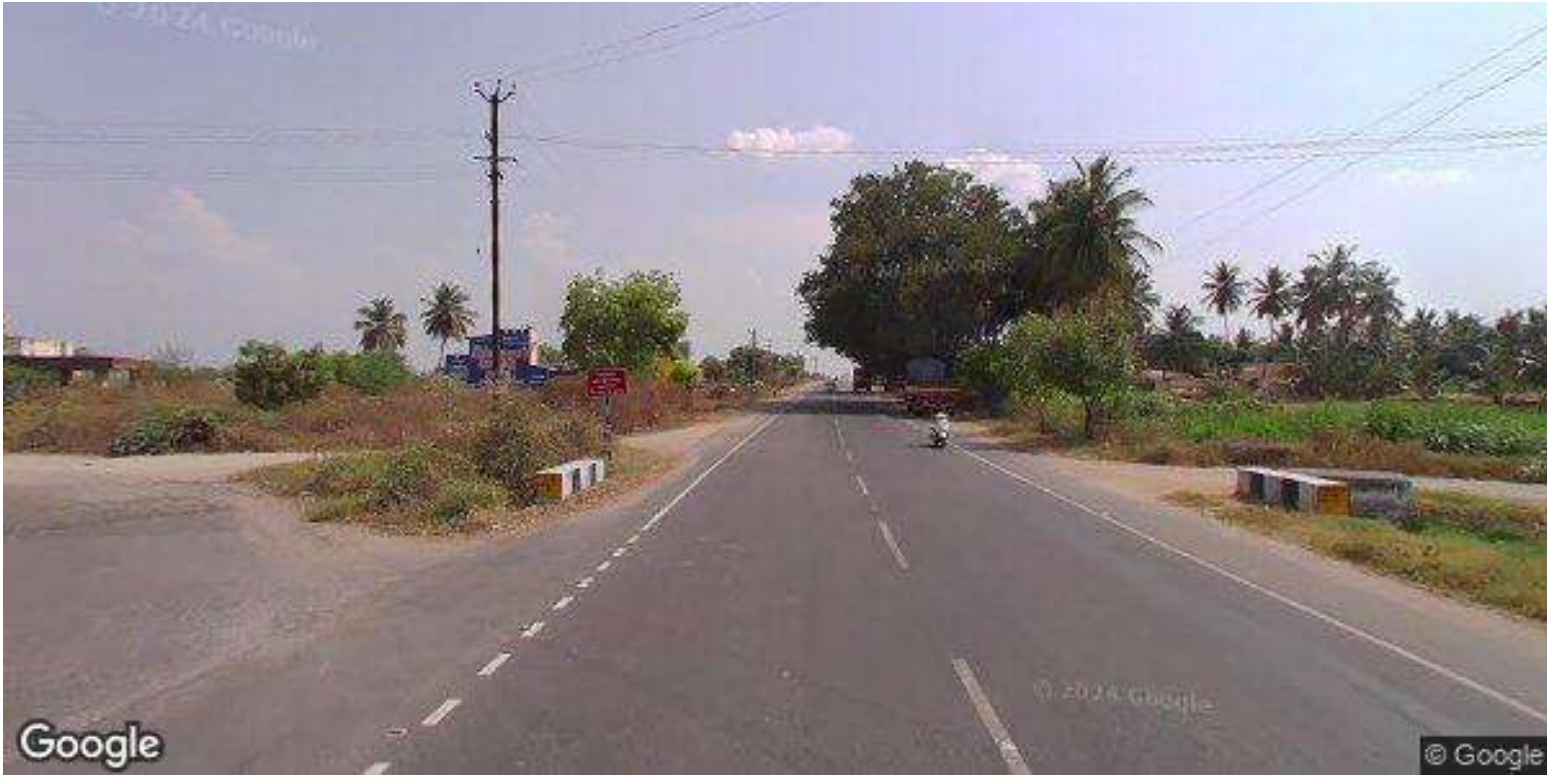
Risk Type: Turn  
Risk Level: High  
Speed Limit: 15 KM/Hr  
Coordinates: 11.14545, 78.02208

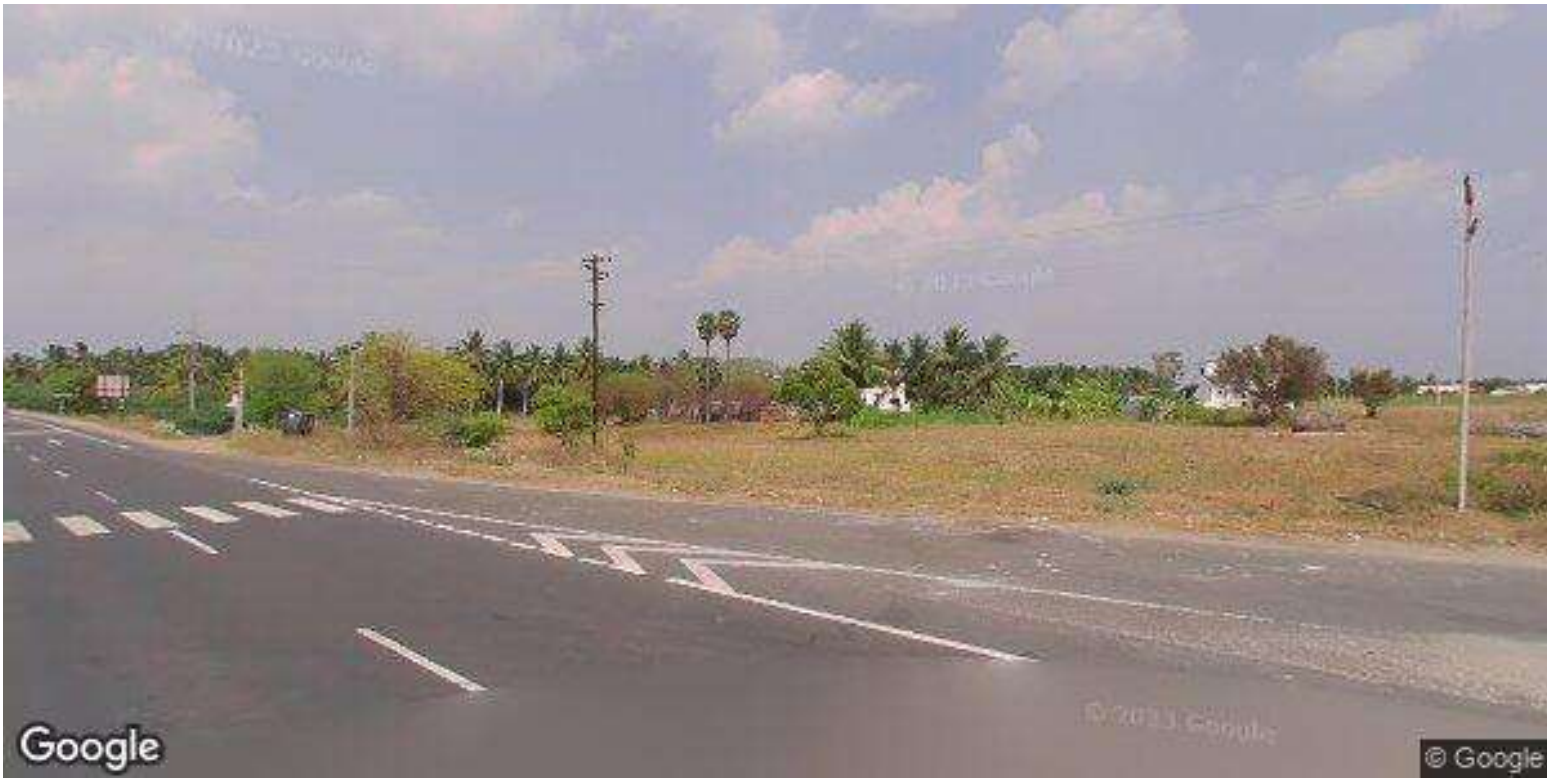
Coordinates: 11.14480, 78.02291

Risk Type: Turn

Risk Level: High

Speed Limit: 15 KM/Hr

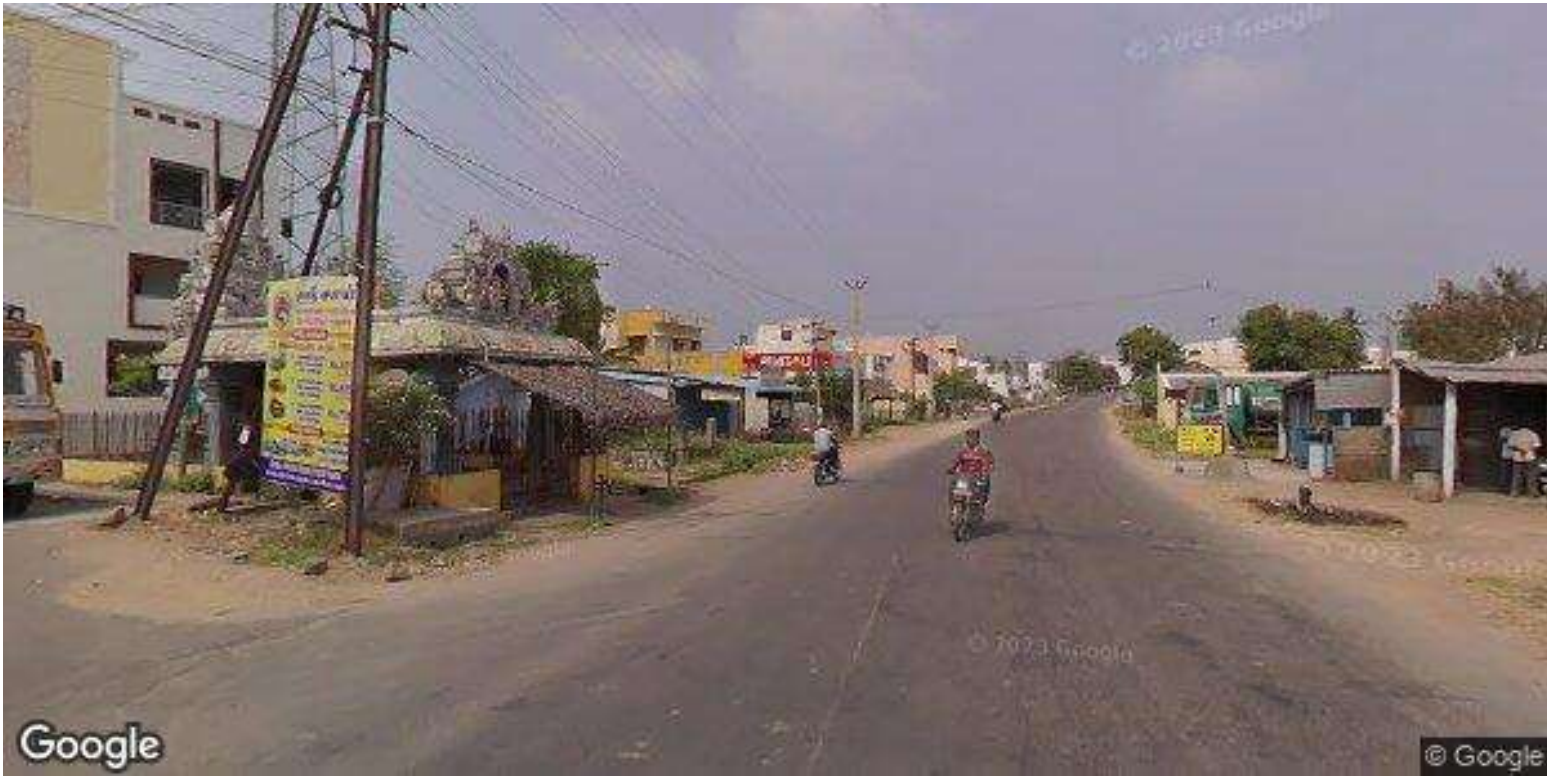
Coordinates: 10.98525, 78.07657

Risk Type: Turn

Risk Level: Medium

Speed Limit: 30 KM/Hr

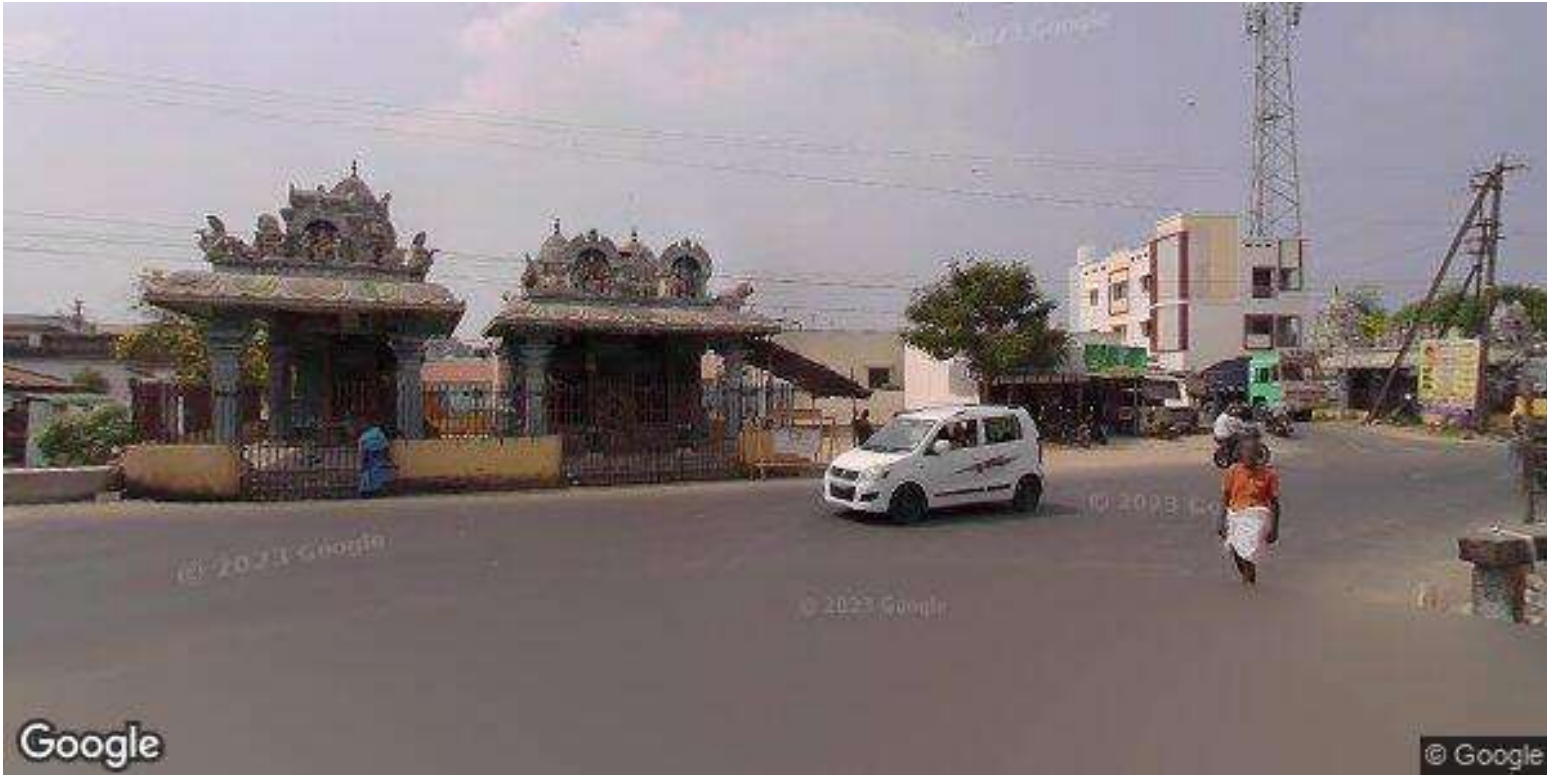
Coordinates: 10.98502, 78.07675

Risk Type: Turn

Risk Level: High

Speed Limit: 15 KM/Hr

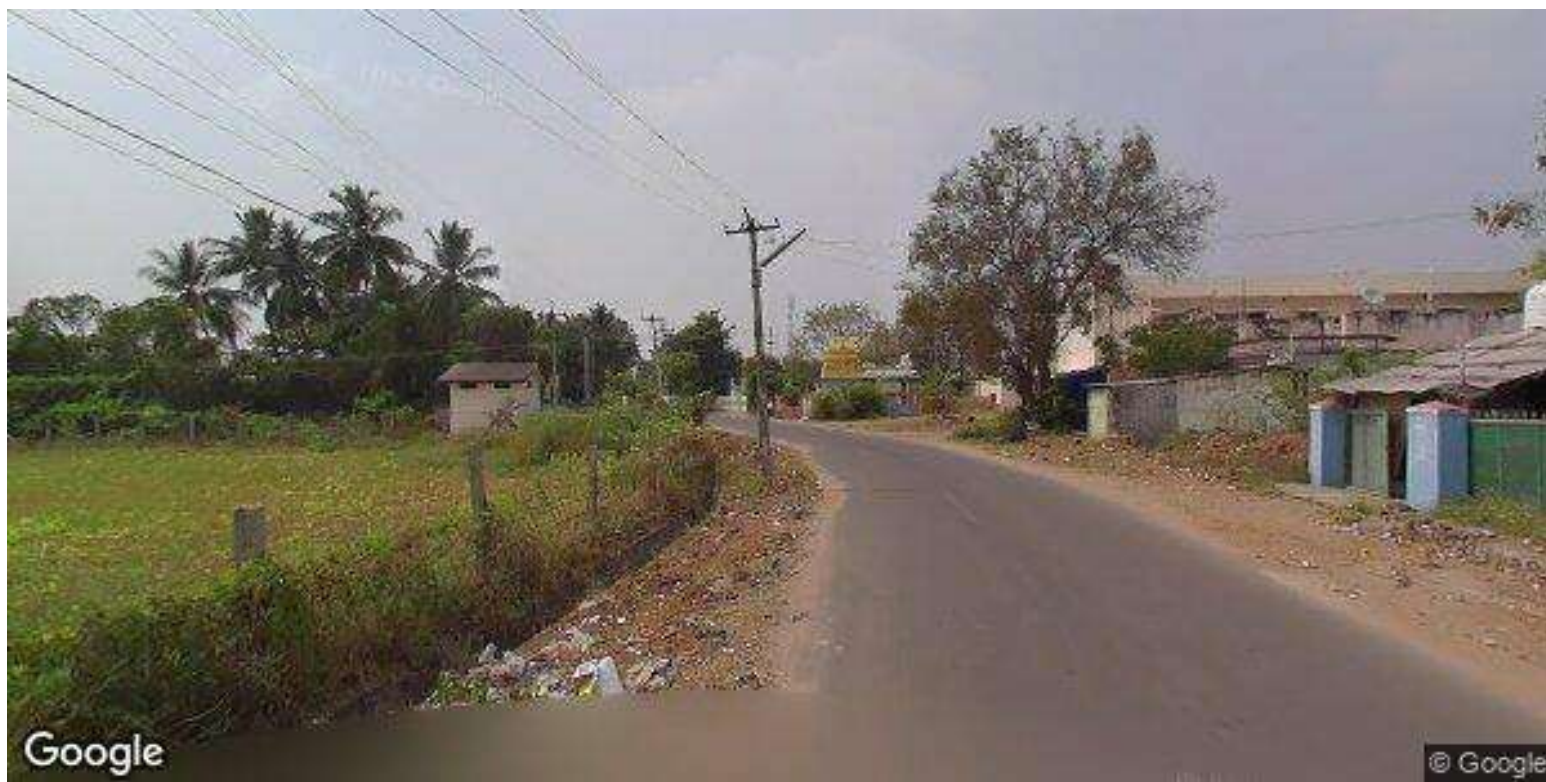
**Coordinates:** 10.98538, 78.07910

**Risk Type:** Turn

**Risk Level:** Medium

**Speed Limit:** 30 KM/Hr

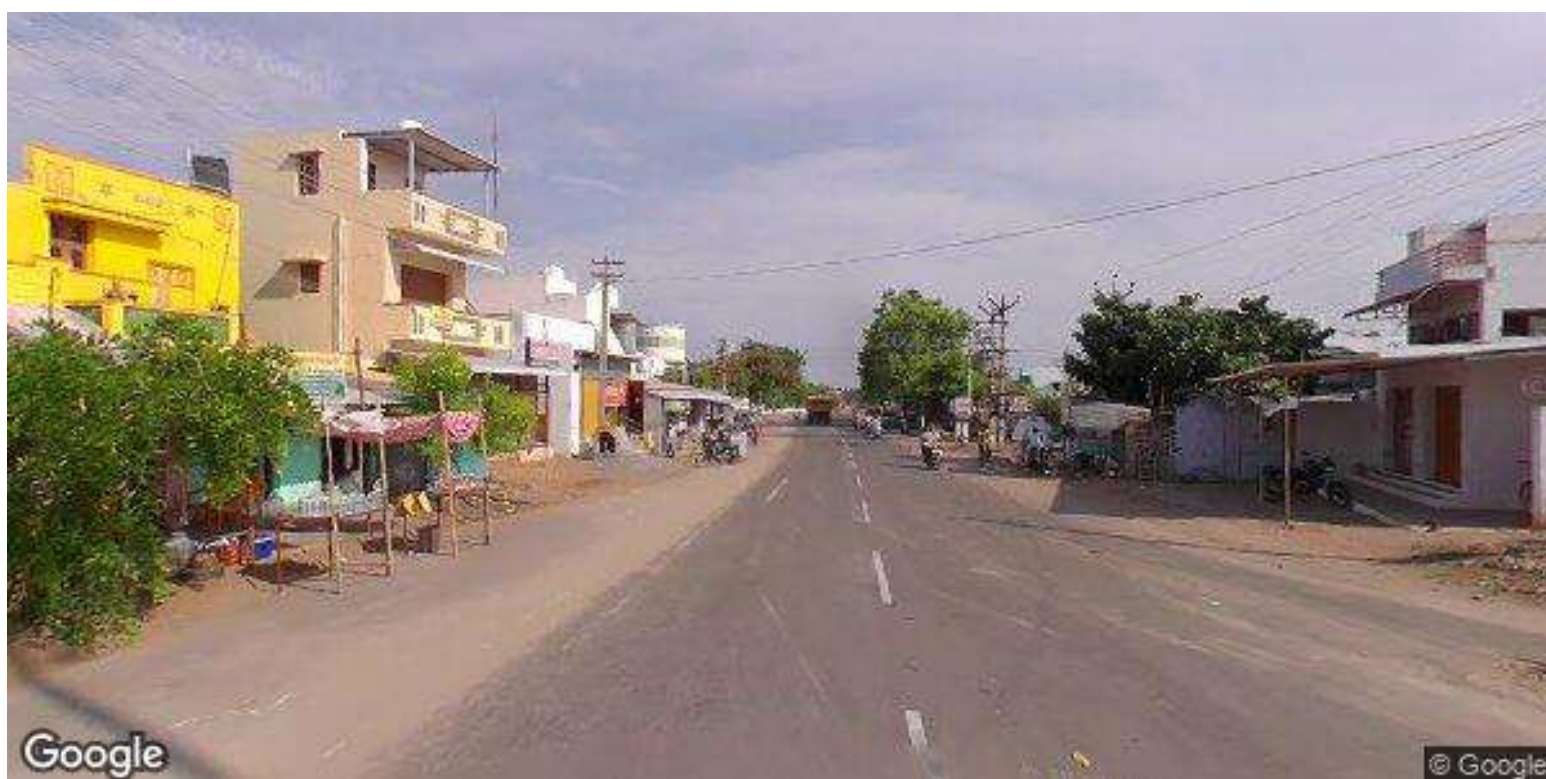
**Coordinates:** 10.98105, 78.09484

**Risk Type:** Turn

**Risk Level:** High

**Speed Limit:** 15 KM/Hr

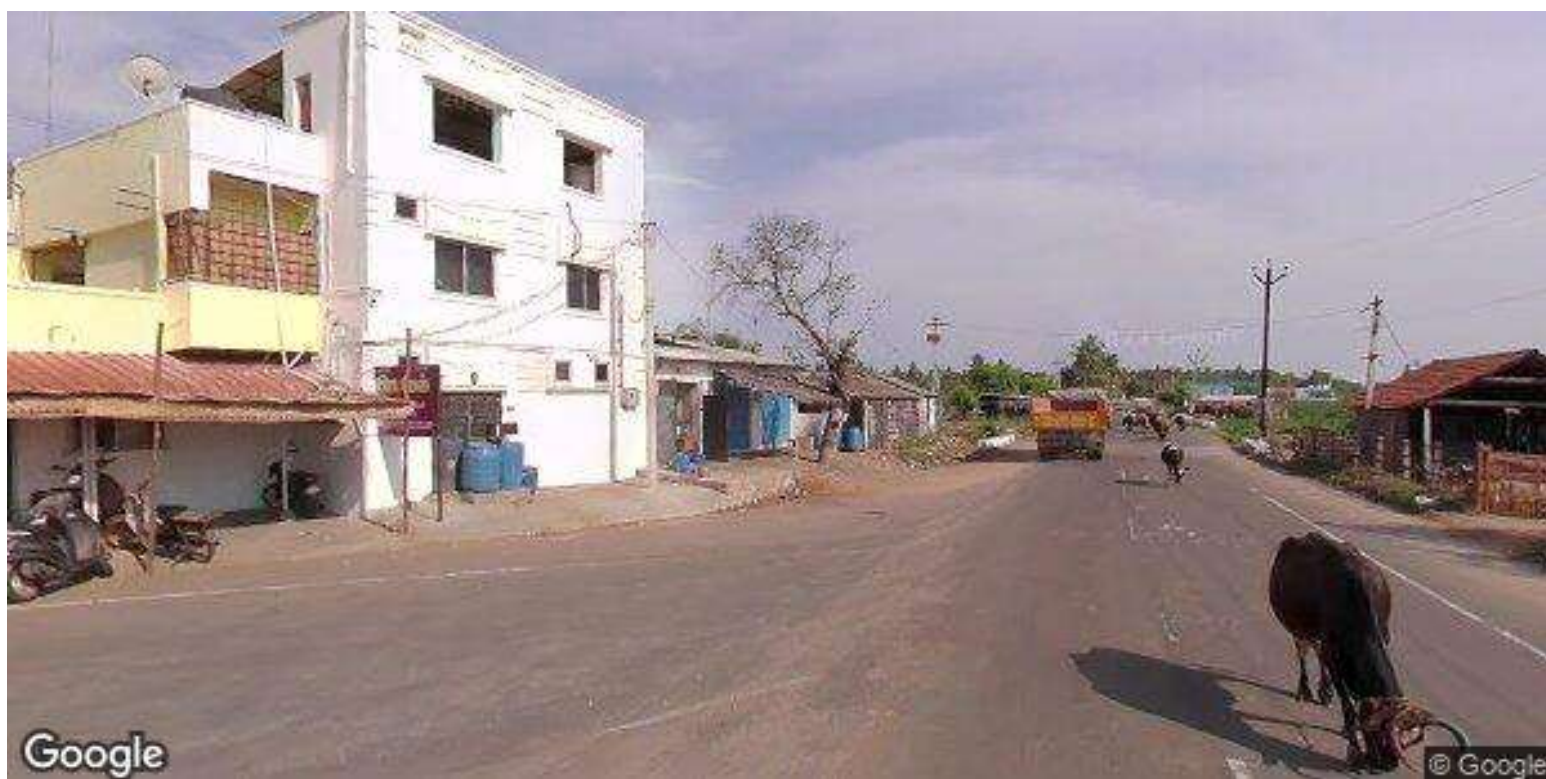
**Coordinates:** 10.97776, 78.09597

**Risk Type:** Blind Spot

**Risk Level:** Blind Spot

**Speed Limit:** 10 KM/Hr

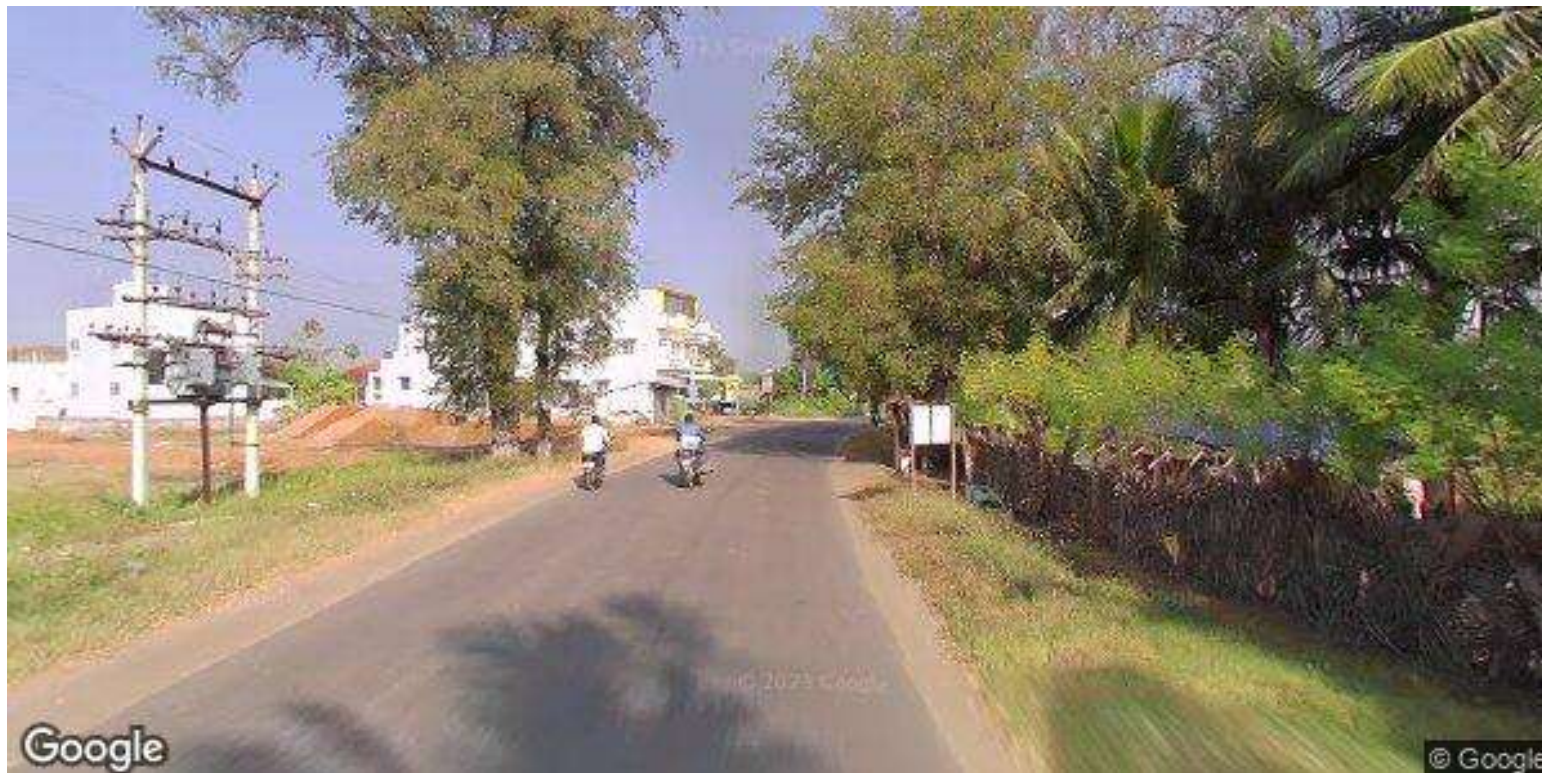
**Coordinates:** 10.97971, 78.09917

**Risk Type:** Turn

**Risk Level:** Medium

**Speed Limit:** 30 KM/Hr

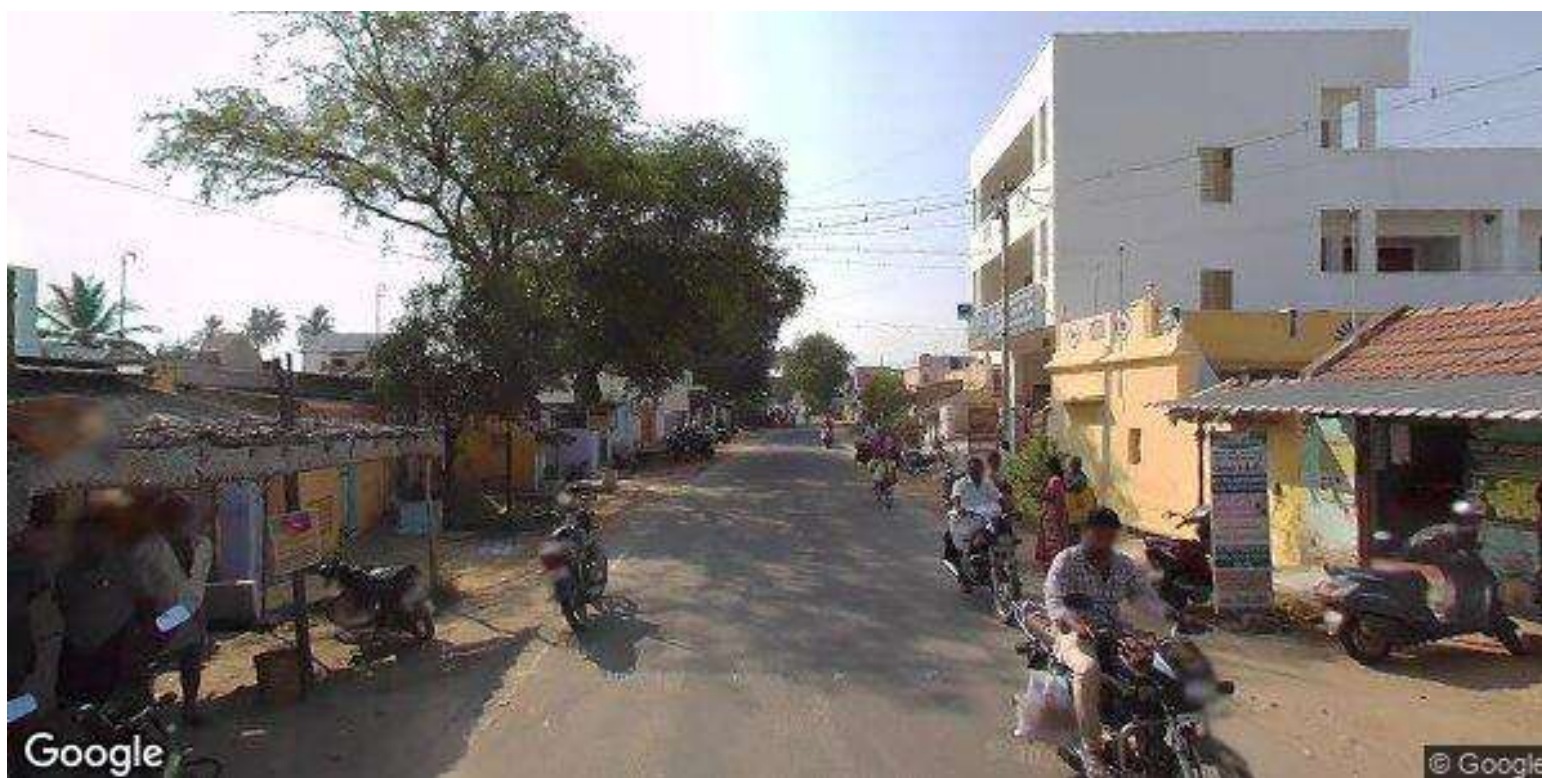
**Coordinates:** 10.97878, 78.10821

**Risk Type:** Turn

**Risk Level:** Medium

**Speed Limit:** 30 KM/Hr

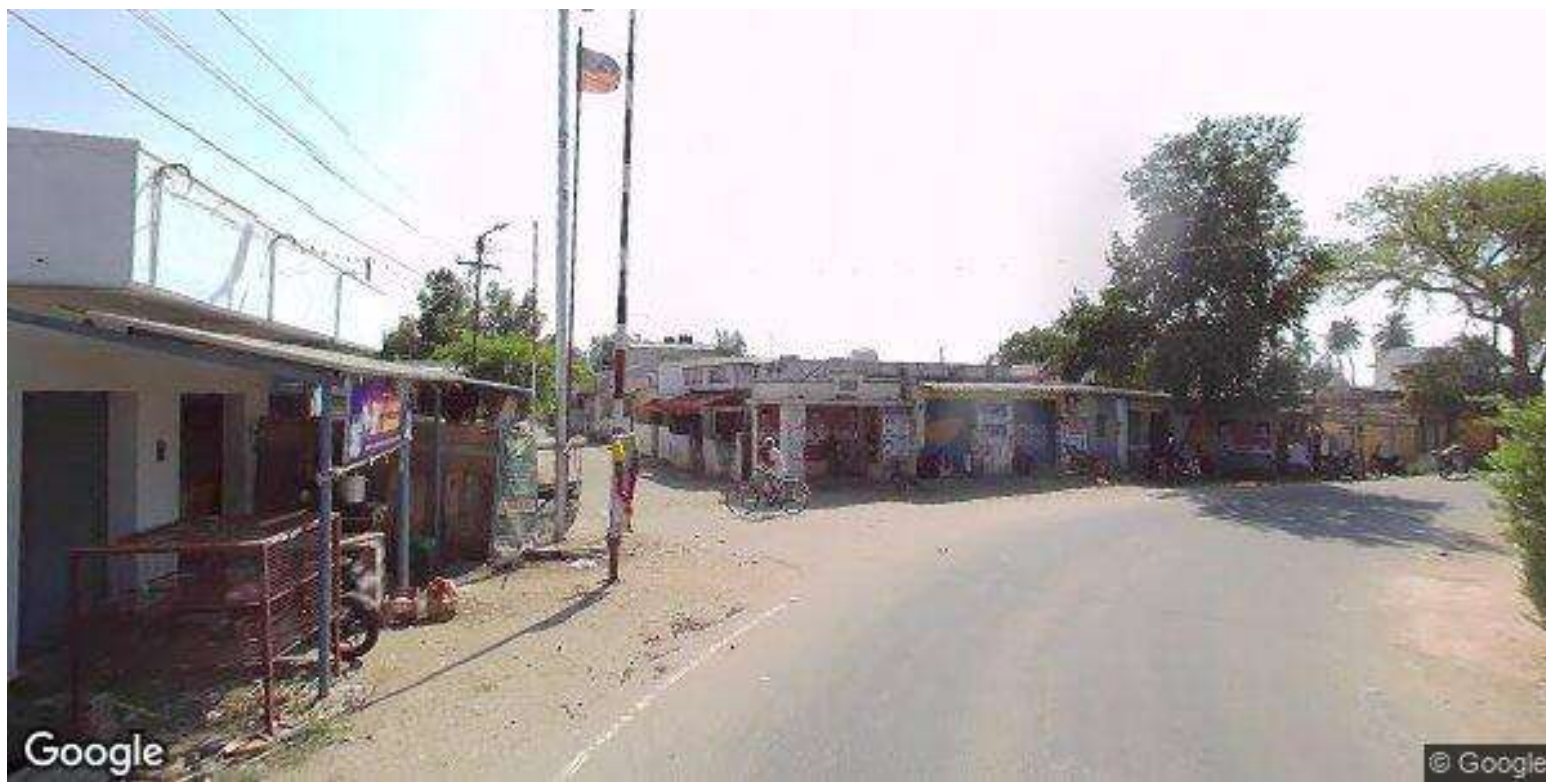
**Coordinates:** 10.97884, 78.10836

**Risk Type:** Turn

**Risk Level:** Medium

**Speed Limit:** 30 KM/Hr

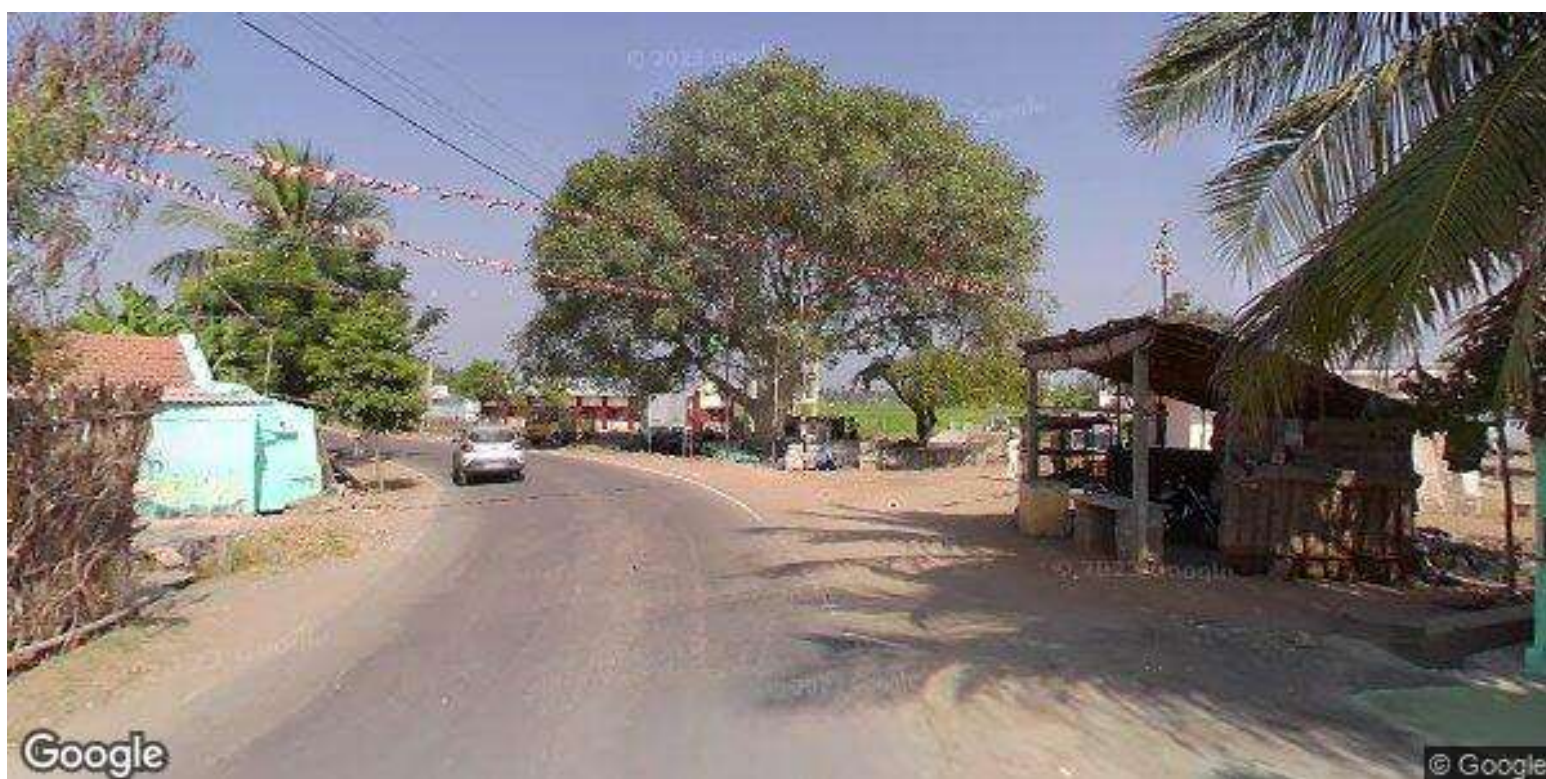
**Coordinates:** 10.97974, 78.11011

**Risk Type:** Turn

**Risk Level:** Medium

**Speed Limit:** 30 KM/Hr

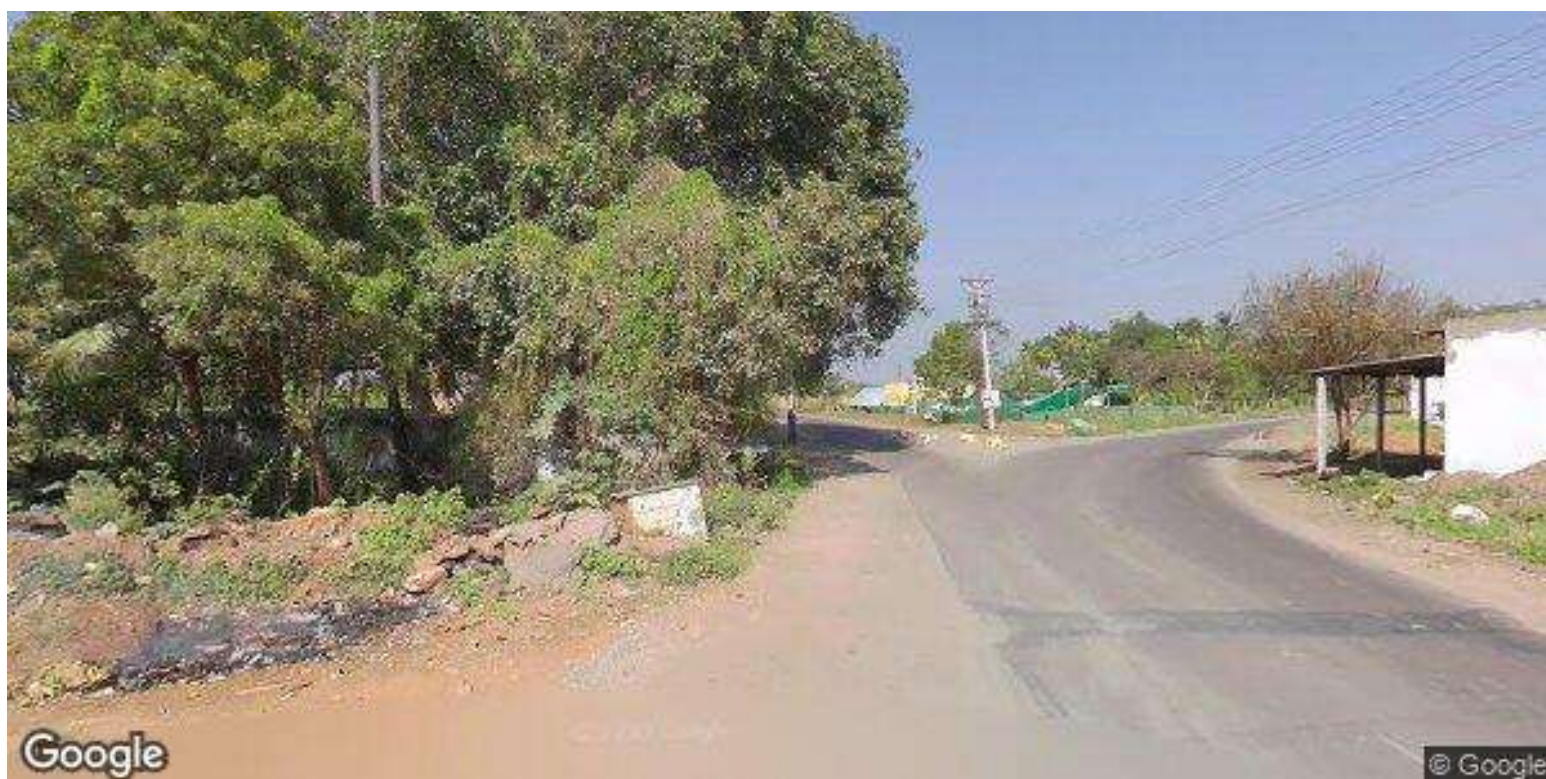
**Risk Type:** Turn  
**Risk Level:** Medium  
**Speed Limit:** 30 KM/Hr  
**Coordinates:** 10.98122, 78.11110

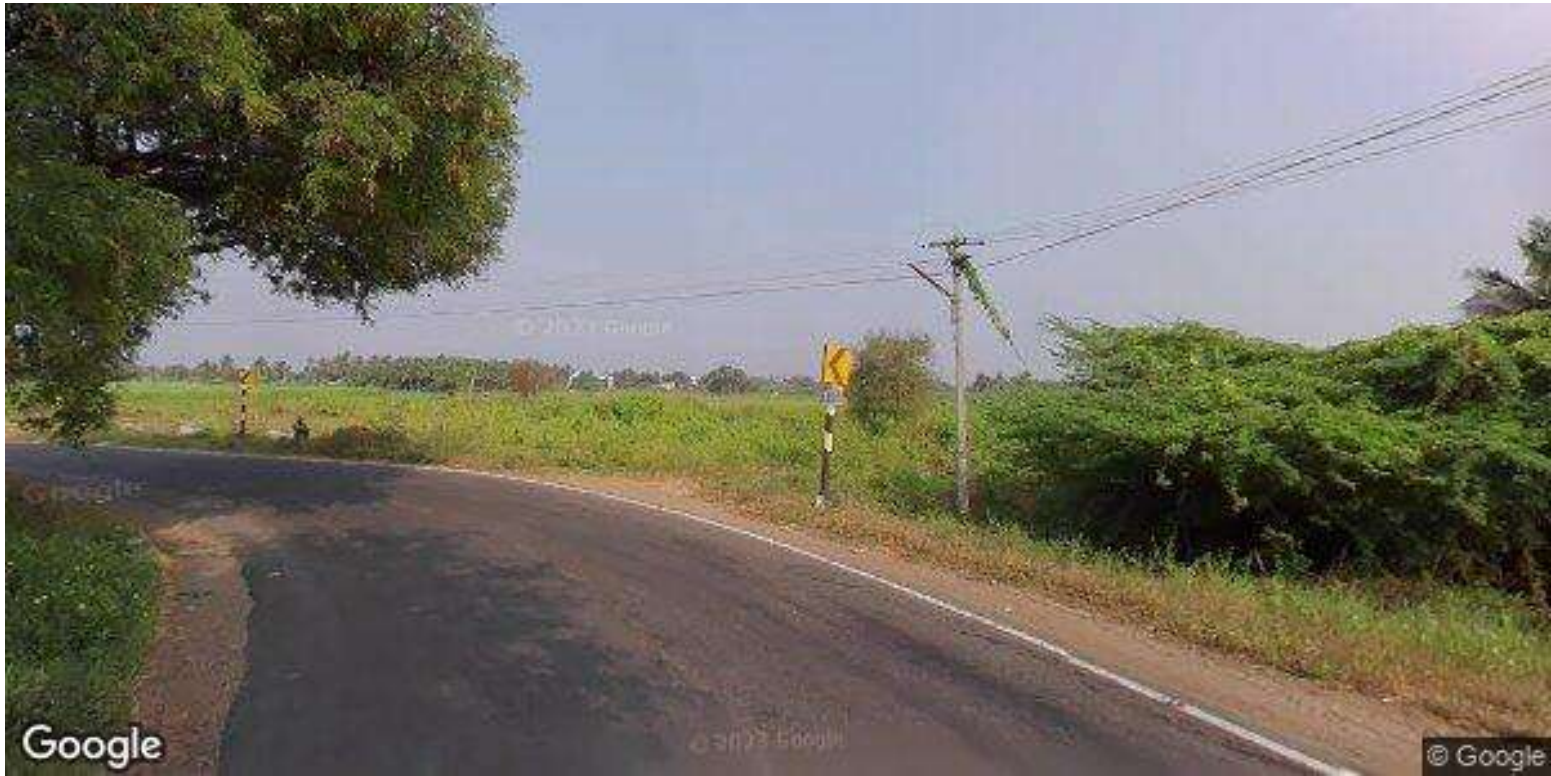
**Risk Type:** Turn  
**Risk Level:** High  
**Speed Limit:** 15 KM/Hr  
**Coordinates:** 10.98164, 78.11315

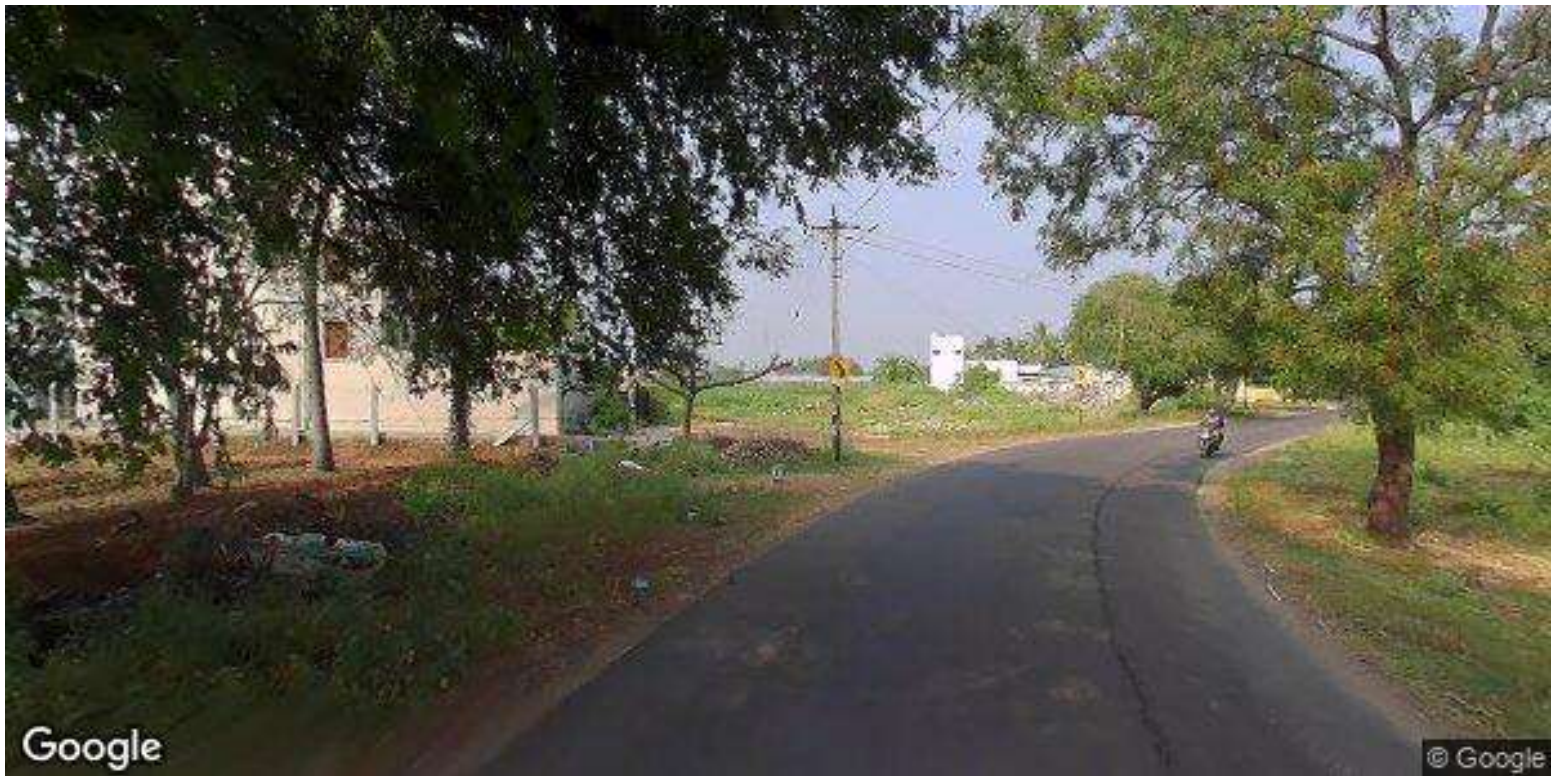
**Risk Type:** Turn  
**Risk Level:** Medium  
**Speed Limit:** 30 KM/Hr  
**Coordinates:** 10.98250, 78.11346

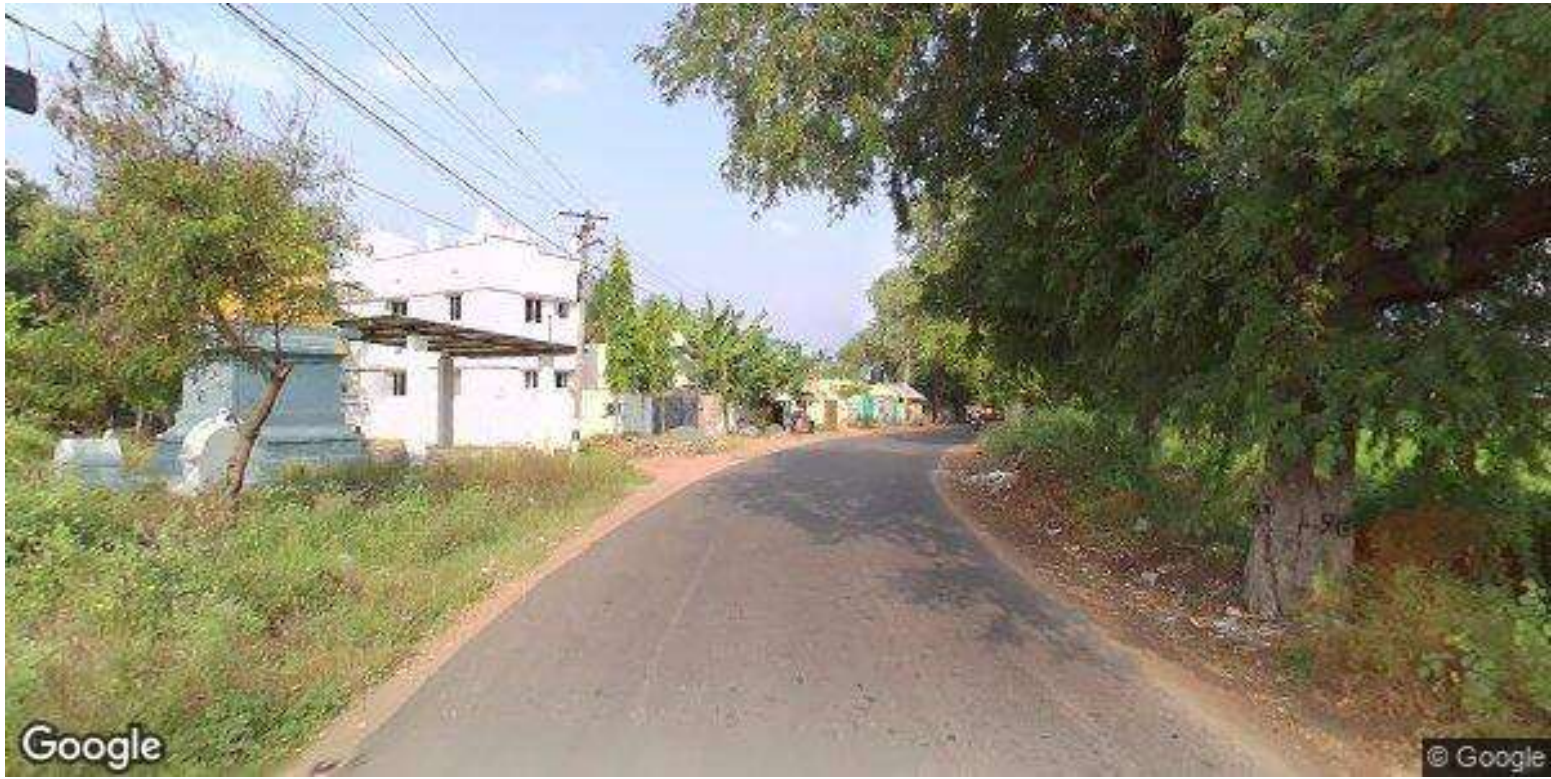
**Risk Type:** Turn  
**Risk Level:** Medium  
**Speed Limit:** 30 KM/Hr  
**Coordinates:** 10.98457, 78.11549

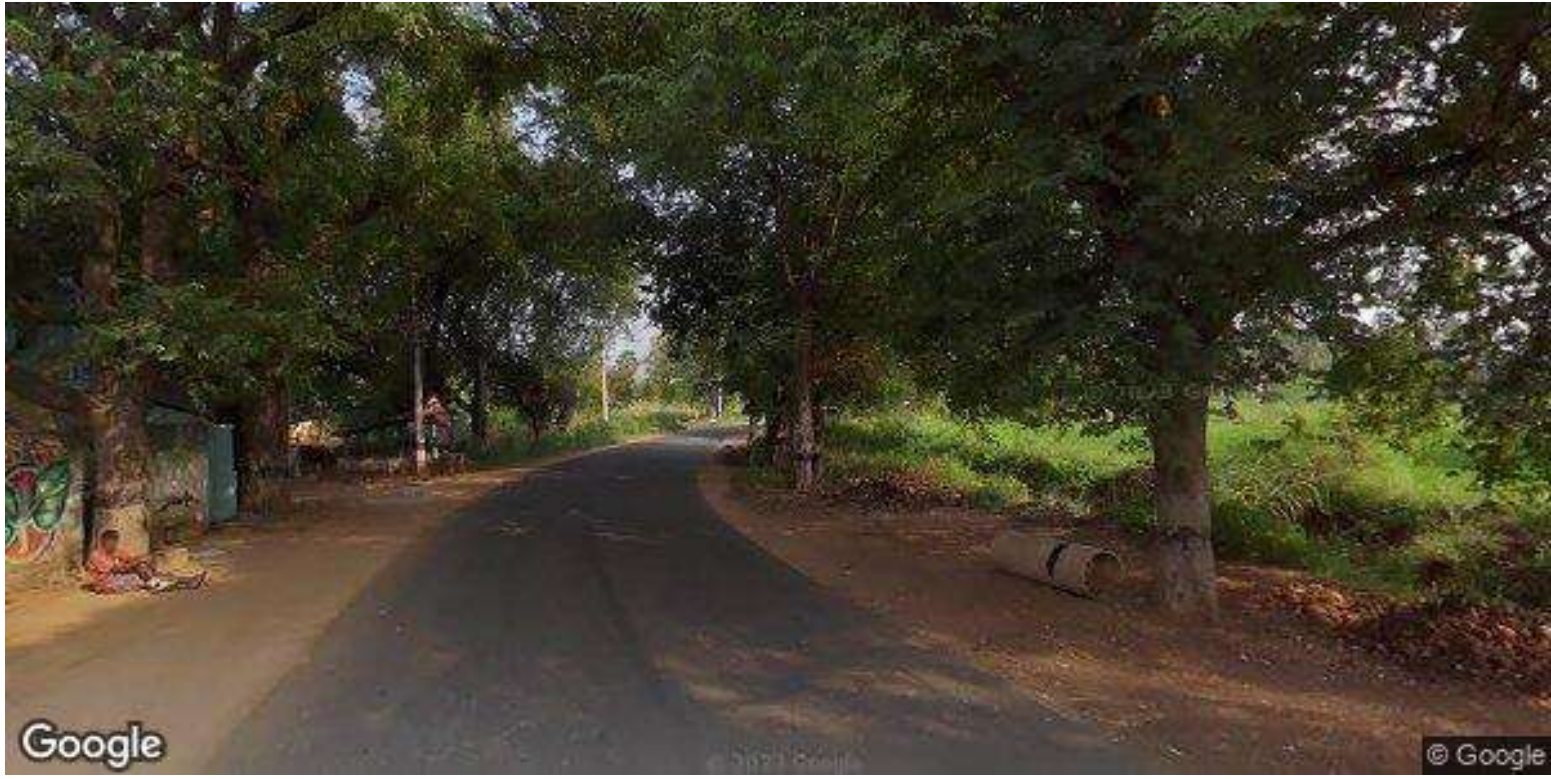
**Risk Type:** Turn  
**Risk Level:** Medium  
**Speed Limit:** 30 KM/Hr  
**Coordinates:** 10.98465, 78.11595
