# IndianOil

## JOURNEY RISK MANAGEMENT (JRM) STUDY

### Salem Terminal TO SINTHIYA NATESAN FUELS

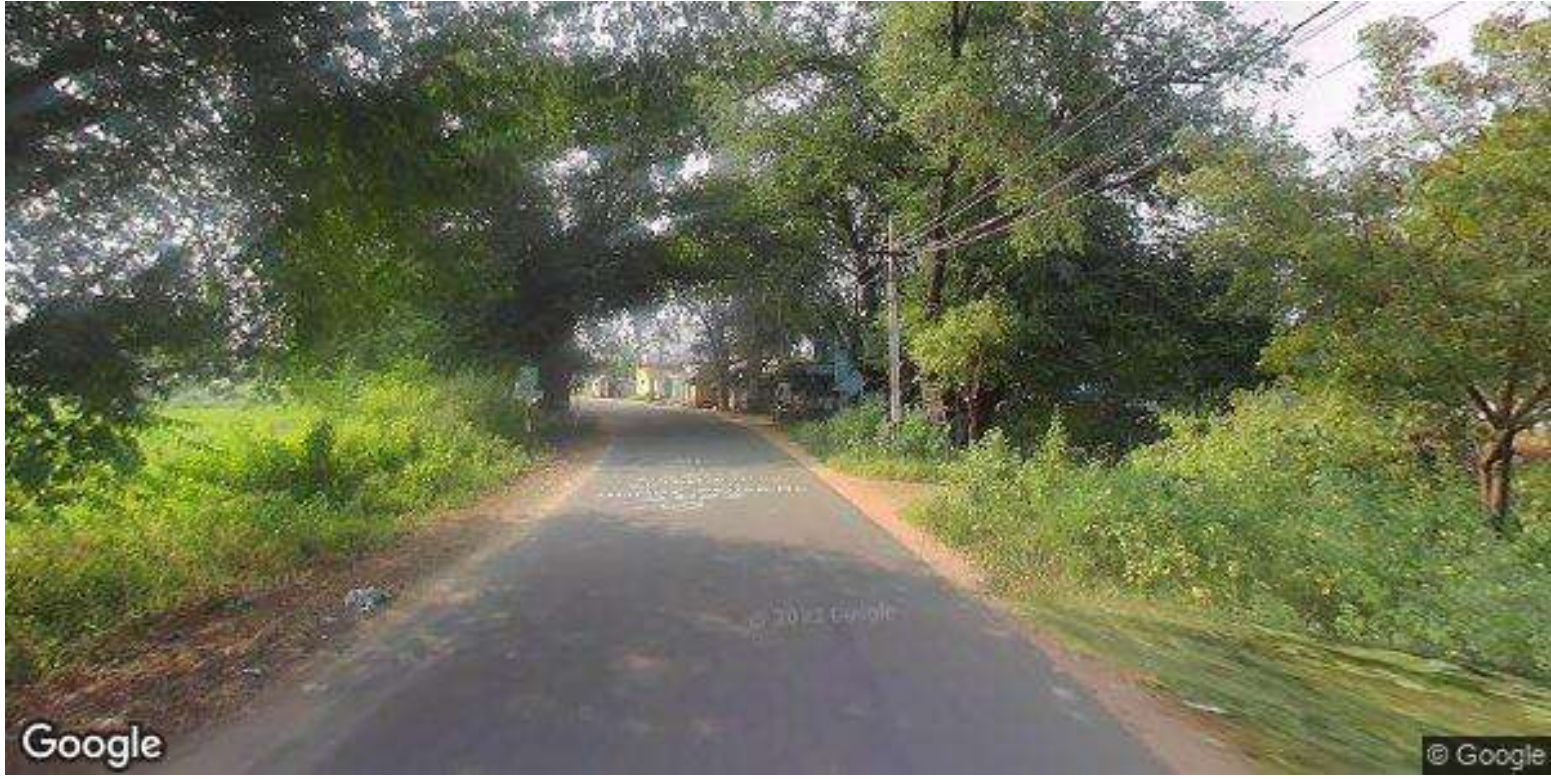
**Risk Type:** Turn  
**Risk Level:** Medium  
**Speed Limit:** 30 KM/Hr  
**Coordinates:** 10.98449, 78.11650

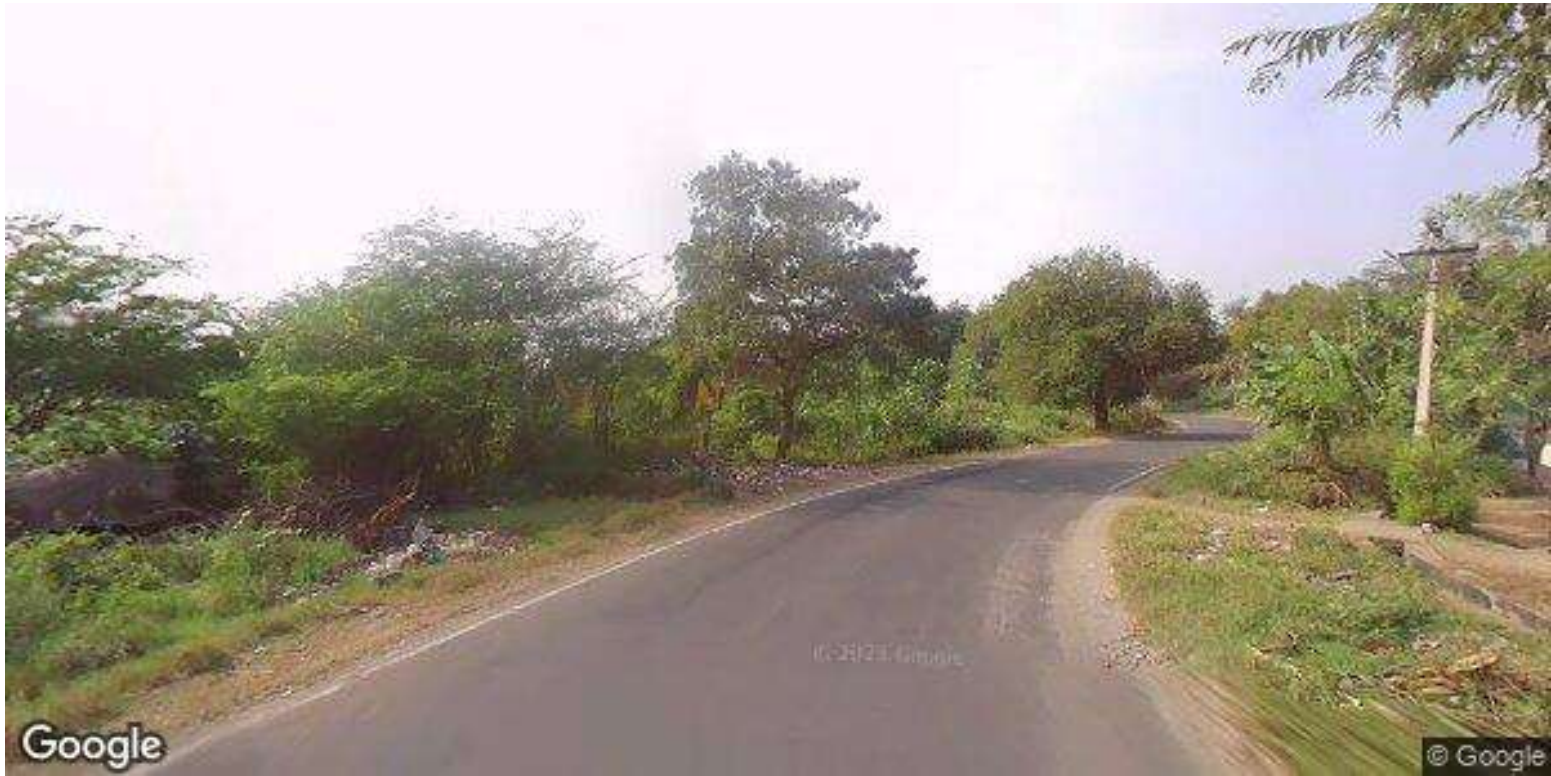
**Risk Type:** Turn  
**Risk Level:** Medium  
**Speed Limit:** 30 KM/Hr  
**Coordinates:** 10.98369, 78.11700

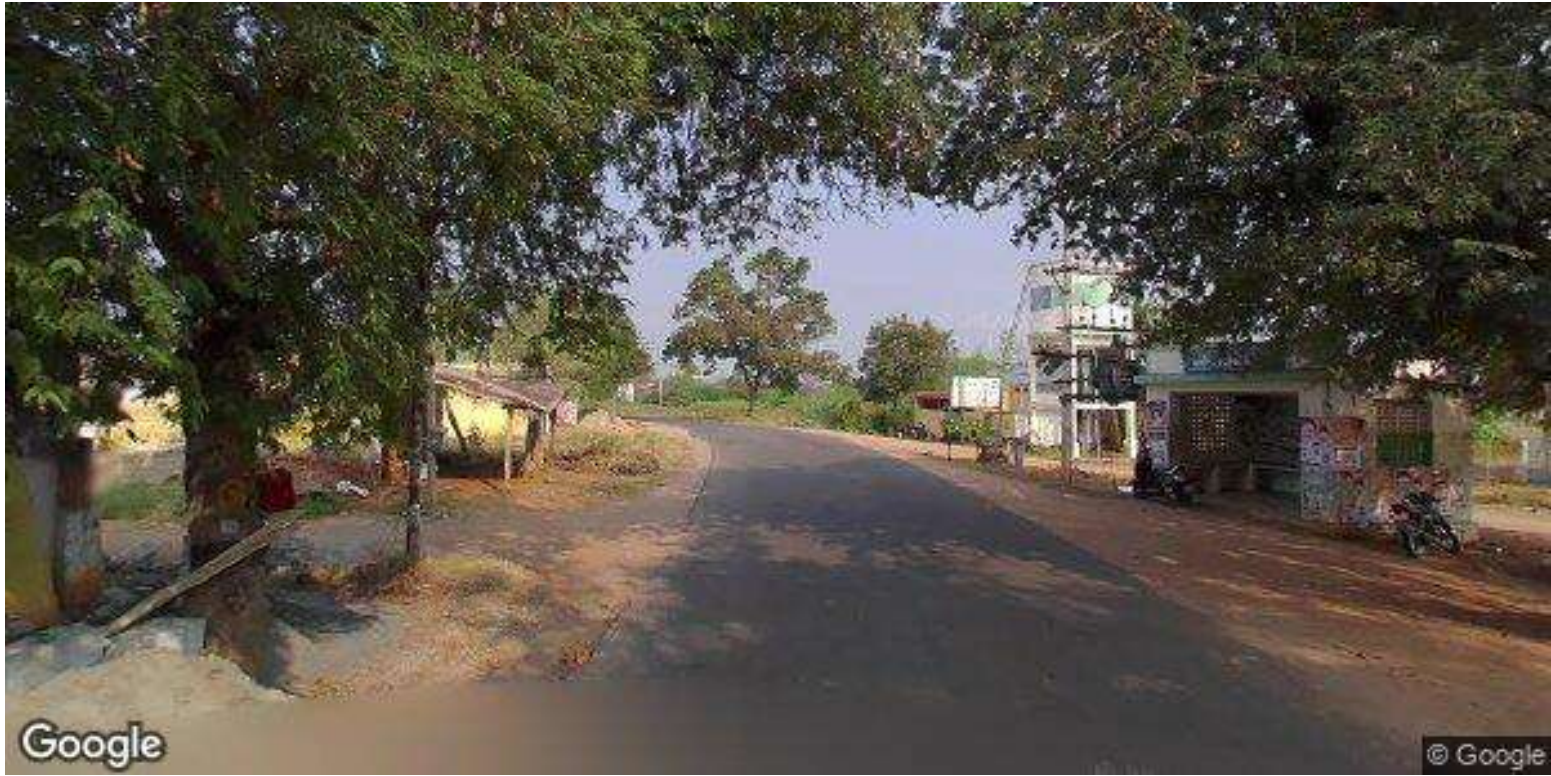
**Risk Type:** Turn  
**Risk Level:** Medium  
**Speed Limit:** 30 KM/Hr  
**Coordinates:** 10.98332, 78.11883
