# IndianOil

## **JOURNEY RISK MANAGEMENT (JRM) STUDY**

### **Salem Terminal to SRINIVASHA AGENCIES**

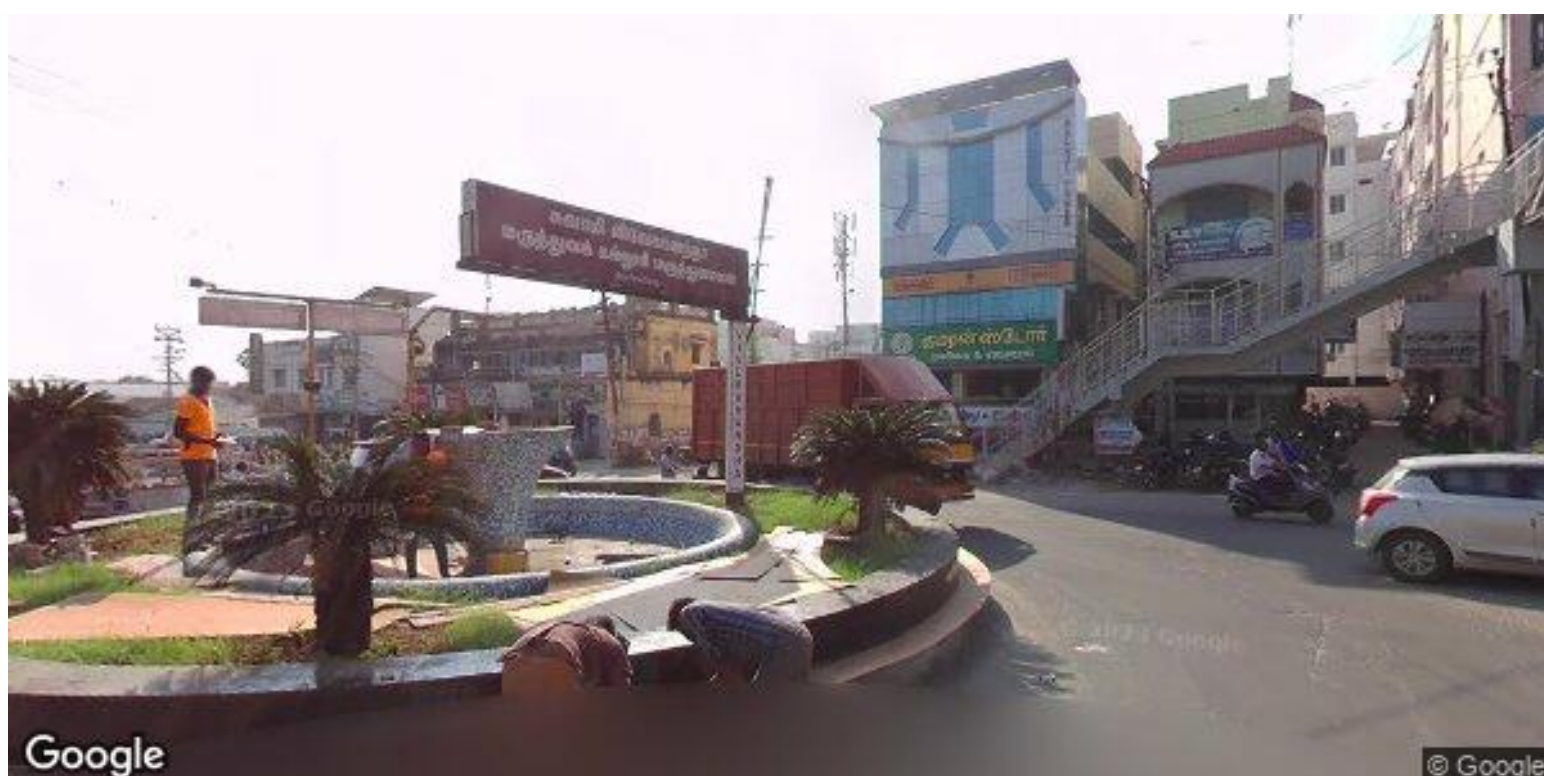
**Risk Type:** Roundabout

**Risk Level:** High

**Speed Limit: 15 KM/Hr**  
**Coordinates: 11.38395, 77.89480**

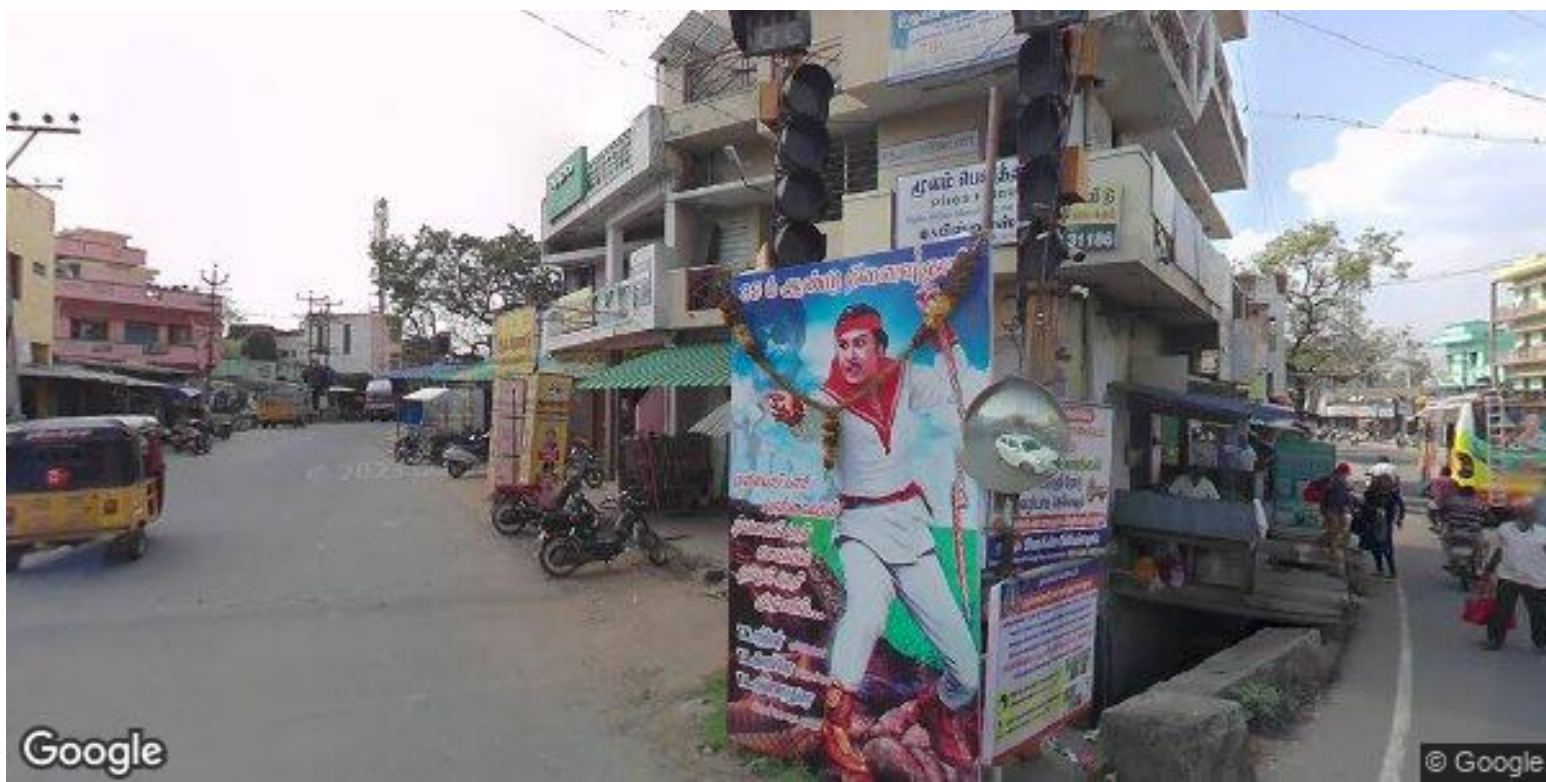
**Risk Type:** Turn

**Risk Level:** Medium

**Speed Limit:** 30 KM/Hr

**Coordinates:** 11.38342, 77.89975

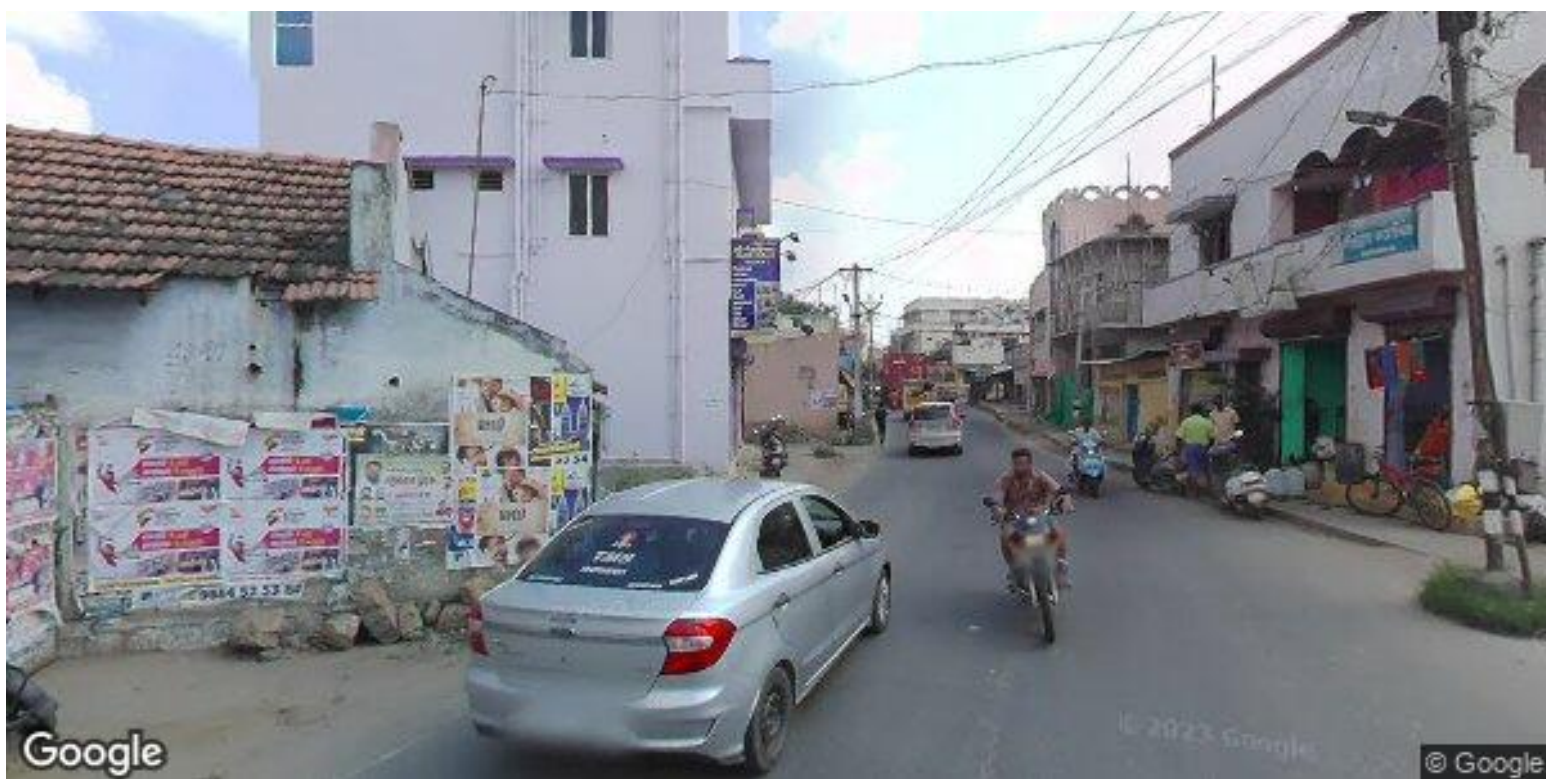
**Risk Type:** Turn

**Risk Level:** Medium

**Speed Limit:** 30 KM/Hr

**Coordinates:** 11.38295, 77.90001

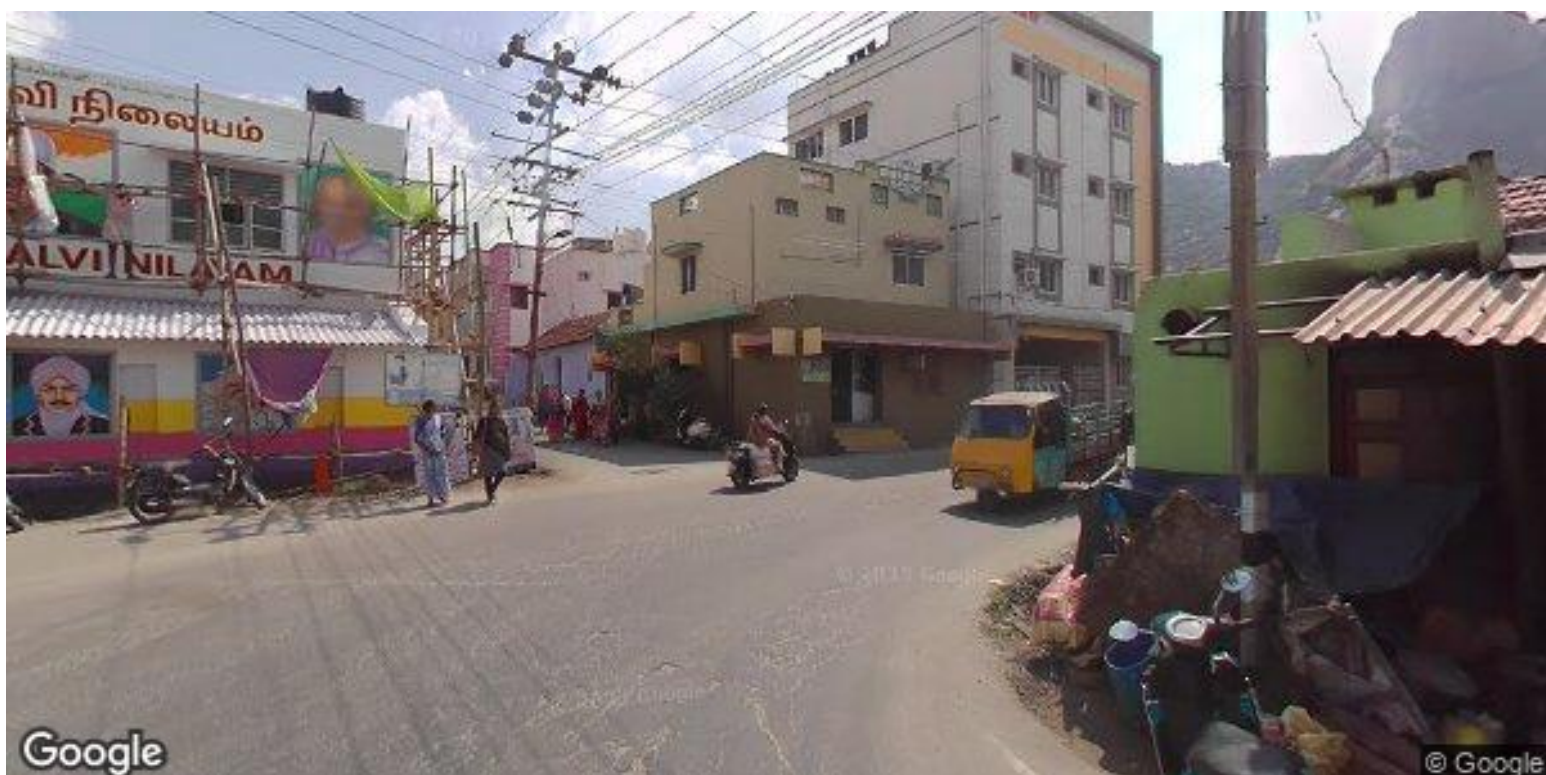
**Risk Type:** Turn  
**Risk Level:** High  
**Speed Limit:** 15 KM/Hr  
**Coordinates:** 11.38186, 77.90258

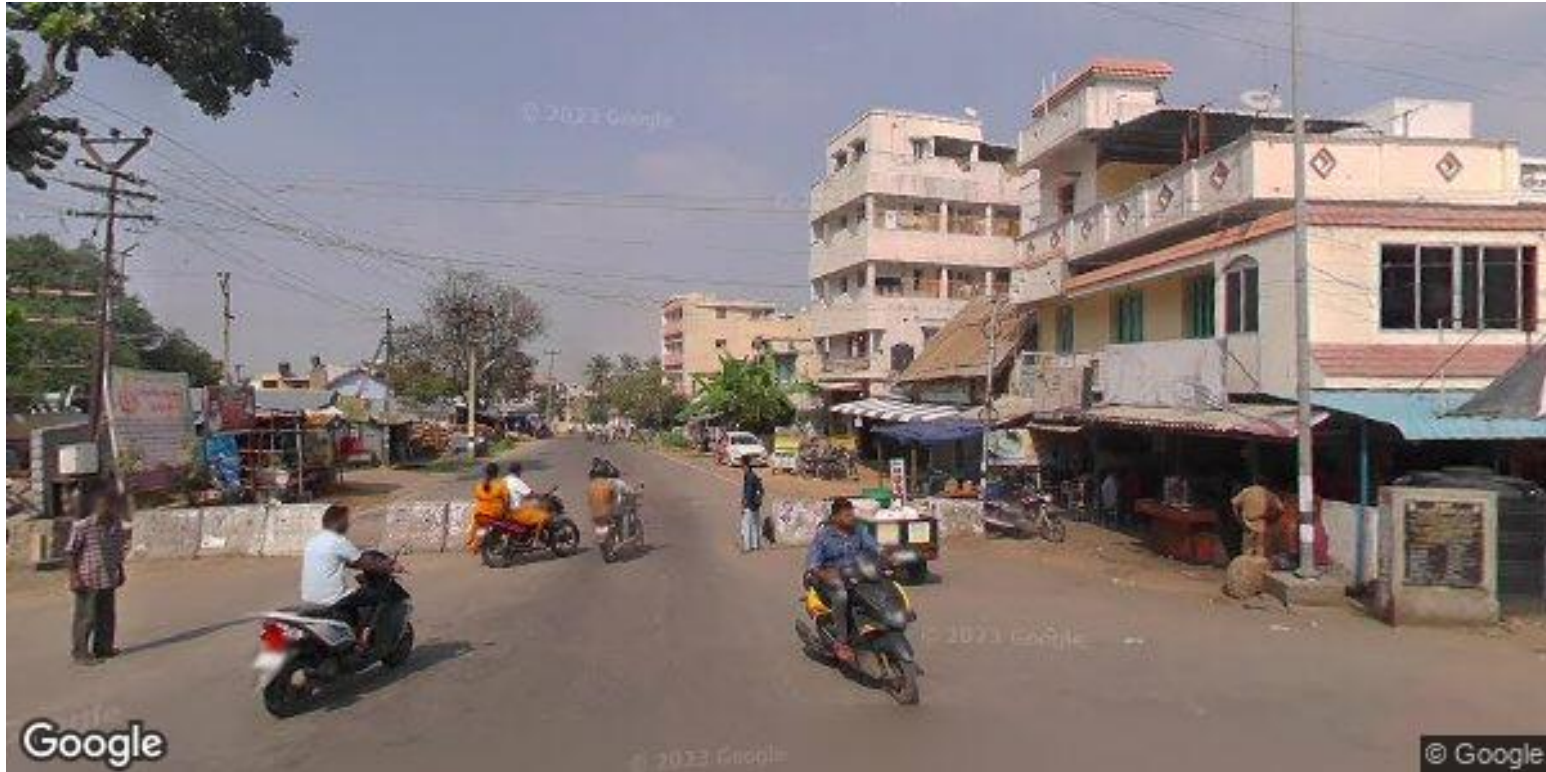
**Risk Type:** Blind Spot  
**Risk Level:** Blind Spot  
**Speed Limit:** 10 KM/Hr  
**Coordinates:** 11.37841, 77.90140

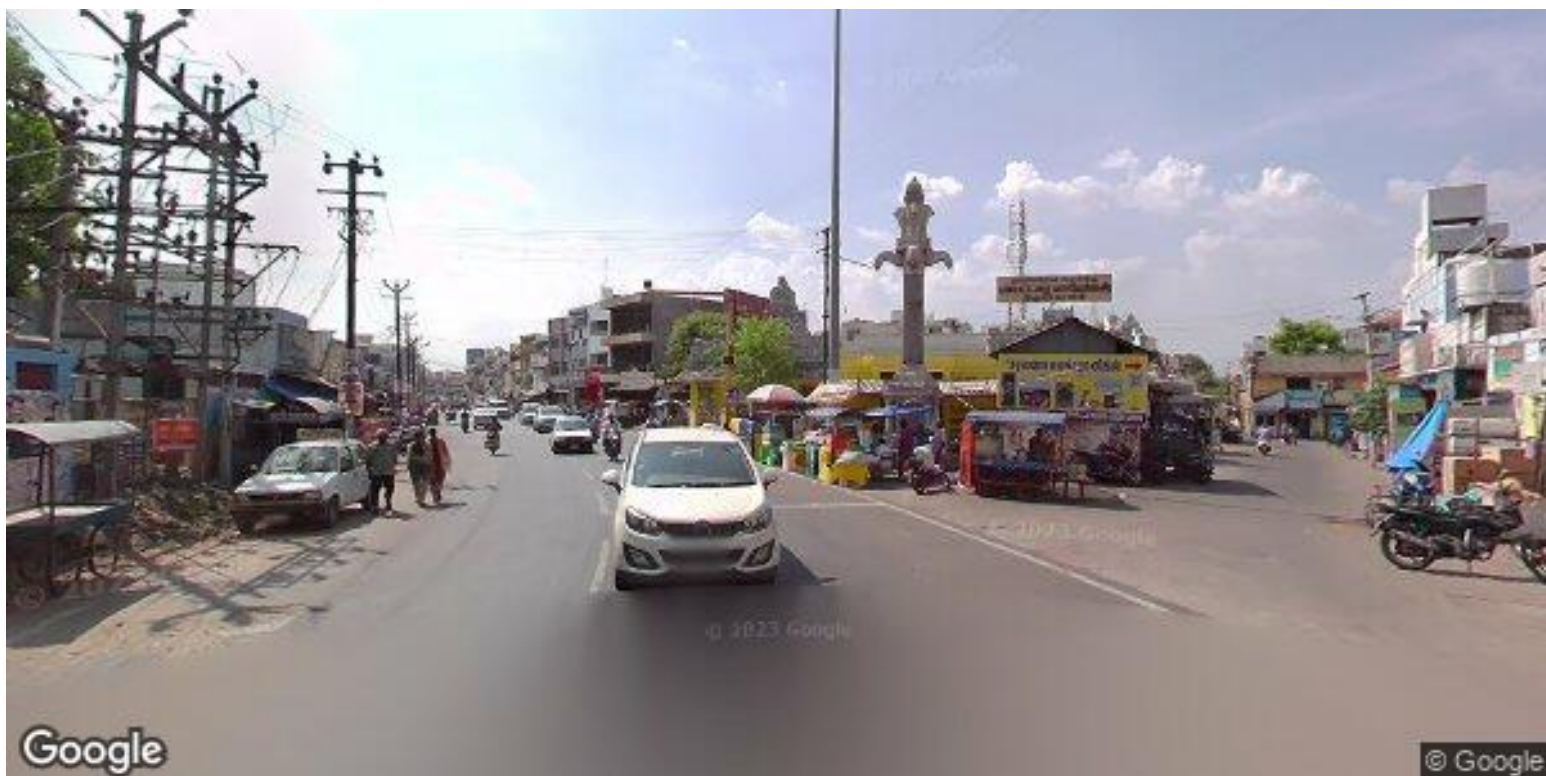
**Risk Type:** Turn  
**Risk Level:** Medium  
**Speed Limit:** 30 KM/Hr  
**Coordinates:** 11.22411, 78.16637

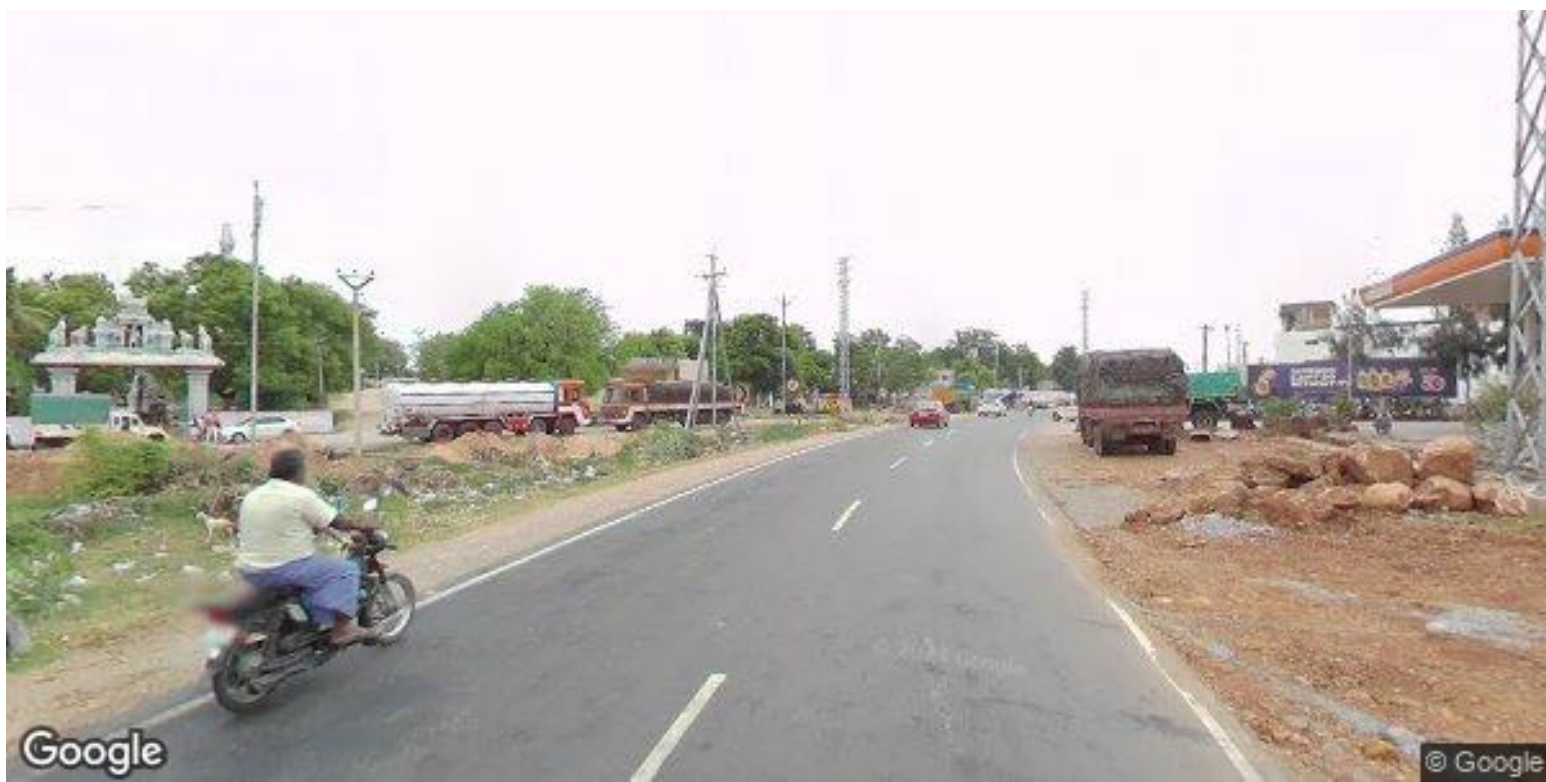
**Risk Type:** Turn

**Risk Level:** Medium

**Speed Limit:** 30 KM/Hr

**Coordinates:** 11.12316, 78.23249

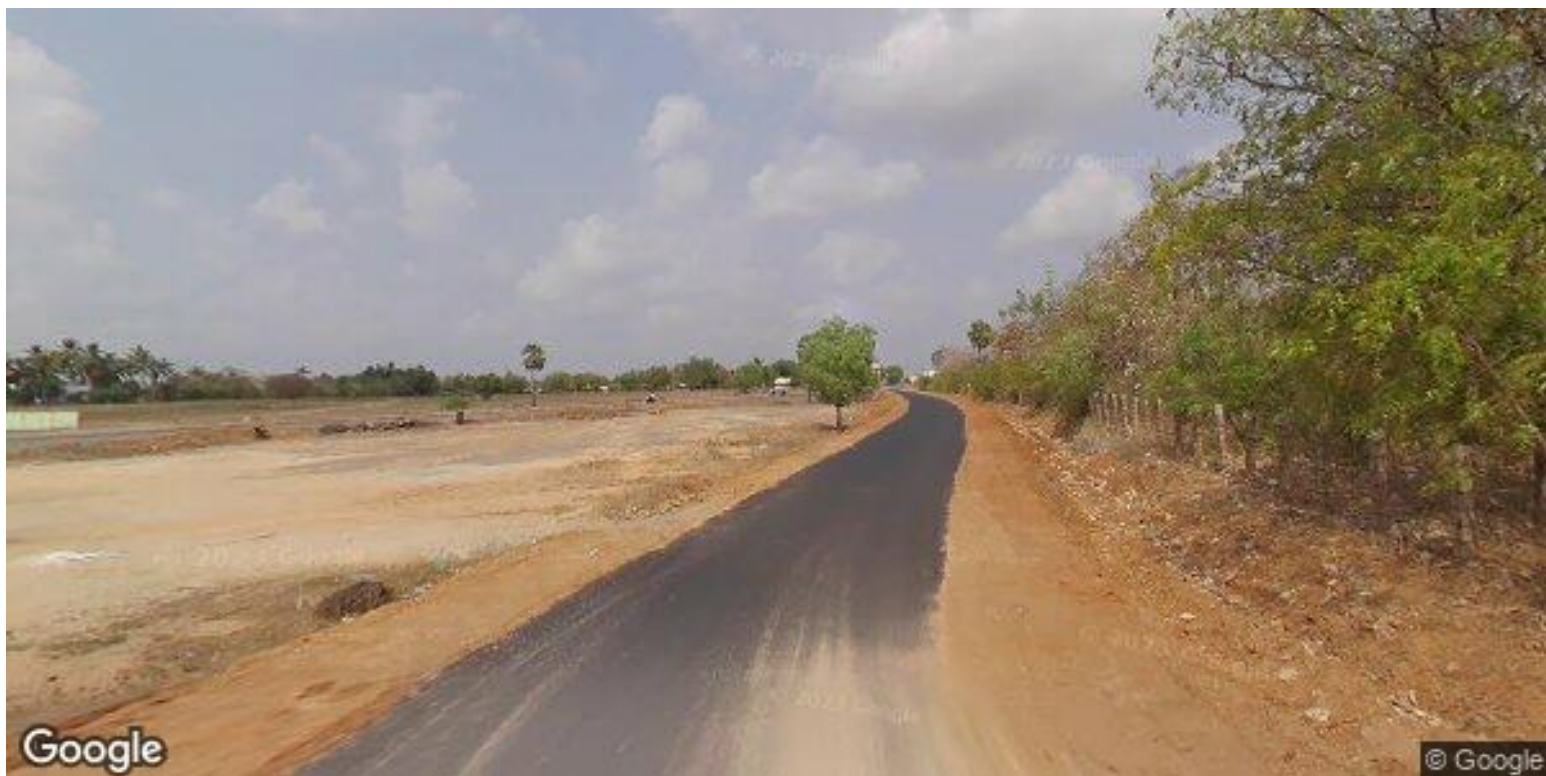
**Risk Type:** Turn

**Risk Level:** Medium

**Speed Limit:** 30 KM/Hr

**Coordinates:** 11.01955, 78.29606

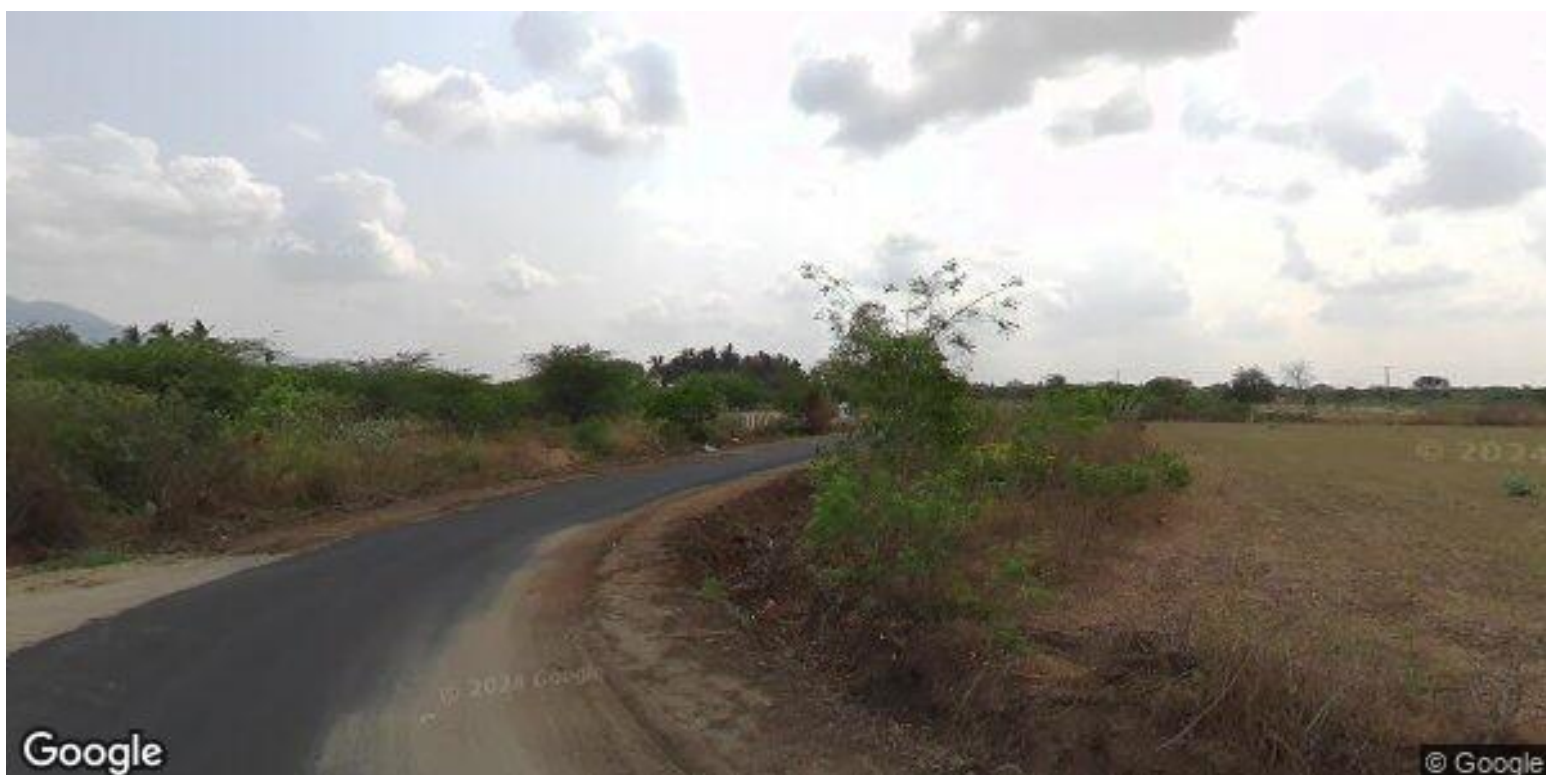
**Risk Type:** Turn  
**Risk Level:** High  
**Speed Limit:** 15 KM/Hr  
**Coordinates:** 11.02380, 78.30469

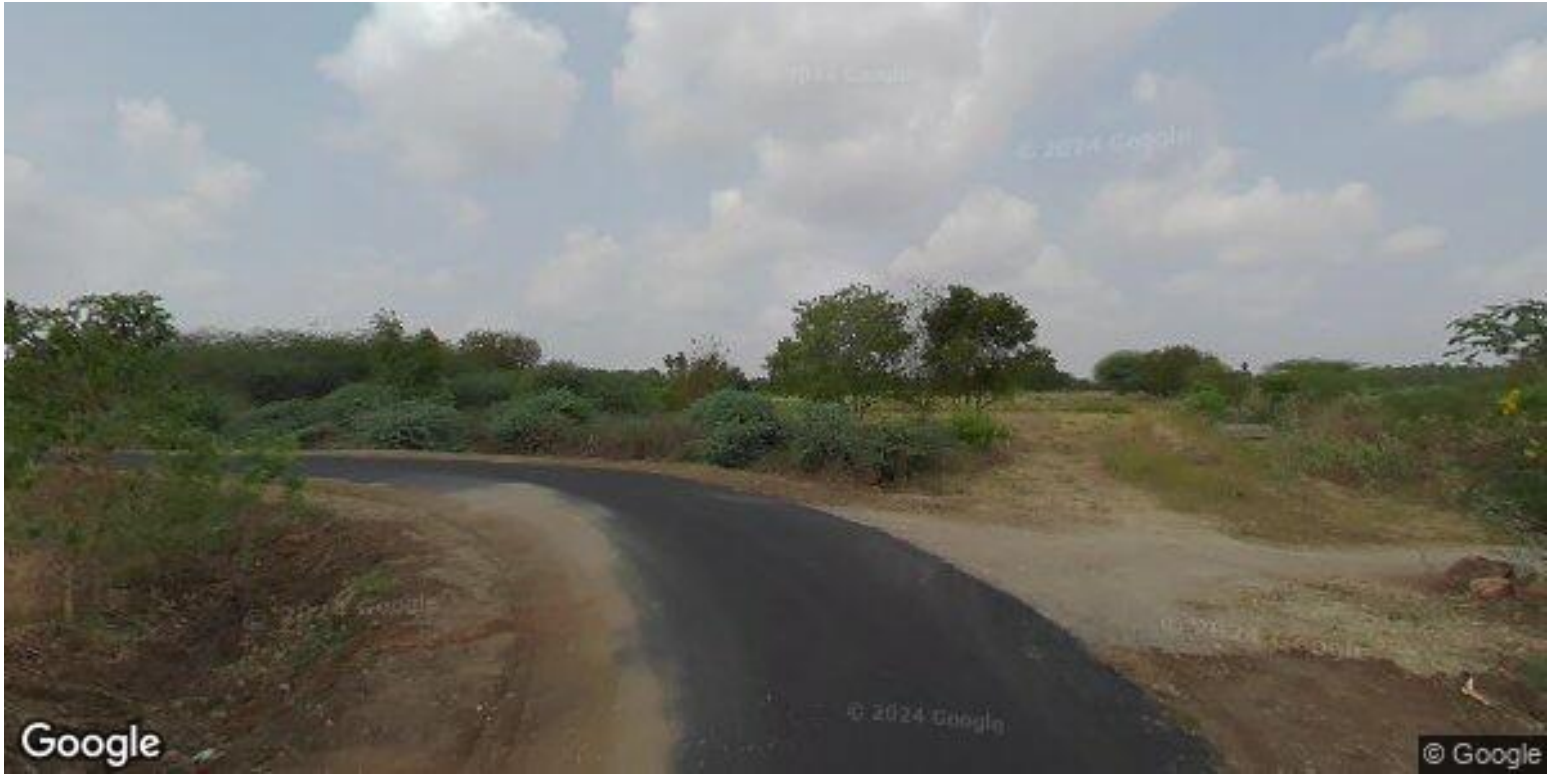
**Risk Type:** Turn  
**Risk Level:** Medium  
**Speed Limit:** 30 KM/Hr  
**Coordinates:** 11.02388, 78.30485

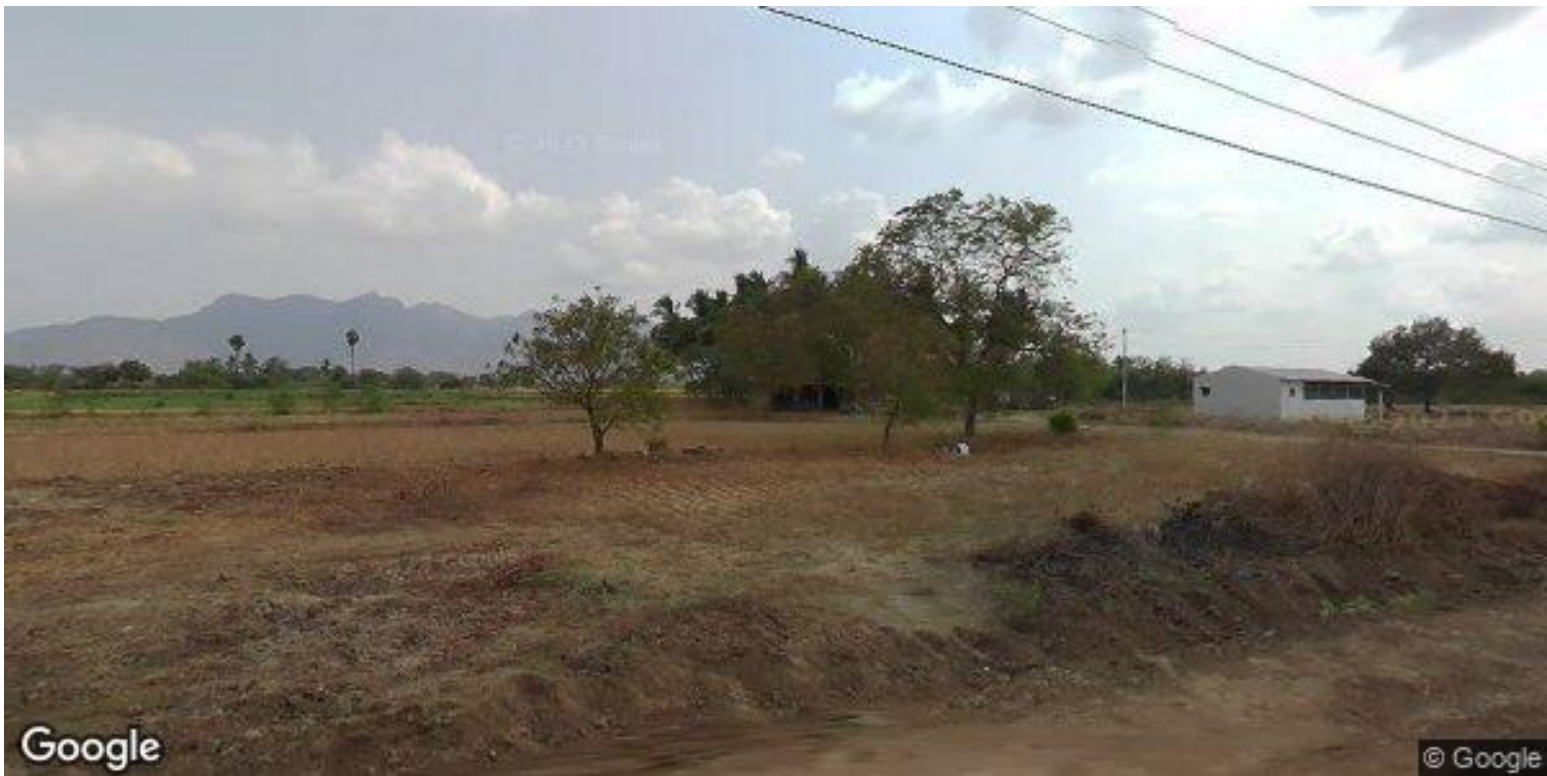
**Risk Type:** Turn  
**Risk Level:** Medium  
**Speed Limit:** 30 KM/Hr  
**Coordinates:** 11.02379, 78.30624

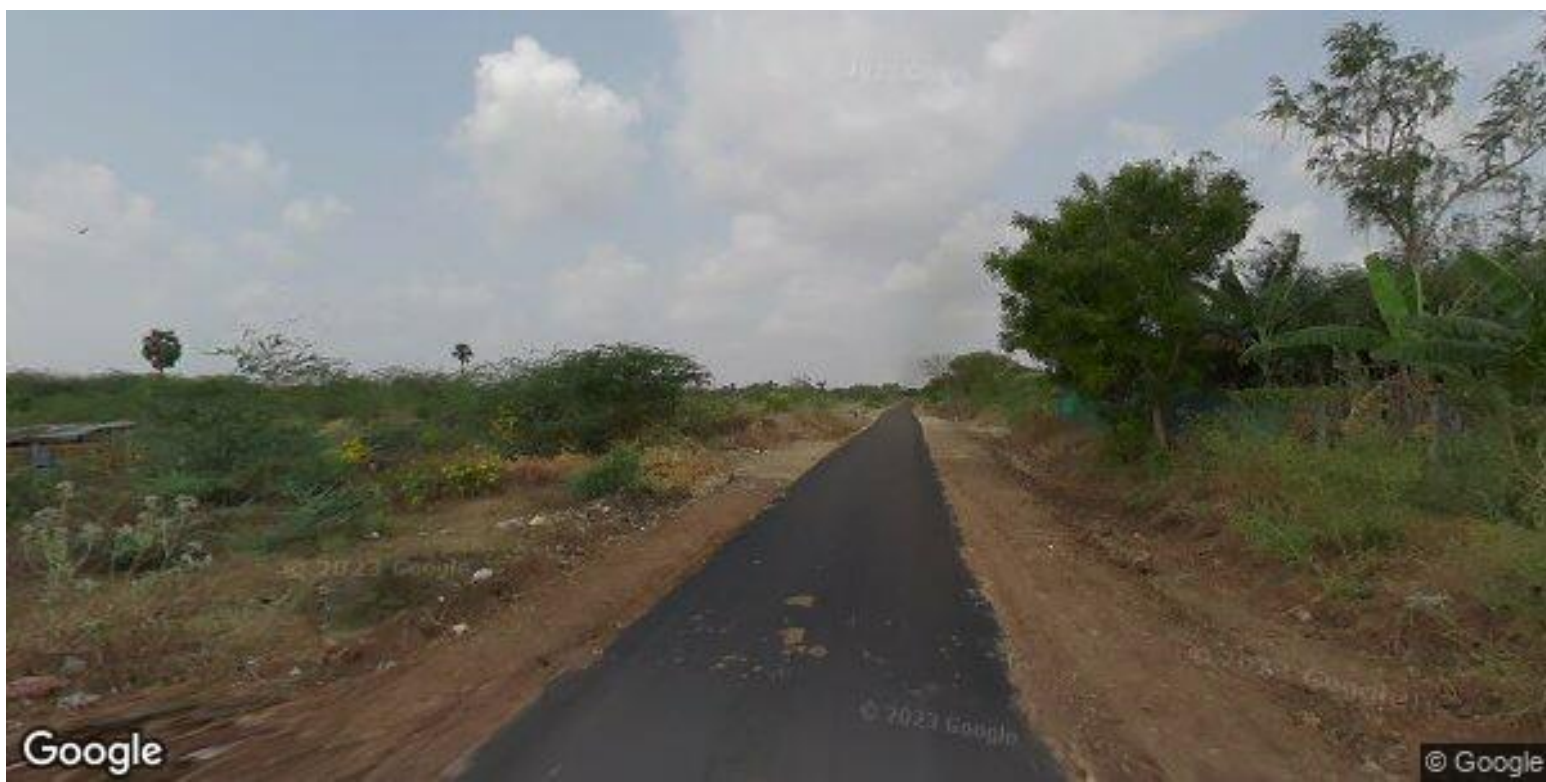
**Risk Type:** Turn

**Risk Level:** Medium

**Speed Limit:** 30 KM/Hr

**Coordinates:** 11.02309, 78.30986

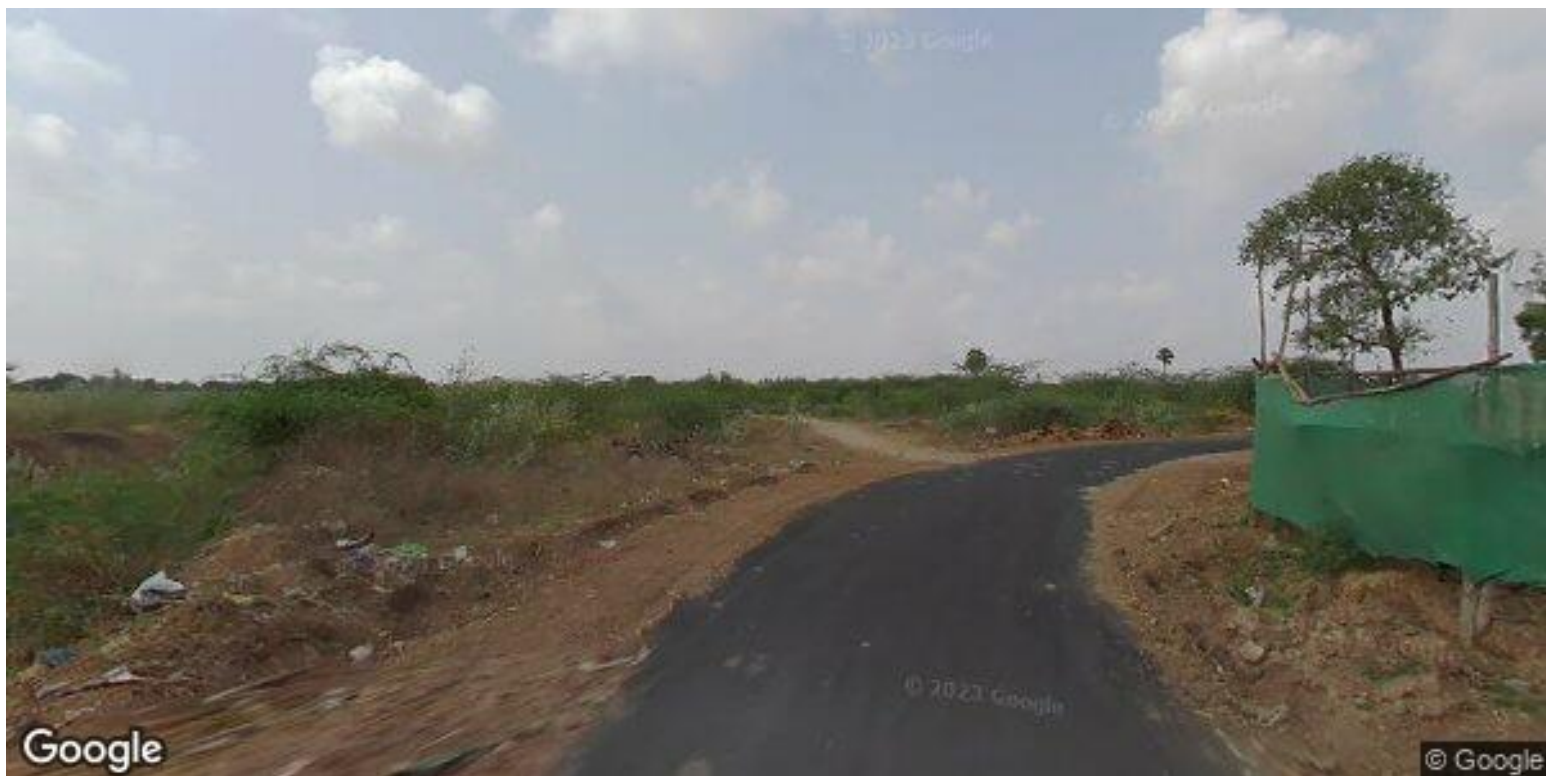
**Risk Type:** Turn

**Risk Level:** Medium

**Speed Limit:** 30 KM/Hr

**Coordinates:** 11.02318, 78.31014

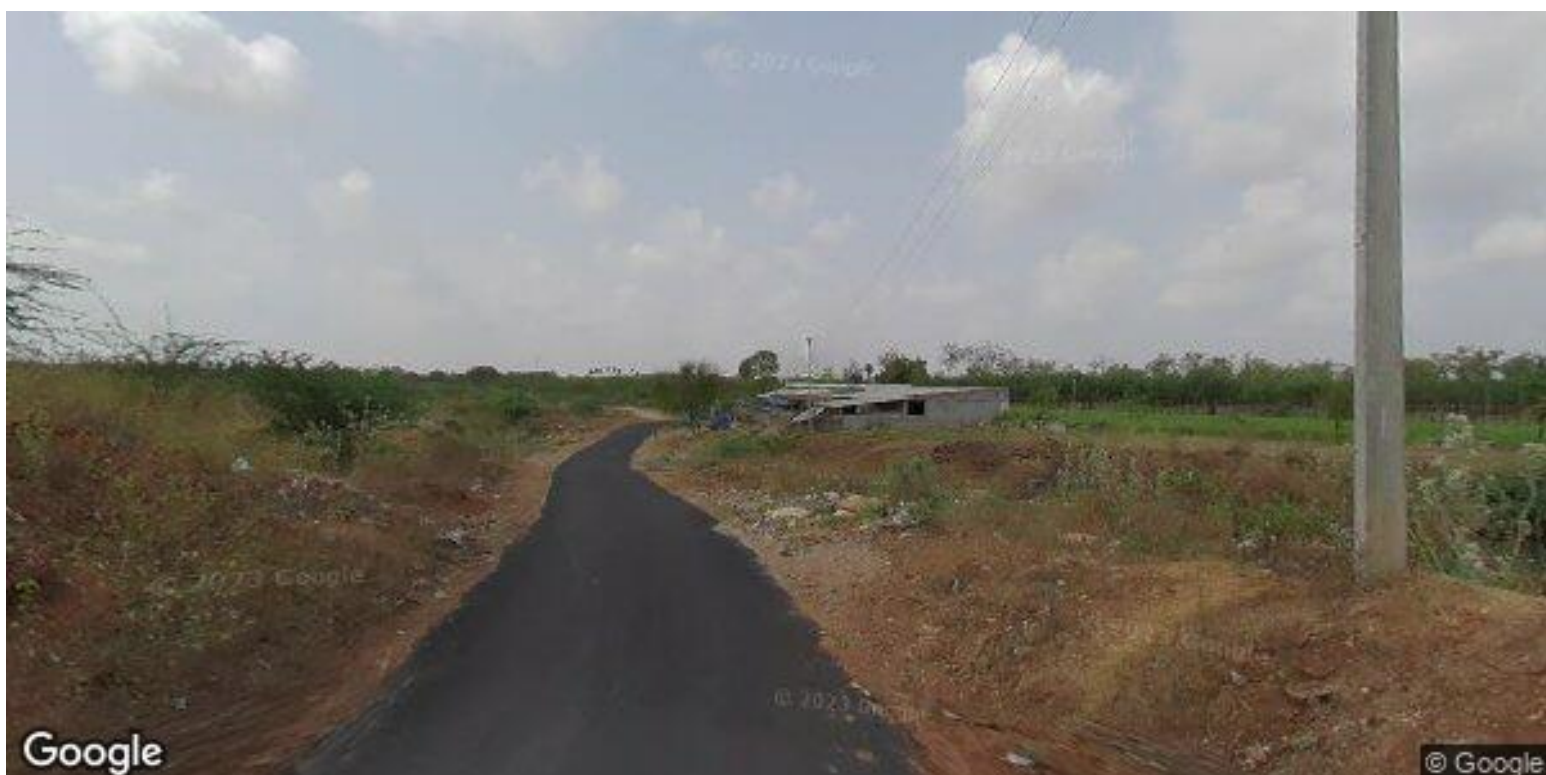
**Risk Type:** Turn  
**Risk Level:** Medium  
**Speed Limit:** 30 KM/Hr  
**Coordinates:** 11.02361, 78.31051

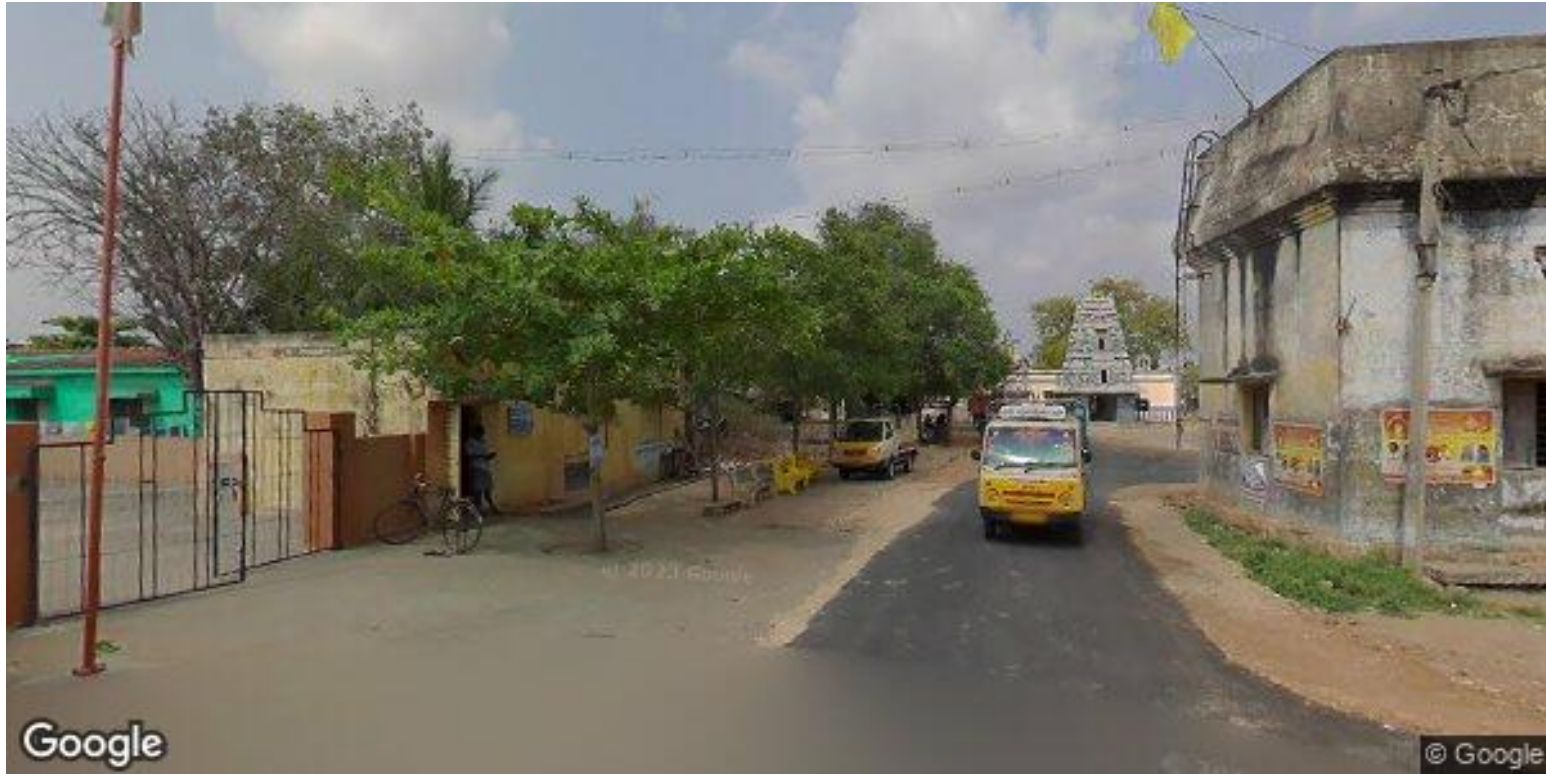
**Risk Type:** Turn  
**Risk Level:** High  
**Speed Limit:** 15 KM/Hr  
**Coordinates:** 11.02379, 78.31257

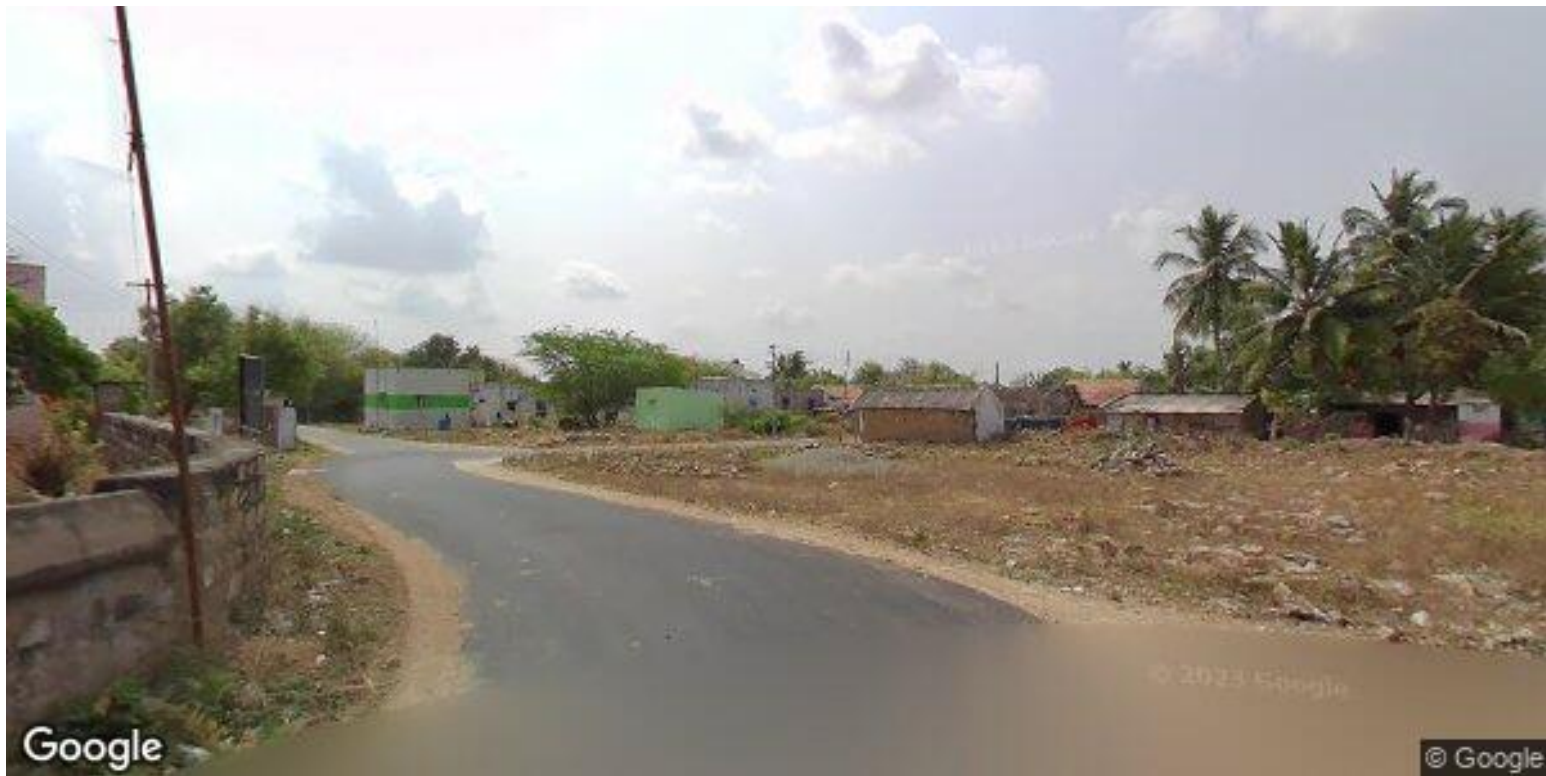
**Risk Type:** Turn  
**Risk Level:** High  
**Speed Limit:** 15 KM/Hr  
**Coordinates:** 11.02331, 78.31290

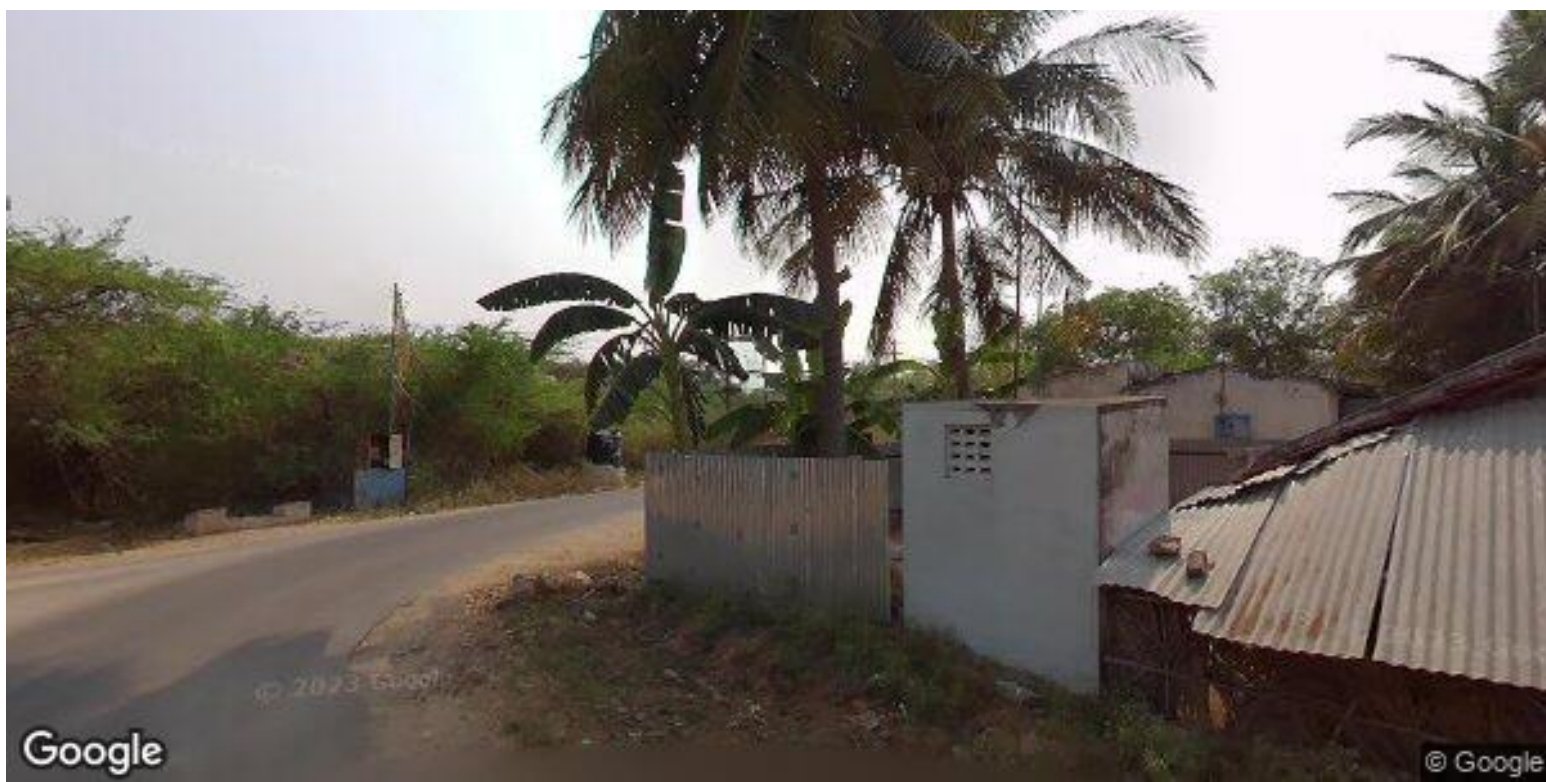
**Risk Type:** Turn

**Risk Level:** Medium

**Speed Limit:** 30 KM/Hr

**Coordinates:** 11.02315, 78.31531

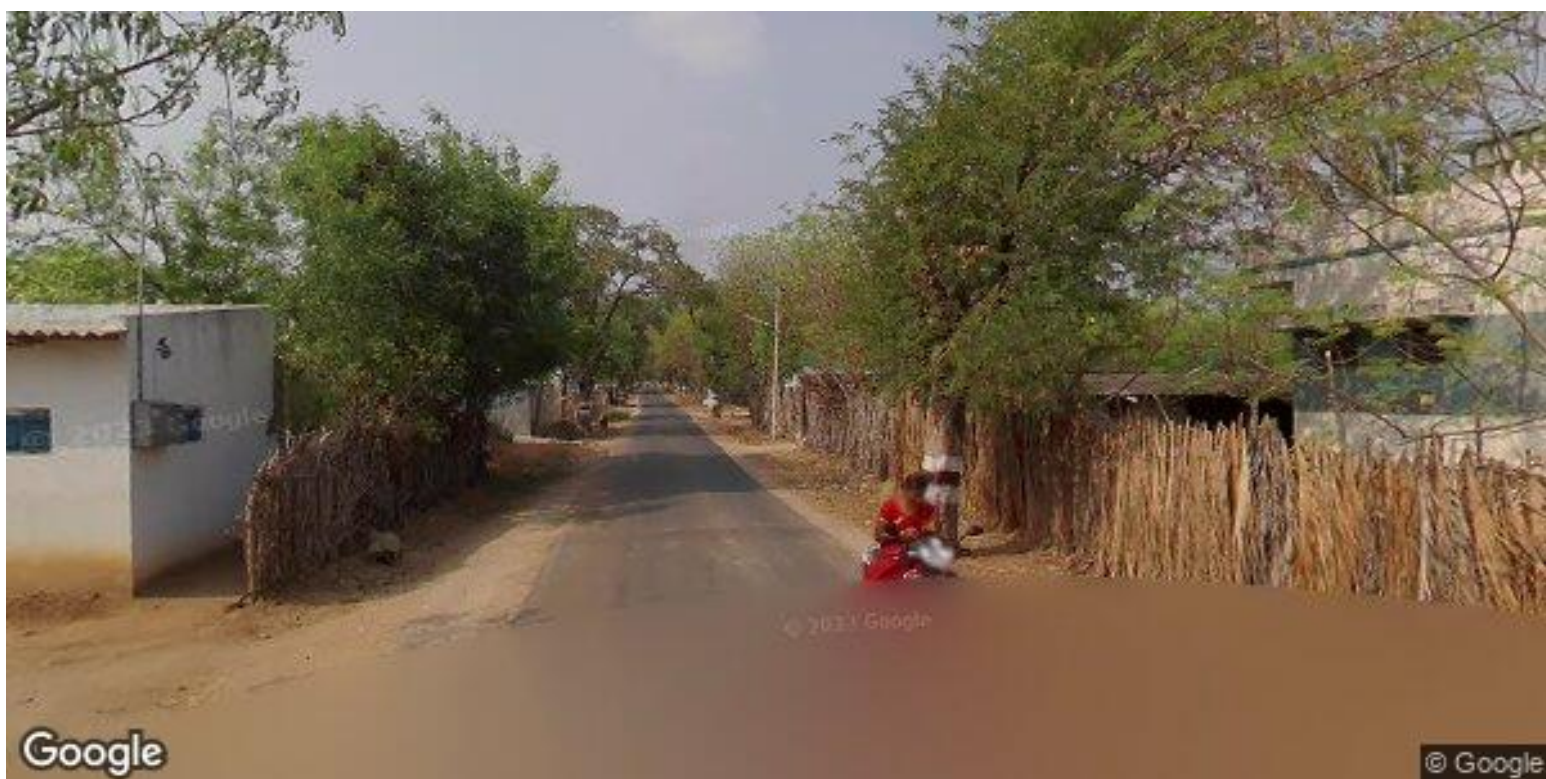
**Risk Type:** Turn

**Risk Level:** Medium

**Speed Limit:** 30 KM/Hr

**Coordinates:** 11.02337, 78.31554
