# IndianOil

## **JOURNEY RISK MANAGEMENT (JRM) STUDY**

### **Salem Terminal to SRINIVASHA AGENCIES**

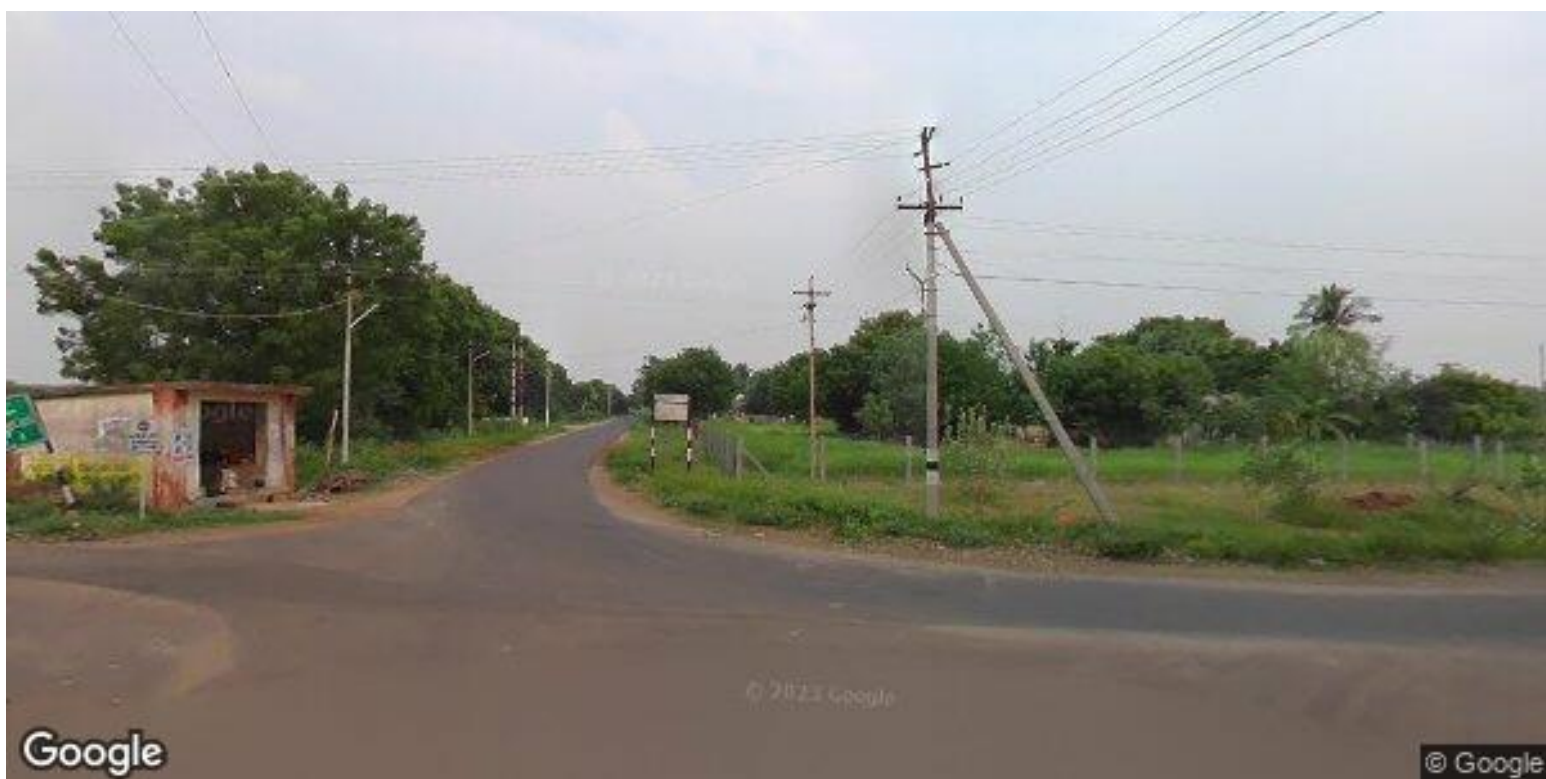
**Risk Type:** Turn  
**Risk Level:** High  
**Speed Limit:** 15 KM/Hr  
**Coordinates:** 11.02636, 78.31603

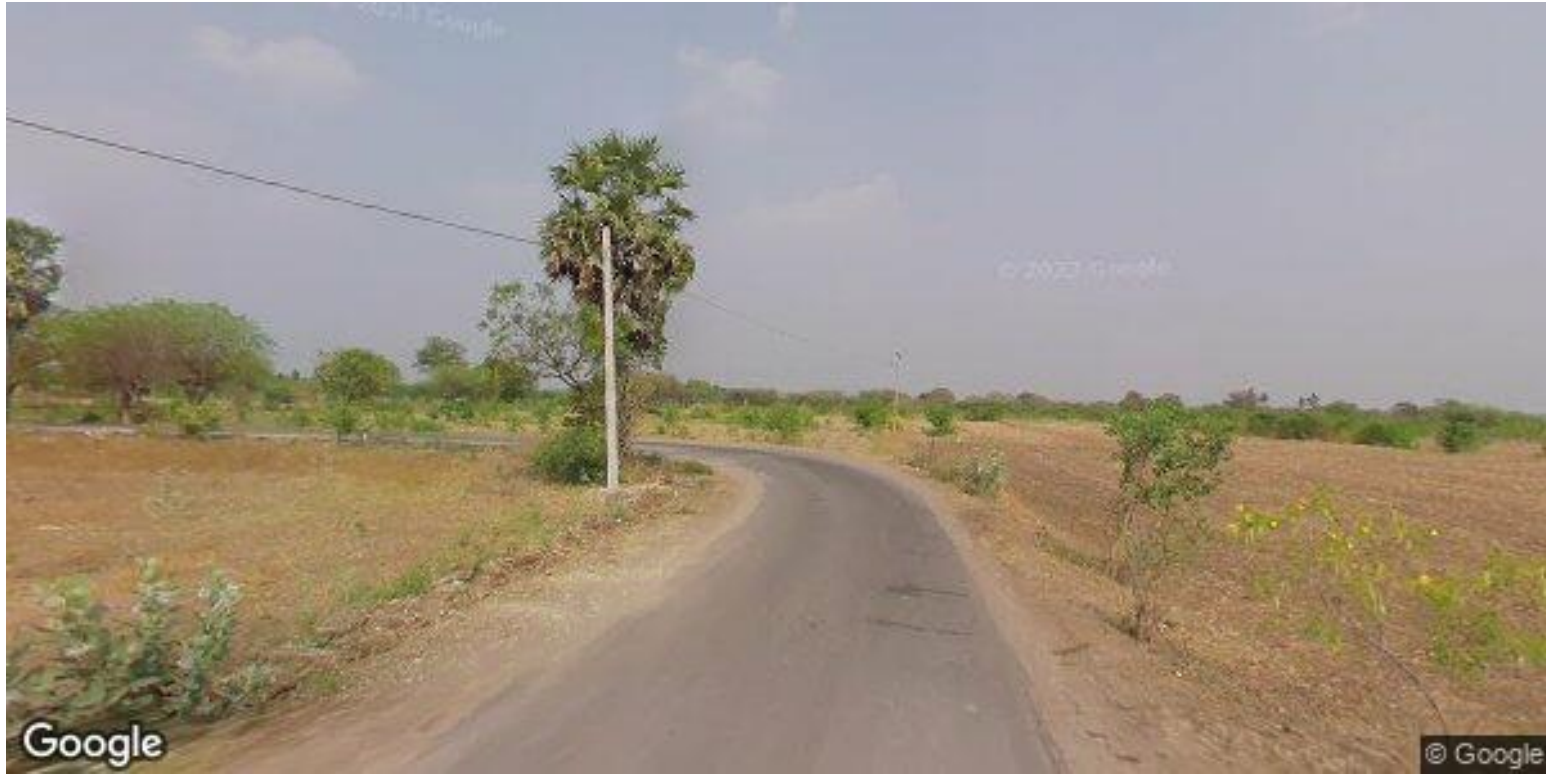
**Risk Type:** Turn  
**Risk Level:** High  
**Speed Limit:** 15 KM/Hr  
**Coordinates:** 11.02623, 78.31782

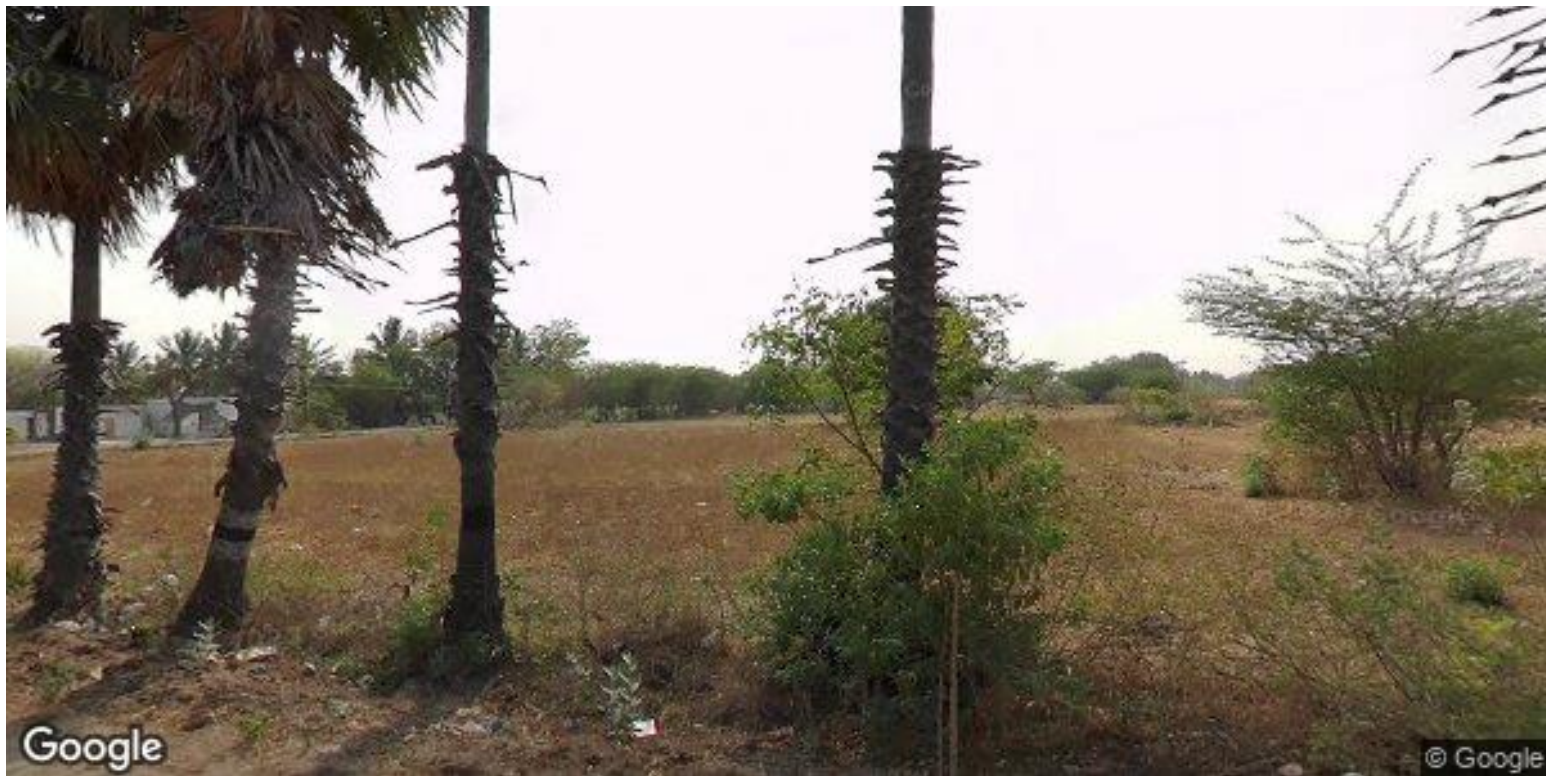
**Risk Type:** Turn  
**Risk Level:** High  
**Speed Limit:** 15 KM/Hr  
**Coordinates:** 11.02669, 78.31793

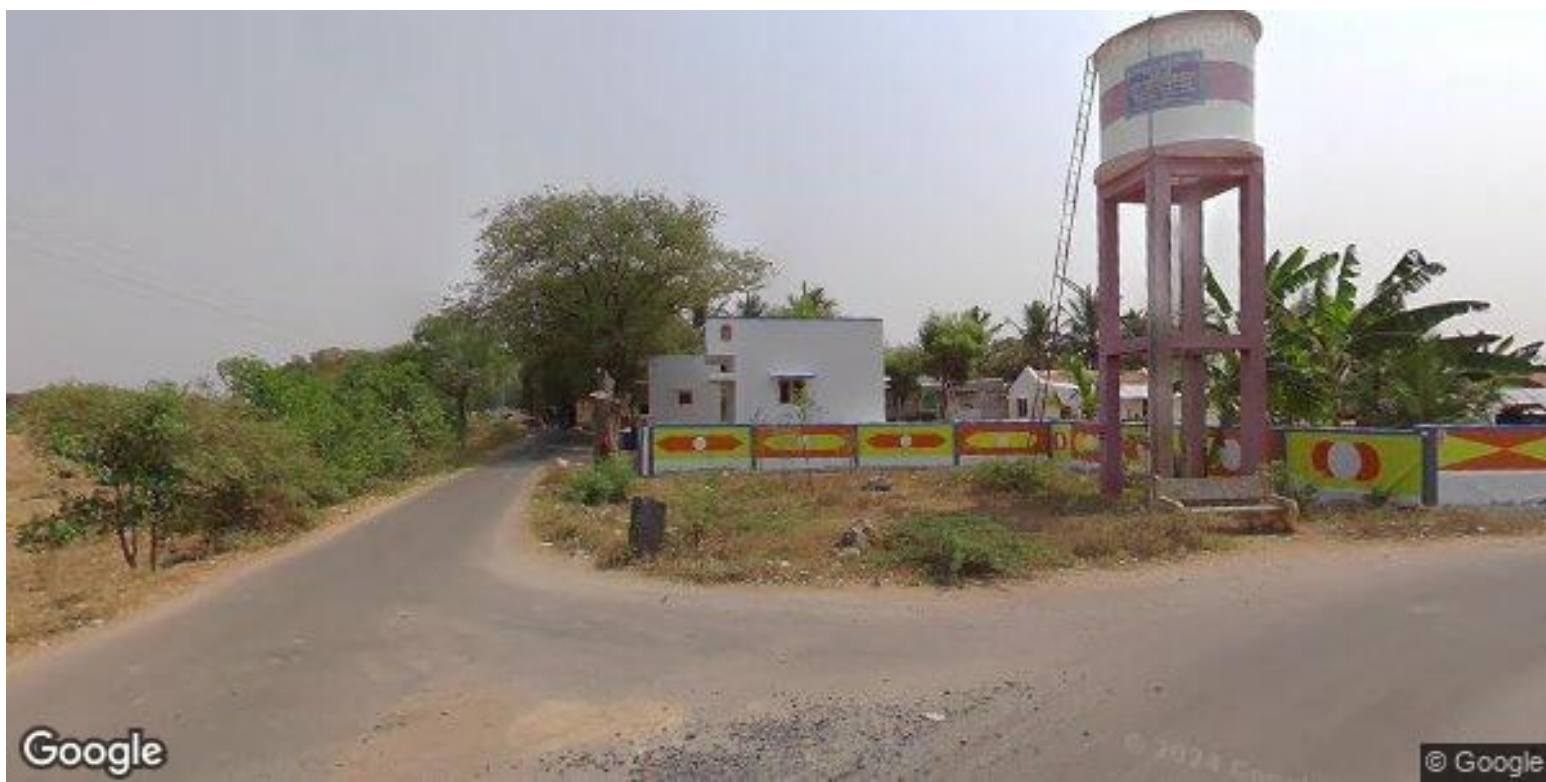
**Risk Type:** Blind Spot

**Risk Level:** Blind Spot

**Speed Limit:** 10 KM/Hr

**Coordinates:** 11.02672, 78.32798

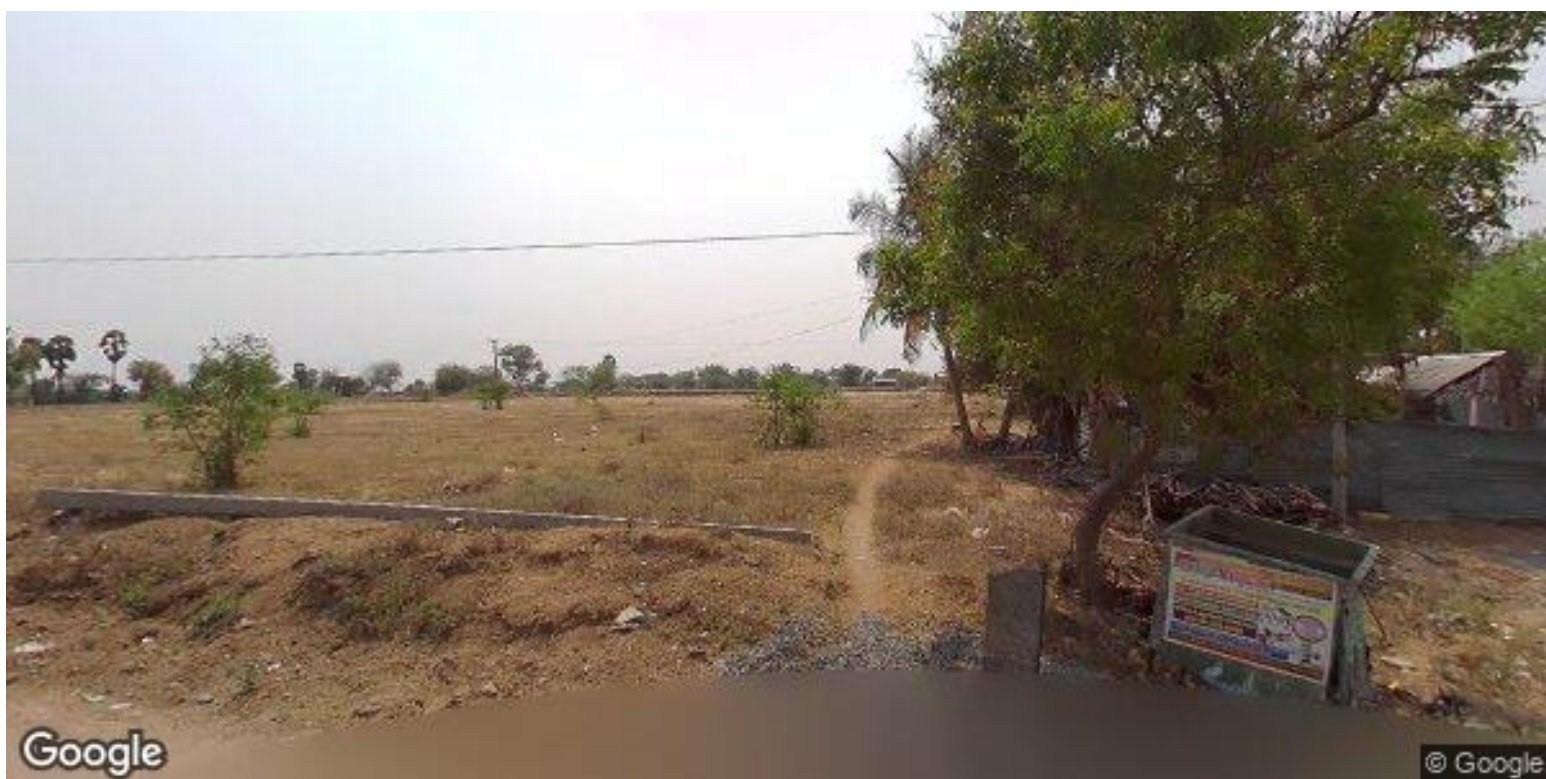
**Risk Type:** Turn

**Risk Level:** High

**Speed Limit:** 15 KM/Hr

**Coordinates:** 11.02792, 78.32782

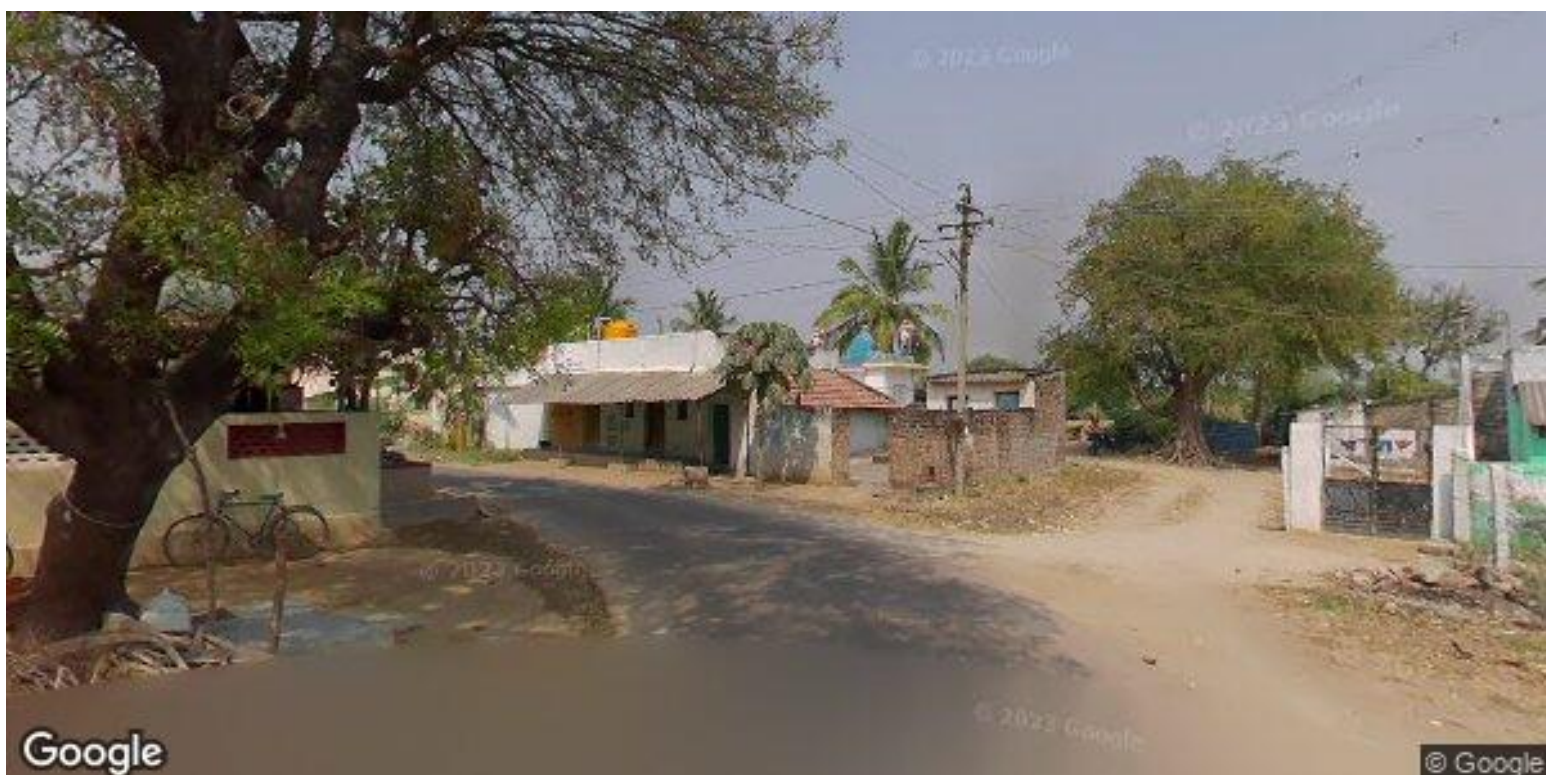
**Risk Type:** Turn  
**Risk Level:** High  
**Speed Limit:** 15 KM/Hr  
**Coordinates:** 11.02840, 78.32974

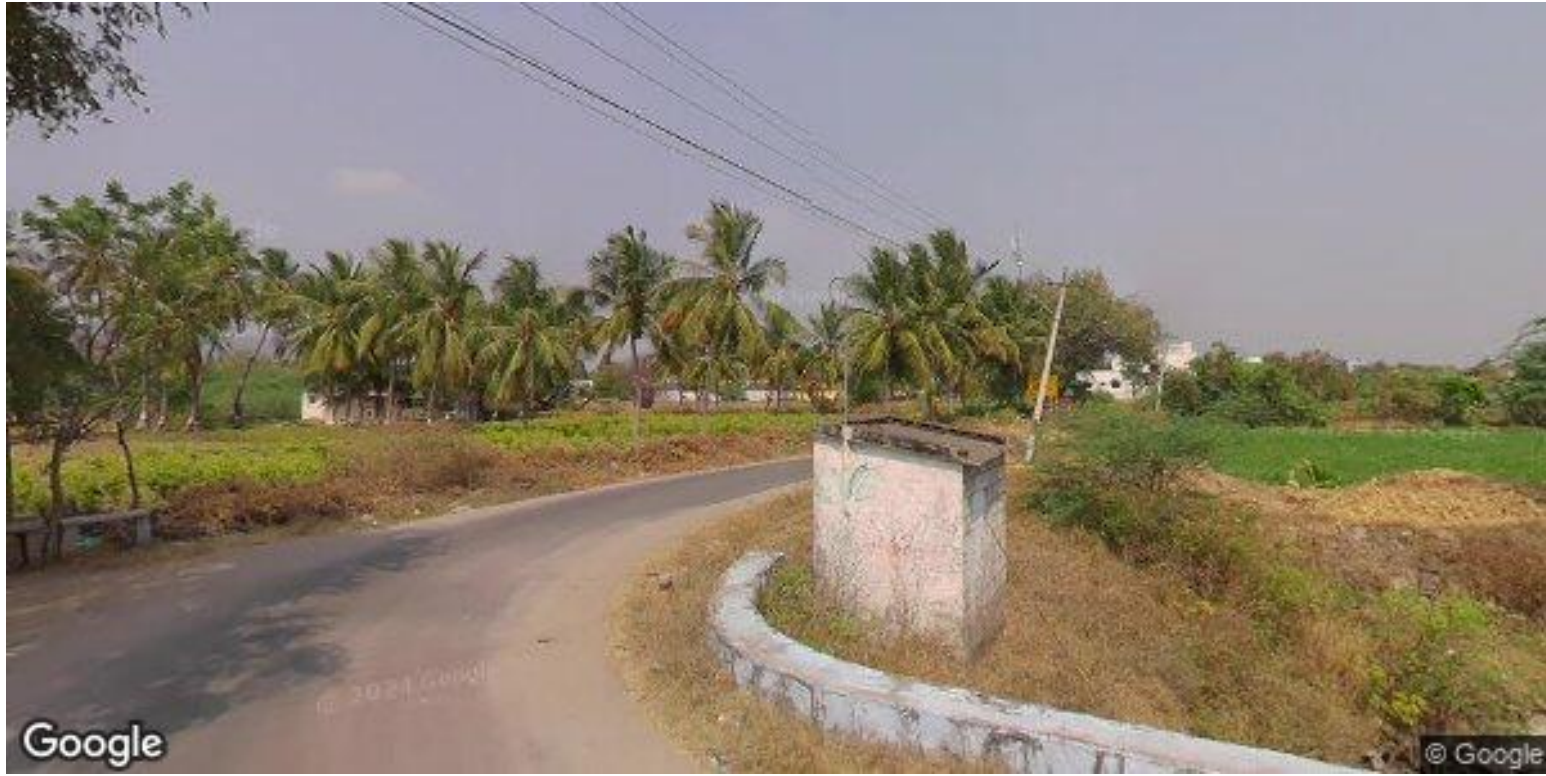
**Risk Type:** Turn  
**Risk Level:** High  
**Speed Limit:** 15 KM/Hr  
**Coordinates:** 11.02989, 78.33033

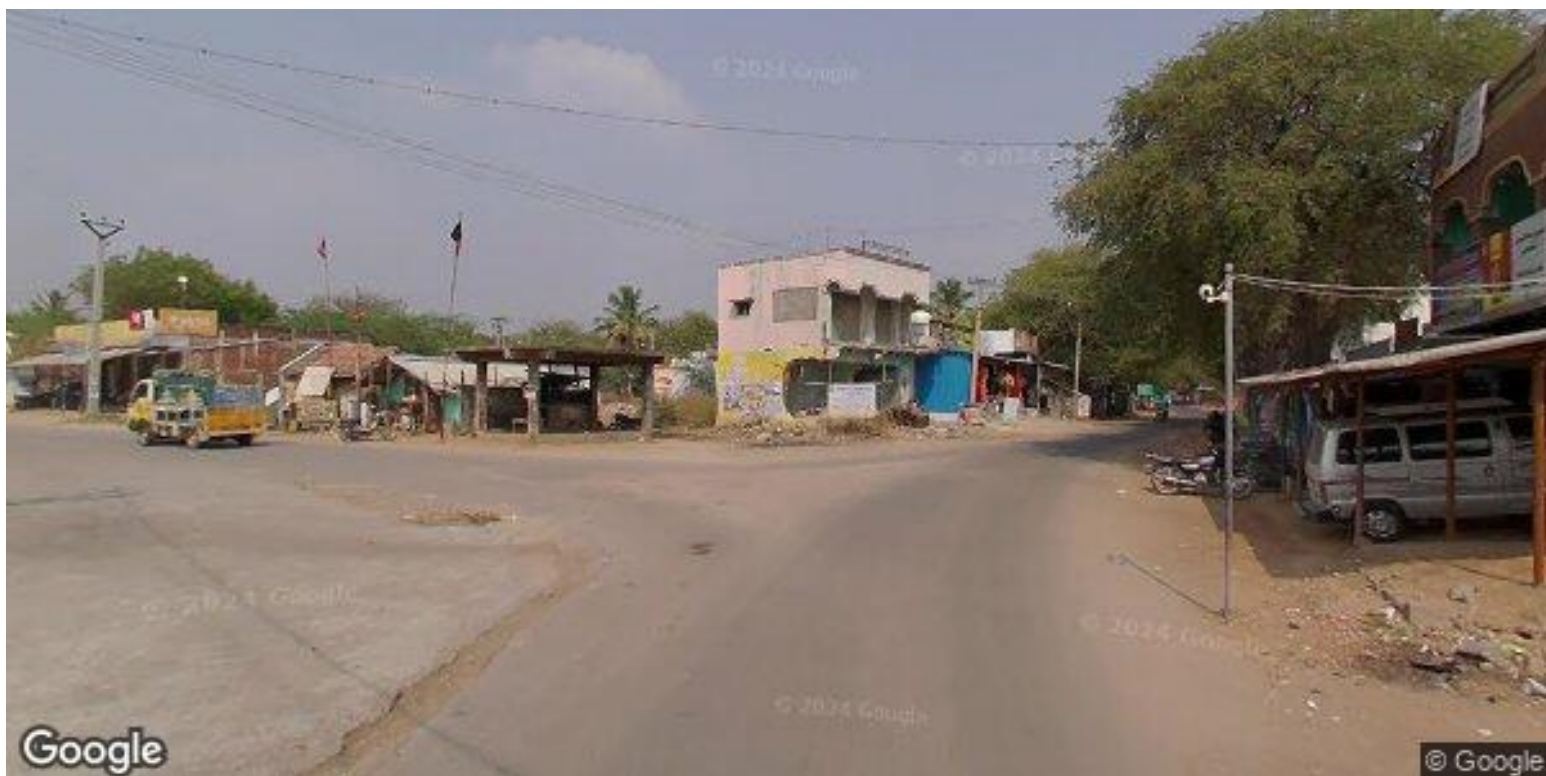
**Risk Type:** Turn  
**Risk Level:** Medium  
**Speed Limit:** 30 KM/Hr  
**Coordinates:** 11.03026, 78.33423

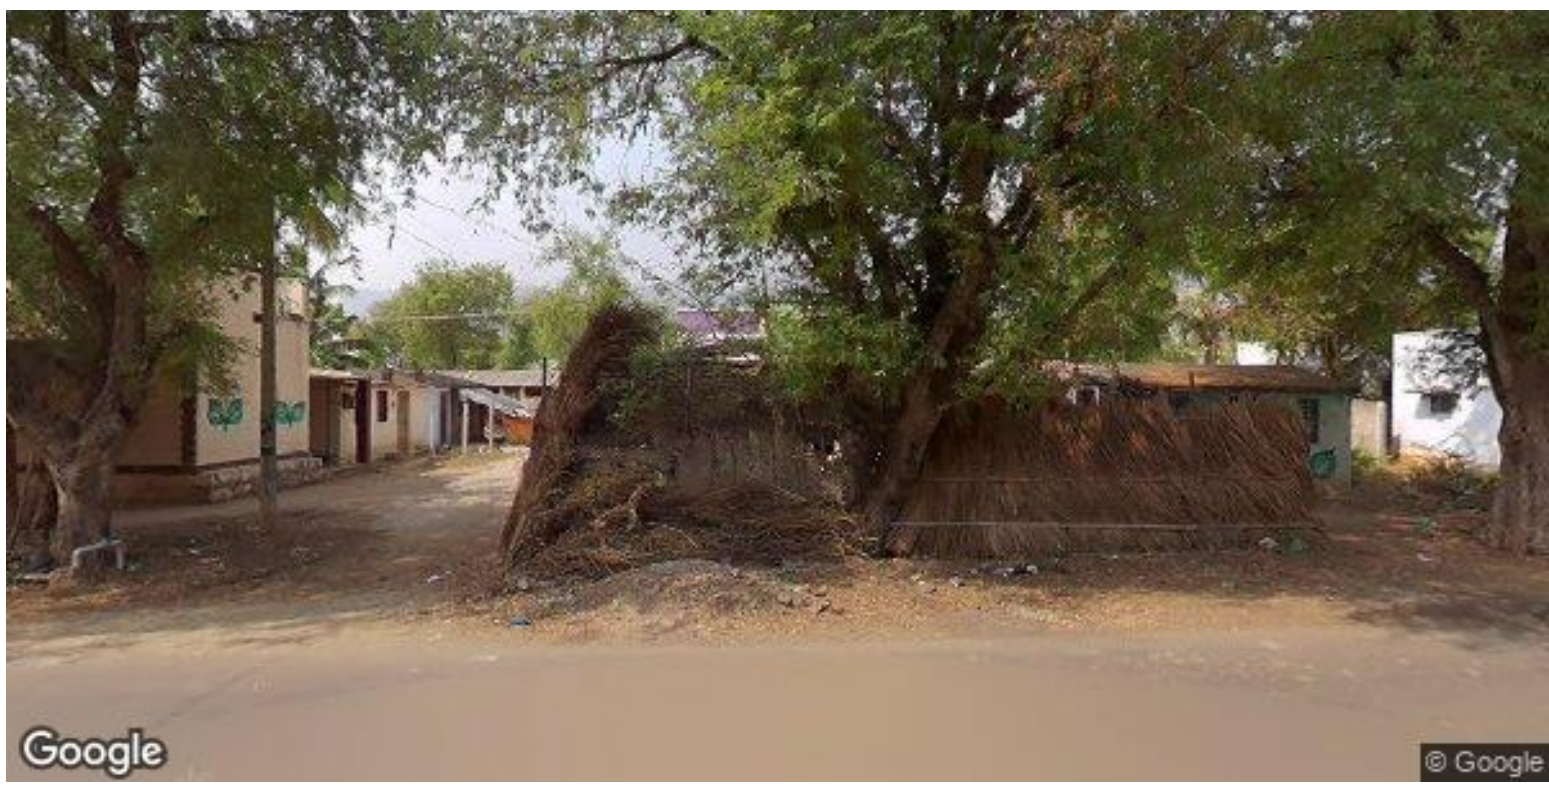
**Risk Type:** Blind Spot

**Risk Level:** Blind Spot

**Speed Limit:** 10 KM/Hr

**Coordinates:** 11.03014, 78.33509
