## JOURNEY RISK MANAGEMENT (JRM) STUDY

### Salem Terminal to MAHA FUEL AGENCY

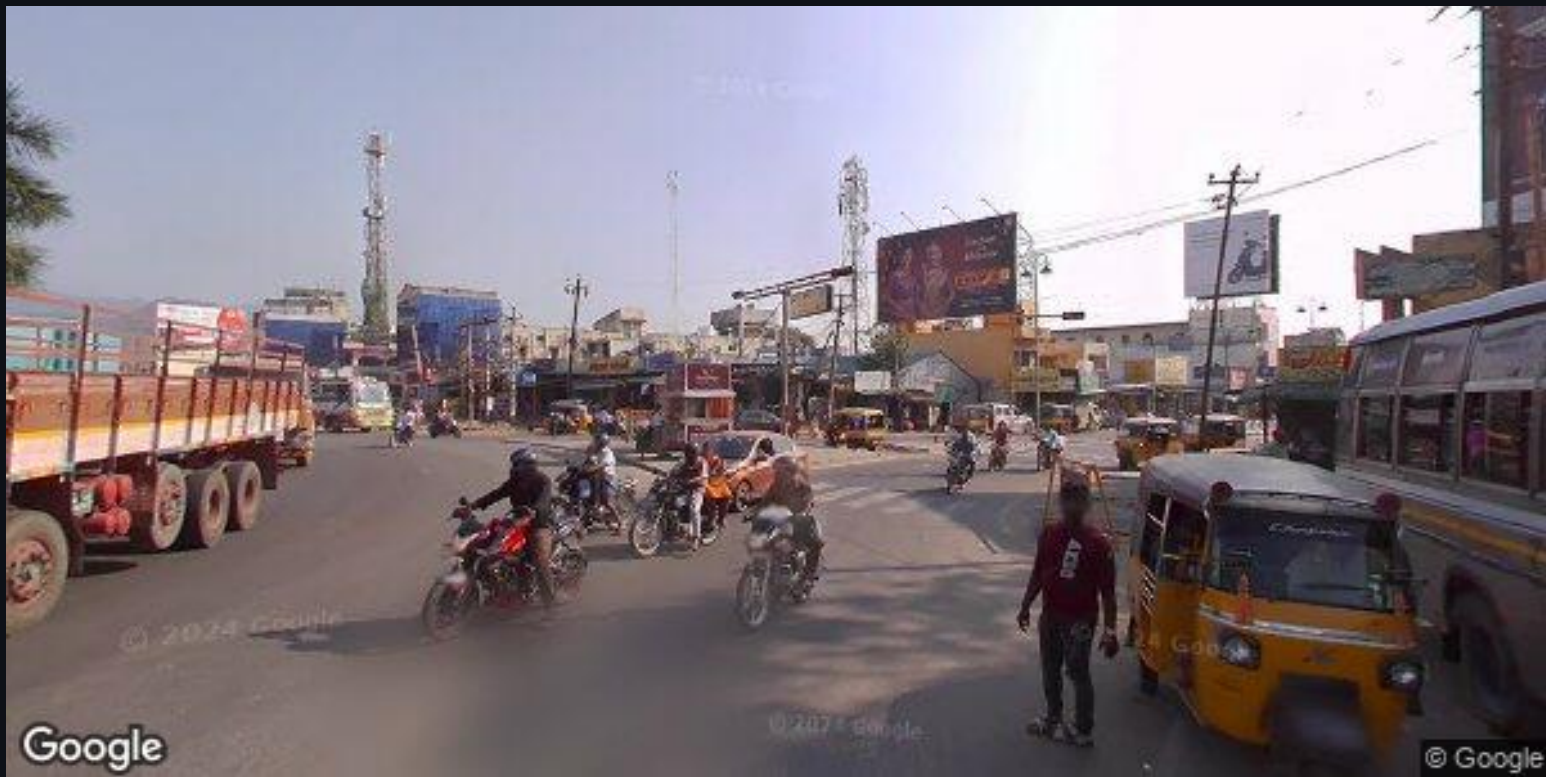
**Coordinates:** 11.63266, 78.12699

**Risk Type:** Roundabout

**Risk Level:** High

**Speed Limit:** 15 KM/Hr

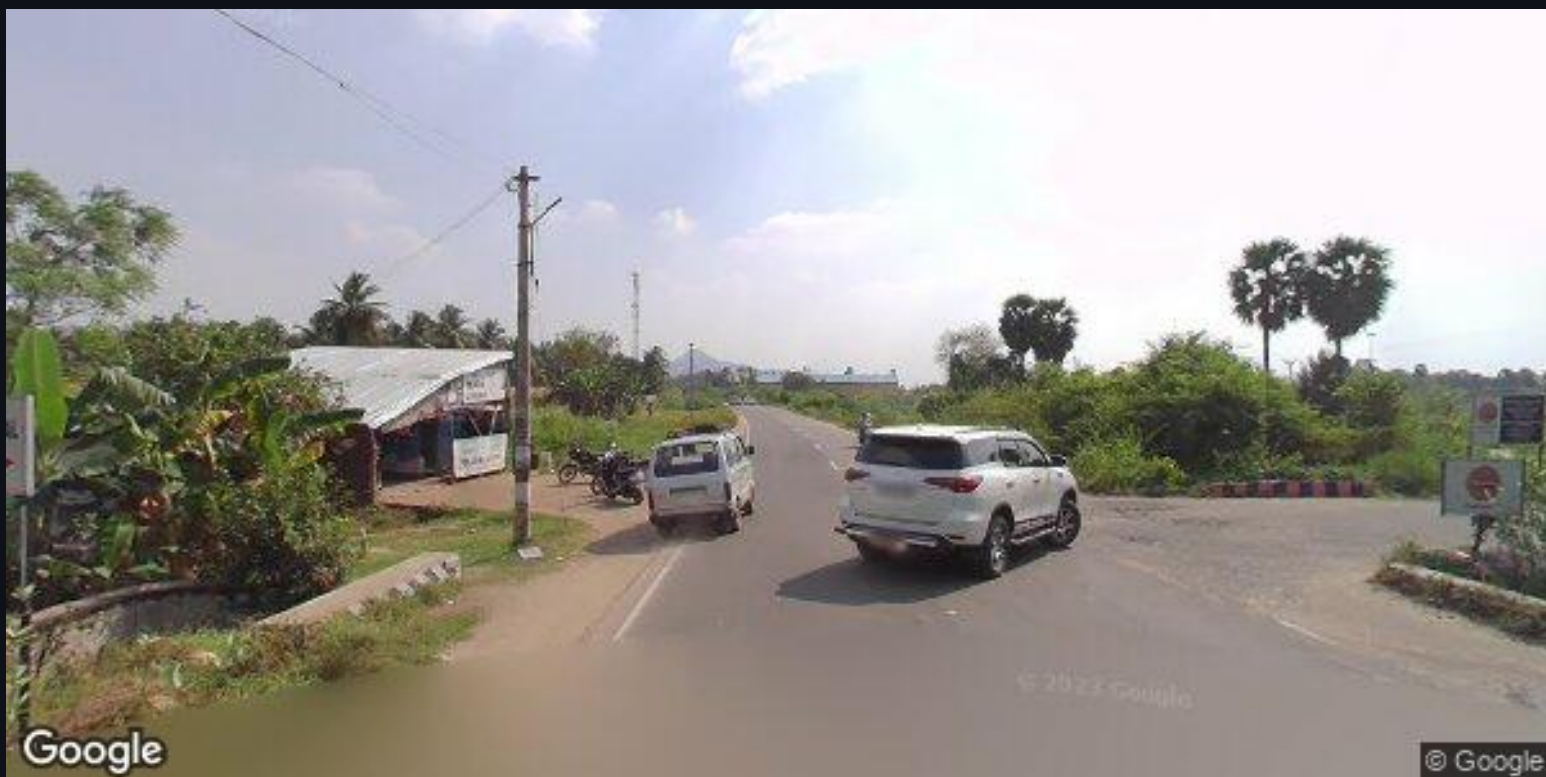
**Coordinates:** 11.44029, 77.87544

**Risk Type:** Turn

**Risk Level:** High

**Speed Limit:** 15 KM/Hr

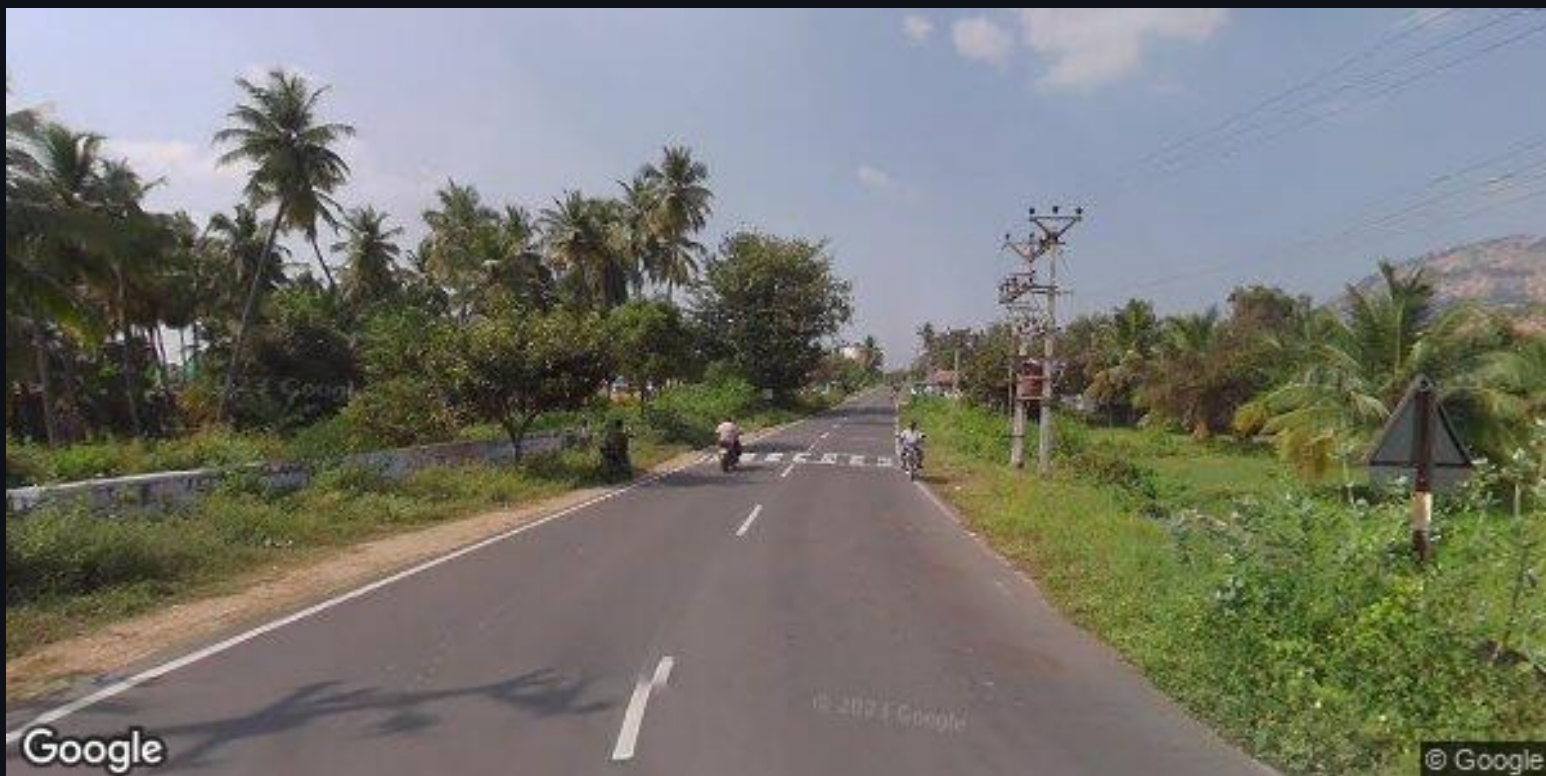
**Coordinates: 11.45353, 77.85697**

**Risk Type: Turn**

**Risk Level: High**

**Speed Limit: 15 KM/Hr**

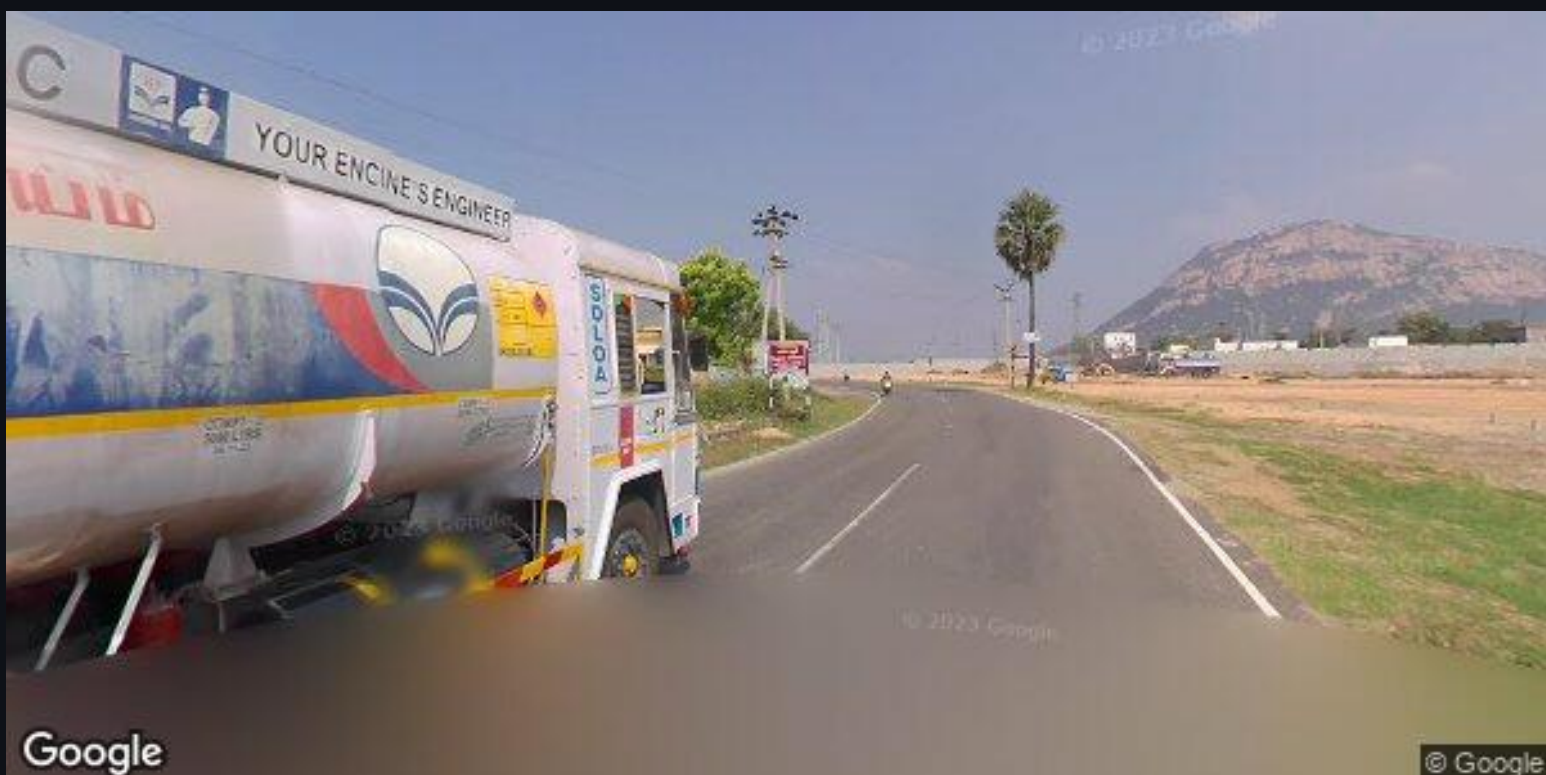
**Risk Type:** Turn  
**Risk Level:** Medium  
**Speed Limit:** 30 KM/Hr  
**Coordinates:** 11.45853, 77.85139

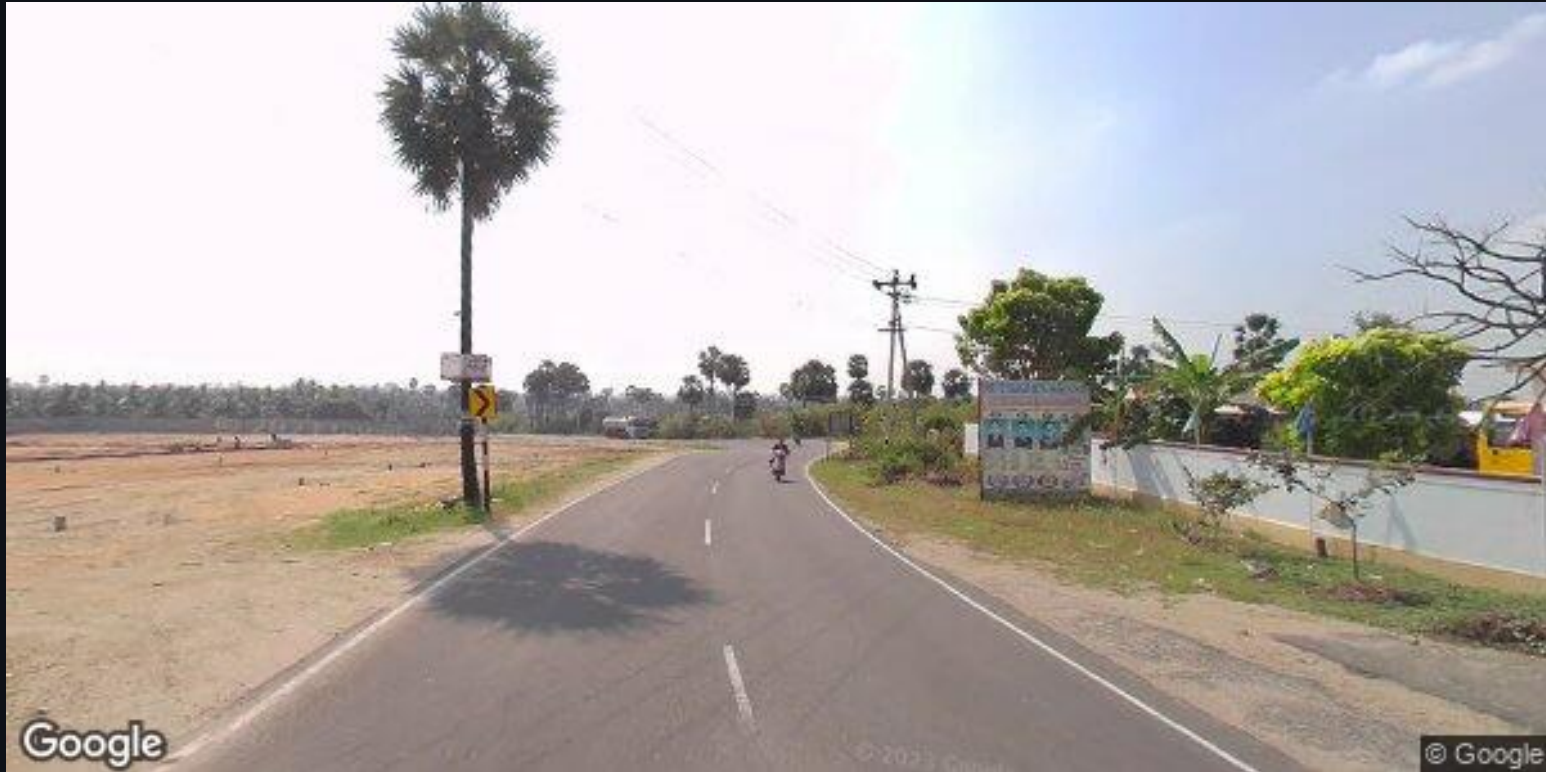
**Risk Type:** Turn  
**Risk Level:** Medium  
**Speed Limit:** 30 KM/Hr  
**Coordinates:** 11.45906, 77.85132

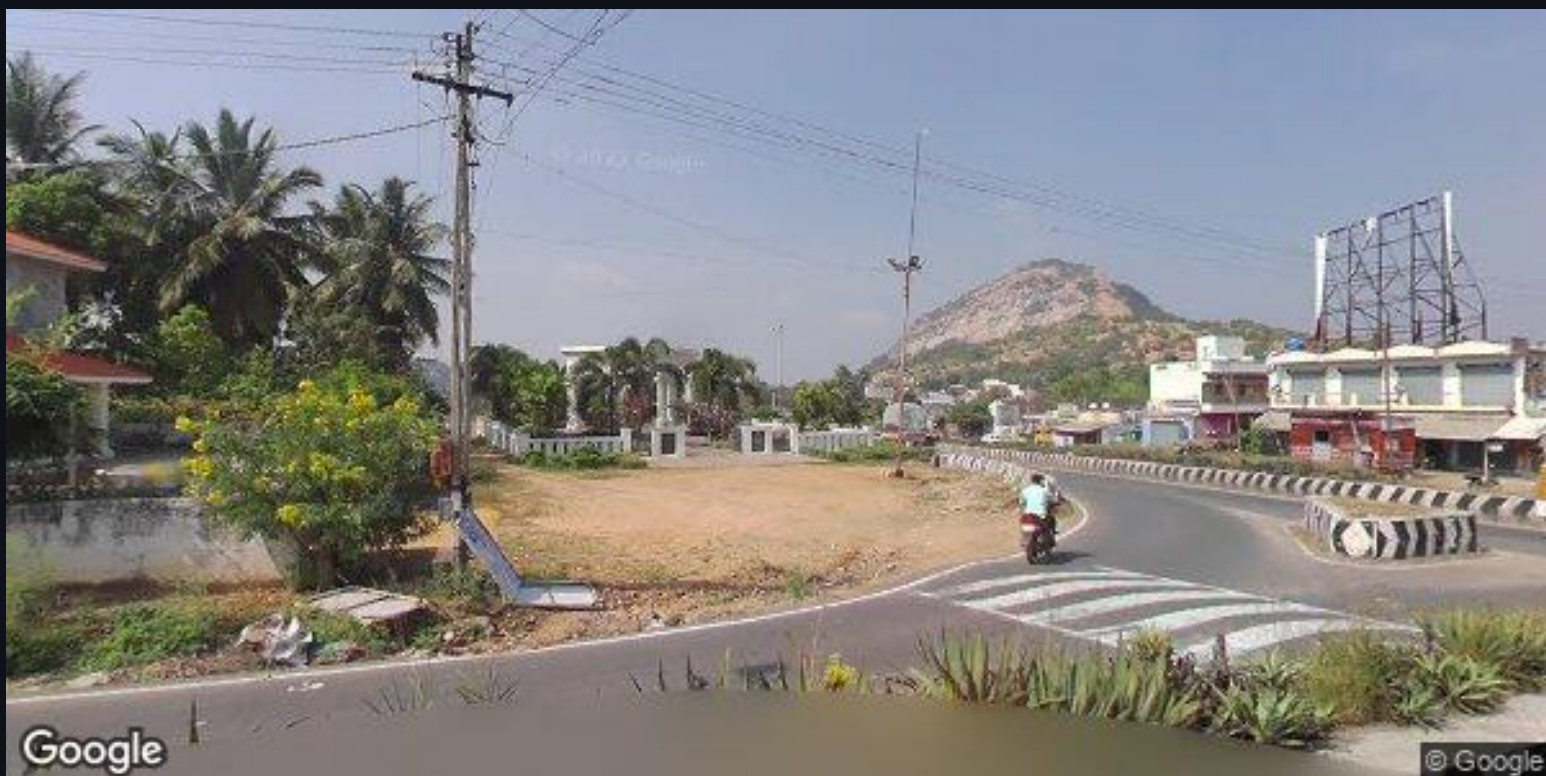
**Risk Type:** Turn  
**Risk Level:** High  
**Speed Limit:** 15 KM/Hr  
**Coordinates:** 11.46307, 77.84941

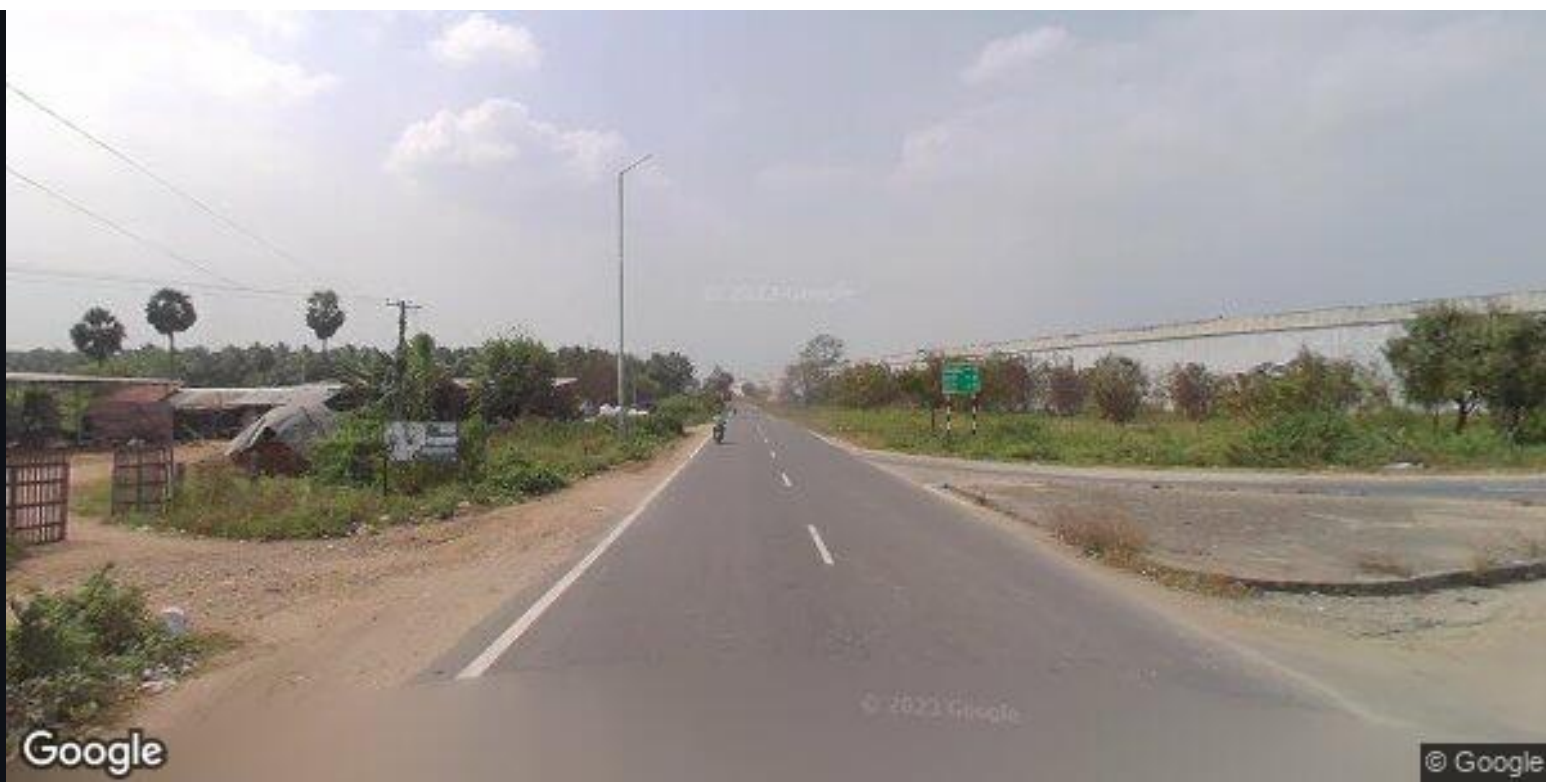
**Coordinates: 11.45542, 77.81725**

**Risk Type: Turn**

**Risk Level: High**

**Speed Limit: 15 KM/Hr**

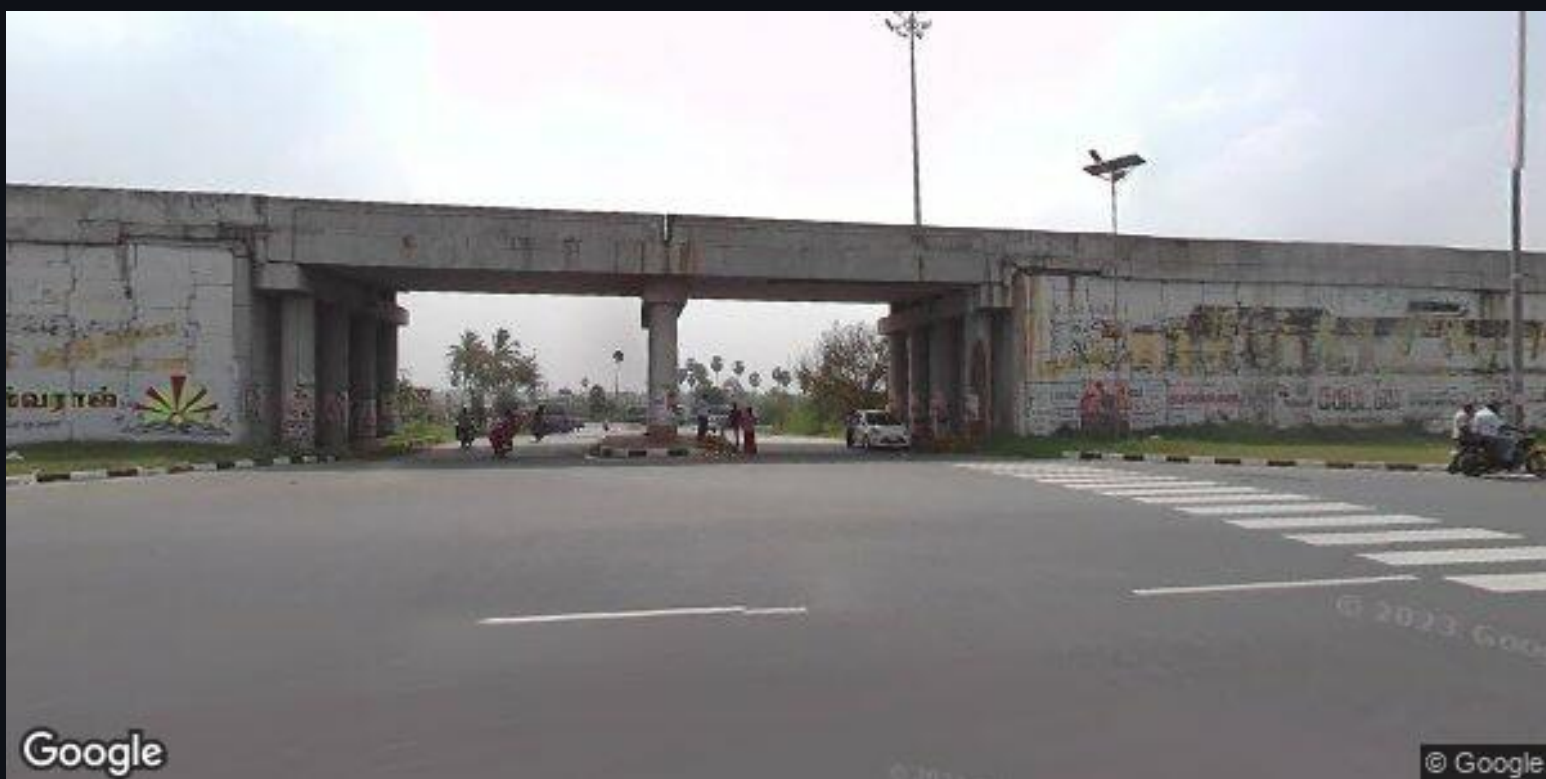
**Coordinates: 11.45636, 77.81678**

**Risk Type: Turn**

**Risk Level: High**

**Speed Limit: 15 KM/Hr**

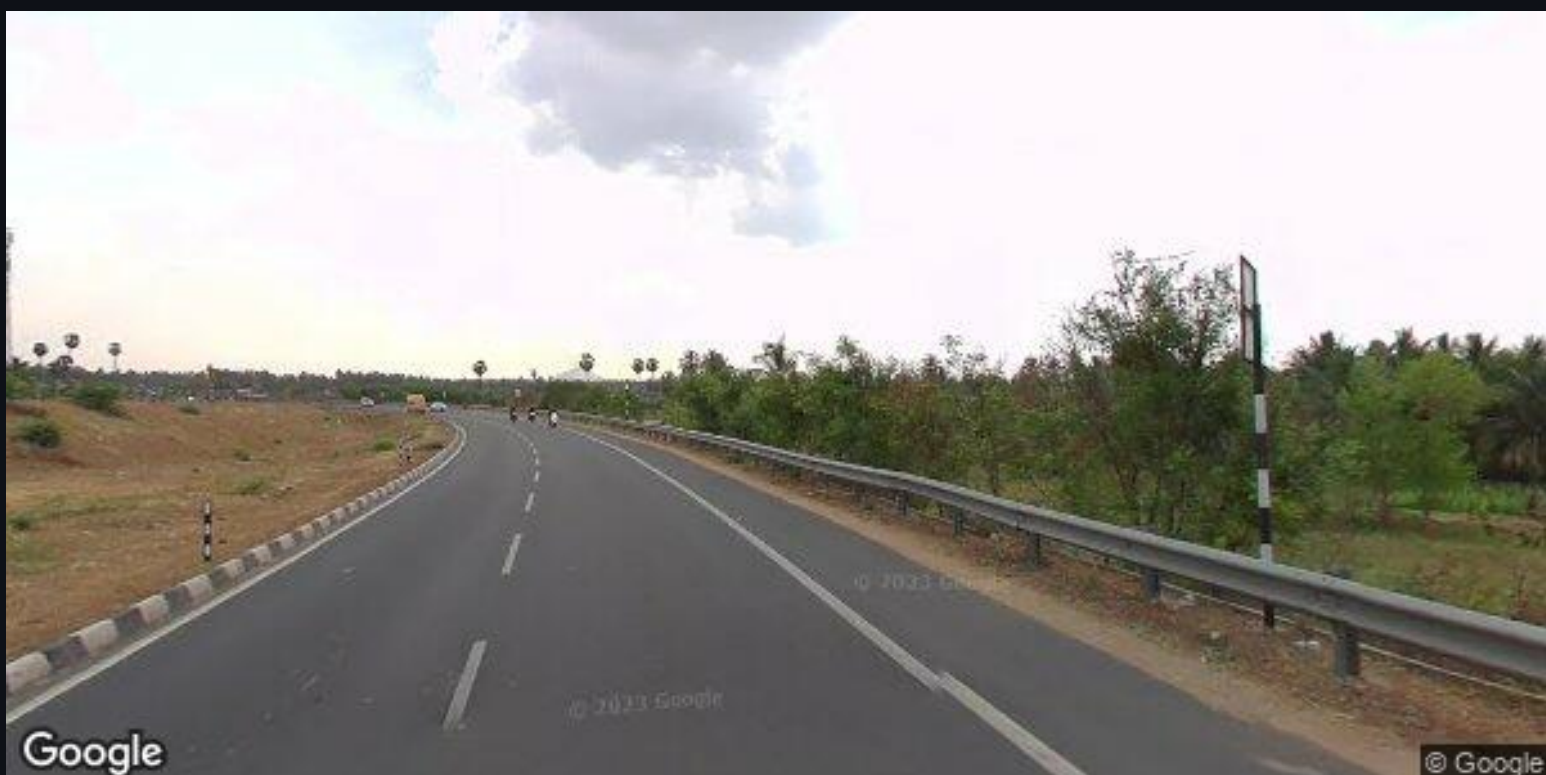
**Coordinates: 11.53578, 77.95802**

**Risk Type: Turn**

**Risk Level: Medium**

**Speed Limit: 30 KM/Hr**

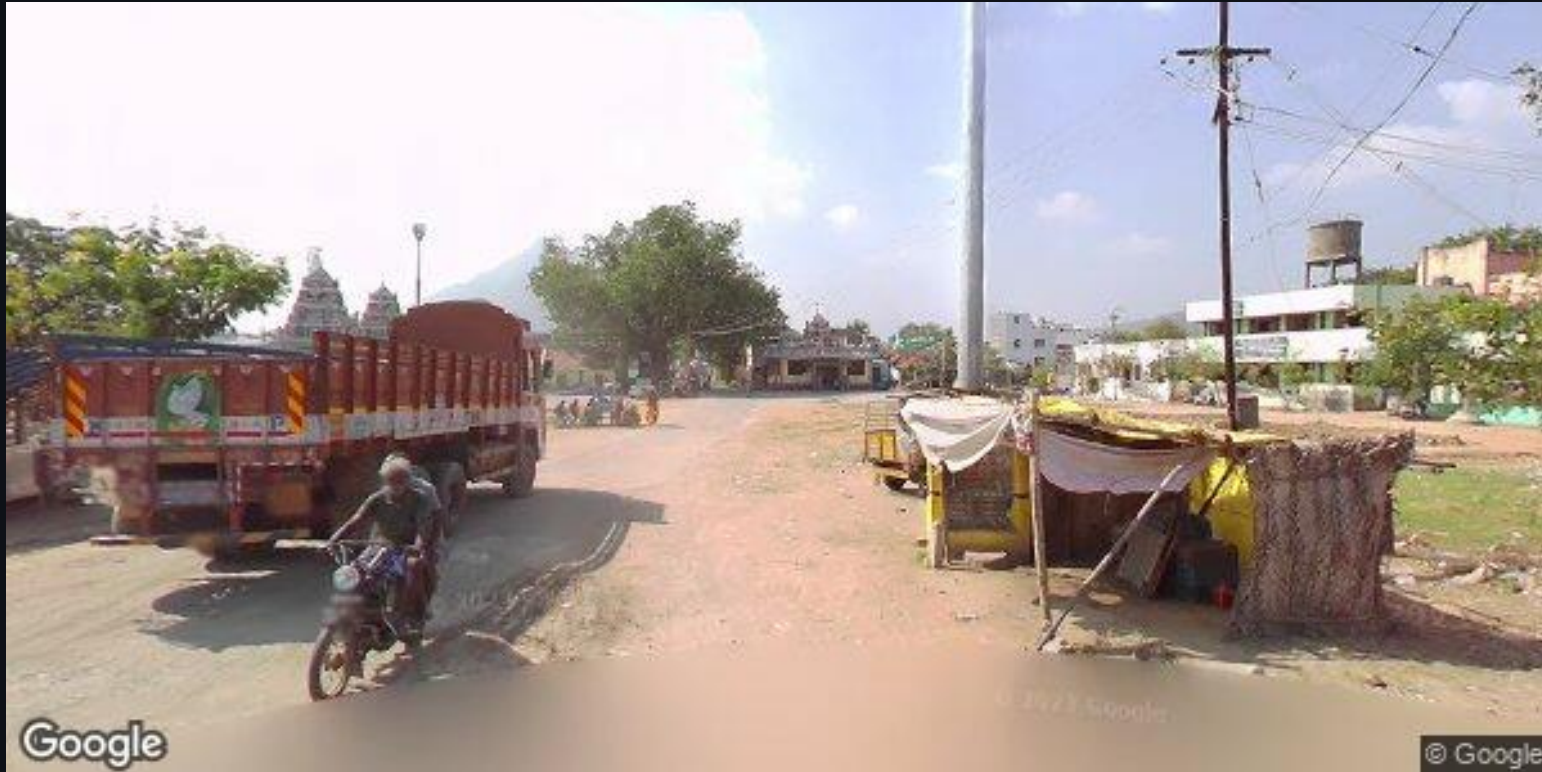
**Coordinates: 11.62145, 78.10740**

**Risk Type: Blind Spot**

**Risk Level: Blind Spot**

**Speed Limit: 10 KM/Hr**

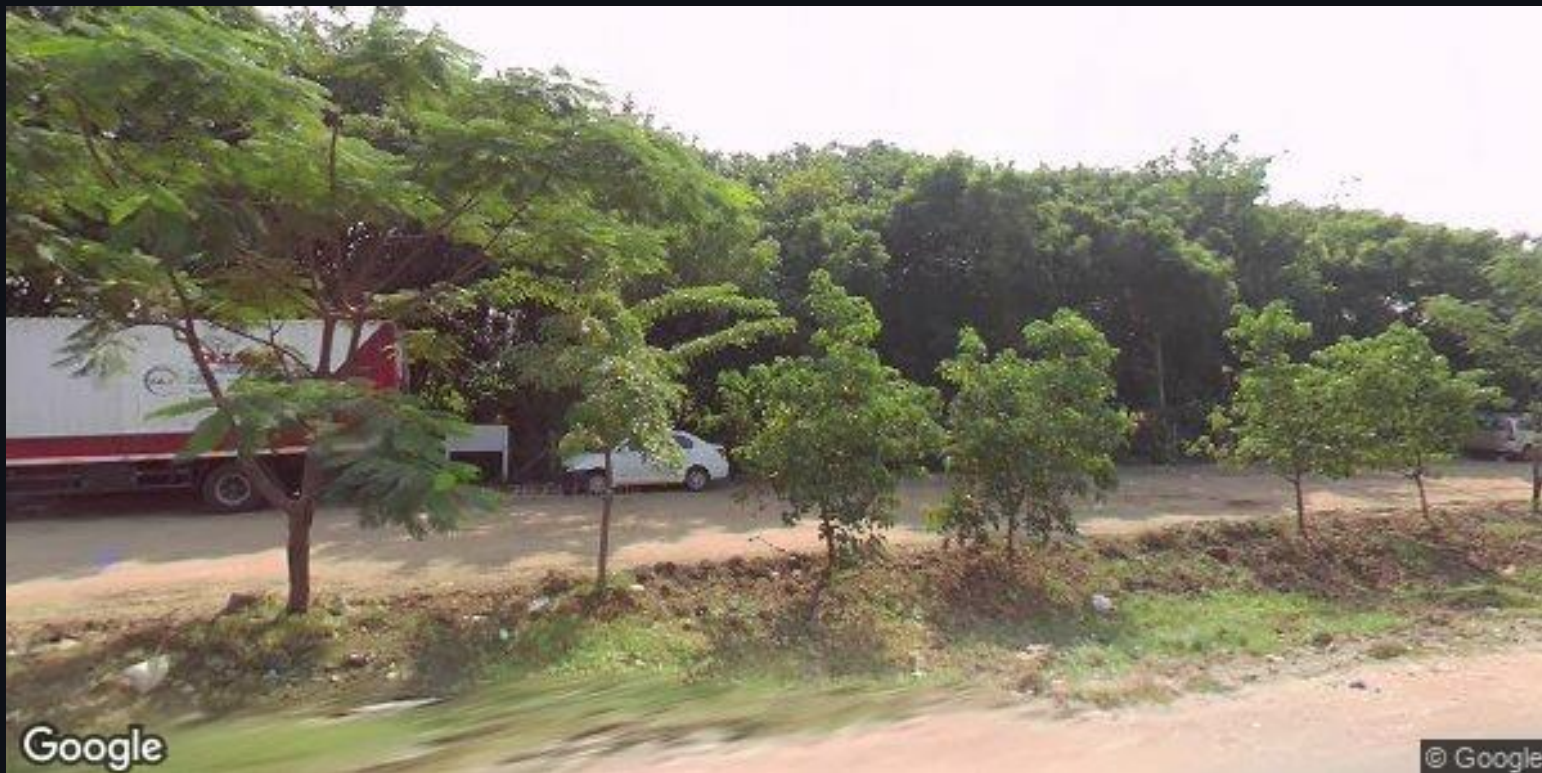
**Coordinates: 11.62106, 78.10767**

**Risk Type: Turn**

**Risk Level: High**

**Speed Limit: 15 KM/Hr**

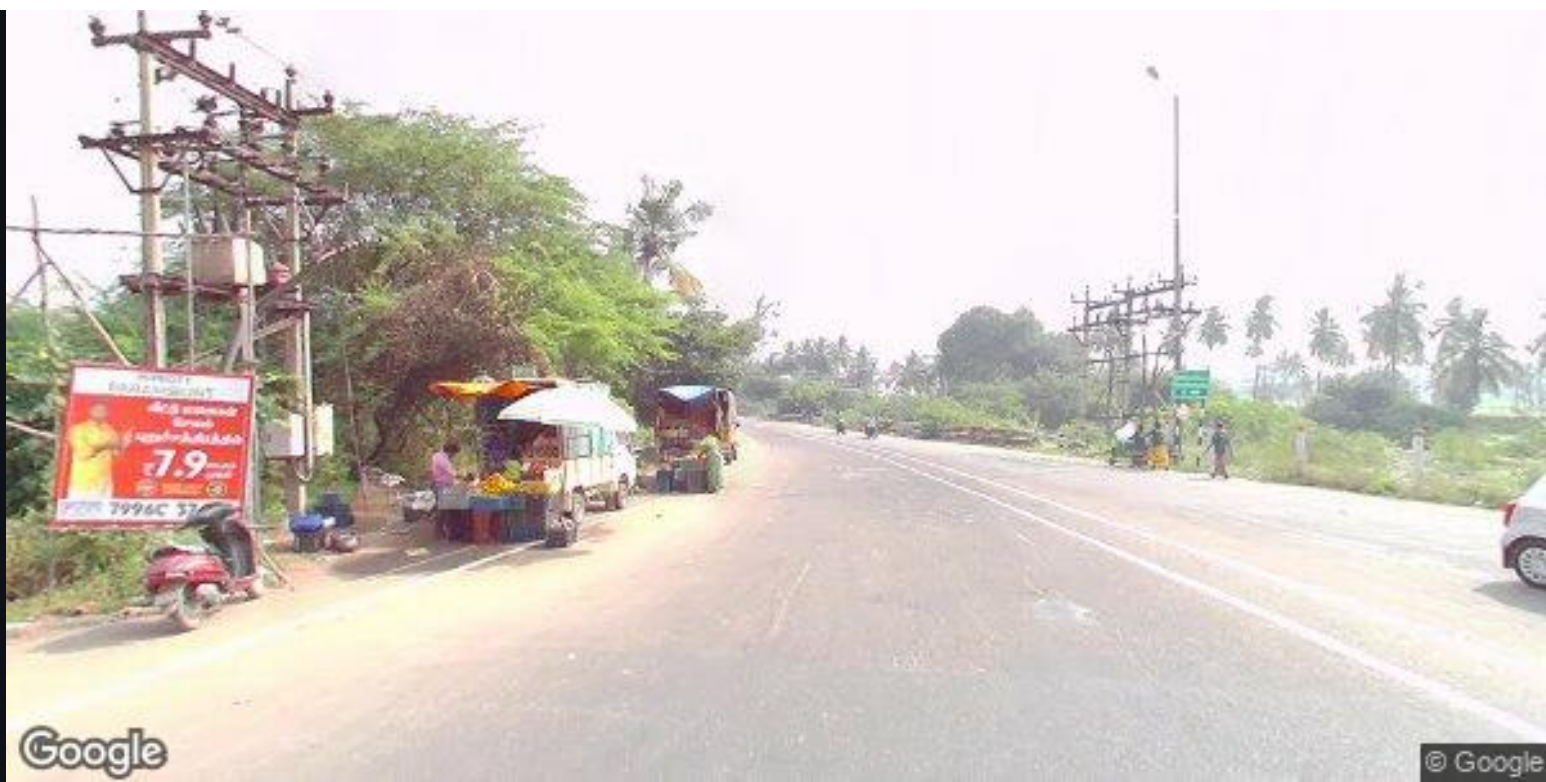
**Risk Type:** Blind Spot  
**Risk Level:** Blind Spot  
**Speed Limit:** 10 KM/Hr  
**Coordinates:** 11.61217, 78.10439

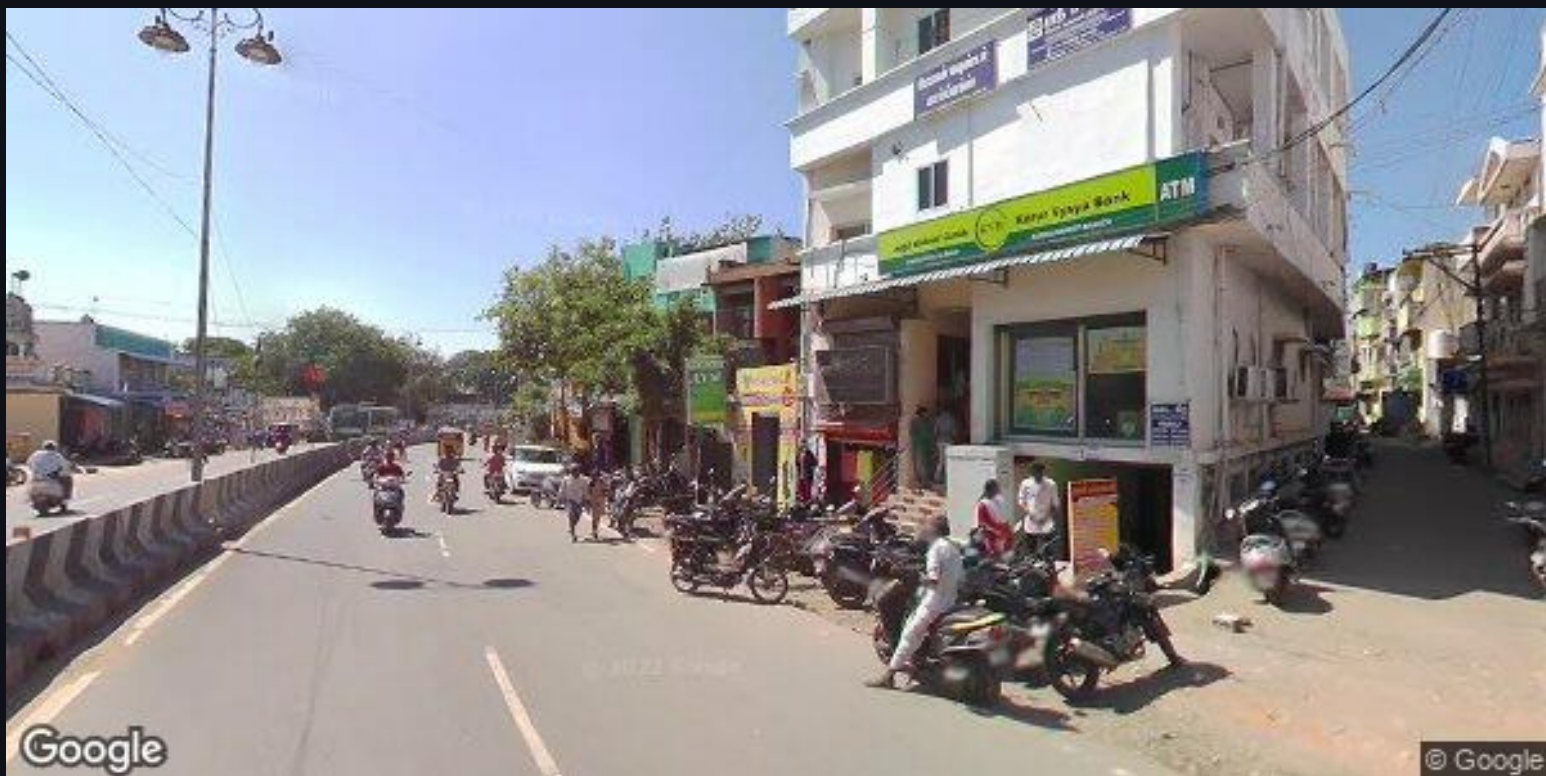
**Risk Type:** Turn  
**Risk Level:** Medium  
**Speed Limit:** 30 KM/Hr  
**Coordinates:** 11.62537, 78.12040

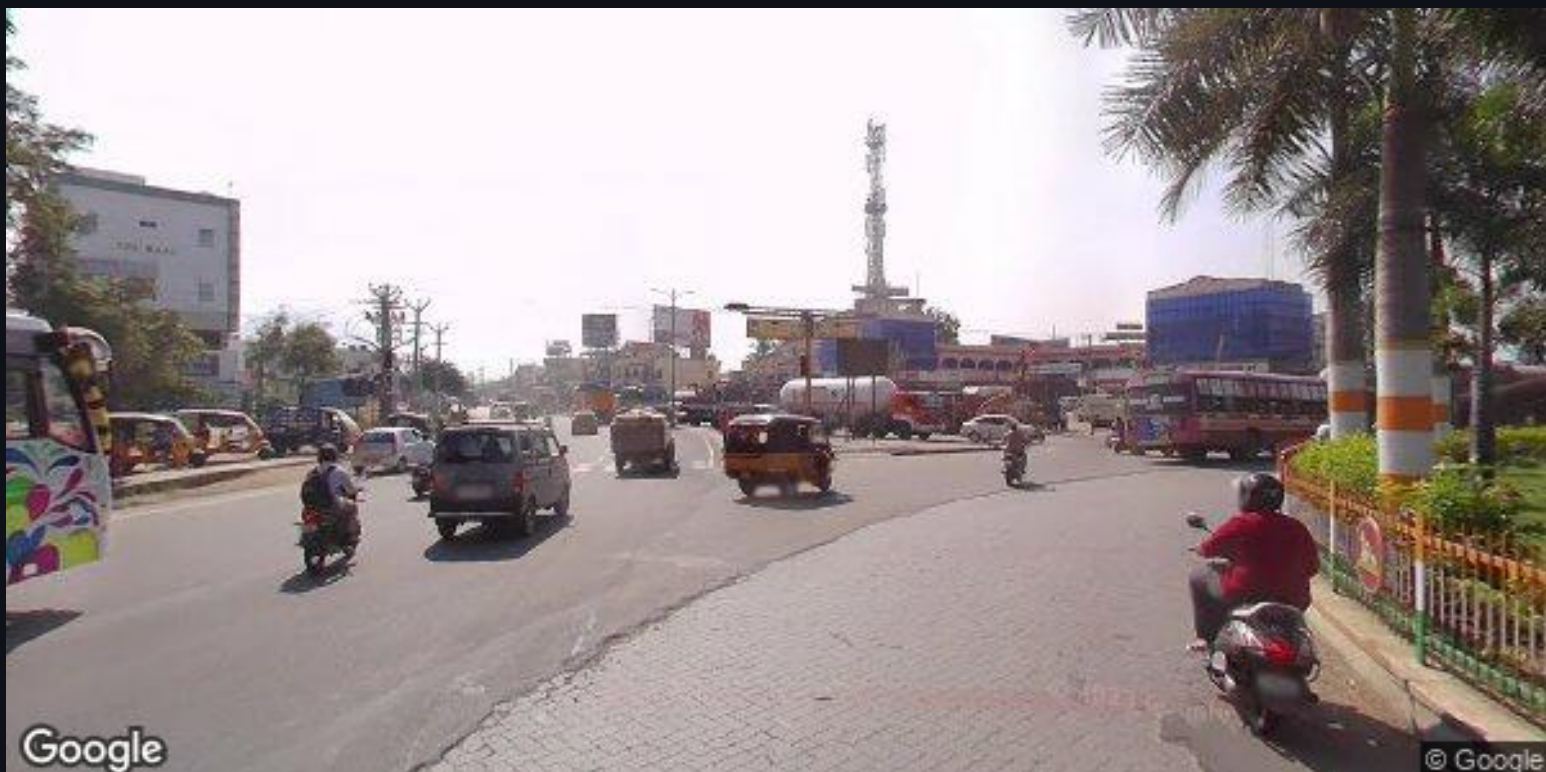
**Risk Type:** Turn  
**Risk Level:** Medium  
**Speed Limit:** 30 KM/Hr  
**Coordinates:** 11.63283, 78.12757

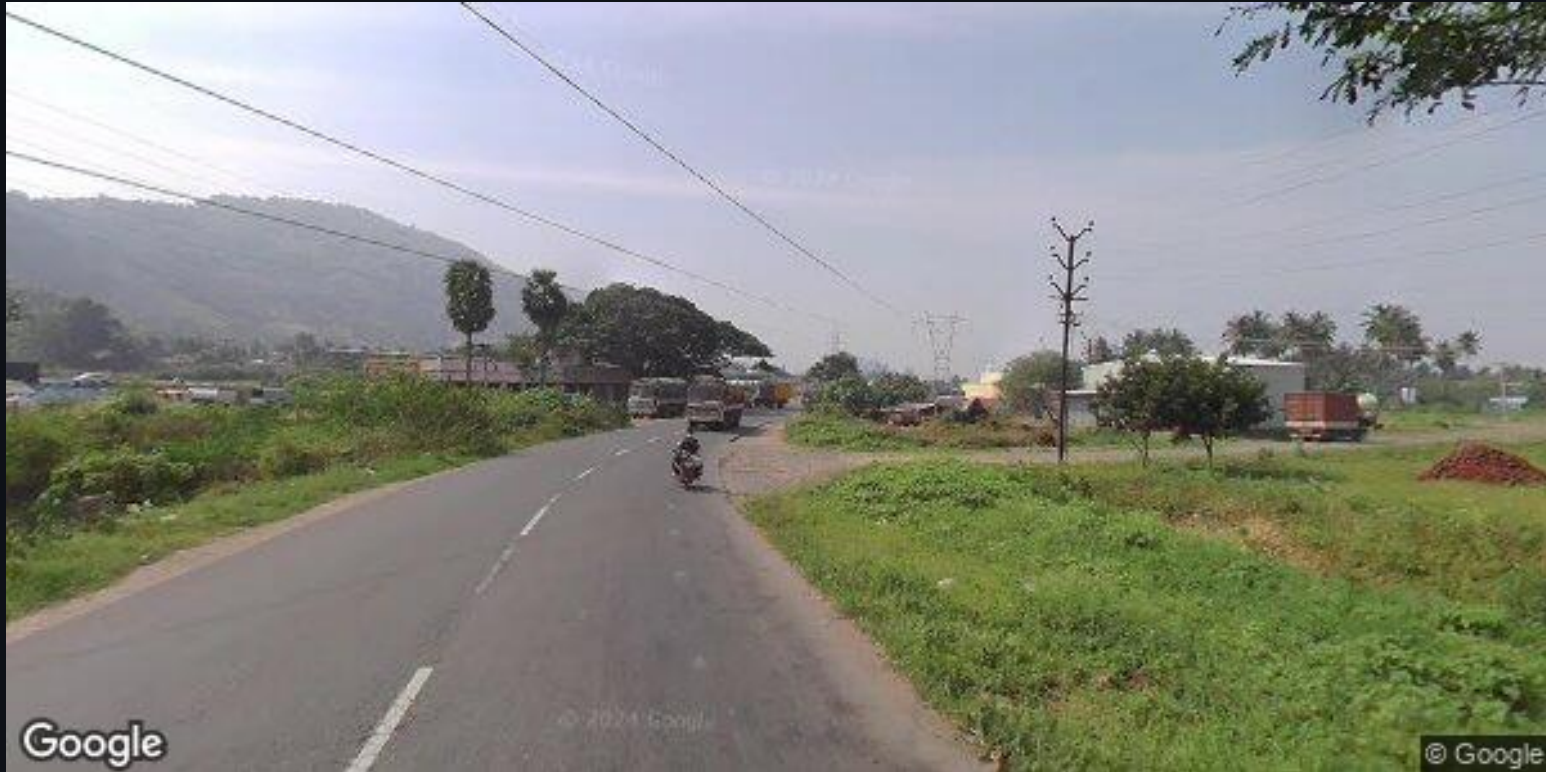
**Risk Type:** Turn  
**Risk Level:** Medium  
**Speed Limit:** 30 KM/Hr  
**Coordinates:** 11.65815, 78.20461

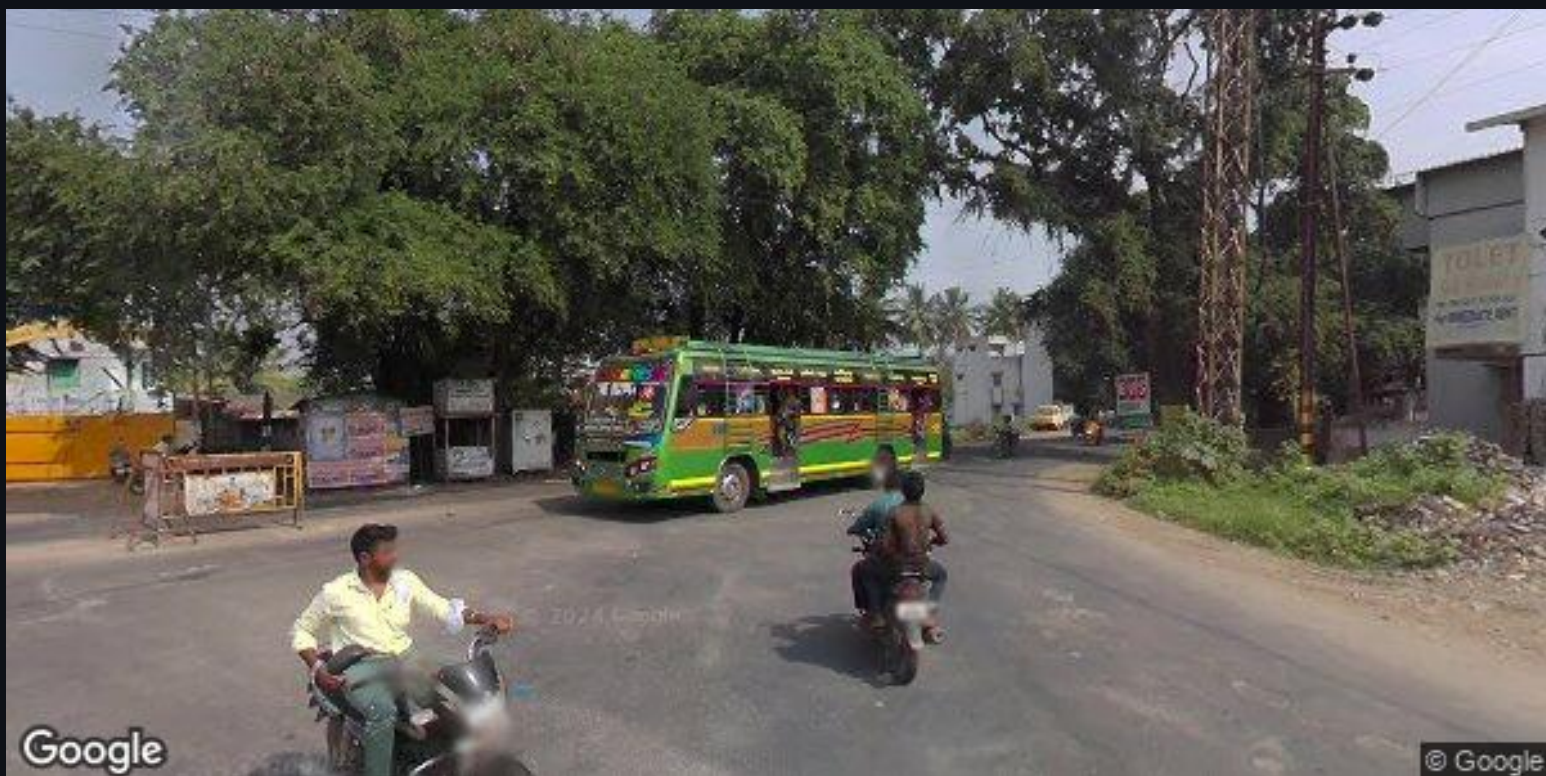
**Risk Type:** Turn  
**Risk Level:** Medium  
**Speed Limit:** 30 KM/Hr  
**Coordinates:** 11.66359, 78.20647

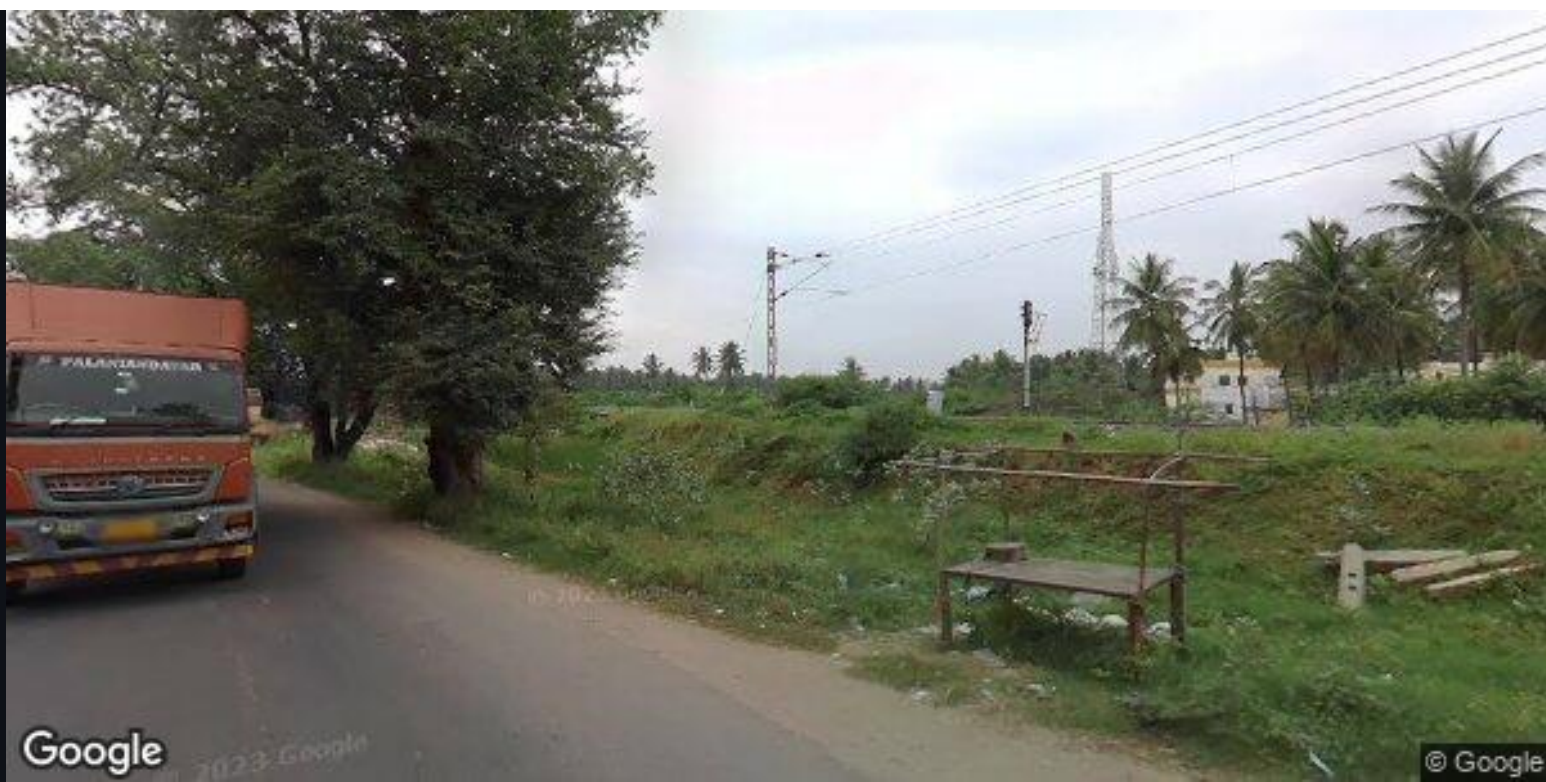
**Coordinates:** 11.67128, 78.22971

**Risk Type:** Turn

**Risk Level:** Medium

**Speed Limit:** 30 KM/Hr

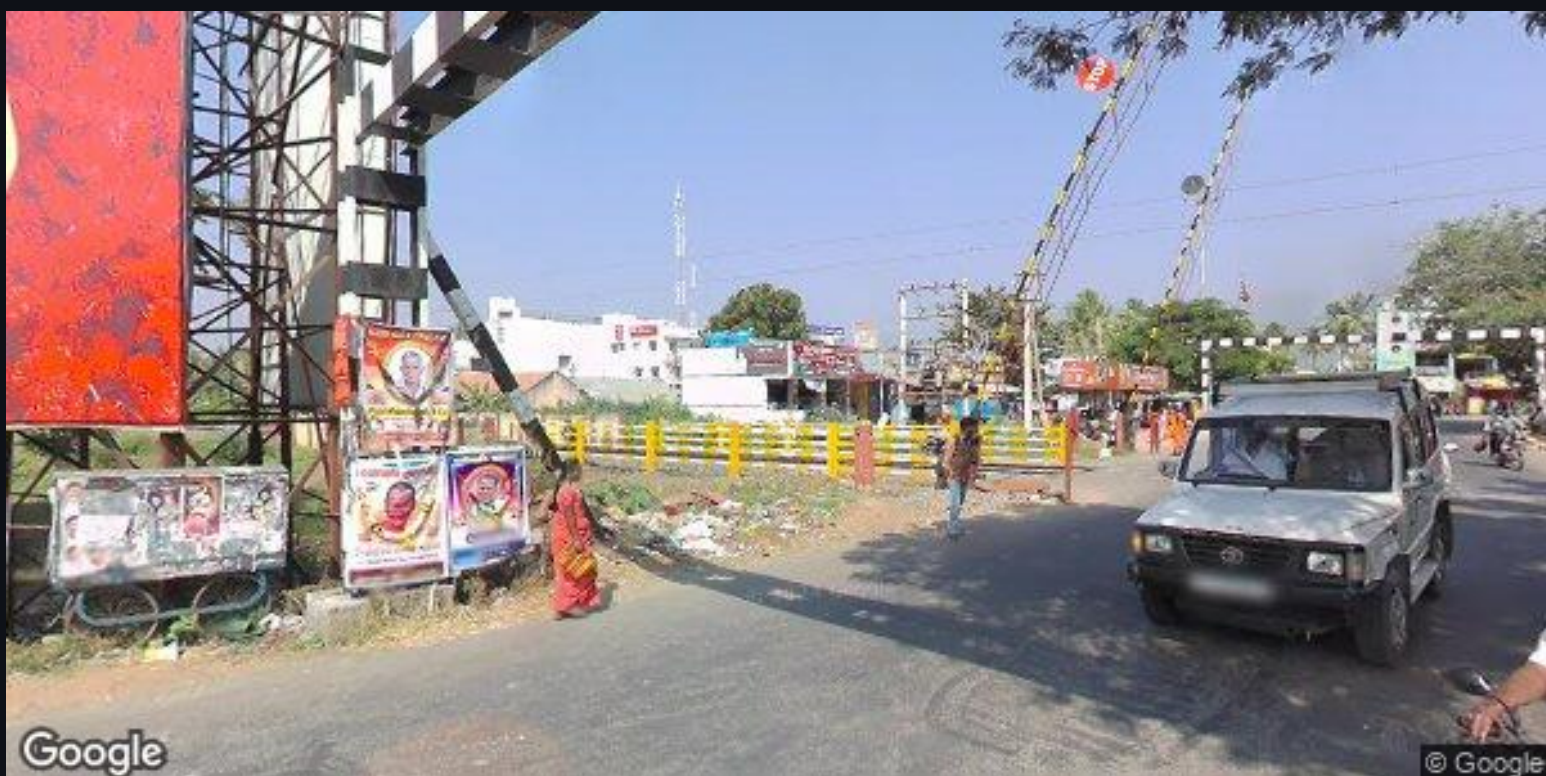
**Coordinates:** 11.67131, 78.23138

**Risk Type:** Turn

**Risk Level:** High

**Speed Limit:** 15 KM/Hr

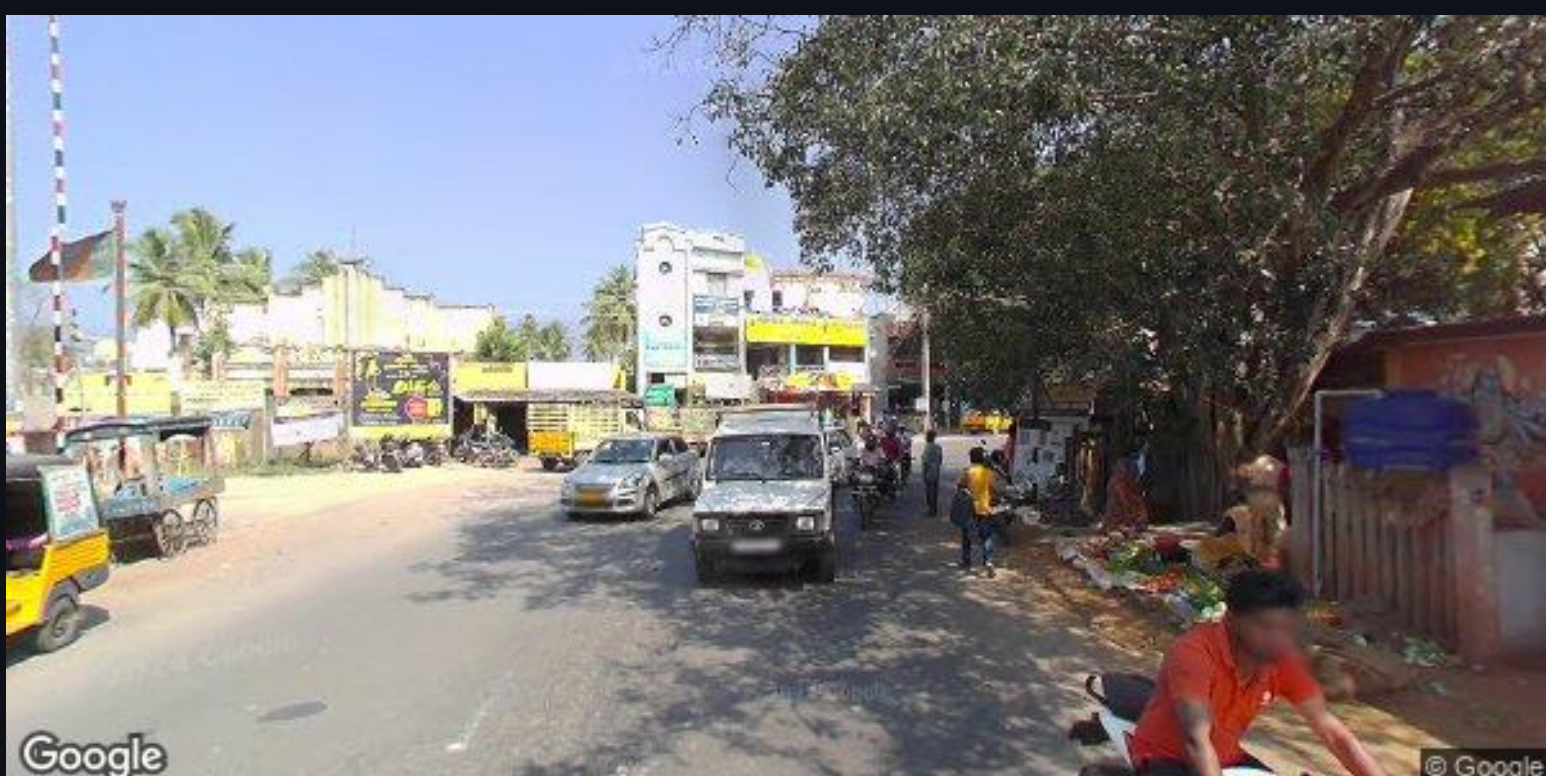
**Risk Type:** Turn  
**Risk Level:** High  
**Speed Limit:** 15 KM/Hr  
**Coordinates:** 11.67177, 78.23140
