## JOURNEY RISK MANAGEMENT (JRM) STUDY

### Salem Terminal to MAHA FUEL AGENCY

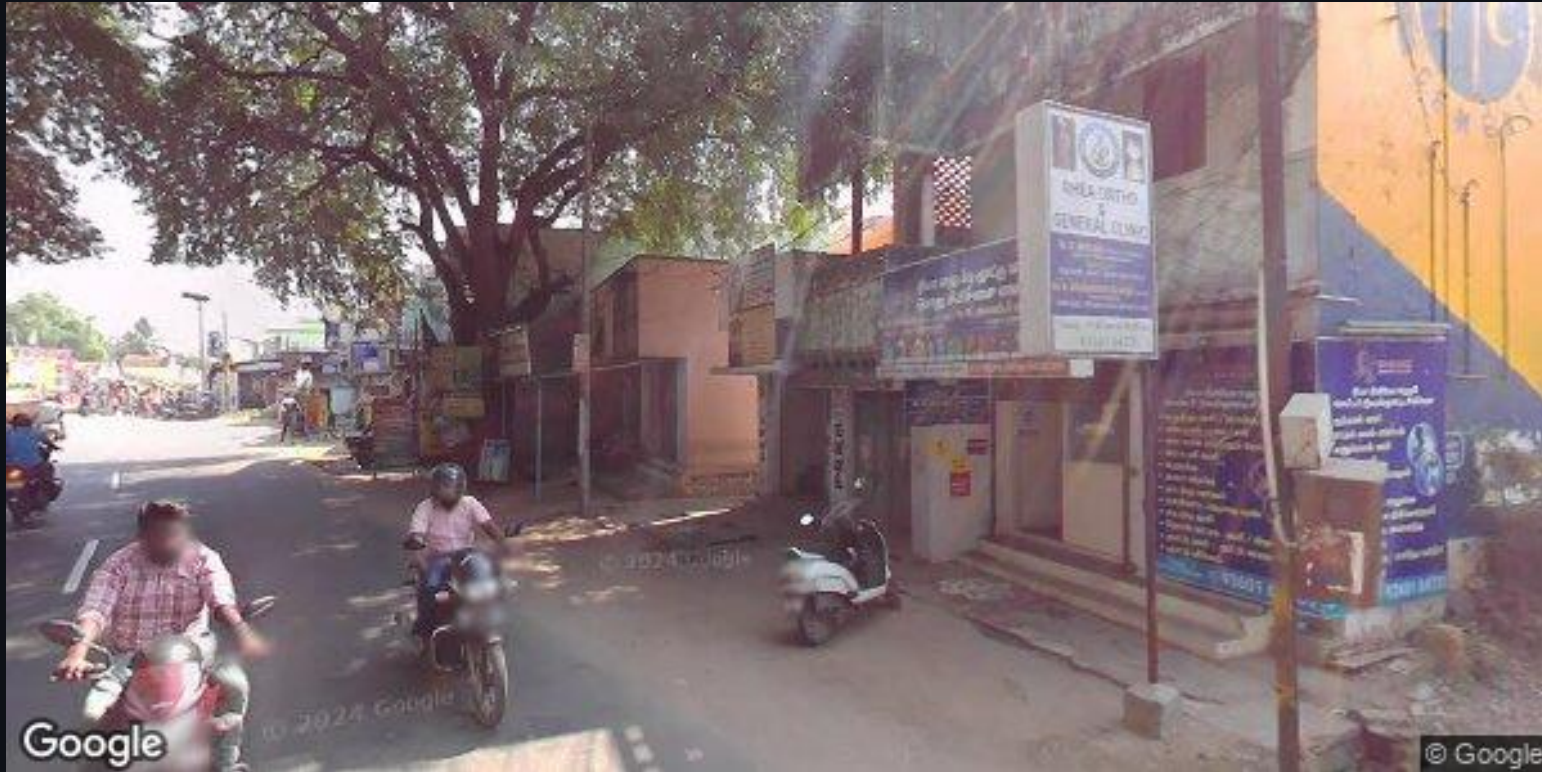
**Risk Type:** Turn  
**Risk Level:** Medium  
**Speed Limit:** 30 KM/Hr  
**Coordinates:** 11.67416, 78.23864

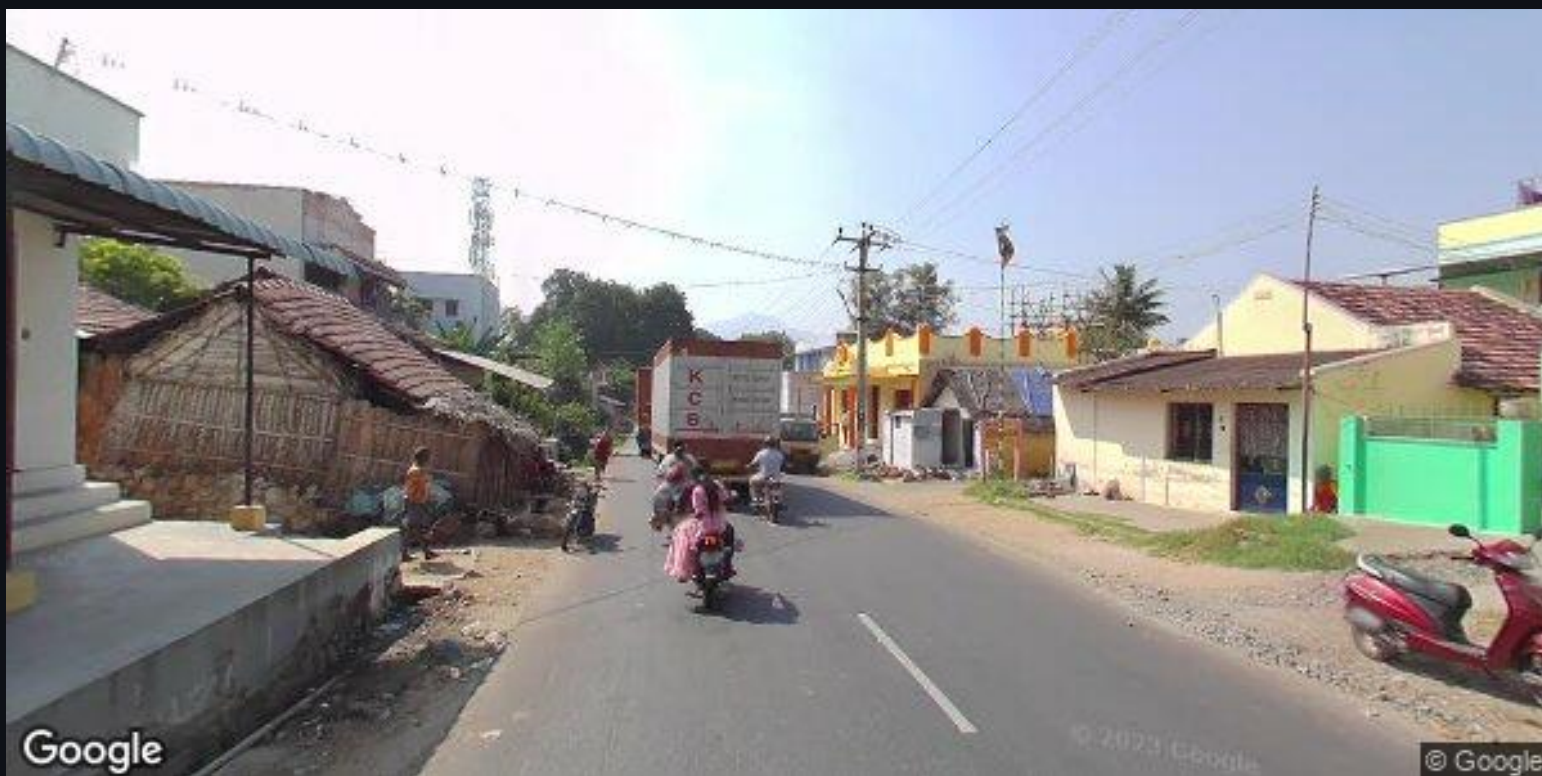
**Risk Type:** Turn  
**Risk Level:** Medium  
**Speed Limit:** 30 KM/Hr  
**Coordinates:** 11.68005, 78.24245

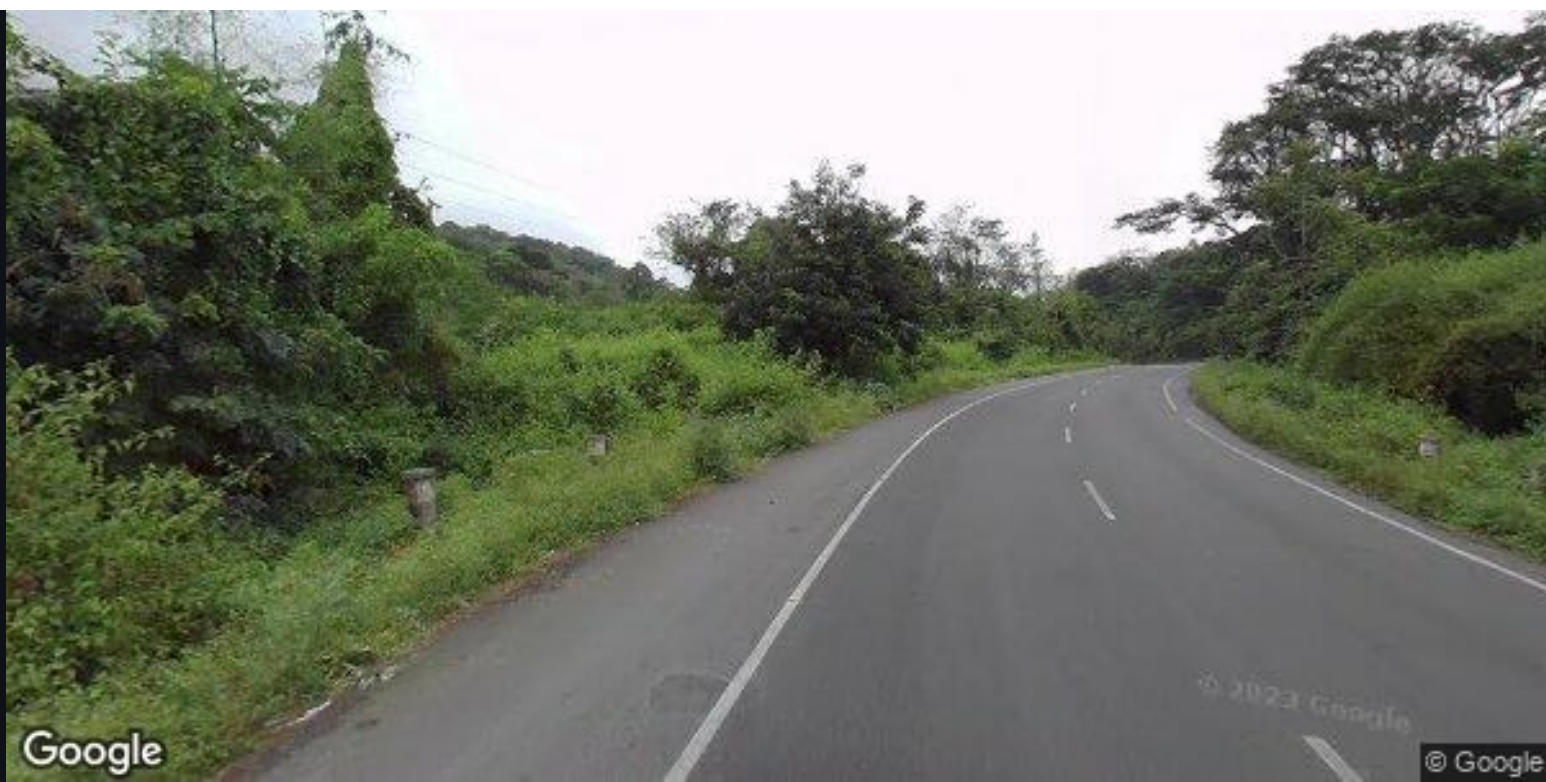
**Coordinates: 11.79058, 78.32176**

**Risk Type: Turn**

**Risk Level: Medium**

**Speed Limit: 30 KM/Hr**

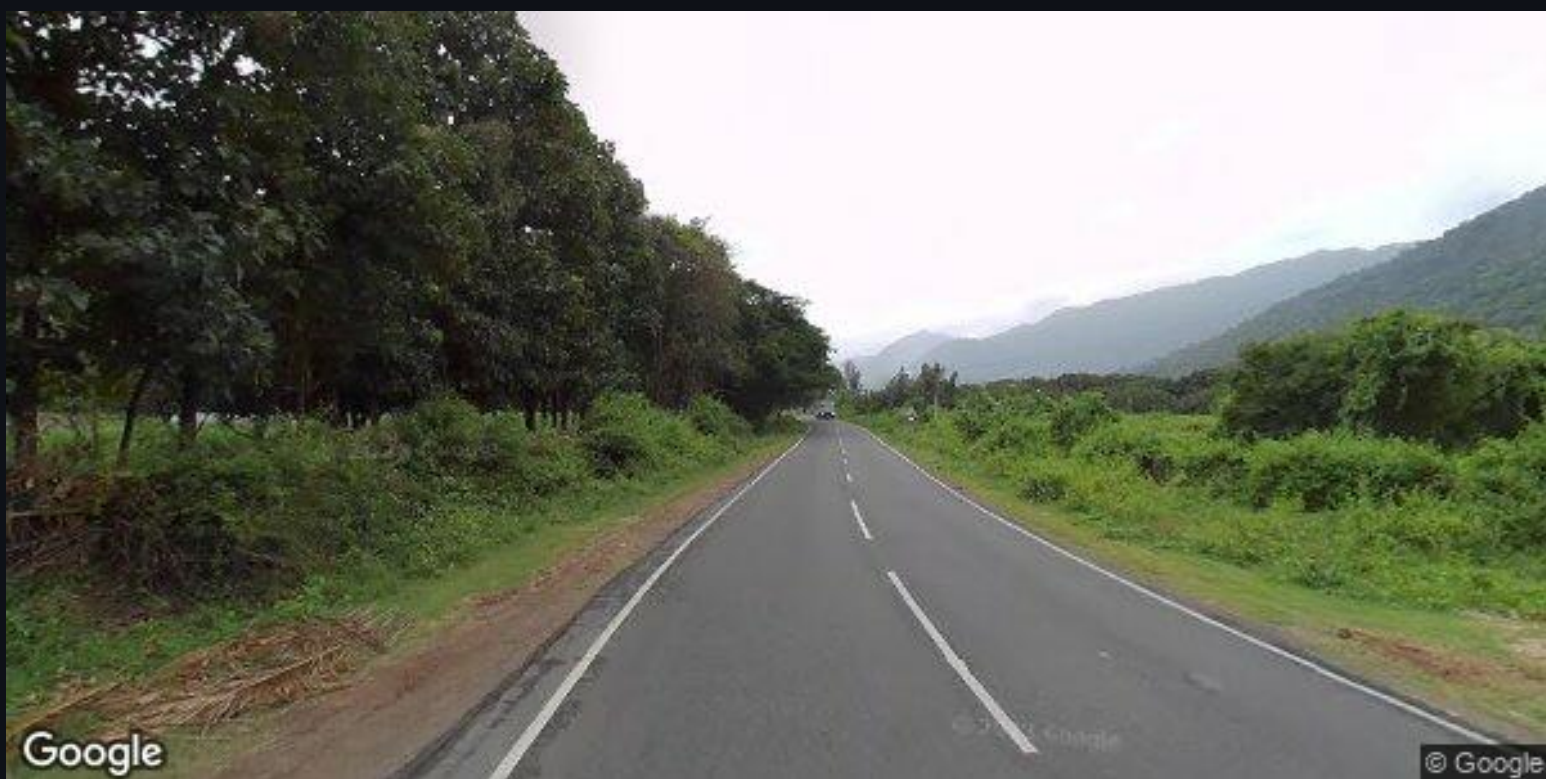
**Coordinates: 11.80467, 78.33345**

**Risk Type: Turn**

**Risk Level: Medium**

**Speed Limit: 30 KM/Hr**

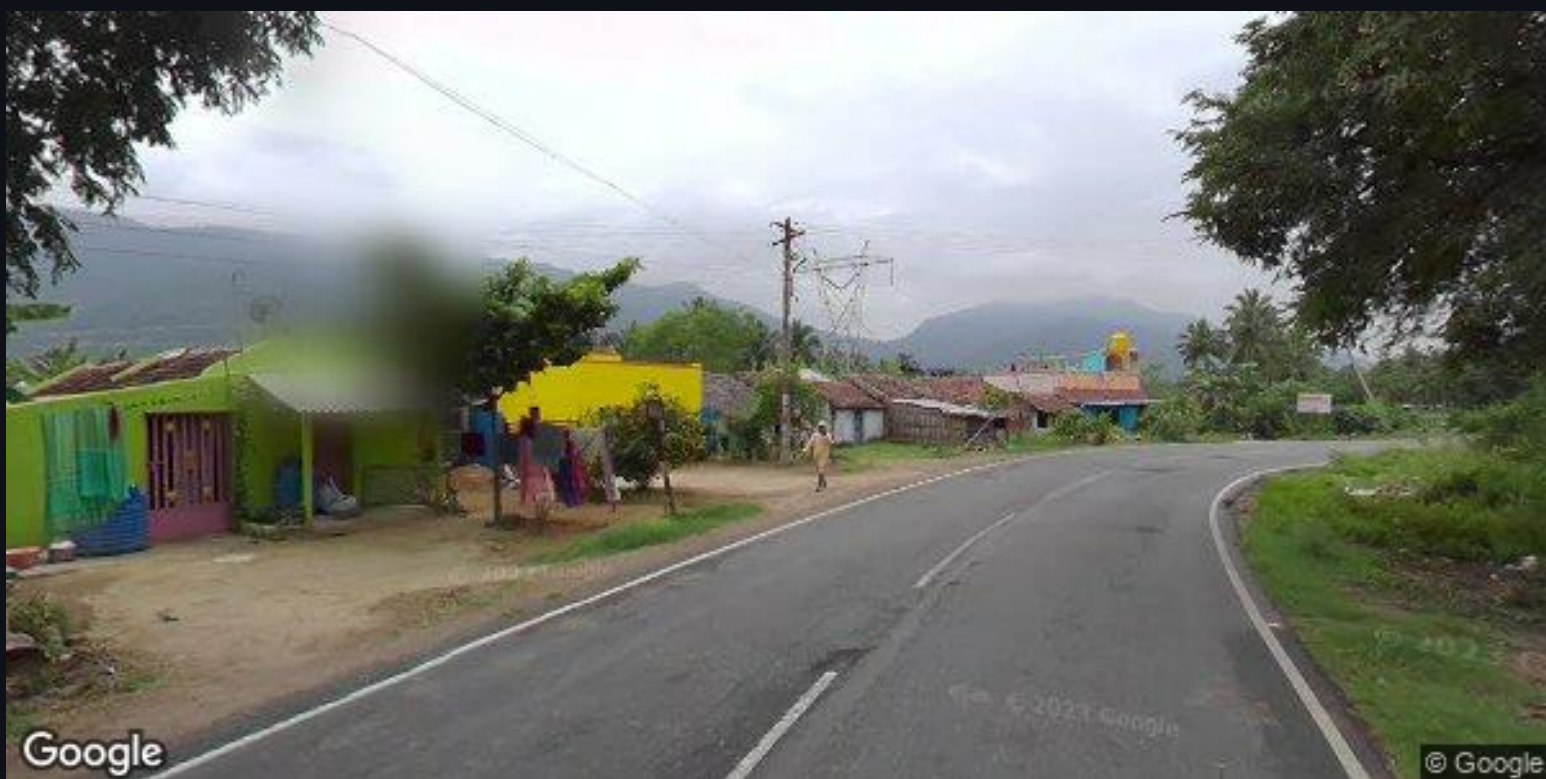
**Risk Type:** Turn  
**Risk Level:** Medium  
**Speed Limit:** 30 KM/Hr  
**Coordinates:** 11.83500, 78.35302

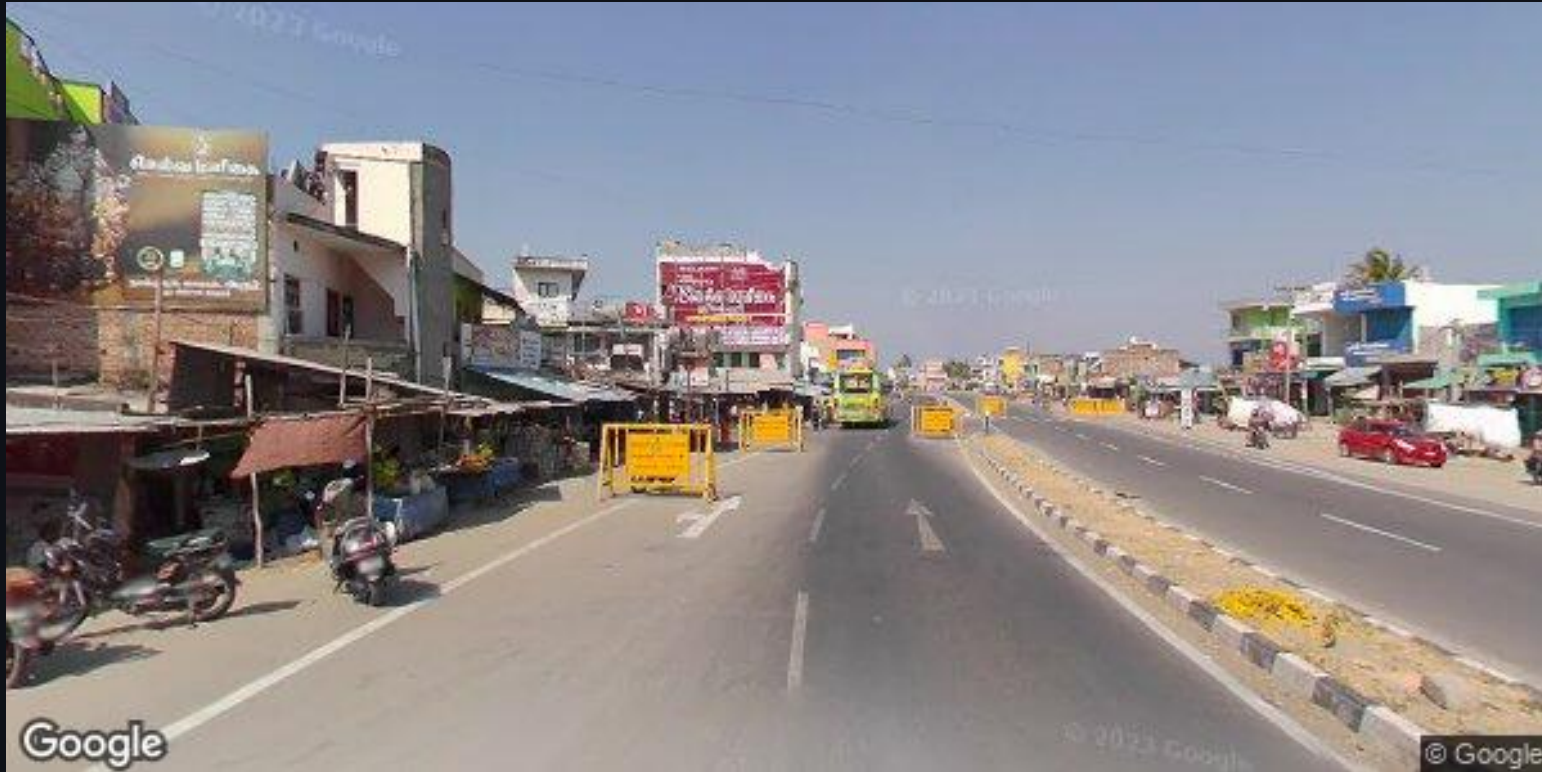
**Risk Type:** Turn  
**Risk Level:** Medium  
**Speed Limit:** 30 KM/Hr  
**Coordinates:** 11.99586, 78.44568

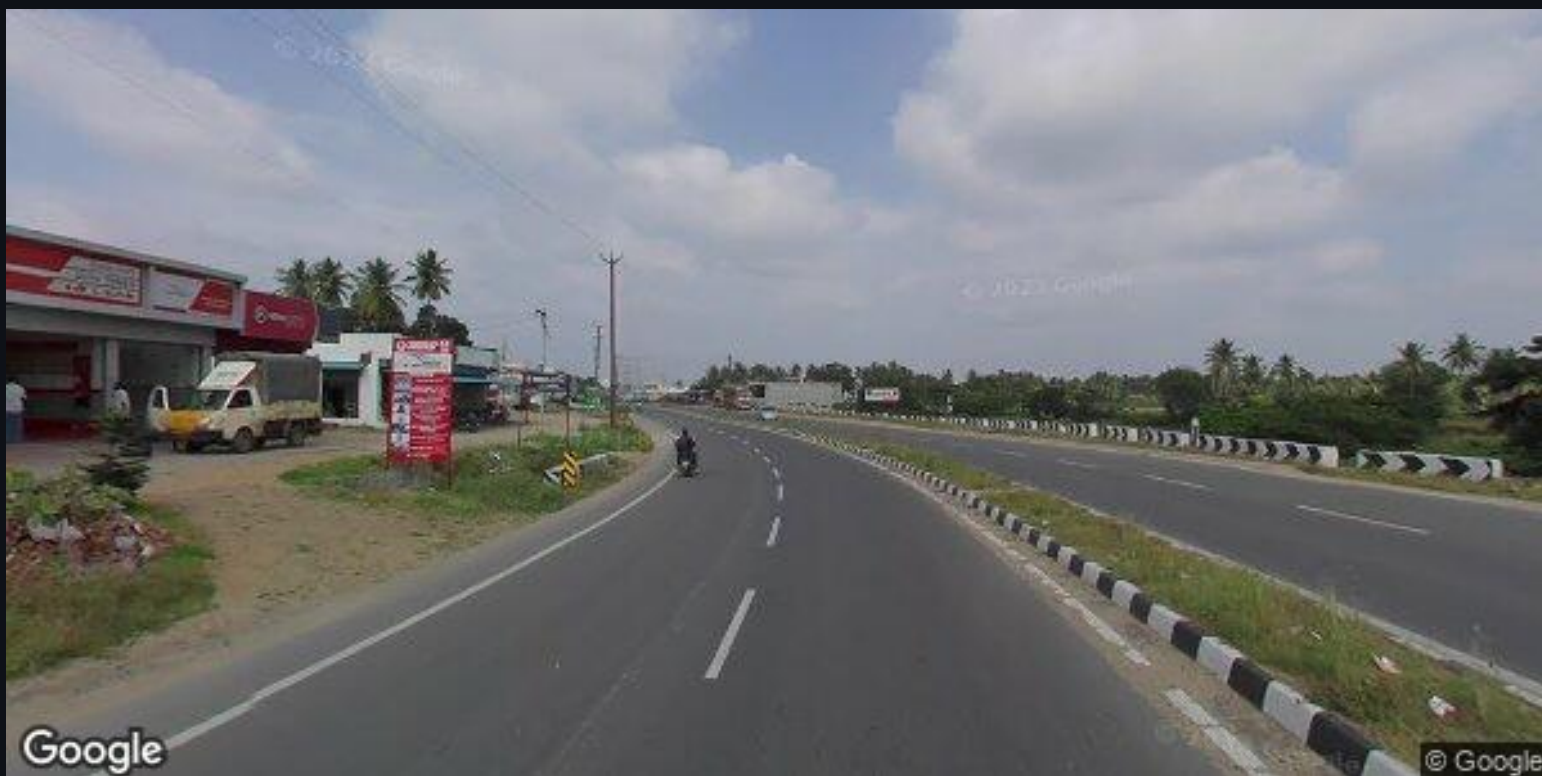
**Risk Type:** Turn  
**Risk Level:** Medium  
**Speed Limit:** 30 KM/Hr  
**Coordinates:** 12.04278, 78.48346

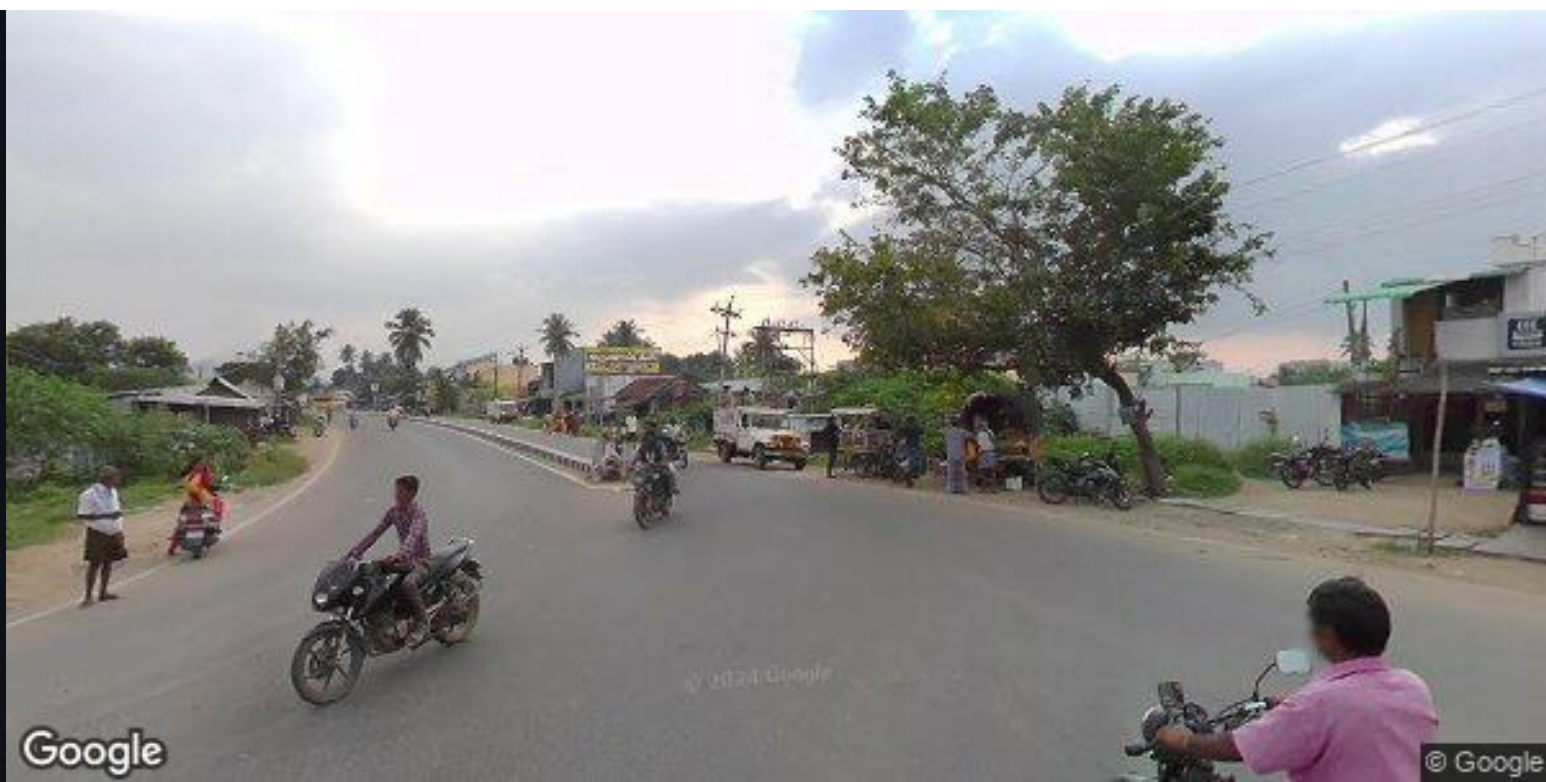
**Coordinates:** 12.04668, 78.48397

**Risk Type:** Turn

**Risk Level:** High

**Speed Limit:** 15 KM/Hr

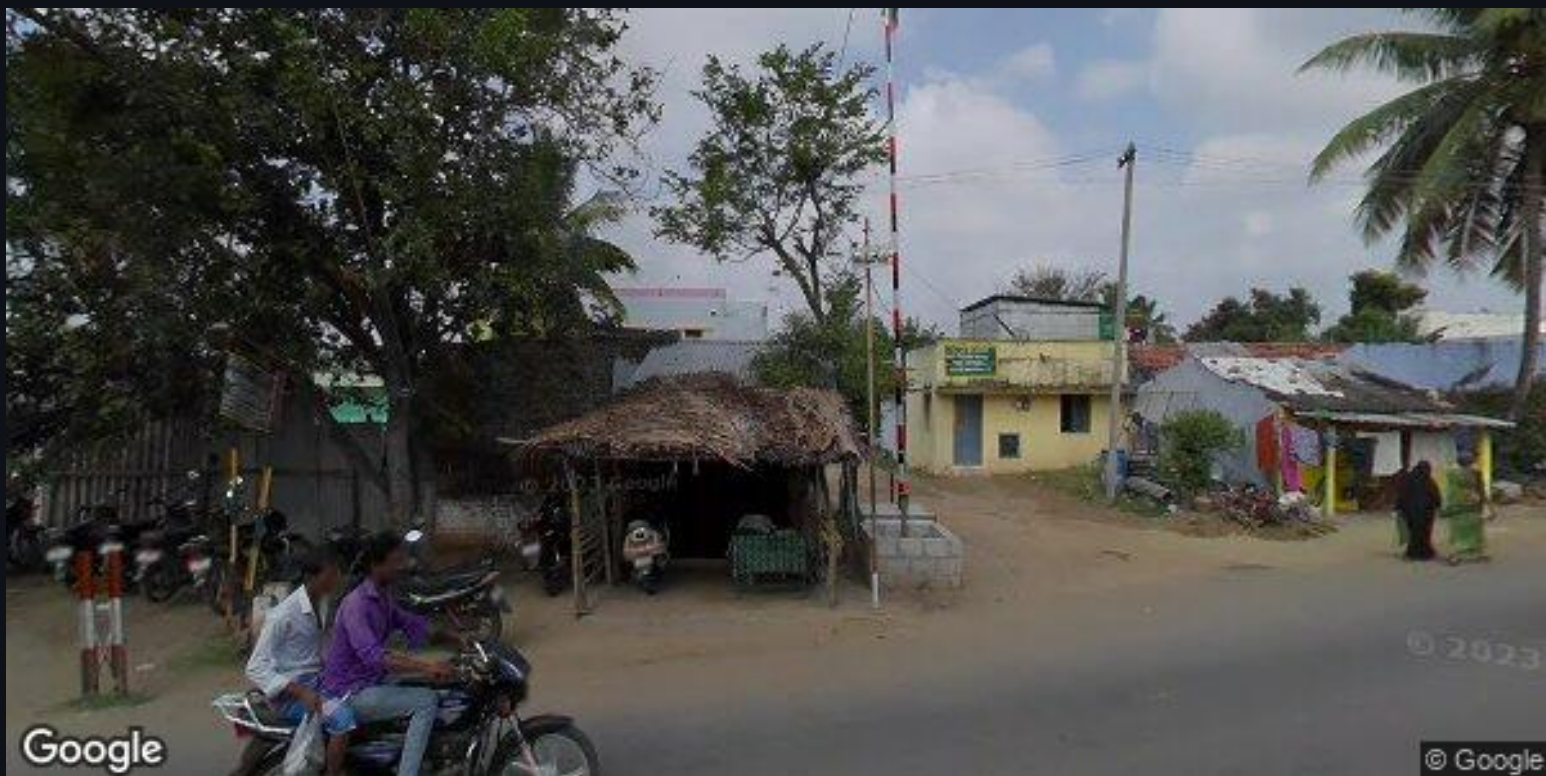
**Coordinates:** 12.04645, 78.48495

**Risk Type:** Turn

**Risk Level:** Medium

**Speed Limit:** 30 KM/Hr

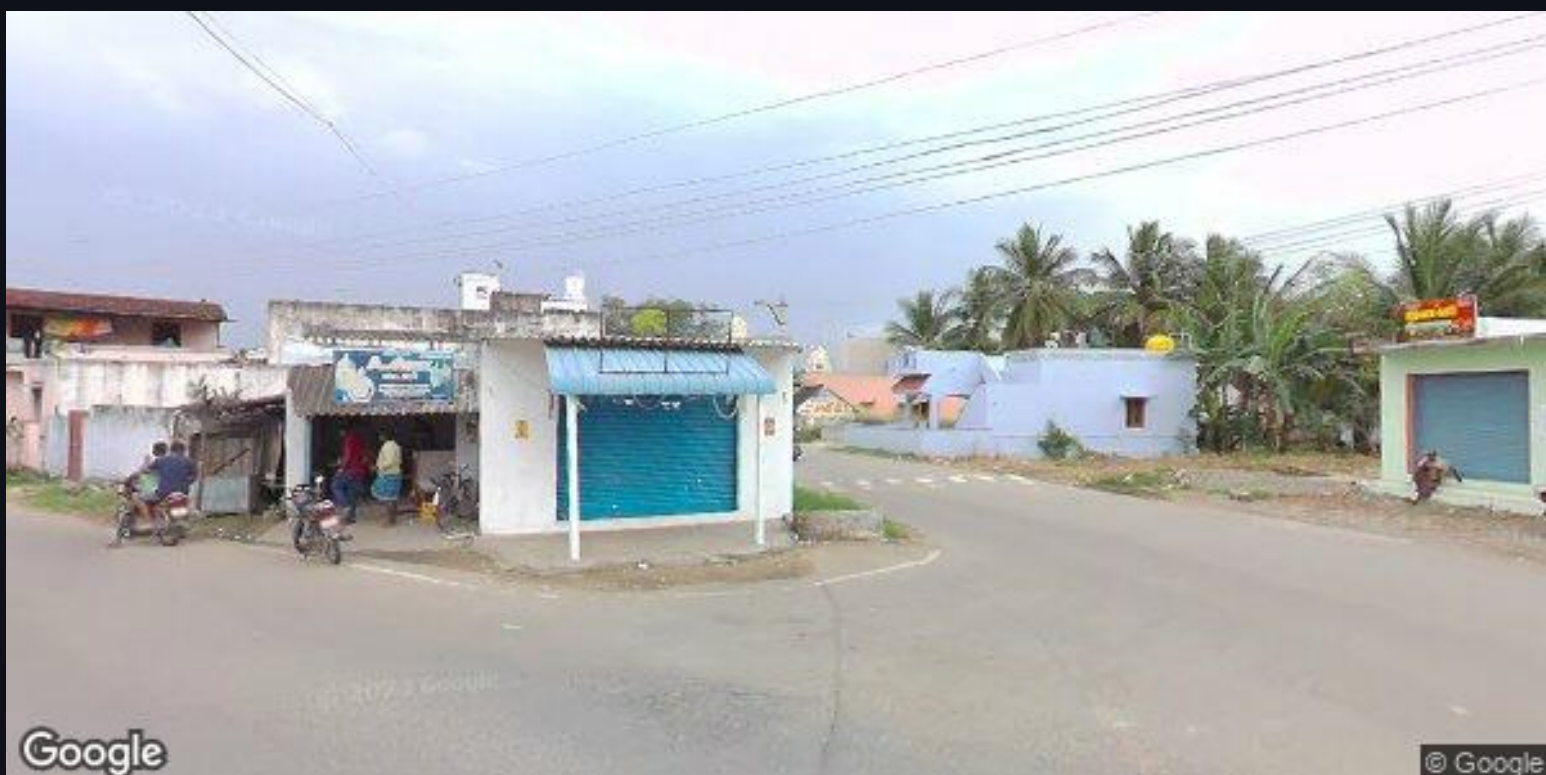
Coordinates: 12.04651, 78.48546

Risk Type: Turn

Risk Level: Medium

Speed Limit: 30 KM/Hr
