# IndianOil

## JOURNEY RISK MANAGEMENT (JRM) STUDY

### Salem Terminal TO SKS AGENCIES

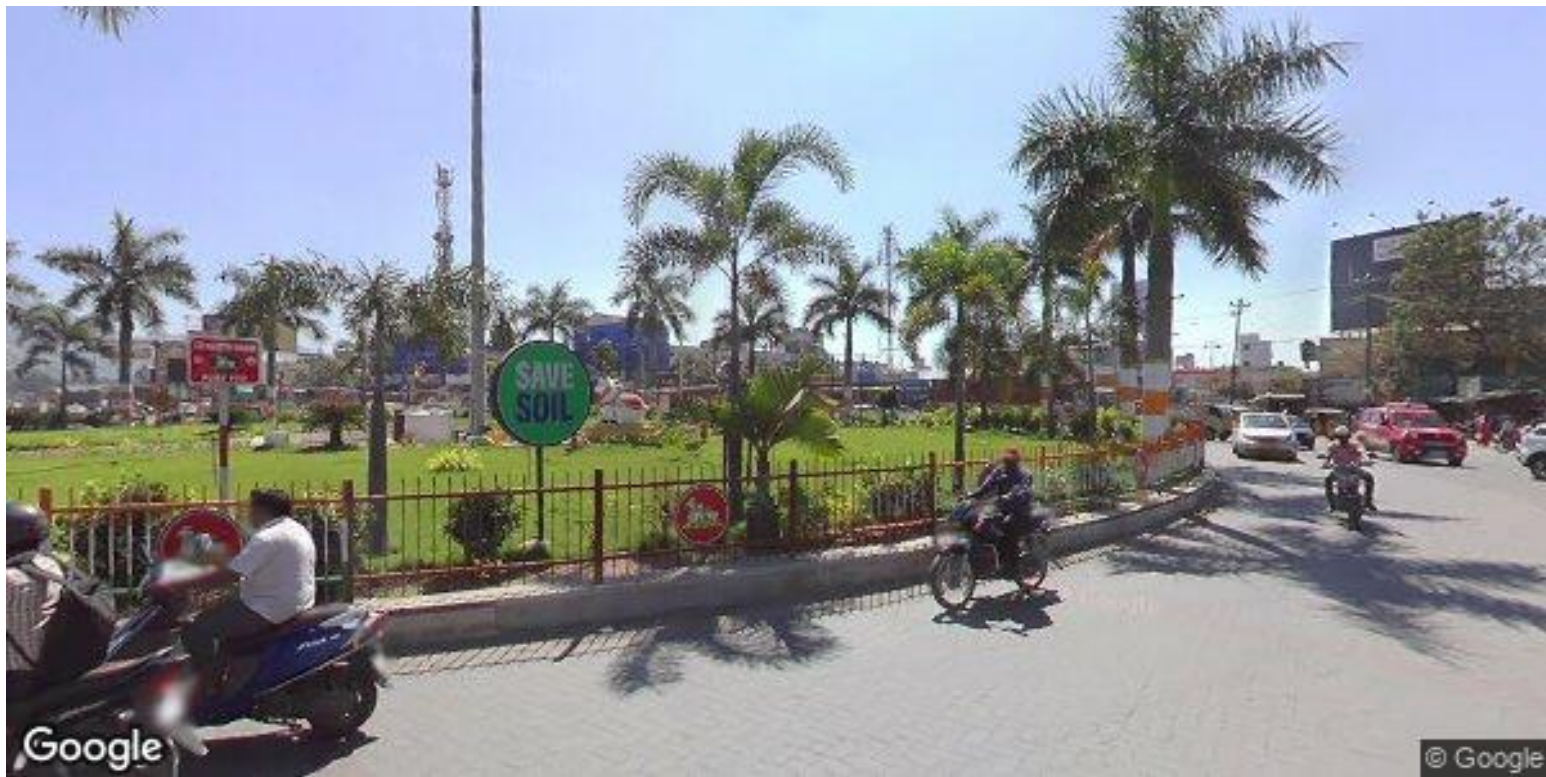
**Coordinates:** 11.63303, 78.12713

**Risk Type:** Roundabout

**Risk Level:** High

**Speed Limit:** 15 KM/Hr

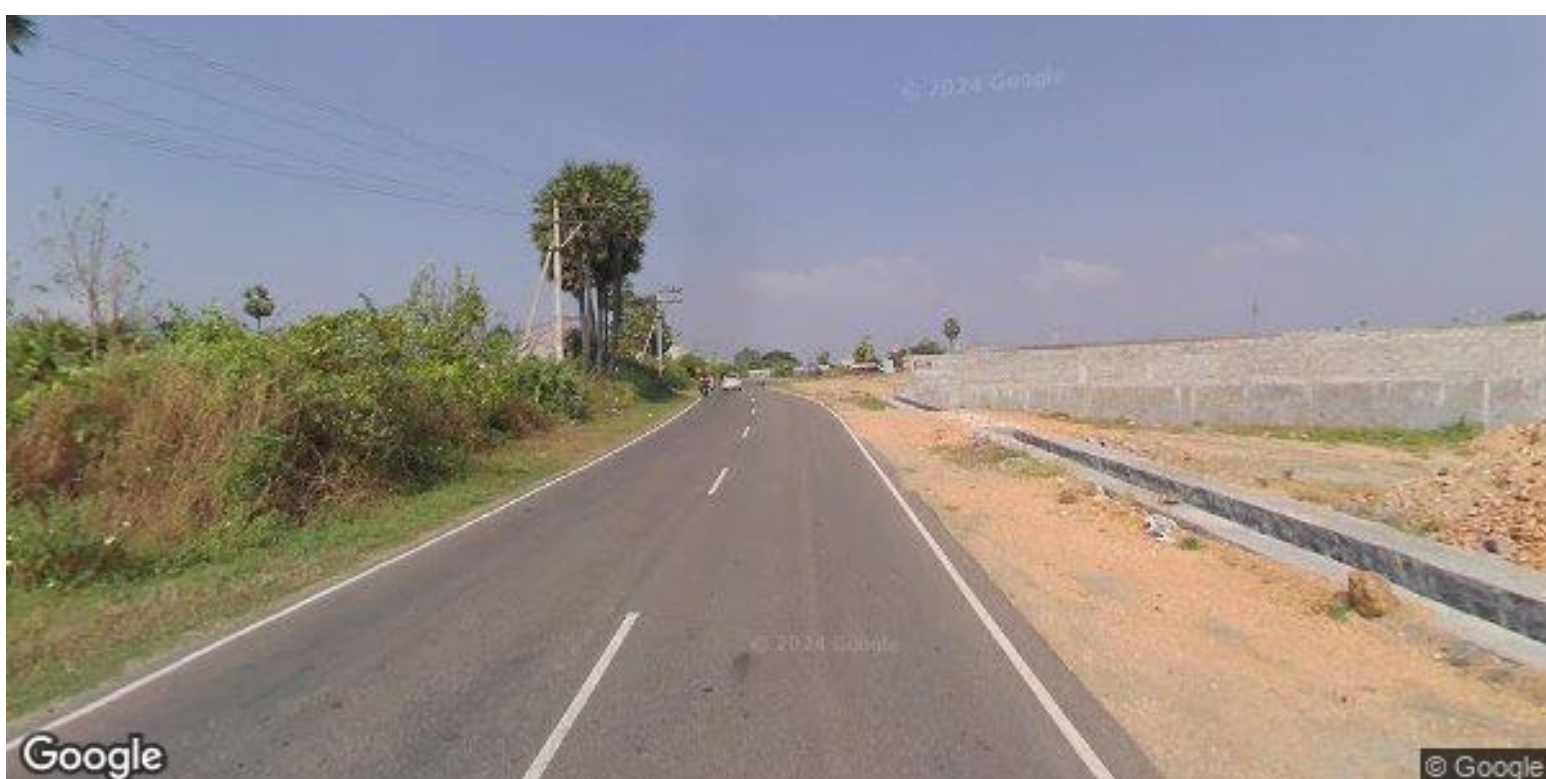
**Risk Type:** Turn  
**Risk Level:** Medium  
**Speed Limit:** 30 KM/Hr  
**Coordinates:** 11.45764, 77.85219

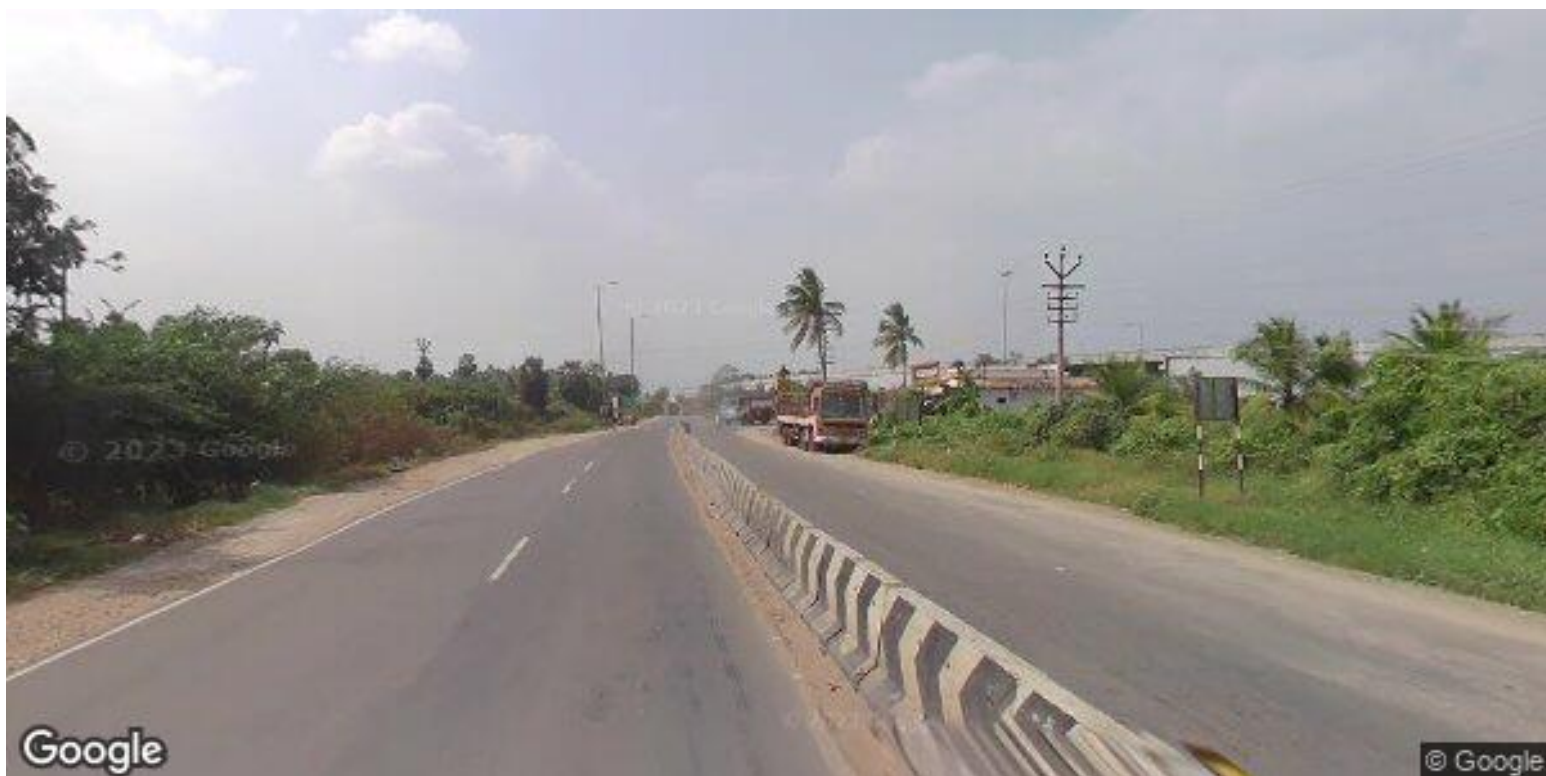
**Risk Type:** Turn  
**Risk Level:** Medium  
**Speed Limit:** 30 KM/Hr  
**Coordinates:** 11.45545, 77.81812

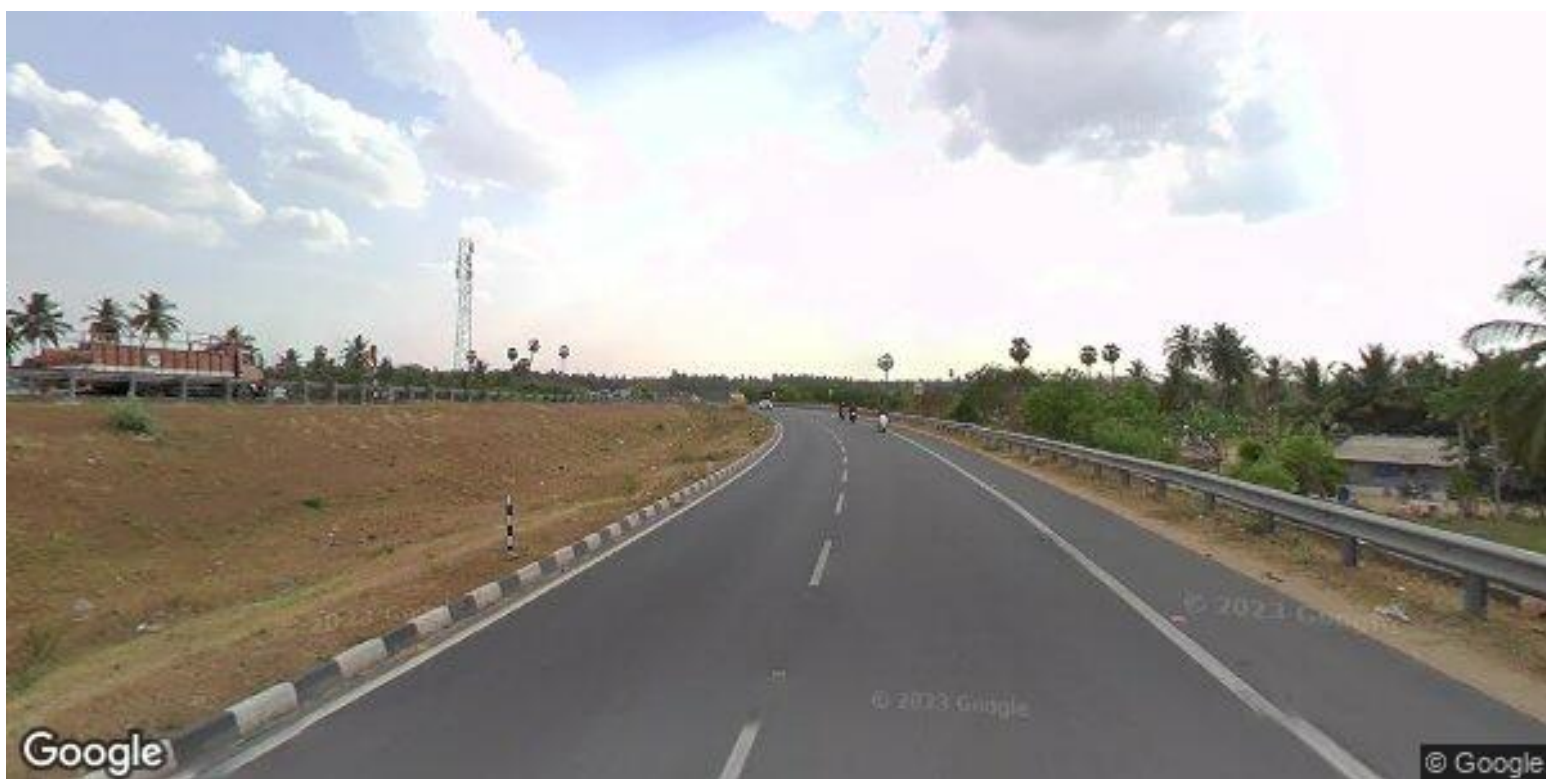
**Risk Type:** Turn  
**Risk Level:** Medium  
**Speed Limit:** 30 KM/Hr  
**Coordinates:** 11.53552, 77.95763

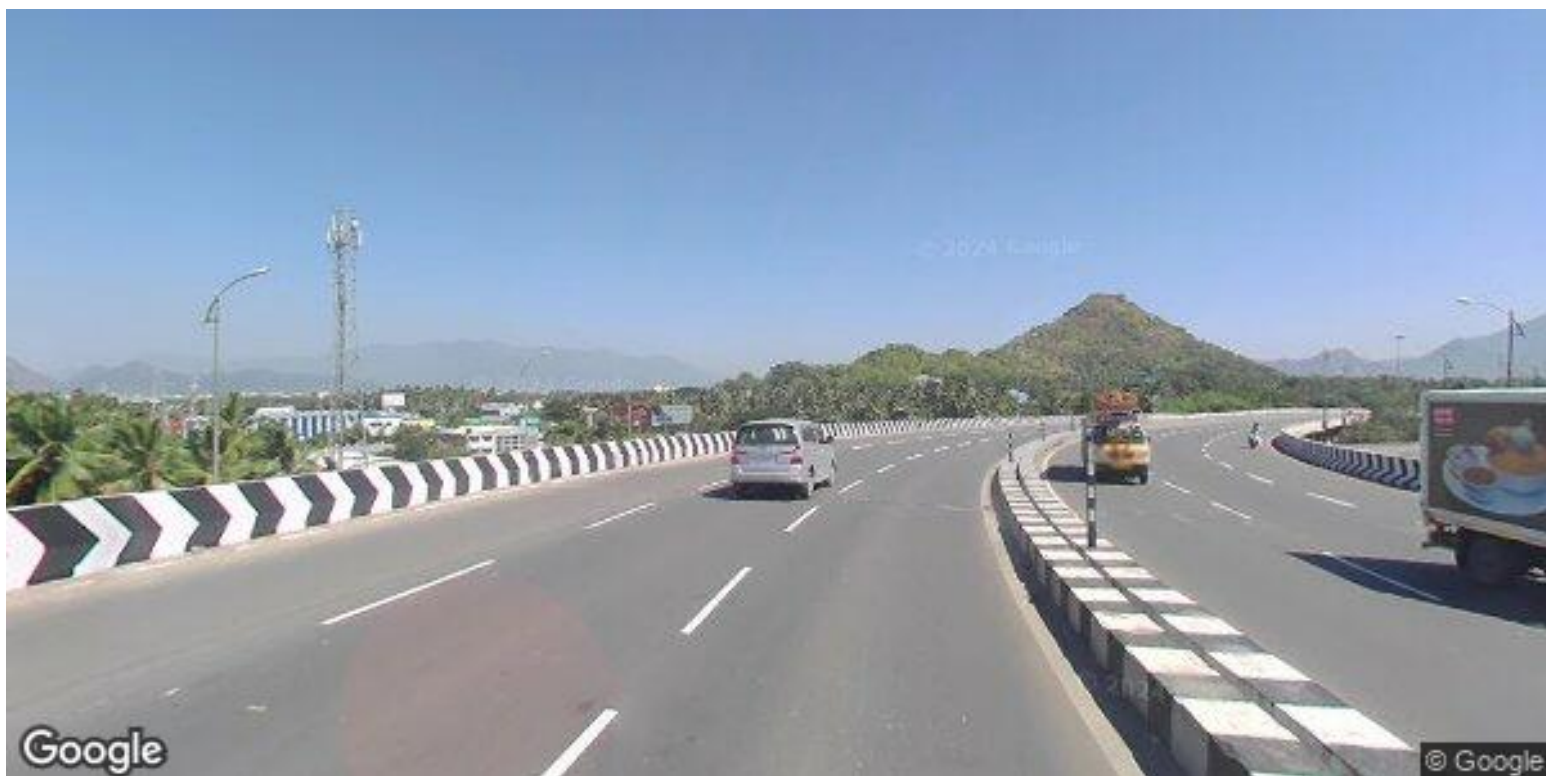
**Risk Type:** Turn  
**Risk Level:** High  
**Speed Limit:** 15 KM/Hr  
**Coordinates:** 11.64210, 78.11860

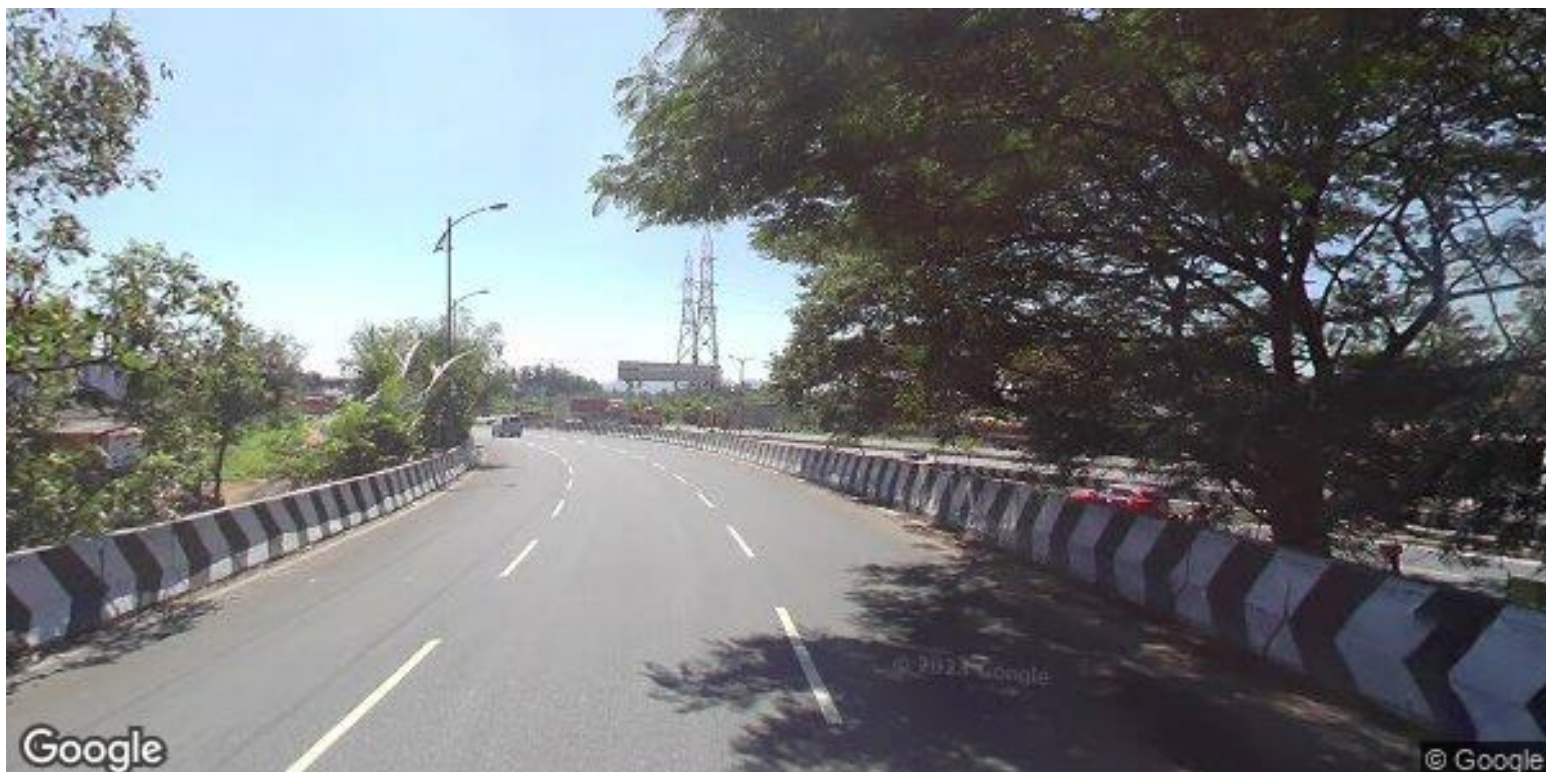
**Risk Type:** Turn  
**Risk Level:** High  
**Speed Limit:** 15 KM/Hr  
**Coordinates:** 11.63972, 78.12083

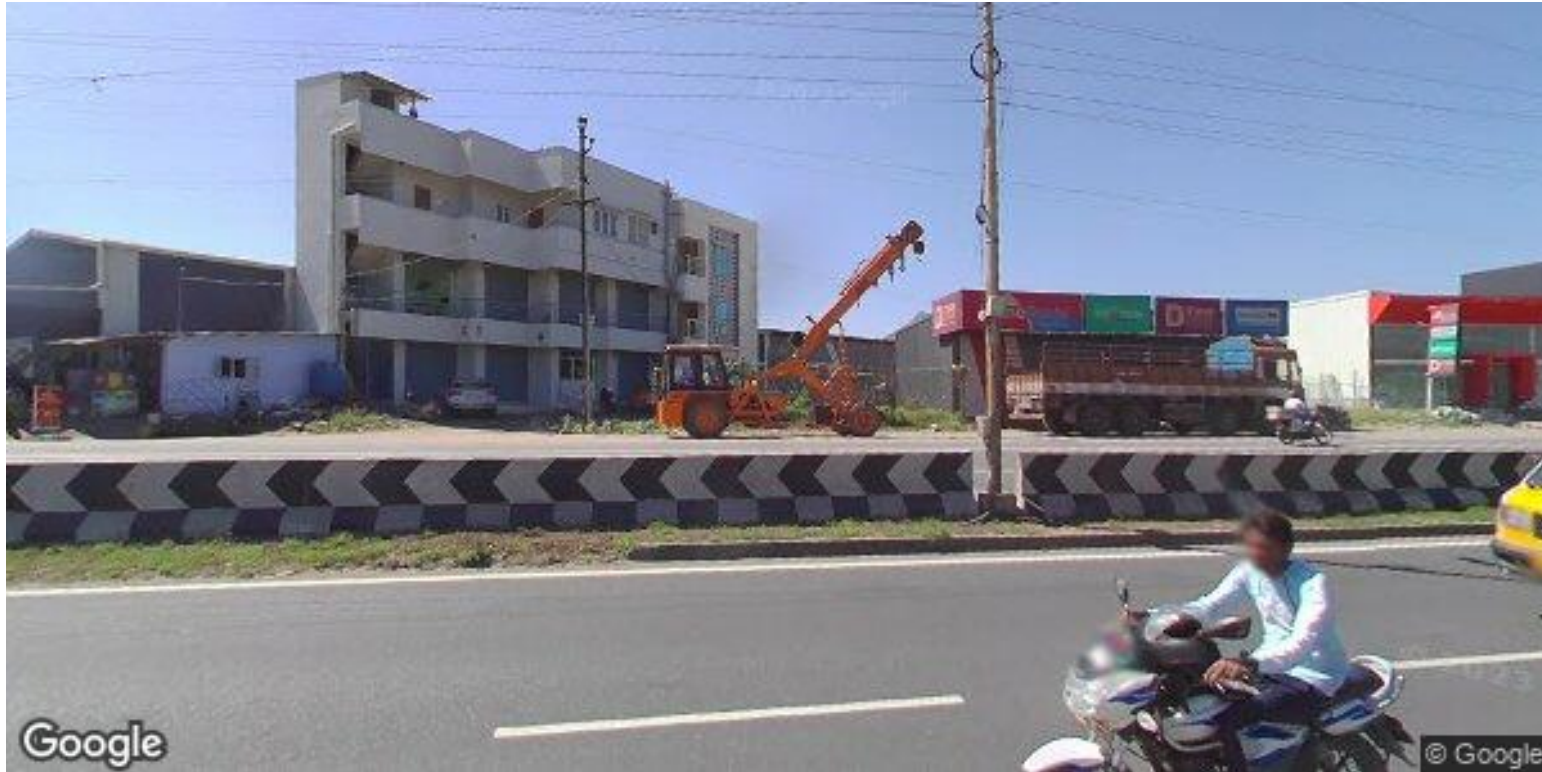
**Risk Type:** Turn  
**Risk Level:** Medium  
**Speed Limit:** 30 KM/Hr  
**Coordinates:** 11.63668, 78.12232

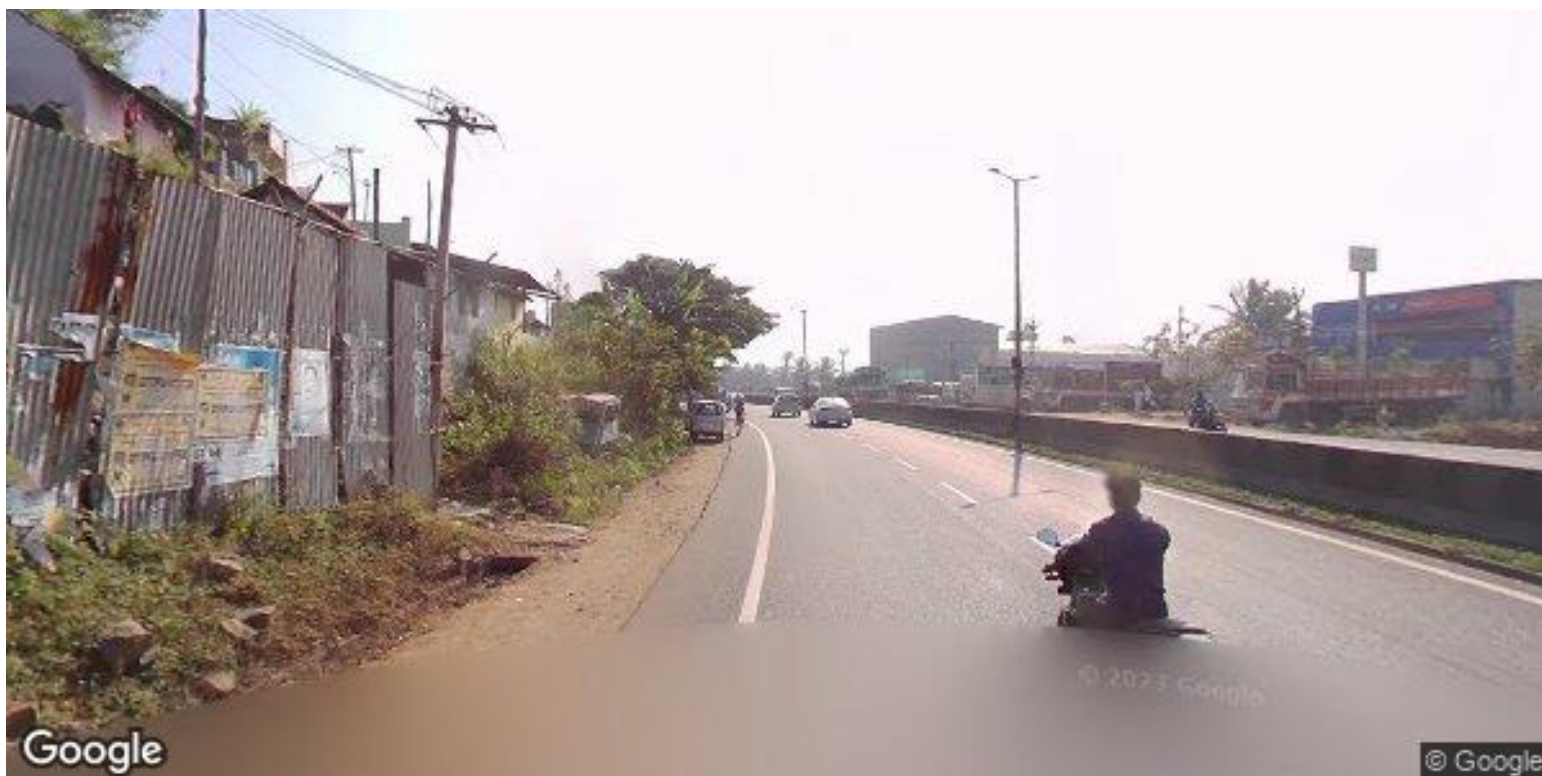
**Risk Type:** Turn  
**Risk Level:** Medium  
**Speed Limit:** 30 KM/Hr  
**Coordinates:** 11.62826, 78.13337

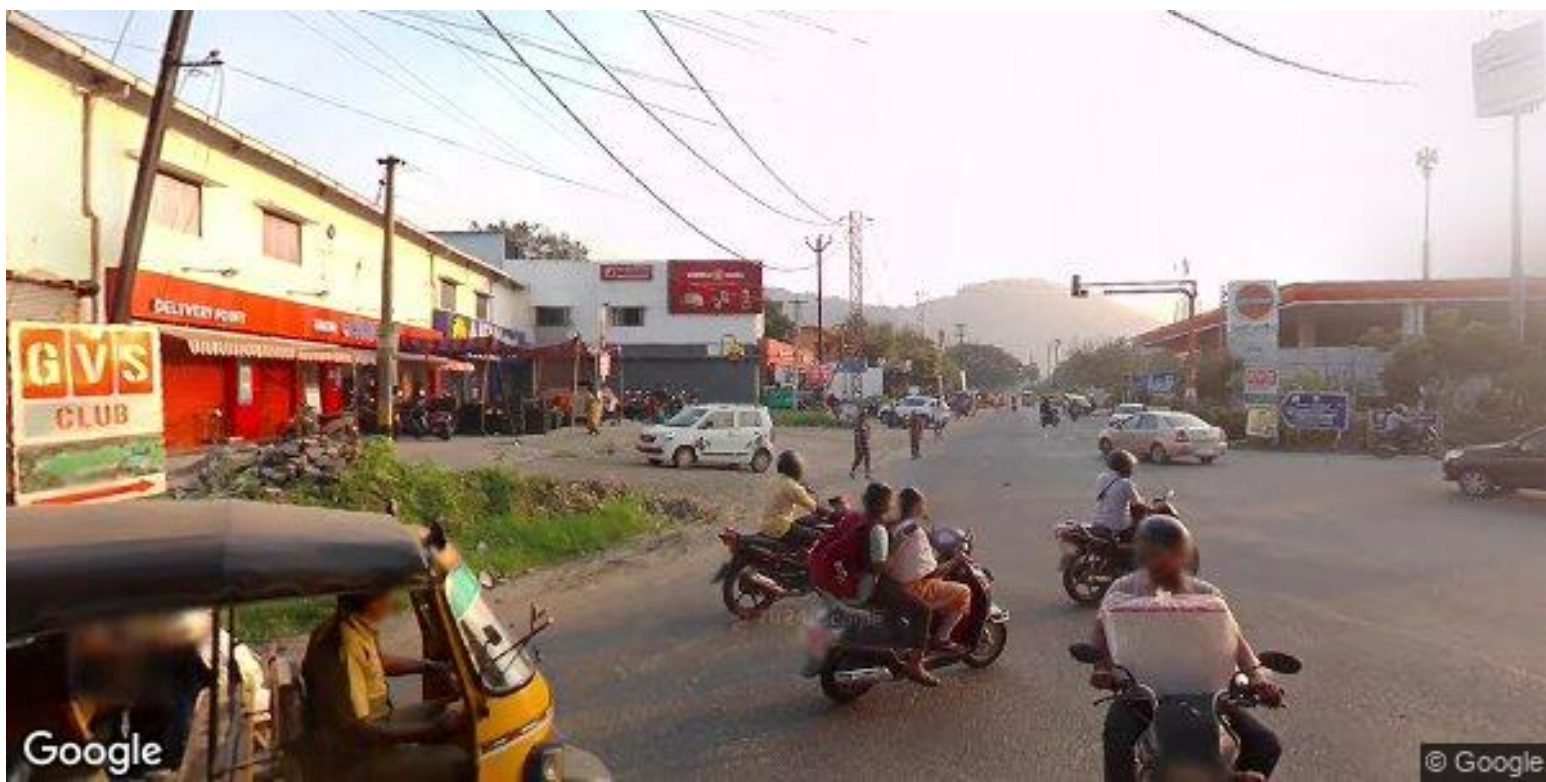
**Coordinates:** 11.66372, 78.20649

**Risk Type:** Turn

**Risk Level:** High

**Speed Limit:** 15 KM/Hr

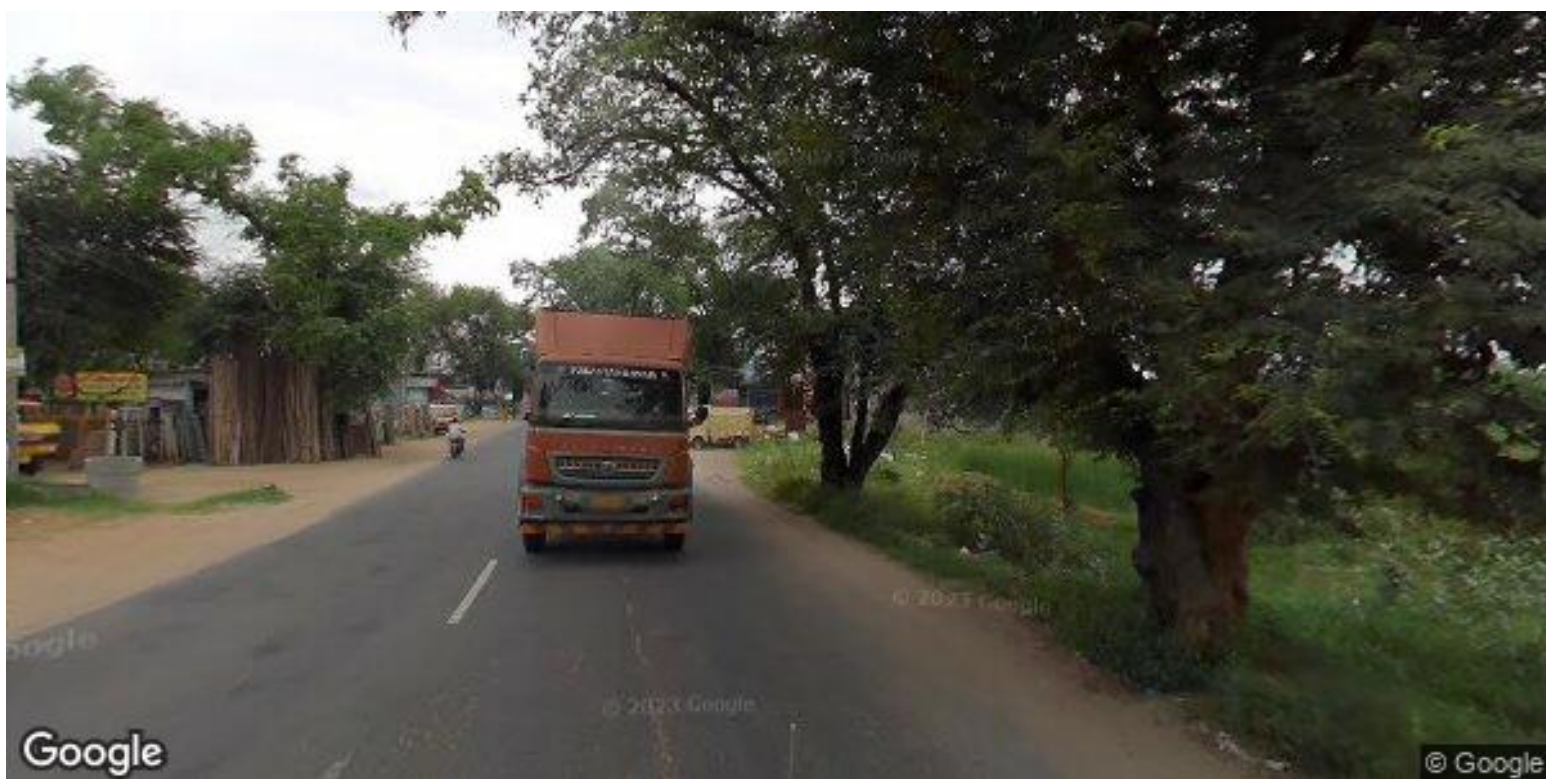
**Coordinates:** 11.67124, 78.22961

**Risk Type:** Turn

**Risk Level:** Medium

**Speed Limit:** 30 KM/Hr

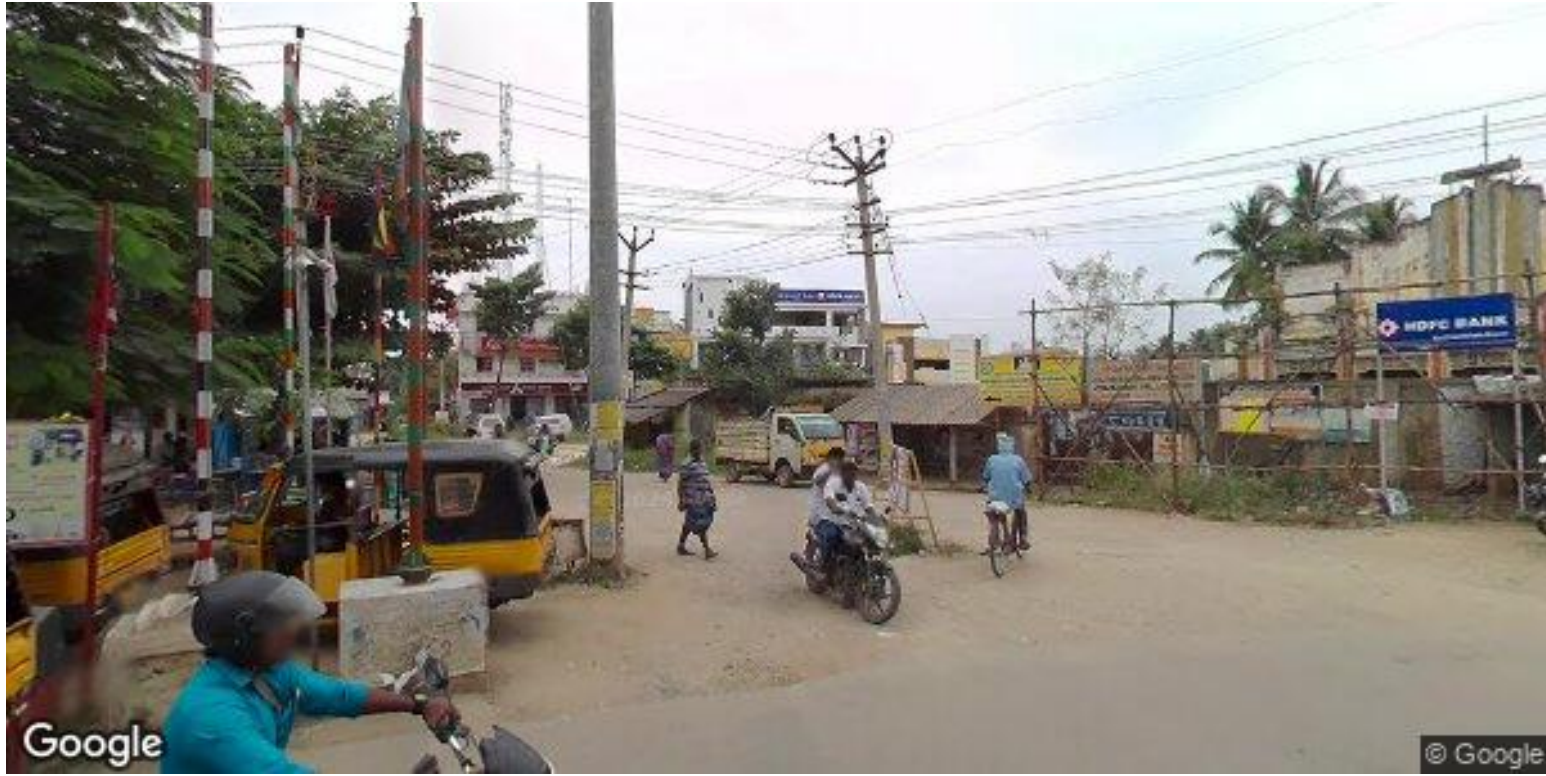
**Risk Type:** Turn  
**Risk Level:** High  
**Speed Limit:** 15 KM/Hr  
**Coordinates:** 11.67187, 78.23142

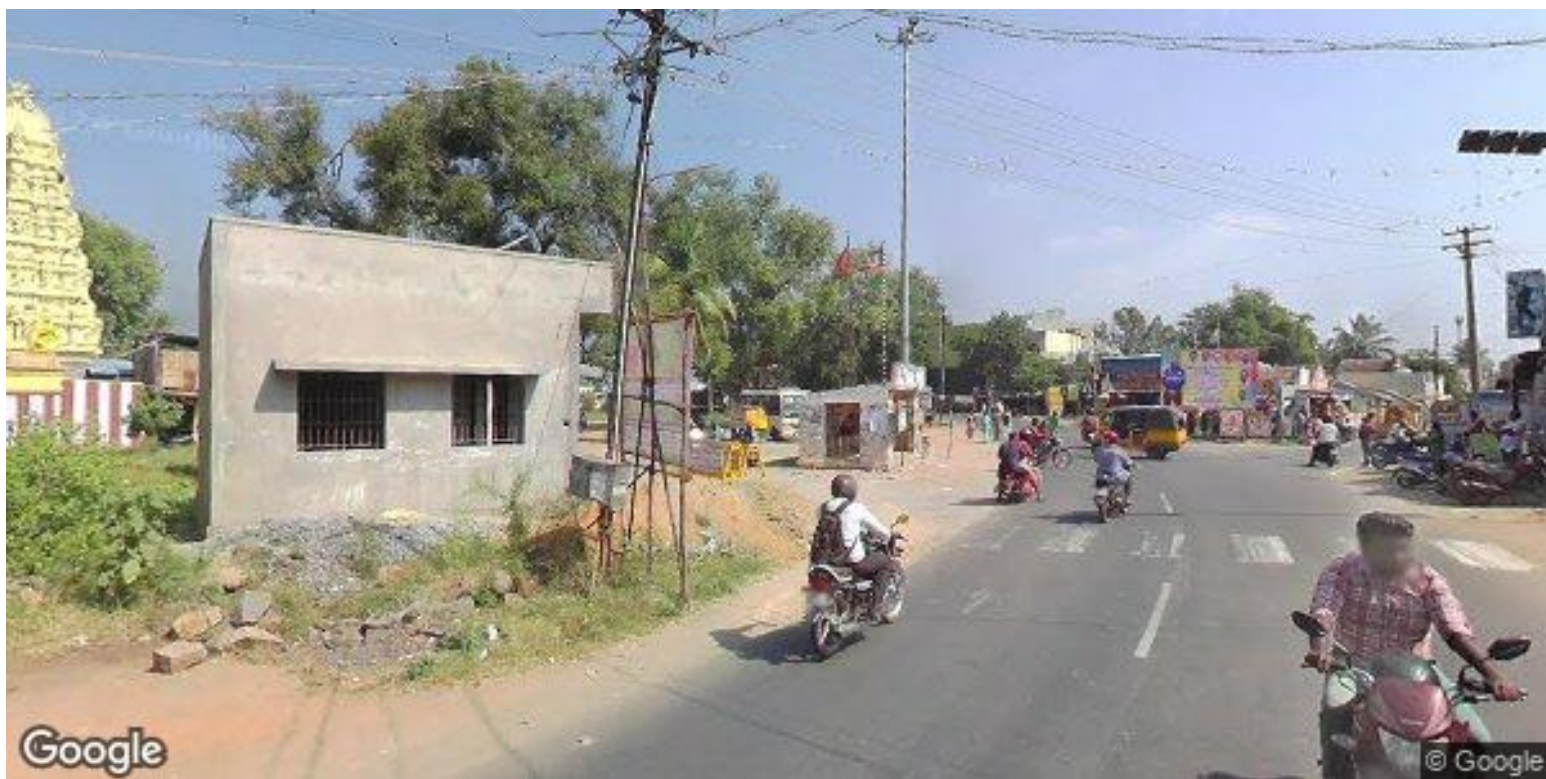
**Risk Type:** Turn  
**Risk Level:** Medium  
**Speed Limit:** 30 KM/Hr  
**Coordinates:** 11.67427, 78.23892

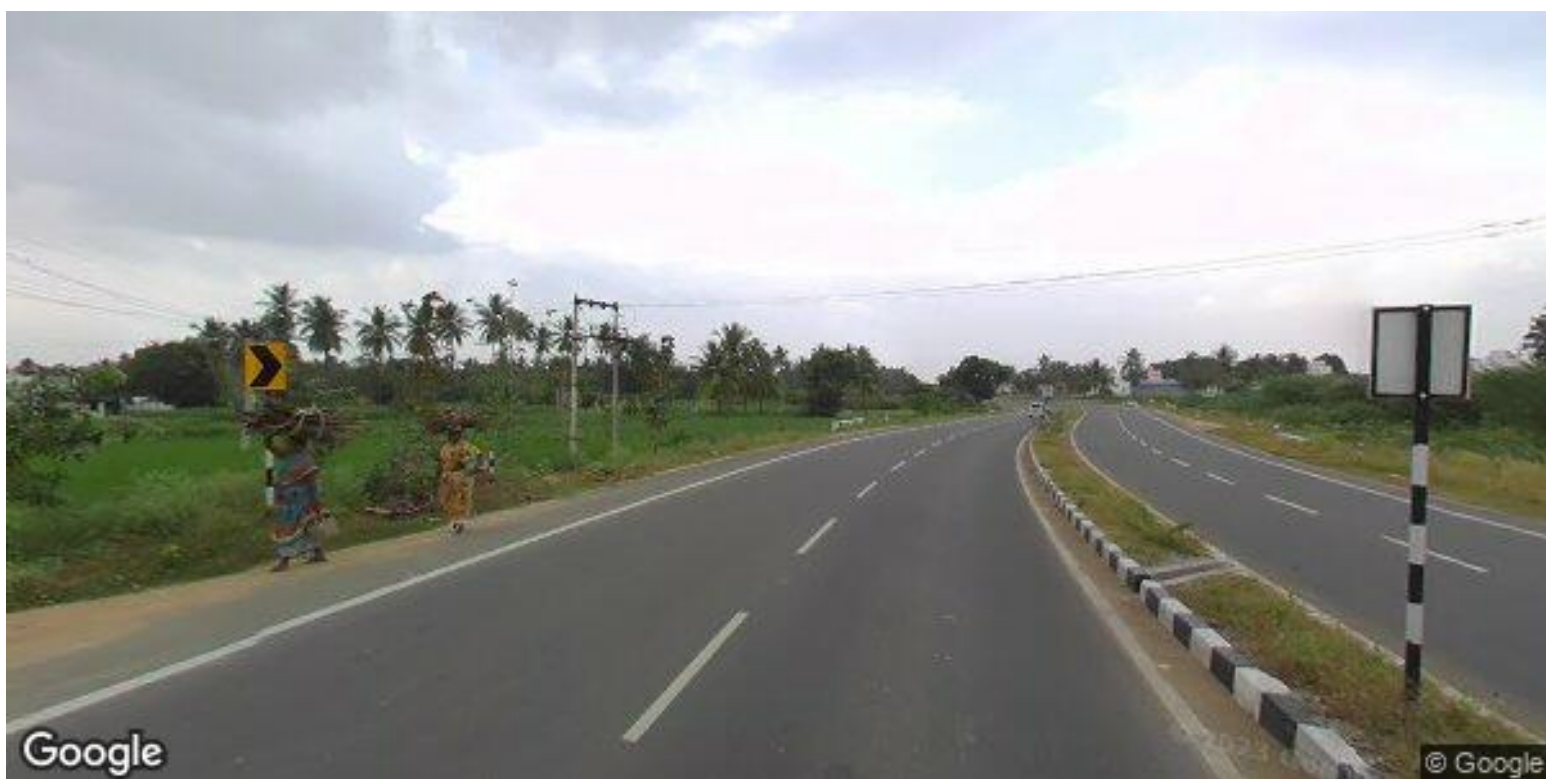
**Coordinates:** 12.07570, 78.47610

**Risk Type:** Turn

**Risk Level:** Medium

**Speed Limit:** 30 KM/Hr

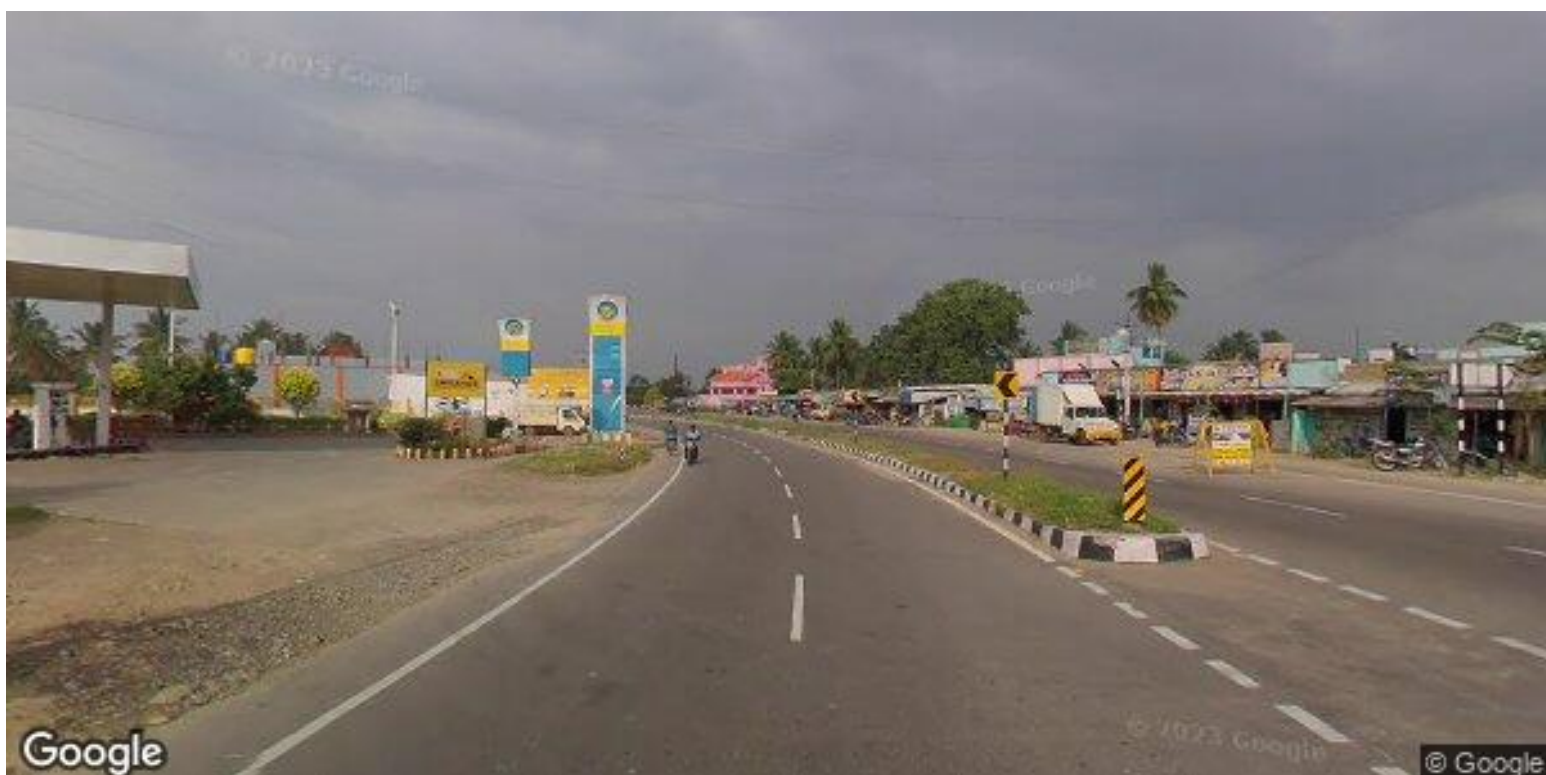
**Risk Type:** Turn  
**Risk Level:** Medium  
**Speed Limit:** 30 KM/Hr  
**Coordinates:** 12.17756, 78.54790

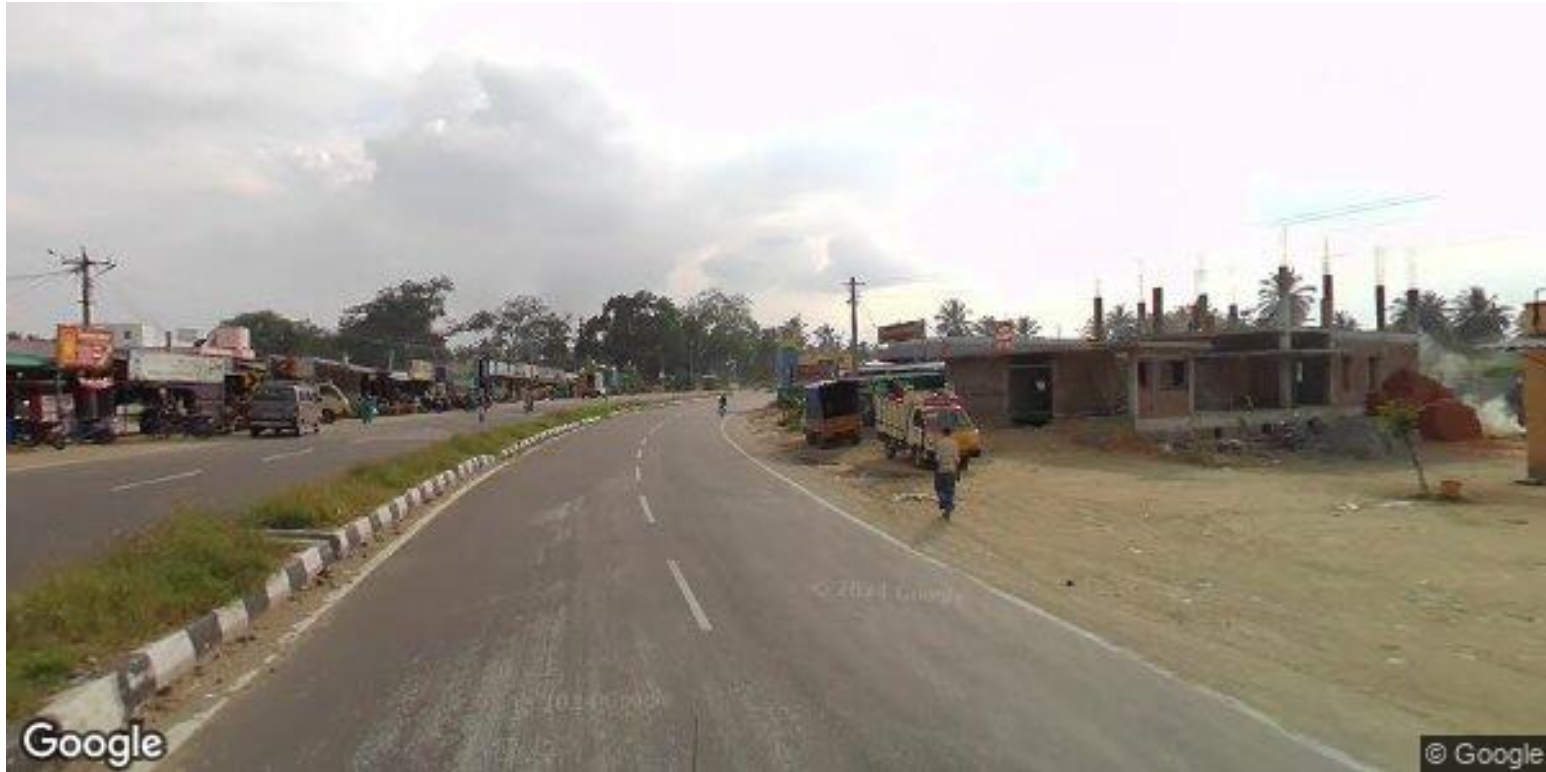
**Risk Type:** Turn  
**Risk Level:** Medium  
**Speed Limit:** 30 KM/Hr  
**Coordinates:** 12.17838, 78.54853

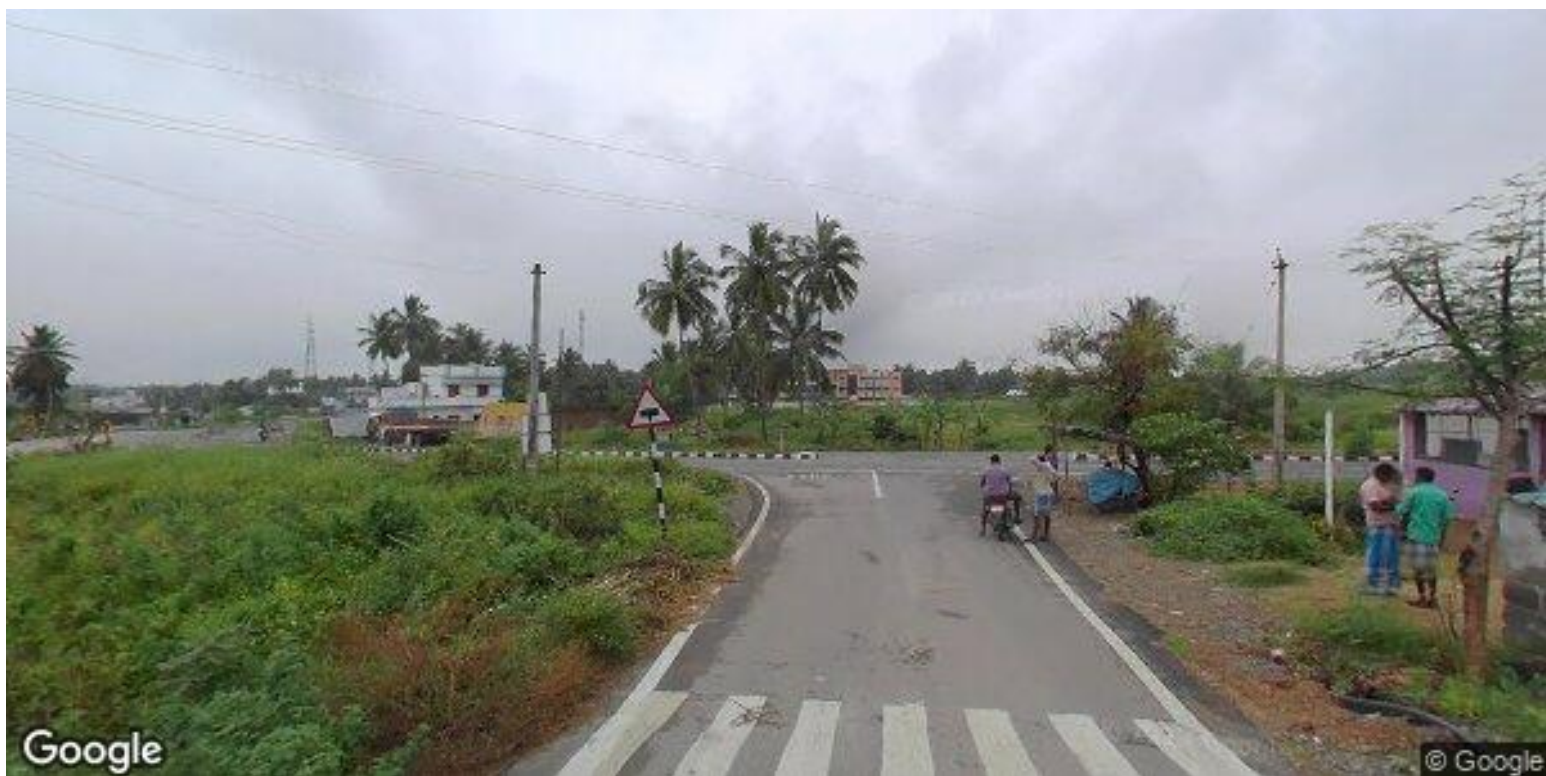
**Risk Type:** Turn  
**Risk Level:** Medium  
**Speed Limit:** 30 KM/Hr  
**Coordinates:** 12.18684, 78.54965

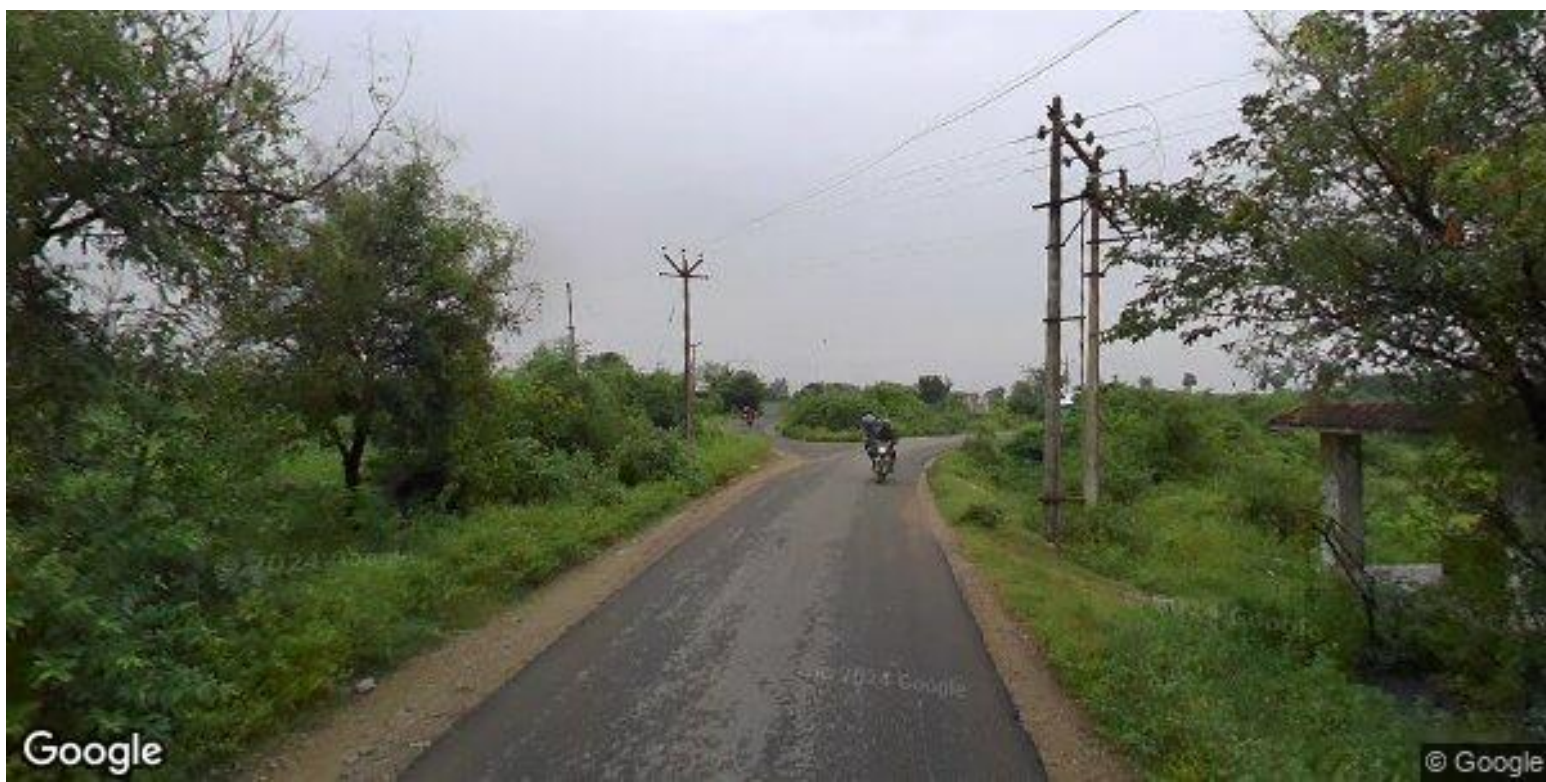
**Coordinates:** 12.18752, 78.55009

**Risk Type:** Turn

**Risk Level:** Medium

**Speed Limit:** 30 KM/Hr

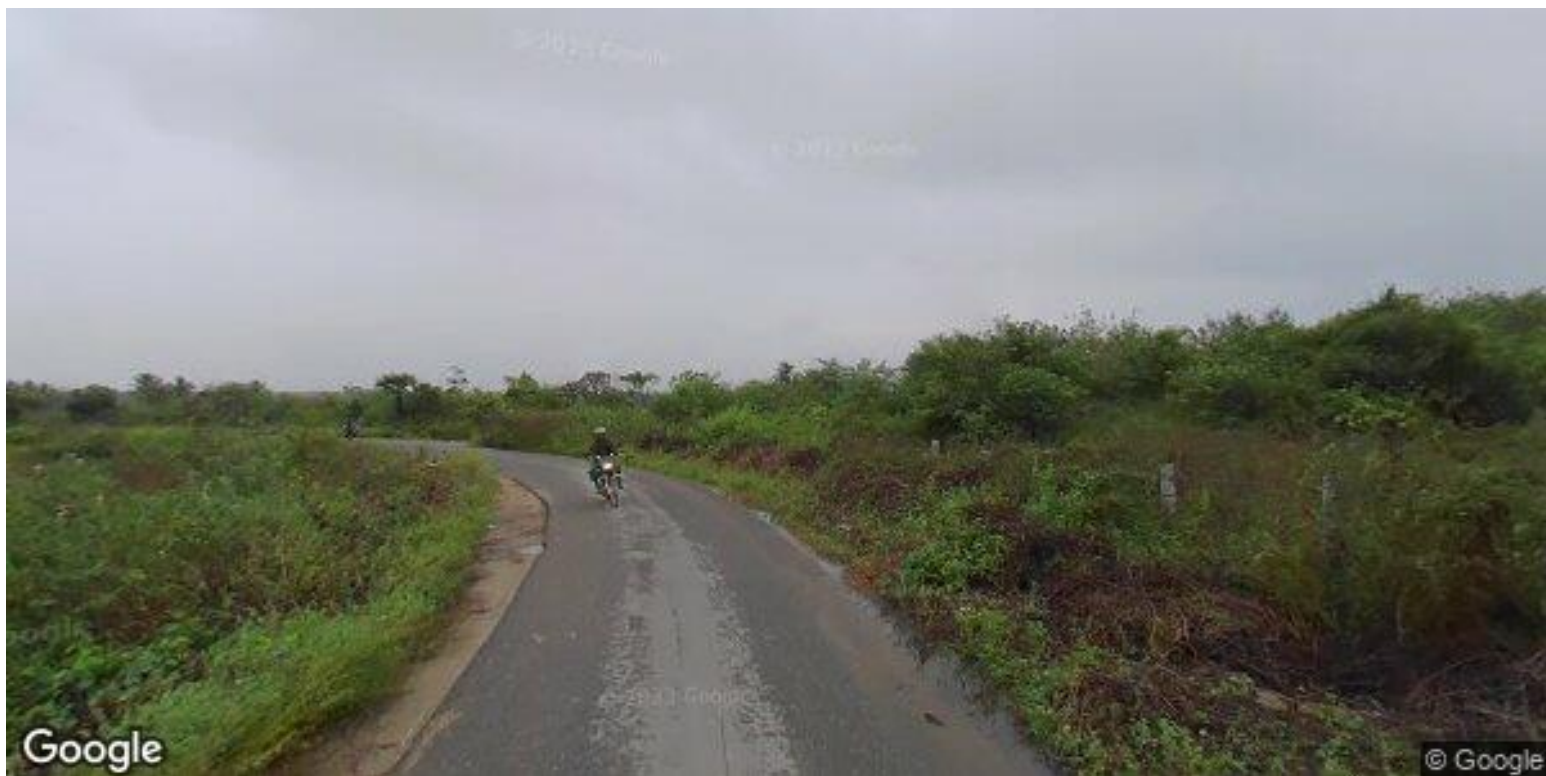
**Coordinates:** 12.18883, 78.55864

**Risk Type:** Turn

**Risk Level:** Medium

**Speed Limit:** 30 KM/Hr

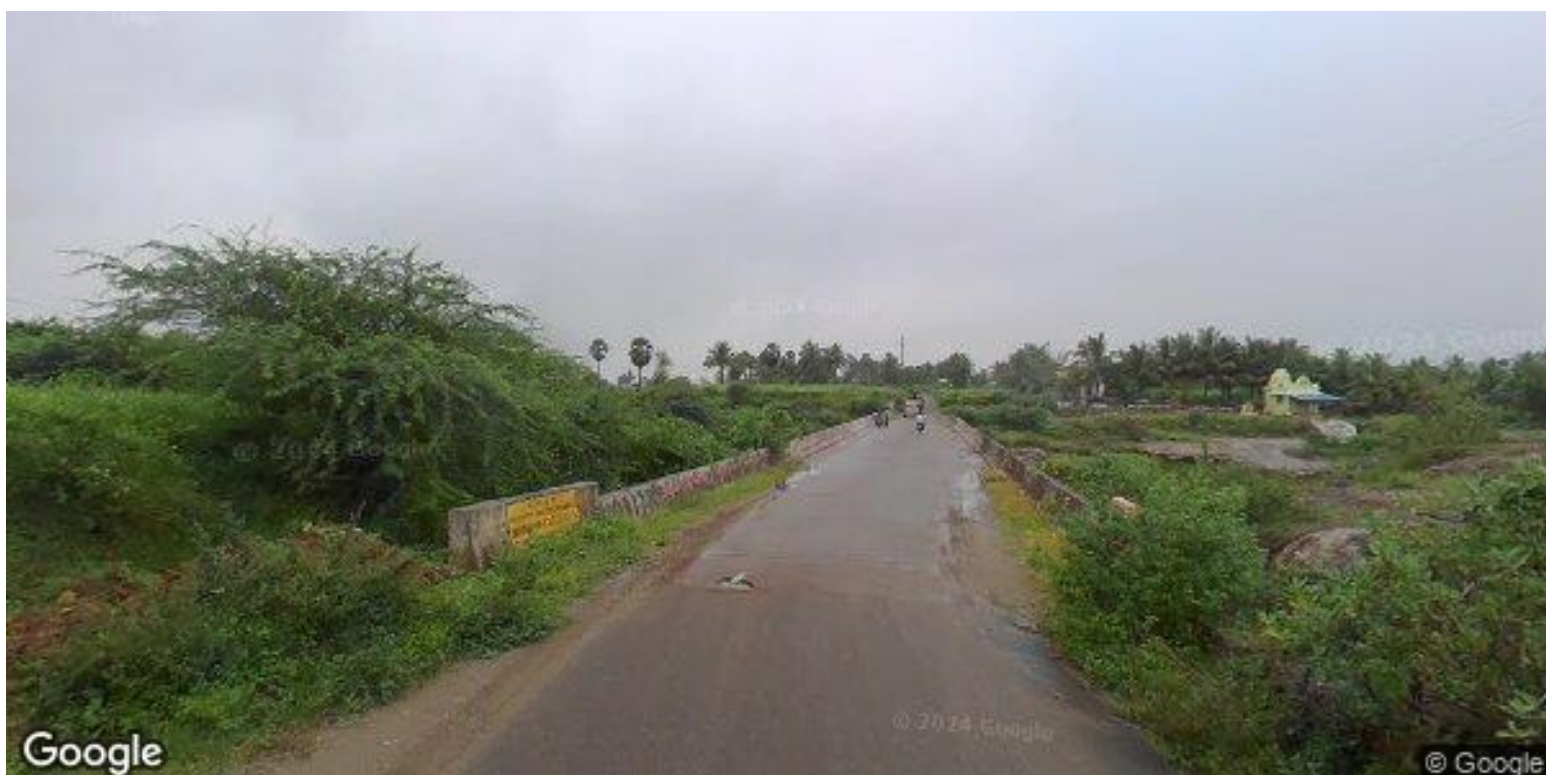
**Risk Type:** Turn  
**Risk Level:** Medium  
**Speed Limit:** 30 KM/Hr  
**Coordinates:** 12.19710, 78.57531
