# IndianOil

## JOURNEY RISK MANAGEMENT (JRM) STUDY

### Salem Terminal TO SKS AGENCIES

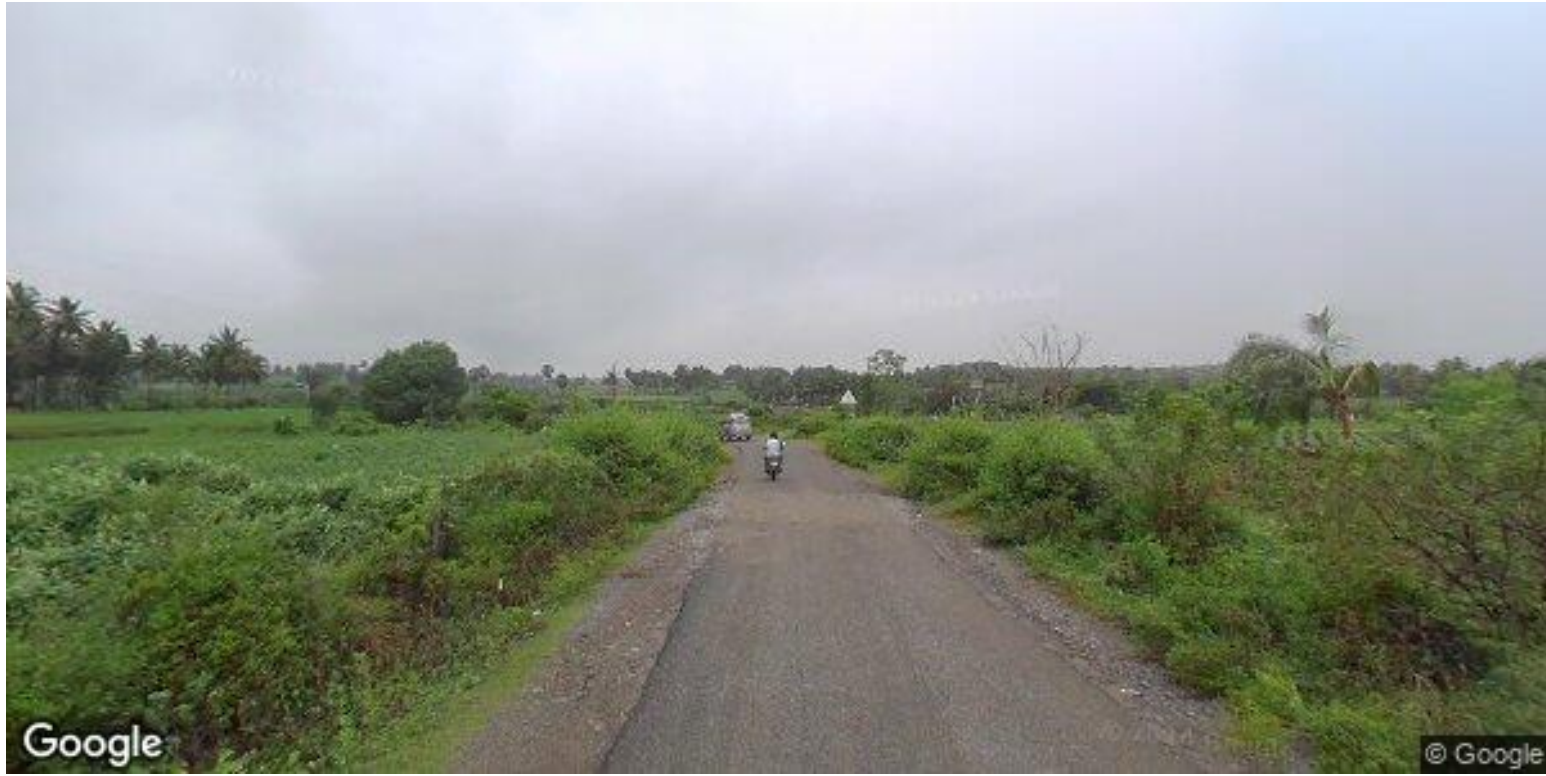
**Risk Type:** Turn  
**Risk Level:** High  
**Speed Limit:** 15 KM/Hr  
**Coordinates:** 12.19786, 78.57624

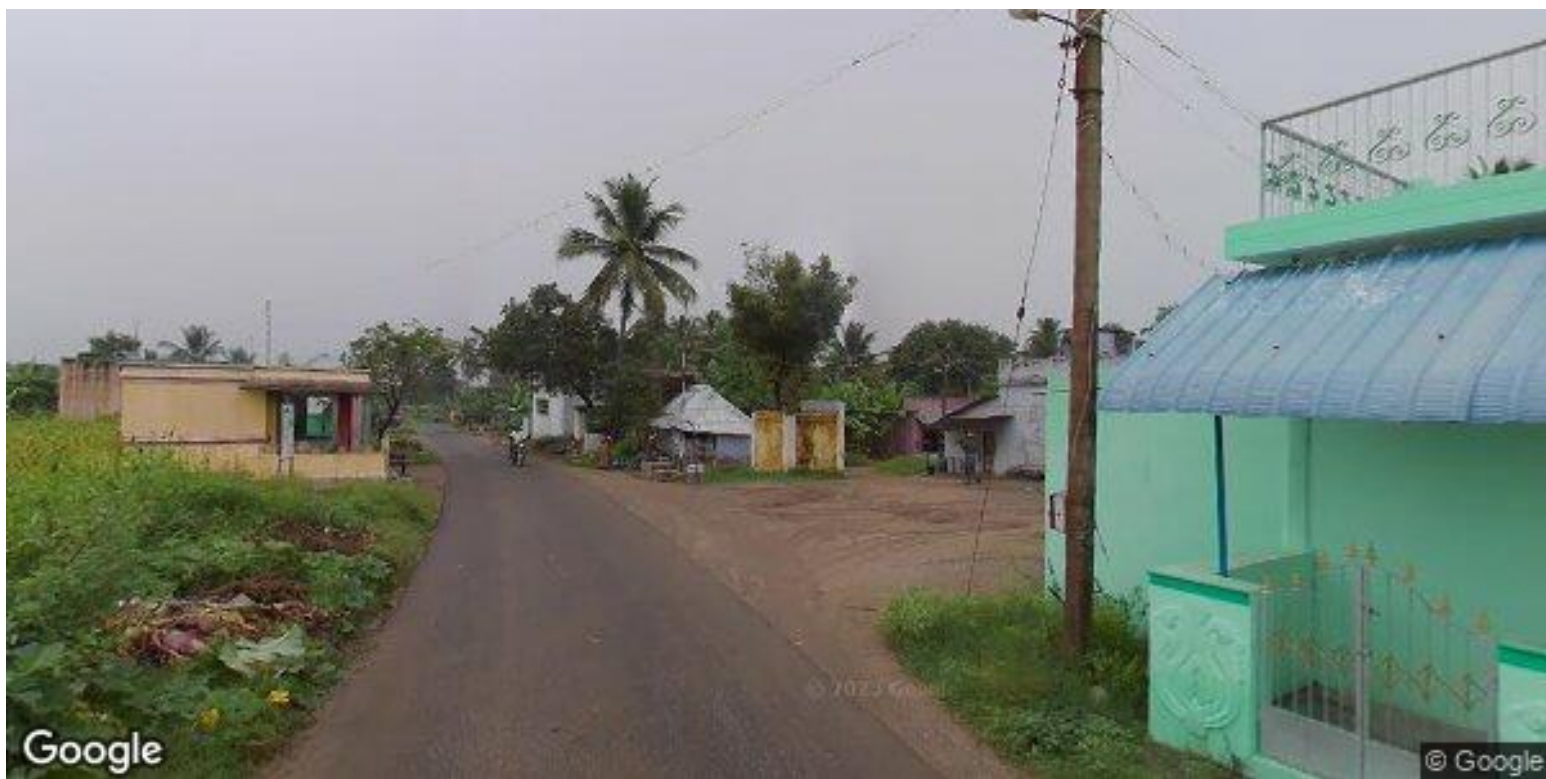
**Risk Type:** Turn  
**Risk Level:** Medium  
**Speed Limit:** 30 KM/Hr  
**Coordinates:** 12.20375, 78.59119

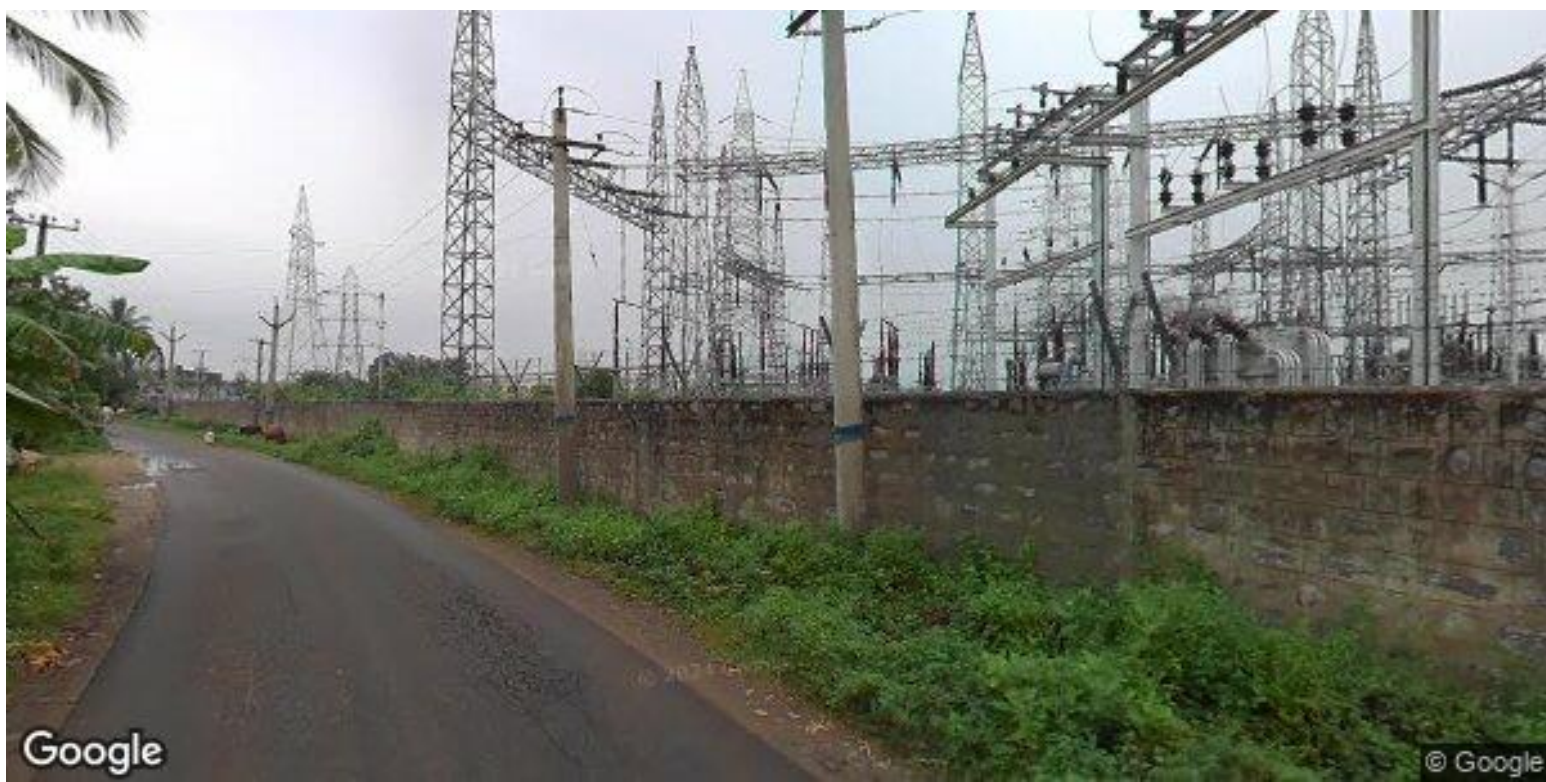
**Coordinates:** 12.22486, 78.59702

**Risk Type:** Turn

**Risk Level:** Medium

**Speed Limit:** 30 KM/Hr

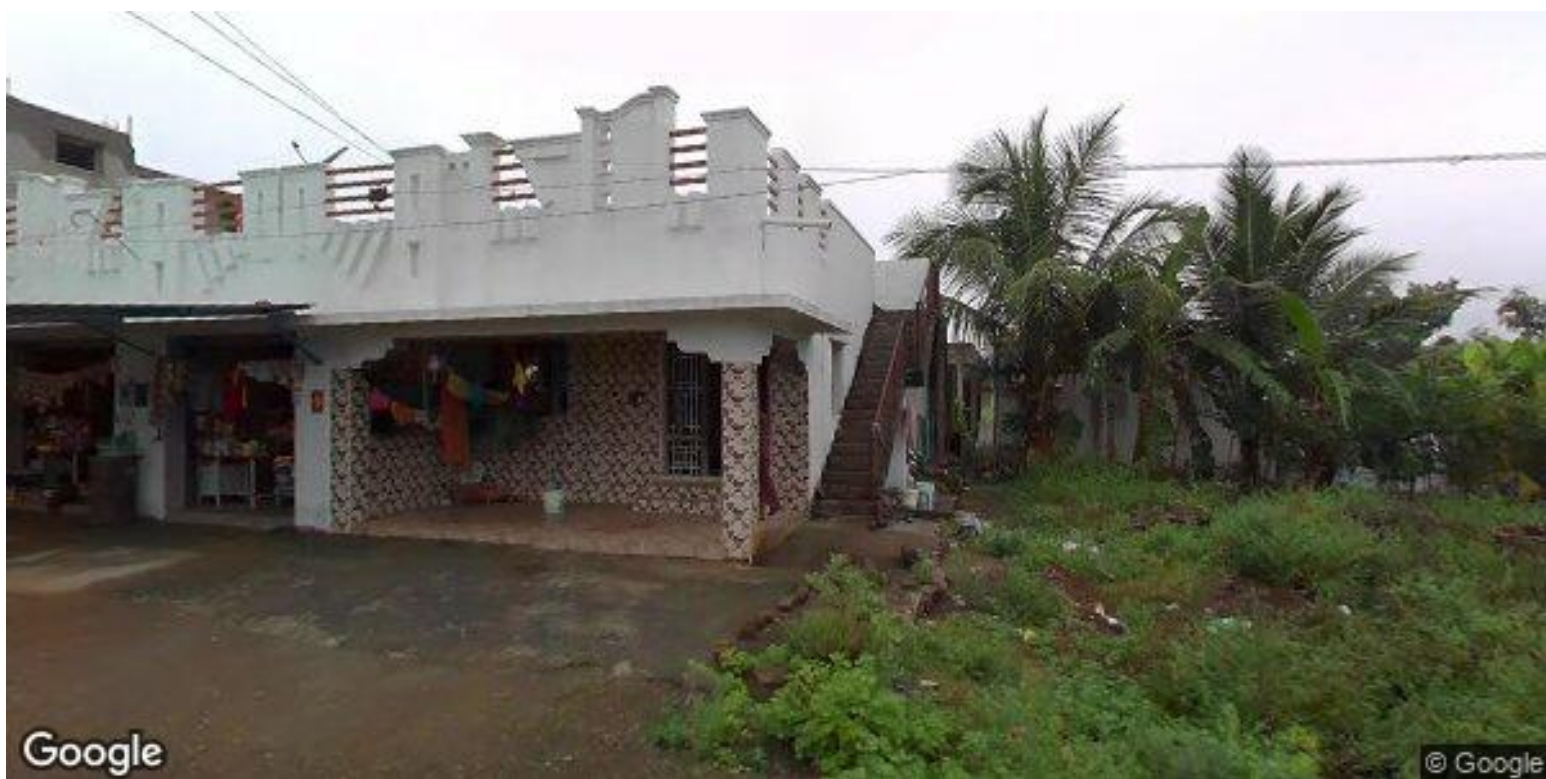
**Coordinates:** 12.22650, 78.59653

**Risk Type:** Turn

**Risk Level:** Medium

**Speed Limit:** 30 KM/Hr

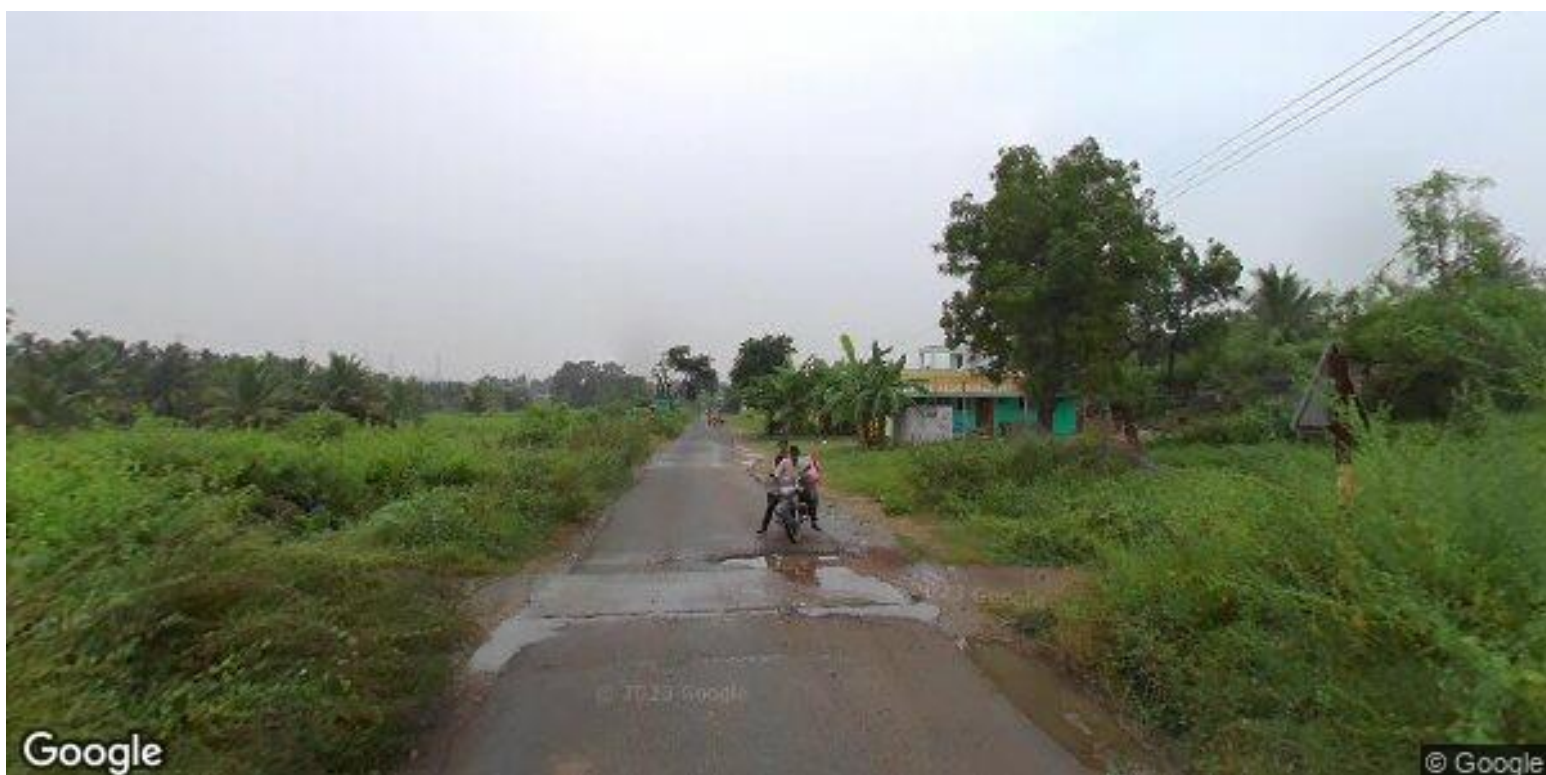
**Risk Type:** Turn  
**Risk Level:** High  
**Speed Limit:** 15 KM/Hr  
**Coordinates:** 12.23464, 78.60023

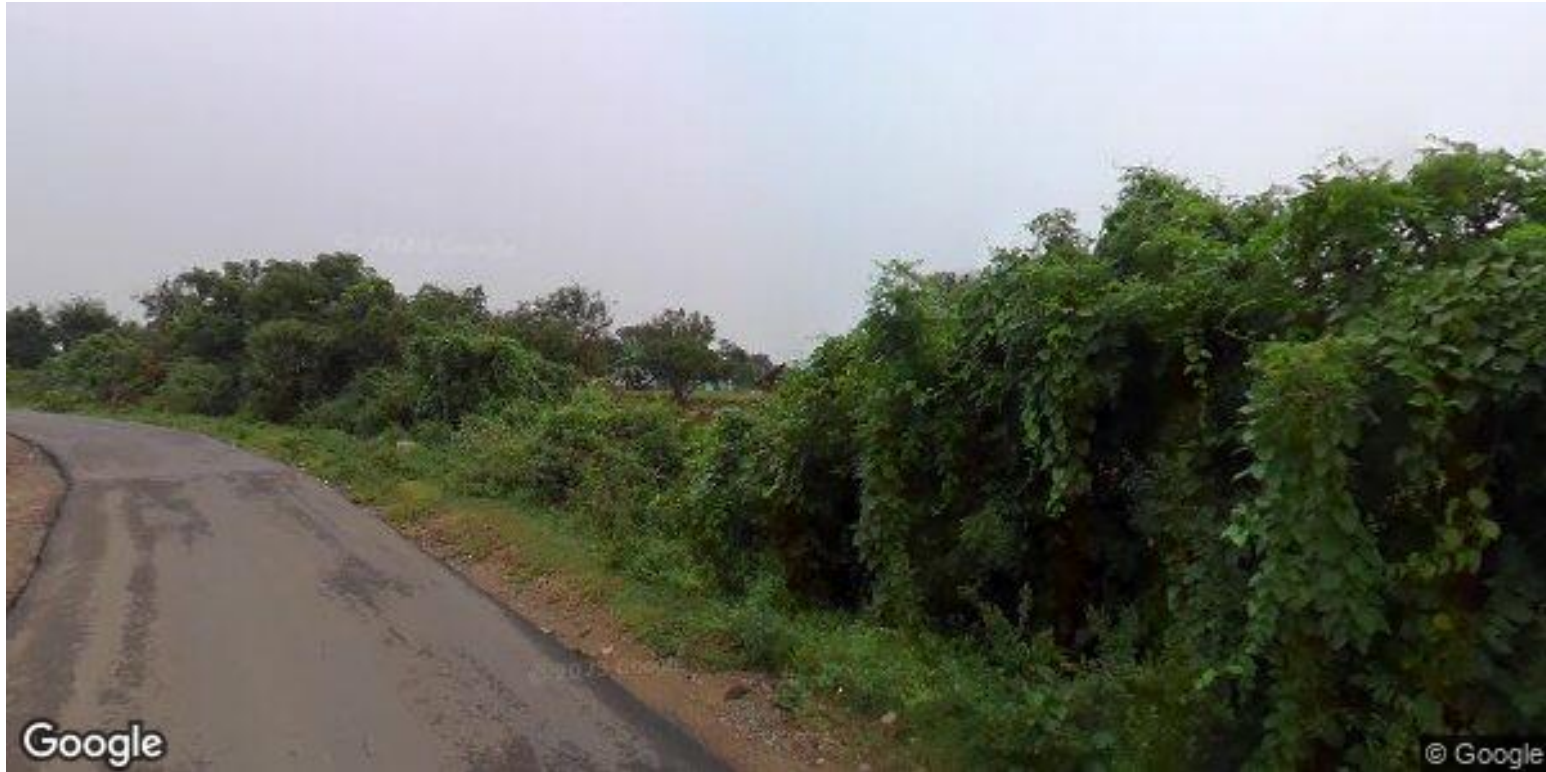
**Risk Type:** Turn  
**Risk Level:** Medium  
**Speed Limit:** 30 KM/Hr  
**Coordinates:** 12.23635, 78.60528

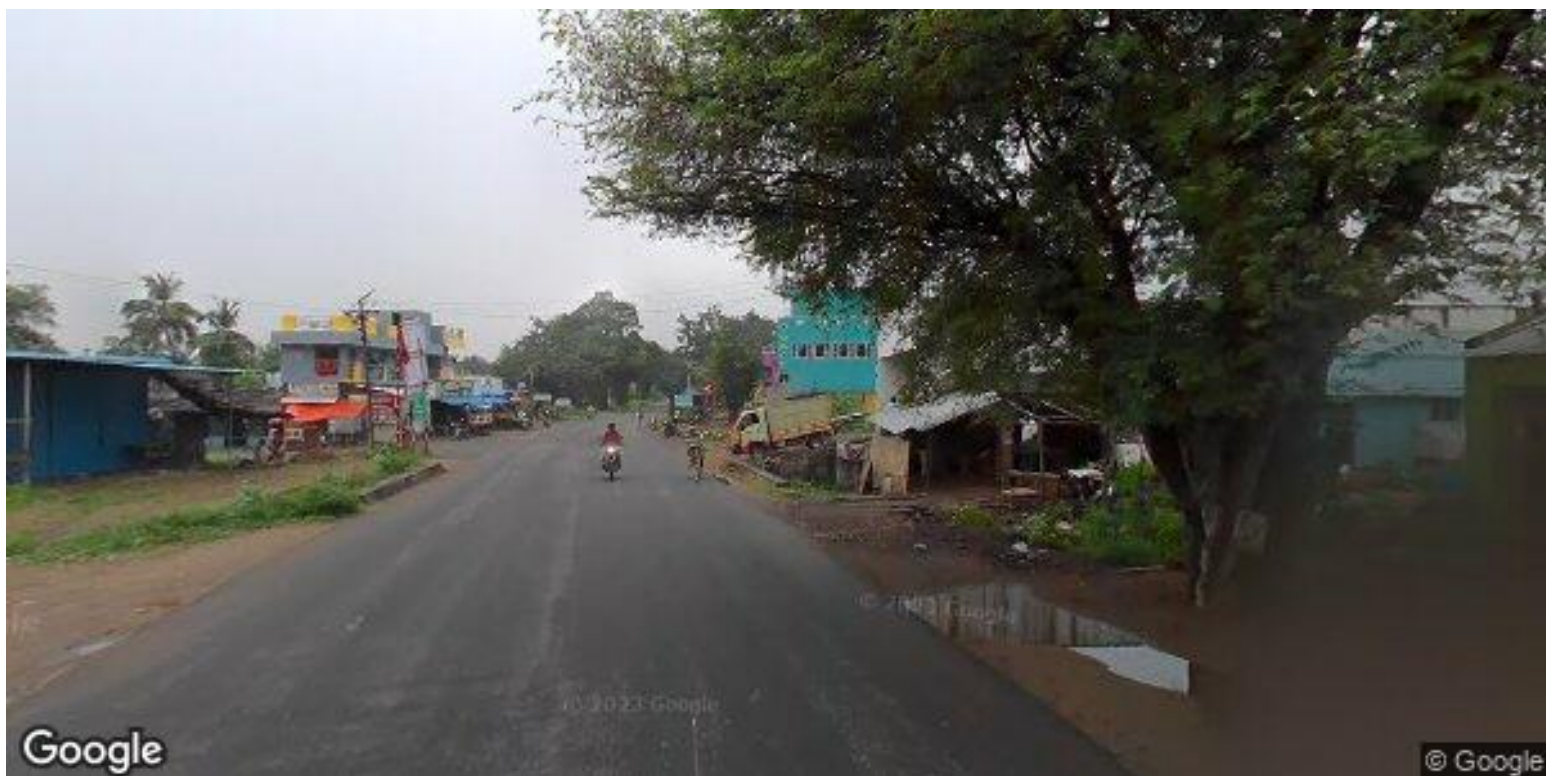
**Risk Type:** Turn  
**Risk Level:** High  
**Speed Limit:** 15 KM/Hr  
**Coordinates:** 12.25218, 78.61196

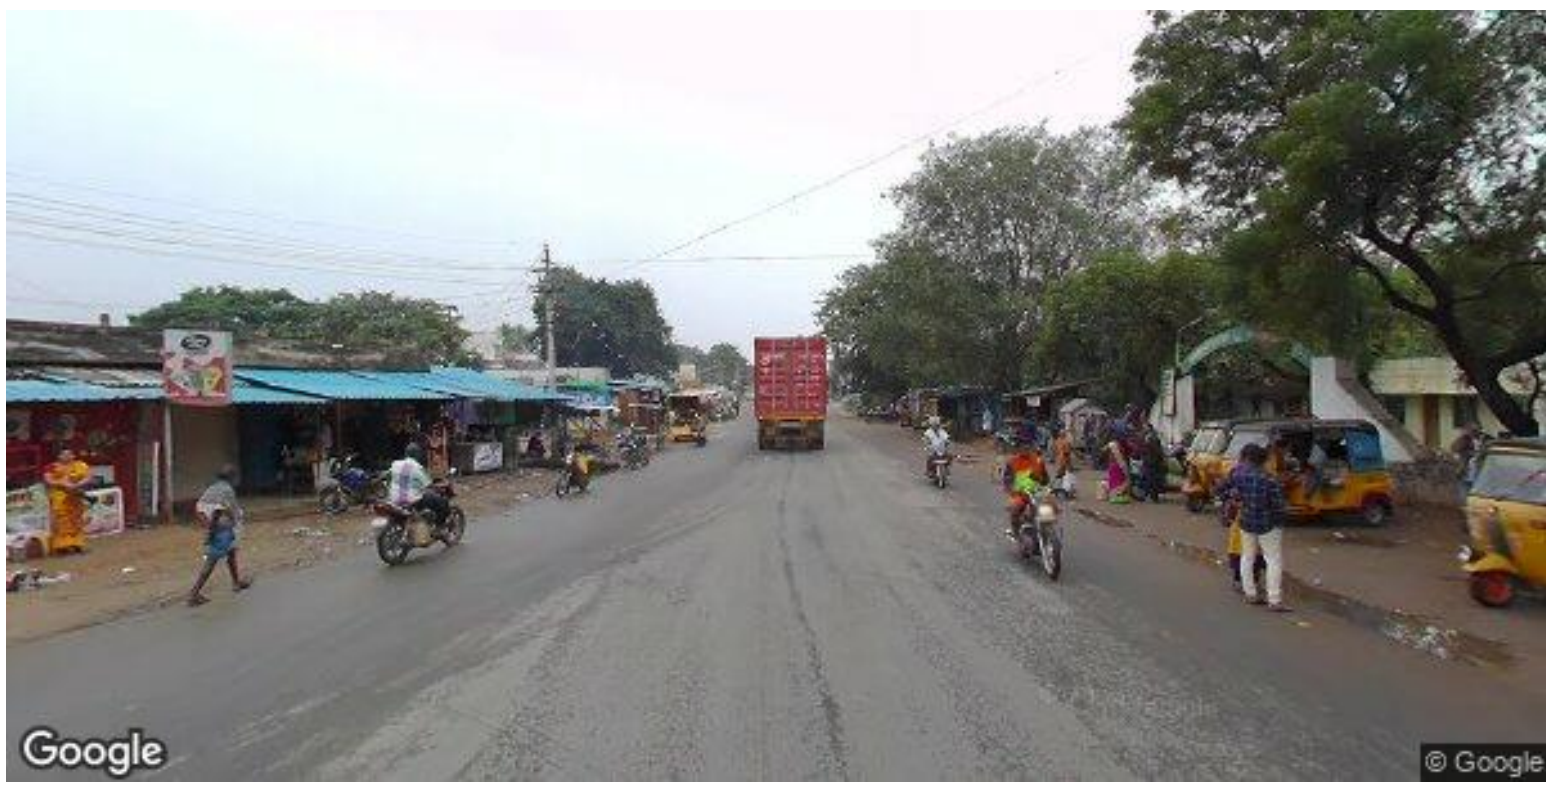
**Coordinates:** 12.25381, 78.61757

**Risk Type:** Turn

**Risk Level:** Medium

**Speed Limit:** 30 KM/Hr
