## JOURNEY RISK MANAGEMENT (JRM) STUDY

### Salem Terminal TO PALANISAMY AGENCIES

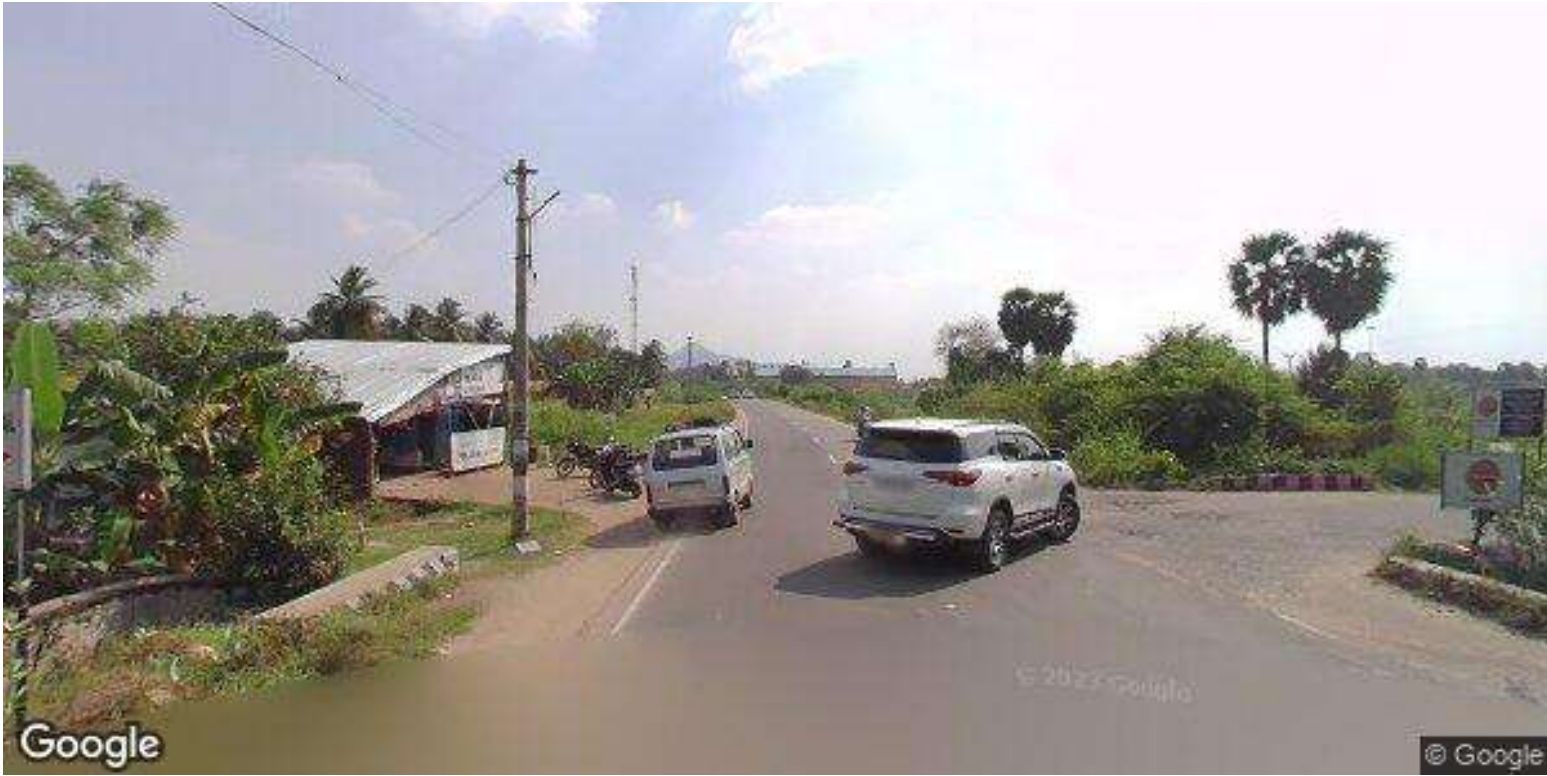
Risk Type: Blind Spot  
Risk Level: Blind Spot  
Speed Limit: 10 KM/Hr  
Coordinates: 11.44029, 77.87544

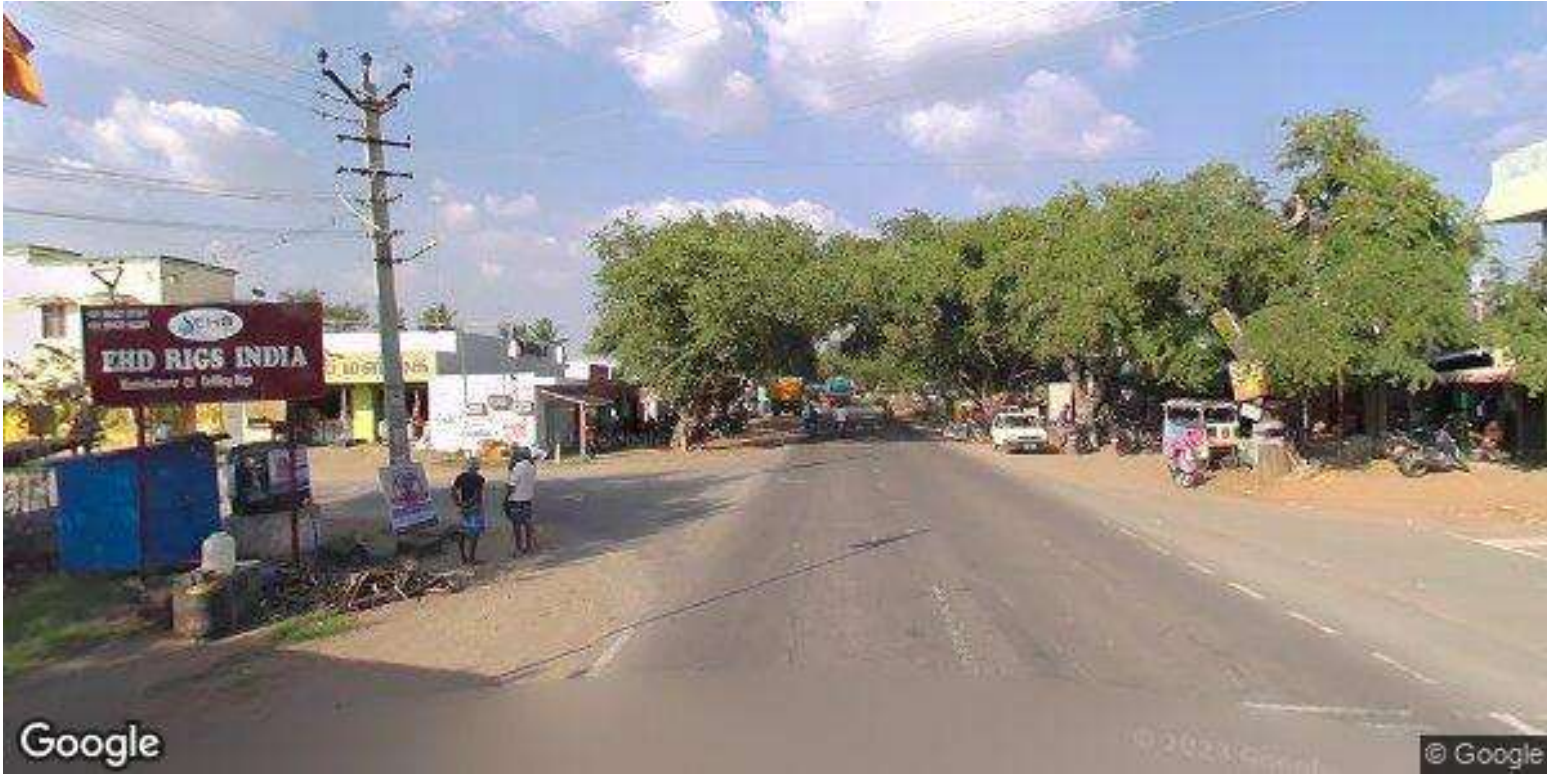
Risk Type: Blind Spot  
Risk Level: Blind Spot

**Speed Limit: 10 KM/Hr**  
**Coordinates: 11.41975, 77.88075**

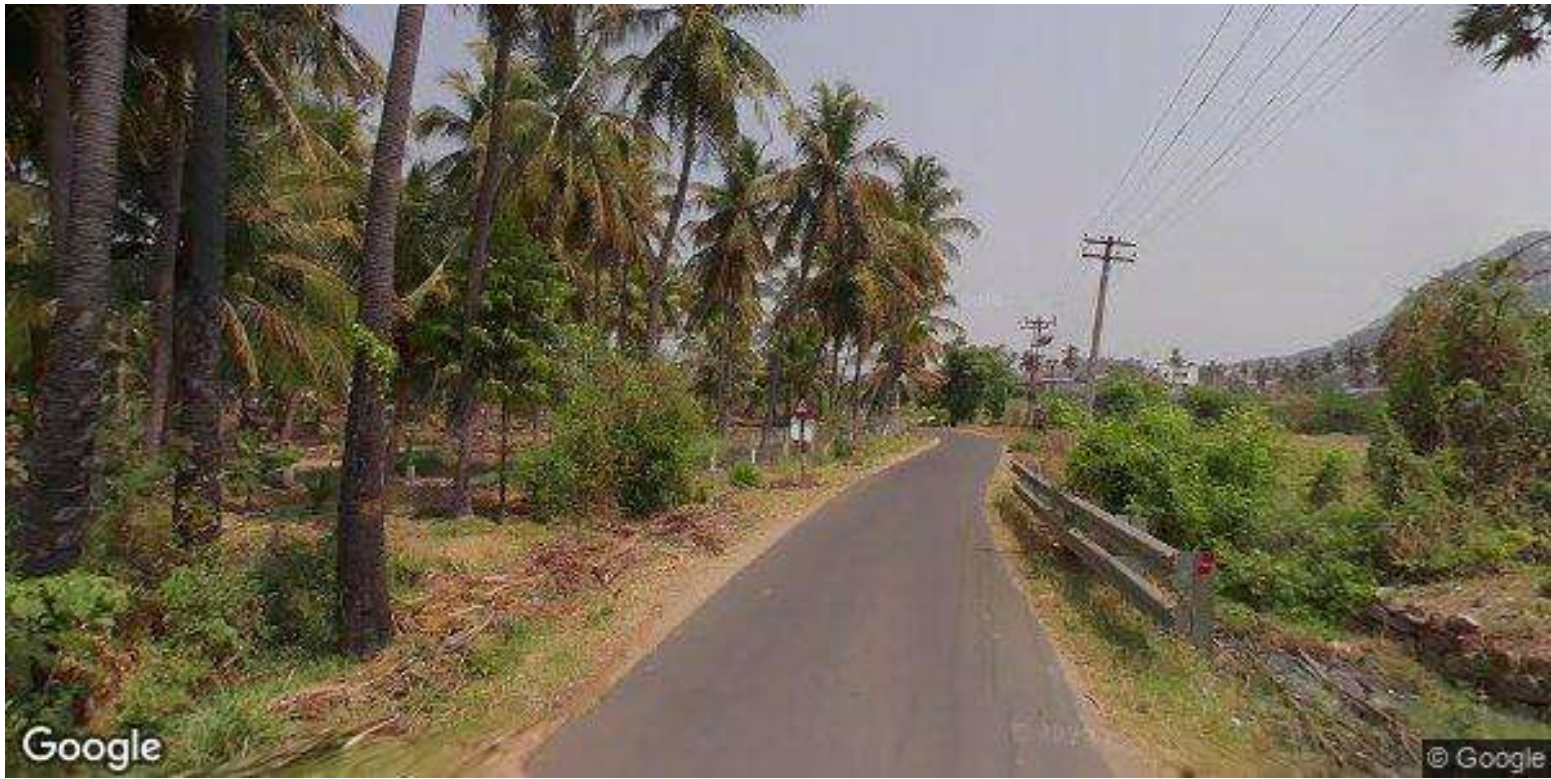
**Risk Type: Turn**  
**Risk Level: Medium**  
**Speed Limit: 30 KM/Hr**  
**Coordinates: 11.41876, 77.88487**

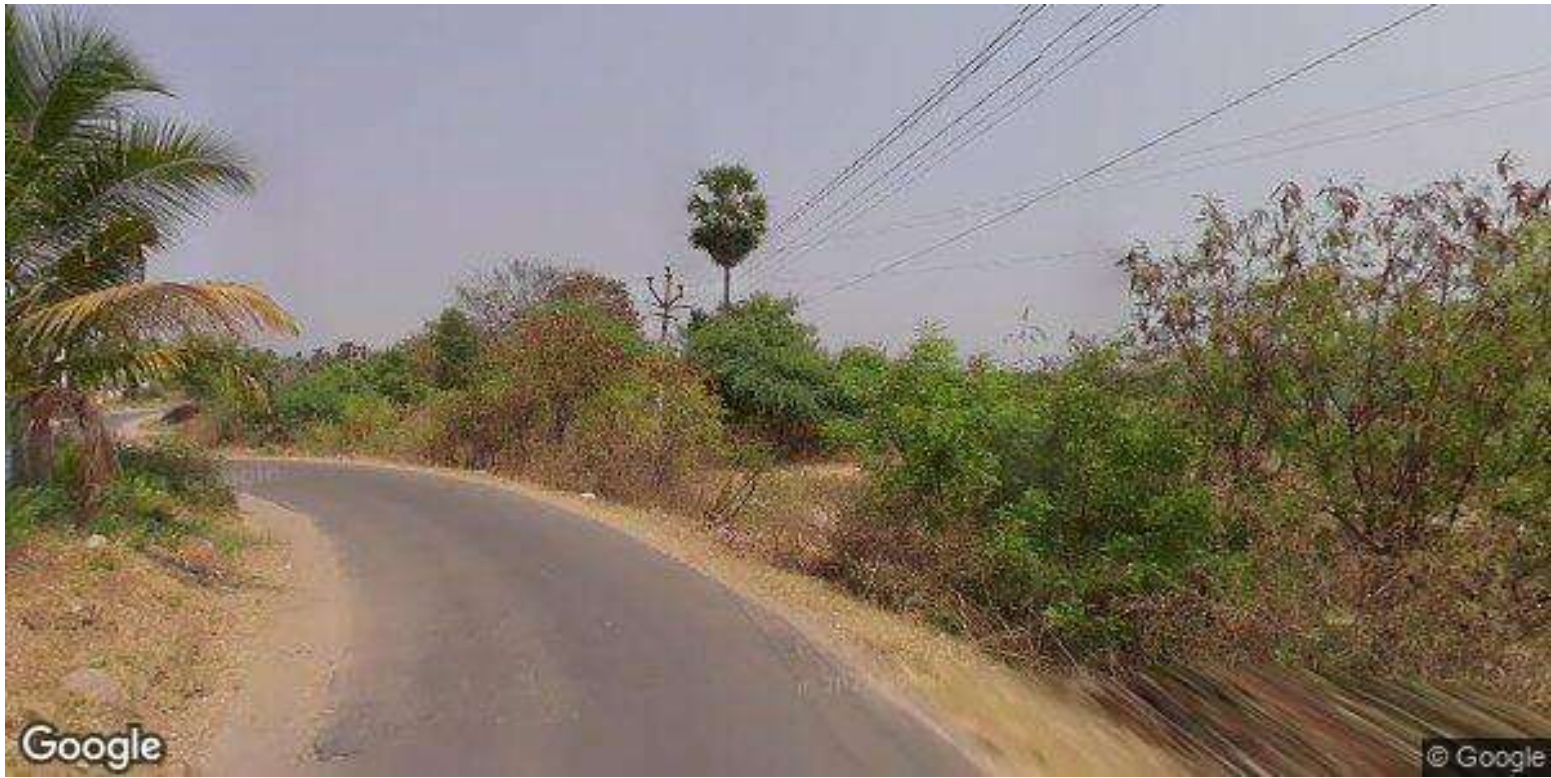
**Risk Type: Turn**  
**Risk Level: Medium**  
**Speed Limit: 30 KM/Hr**  
**Coordinates: 11.41829, 77.88568**

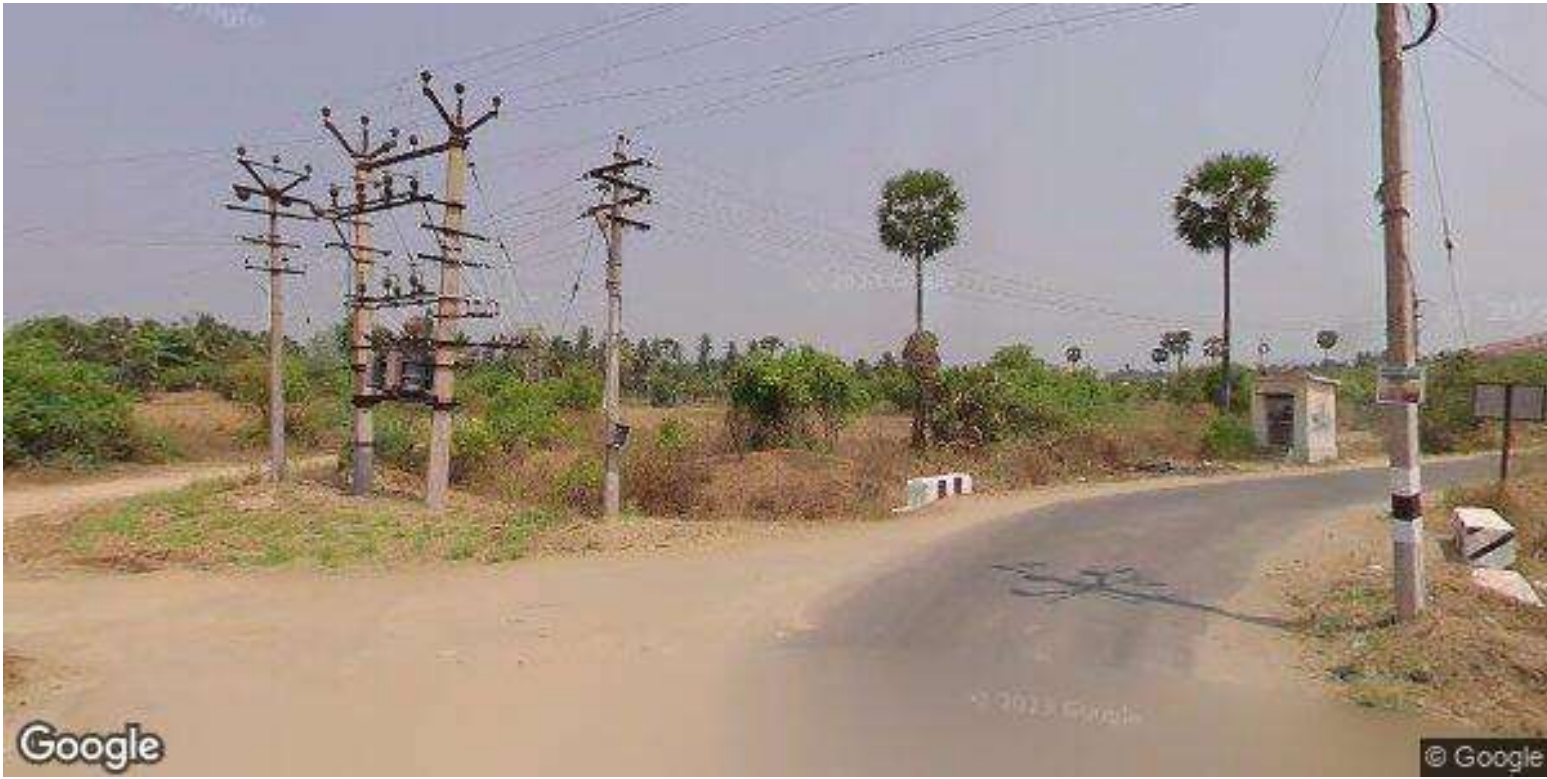
**Risk Type:** Turn  
**Risk Level:** High  
**Speed Limit:** 15 KM/Hr  
**Coordinates:** 11.41859, 77.88692

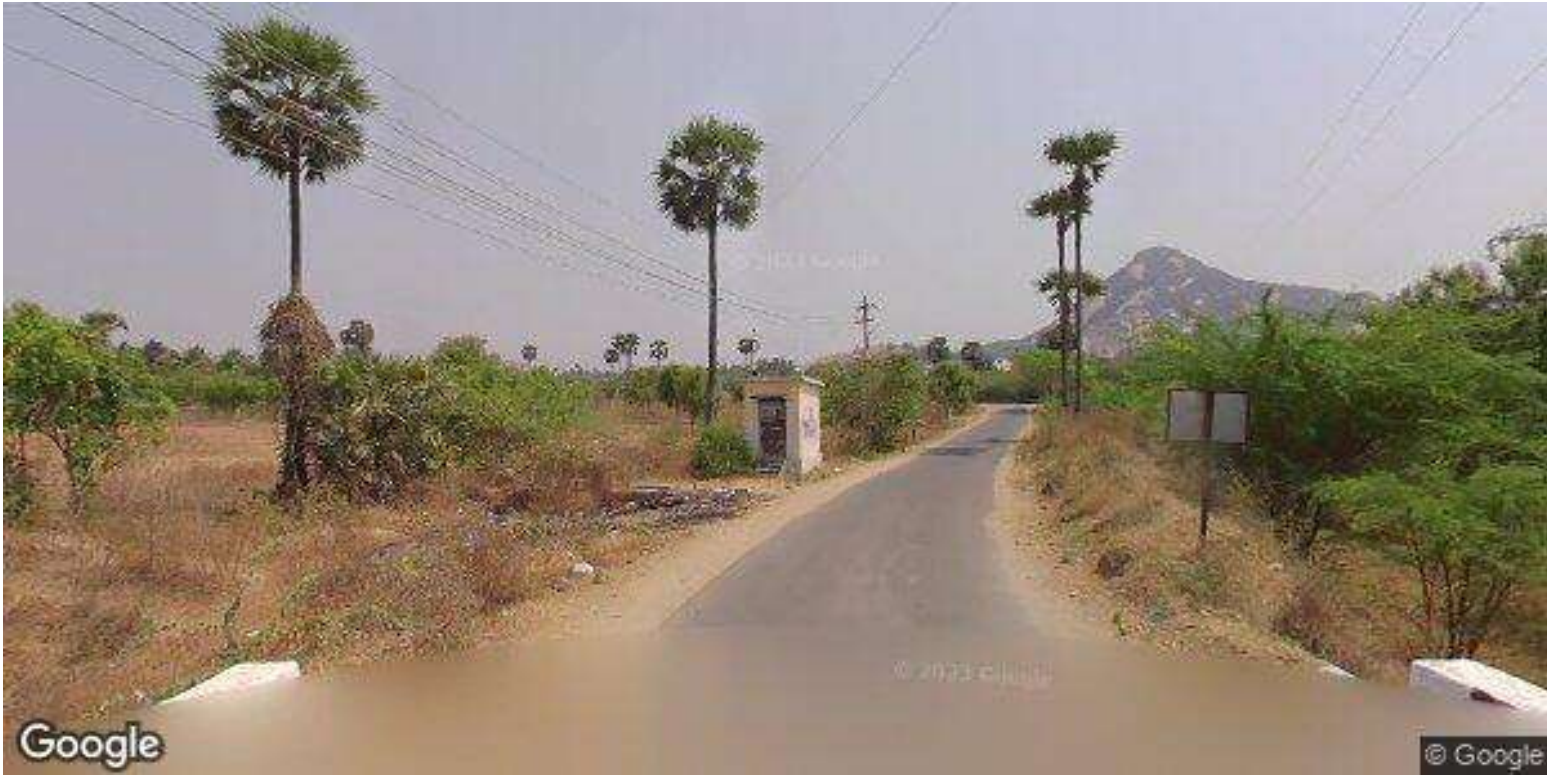
**Risk Type:** Turn  
**Risk Level:** Medium  
**Speed Limit:** 30 KM/Hr  
**Coordinates:** 11.41852, 77.88700

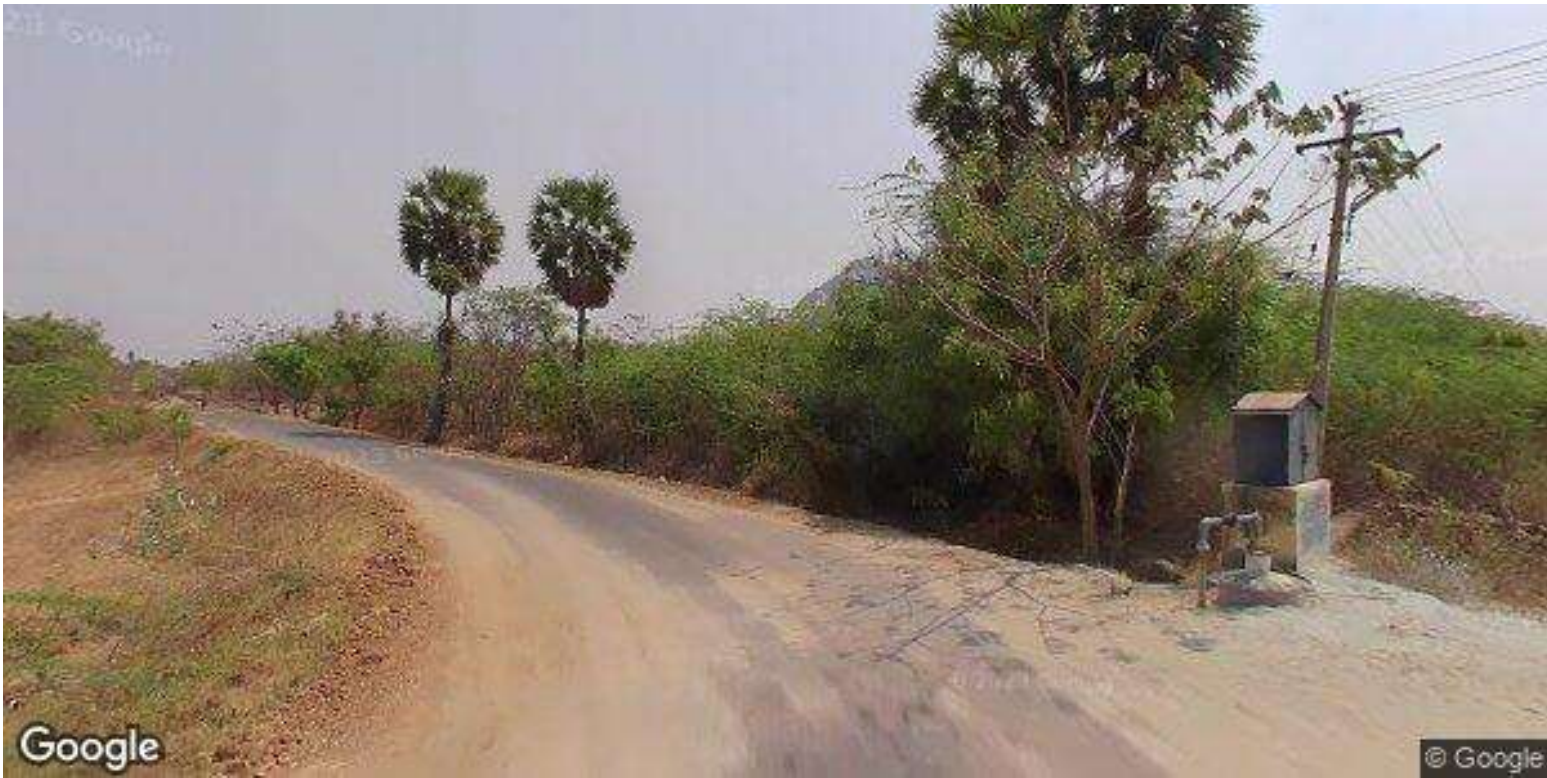
**Risk Type:** Turn  
**Risk Level:** Medium  
**Speed Limit:** 30 KM/Hr  
**Coordinates:** 11.41769, 77.88730

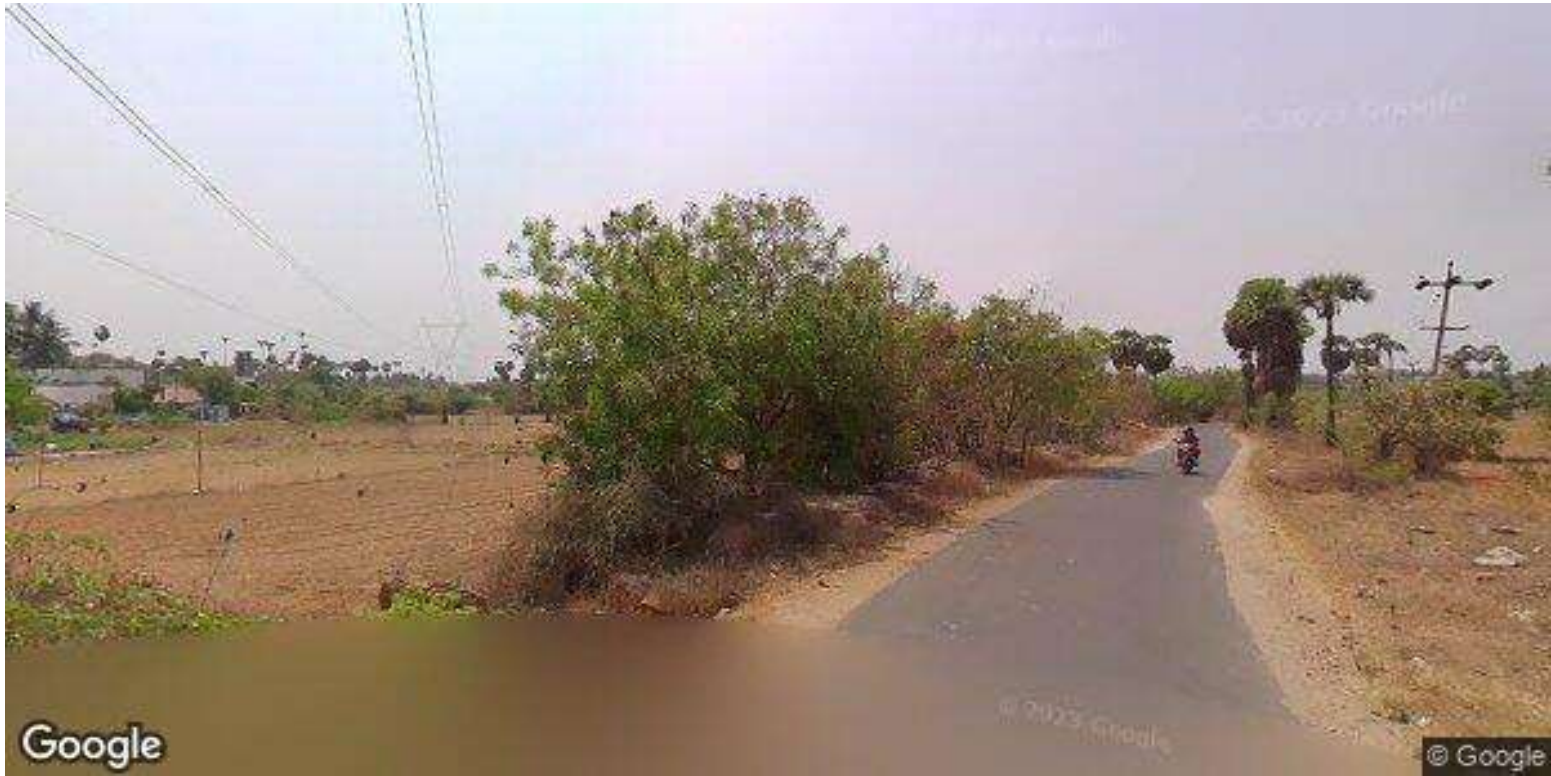
**Risk Type:** Turn  
**Risk Level:** Medium  
**Speed Limit:** 30 KM/Hr  
**Coordinates:** 11.41630, 77.89077

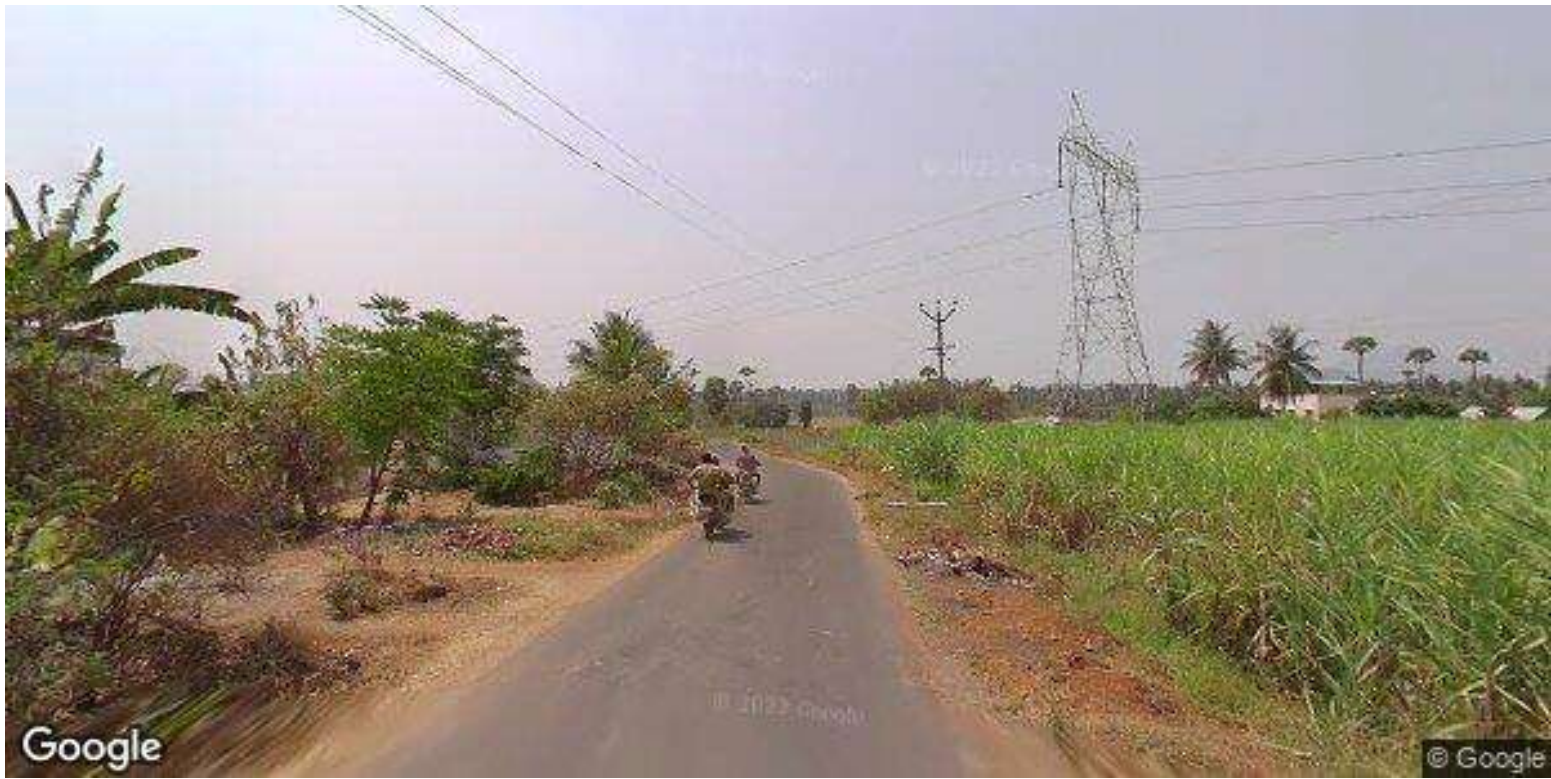
**Risk Type:** Turn  
**Risk Level:** Medium  
**Speed Limit:** 30 KM/Hr  
**Coordinates:** 11.41601, 77.89198

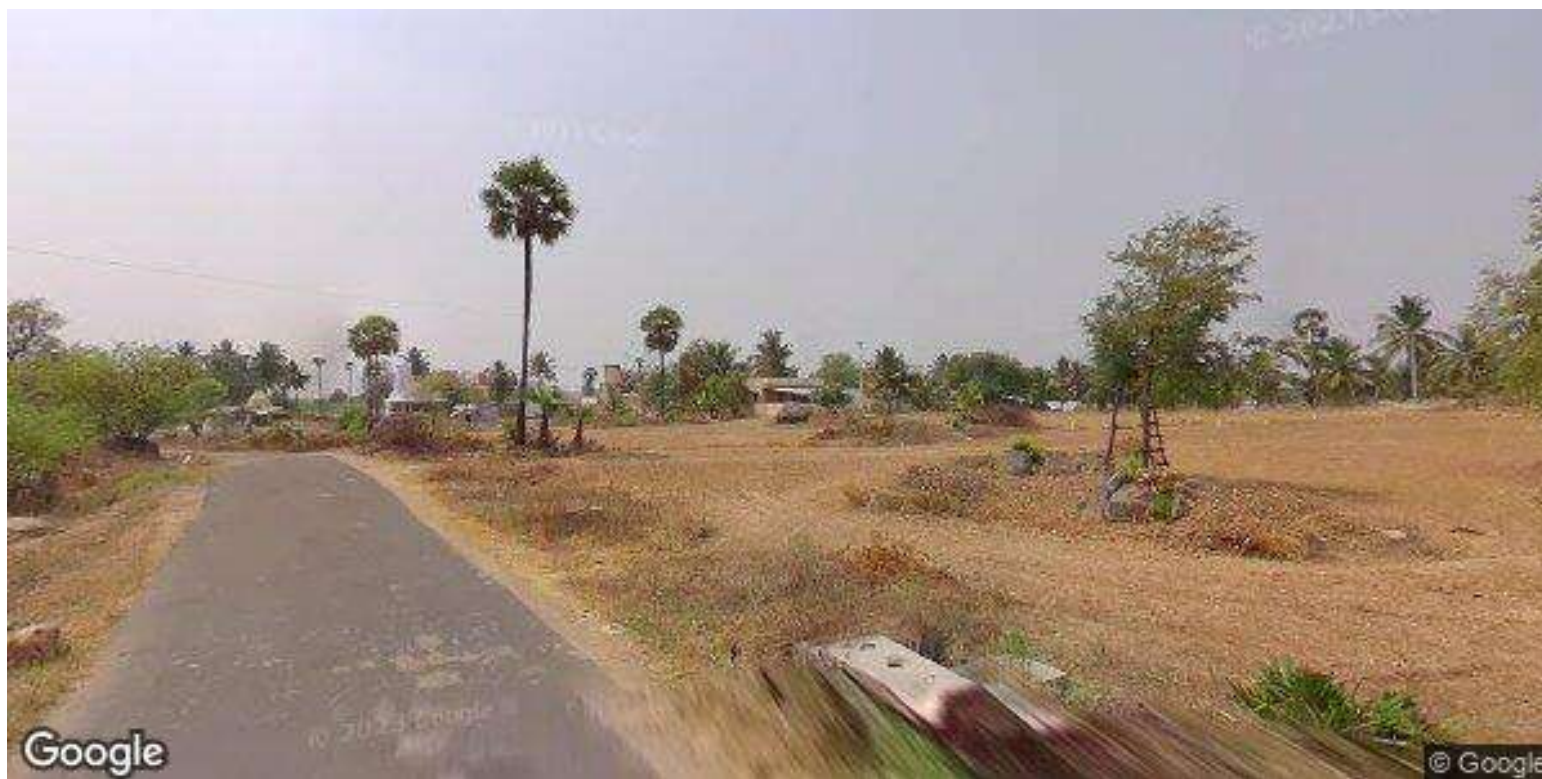
**Risk Type:** Turn

**Risk Level:** Medium

**Speed Limit:** 30 KM/Hr

**Coordinates:** 11.41603, 77.89479

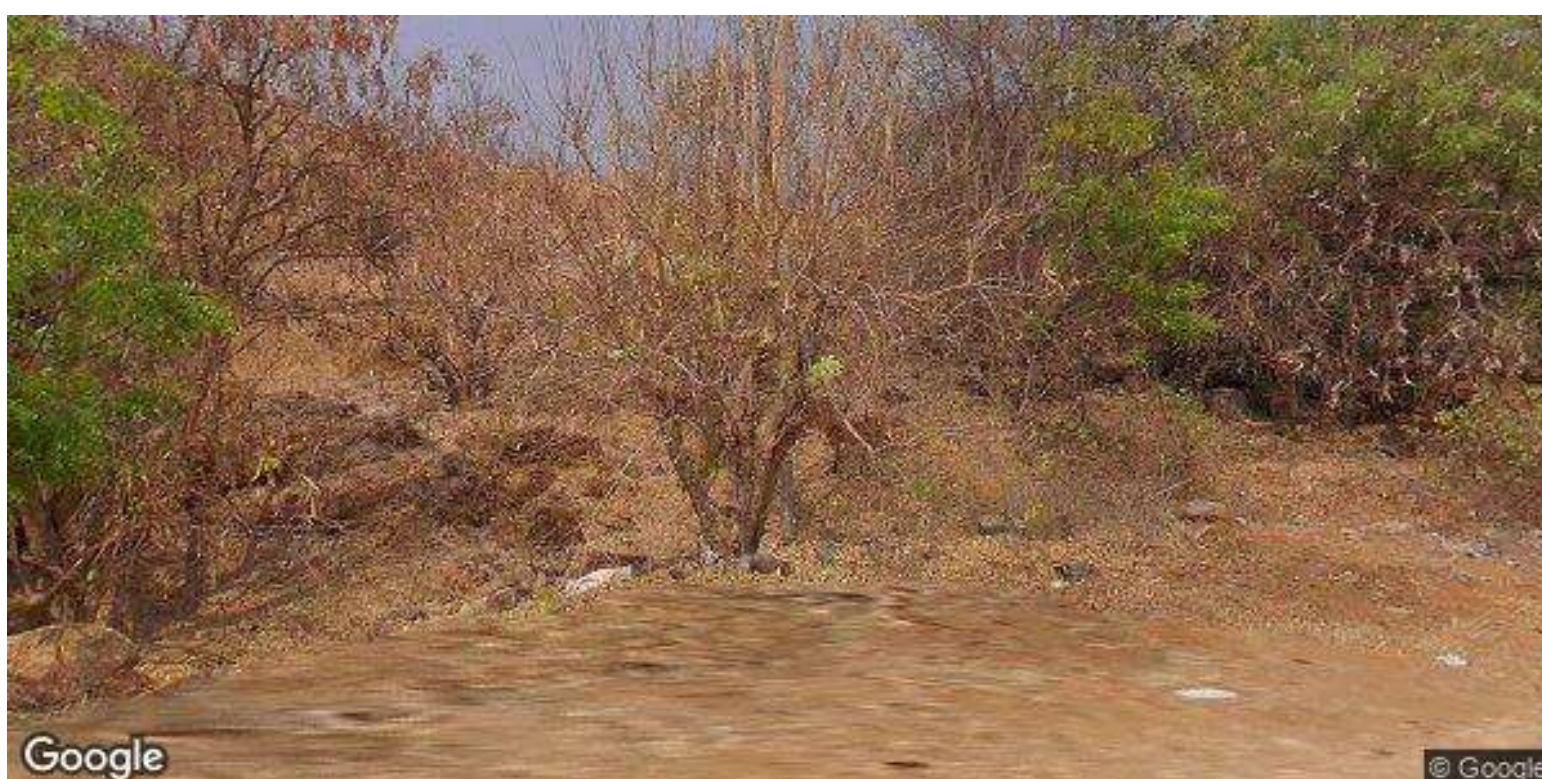
**Risk Type:** Turn

**Risk Level:** Medium

**Speed Limit:** 30 KM/Hr

**Coordinates:** 11.41439, 77.90025

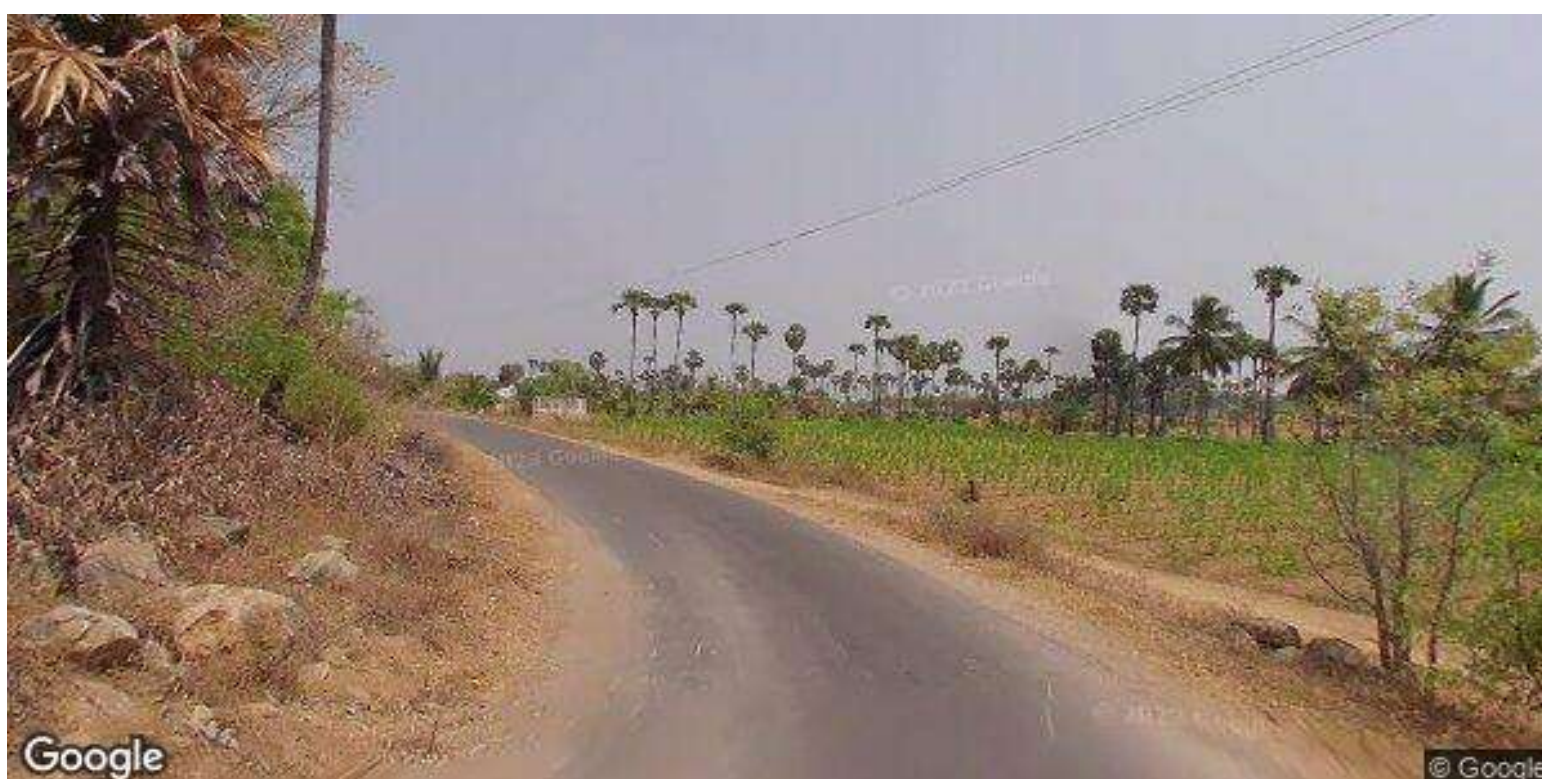
**Risk Type: Turn**

**Risk Level: Medium**

**Speed Limit: 30 KM/Hr**

**Coordinates: 11.41377, 77.90073**

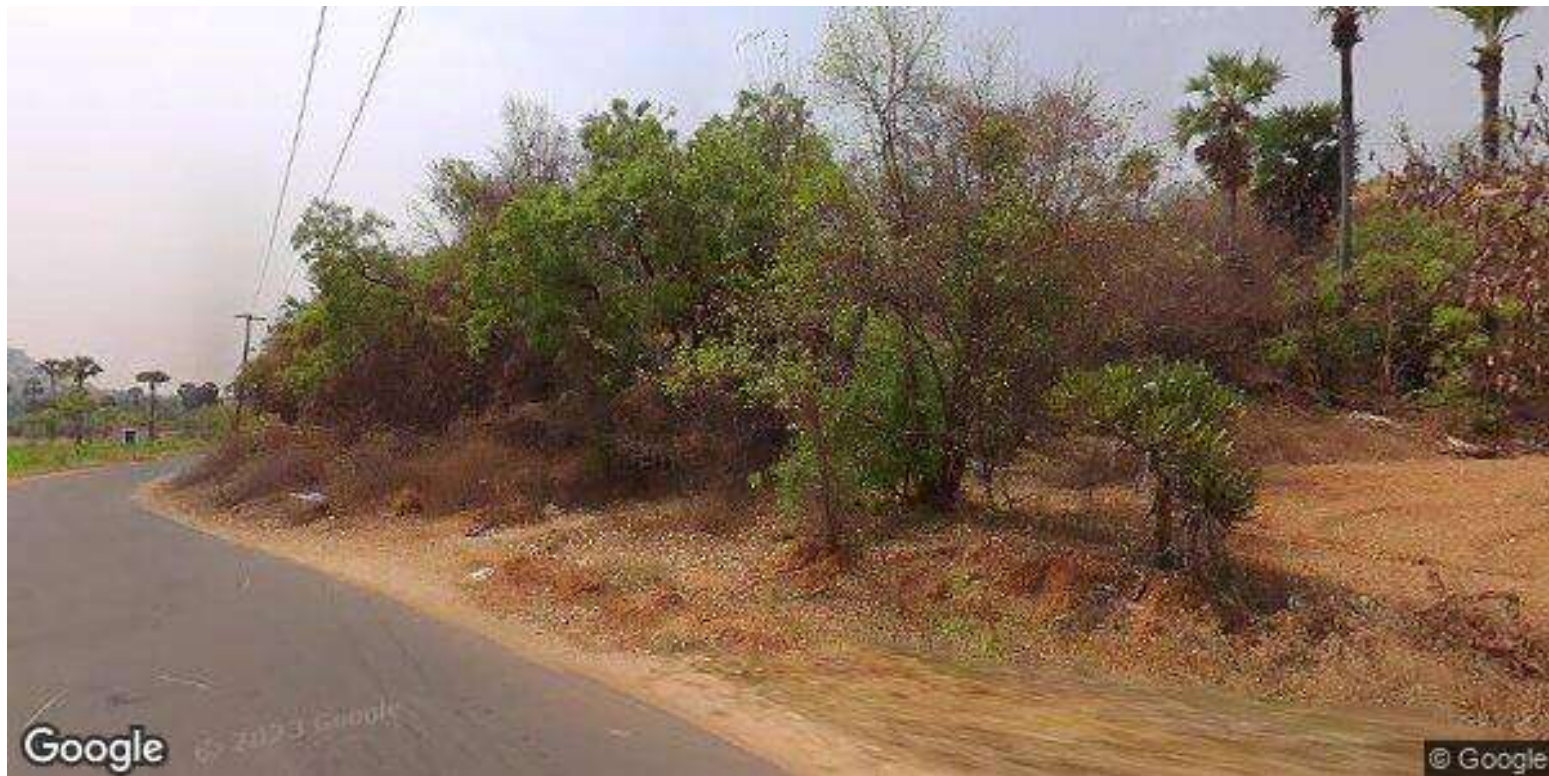
**Risk Type: Turn**

**Risk Level: Medium**

**Speed Limit: 30 KM/Hr**

**Coordinates: 11.41389, 77.90161**

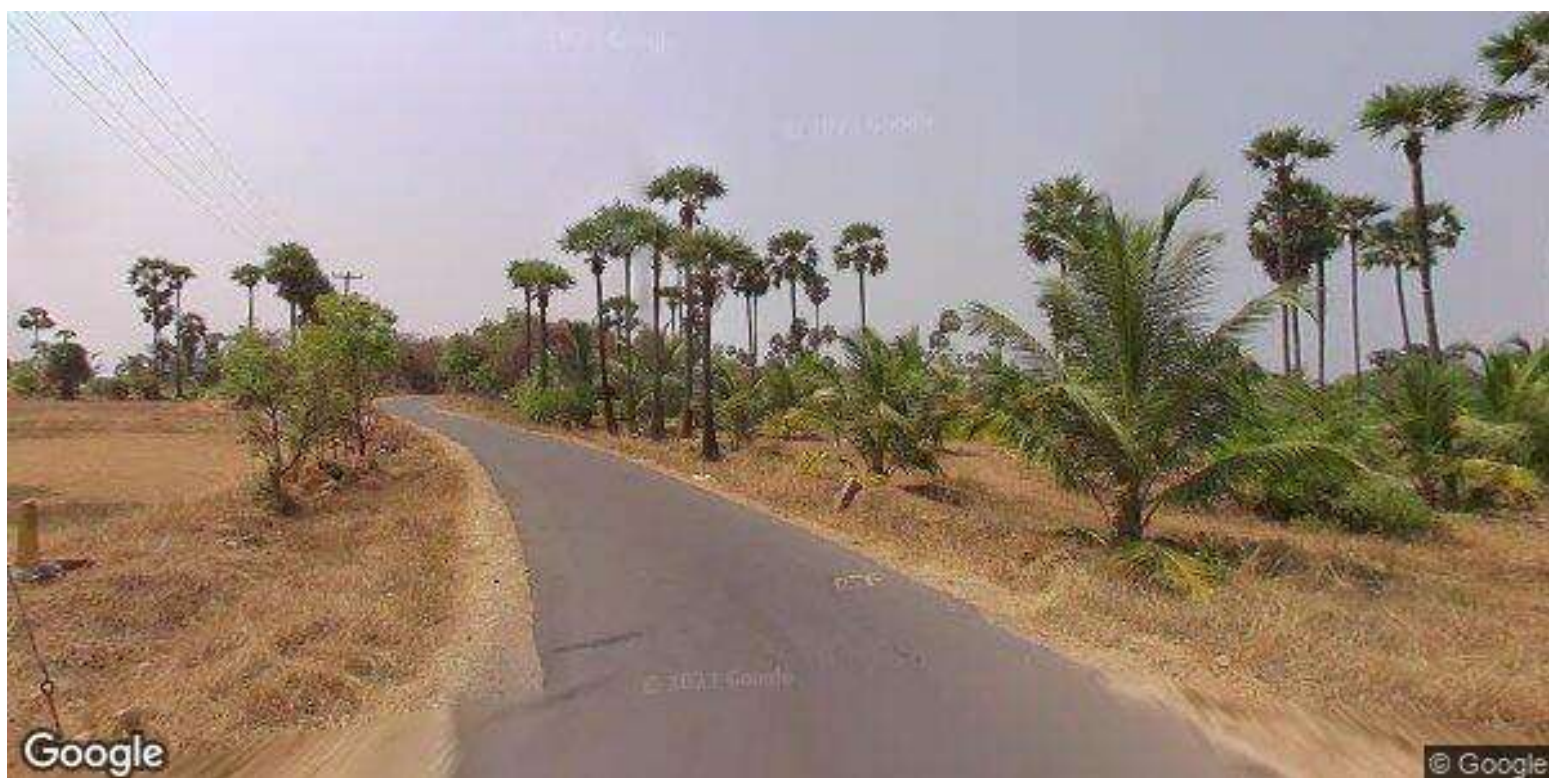
**Risk Type: Turn**

**Risk Level: Medium**

**Speed Limit: 30 KM/Hr**

**Coordinates: 11.41325, 77.90313**

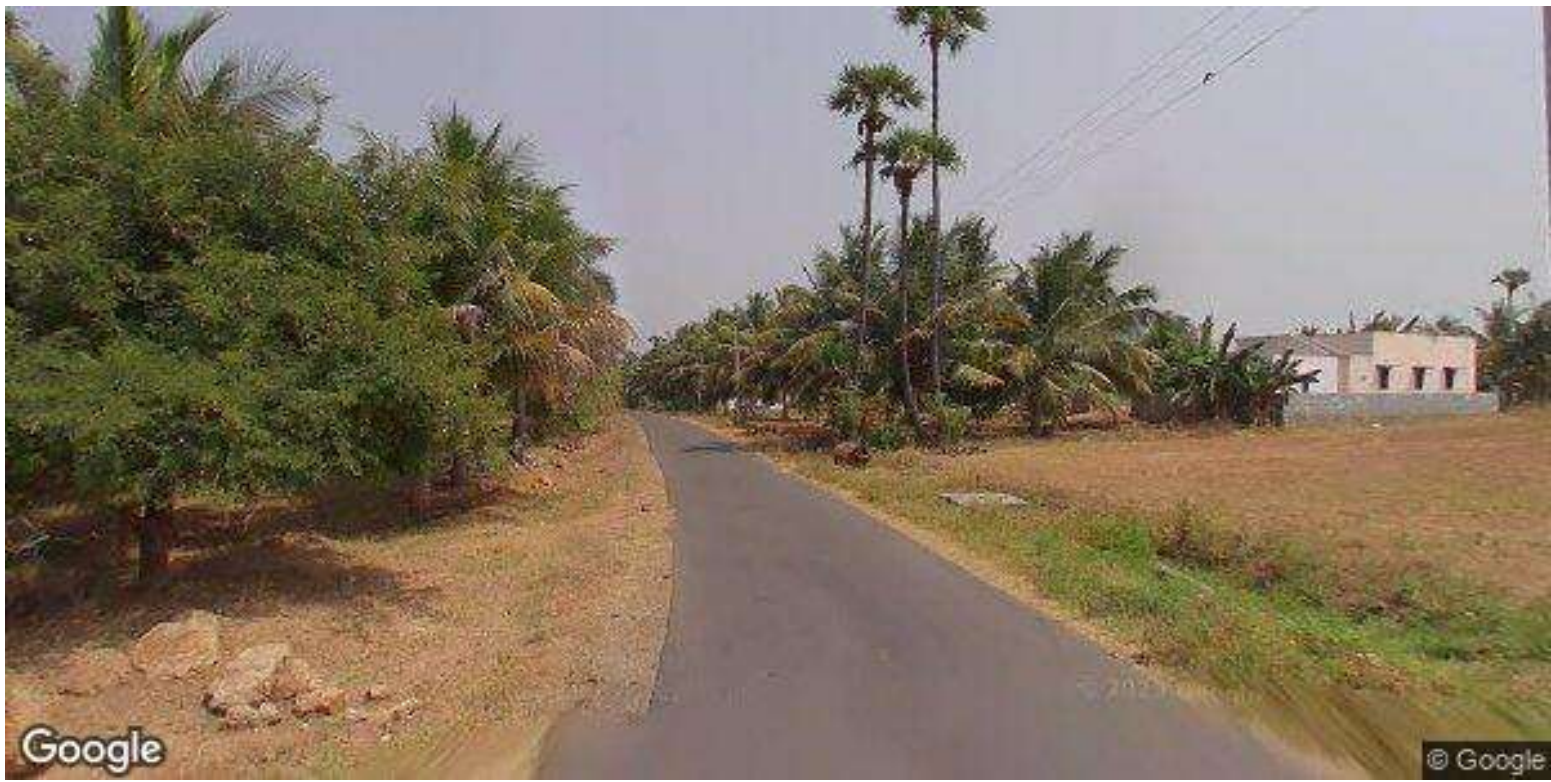
**Risk Type:** Turn

**Risk Level:** Medium

**Speed Limit:** 30 KM/Hr

**Coordinates:** 11.41276, 77.90349

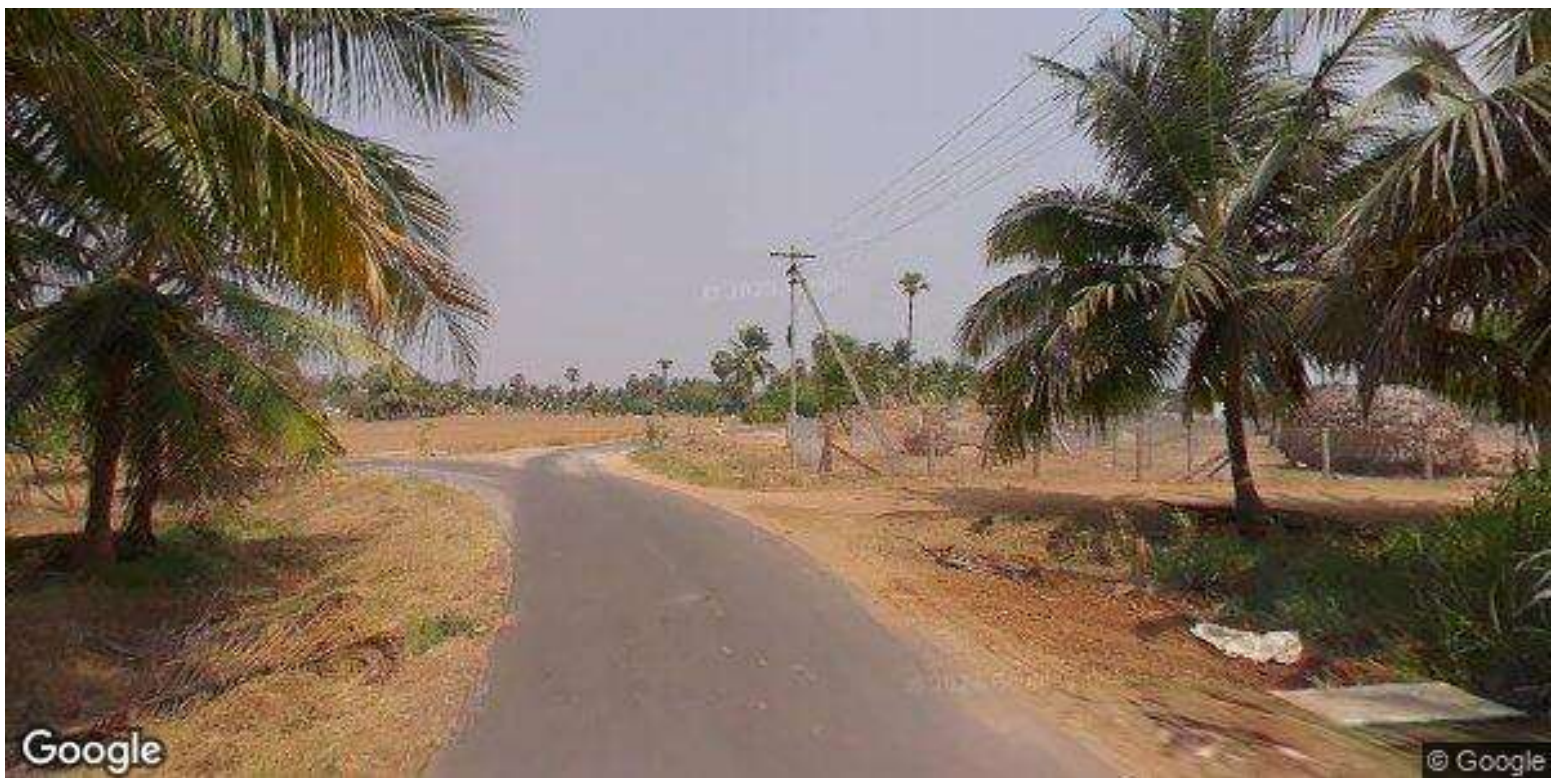
**Risk Type:** Turn

**Risk Level:** Medium

**Speed Limit:** 30 KM/Hr

**Coordinates:** 11.41227, 77.90470

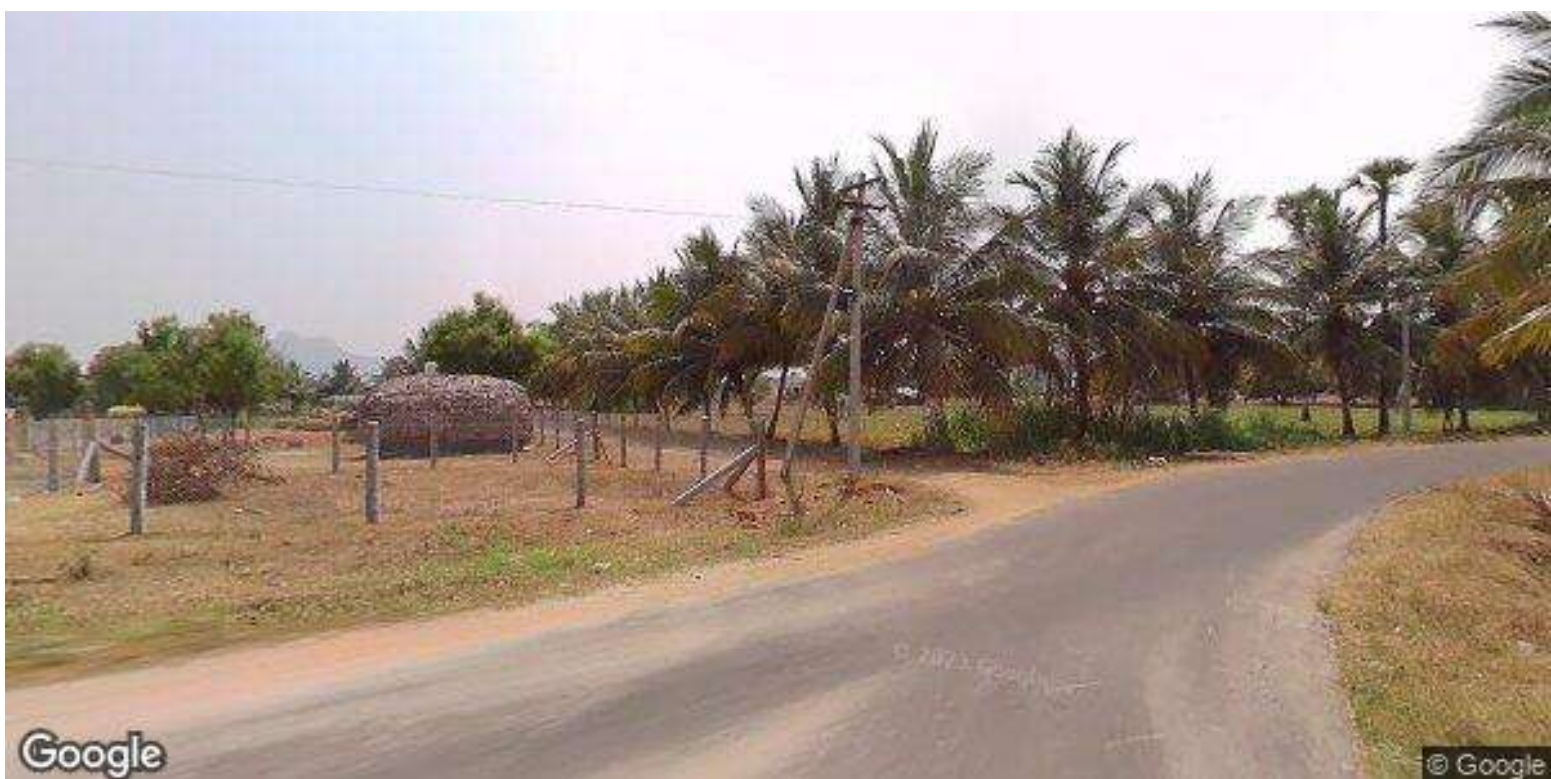
**Risk Type:** Turn  
**Risk Level:** Medium  
**Speed Limit:** 30 KM/Hr  
**Coordinates:** 11.41235, 77.90492

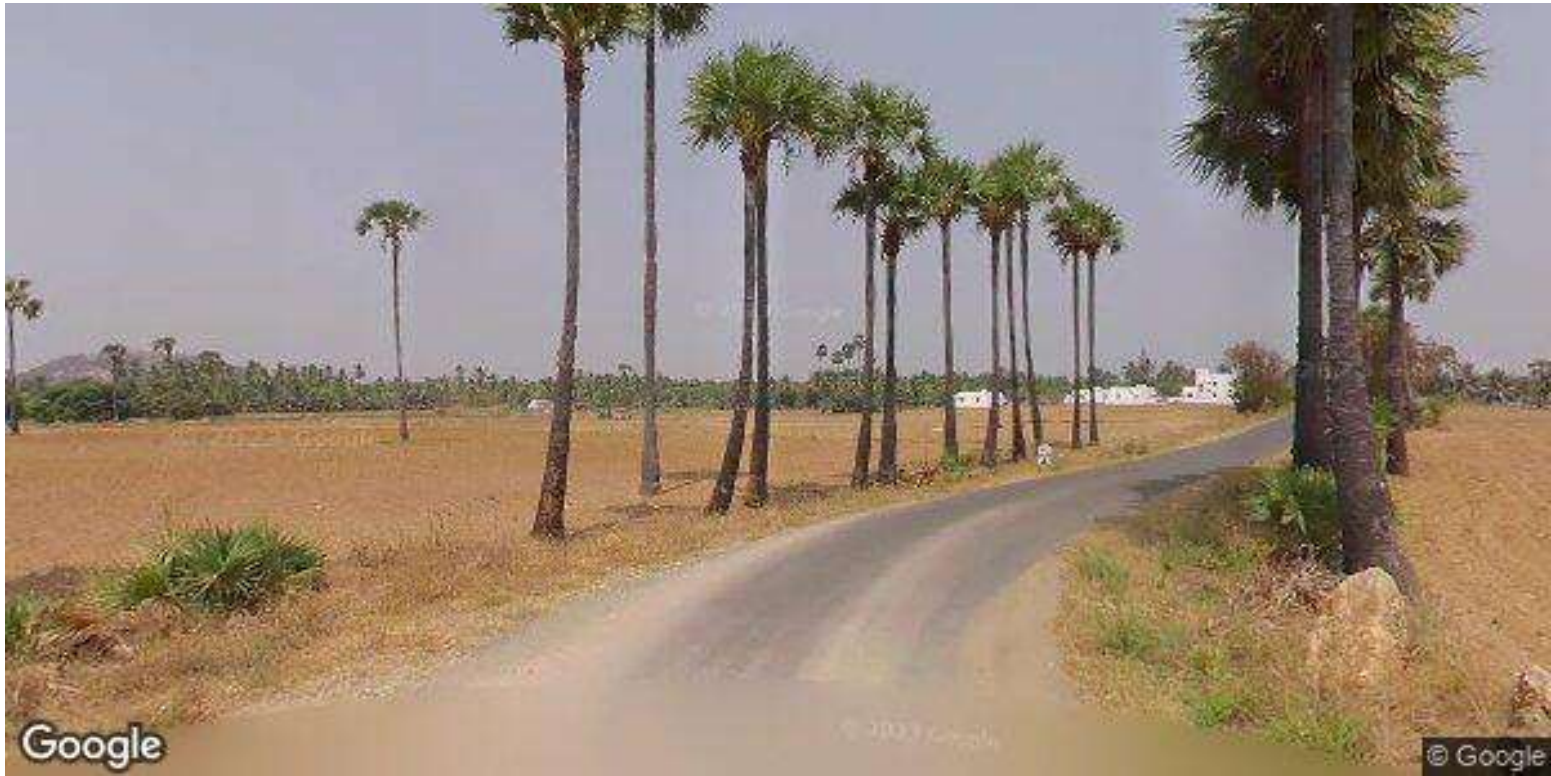
**Risk Type:** Turn  
**Risk Level:** Medium  
**Speed Limit:** 30 KM/Hr  
**Coordinates:** 11.41271, 77.90516
