## JOURNEY RISK MANAGEMENT (JRM) STUDY

### Salem Terminal TO PALANISAMY AGENCIES

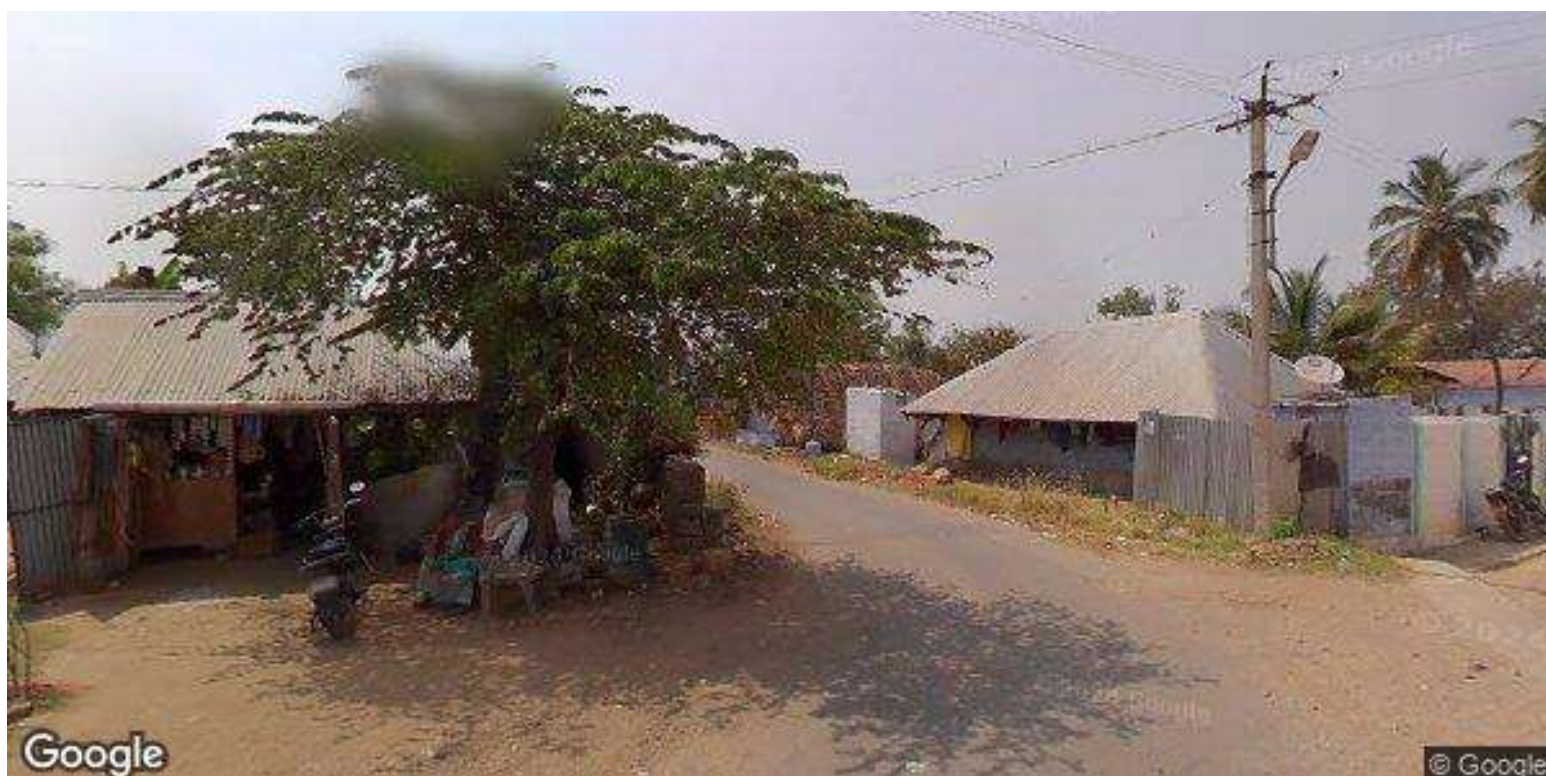
**Risk Type:** Turn  
**Risk Level:** High  
**Speed Limit:** 15 KM/Hr  
**Coordinates:** 11.41307, 77.91058

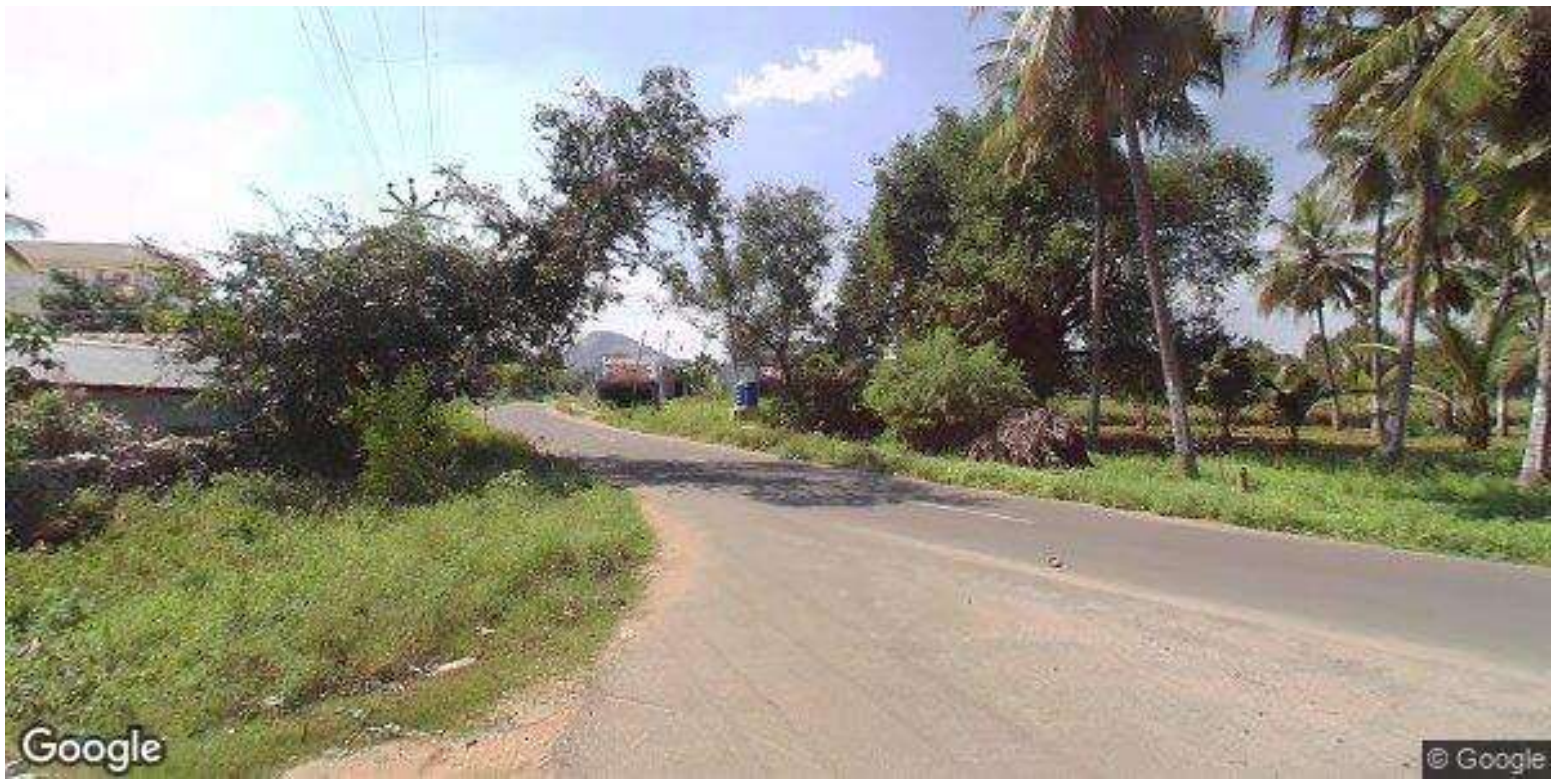
**Risk Type:** Turn  
**Risk Level:** Medium  
**Speed Limit:** 30 KM/Hr  
**Coordinates:** 11.41334, 77.91266

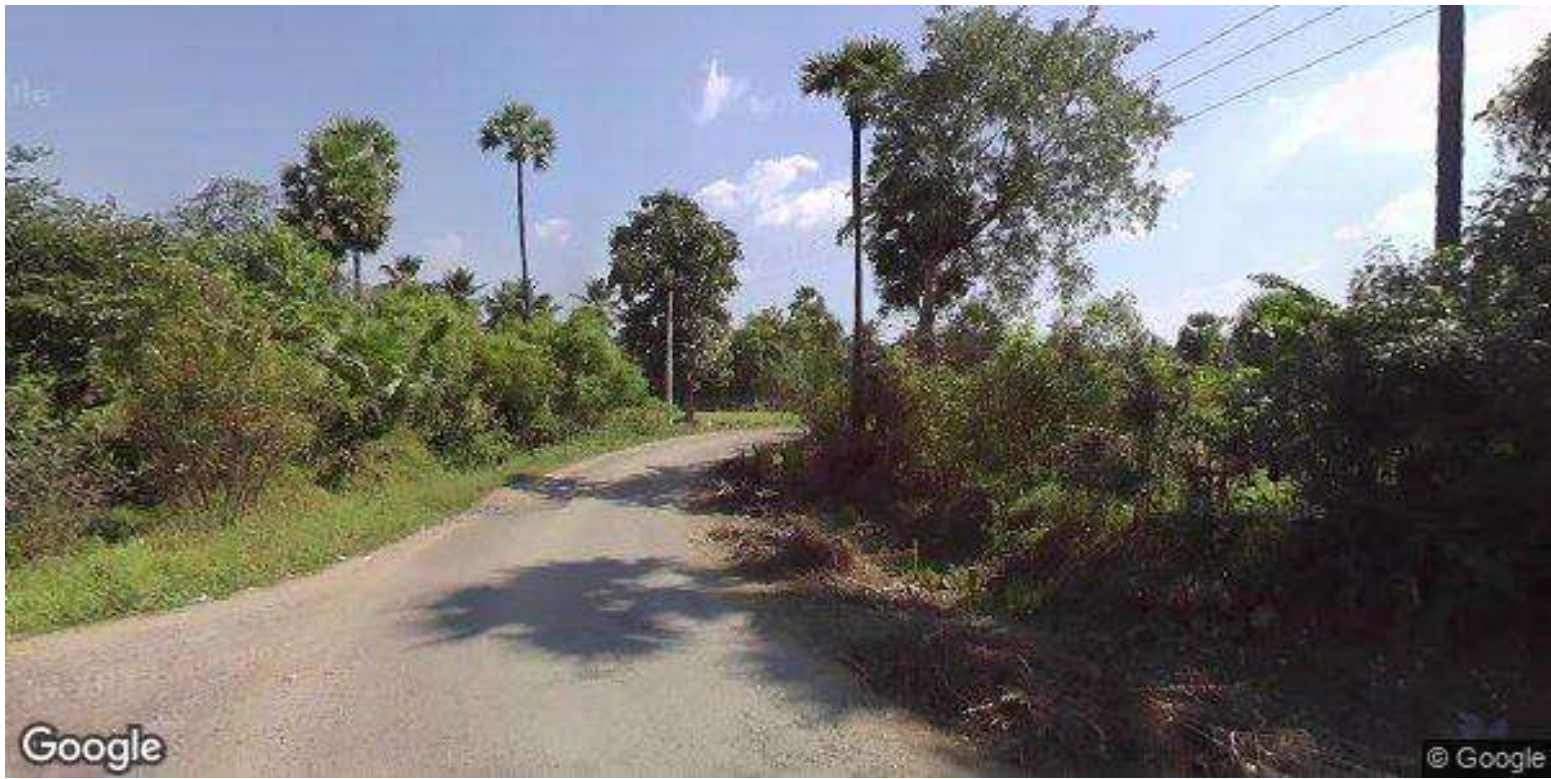
**Risk Type:** Turn  
**Risk Level:** High  
**Speed Limit:** 15 KM/Hr  
**Coordinates:** 11.41424, 77.91433

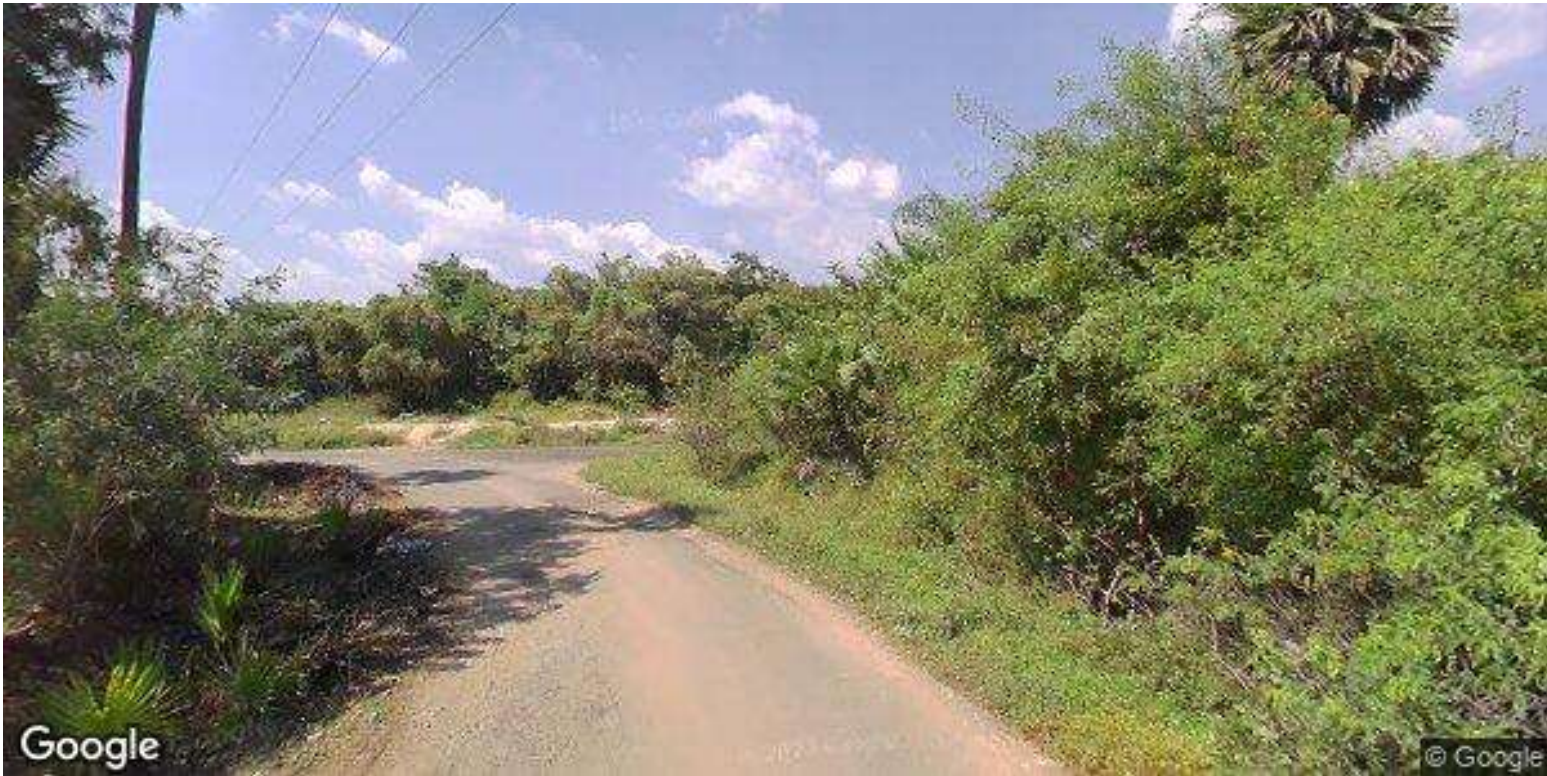
**Risk Type:** Turn  
**Risk Level:** Medium  
**Speed Limit:** 30 KM/Hr  
**Coordinates:** 11.41409, 77.91458

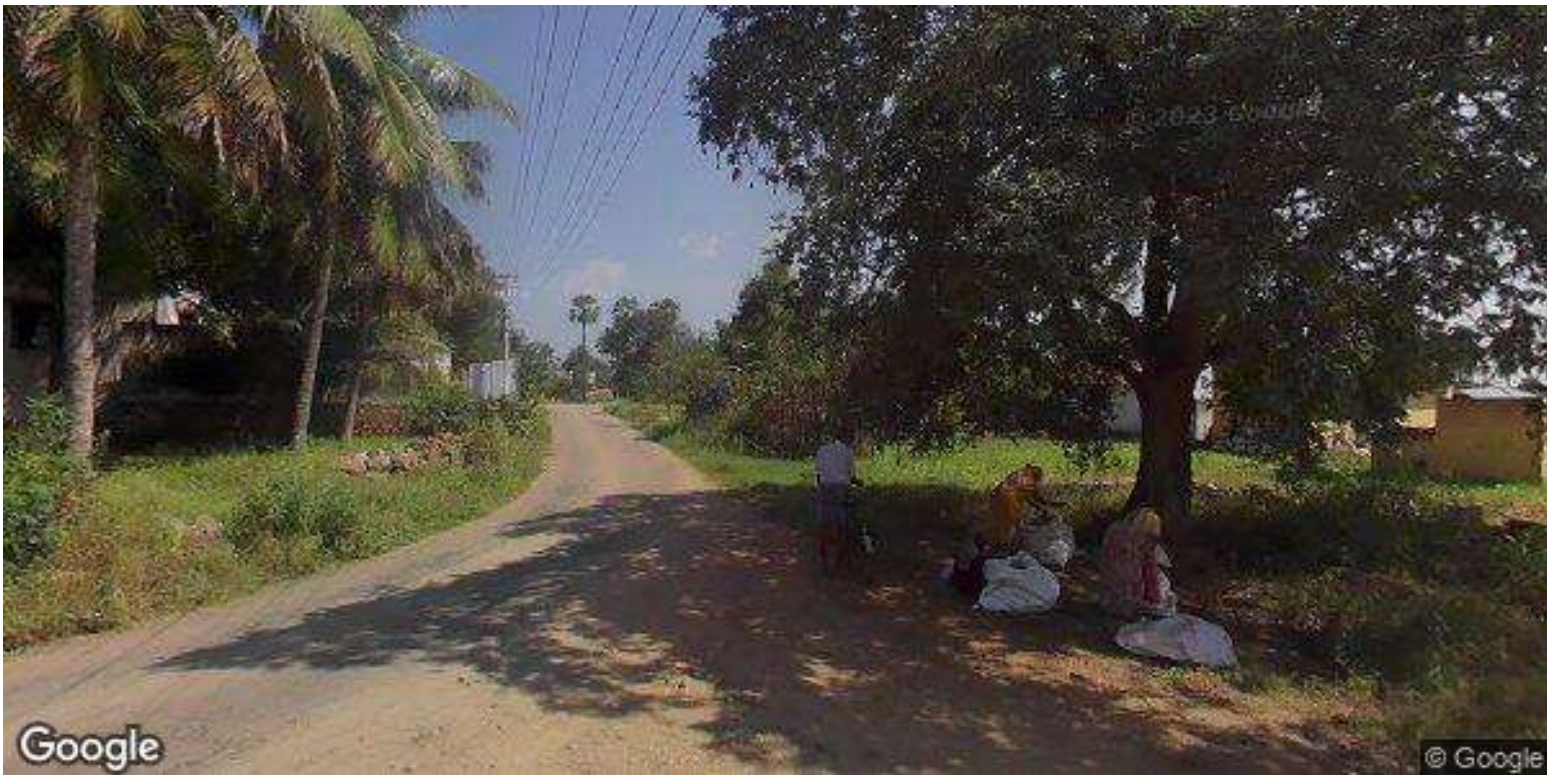
**Risk Type:** Turn  
**Risk Level:** High  
**Speed Limit:** 15 KM/Hr  
**Coordinates:** 11.41208, 77.91551

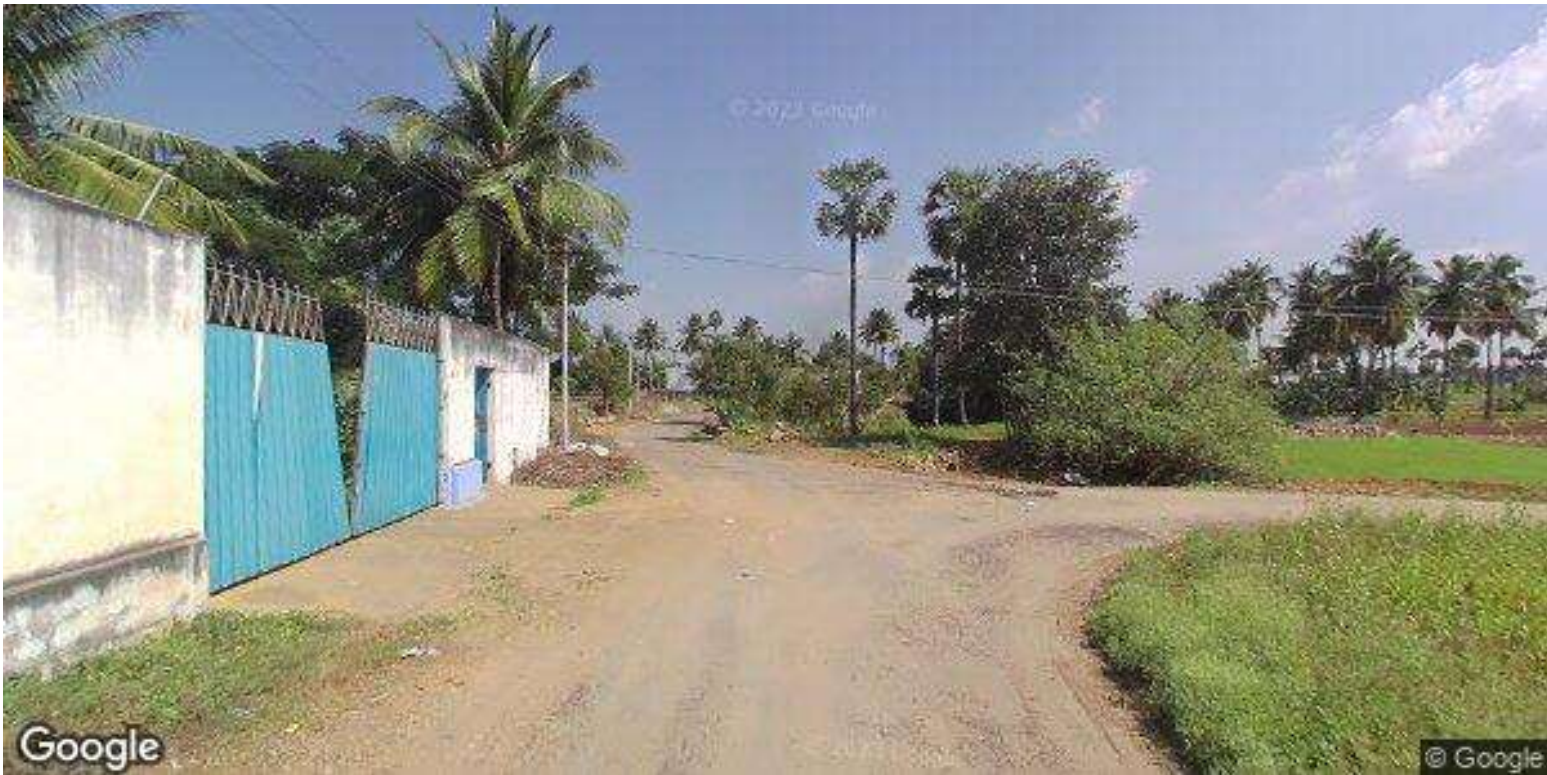
**Risk Type:** Turn  
**Risk Level:** Medium  
**Speed Limit:** 30 KM/Hr  
**Coordinates:** 11.41207, 77.91604

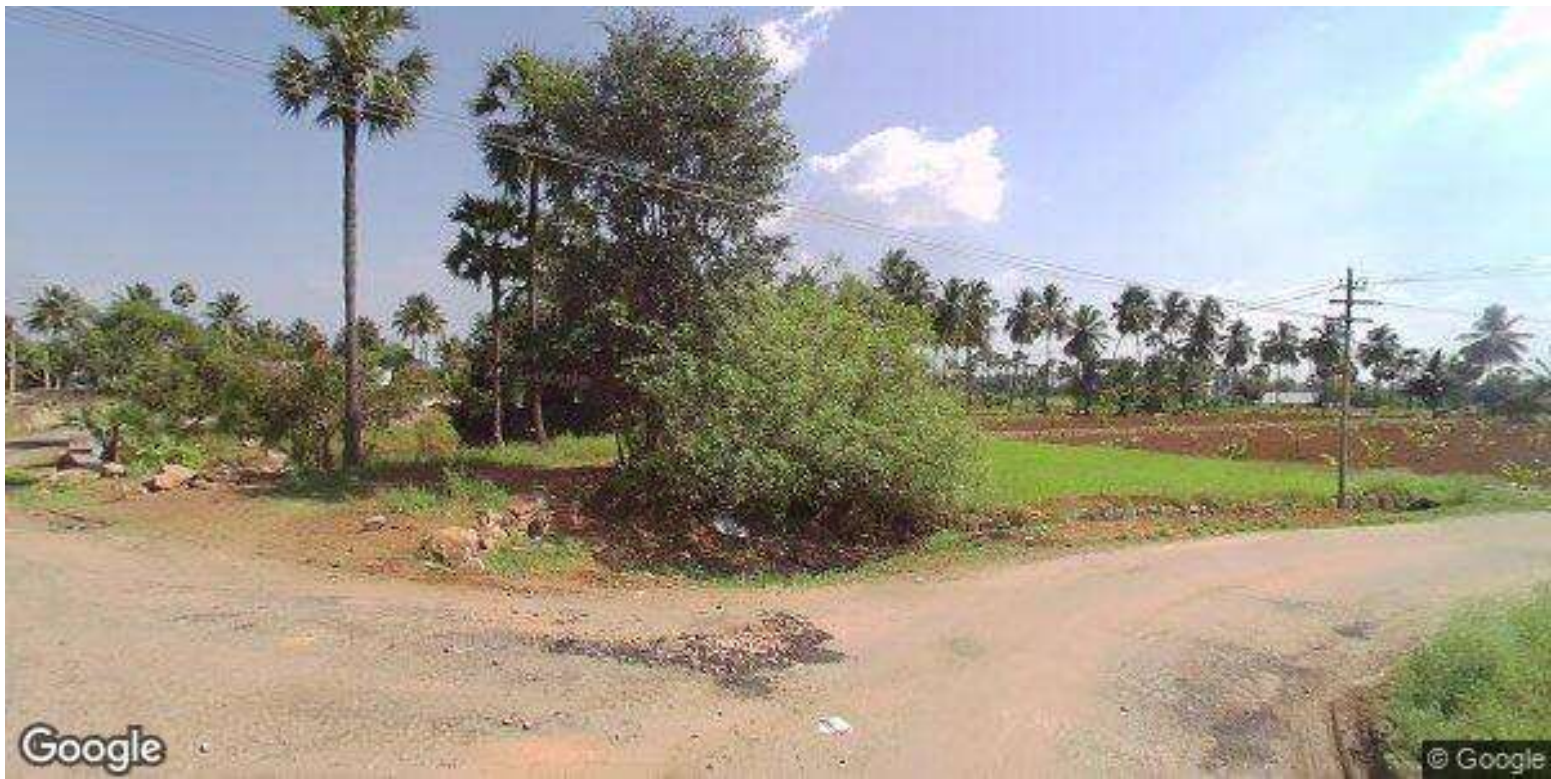
**Risk Type:** Turn  
**Risk Level:** High  
**Speed Limit:** 15 KM/Hr  
**Coordinates:** 11.41204, 77.91610

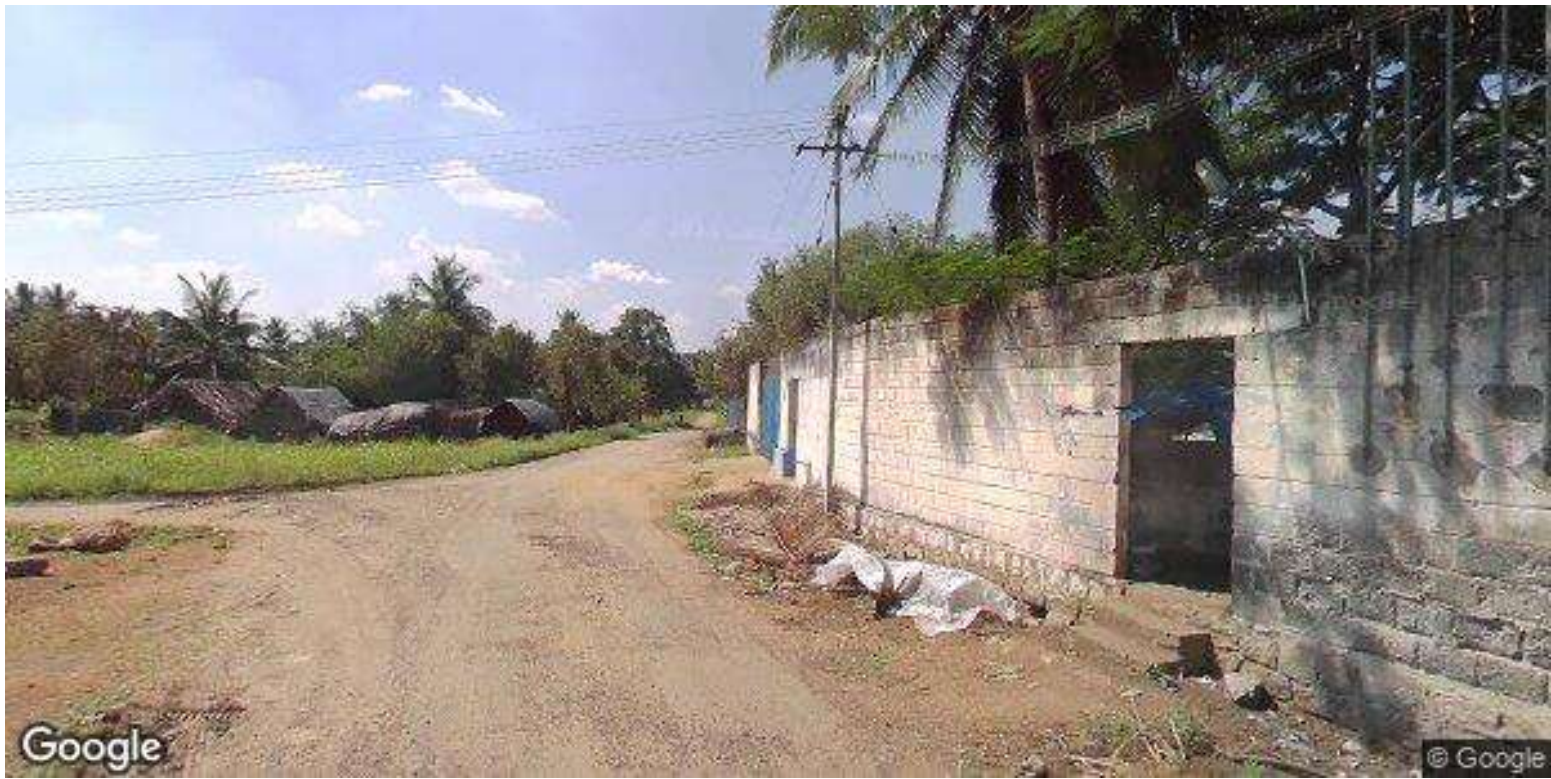
**Risk Type:** Turn  
**Risk Level:** Medium  
**Speed Limit:** 30 KM/Hr  
**Coordinates:** 11.41216, 77.91626

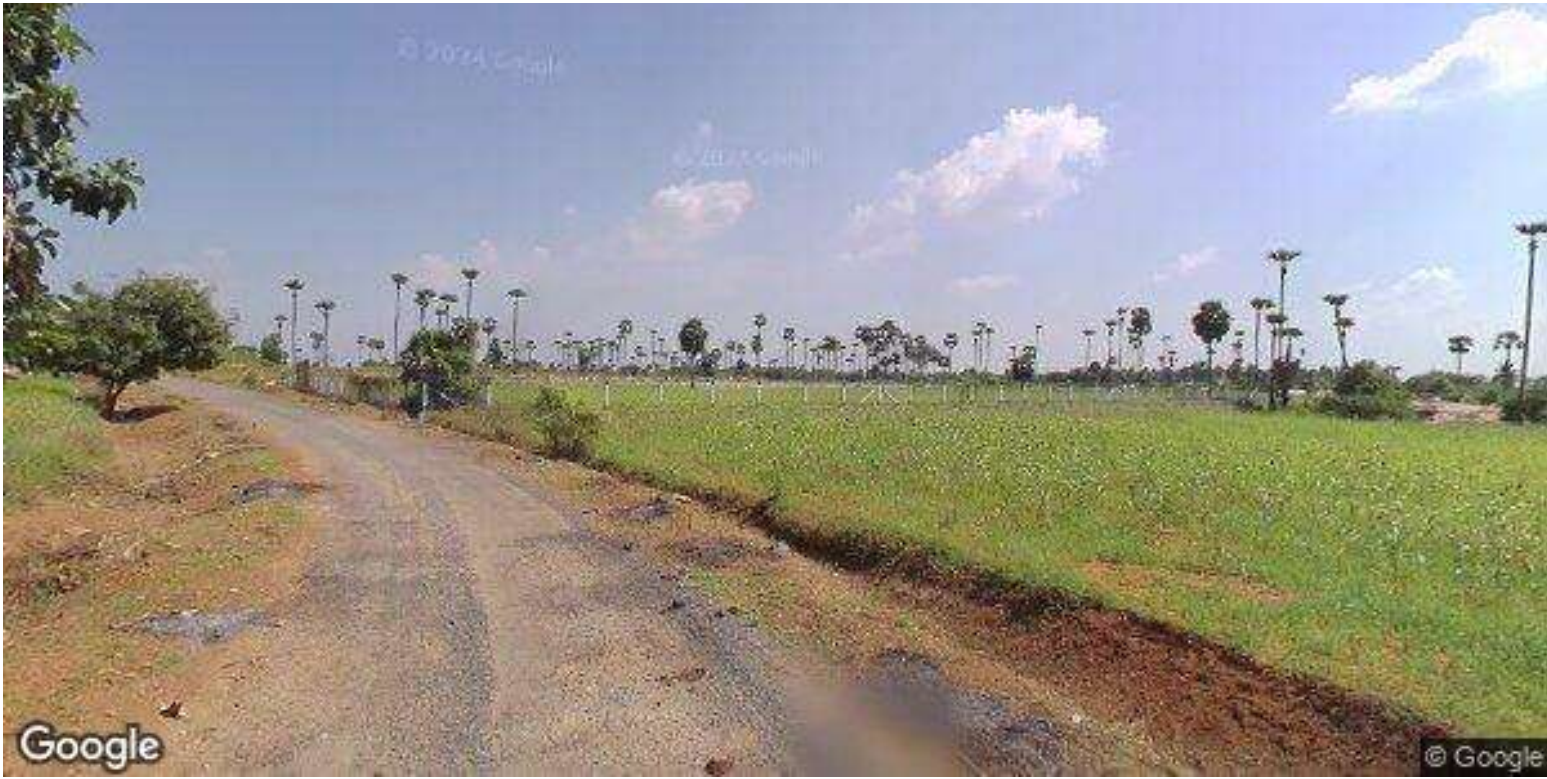
**Risk Type:** Turn  
**Risk Level:** Medium  
**Speed Limit:** 30 KM/Hr  
**Coordinates:** 11.41183, 77.91755

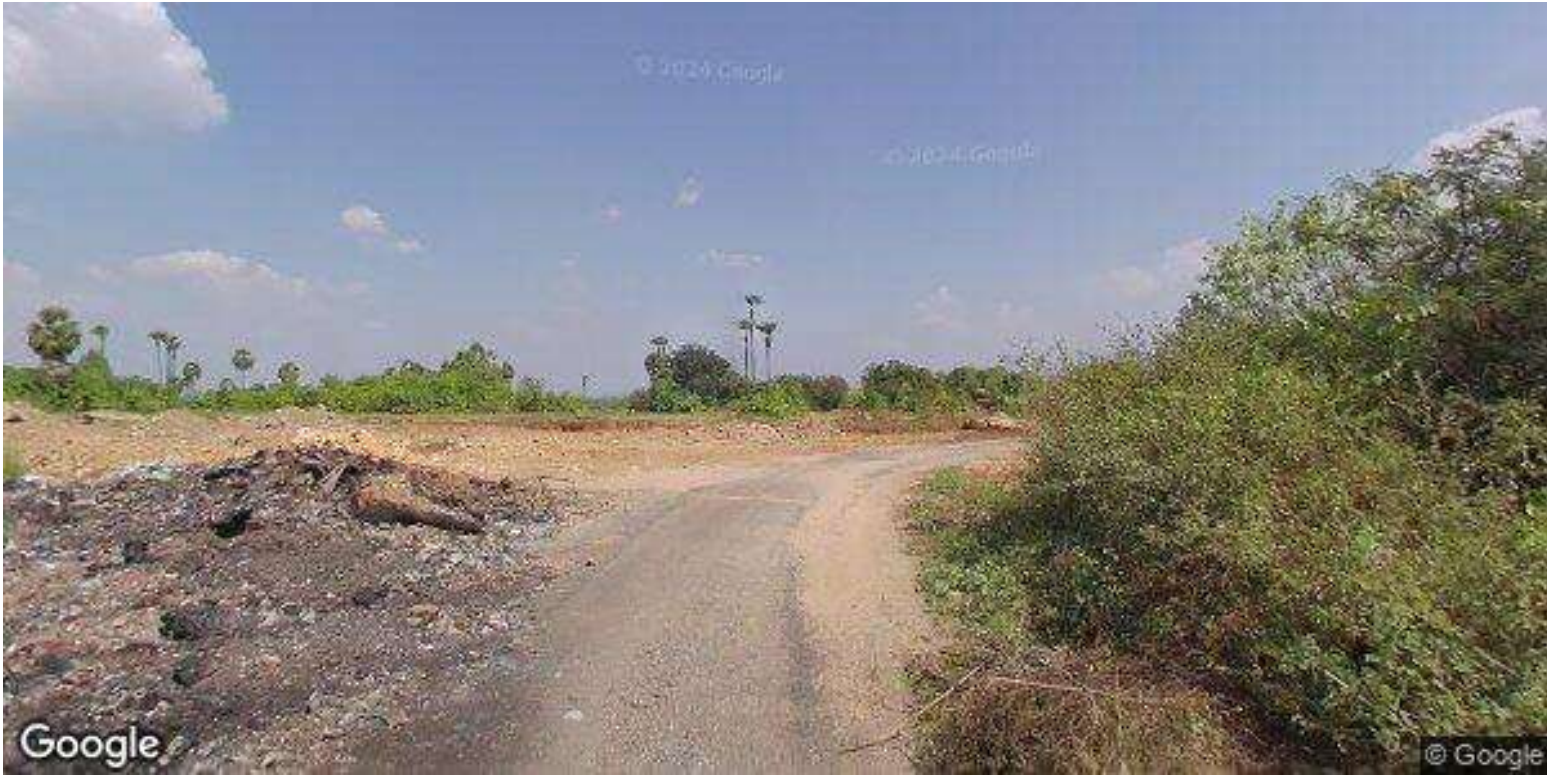
**Risk Type:** Turn  
**Risk Level:** Medium  
**Speed Limit:** 30 KM/Hr  
**Coordinates:** 11.41342, 77.92087

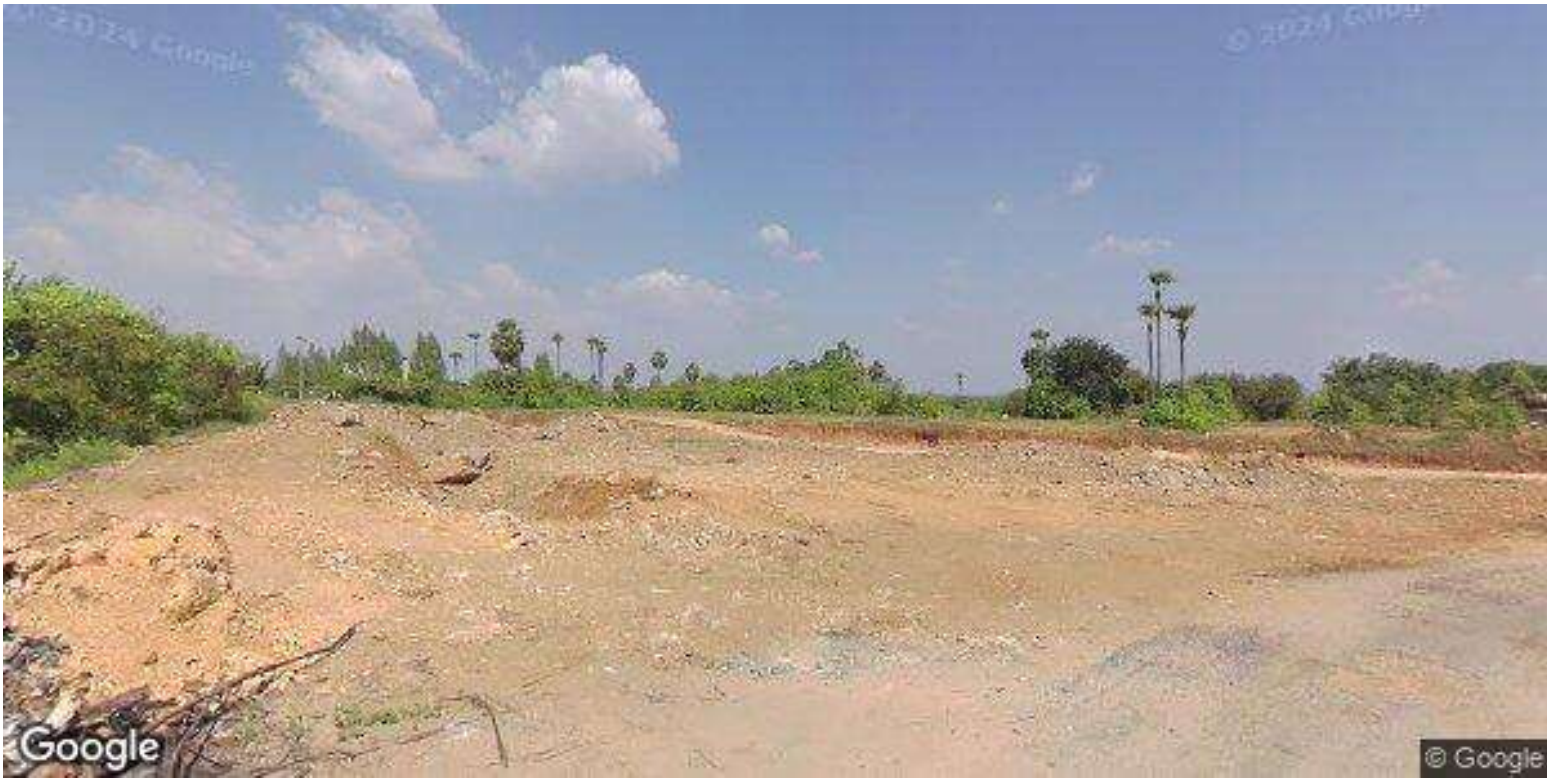
**Risk Type:** Blind Spot  
**Risk Level:** Blind Spot  
**Speed Limit:** 10 KM/Hr  
**Coordinates:** 11.41350, 77.92093

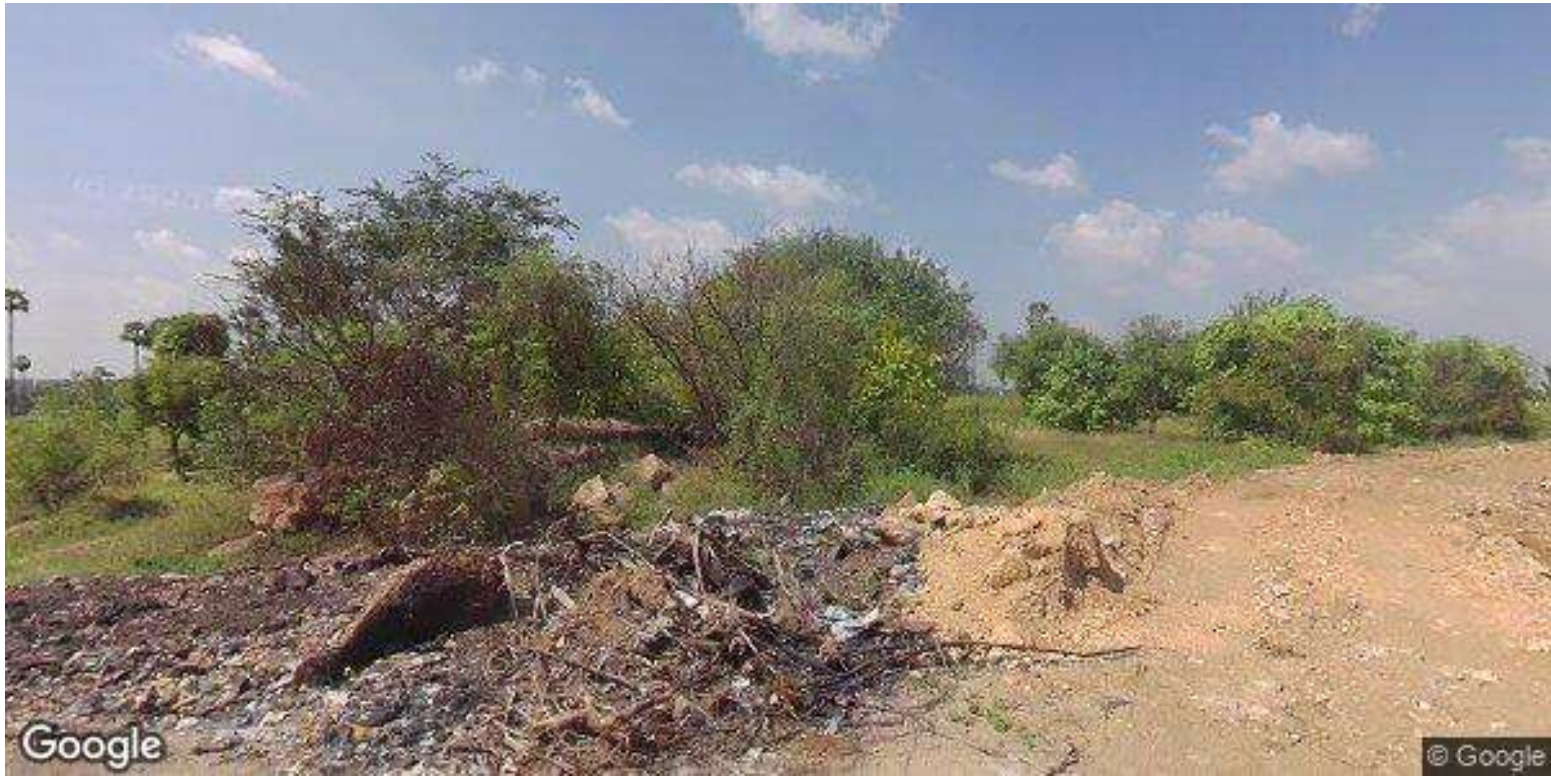
**Risk Type:** Turn  
**Risk Level:** Medium  
**Speed Limit:** 30 KM/Hr  
**Coordinates:** 11.41347, 77.92096

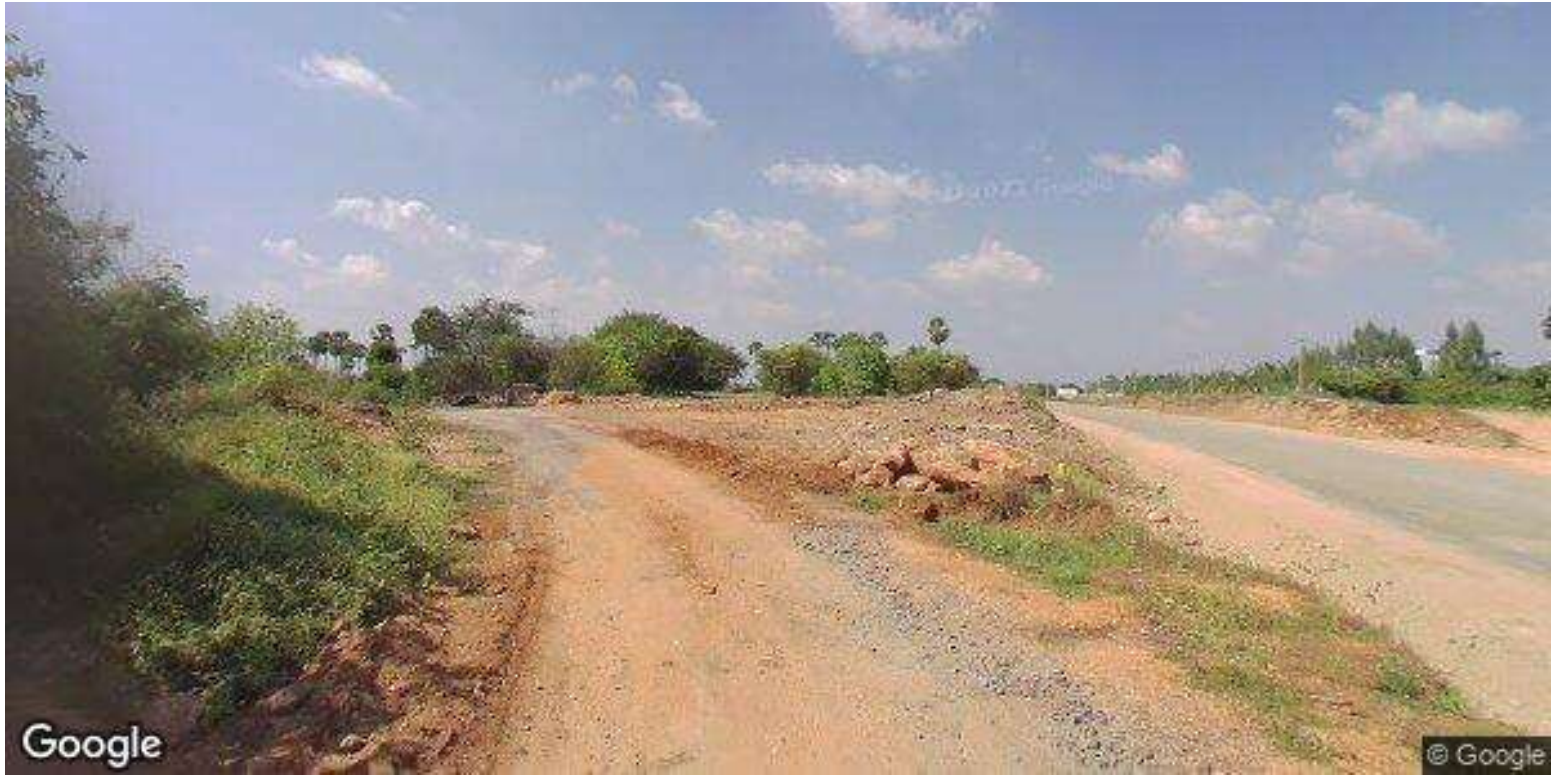
**Risk Type:** Turn  
**Risk Level:** Medium  
**Speed Limit:** 30 KM/Hr  
**Coordinates:** 11.41336, 77.92130

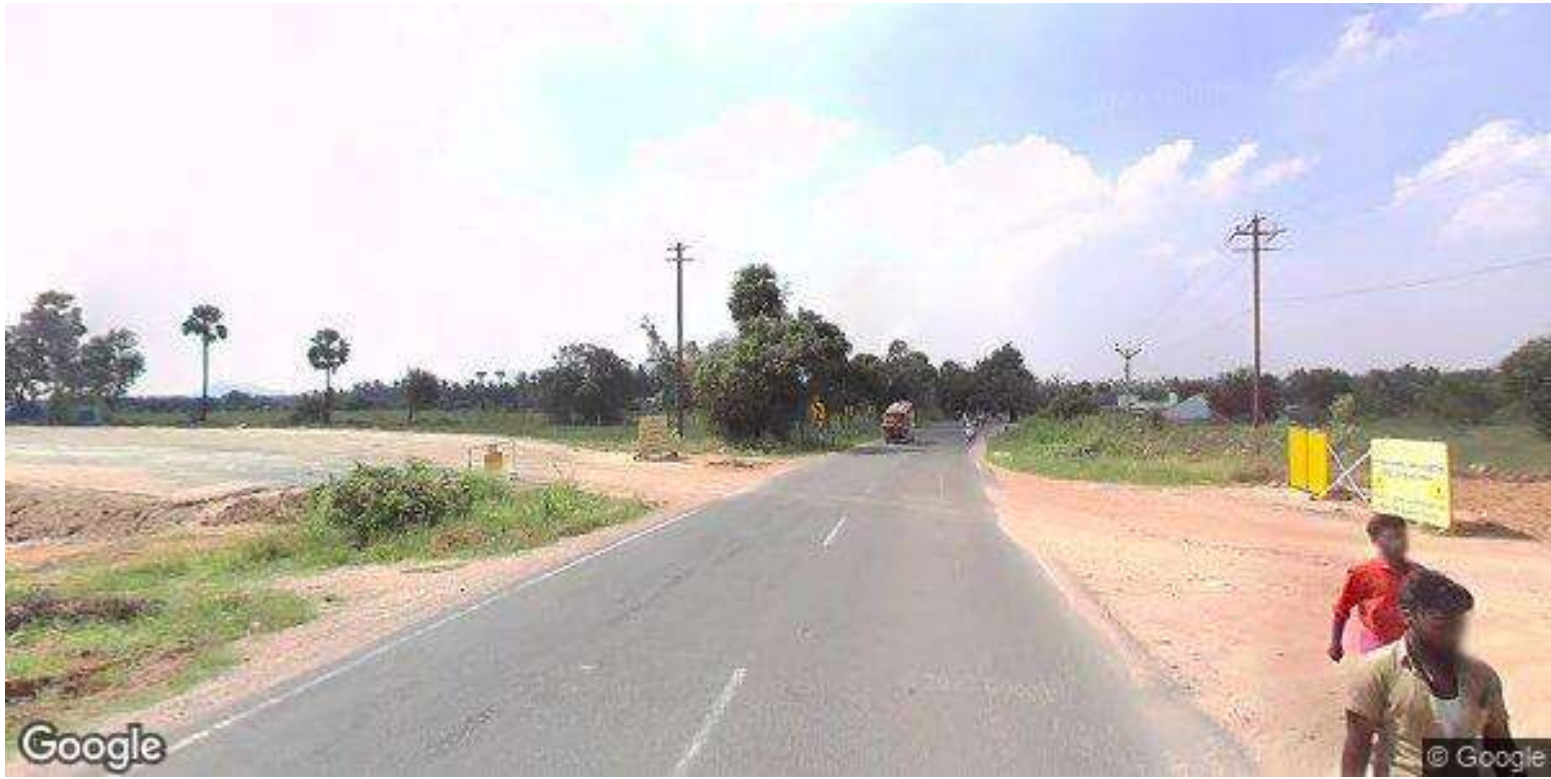
**Risk Type:** Turn  
**Risk Level:** High  
**Speed Limit:** 15 KM/Hr  
**Coordinates:** 11.40566, 77.92355

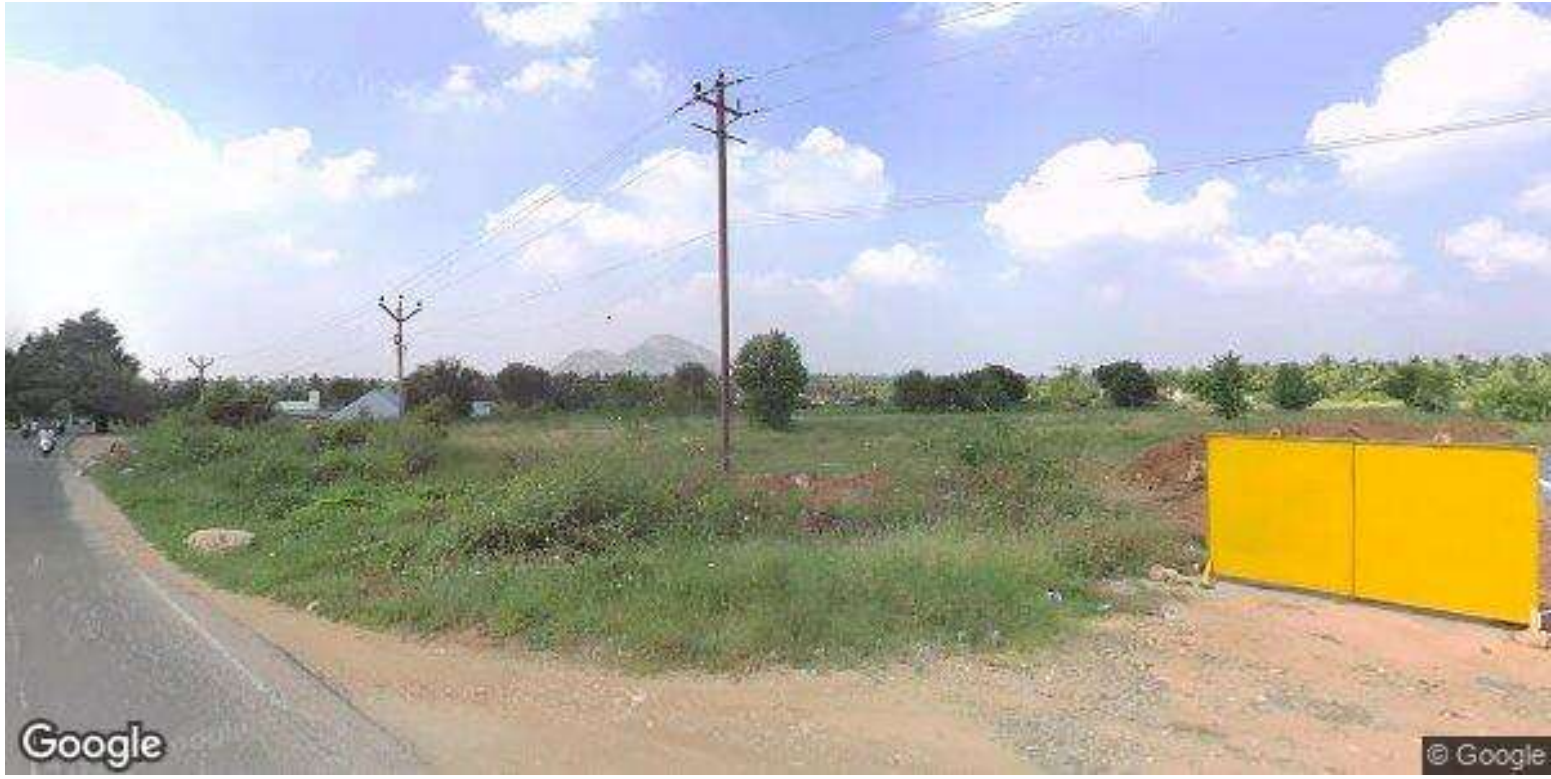
**Risk Type:** Turn  
**Risk Level:** High  
**Speed Limit:** 15 KM/Hr  
**Coordinates:** 11.40557, 77.92343

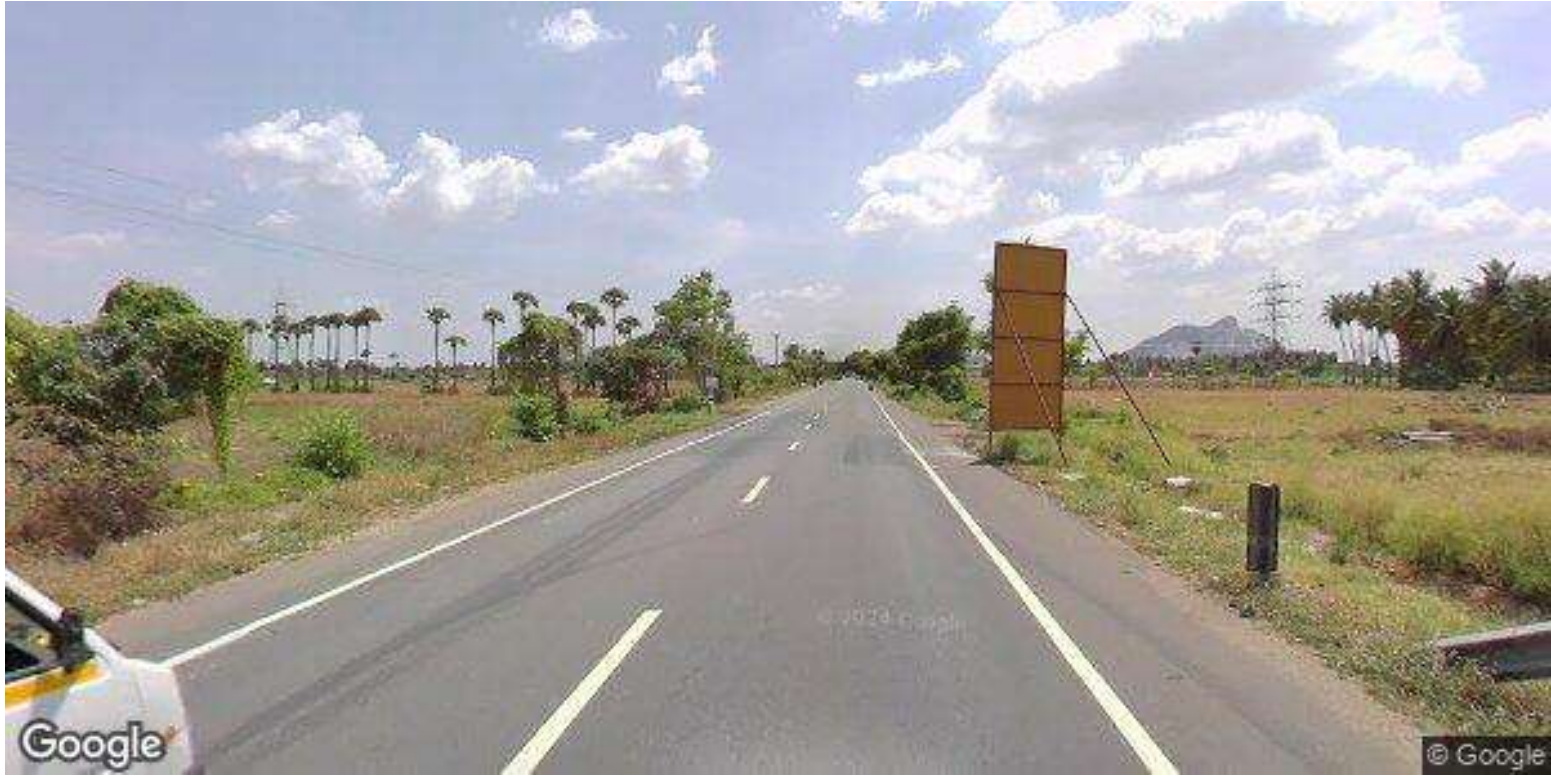
**Risk Type:** Blind Spot  
**Risk Level:** Blind Spot  
**Speed Limit:** 10 KM/Hr  
**Coordinates:** 11.36920, 77.94568
