# IndianOil

## JOURNEY RISK MANAGEMENT (JRM) STUDY

### Salem Terminal TO NSA FUELS

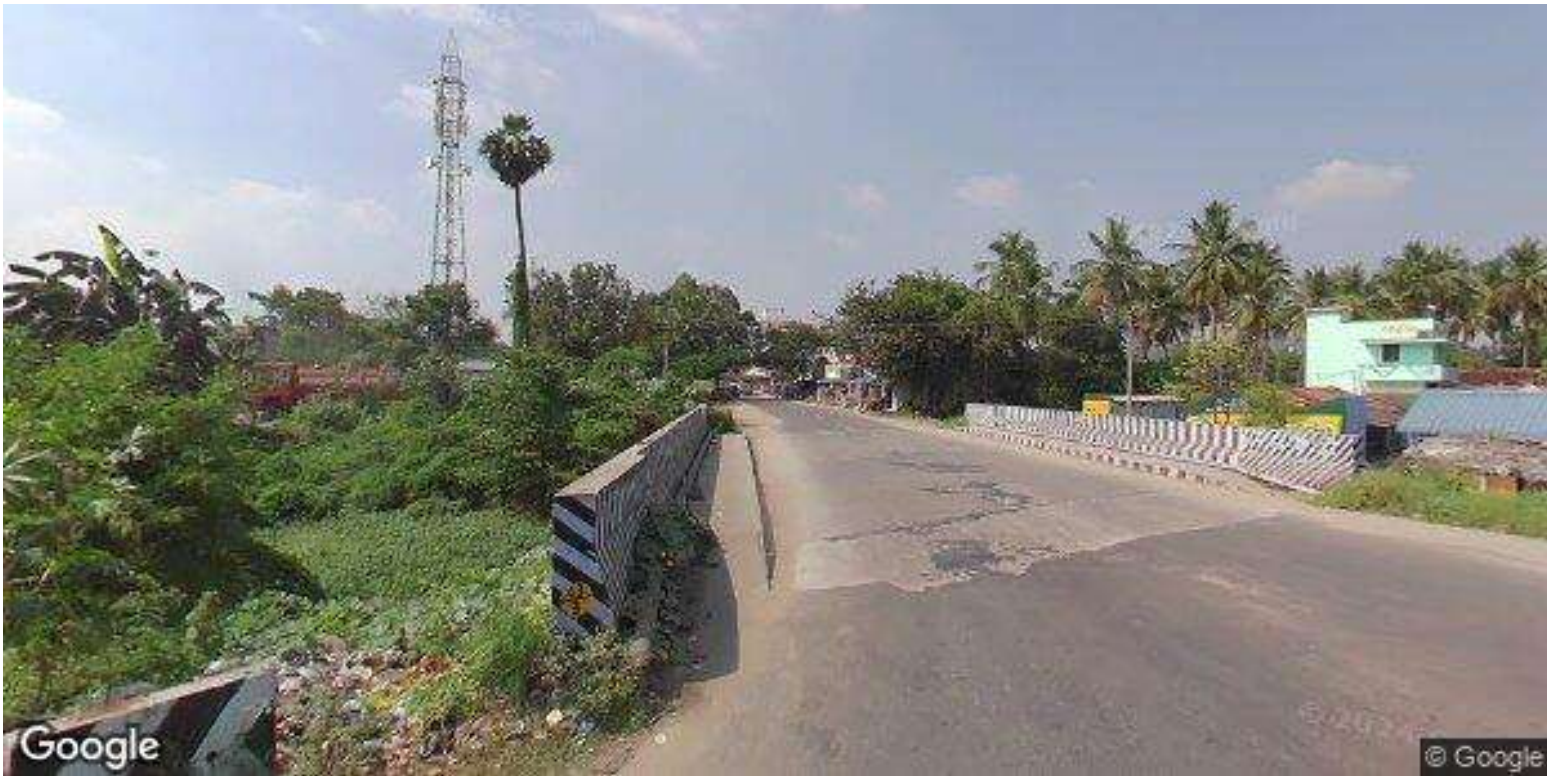
Risk Type: Turn

Risk Level: High

Speed Limit: 15 KM/Hr

Coordinates: 11.44900, 77.87406

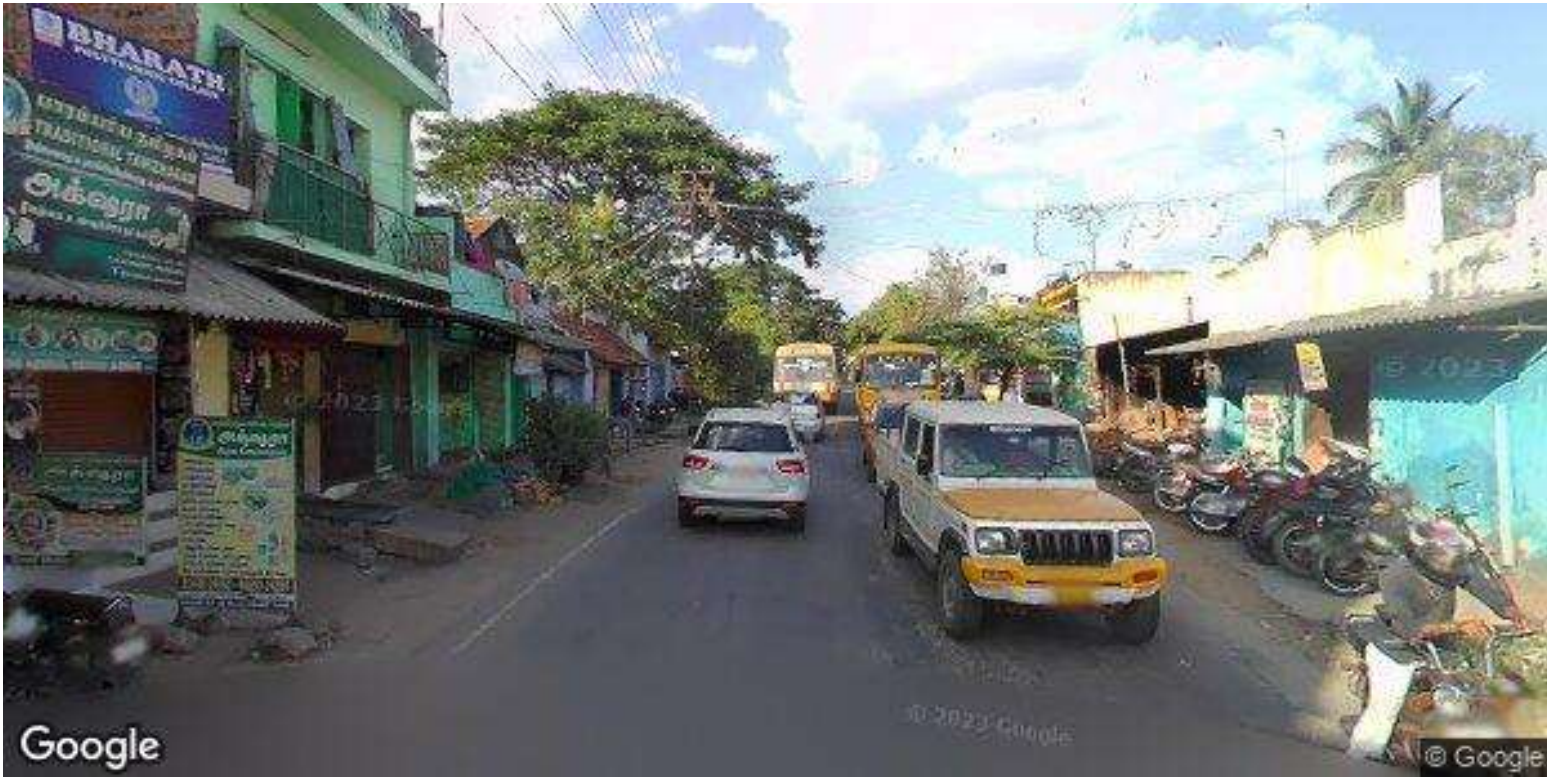
**Risk Type:** Turn  
**Risk Level:** High  
**Speed Limit:** 15 KM/Hr  
**Coordinates:** 11.45028, 77.87202

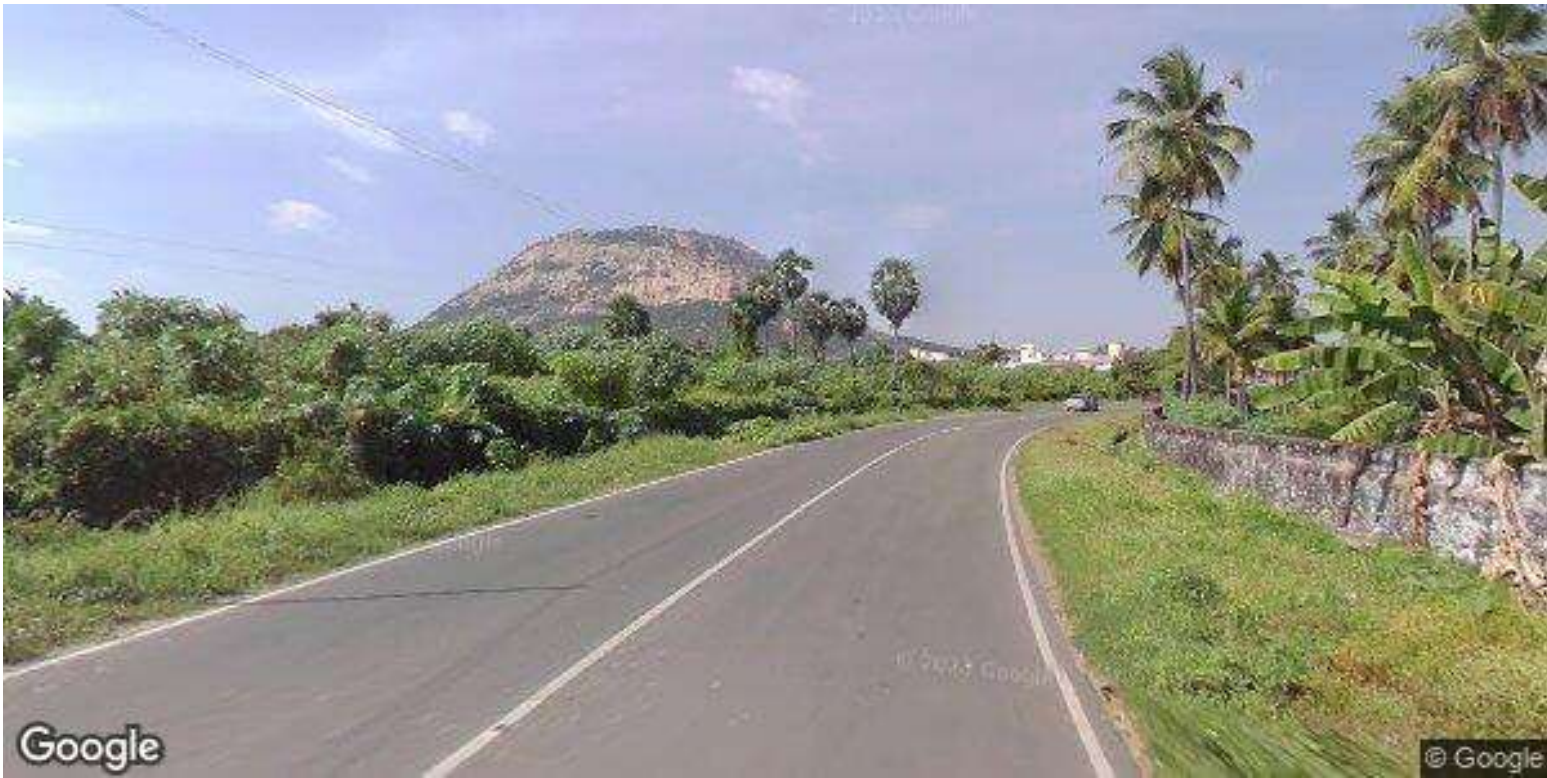
**Risk Type:** Turn  
**Risk Level:** Medium  
**Speed Limit:** 30 KM/Hr  
**Coordinates:** 11.46765, 77.87037

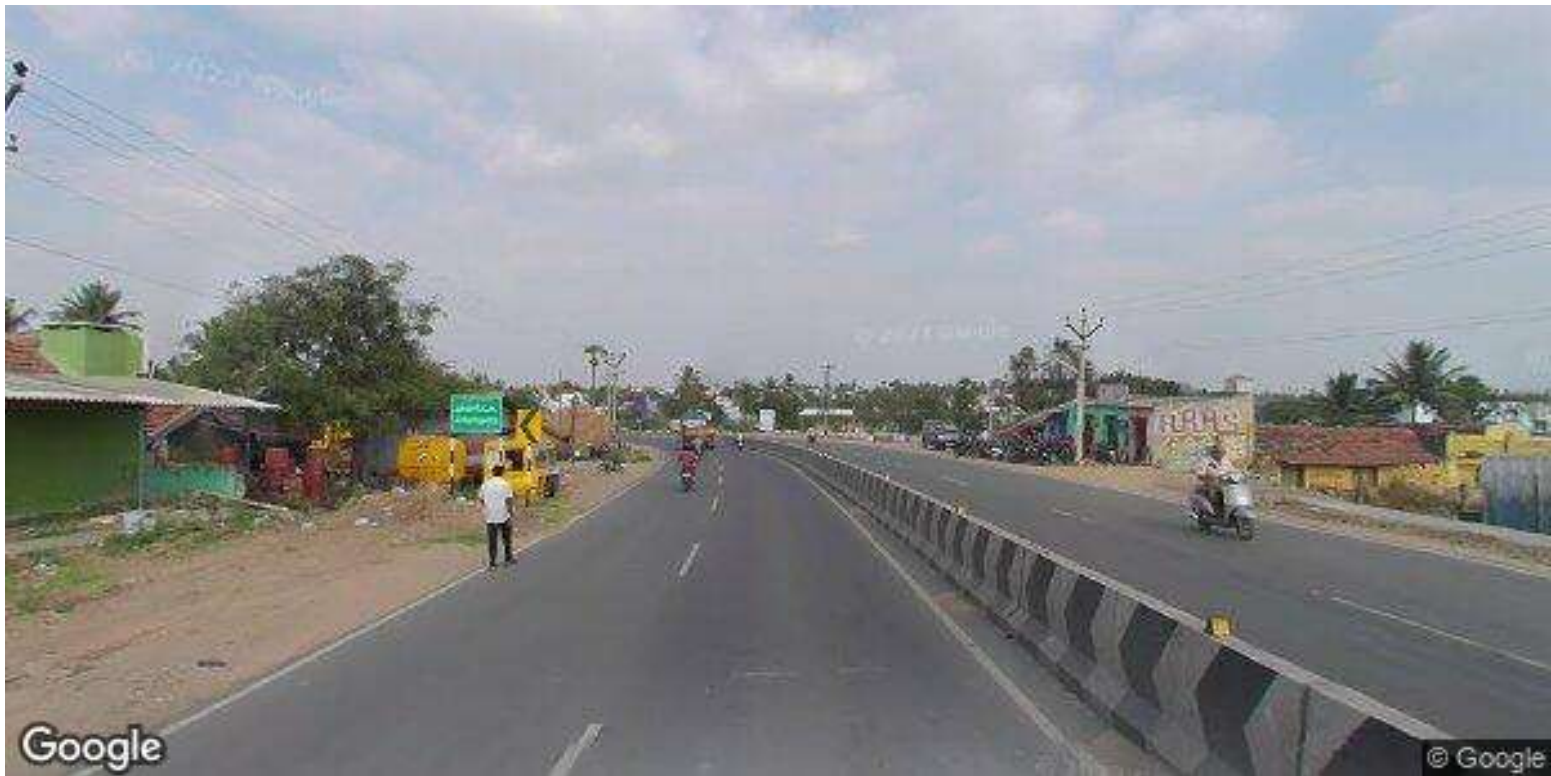
**Risk Type:** Turn  
**Risk Level:** Medium  
**Speed Limit:** 30 KM/Hr  
**Coordinates:** 11.47986, 77.88397

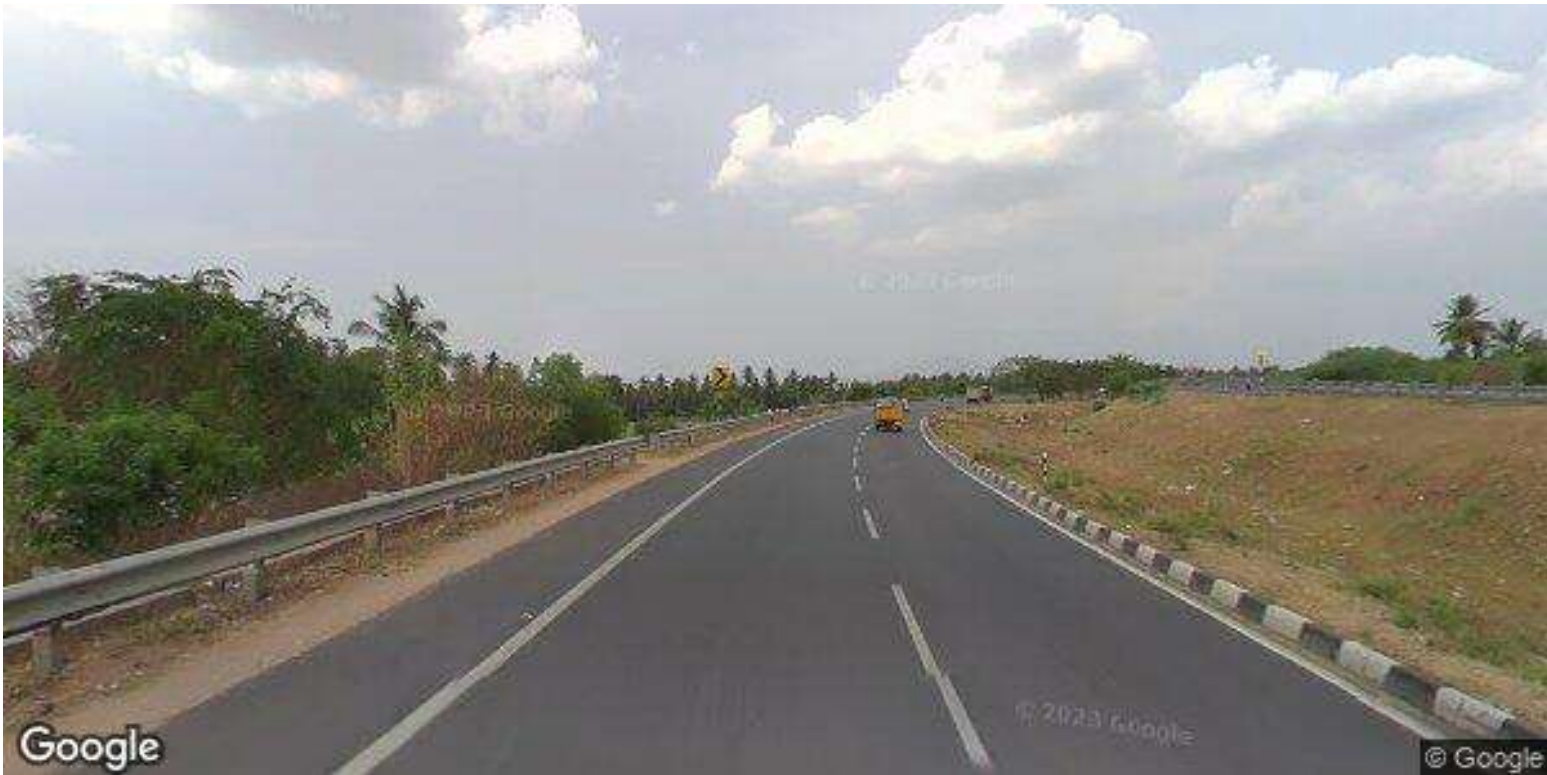
**Risk Type:** Turn  
**Risk Level:** Medium  
**Speed Limit:** 30 KM/Hr  
**Coordinates:** 11.53501, 77.95707

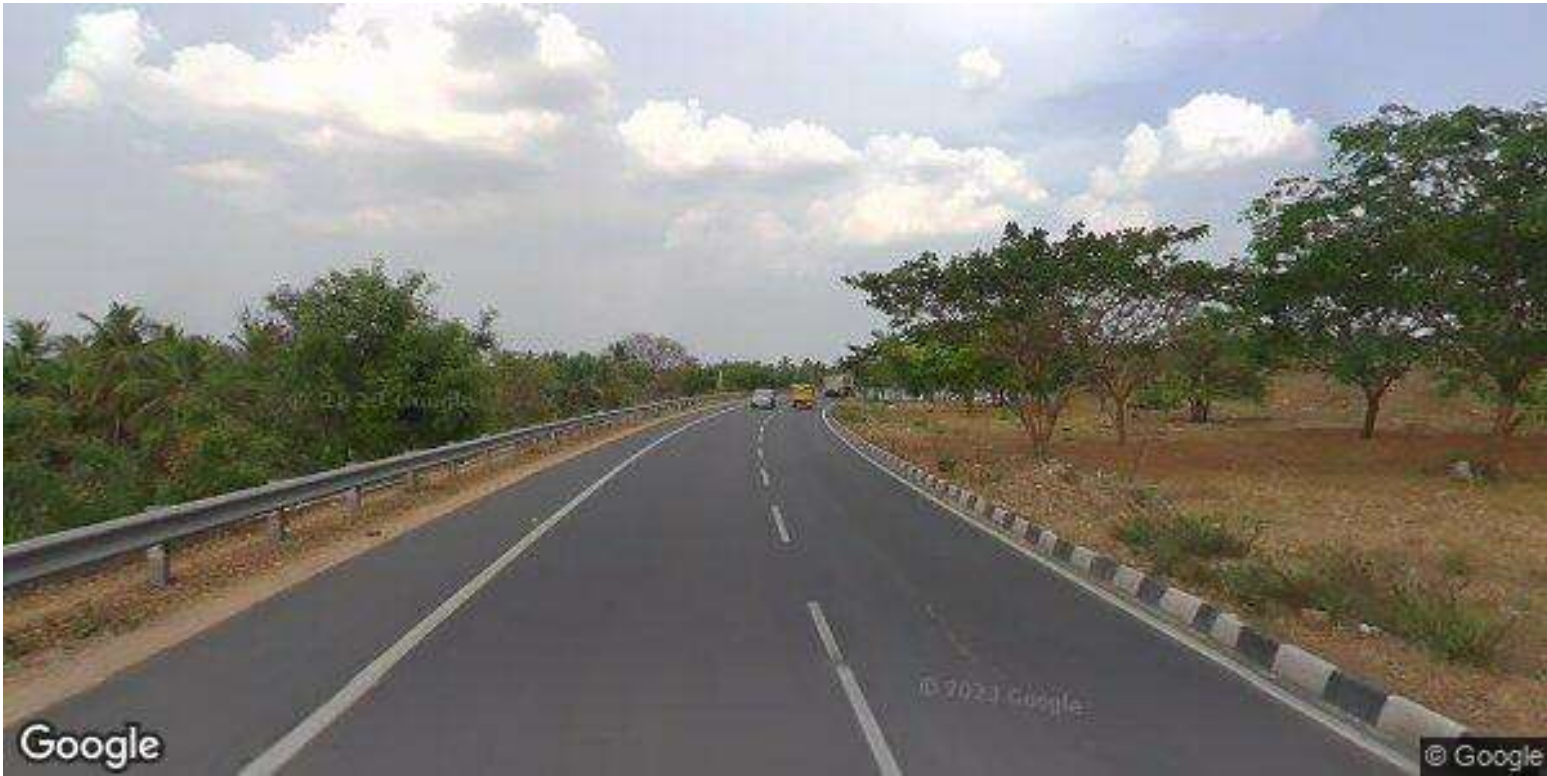
**Risk Type:** Turn  
**Risk Level:** Medium  
**Speed Limit:** 30 KM/Hr  
**Coordinates:** 11.53601, 77.95856

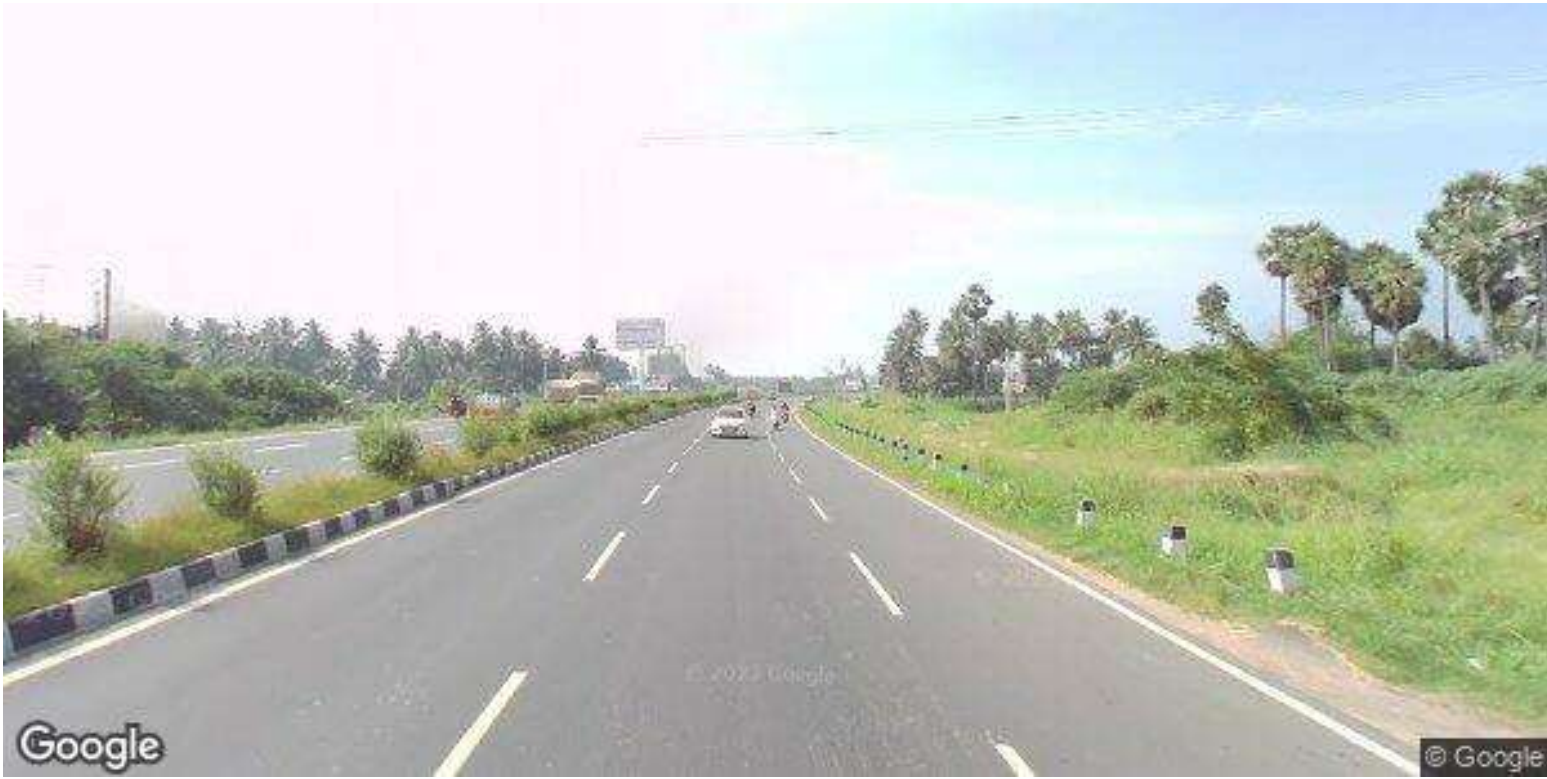
**Risk Type:** Turn  
**Risk Level:** Medium  
**Speed Limit:** 30 KM/Hr  
**Coordinates:** 11.62917, 78.11648

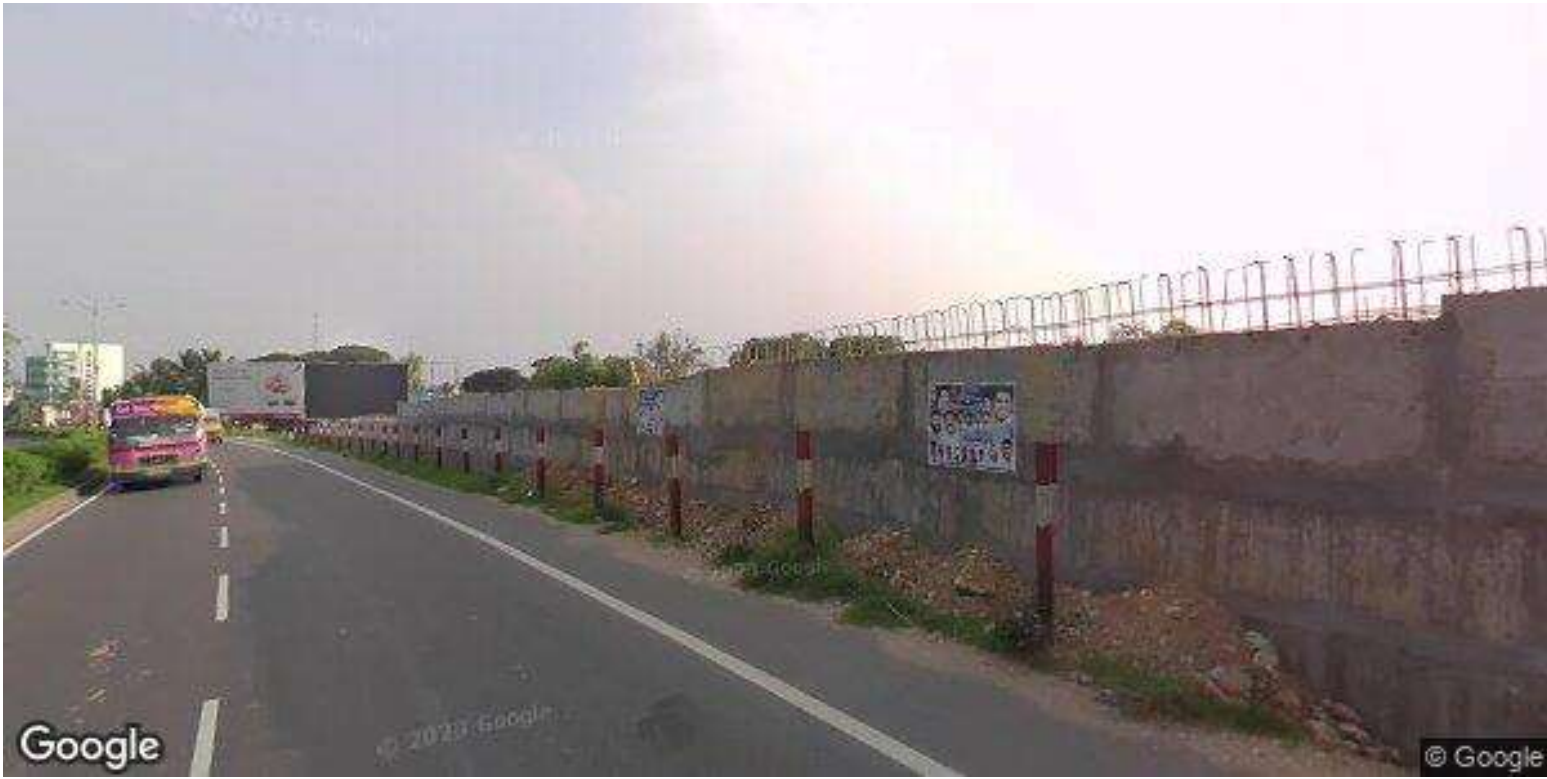
**Risk Type:** Turn  
**Risk Level:** Medium  
**Speed Limit:** 30 KM/Hr  
**Coordinates:** 11.69519, 78.10775

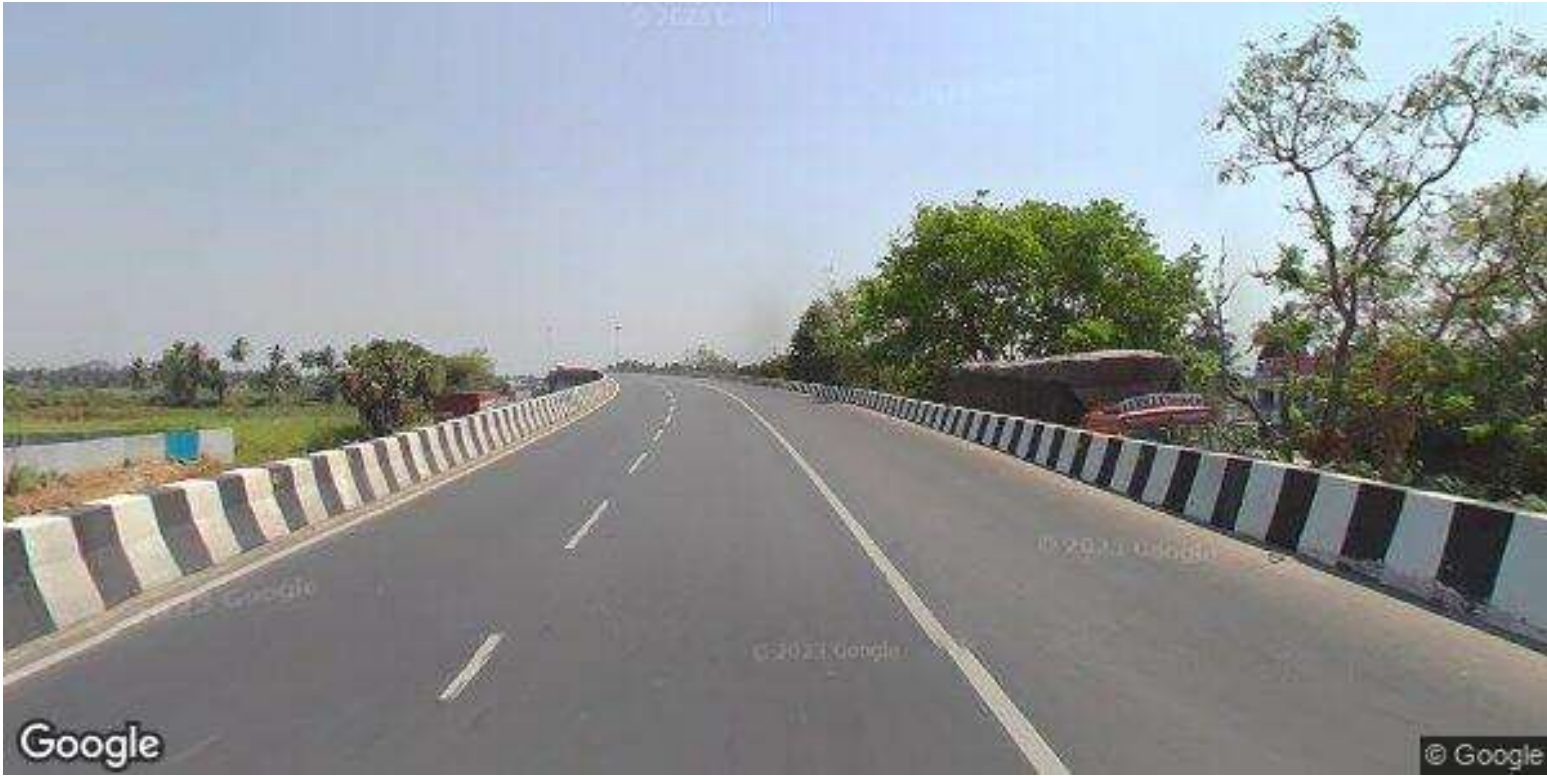
**Risk Type:** Turn  
**Risk Level:** Medium  
**Speed Limit:** 30 KM/Hr  
**Coordinates:** 11.73958, 78.05105

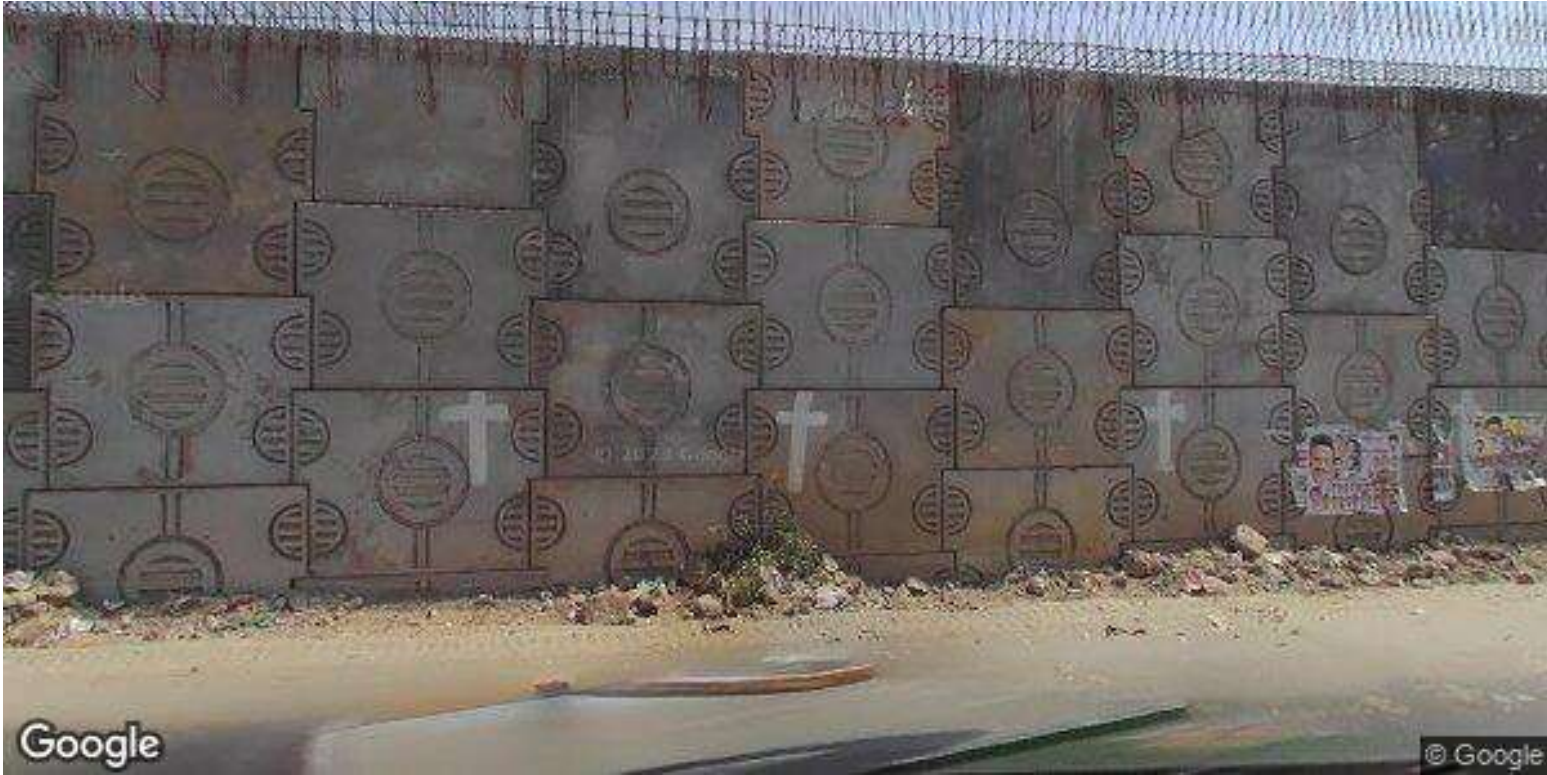
**Risk Type:** Turn  
**Risk Level:** Medium  
**Speed Limit:** 30 KM/Hr  
**Coordinates:** 11.75835, 78.05016

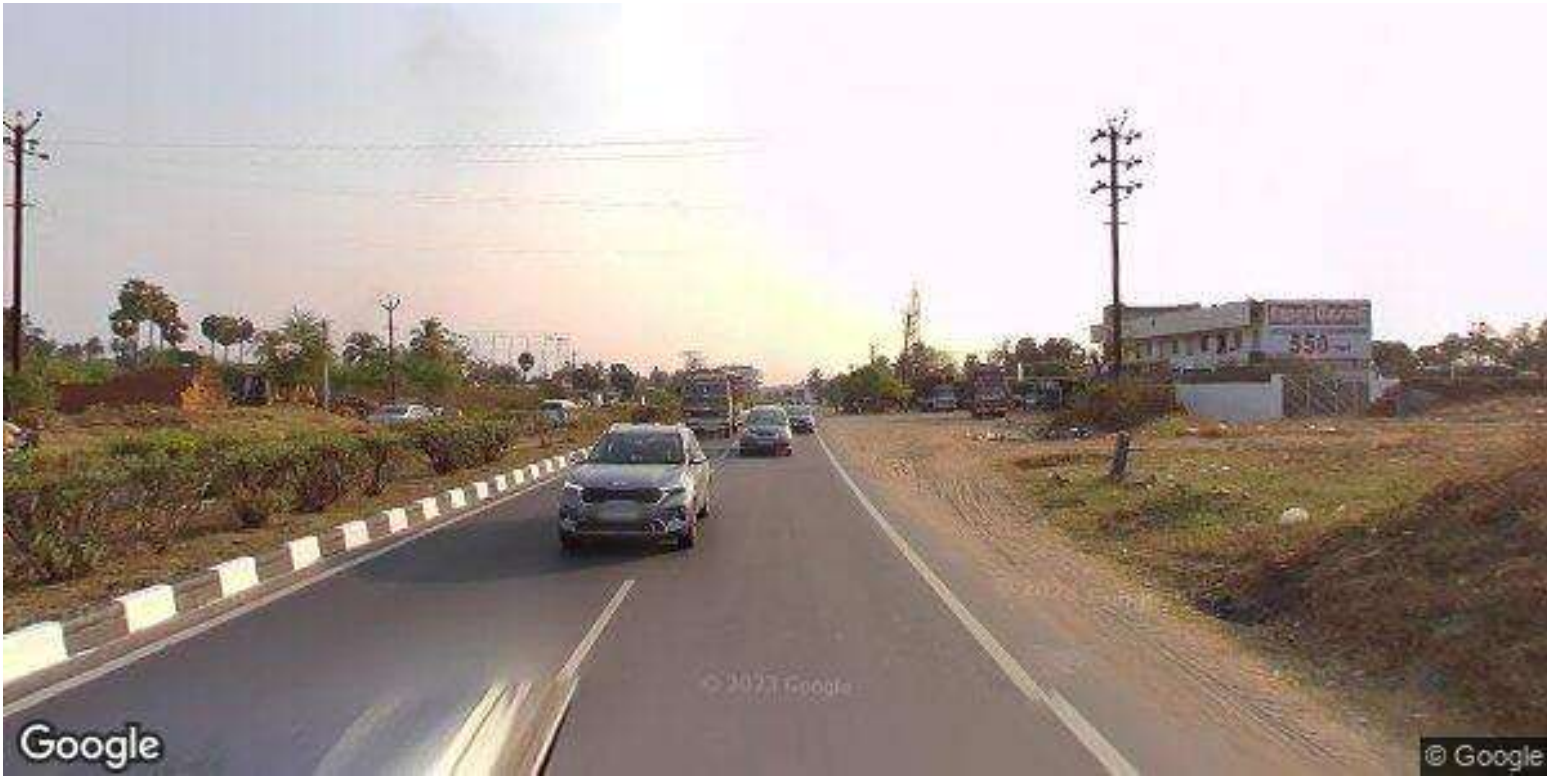
**Risk Type:** Turn  
**Risk Level:** Medium  
**Speed Limit:** 30 KM/Hr  
**Coordinates:** 11.77934, 78.05765

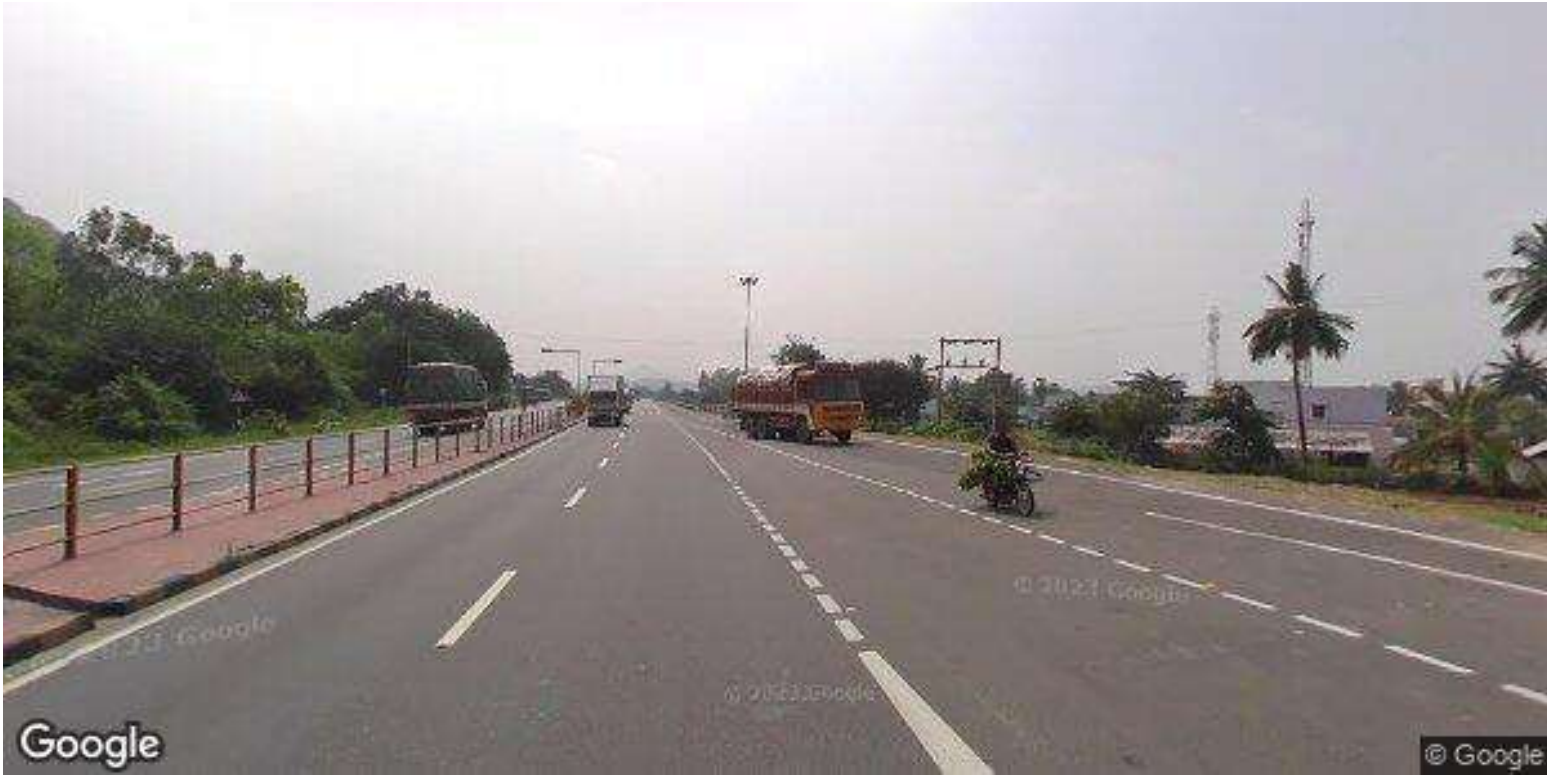
**Risk Type:** Turn  
**Risk Level:** Medium  
**Speed Limit:** 30 KM/Hr  
**Coordinates:** 11.91177, 78.05854

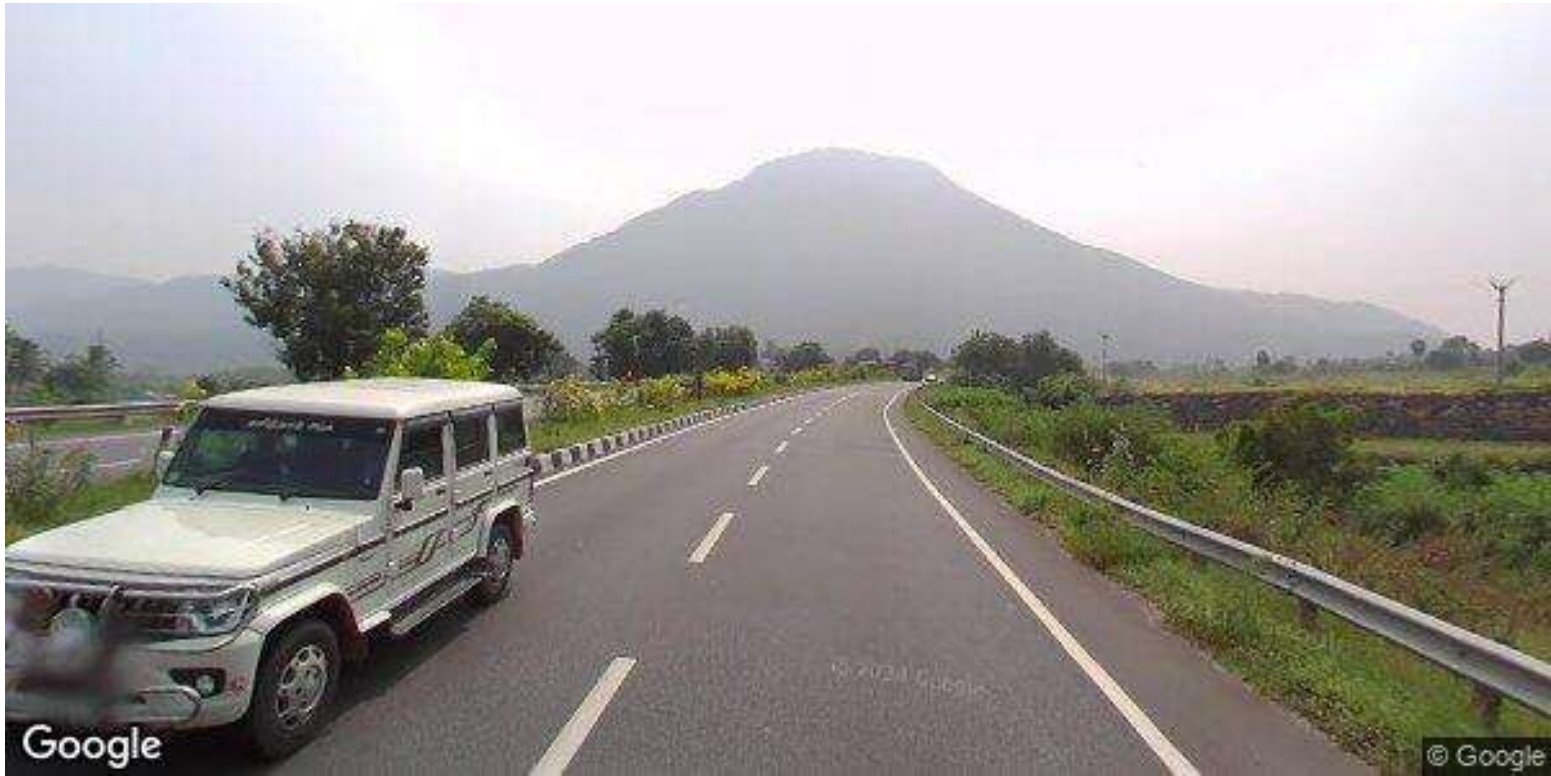
**Risk Type:** Turn  
**Risk Level:** Medium  
**Speed Limit:** 30 KM/Hr  
**Coordinates:** 11.93319, 78.06419

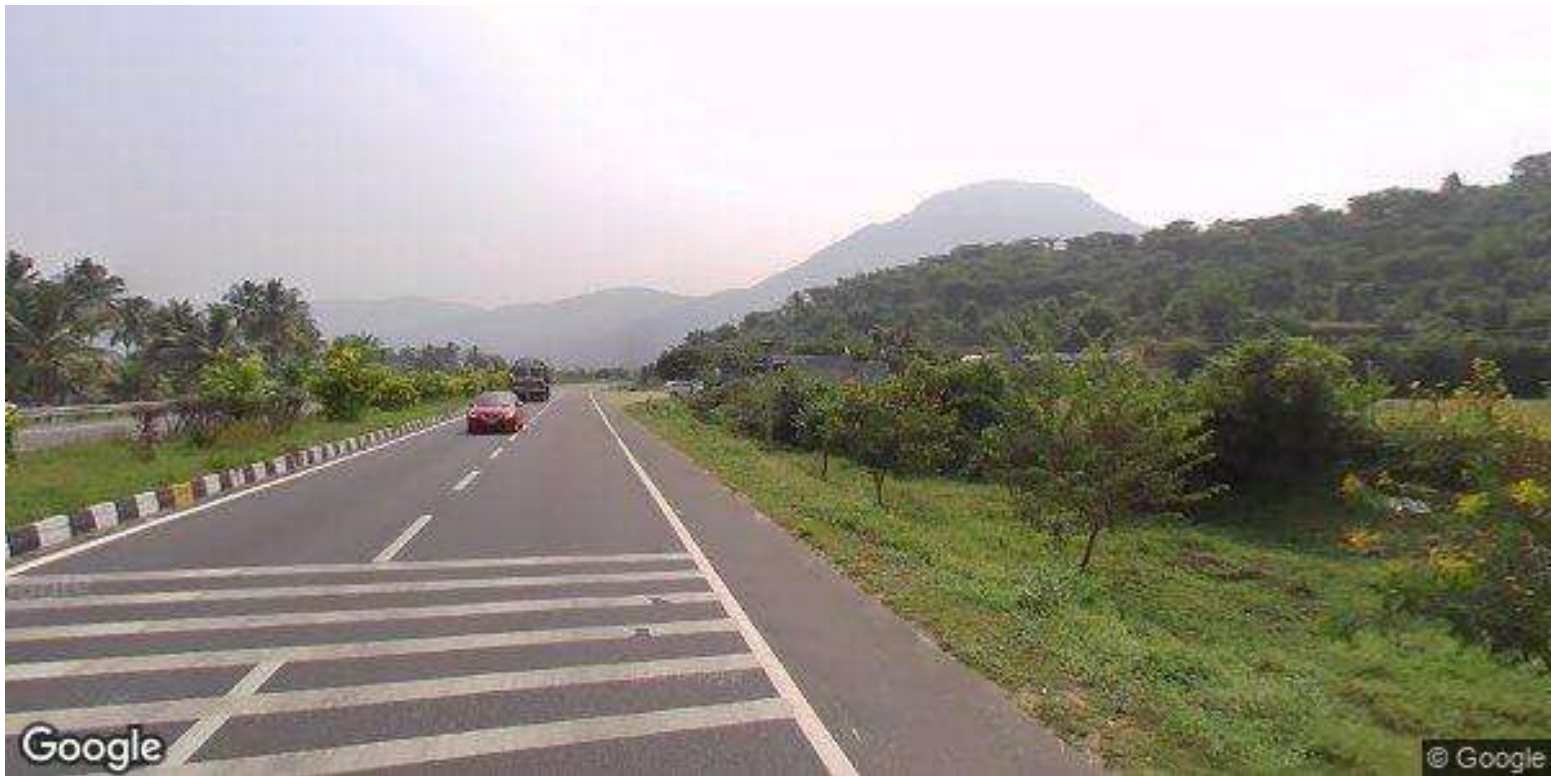
**Risk Type:** Turn  
**Risk Level:** Medium  
**Speed Limit:** 30 KM/Hr  
**Coordinates:** 11.93557, 78.06103

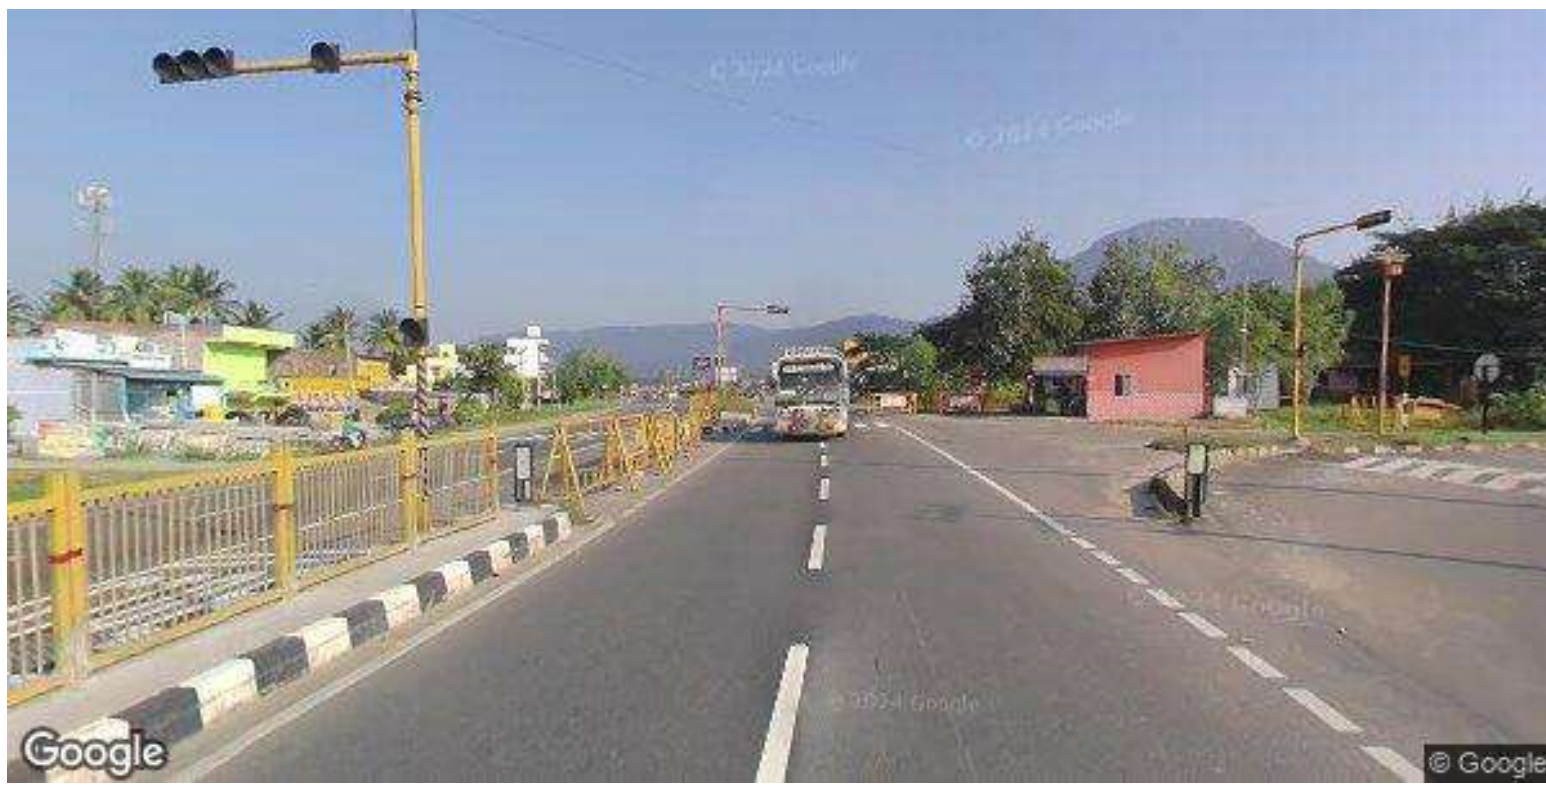
**Risk Type: Turn**

**Risk Level: Medium**

**Speed Limit: 30 KM/Hr**

**Coordinates: 11.93704, 78.05402**

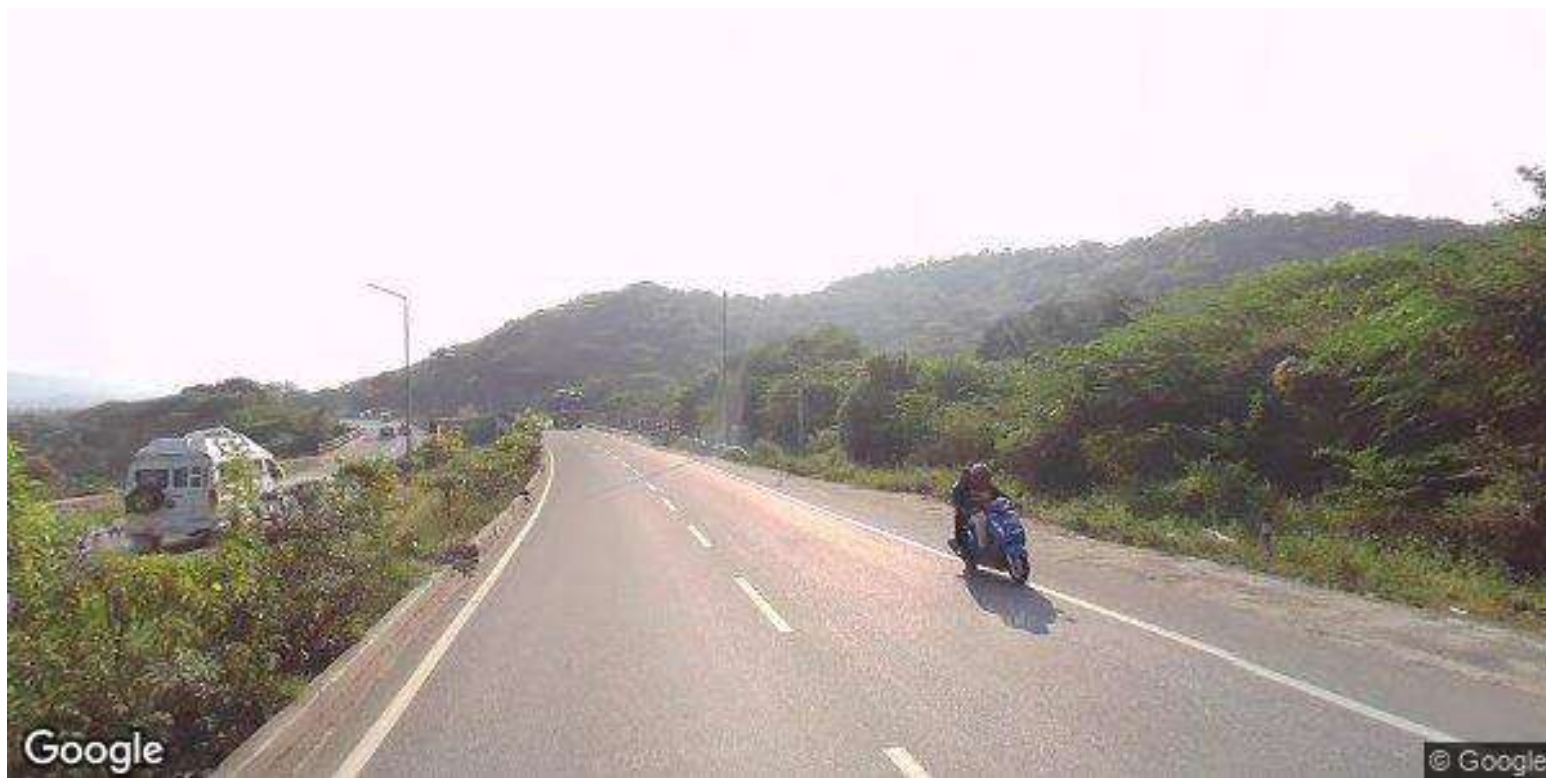
**Risk Type: Turn**

**Risk Level: Medium**

**Speed Limit: 30 KM/Hr**

**Coordinates: 11.95664, 78.04781**

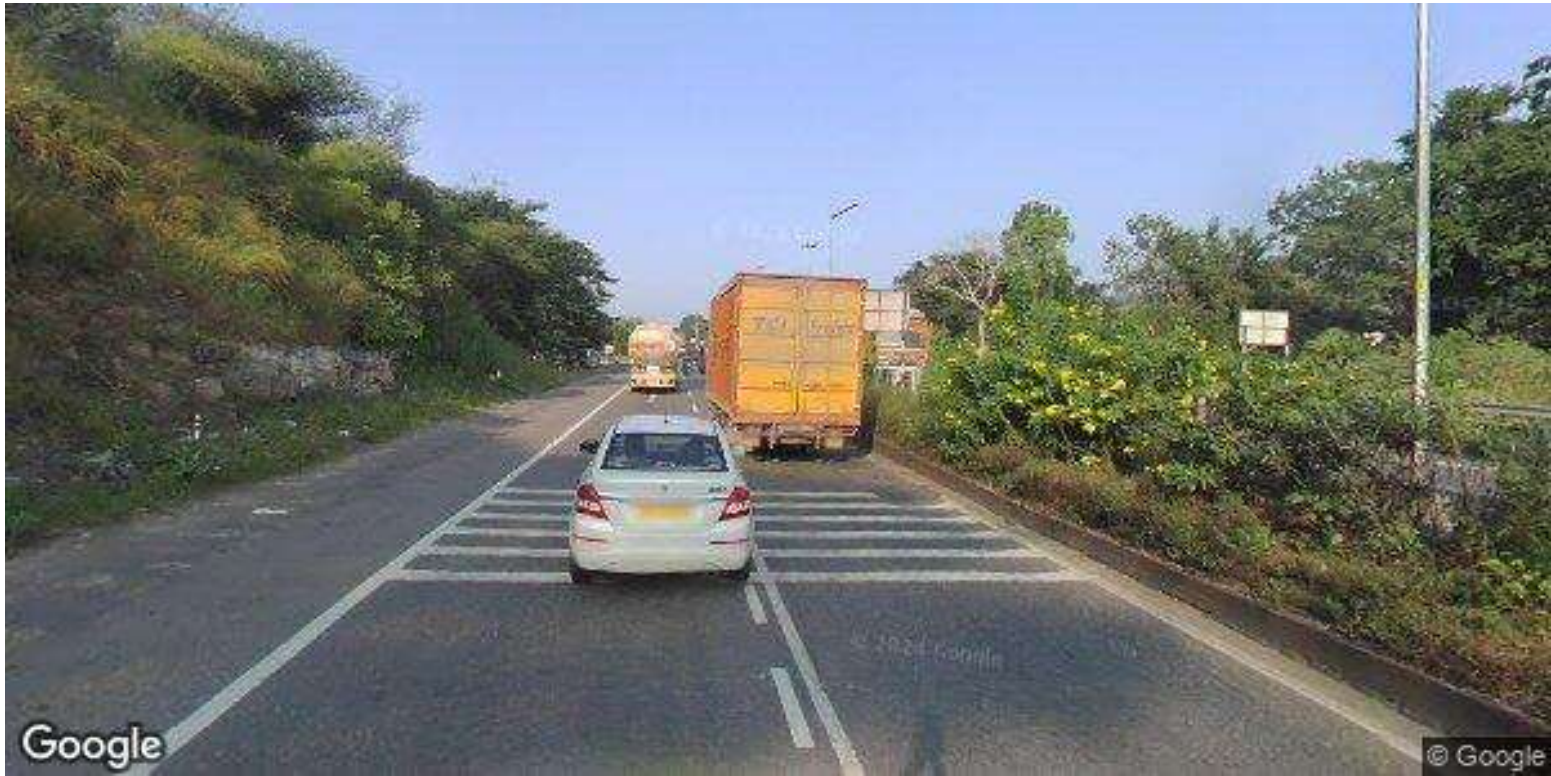
**Risk Type:** Turn  
**Risk Level:** Medium  
**Speed Limit:** 30 KM/Hr  
**Coordinates:** 11.96090, 78.04976

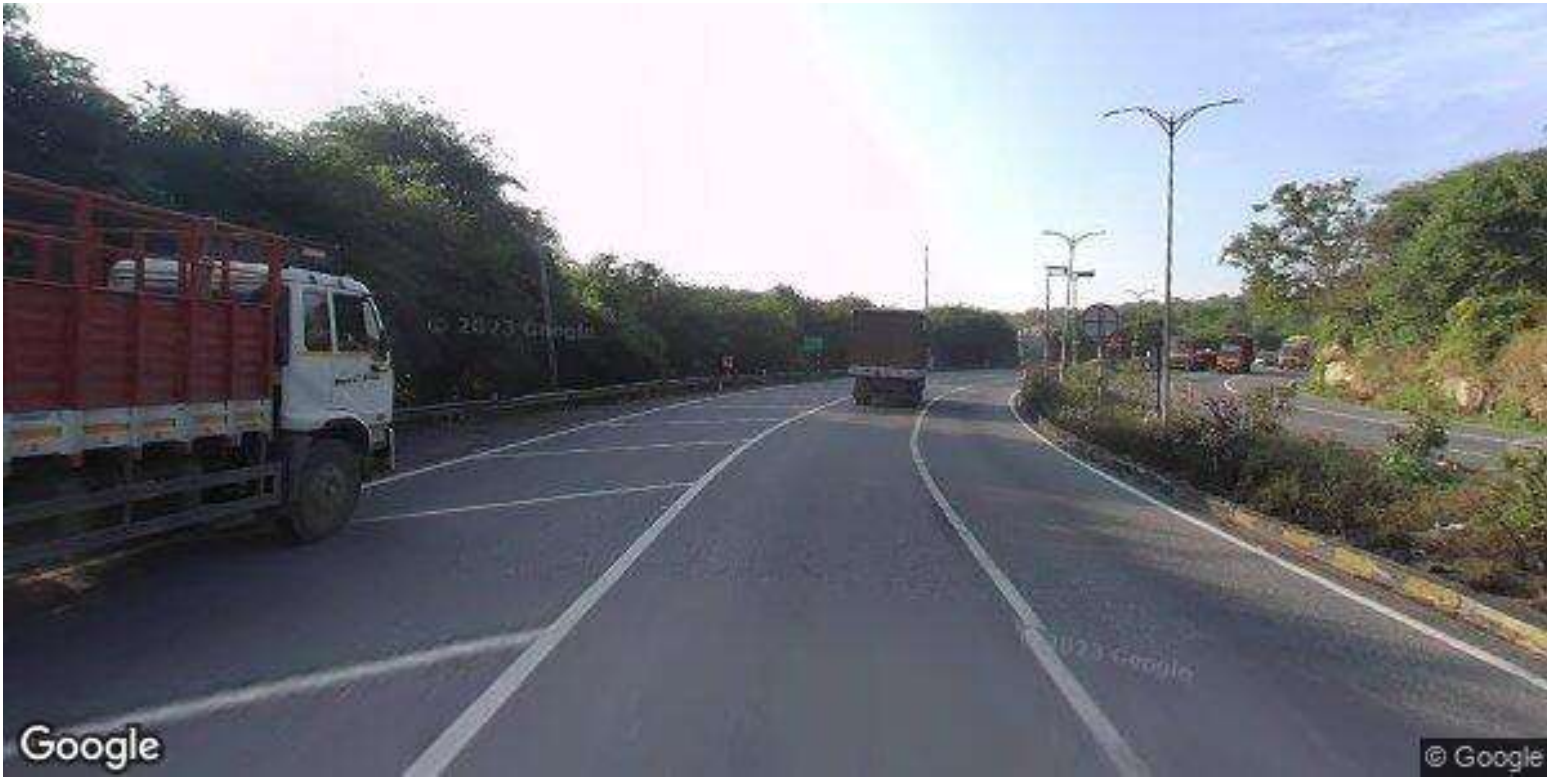
**Risk Type:** Turn  
**Risk Level:** Medium  
**Speed Limit:** 30 KM/Hr  
**Coordinates:** 11.96496, 78.04988
