# IndianOil

## JOURNEY RISK MANAGEMENT (JRM) STUDY

### Salem Terminal TO NSA FUELS

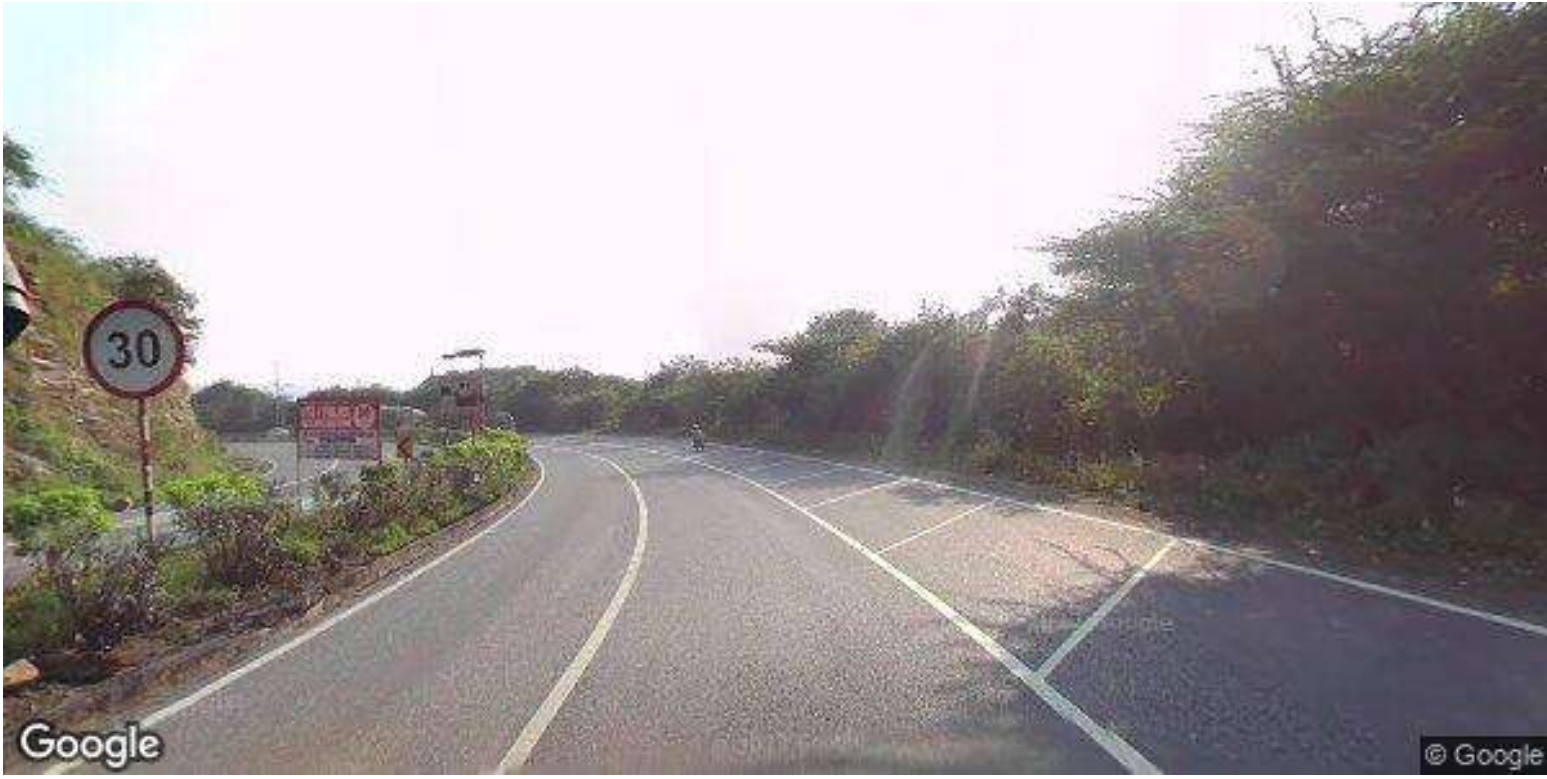
**Risk Type:** Turn  
**Risk Level:** High  
**Speed Limit:** 15 KM/Hr  
**Coordinates:** 11.96675, 78.04939

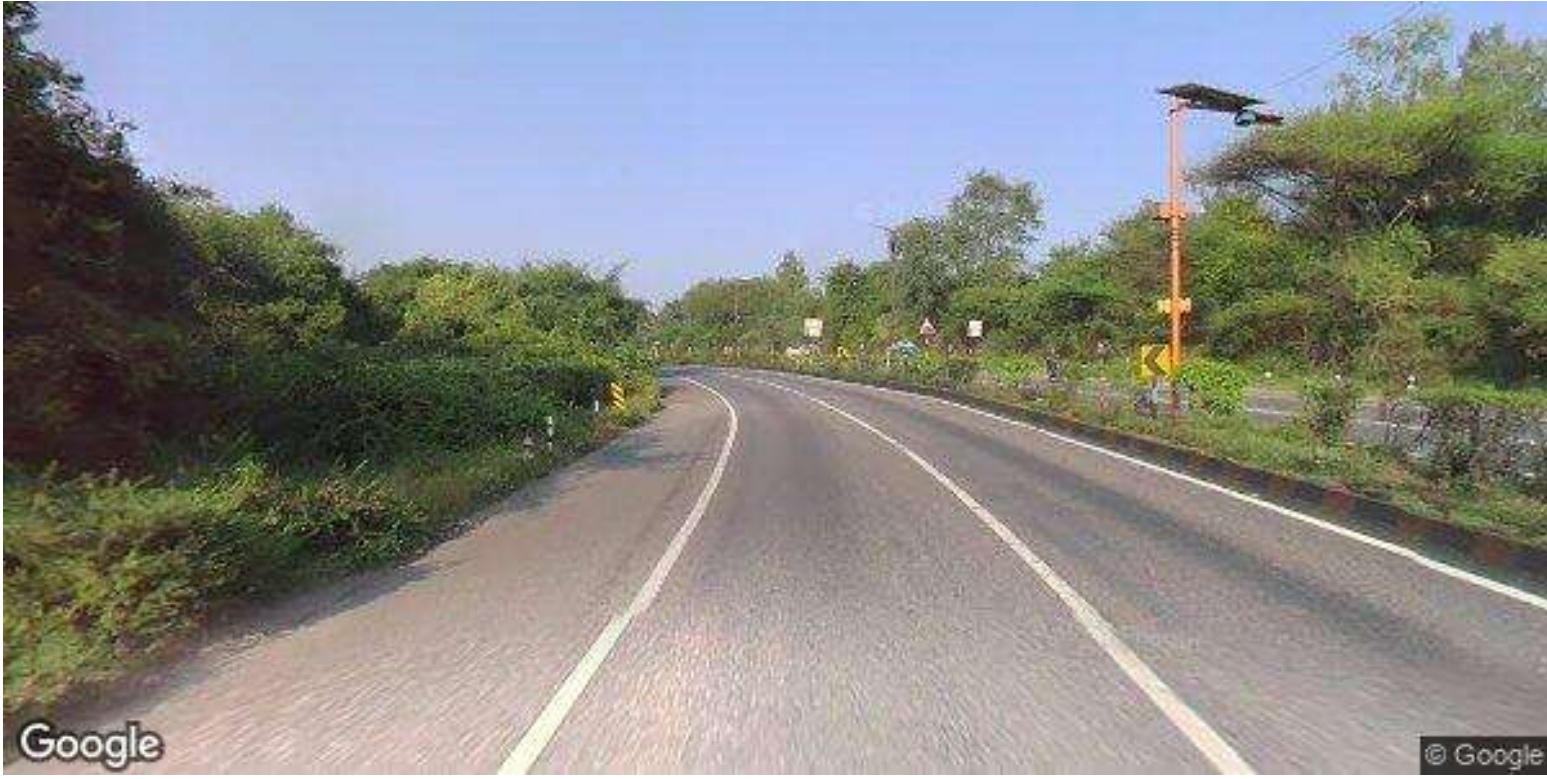
**Risk Type:** Turn  
**Risk Level:** Medium  
**Speed Limit:** 30 KM/Hr  
**Coordinates:** 11.96791, 78.05070

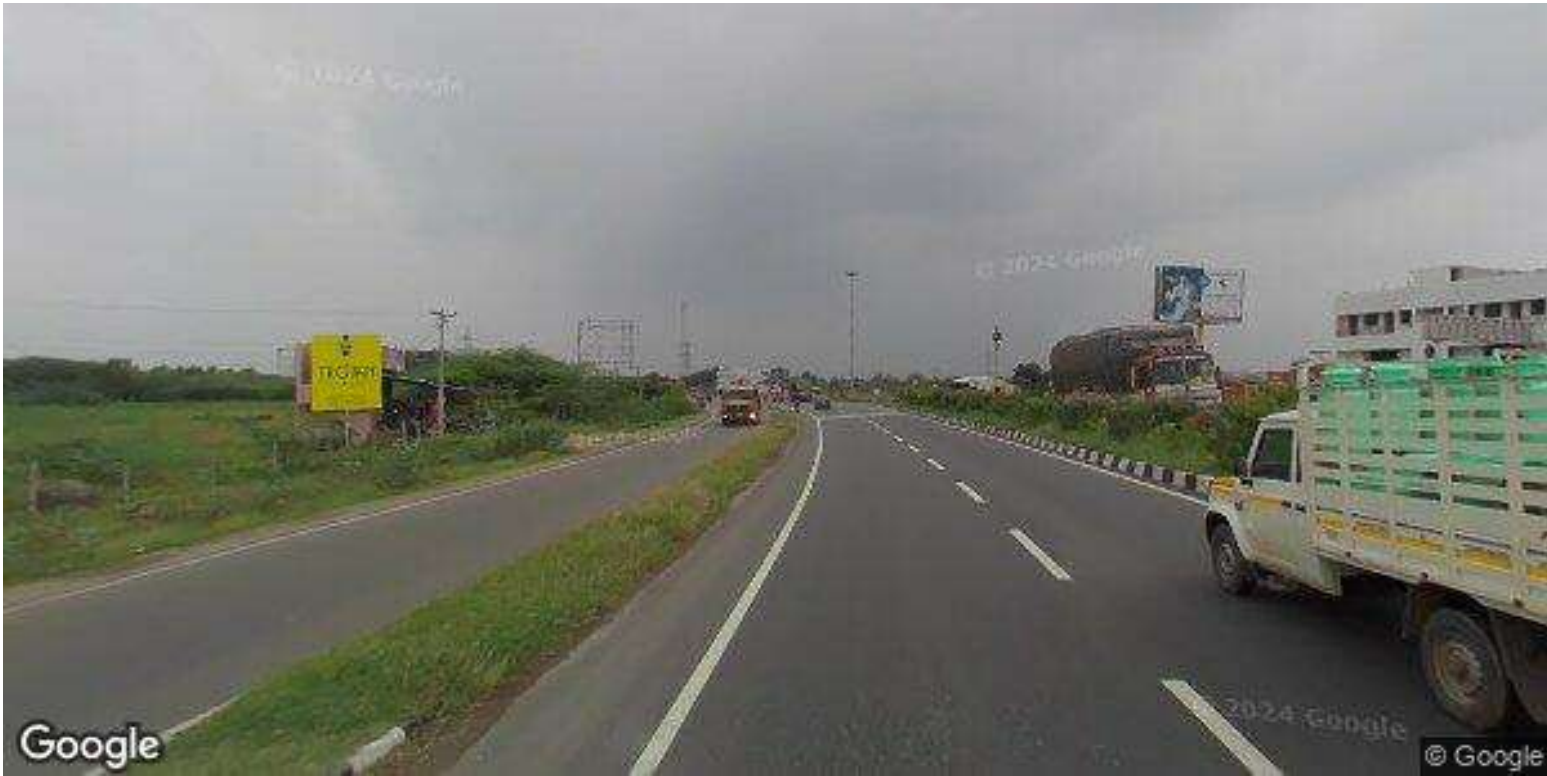
**Risk Type:** Turn  
**Risk Level:** Medium  
**Speed Limit:** 30 KM/Hr  
**Coordinates:** 12.16983, 78.16769

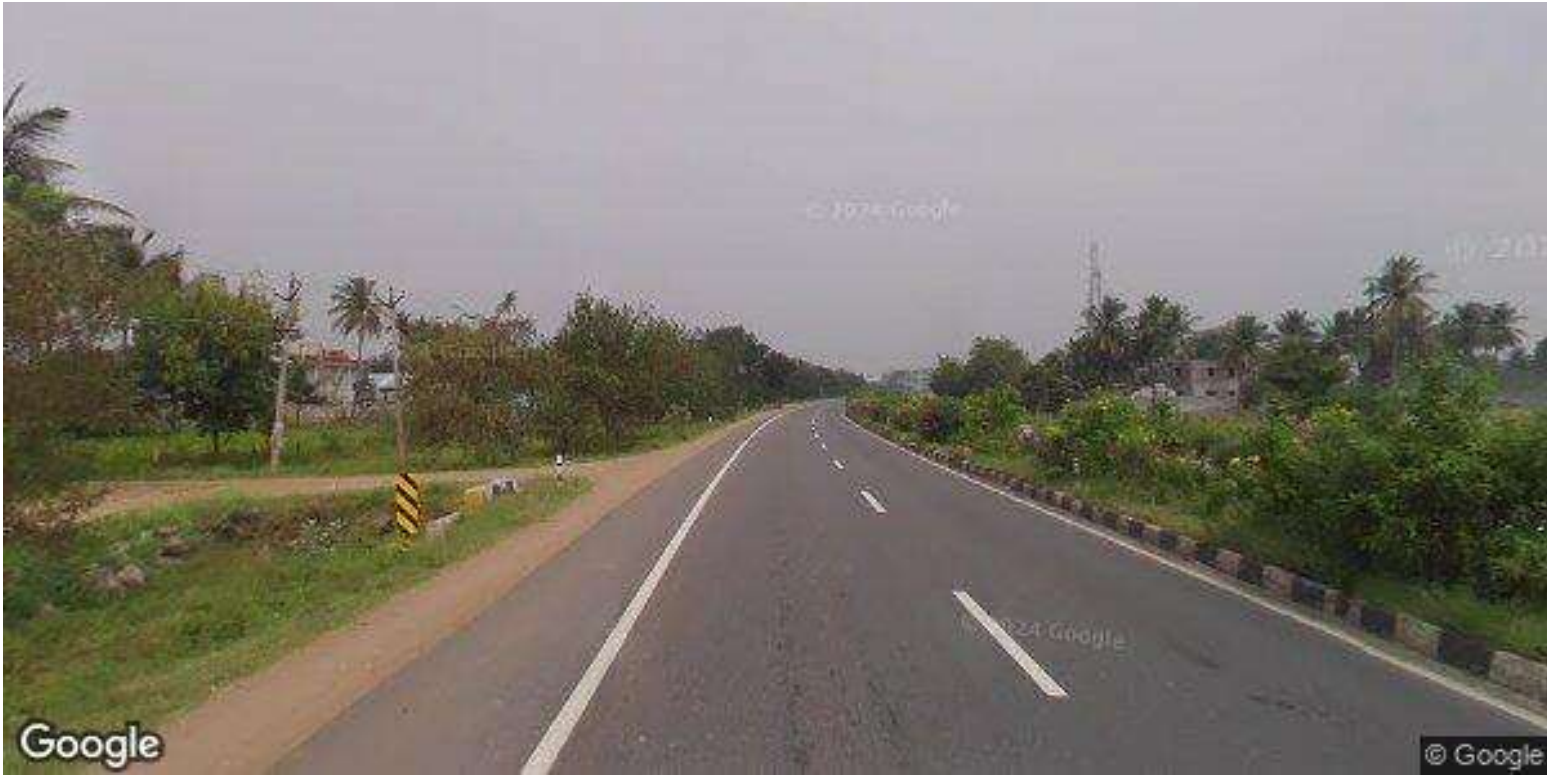
**Risk Type:** Turn  
**Risk Level:** Medium  
**Speed Limit:** 30 KM/Hr  
**Coordinates:** 12.19881, 78.18157

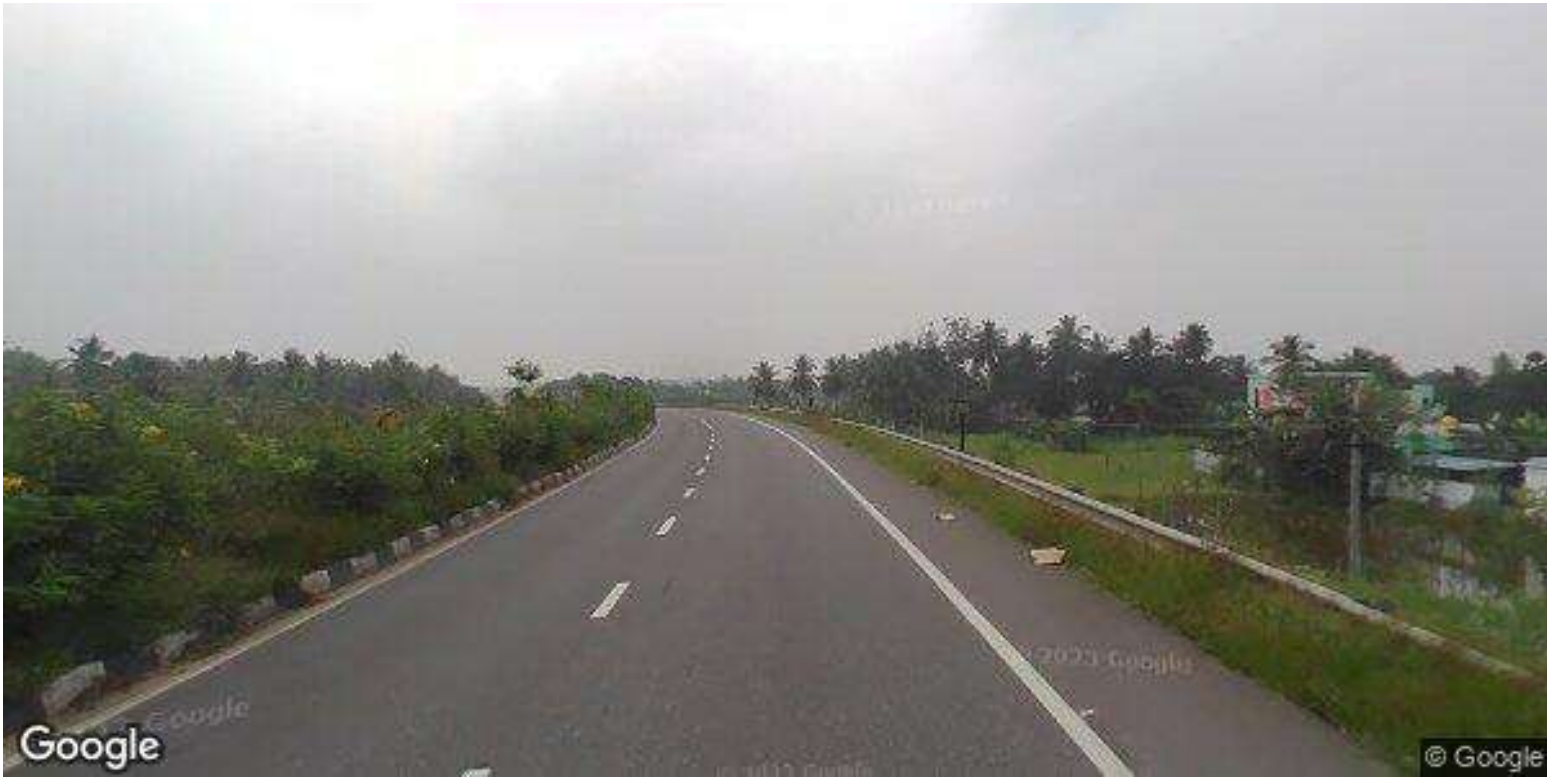
**Risk Type:** Turn  
**Risk Level:** Medium  
**Speed Limit:** 30 KM/Hr  
**Coordinates:** 12.22459, 78.19136

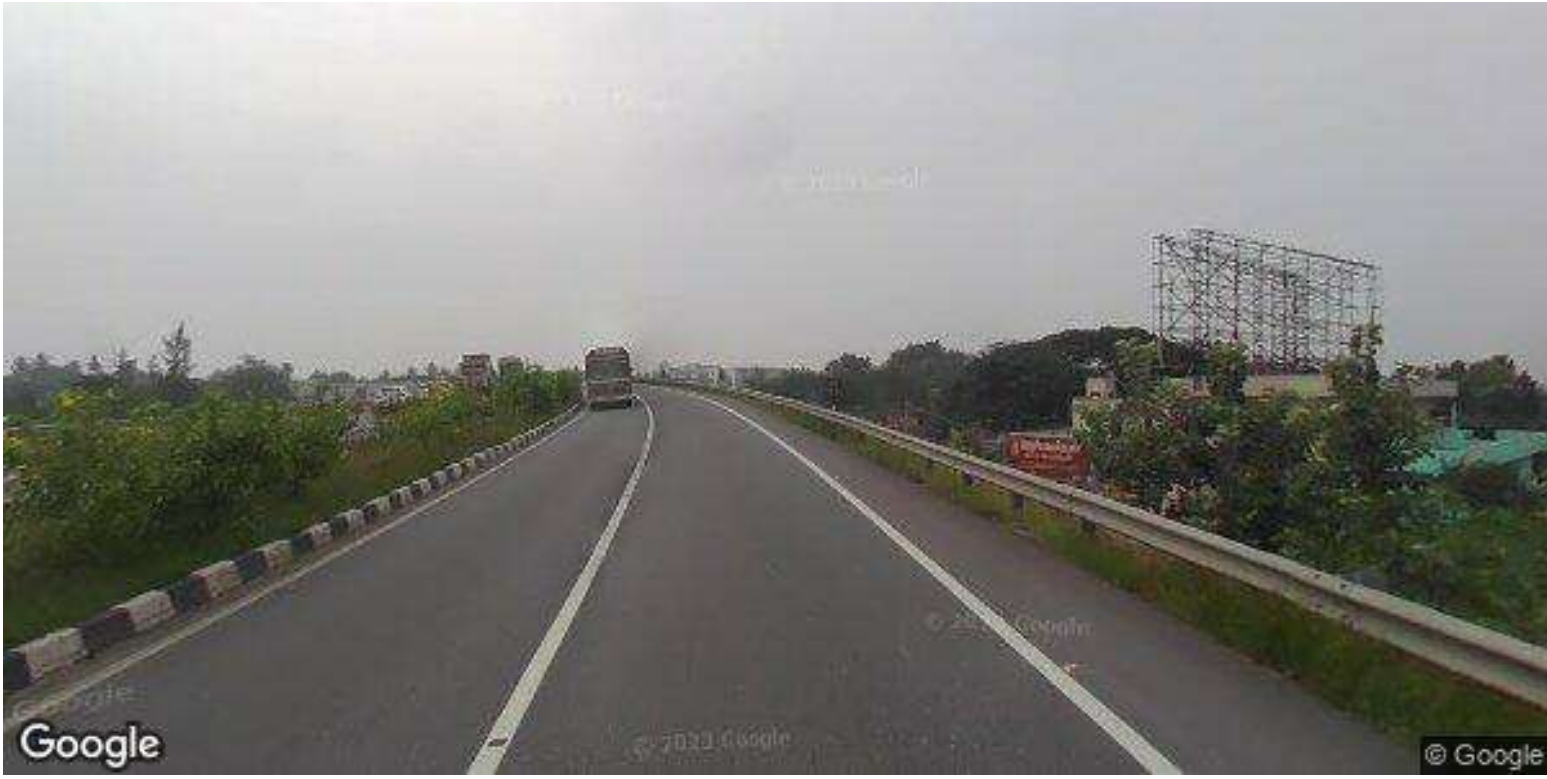
**Risk Type:** Turn  
**Risk Level:** Medium  
**Speed Limit:** 30 KM/Hr  
**Coordinates:** 12.24731, 78.19601

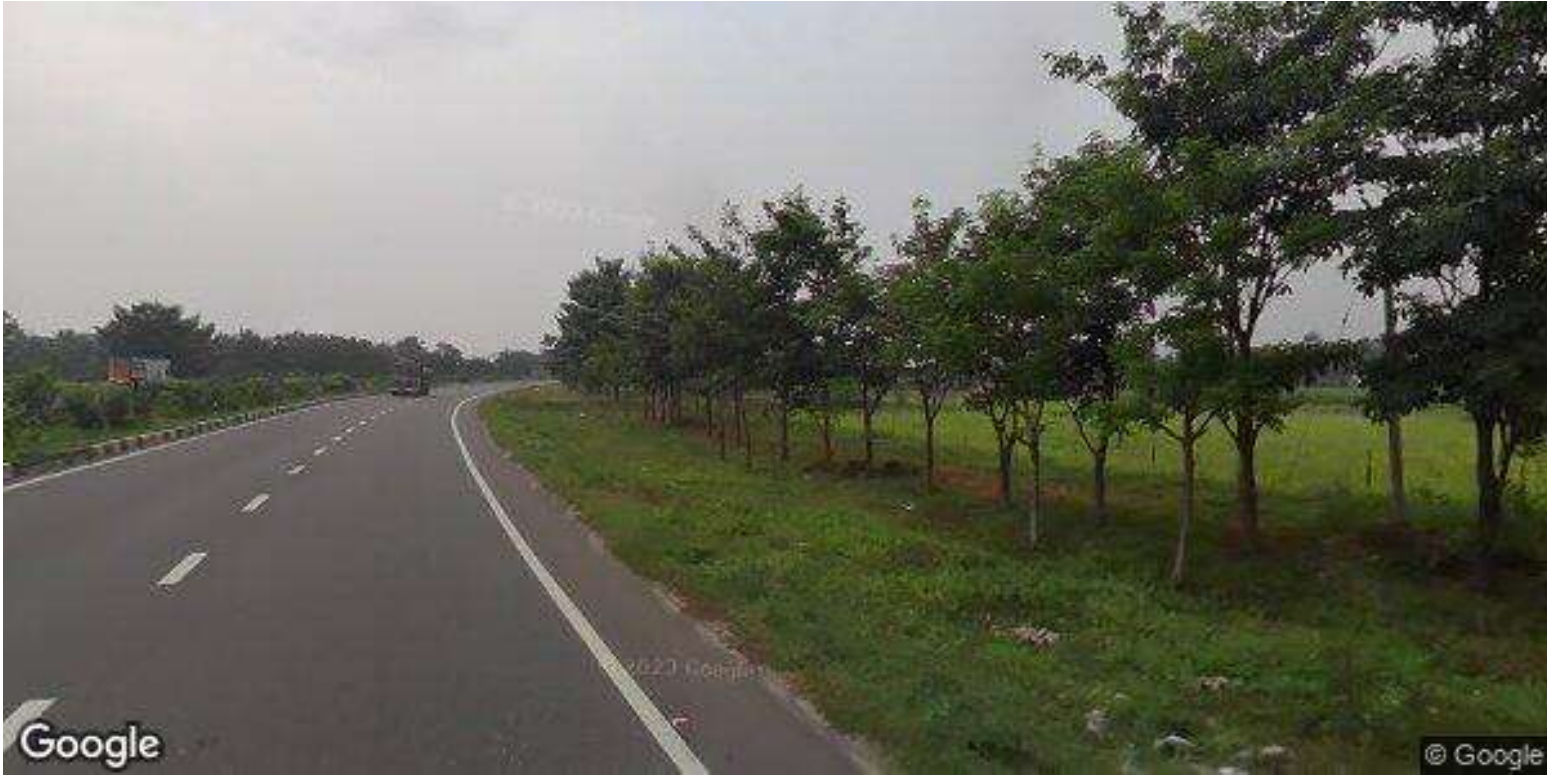
**Risk Type:** Turn  
**Risk Level:** Medium  
**Speed Limit:** 30 KM/Hr  
**Coordinates:** 12.25060, 78.19977

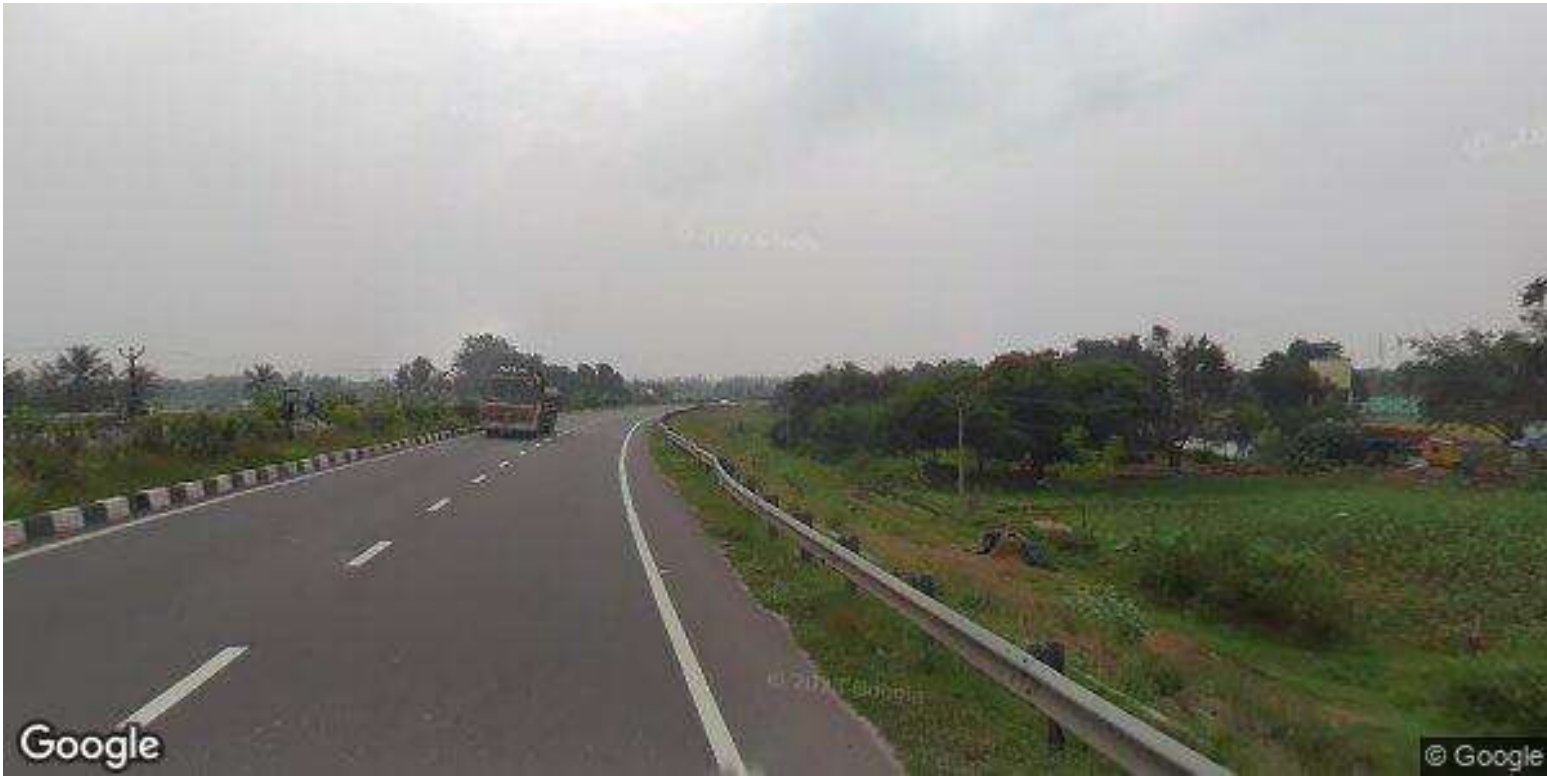
**Risk Type:** Turn  
**Risk Level:** Medium  
**Speed Limit:** 30 KM/Hr  
**Coordinates:** 12.25329, 78.20039

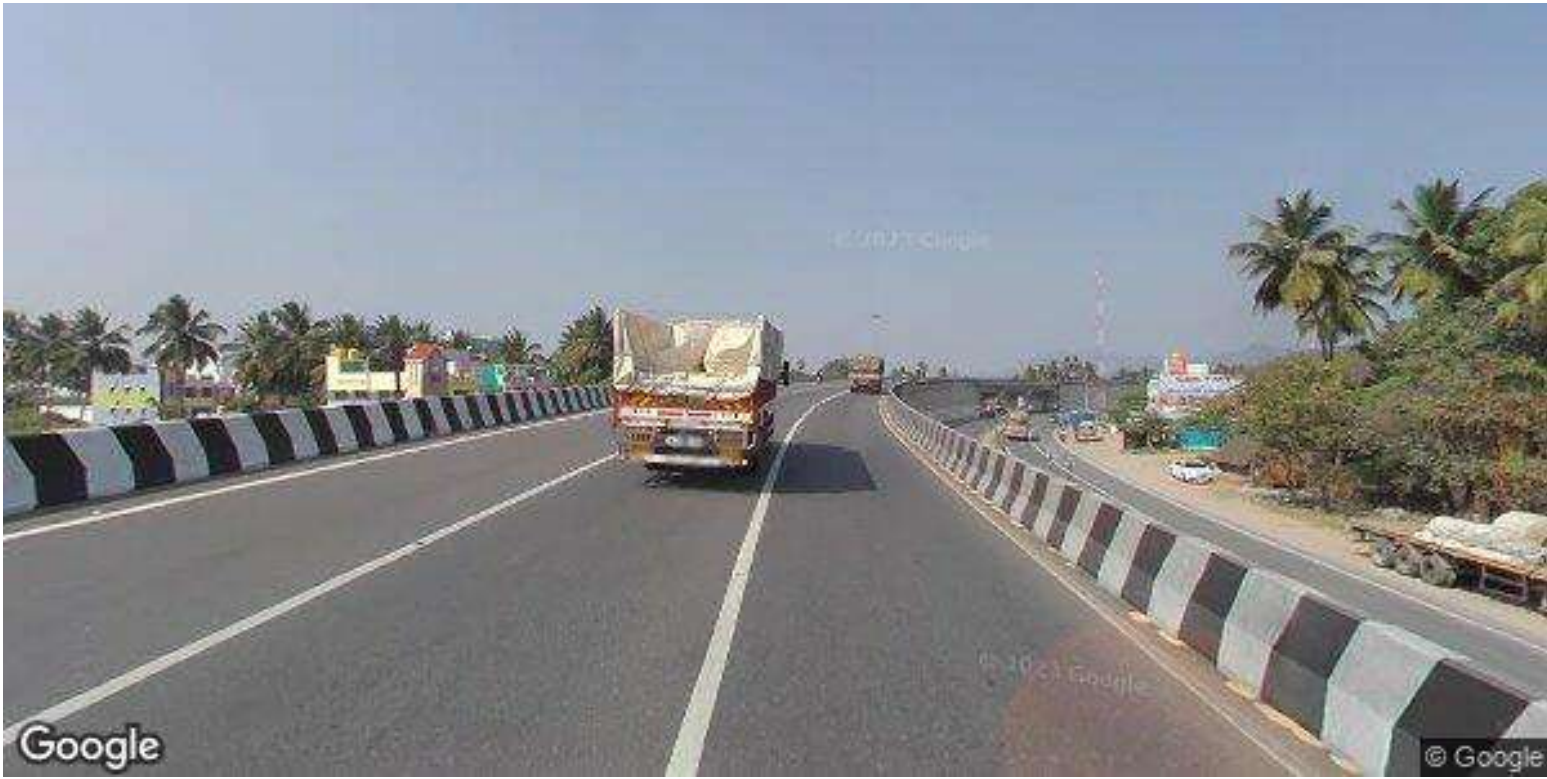
**Risk Type:** Turn  
**Risk Level:** Medium  
**Speed Limit:** 30 KM/Hr  
**Coordinates:** 12.39904, 78.21764

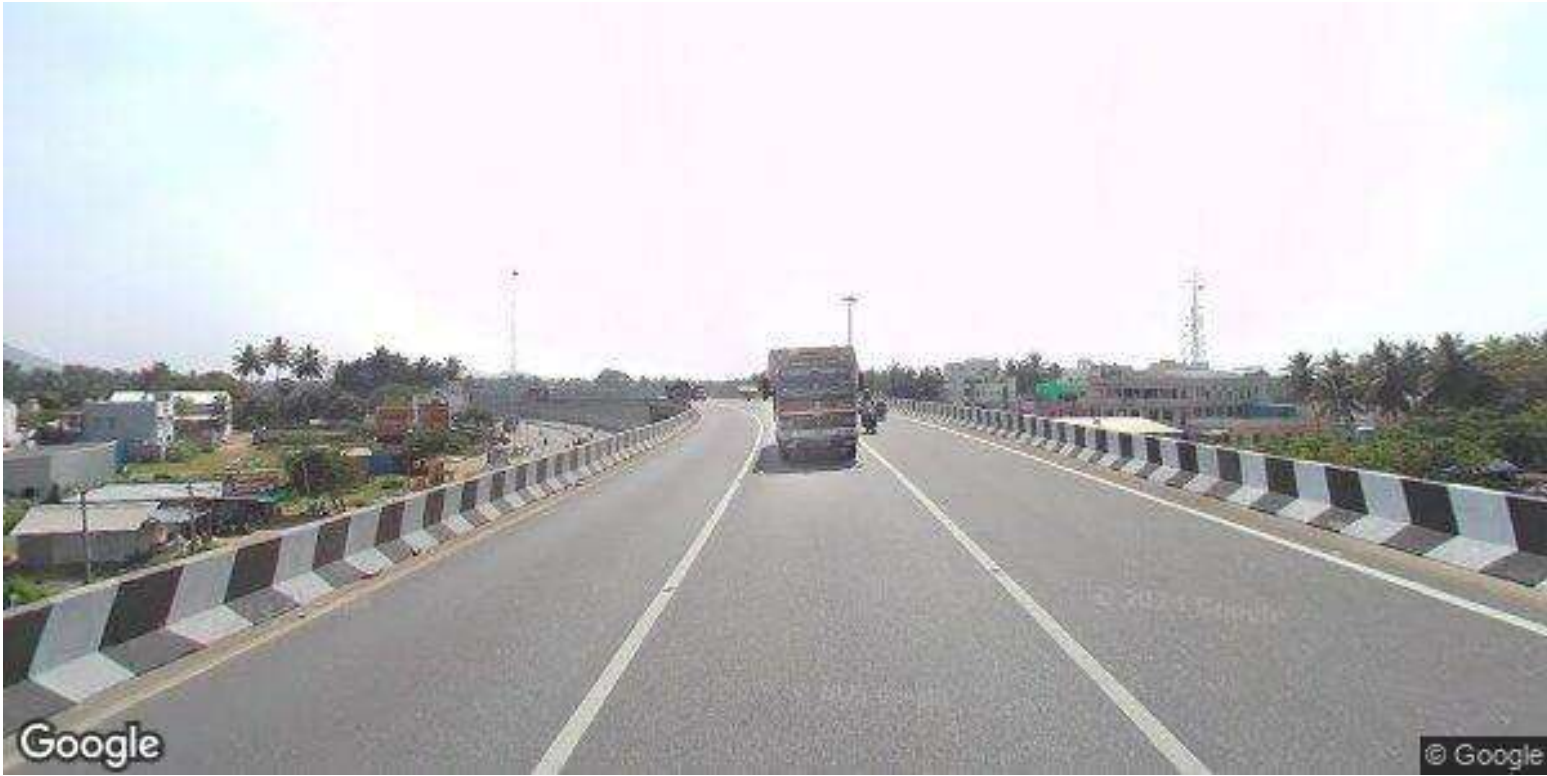
**Risk Type:** Turn  
**Risk Level:** Medium  
**Speed Limit:** 30 KM/Hr  
**Coordinates:** 12.40156, 78.21845

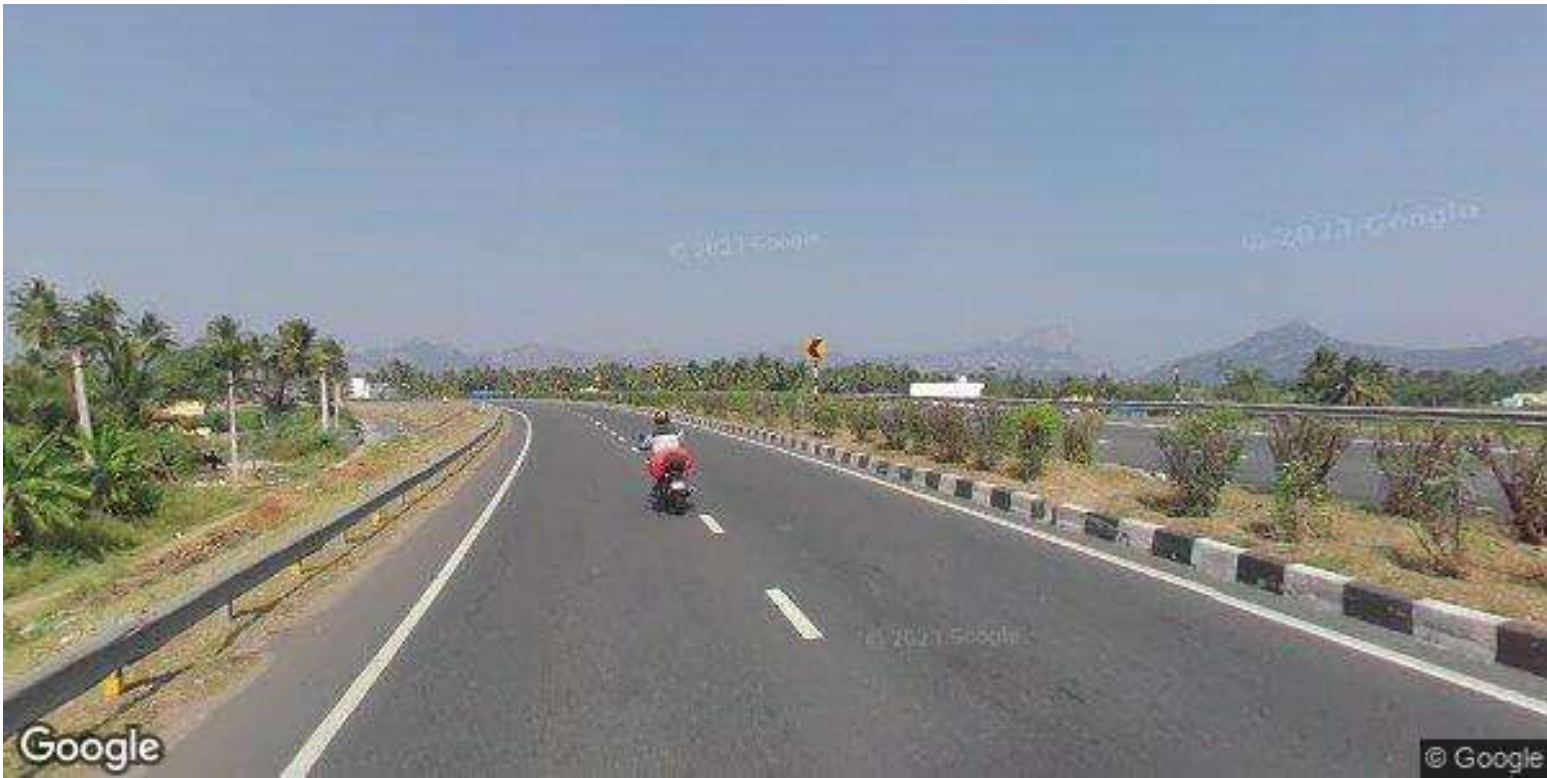
**Risk Type:** Turn  
**Risk Level:** Medium  
**Speed Limit:** 30 KM/Hr  
**Coordinates:** 12.40589, 78.22275

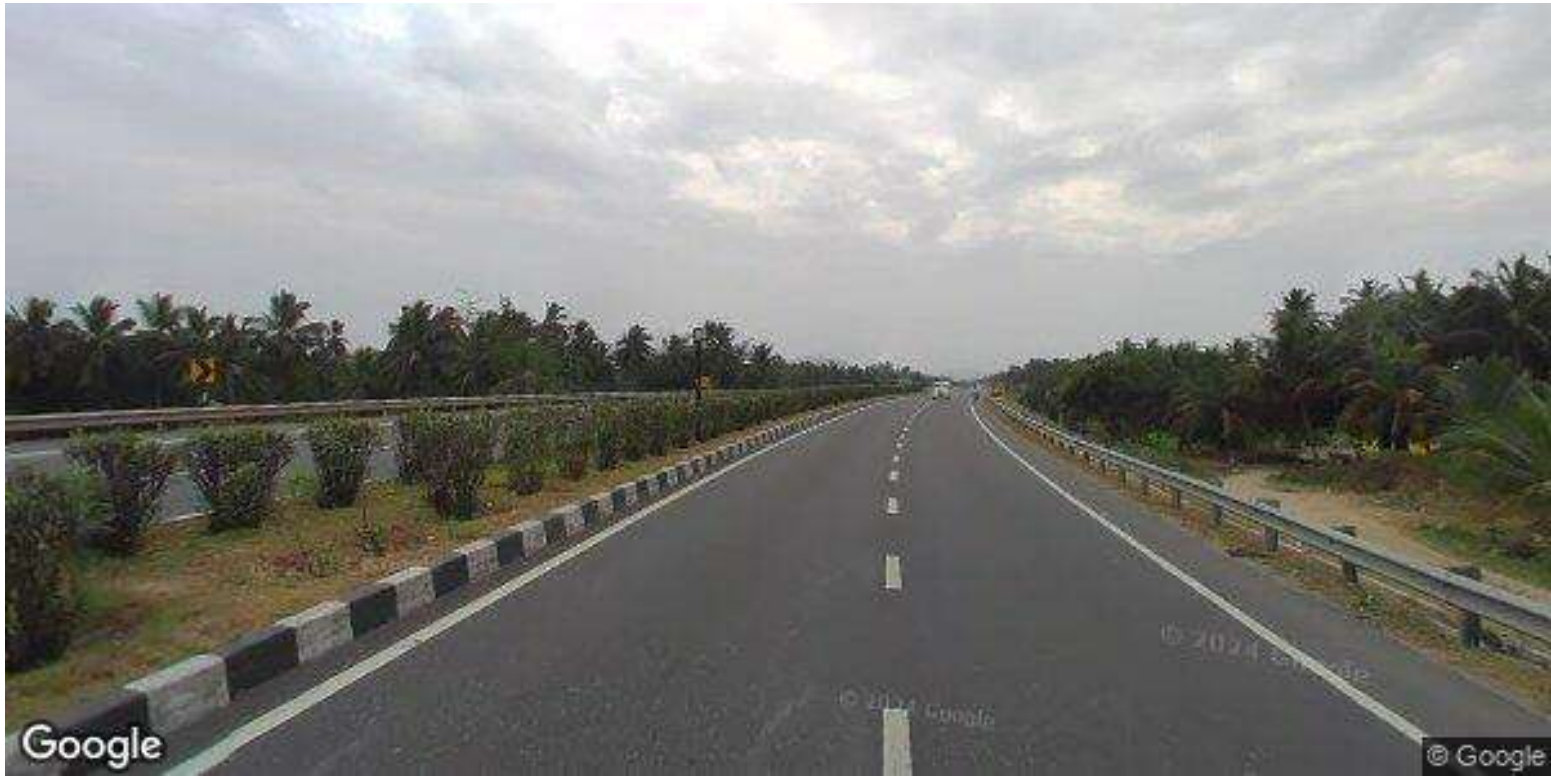
**Risk Type:** Turn  
**Risk Level:** Medium  
**Speed Limit:** 30 KM/Hr  
**Coordinates:** 12.42428, 78.22671

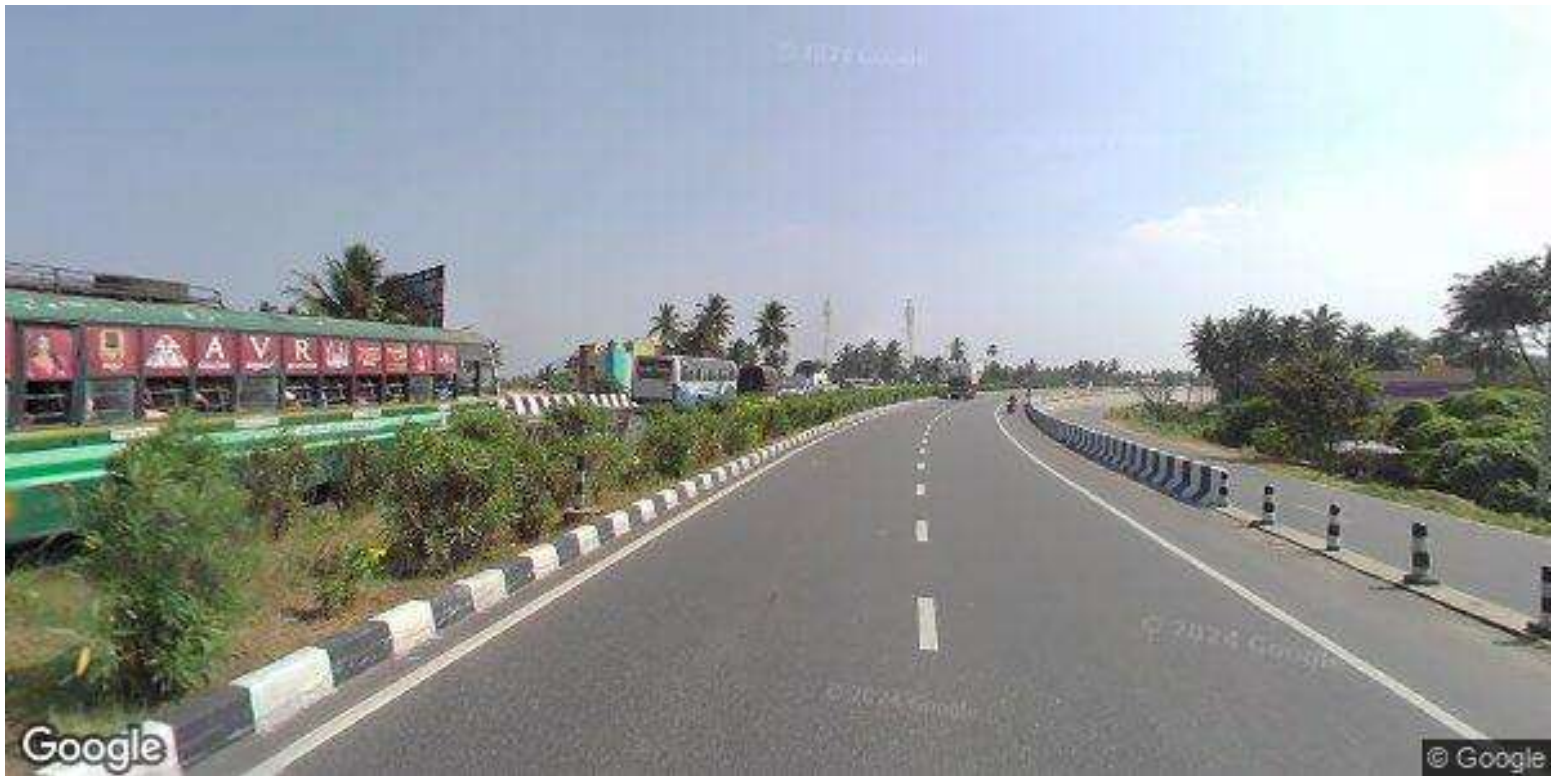
**Risk Type:** Turn  
**Risk Level:** Medium  
**Speed Limit:** 30 KM/Hr  
**Coordinates:** 12.45154, 78.21792

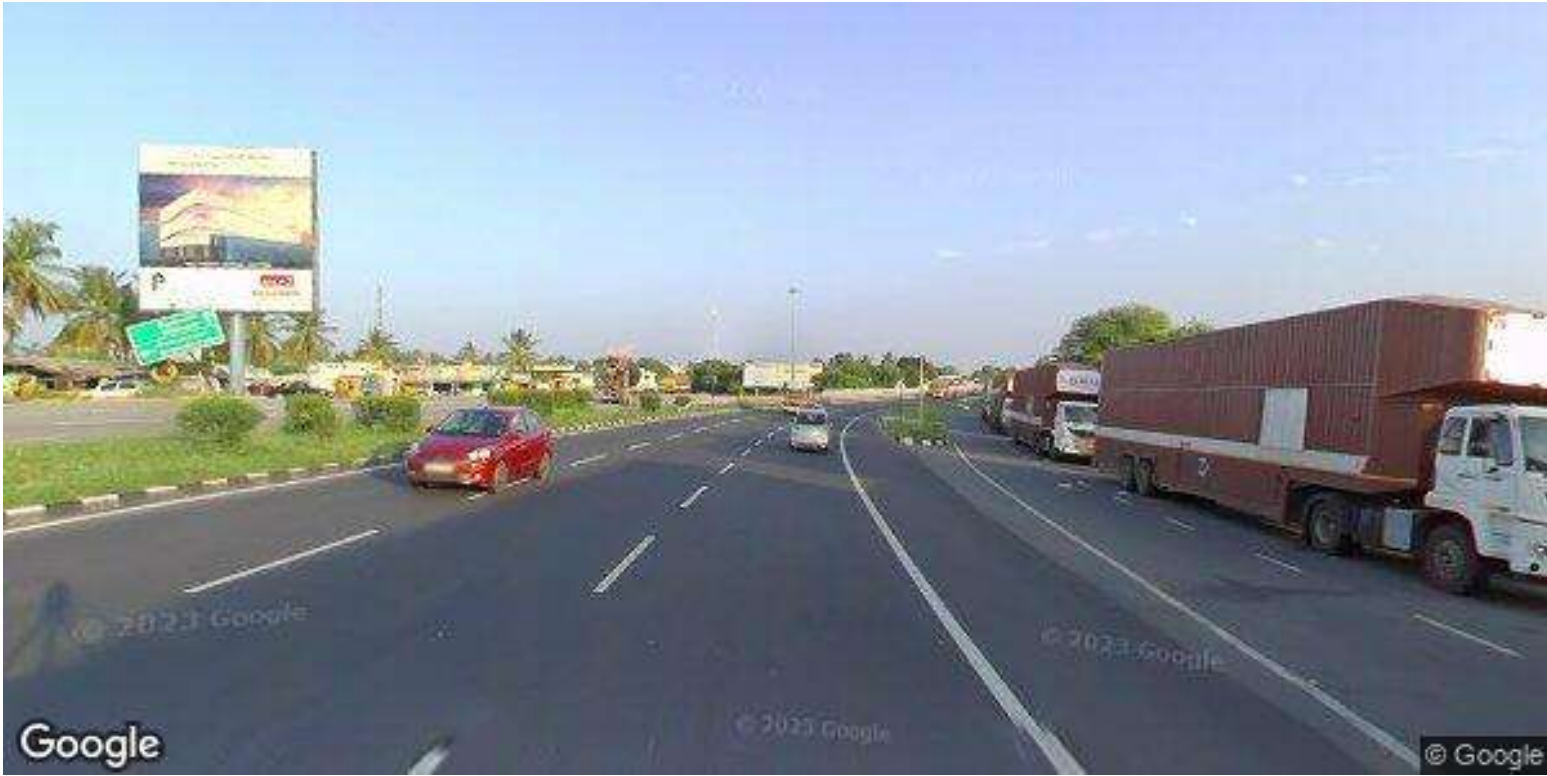
**Risk Type:** Turn  
**Risk Level:** Medium  
**Speed Limit:** 30 KM/Hr  
**Coordinates:** 12.59749, 78.13593

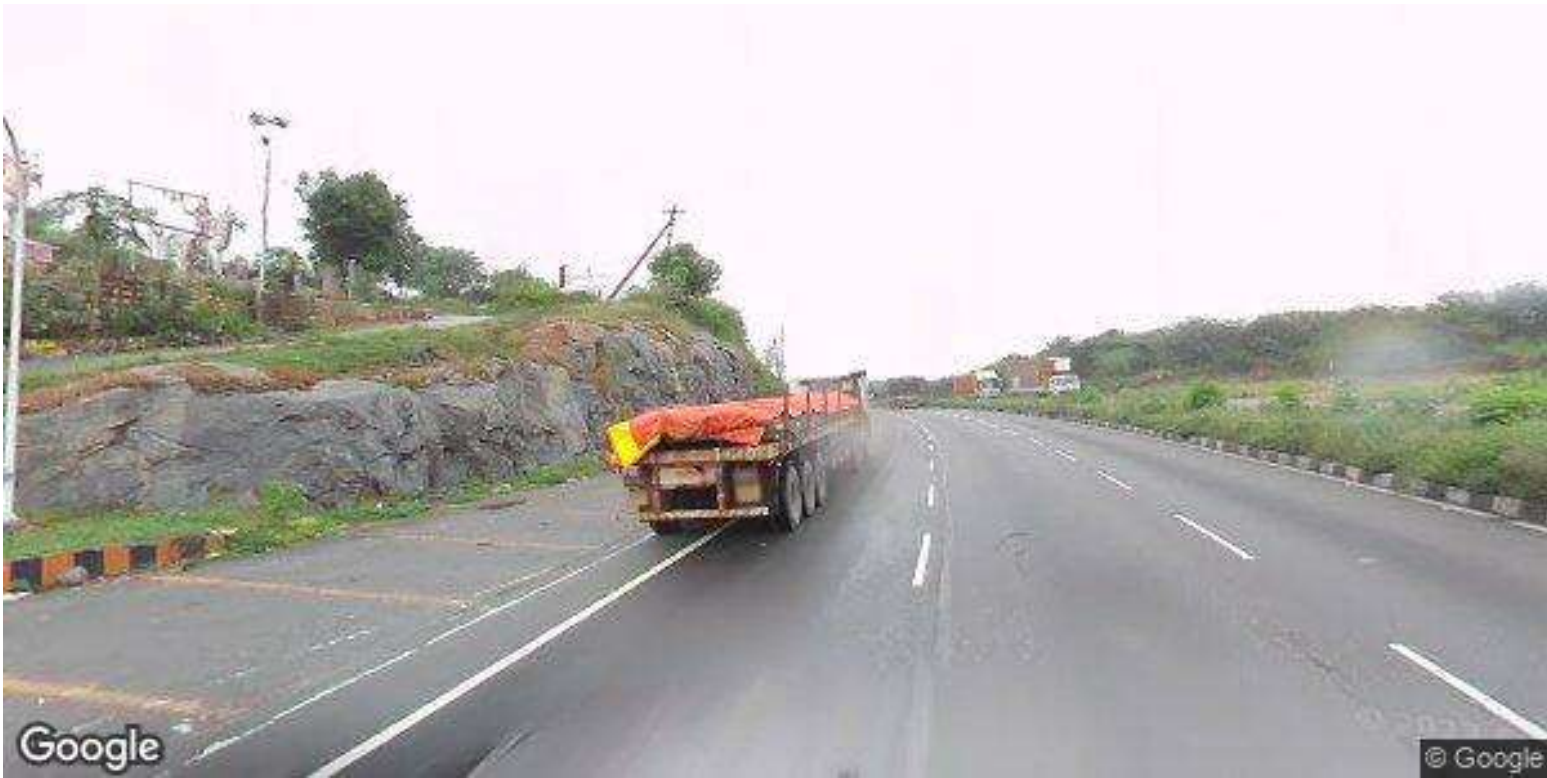
**Risk Type:** Turn  
**Risk Level:** Medium  
**Speed Limit:** 30 KM/Hr  
**Coordinates:** 12.63696, 78.07061

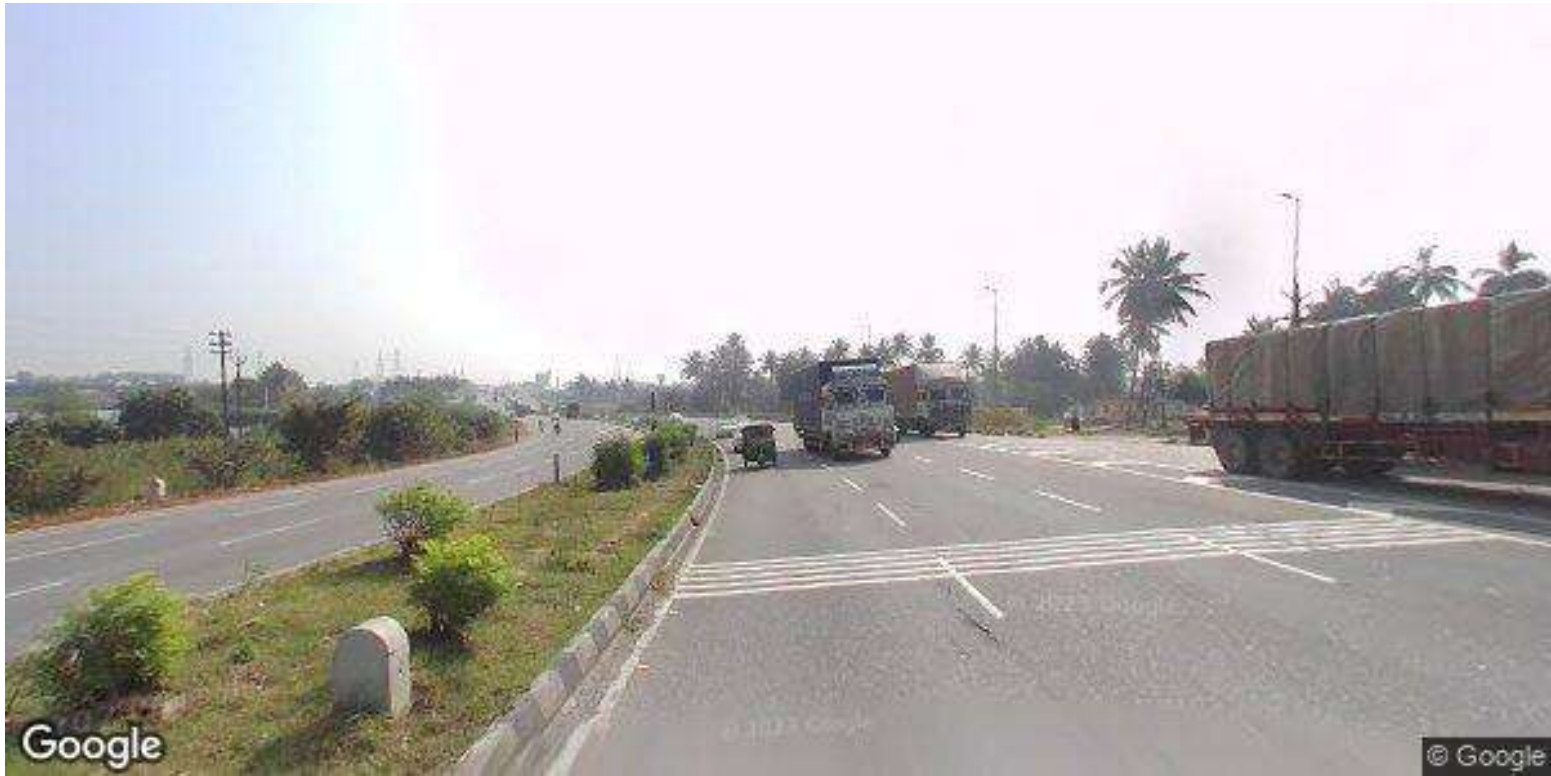
**Risk Type:** Turn  
**Risk Level:** Medium  
**Speed Limit:** 30 KM/Hr  
**Coordinates:** 12.67143, 77.97400

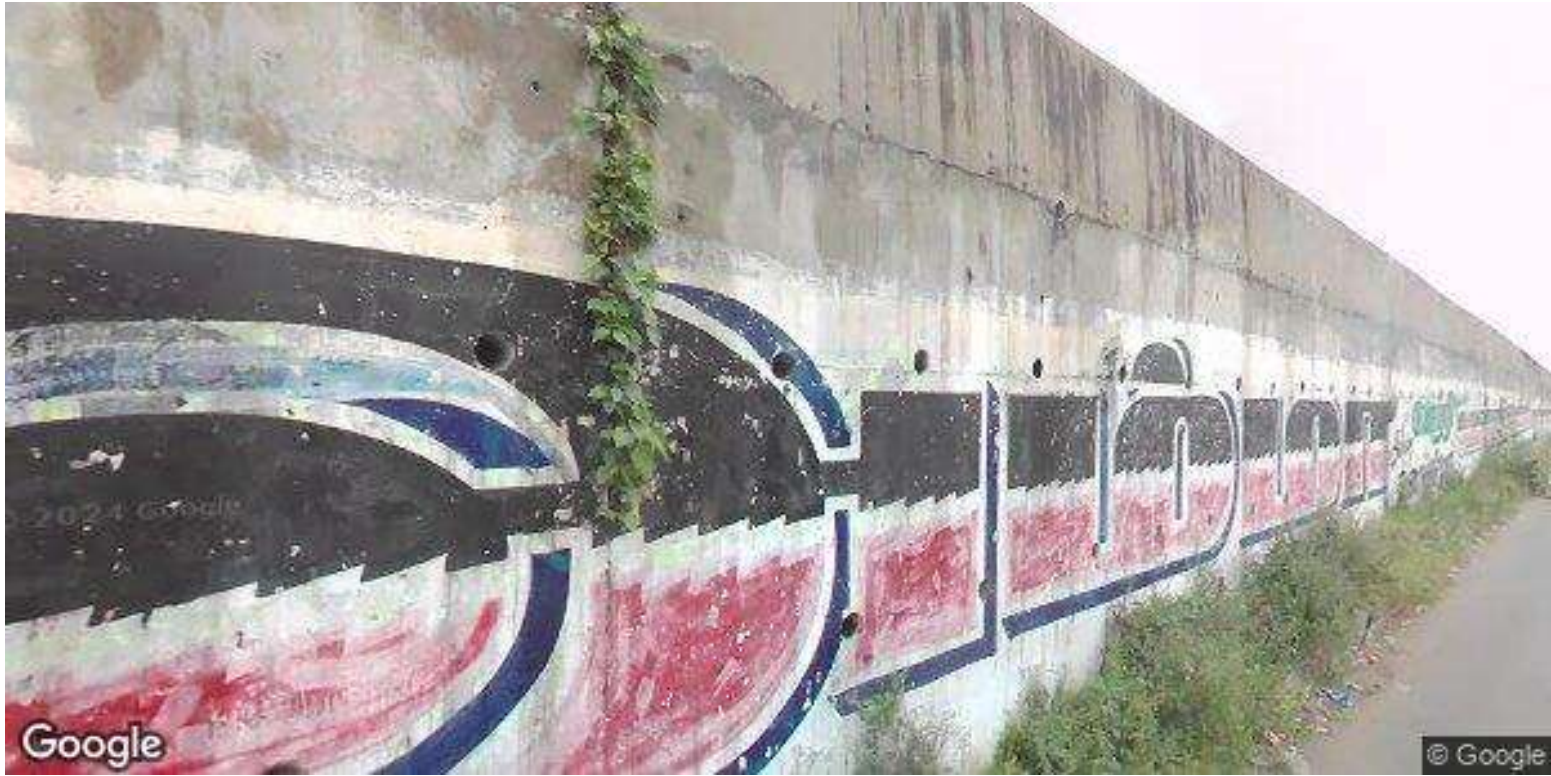
**Risk Type:** Blind Spot  
**Risk Level:** Blind Spot  
**Speed Limit:** 10 KM/Hr  
**Coordinates:** 12.68367, 77.93734

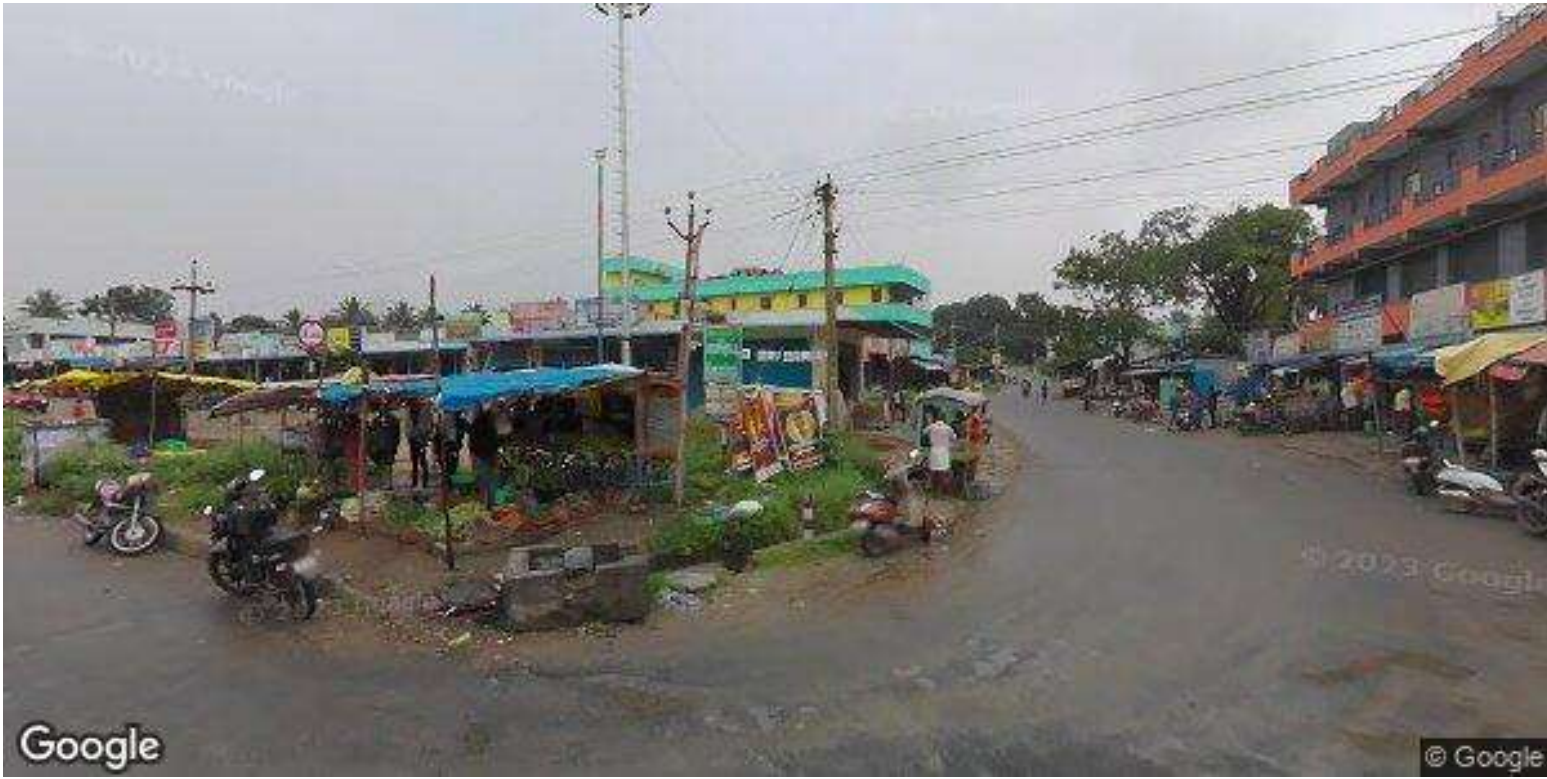
**Risk Type:** Turn

**Risk Level:** High

**Speed Limit:** 15 KM/Hr

**Coordinates:** 12.68387, 77.93773
