## **JOURNEY RISK MANAGEMENT (JRM) STUDY**

### **Salem Terminal to SRI VANGALAMMAN FUEL AGENCIES**

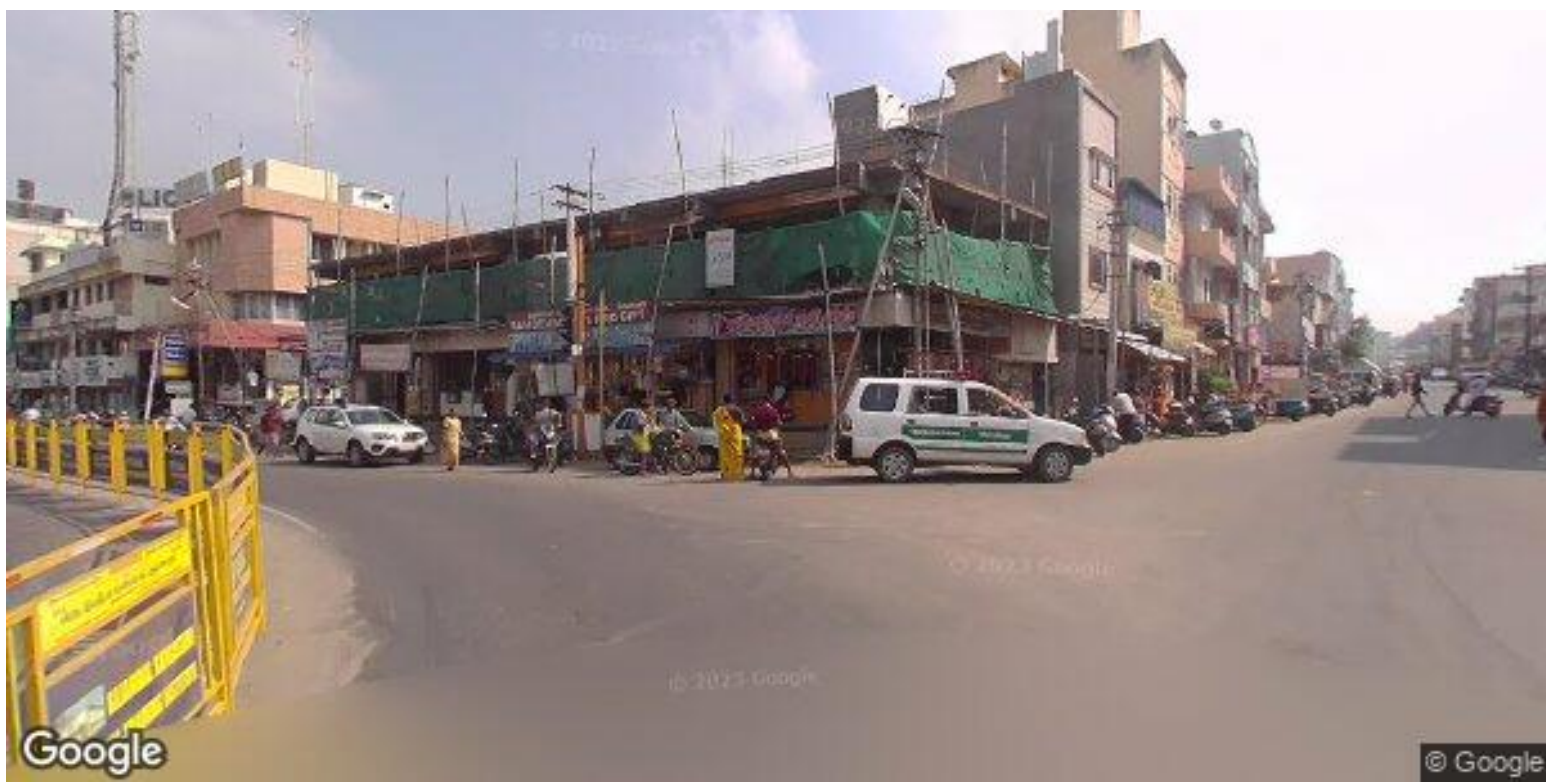
**Coordinates:** 11.37868, 77.89498

**Risk Type:** Turn

**Risk Level:** High

**Speed Limit:** 15 KM/Hr

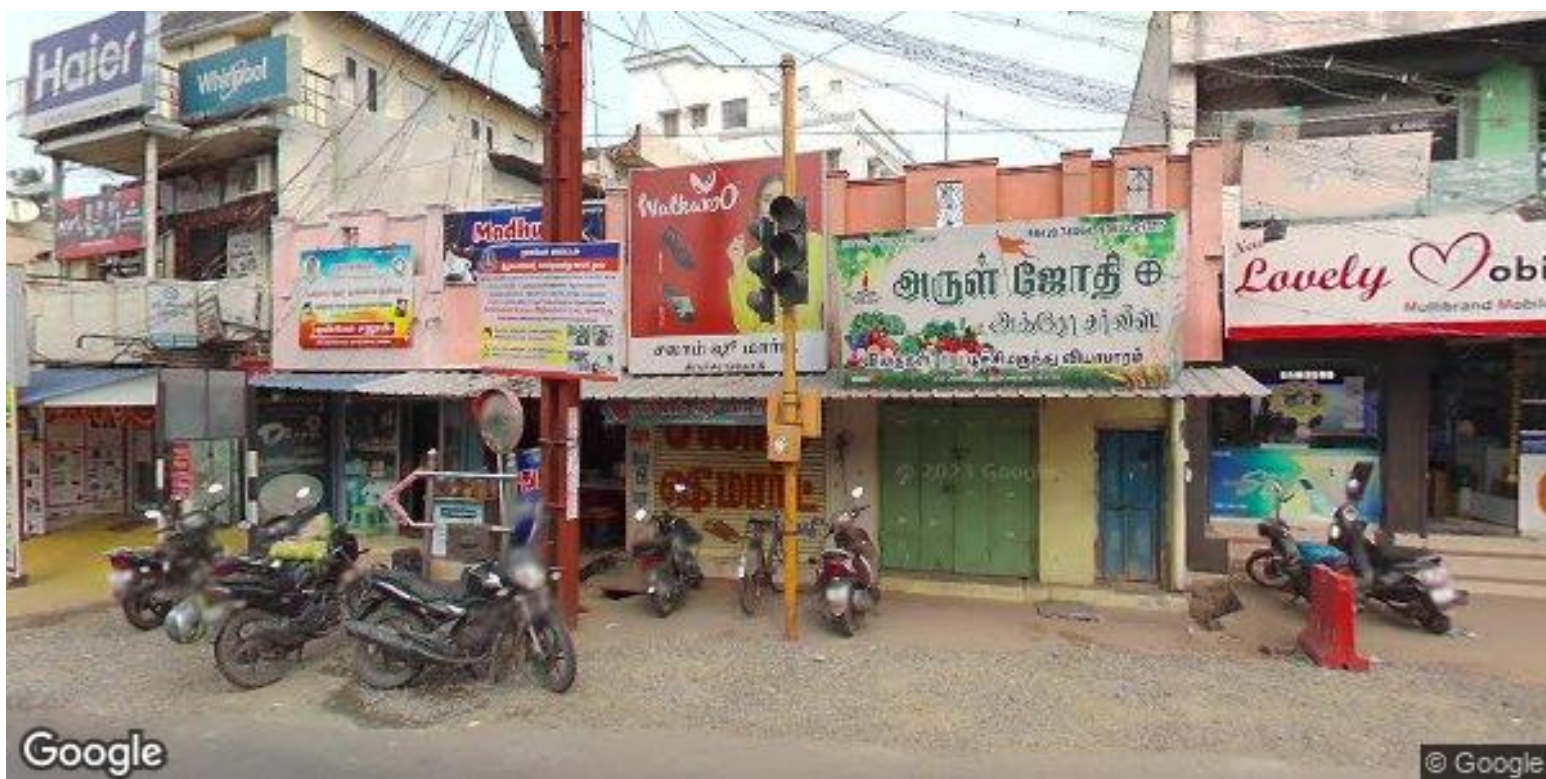
**Coordinates:** 11.37850, 77.89453

**Risk Type:** Turn

**Risk Level:** High

**Speed Limit:** 15 KM/Hr

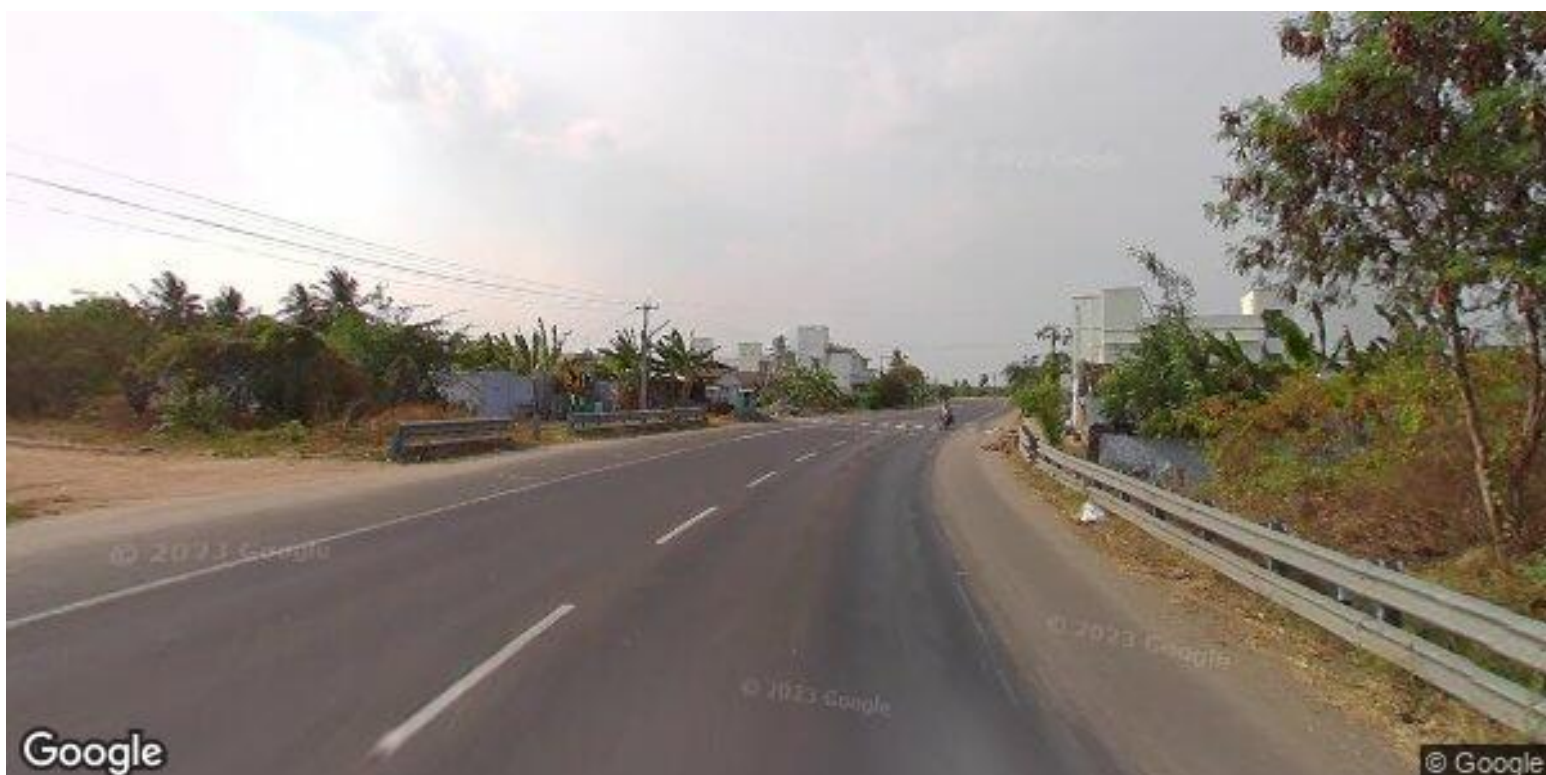
**Coordinates:** 11.16764, 78.01565

**Risk Type:** Turn

**Risk Level:** Medium

**Speed Limit:** 30 KM/Hr

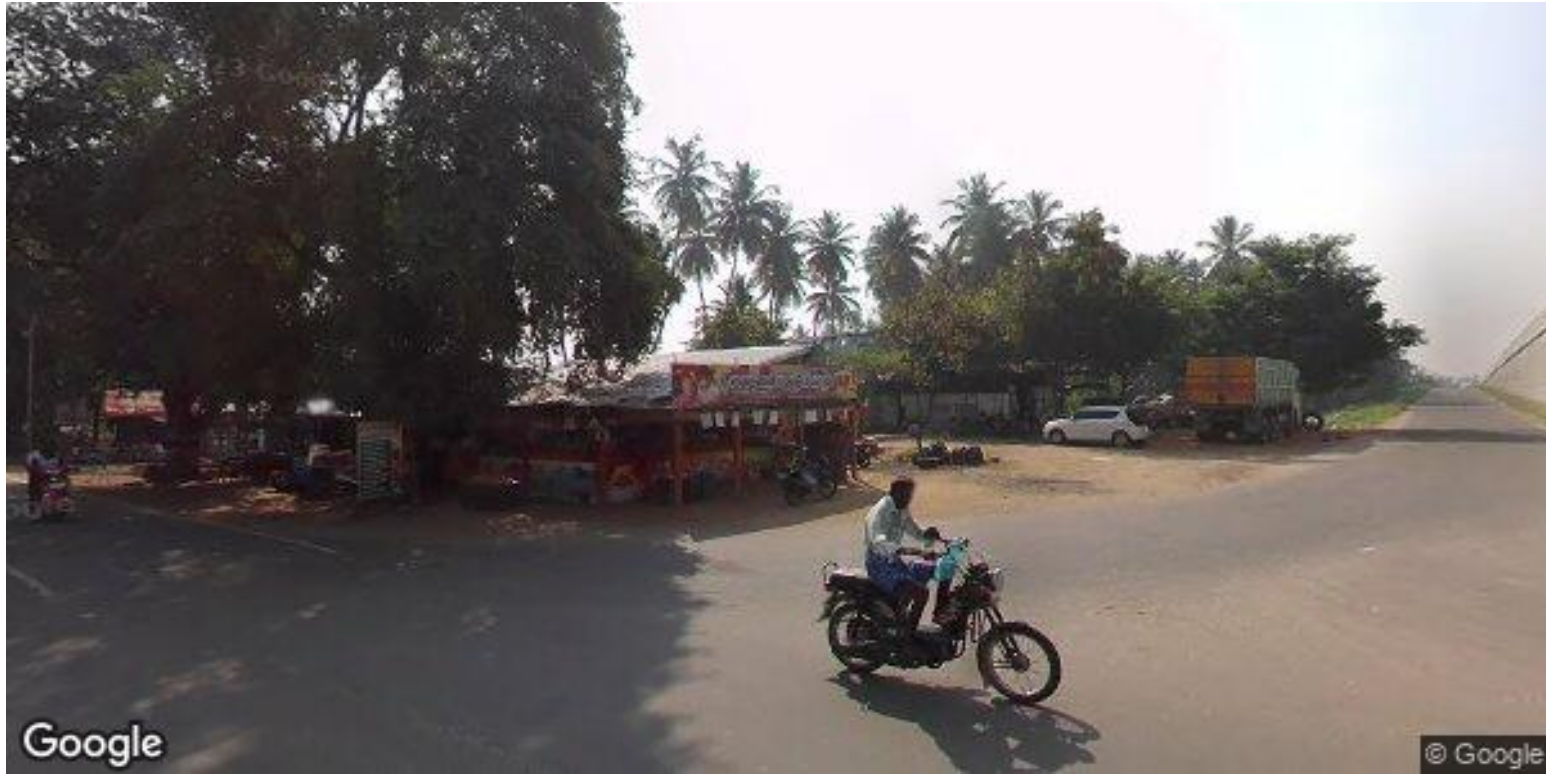
**Risk Type:** Blind Spot  
**Risk Level:** Blind Spot  
**Speed Limit:** 10 KM/Hr  
**Coordinates:** 11.11397, 78.01722

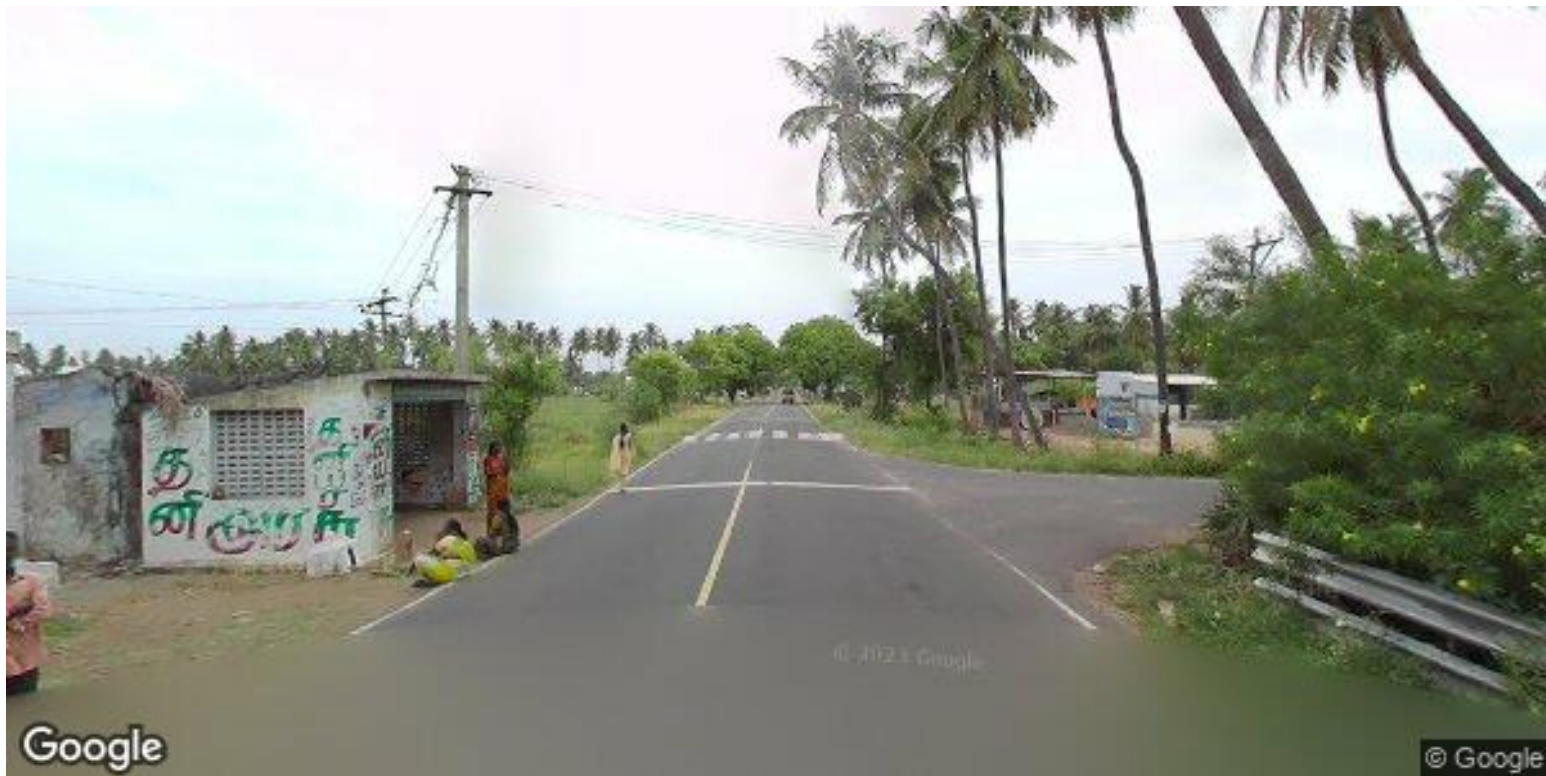
**Risk Type:** Turn  
**Risk Level:** Medium  
**Speed Limit:** 30 KM/Hr  
**Coordinates:** 11.10418, 78.04796
