# IndianOil

## JOURNEY RISK MANAGEMENT (JRM) STUDY

### Salem Terminal to A1 SUBRAMANIAN AGENCY

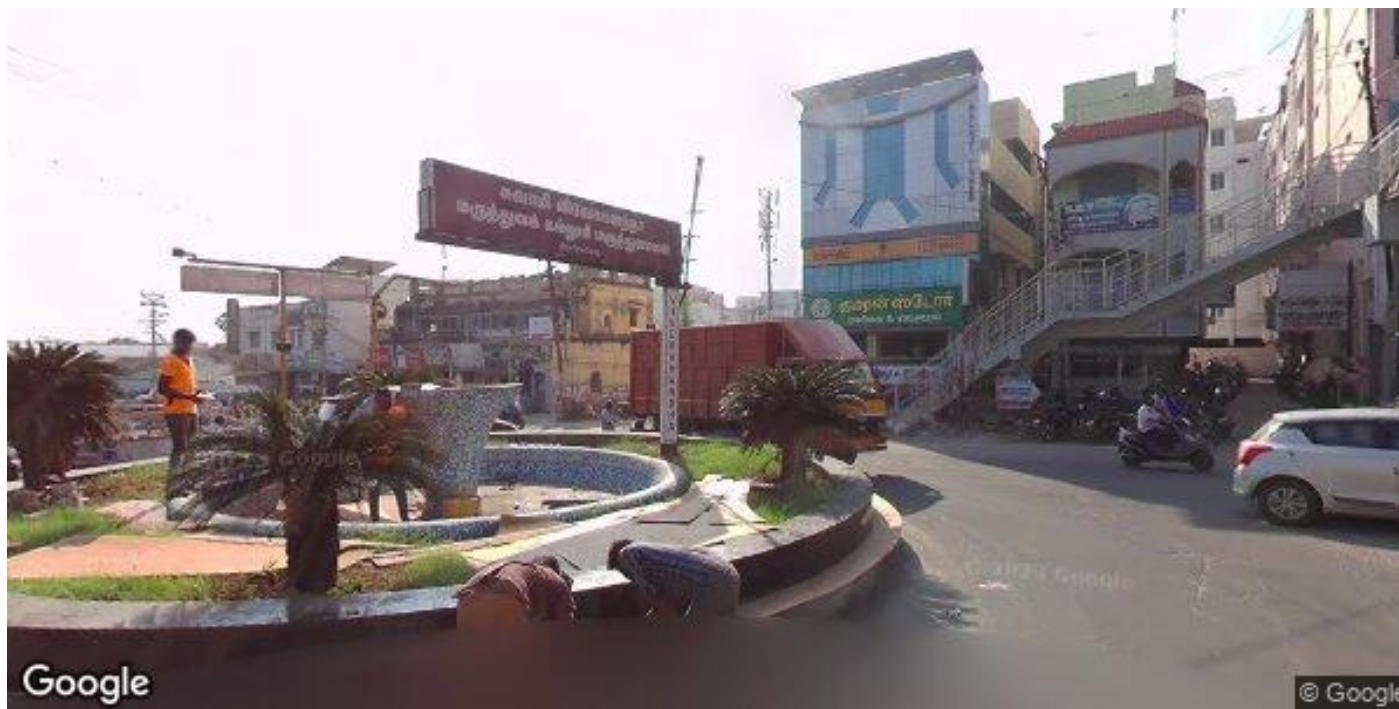
**Risk Type:** Roundabout  
**Risk Level:** High  
**Speed Limit:** 15 KM/Hr  
**Coordinates:** 11.38395, 77.89480

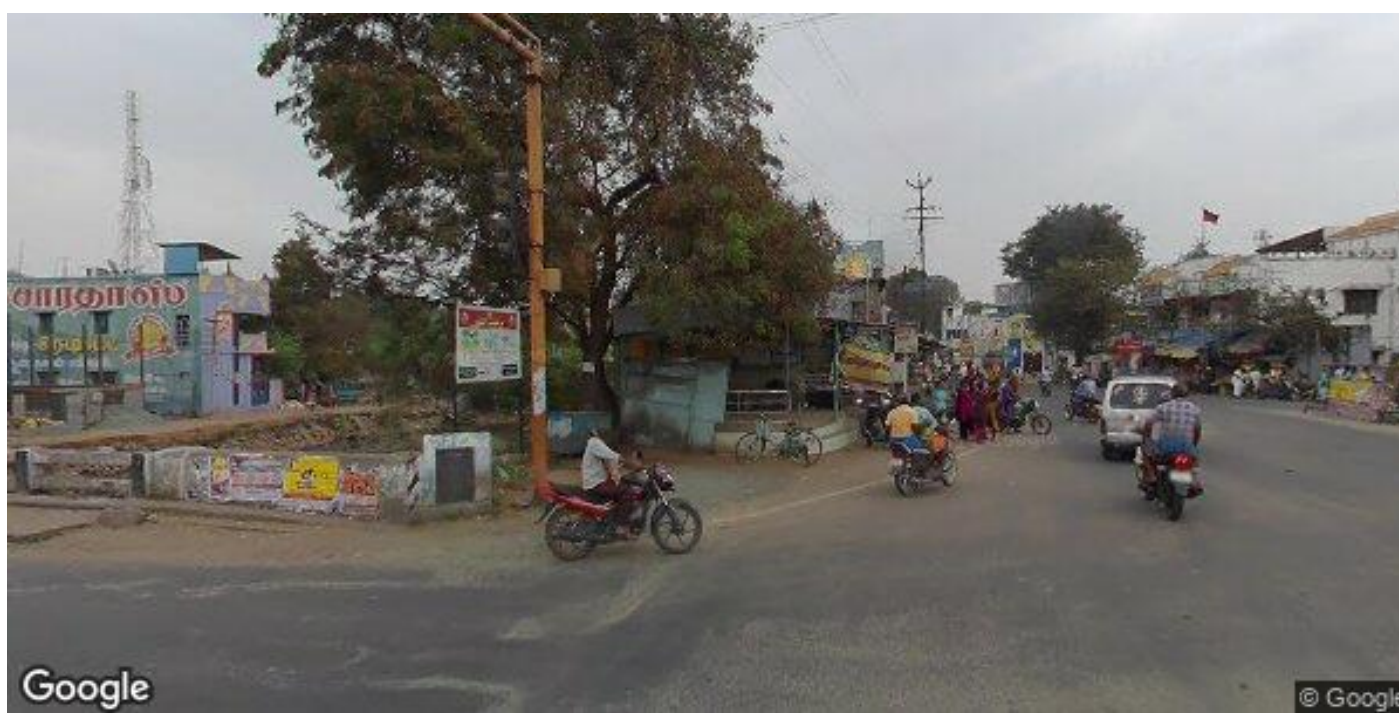
**Risk Type:** Roundabout  
**Risk Level:** High  
**Speed Limit:** 15 KM/Hr  
**Coordinates:** 10.94342, 78.41370

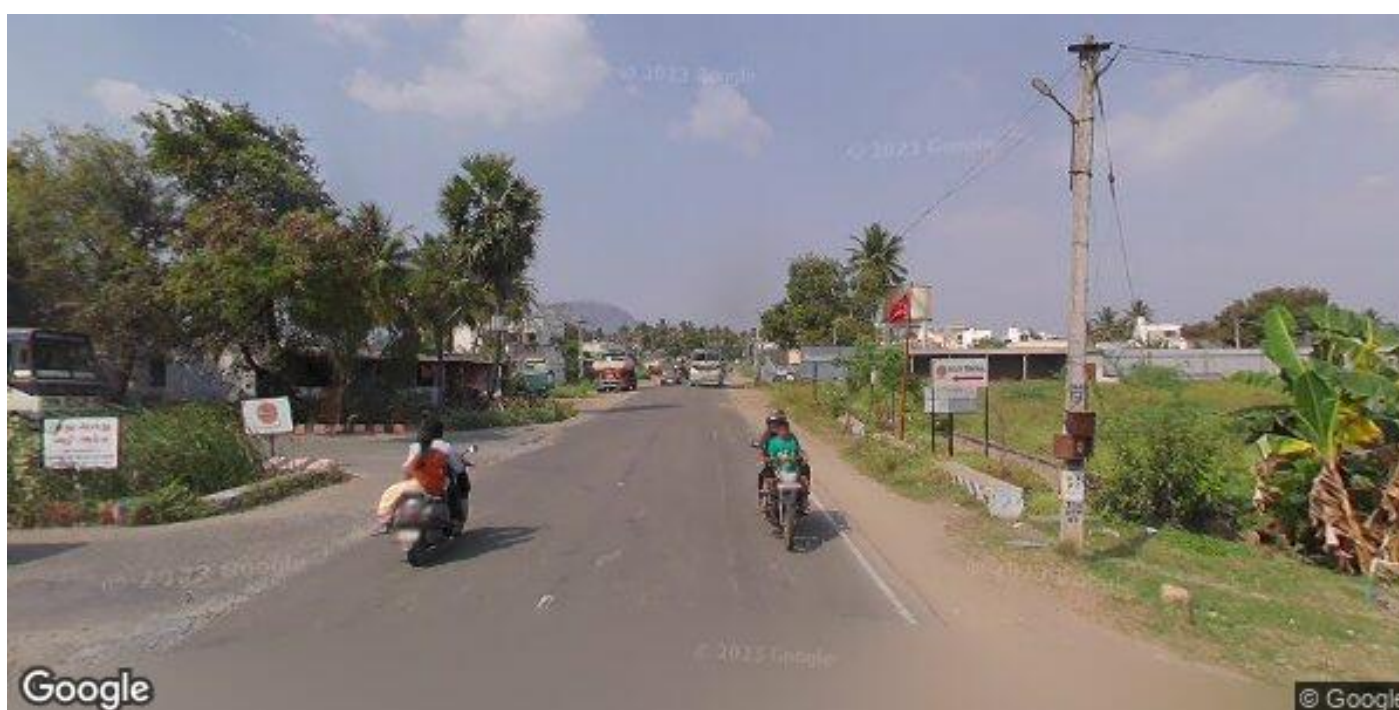
**Risk Type:** Turn  
**Risk Level:** High  
**Speed Limit:** 15 KM/Hr  
**Coordinates:** 11.44019, 77.87547

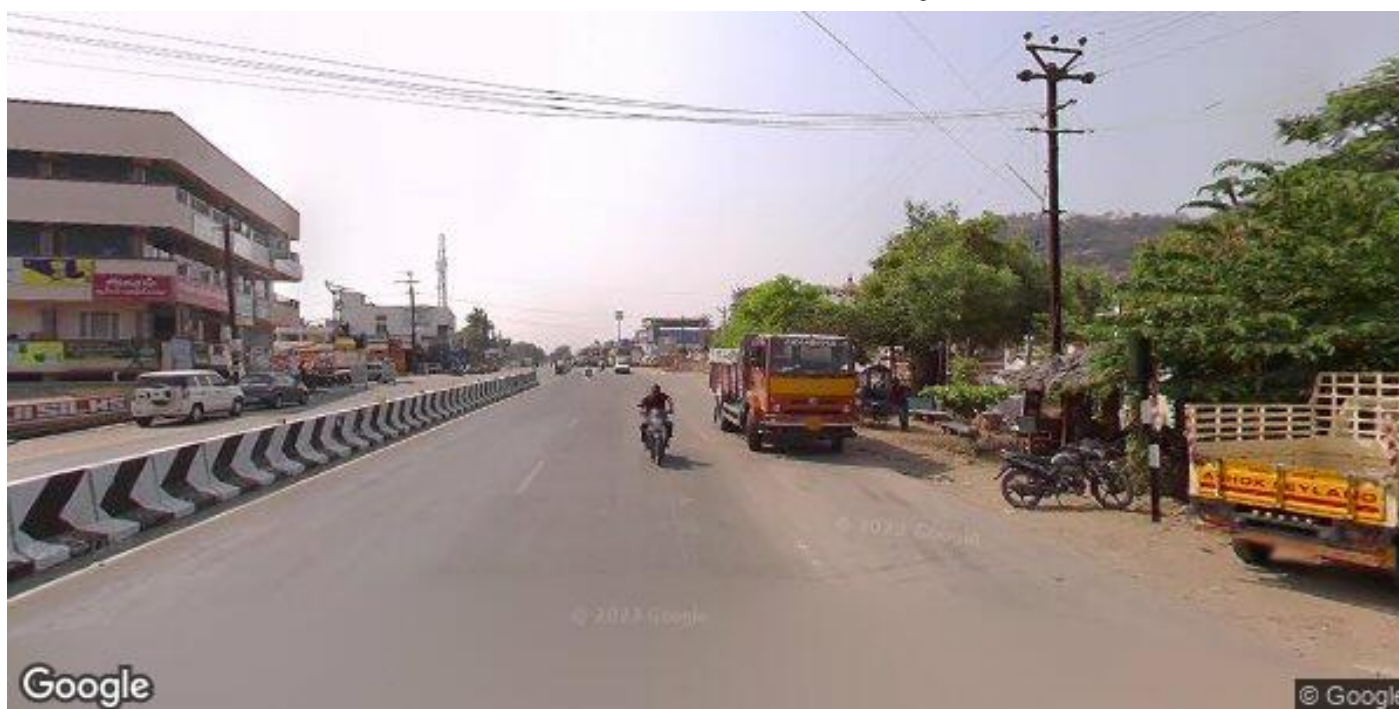
**Risk Type:** Turn  
**Risk Level:** Medium  
**Speed Limit:** 30 KM/Hr  
**Coordinates:** 11.39685, 77.88861

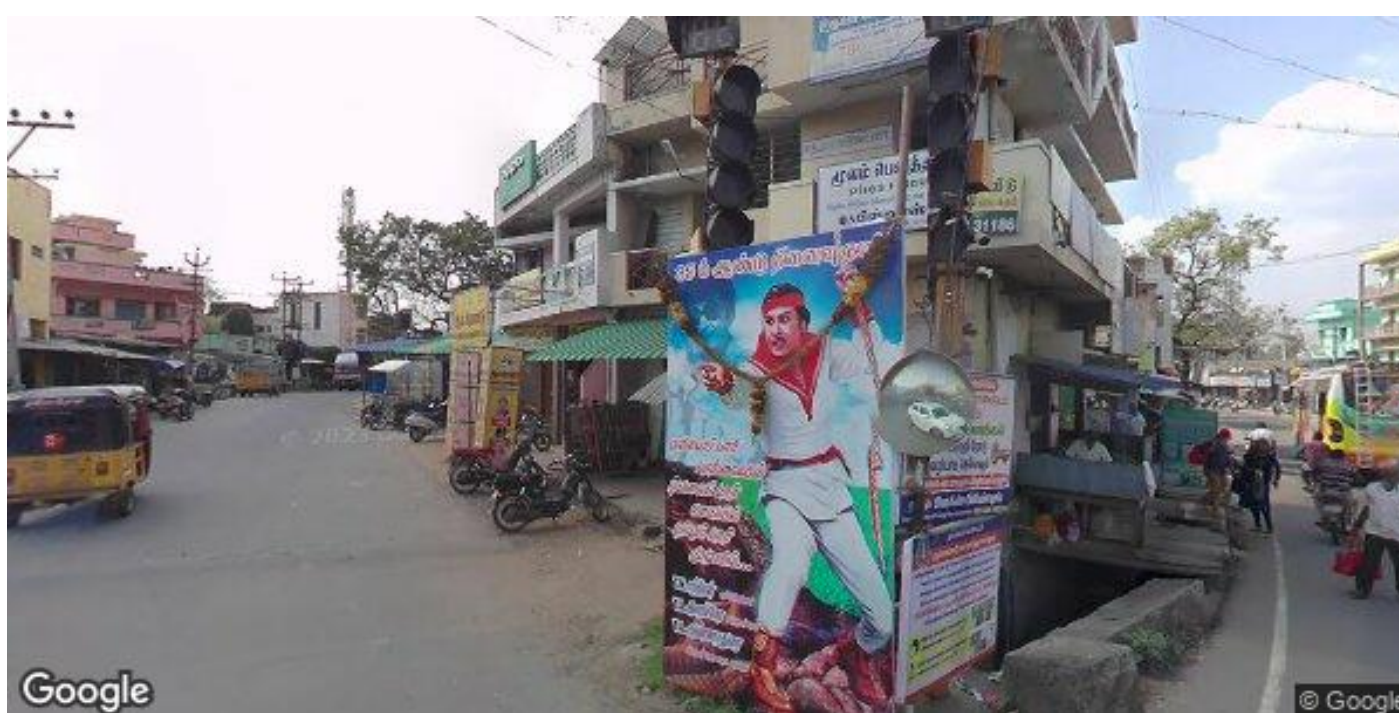
**Risk Type:** Turn  
**Risk Level:** Medium  
**Speed Limit:** 30 KM/Hr  
**Coordinates:** 11.38342, 77.89975

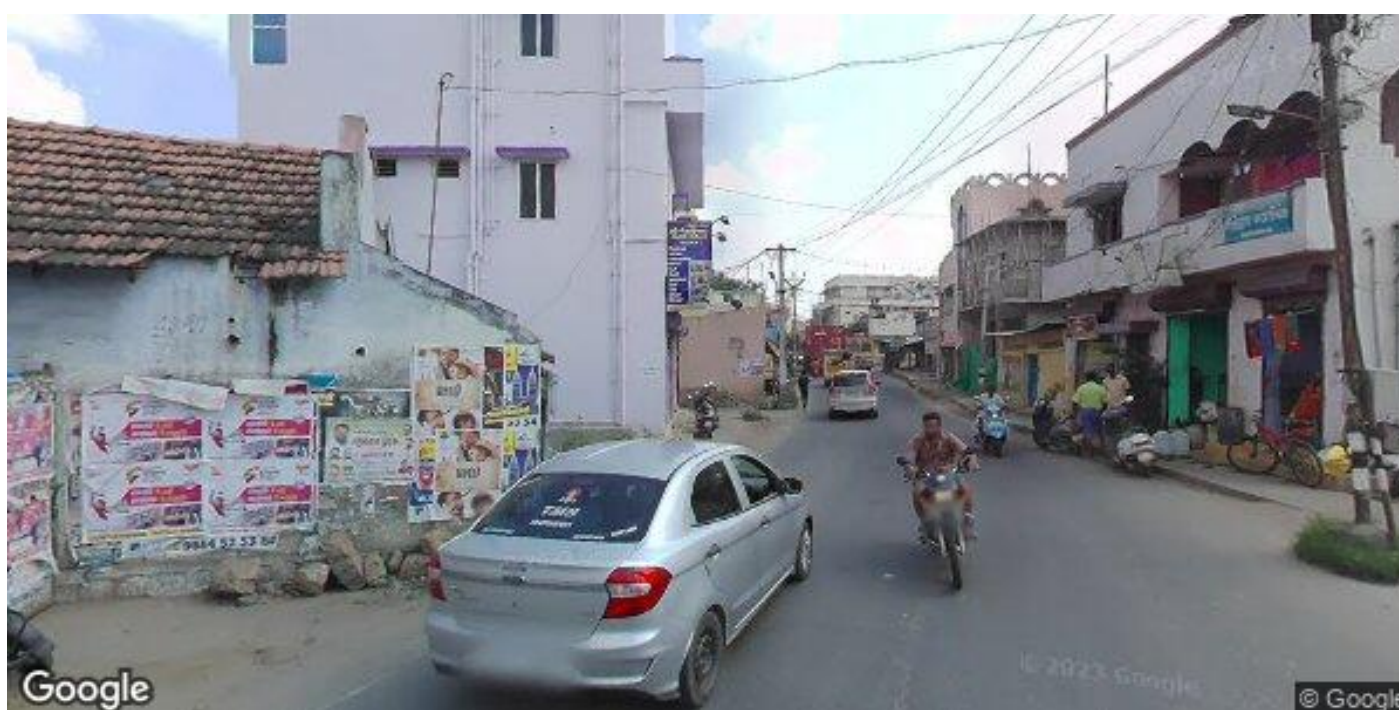
**Risk Type:** Turn  
**Risk Level:** Medium  
**Speed Limit:** 30 KM/Hr  
**Coordinates:** 11.38295, 77.90001

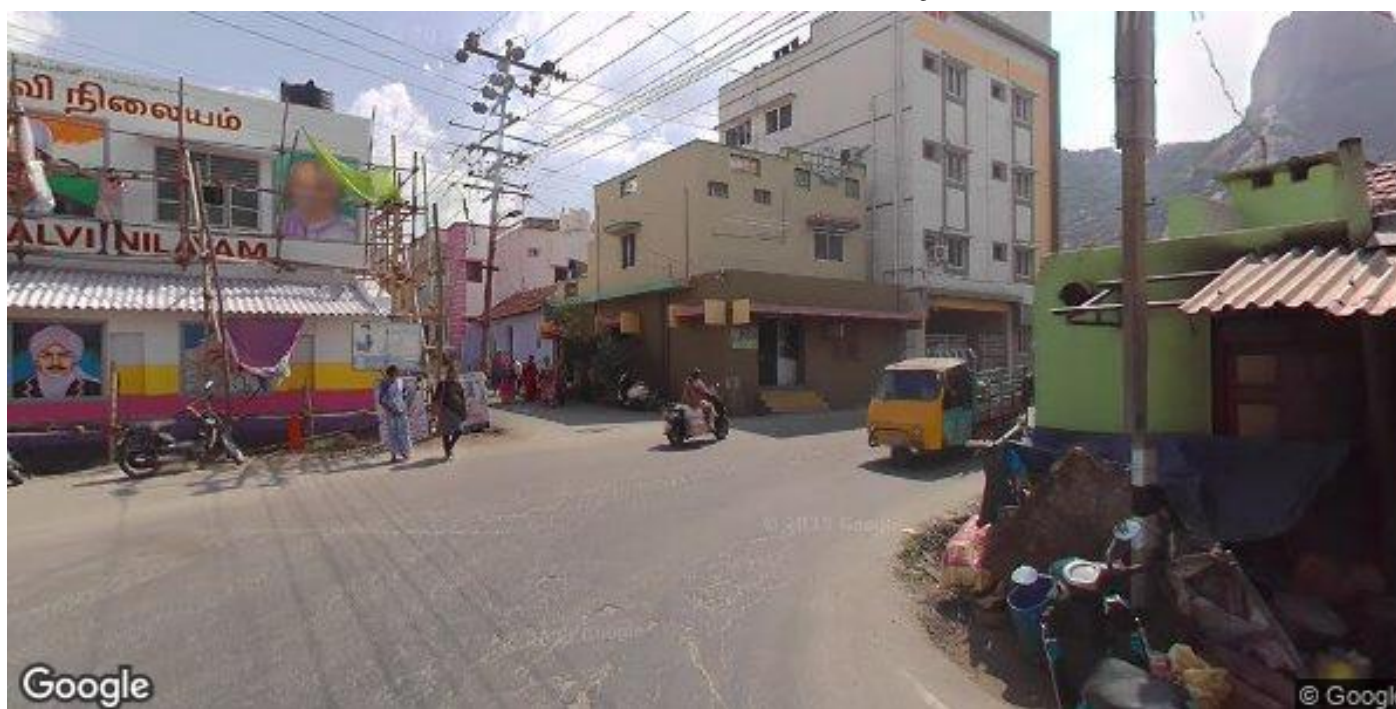
**Risk Type:** Turn  
**Risk Level:** High  
**Speed Limit:** 15 KM/Hr  
**Coordinates:** 11.38186, 77.90258

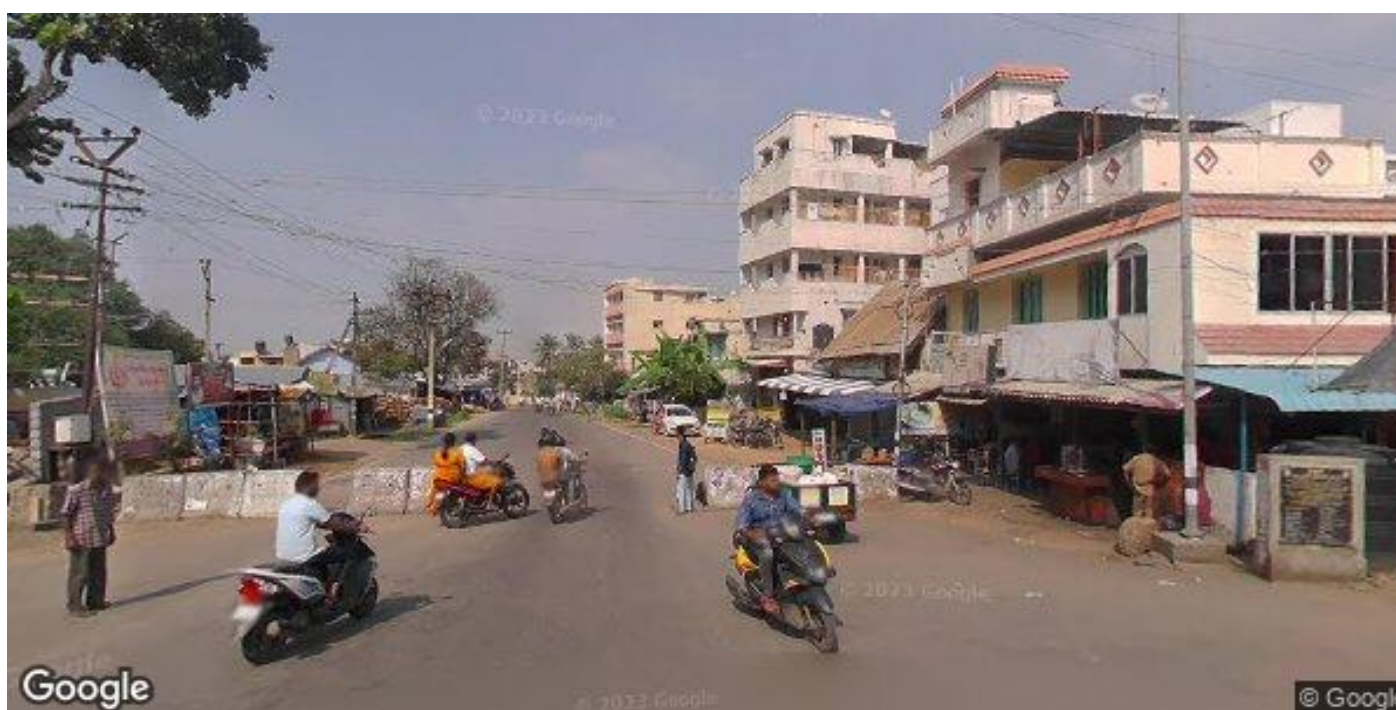
**Risk Type:** Blind Spot  
**Risk Level:** Blind Spot  
**Speed Limit:** 10 KM/Hr  
**Coordinates:** 11.37841, 77.90140

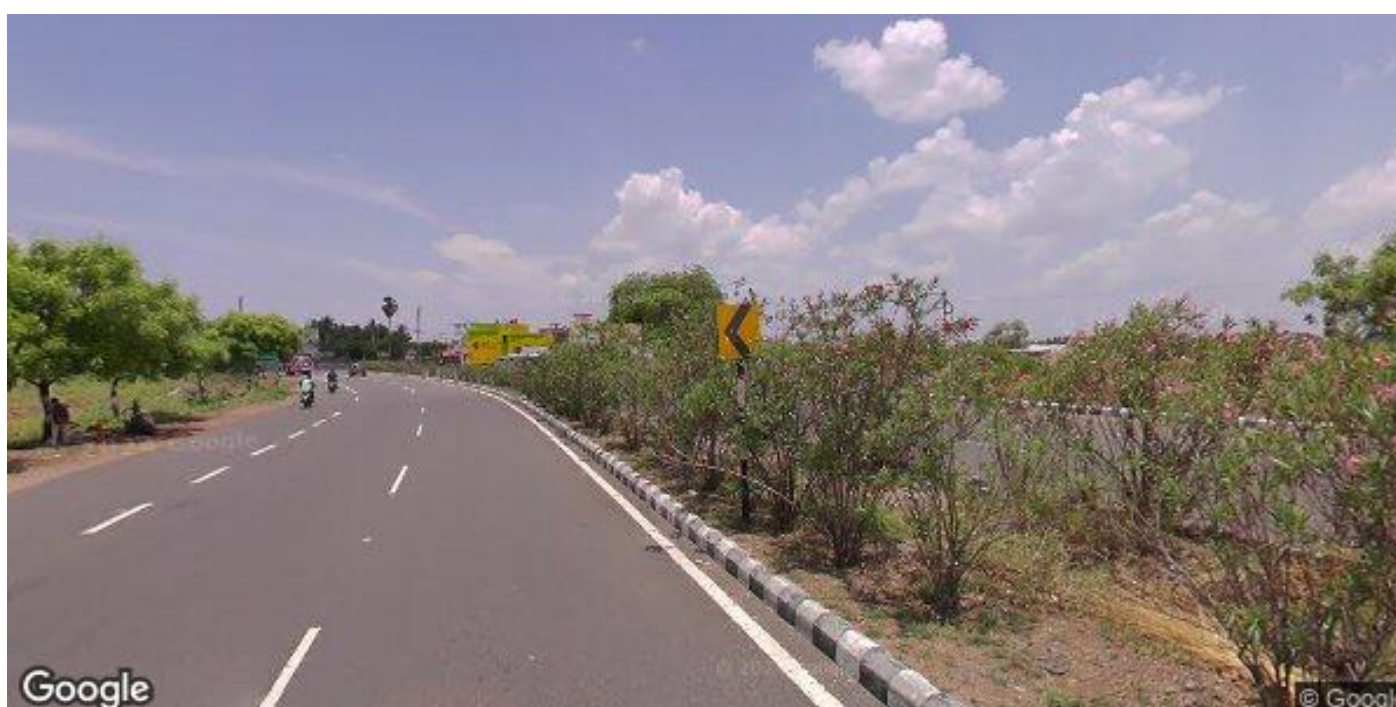
**Risk Type:** Turn  
**Risk Level:** Medium  
**Speed Limit:** 30 KM/Hr  
**Coordinates:** 11.28043, 78.07413

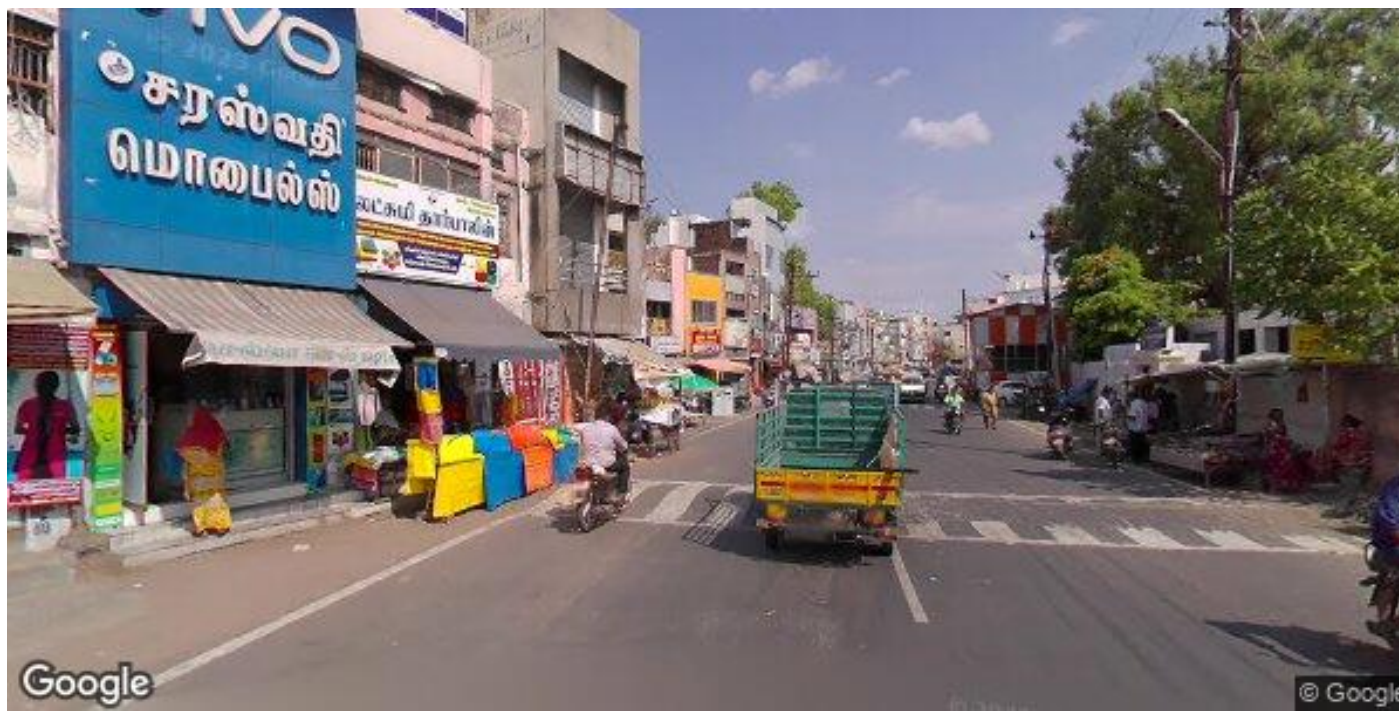
**Risk Type:** Turn  
**Risk Level:** Medium  
**Speed Limit:** 30 KM/Hr  
**Coordinates:** 11.22407, 78.16640

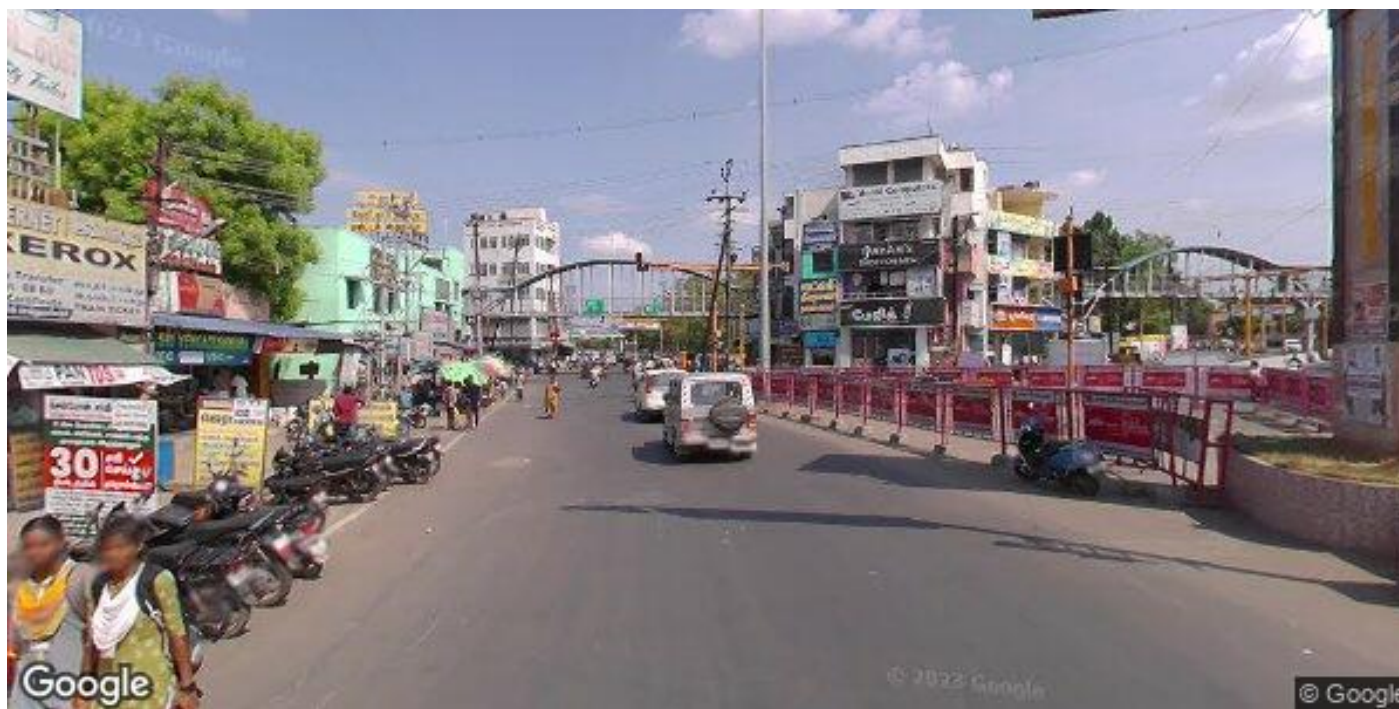
**Risk Type:** Turn  
**Risk Level:** Medium  
**Speed Limit:** 30 KM/Hr  
**Coordinates:** 11.21962, 78.16777

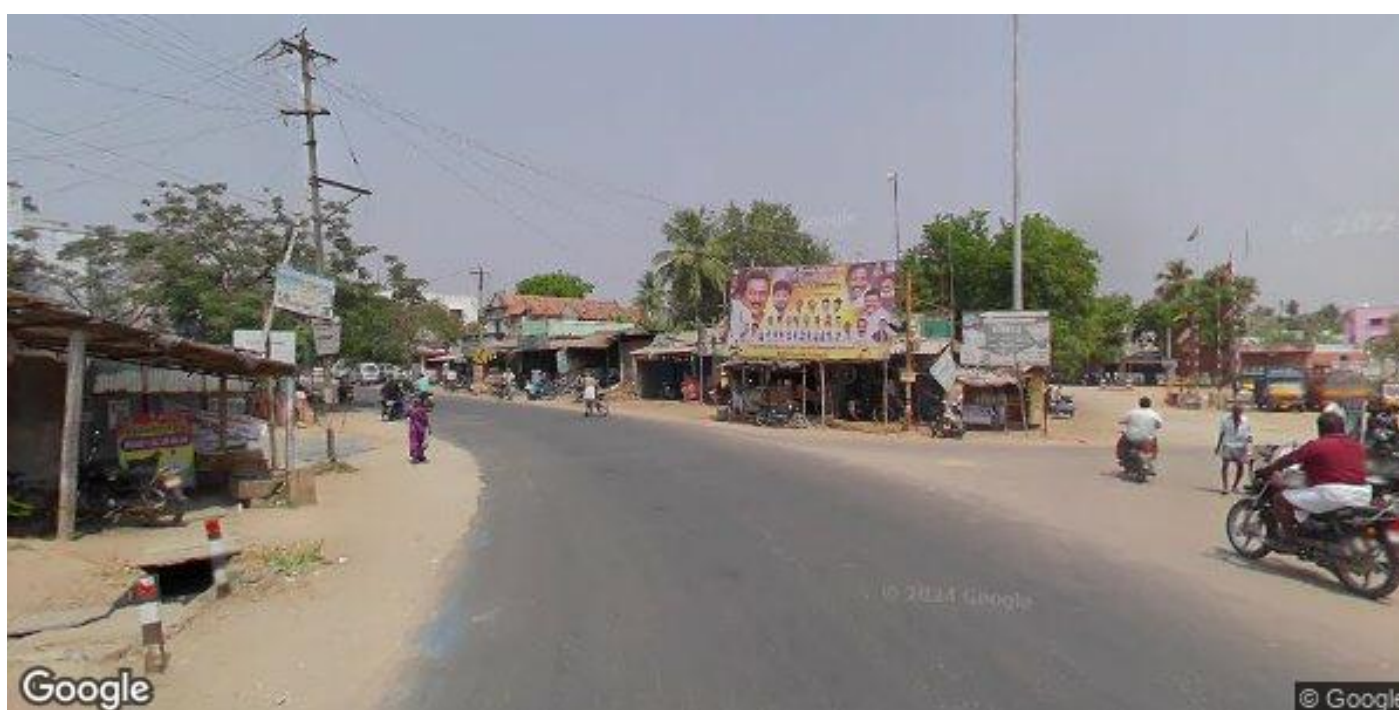
**Risk Type:** Turn  
**Risk Level:** Medium  
**Speed Limit:** 30 KM/Hr  
**Coordinates:** 10.98680, 78.33772

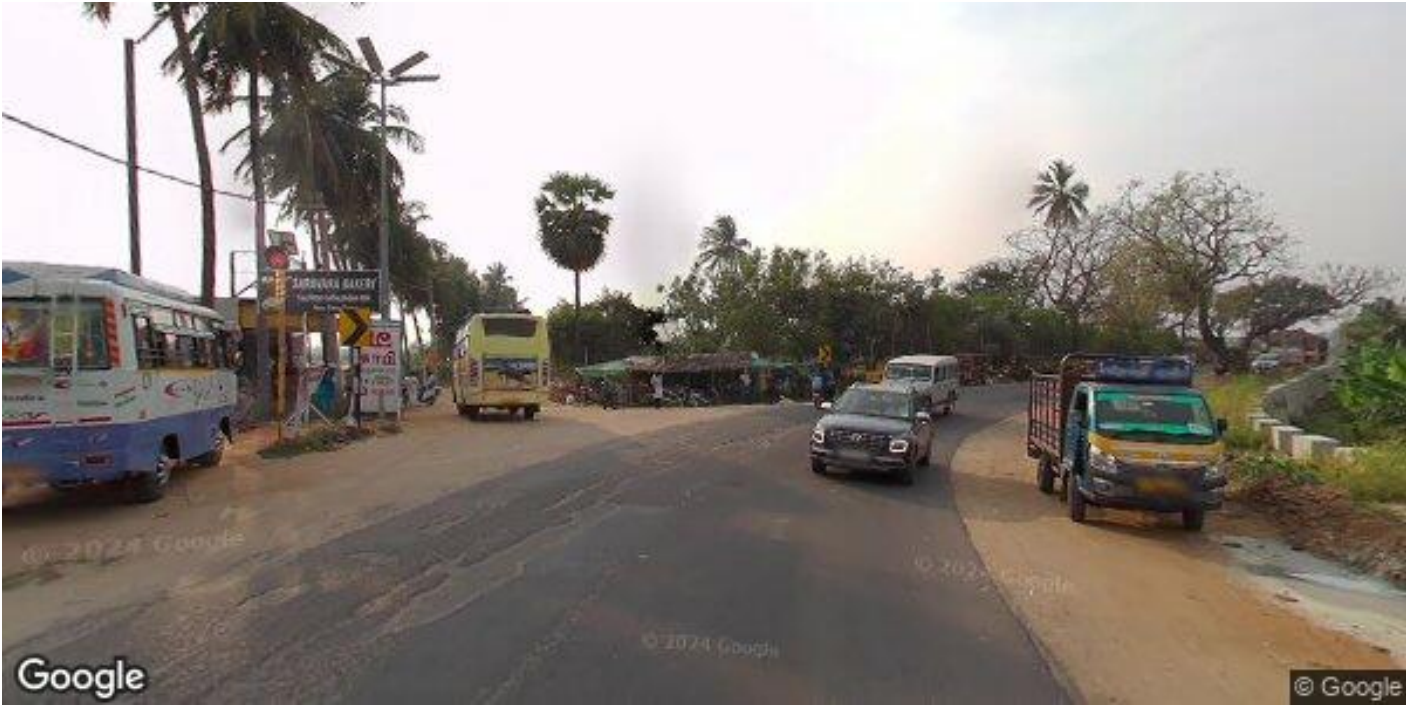
**Risk Type:** Turn  
**Risk Level:** Medium  
**Speed Limit:** 30 KM/Hr  
**Coordinates:** 10.97261, 78.34387

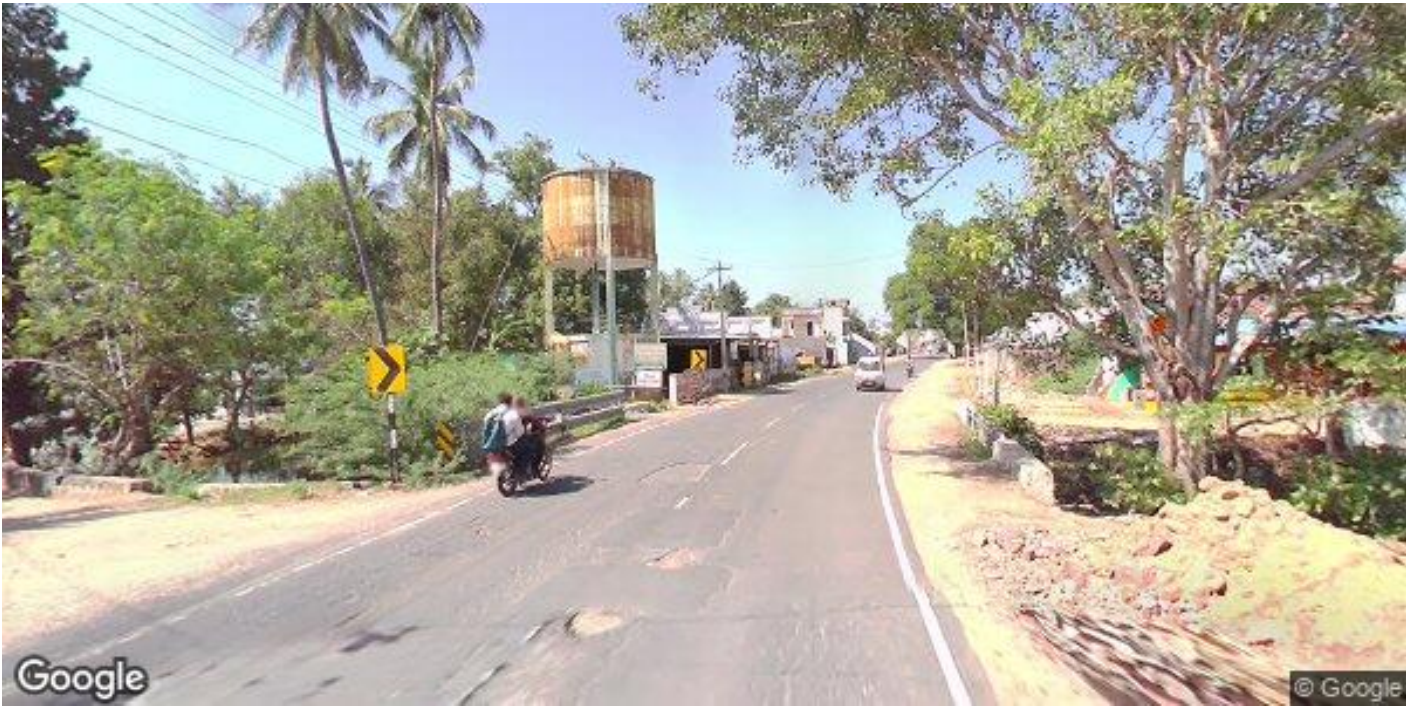
**Risk Type:** Turn  
**Risk Level:** Medium  
**Speed Limit:** 30 KM/Hr  
**Coordinates:** 10.97202, 78.36602

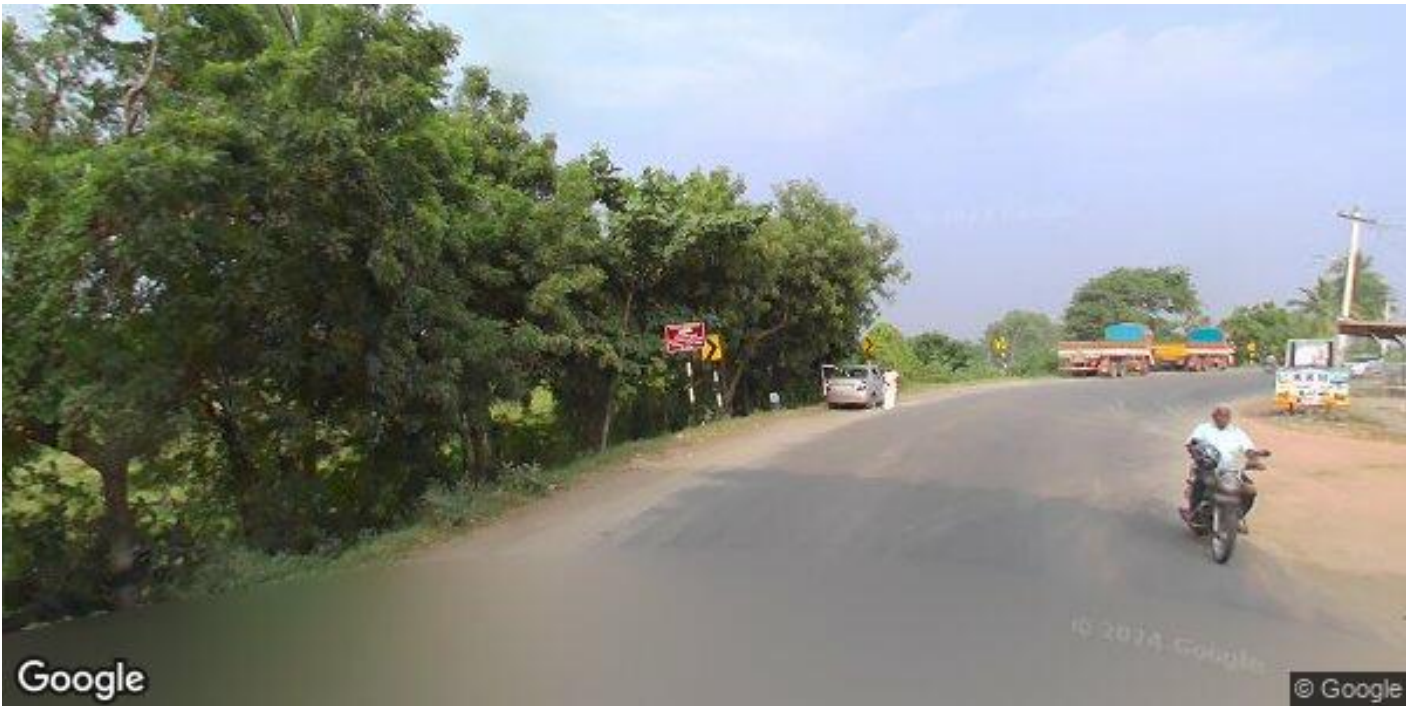
**Risk Type:** Turn  
**Risk Level:** Medium  
**Speed Limit:** 30 KM/Hr  
**Coordinates:** 10.96069, 78.42248

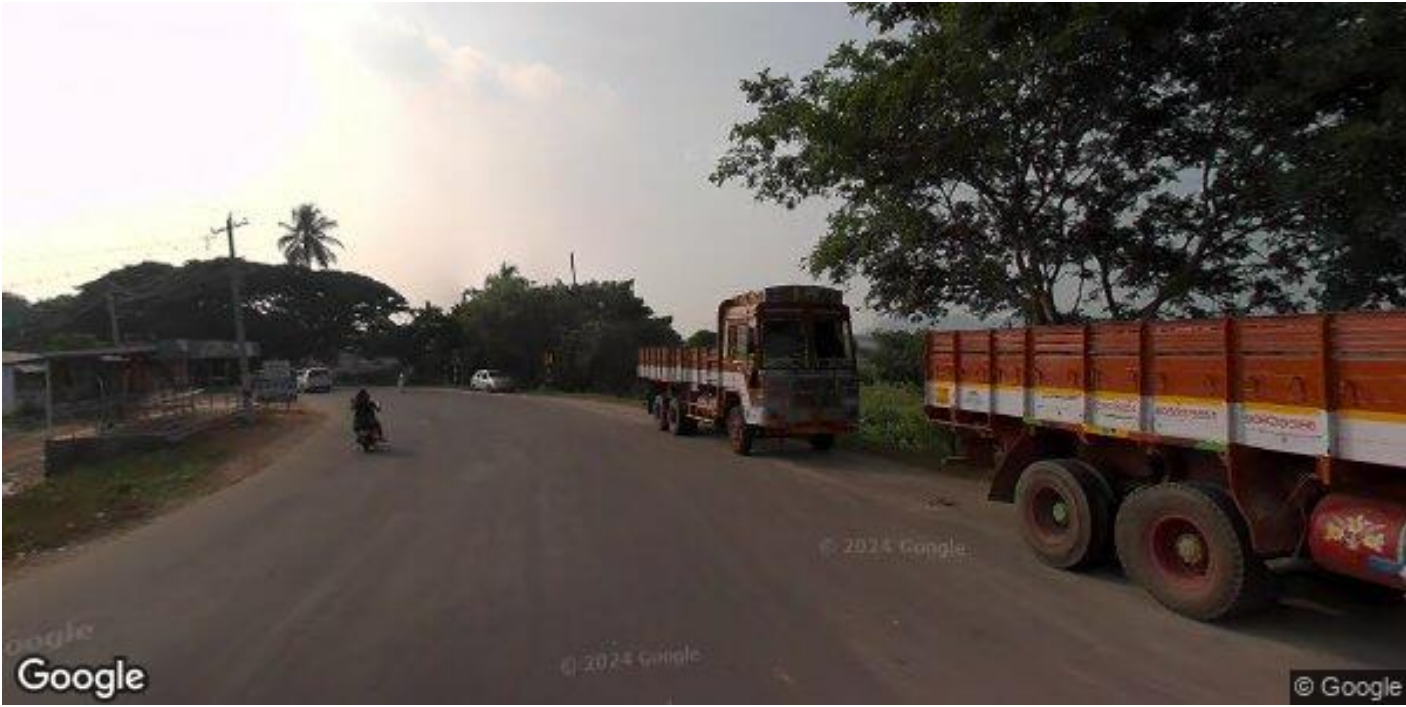
**Risk Type:** Turn  
**Risk Level:** Medium  
**Speed Limit:** 30 KM/Hr  
**Coordinates:** 10.96084, 78.42307

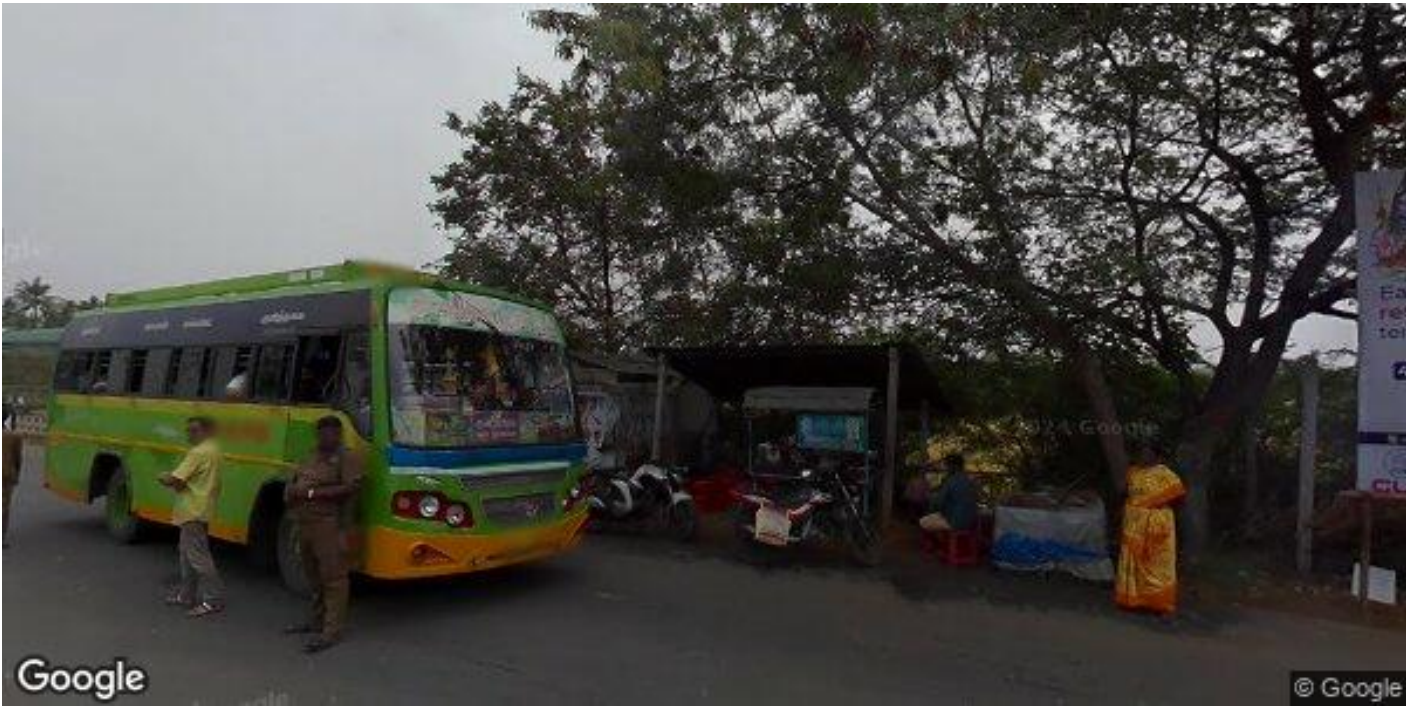
**Risk Type:** Blind Spot  
**Risk Level:** Blind Spot  
**Speed Limit:** 10 KM/Hr  
**Coordinates:** 10.96050, 78.42371
