## **JOURNEY RISK MANAGEMENT (JRM) STUDY**

### **Salem Terminal To SREE BALAJI AGENCIES**

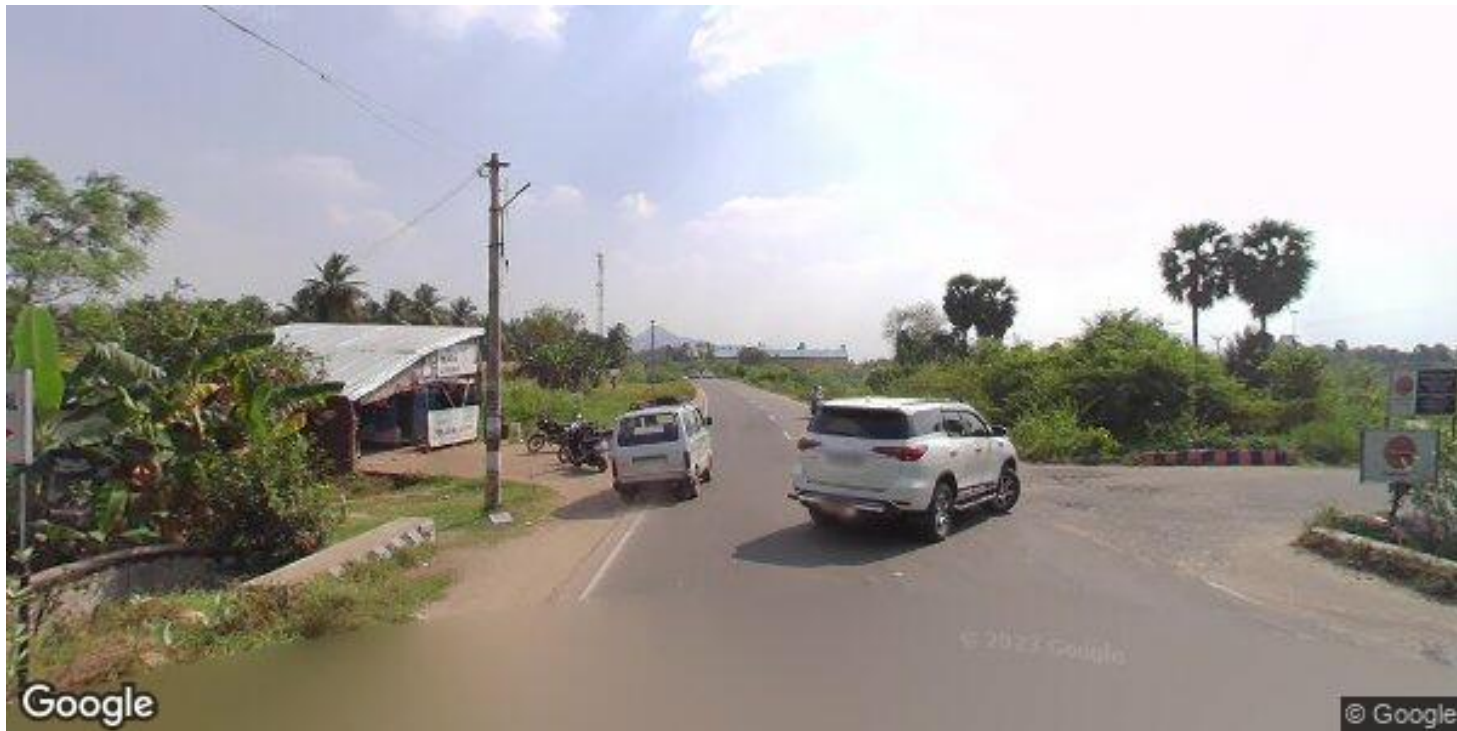
**Coordinates:** 11.44029, 77.87544

**Risk Type:** Turn

**Risk Level:** High

**Speed Limit:** 15 KM/Hr

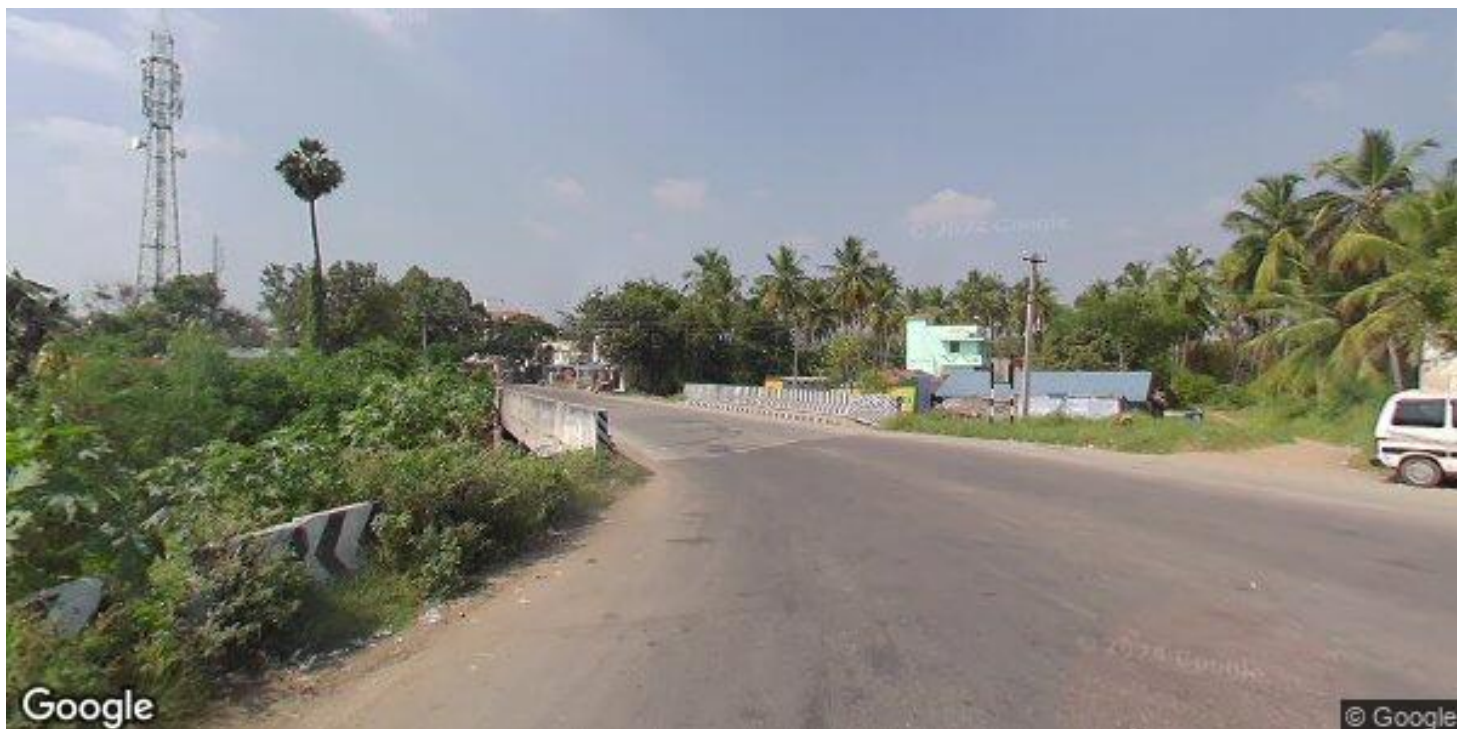
**Coordinates: 11.44893, 77.87413**

**Risk Type:** Turn

**Risk Level:** Medium

**Speed Limit: 30 KM/Hr**

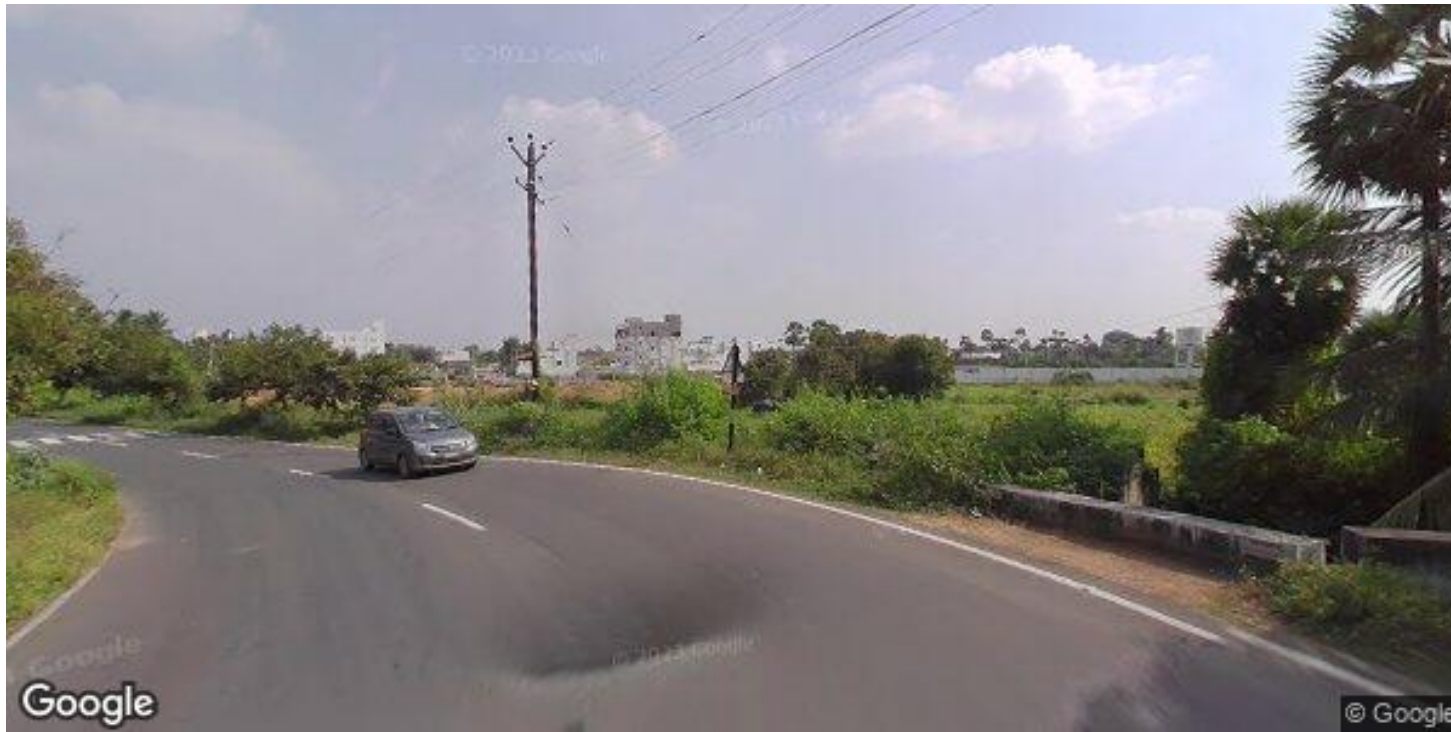
**Coordinates: 11.45350, 77.85700**

**Risk Type: Turn**

**Risk Level: High**

**Speed Limit: 15 KM/Hr**

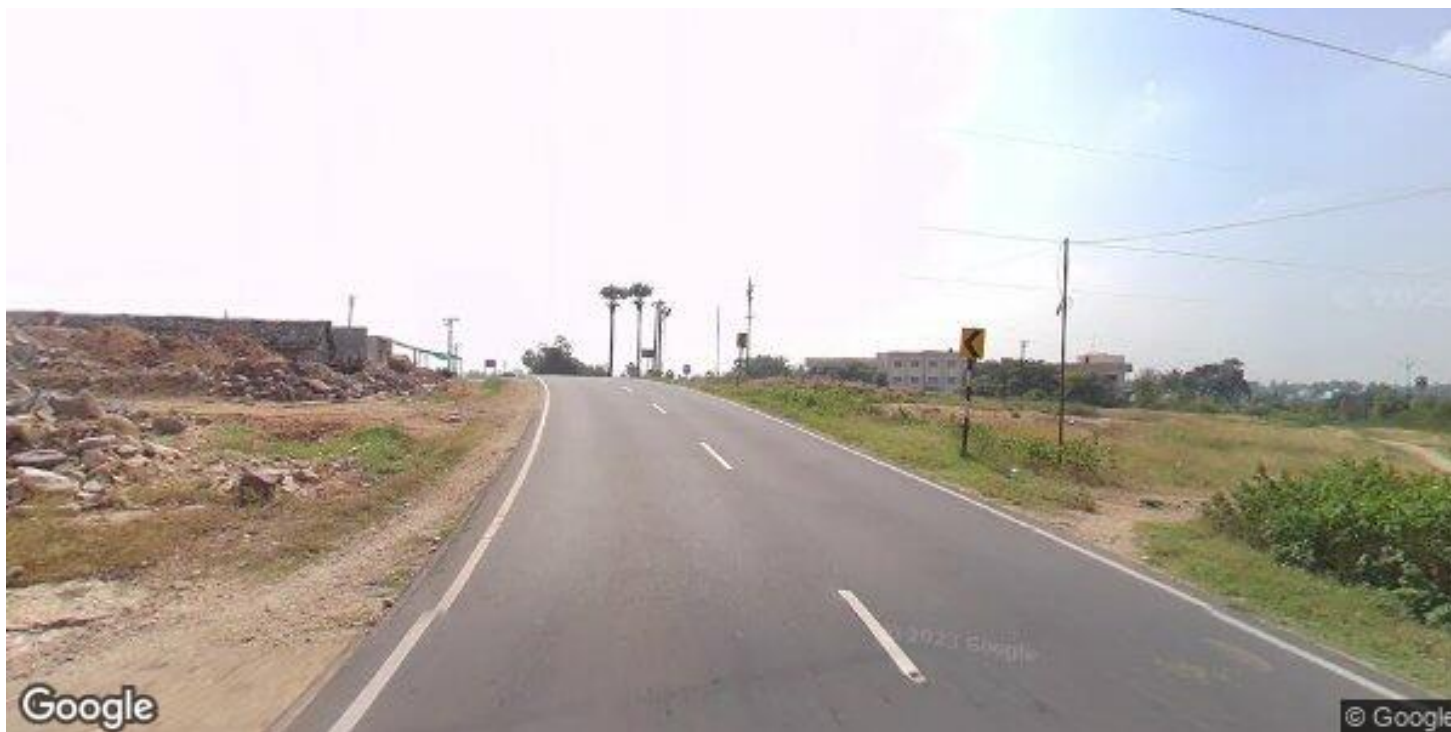
**Coordinates: 11.46046, 77.85037**

**Risk Type: Turn**

**Risk Level: Medium**

**Speed Limit: 30 KM/Hr**

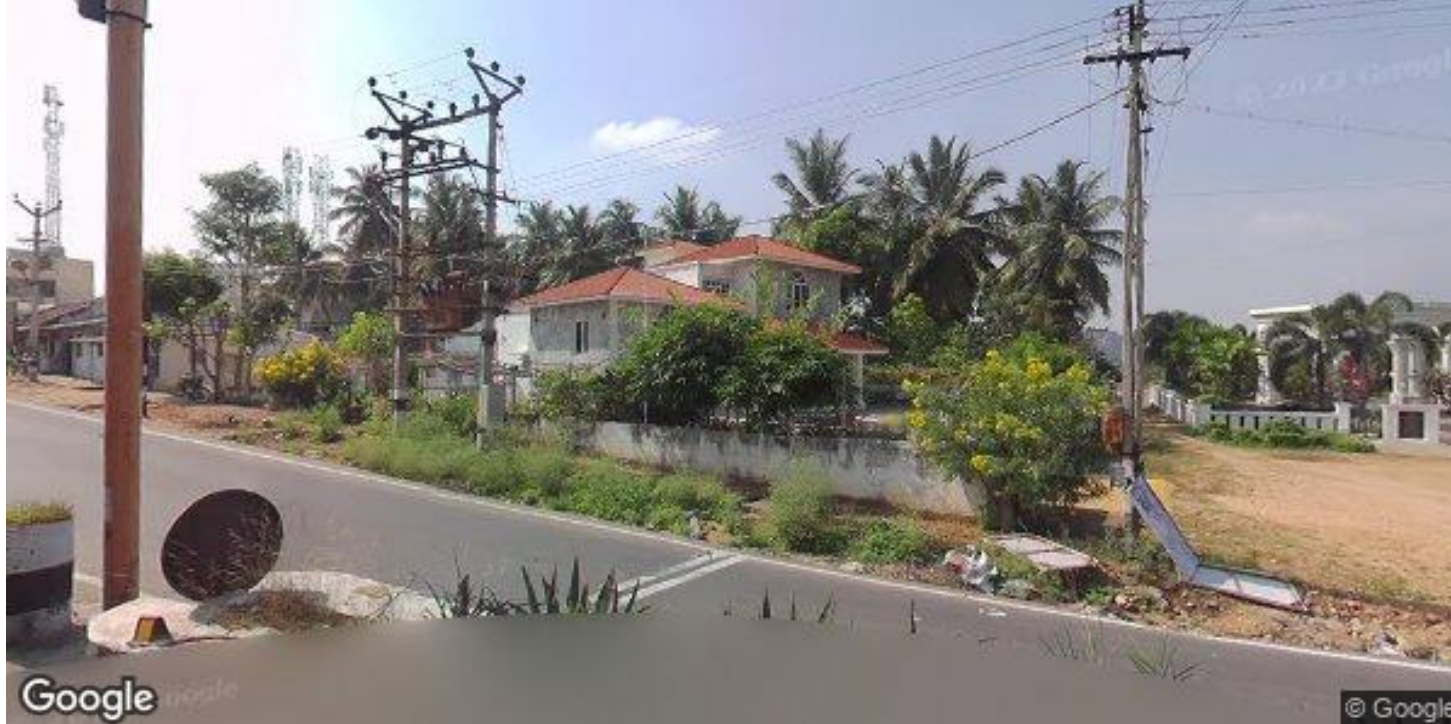
**Coordinates:** 11.46303, 77.84945

**Risk Type:** Turn

**Risk Level:** Medium

**Speed Limit:** 30 KM/Hr

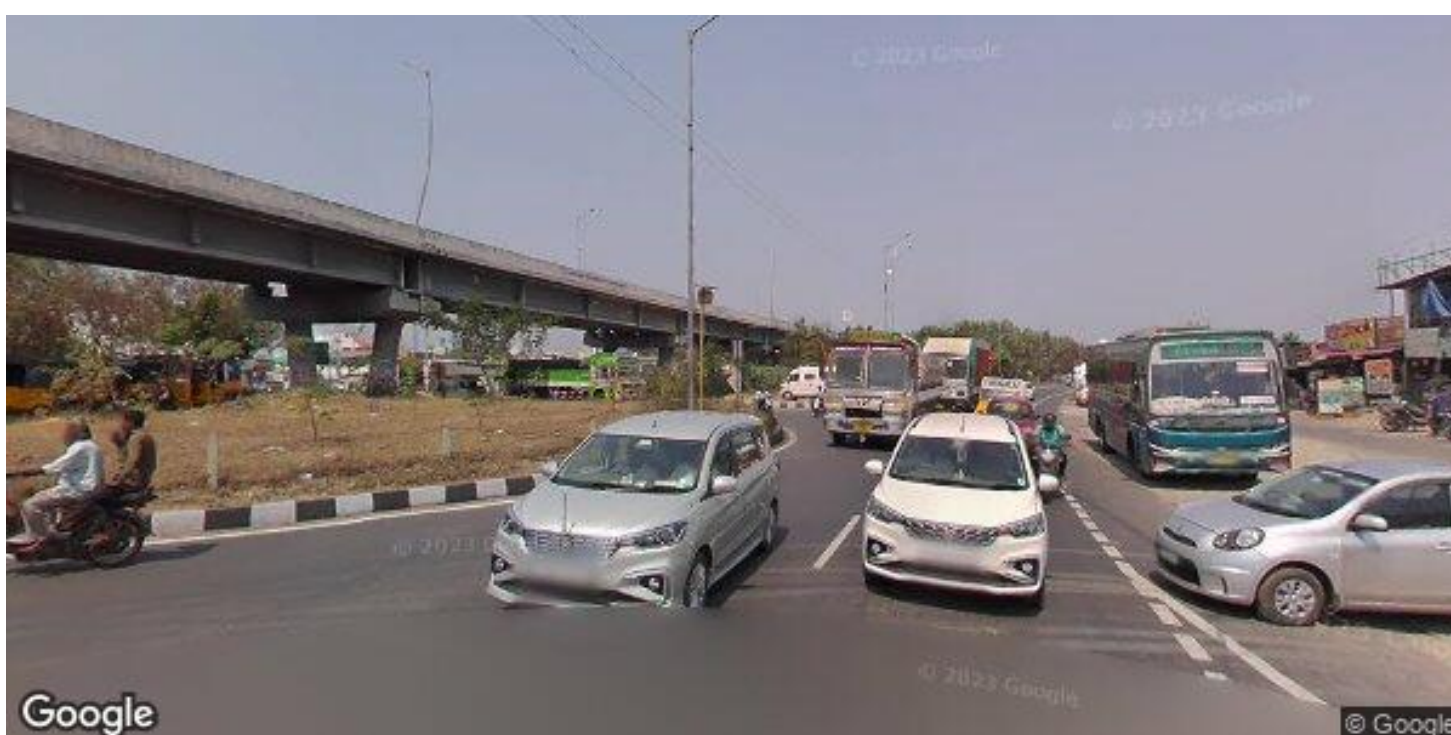
**Coordinates:** 11.43001, 77.67575

**Risk Type:** Turn

**Risk Level:** High

**Speed Limit:** 15 KM/Hr

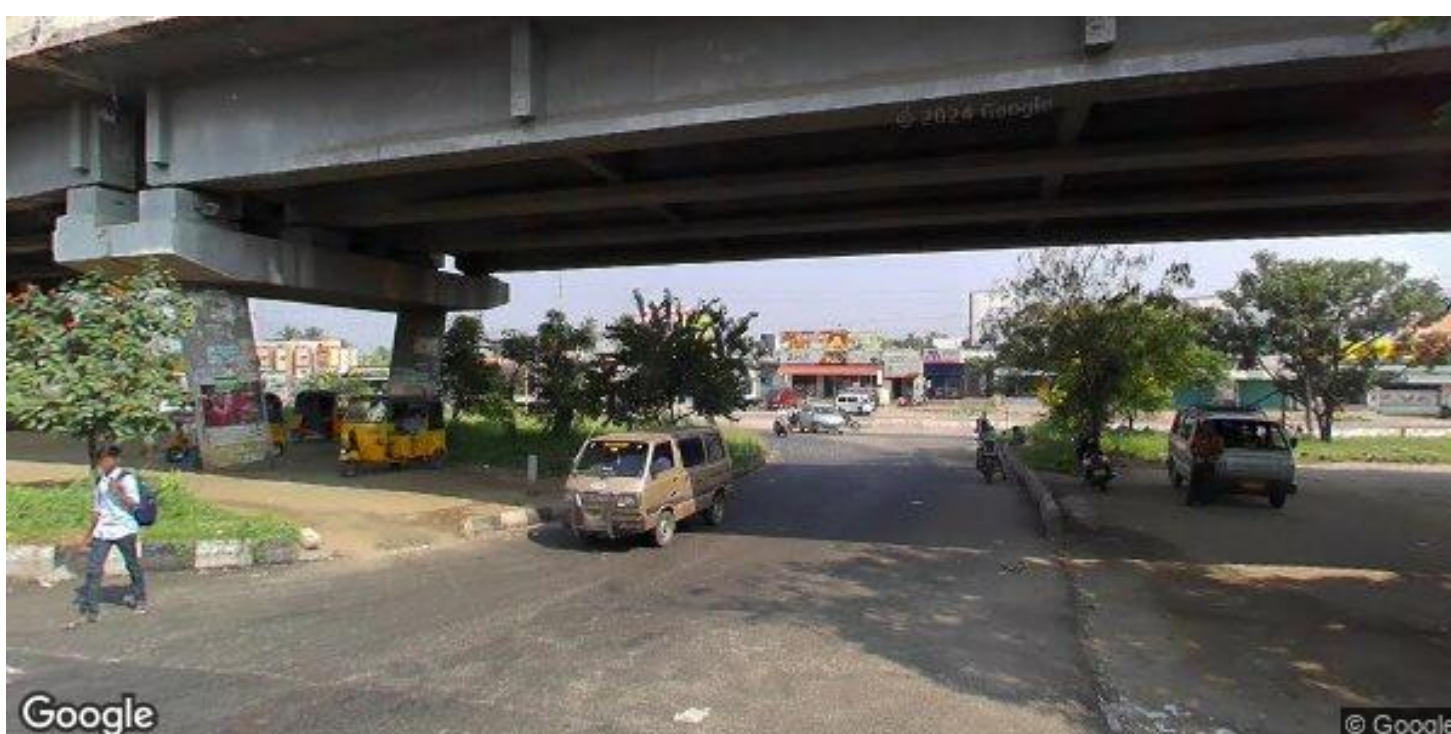
**Coordinates: 11.43007, 77.67543**

**Risk Type:** Turn

**Risk Level:** Medium

**Speed Limit: 30 KM/Hr**

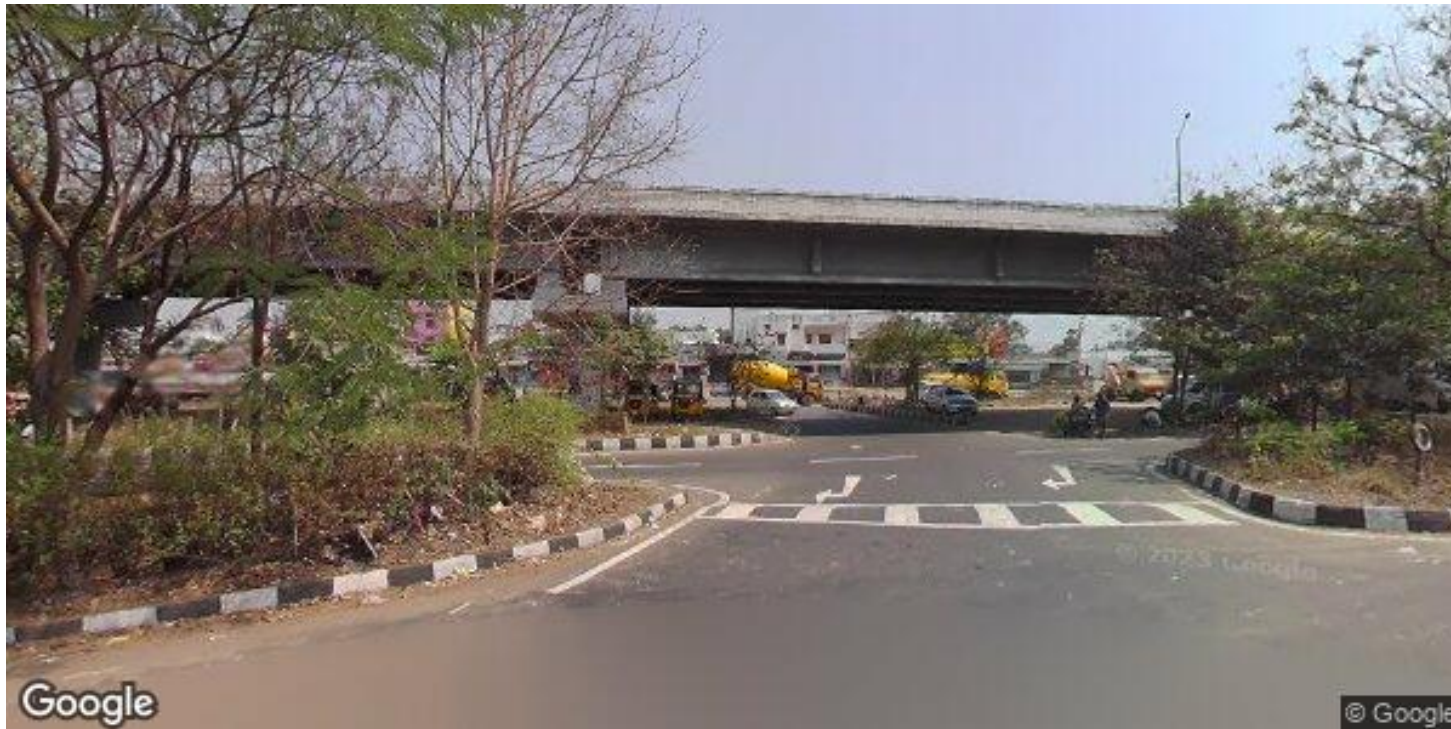
**Coordinates: 11.43026, 77.67525**

**Risk Type: Turn**

**Risk Level: High**

**Speed Limit: 15 KM/Hr**

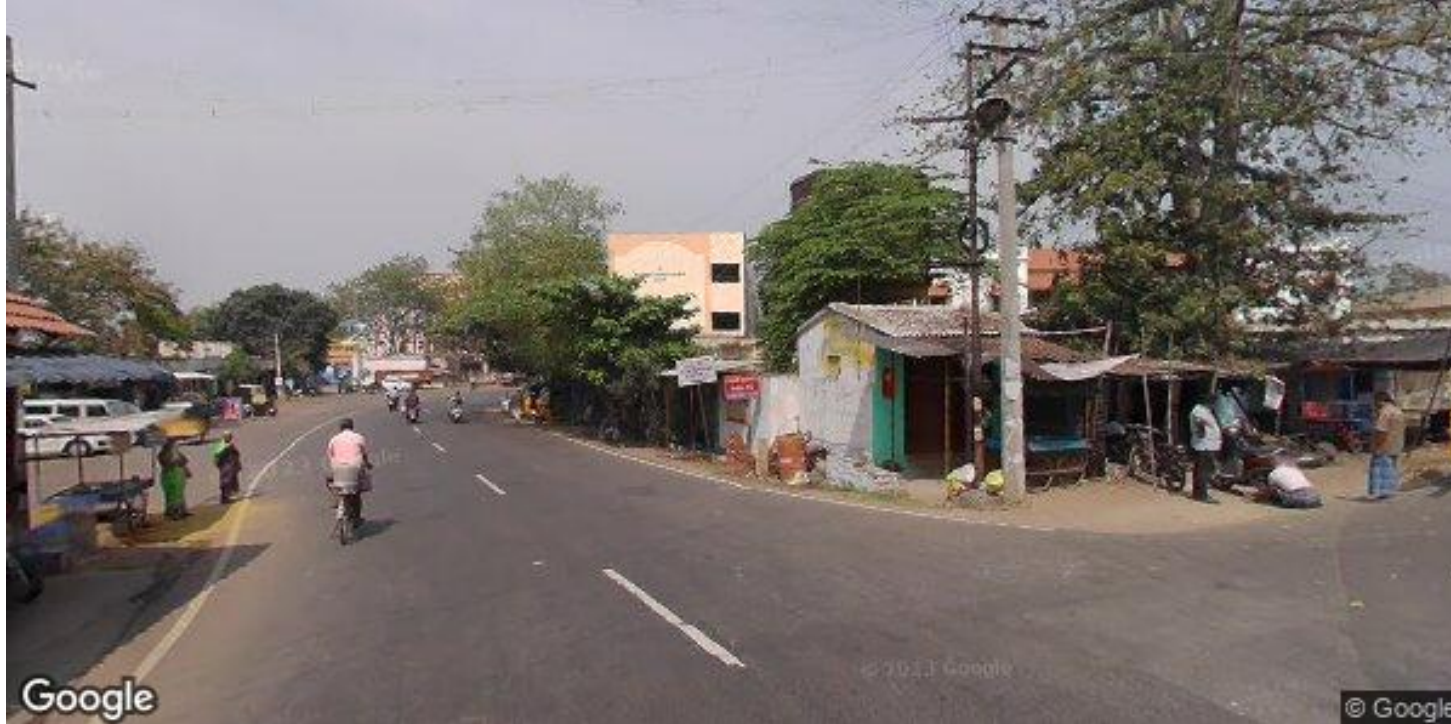
**Coordinates:** 11.43965, 77.68224

**Risk Type:** Turn

**Risk Level:** Medium

**Speed Limit:** 30 KM/Hr

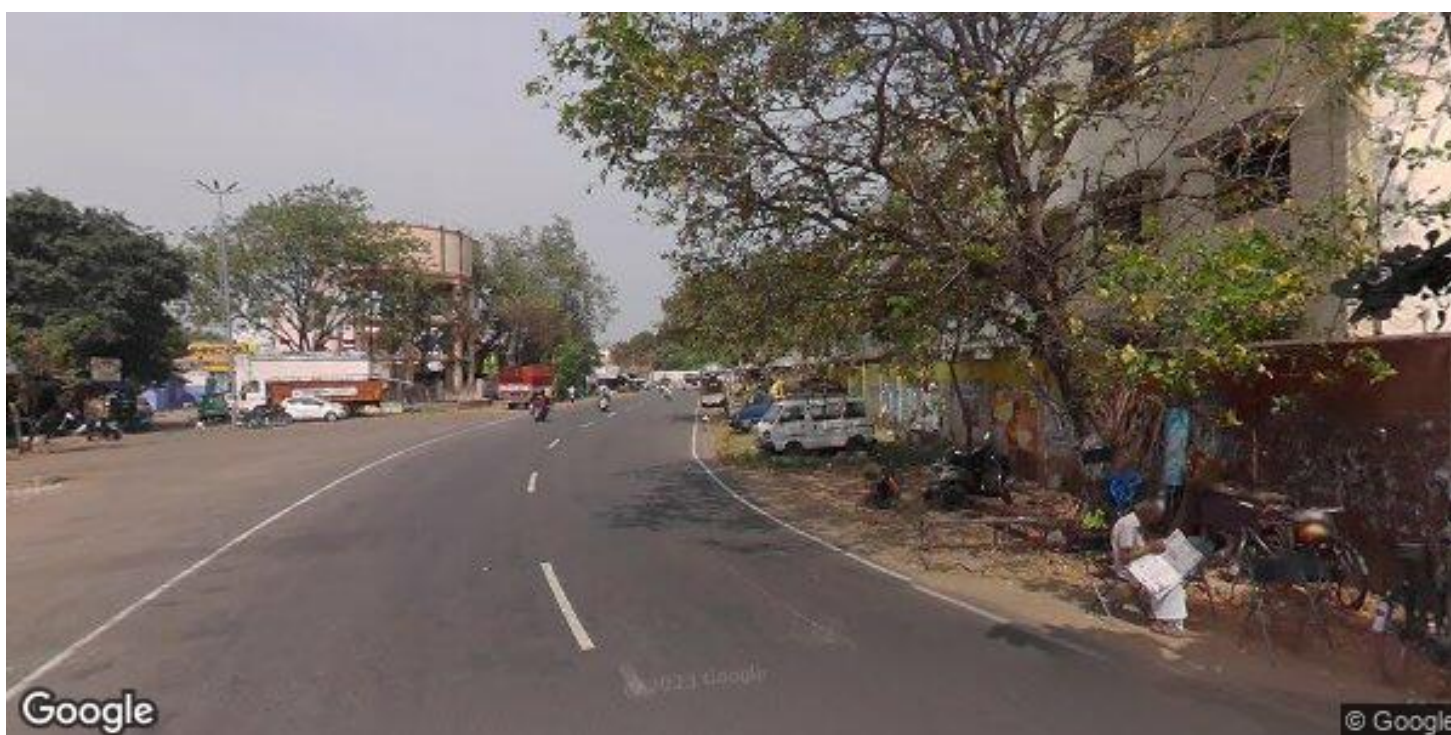
**Coordinates:** 11.43997, 77.68198

**Risk Type:** Turn

**Risk Level:** Medium

**Speed Limit:** 30 KM/Hr

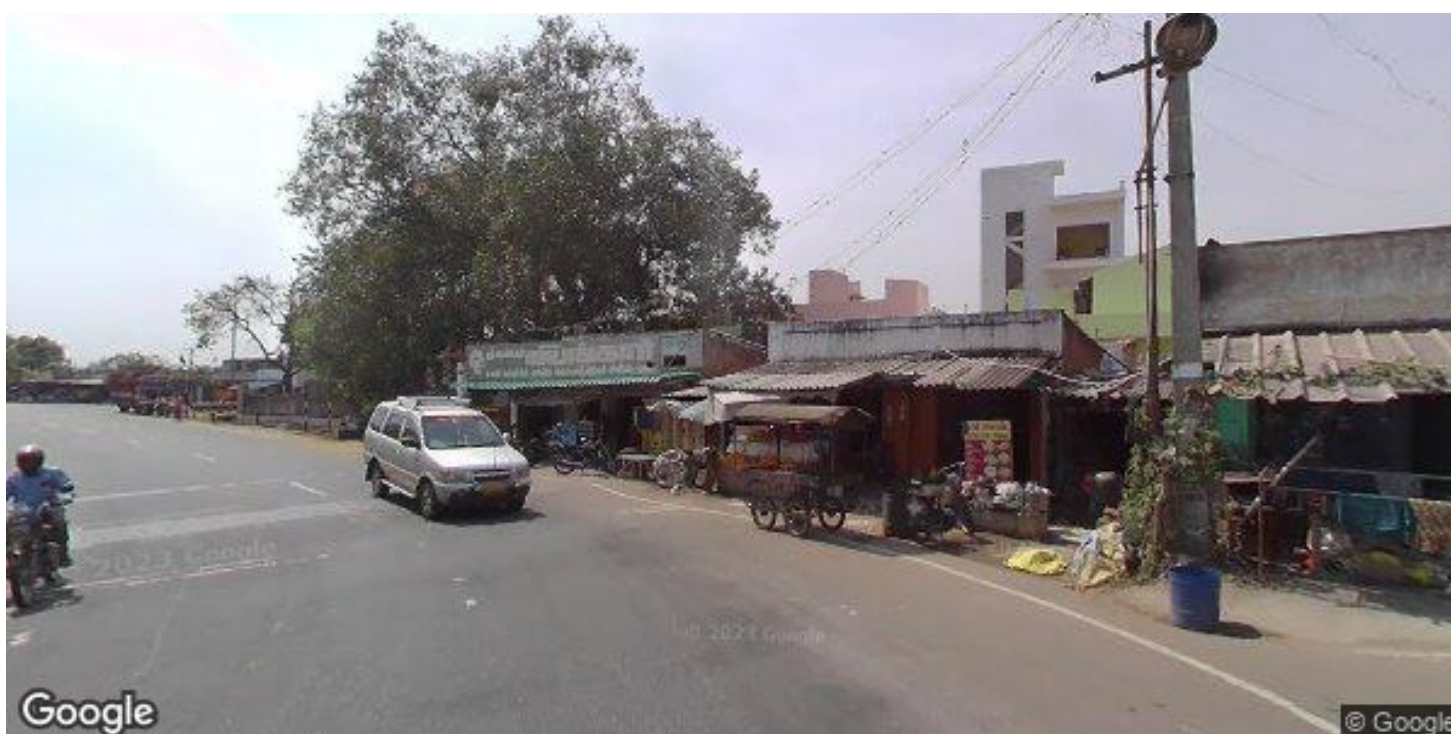
Coordinates: 11.44105, 77.68187

**Risk Type:** Turn

**Risk Level:** High

Speed Limit: 15 KM/Hr

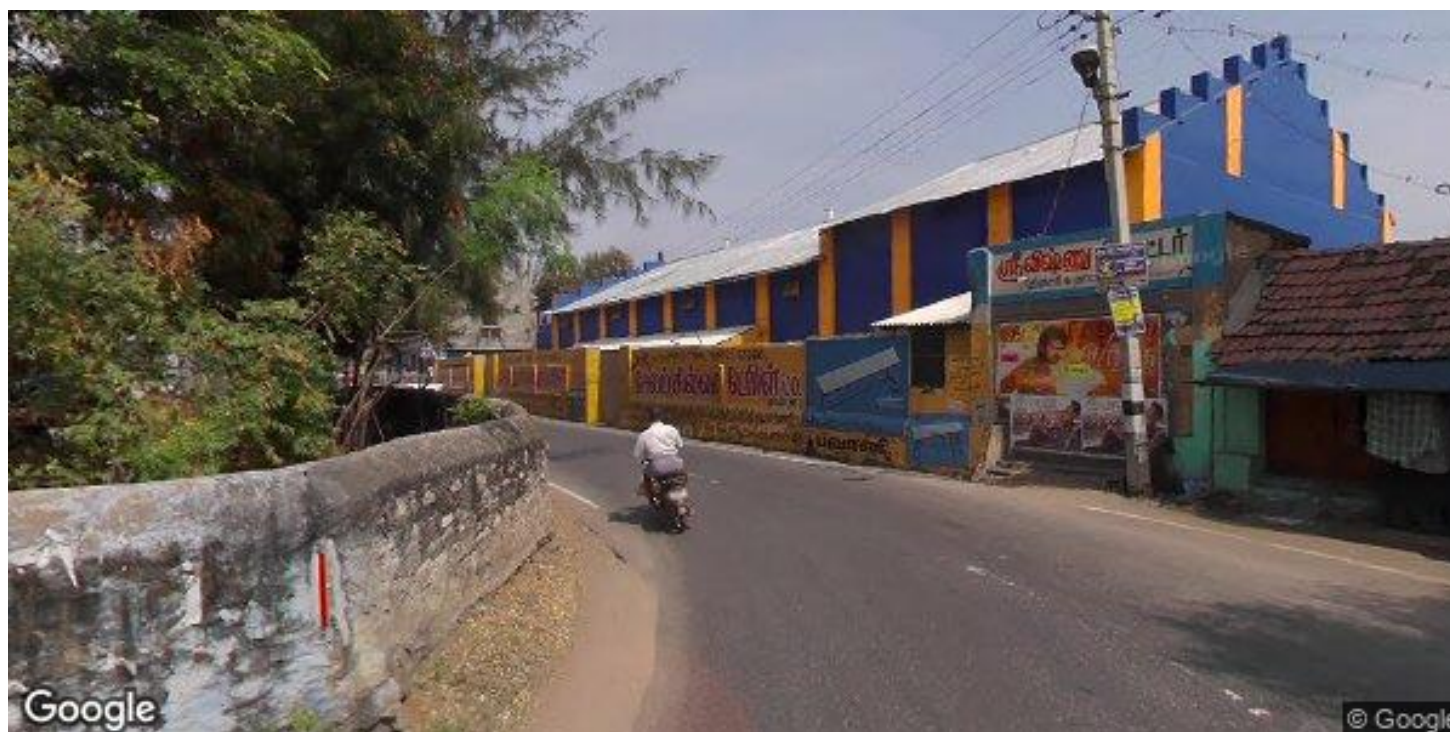
Coordinates: 11.44119, 77.68217

Risk Type: Turn

Risk Level: High

Speed Limit: 15 KM/Hr

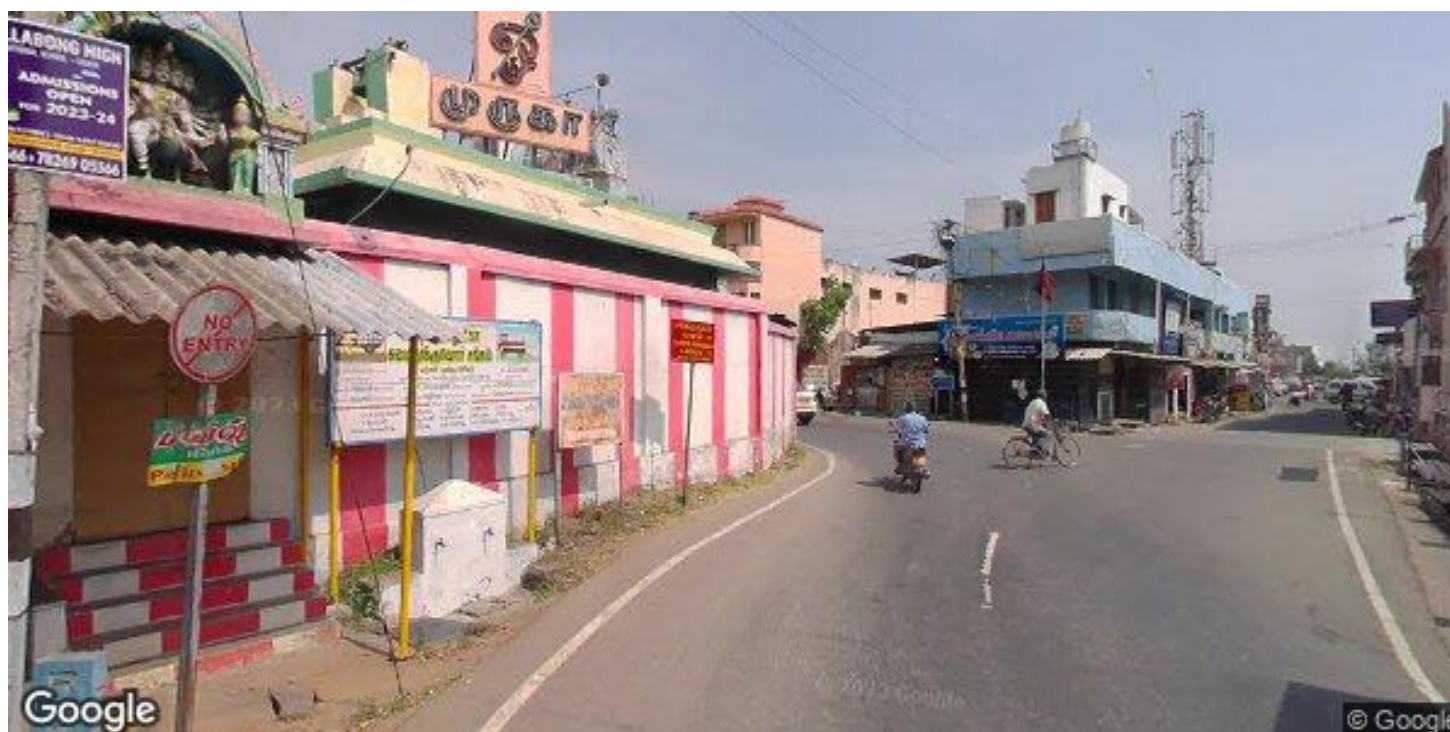
Coordinates: 11.44295, 77.68261

Risk Type: Turn

Risk Level: Medium

Speed Limit: 30 KM/Hr

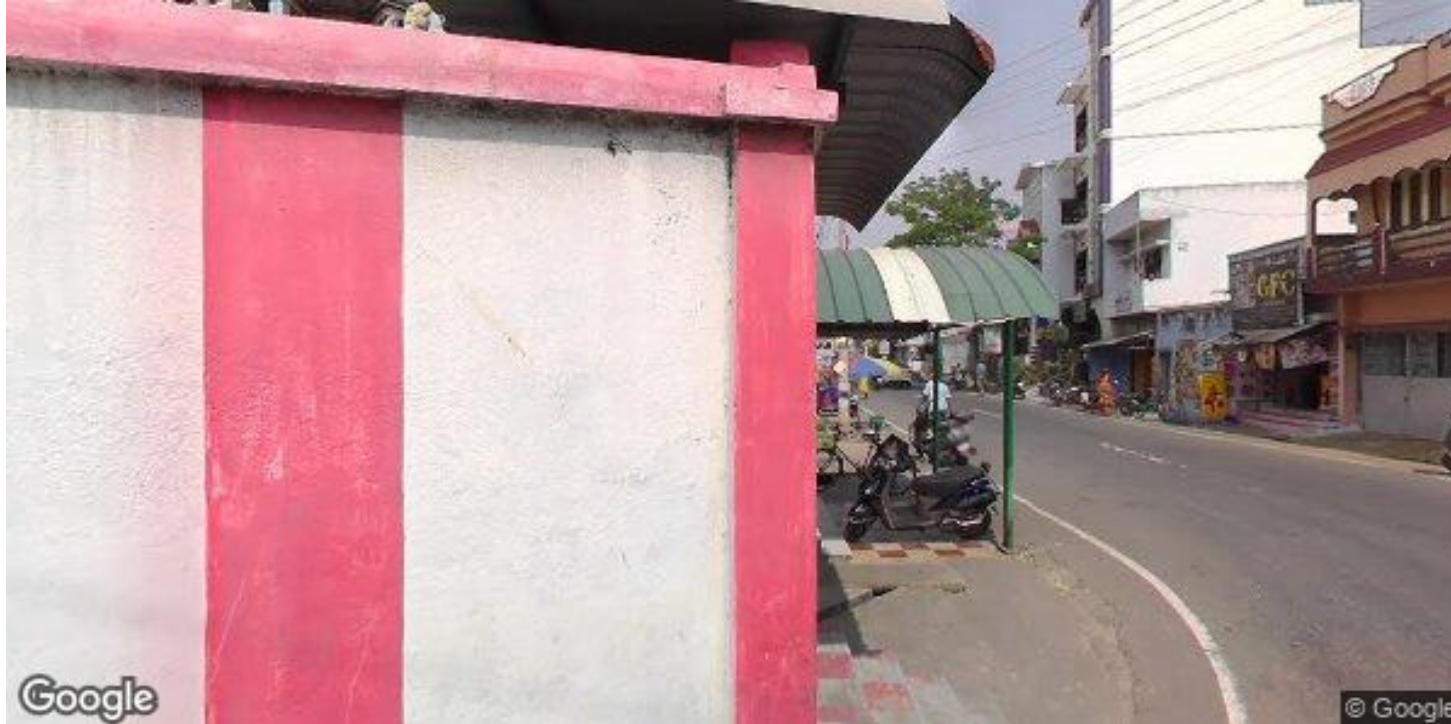
**Coordinates:** 11.44298, 77.68272

**Risk Type:** Turn

**Risk Level:** Medium

**Speed Limit:** 30 KM/Hr

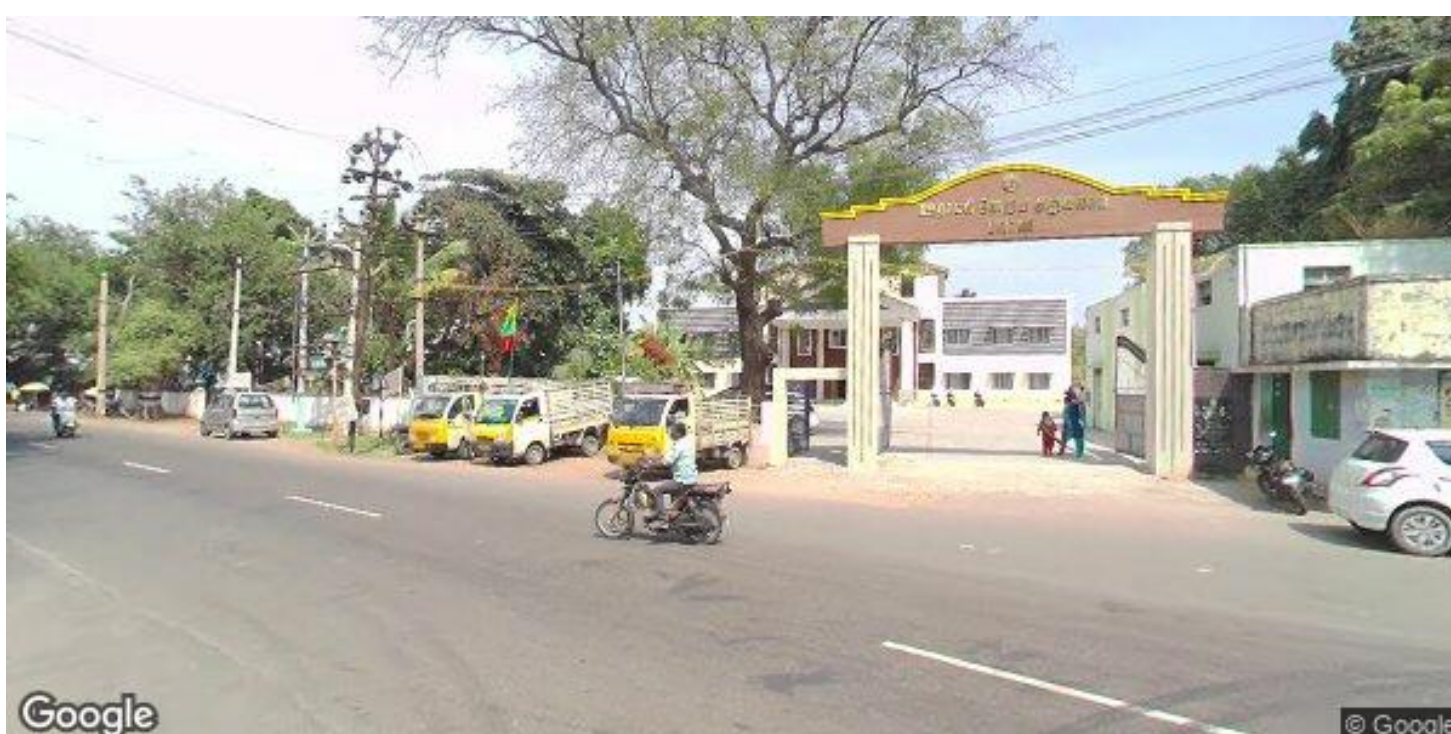
**Coordinates: 11.44853, 77.68331**

**Risk Type:** Turn

**Risk Level:** High

**Speed Limit: 15 KM/Hr**

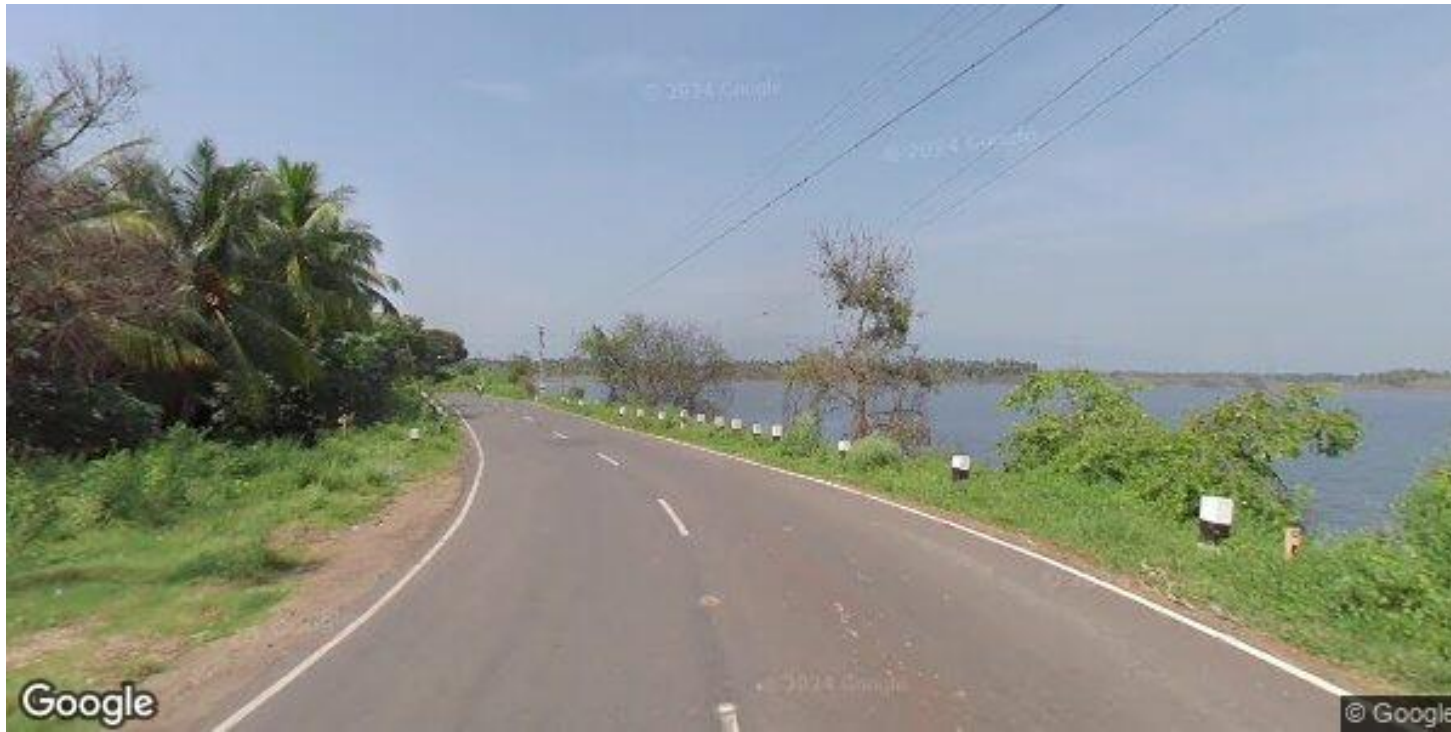
**Coordinates: 11.48124, 77.57031**

**Risk Type: Turn**

**Risk Level: Medium**

**Speed Limit: 30 KM/Hr**

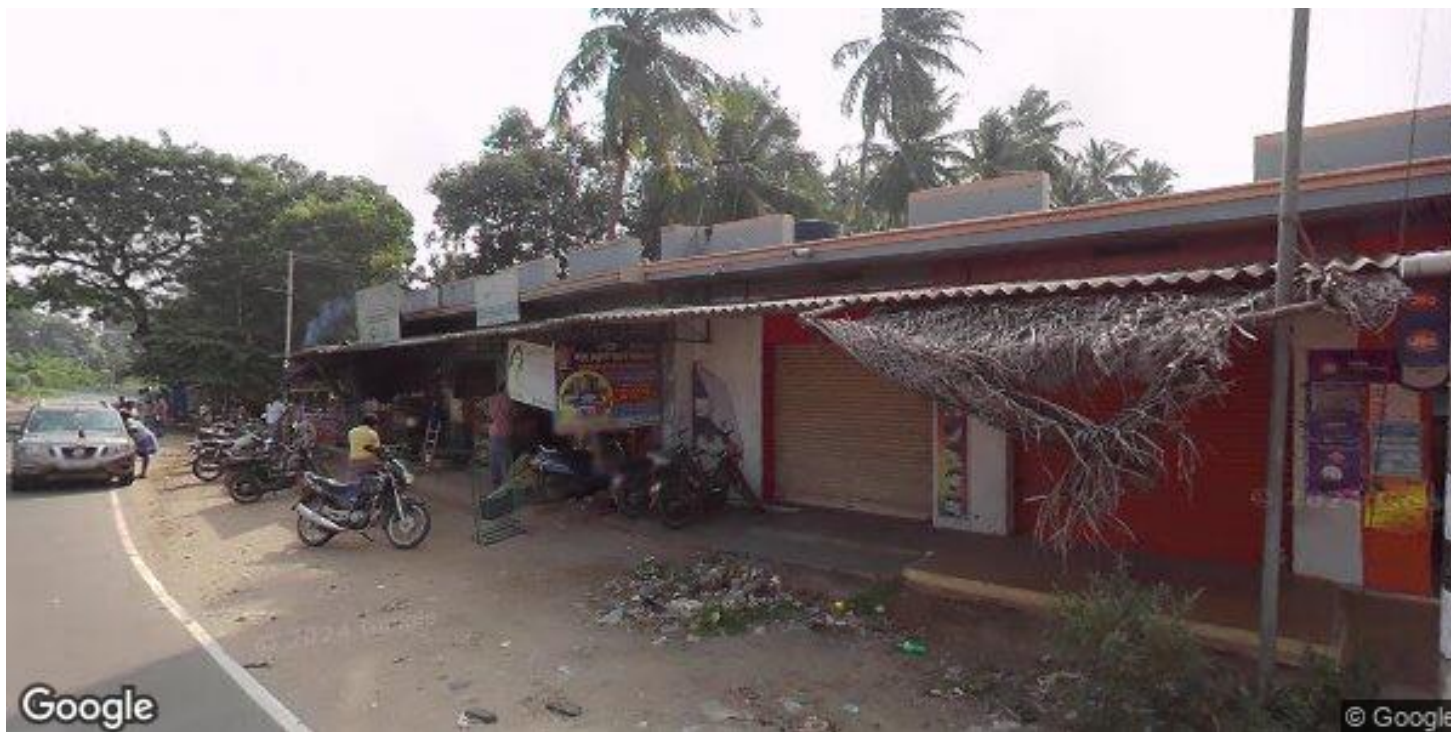
**Coordinates: 11.52420, 77.52412**

**Risk Type: Blind Spot**

**Risk Level: Blind Spot**

**Speed Limit: 10 KM/Hr**
