# IndianOil

## JOURNEY RISK MANAGEMENT (JRM) STUDY

### Salem Terminal to VELLAVAN SAKKTHI FILLING

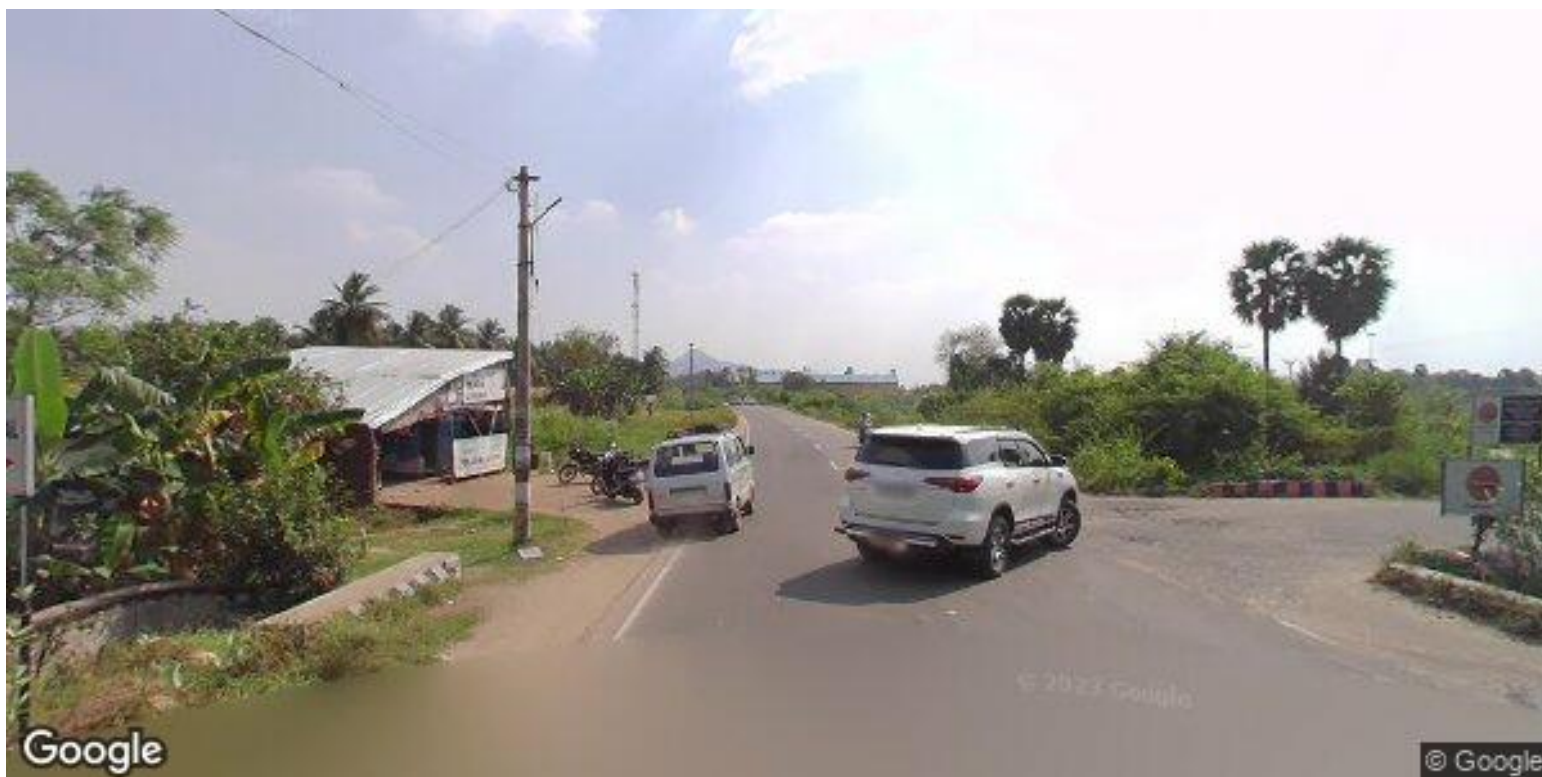
**Coordinates:** 11.44029, 77.87544

**Risk Type:** Turn

**Risk Level:** High

**Speed Limit:** 15 KM/Hr

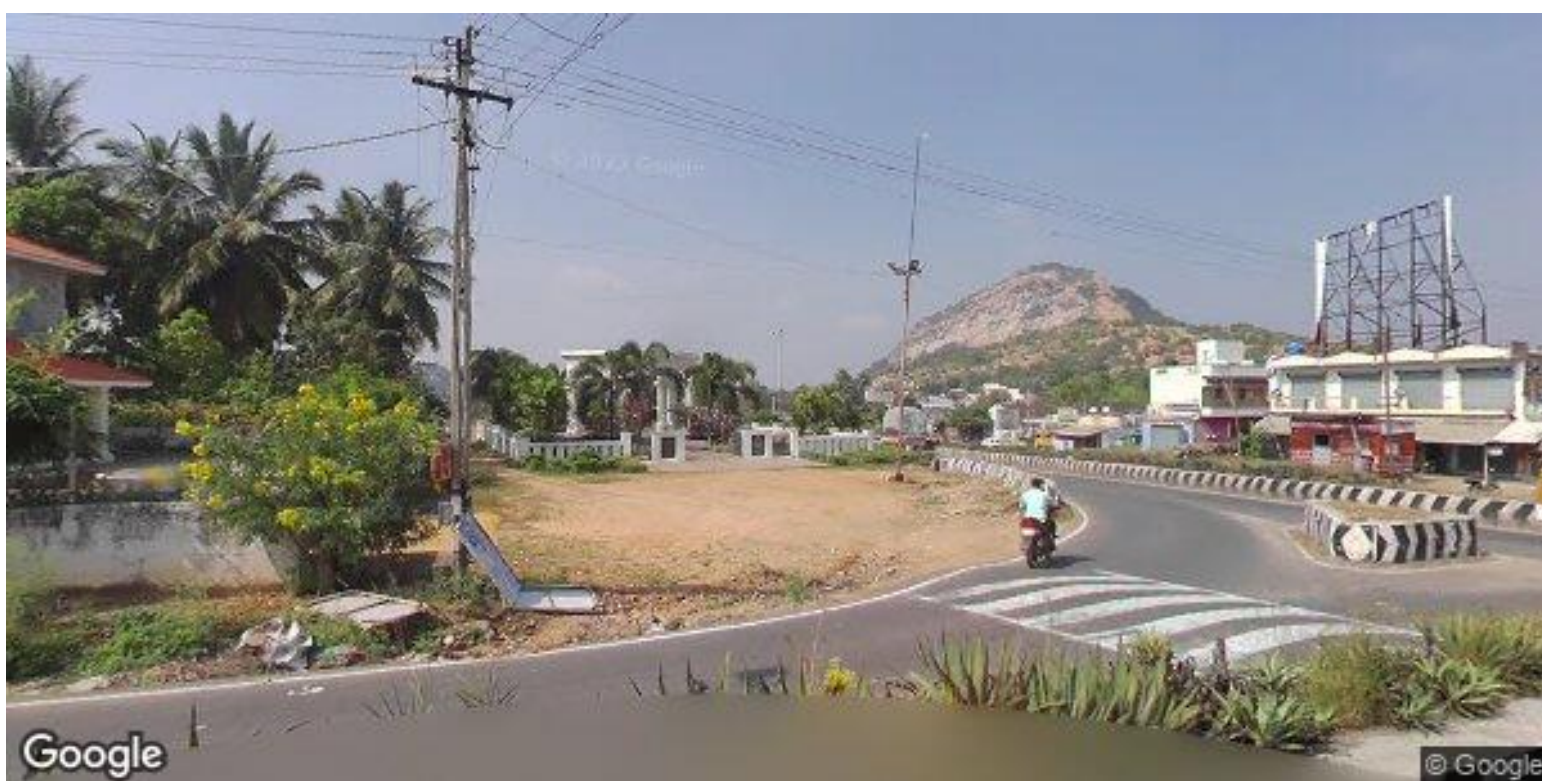
**Coordinates:** 11.46307, 77.84941

**Risk Type:** Turn

**Risk Level:** Medium

**Speed Limit:** 30 KM/Hr

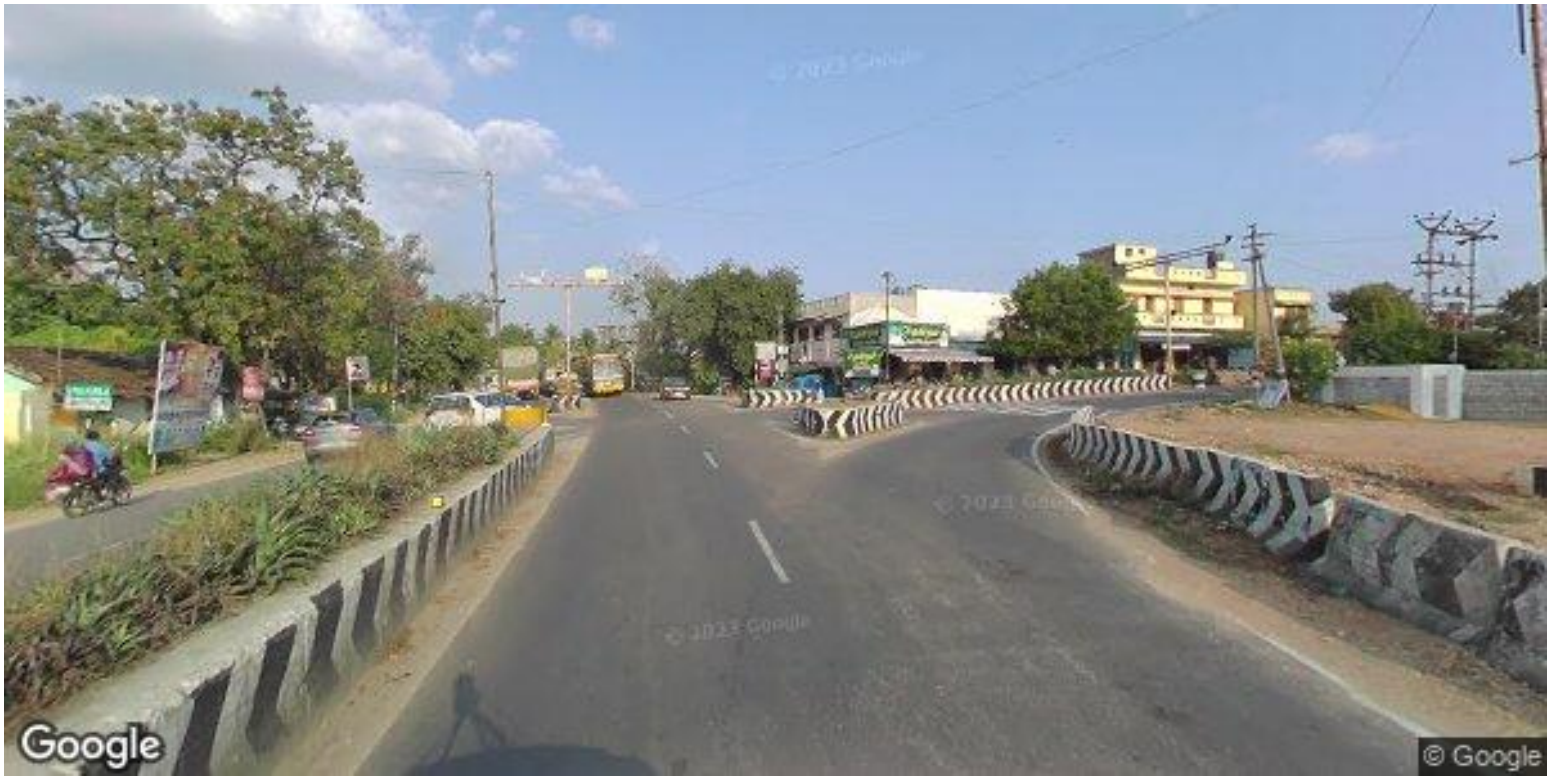
**Coordinates:** 11.46318, 77.84913

**Risk Type:** Turn

**Risk Level:** Medium

**Speed Limit:** 30 KM/Hr

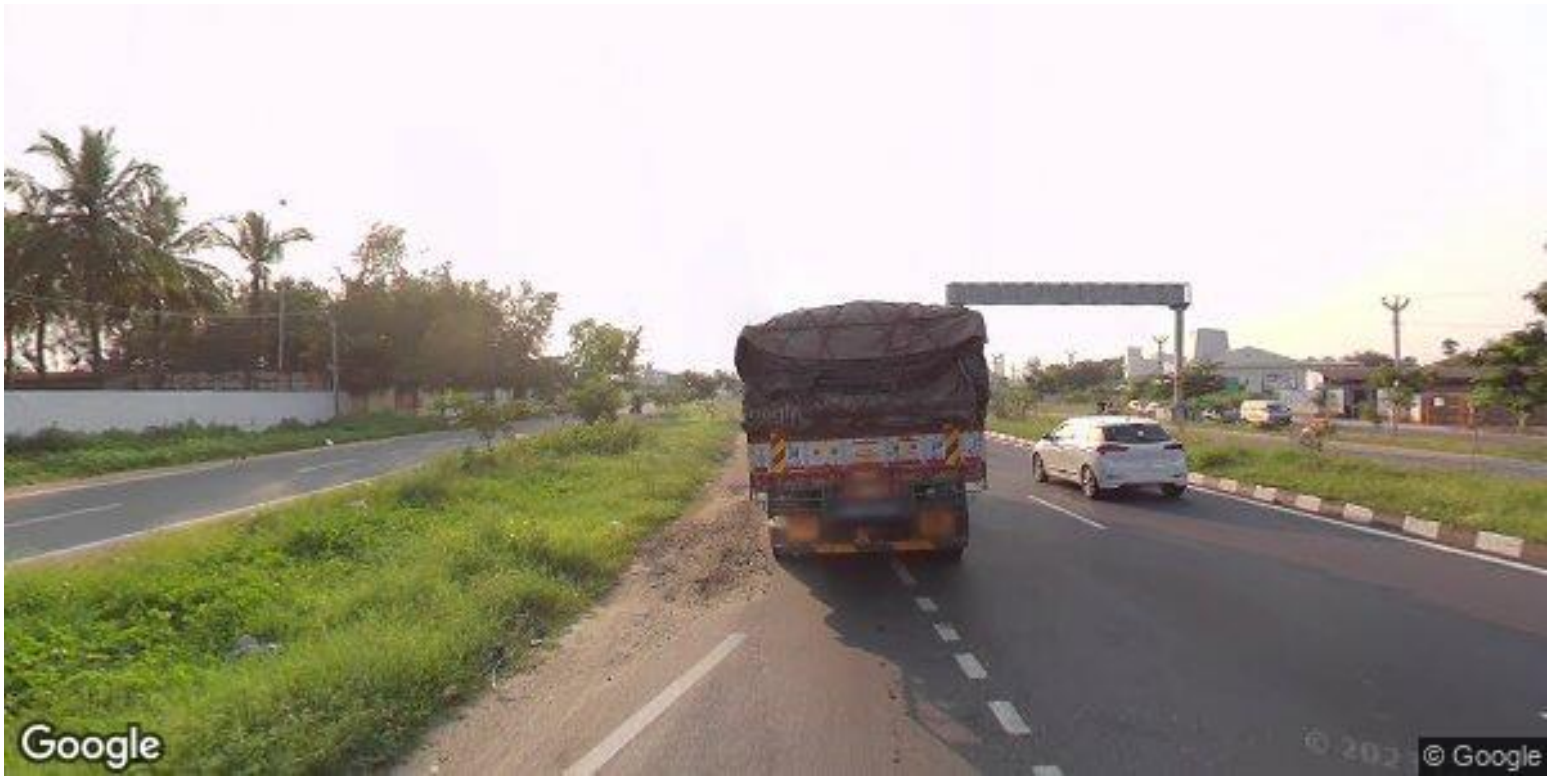
**Coordinates:** 11.45517, 77.81345

**Risk Type:** Turn

**Risk Level:** High

**Speed Limit:** 15 KM/Hr

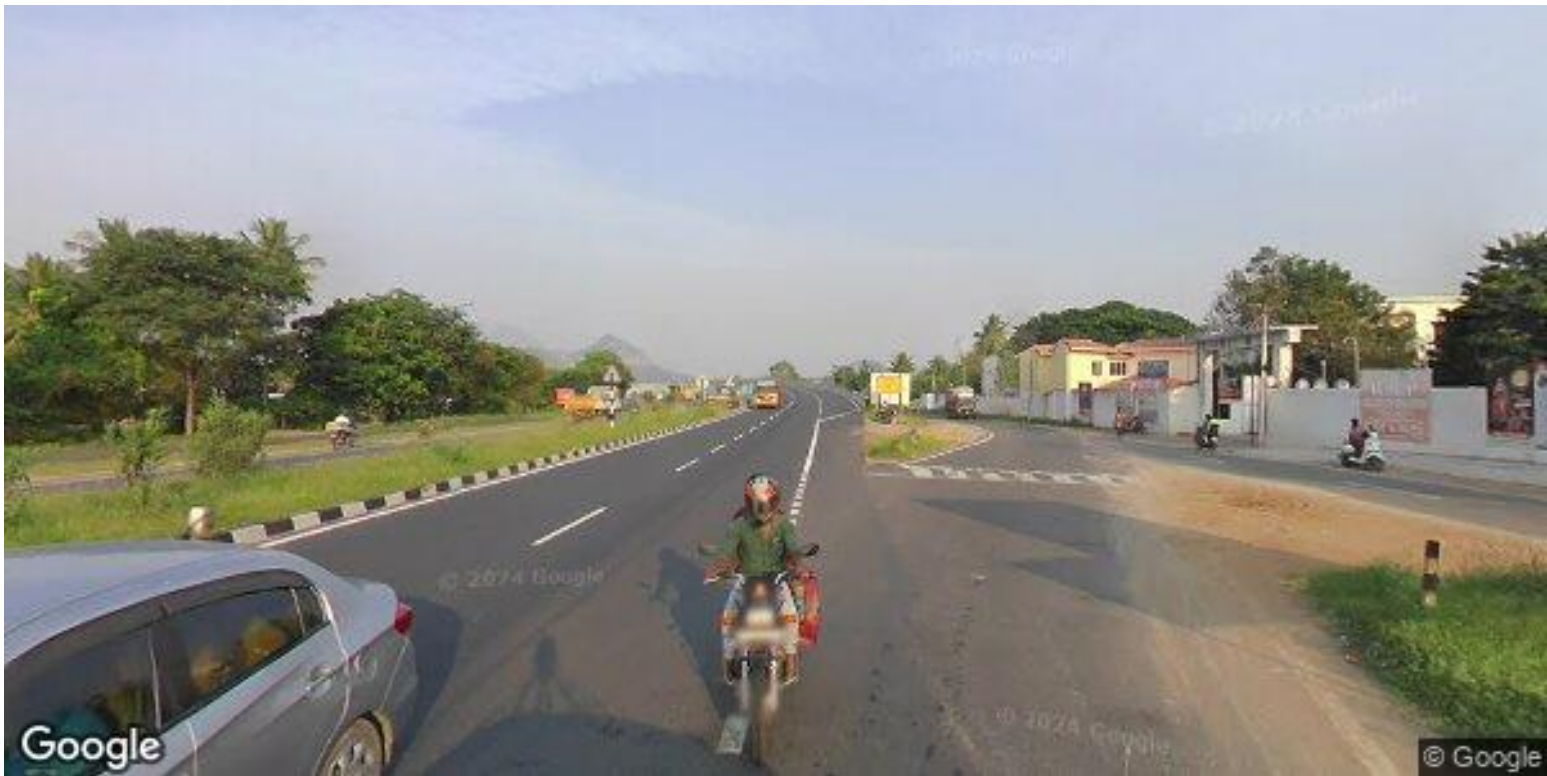
**Risk Type:** Turn  
**Risk Level:** High  
**Speed Limit:** 15 KM/Hr  
**Coordinates:** 11.45521, 77.81343

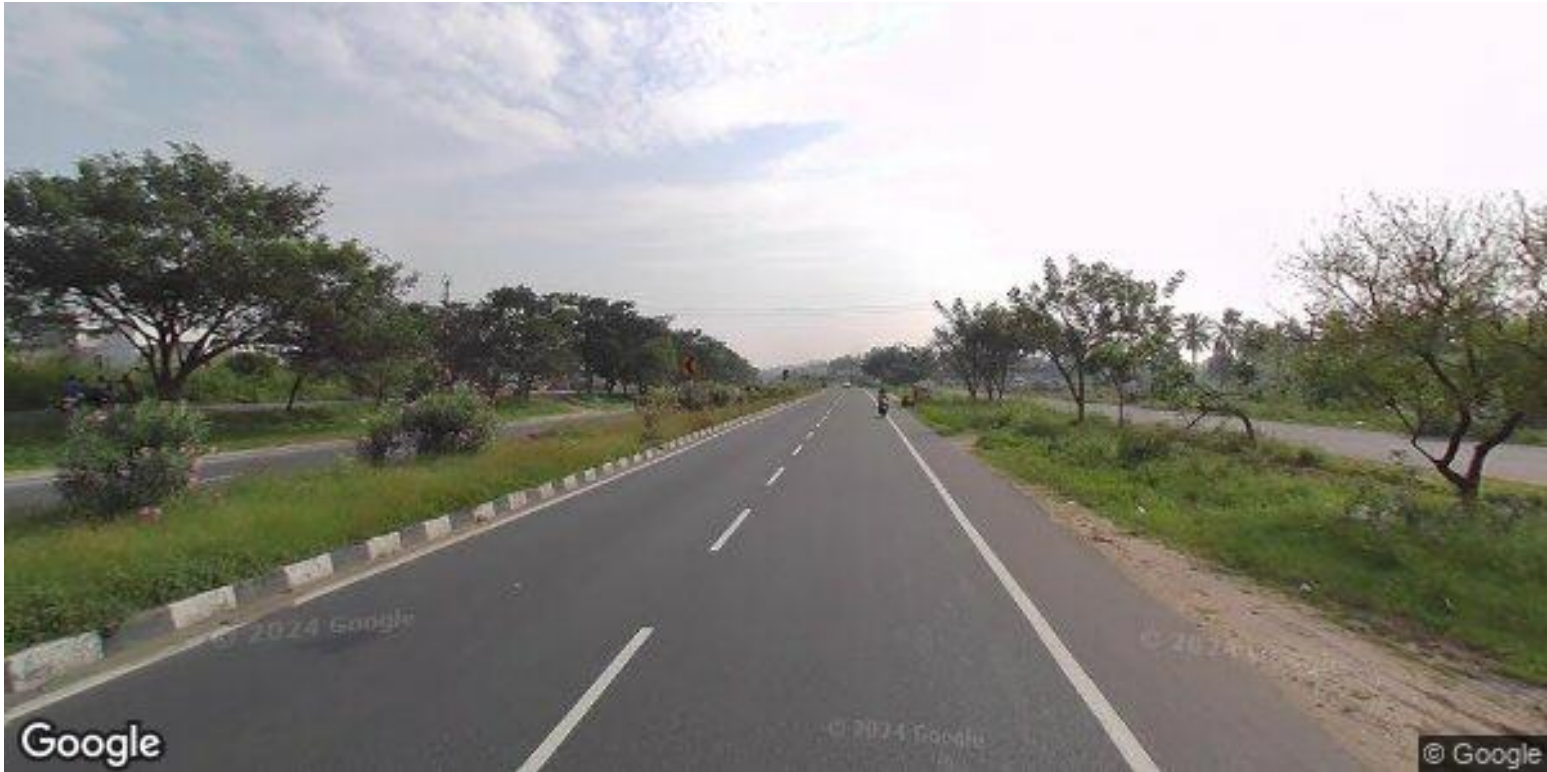
**Risk Type:** Turn  
**Risk Level:** Medium  
**Speed Limit:** 30 KM/Hr  
**Coordinates:** 11.44467, 77.72092

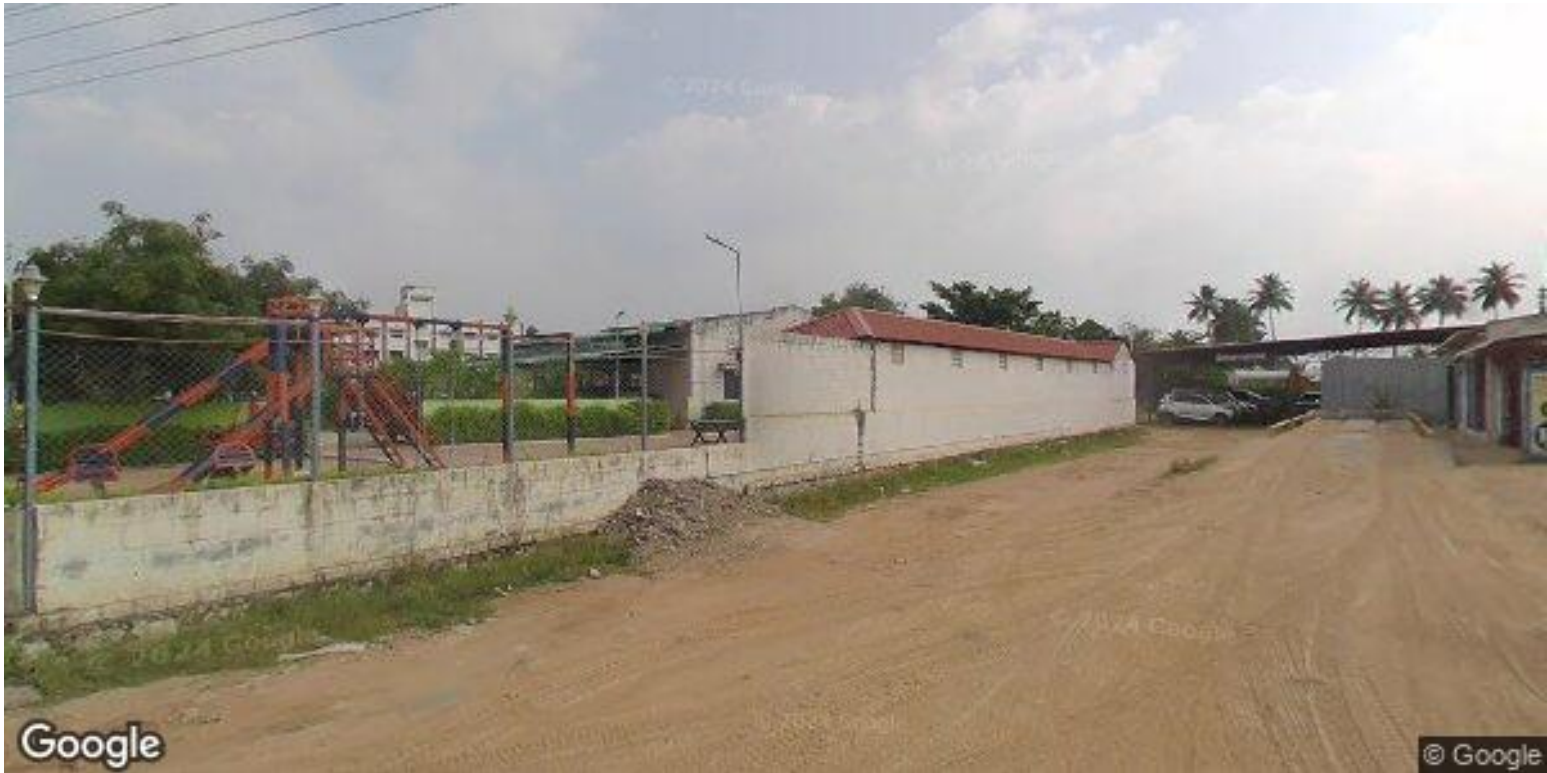
**Risk Type:** Turn  
**Risk Level:** High  
**Speed Limit:** 15 KM/Hr  
**Coordinates:** 11.44377, 77.71562

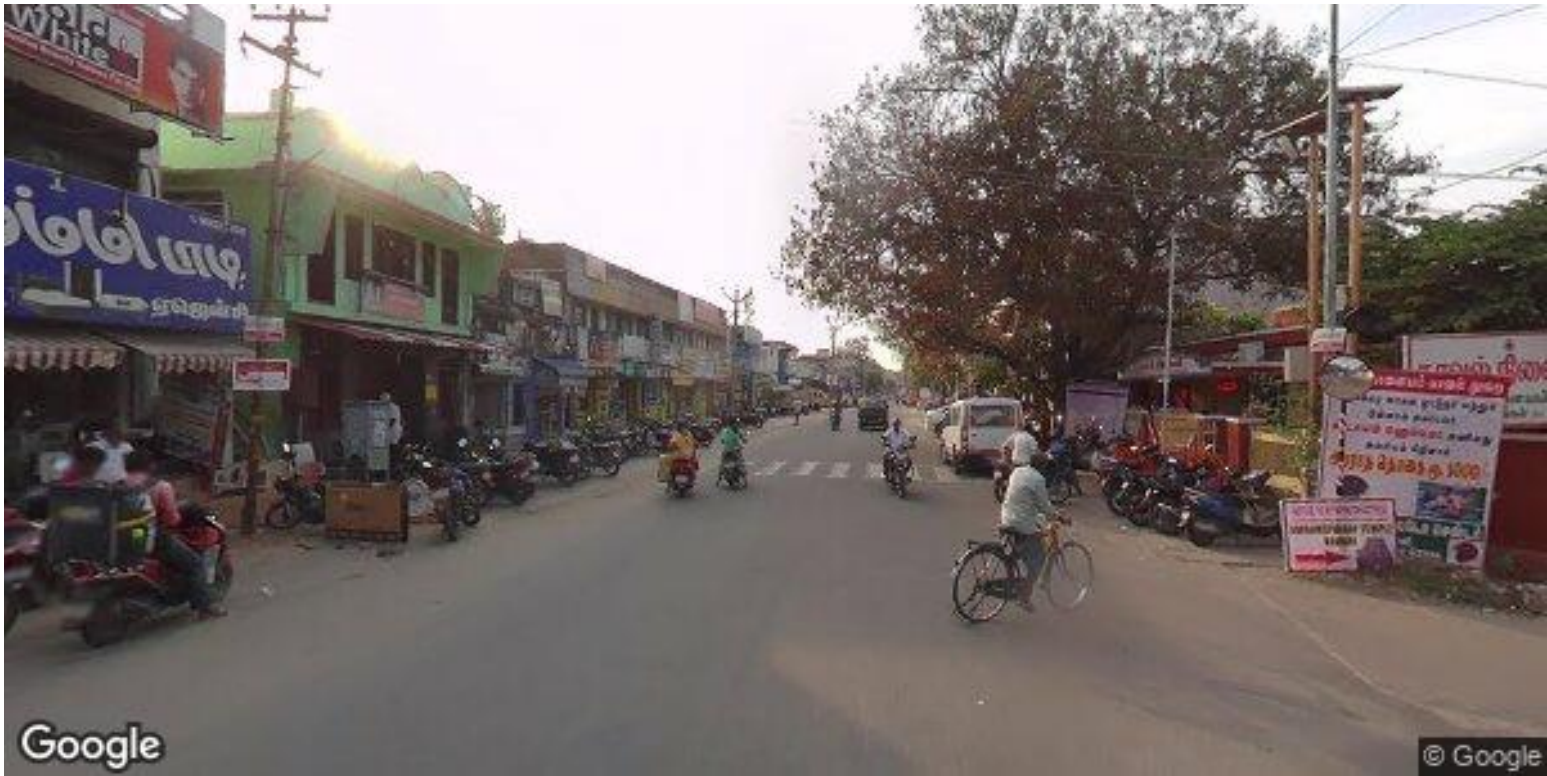
**Risk Type:** Blind Spot  
**Risk Level:** Blind Spot  
**Speed Limit:** 10 KM/Hr  
**Coordinates:** 11.44105, 77.69331

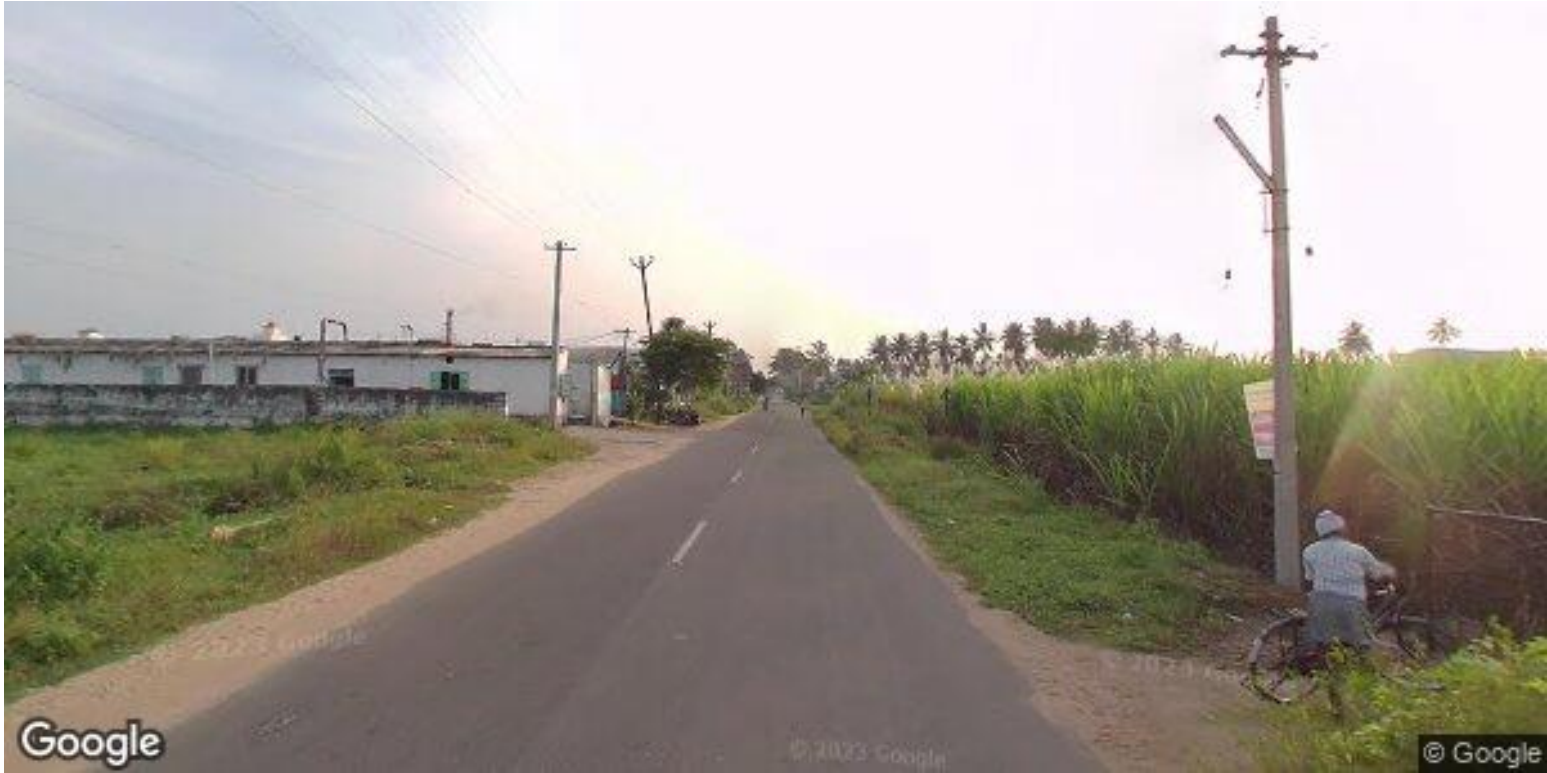
**Risk Type:** Turn  
**Risk Level:** High  
**Speed Limit:** 15 KM/Hr  
**Coordinates:** 11.45711, 77.69765
