# IndianOil

## JOURNEY RISK MANAGEMENT (JRM) STUDY

### Salem Terminal TO SAI VENKATESWARA FUELS

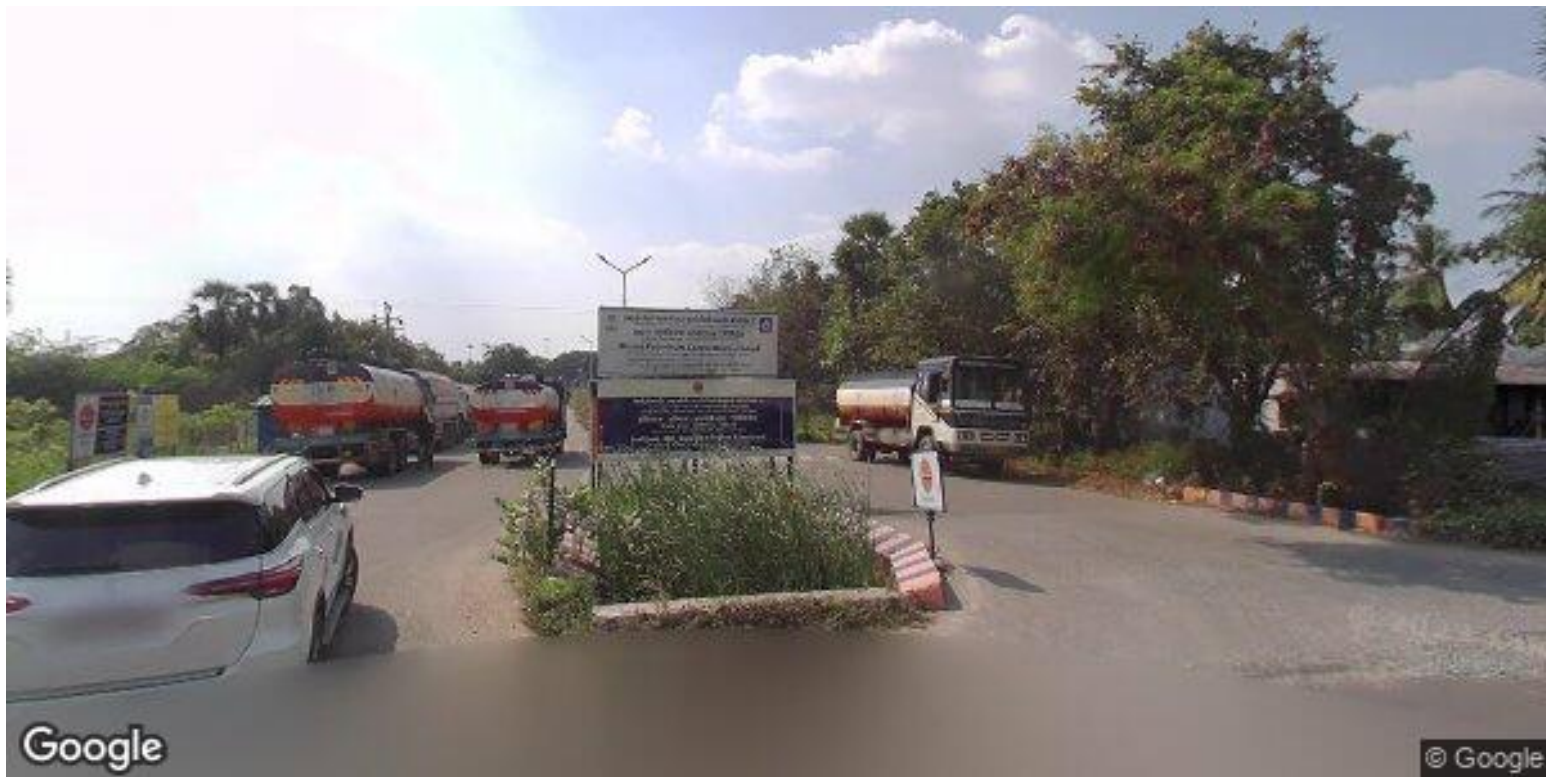
**Coordinates:** 11.44024, 77.87528

**Risk Type:** Turn

**Risk Level:** High

**Speed Limit:** 15 KM/Hr

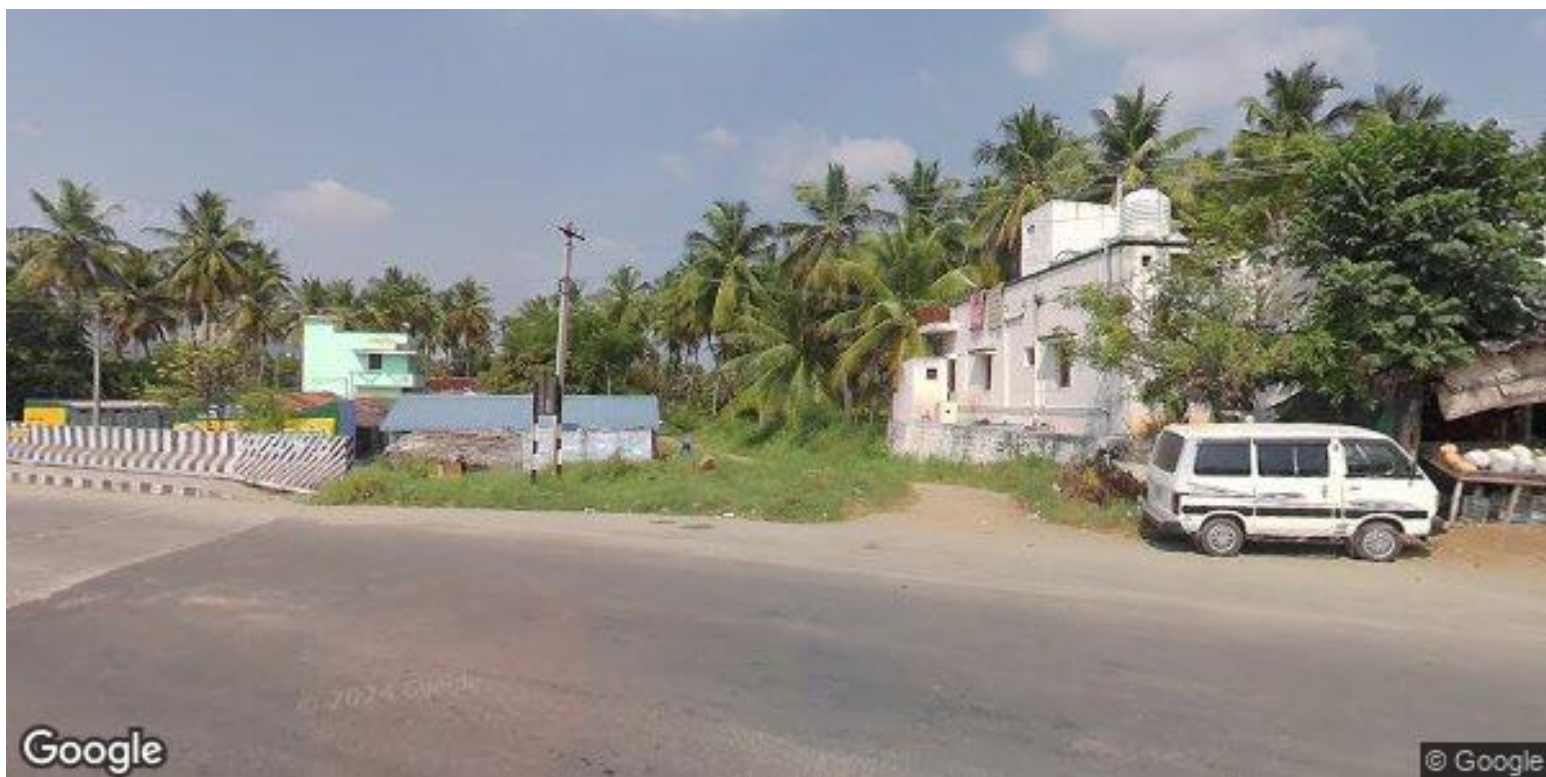
**Coordinates:** 11.44898, 77.87410

**Risk Type:** Turn

**Risk Level:** High

**Speed Limit:** 15 KM/Hr

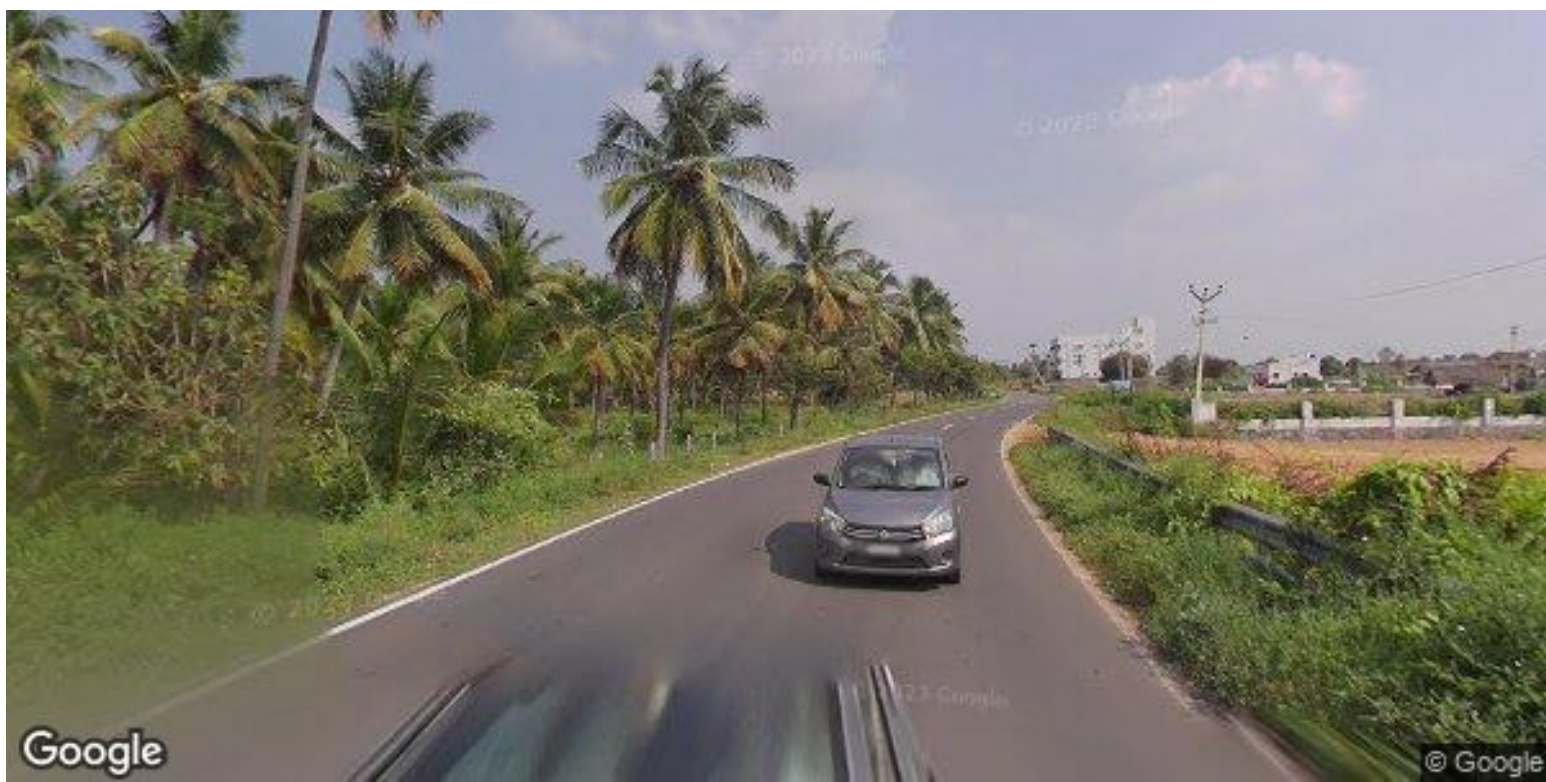
**Coordinates:** 11.45357, 77.85789

**Risk Type:** Turn

**Risk Level:** Medium

**Speed Limit:** 30 KM/Hr

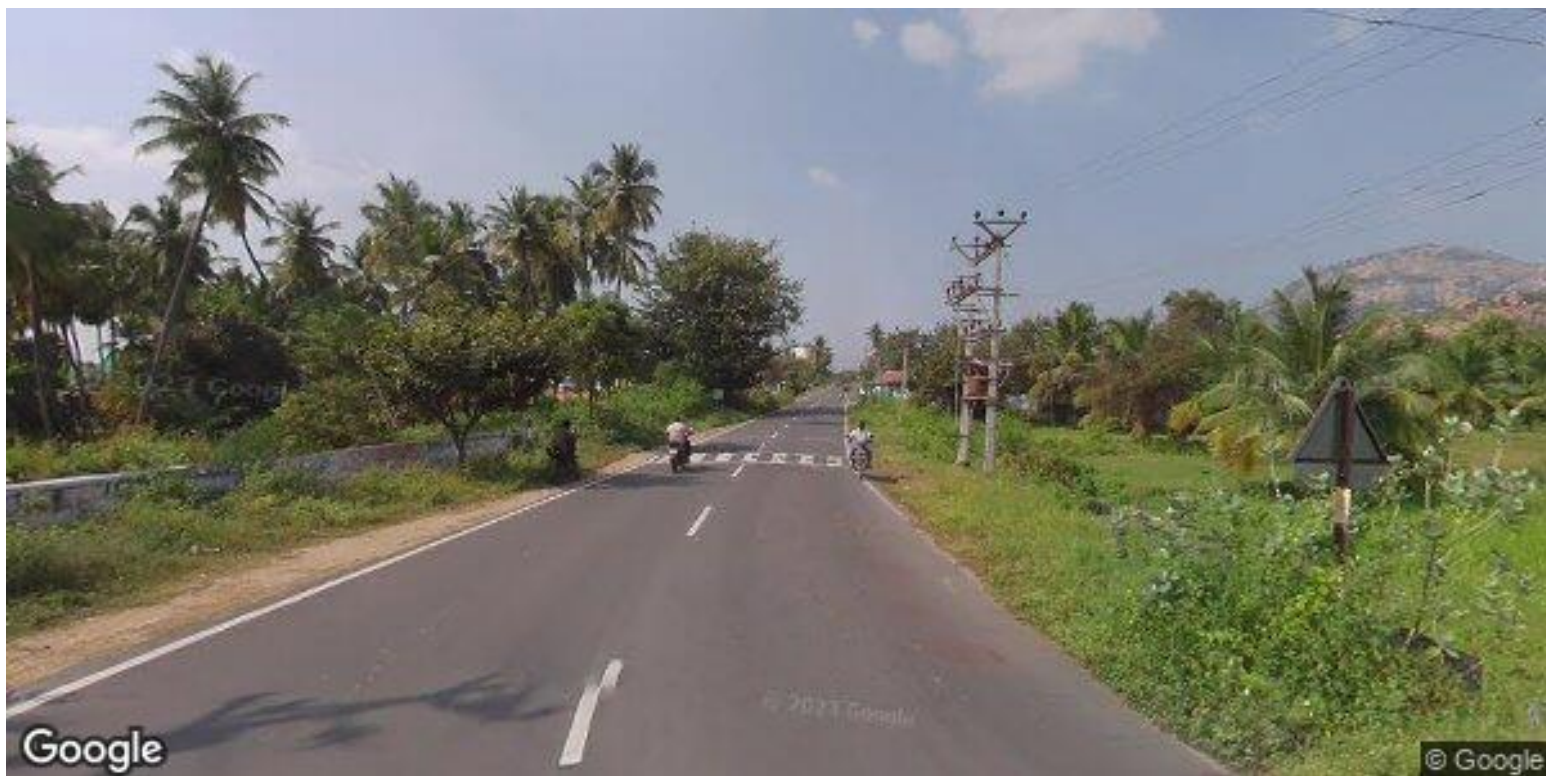
**Coordinates:** 11.45352, 77.85698

**Risk Type:** Turn

**Risk Level:** High

**Speed Limit:** 15 KM/Hr

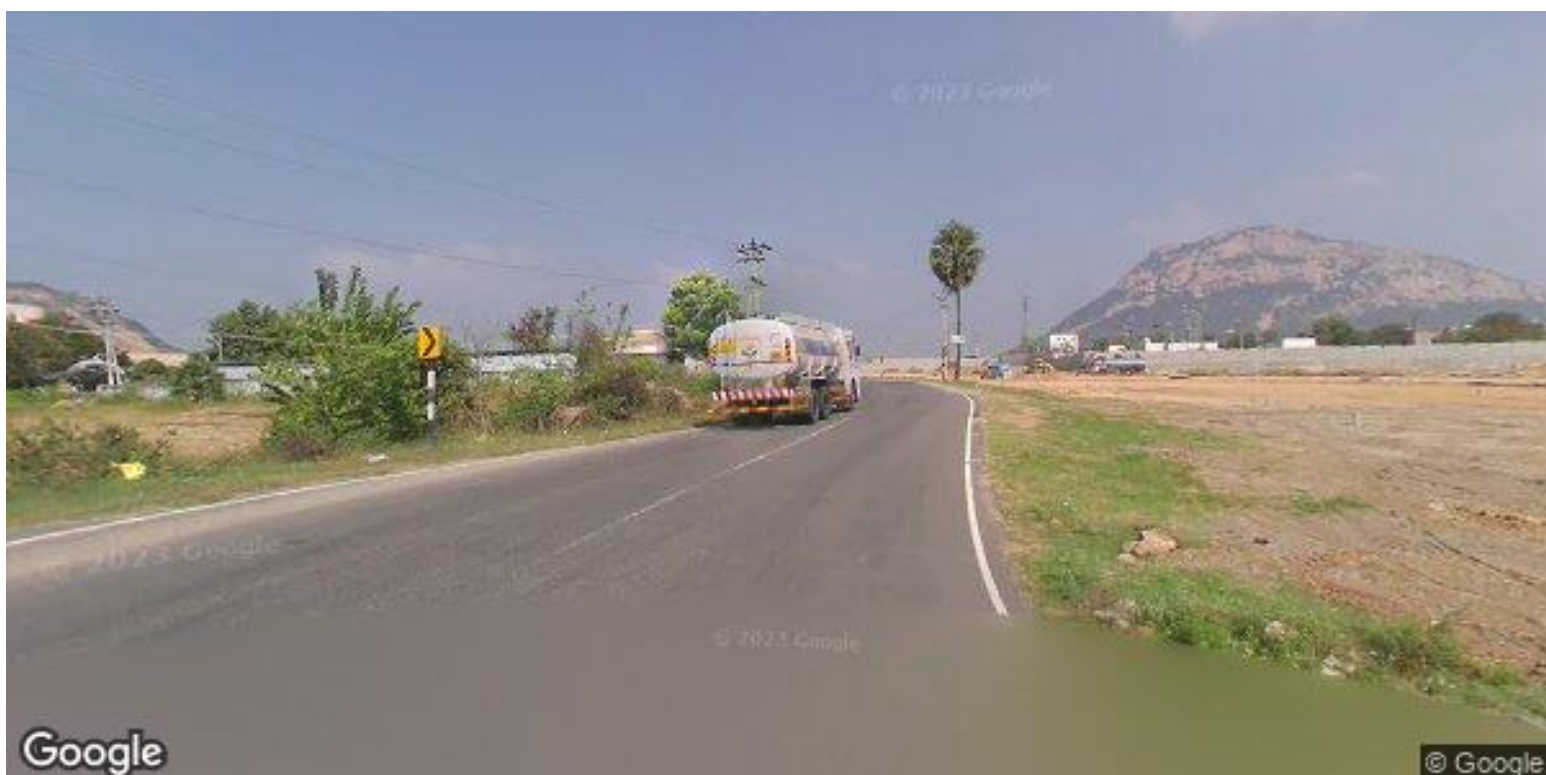
**Coordinates:** 11.45847, 77.85140

**Risk Type:** Turn

**Risk Level:** Medium

**Speed Limit:** 30 KM/Hr

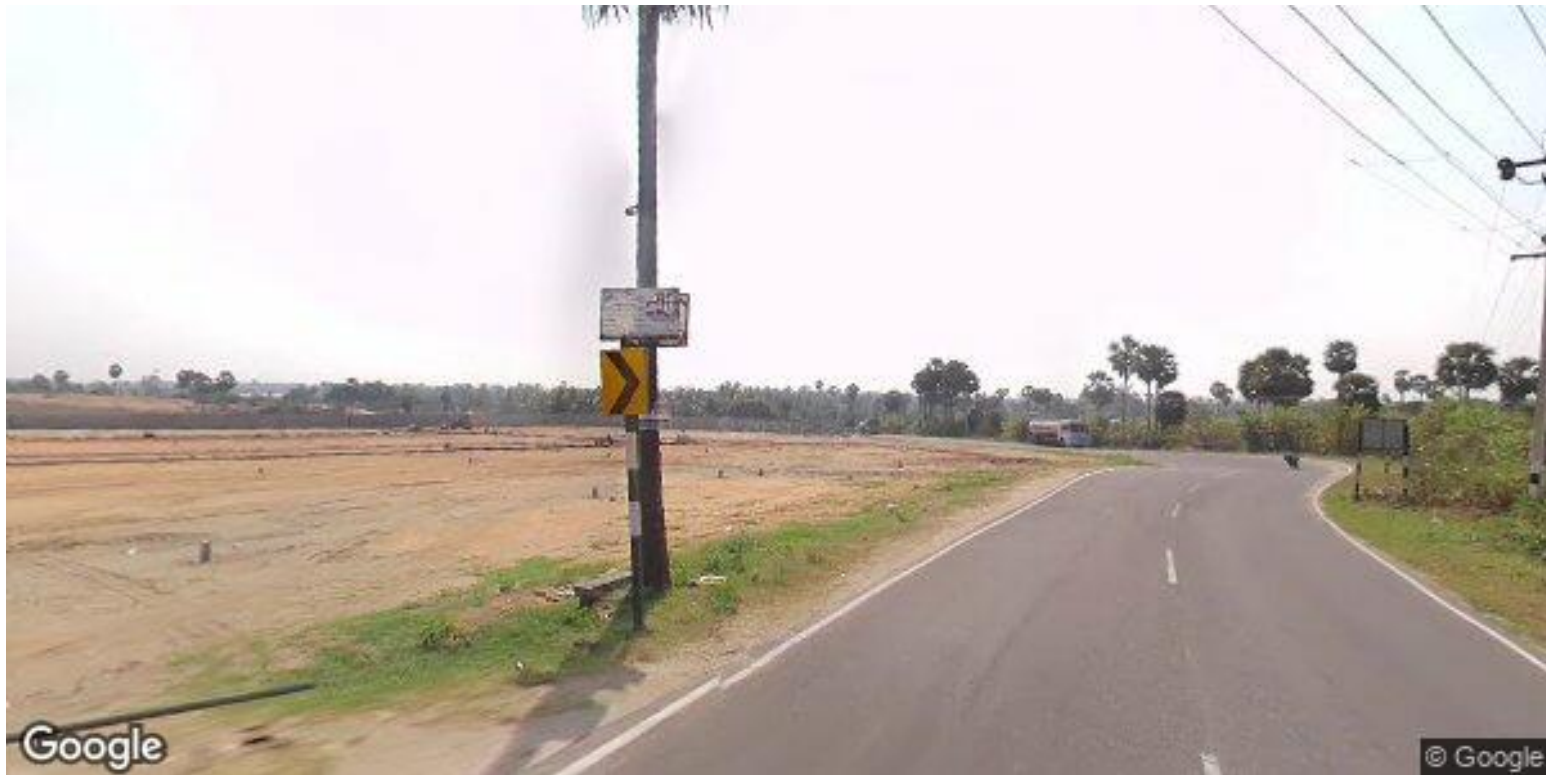
**Coordinates:** 11.45898, 77.85135

**Risk Type:** Turn

**Risk Level:** Medium

**Speed Limit:** 30 KM/Hr

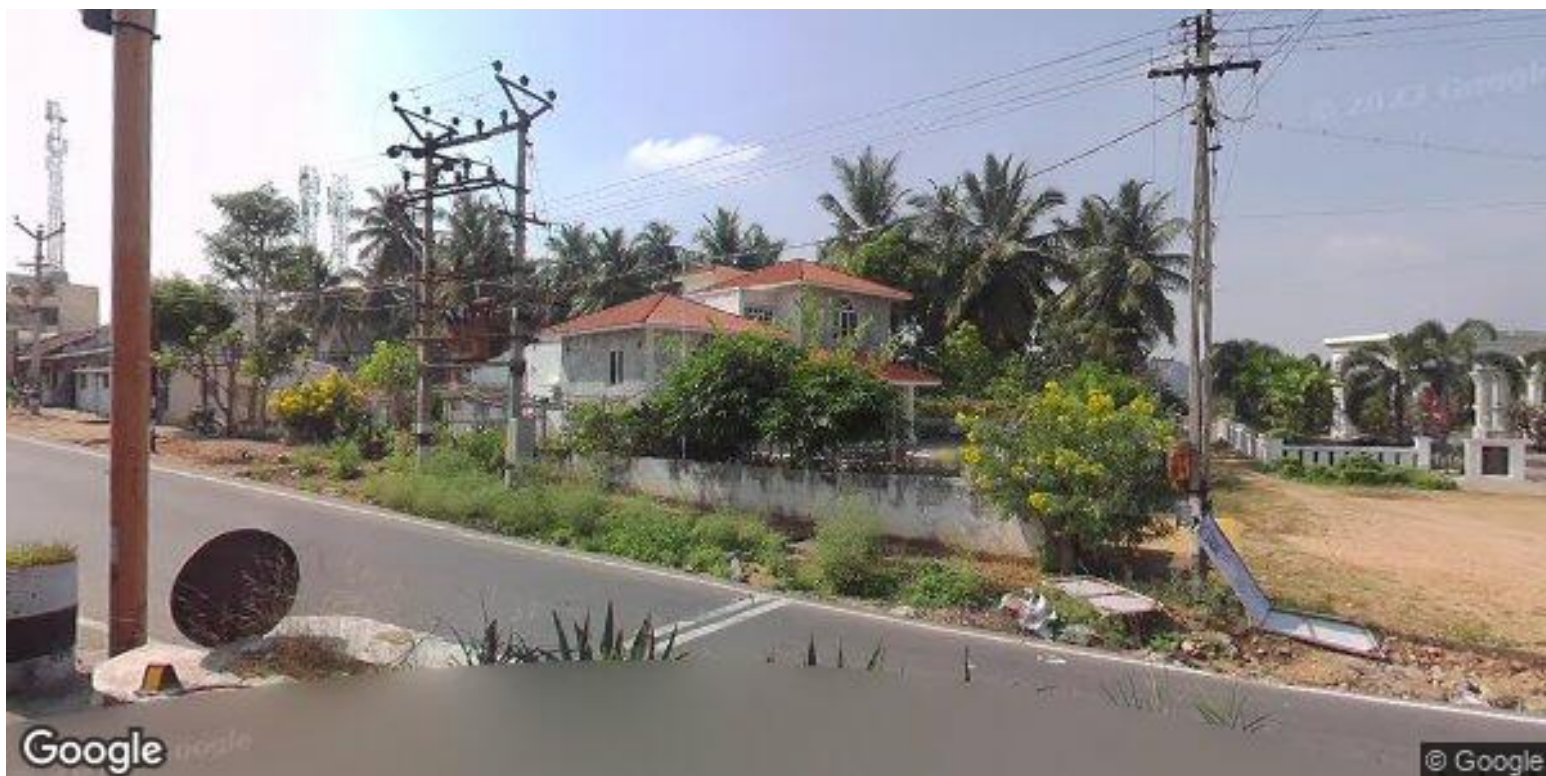
**Coordinates:** 11.46303, 77.84945

**Risk Type:** Turn

**Risk Level:** High

**Speed Limit:** 15 KM/Hr

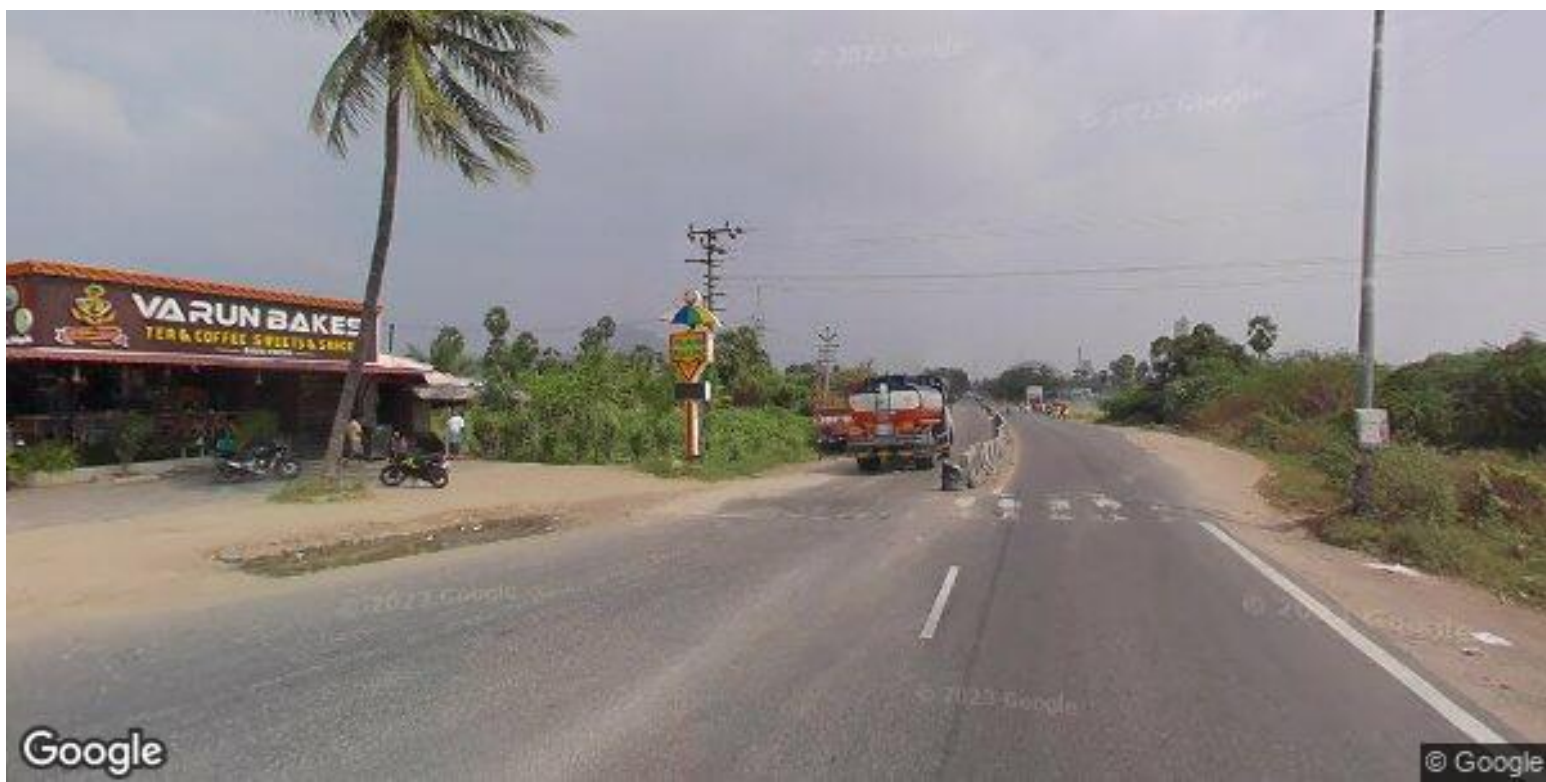
**Coordinates:** 11.45543, 77.81740

**Risk Type:** Turn

**Risk Level:** Medium

**Speed Limit:** 30 KM/Hr

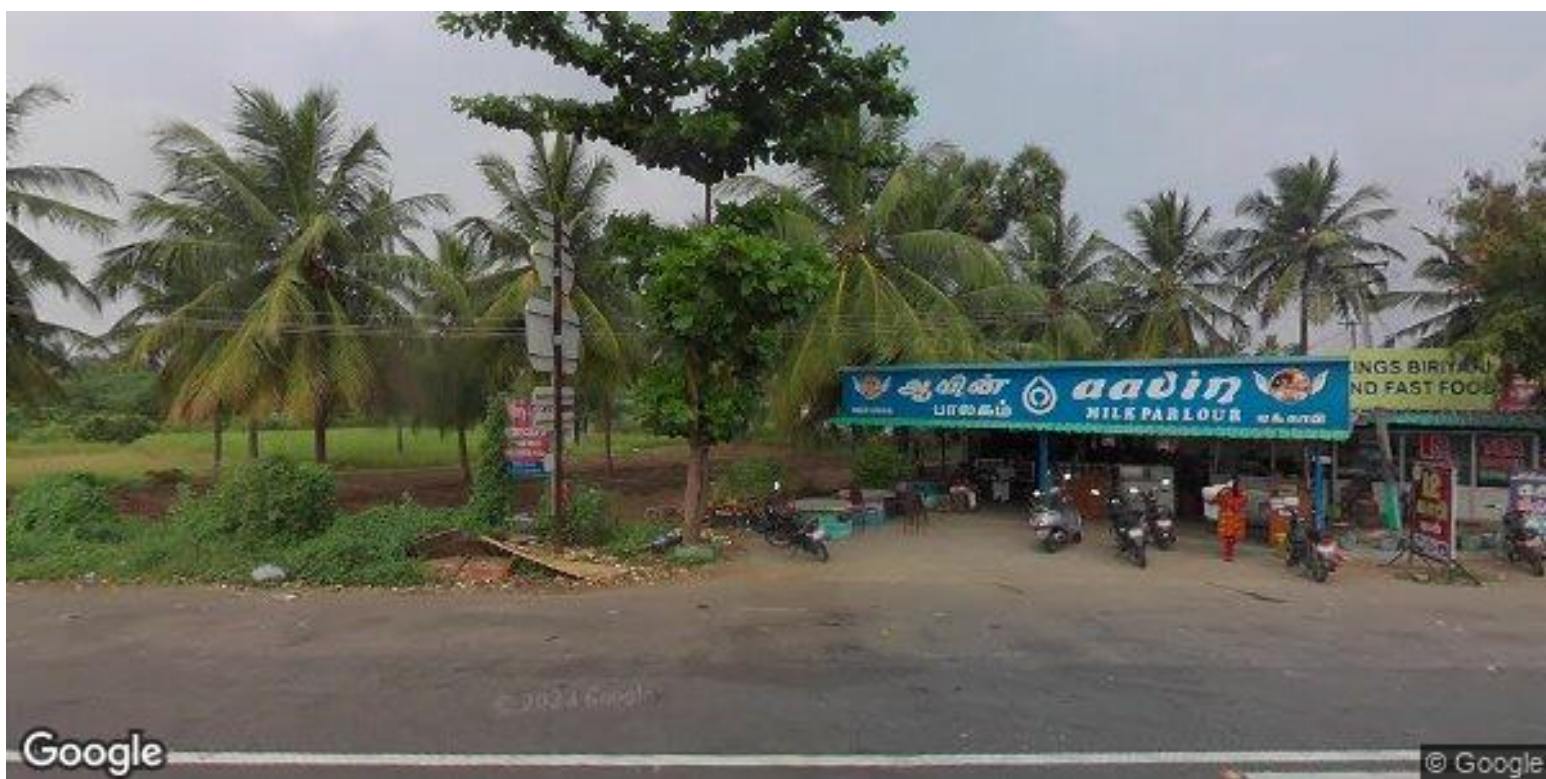
**Coordinates:** 11.45631, 77.81668

**Risk Type:** Turn

**Risk Level:** High

**Speed Limit:** 15 KM/Hr

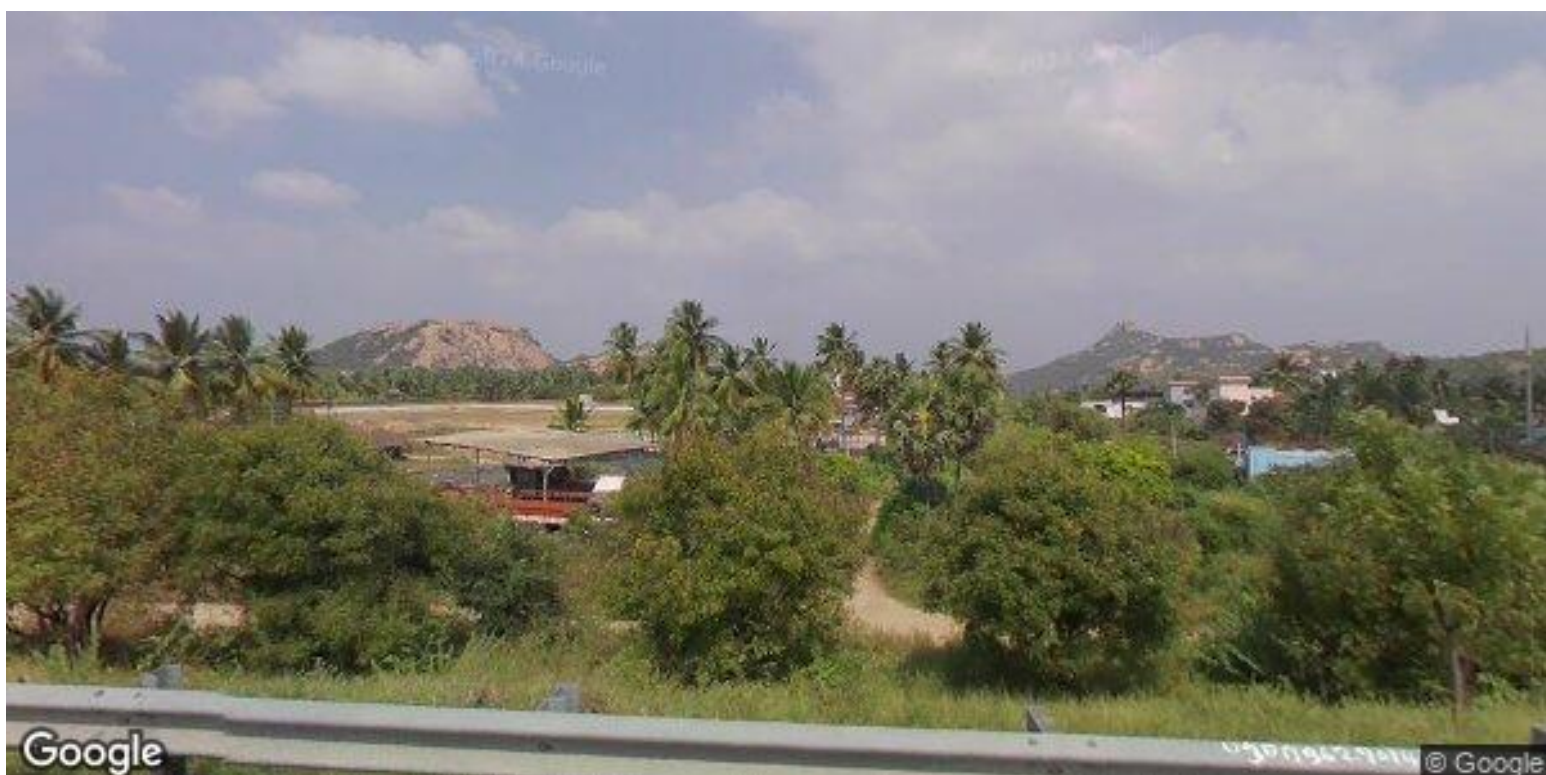
**Risk Type:** Turn  
**Risk Level:** High  
**Speed Limit:** 15 KM/Hr  
**Coordinates:** 11.49383, 77.88442

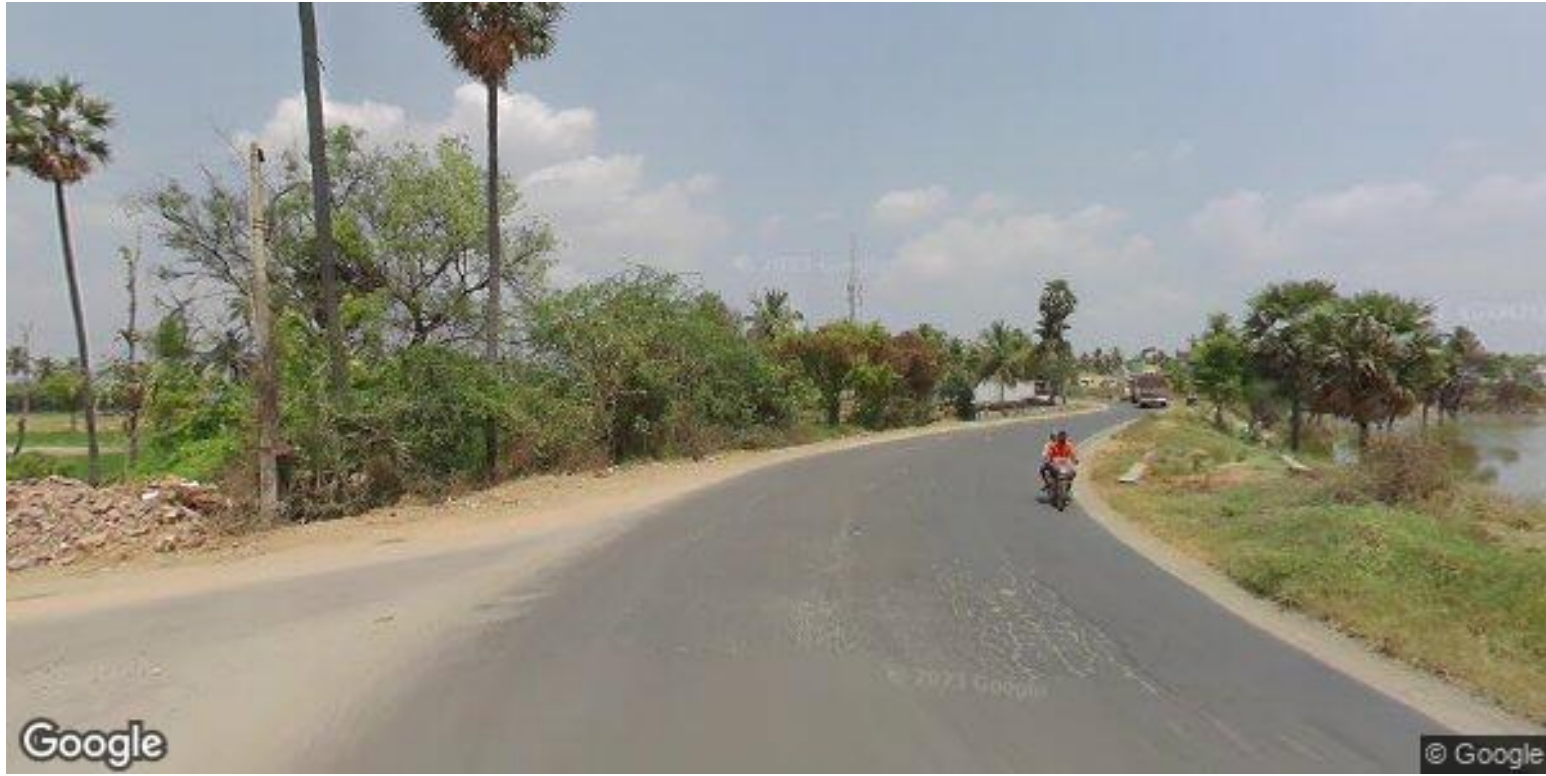
**Risk Type:** Turn  
**Risk Level:** Medium  
**Speed Limit:** 30 KM/Hr  
**Coordinates:** 11.56083, 77.89921

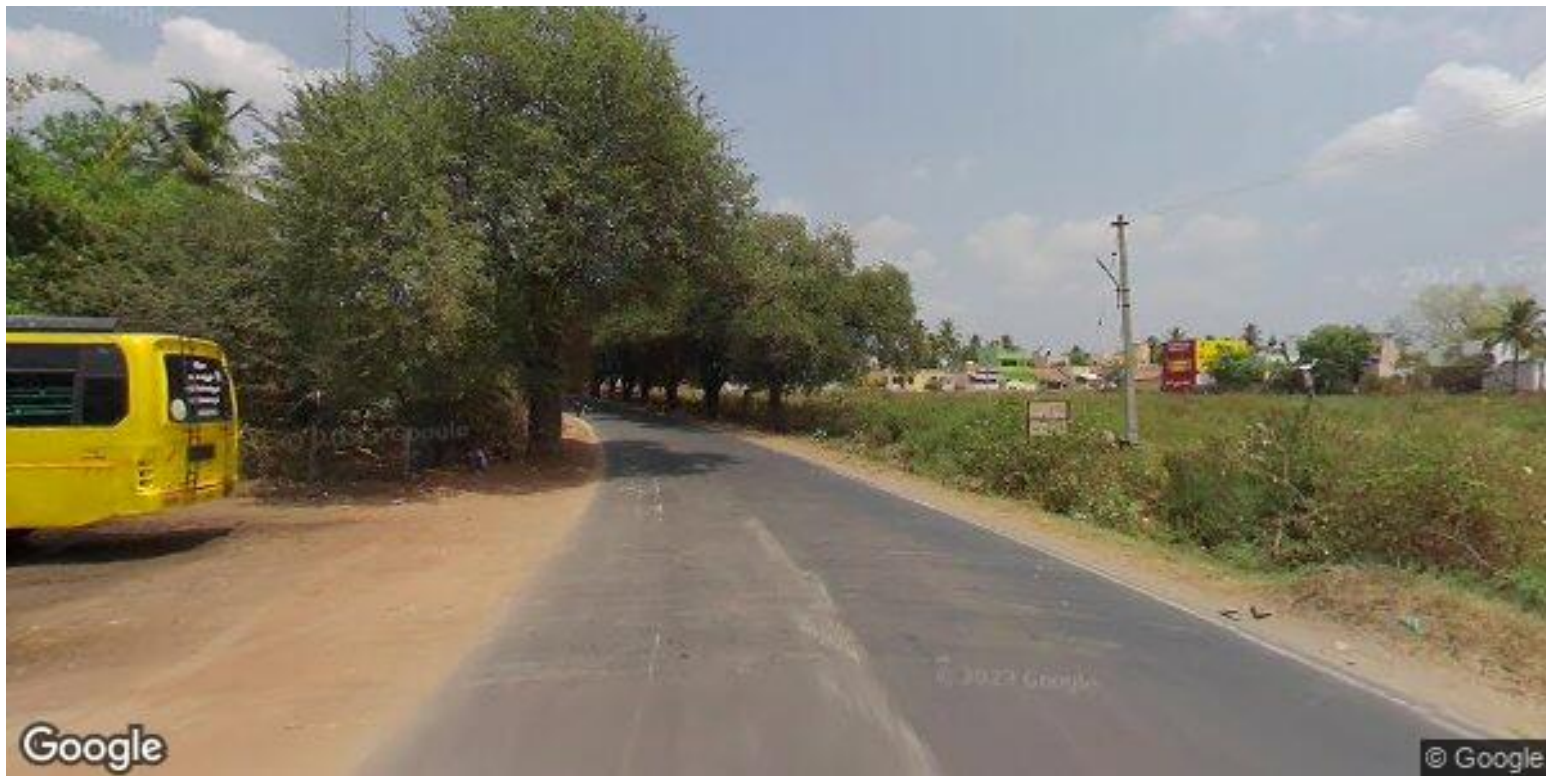
**Risk Type:** Turn  
**Risk Level:** Medium  
**Speed Limit:** 30 KM/Hr  
**Coordinates:** 11.56180, 77.90019

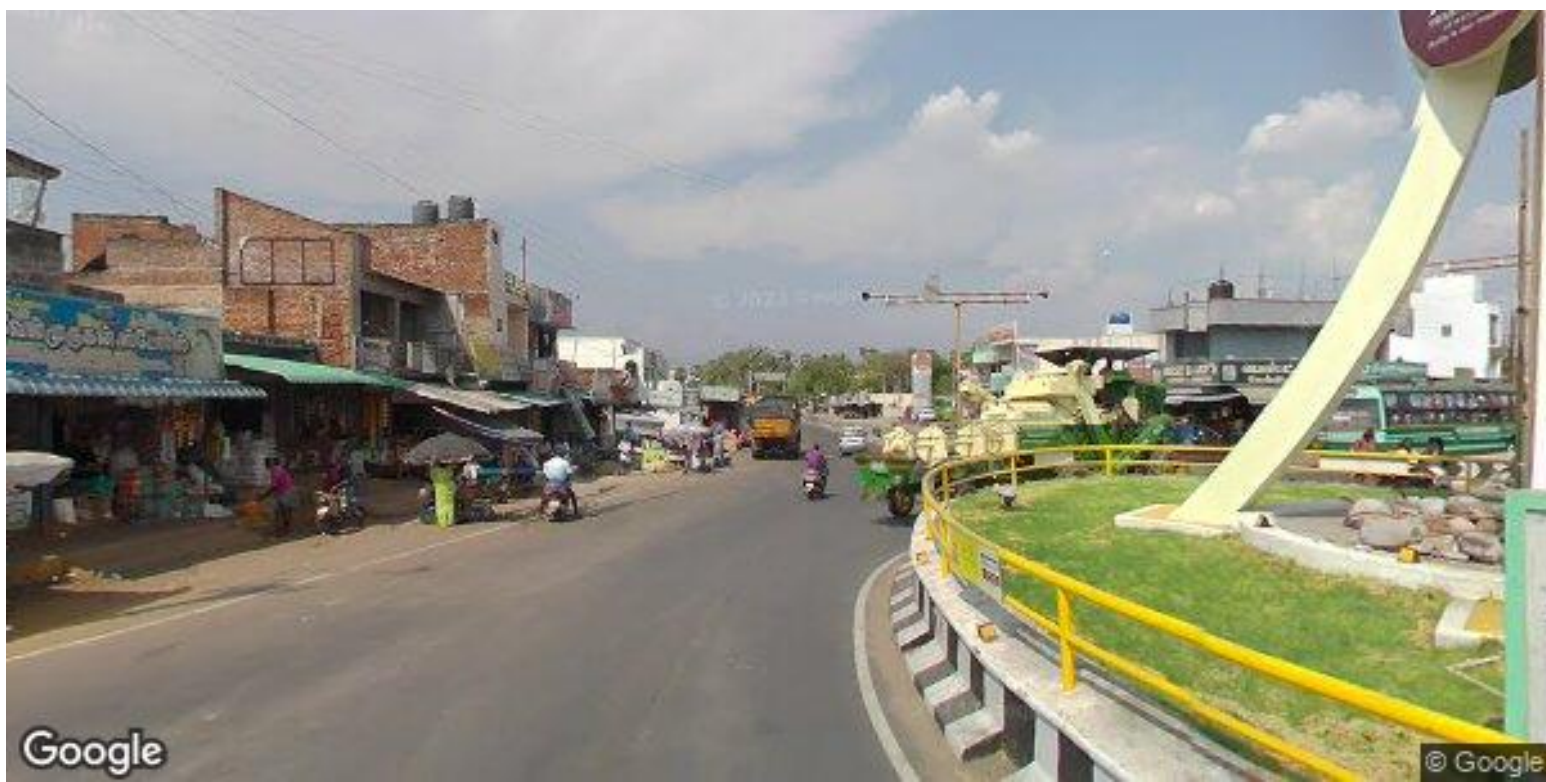
**Coordinates:** 11.57048, 77.90224

**Risk Type:** Turn

**Risk Level:** Medium

**Speed Limit:** 30 KM/Hr

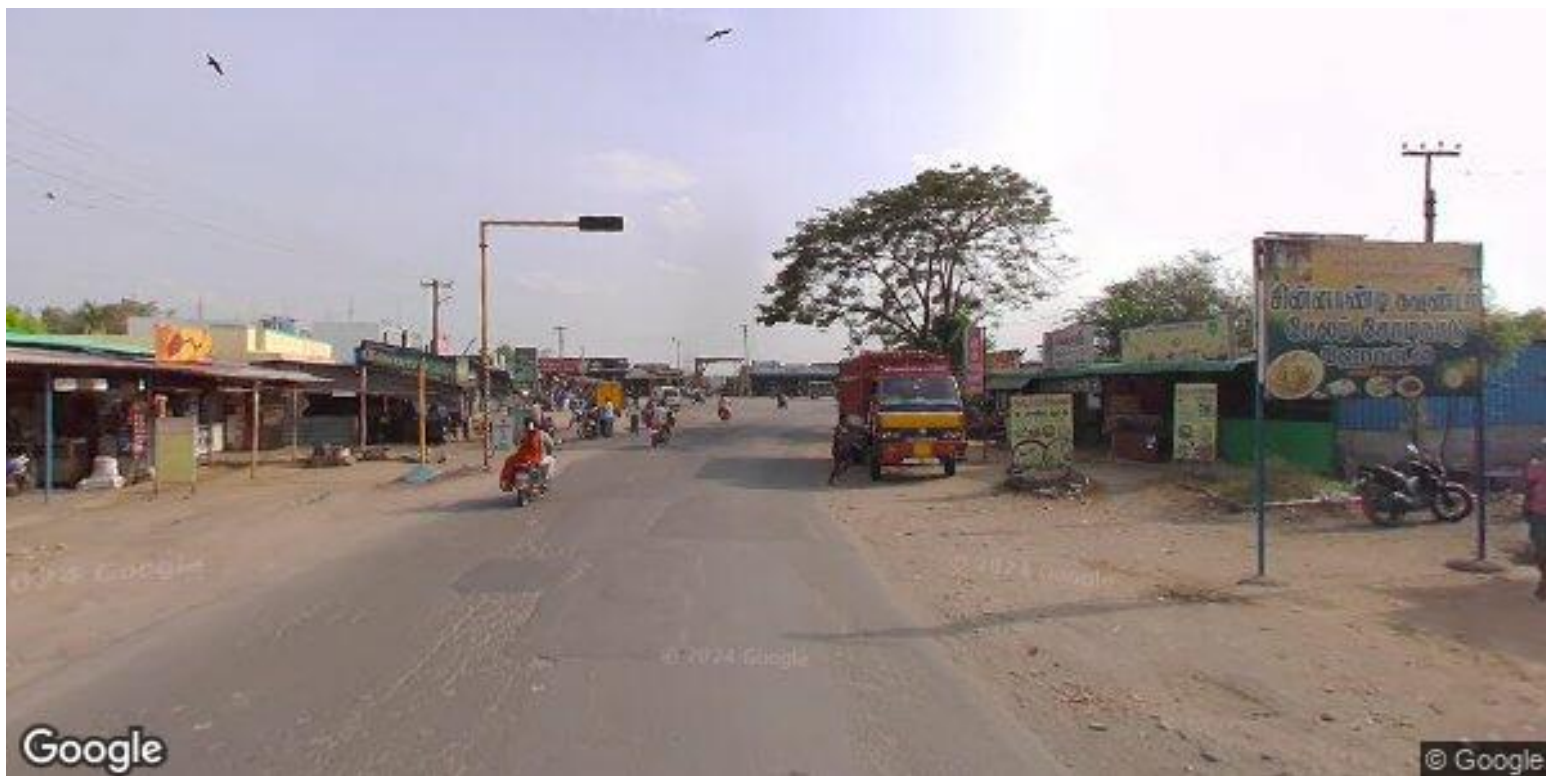
**Coordinates:** 11.64217, 77.95200

**Risk Type:** Turn

**Risk Level:** Medium

**Speed Limit:** 30 KM/Hr

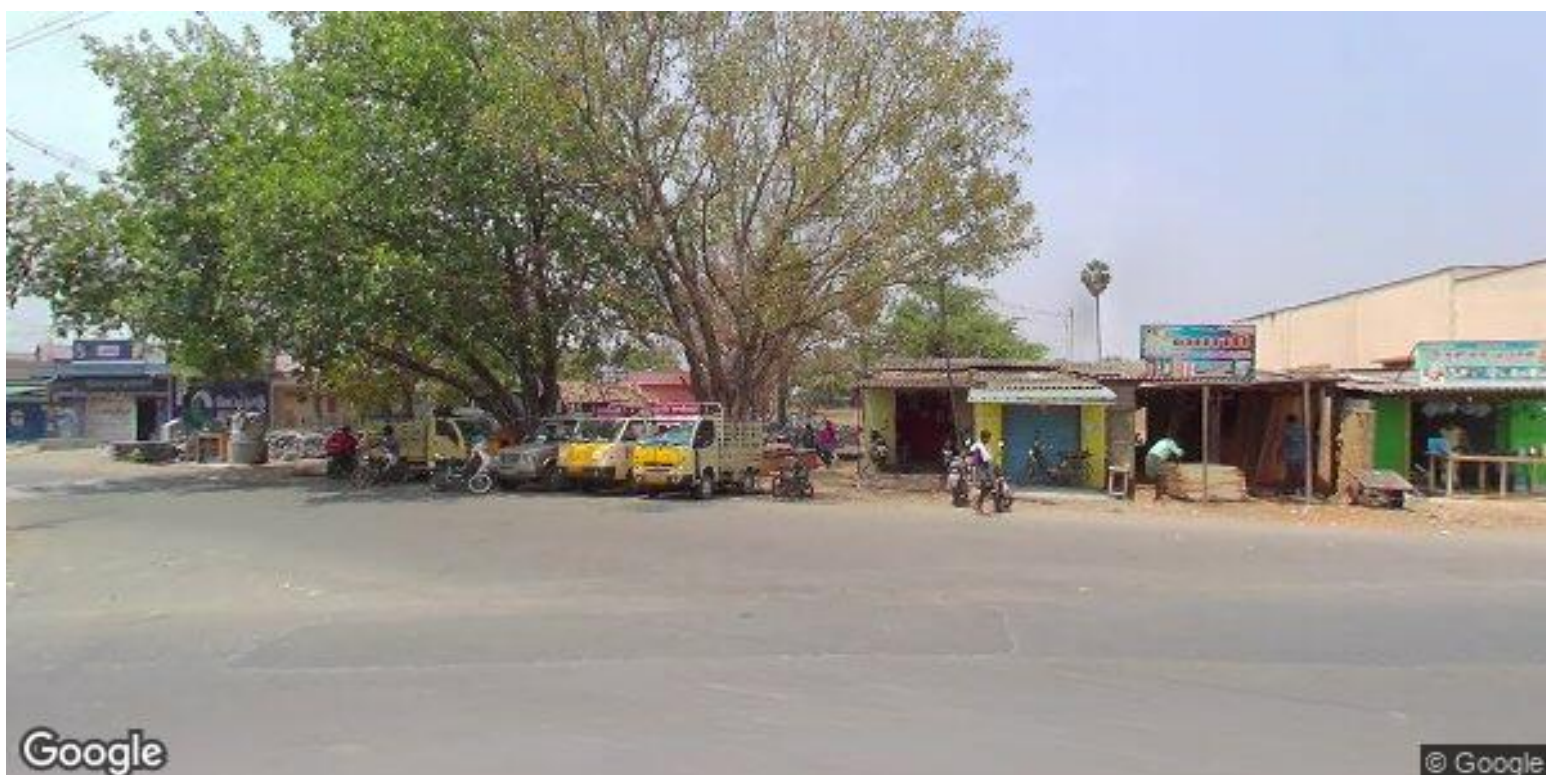
**Coordinates:** 11.64712, 77.95118

**Risk Type:** Turn

**Risk Level:** Medium

**Speed Limit:** 30 KM/Hr

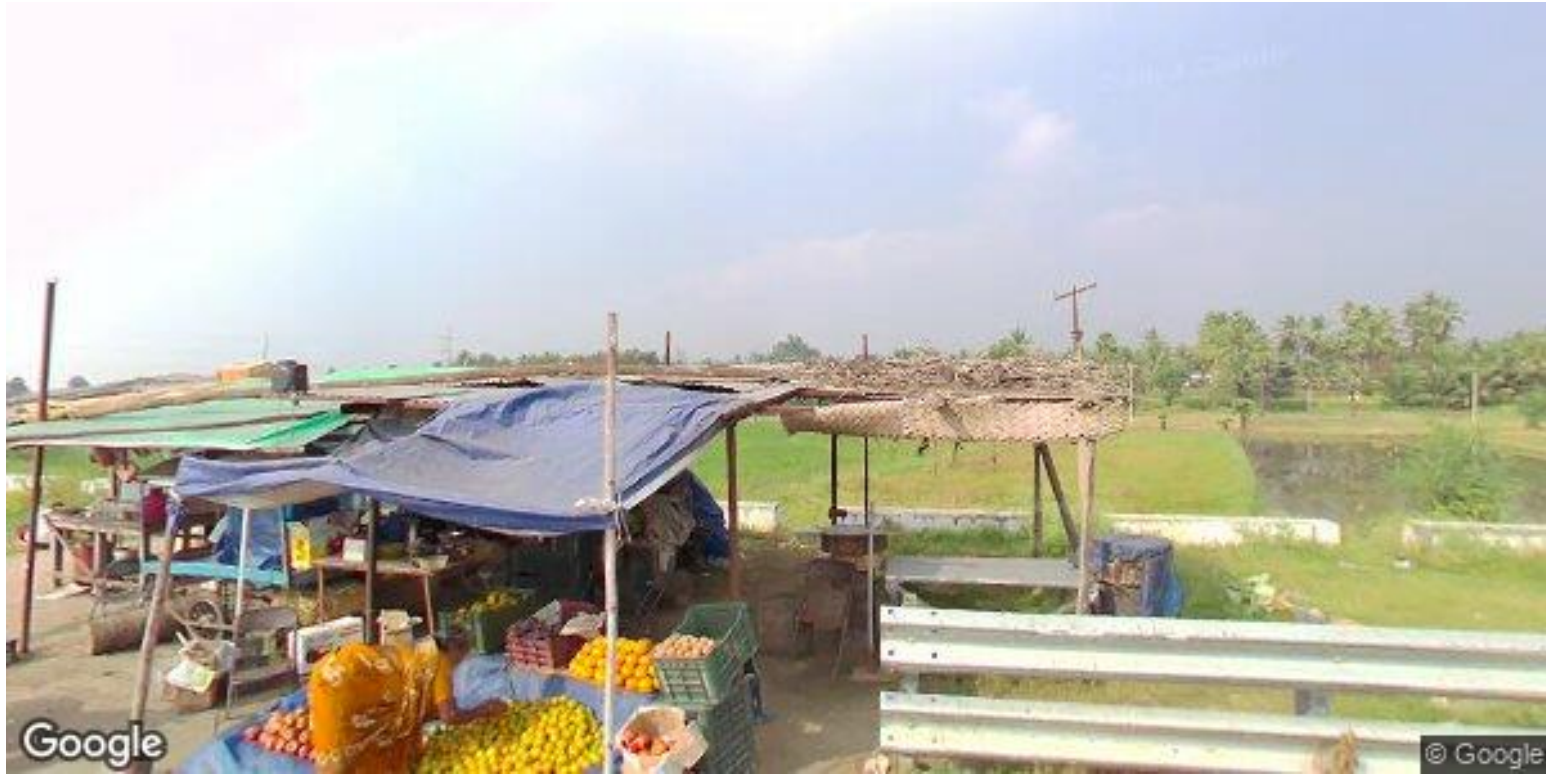
**Coordinates:** 11.67858, 77.96834

**Risk Type:** Turn

**Risk Level:** High

**Speed Limit:** 15 KM/Hr

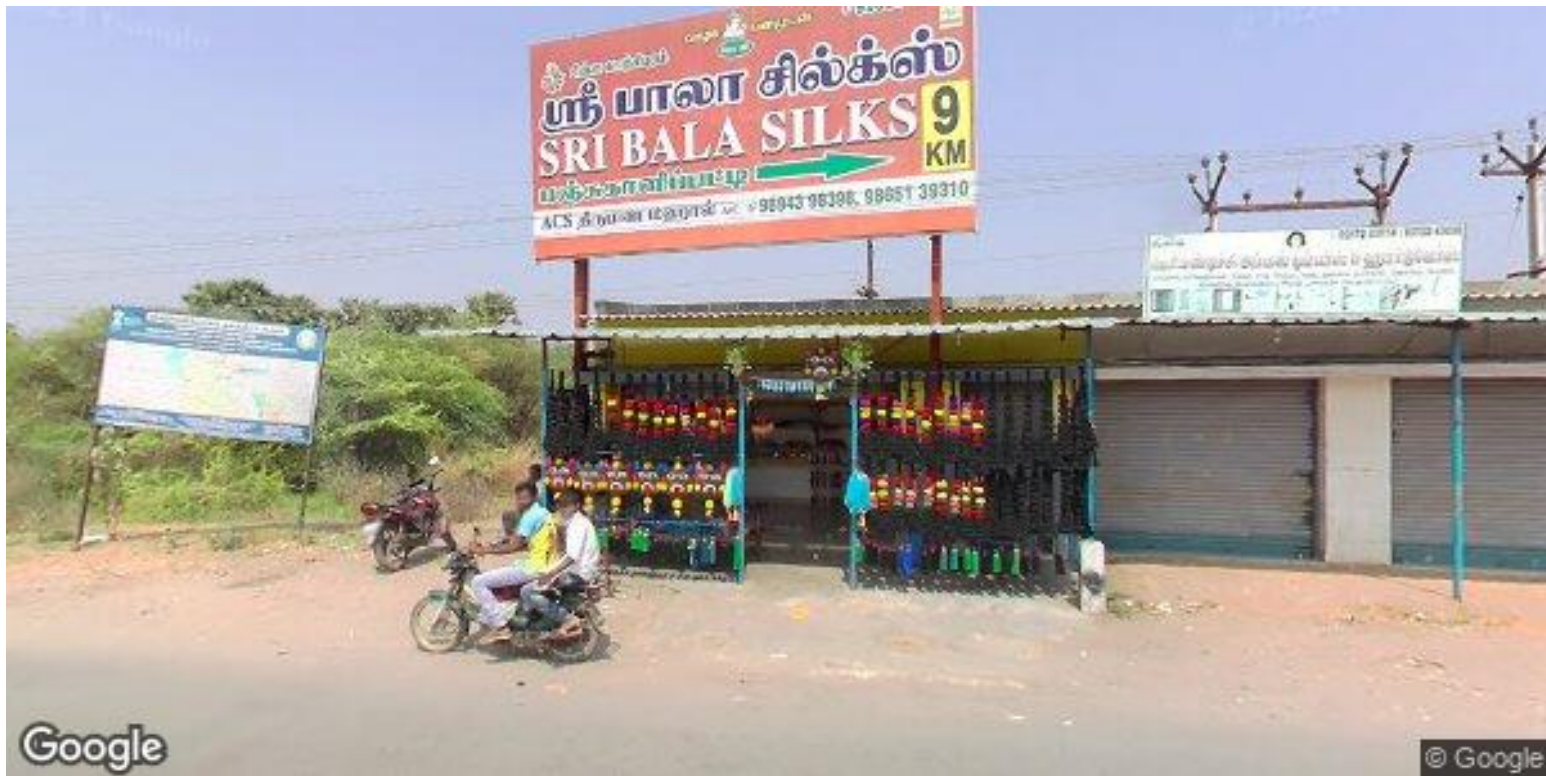
**Coordinates:** 11.70233, 77.97869

**Risk Type:** Turn

**Risk Level:** High

**Speed Limit:** 15 KM/Hr

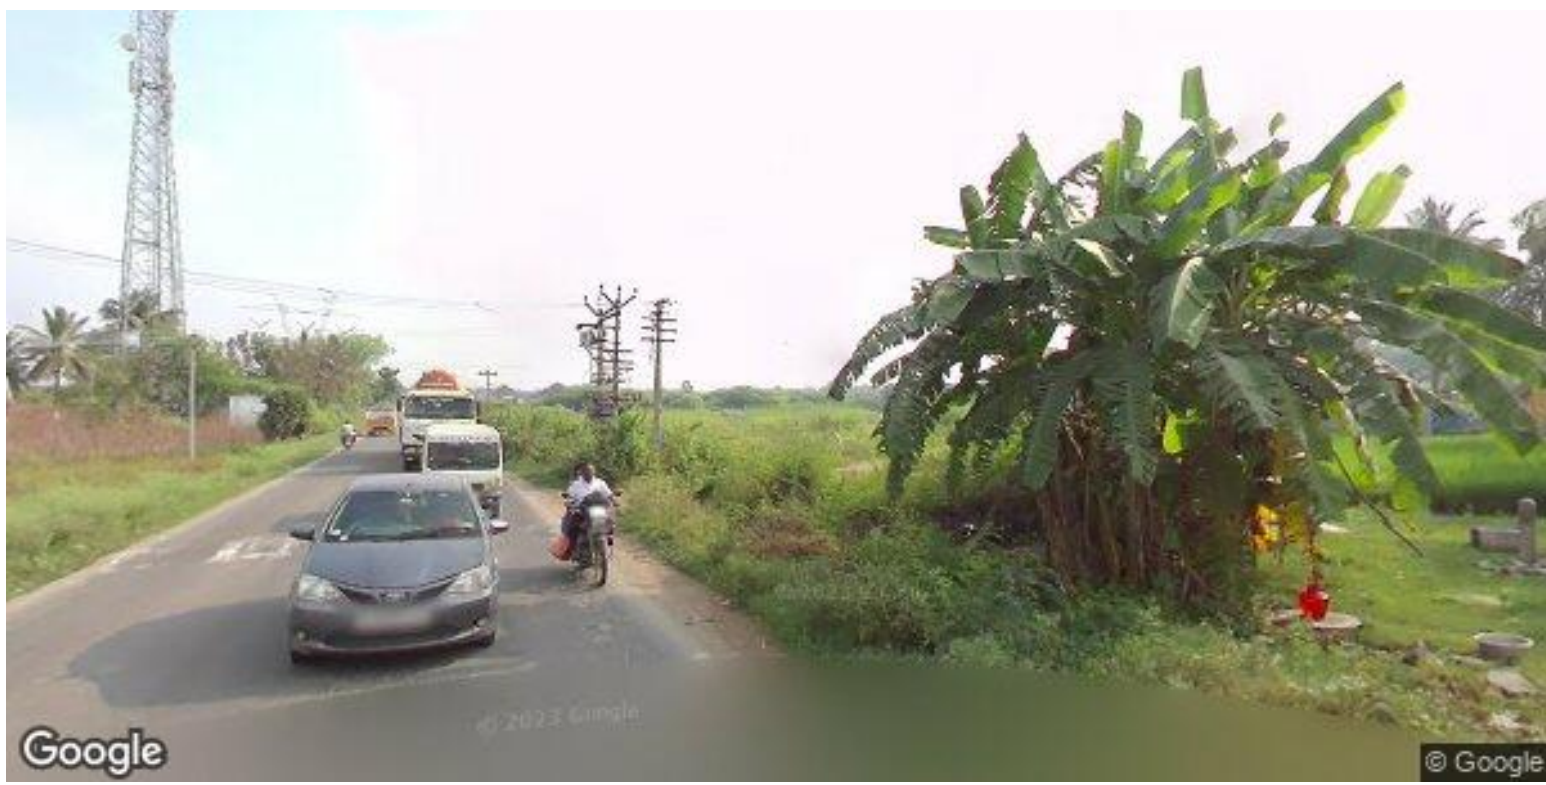
**Coordinates:** 11.71394, 77.99572

**Risk Type:** Turn

**Risk Level:** Medium

**Speed Limit:** 30 KM/Hr

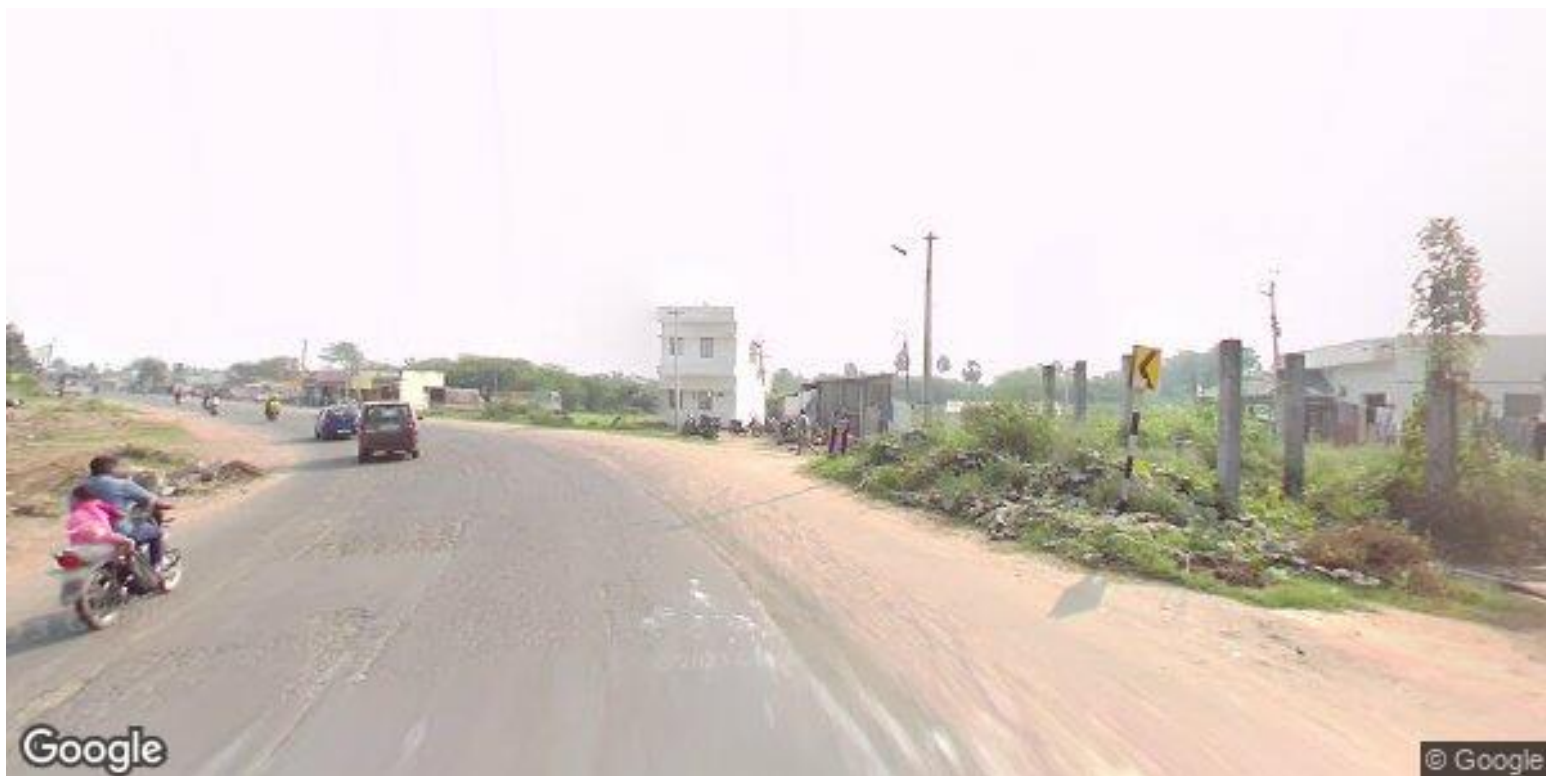
**Coordinates:** 11.71916, 78.01117

**Risk Type:** Turn

**Risk Level:** Medium

**Speed Limit:** 30 KM/Hr
