# IndianOil

## JOURNEY RISK MANAGEMENT (JRM) STUDY

### Salem Terminal TO SAI VENKATESWARA FUELS

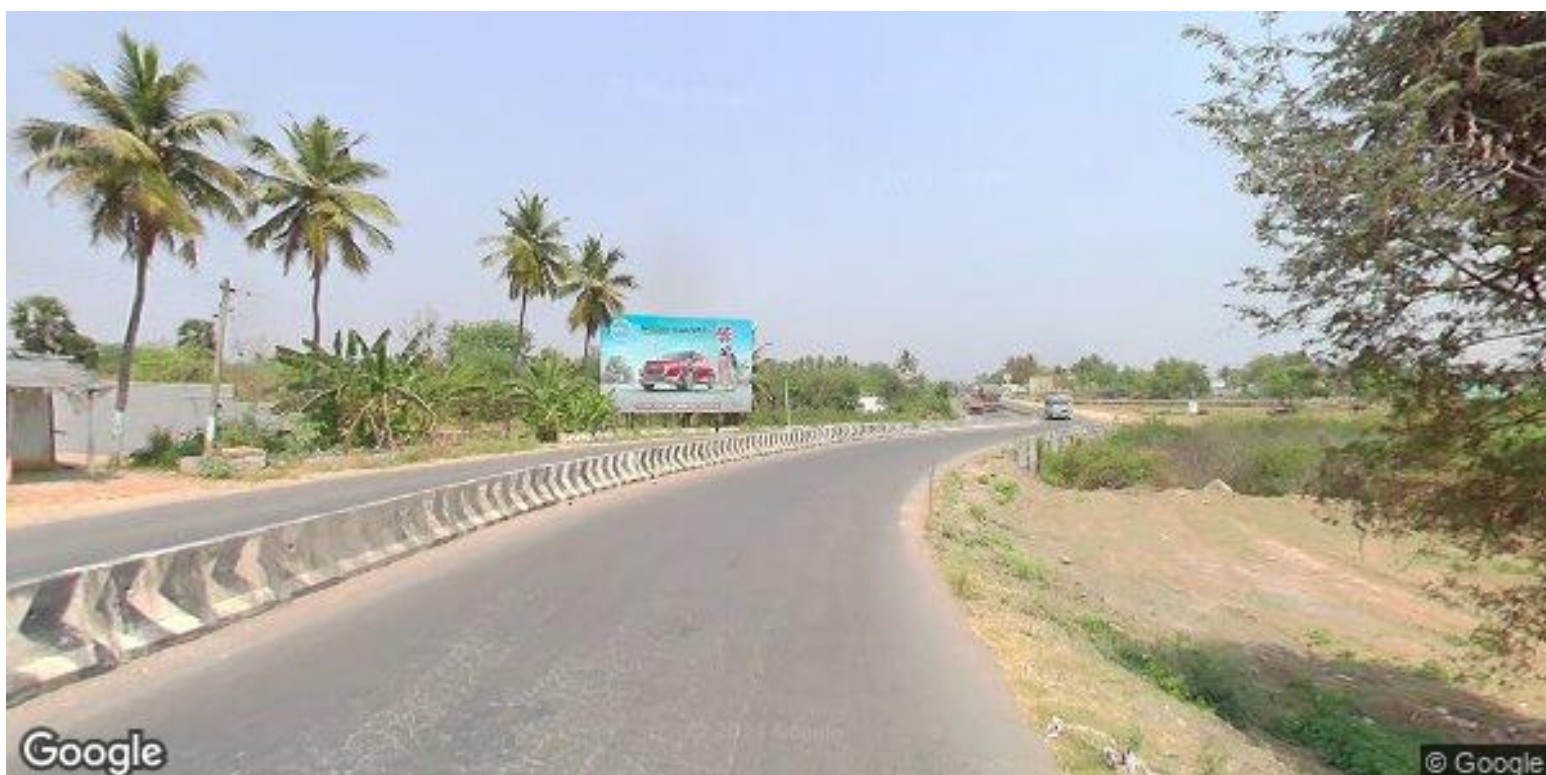
**Coordinates:** 11.72559, 78.01758

**Risk Type:** Turn

**Risk Level:** Medium

**Speed Limit:** 30 KM/Hr

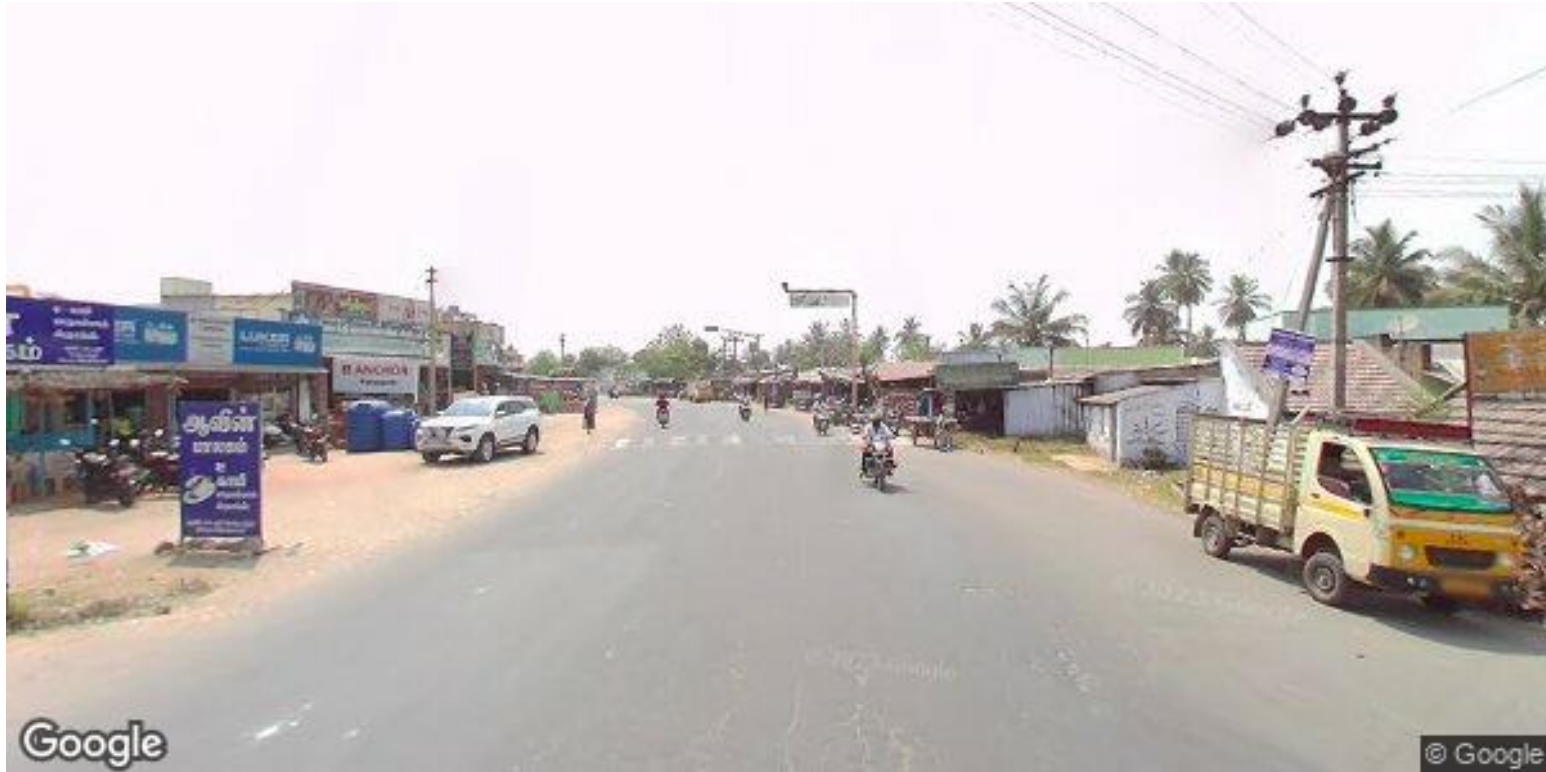
**Coordinates:** 11.73787, 78.03528

**Risk Type:** Turn

**Risk Level:** Medium

**Speed Limit:** 30 KM/Hr

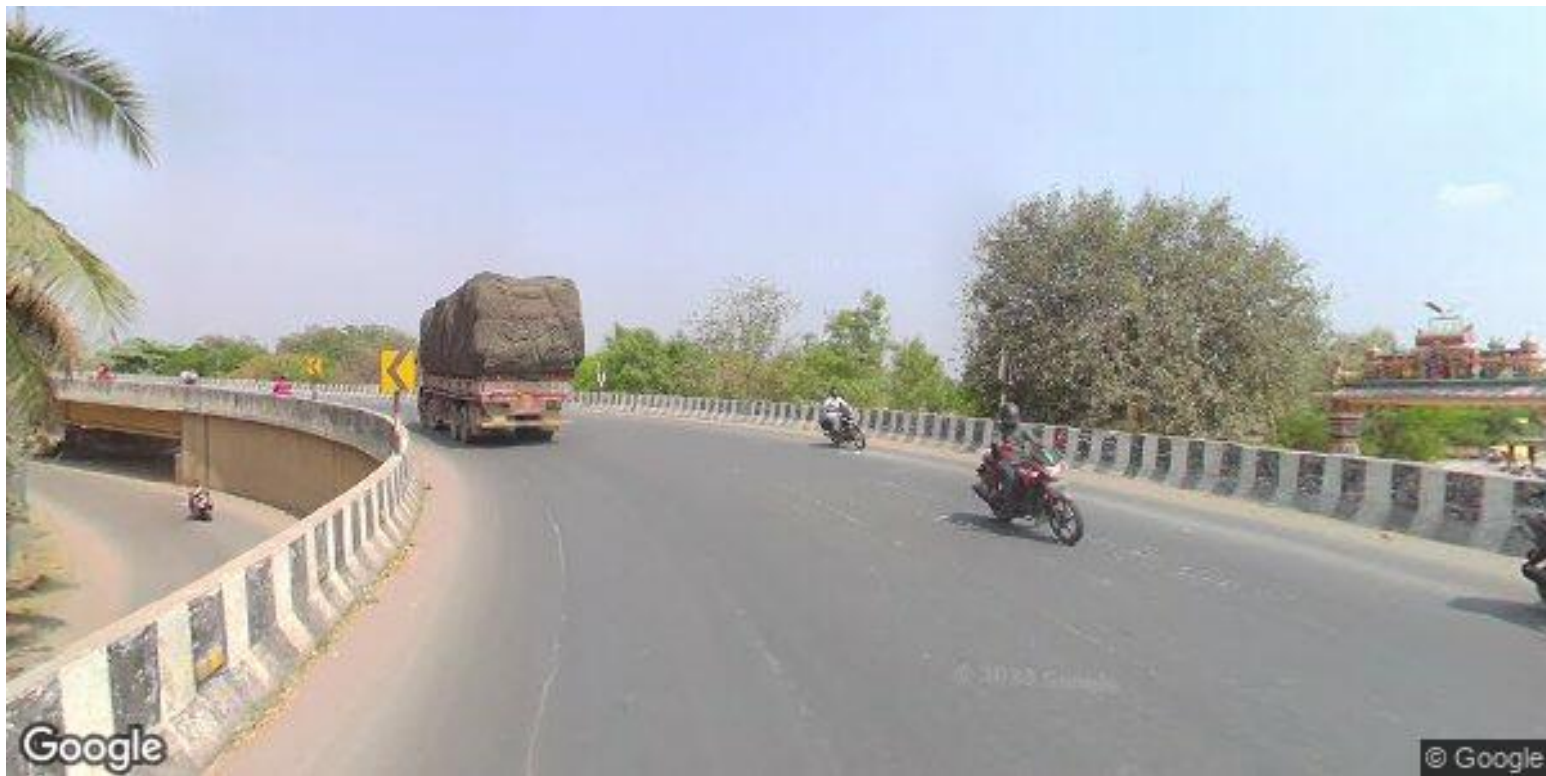
**Coordinates:** 11.73651, 78.03868

**Risk Type:** Turn

**Risk Level:** High

**Speed Limit:** 15 KM/Hr

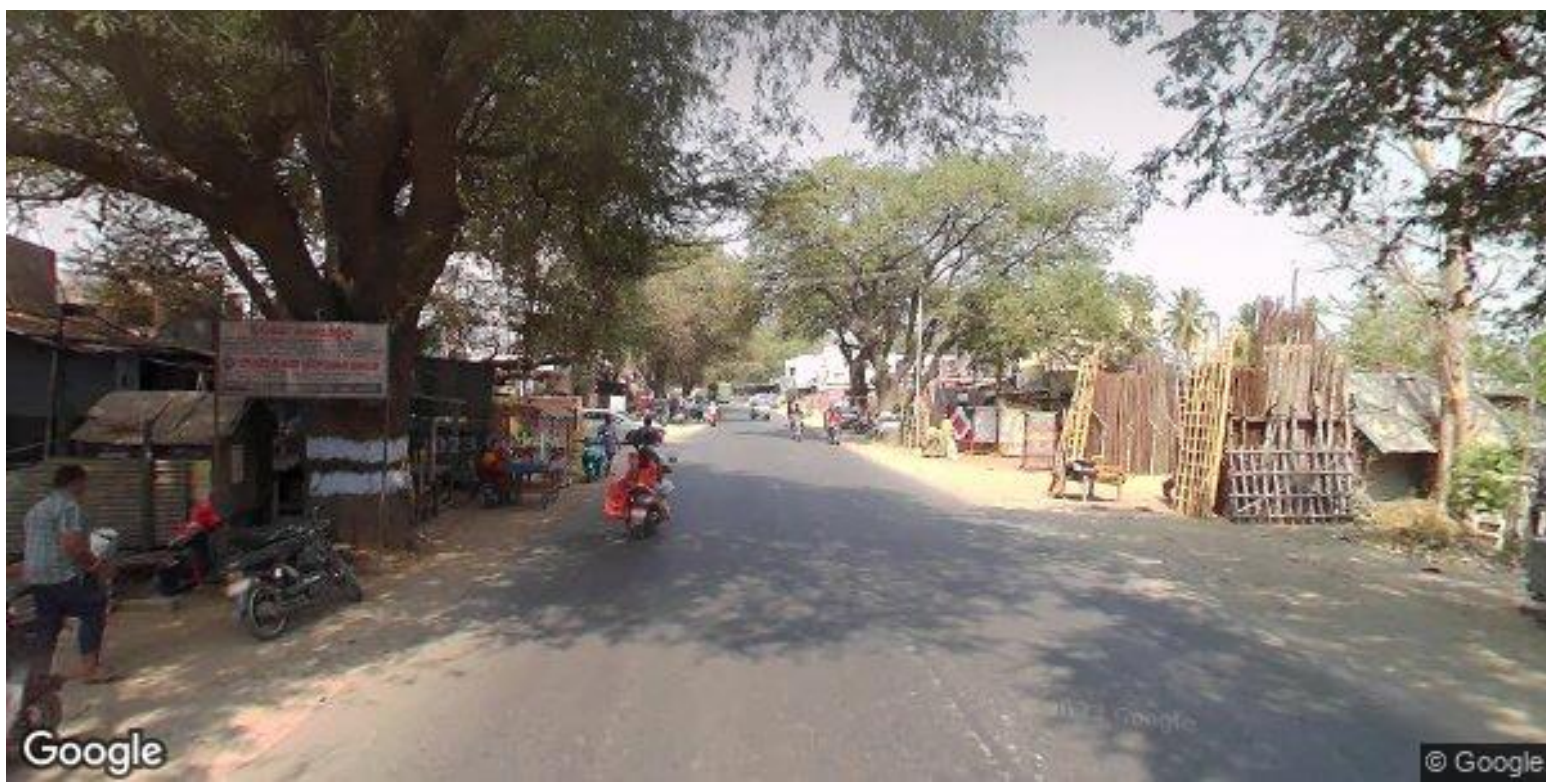
**Coordinates:** 11.74120, 78.04588

**Risk Type:** Turn

**Risk Level:** Medium

**Speed Limit:** 30 KM/Hr

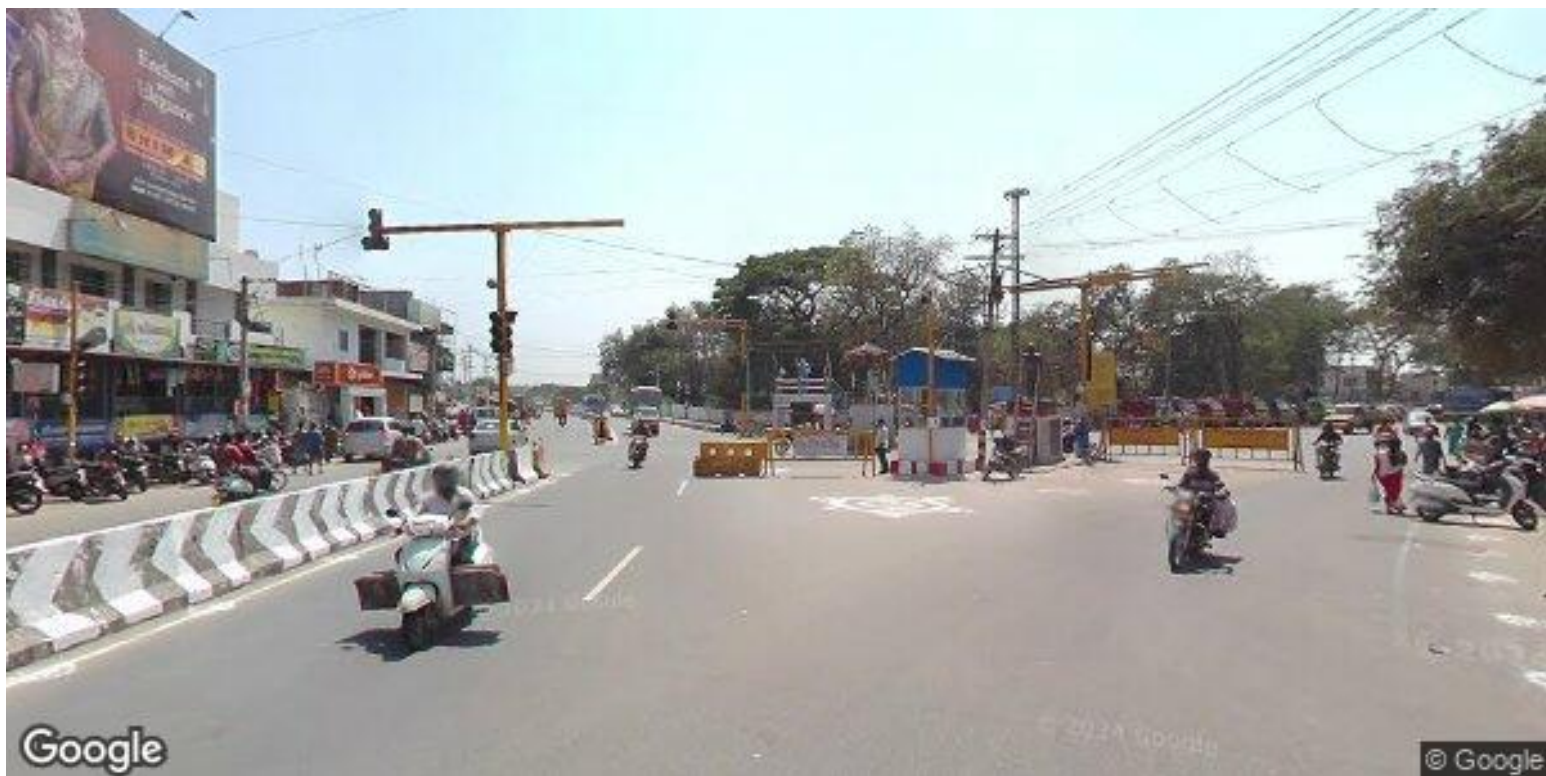
**Coordinates:** 11.74309, 78.04725

**Risk Type:** Turn

**Risk Level:** Medium

**Speed Limit:** 30 KM/Hr

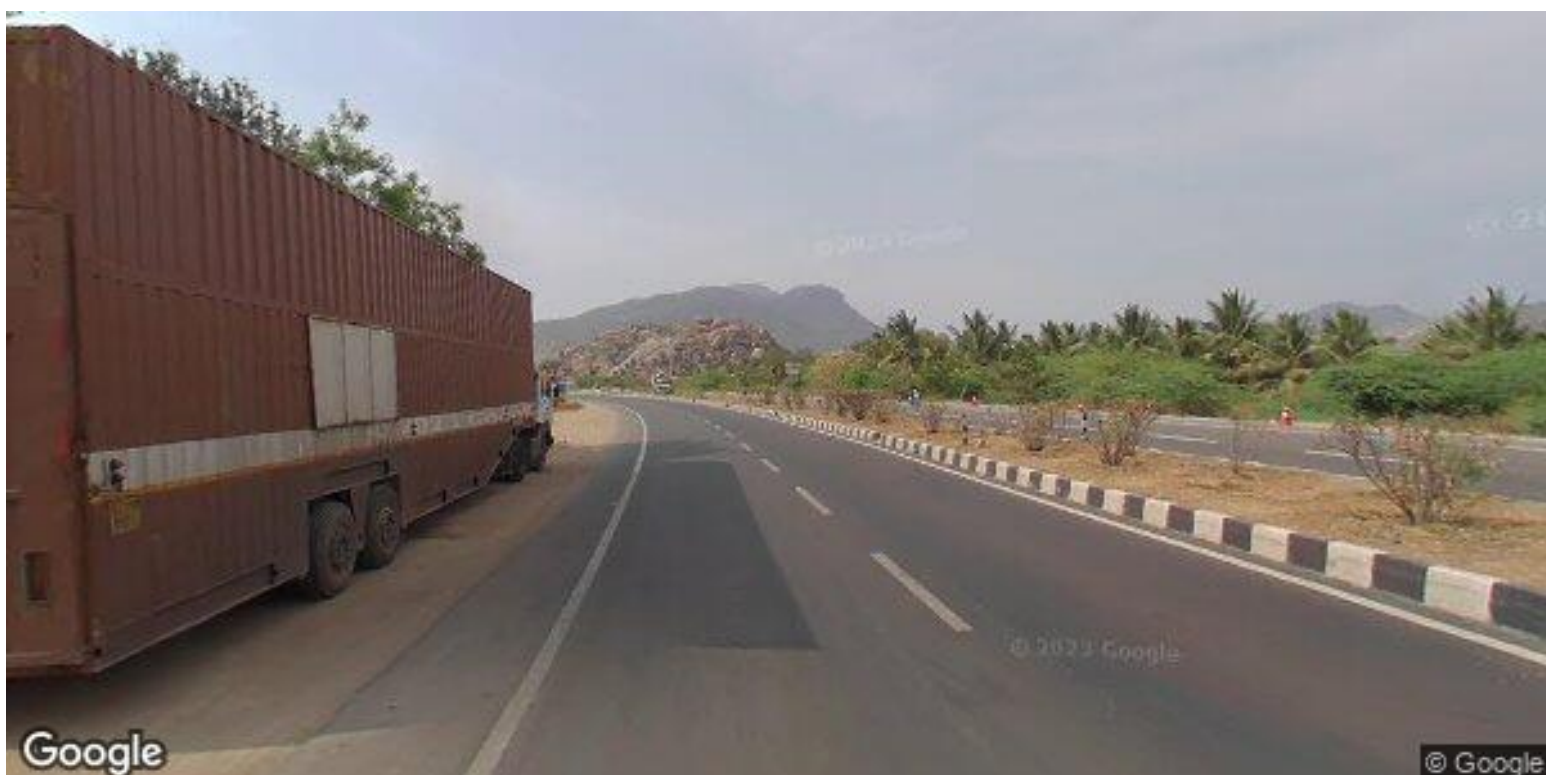
**Risk Type:** Turn  
**Risk Level:** Medium  
**Speed Limit:** 30 KM/Hr  
**Coordinates:** 11.87913, 78.08206

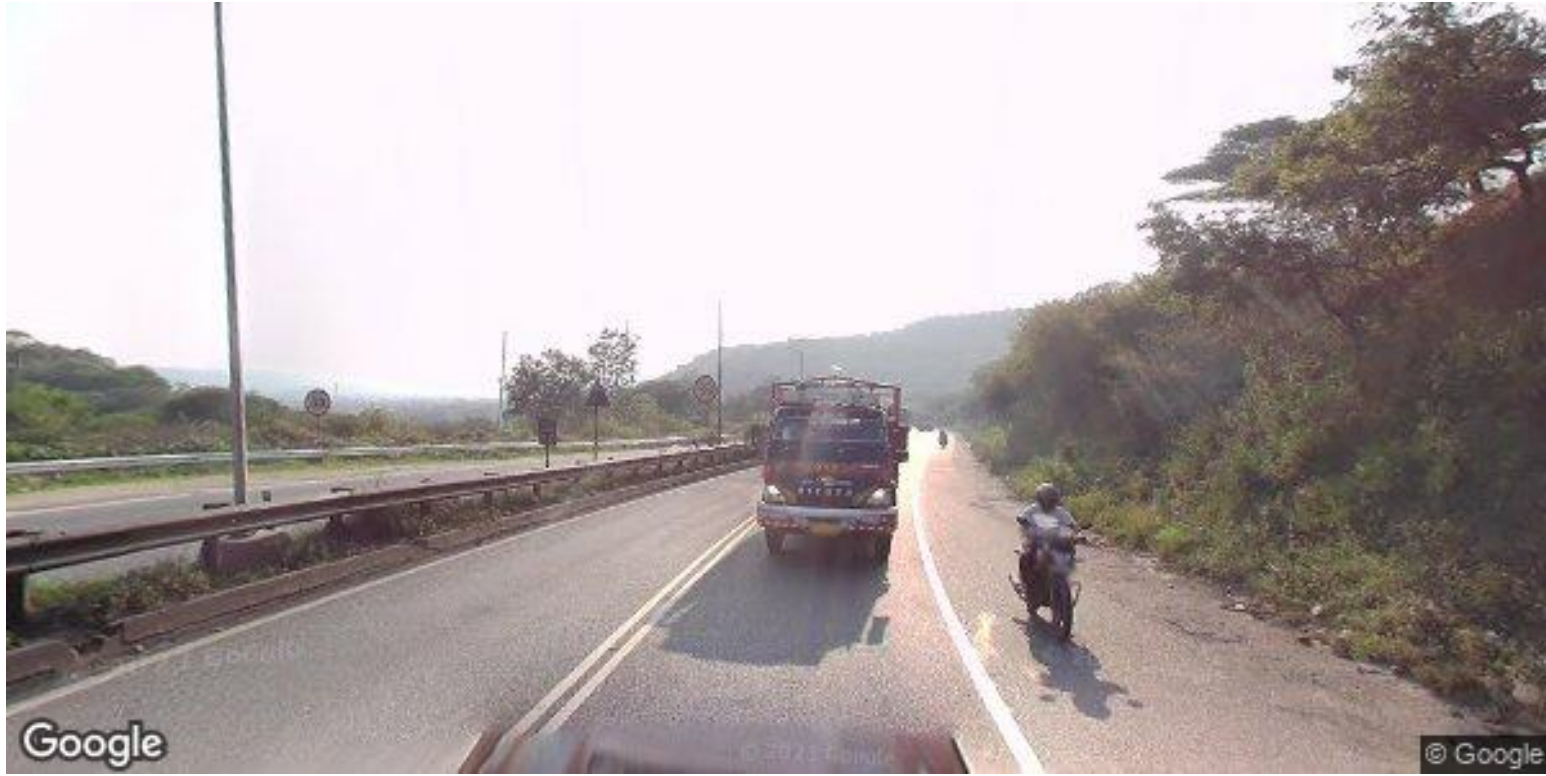
**Risk Type:** Turn  
**Risk Level:** Medium  
**Speed Limit:** 30 KM/Hr  
**Coordinates:** 11.95803, 78.04964

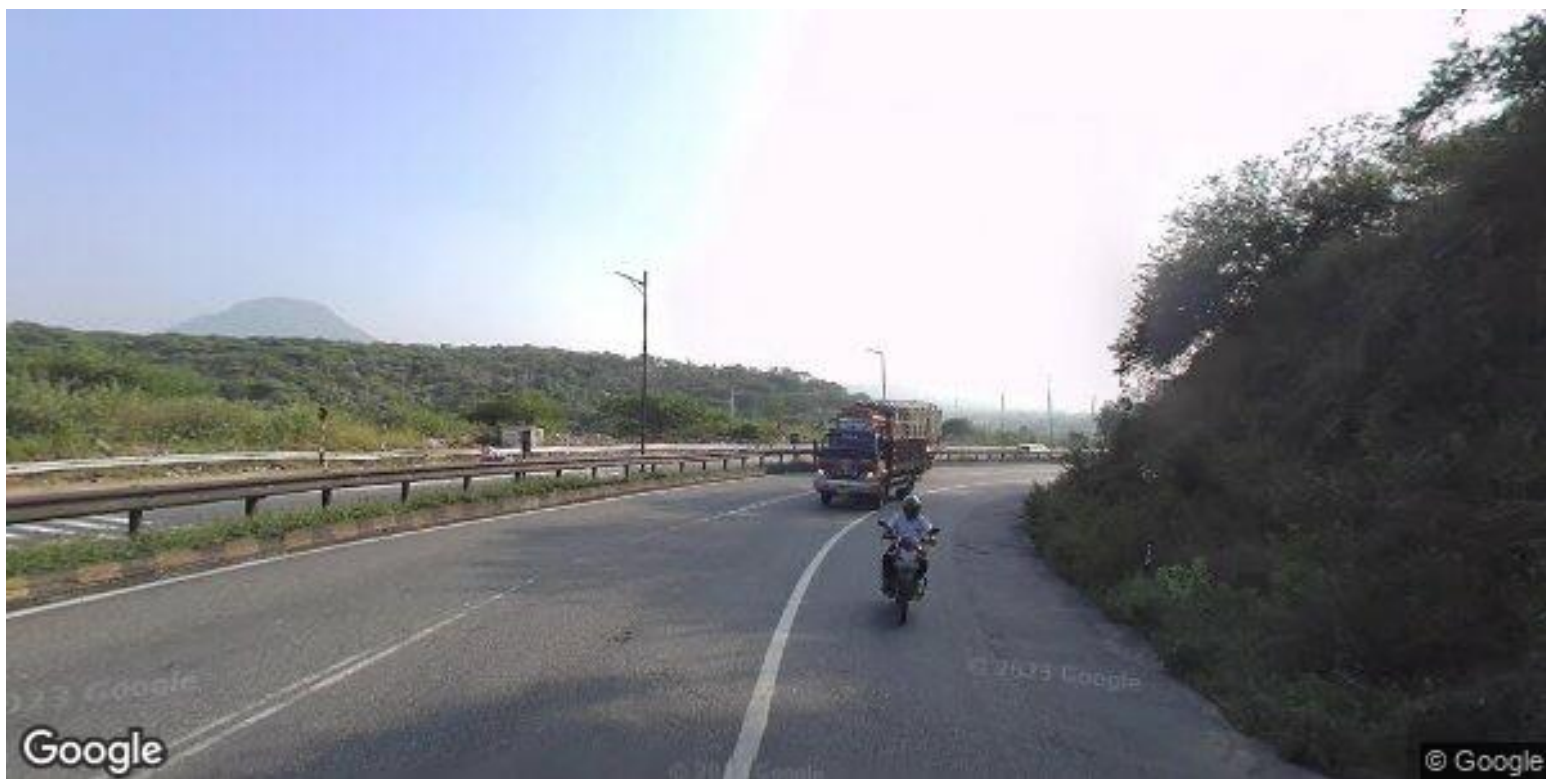
**Risk Type:** Turn  
**Risk Level:** Medium  
**Speed Limit:** 30 KM/Hr  
**Coordinates:** 11.95854, 78.04990

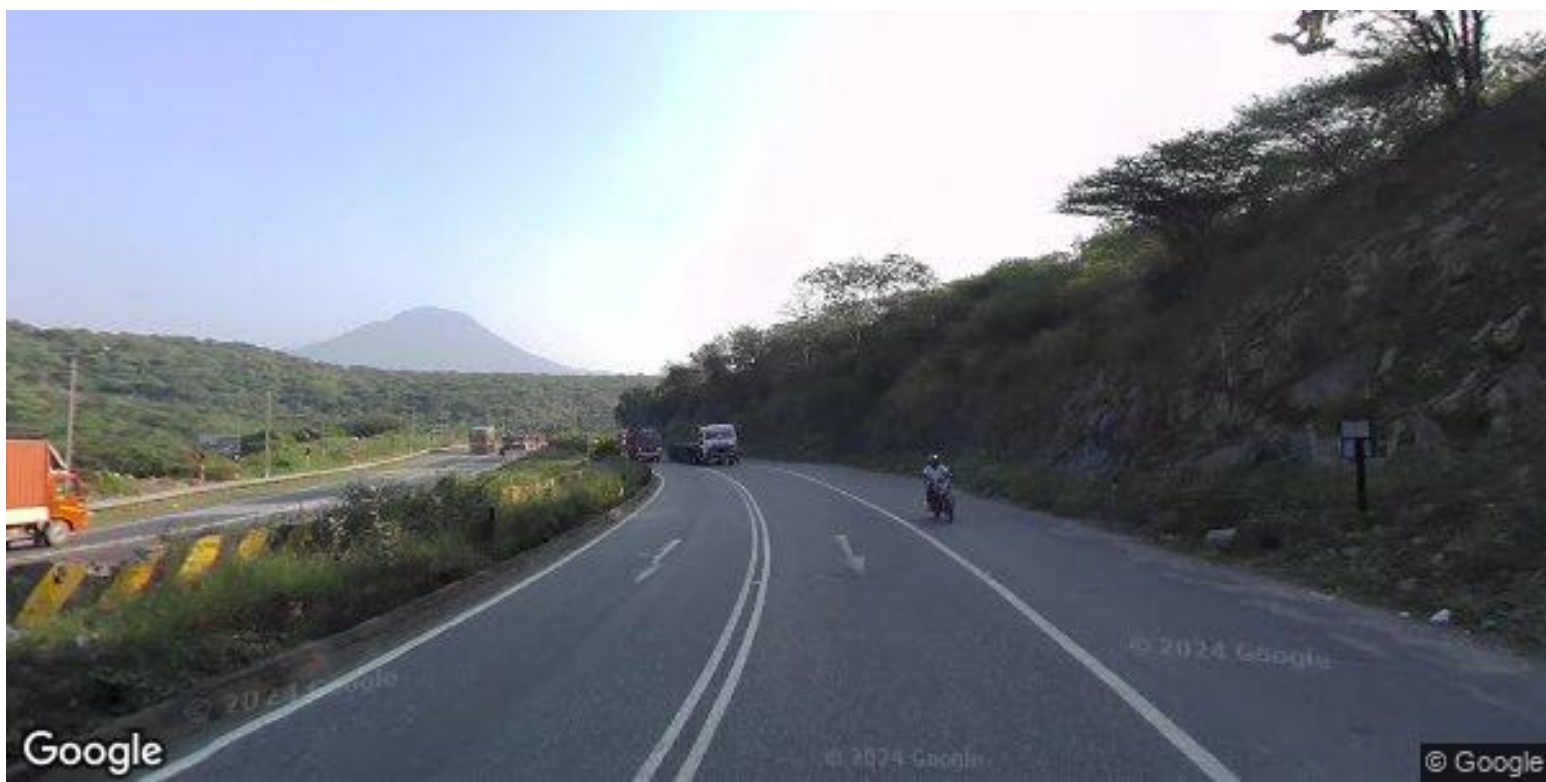
**Coordinates:** 11.96015, 78.04945

**Risk Type:** Turn

**Risk Level:** Medium

**Speed Limit:** 30 KM/Hr

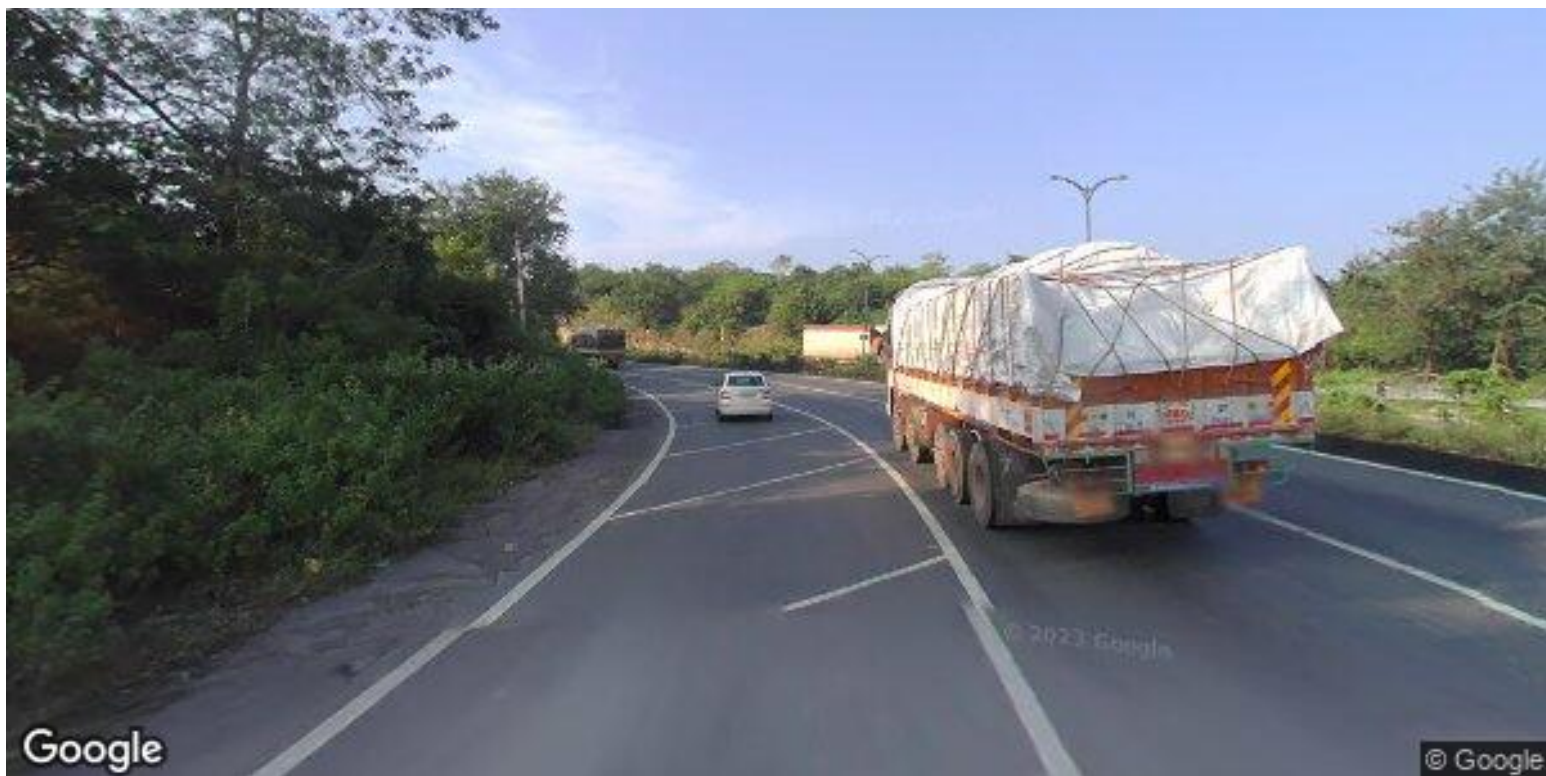
**Coordinates:** 11.96370, 78.05142

**Risk Type:** Turn

**Risk Level:** Medium

**Speed Limit:** 30 KM/Hr

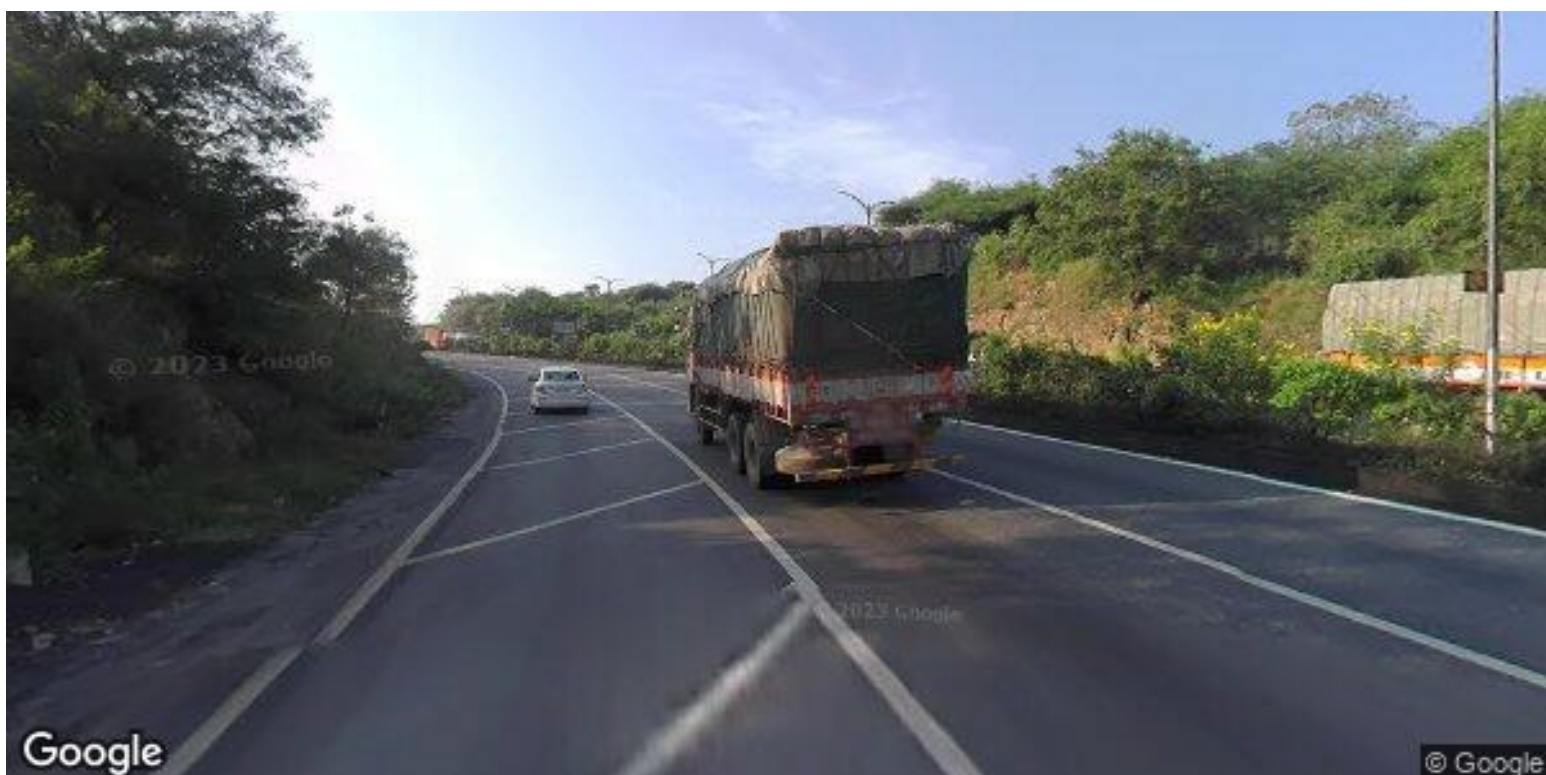
**Risk Type:** Turn  
**Risk Level:** Medium  
**Speed Limit:** 30 KM/Hr  
**Coordinates:** 11.96433, 78.05113

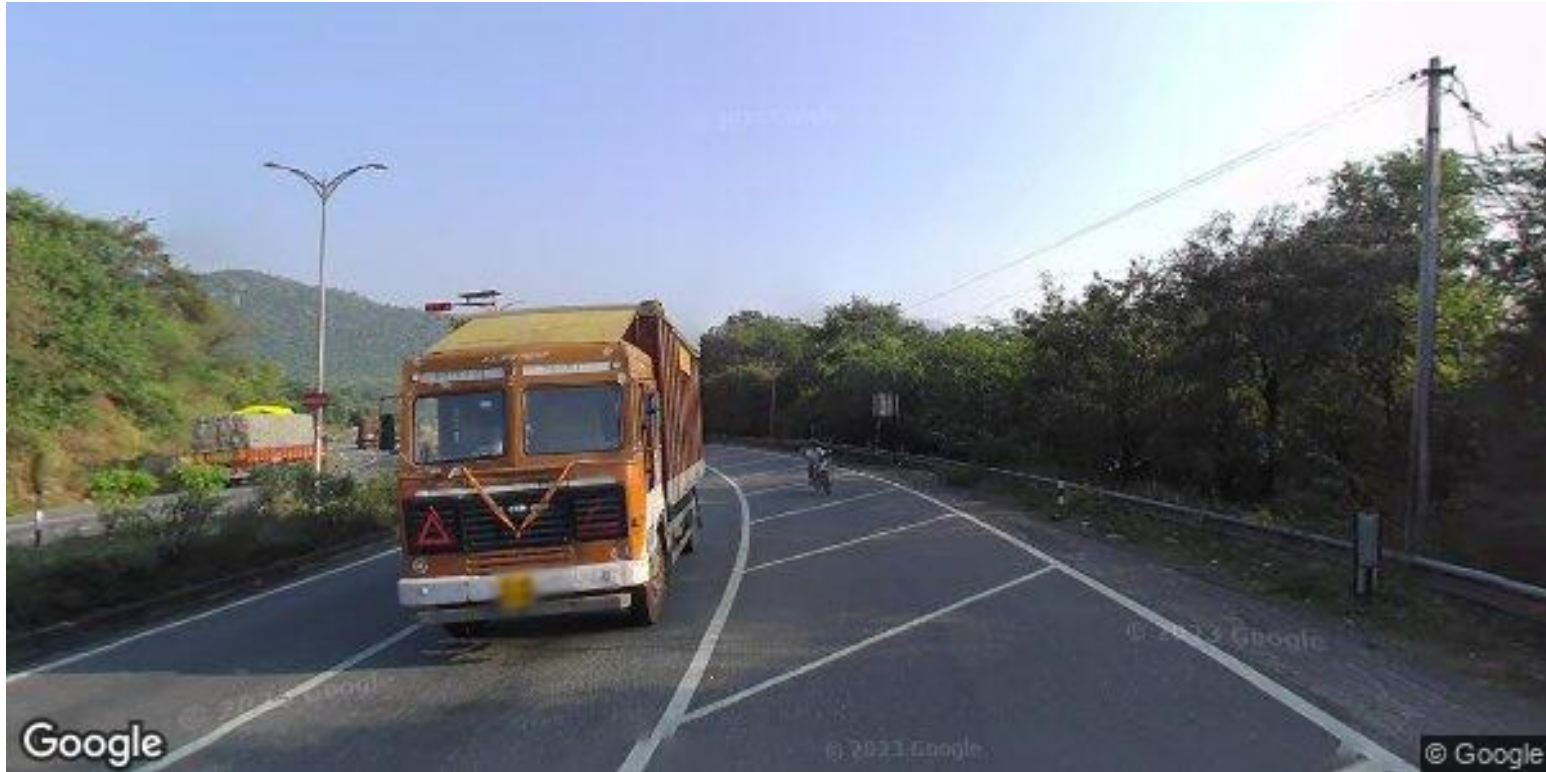
**Risk Type:** Turn  
**Risk Level:** High  
**Speed Limit:** 15 KM/Hr  
**Coordinates:** 11.96542, 78.04938

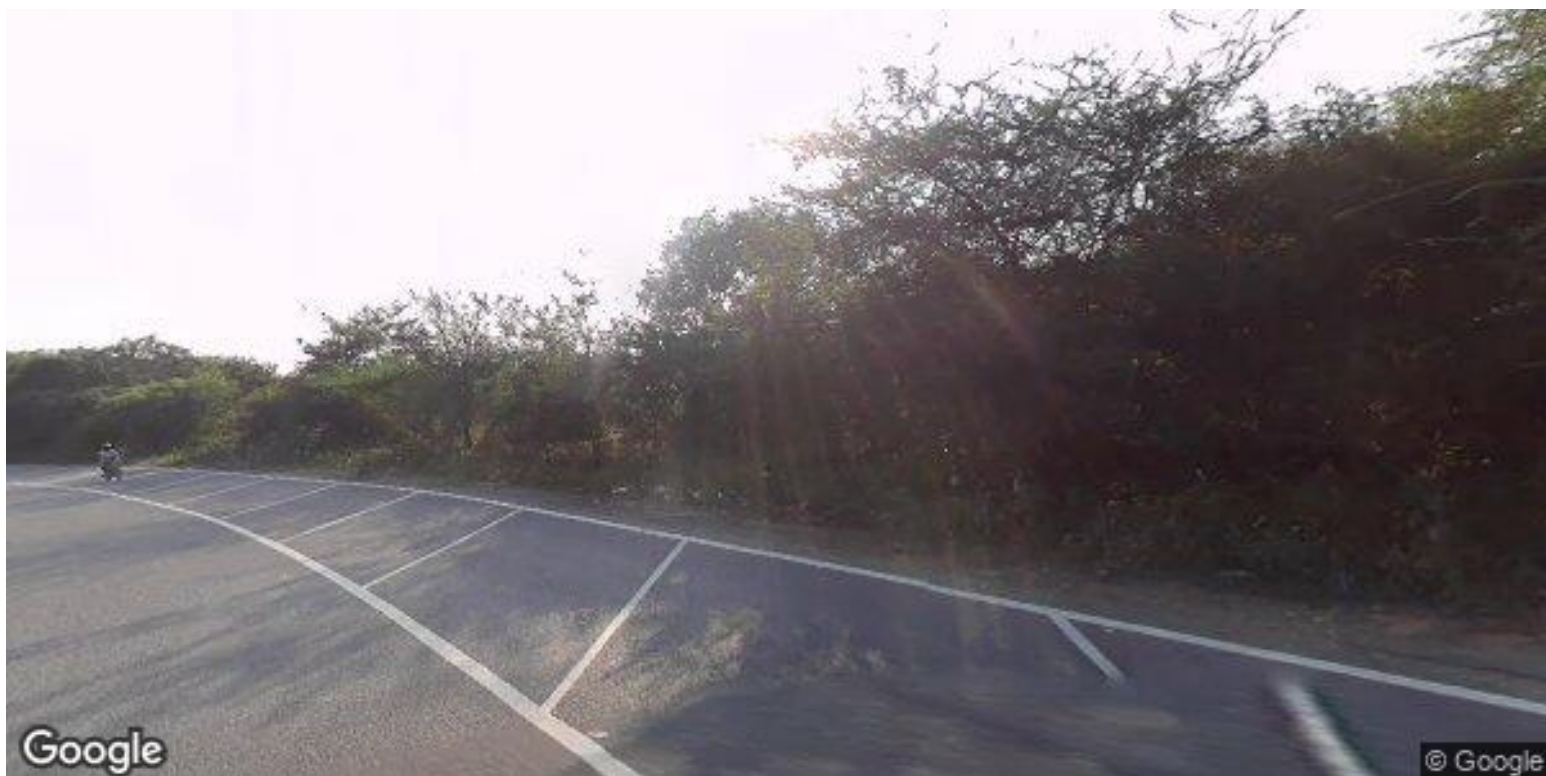
**Risk Type:** Turn  
**Risk Level:** High  
**Speed Limit:** 15 KM/Hr  
**Coordinates:** 11.96650, 78.04927

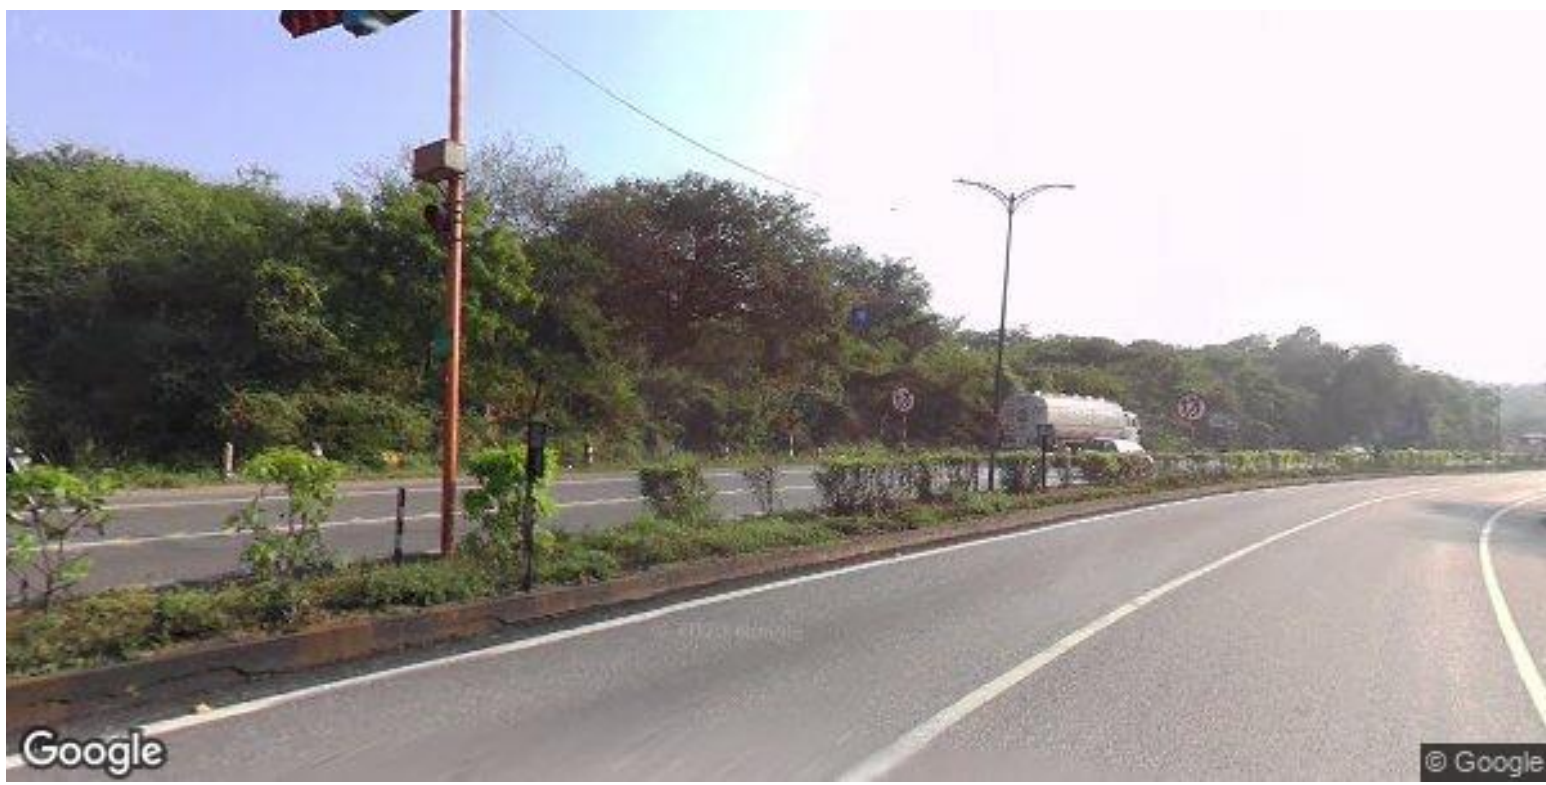
**Coordinates:** 11.96804, 78.05080

**Risk Type:** Turn

**Risk Level:** Medium

**Speed Limit:** 30 KM/Hr

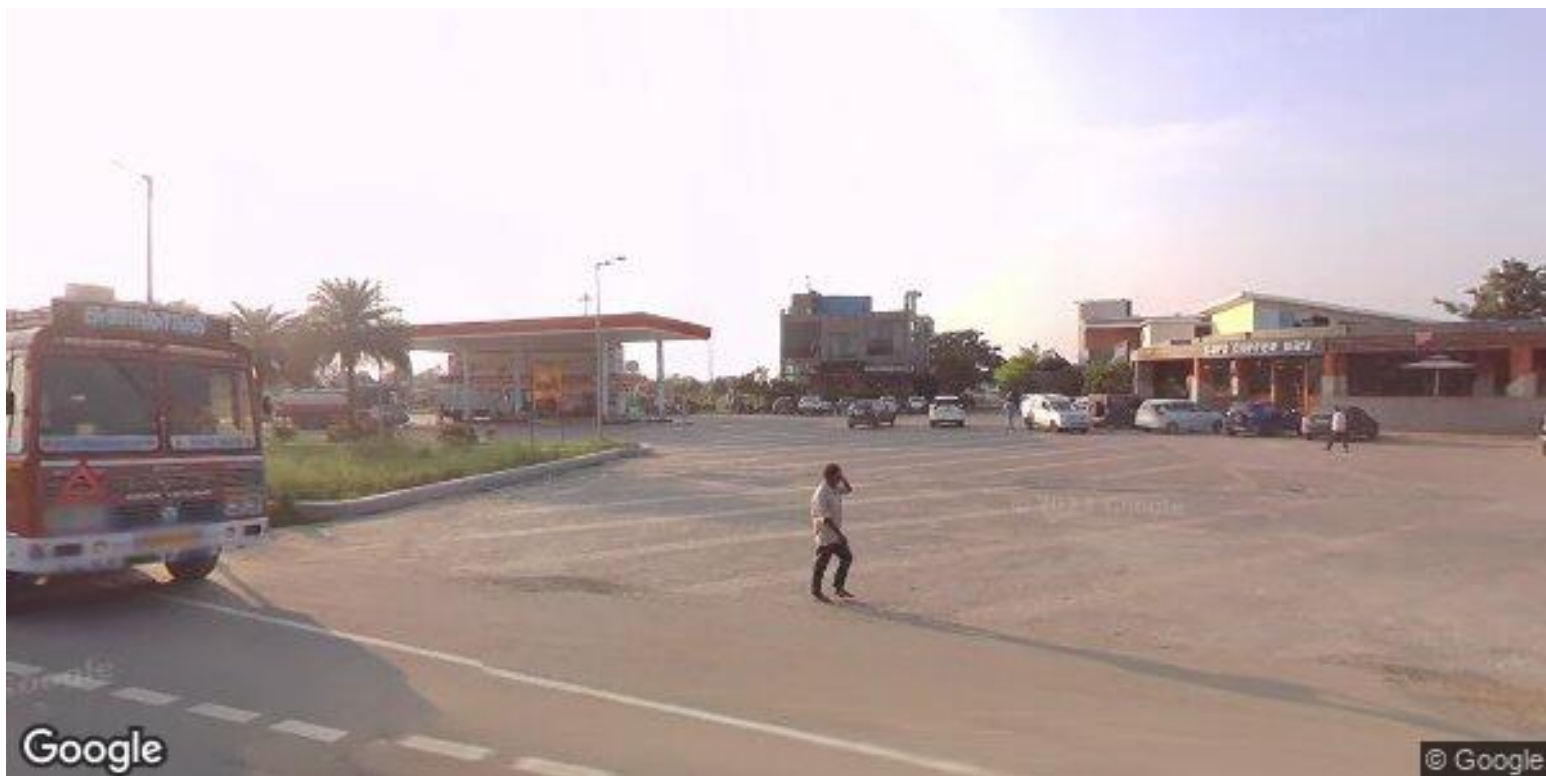
**Coordinates:** 12.02456, 78.09864

**Risk Type:** Blind Spot

**Risk Level:** Blind Spot

**Speed Limit:** 10 KM/Hr
