# IndianOil

## JOURNEY RISK MANAGEMENT (JRM) STUDY

### Salem Terminal to Sri Vinayaga Enterprises

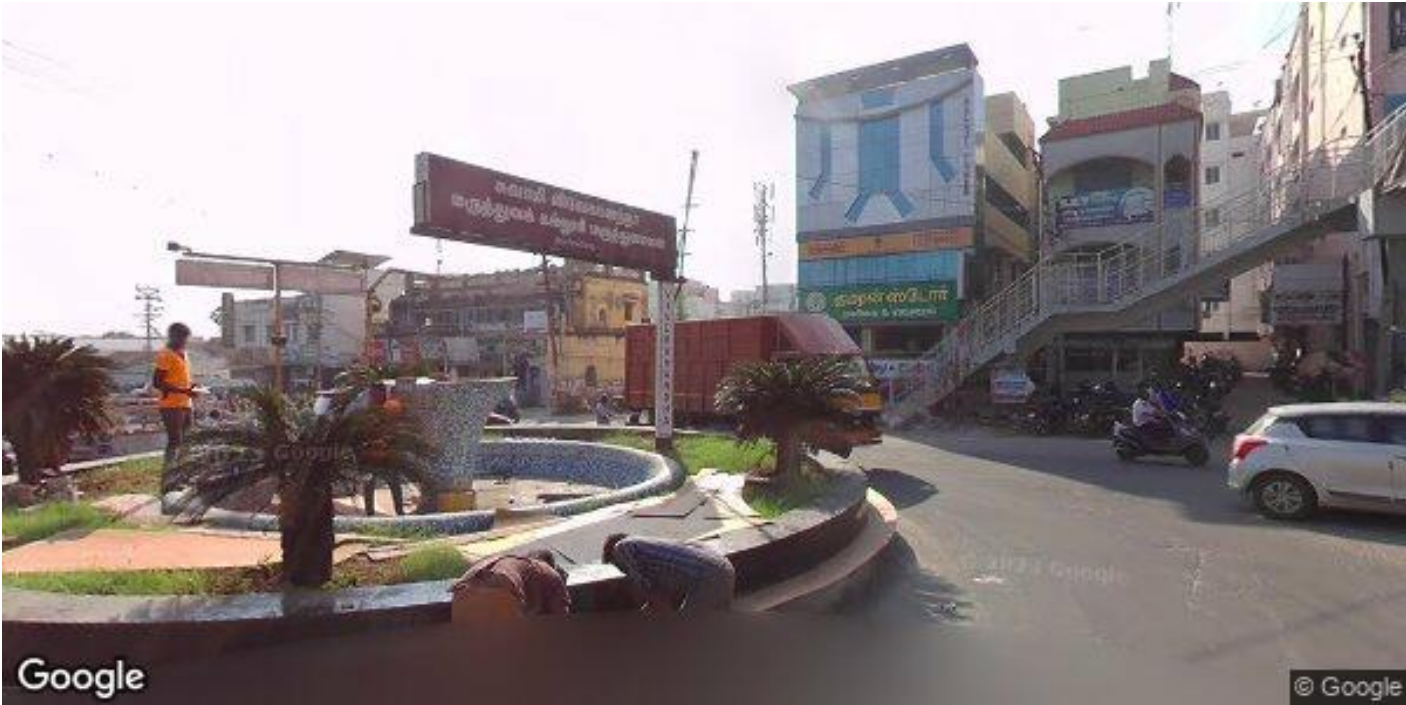
Risk Type: Roundabout  
Risk Level: High  
Speed Limit: 15 KM/Hr  
Coordinates: 11.38395, 77.89480

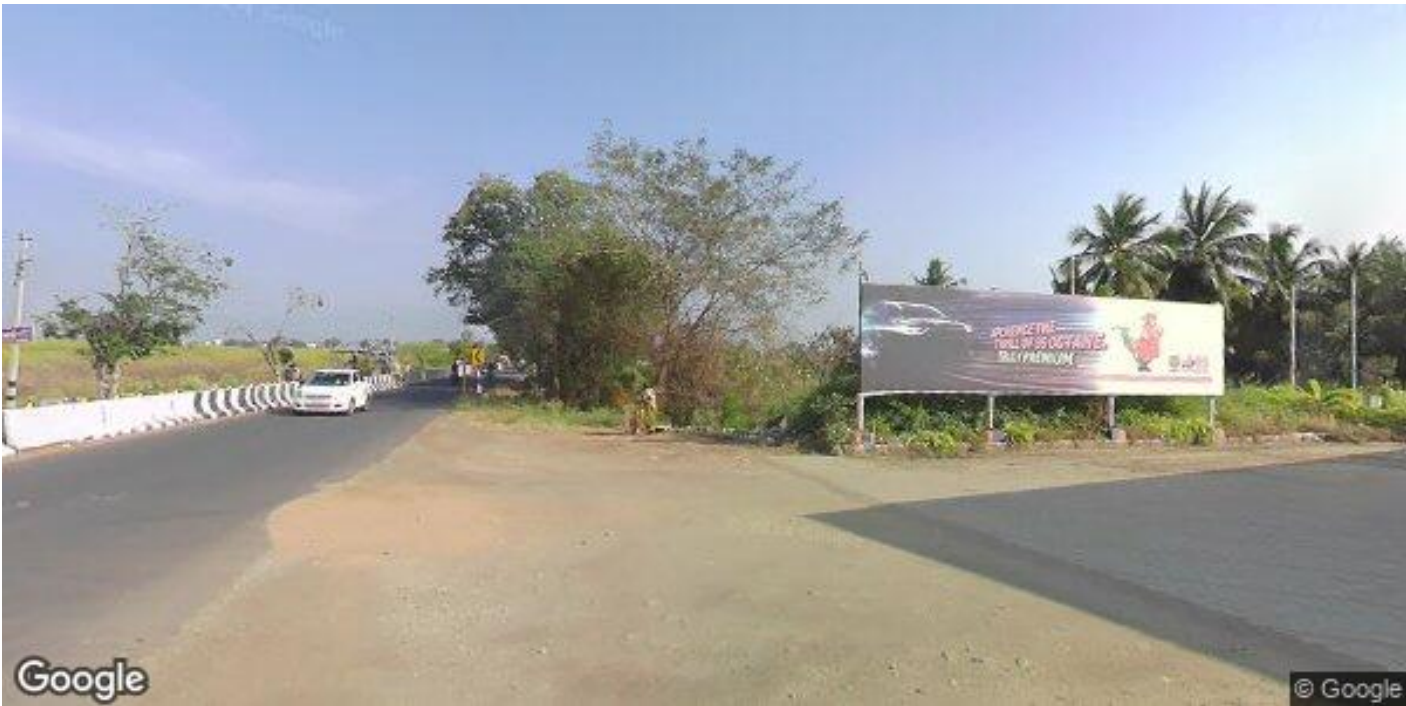
Risk Type: U-Turn  
Risk Level: High  
Speed Limit: 10 KM/Hr  
Coordinates: 11.4535263, 78.1964113

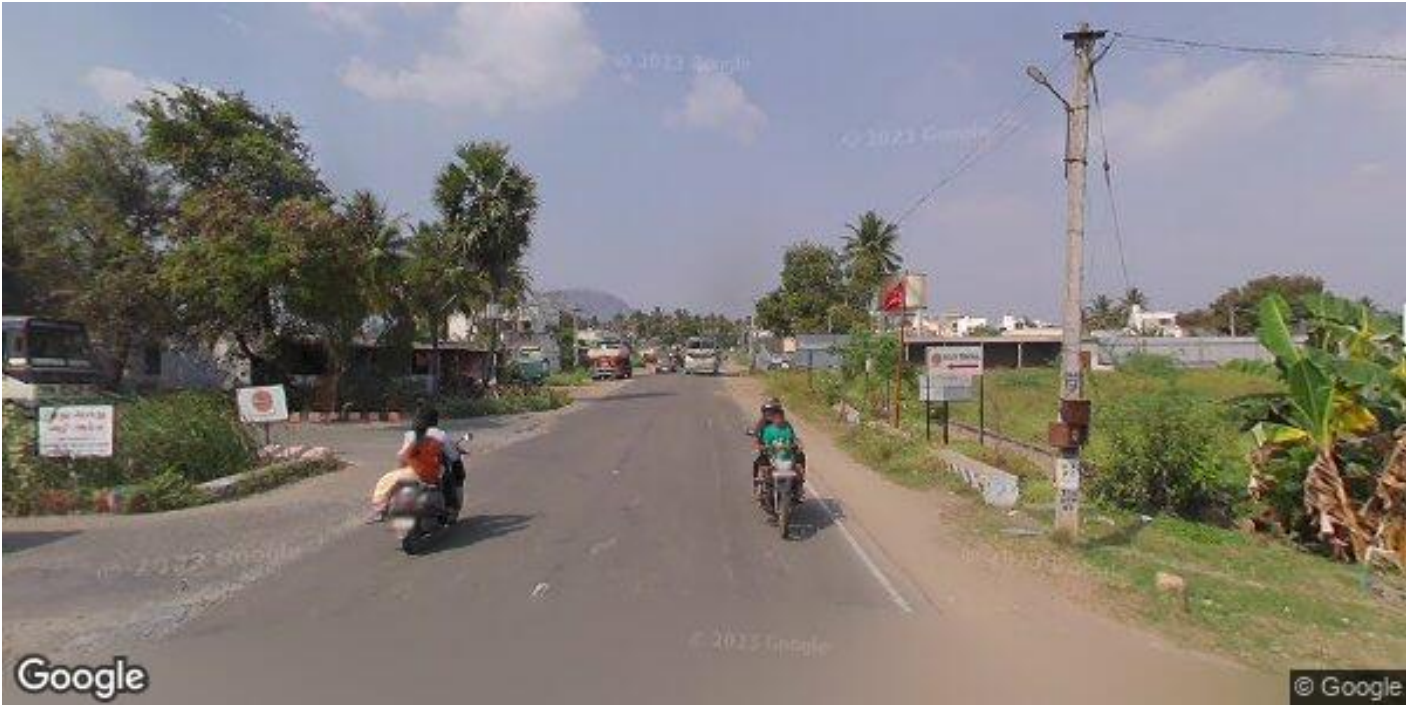
**Risk Type:** Turn  
**Risk Level:** High  
**Speed Limit:** 15 KM/Hr  
**Coordinates:** 11.44019, 77.87547

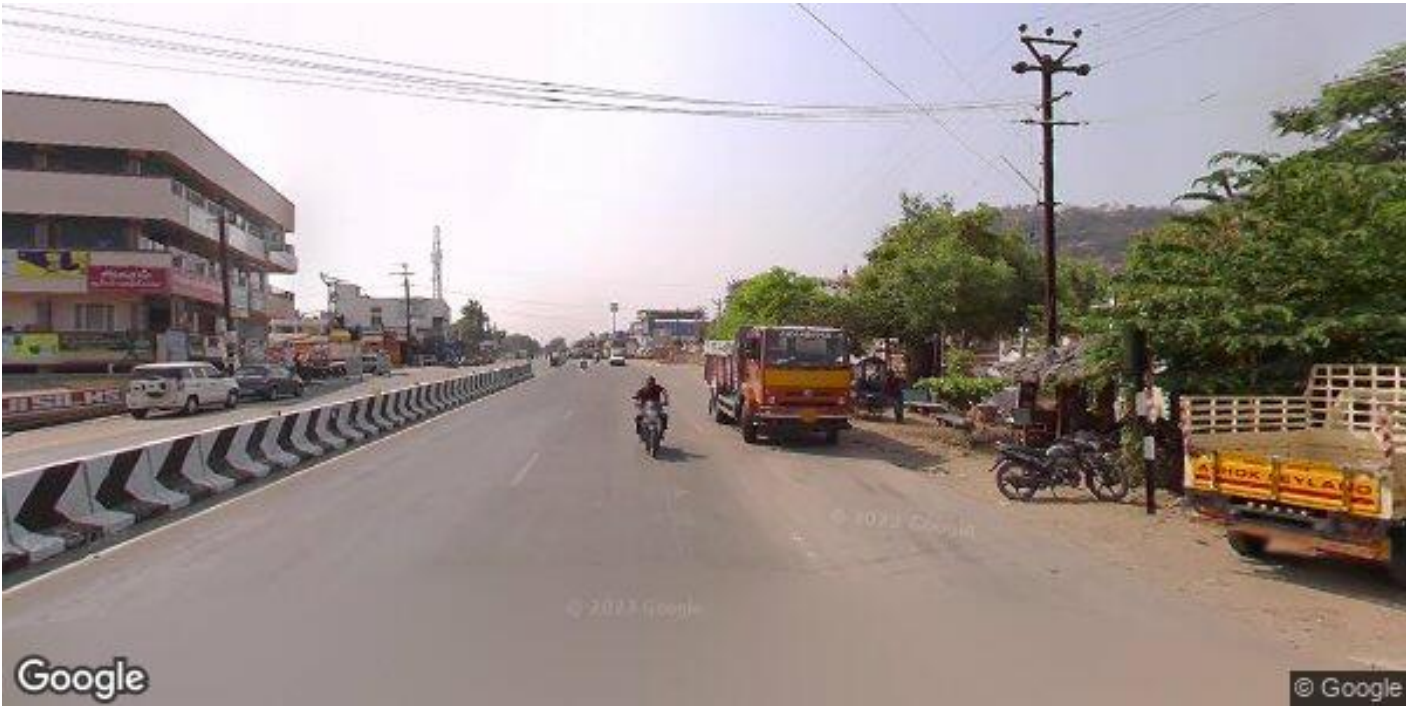
**Risk Type:** Turn  
**Risk Level:** Medium  
**Speed Limit:** 30 KM/Hr  
**Coordinates:** 11.39685, 77.88861

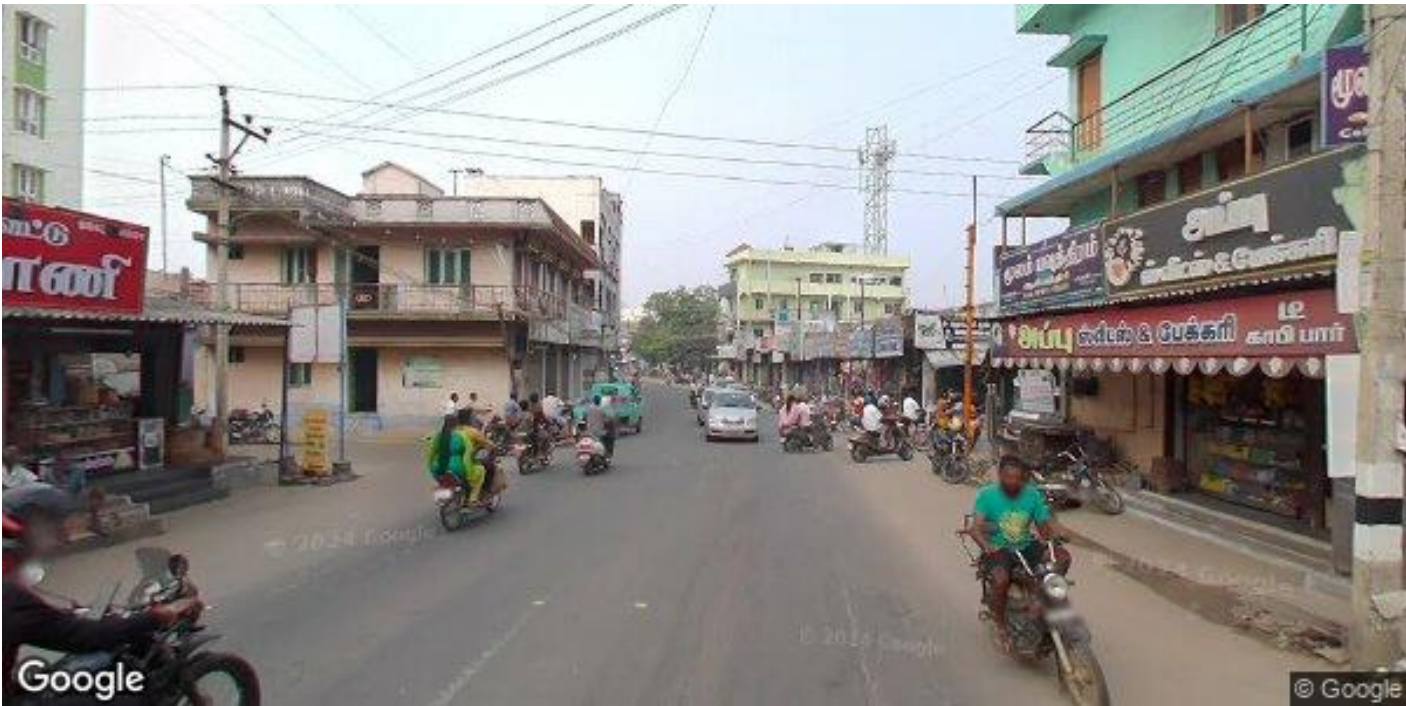
**Risk Type:** Turn  
**Risk Level:** Medium  
**Speed Limit:** 30 KM/Hr  
**Coordinates:** 11.38376, 77.89914

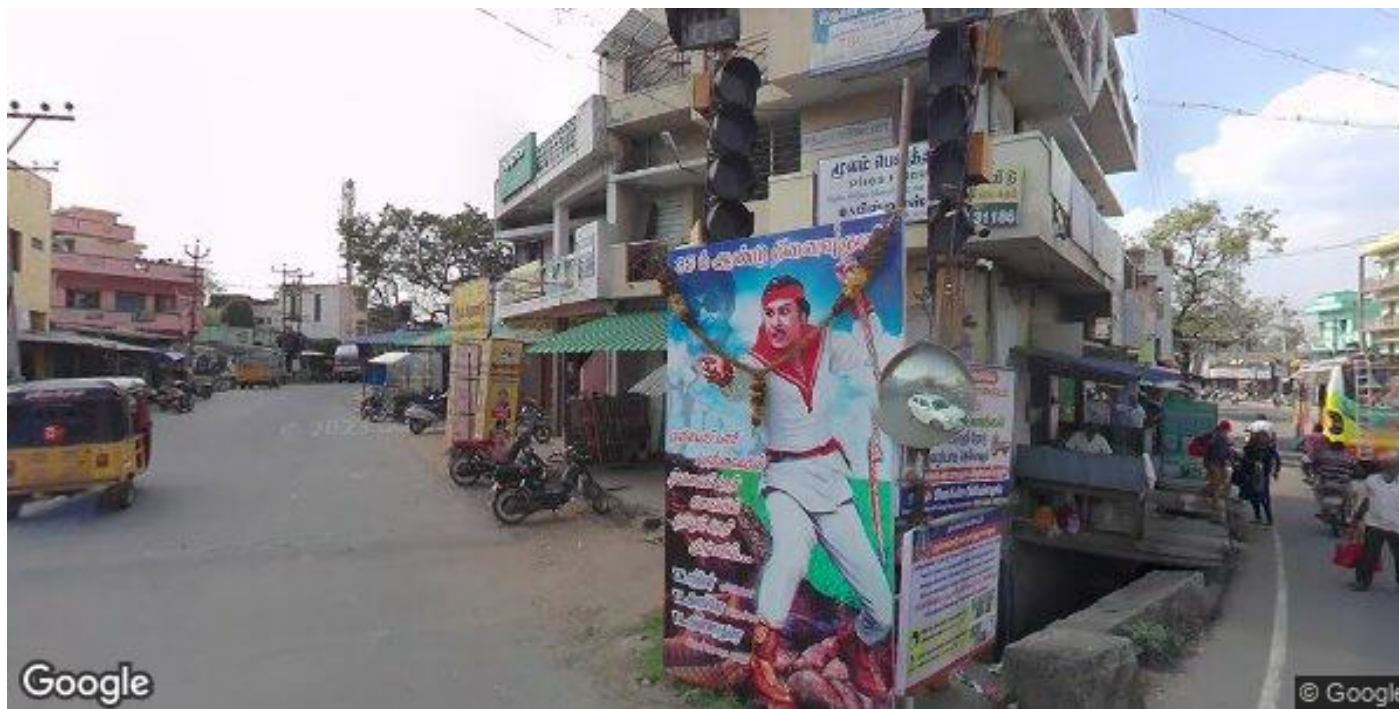
**Risk Type:** Turn  
**Risk Level:** Medium  
**Speed Limit:** 30 KM/Hr  
**Coordinates:** 11.38342, 77.89975

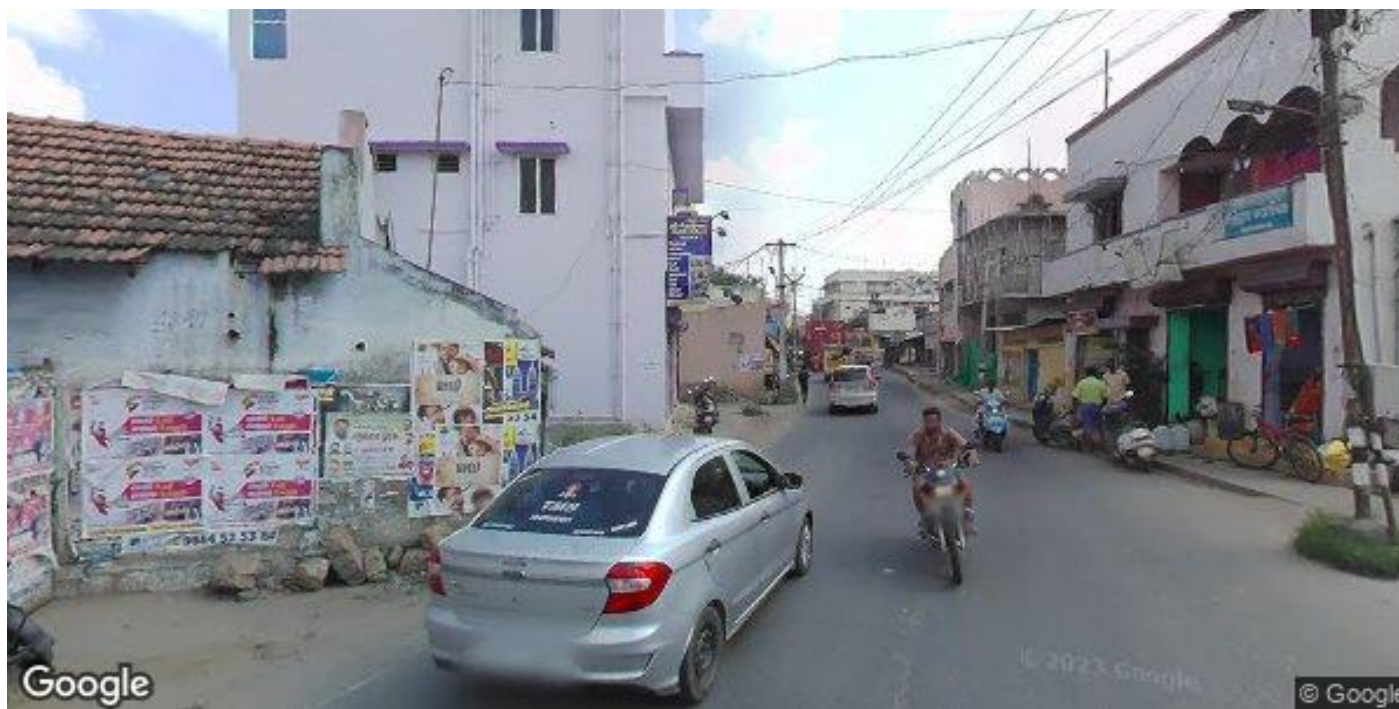
**Risk Type:** Turn  
**Risk Level:** Medium  
**Speed Limit:** 30 KM/Hr  
**Coordinates:** 11.38295, 77.90001

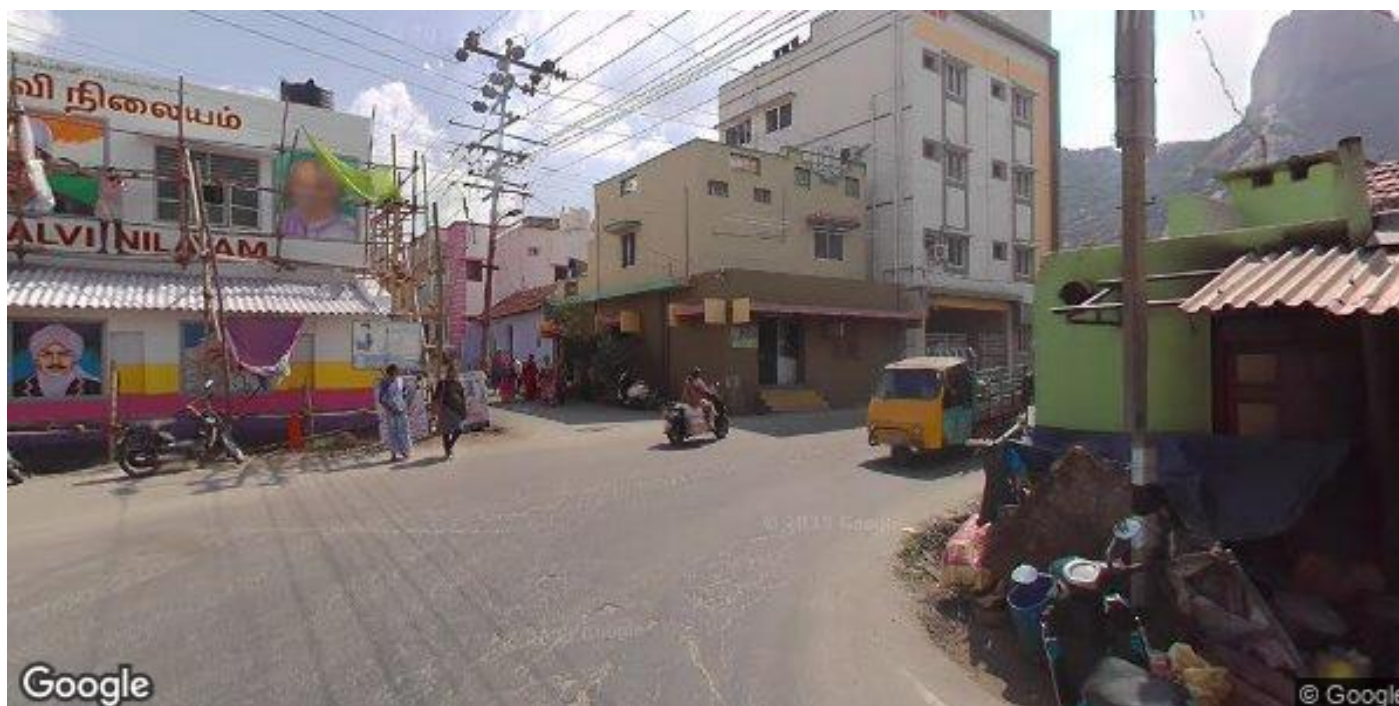
**Risk Type:** Turn  
**Risk Level:** High  
**Speed Limit:** 15 KM/Hr  
**Coordinates:** 11.38186, 77.90258

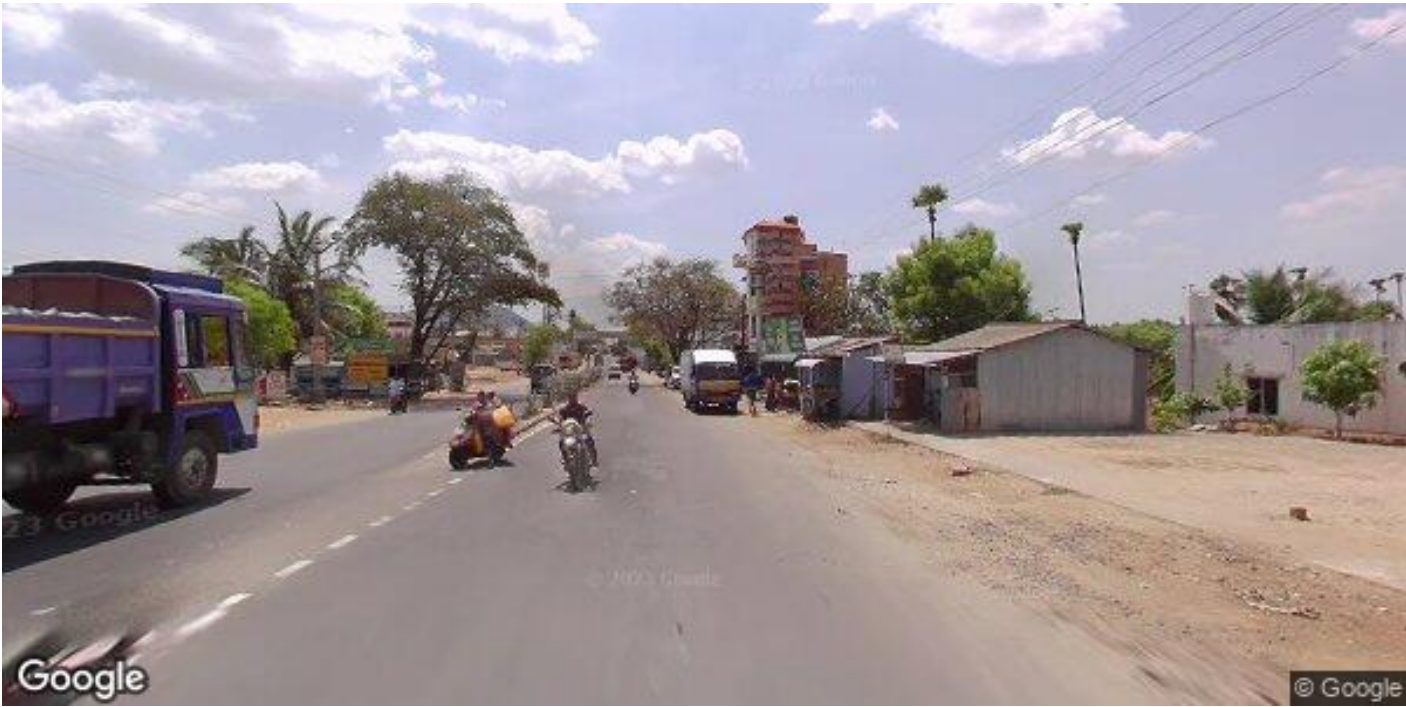
**Risk Type:** Turn  
**Risk Level:** Medium  
**Speed Limit:** 30 KM/Hr  
**Coordinates:** 11.36754, 77.93919

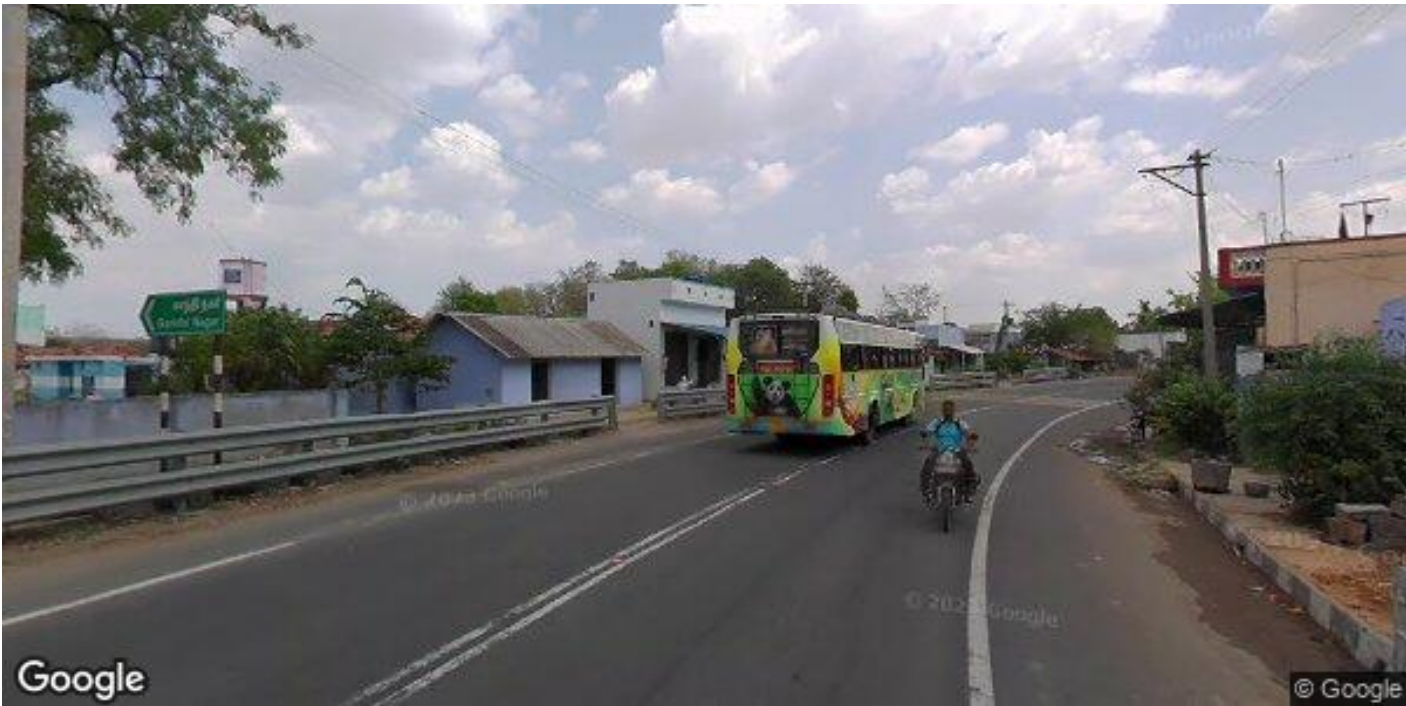
**Risk Type:** Turn  
**Risk Level:** Medium  
**Speed Limit:** 30 KM/Hr  
**Coordinates:** 11.41354, 78.08075

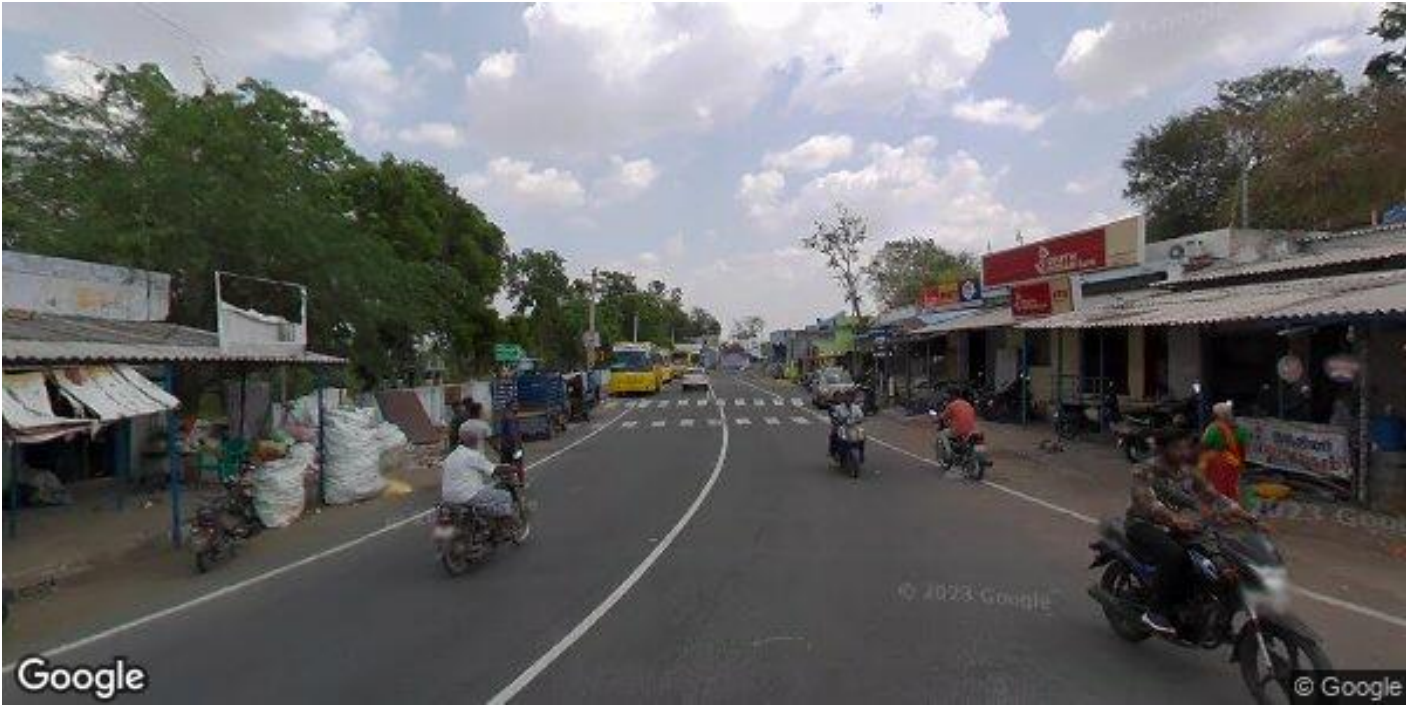
Risk Type: Turn  
Risk Level: High  
Speed Limit: 15 KM/Hr  
Coordinates: 11.41447, 78.08063

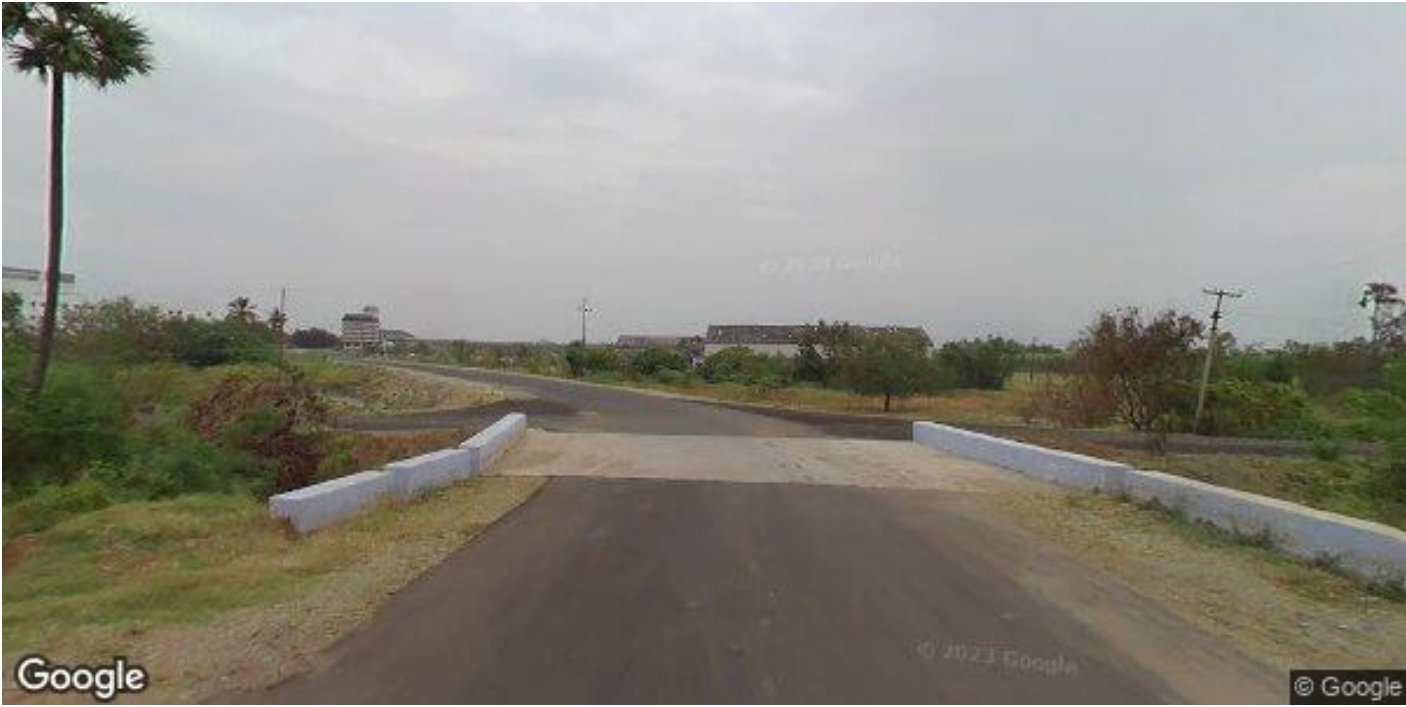
**Risk Type:** Turn  
**Risk Level:** Medium  
**Speed Limit:** 30 KM/Hr  
**Coordinates:** 11.42447, 78.15264

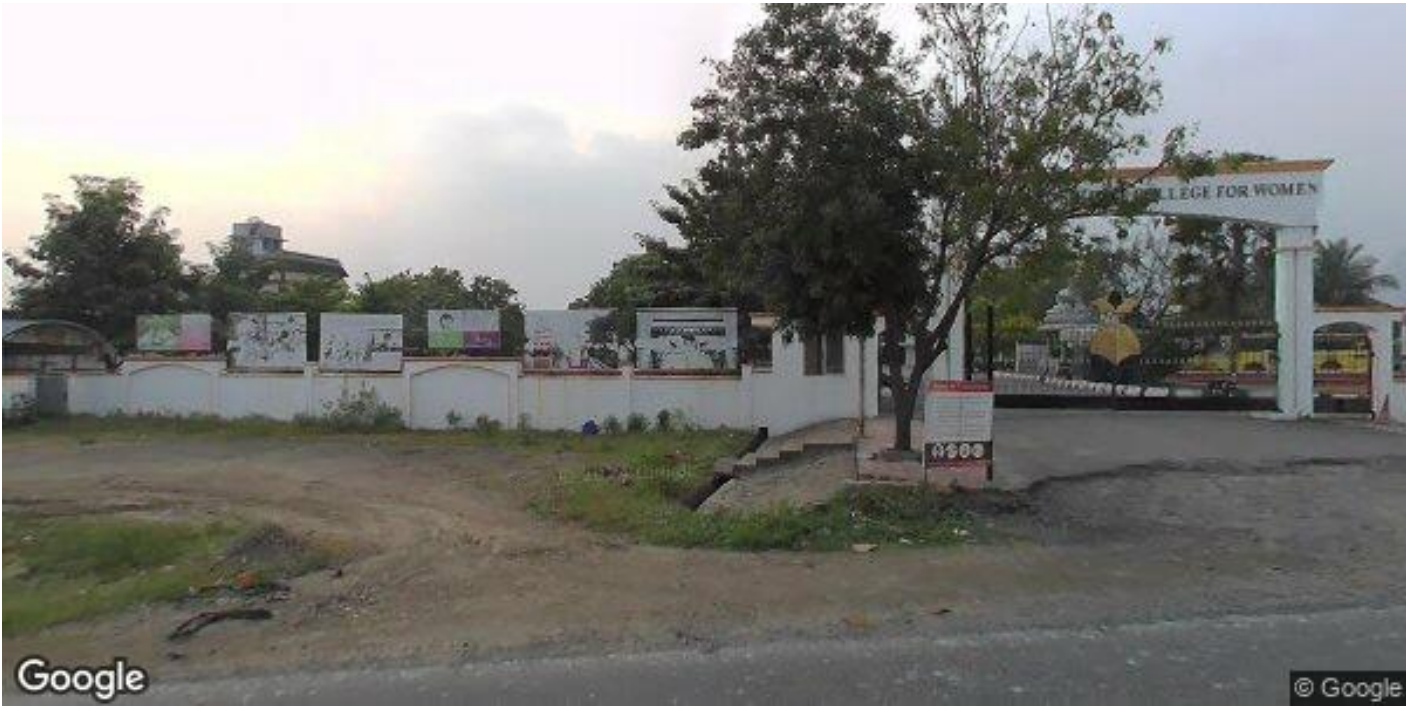
**Risk Type:** Turn  
**Risk Level:** Medium  
**Speed Limit:** 30 KM/Hr  
**Coordinates:** 11.42611, 78.15532

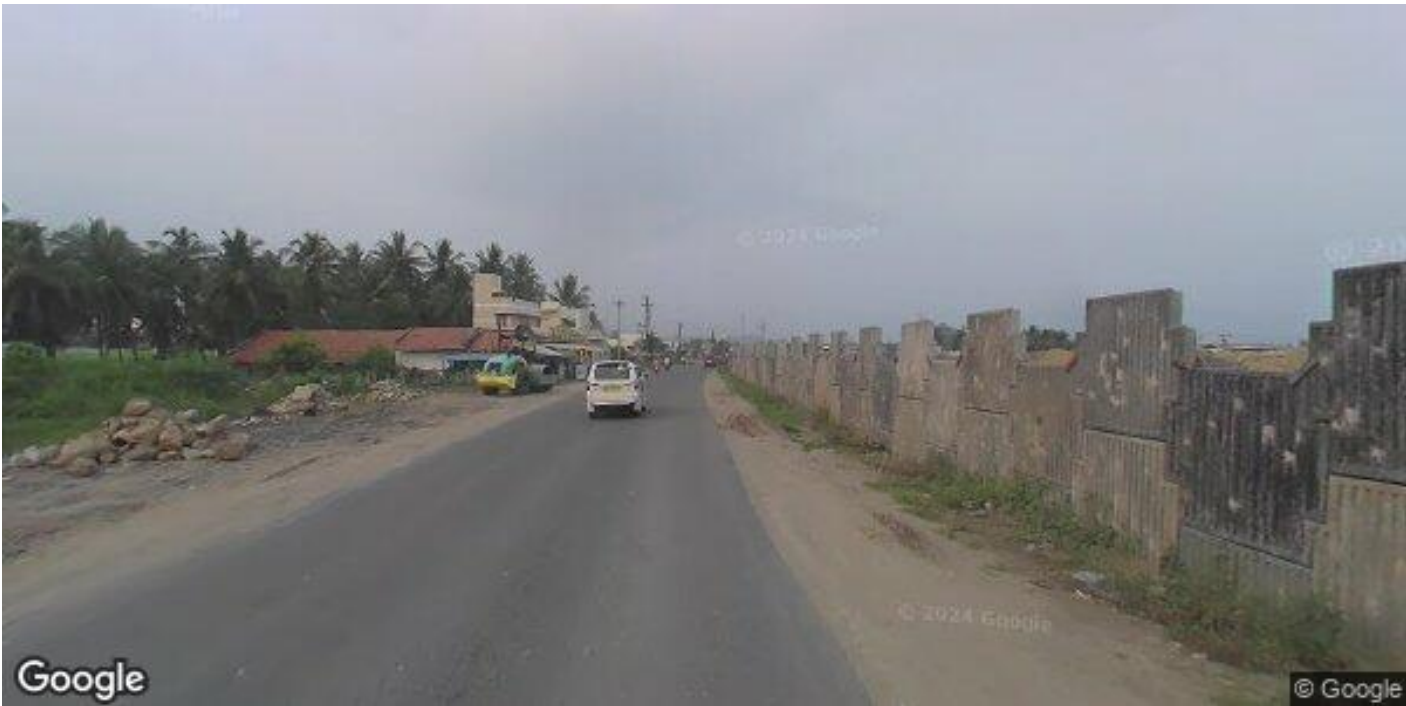
**Risk Type:** Turn  
**Risk Level:** Medium  
**Speed Limit:** 30 KM/Hr  
**Coordinates:** 11.42651, 78.15557

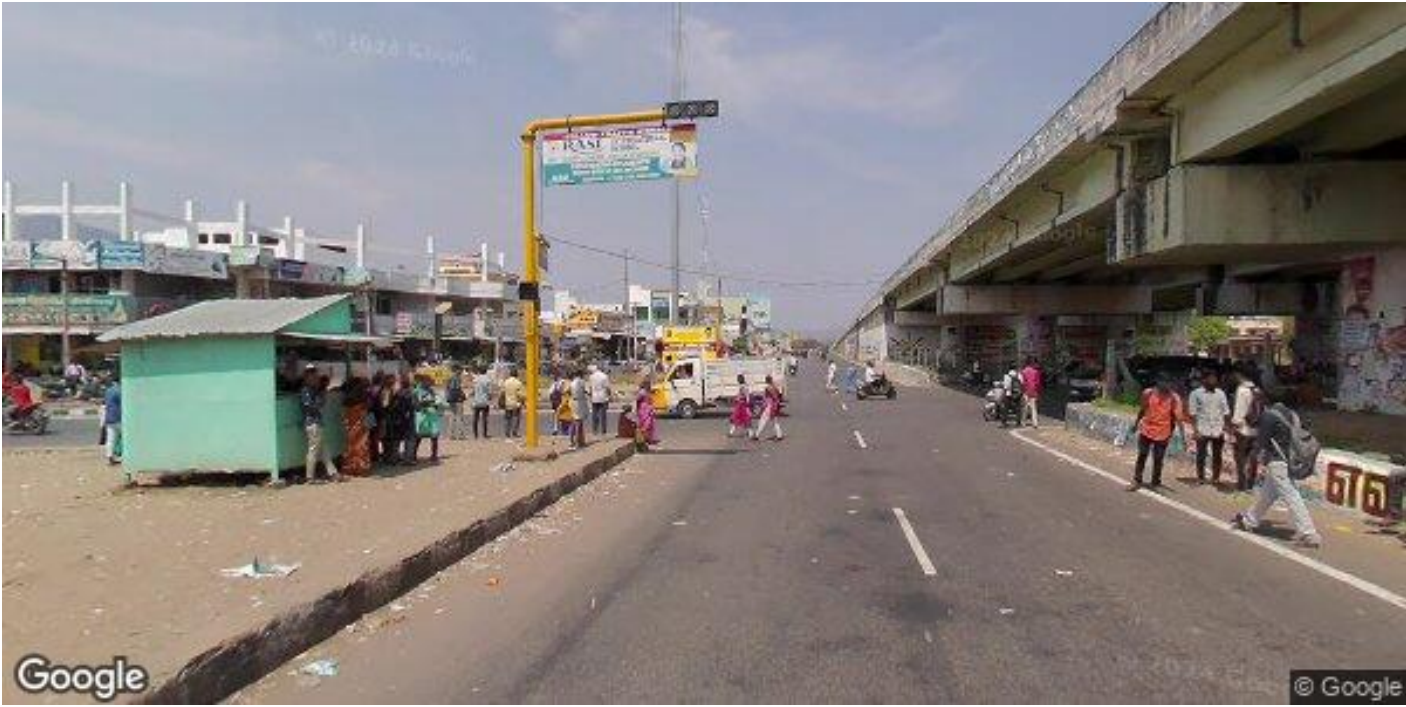
**Risk Type:** Turn  
**Risk Level:** High  
**Speed Limit:** 15 KM/Hr  
**Coordinates:** 11.44521, 78.15833

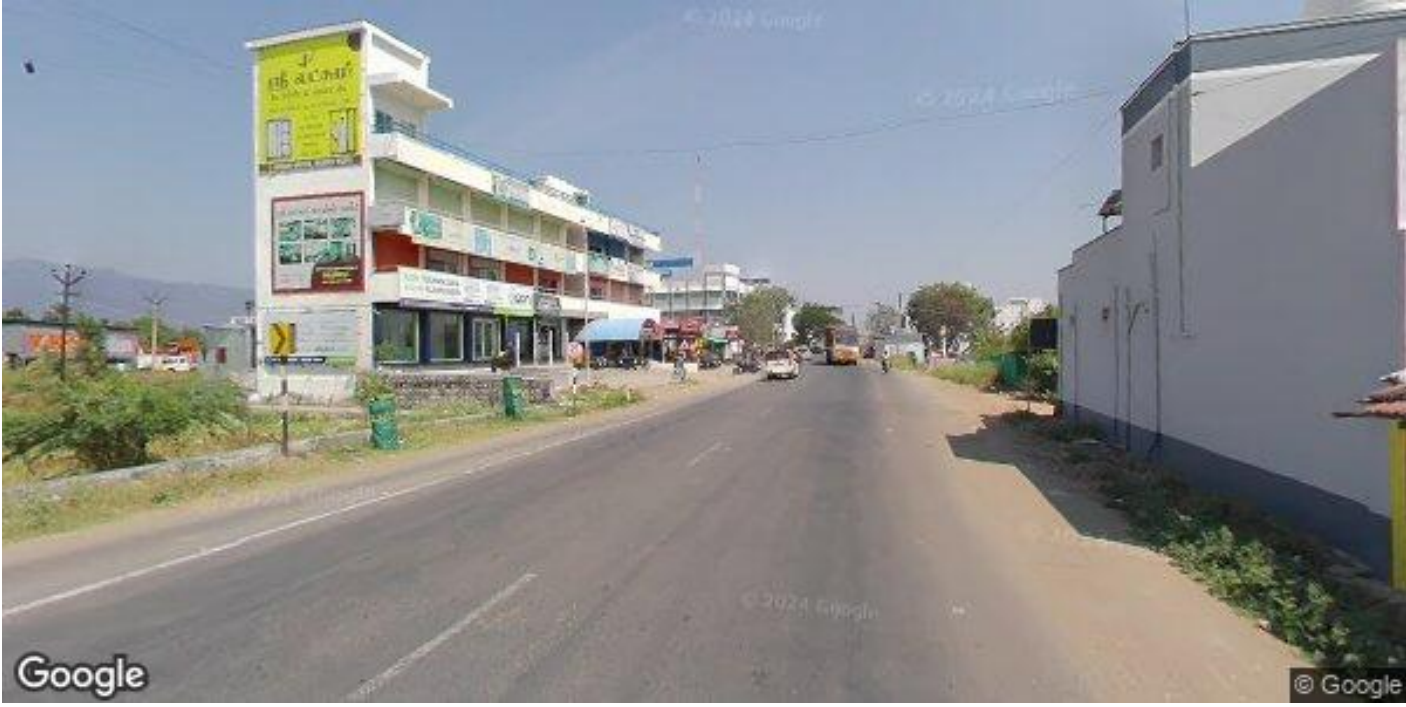
**Risk Type:** Turn  
**Risk Level:** Medium  
**Speed Limit:** 30 KM/Hr  
**Coordinates:** 11.45566, 78.17361

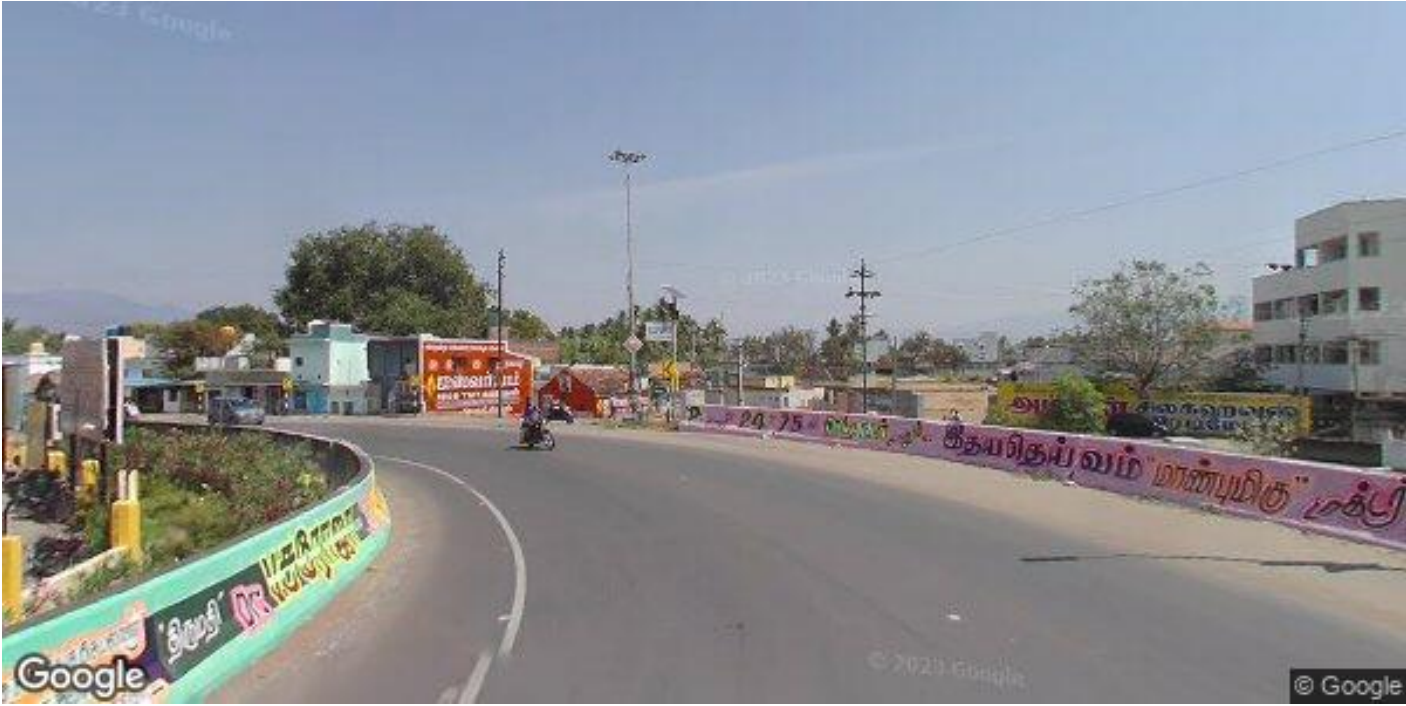
**Risk Type:** Turn  
**Risk Level:** High  
**Speed Limit:** 15 KM/Hr  
**Coordinates:** 11.45587, 78.18057

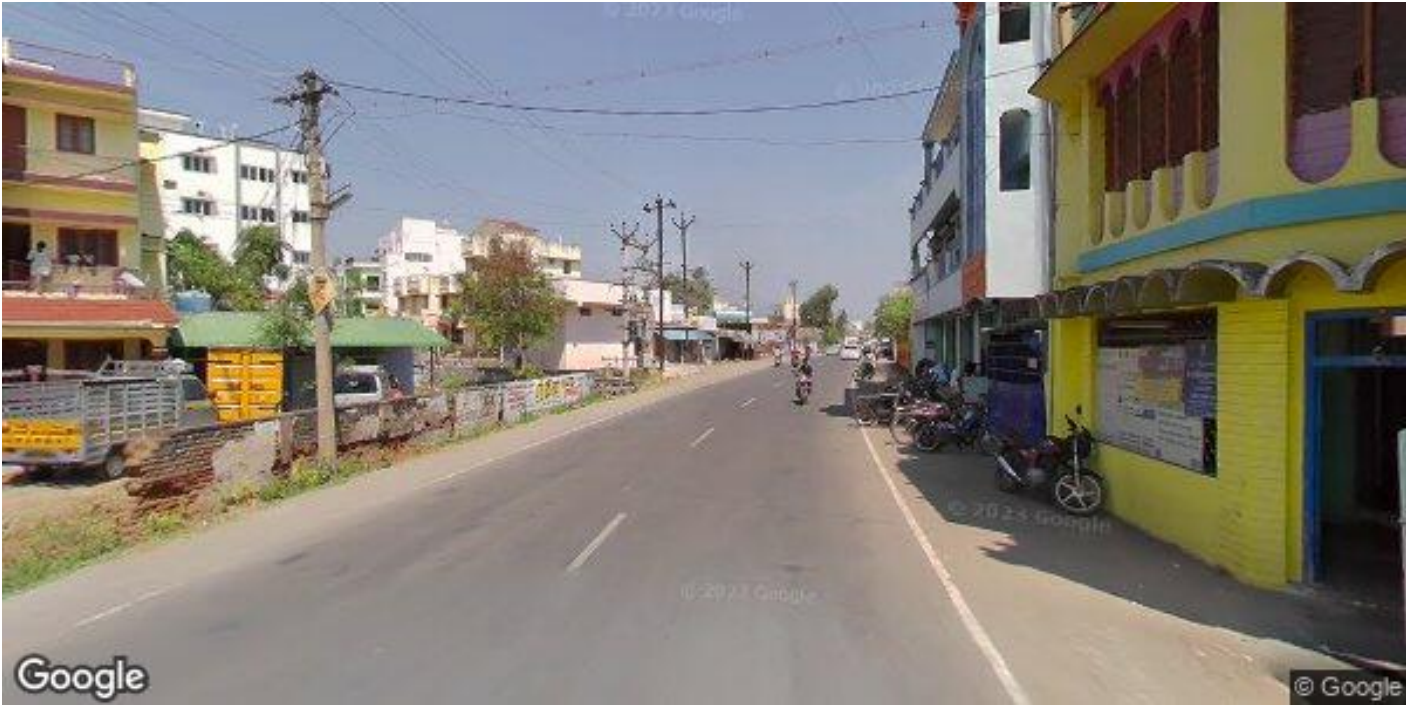
**Risk Type:** Turn  
**Risk Level:** Medium  
**Speed Limit:** 30 KM/Hr  
**Coordinates:** 11.45760, 78.18140

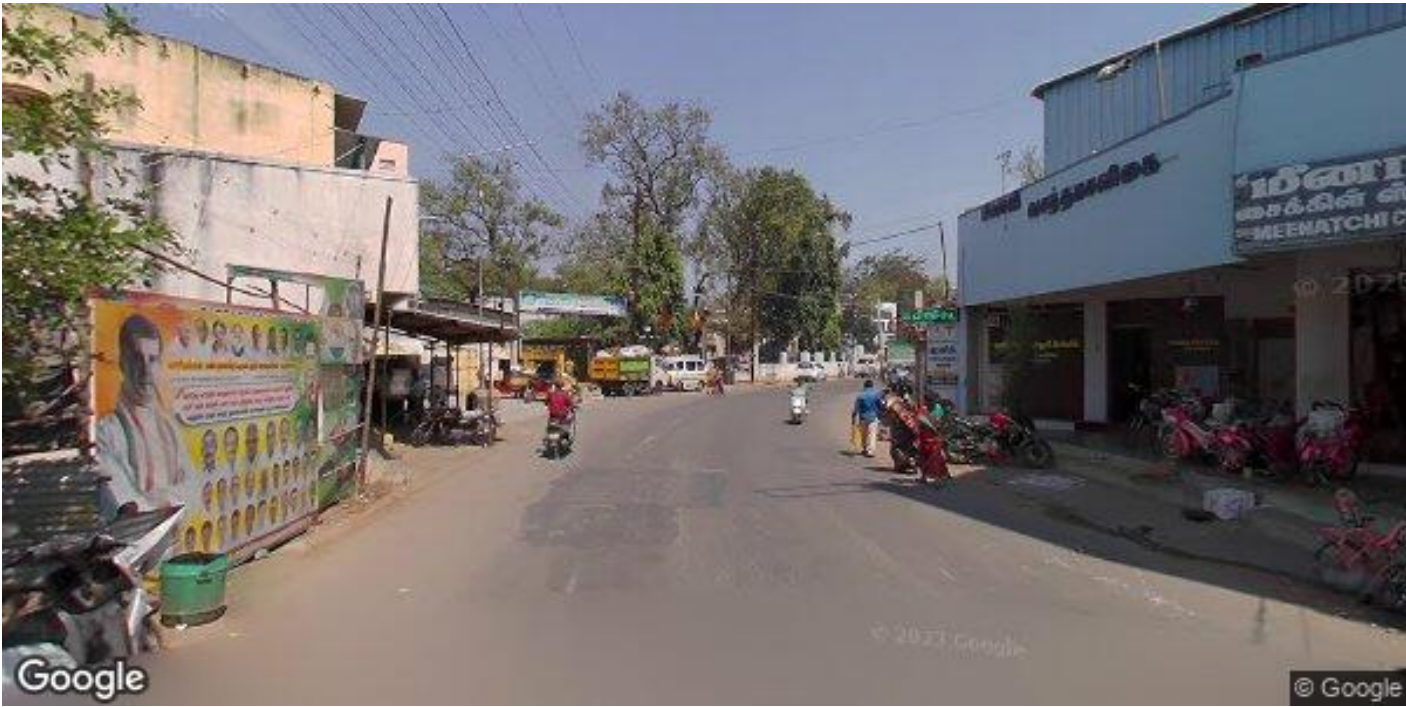
**Risk Type:** Turn  
**Risk Level:** Medium  
**Speed Limit:** 30 KM/Hr  
**Coordinates:** 11.45990, 78.18413

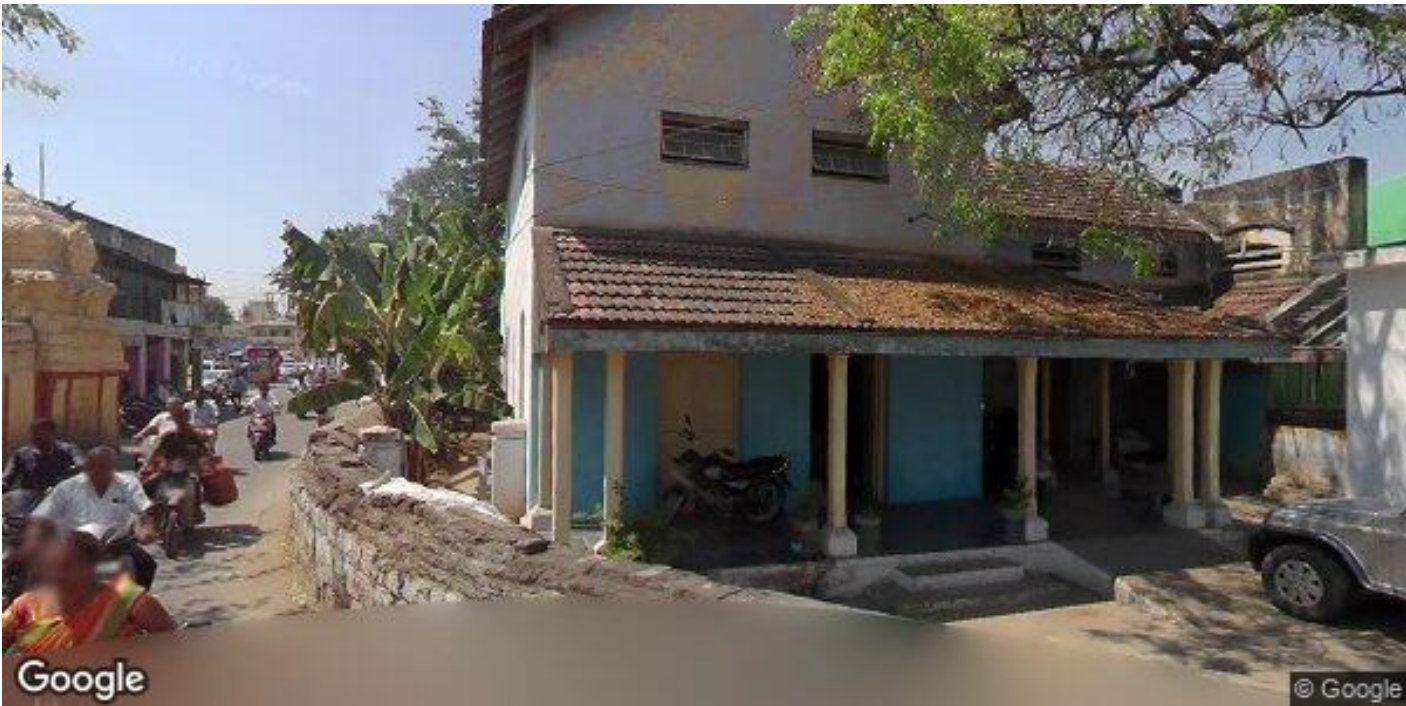
**Risk Type:** Blind Spot  
**Risk Level:** Blind Spot  
**Speed Limit:** 10 KM/Hr  
**Coordinates:** 11.46035, 78.18534

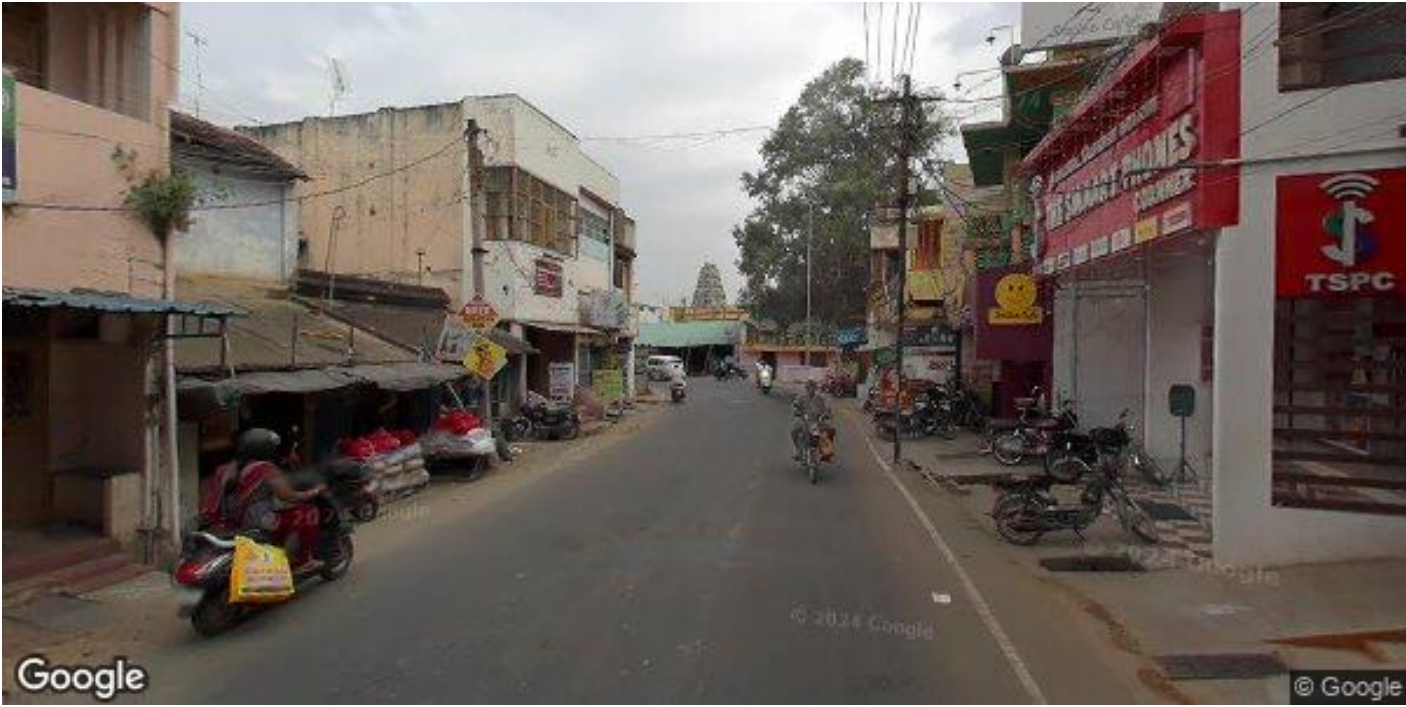
**Risk Type:** Turn  
**Risk Level:** Medium  
**Speed Limit:** 30 KM/Hr  
**Coordinates:** 11.45929, 78.18544

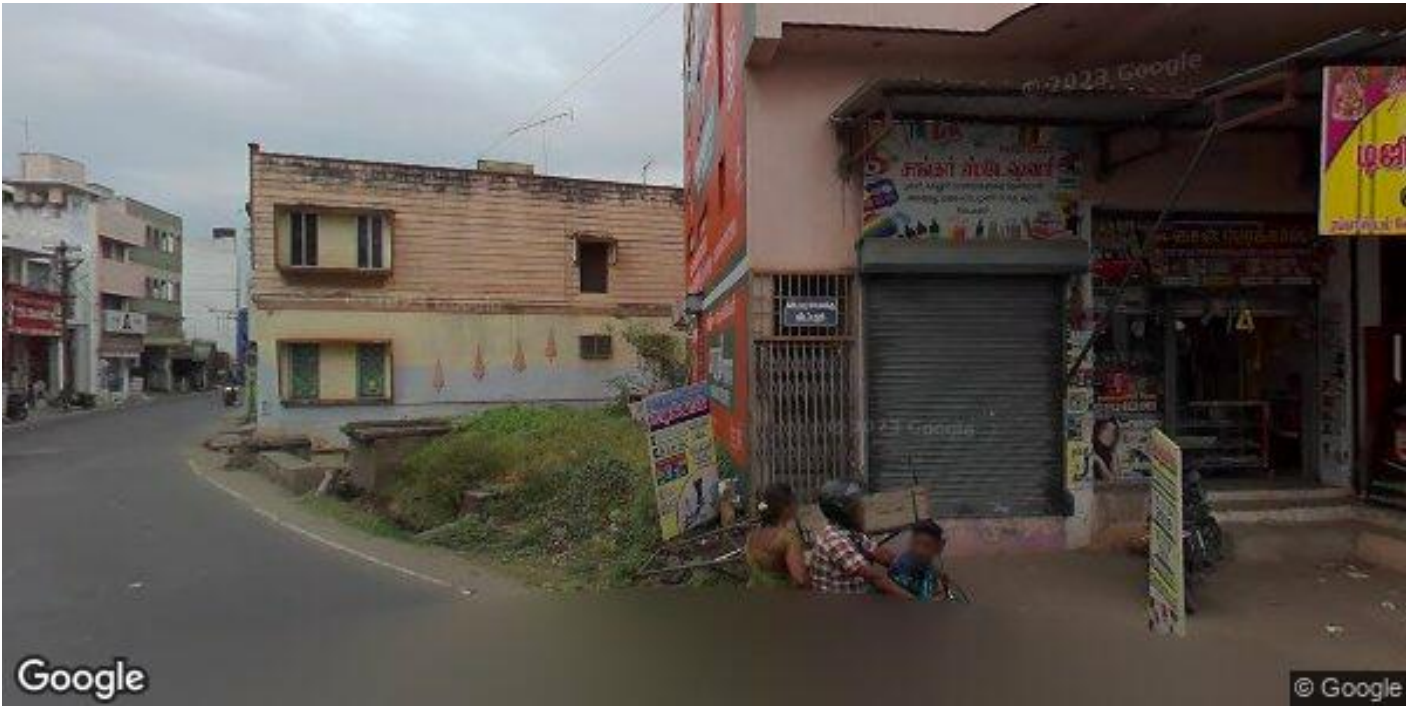
**Risk Type:** Turn  
**Risk Level:** Medium  
**Speed Limit:** 30 KM/Hr  
**Coordinates:** 11.45895, 78.18572
