# IndianOil

## JOURNEY RISK MANAGEMENT (JRM) STUDY

### Salem Terminal to Sri Vinayaga Enterprises

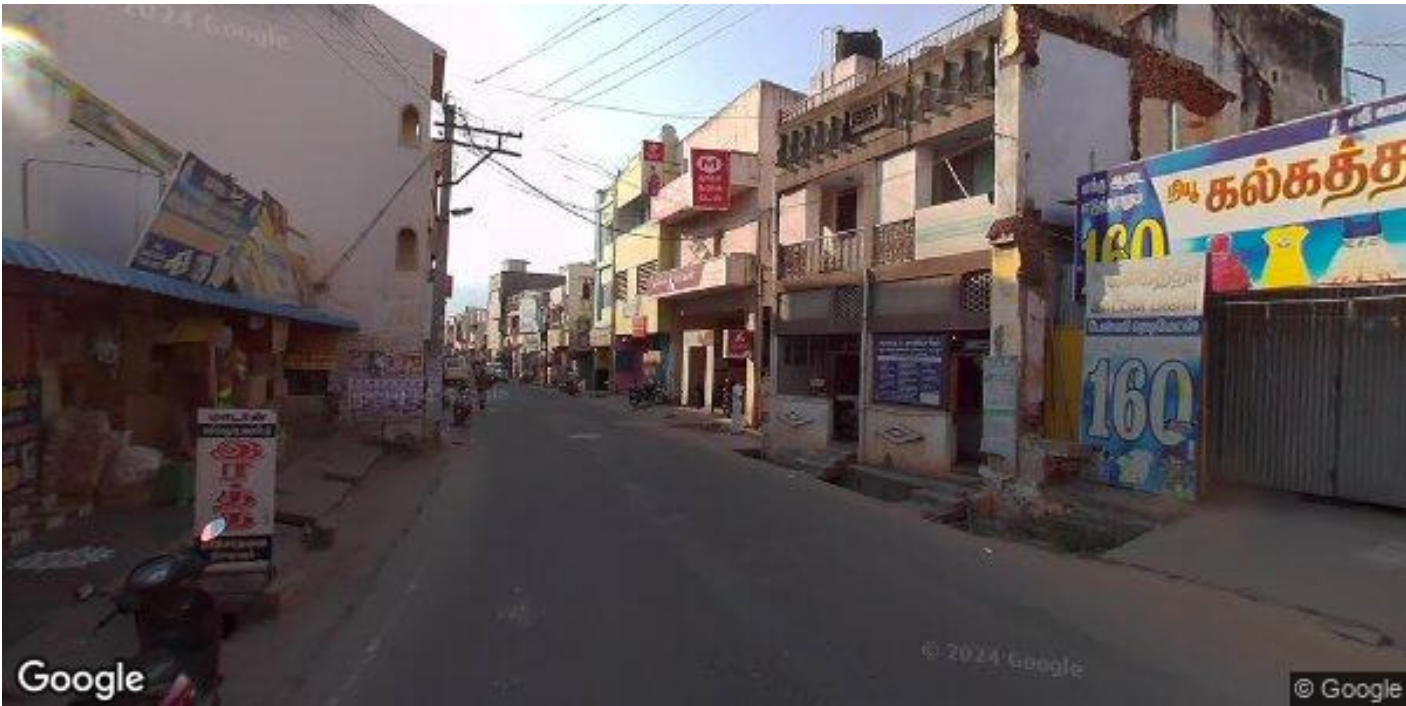
**Risk Type:** Turn  
**Risk Level:** Medium  
**Speed Limit:** 30 KM/Hr  
**Coordinates:** 11.45856, 78.18775

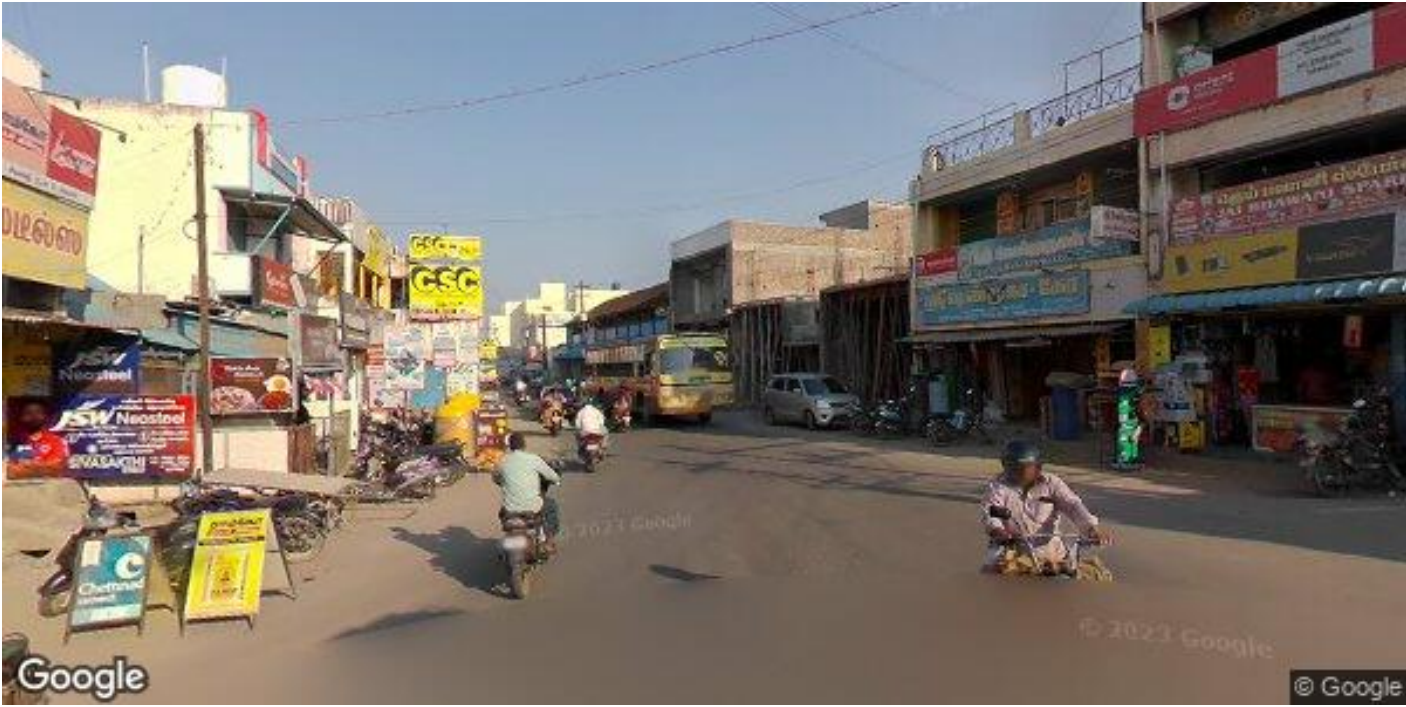
**Risk Type:** Turn  
**Risk Level:** Medium  
**Speed Limit:** 30 KM/Hr  
**Coordinates:** 11.45824, 78.18811

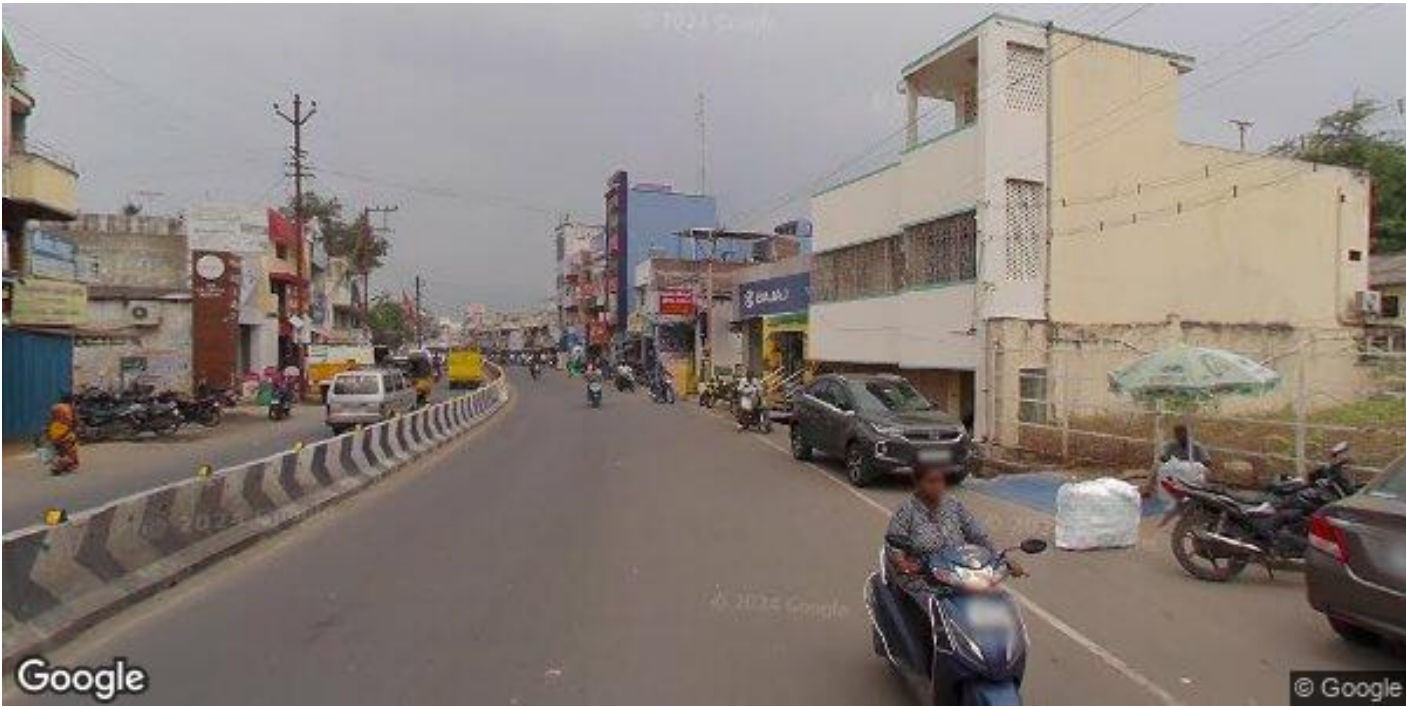
**Risk Type:** Turn  
**Risk Level:** Medium  
**Speed Limit:** 30 KM/Hr  
**Coordinates:** 11.45764, 78.19208

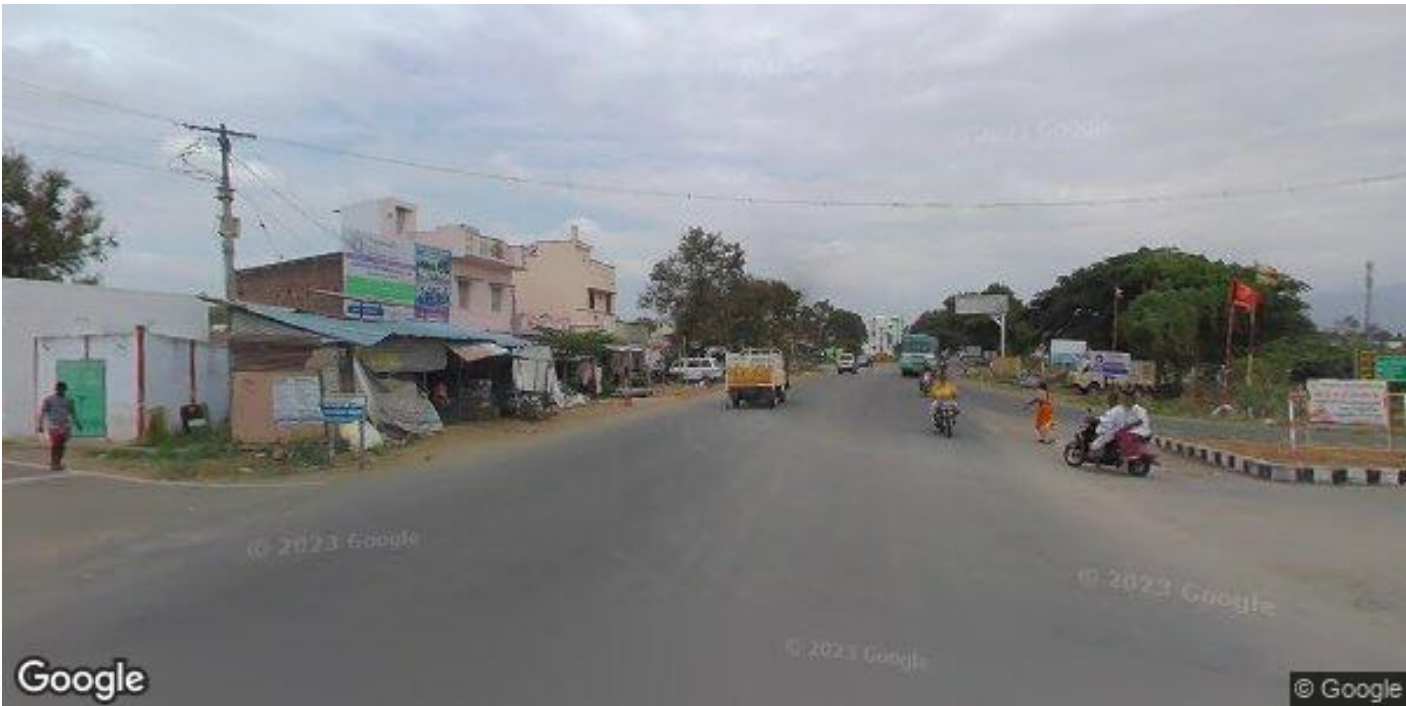
**Risk Type:** Blind Spot  
**Risk Level:** Blind Spot  
**Speed Limit:** 10 KM/Hr  
**Coordinates:** 11.45100, 78.20385

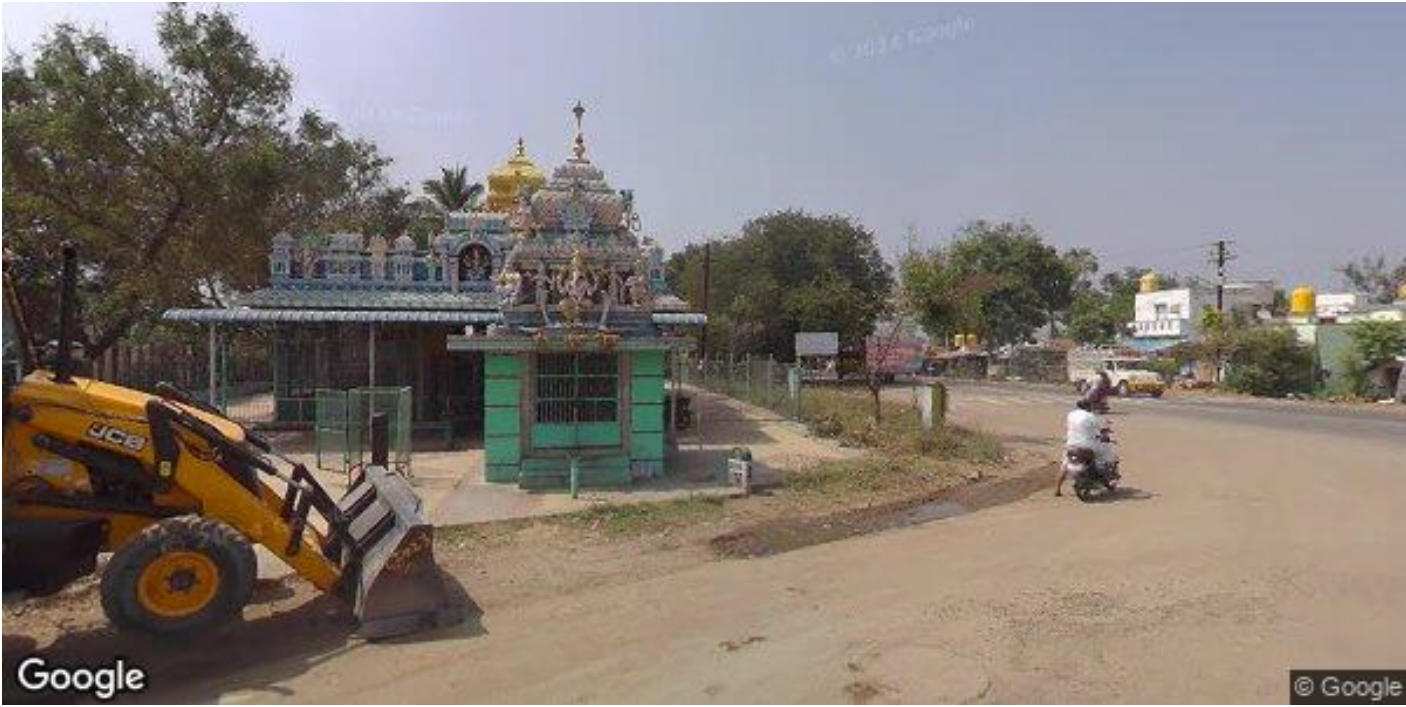
**Risk Type:** Turn  
**Risk Level:** High  
**Speed Limit:** 15 KM/Hr  
**Coordinates:** 11.45084, 78.20378

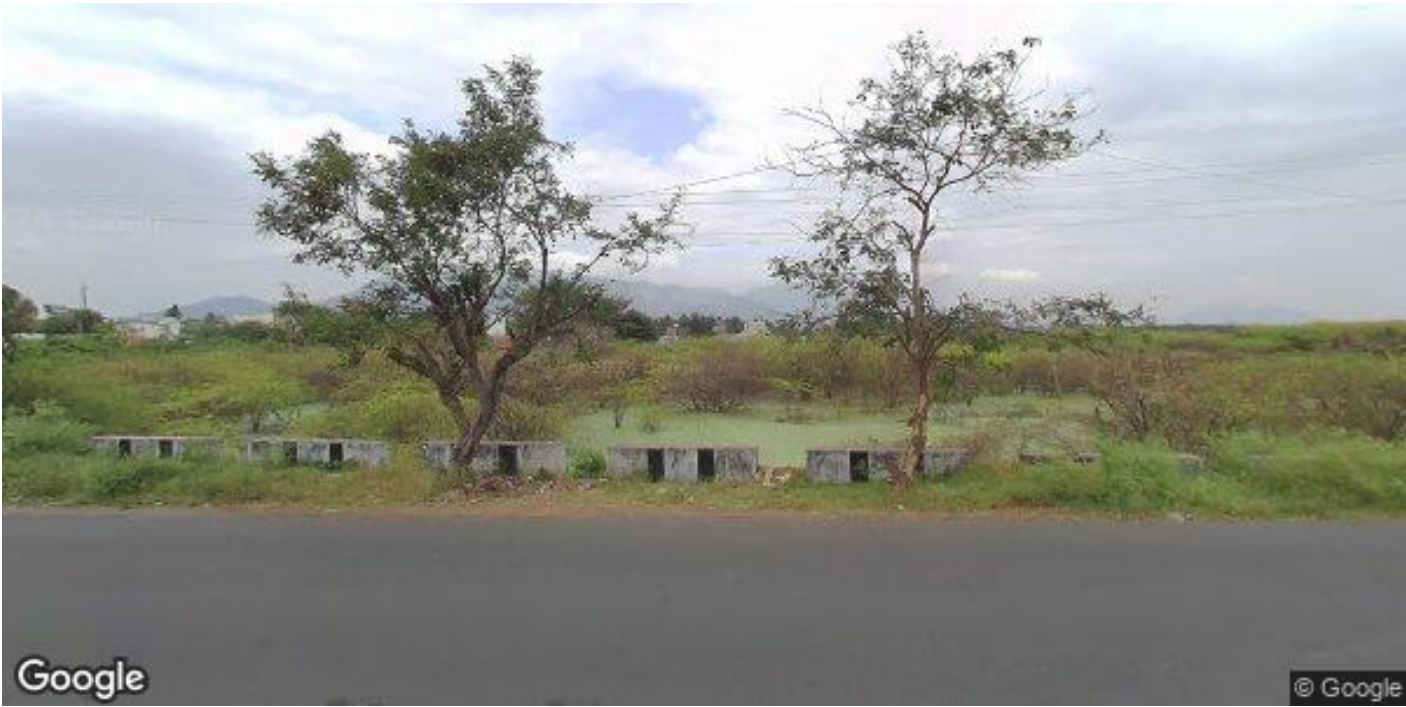
**Risk Type:** Blind Spot  
**Risk Level:** Blind Spot  
**Speed Limit:** 10 KM/Hr  
**Coordinates:** 11.45354, 78.19642

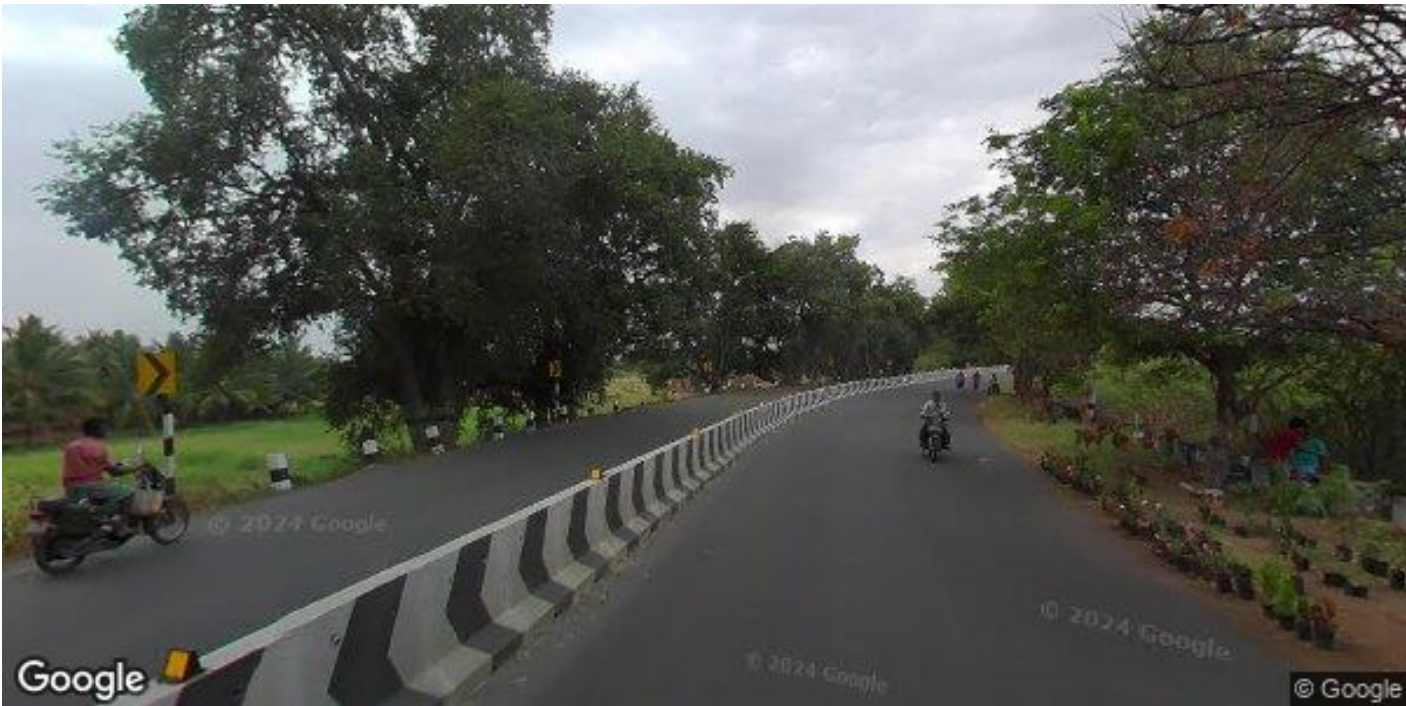
**Risk Type:** Turn  
**Risk Level:** Medium  
**Speed Limit:** 30 KM/Hr  
**Coordinates:** 11.45117, 78.20024

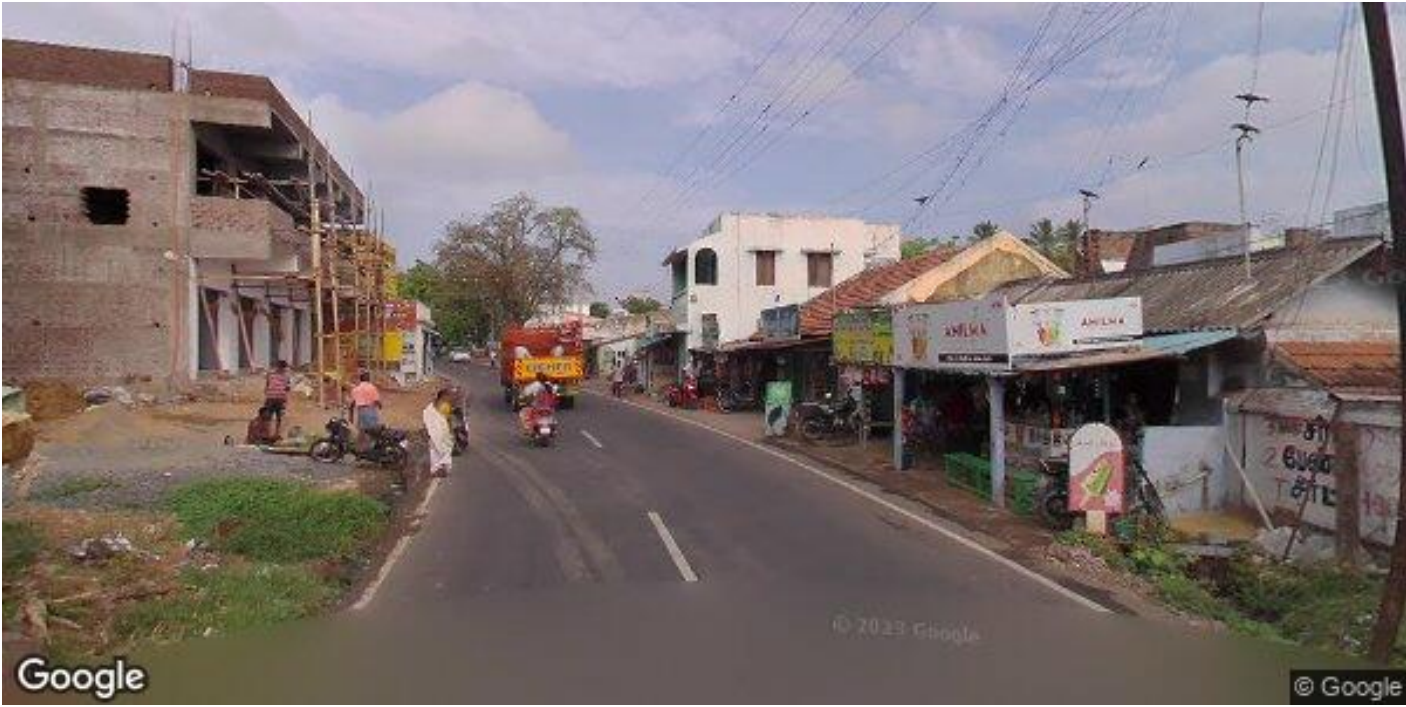
**Risk Type:** Turn  
**Risk Level:** Medium  
**Speed Limit:** 30 KM/Hr  
**Coordinates:** 11.44993, 78.22152

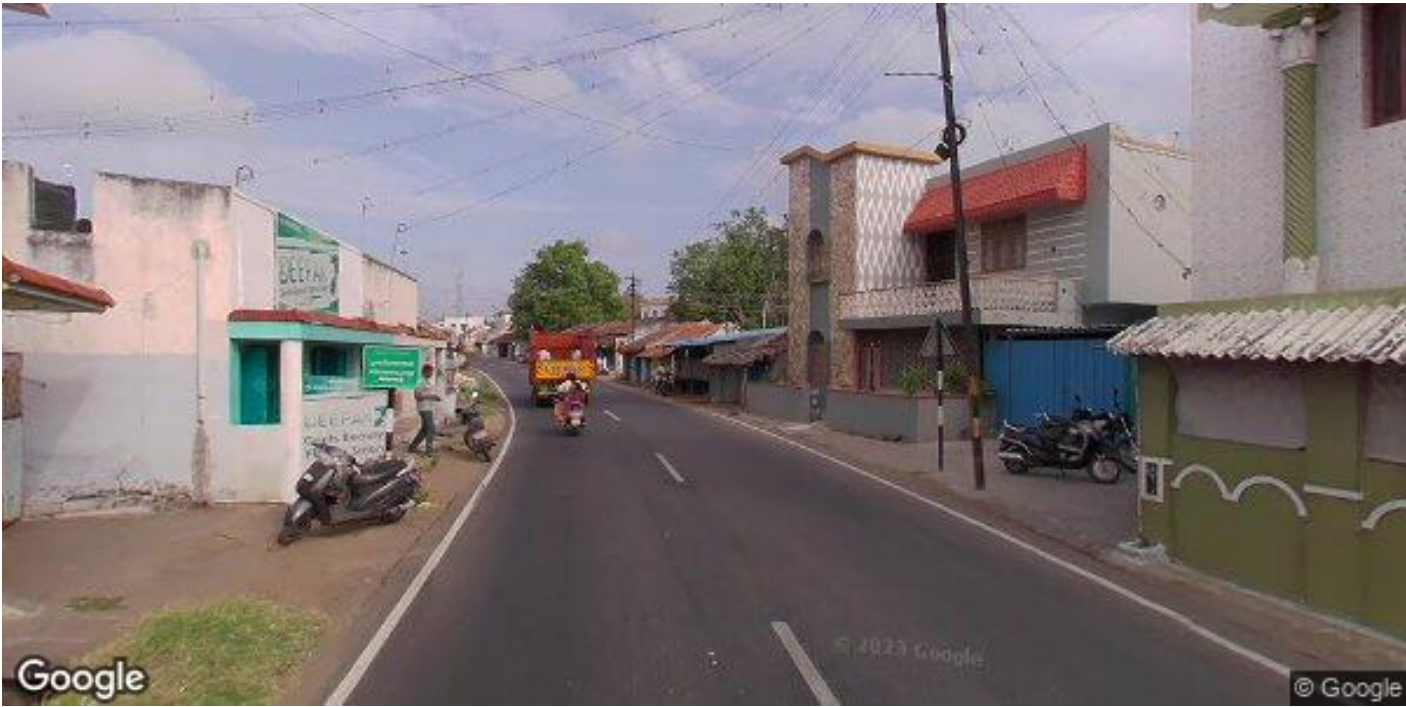
**Risk Type:** Turn  
**Risk Level:** Medium  
**Speed Limit:** 30 KM/Hr  
**Coordinates:** 11.44951, 78.22263

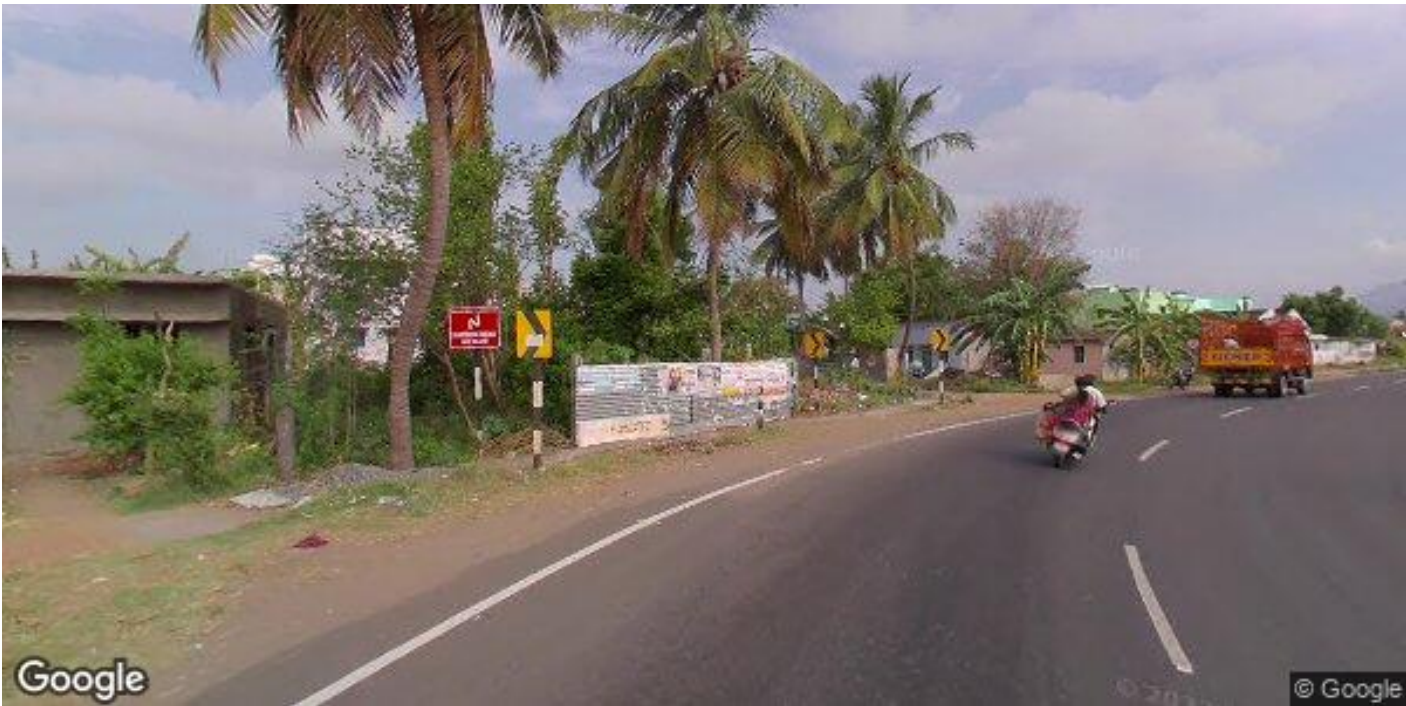
**Risk Type:** Turn  
**Risk Level:** High  
**Speed Limit:** 15 KM/Hr  
**Coordinates:** 11.44797, 78.22314

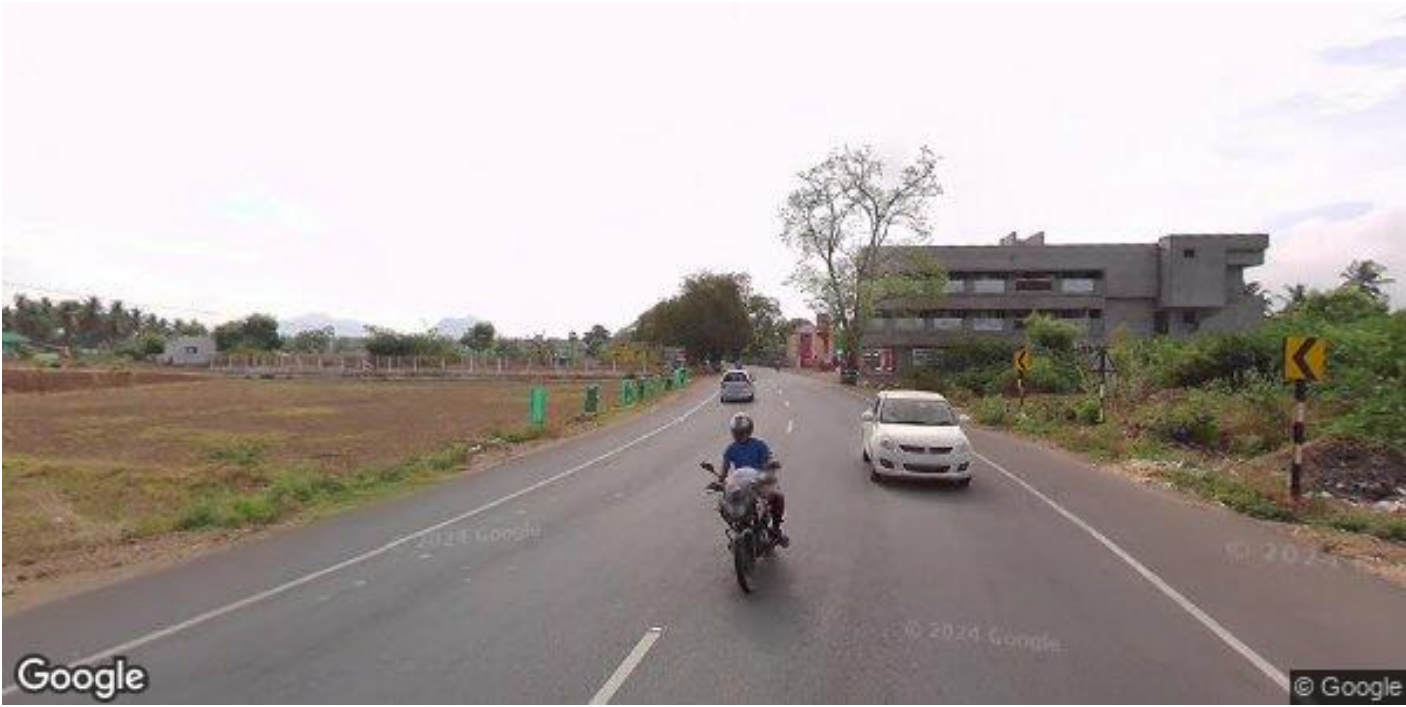
**Risk Type:** Turn  
**Risk Level:** Medium  
**Speed Limit:** 30 KM/Hr  
**Coordinates:** 11.44756, 78.22414

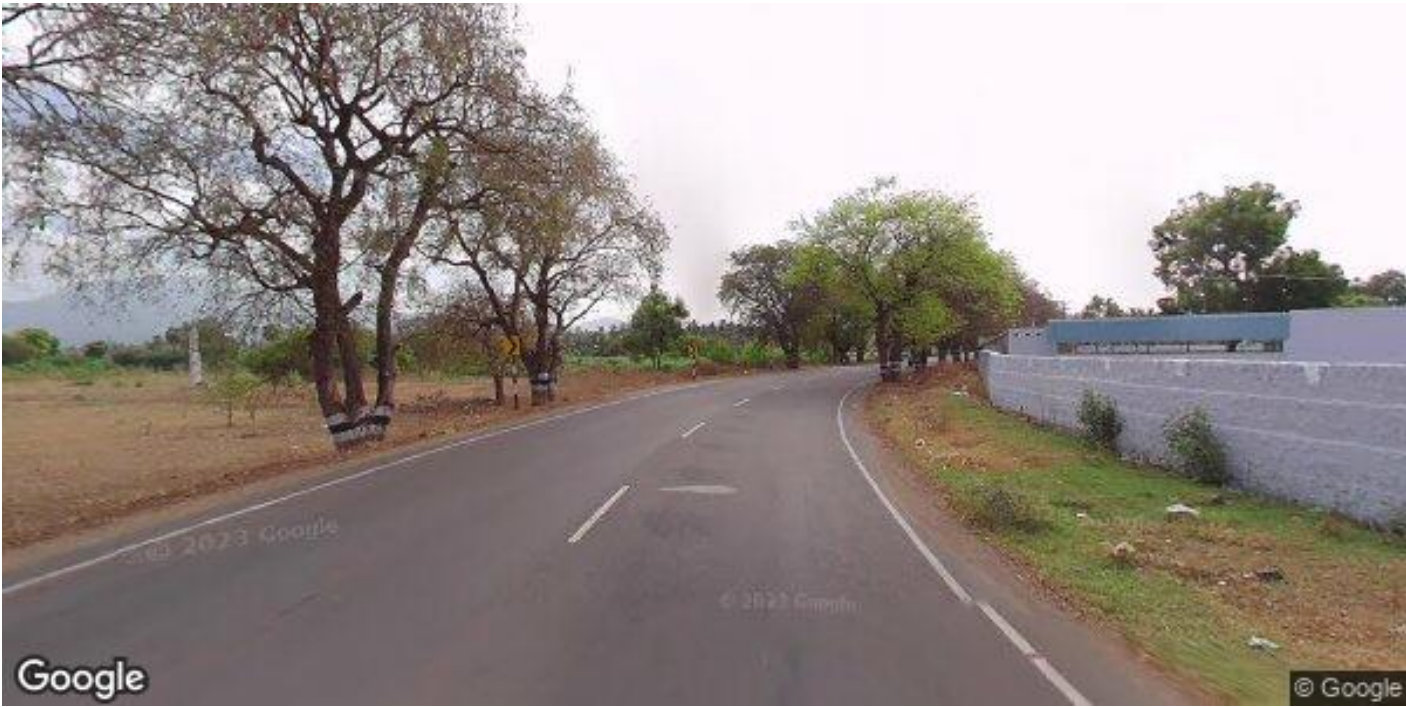
**Risk Type:** Turn  
**Risk Level:** Medium  
**Speed Limit:** 30 KM/Hr  
**Coordinates:** 11.45353, 78.23584

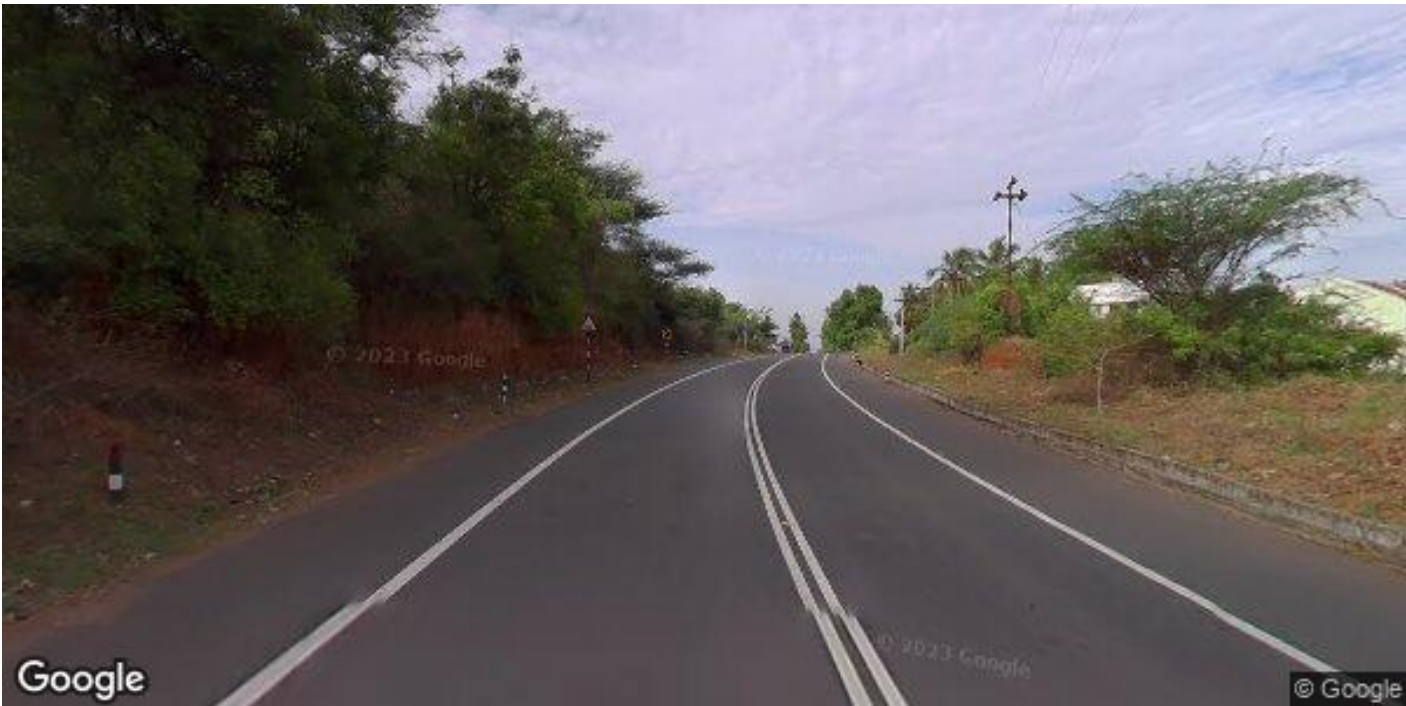
**Risk Type:** Turn  
**Risk Level:** Medium  
**Speed Limit:** 30 KM/Hr  
**Coordinates:** 11.49617, 78.32335

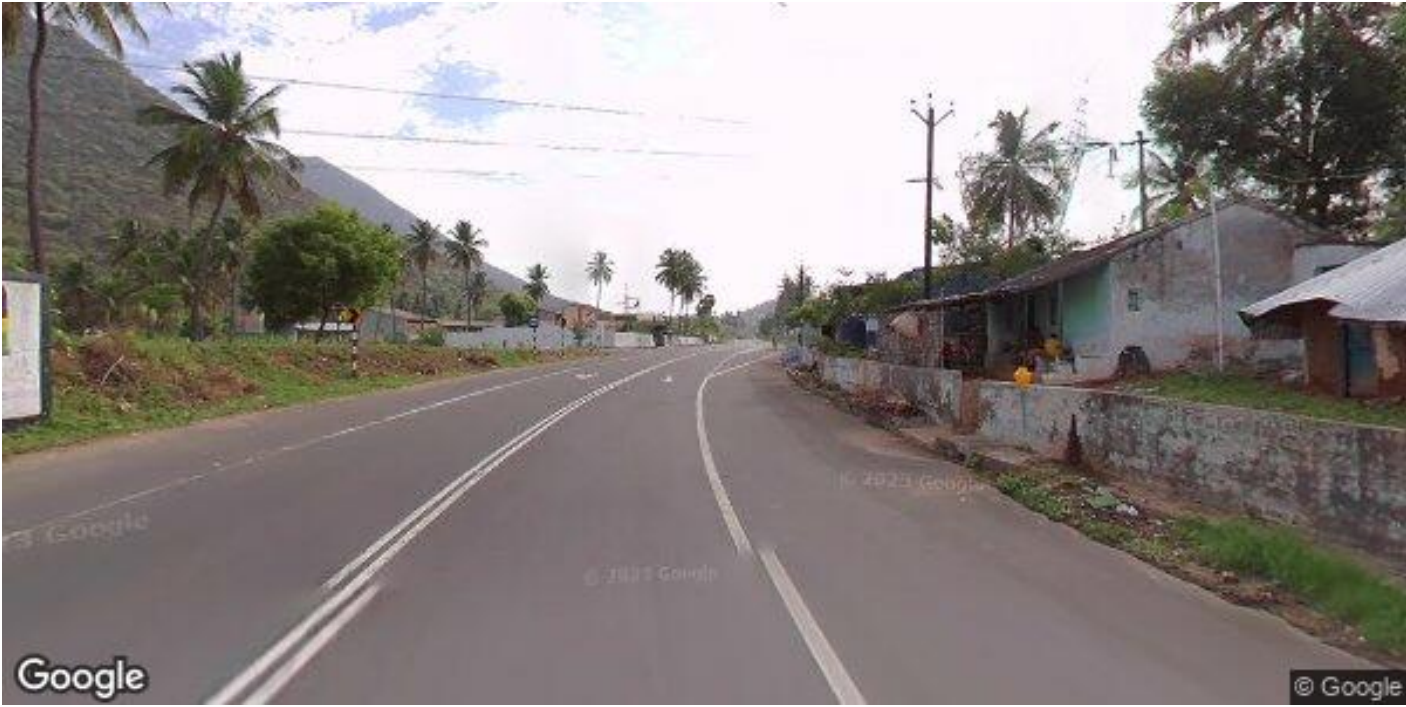
**Risk Type:** Turn  
**Risk Level:** Medium  
**Speed Limit:** 30 KM/Hr  
**Coordinates:** 11.49835, 78.32417

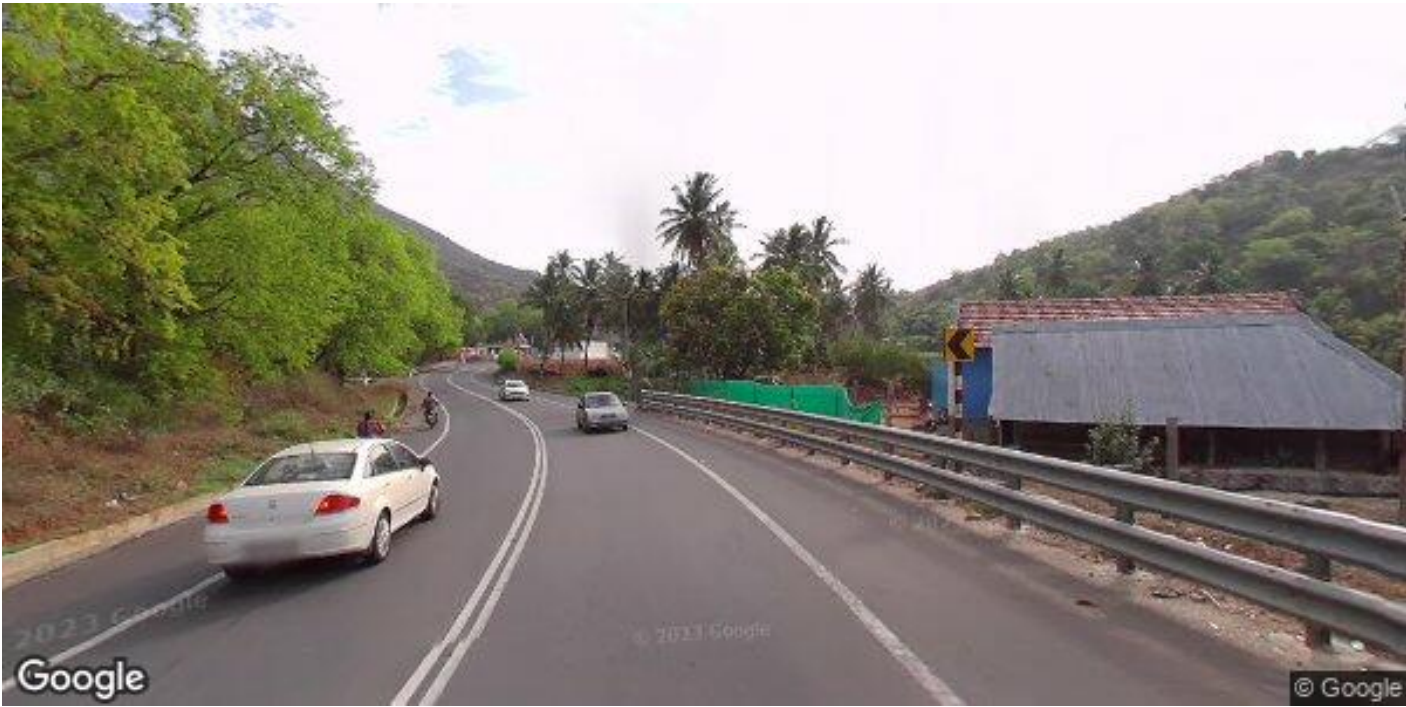
**Risk Type:** Turn  
**Risk Level:** Medium  
**Speed Limit:** 30 KM/Hr  
**Coordinates:** 11.50506, 78.33087

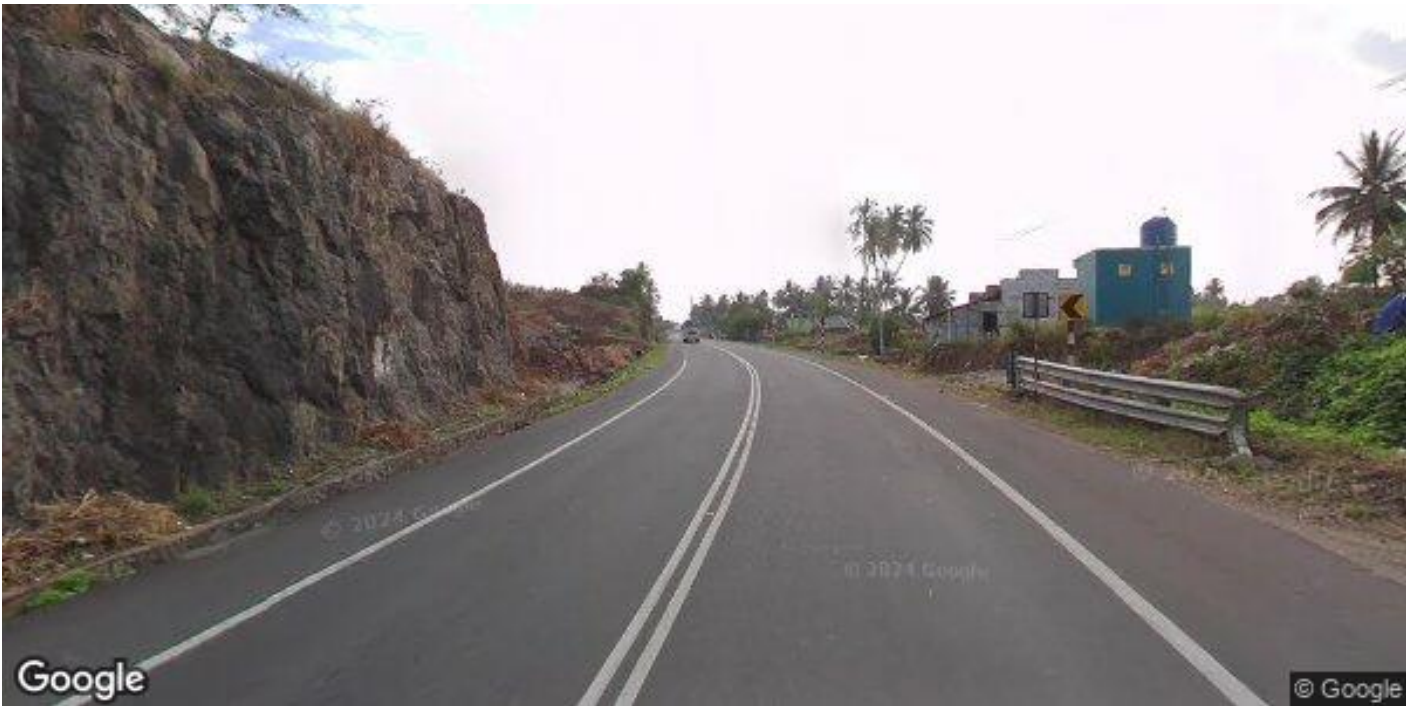
**Risk Type:** Turn  
**Risk Level:** Medium  
**Speed Limit:** 30 KM/Hr  
**Coordinates:** 11.50865, 78.33966

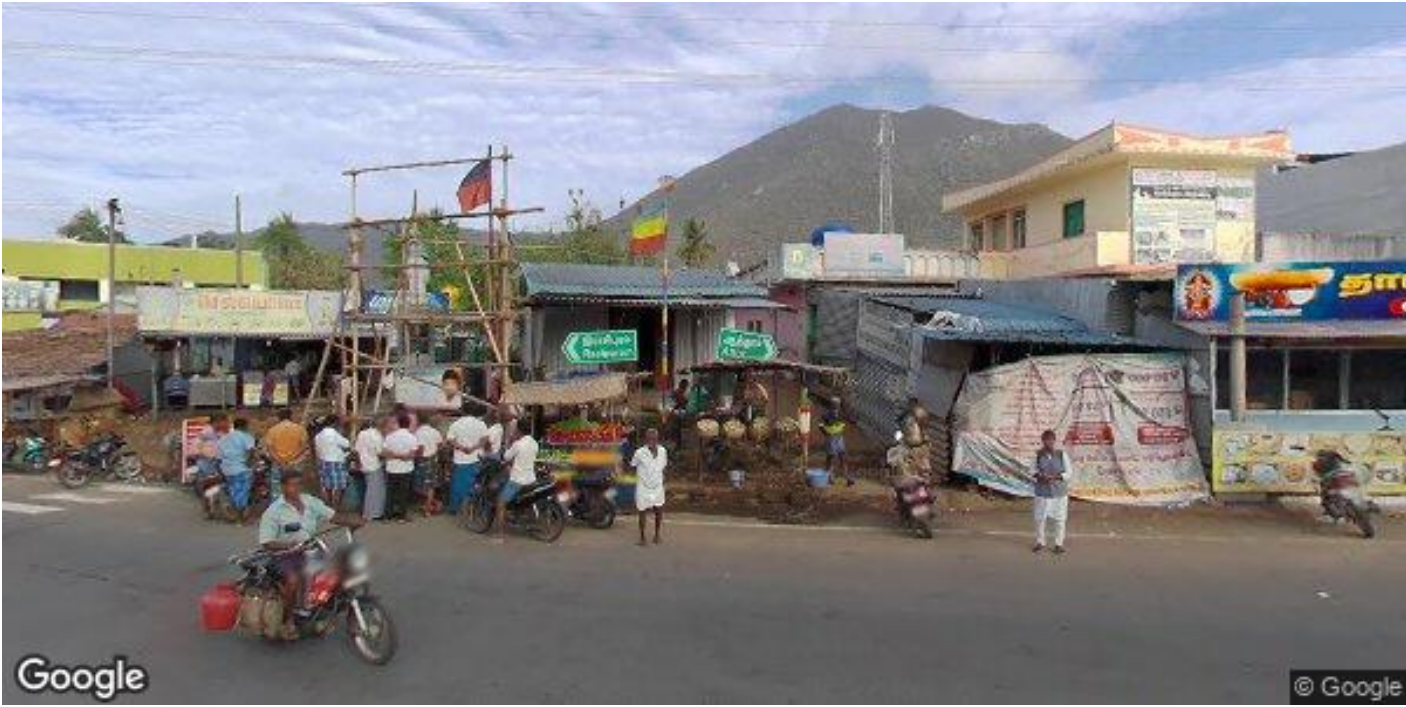
**Risk Type:** Turn  
**Risk Level:** Medium  
**Speed Limit:** 30 KM/Hr  
**Coordinates:** 11.51183, 78.34416

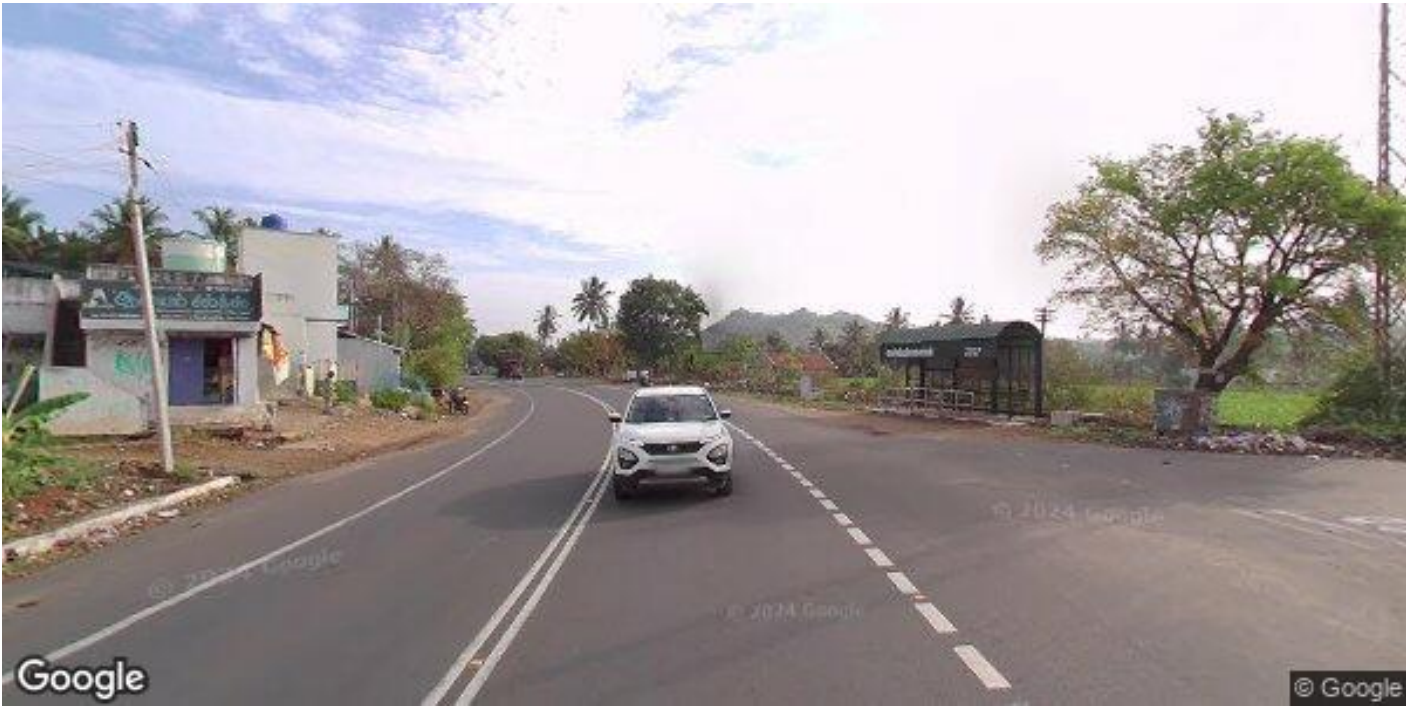
**Risk Type:** Turn  
**Risk Level:** Medium  
**Speed Limit:** 30 KM/Hr  
**Coordinates:** 11.51870, 78.34816

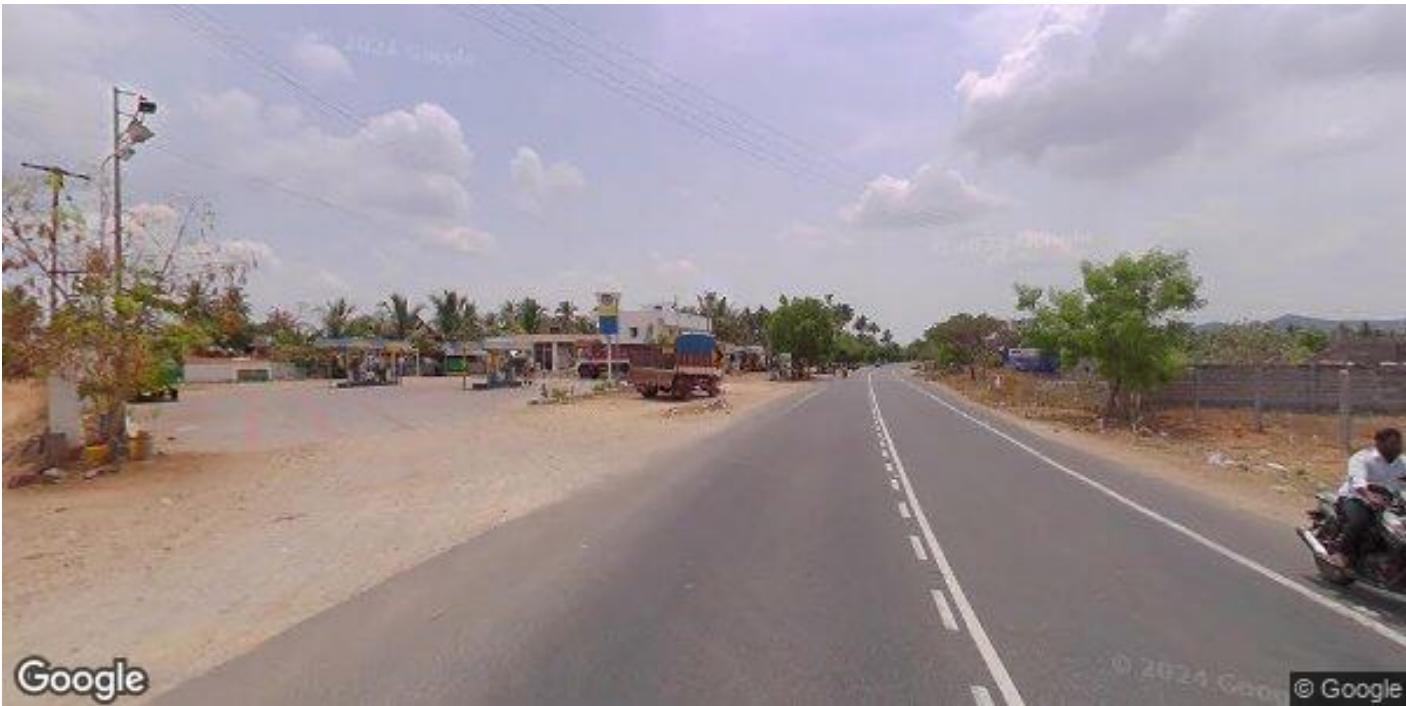
**Risk Type:** Turn  
**Risk Level:** Medium  
**Speed Limit:** 30 KM/Hr  
**Coordinates:** 11.54842, 78.35627

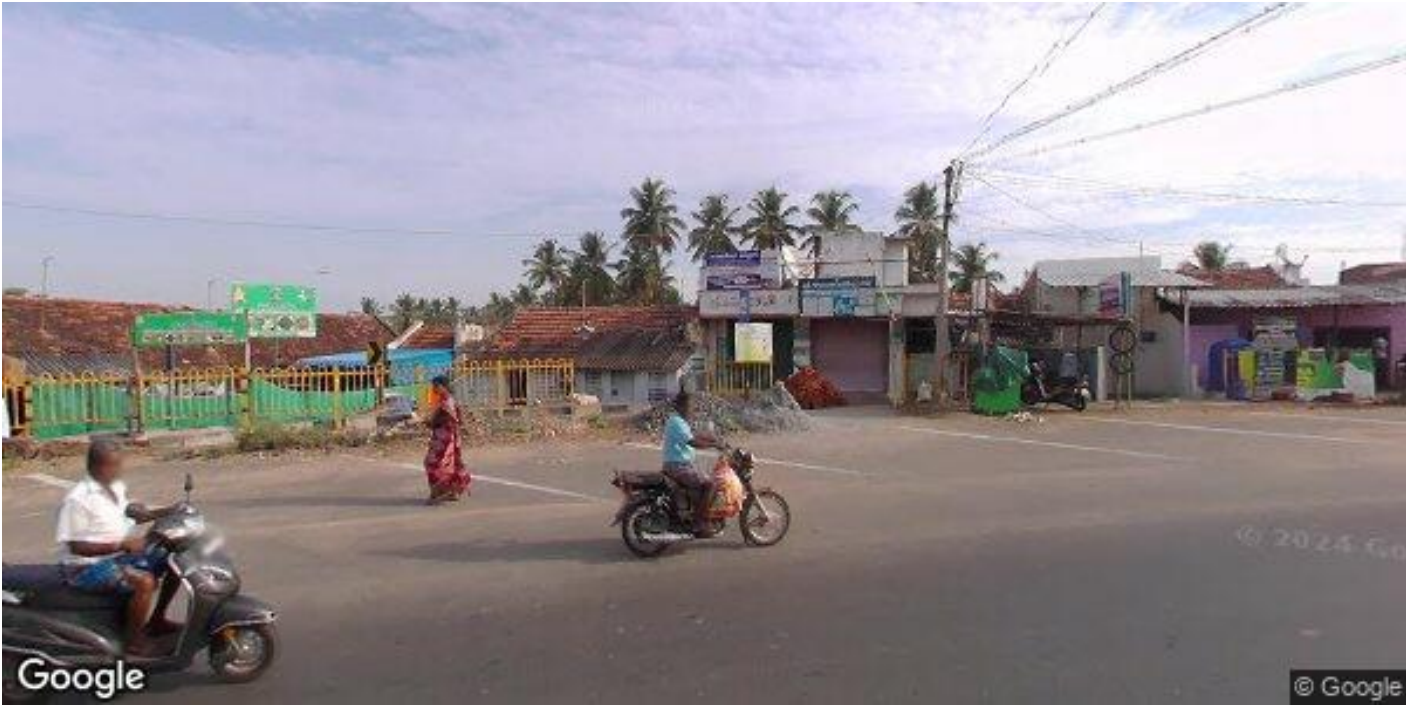
**Risk Type:** Turn  
**Risk Level:** Medium  
**Speed Limit:** 30 KM/Hr  
**Coordinates:** 11.56719, 78.37813

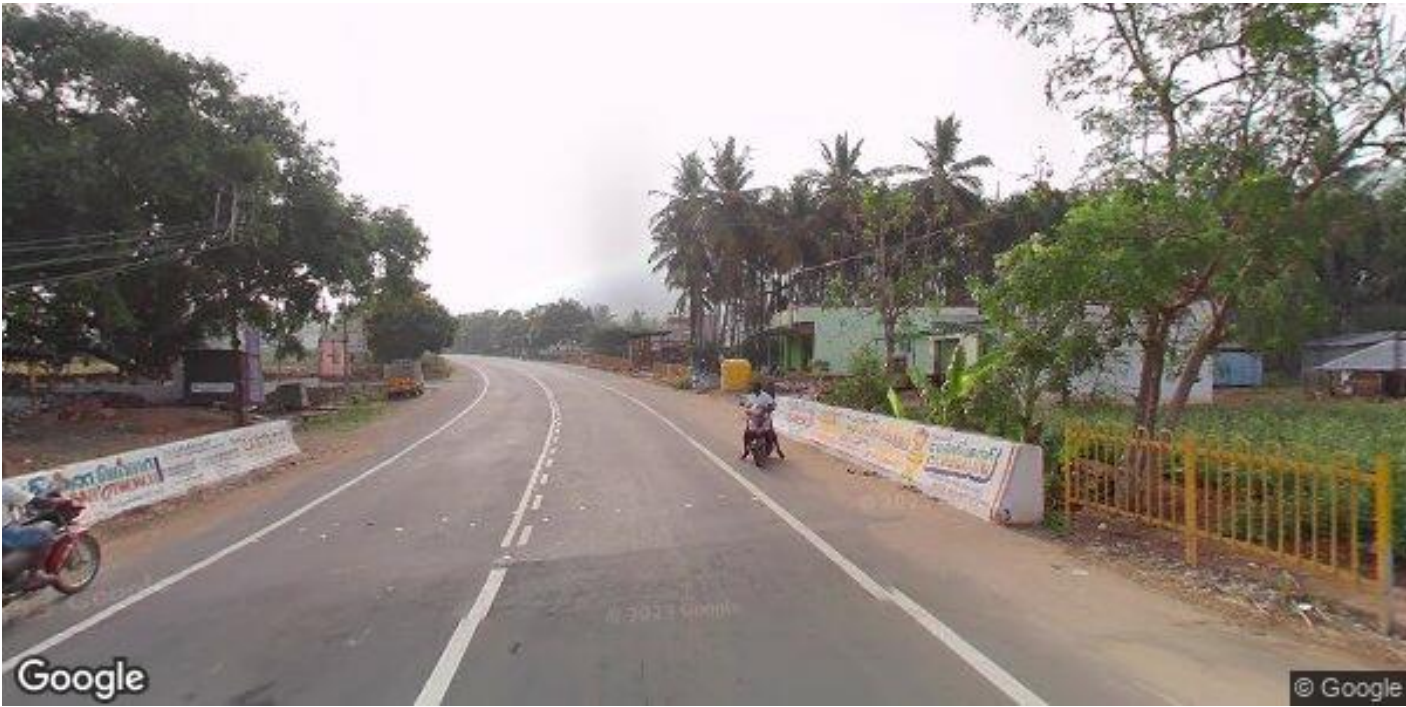
**Risk Type:** Turn  
**Risk Level:** Medium  
**Speed Limit:** 30 KM/Hr  
**Coordinates:** 11.56940, 78.39856

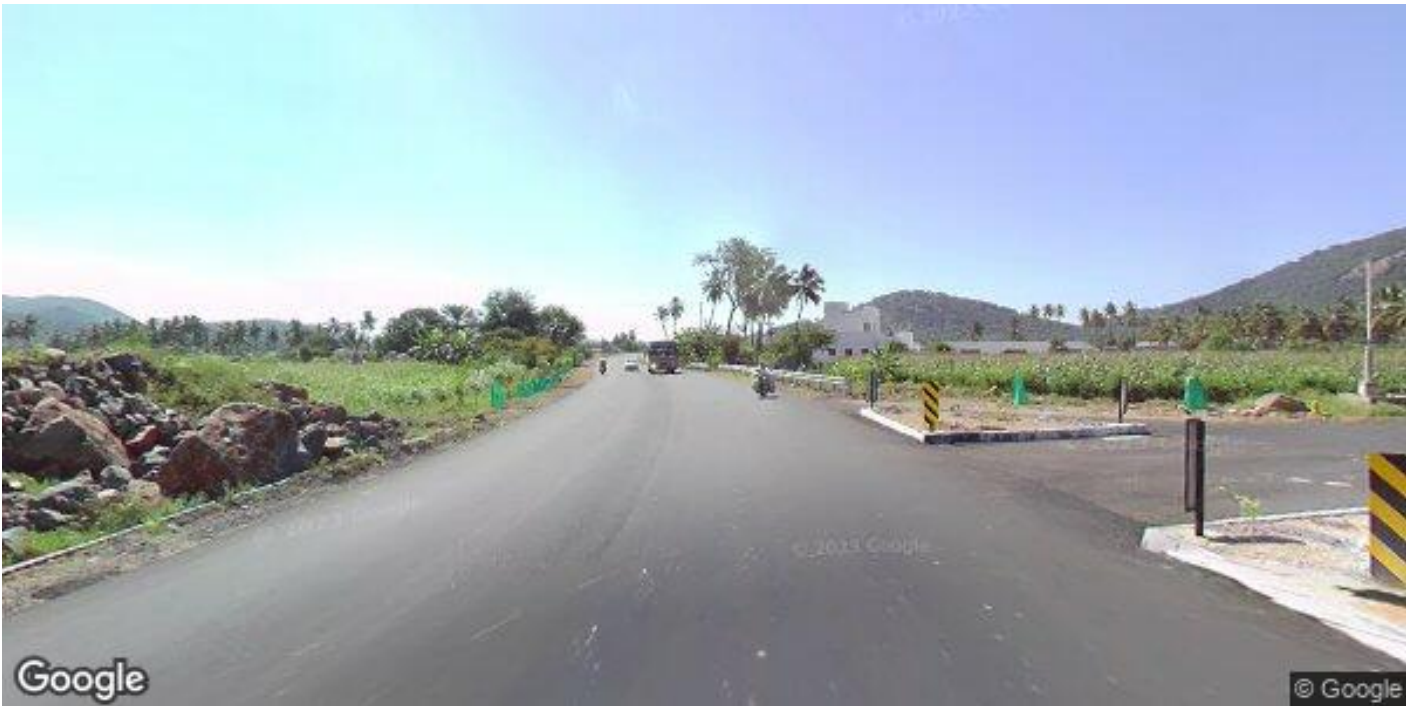
**Risk Type:** Turn  
**Risk Level:** Medium  
**Speed Limit:** 30 KM/Hr  
**Coordinates:** 11.57829, 78.51245
