# IndianOil

## JOURNEY RISK MANAGEMENT (JRM) STUDY

### Salem Terminal to Sri Vinayaga Enterprises

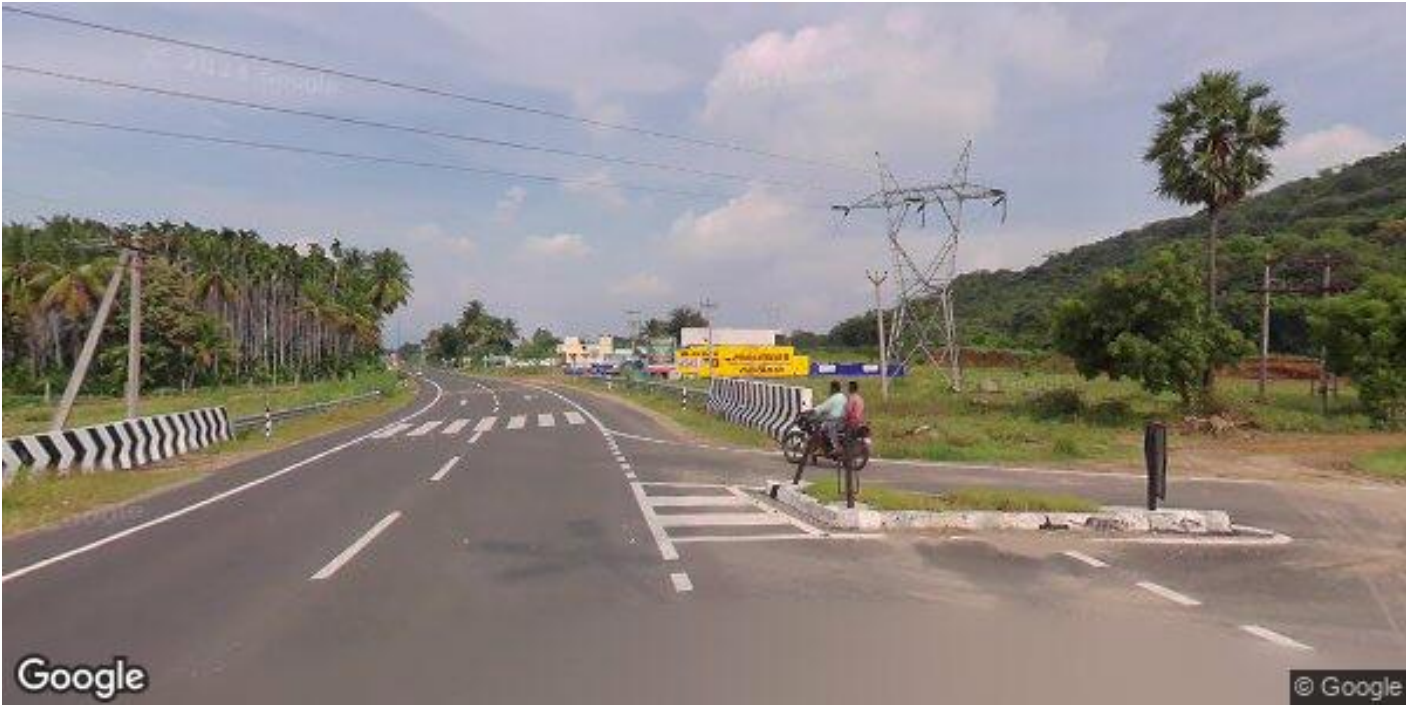
**Risk Type:** Turn  
**Risk Level:** Medium  
**Speed Limit:** 30 KM/Hr  
**Coordinates:** 11.58679, 78.54553
