# IndianOil

## JOURNEY RISK MANAGEMENT (JRM) STUDY

### Salem Terminal TO SELVA VINAYAGA FUELS

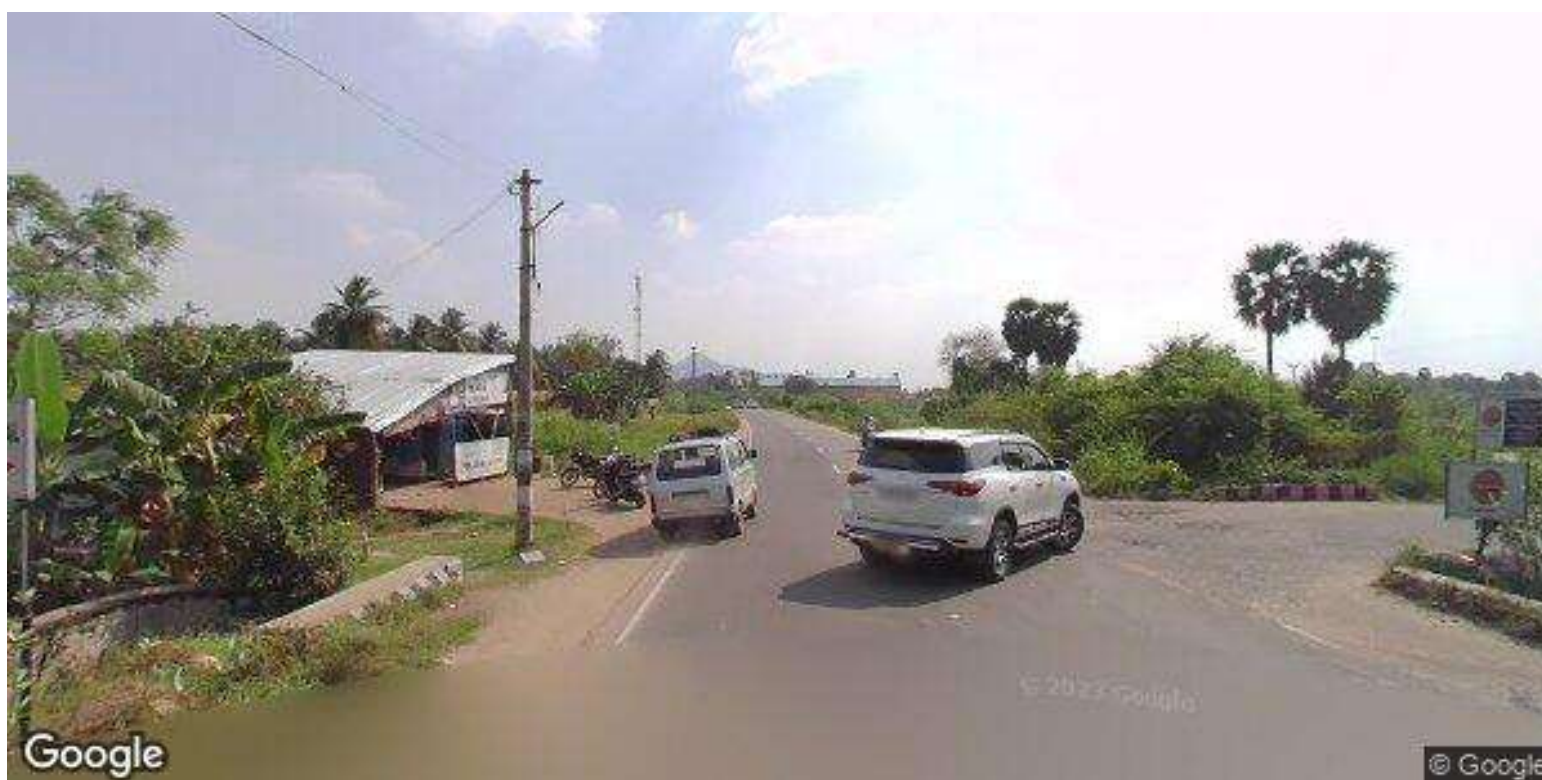
**Coordinates:** 11.44029, 77.87544

**Risk Type:** Turn

**Risk Level:** High

**Speed Limit:** 15 KM/Hr

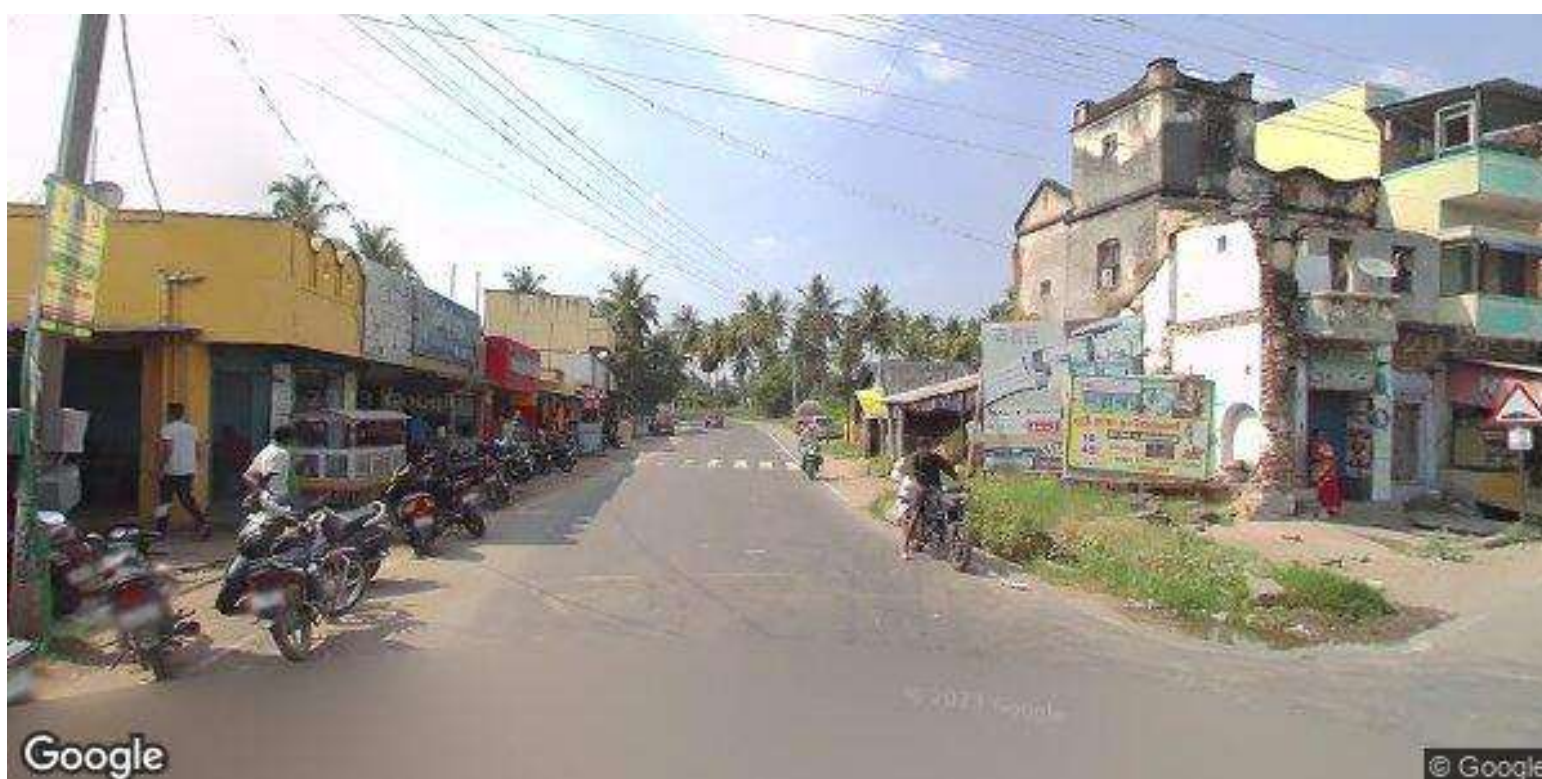
**Coordinates:** 11.45007, 77.87201

**Risk Type:** Turn

**Risk Level:** High

**Speed Limit:** 15 KM/Hr

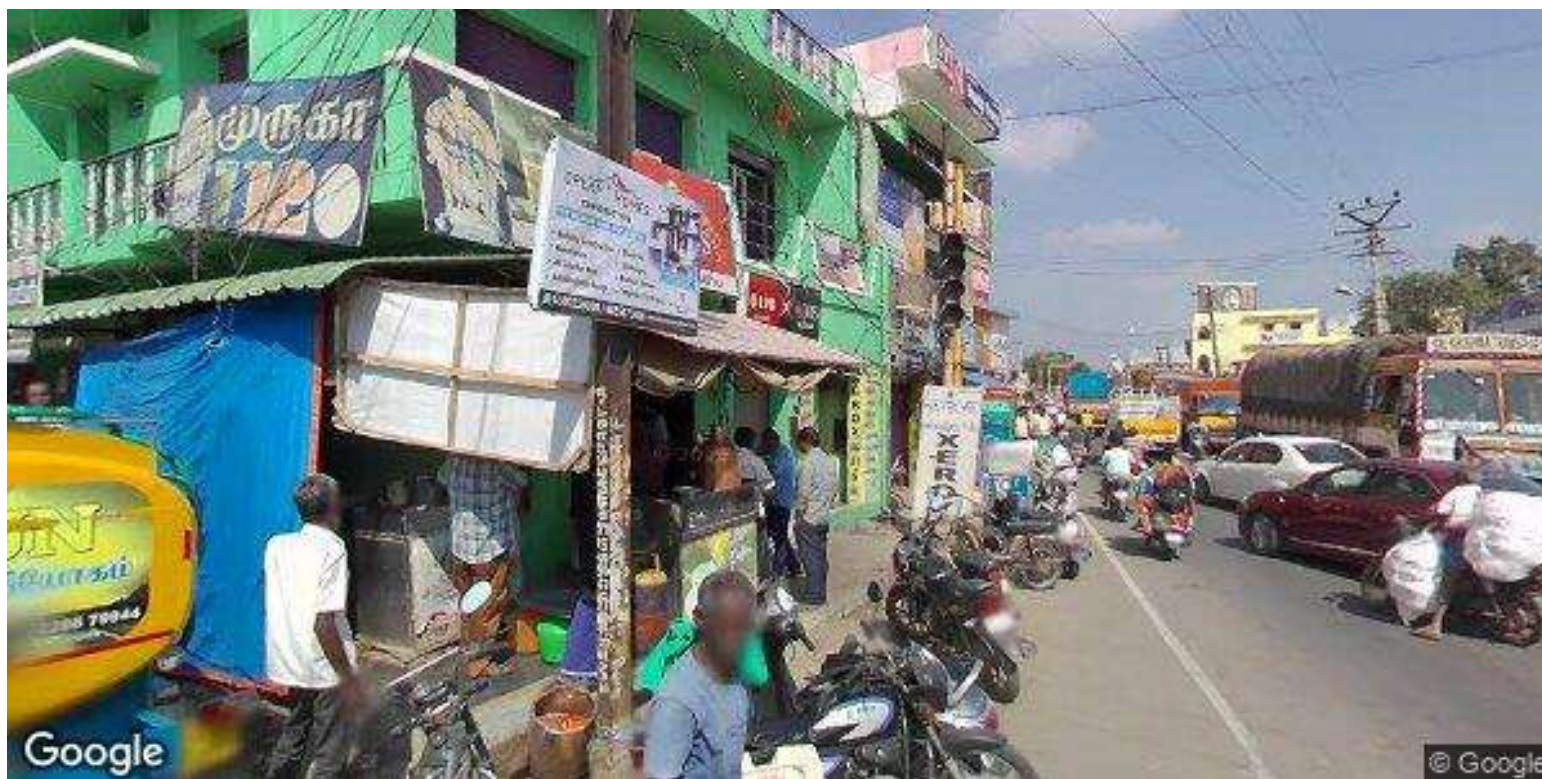
**Coordinates:** 11.47407, 77.86839

**Risk Type:** Turn

**Risk Level:** High

**Speed Limit:** 15 KM/Hr

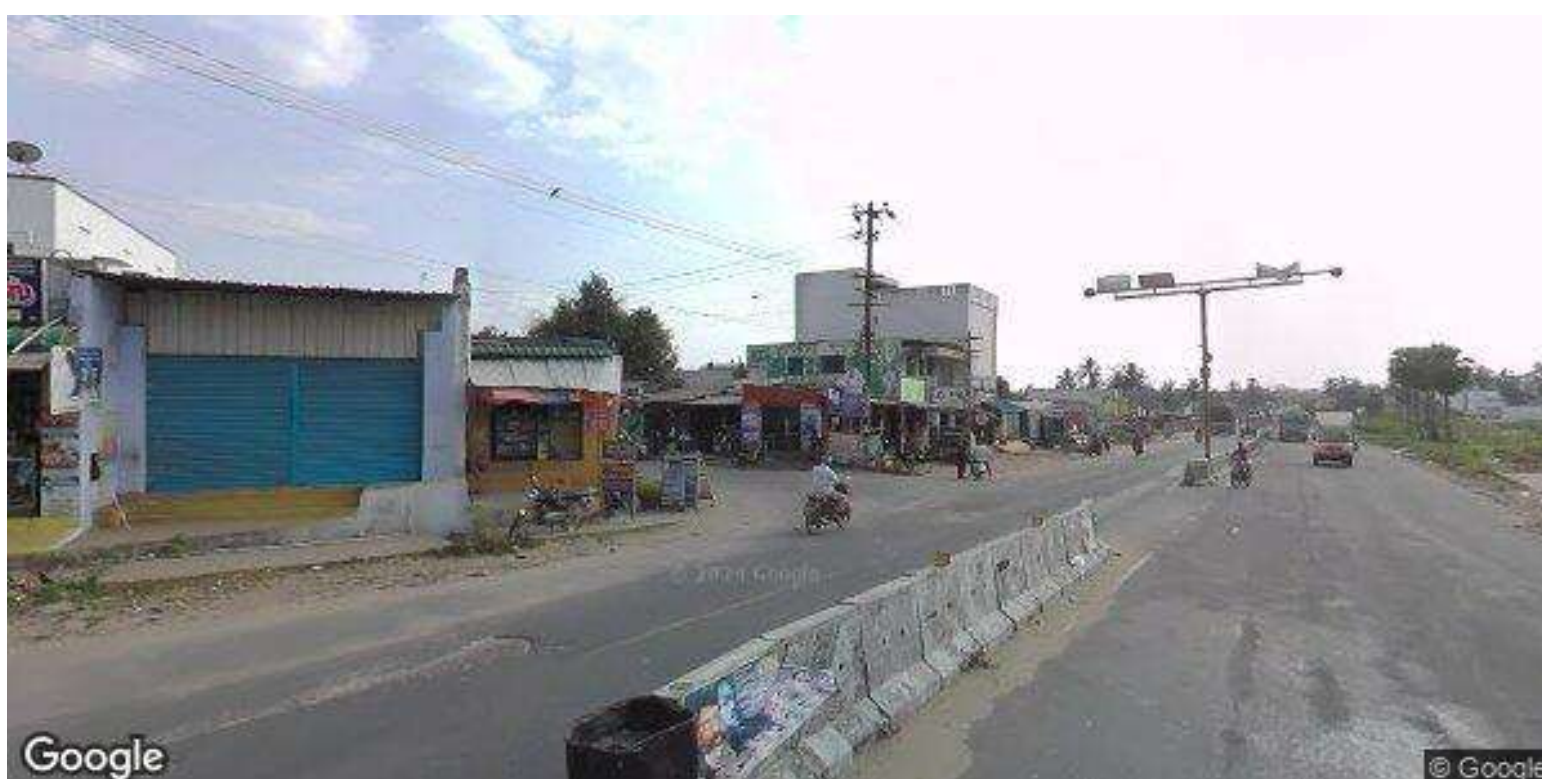
**Coordinates:** 11.48363, 77.88780

**Risk Type:** Turn

**Risk Level:** Medium

**Speed Limit:** 30 KM/Hr

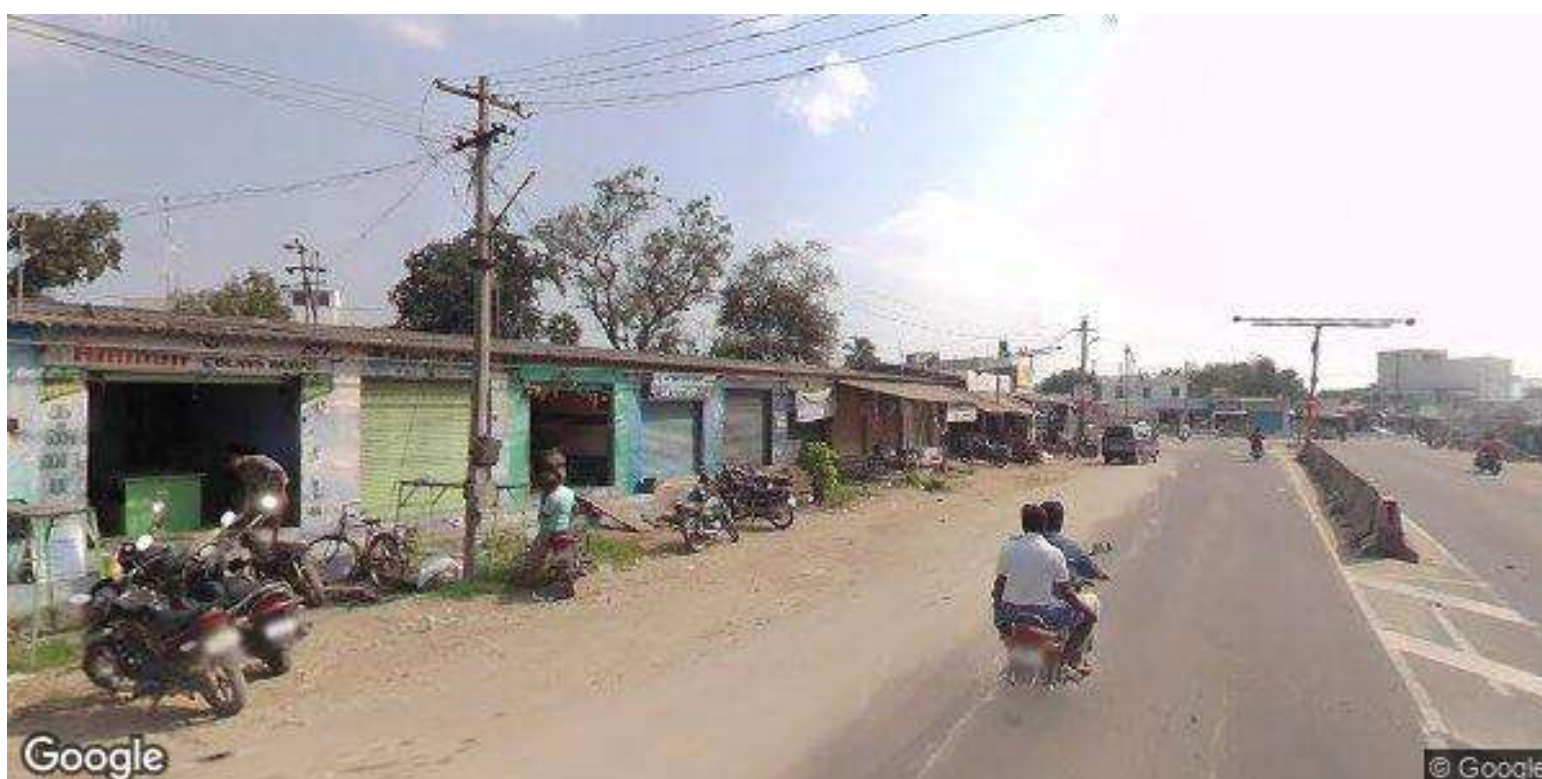
**Risk Type:** Turn  
**Risk Level:** Medium  
**Speed Limit:** 30 KM/Hr  
**Coordinates:** 11.48446, 77.88787

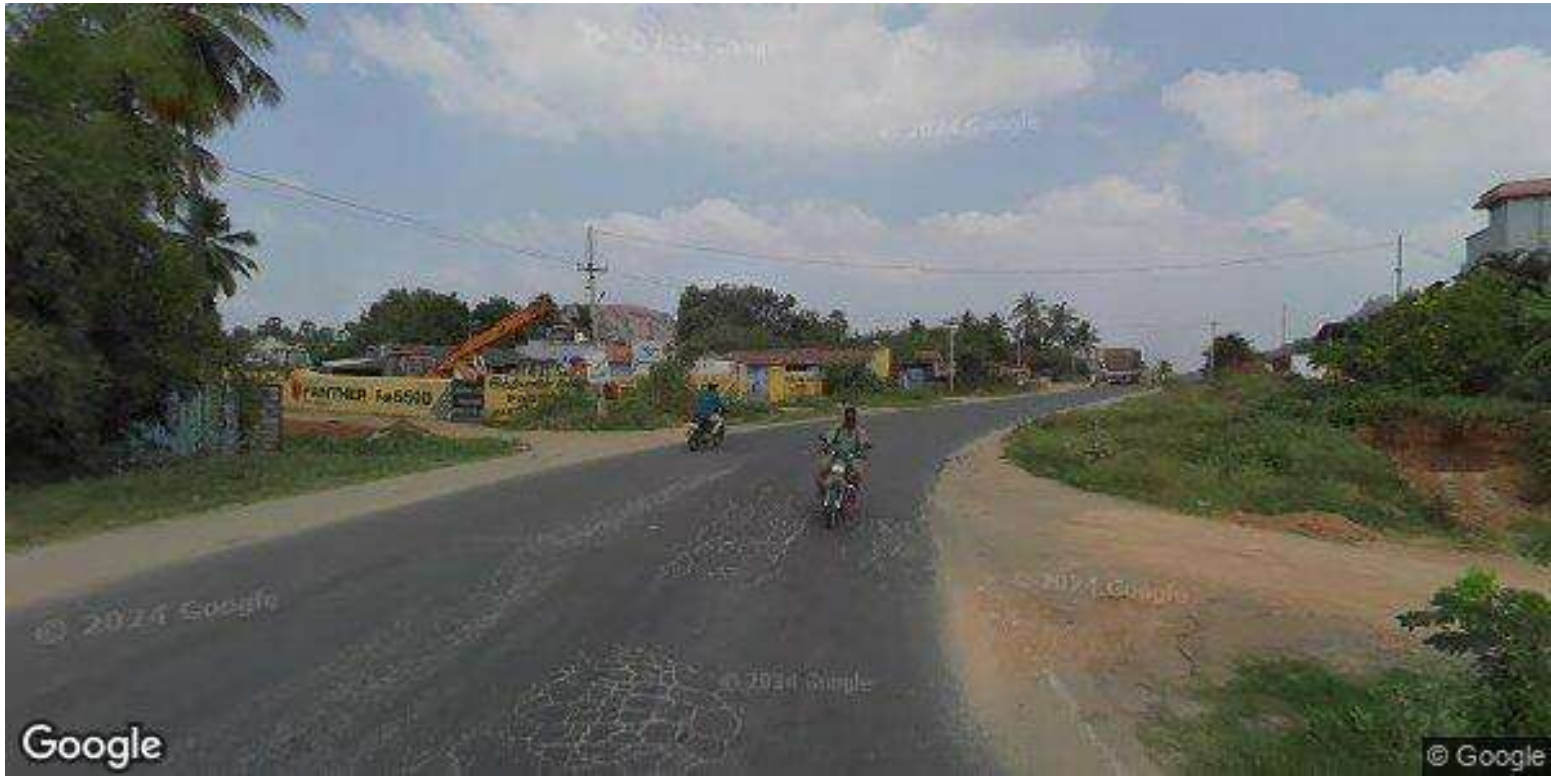
**Risk Type:** Turn  
**Risk Level:** Medium  
**Speed Limit:** 30 KM/Hr  
**Coordinates:** 11.49451, 77.88489

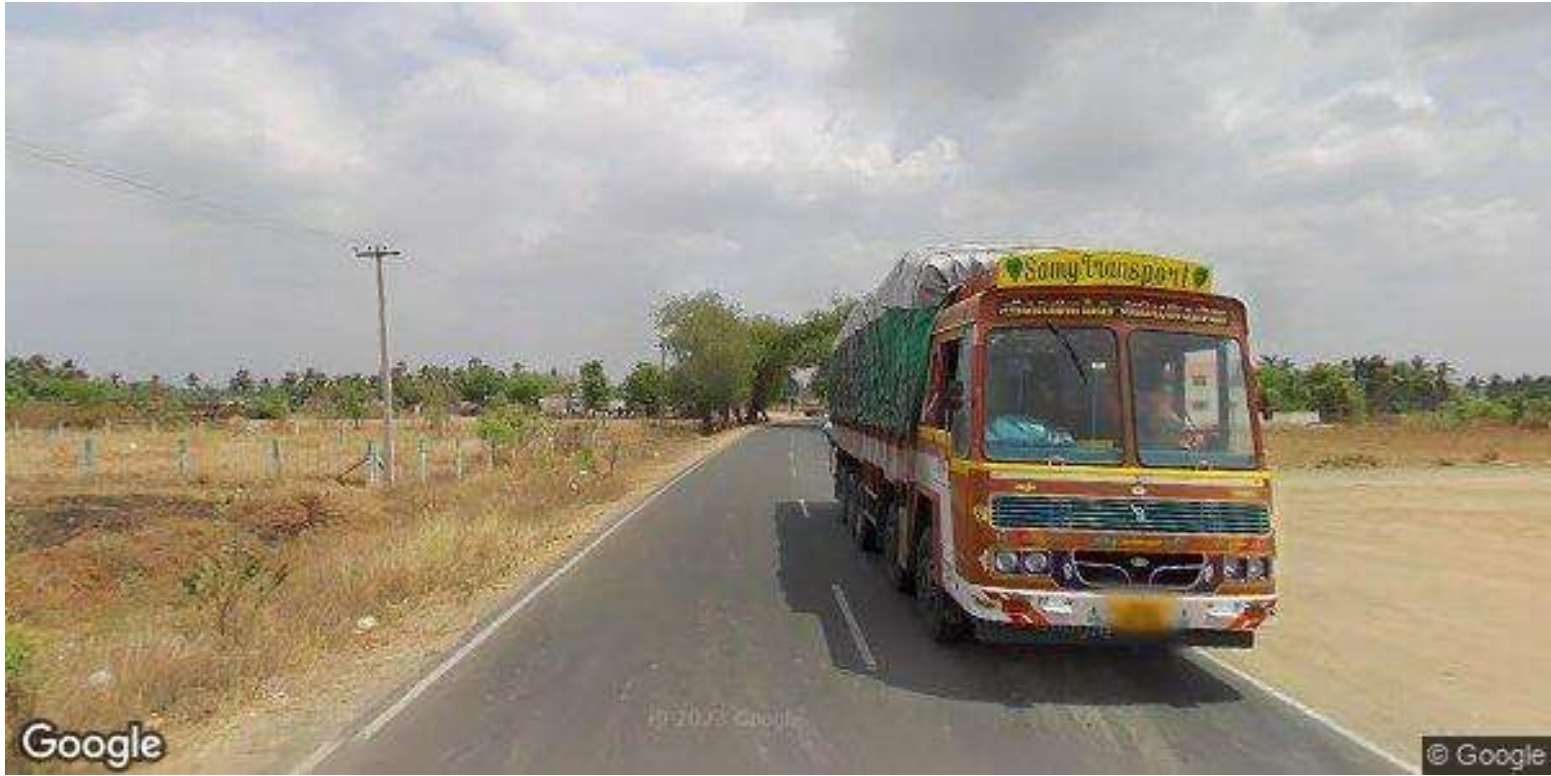
**Risk Type:** Turn  
**Risk Level:** High  
**Speed Limit:** 15 KM/Hr  
**Coordinates:** 11.55614, 77.89764

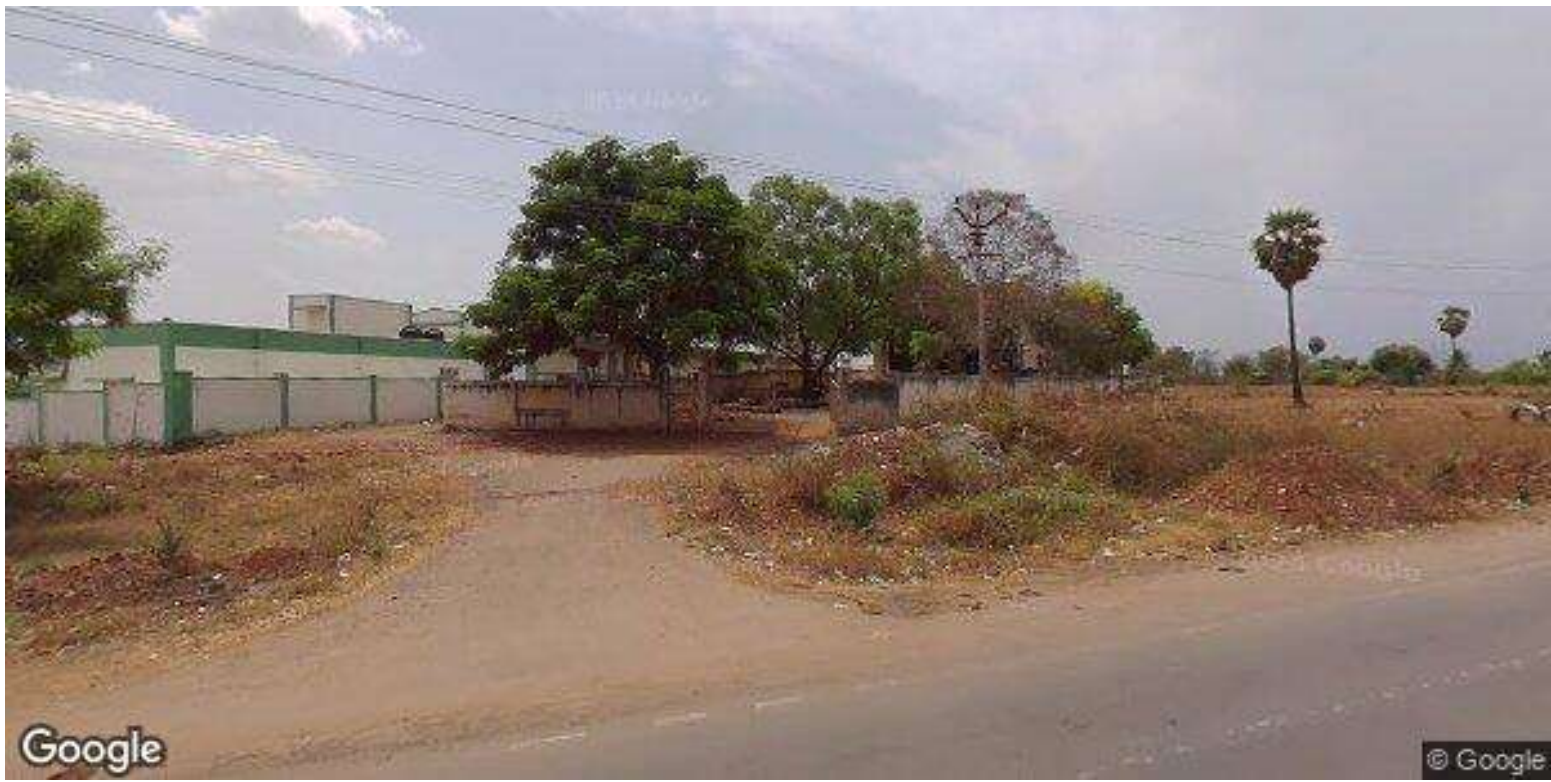
**Coordinates:** 11.58317, 77.90647

**Risk Type:** Turn

**Risk Level:** High

**Speed Limit:** 15 KM/Hr

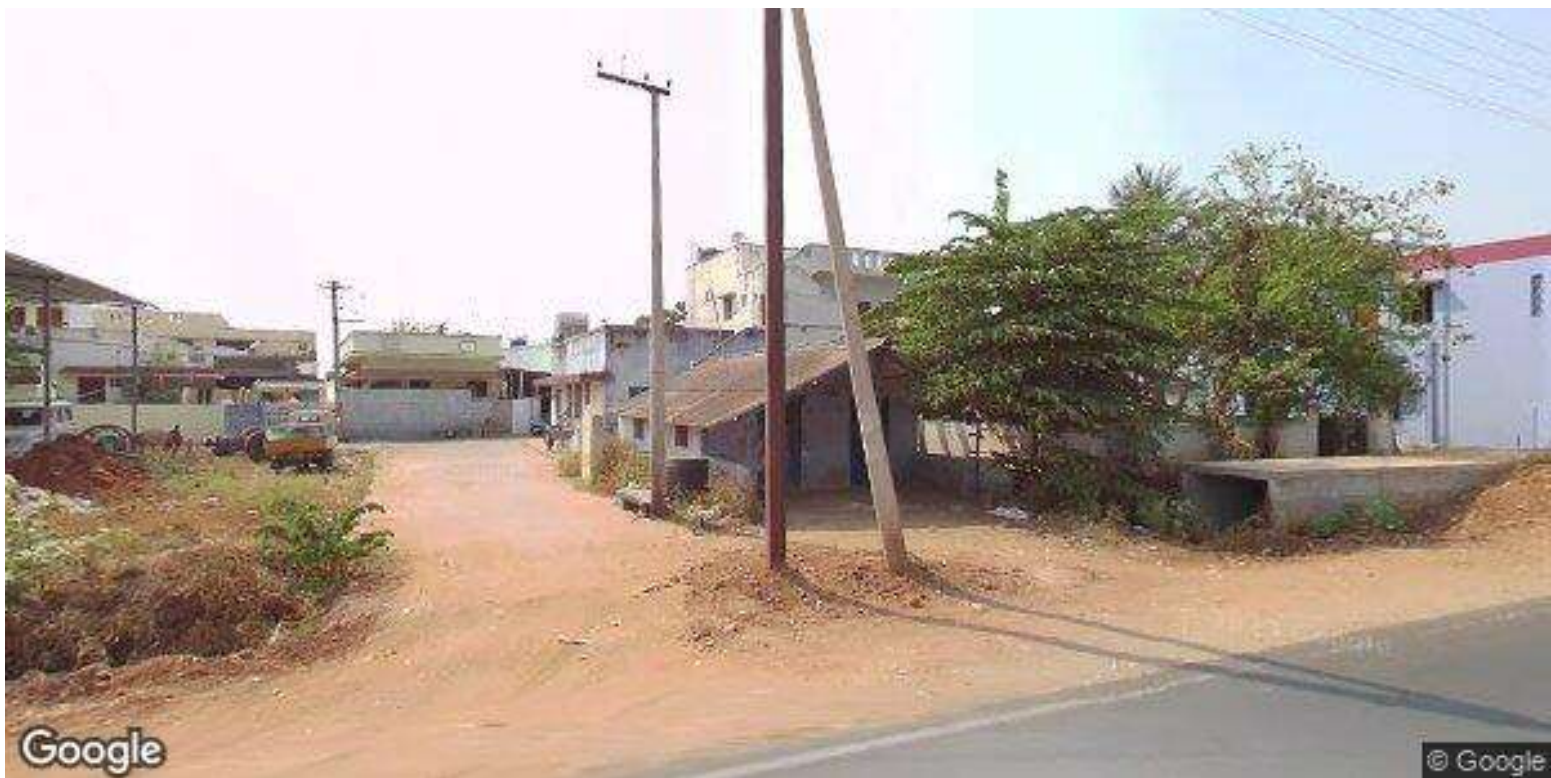
**Coordinates:** 11.59061, 77.90583

**Risk Type:** Turn

**Risk Level:** Medium

**Speed Limit:** 30 KM/Hr
